Landslides at Rock Glacier Site, Highwood Pass, Alberta

For submission to the Canadian Geotechnical Journal

by: McAfee, R.P. and Cruden, D.M.

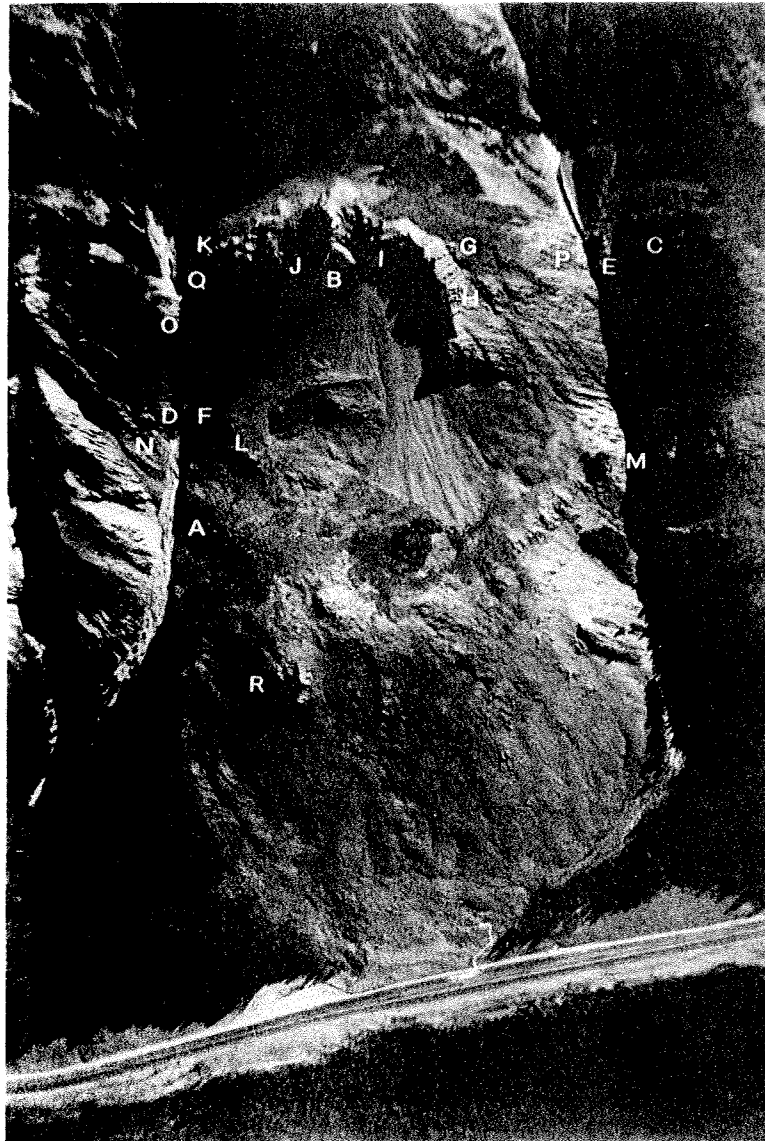
- Figure 6: Airphoto of Rock Glacier Site with the location of all 20 topples identified and labelled from "A" through "R". Bearing along highway is 140 degrees and the field of view is approximately 1250 m.

Table 1 lists the style of toppling, thickness of bedding, and the h/b ratio for each of the 20 topples. Figure 6 shows the location on the airphoto of all 20 topples listed in Table 1. Table 1 indicates that the possible block flexure topples occur with h/b ratios ranging from 0.1 to 10, block topples occur with h/b ratios below 1.5 and multiple block topples have h/b ratios ranging from 1 to 6.7. Clearly, these results suggest that the limits in Cruden and Hu's (1994) criterion might be expanded. The variations between the two samples can be attributed to the small databases used for forming these empirical relationships.

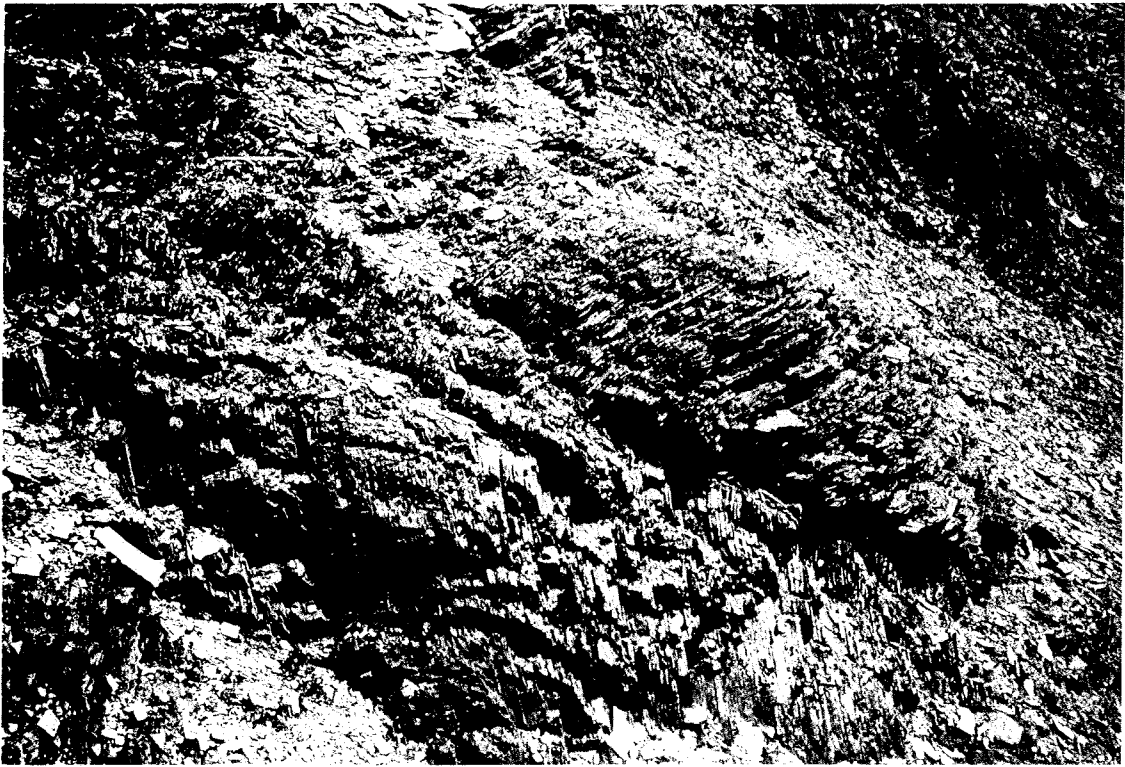
- Figure 9: Surface of rupture in south gully (labelled as "E" on Fig. 6 with viewing direction towards south). Field of view approximately 15 m.
- Figure 10: Example of shallow failure surface in the colluvium found using SLOPE/W.

Figure 9 shows surfaces of rupture in the upper south gully at "E" (Figure 6, Table 1) developed in shales and interbedded sandstones. These surfaces of rupture were not open but filled with local debris. This topple is a multiple block topple (Cruden and Hu 1994). The 46° angular rotation of the beds was divided between two displaced masses, suggesting that two topples have occurred here. Clearly, the characteristics of the surface of rupture and the style of toppling vary with the rock types in the displaced mass.

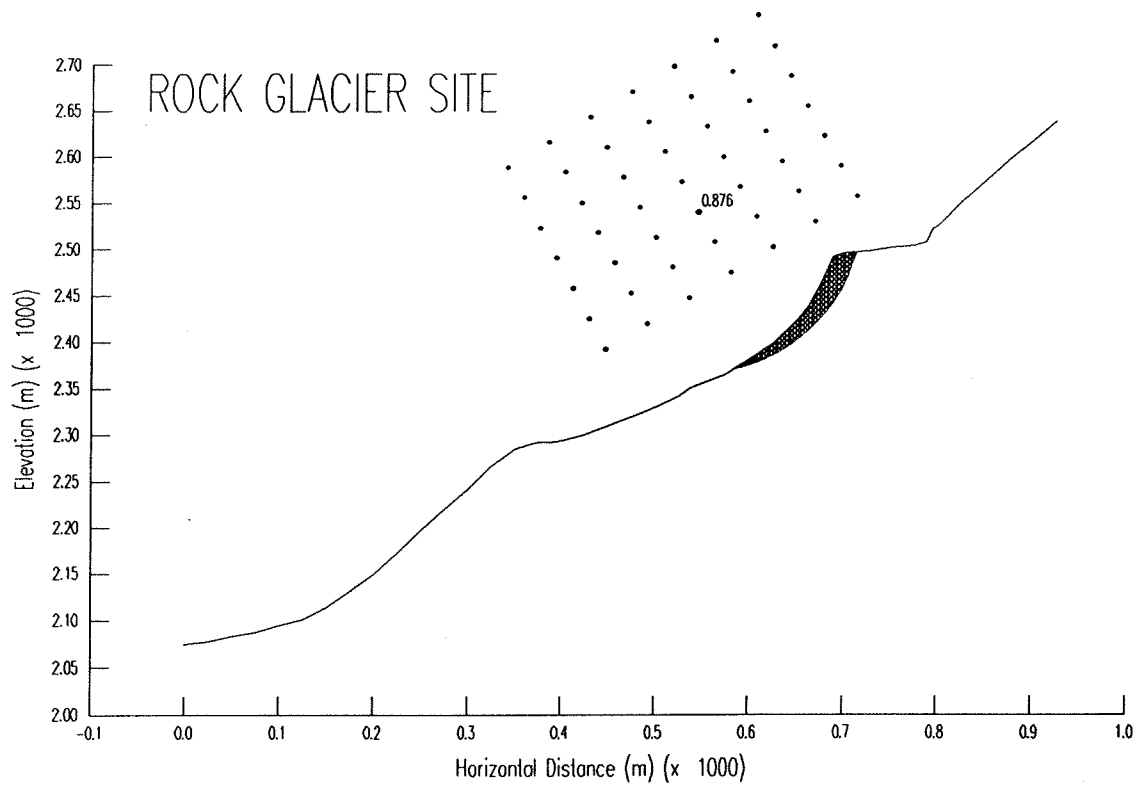
Figure 11

- Figure 11: Possible location for failure surface at upper section of the slope found using SLOPE/W.
- Figure 12: Back analysis of single large movement creating colluvium at toe of slope found using SLOPE/W.

A second part of the stability analysis evaluated the stability of the upper part of the slope. The results of the analysis are illustrated in Figure 11. A 25 m deep slip surface in the upper part of the slope had a factor of safety less than unity (McAfee 1995). The failure would involve approximately $50\,000\text{ m}^3$ of material with the assumption of a continuous slip surface with no effective cohesion (Terzaghi 1962). Since the slope has not failed, we can conclude that there is adequate cohesion within

the rock mass. This raises concern for long term stability in this area, as cohesion cannot be relied upon in perpetuity. Cohesion will eventually be destroyed by weathering or by the formation of a surface of rupture brought about by the toppling processes that are currently active in the upper slope. Once cohesion is destroyed, there will likely be a large movement in this area of the slope if smaller movements do not occur first.
