The undersigned certify that they have read, and
recommend to the Faculty of Graduate Studies and Research,
for acceptance, a thesis entitled "Prestressed Concrete
Beams With Large Rectangular Web Openings" submitted by
Teresinha do Menino Jesus Alves in partial fulfilment of
the requirements for the degree of Doctor of Philosophy in
Civil Engineering.

The aim of this research was to investigate behavior of prestressed concrete beams with large rectangular web openings and to provide recommendations for design. The study included tests on laboratory beams and development of an analytical model based on a truss analogy.

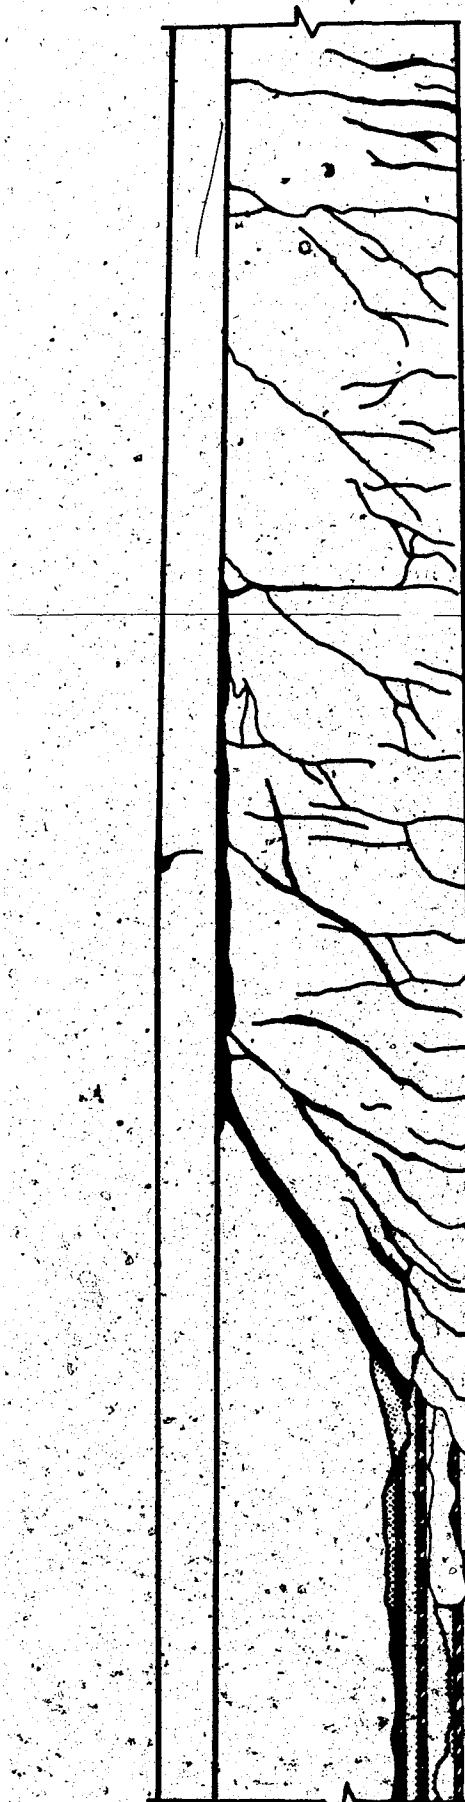
Figure 3.2.1.1 Crack Pattern - BEAM 'A1.'

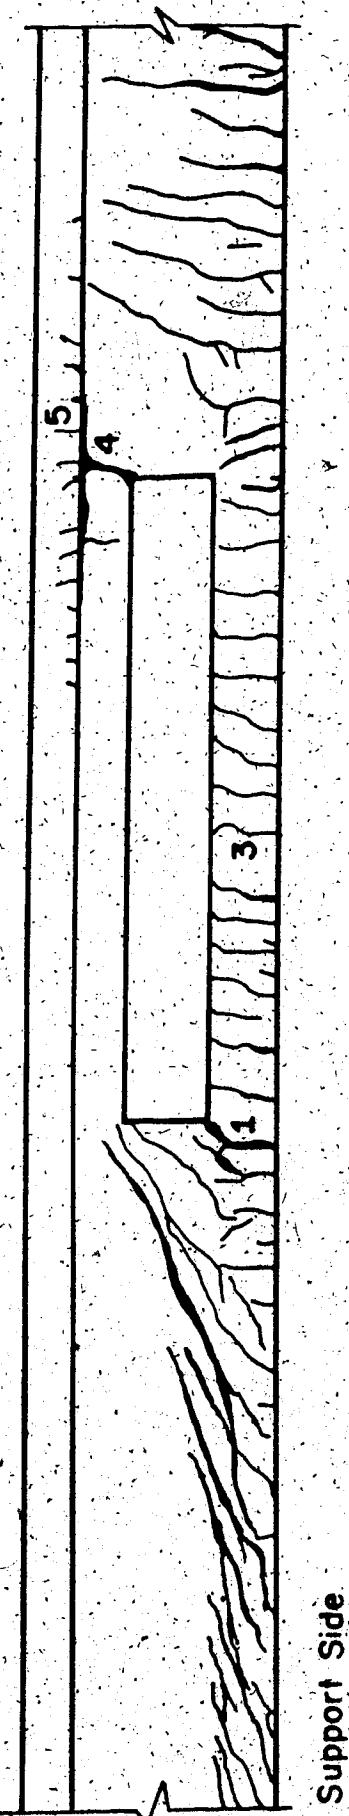
Figure 3.2.3.1 Crack Pattern - BEAM C1.

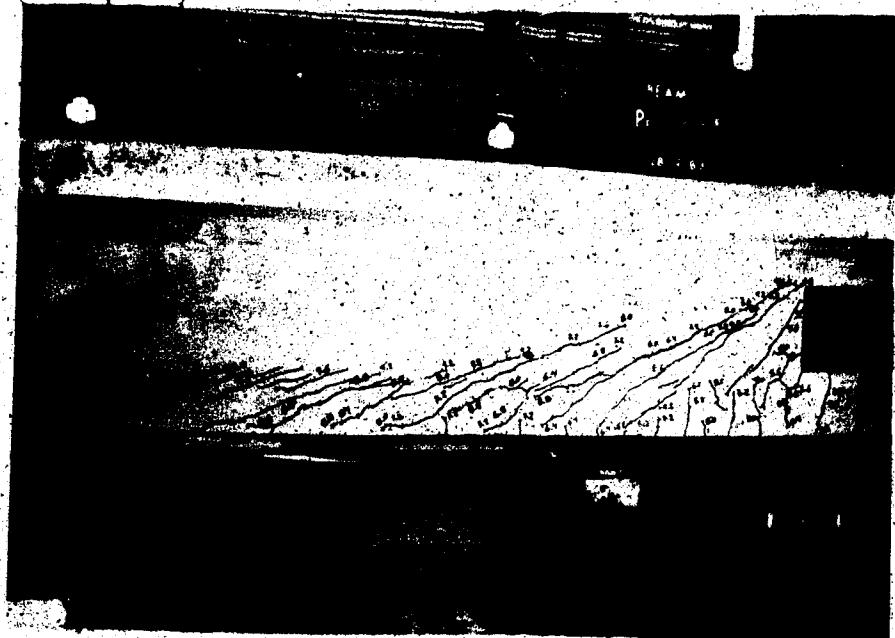
Figure 3.2.3.2 : BEAM C1 after Unloading.

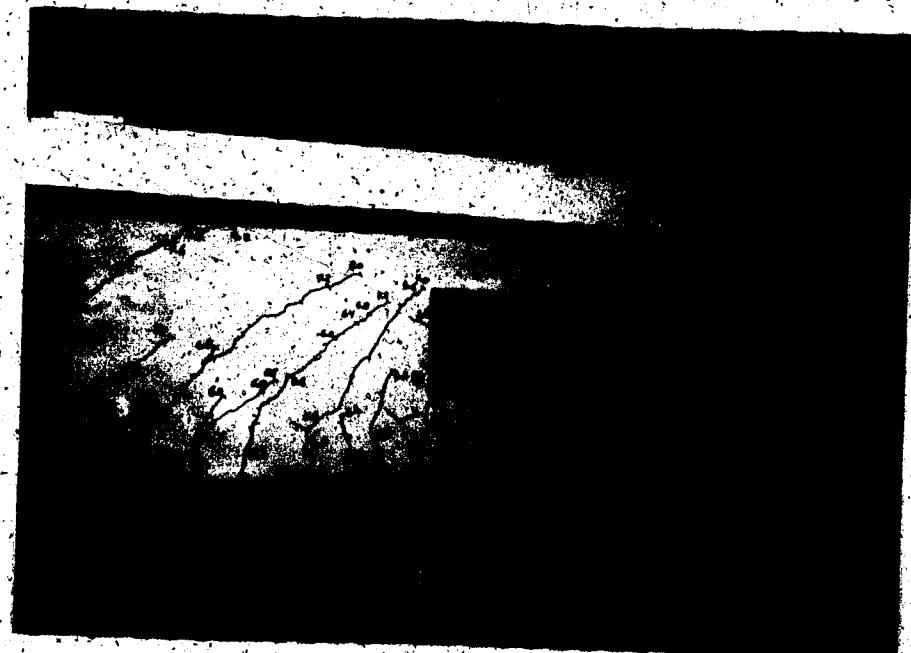
Figure 3.2.3.12 BEAM C3 after Unloading.

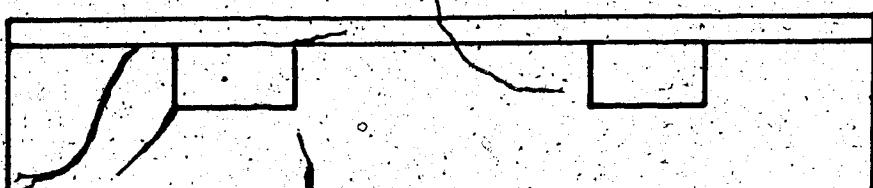
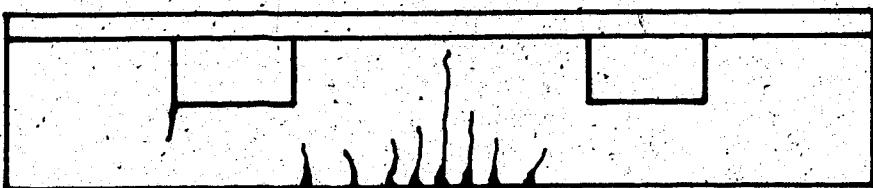
Shear failure followed by strand debonding

Flexural failure at midspan

Figure 6.2.1.1 Primary Crack Pattern Associated with Failure Modes Observed in Tests.
