Effect of Field Bending and Girth Weld on the Initiation and Early Growth of Near-Neutral pH Circumferential Stress Corrosion Cracking (NNpHCSCC) in Thin-walled Pipeline

A thesis submitted in partial fulfillment of the requirements for the degree of

Master of Science

Materials Engineering

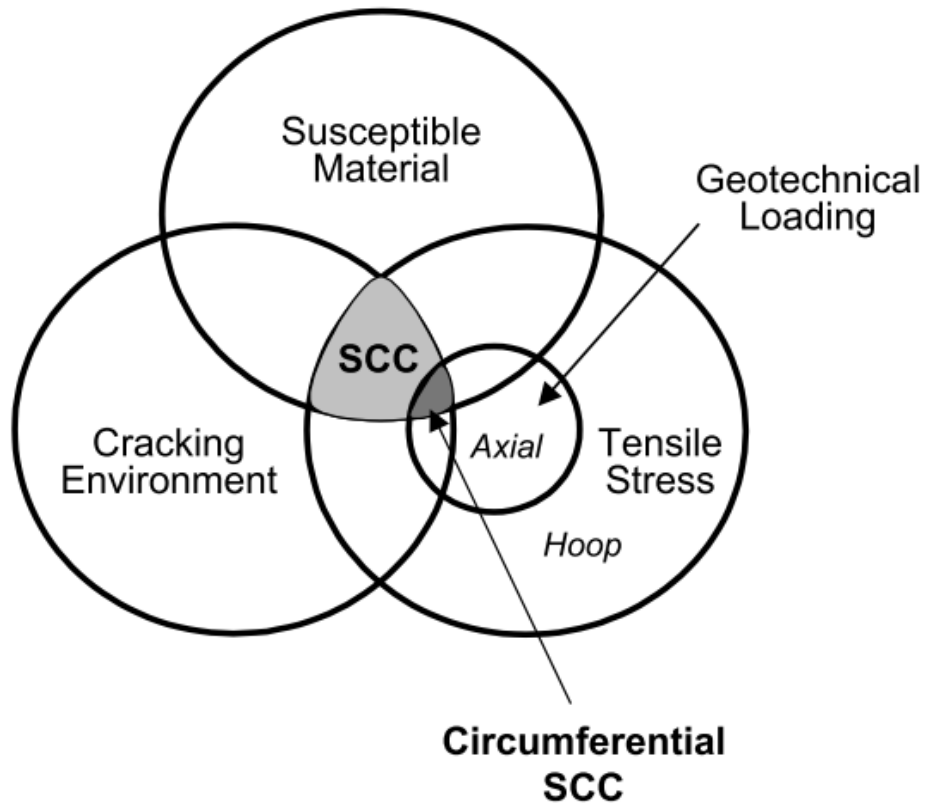
Figure 2.1 Three factors that cause C-NNpHSCC [10]

Similar to SCC, C-NNpHSCC requires three factors: axial tensile residual and applied stress, NNpH environment, and susceptible material to the environment, which is visible in Figure 2.1 [10]. Each factor is explained in detail in the following sections.

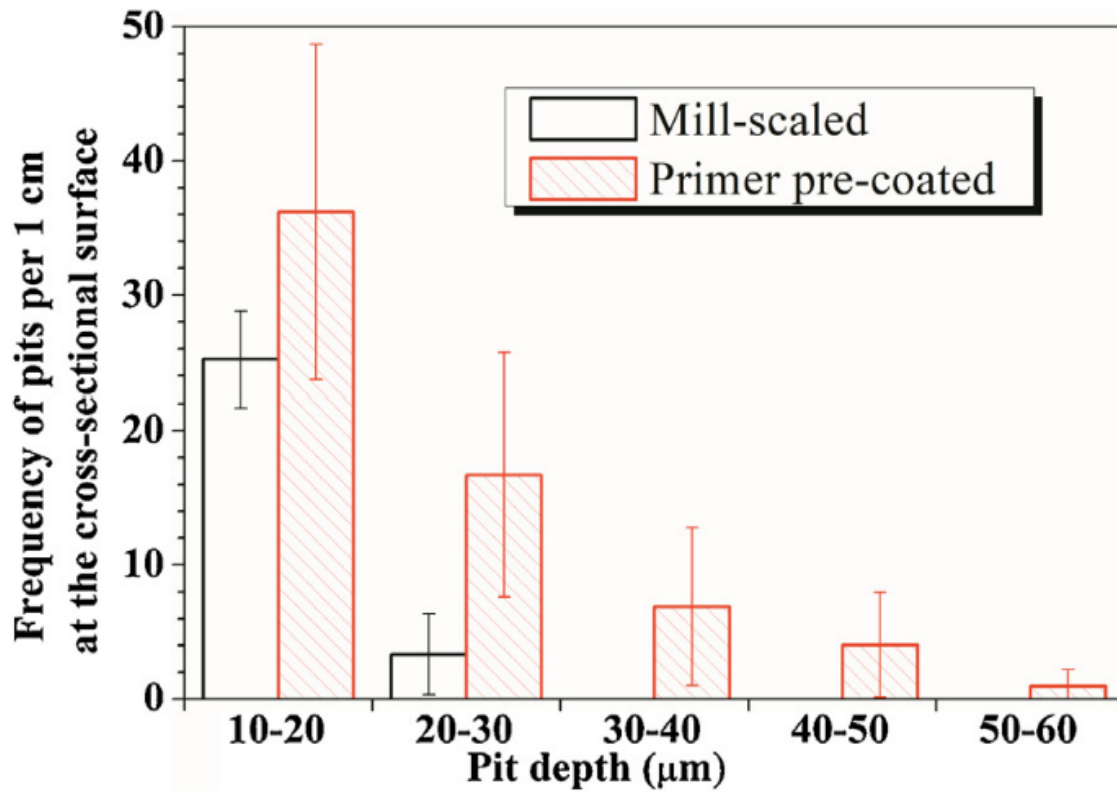
Figure 2.3 Pit depth distribution per 1 cm at the cross-sectional surface of corroded samples with and without primer for 90 days [9]

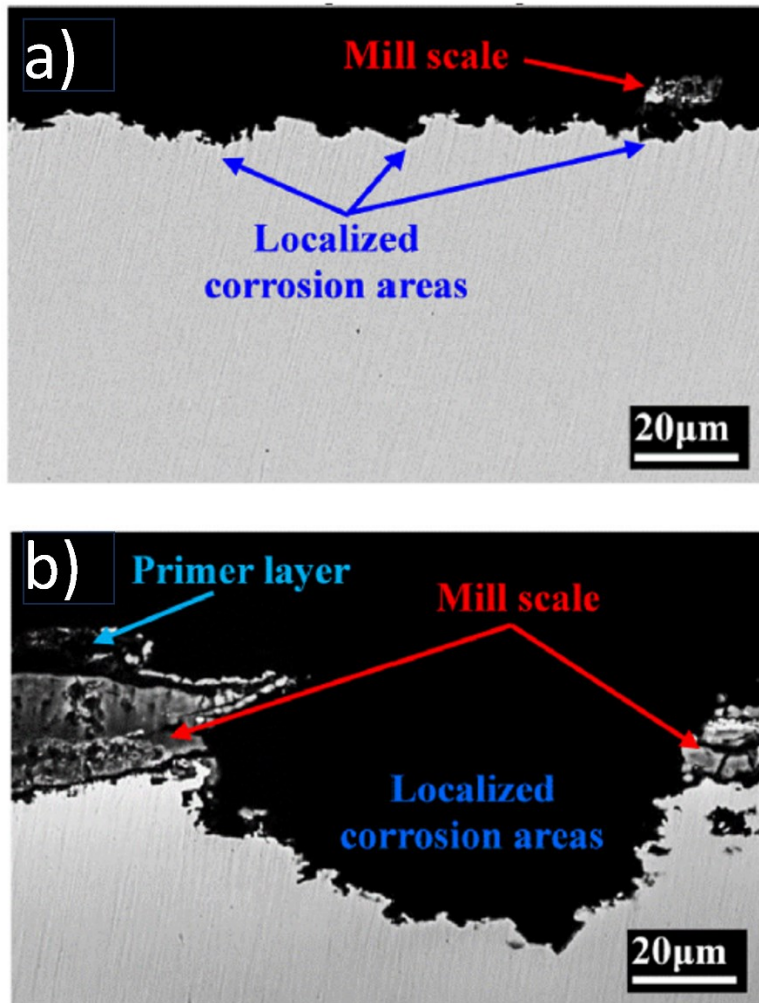
Figure 2.4 Cross-sectional morphology of mill scale and corrosion pits on the samples a) without primer and b) with primer corroded for 90 days [9]

Figure 2.4 a) and b) show the cross-sectional morphologies of mill scale and corrosion pits on the specimens a) with primer and b) without primer, respectively.

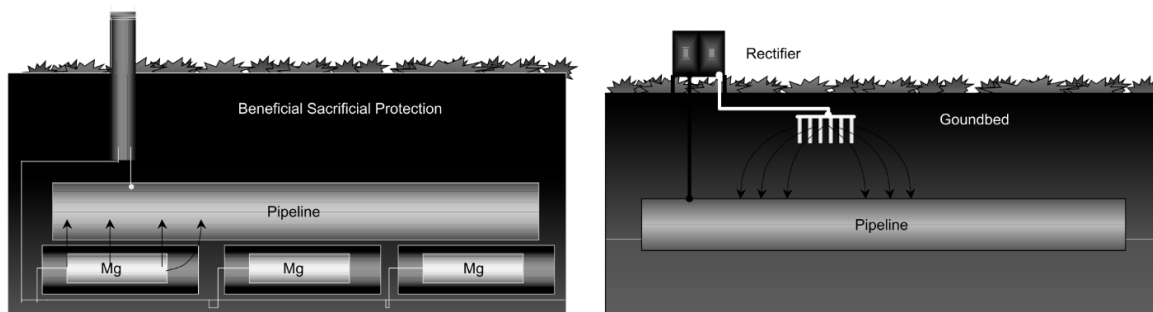
Figure 2.6 Schematics of cathodic protection [20]

the circuit. This helps to prevent corrosion from occurring. The schematics of these systems are shown in Figure 2.6.

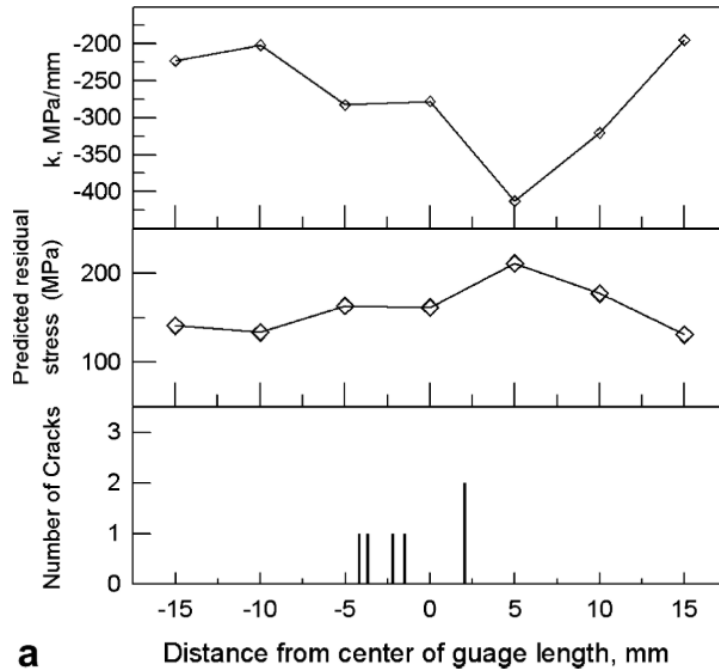
Figure 2.7 The relationship between predicted surface residual stress, number of cracks, and residual stress gradient, k (MPa/mm) [22]

Residual stresses greatly influence the initiation and Stage I growth of NNpHSCC, as the surface with high compressive residual stress becomes more anodic than the adjacent areas, forming a stress corrosion cell [7]. Although both tensile and compressive residual stress decrease the activation energy required for metal atoms to leave the surface, compressive stress also increases the surface atomic density, ultimately increasing corrosion resistance [21]. Furthermore, since tensile stress is required for pit-to-crack transition, the surface with high tensile residual stress will likely exhibit more crack initiation sites than the others. This, however, does not mean that the number and depth of cracks are proportional to the surface tensile residual stress. Van Boven *et al.* investigated the effect of surface residual stress on the initiation and early growth of NNpHSCC by applying cyclic loadings on the specimens immersed in NNpH solution [7][22]. They plotted the surface residual stress on the specimen measured with neutron diffraction (ND) over the length and superimposed it with the frequencies of cracks, of which the result is visible in Figure 2.7.

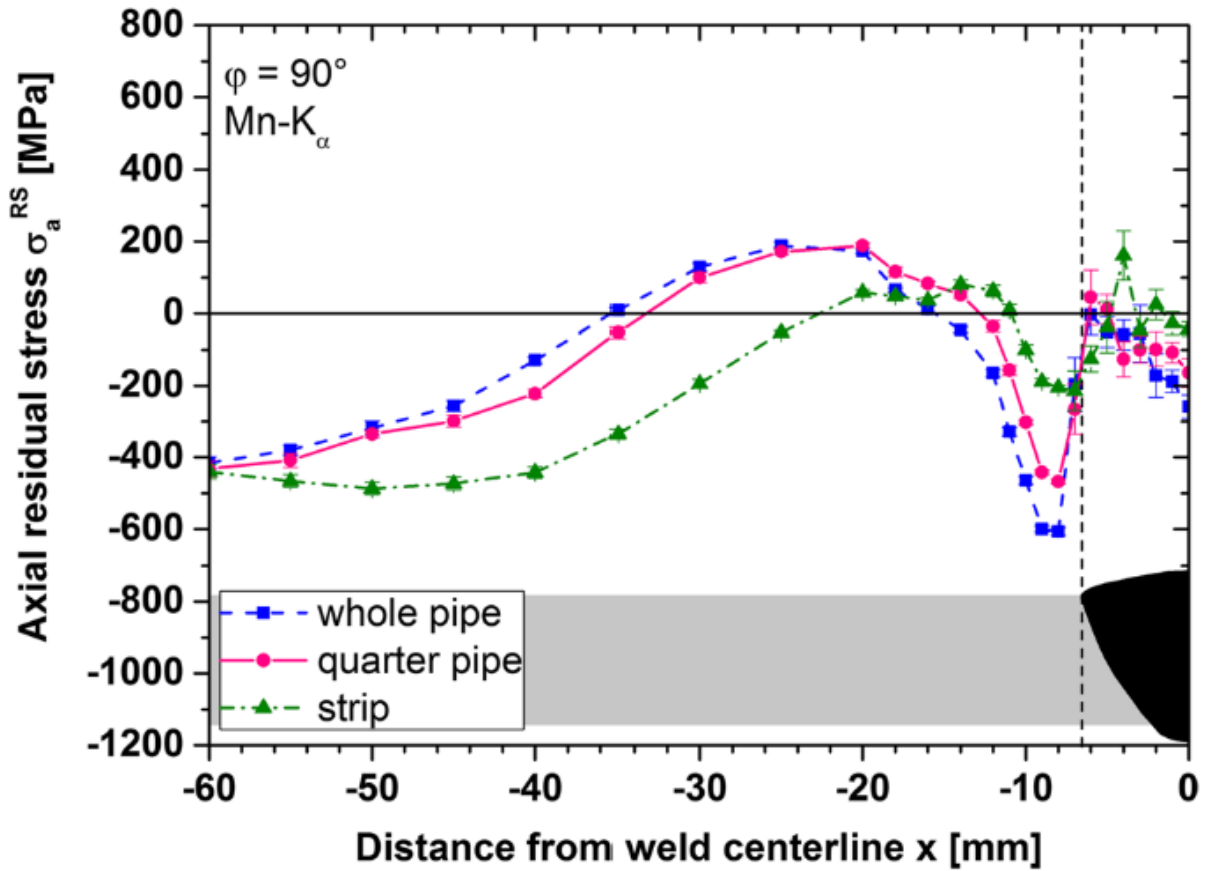
Figure 2.13 Axial residual stress distribution from WCL on whole pipe, quarterly sectioned pipe, and 6 mm width strip sectioned from a quarter pipe [31]

One of the challenges in measuring welding residual stress and its effect on SCC is the stress relaxation effect after the sectioning process. Hempel *et al.* cut the girth-welded pipe of the austenitic steel X6CrNiTi18-10 with a wall thickness of 7.5 mm into quarter pipes and 6 mm width strips [31]. They measured the residual stress distribution from the weld centerline on each sample with XRD and ND to investigate the residual stress change after sectioning. Figure 2.13 shows the axial residual stress distribution on the outer surface of the specimen before and after sectioning [31].

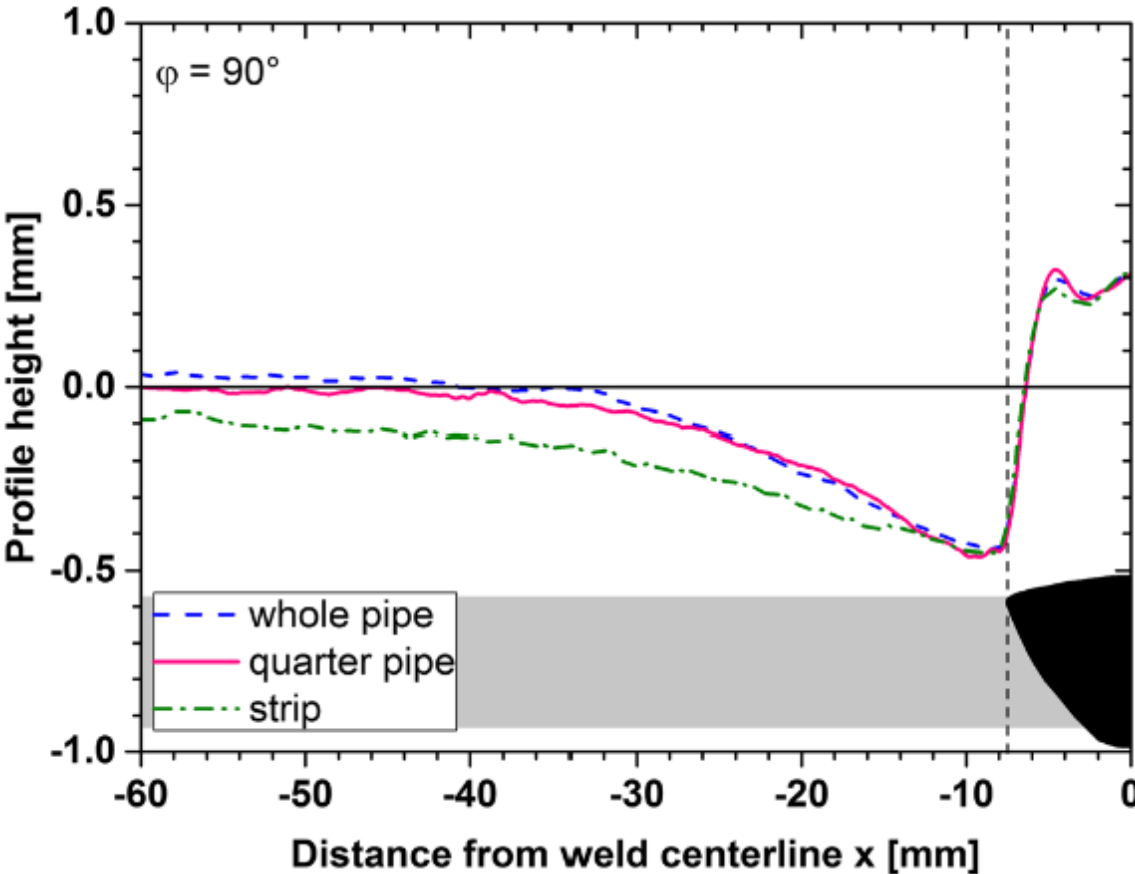
Figure 2.14 Surface profiles at $\phi = 90^\circ$ on the outer surface of a girth welded pipe before and after sectioning [31]

stress distribution shifting downward was observed, resulting in a narrower tensile zone at $12 \text{ mm} < |x| < 20 \text{ mm}$. The effect of sectioning eventually diminishes at $|x| > 60 \text{ mm}$. The axial strain release after sectioning can account for this shift in the axial residual stress. As shown in Figure 2.14, the surface profile on the outer surface of the base metal shifted downward after sectioning. It into 6 mm strips [31]. The authors concluded that this massive release of axial strain is attributed to the significant contribution of bending components to axial welding stress.

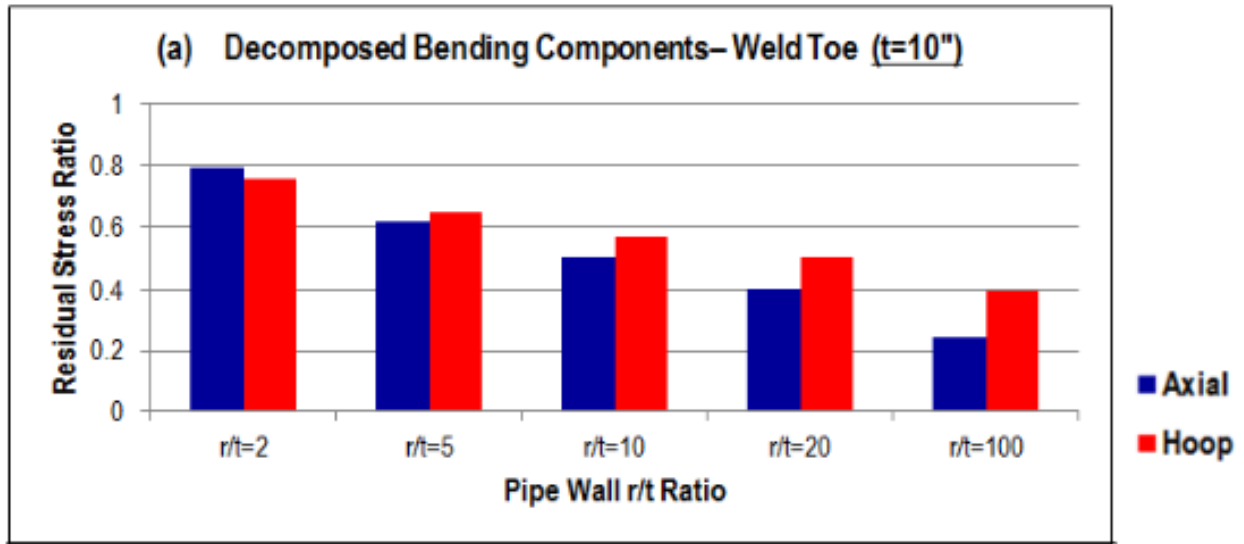
Figure 2.16 Change in bending component of the hoop and axial residual stress with an increase in r/t ratio [30]

As shown in Figure 2.16, the bending component of axial residual stress decreases with an increase in r/t and vice versa for the self-equilibrate component [30]. This indicates that the component geometry primarily influences the significance of axial strain relaxation. As such, one must consider these factors when performing lab-scale tests.

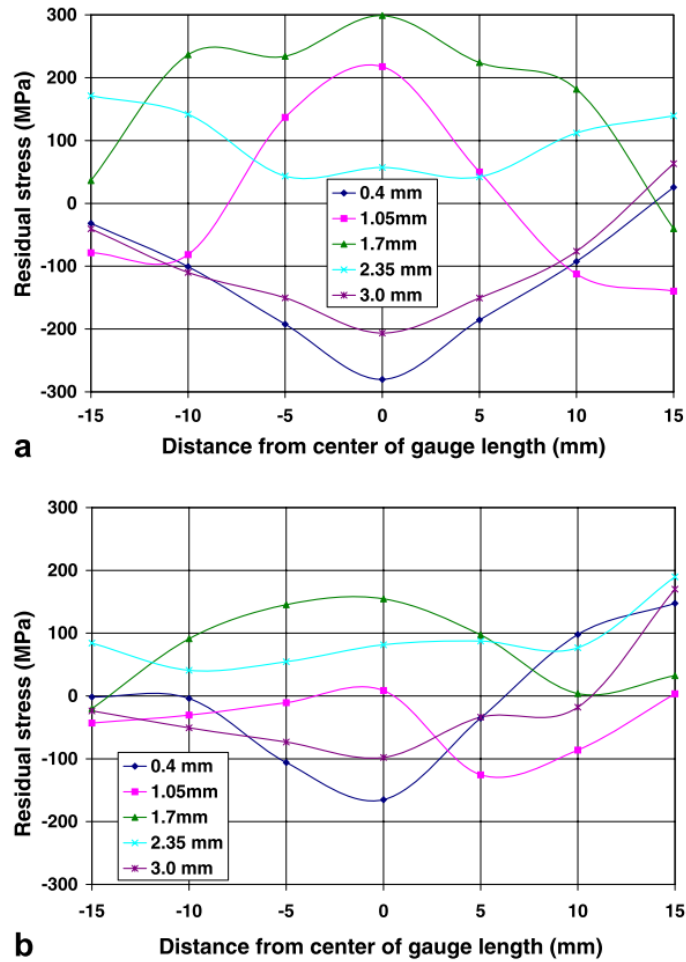
Figure 2.17 Residual stress distribution measure by ND on a tensile specimen a) before and b) after tensile cyclic loadings [22]. Distances from the outer surface are shown in legends.

As discussed in the later section, oil and gas pipelines are subjected to cyclic loading because of internal pressure fluctuations during the operation. As such, just as the effect of bending stress discussed above, the effect of cyclic loading on residual stress distribution must be considered. Van Boven *et al.* applied tensile cyclic loading on tensile specimens in air [7]. As illustrated in Figure 2.17 a) and b), They measured the residual stress distribution in gauge and thickness directions on the specimens before and after the tests through the neutron diffraction (ND) method to investigate the interaction between the effect of cyclic loading on residual stress distribution [22].

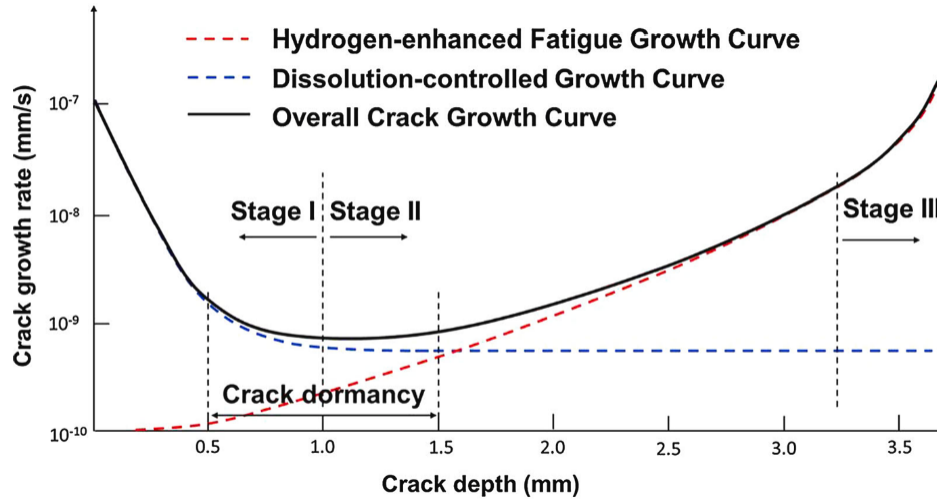
Figure 2.20 Bathtub model for NNpH stress cracking [43]

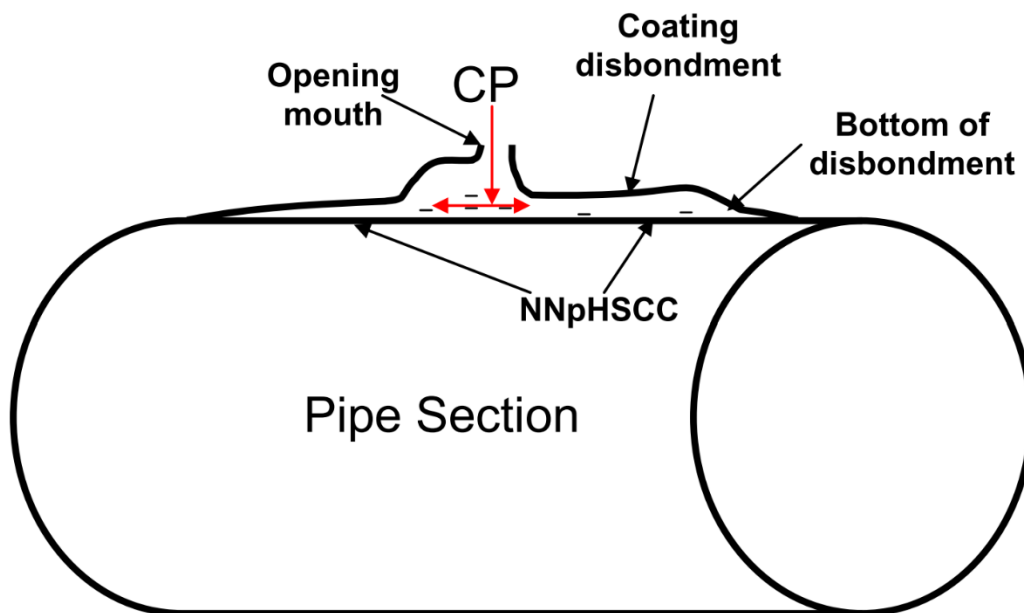
Figure 2.21 Schematic of NNpHSCC initiation from coating disbondment [15]

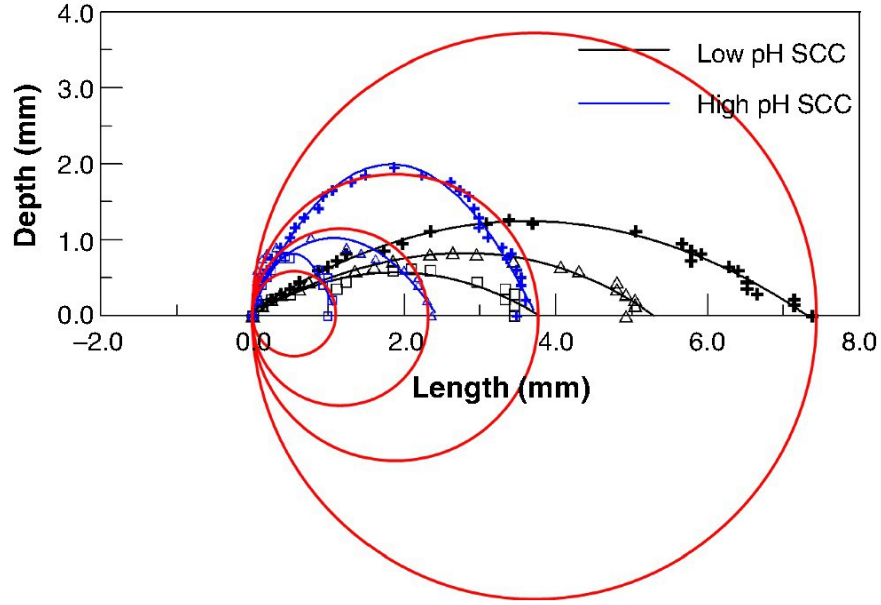
Figure 2.22 Crack length-depth profiles of near-neutral pH SCC and high pH SCC [4]

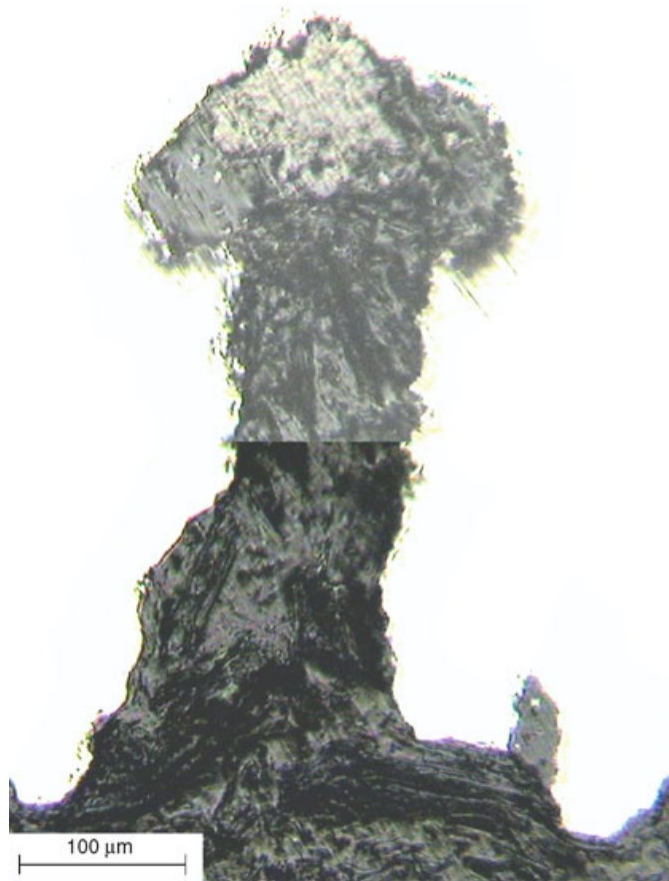
Figure 2.23 Blunted, the balloon-shaped crack propagated in the NNpH environment [45]

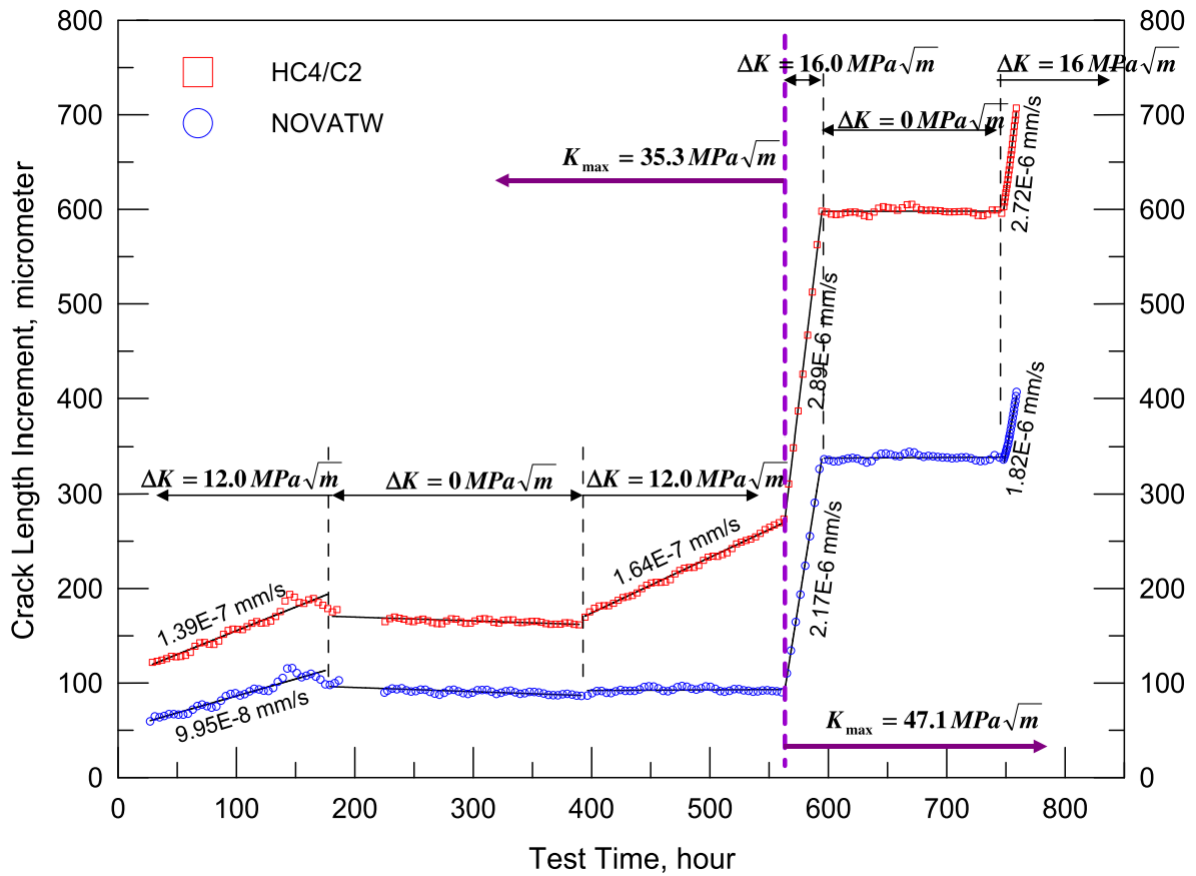
Figure 2.24 The increase in crack length over time in two NNpH solutions with cyclic loadings [46]

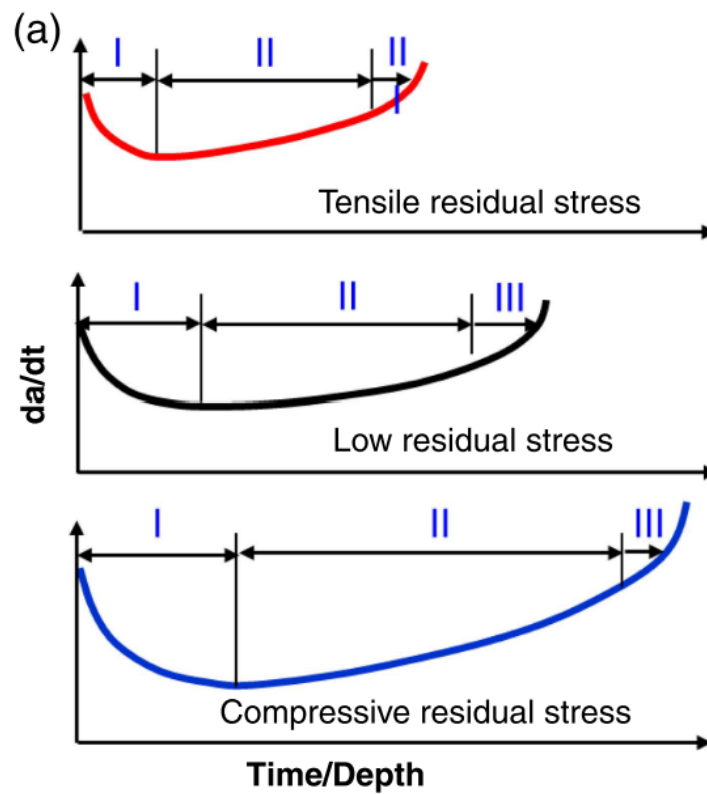
Figure 2.25 The effect of stress on the growth and dormancy of cracks [4]

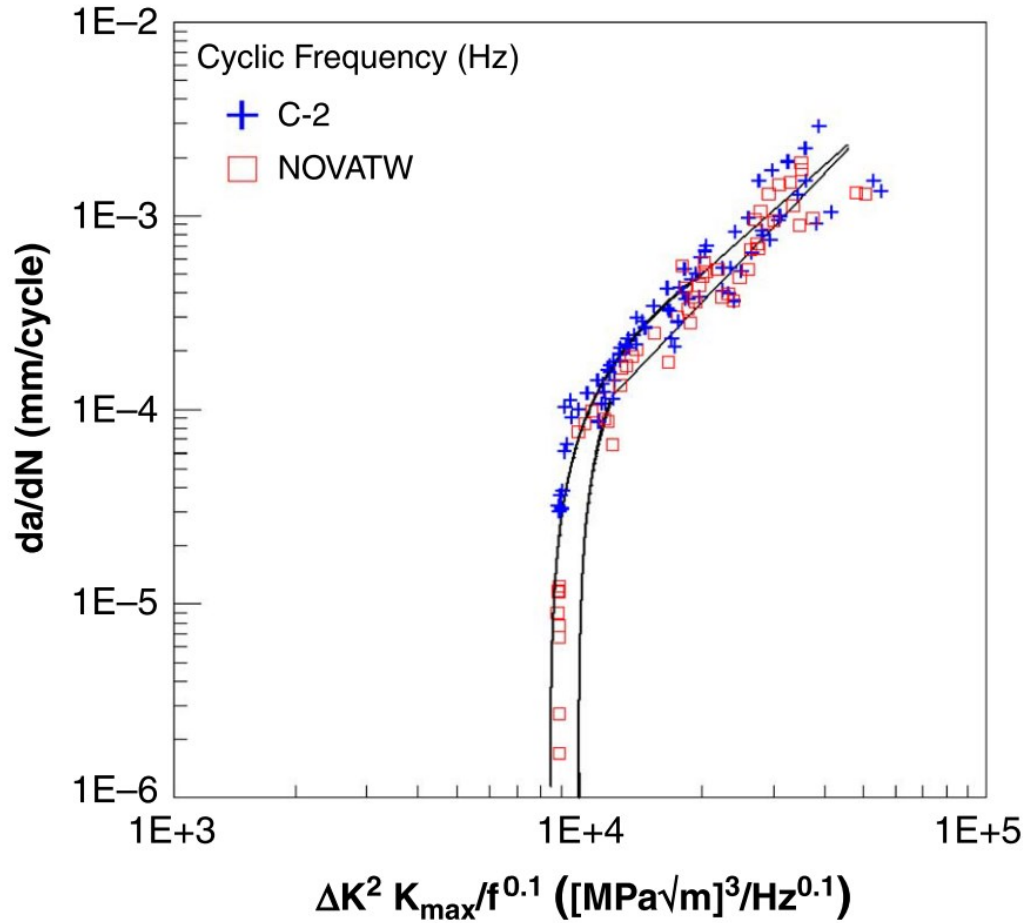
Figure 2.27 Crack growth rate (da/dN) as a function of combined factor in C2 and NOVATW solutions [48]

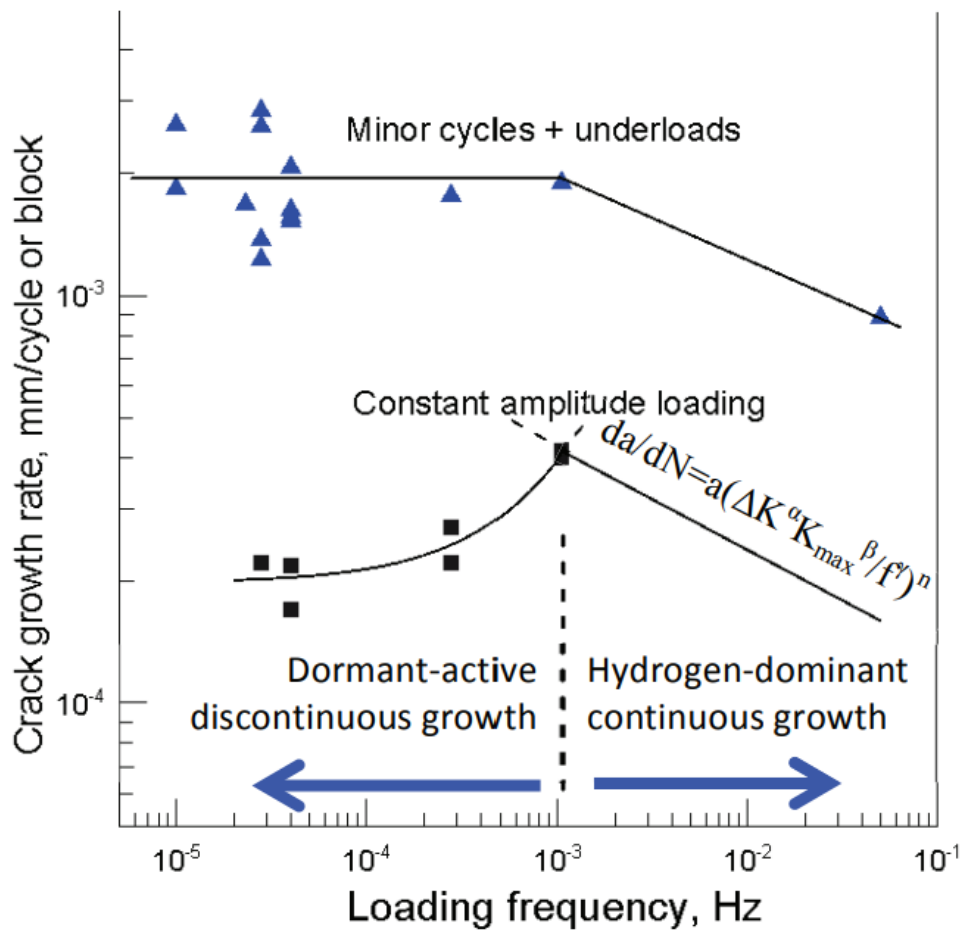
Figure 2.28 Crack growth rate and change in the mechanism of crack growth at different loading frequencies [49]

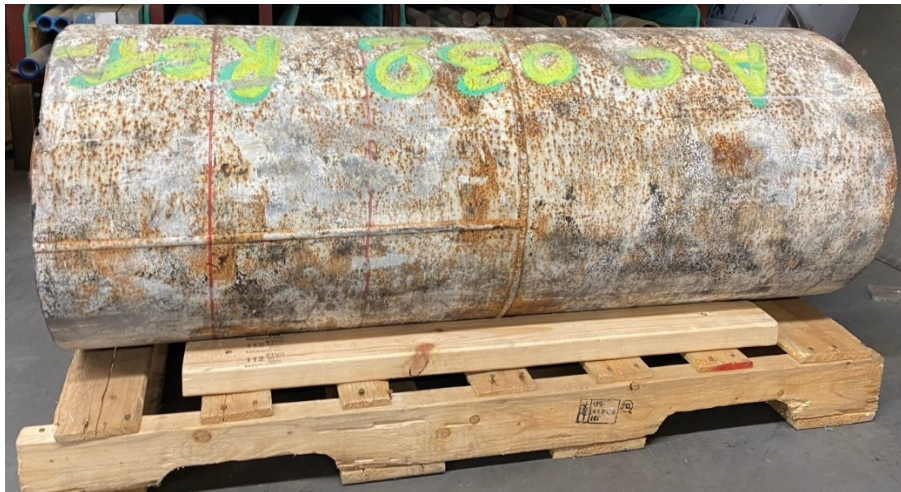
Figure 3.1 X52 pipeline steel used for the experiment.

For this research, a 45.4 cm OD X52 pipeline with a thickness of 6.35 mm, as shown in Figure 3.1, has been selected.

This pipeline had a girth weld, a longitudinal weld seam, and a coating on its surface.

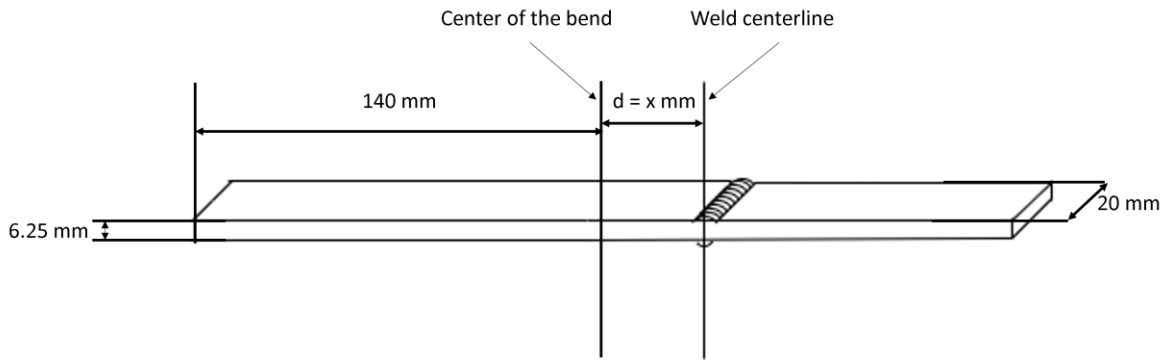
Figure 3.3 Schematic of a stick-shaped specimen

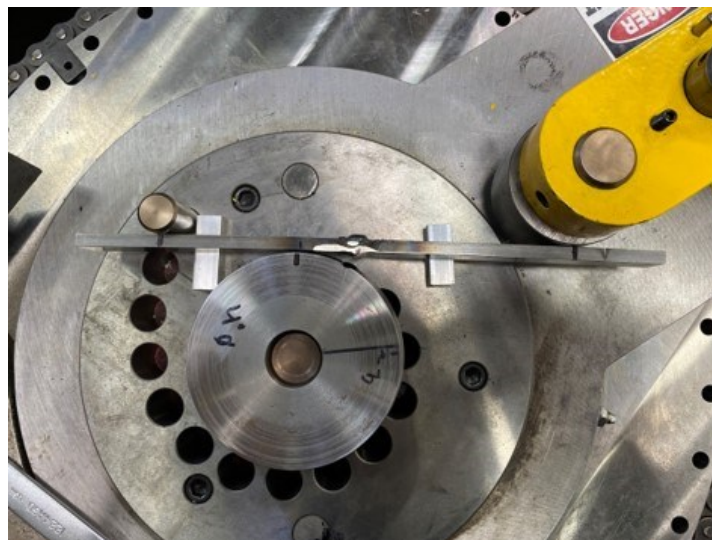
Figure 3.5 Picture of a specimen subjected to the mechanical bending process.

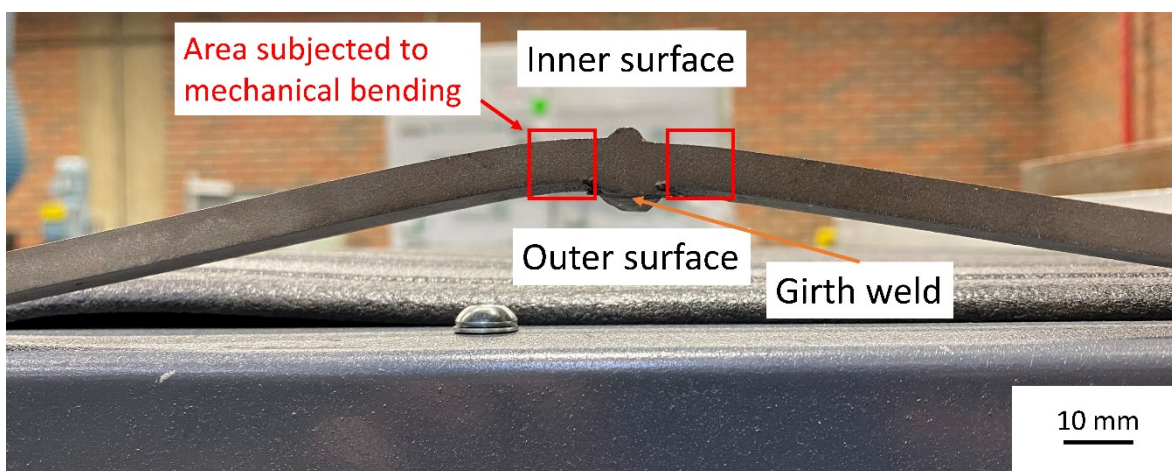
Figure 3.6 Front of a fabricated specimen ($d = 0$ mm) with the locations at which bending force was applied

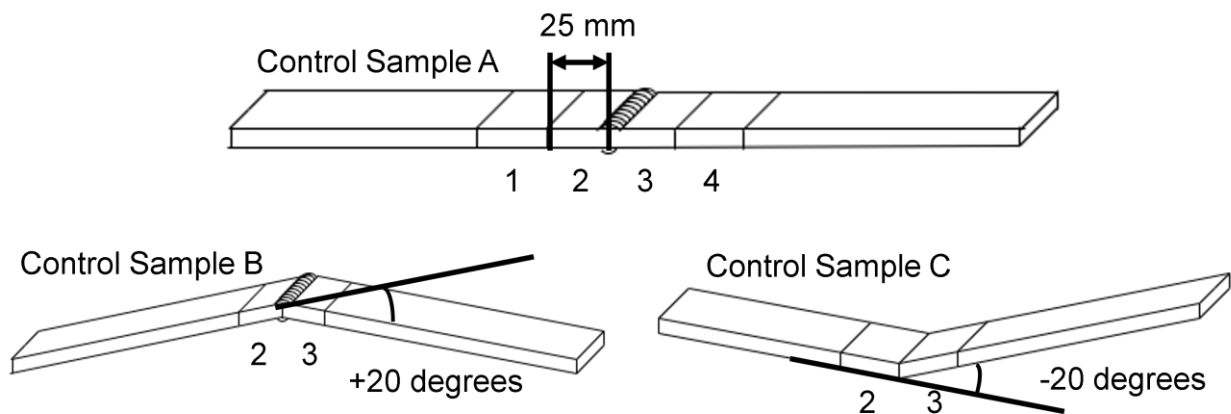
Figure 3.7 Schematics of control samples

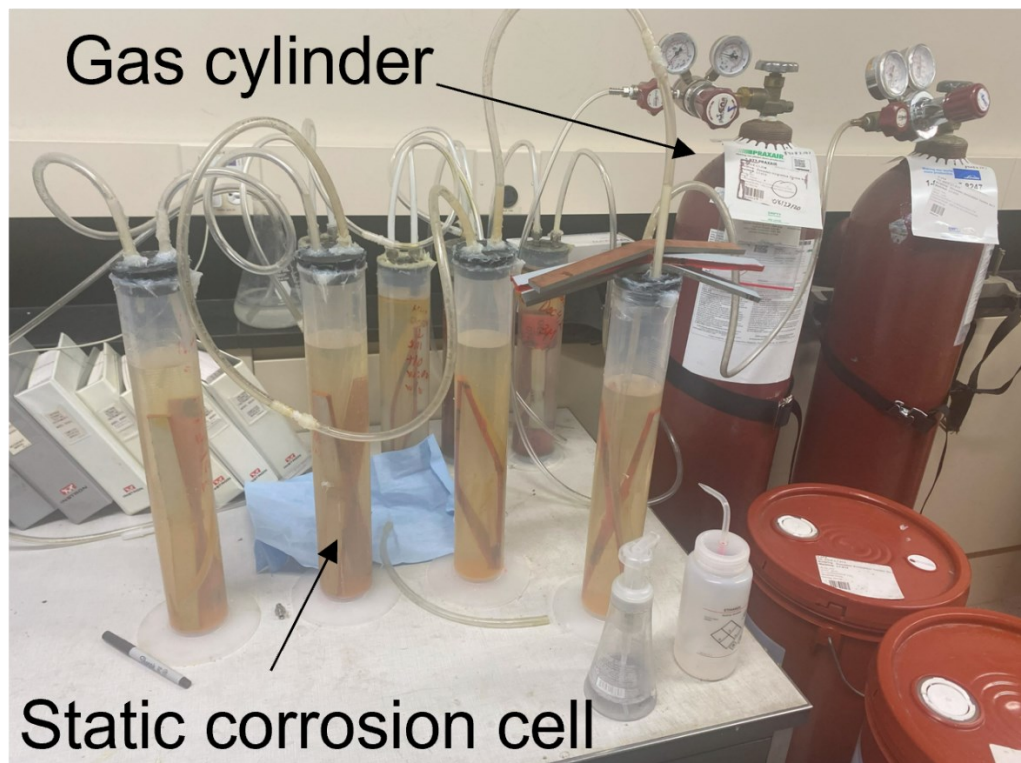
Figure 3.8 Static corrosion cells filled with C2 solution and the specimens, connected to 5% CO₂ + balanced N₂ gas cylinders

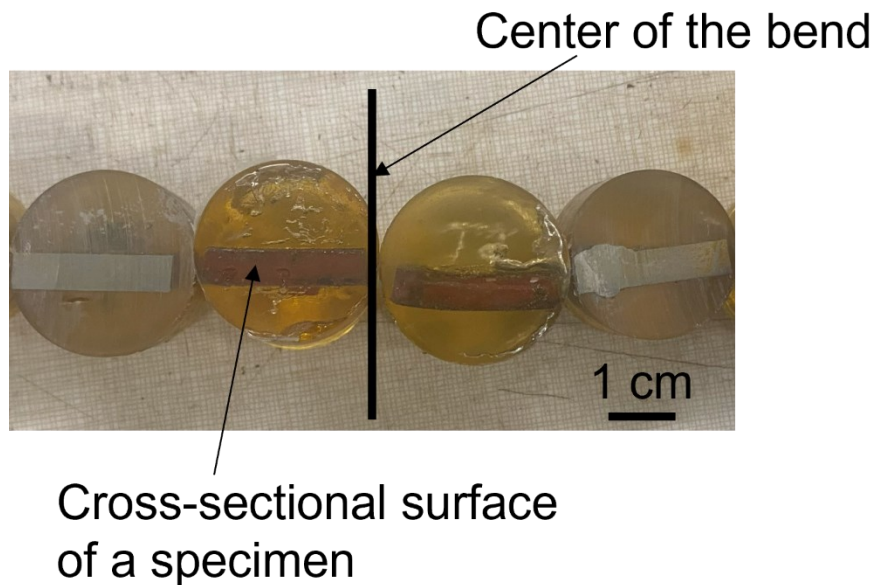
Figure 3.9 Cross-sectional surfaces of sectioned samples mounted in epoxy resin.

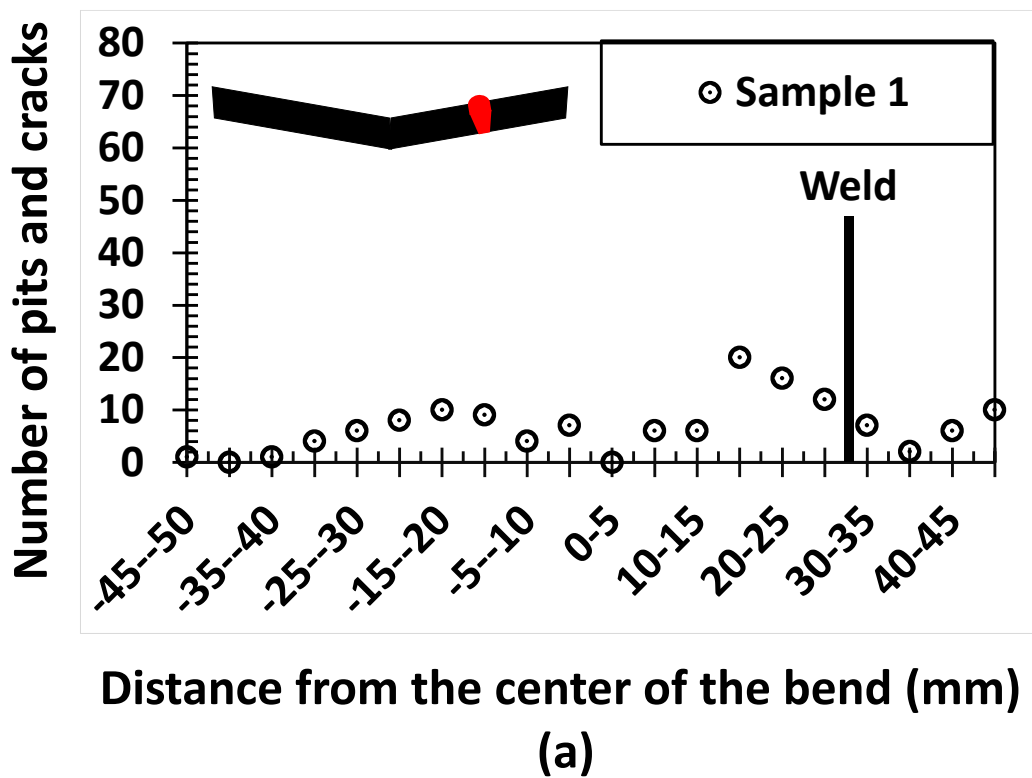
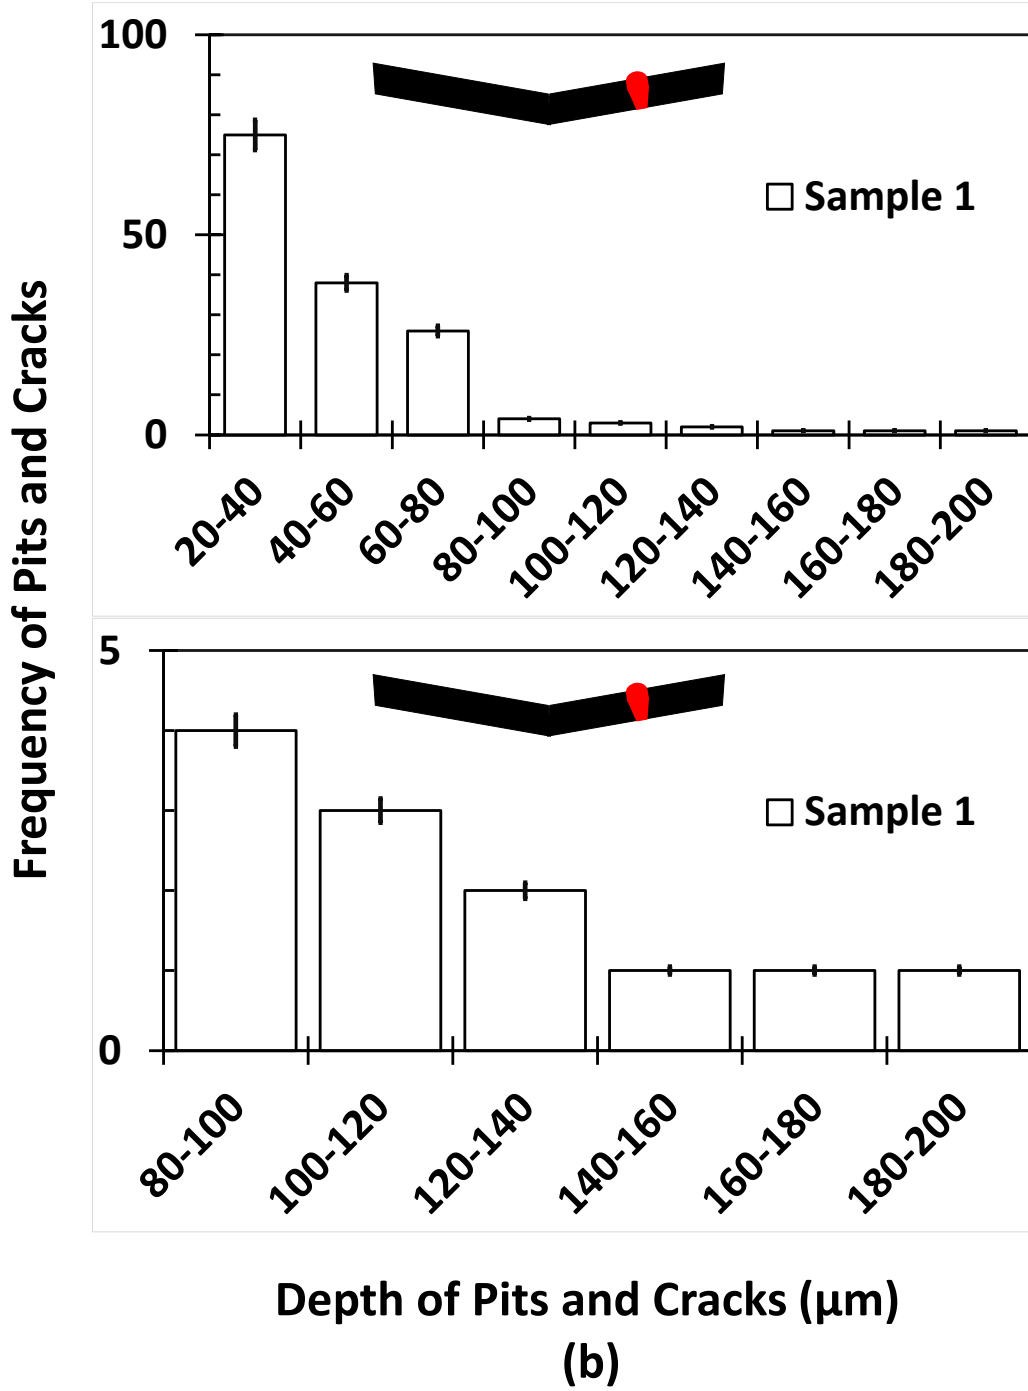
Figure 3.10 a) Distribution of pits and cracks over the length of a corroded sample and b) frequencies of pits and cracks in varying depths derived from characterization processes.

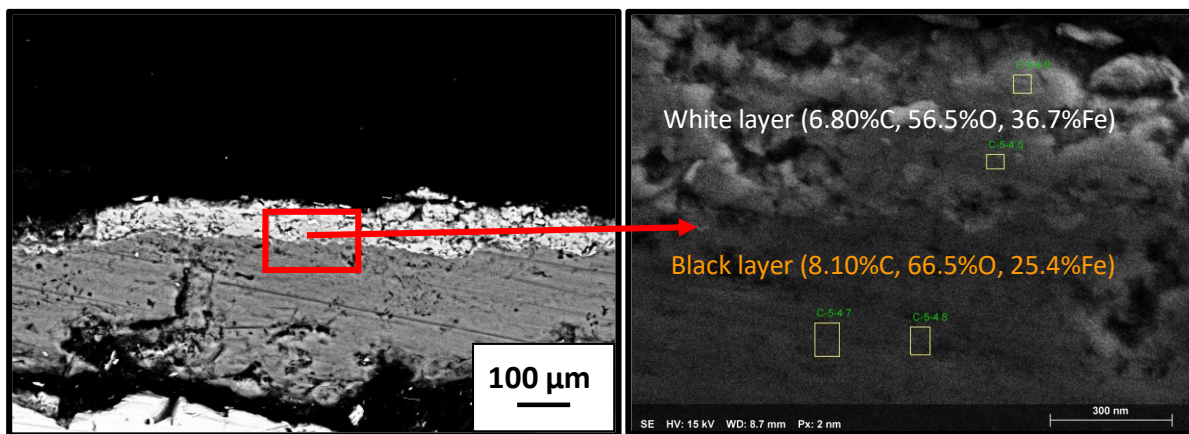
Figure 4.2 Atomic concentration (%) of a) white layer and b) dark layer of oxide in Figure 4.1 d)
