Effect of Field Bending and Girth Weld on the Initiation and Early Growth of Near-Neutral pH Circumferential Stress Corrosion Cracking (NNpHCSCC) in Thin-walled Pipeline

A thesis submitted in partial fulfillment of the requirements for the degree of

Master of Science

Materials Engineering

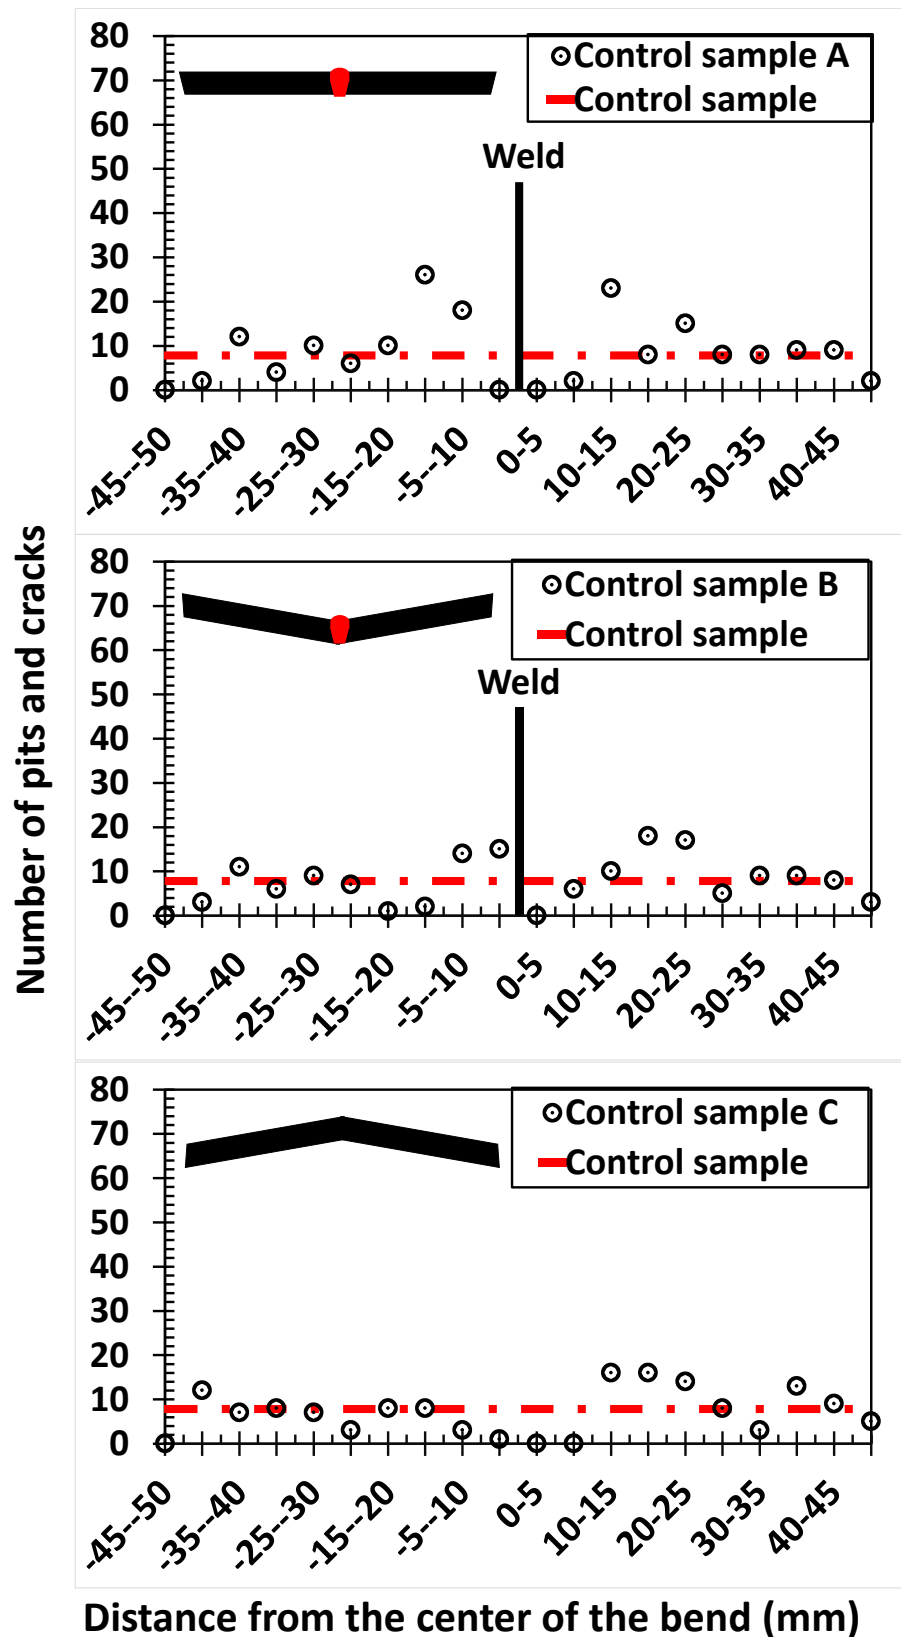
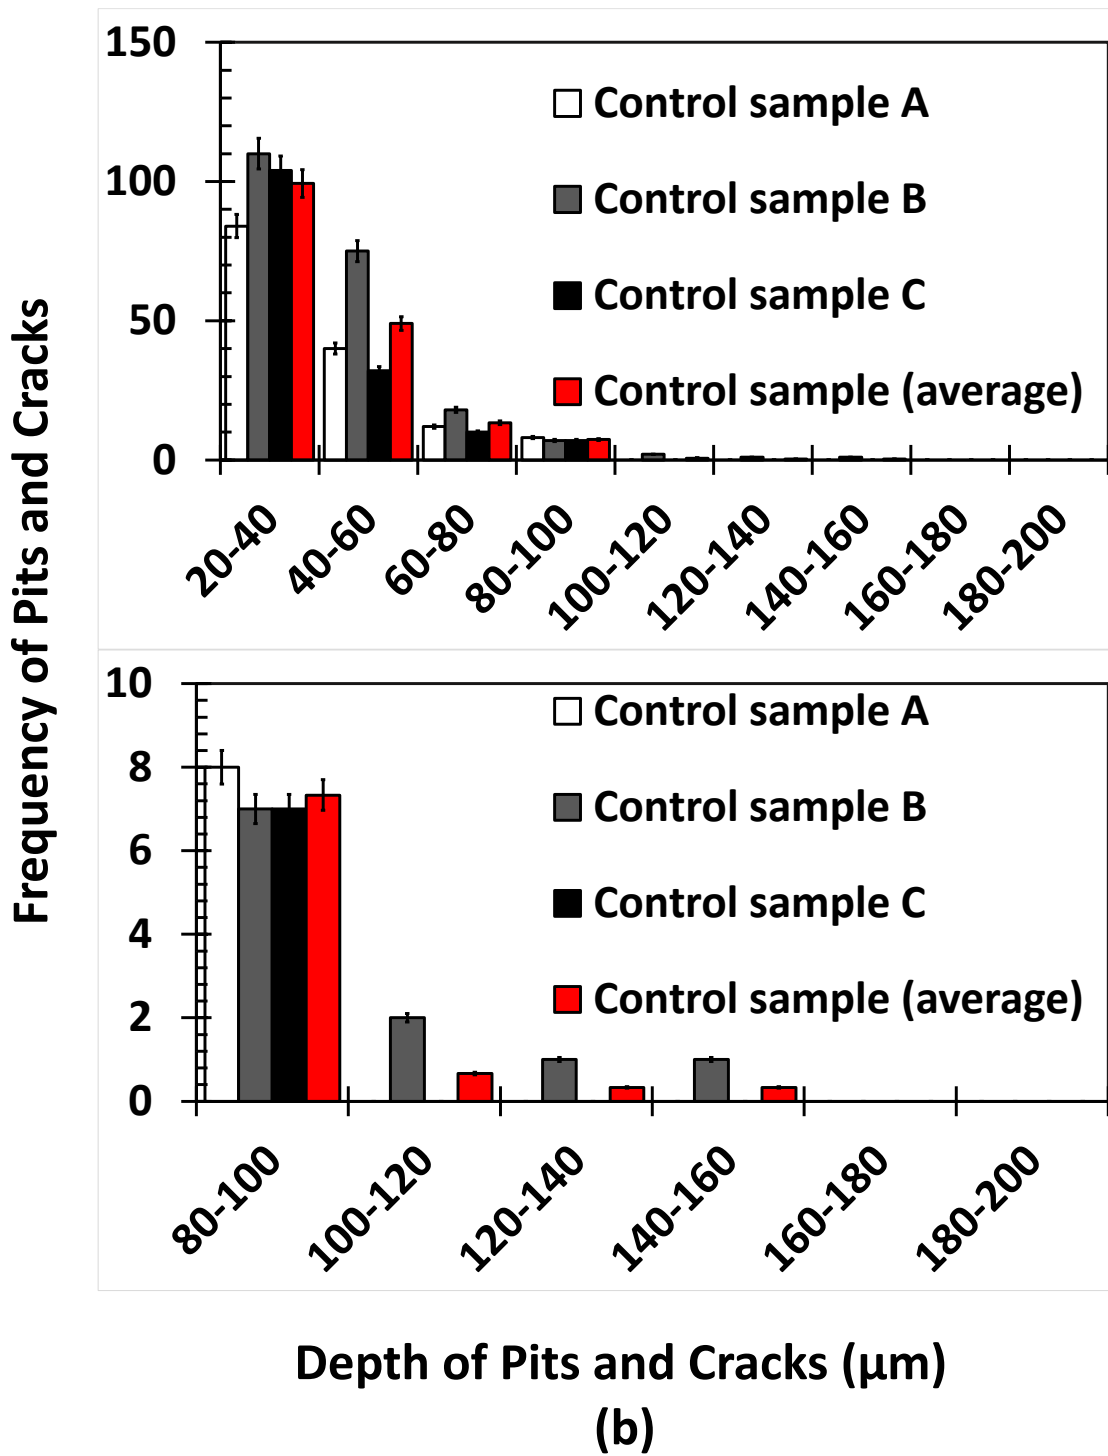
Figure 4.6 a) Distribution and b) Total frequency of pits and cracks in the control samples vs. depth of pits and cracks

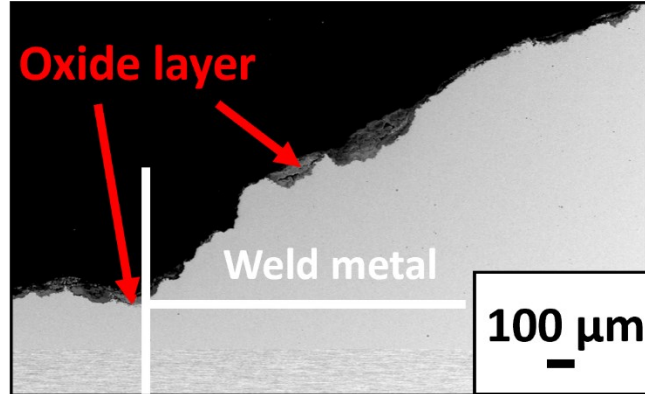
Figure 4.7 Cross-sectional morphology of a corroded sample at the weld toe

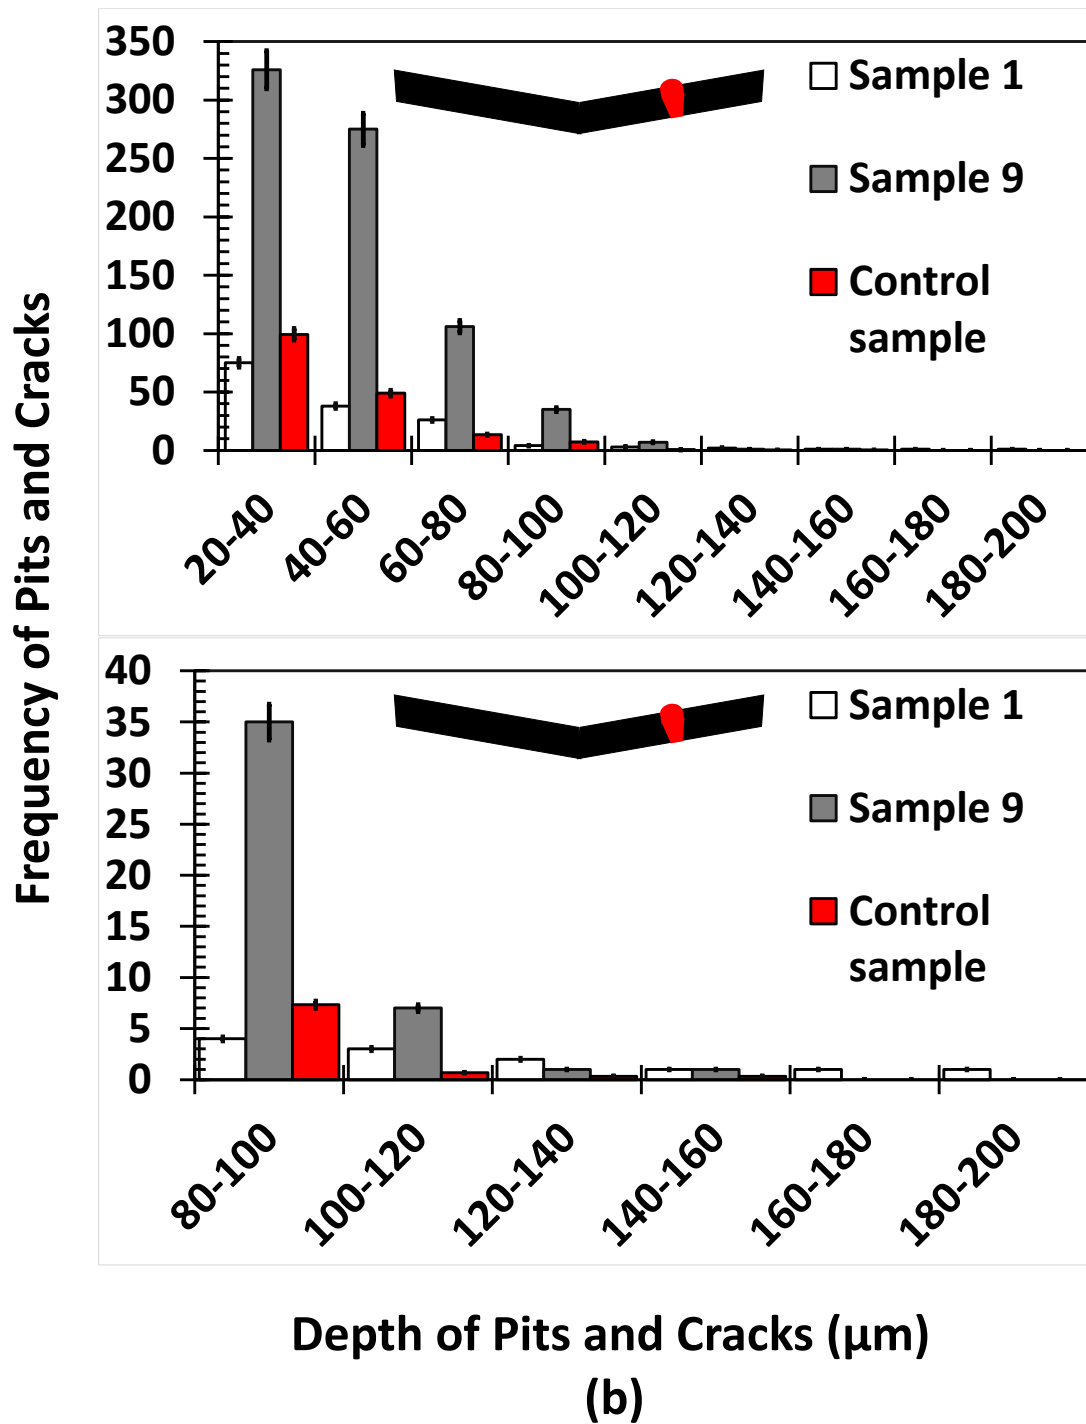
Figure 4.9 a) Distribution and b) frequency of pits and cracks in samples 1 (90 days) & 9 (150 days) and control samples.

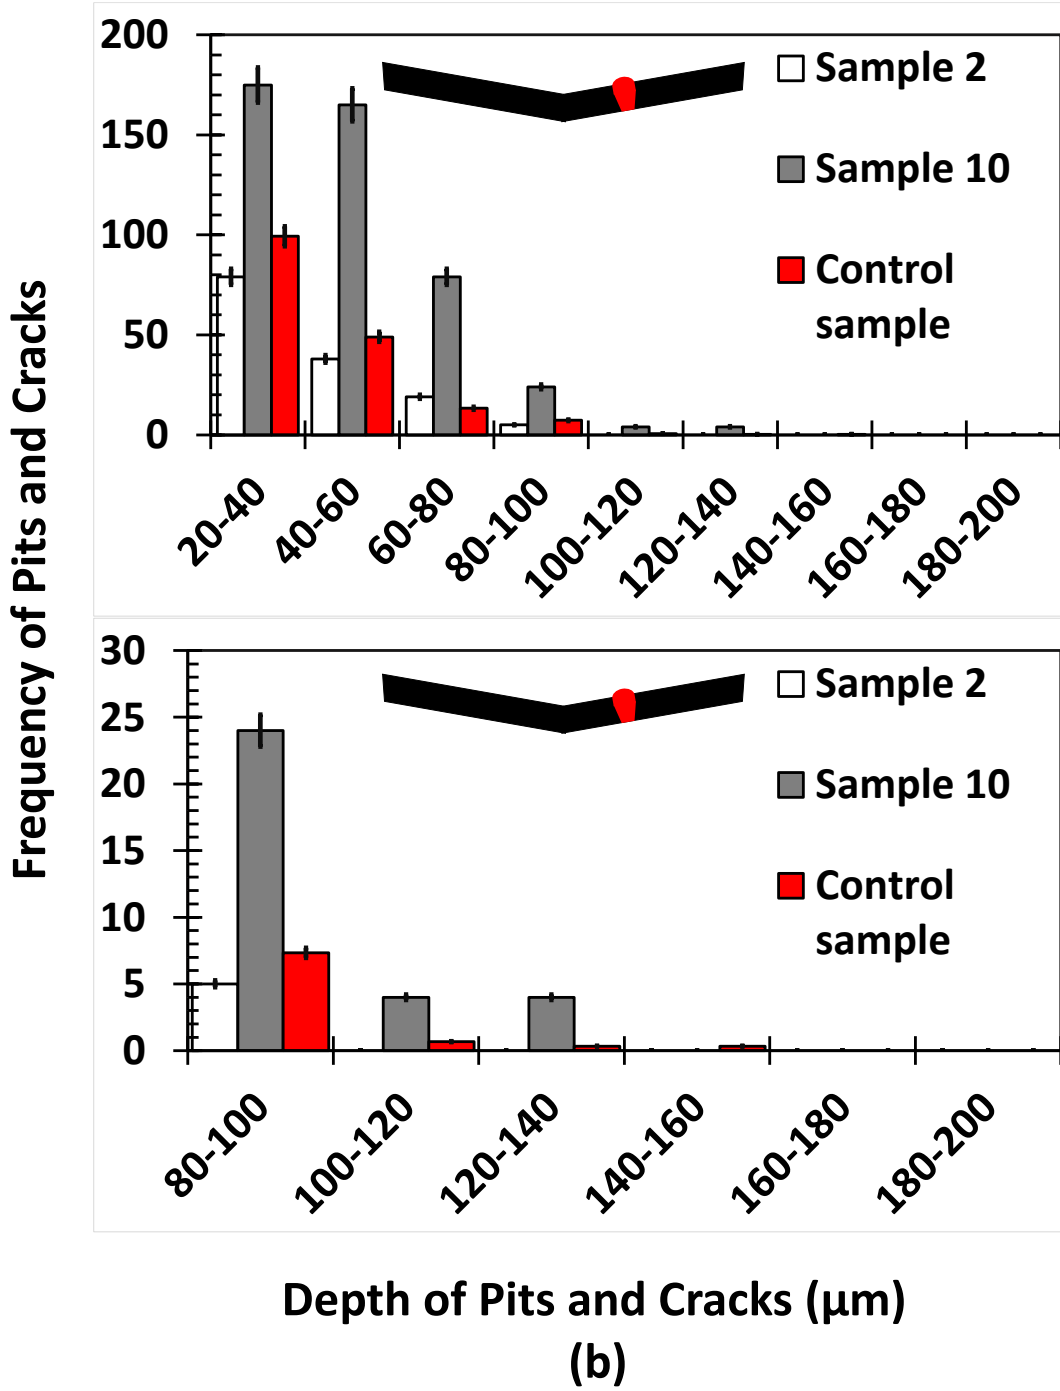
Figure 4.11 a) Distribution and b) frequency of pits and cracks in Sample 2 (90 days) & 10 (150 days) and control samples.

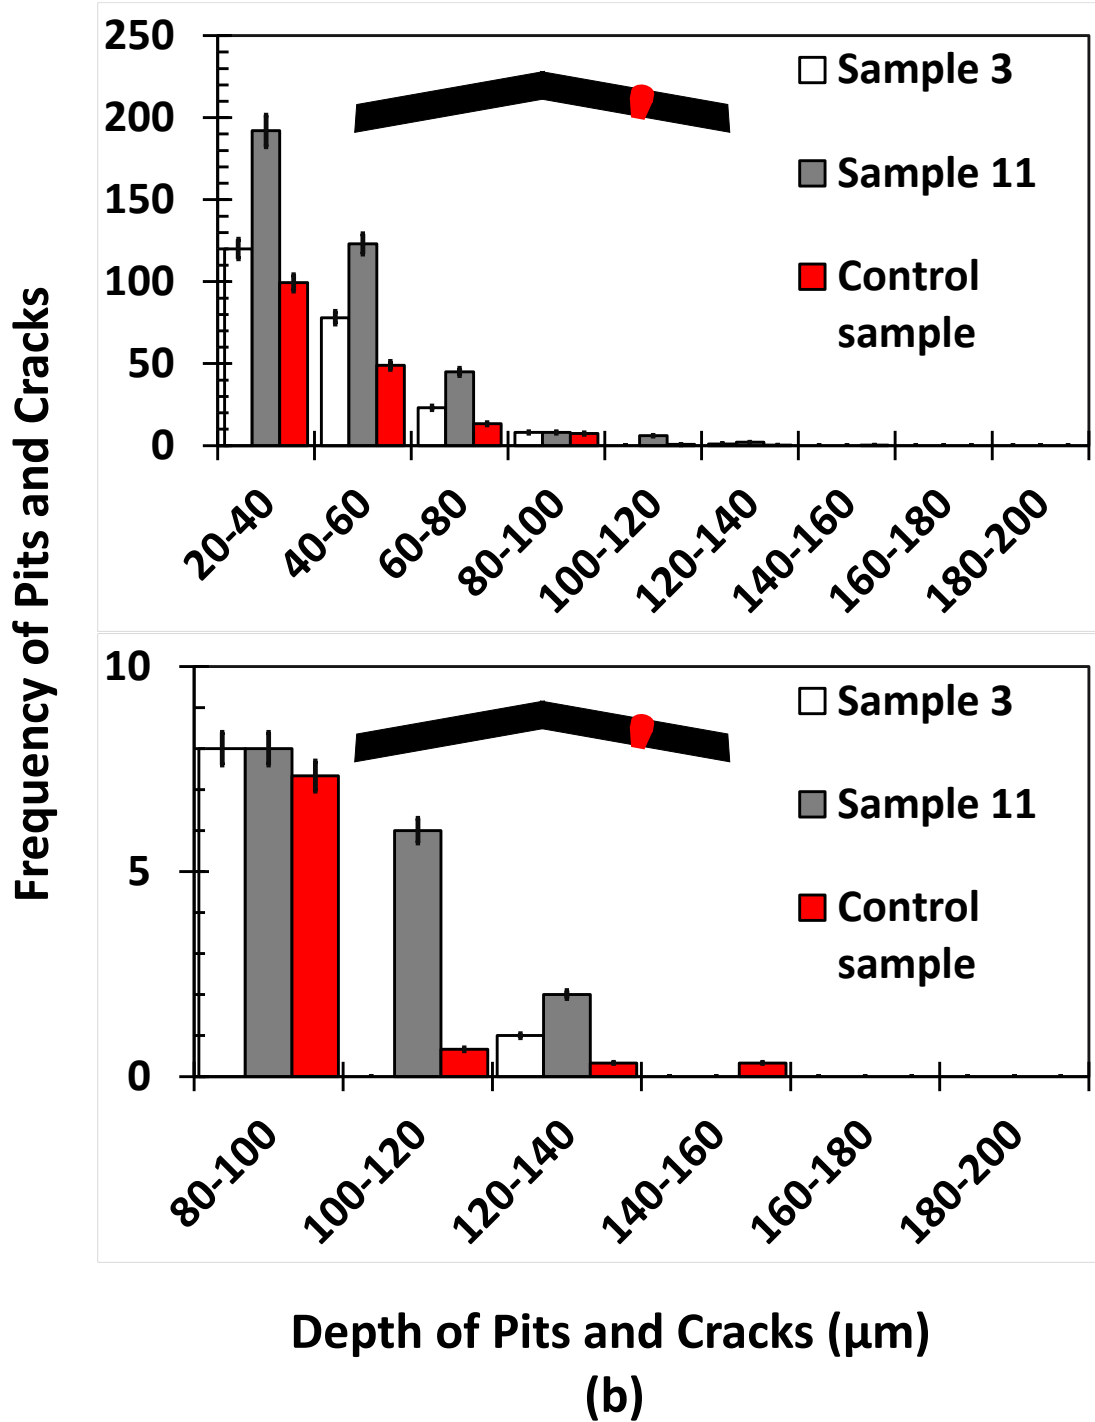
Figure 4.13 a) Distribution and b) frequency of pits and cracks in Sample 3 (90 days) & 11 (150 days) and control samples.

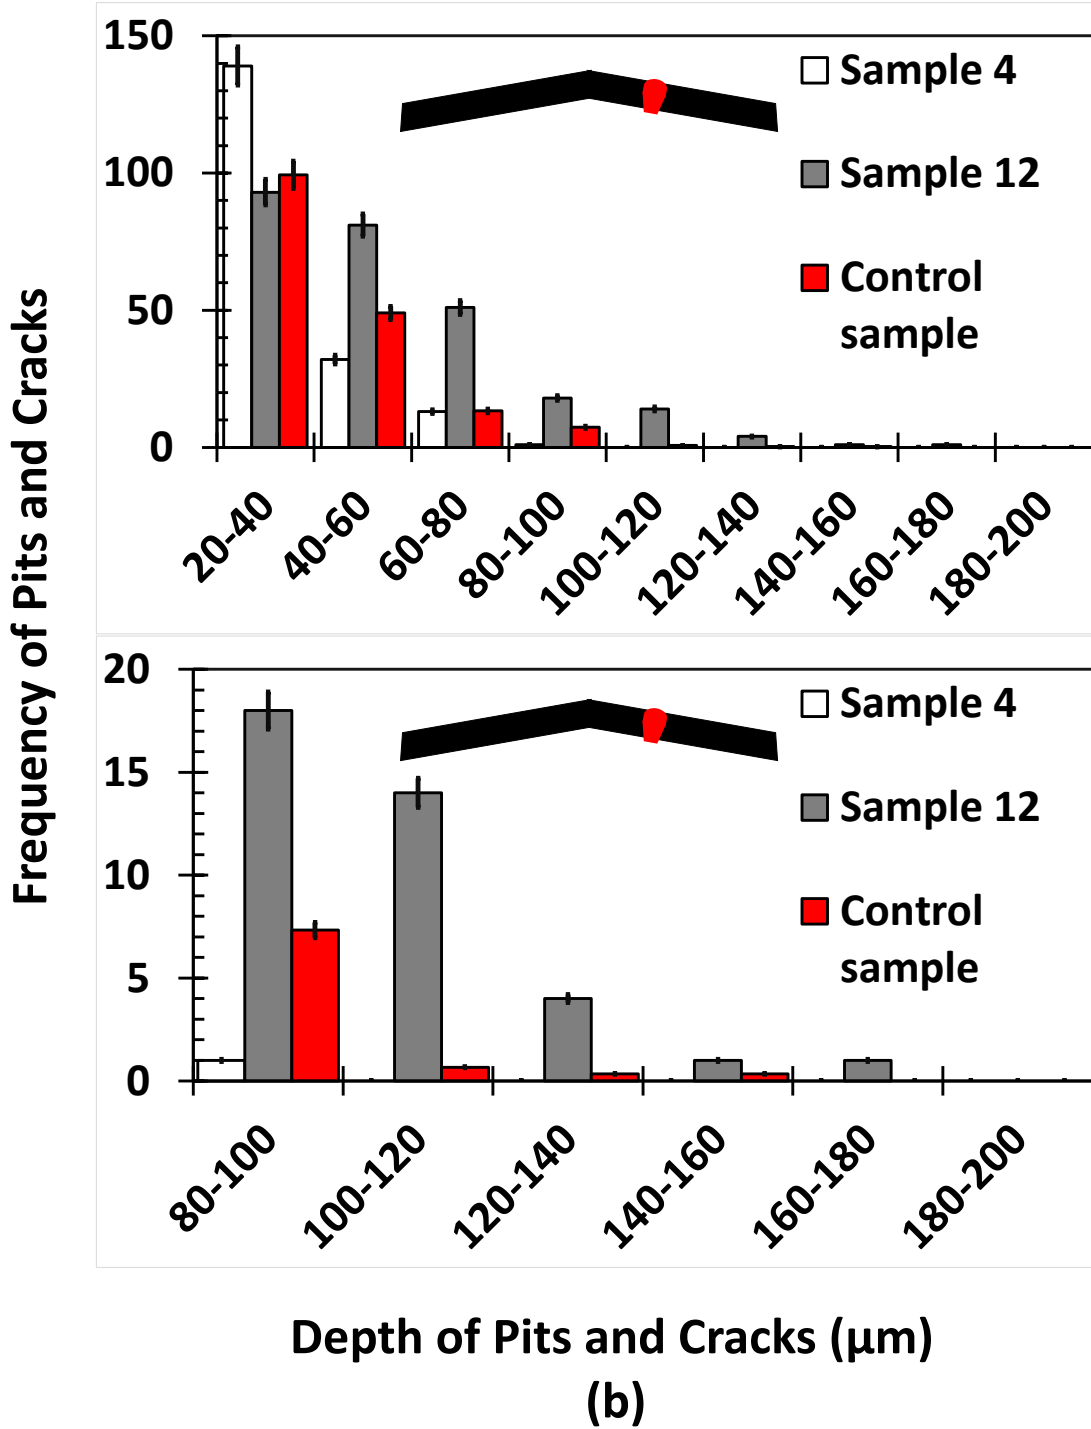
Figure 4.15 a) Distribution and b) frequency of pits and cracks in samples 4 (90 days) & 12(150 days) and control samples.

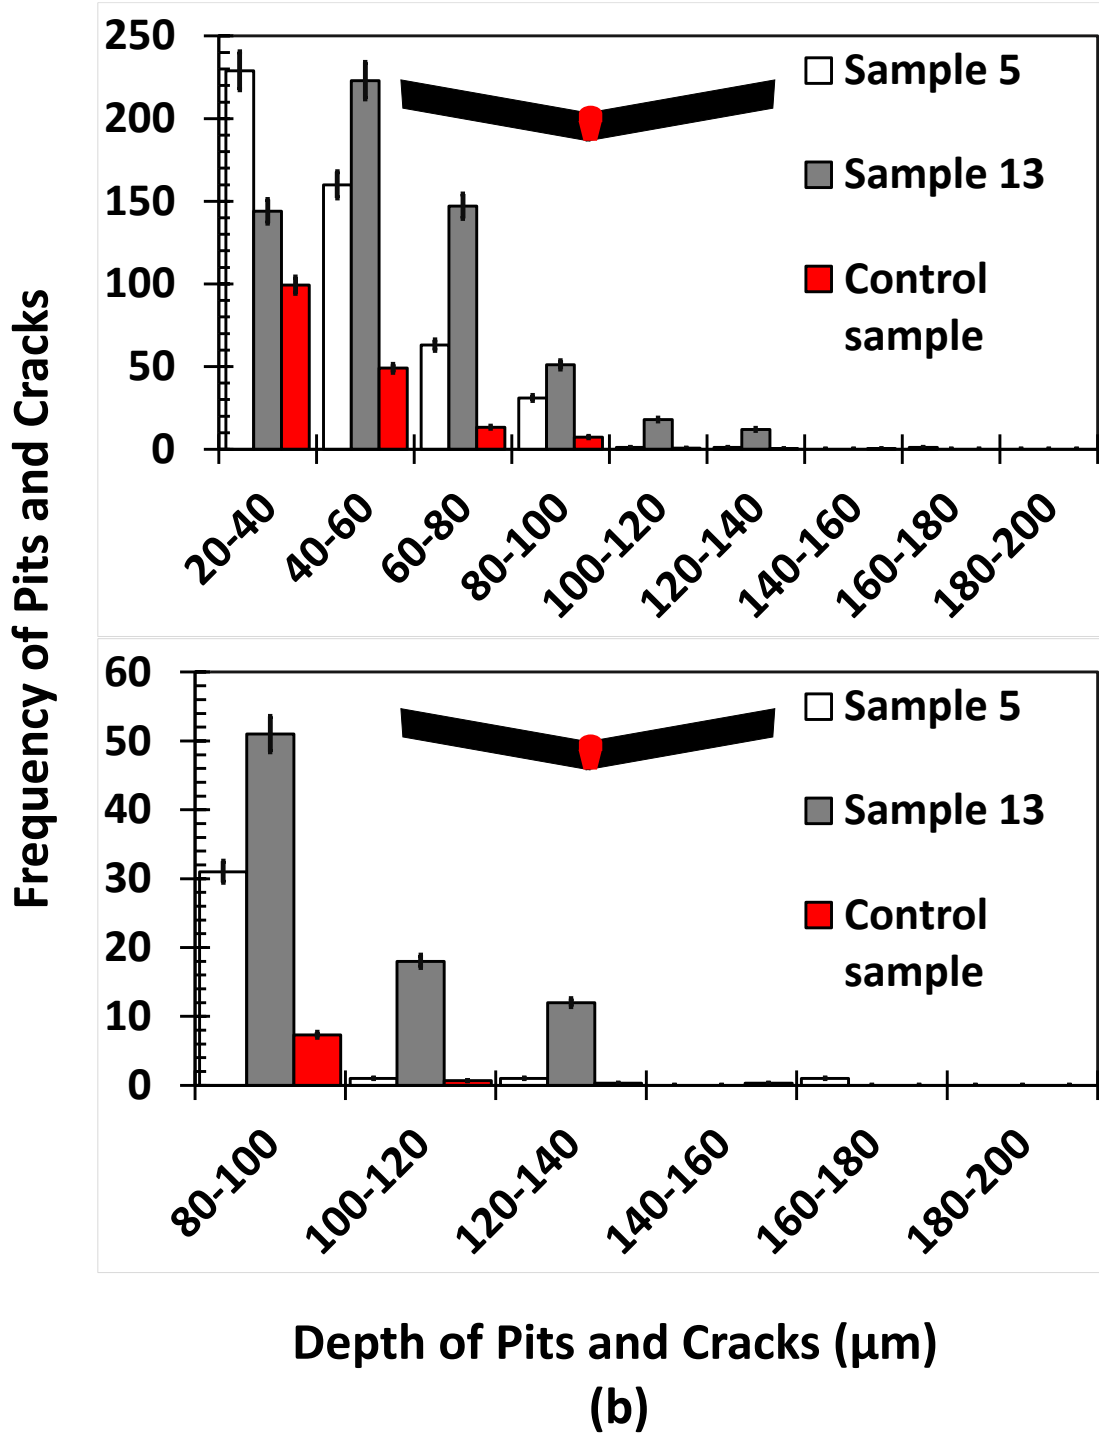
Figure 4.17 a) Distribution and b) frequency of pits and cracks in Sample 5 (90 days) & 13 (150 days) and control samples

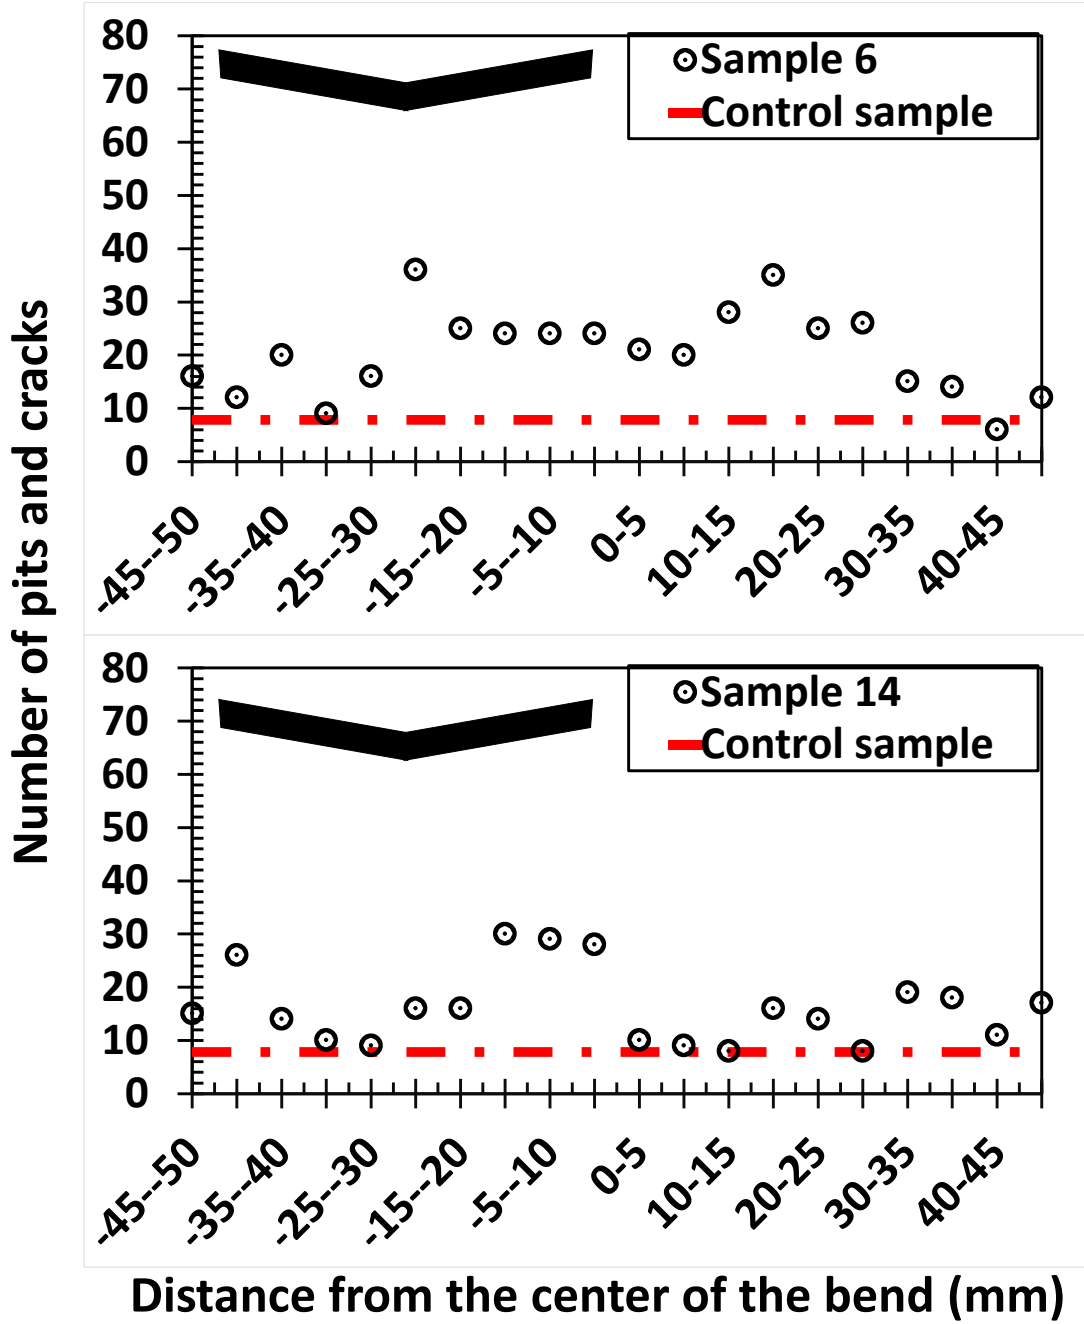
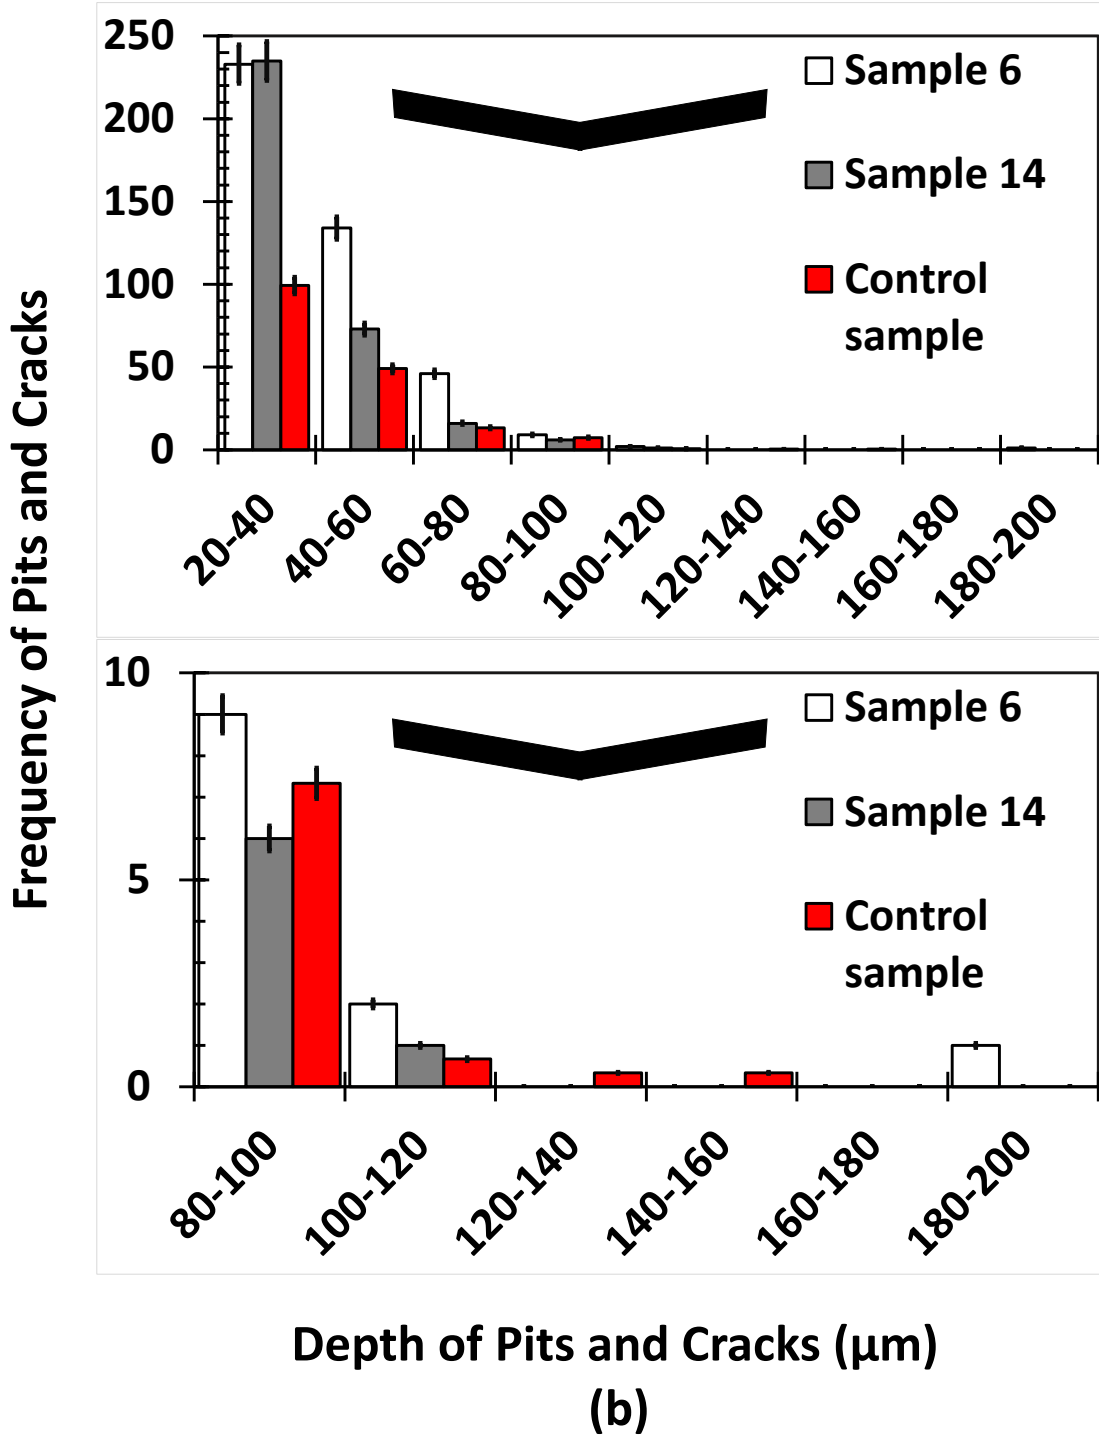
Figure 4.19 a) Distribution and b) frequency of pits and cracks in samples 6 (90 days) & 14 (150 days) and control samples.

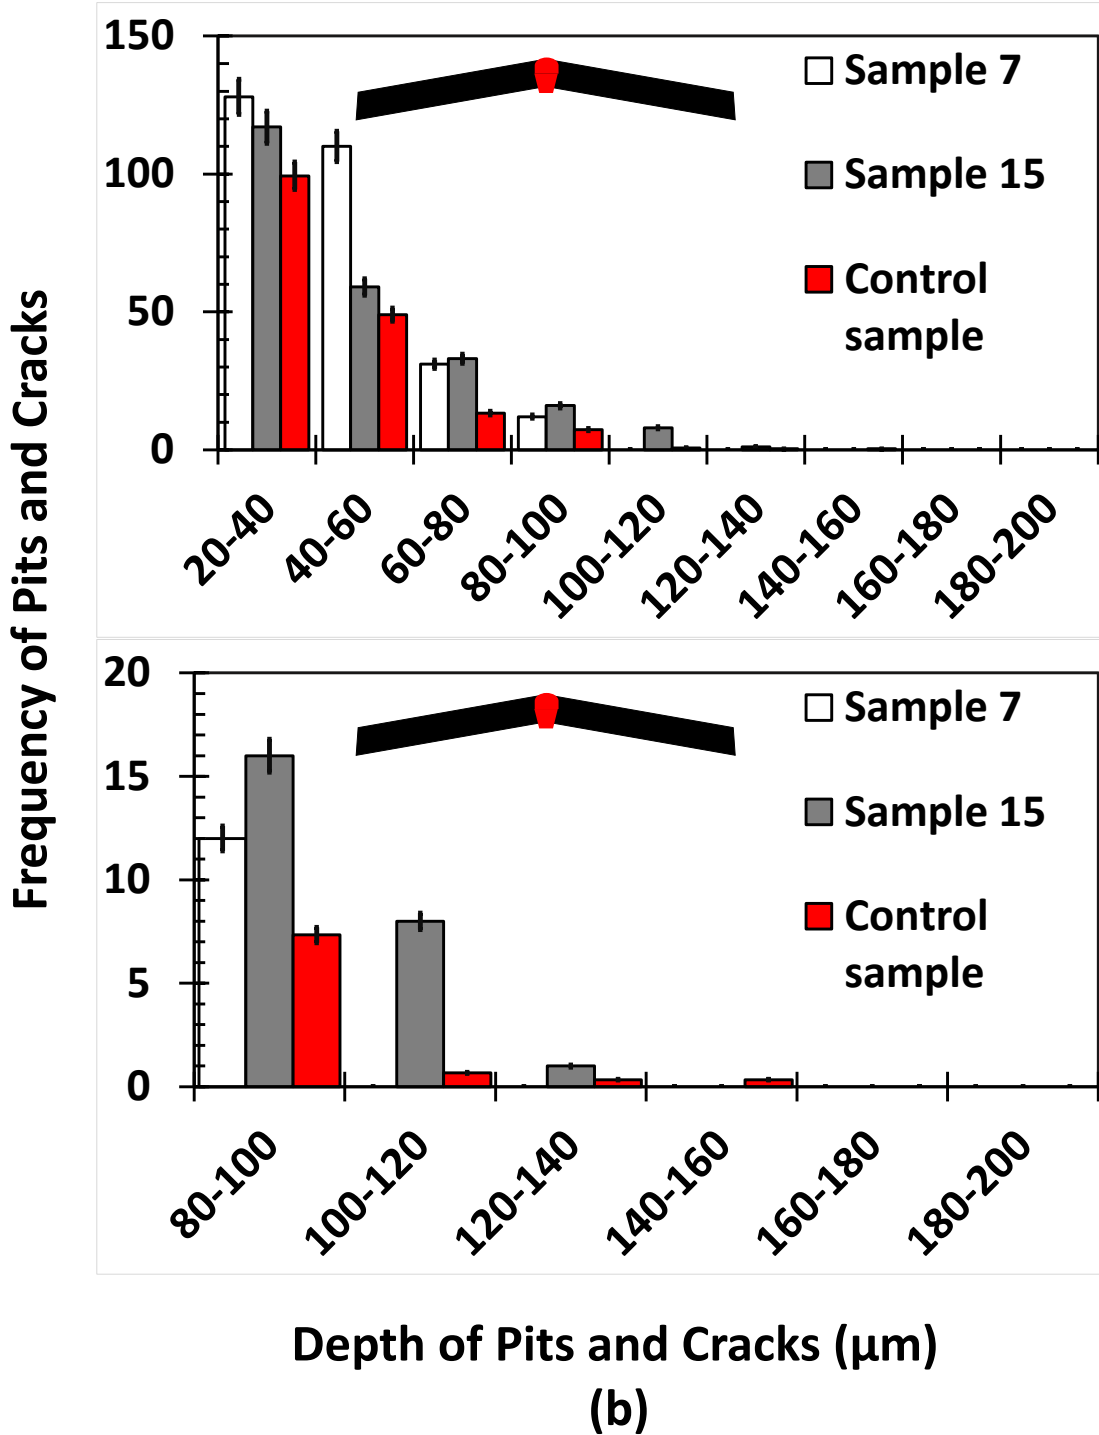
Figure 4.21 Distribution and frequency of pits and cracks in Samples 7 (90 days) & 15 (150 days) and control samples.

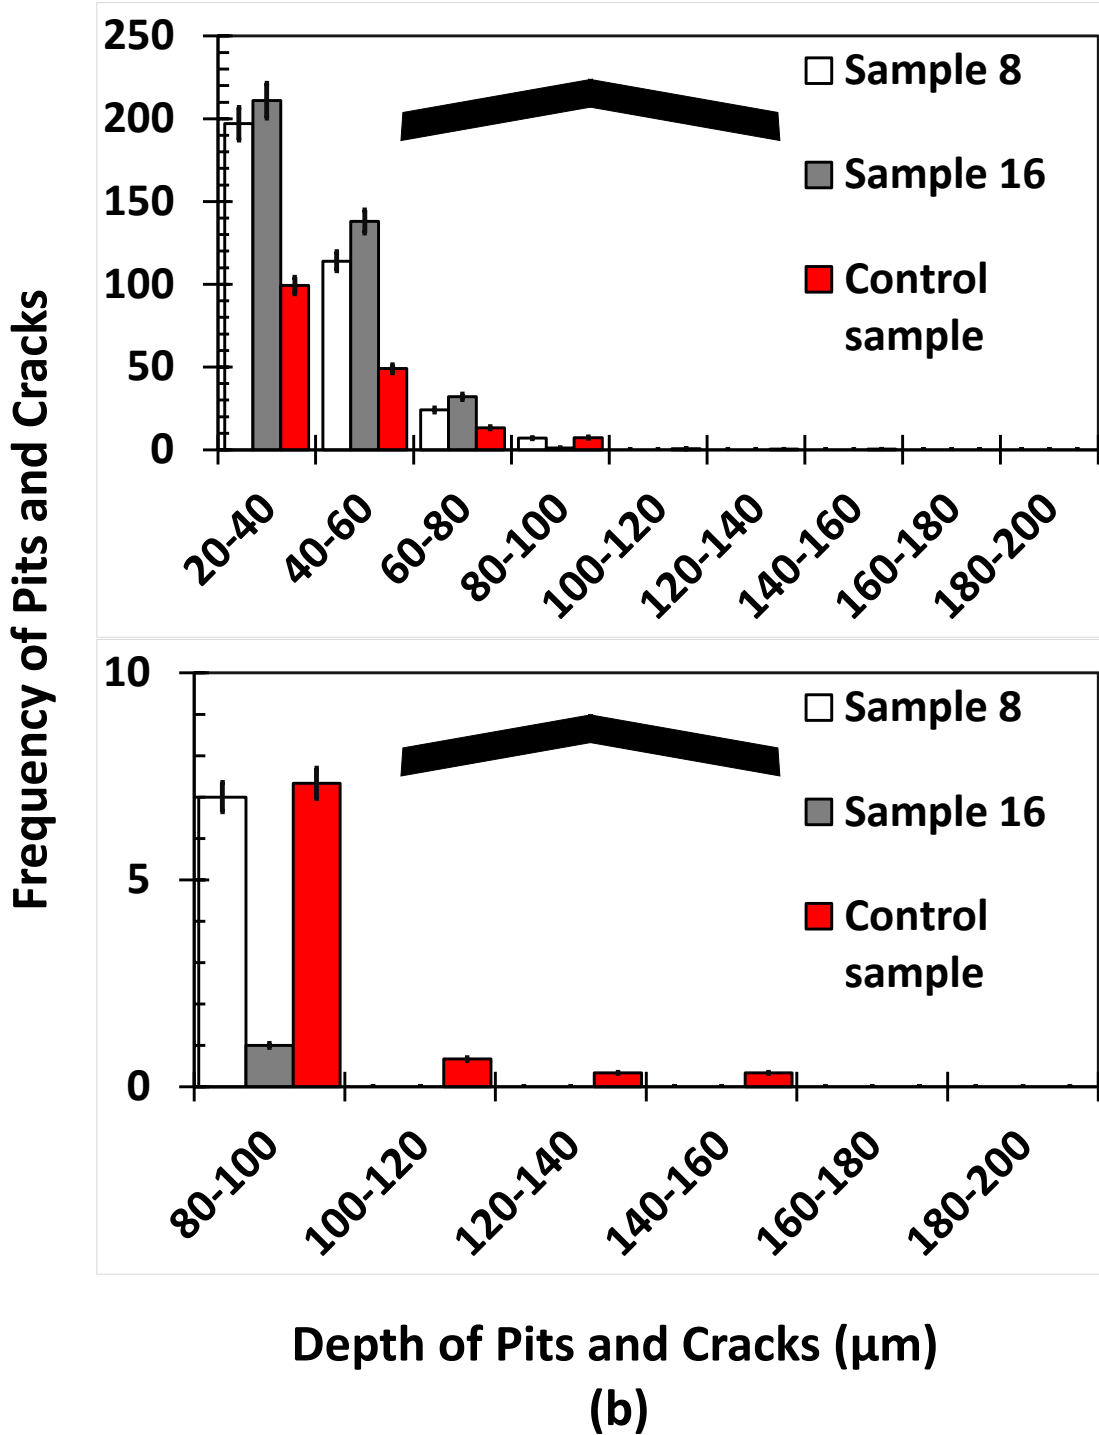
Figure 4.23 a) Distribution and b) frequency of pits and cracks in samples 8 & 16 and control samples.

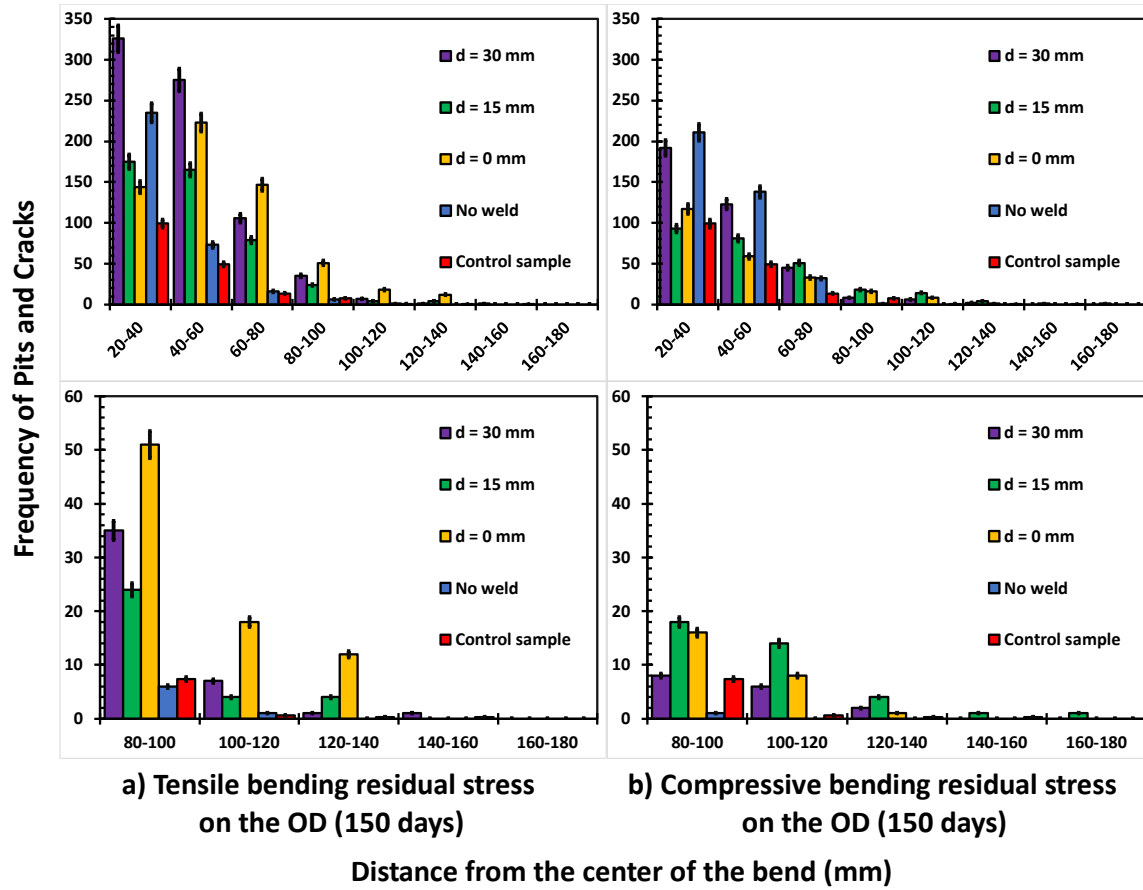
Figure 5.2 Frequencies of pits and cracks in different depths on the samples corroded for 150 days with a) tensile bending residual stress on the OD and b) compressive bending residual stress on the OD.

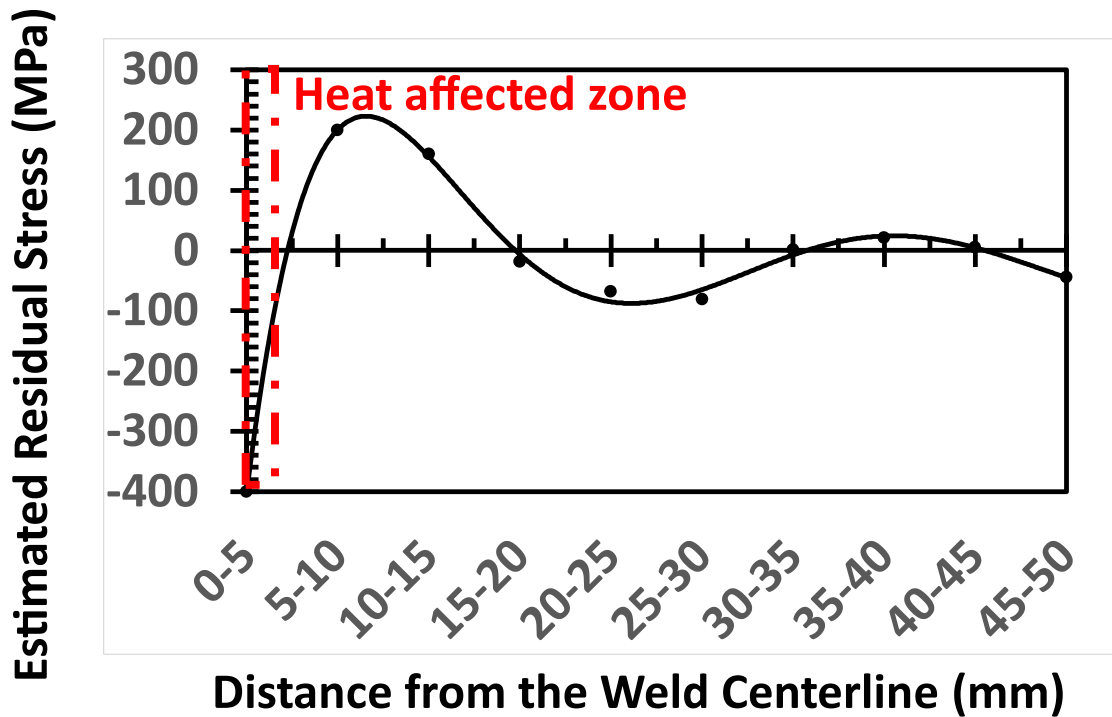
Figure 5.3 Estimated axial residual stress from WCL on the outer surface of the corroded samples.
