**Landslides in the Morkill River Valley,  
British Columbia**

**Corey Raymond Froese**

**A thesis submitted to the Faculty of Graduate Studies and Research in partial  
fulfillment of the requirements for the degree of Master of Science**

**Geotechnical Engineering**

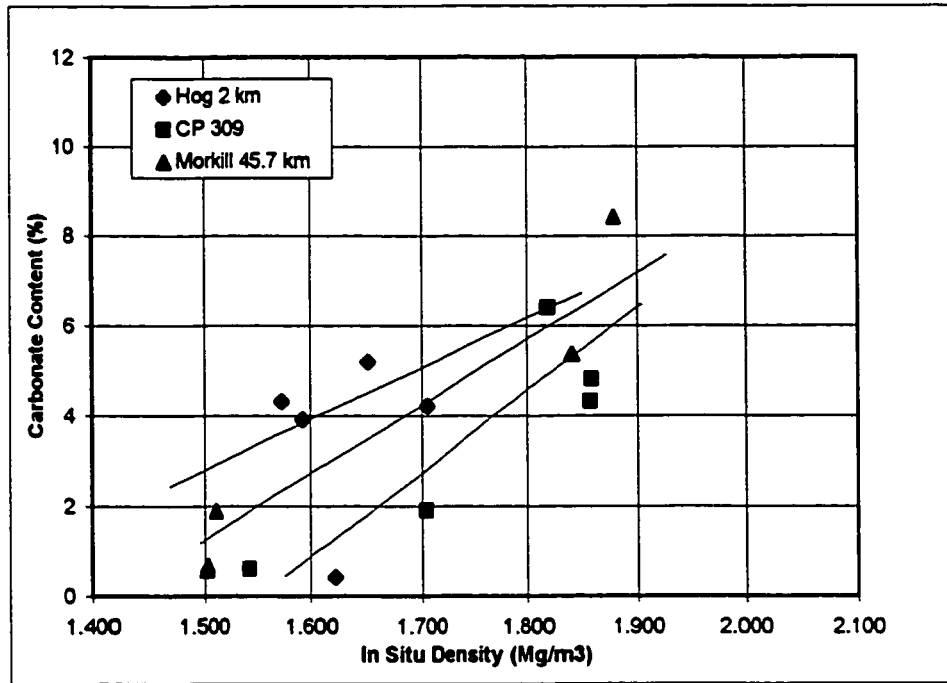
Figure 7.8 Lake C: Density vs. carbonate content

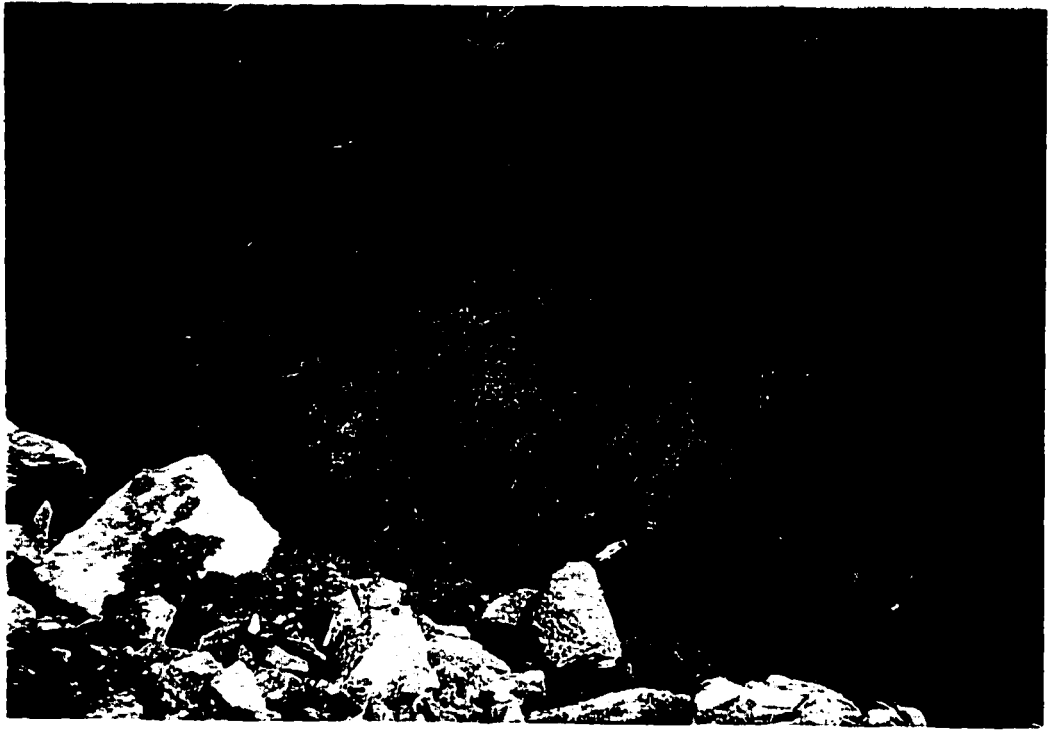
**Figure 7.10 Erosion in silty soils in road cut at Morkill 47 km**

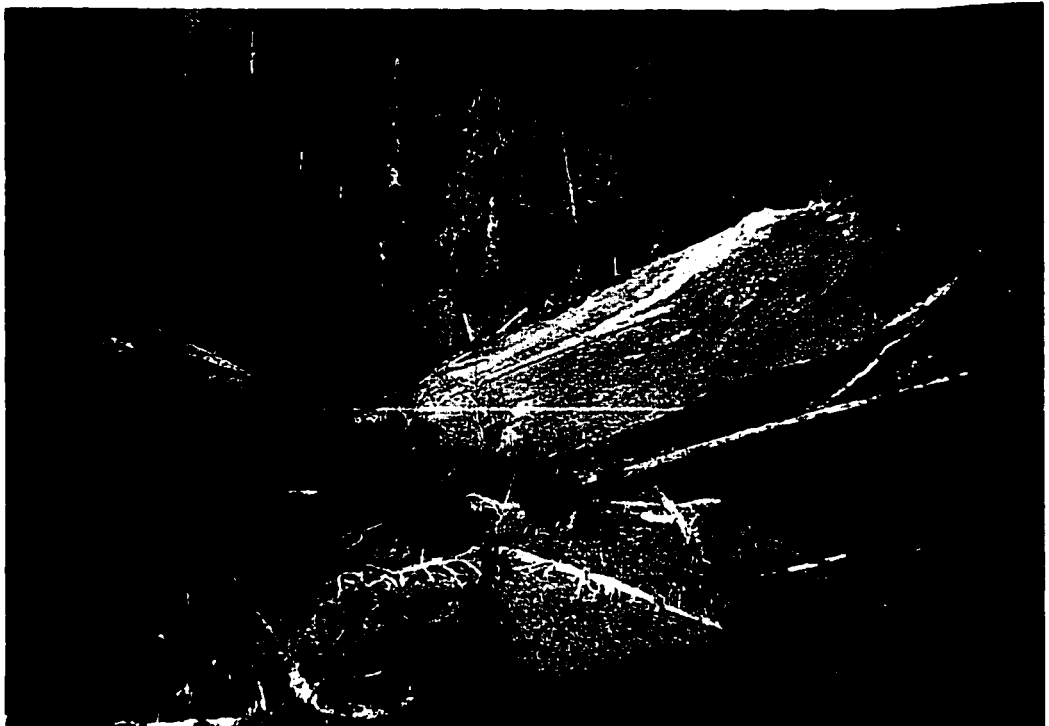
**Figure 7.15 Gully shaped rupture surface in earth slide (65235:06)**

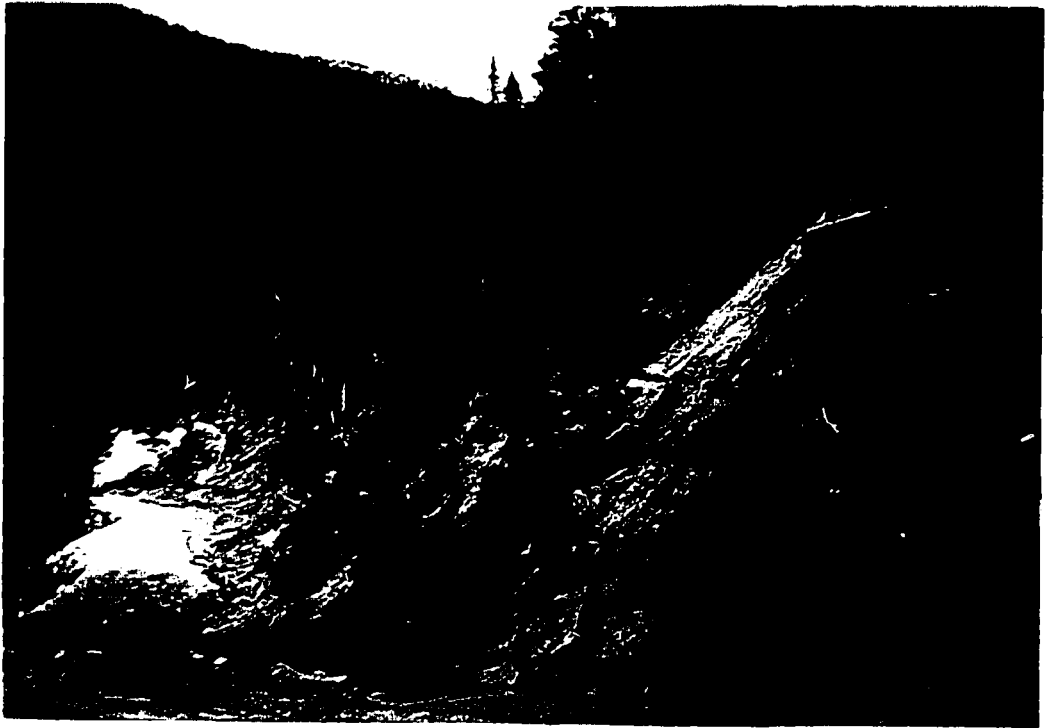
**Figure 7.22 Slide 65243:03.(Morkill 45.7 km) Earth slide in sandy soils adjacent to road**

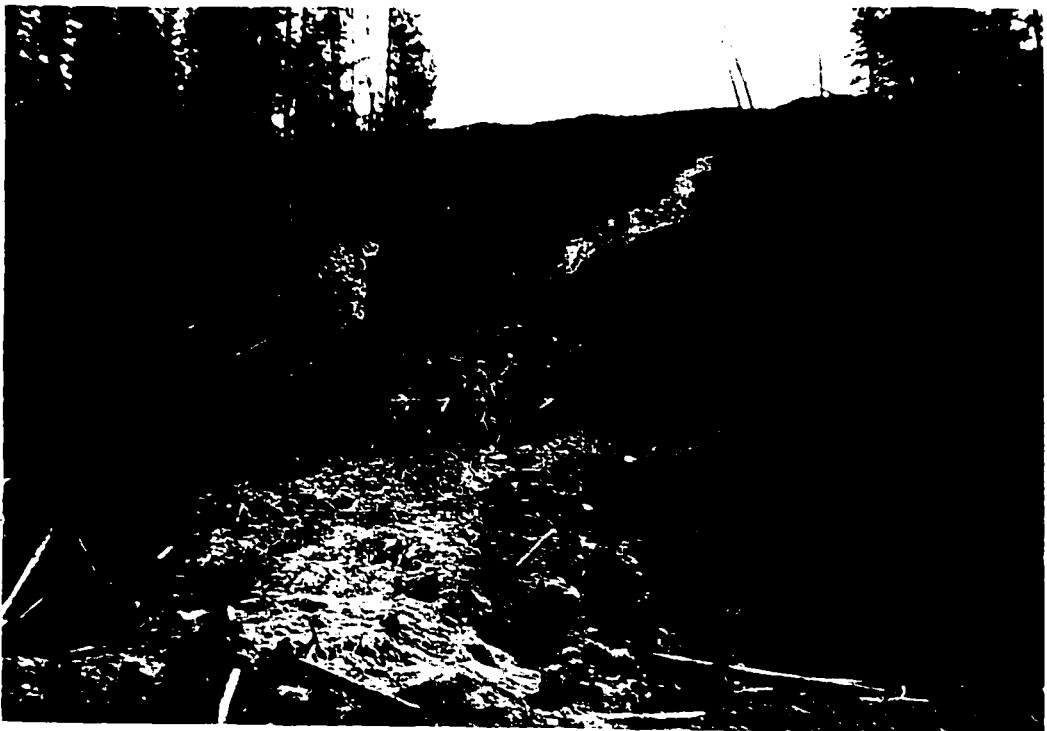
**Figure 7.23 Slide 65237:03.(Morkill 31.5 km) Earth slide in sandy soil below an abandoned cutting permit access road**
