**Flexural and Shear Response of Deteriorated Prestressed Concrete Girders Taken from a
Decommissioned Bridge in Alberta**

Zhaohan Wu

A thesis submitted in partial fulfillment of the requirements for the degree of

University of Alberta

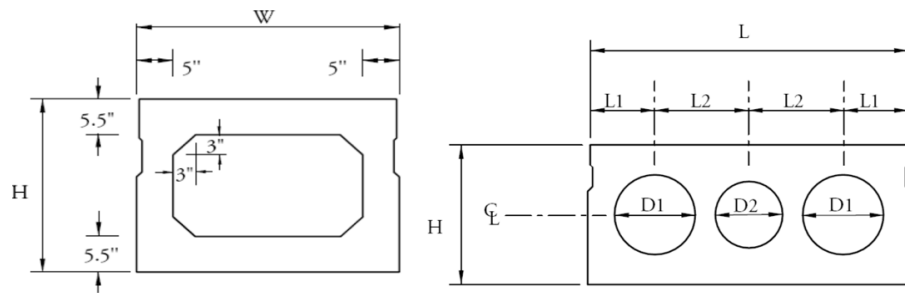
Figure 2- 1: AASHTO/PCI standard products: box girder (left), voided slab (right) (PCI Design Manual,2011).

Reinforced/prestressed concrete roadway bridges are an important component of North America's transportation network. Girder bridges are the most common highway bridge in the United States. The majority of bridges span less than 50 m, rarely exceeding 150 m. Girder bridges are popular because they have greater stiffness and subject to fewer vibrations (Barker and Puckett, 2013). In North America, most highway bridges have spans less than 30 m. In the United States, 90% of roadway bridges have spans less than 30.5 m and 67% of these bridges have spans ranging between 6.1 m to 18.3 m (Hurd, 1985). There are several types of short-span concrete bridge girders in terms of their cross-section geometry – such as box shaped, voided slab, or solid rectangular. Box-shaped and voided slab girders are primarily used as prestressed members in small span bridges (Figure 2-1). These girders are placed side by side and connected with shear keys that allow for transverse load sharing.

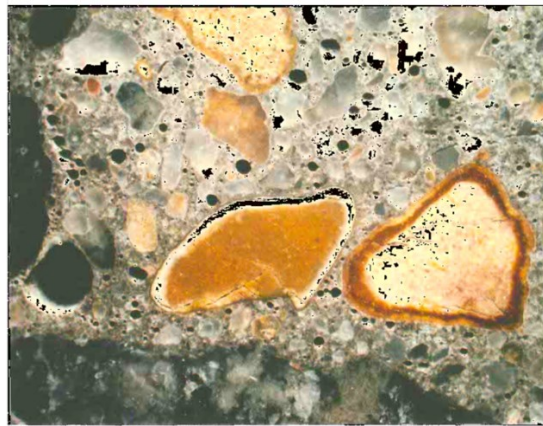
Figure 2- 2: ASR within the concrete (darkened rim on granite gneiss and chert particles by ASR) (Lane, 1994).

Alkali aggregate reactions occur when the reactive silica in concrete aggregates react with alkali hydroxides in the mix, causing expansion and cracking over time. There are two types of alkali aggregate reactions: alkali-silica reaction (ASR) and alkali-carbonate reaction (ACR). ASR is common when aggregates contain reactive silica materials. These silica materials react with alkali hydroxide in the concrete to form gel around the aggregates. This occurs when water from the cement paste or overall environment (humidity, rain) is absorbed. If the aggregate is composed entirely with reactive silica, the surface of the aggregate may quick react with the alkaline pore solution to form ASR gel (darkened rim) at the surface as indicated in Figure 2-2 (Rajabipour et al., 2015).

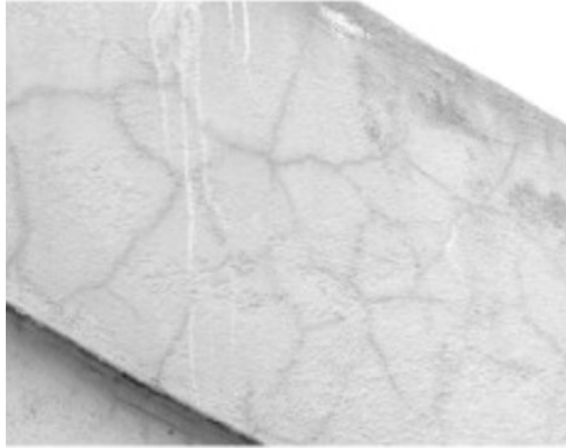
Figure 2- 3: ASR cracking on a bridge built in Czech Republic (Lukschová et al., 2008).

Gel formed around aggregates swells and causes the concrete to expand and eventually form a map-like cracking pattern. Figure 2-3 shows Lukschová et al. (2008) inspected a bridge that was repaired in the late 1990s due to extensive signs of ASR, finding severe map-like cracking by ASR.

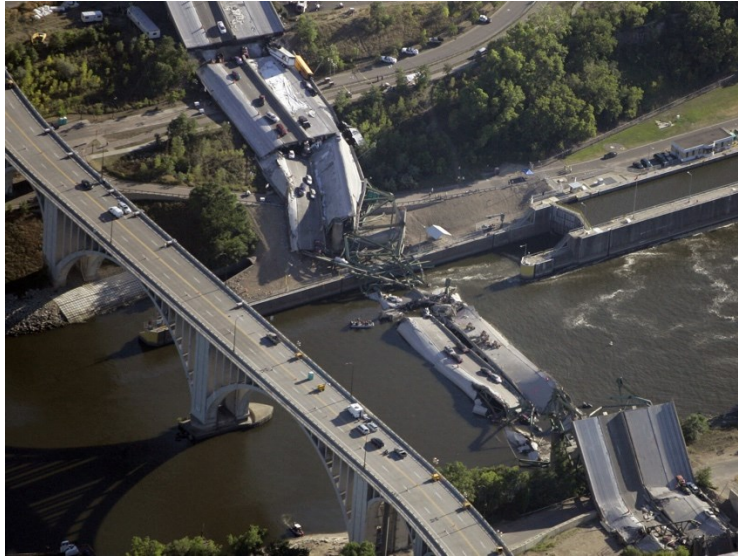
On August 1, 2007, the I-35W Bridge over the Mississippi River in Minneapolis collapsed killing 13 people and injured 145. There were many factors contributing to the failure of this eight-lane concrete deck steel truss arched bridge which includes insufficient design where the gusset plate had inadequate capacity due to incorrect calculation and deterioration which eventually caused the bridge's collapse when one of the gusset plates failed due to inadequate capacity (National Transportation Safety Board, 2008). In addition to the lives lost, the collapse of the bridge interrupted 140,000 daily traffic crossings and disturbed traffic flow in the area which generated significant economic loss due to longer traffic hours, distance, and higher congestion volumes (Zhu and Levinson, 2010). \$400,000 daily were estimated to be lost by the Minnesota Department of Transportation due to rerouting travellers and commercial vehicles alone. Goodwin (1977) argued that previous experience is crucial for traveller decisions, so the collapse of the I-35W could potential cause travel pattern change which eventually results ongoing capital loss from disturbed traffic flow. Zhu and Levinson (2010) indicated that total number of river crossing trips dropped 6.3% and that only 3.1% were restored after a replacement bridge was opened.

Figure 2- 4: Collapsed I-35W bridge in Minneapolis, MN (Gash, 2007).

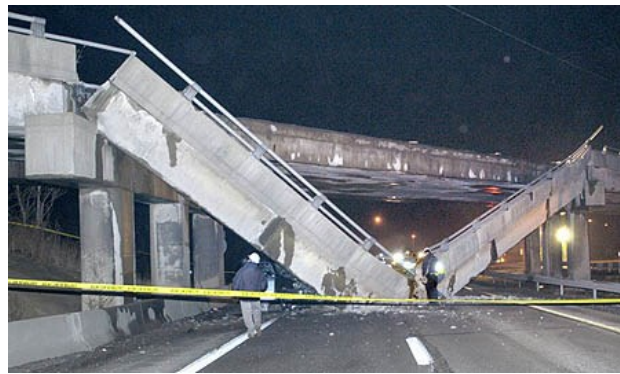
In 2005, a 16.2 m long prestressed concrete girder weighing 60 tons of the Lake View Drive Bridge in Pennsylvania failed under service. This bridge was built in the late 1950s and, before one of its beams failed, an inspection team gave this overpass a score of 4 out of 10 indicating structural deficiency. Post-failure inspections showed that 39 out of 60 prestressing strands had corrosion-induced failure. There was also heavy concrete spalling and strand corrosion on the bottom flange of the voided box girder. Naito et al. (2006) evaluated the failed beam and found that the construction generally met design requirements, but the bottom flange cover was 60% thinner than required and the thickness of the bottom flange 15% was smaller than the designed value. Inadequate cover could have induced premature strand corrosion. Additionally, vent holes in the girder's top flange were not indicated on shop drawings and did not align with drain holes used for rainfall drainage leading to half of the void being filled with water, adding significant superimposed loading on the girder. Additionally, high chloride levels were measured in the water which would induce reinforcement corrosion. Due to the thinner cover, the chloride was able to

corrode the bottom strand layer. Fortunately, only minor injuries were sustained during the failure but an estimated 60,000 vehicles per day were redirected due to the collapse.

Figure 2- 5: Collapse of Lake View Drive bridge girder in 2005 (Panchak, 2005).

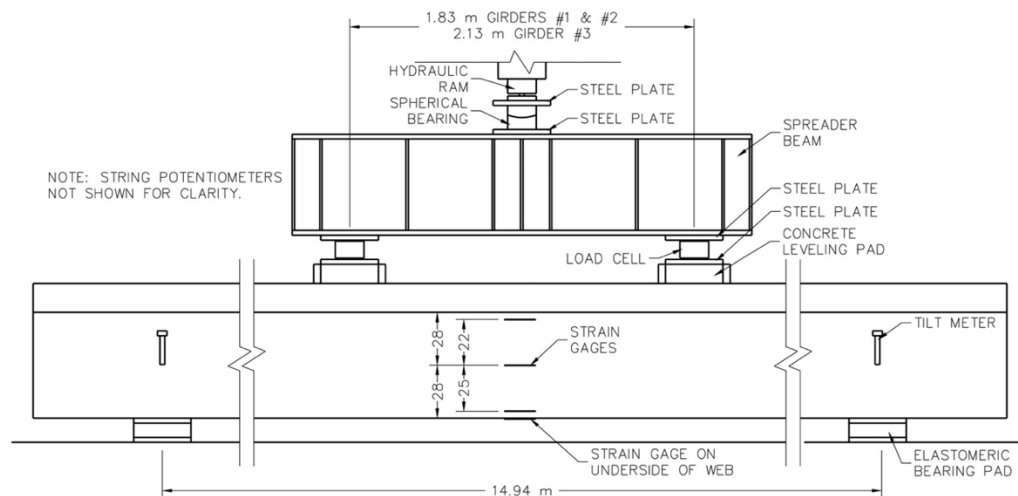
Figure 2- 7: Four-point bending test setup (Pettigrew et al. 2016).

Flexural tests are widely used to analyze the response of bridge girders under bending moments. A typical 4-point bending setup is shown in Figure 2-7. A stiff spreader beam distributes load from an actuator to the test specimen to create a region under constant moment and zero shear near midspan. Flexural testing determines the moment resistance of the test specimen, related failure modes (e.g. concrete crushing in compression, reinforcement rupture or pulling out), member properties (e.g. flexural stiffness), and also how deterioration affects different part of the member.

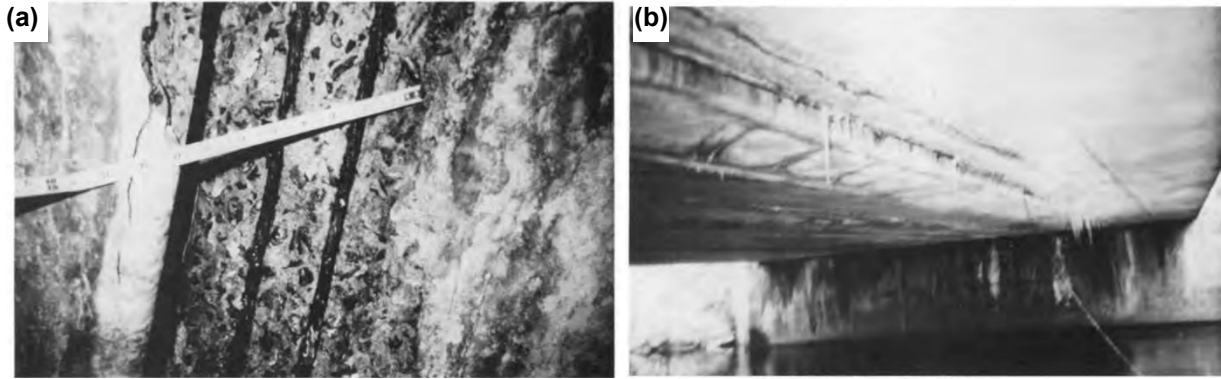
Figure 2- 8: The deterioration on the Walnut Street Bridge (a) Spalling of concrete cover (b) Ruptured prestressing strands hanging under the bridge into river (Shenoy and Frantz, 1991).

Shenoy and Frantz (1991) studied 27-year old prestressed concrete bridge girders from the Walnut Street Bridge built in 1960 in East Hartford, Connecticut. Bridges from this era were built without waterproofing membranes and at risk of corrosion in the from de-icing salt run-off penetrating into concrete. The beams in the worst condition had significant concrete spalling and exhibited ruptured prestressing strands due to corrosion (Figure 2-8)

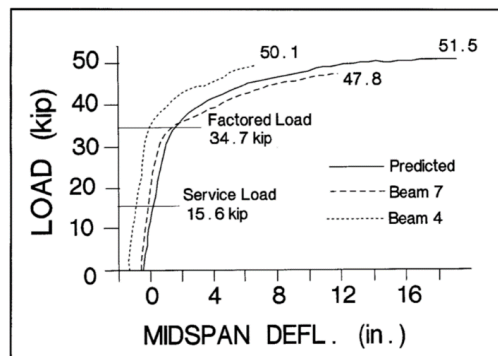
Figure 2- 9: Load deflection curves (solid curves was the prediction calculated by strain compatibility method; factored and service load were calculated using 1989 AASHTO specification) (Shenoy and Frantz, 1991). Note: 1 kip = 4.45 kN, 1 in. = 25.4 mm.

Two 17-m long box beams were tested under four-point bending at third points, monitoring load, and midspan deflection. One beam had moderate staining on both sides from water leakage from shear keys without visible damage. The other beam had severe staining and sign of minor cracking and spalling on one side while the other side only showed moderate staining. For both beams, despite the deterioration, flexural cracking was first observed at approximately twice the 1989 AASHTO service limit and the ultimate load of the two beams (223 kN and 213kN) also greatly exceeded the required factored load (156 kN) using 1989 AASHTO specification (Figure 2-9). The higher strength is attributed to these members being designed to carry a heavier live load of 80% of an HS-20 truck wheel load which is different than the AASHTO specification in 1989, but the strain compatibility method could accurately the behaviour as shown in Figure 2-9.

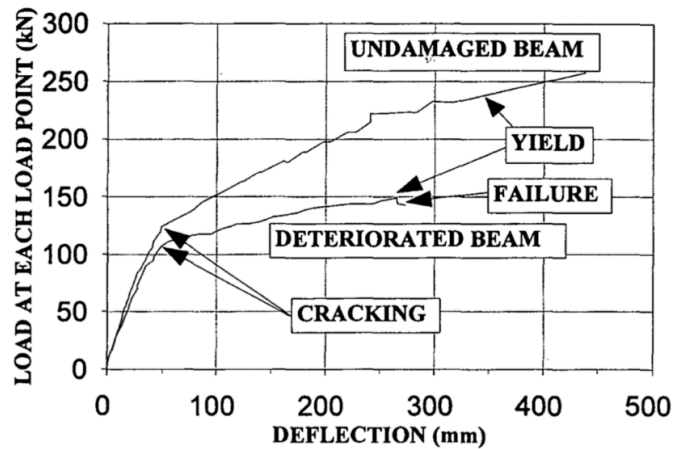
Figure 2-10: Load versus midspan deflection of the damaged and undamaged beams (Miller and Parekh, 1994).

(Figure 2-10). The authors believed the lower values were due to a combination of prestress loss and loss of cross-sectional area due to corrosion, but prestress loss could not be estimated because of the sudden failure. The damaged beam also experienced a relatively large (28 mm) lateral deflection because the deterioration caused asymmetry of the strands and cross section. The authors recommended adding transverse post tensioning which ties the beams together and can help resist the lateral deflection.

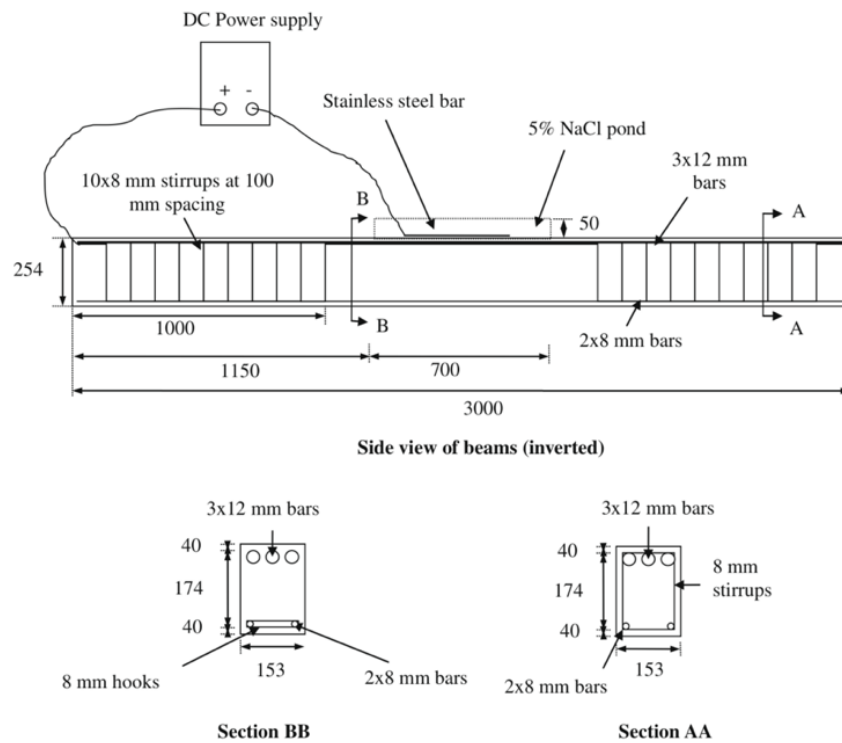
Figure 2- 11: Accelerated corrosion setup and steel configurations for test beams (Malumbela et al., 2010).

Malumbela et al. (2010) investigated the variation of mass loss of rebar due to deterioration in reinforced concrete beams. Nine beams with a dimension of 153×254×3000 mm were cast. These ‘virgin’ beams were then put under sustained loading up to 12 % of the expected ultimate load capacity. The three tensile reinforcing bars of the beam were then artificially corroded locally at around midspan for a length of 700 mm by placing this region into a 5% NaCl solution combined with an impressed current and different wet and dry cycles (Figure 2-11).

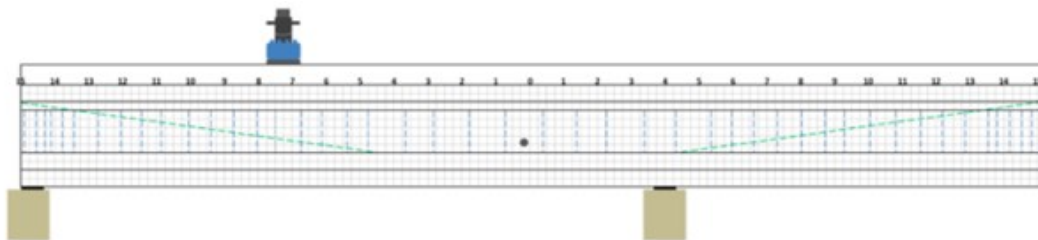
Figure 2- 12: Three-point bending setup (Floyed et al., 2016).

Shear behaviour needs to be studied to investigate whether deterioration would cause undesired shear failures. Shear test setups create a shear-critical region in the specimen by applying loads near supports. This region is subject to large shear forces and small moments and simulates wheel loading near girder ends. A typical setup is shown in Figure 2-12 with a simply supported girder and point load on top (Floyed et al., 2016). Shear tests allow the study of mechanisms such as diagonal tension cracking, diagonal compression failure, and reinforcement dowel action.

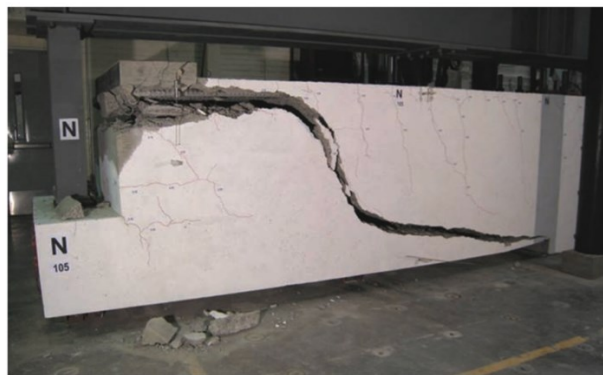
Figure 2- 13: Shear failure of the prototype cantilever using the as built properties of the de la Concorde overpass (Johnson et al., 2007).

The collapse of de la Concorde overpass in Laval is unfortunate proof that shows the importance of understanding the shear behaviour of deteriorated girders. This overpass collapsed due to shear failure because of a combination of faulty design, deterioration and construction errors (Johnson et al., 2007). Laboratory testing of a specimen constructed with the as-built properties of this bridge without deterioration showed an explosive and sudden shear failure. A horizontal crack at the upper part of the slab extended up to the diagonal bars. This crack later turned into inclined shear crack propagating downward through the slab and created the similar horizontal crack around the lower rebar splitting the member (Figure 2-13). The prototype without deterioration was able to resist loading present on the overpass when it collapsed which indicates that deterioration played a decisive role on load carrying capacity.

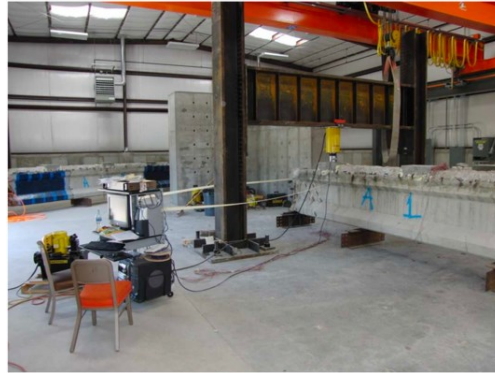
Figure 2- 14: Three- point bending test setup (Osborn et al., 2012).

between 28% to 55% of the ultimate shear capacity due to the code's assumption of plane sections remaining plane. Strut and tie models more accurately predicted the strength of the tested girders within 2% to 22% of the average measured value Osborn et al. (2012).

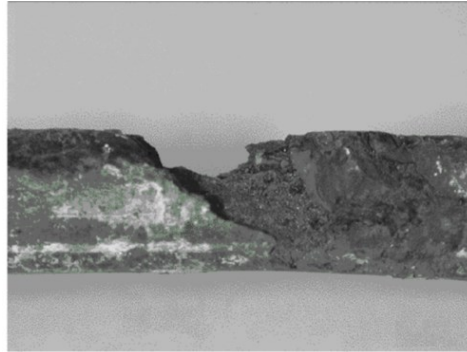
Figure 3- 1: Pitting corrosion of steel reinforcement used in concrete (Bertolini et al., 2004).

Brownish bleeding stains on the outer surface of the structure caused by the chloride corrosion product, FeCl_3 , are indicators of chloride induced corrosion. Pitting corrosion, shown in Figure 3-1, is a localized and difficult to detect form of corrosion that results in significant reinforcement cross-section loss. Pitting corrosion is associated with prolonged chloride induced corrosion concentrated in small regions from chemicals accumulated inside the pit (Bertolini et al., 2004).

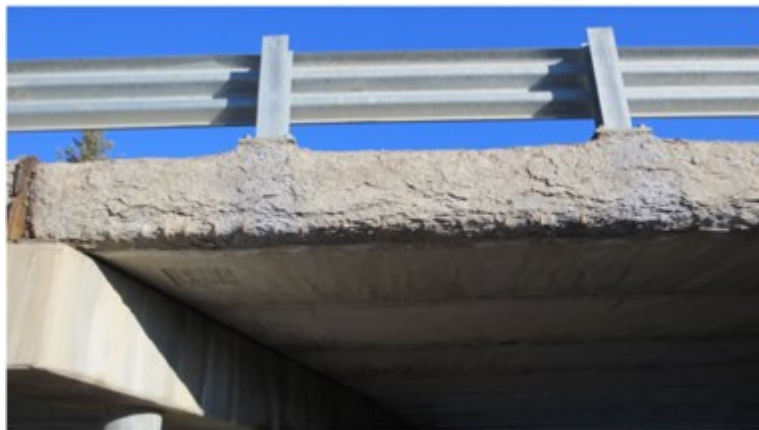
Figure 3- 2: Concrete section loss due to freeze and thaw damage (AT, 2017).

Another type of deterioration is caused by freeze-thaw cycling. Deterioration occurs when water volume in concrete pores increases due to freezing, which induces tensile stresses in concrete around the freezing water. This leads to a cascading effect where water further infiltrates these pores and eventually causes damage such as scaling or spalling after undergoing multiple freeze-thaw cycles as shown in Figure 3- 2.

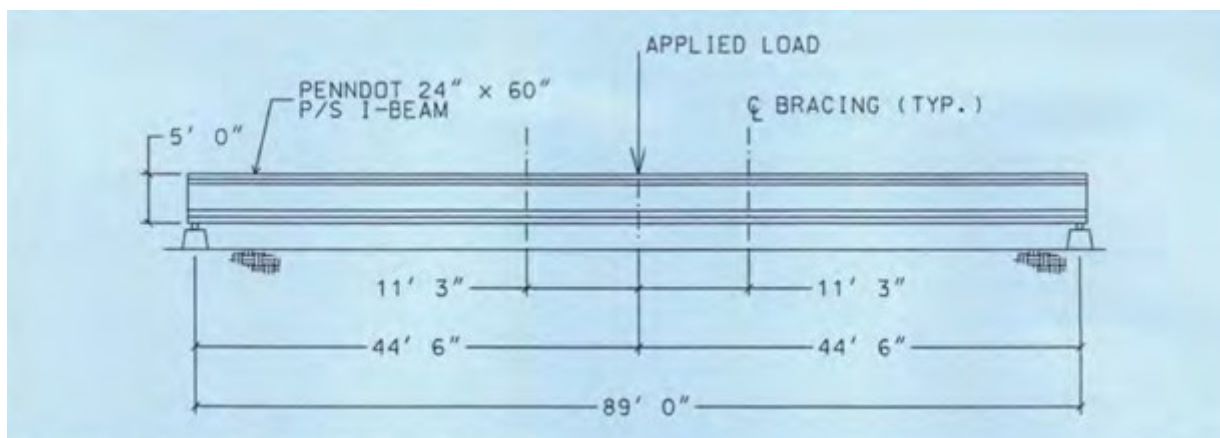
Figure 3- 3: Test setup used by Pessiki et al (1996) to determine cracking and decompression loads in prestressed ‘I’ girders. 1 foot = 305 mm, 1 inch = 25.4 mm (Pessiki et al., 1996).

The residual capacity of deteriorated bridges can be determined effectively through testing. Pessiki et al (1996) studied the prestress loss in the strands of two full scale “I” shaped prestressed concrete bridge beams after 28 years in service. Each beam was first loaded a series of flexural cracks formed. These cracks were tracked by cable transducers and strain gauges. Later these beams were repeatedly loaded in a quasistatic manner using the same instrumentation to track crack opening and determine the decompression load (Figure 3-3). The authors found an average prestress loss of 18% for the beams, while design specifications (AASHTO, 1992) only predicted a prestress loss of 10.8%.

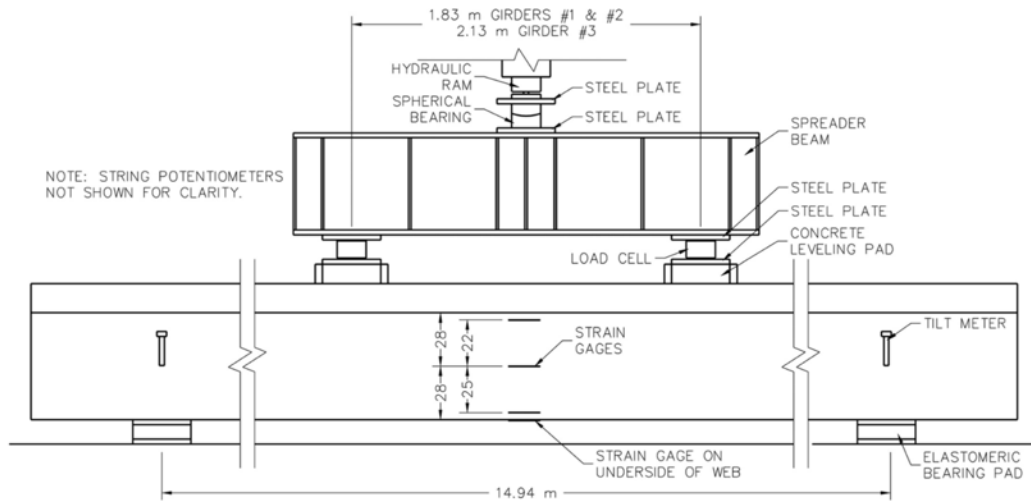
Figure 3- 4: Four-point bending test setup (Pettigrew et al., 2016).

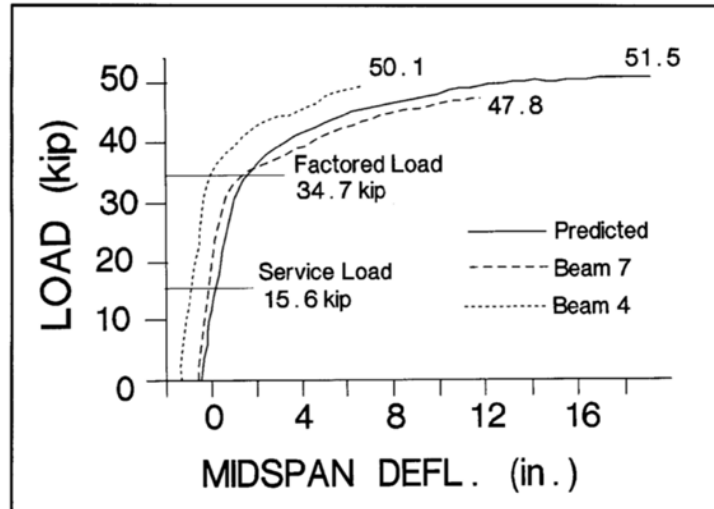
Figure 3- 5: Experimental and predicted load deflection curves from prestressed concrete girders tested by (Shenoy and Frantz, 1991). 1 kip = 4.45 kN, 1 inch = 25.4 mm.

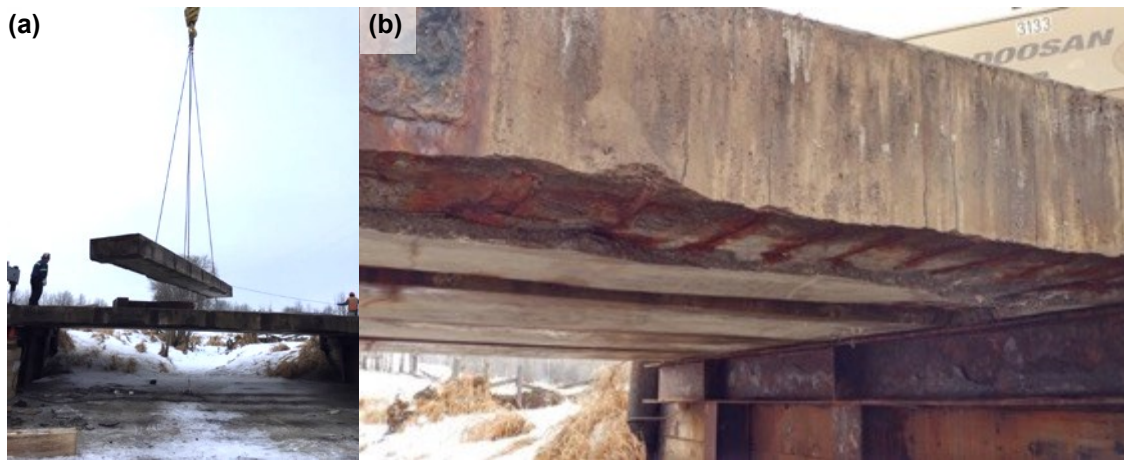
Figure 3- 6: (a) Bridge being taken apart, (b) photo of heavily deteriorated girder.

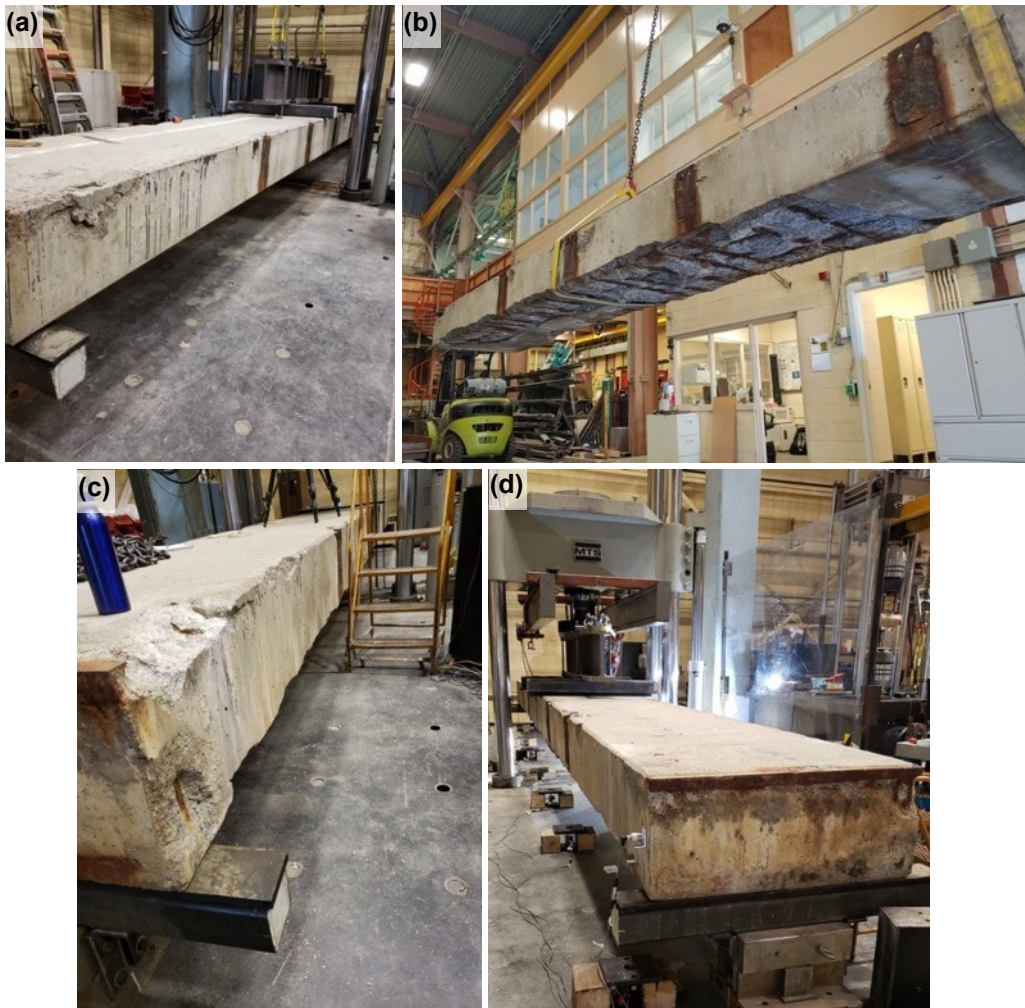
Figure 3- 8: Girder conditions (a)Girder LD with no visible damage (b) Girder HD with severe concrete loss and steel corrosion (c)Girder MD with moderate deterioration (d) Girder ID with moderate deterioration and induced corrosion .

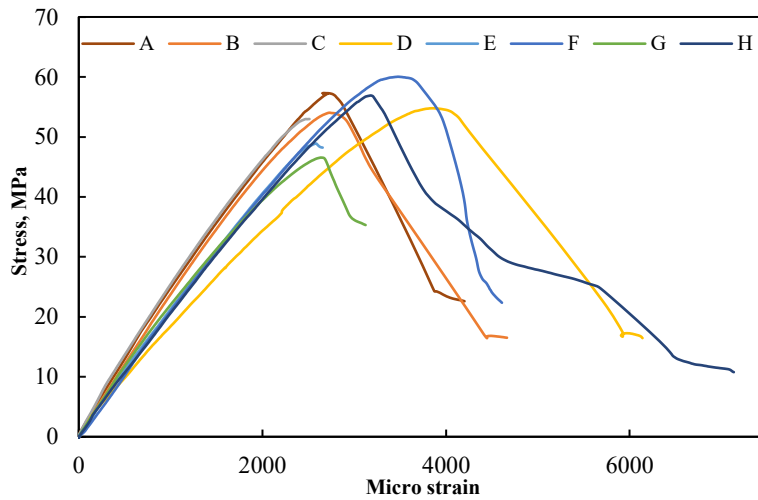
Figure 3- 11: Stress Strain Curves from concrete cylinders extracted from the tested girders.

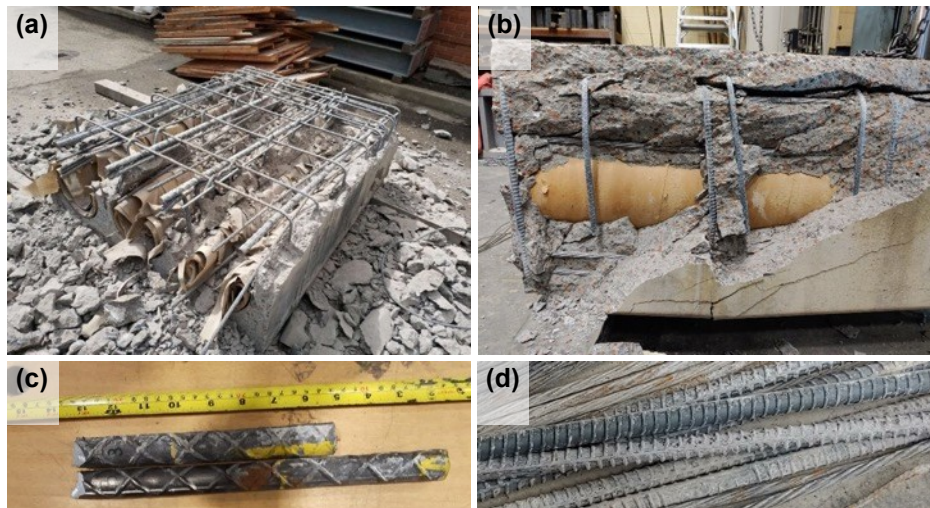
Figure 3- 12: (a) Extraction of rebar from Girder LD (b) Failed Girder MD with both types of bars visible (c) ‘X’ ribbing in Girder LD’s 25M bars and (d) ‘bamboo’ ribbing on 25M bars from other girders.

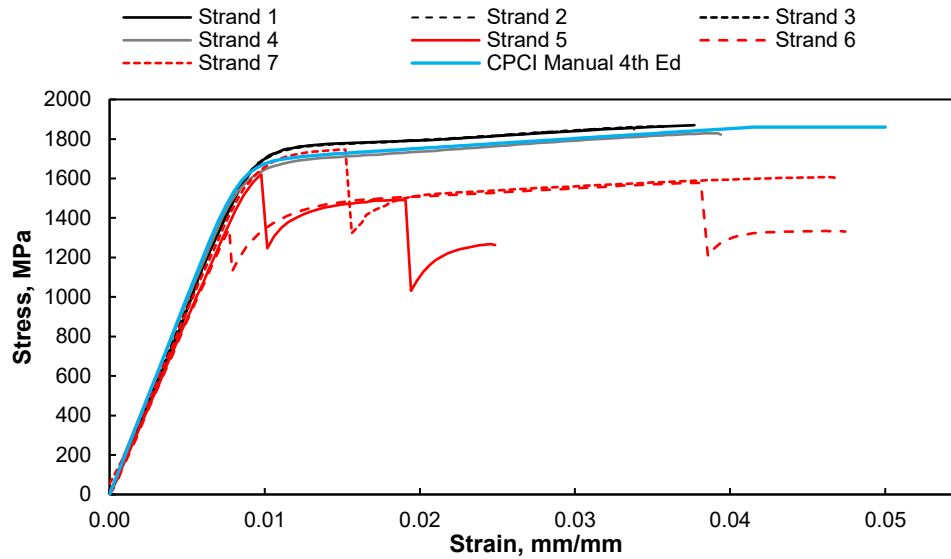
Figure 3-15: Stress and strain curve for prestressing seven wire strands.

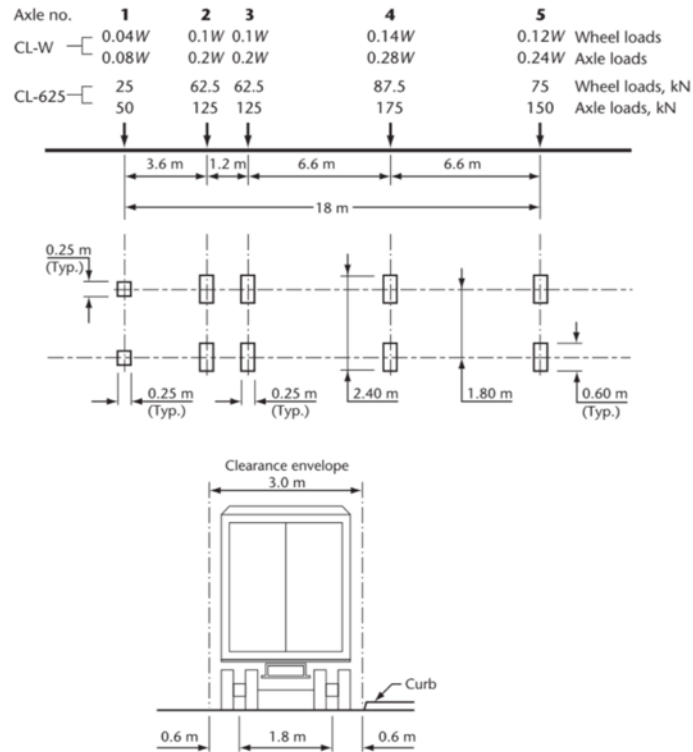
Figure 3- 17: CL-W truck load (CSA S6:14, 2014)

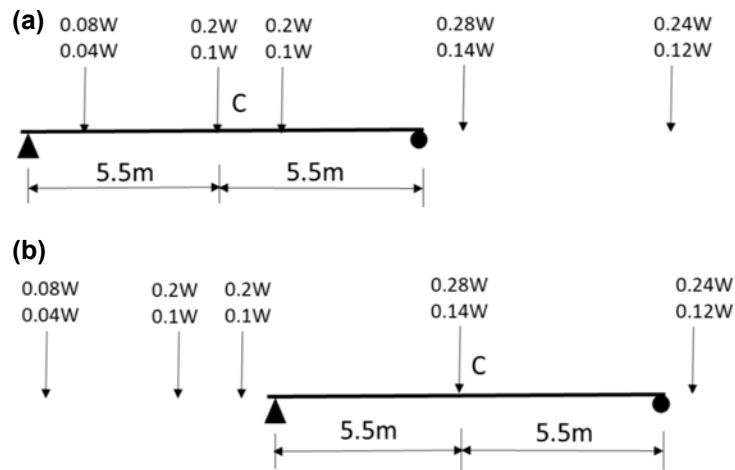
Figure 3- 18: possible critical midspan moment cases using truck load (a) first three axle numbers of the truck are on the bridge girder (b) the heaviest axle (no.4) is located at midspan of the girder (Huang, 2020).

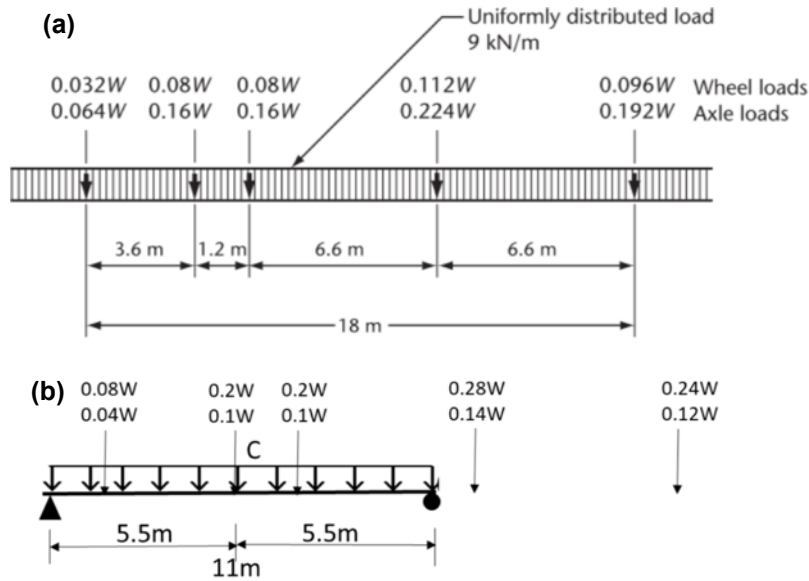
Figure 3- 19: Lane load considered (a) CL-W lane load (CSA S6:14,2014) (b) possible critical midspan moment (Huang, 2020).

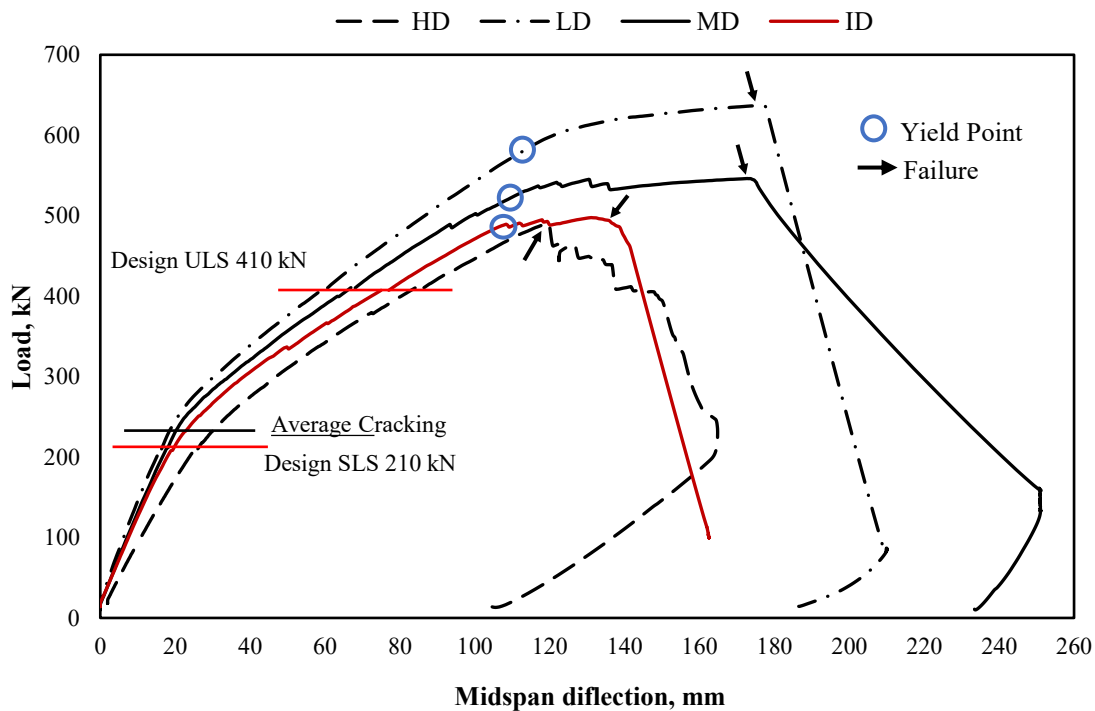
Figure 3- 20: Load deflection curves.

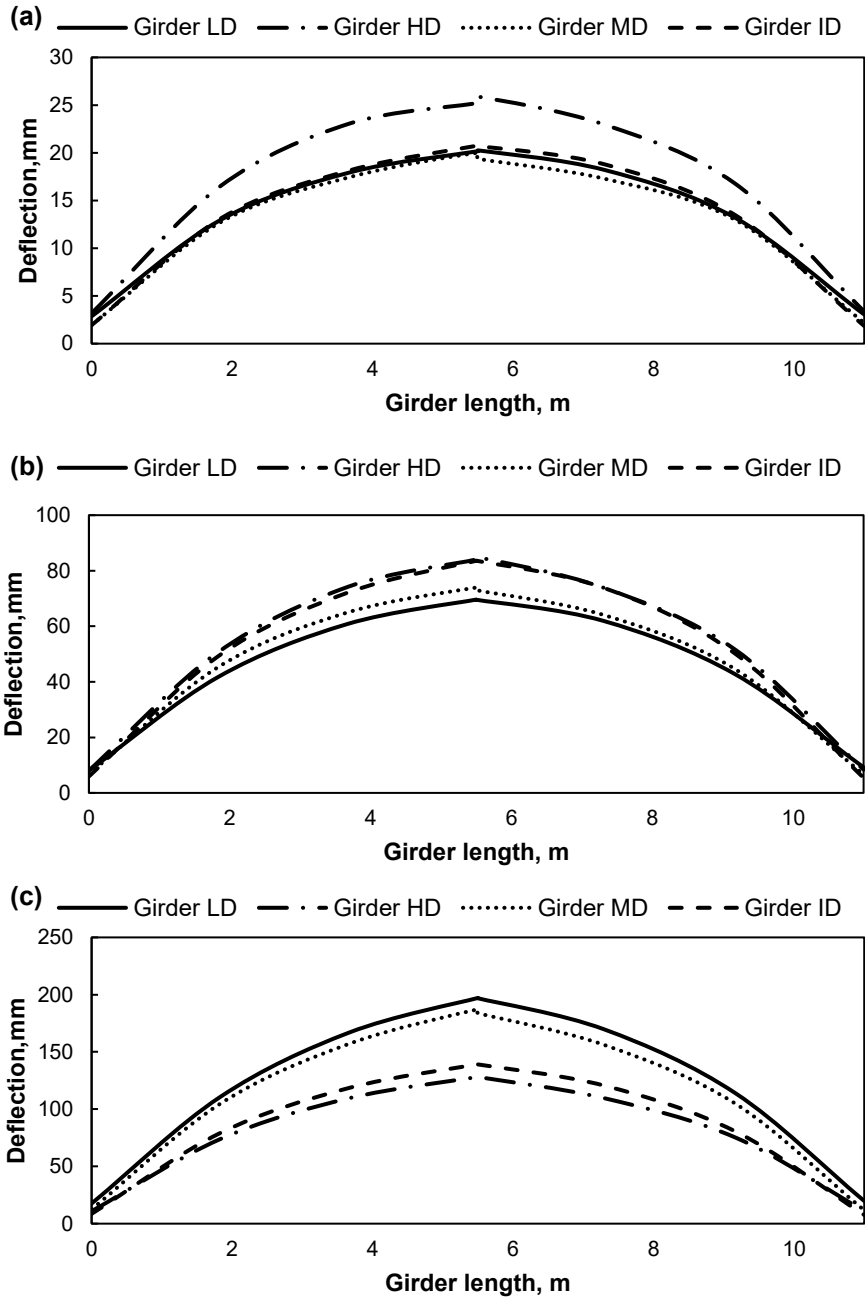
Figure 3- 21: Deflected shapes at (a) SLS, (b) ULS, (c) failure.

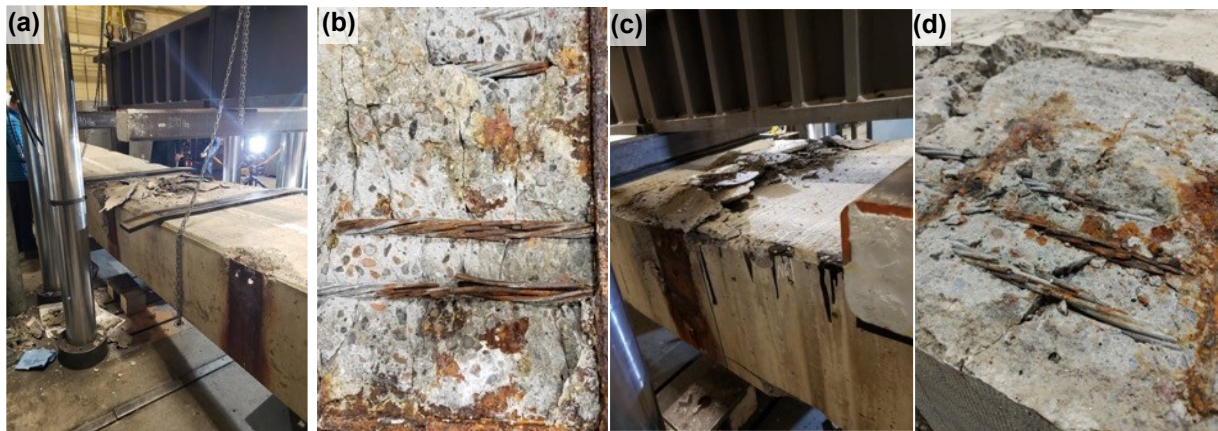
Figure 3- 22: Failure modes of tested girders (a) Girder LD – concrete crushing, (b) Girder HD– strand rupture, and (c) Girder MD – concrete crushing, (d) Girder ID – strand rupture.

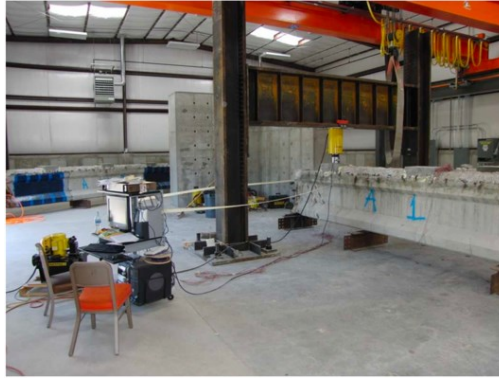
Figure 4- 1: Three- point bending test setup (Osborn et al., 2012).

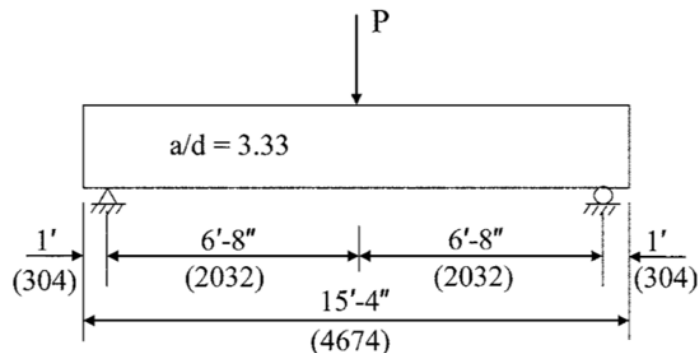
Figure 4- 2: Three- point bending test setup. Dimensions in parenthesis are in mm. (Saqan and Frosch, 2009).

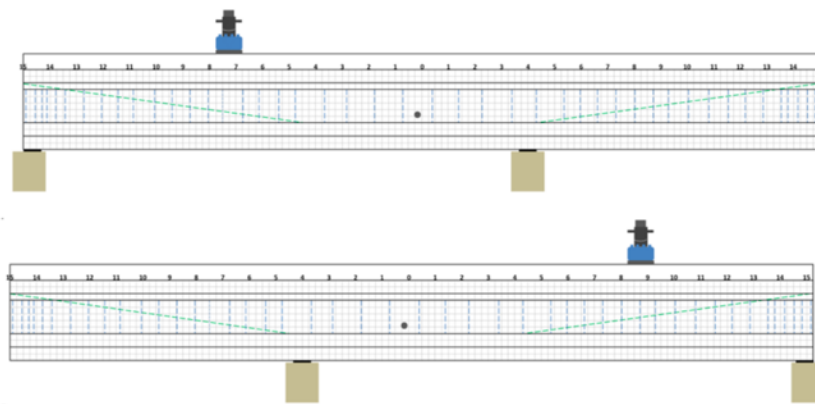
Figure 4- 3: Three- point bending test setup (Floyed et al., 2016).

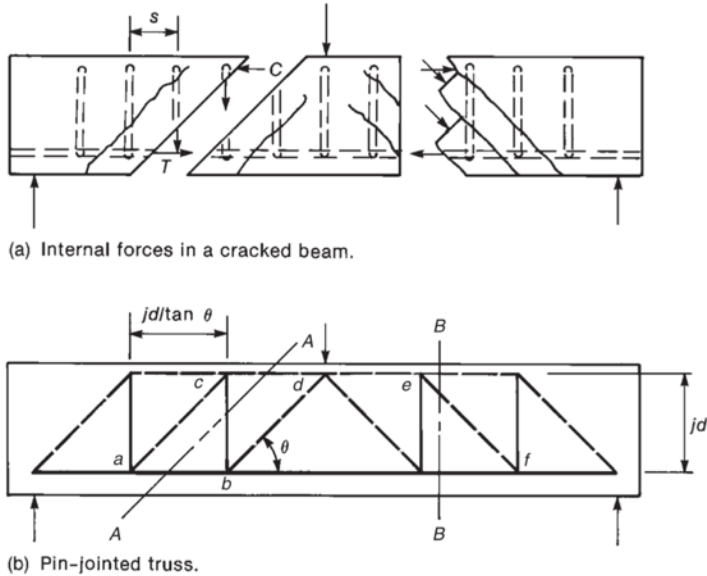
Figure 4- 4: Truss analogy (Wight and MacGregor, 2012).

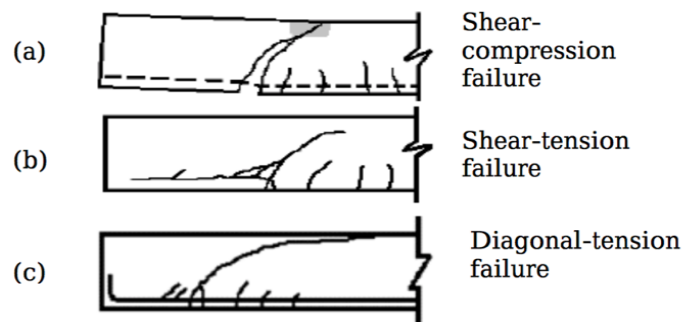
Figure 4- 5: Different types of shear failures (Sinha, 2002).

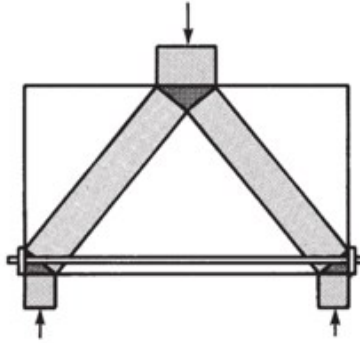
Figure 4- 6: A strut and tie model of a deep beam (Sinha, 2002).

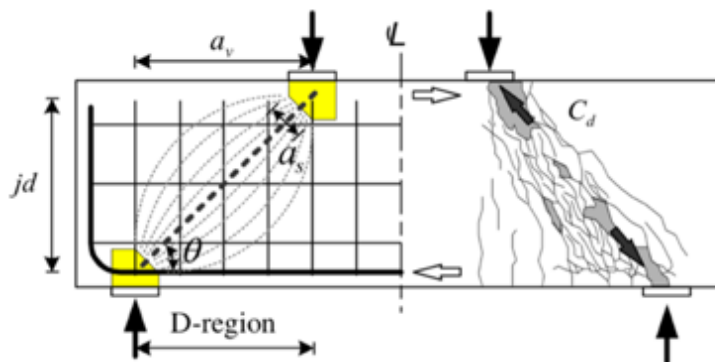
Figure 4- 7: A strut and tie model of a deep beam (Kuo et al., 2010).

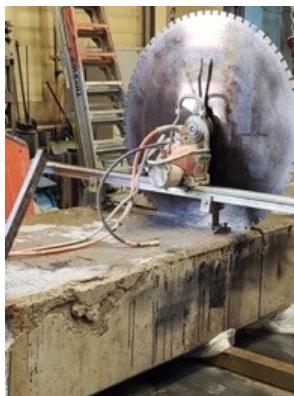
Figure 4- 8: Flexural girder cutting.

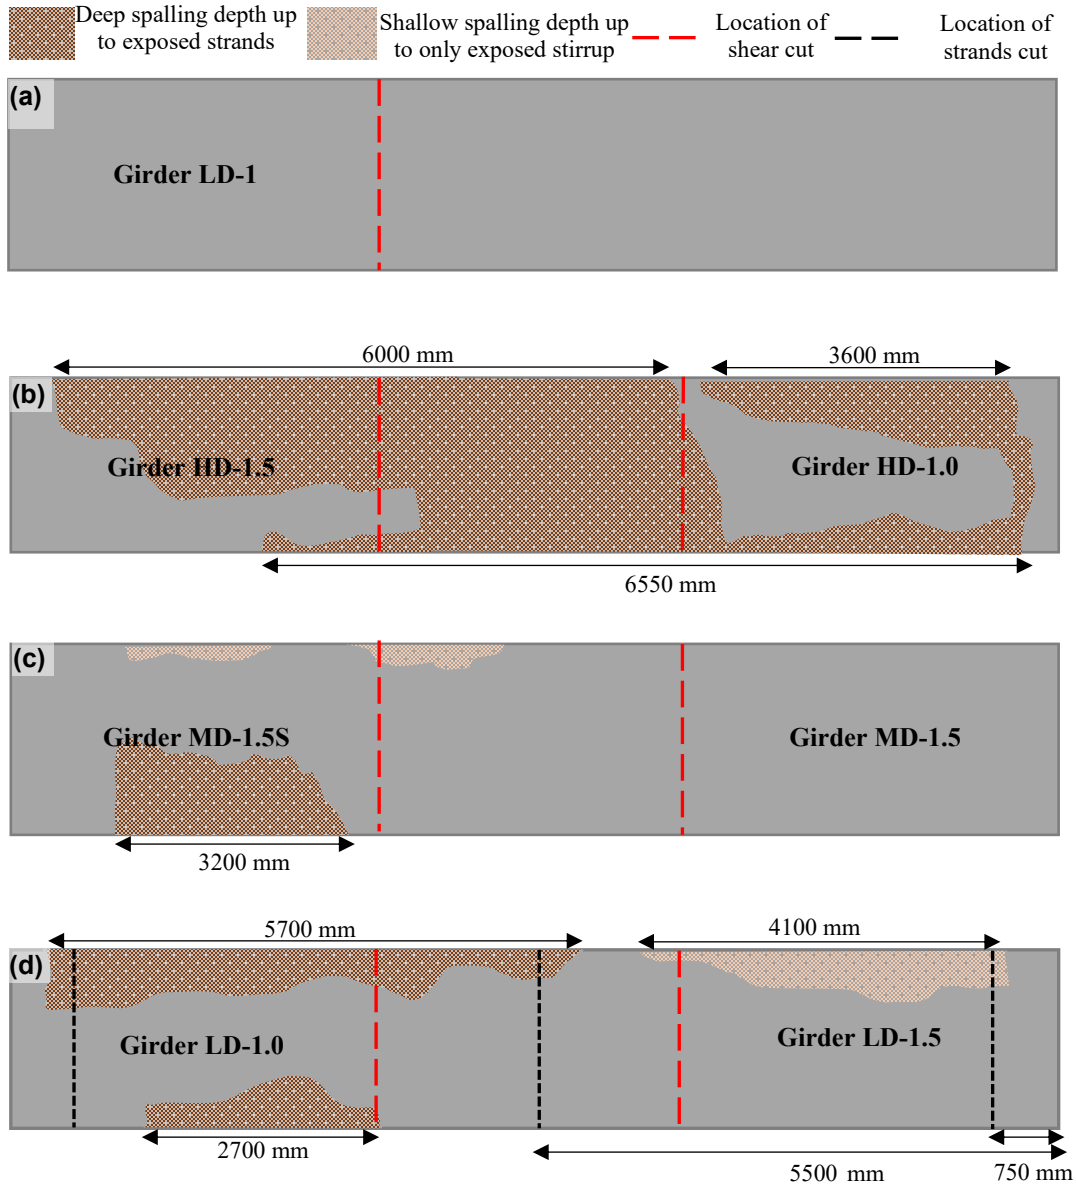
Figure 4- 9: Shear girders from the original flexural girders and their deterioration mapping (a) LD-1 (b) HD-1.5 and HD-1.0 (c) MD-1.5S and MD-1.5 (d) ID-1.5 and LD-1.0.

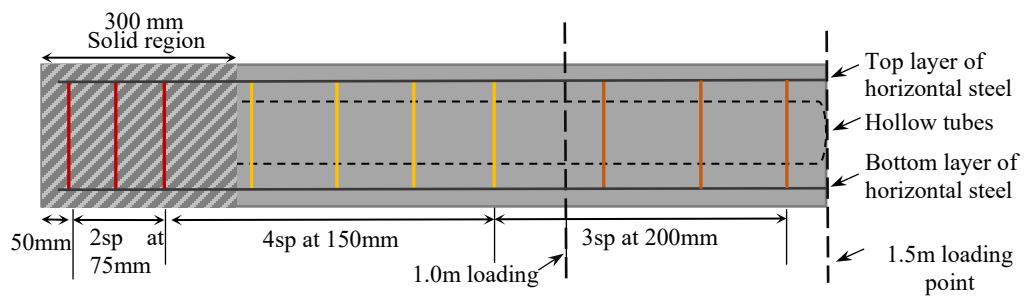
Figure 4- 10:Stirrups layout on the girder up to 1.5m load point.

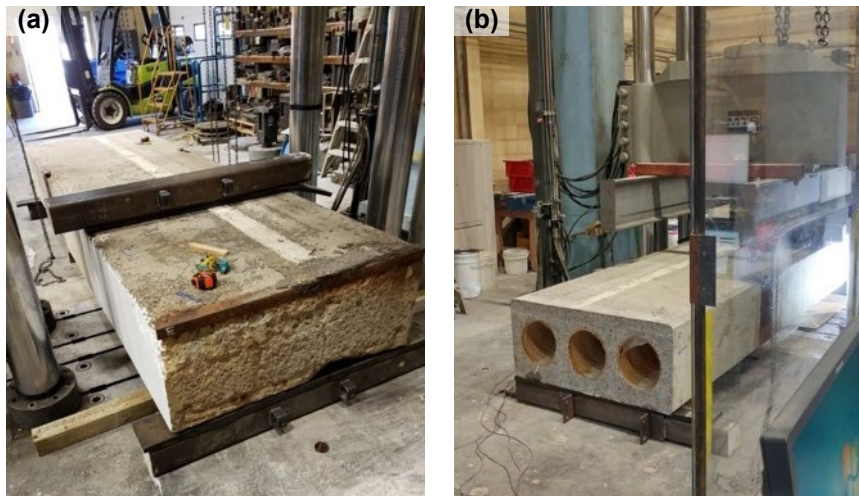
Figure 4- 11: Girder LD-1 with no visible deterioration damage (a) tested shear span region (b) other end.

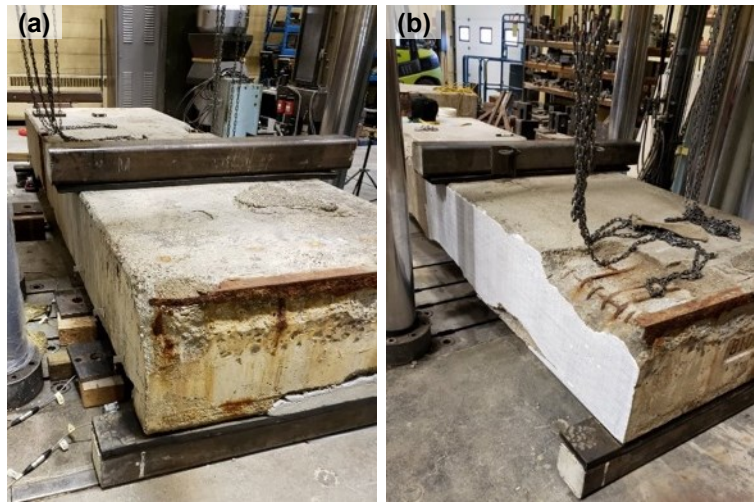
Figure 4- 12: (a) Girder HD-1 and (b) Girder HD-1.5.

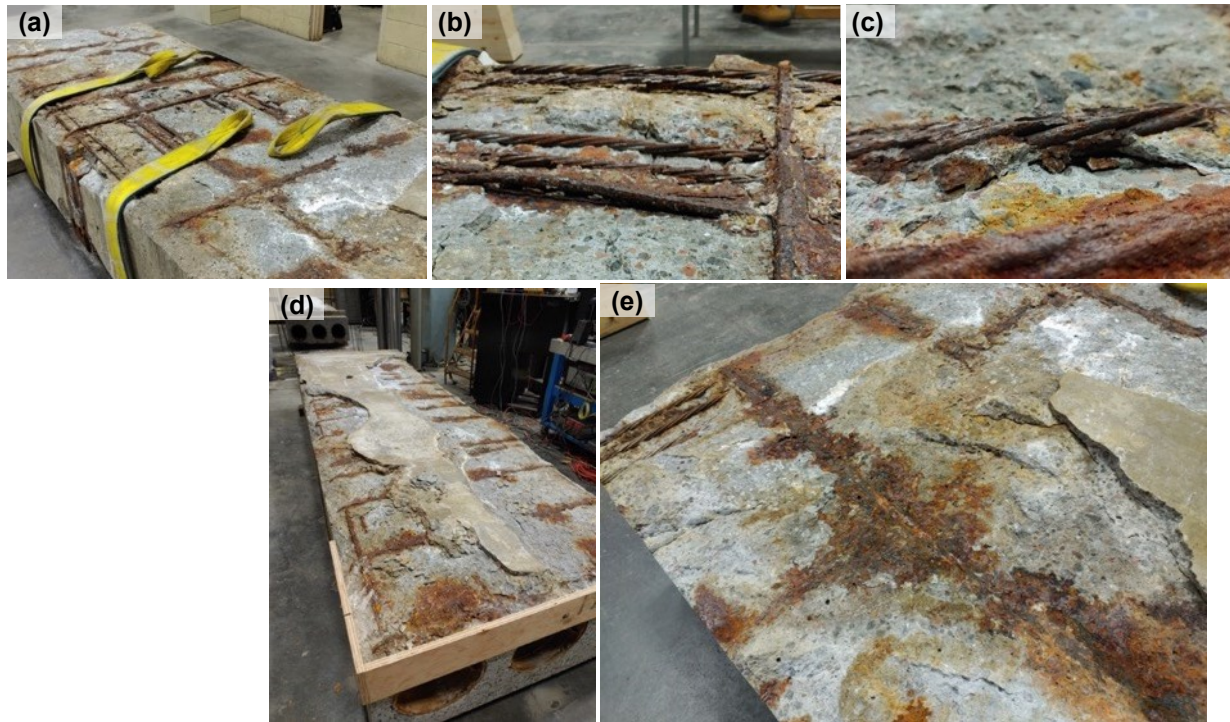
Figure 4- 13: Location of deterioration on the tension side of Girder HD (a) midspan region of girder with most severe corrosion (b) strands in midspan region showing evidence of pitting corrosion (c) photo of single strand showing damage at midspan (d) significant spalling and reinforcement corrosion but limited strand corrosion for Girder HD-1 (e) significant spalling and reinforcement corrosion but limited strand corrosion for Girder HD-1.5.
