**Flexural and Shear Response of Deteriorated Prestressed Concrete Girders Taken from a
Decommissioned Bridge in Alberta**

Zhaohan Wu

A thesis submitted in partial fulfillment of the requirements for the degree of

University of Alberta

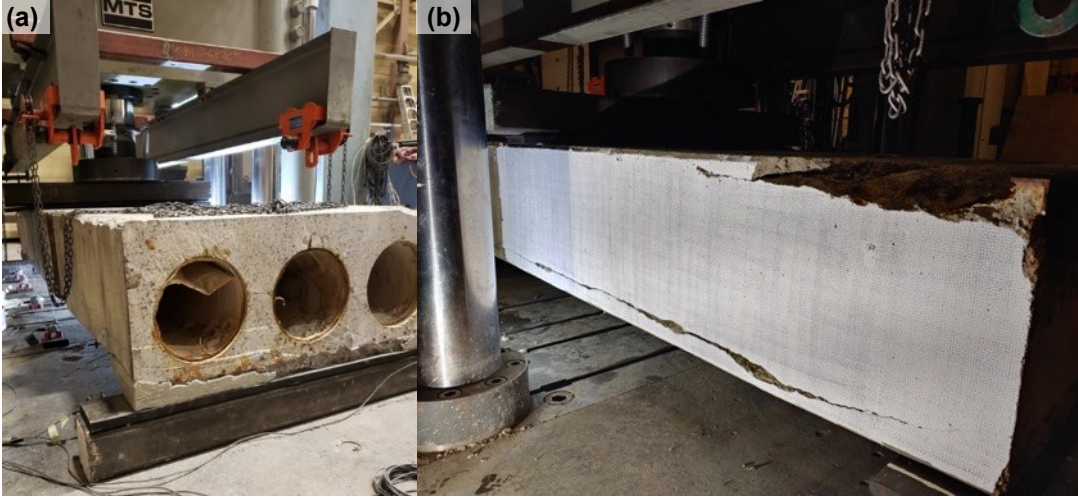
Figure 4- 14: (a) Girder MD-1.5S (b) Girder MD-1.5.

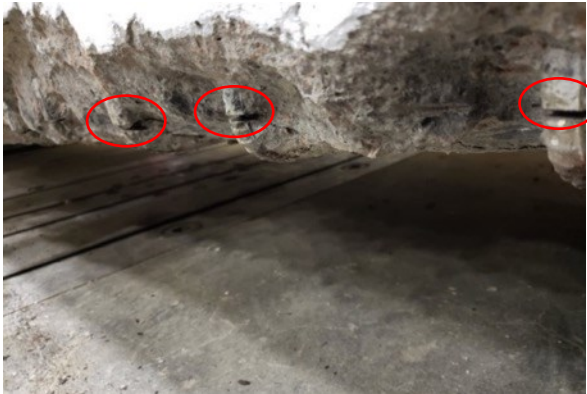
Figure 4- 15: Cut stirrups (cuts circled) on girder MD-1.5S. These stirrups had limited deterioration as evidenced by their colour and lack of pitting corrosion.

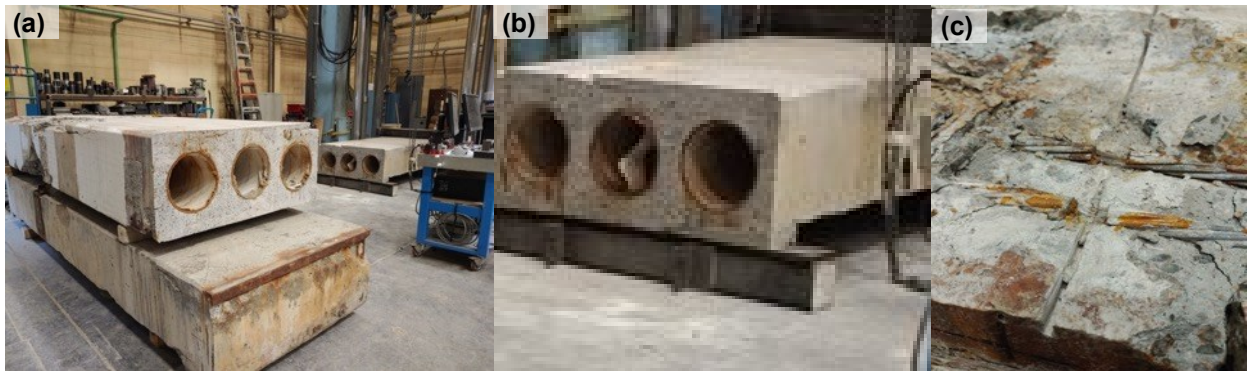
Figure 4- 16: (a) Girder LD-1, (b) Girder LD-1.5, and (c) Cut strands for Girder ID for induced deterioration.

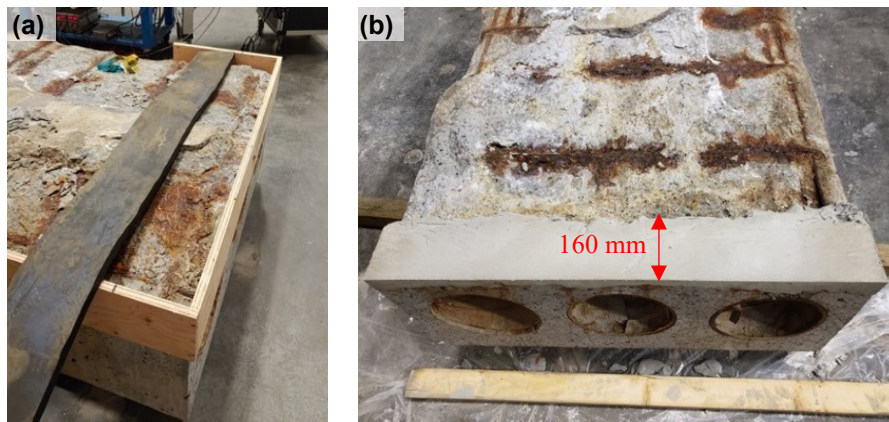
Figure 4- 18: Grouting of girder end with damage (a) before grouting (b) after grouting.

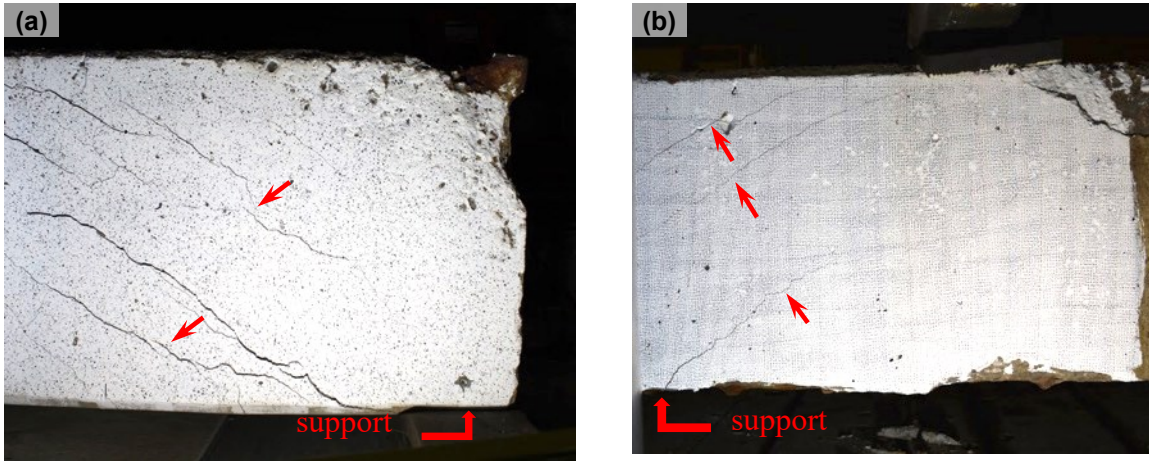
Figure 4- 20: Strut formation on shear girders with diagonal cracking indicated with arrows (a) Girder LD-1 (b) Girder HD-1.

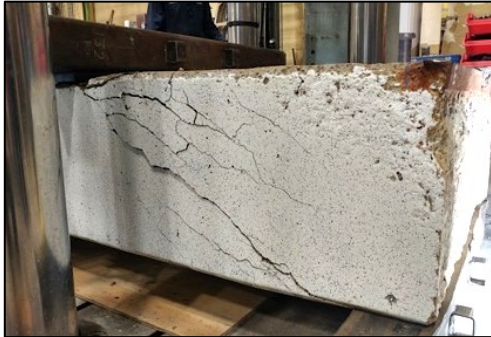
strut crushing under load point
Girder HD-1

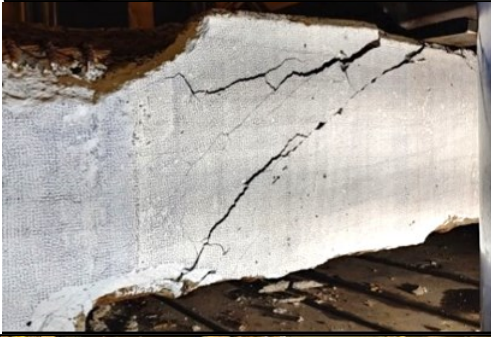
strut crushing under load point
Girder ID-1

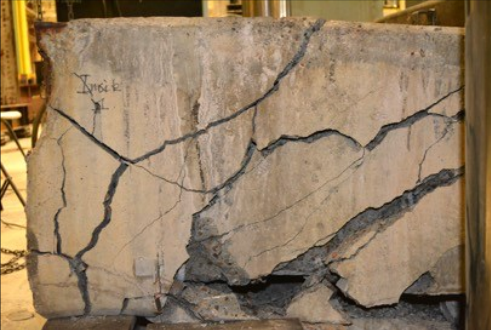
Strut crushing accompanied with some anchorage failure at support

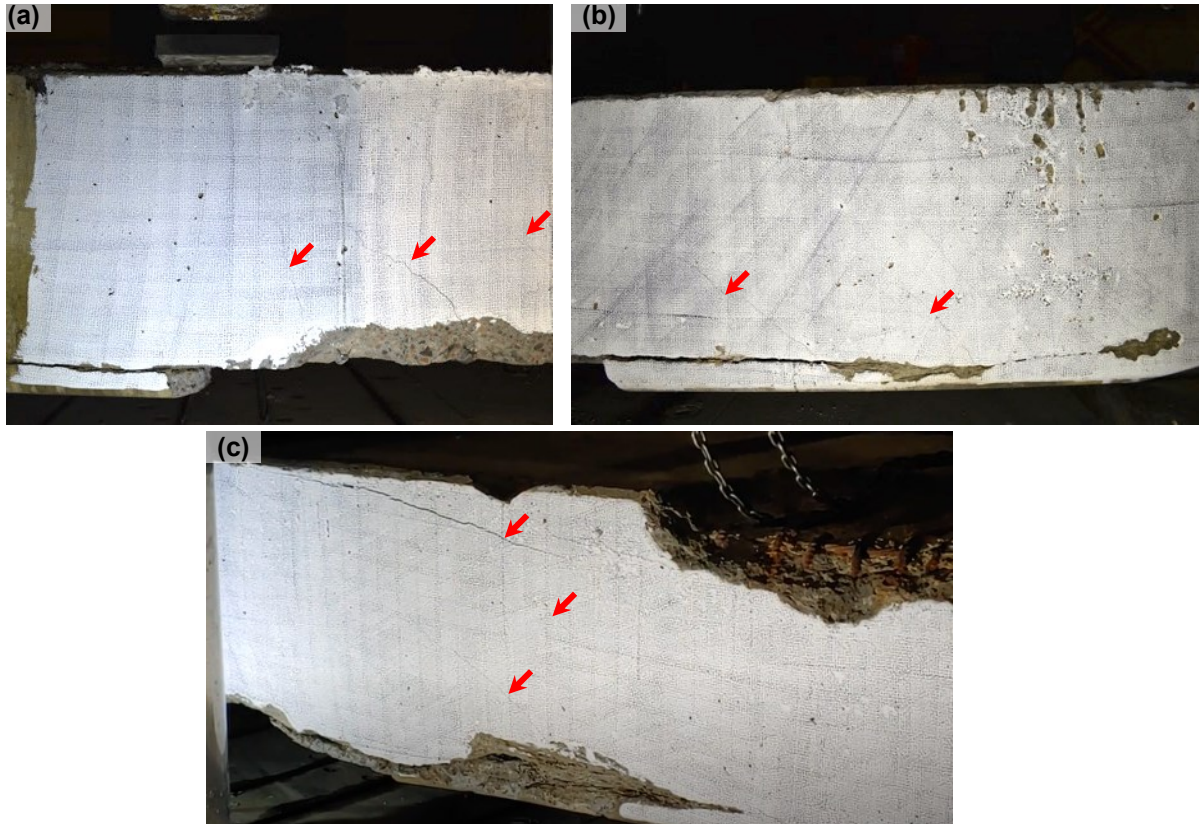
Figure 4- 22:Strut formation with crack location indicated by arrows (a) Girder MD-1.5S (b) Girder ID-1.5 (c) Girder HD-1.

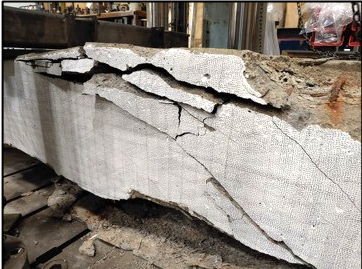
<p>Shear compression failure with crushing of concrete beside load point at the top of the shear crack</p>
Girder MD-1.5

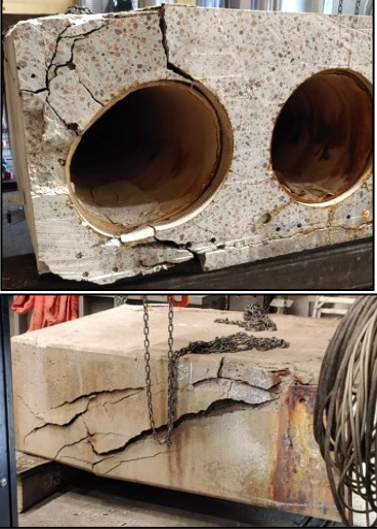
<p>Anchorage failure of horizontal reinforcement on the cut side of the girder which also led to strut crushing. The cross section indicated that reinforcement and strands slipped and retracted into the girder</p>
Girder MD-1.5S

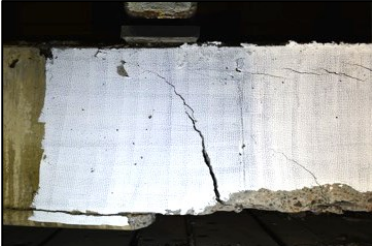
<p>Diagonal tension failure due to insufficient stirrups</p>
Girder ID-1.5

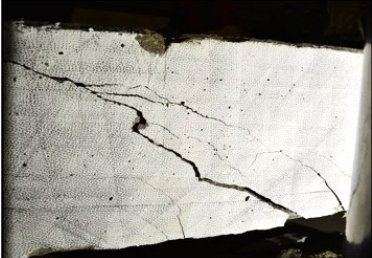
<p>Shear compression failure</p>
