Evaluation of Backfill Solution for Micro-Trenching in Cold Regions

A thesis submitted in partial fulfillment of the requirements for the degree of

Civil (cross-disciplinary)

University of Alberta

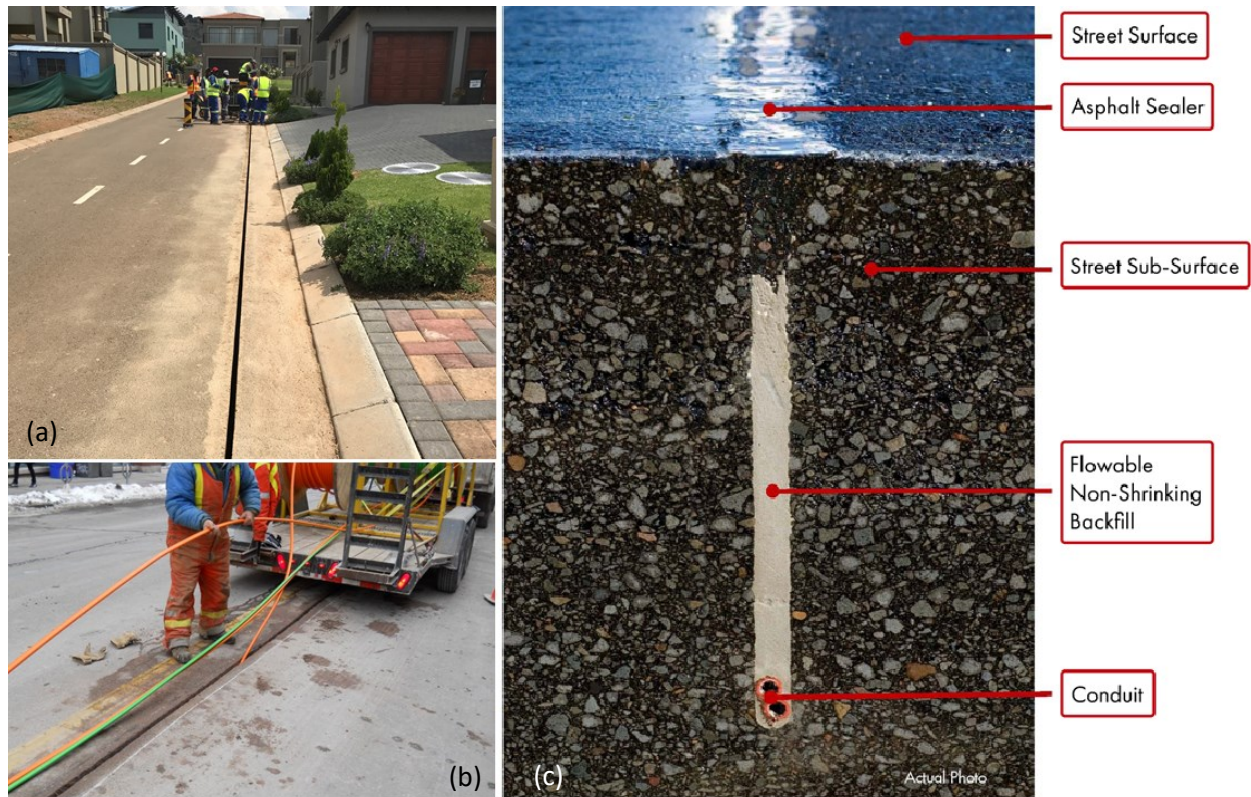
Figure 2-1: Micro-trenching application. (a) Cutting (Linteg Technologies). (b) Laying cables (The Fiber Optic Association). (c) Backfill cross-section (Certus View)

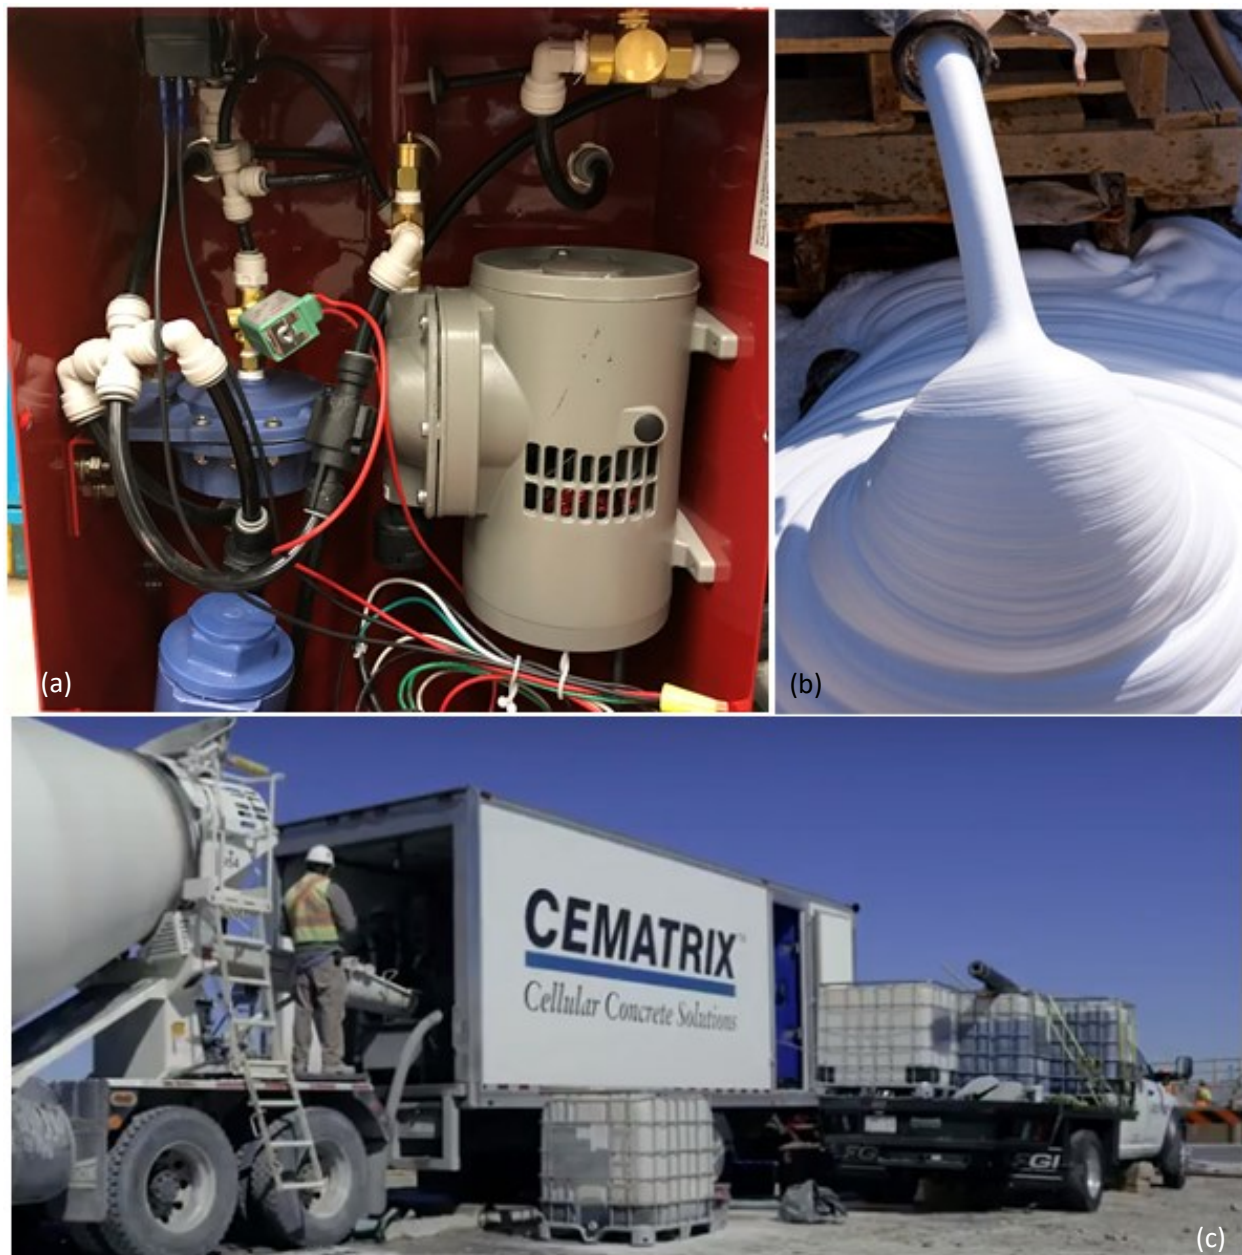
Figure 2-2: Cellular concrete production. (a) Foam dry method system. (b) Foam consistency (Thiessen Team, 2011). (c) In-situ application (Cematrix, 2018)

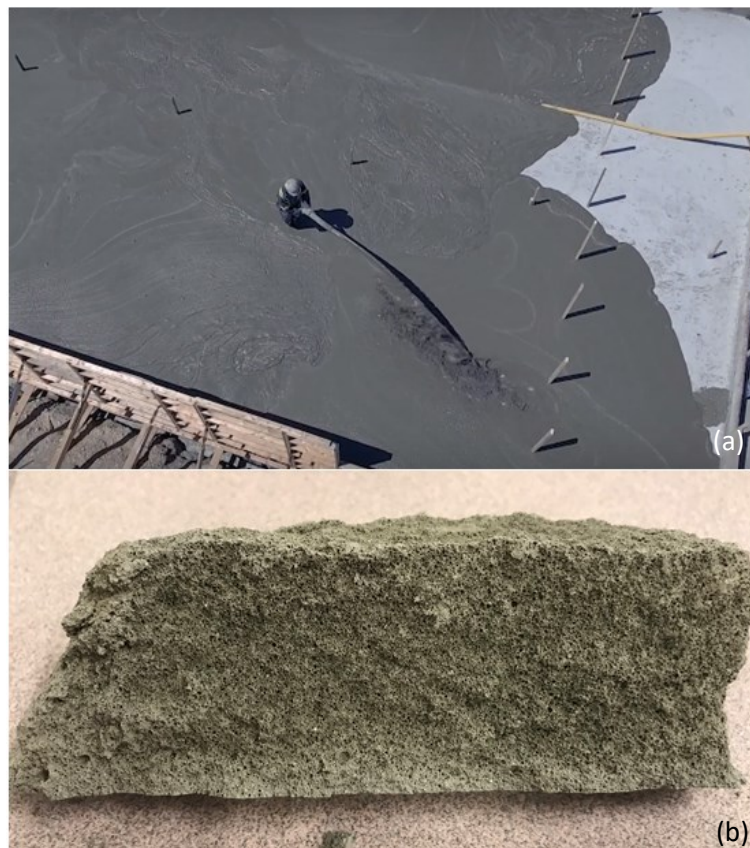
Figure 2-3: Details of foam grout (a) flowability (Cematrix, 2018), and (b) air void content

The ability to be produced and modified on-site is likely the biggest advantage of foam grout (Liew, 2005). A foam generator can guarantee a constant production of foam while the mix's density can be easily manipulated by the quantity of foam added. For foam grout, density and compressive strength are directly proportional (Jones, 2005, Kearsley, 2005, Liew, 2005, Ramamurthy, 2009). Such property creates a balance between the percentage of foam in the mix, and consequent volume expansion, and the strength requirements of each particular project. Liew (2005) provided insight on possible applications for the material based on different properties and density ranges. Low density materials were recommended for road sub-base over soft soil, as well as roofing insulation and fire breaks due to its thermal resistance. Medium density mixes were suggested for trench reinstatement, void filling and floor construction once it is extremely fluid, does not settle and requires no compaction (Figure 2.3-a). High density mixes are not considerably different from regular grout and could, therefore, be used as reinforced slabs and retaining walls. Additionally, the aerated constitution of the material is extremely effective for freezing/thawing resistance in cold region applications (Figure 2-3.b).

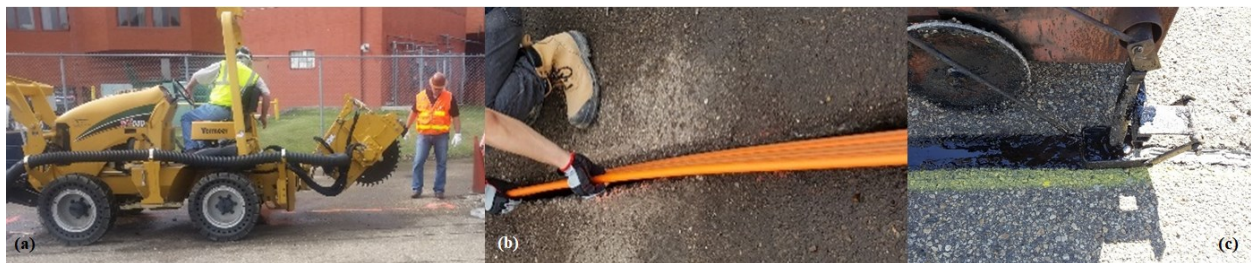
Figure 3-1: Micro-trenching procedure (Rezai, 2016). (a) Cutting the trench. (b) Laying cable. (c) Backfilling

to service providers as fiber-to-the-home (FTTH) (Duraline, 2016). Using this technique, a trench no wider than 40 mm and between 120-300 mm deep is created alongside the edge of the road; trenching closer to the curb is preferable in order to avoid direct load caused by vehicles in their wheel path (Network Strategies, 2008). The trench is then cleaned and cables are laid inside. The most important step of this method is backfilling. The pavement must be – as much as possible – reinstated to its original condition. However, the size of the trench poses a great challenge to this process. Materials used as backfill must secure the cable inside the trench and be self-compact, flowable, stable, properly bond with the existing structure, and prevent water penetration (Stirling Lloyd Polychem, 2011). It is important to note that the cut normally affects more than one layer of the pavement. Therefore, more than one material is usually applied as backfill. Figure 3-1 presents the three-step procedure for micro-trenching including cutting the trench (a), laying the cable (b) and backfilling (c).

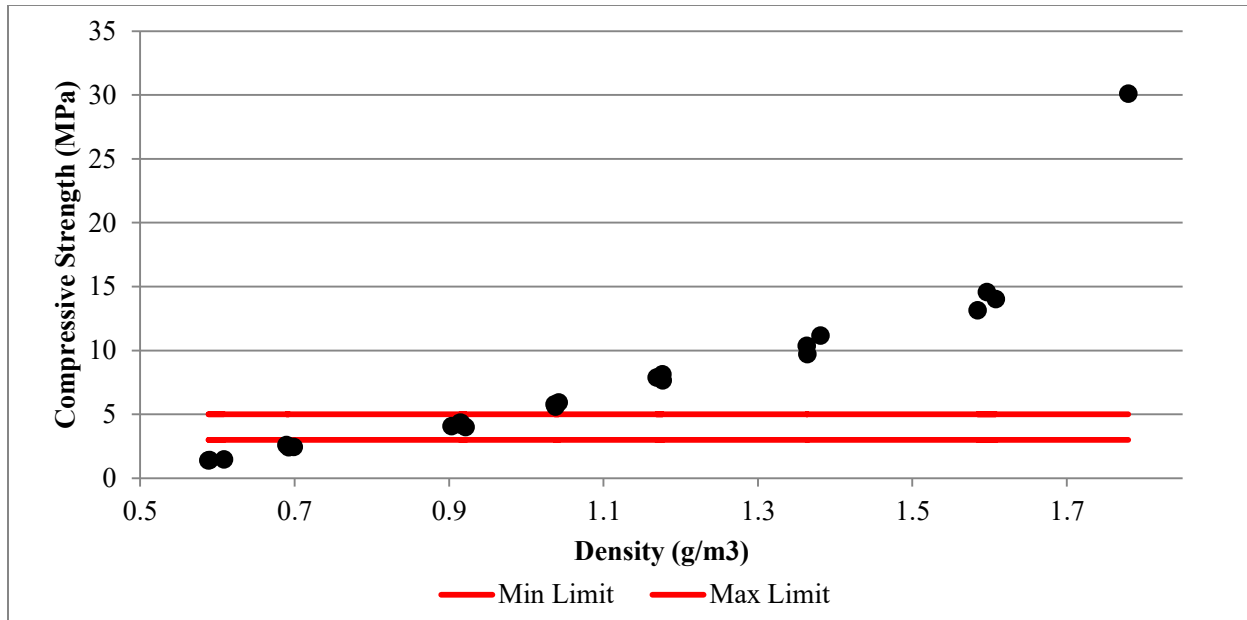
Figure 3-4: Compressive strength variations with density

Figure 3-4 demonstrates the decrease in compressive strength obtained after decreasing the density of the foam grout mixture. As mentioned before, in foamed grout the air bubbles formed by the foam behave as aggregates in the mortar. Any increase in foam volume means more air inside the mortar and consequently, a lower density; that fact alone explains the compressive strength behavior as air has no measurable strength.

Another interesting observation is that the simple addition of foam in any amount results in a plunge in compressive strength. For this experiment, adding 0.17% of foam in mass to regular grout caused the compressive strength to drop from 30 MPa to 14 MPa. Note that this reduction becomes way less steep after the first increment.

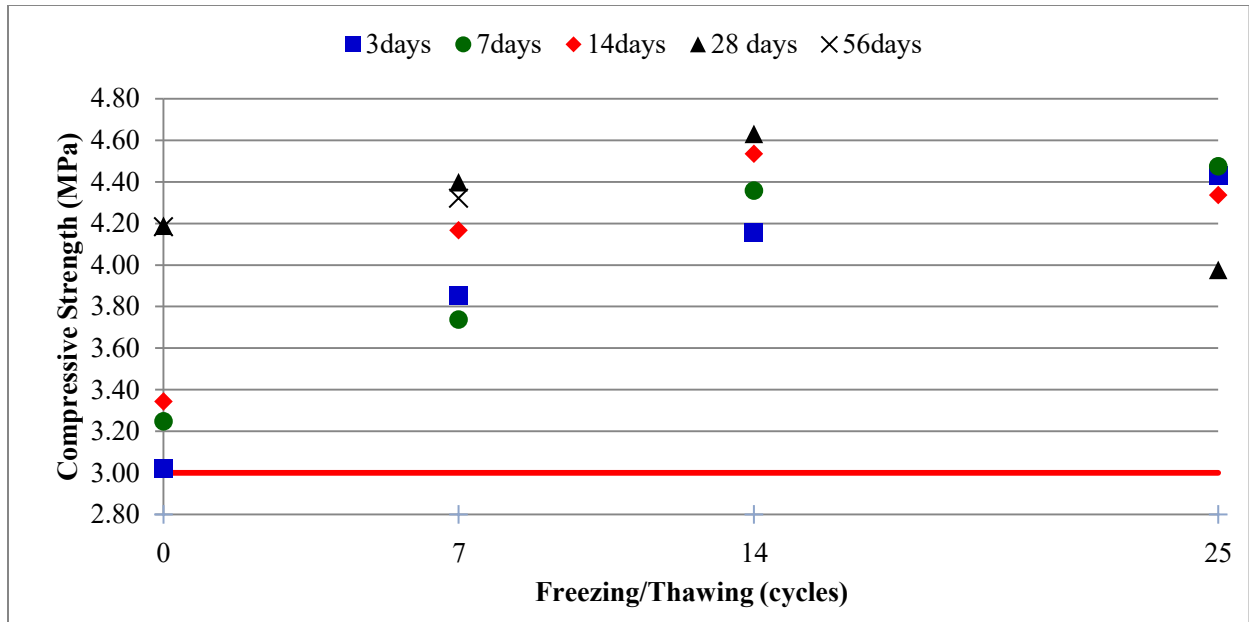
Figure 3-5: Compressive strength for regular and conditioned samples

Figure 3-5 shows the compressive strength results after exposure to multiple freeze and thaw cycles. After 3 days of curing, the ideal target of 3 MPa for compressive strength was obtained. A steady increase in strength for 7 and 14 cycles was observed for all tested samples, reaching a maximum of 4.63 MPa for samples cured for 28 days and conditioned for 14 cycles; however, for cycle 25, a very clear distinction appeared between the samples cured for 3 and 7 days and the samples cured for 14 and 28 days. It was observed that in the early stages of curing, when the material is still building strength, the increase in density counter-balanced the deterioration caused by conditioning. Characteristically, in the last stages, the harsh environment prevails and the specimens begin to lose strength. The significant presence of air voids can be explanation for such a long period before those effects were noticeable in the samples. The crushed samples did not have a plain and clean cut typical of cementitious material, which could be indicative that foam grout might be able to stop, at a certain level, the progression of cracks. Further comparison with regular grout samples is suggested as a base point for this analysis.

In either scenario, an unexpected increase of strength was observed for all samples after conditioning, which demanded further investigation for a clear understanding. A deeper analysis of the specimens before and after conditioning revealed an increase in density, as observed in Figure 3-6. For each testing condition, identified as days of curing and freezing/thawing cycles, the results of the 3 samples were plotted in the graph. The circle and square points in the vertical direction represent the same sample before and after conditioning, respectively. Consequently, as observed in the previous test, once the samples become heavier, their compressive strength also increases.

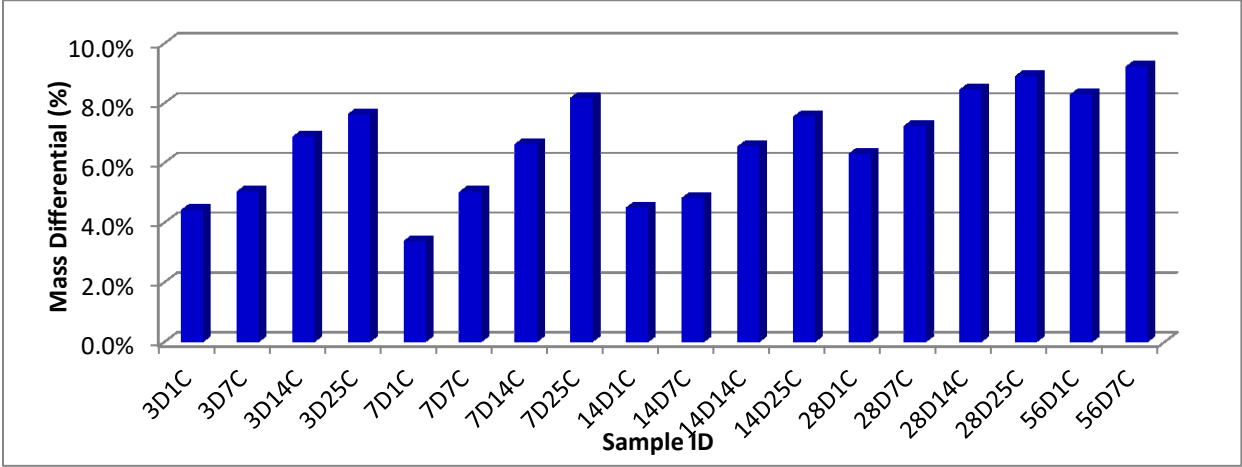
Figure 3-7: Increase in Mass

7 shows the percentage increase in mass of each group of conditioned samples. These groups were selected based on the number of days the sample was cured (first number, e.g.: 3D) and the number of freezing/thawing cycles (second number, e.g.: 1C).

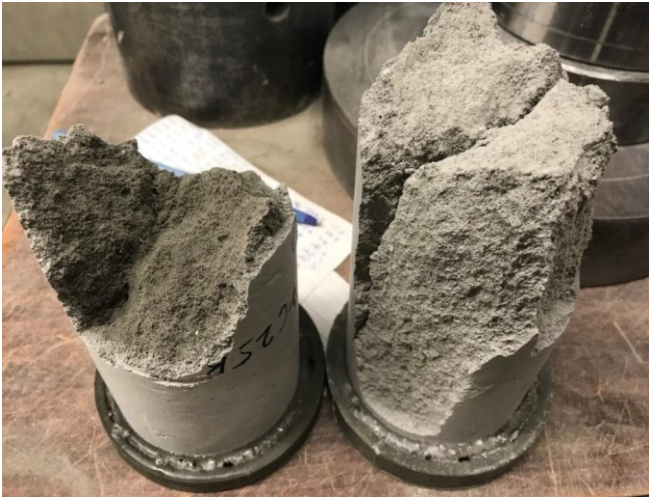
Corroborating with this theory, Figure 3-8 presents a distinct color difference between a sample that was submitted to freeze/thaw cycles (on the left) and one that was not (on the right). The darker gray shade clearly indicates the presence of water within the conditioned sample, despite the fact that the outside surface is bare dry. Additionally, the dimensions of each sample were measured before and after they were conditioned and no apparent differences were detected; hence, density increment could be a result of the sample’s water absorption.

Figure 3-8: Water absorption samples before (right) and after conditioning (left)

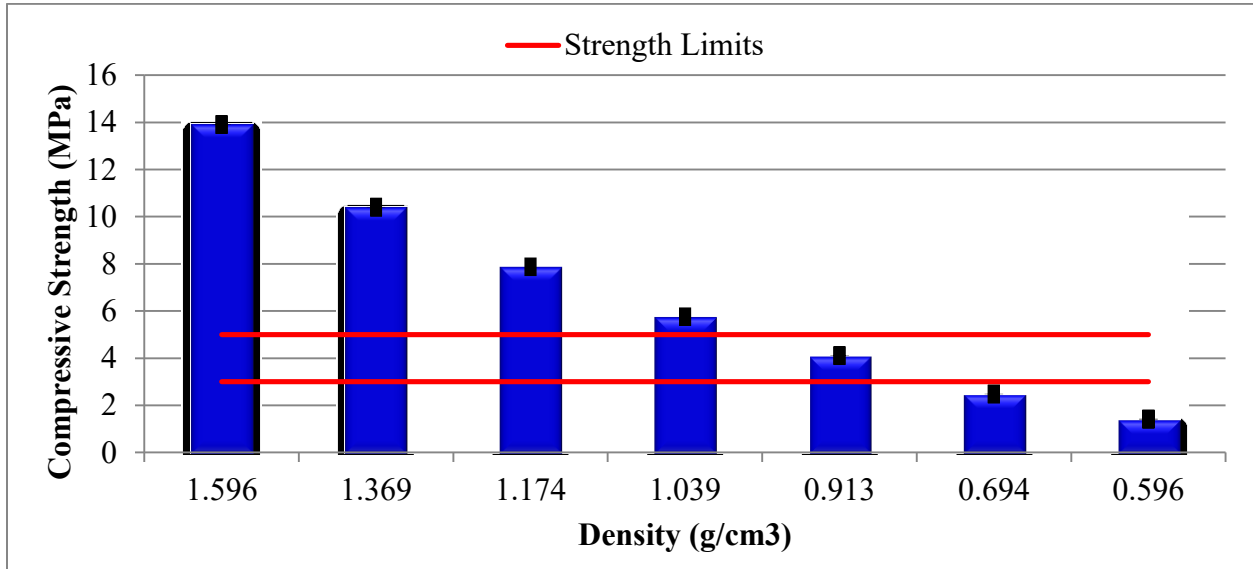
Figure 4-1: Compressive strength versus density

consists of using a capping plate and a sulfur mortar to create a leveled cap in the specimens. The sulfur mortar is heated at 130°C and then poured into a capping plate. Samples are then carefully slid down the mortar following alignments guides found in the apparatus. All surfaces must be clean of debris and water to ensure a proper bond between the sulfur and the test specimen. As proposed by Chorus (2011), the limits of 3 to 5 MPa were determined as the acceptable limit for the foam grout strength. Test results are plotted (Figure 4-1).

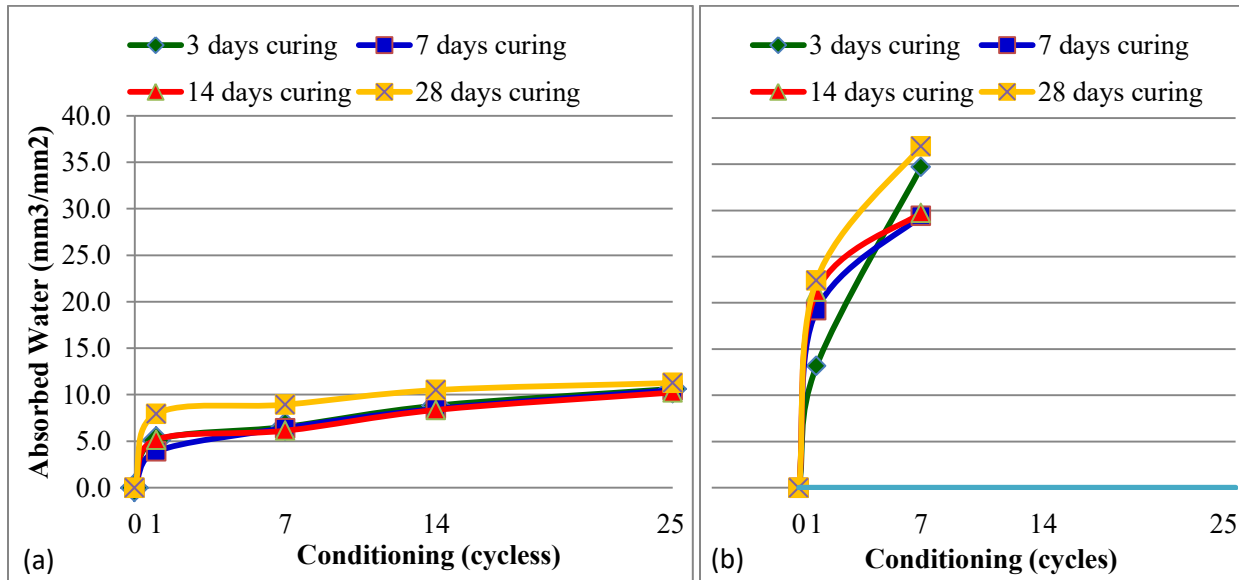
After a thorough analysis of the possible reasons behind the increase in mass in foam grout and considerations with respect to the lack of changes in specimens' dimensions before and after freezing/thawing, water absorption was proposed as the most likely factor causing such weight gain. The work of Li (2012) was used to draw a trend of water absorption for each sample (Figure 5). This study proposes a normalization of the amount of absorbed water by dividing the change in specimens mass before and after conditioning for the surface area exposed to water. As expected, water percentages rise at the initial stages of freezing cycles and reach a plateau in the later, as well as specimens cured for longer periods absorbed a slighter higher amount of water

during the hydration process. Despite the fact that the integrity of regular grout specimens prevented the reliable analysis of mass differences, the investigation still presents a fairly decent explanation for such contrasting results for both materials. For foam grout, water fills in the air voids within the sample, improving the material density and strength. Comparatively, for regular grout, the excess of water and lack of internal space during freezing cycles are extremely detrimental to the material.

Figure 4-5: Water absorption. (a) Foam grout. (b) Regular grout

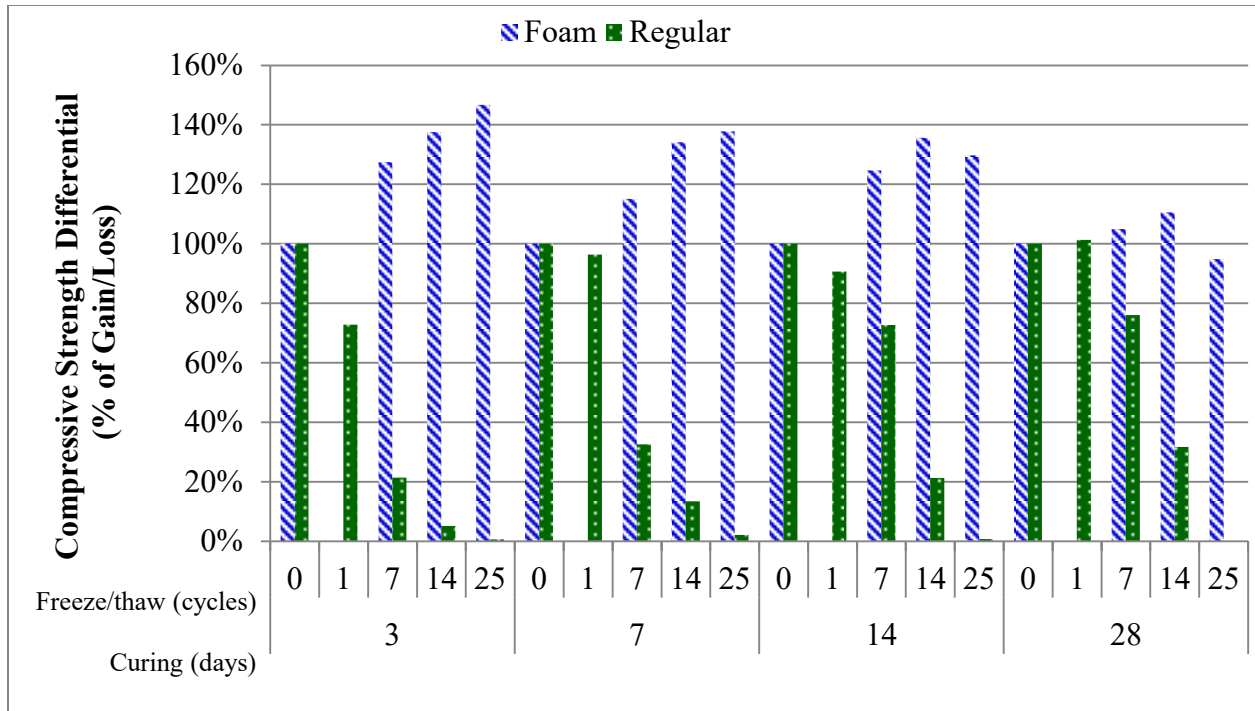
Figure 4-6: Compressive strength differential

In order to compare the test results for regular and foam grout, all values were plotted in duration against a compressive strength differential graph (Figure 4-6). The base point was designated as the strength value of each cured sample in its regular state (not conditioned). In the most extreme case, foam grout specimens cured for 3 days had a 27.5% strength gain after 7 cycles, 37.6% after 14 cycles, and 46.7% after 25 cycles. For regular grout, the same 3 days of curing produced samples with a 27.2% loss after 1 single cycle, 78.7% after 7 cycles, 94.9% after 14 cycles, and 99.4% after 25 cycles.

Such behavior can be explained by the presence of air voids inside the material. During freezing cycles, water will expand inside the samples, and for foam grout, this water will fill existing spaces created by air bubbles, for regular grout, this expansion will generate cracks in the material from the inside to the outside. The damage observed in regular grout specimens is more significant for specimens that have short curing periods, due to the presence of excessive water in the mortar; in long conditioning cycles, the damage is result of the first crack creating an entry point for more water. Foam grout presented an interesting behavior in the sense that for short curing ages, while the material is still building strength, the increase in density observed after each conditioning cycle is beneficial for the material as a whole; however, as soon as curing was complete, specimens began to experience the wearing effects of freezing environments and started to degrade. Regular grout samples not submitted to conditioning cycles displayed the traditional clean and plain cut of cementitious materials, while conditioned samples were scattered like compacted aggregates. For foam grout, the propagation of cracks is disrupted due to the presence of air voids inside the samples. As soon as an air pocket is reached, the continuity of the crack stops and a new one needs to be formed until complete failure is established. With

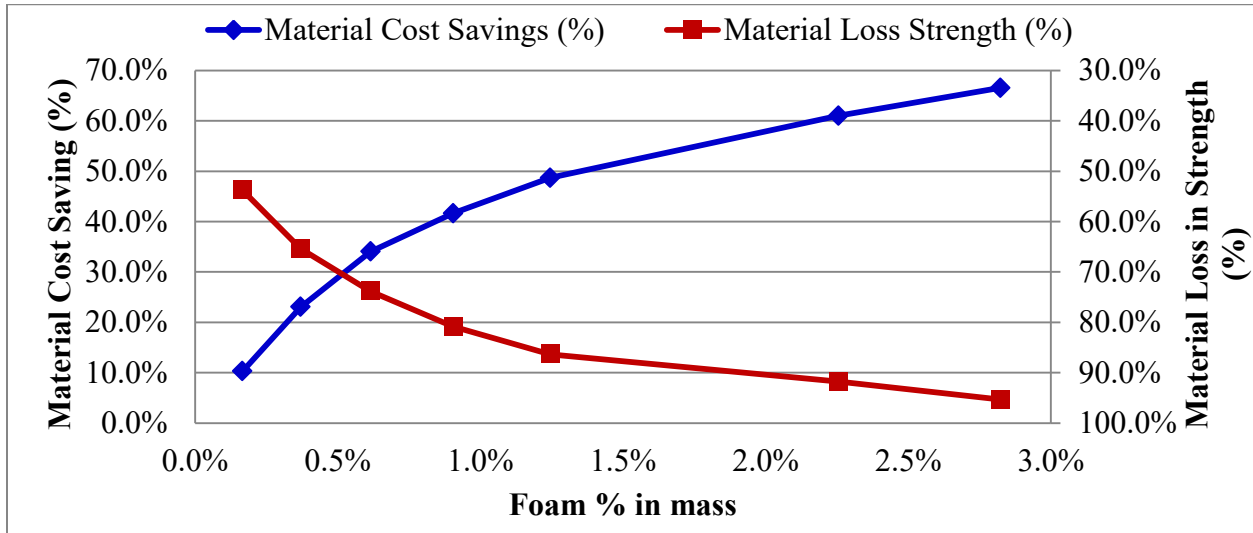
Figure 4-7: Cost versus strength analysis

of a small quantity of foam could significantly affect the grout strength. Additionally, the graph presents an increase in savings in cement cost that can be obtained at each increment in foam quantity, without sacrificing the compressive strength greatly.

For example, adding 1.25% in mass of foam could produce almost a 50% drop in material cost. At this density, a compressive strength of 4 MPa could still be obtained, which is reasonable enough for many applications. The foaming agent cost of \$10/L is inexpensive when compared to Portland cement (Cematrix, 2018). In a ready mix truck of 8 m³ with a 900 kg/m³ density and 1:2 water to cement ratio, there is 2.4 t of water, 4.8 t of cement and between 3 to 5 L of agent, which results in a maximum \$50 of foaming agent/truck. A mix truck with the same base mix for regular grout would contain 4.8 t of water and 9.6 t of cement. Another interesting observation provided by this analysis is the fact that the simple addition of foam in any quantity creates a high initial loss in strength. As presented, a 0.17% in mass of foam resulted in more than 50% decrease in strength with cost savings around 10%. Accordingly, there is a balance of cost and performance which is ideal for each specific project, as well as investigations similar to this can provide a reliable start point for research and improvement.

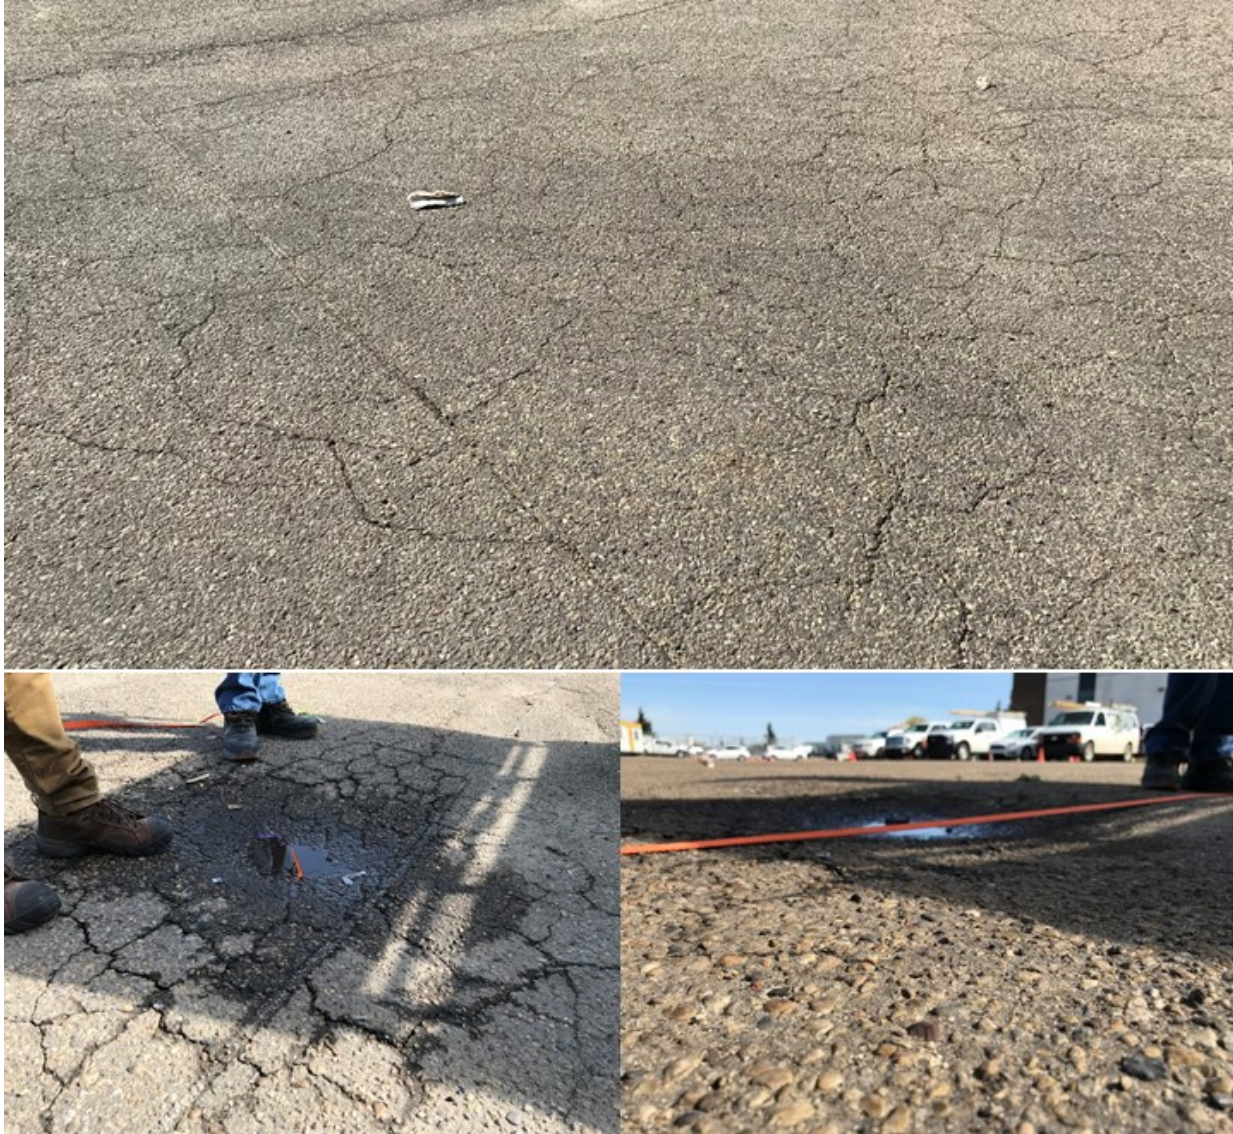
The VIF technology presented a fair to poor performance considering regular pavement distresses. The absence of sealant assists the technique in blending with the existing structure. From a user point of view the trench is barely noticeable, but it facilitates the ingress of water. Alligator cracks and permanent deformation was found in the entire surrounding area of the application, which is a consequence of excessive water in the granular base layer. Guaranteeing that mud from the cutting process is not present during backfilling and ensuring that proper tack coat is applied to the walls of the trench is a reliable method to mitigate such distresses without having to consider sealant applications. Some settlement was observed along the trench, although the trench deformed in a same manner and quantity as the pavement around it, which is a good sign in reducing stresses in the interface between backfill and existing structure (Figure 5-3).

Figure 5-3: Distresses encountered in VIF segment

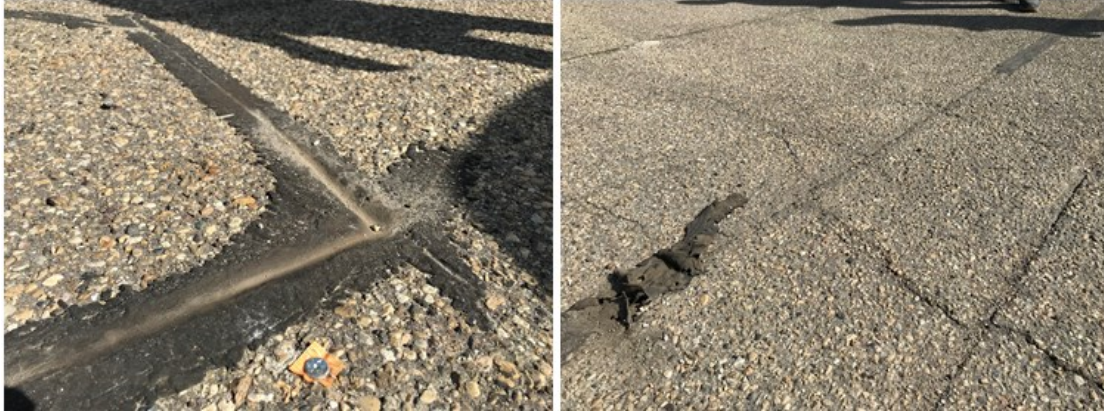
Considerable settlement was encountered in the entire length of the SMCI application, and was especially severe in the curves of the trench path. Sand has been proved to be a poor backfilling material in past literatures due not only to the inability to secure the cable, but also to how easily the material can be densified or simply washed away from inside the trench (Rezai, 2016). Either excessive use or lack of sealant were mistakes committed during the application, resulting in pathologies later on. Furthermore, sand and existing asphalt edges provide a weak bond with the bitumen sealant, of which was a main cause of the pulling-out failures observed (Figure 5-4).

Figure 5-4: Distresses encountered in SMCI segment

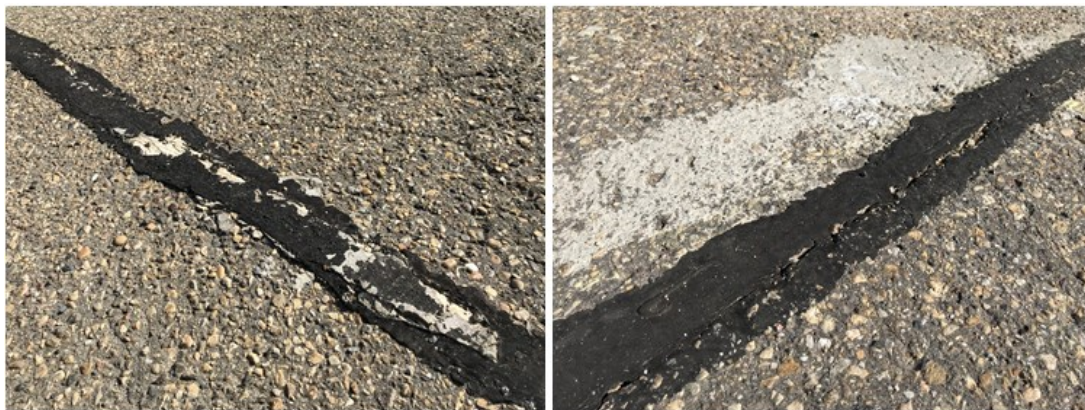
Both scenarios in which grout was backfilled up to the top of the trench and sealed with bitumen sealant presented a considerable amount of cracks and heaving; these observations were intensified in the regular grout section due to the compressive strength and rigidity properties of the material. Once adhesion between bituminous and cementitious materials is fairly poor, continuous freezing and thawing seasons generate cracks in the interface of both materials and allow water to entrain the trench. During winter, this water freezes and expands, forcing all materials to shift in the trench. Grout backfill, unlike the asphalt and granular base layers, does not have room to accommodate these movements, which results in heaving and consequent expansion of cracks in the sealant. In the foam grout segment, this expanding and shifting process was less significant as the strength values are closer to the surrounding materials, and the air pockets inside the mix can withstand a certain degree of deformation (Figure 5-5).

Figure 5-5: Distresses encountered in grout + sealant segments. (a) F-G. (b) H-I

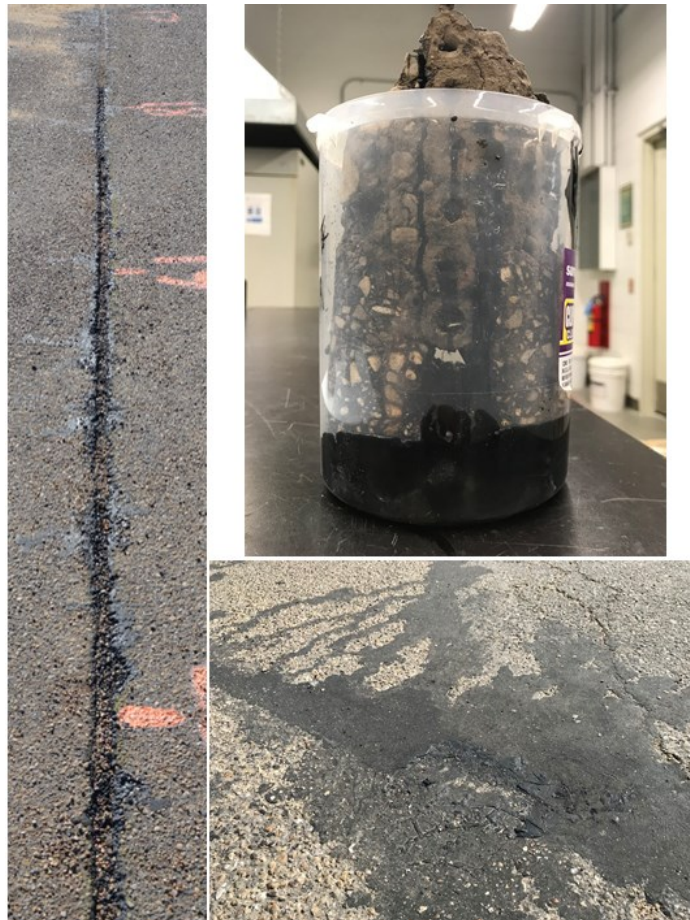
A considerable amount of problems arose from this type of backfill. It is difficult to determine the exact amount of emulsion required to fill the trench, resulting in segments where emulsion overflowed the trench and spread around the pavement and segments where there were gaps inside the material that later caused settlement. Two years have passed since the application and the material is still extremely soft. The excess of emulsion not only caused bleeding around the trench but it also made the material considerably fluid. A core sample was extracted from the field and kept inside a receptacle. After a few hours, the material spread throughout the receptacle accumulating in the bottom and leaving an empty space in the trench (Figure 5-6).

Figure 5-6: Distresses encountered in the aggregate + emulsion segment (I-J)

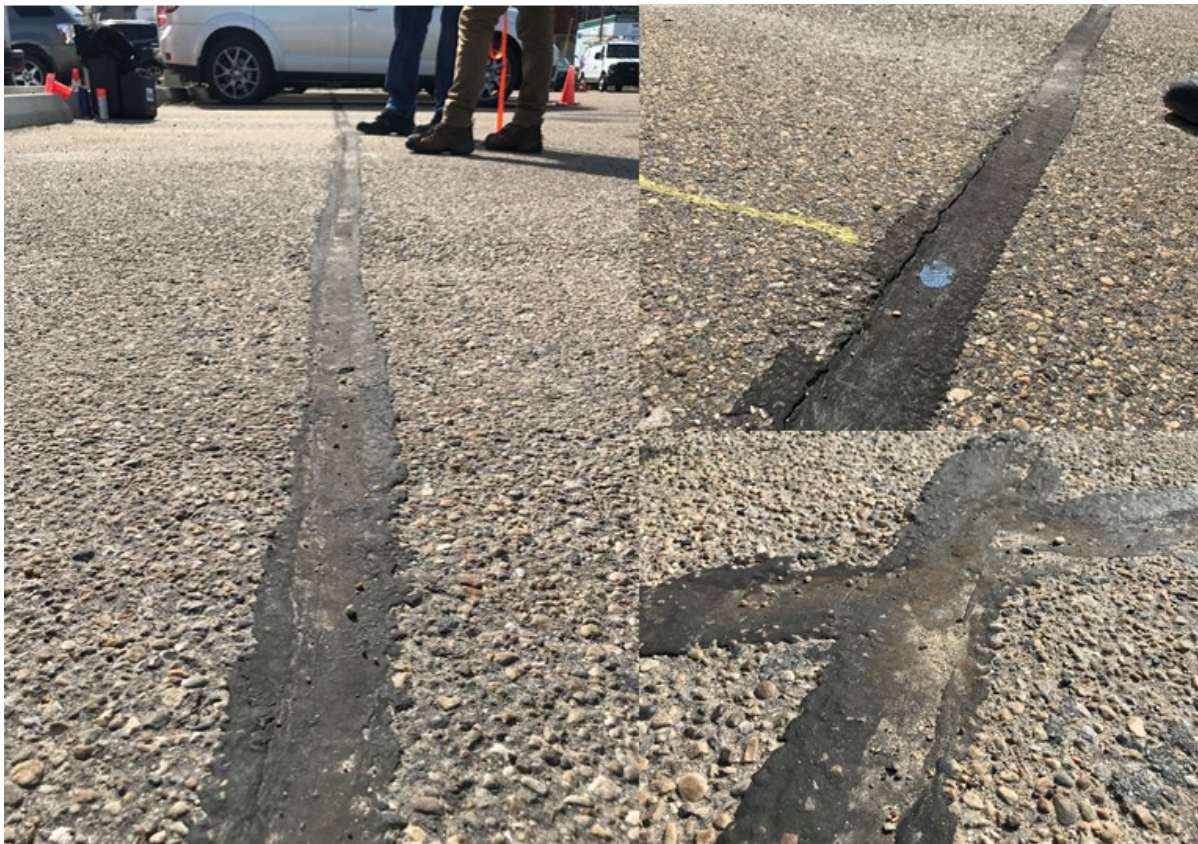
Grout and cold mix proved to be the best combination evaluated. The cold mix bonds extremely well with the asphalt layer of the pavement when tack coat and compaction are performed properly. Different types of grout performed differently, but well enough to secure the cable in place and fill the entire extension of the trench. Small cracks were observed in the sealant, especially in the regular grout section. The large difference in compressive strength values creates a weak point in the interface of the backfilling material and the existing structure. Foam grout is less susceptible to differential displacement as its compressive strength values are closer to the other materials in the surrounding area. Fast setting and regular grout are fairly similar materials; however, care should be taken with the first during application so the material does not set before pouring is complete. Settlement was noticed in most curved sections in the trench path. Considering that those segments were not submitted to any special load or conditions, defects during application are believed to be the main cause of such distresses. Overall, these areas presented good results and very few distresses were observed (Figure 5-7).

Figure 5-7: Distresses encountered in the grout + cold mix + sealant segment (A-F)

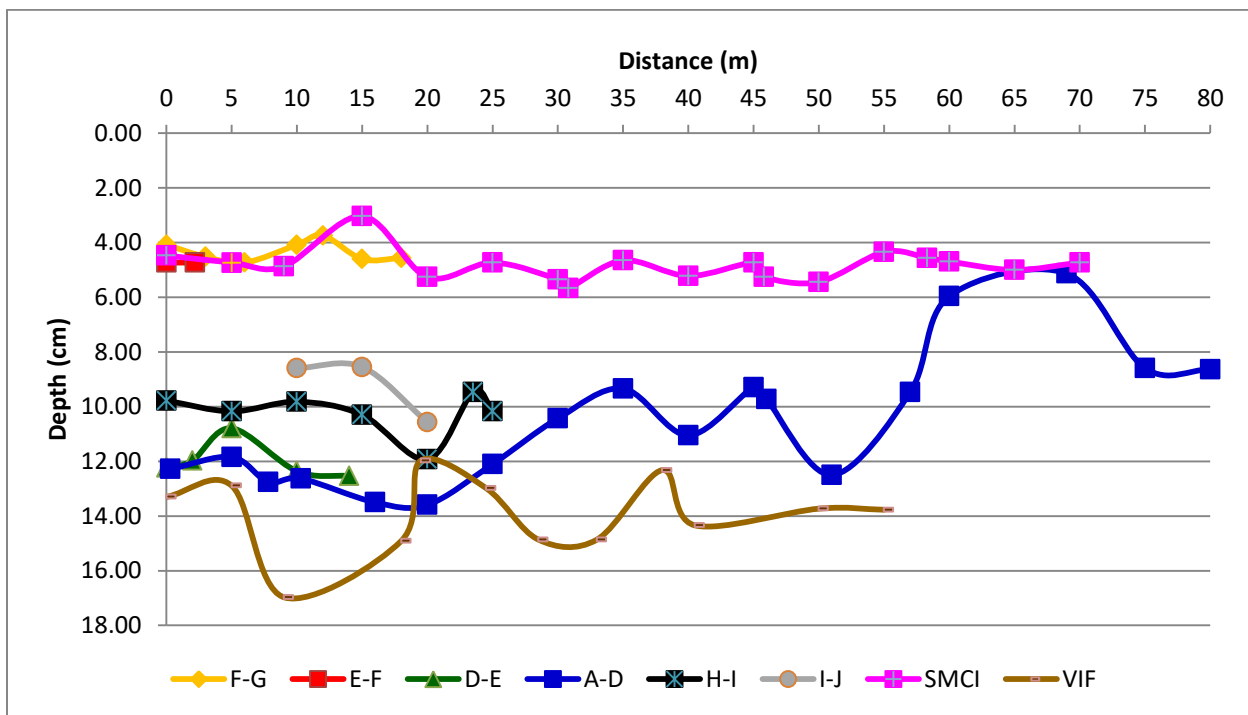
The inability of backfilling materials to secure the conduit in its original position is a concerning problem, as any bending might damage the cables therefore affecting functionality. Such property is vital especially after freeze/thaw cycles, when the upwards and downwards movements are at a peak level. GPR analysis revealed a consistent value of 5.42 for the dielectric of the studied pavement section. It is important to note that it rained in Edmonton the day previous to data collection and the presence of water is known to cause distortion in the signal as well as increase the materials' dielectric (Geophysical Survey Systems, 2016). The results obtained were plotted based on the distance traveled along the trench for each individual segment and the respective depth of the conduit as presented in Figure 5-8. Segment I-J has no conduit in the initial 10 m and no observations were made up to this start point.

Figure 5-8: GPR data for September 2018 analysis

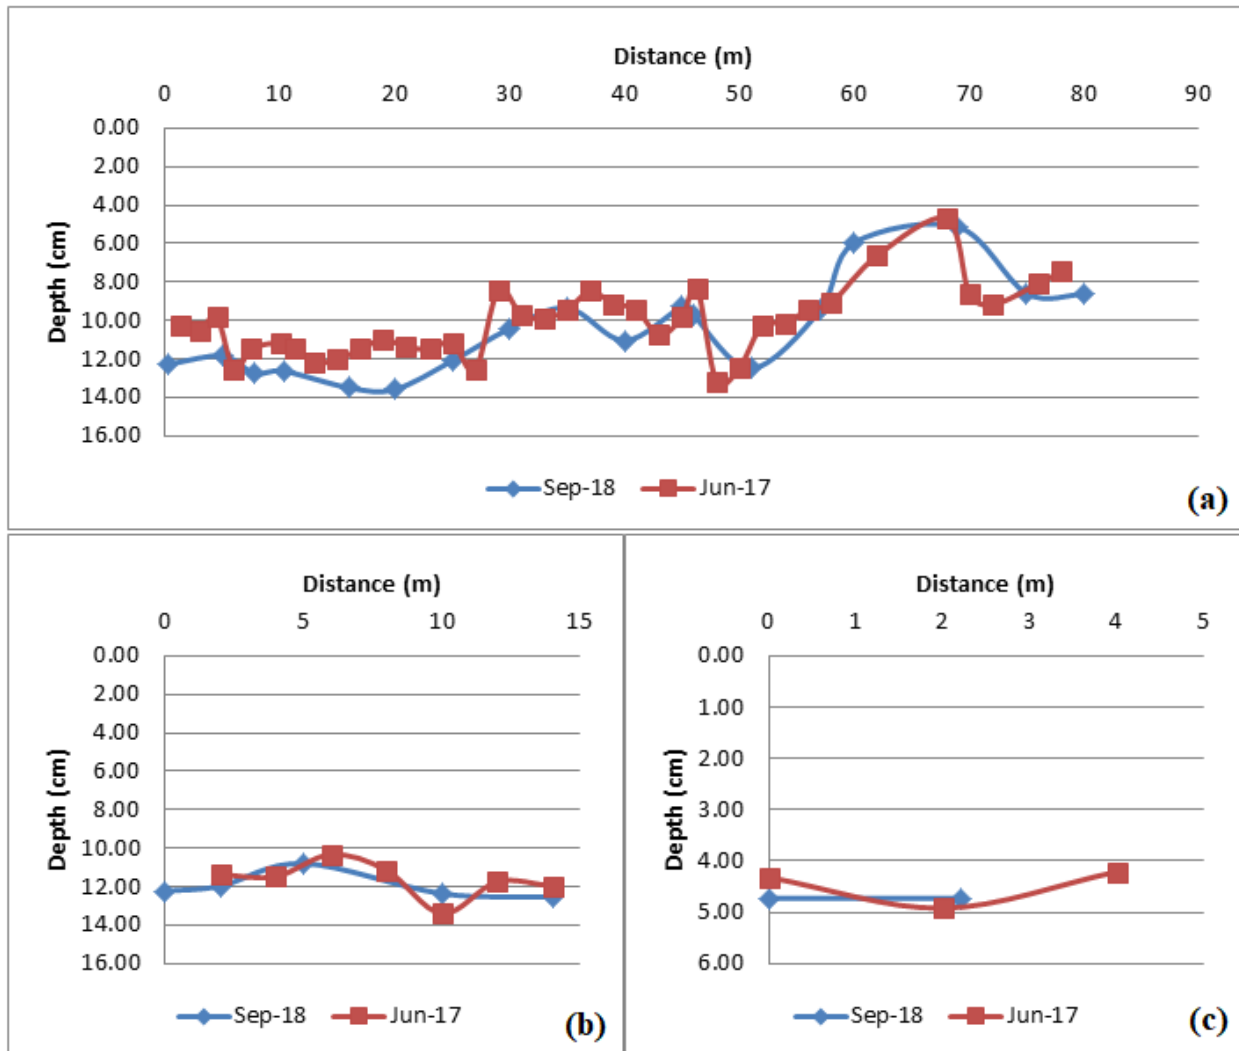
lower than VIF and SMCI applications. Aggregate + emulsion also presented a reliable form of securing the cable down the trench; emulsion fills in the voids in the uniformly distributed aggregate and provides bonding properties to the material. As long as the rupture is concluded, bitumen will harden and grant a similar level of protection as observed in grout. Figures 5-11 to 5-13 present GPR analysis for consecutive years in segments A-G and H-J.

Figure 5-11: GPR data for grout + cold mix + sealant segments. (a) A-D. (b) D-E. (c) E-F

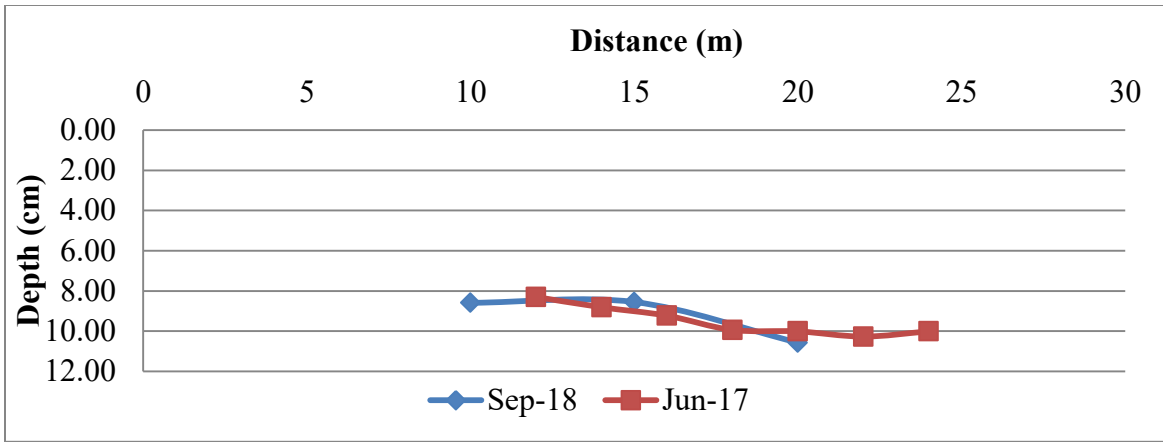
Figure 5-12: GPR data for aggregate + emulsion segment (I-J)

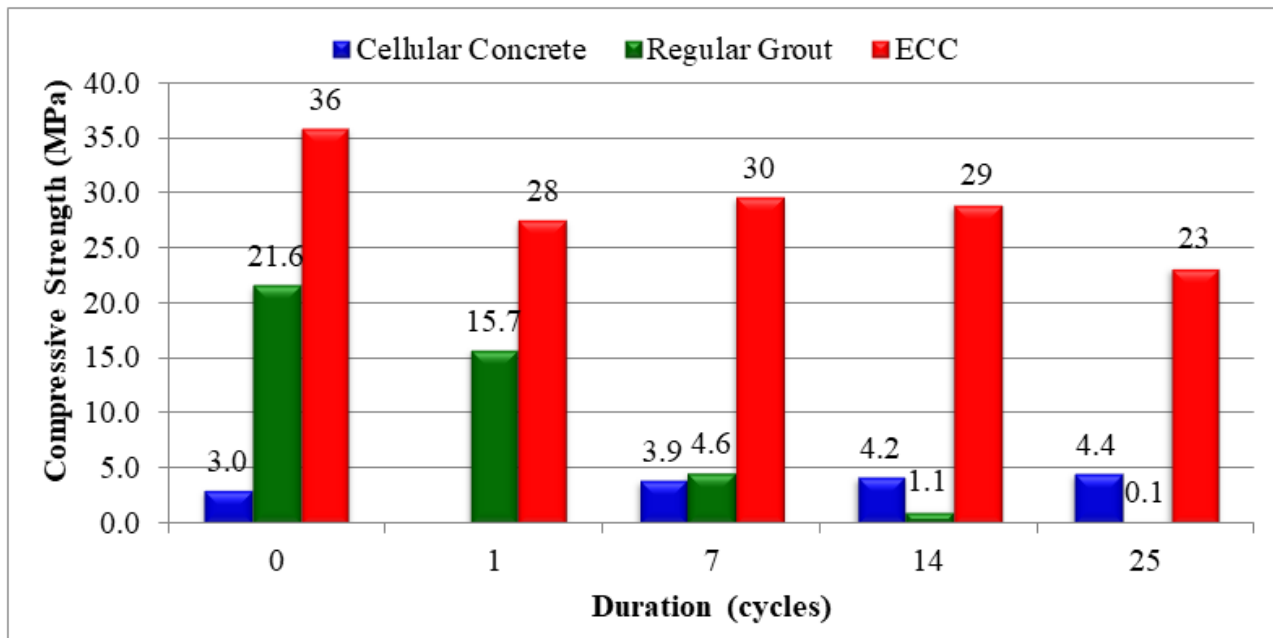
Cementitious materials were tested for resistance to freeze/thaw cycles using the same methodology as presented in previous papers on this research, as well as, flexural strength according to ASTM C78: Standard Test Method for Flexural Strength of Concrete (Using Simple Beam with Third-Point Loading). All materials were tested for resistance to permanent deformation according to AASHTO T 324: Standard Method of Test for Hamburg Wheel-Track Testing of Compacted Asphalt Mixtures. Test results are presented as follows:

Figure: Compressive strength comparison

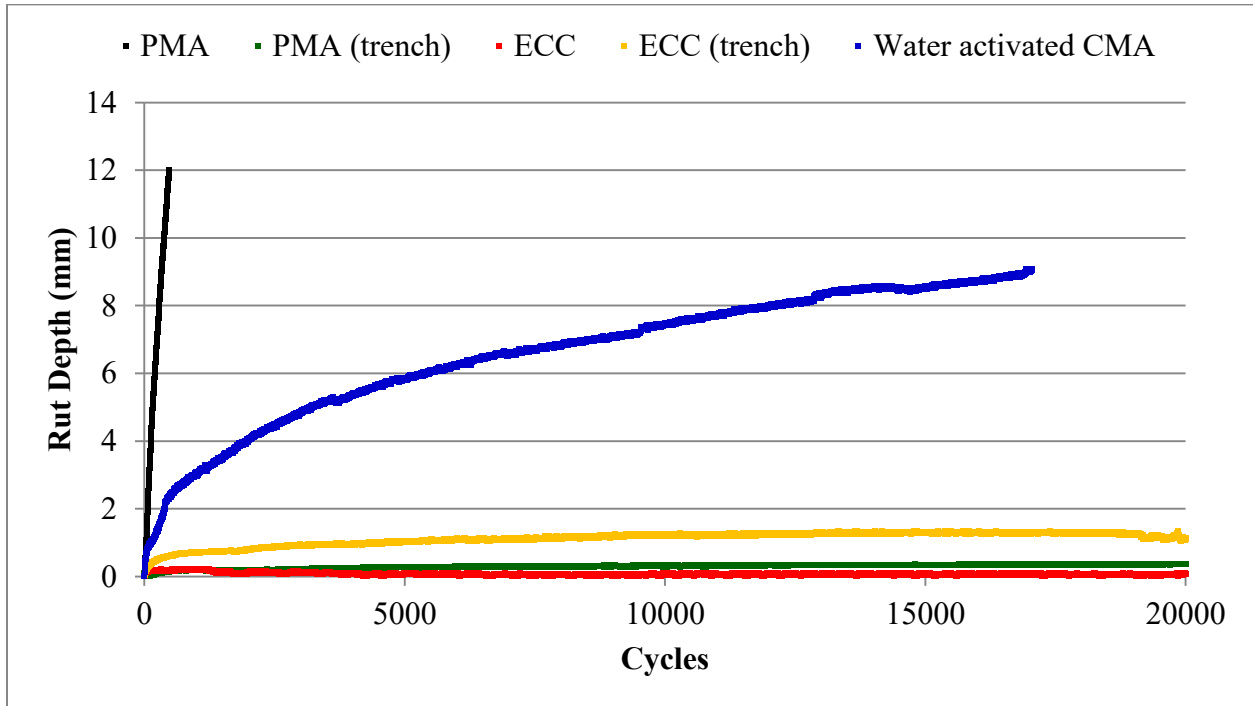
Figure: Test results for wheel tracker
