Evaluation of Backfill Solution for Micro-Trenching in Cold Regions

A thesis submitted in partial fulfillment of the requirements for the degree of

Civil (cross-disciplinary)

University of Alberta

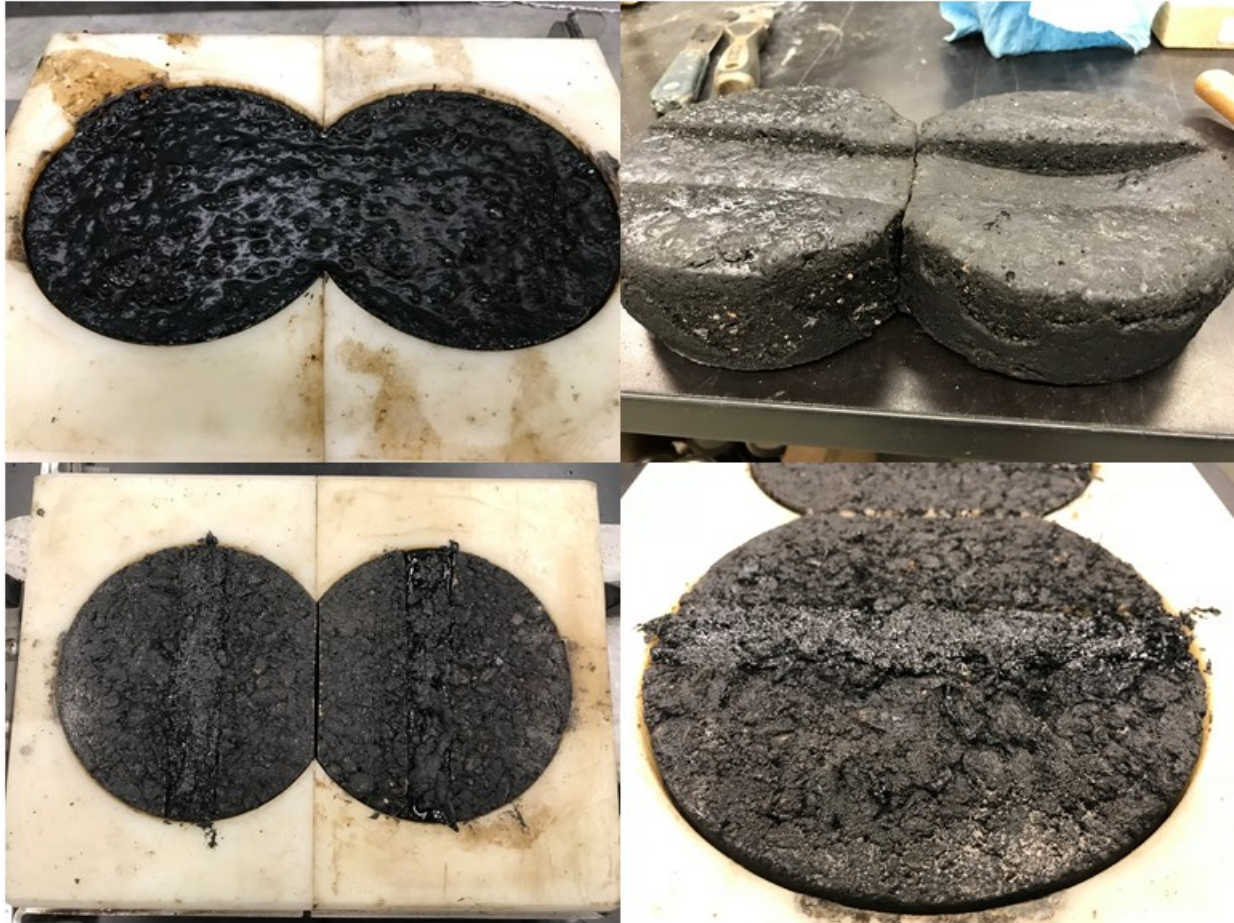
Figure: Details of PMA and PMA (trench) before and after wheel tracker test

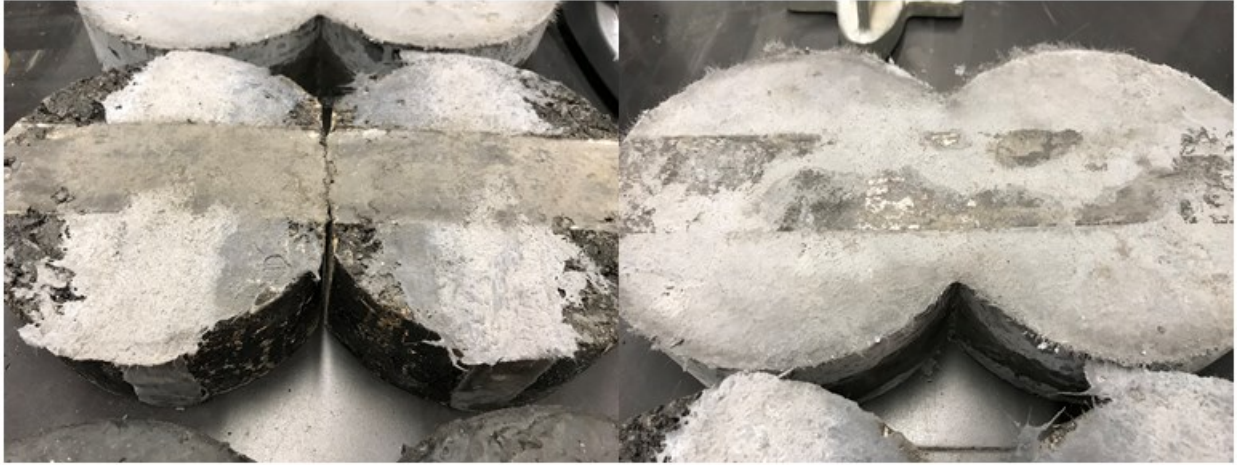
Figure: Details of ECC and ECC (trench) after wheel tracker test

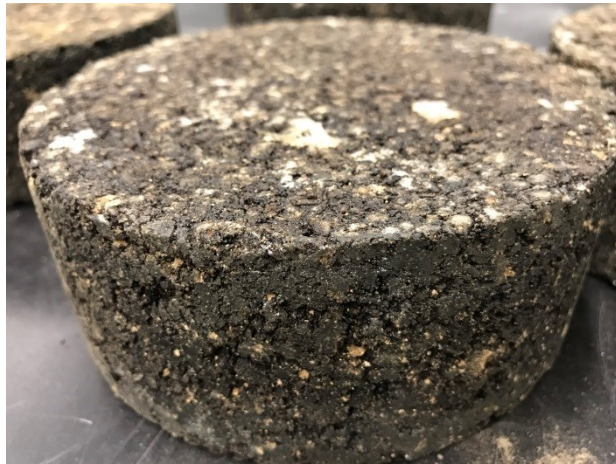
Figure: Details of water activated CMA before wheel tracker test
