Title of Thesis: Hazard Analysis of Reactivated Earth Slides in the Thompson River Valley, Ashcroft, British Columbia

Hazard Analysis of Reactivated Earth Slides in the Thompson River Valley,
Ashcroft, British Columbia

Geotechnical Engineering

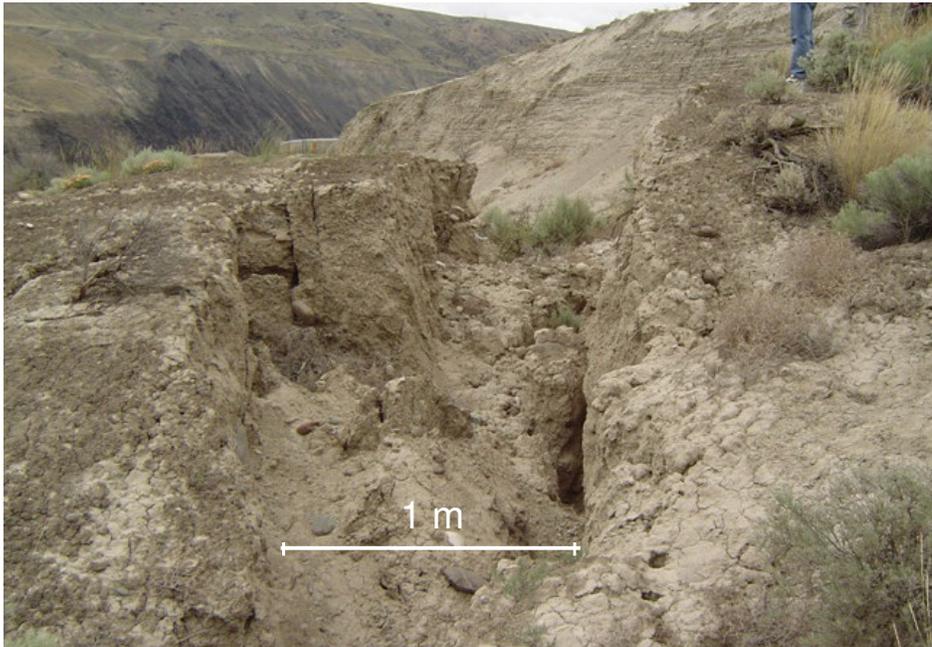
Figure 3.17. New cracks developing at the toe of the Goddard slide observed in May 2005 (probably developed in fall 2004).

- Figure 3.16. Cross section after the Goddard 1982 Slide and surface profile before the Goddard 1982 Slide. 81
- Figure 3.17. New cracks developing at the toe of the Goddard slide observed in May 2005 (probably developed in fall 2004). 82

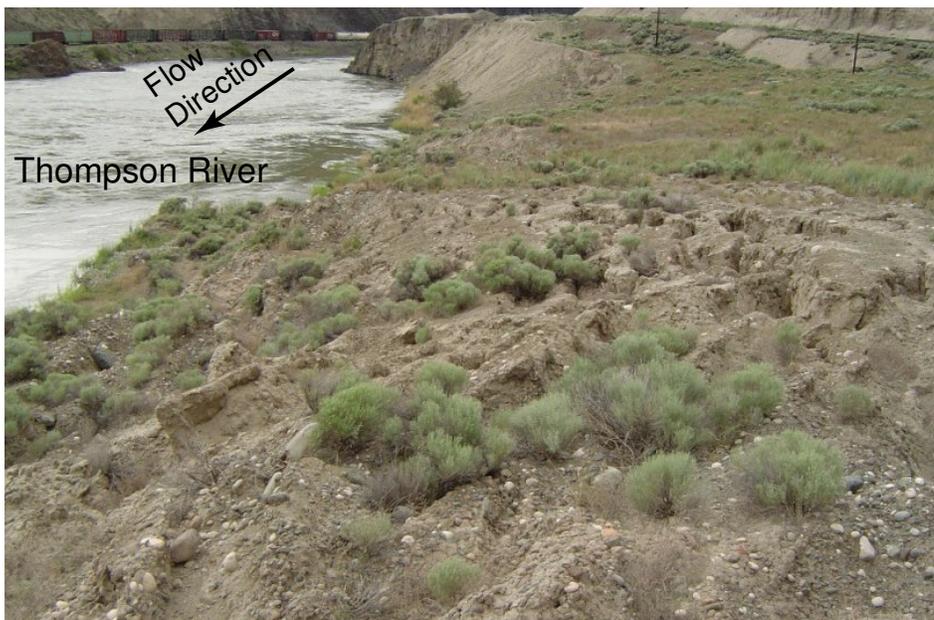
Figure 3.18. Cracks at the Goddard Slide toe resulted from Thompson River erosion.

- Figure 3.18. Cracks at the Goddard Slide toe resulted from Thompson River erosion. 82
- Figure 3.19. View of the South Slide from the west with its three scarps, CN and CPR rail lines, borehole locations, a scour hole in the Thompson River bed, and the Black Canyon tunnel. At river level the slide is 700 m wide. 83
