Reconnaissance of rockslide hazards in Kananaskis Country, Alberta

D.M. Cruden  
T.M. Eaton

Department of Civil Engineering  
University of Alberta  
Edmonton, Alberta  
T6G 2G7

for submission to the Canadian Geotechnical Journal

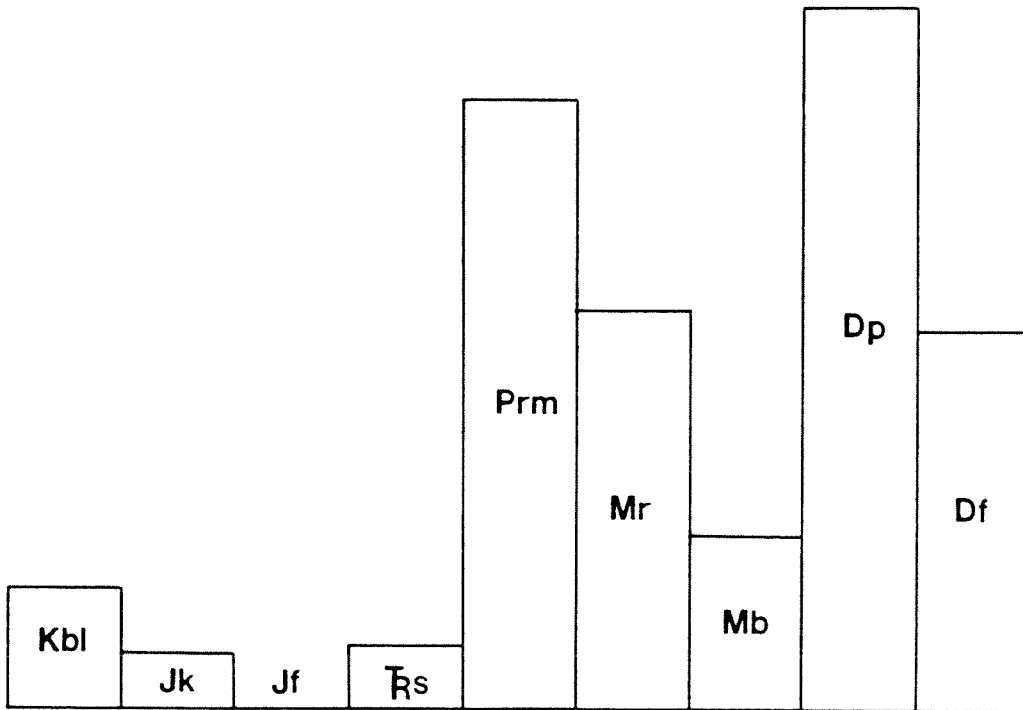
Figure 6. Relative probability of a rockslide according to rock unit. Symbols are explained in Table 1.

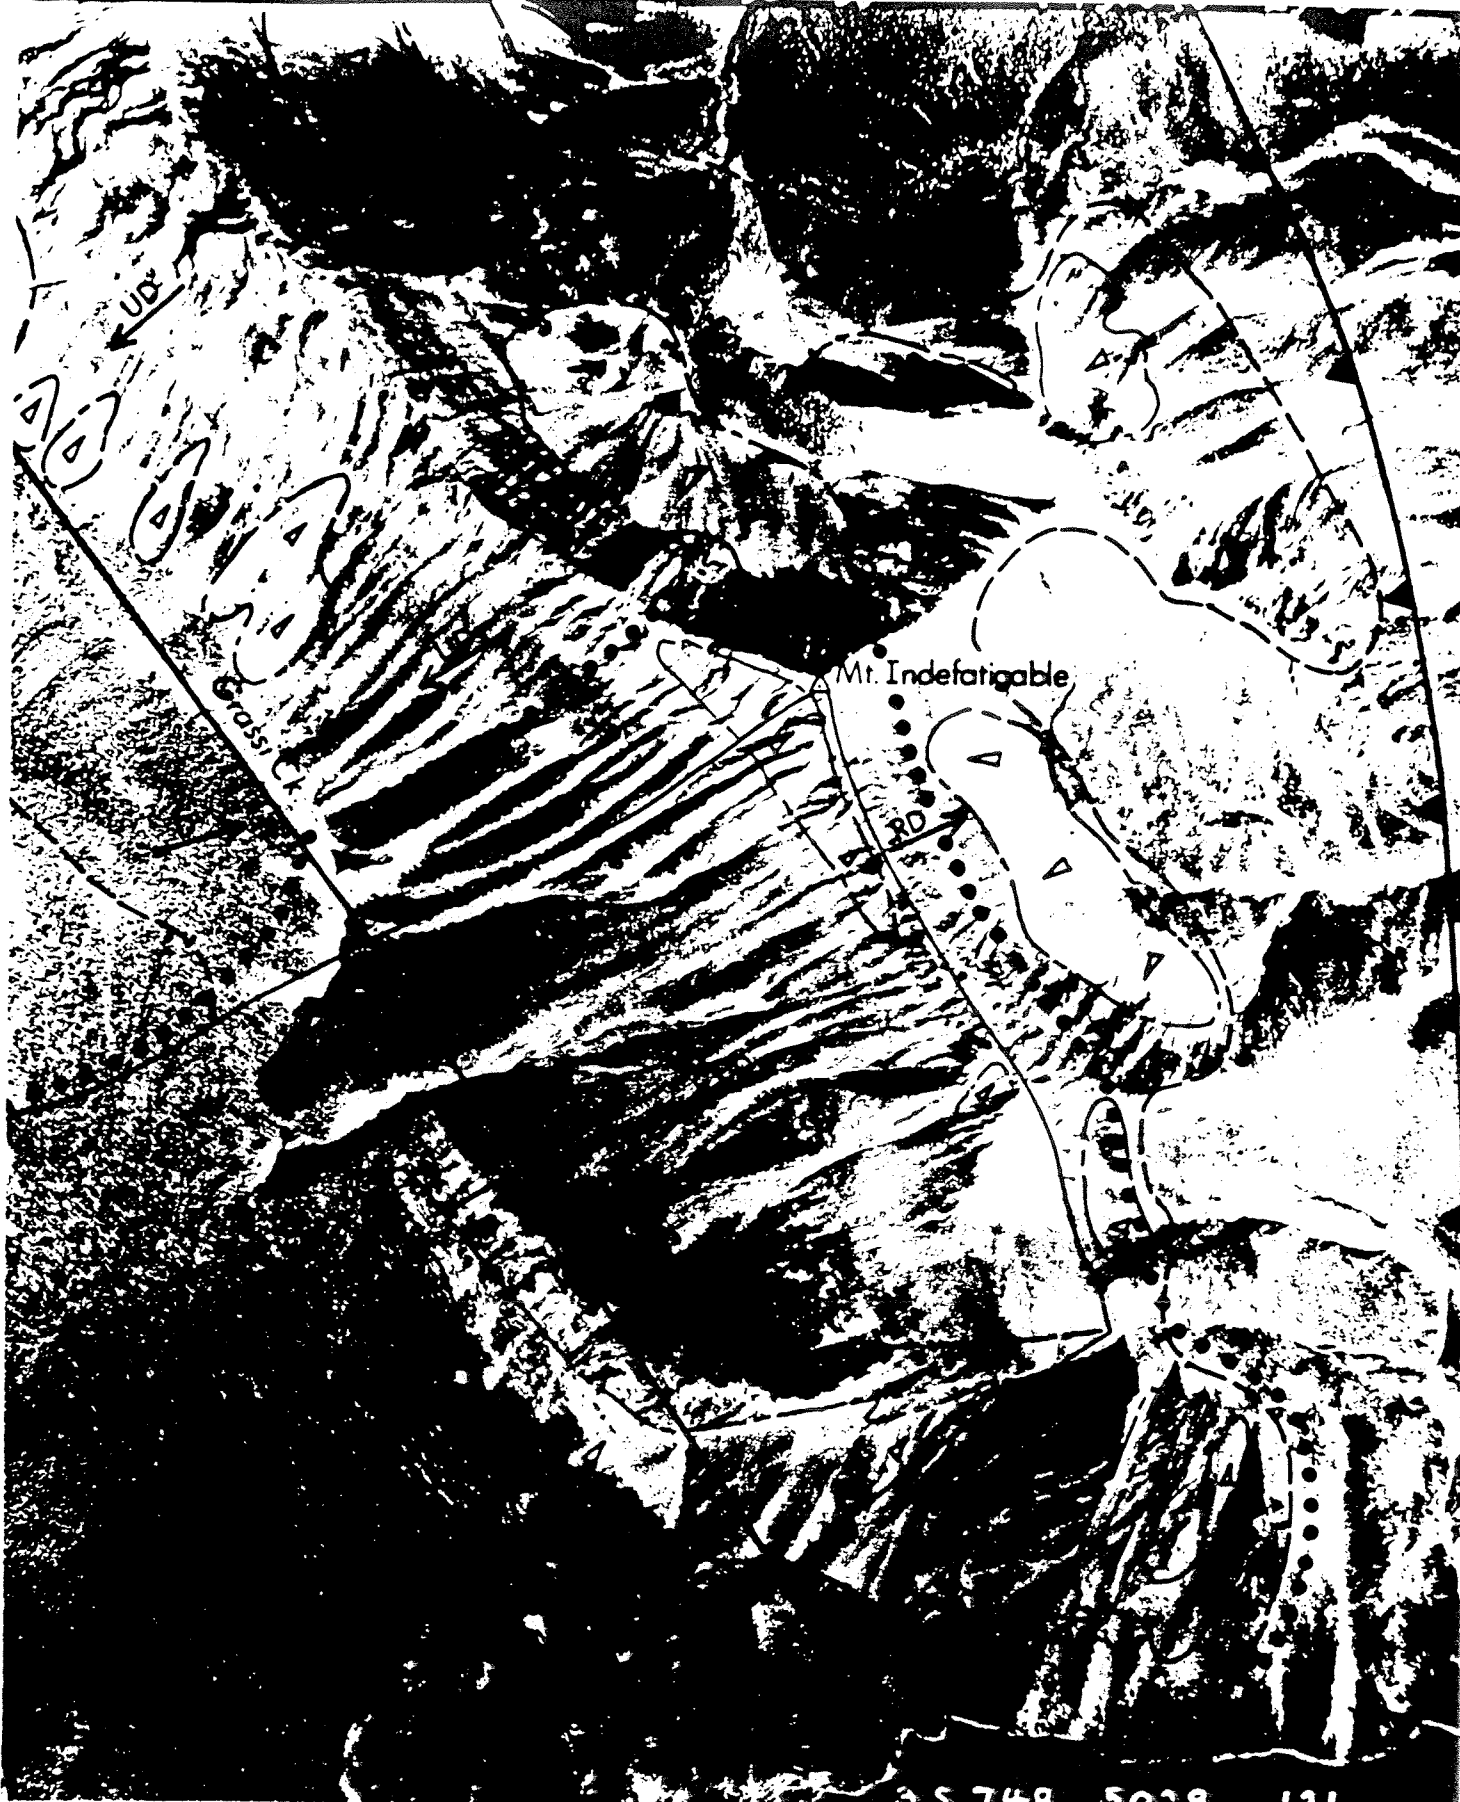
Figure 12. A sample air photograph interpretation showing Mount Indefatigable, the rupture surfaces and rockslide deposit. Symbols on the overlay of Alberta Government photo AS 748-121 follow the Appendix, scale and directions may be locally distorted.

through the Rockies in 1858 (Spry 1963, p. 135). A sample air photograph interpretation from Eaton (1986) shows the Palliser Rockslide deposit and rupture surfaces (Figure 12).

The main structural features are indicated in Figure 12. The Bourgeau Thrust Fault cuts along the base of the northeast slopes of Mount Indefatigable trending northwest. The trace of the synclinal axis passes northwestwards down Grassi Creek just behind the scarp face in the toe of the southwest slopes of Mount Indefatigable. Limestones and dolomites of Mississippian and Devonian age are thrust over Jurassic shales and sandstones (Halladay and Mathewson, 1971).

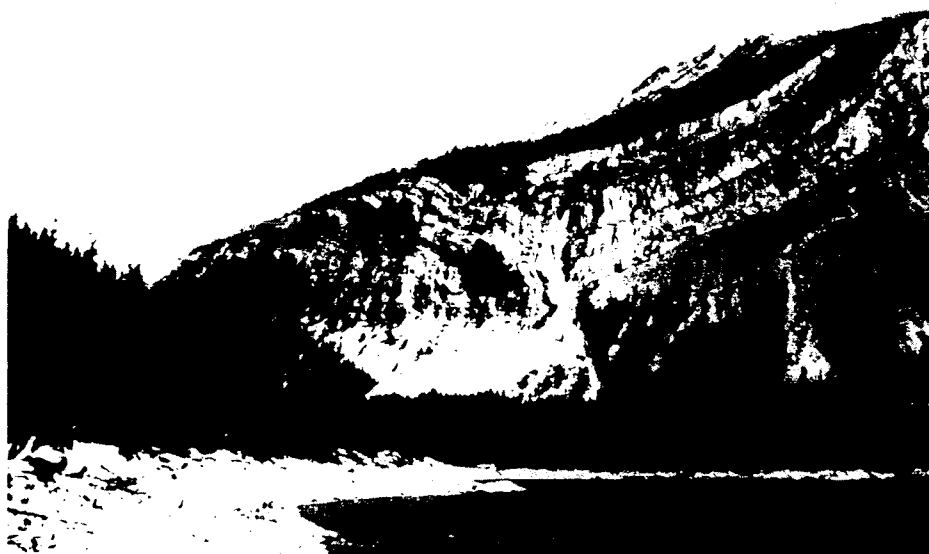
Figure 13. The hypothetical rockslide slope on Mount Indefatigable seen from near the tip of the debris, volume exceeds  $300 \times 10^6 \text{ m}^3$ . Symbols in the overlay above follow those in the Appendix.

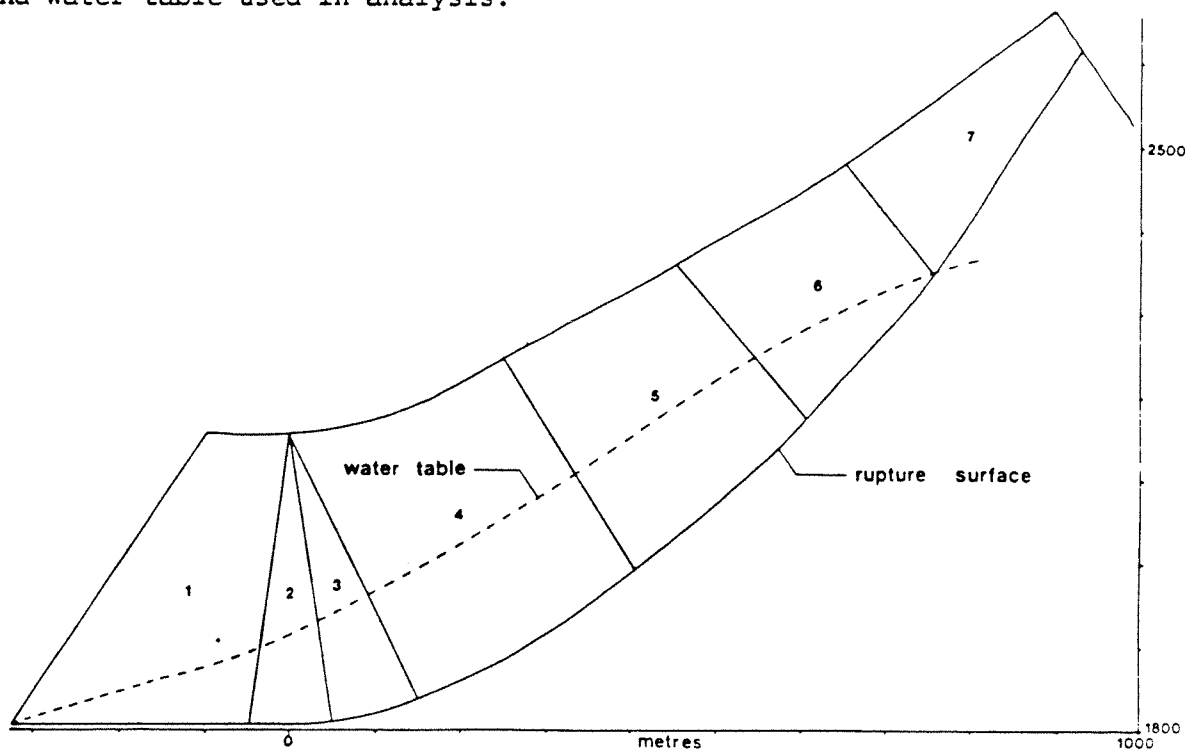
Figure 17. Hypothetical section through Mount Indefatigable showing slices and water table used in analysis.

It is reasonable to assume that the pre-slide configuration south of the sidescarp possessed a similar or less stable geometry. The effect of buttress support is examined in the hypothetical section (Figure 17). It possesses a longer slip surface and additional rock buttress in the toe of the slope. The slip surface in the toe was assumed horizontal as there is no evidence at the site to support the idea that the present rockslide debris slid up northeast dipping beds when the slope failed. Rupture could have occurred across bedding in the toe, or the buttress weathered back to horizontal bedding before failure.

So, the analysis gives a post-mortem on the north slide margin, section A-A, and the present state of health for the hypothetical slope, section B-B. The Palliser Rockslide occurred when retreat of the synclinal buttress, pore pressures and seismic loading acting independently or in combination triggered the rockslide. The hypothetical slope has a higher factor of safety at present. Severe conditions, exceeding those used in the analysis, would be necessary to trigger a rockslide in the immediate future.
