Structural Engineering Report No. 123

**PRESTRESSED CONCRETE BEAMS WITH
LARGE WEB OPENINGS**

By
Teresinha do M. J. Alves
and
Andrew Scanlon

December, 1984

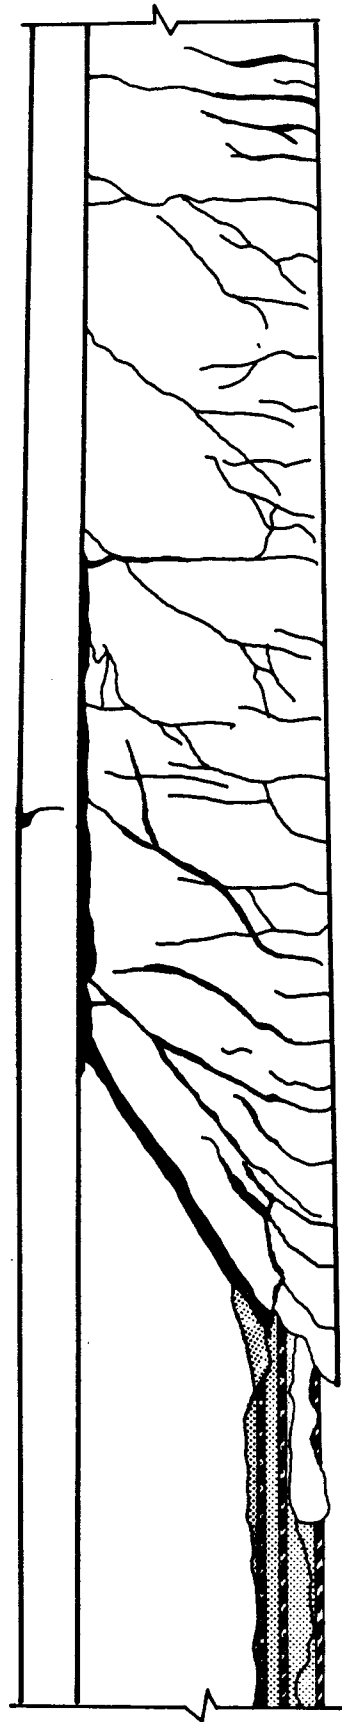
Figure 3.2.1.1 Crack Pattern - BEAM A1.
