The Field Estimation of Shear  
Strength on Rock Discontinuities

University of Alberta

Ph D.

1978

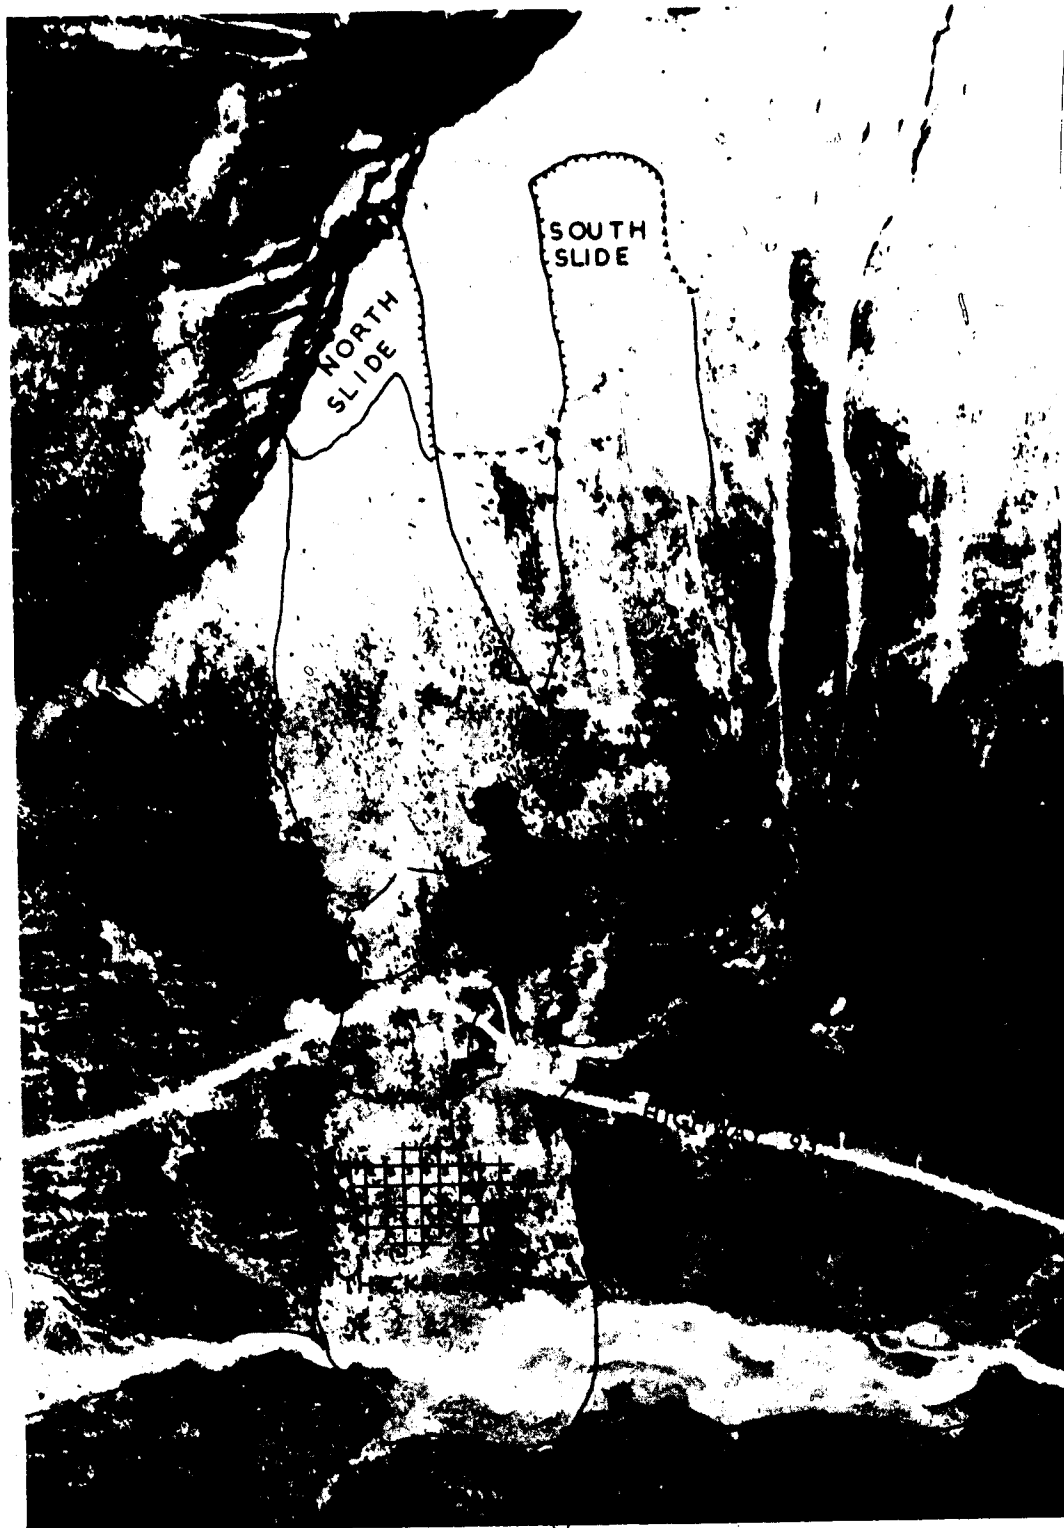
PLATE 2-1 Air Photo Of The Jonas Creek Slide Area Showing  
Debris Outlines And Thicknesses.

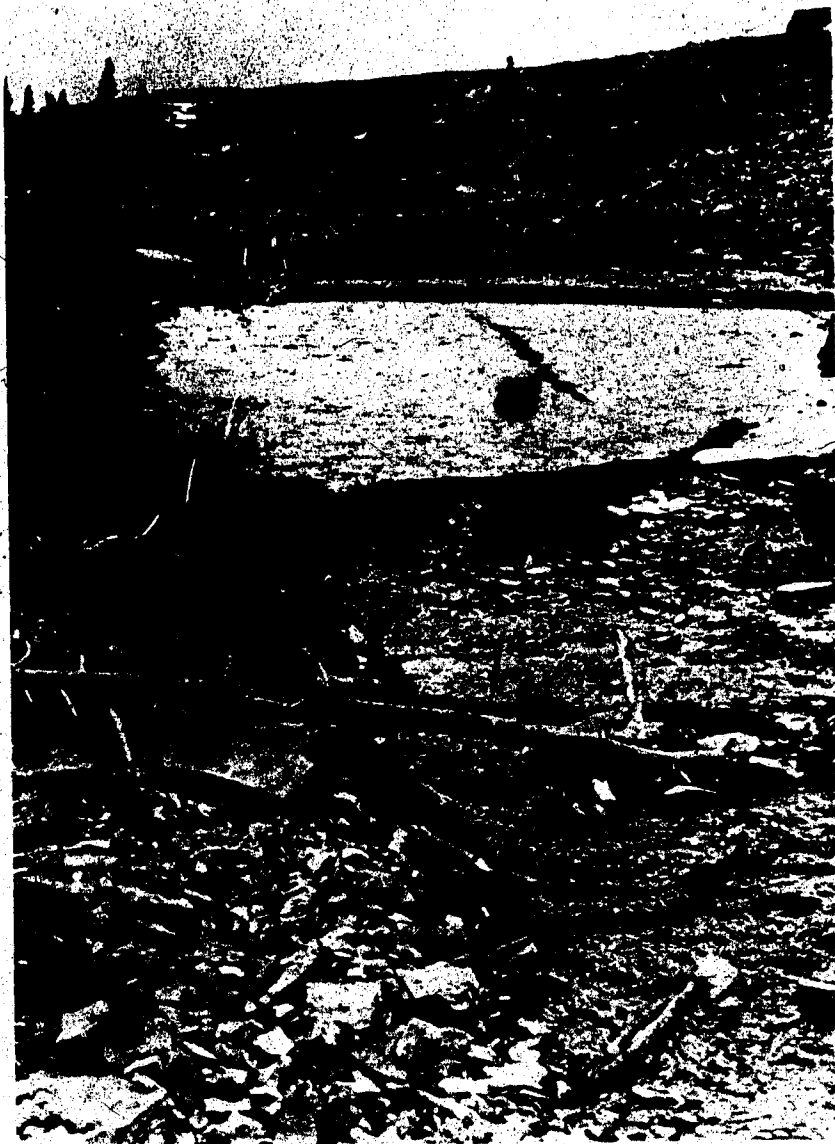
PLATE 3-3 Photograph Of Part Of The Failure Surface At Whitehorse  
Creek Showing Small Vertical Steps.

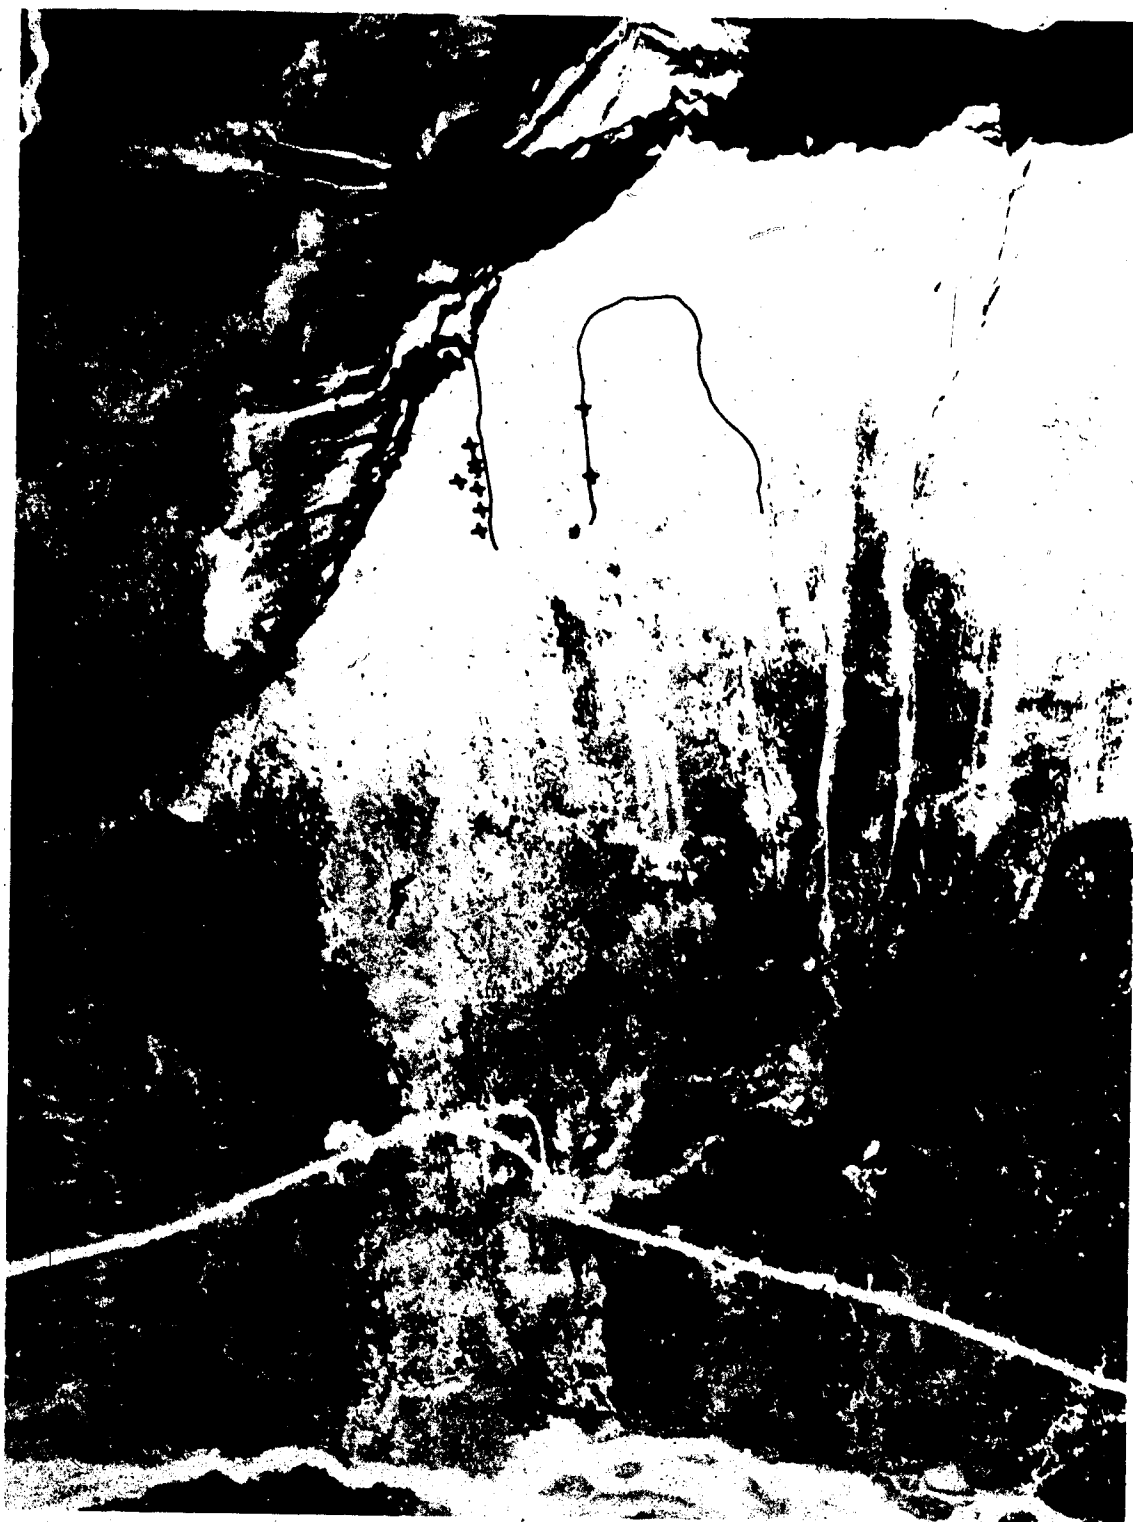
PLATE 4-2 Air Photo Illustrating The Rough Bedding Plane Locations  
At Jonas Creek.

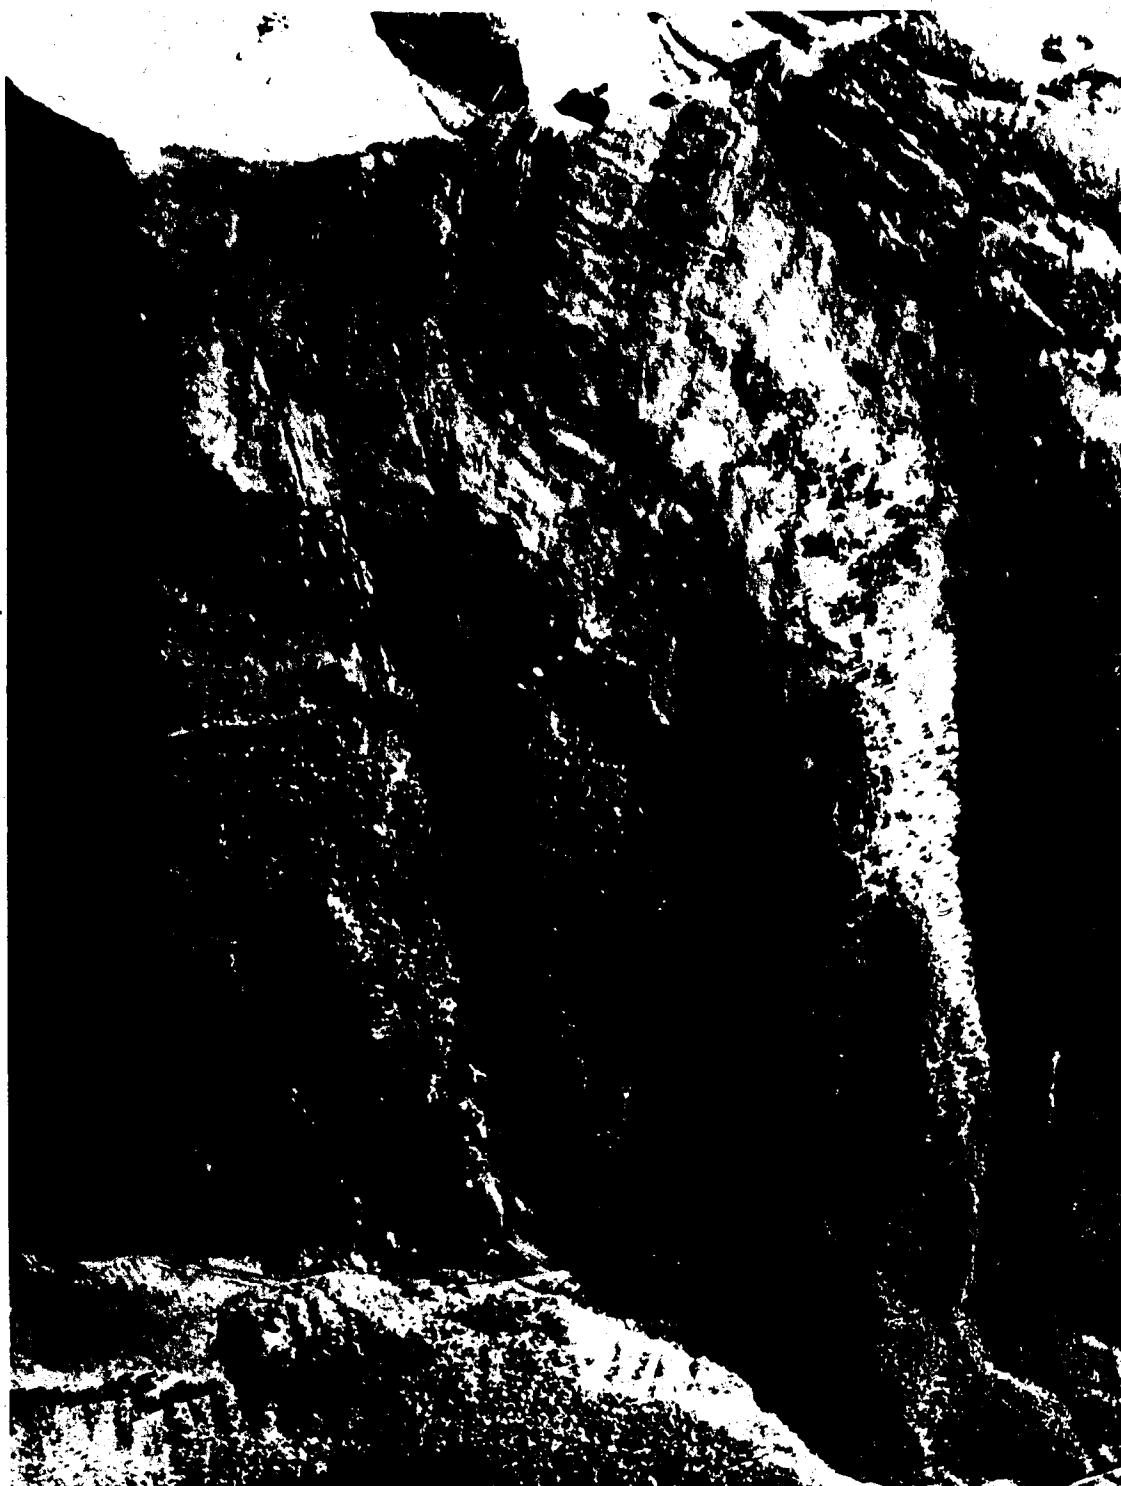
PLATE 4-3 Air Photo Illustrating The Rough Bedding Plane Locations  
At Whitehorse Creek.
