**Shear Behaviour of  
OSB Wood Composite I-Beams with  
Web Openings**

**Sammy Wang**

A thesis submitted to the Faculty of Graduate Studies and Research in partial fulfillment of the requirements for the degree of Master of Science.

DEPARTMENT OF CIVIL ENGINEERING

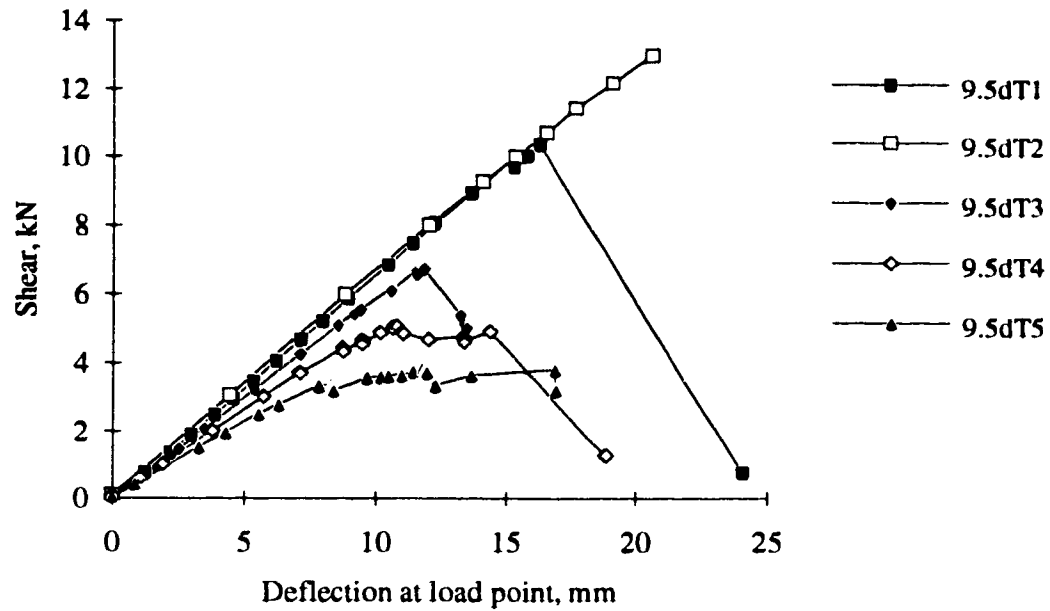
Figure 5.3. Shear vs. deflection of beam during test, specimens 9.5dT1 to 9.5dT5

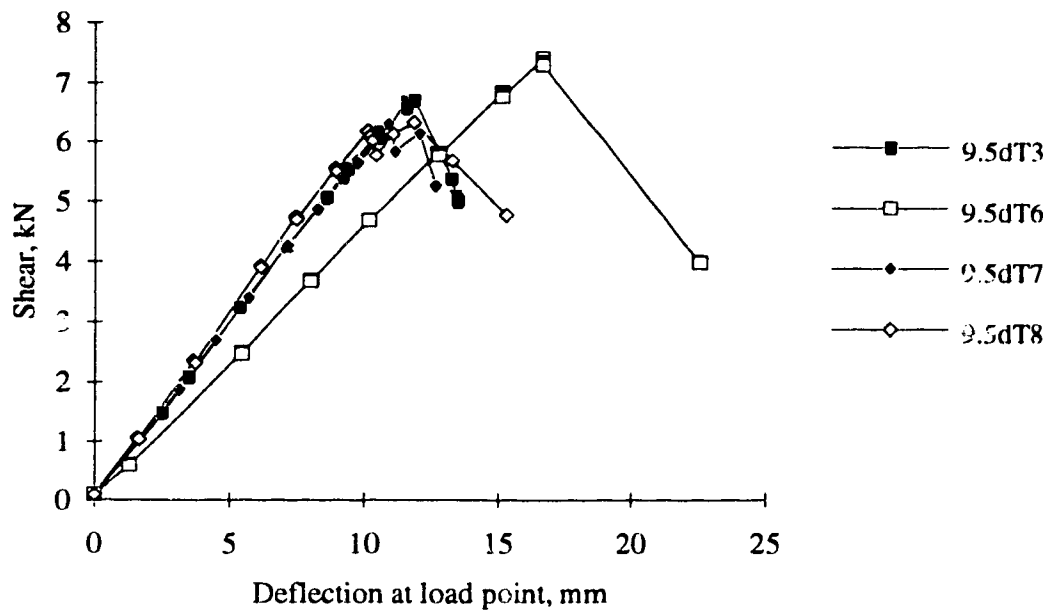
Figure 5.4. Shear vs. deflection of beam during test, specimens 9.5dT3, 6, 7 and 8

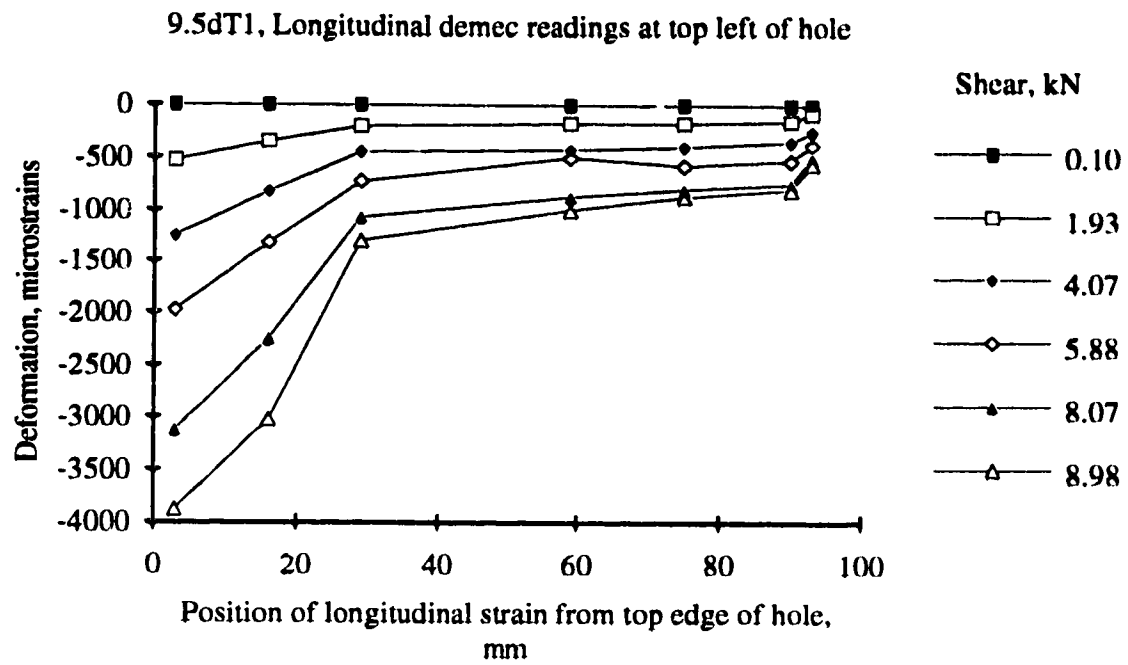
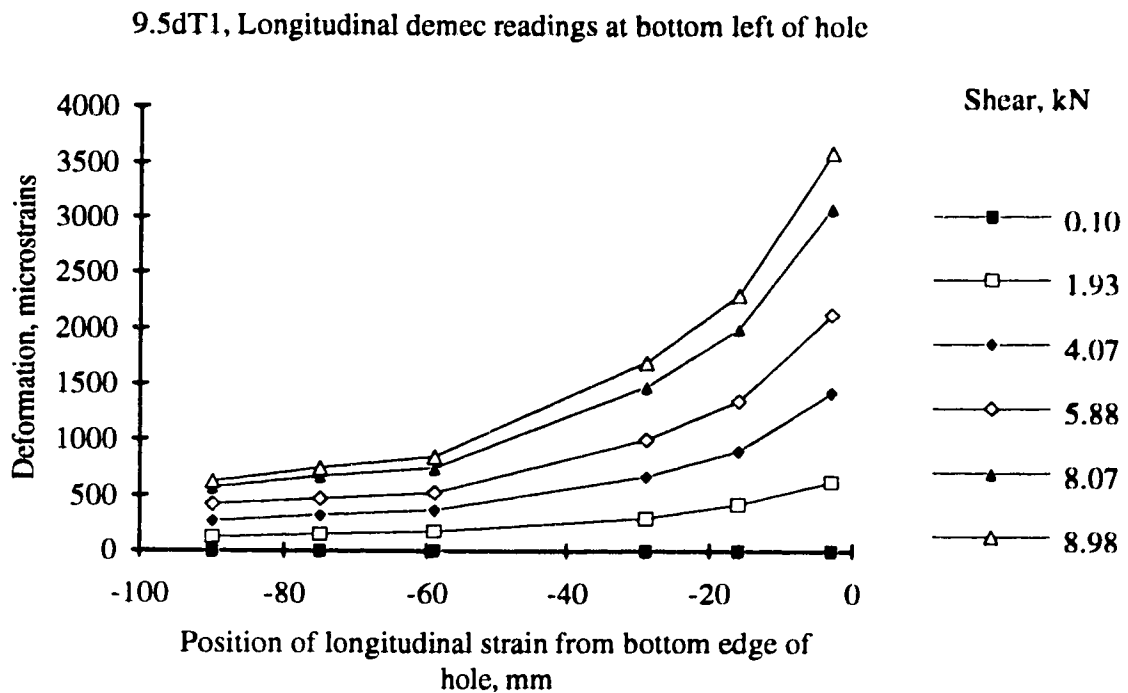
Figure 5.9. Longitudinal strain at the left section of the hole in specimen 9.5dT1

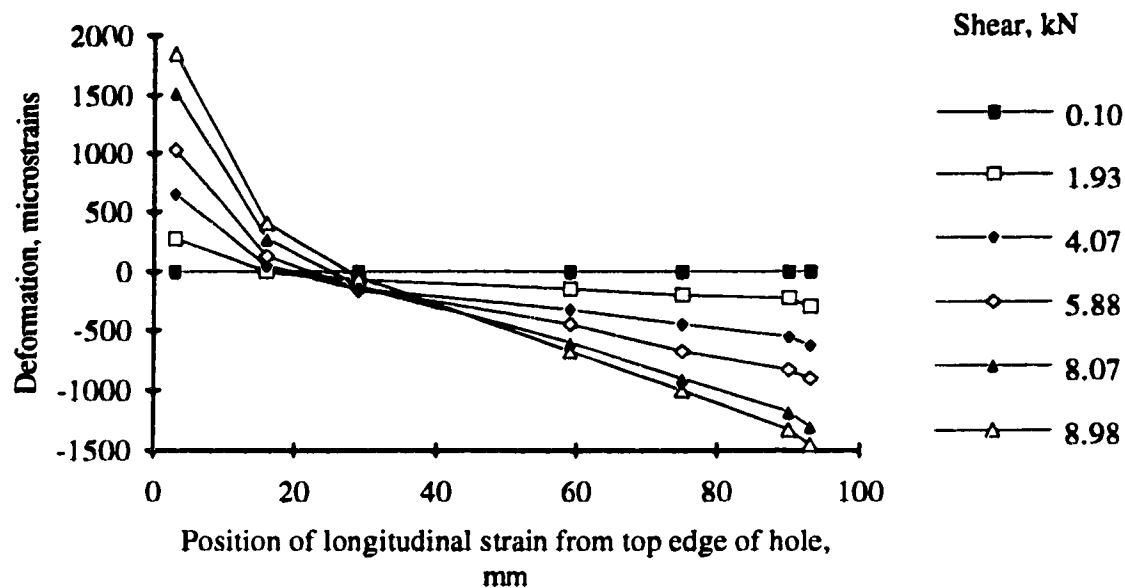
9.5dT1, Longitudinal demec readings at top right of hole

9.5dT1, Longitudinal demec readings at bottom right of hole

Figure 5.10. Longitudinal strain at the right section of the hole in specimen 9.5dT1
