**Effect of an Embankment Reconstruction Using a Wicking Geotextile in the Drainage and
Strength of Subgrade**

A thesis submitted in partial fulfillment of the requirements for the degree of

Geotechnical Engineering

University of Alberta

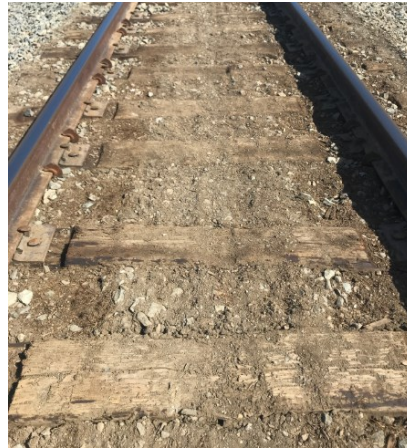
Figure 1.3. Track conditions at the research site before renovation (Abdulrazagh 2019 – with permission).

The selected site was provided by CP based on the history of issues found at the site, such as settlement, frost heave, and clay pumping/ballast fouling (Figure 1.3). These issues were attributed to poor drainage and retention of moisture within both the embankment and subgrade.

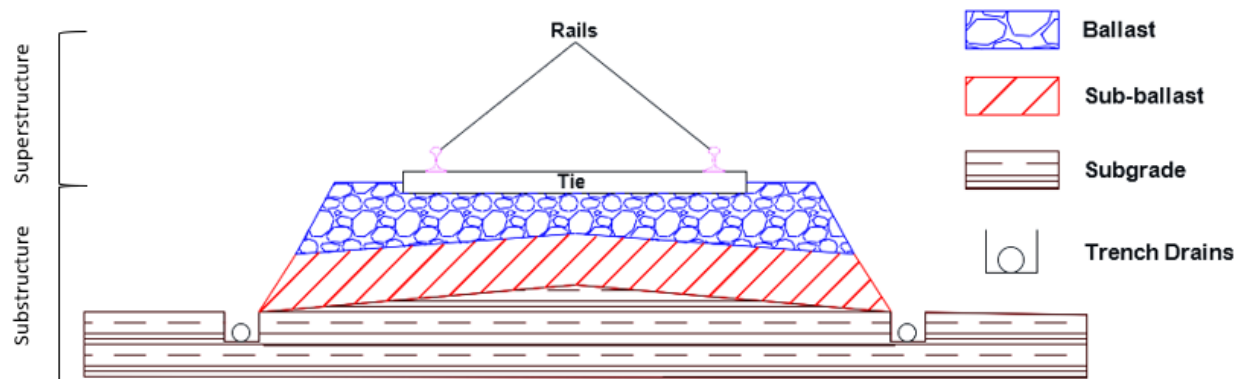
Figure 2.1. Cross-section of a ballasted track.

The railway track structure is divided into superstructure and substructure components (Figure 2.1). The superstructure is composed of rails, ties, and a fastening system. Below the superstructure, three different soil layers comprise the substructure: ballast, sub-ballast, and subgrade. (Indraratna and Salim, 2005)

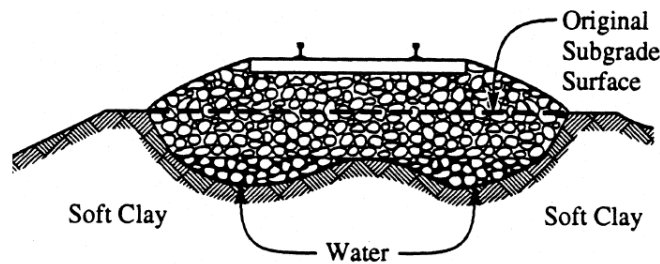
Figure 2.3. Formation of subgrade squeeze zones beneath track substructure filled with ballast (Li et al. 1996)

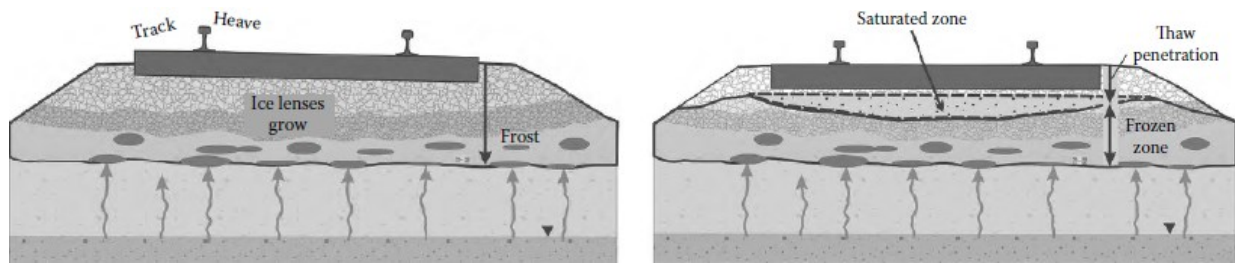
Figure 2.4. Illustration of the development of a) frost heave and b) thawing of the track (Li et al. 2002).

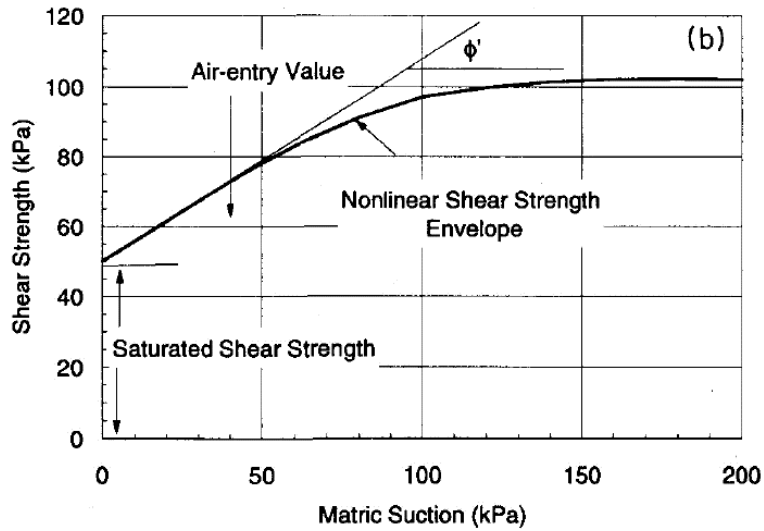
Figure 2.6. Non-linearity of Shear Strength Envelope (Vanapalli et al. 1996).

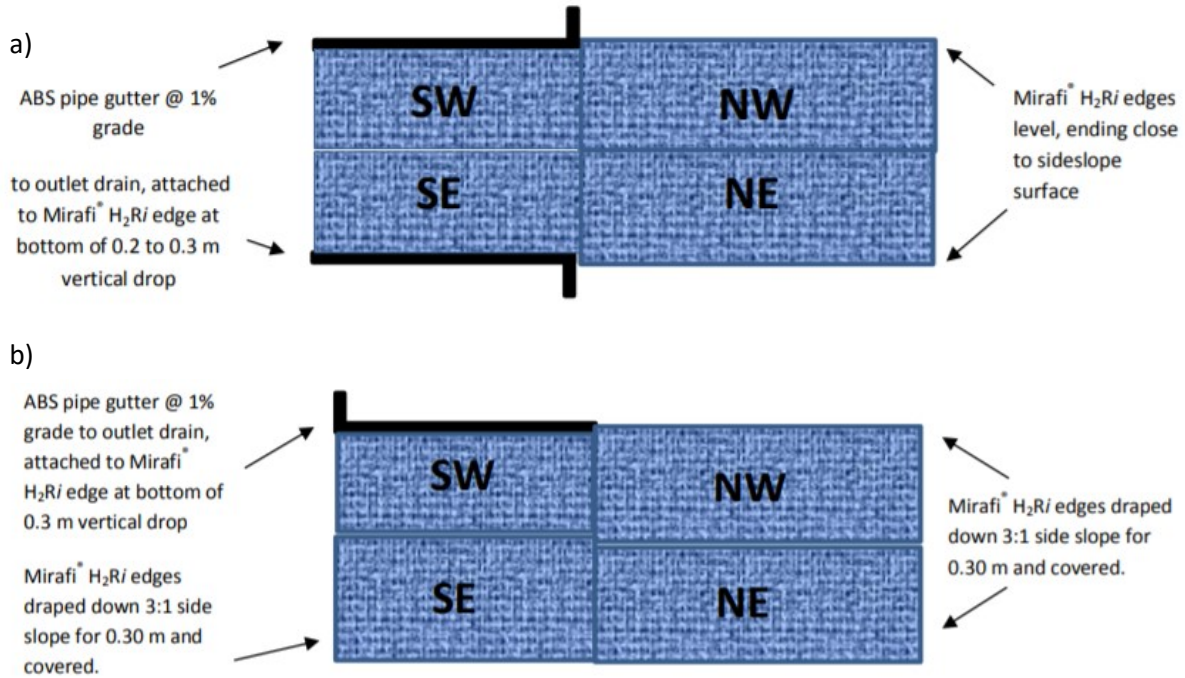
Figure 2.8. Edge treatments by quadrant for Mirafi® H₂Ri geosynthetic at a) test site 4 and b) test site 6 (Bradley et al. 2017).

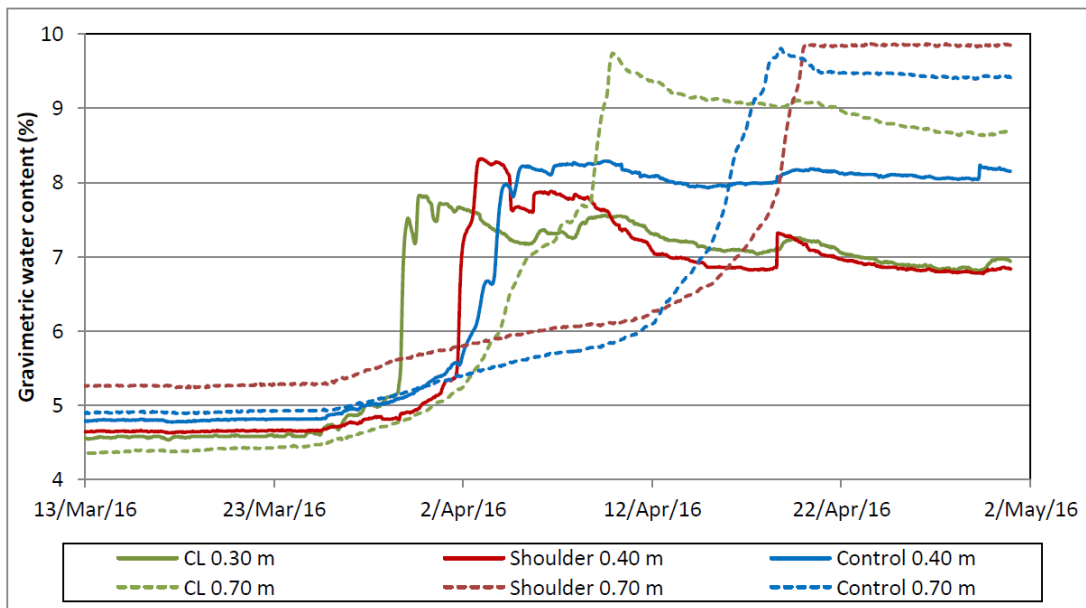
Figure 2.9. Moisture data for site 4. (Bradley et al. 2017).

The results from site 4 are shown in Figure 2.9. Bradley et al. (2017) mentioned that moisture contents reached 7.8% on the road centreline at 0.3 m depth and 8.2% on the treated shoulder at 0.4m depth due to the snow melting. On the untreated shoulder, the moisture content at 0.4 m depth increased to 8.2% after thawing. Therefore, the moisture content after thawing was similar for the treated and untreated areas. Days later, a percentage of the moisture dissipated, and moisture contents were down to 6.8% at the road centreline and treated shoulder. In contrast, the moisture measurements for the untreated area remained at a high level throughout the spring period.

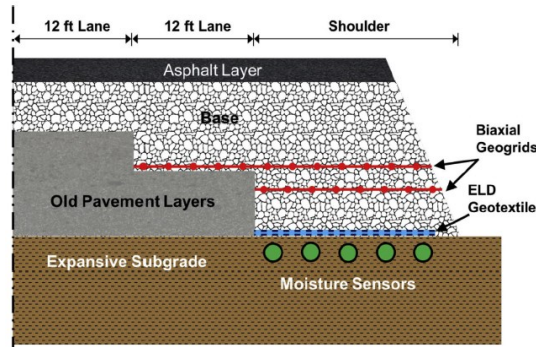
Figure 2.10. Position of moisture sensors at SH 21 (Zornberg et al. 2017).

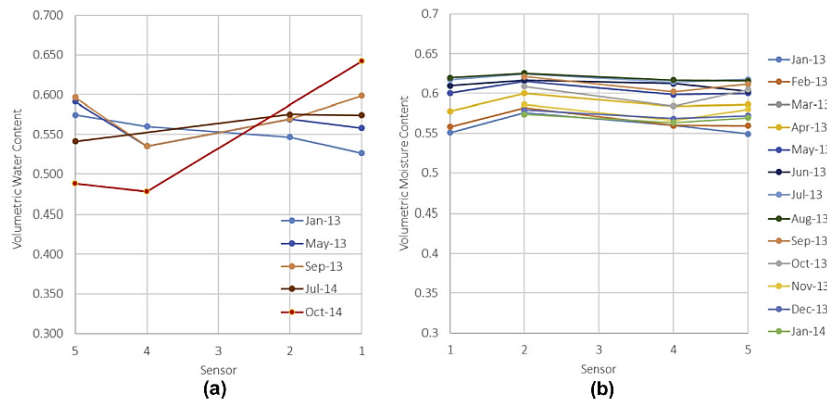
Figure 2.11. Moisture content distribution along the shoulder of SH 21: (a) In the section with conventional geotextile, (b) In the section with wicking geotextile (Zornberg et al. 2017).

Zornberg et al. (2017) concluded that the moisture content at the section remediated with the wicking geotextile remained relatively uniform over time and across the entire width of the road shoulder. Even though there were points with less moisture at other sections (Figure 2.11), the wicking geotextile section showed a more uniform distribution. The authors stated that the moisture content values across the width of the shoulder indicated that the wicking geotextile was capable of controlling the development of differential settlements. The tests also demonstrated that the enhanced lateral drainage effectively homogenized the moisture content distribution across the pavement section in an expansive clay subgrade.

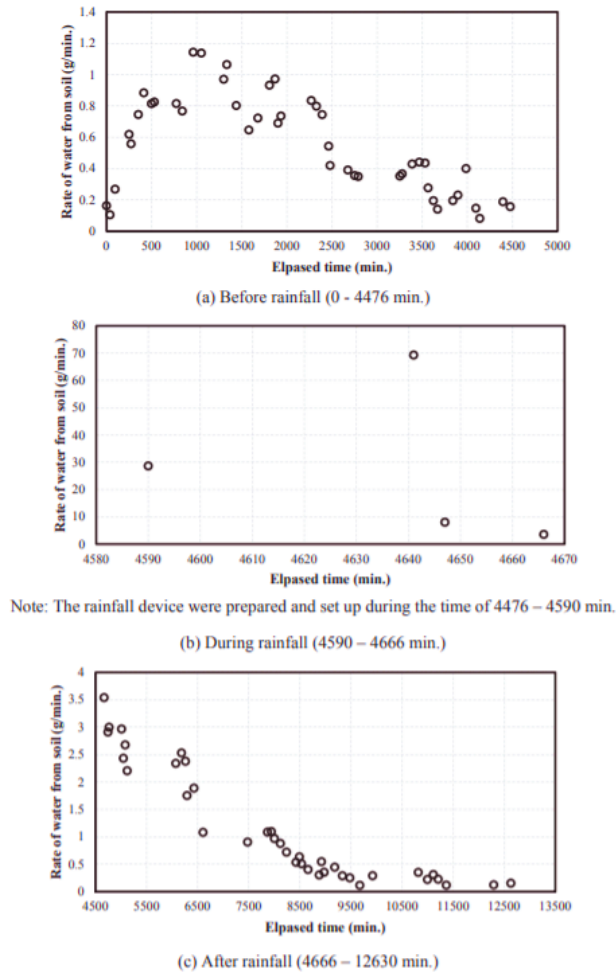
Figure 2.12. Water removal rate at different test stages (Wang et al. 2017).

water came out from the soil. The road section was exhumed after the test, and the moisture contents of the materials were measured. These contents were compared to the initial values and the values calculated under saturated conditions to demonstrate the effectiveness of the wicking geotextile (Wang et al. 2017).

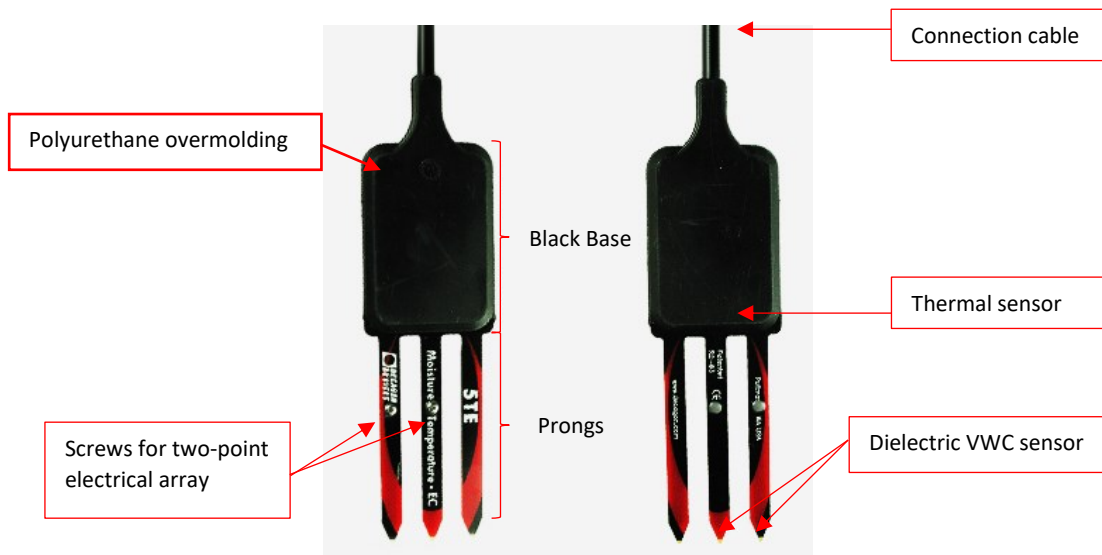
Figure 3.1. 5TE Moisture Sensors (Hoskin Scientific Ltd, n.d.).

During and after the reconstruction, 5TE moisture sensors (Figure 3.1) were also placed at the site for the investigation. These sensors can measure bulk electrical conductivity, volumetric water content, and soil temperature using an oscillator running at 70 MHz to measure the soil dielectric permittivity. The details on the sensor physical specifications are presented in Table 3.1.

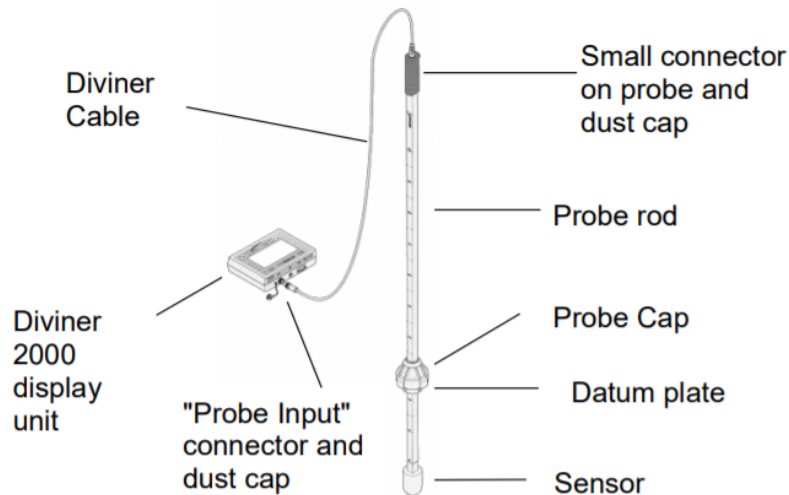
Figure 3.2. Diviner 2000 setup. (Sentek Pty Ltd, 1999).

Diviner 2000 comprises a data display unit and a portable probe, as shown in Figure 3.2. It measures the volumetric water content along the soil profile using frequency domain reflectometry (FDR) at regular intervals of 10 cm (4 inches). The readings are taken through the wall of 5 cm diameter PVC access pipes installed at the site. In order to generate absolute data, a gravimetric sampling is necessary to calibrate the Diviner 2000 for the soil present at the site.

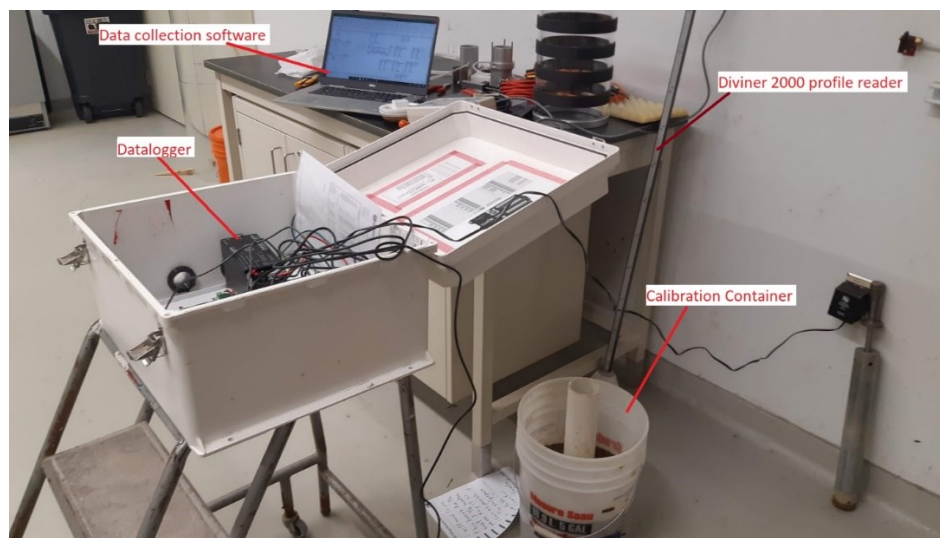
Figure 3.3. Calibration setup for 5TE and Diviner 2000 sensors.

The soil container was composed of a bucket with an internal diameter of 29 cm and a 7.2 cm PVC tube inserted in the center to allow readings with the Diviner 2000 probe (Figure 3.3). For the proper installation of the ECH₂O 5TE sensors, one hole was cut 10 cm from the bottom of the bucket. The placement of this hole ensured the sensor moisture measurements would coincide with the ones from the Diviner probe for a direct comparison.

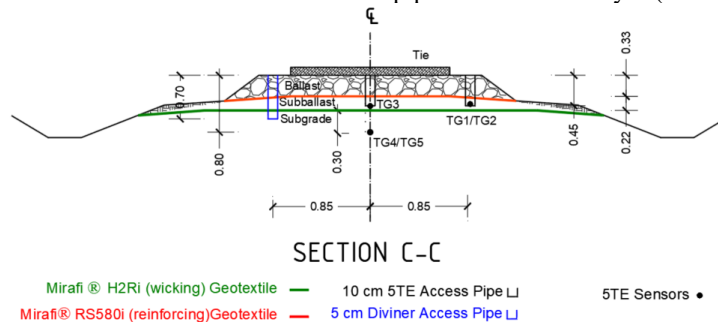
Figure 3.8. Cross-section of remediated section (dimensions in meters).

The geotextile represented in green in Figure 3.8 is Mirafi® H2Ri, a woven geotextile that provides continuous moisture management of the materials and the functions of reinforcement, confinement, separation, and filtration. The wicking yarns sewed within this geotextile are believed to provide enhanced lateral drainage along the geosynthetic plane during its lifetime (Wang et al. 2017). This geotextile lifetime is defined by the other functions performed, ranging from 5 to 100 years depending on its primary function (Geosynthetic Institute, 2019; Tencate, n.d.). Mirafi® H2Ri properties are listed in Table 3.4.

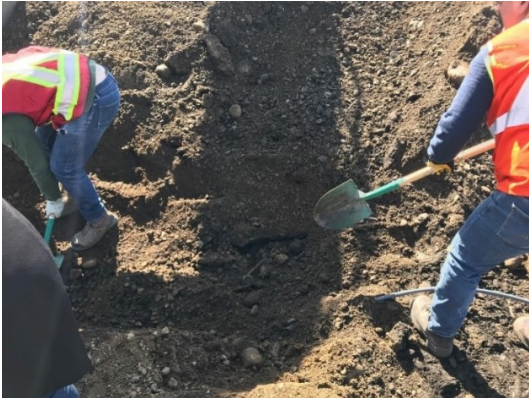
Figure 3.10. Subgrade sensor buried with an electric shield on April 23, 2019 (Abdulrazagh 2019 – with permission).

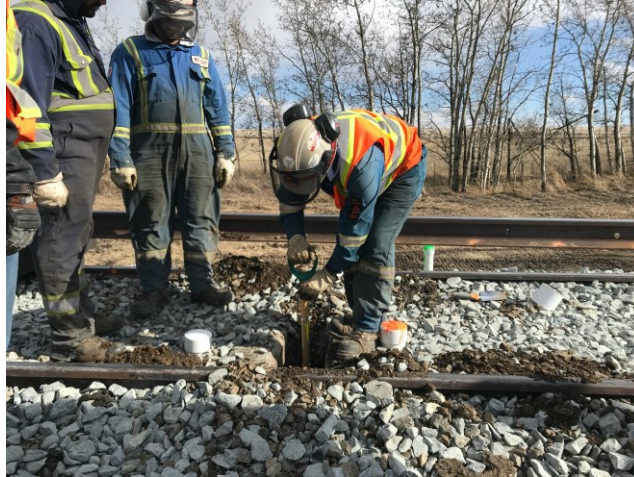
Figure 3.14. Trench boring for access pipe on April 24, 2019 (Abdulrazagh 2019 – with permission).

On April 24, 2019, a trench was dug for each access pipe in the ballast (Figure 3.14). At the remediated section, the trenches were dug before dumping the final layer of ballast for leveling the track panel. The sub-ballast and subgrade materials were dug through the trenches by a gas-powered earth auger (Figure 3.15) while using a sledgehammer and local excavator to push down the PVC pipes into the soil. A total of ten access pipes were installed. Eight of these pipes were used for 5TE sensors, and the remaining two allowed the use of the Diviner 2000 portable probe for moisture profile readings.

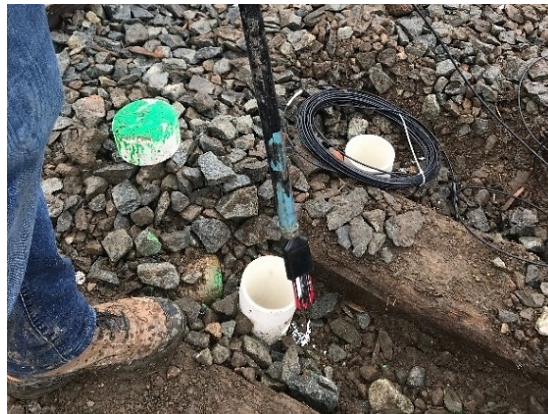
Figure 3.17. 5TE sensors installation using a notched pipe on May 15, 2019 (Abdulrazagh 2019 – with permission).

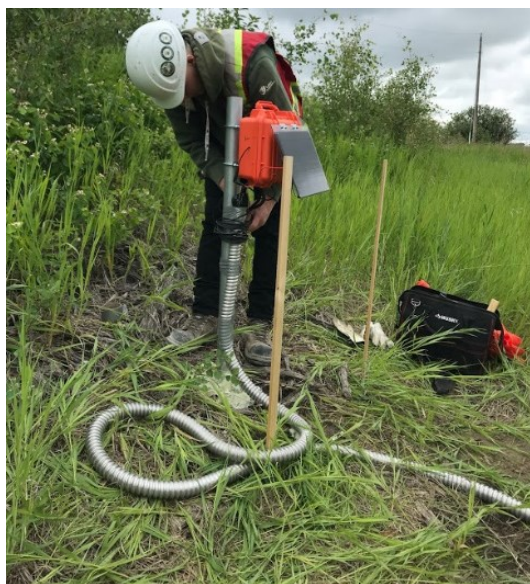
Figure 3.19 - Protection of wires by metal electrical conduits where the cables could not be buried beneath the soil on May 15, 2019 (Abdulrazagh 2019 – with permission).

The sensors' wires were protected by electric conduits at their ends to avoid damage from upcoming tamping activities, train cyclic loading, as well as water damage near both the track and dataloggers. The protection consisted of plastic shields in the track (Figure 3.18) and metal conduits around the dataloggers (Figure 3.19).

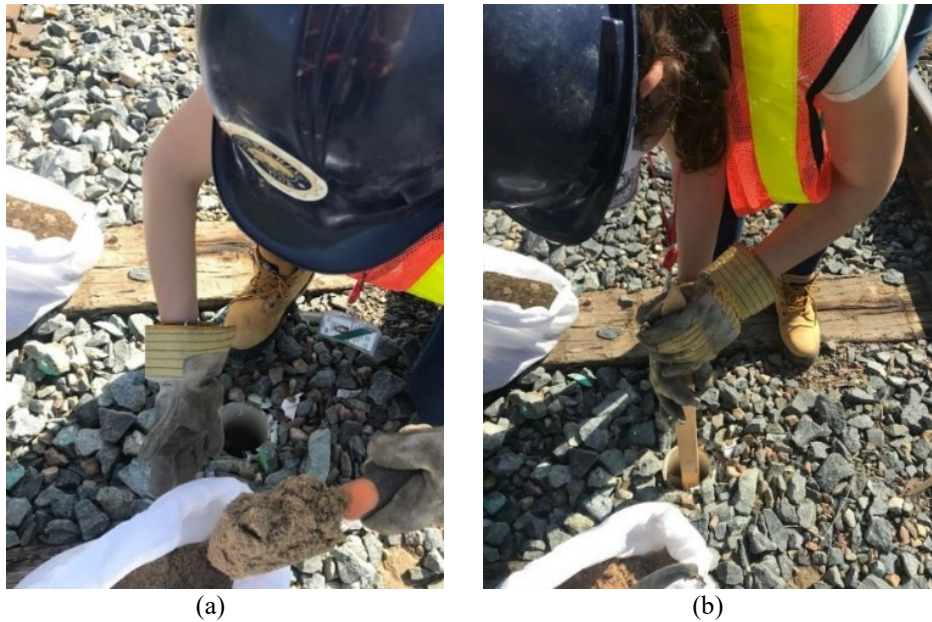
Figure 3.22. Insertion and compaction of sub-ballast soil into access pipes on July 23, 2019 (Abdulrazagh 2019 – with permission).

On July 23, 2019, all the 5TE sensors were covered with clean sub-ballast soil. The material was poured in layers that were gradually compacted to hold the sensors in place (Figure 3.22).

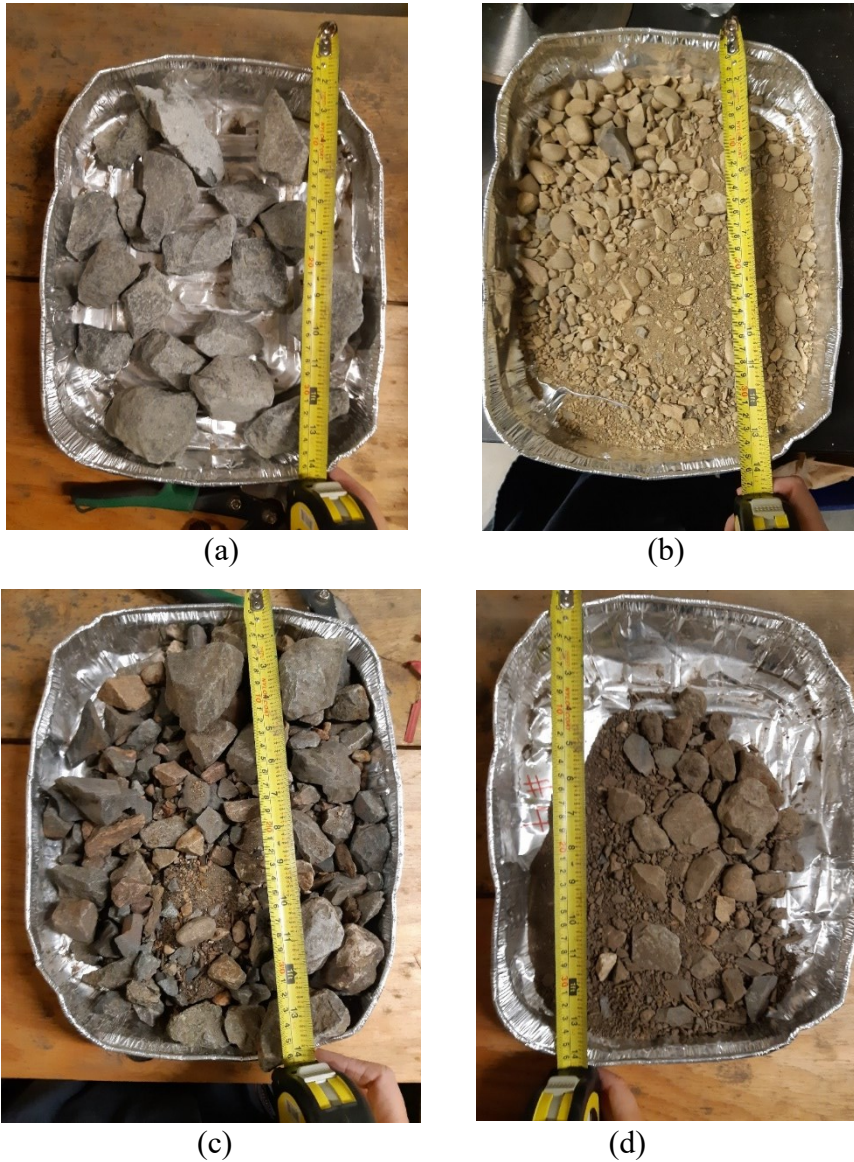
Figure 4.1- Samples of the embankment materials. (a) Clean ballast (b) Clean sub-ballast, (c) Control Ballast and (d) Control Sub-ballast.

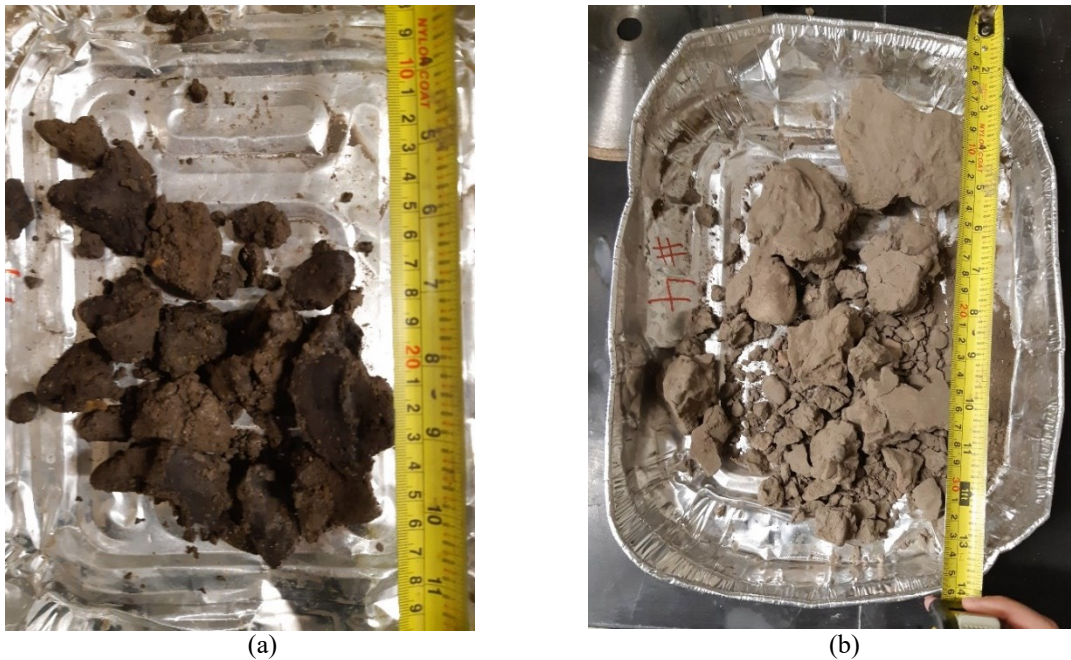
Figure 4.2-Subgrade sample in (a) wet and (b) dry conditions.

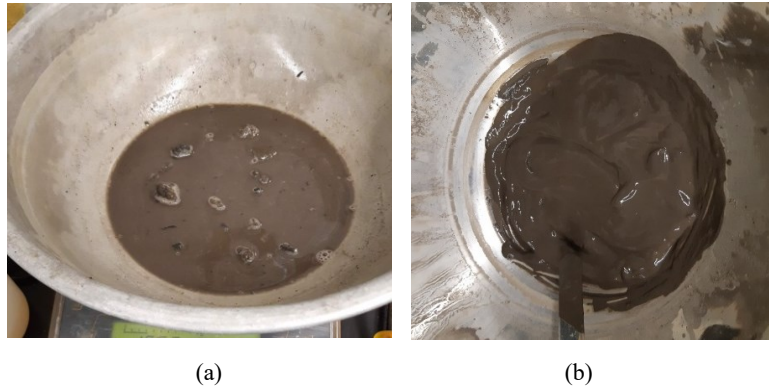
Figure 4.5. Wet preparation method of the specimen for liquid and plastic limit tests. (a) Soaked soil (b) Washed soil after drying for a few days.

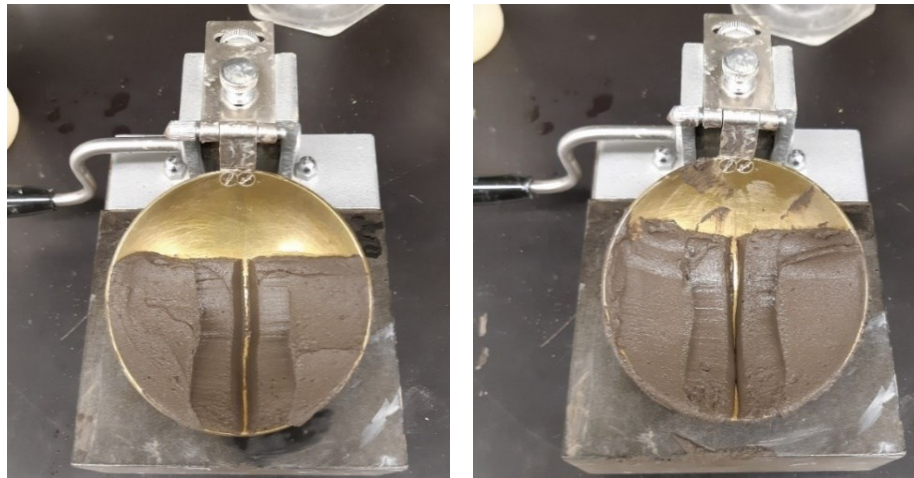
Figure 4.6. Liquid Limit Test.

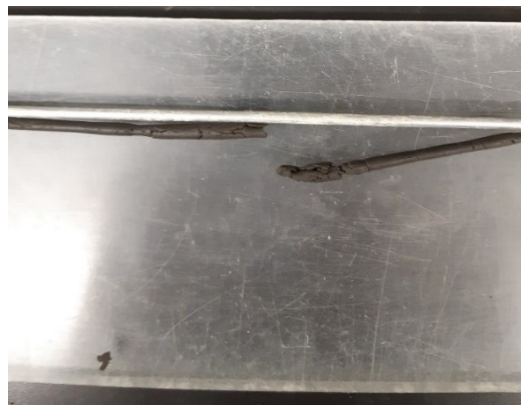
Figure 4.7. Plastic Limit sample after crumbling.

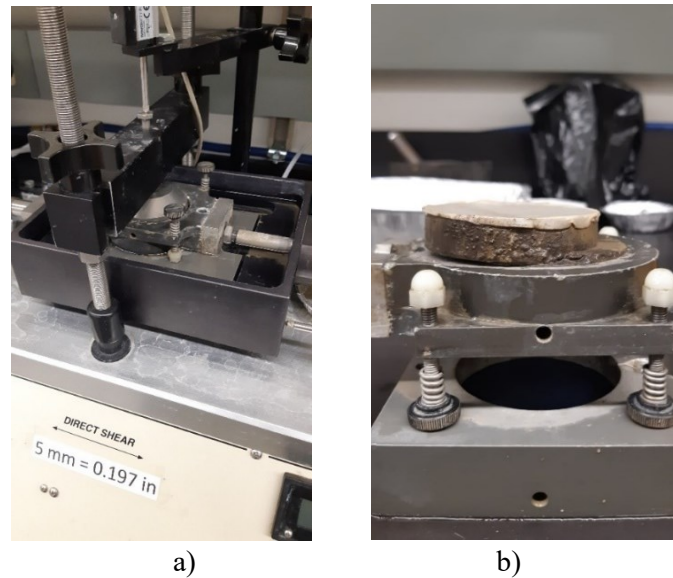
Figure 4.9. Direct Shear a) Test Setup and b) Subgrade sample after shearing.

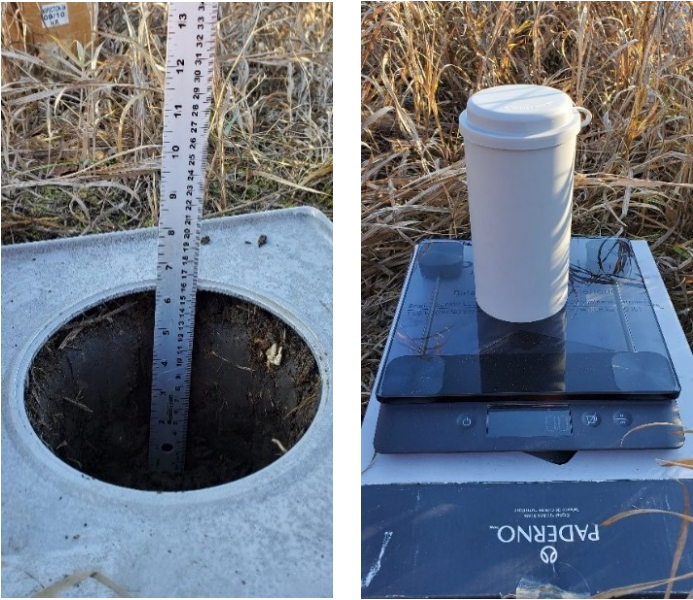
Figure 4.10- Field Dry Density Test procedure.

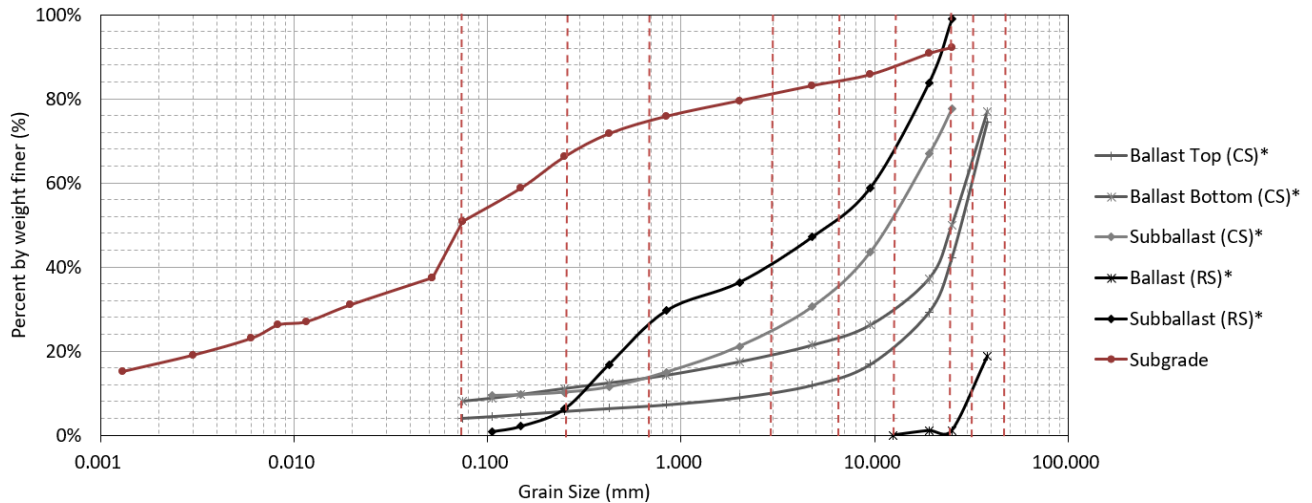
Figure 5.1. Grain-size analysis of embankment soils.

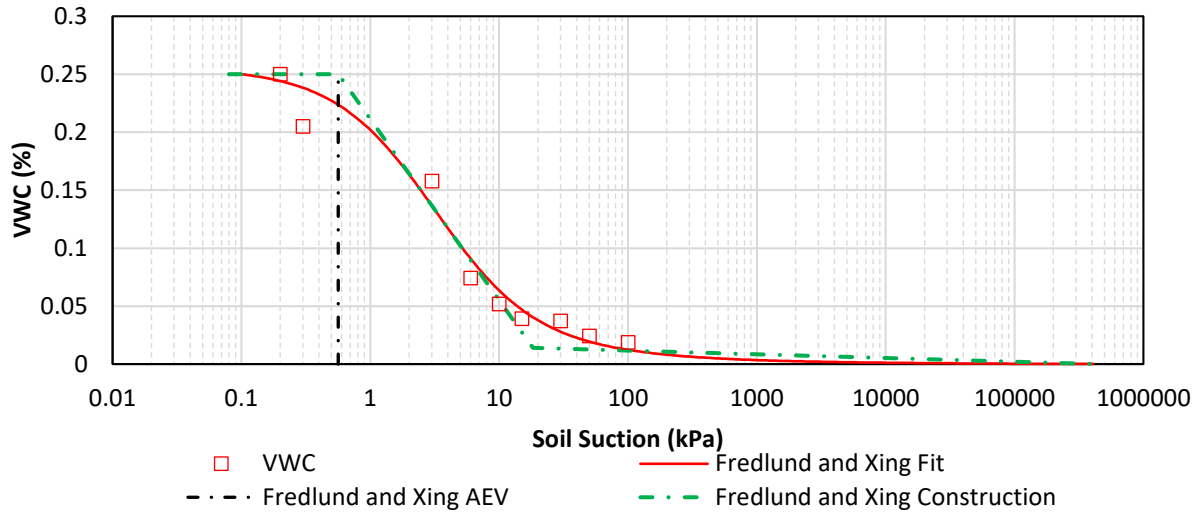
Figure 5.2. SWCC for clean sub-ballast.

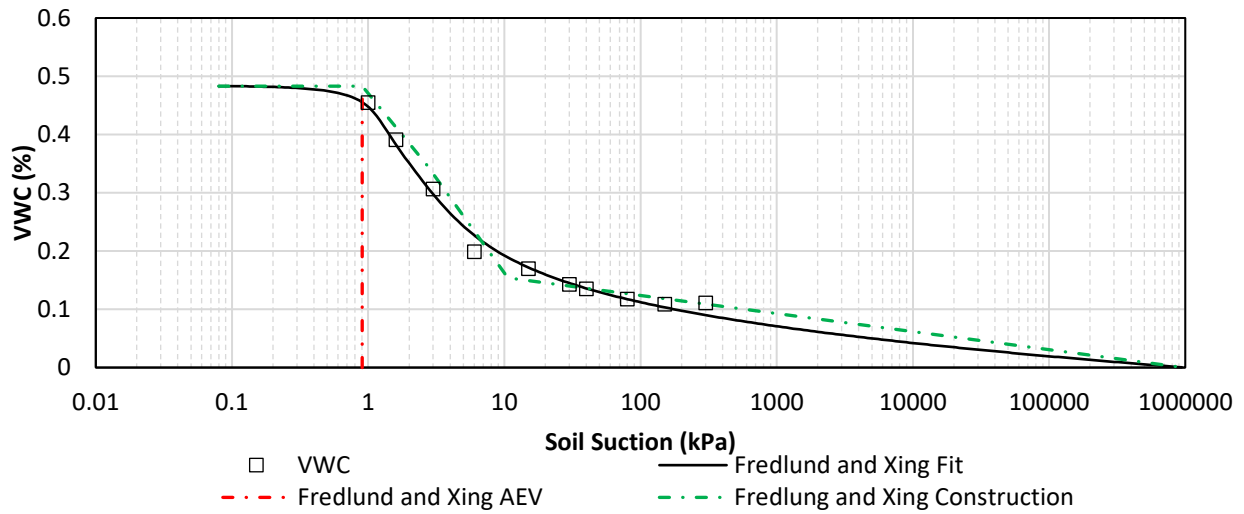
Figure 5.3. SWCC for control sub-ballast.

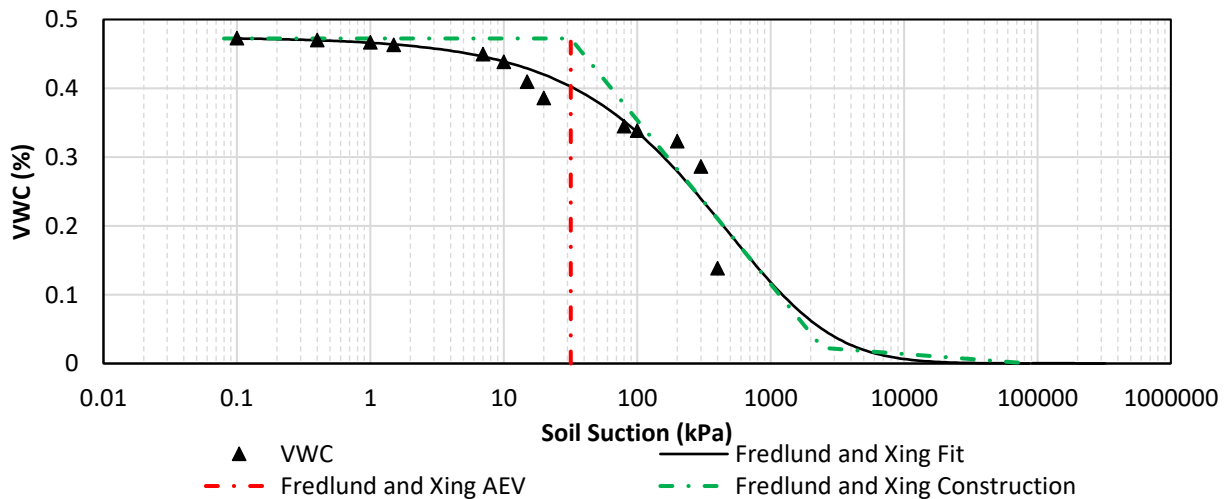
Figure 5.4. SWCC for subgrade.

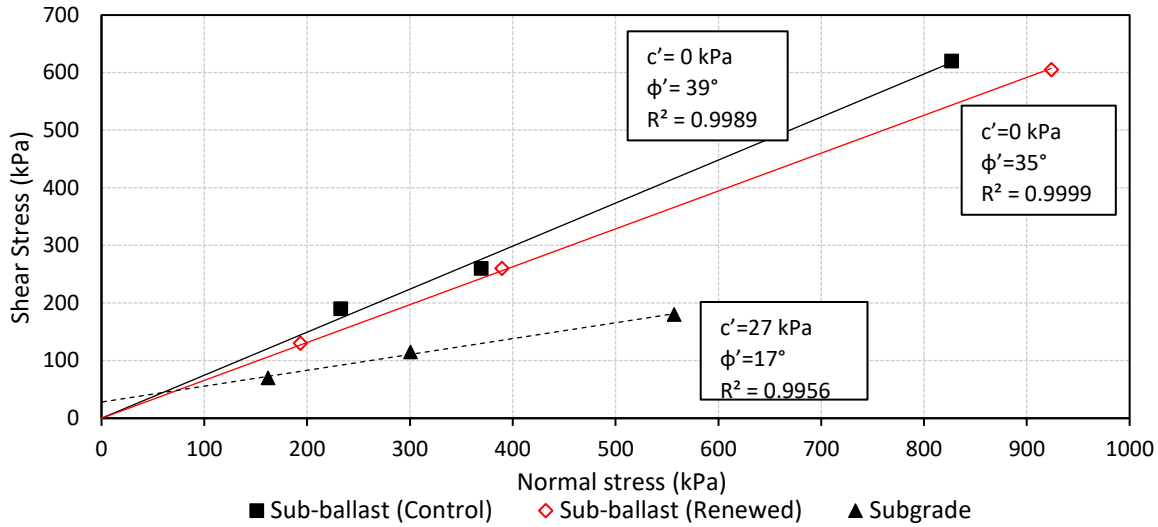
Figure 5.8. Shear Stress of Embankment Materials.

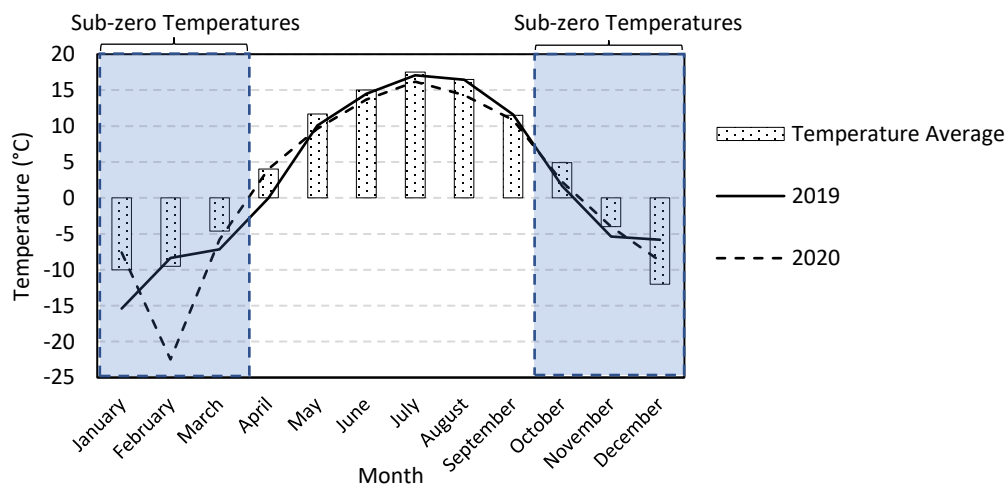
Figure 6.1. 10-year average temperature (2008-2018) vs. recorded temperatures (2019-2020) (ECCC, 2020).

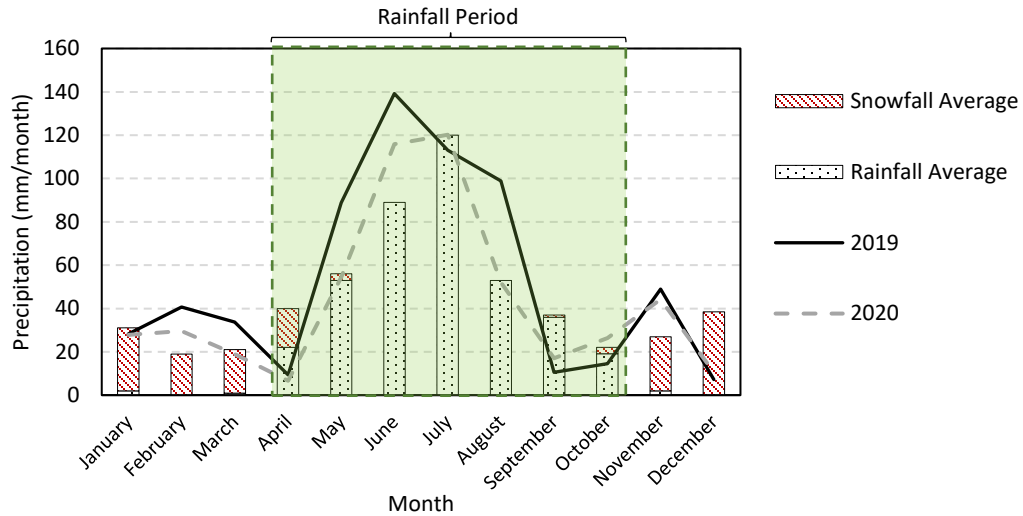
Figure 6.2. 10-year average precipitation (2008- 2018) vs. recorded precipitation (2019 and 2020) (ECCC, 2020).

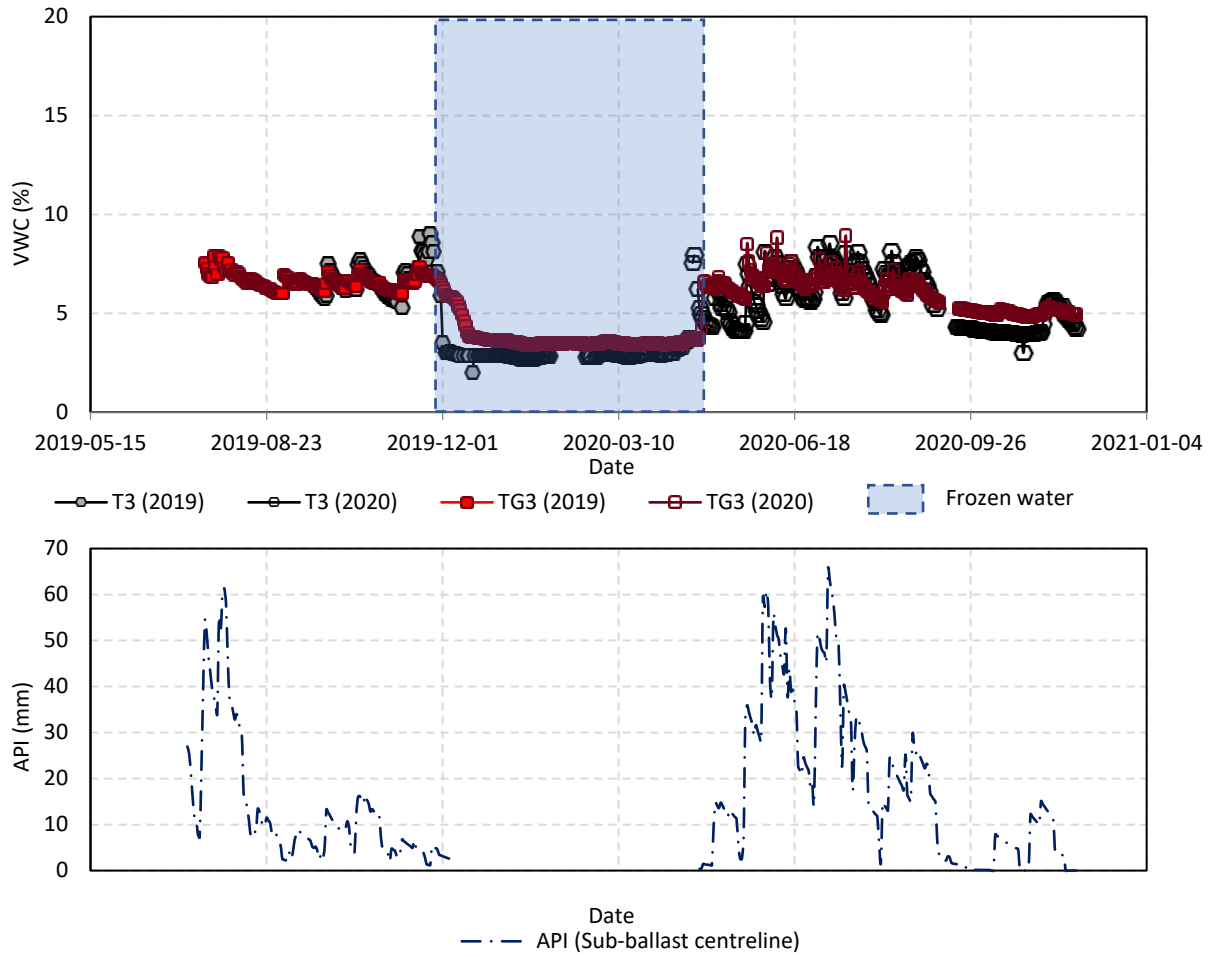
Figure 6.4. VWC measurements comparison with antecedent precipitation index values found for Sub-ballast centreline.

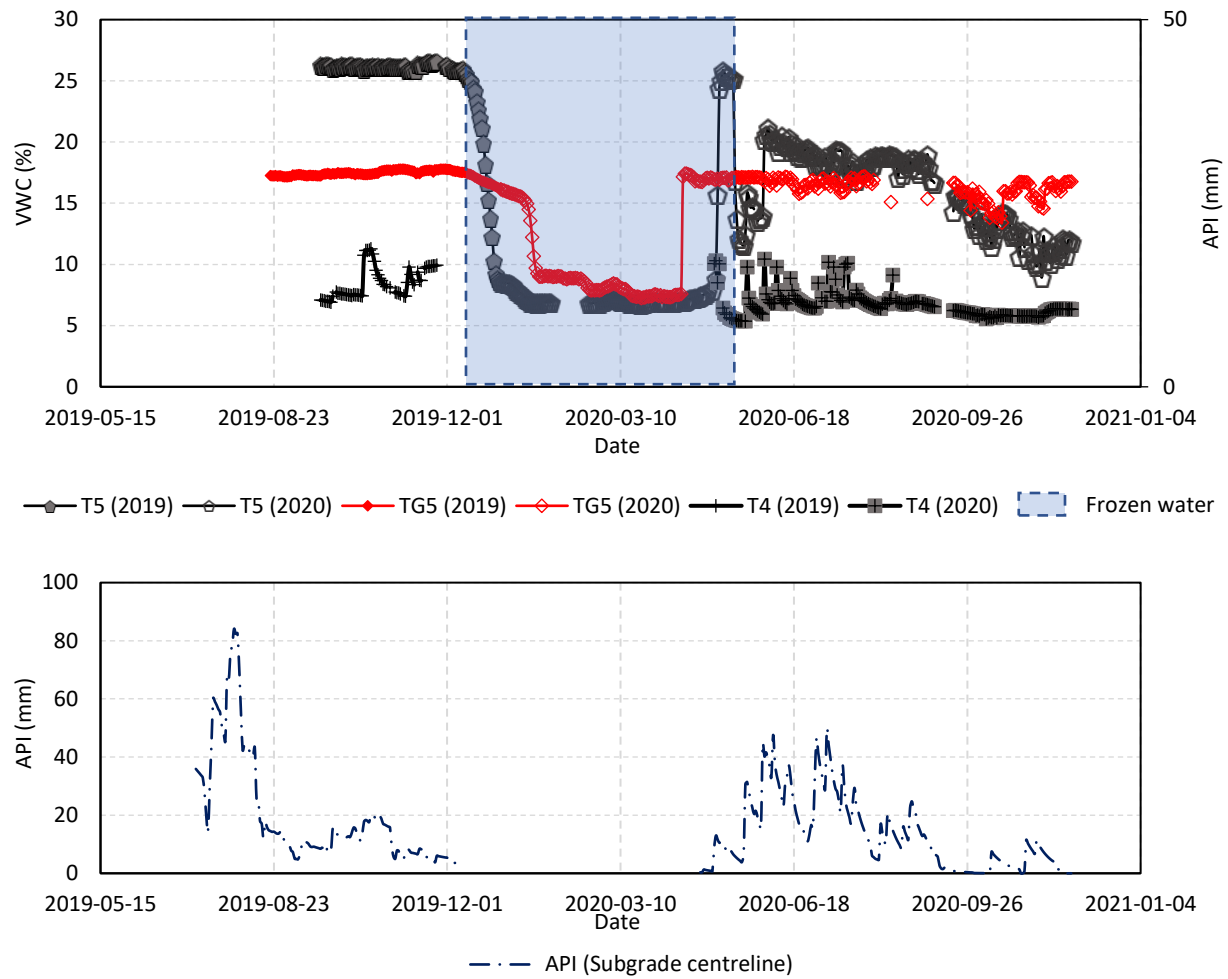
Figure 6.5. VWC measurements comparison with antecedent precipitation index values found for a) Sub-ballast shoulder, b) Sub-ballast centreline, and c) Subgrade centreline.

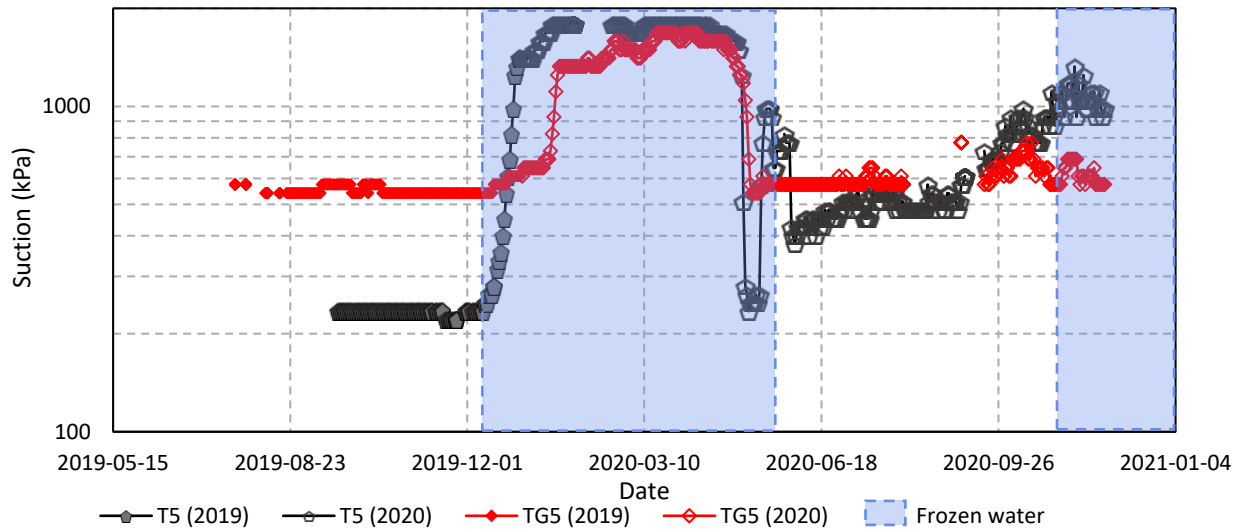
Figure 6.8. Estimated in-situ suction values for the subgrade centreline at the control section (T5) and remediated section (TG5).

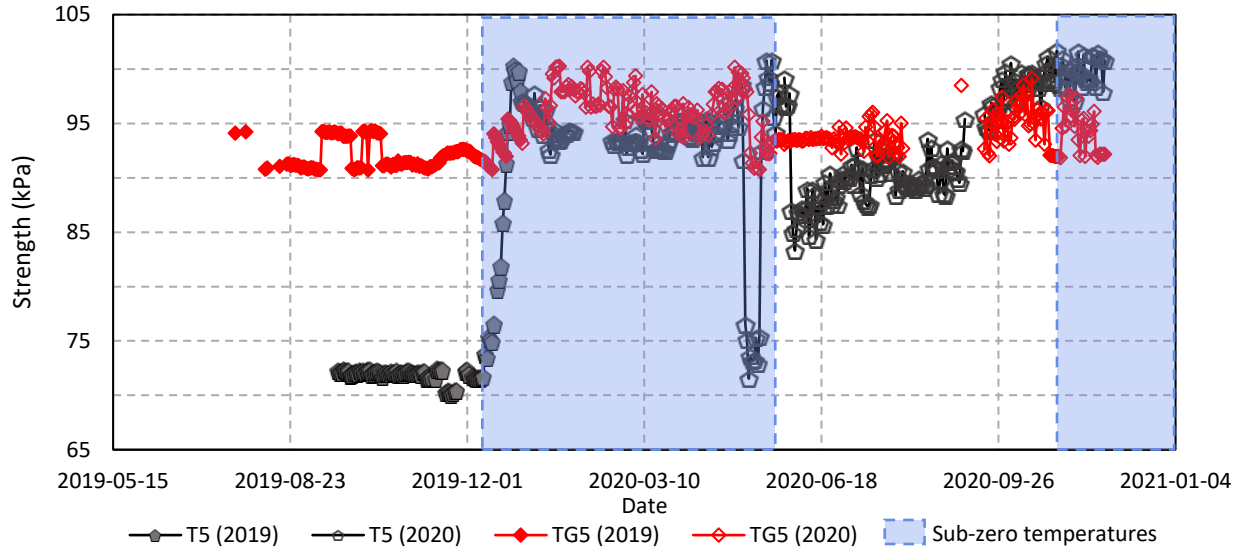
Figure 6.9- Variation of in-situ strength values at the subgrade (93 cm depth) through the time of the study for control section (T5) and remediated section (TG5).

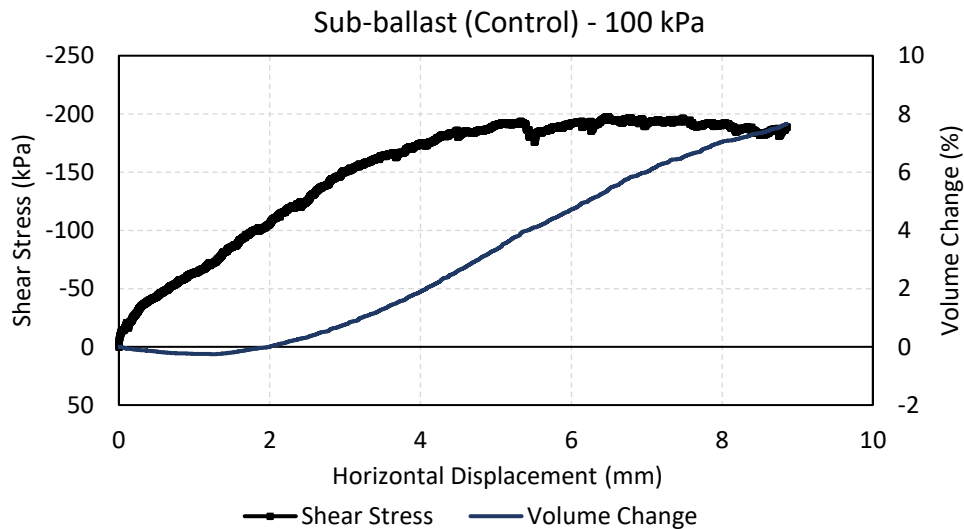
Figure I.11. Hor. Displacement vs. Shear Stress/Volume Change for Control Subballast with $\sigma=100$ kPa.

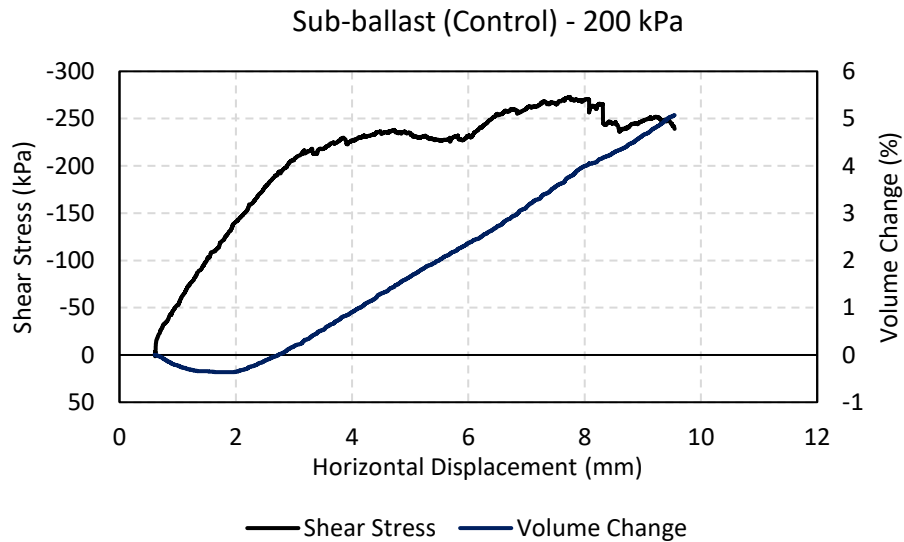
Figure I.12. Hor. Displacement vs. Shear Stress/Volume Change for Control Subballast with $\sigma=200$ kPa.

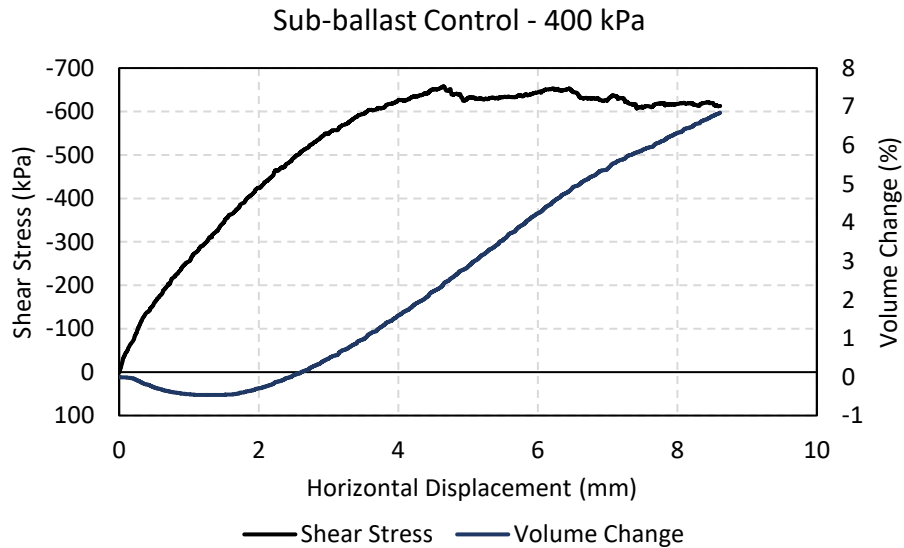
Figure I.13. Hor. Displacement vs. Shear Stress/Volume Change for Control Subballast with $\sigma=400$ kPa.
