**Effect of an Embankment Reconstruction Using a Wicking Geotextile in the Drainage and
Strength of Subgrade**

A thesis submitted in partial fulfillment of the requirements for the degree of

Geotechnical Engineering

University of Alberta

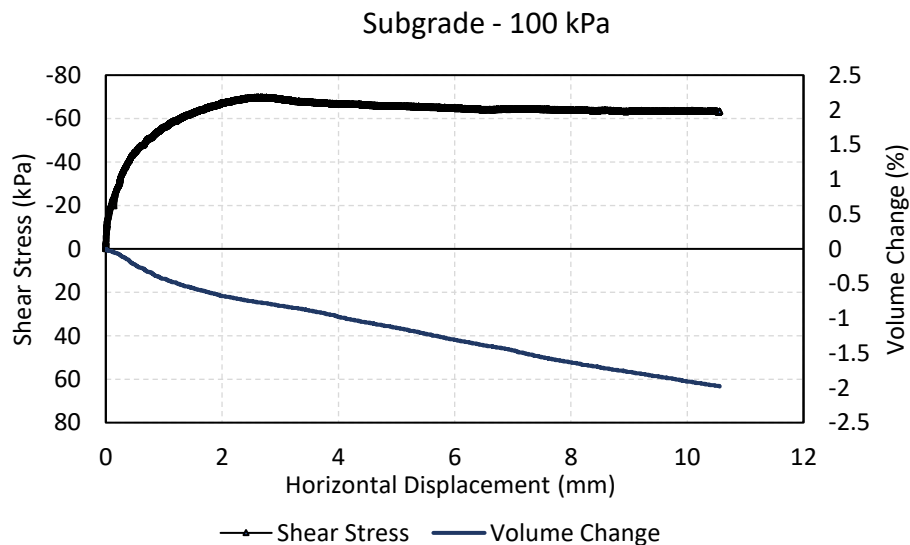
Figure I.14. Hor. Displacement vs. Shear Stress/Volume Change for Subgrade with $\sigma=100$ kPa.

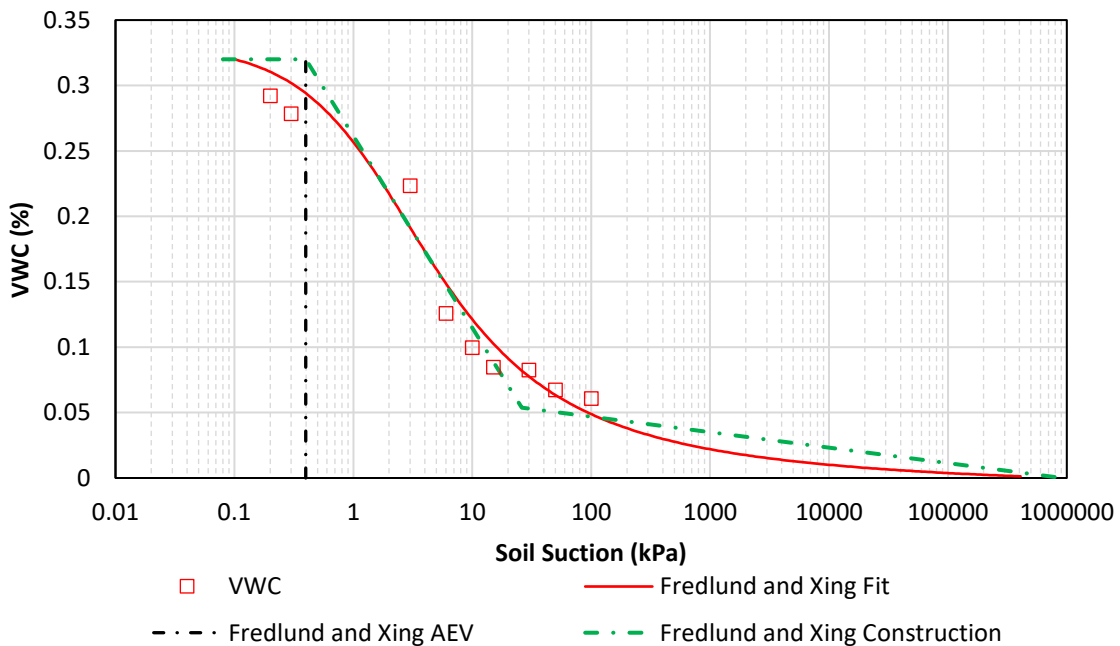
Figure I.17. Soil-water characteristic curve for first Clean Subballast test.

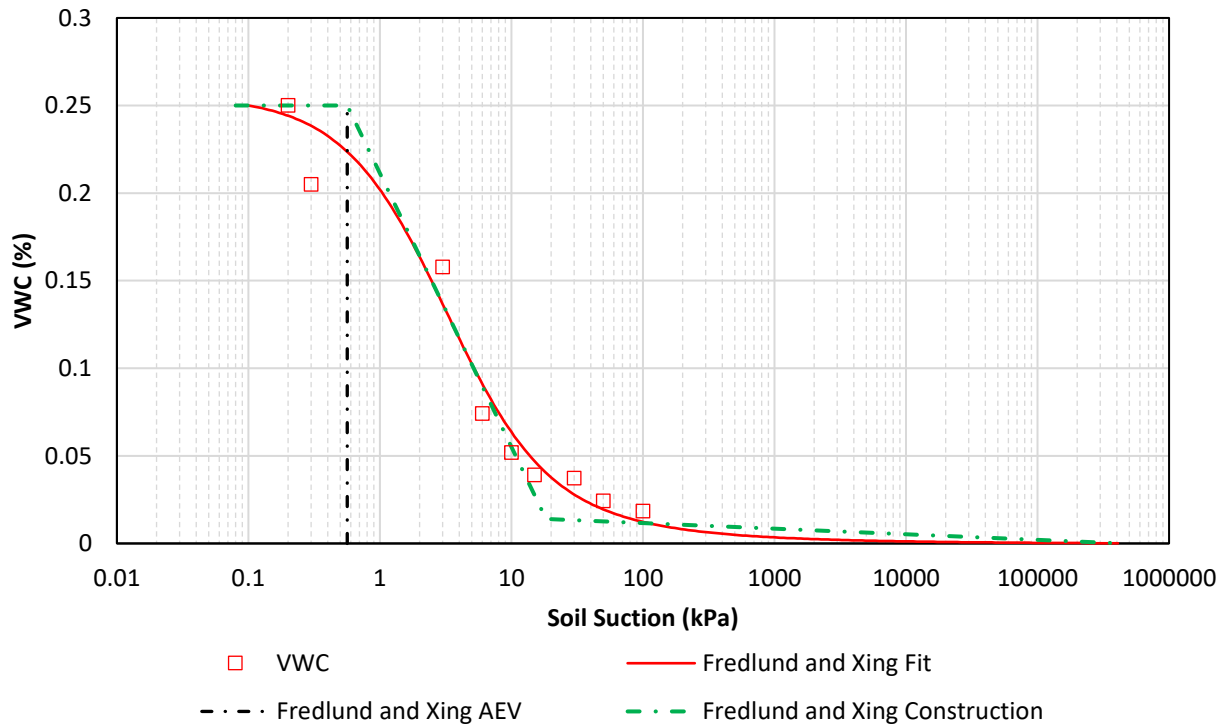
Figure I.18. Soil-water characteristic curve for second Clean Subballast test.

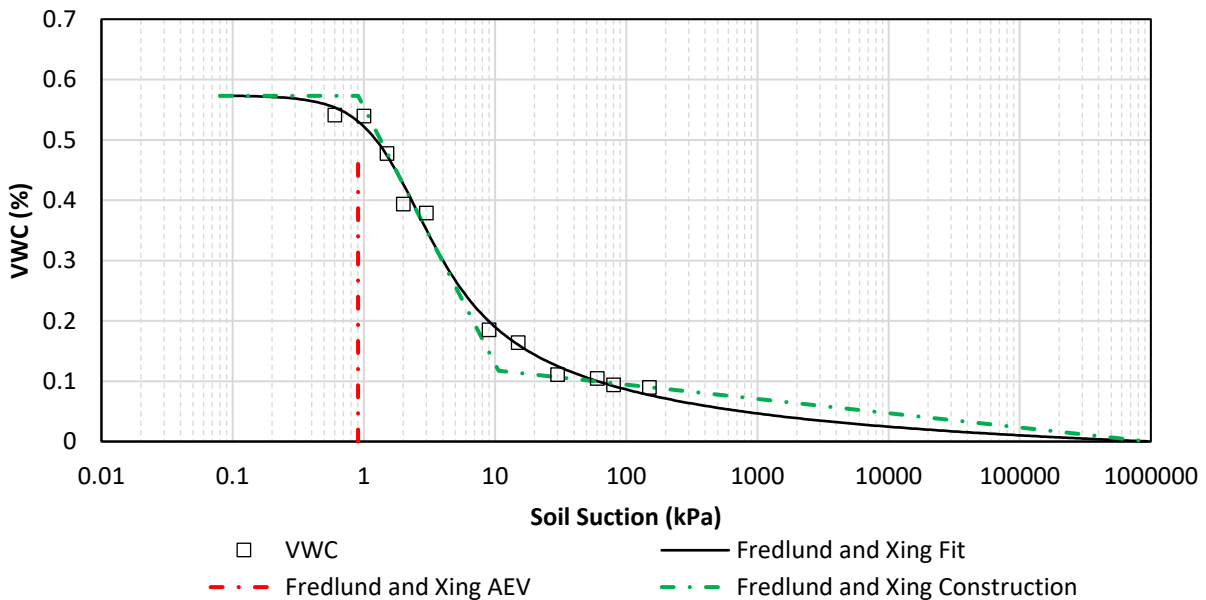
Figure I.19. Soil-water characteristic curve for first Control Subballast test.

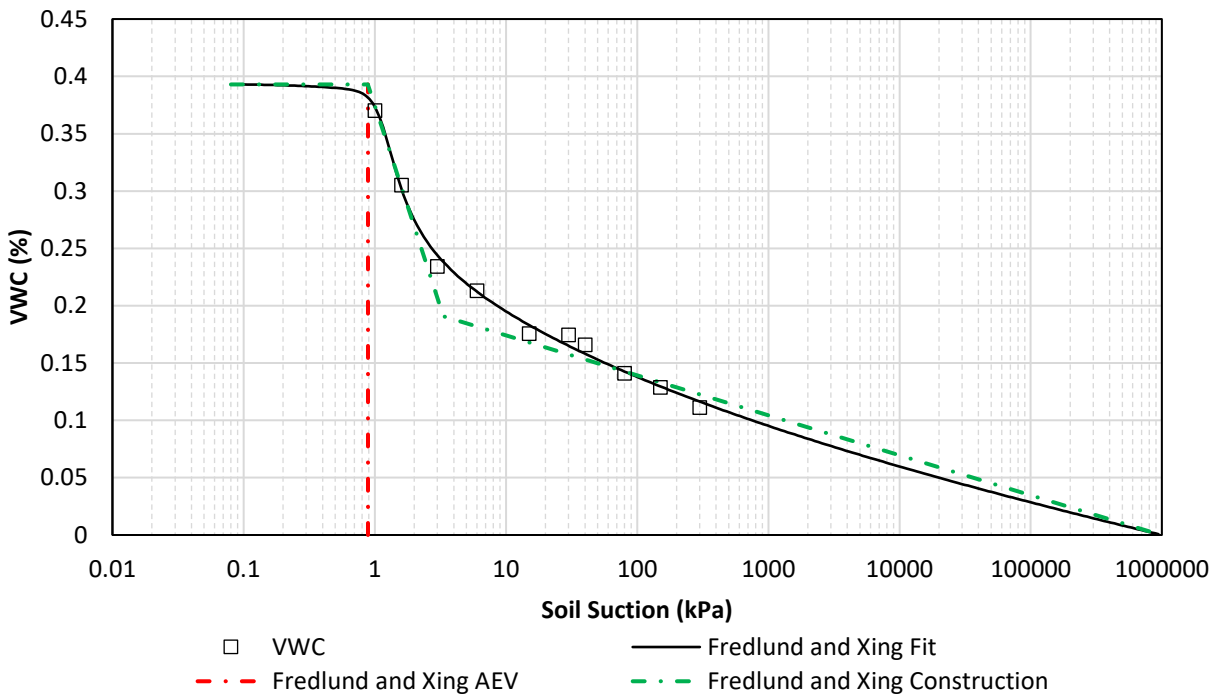
Figure I.20. Soil-water characteristic curve for second Control Subballast test.

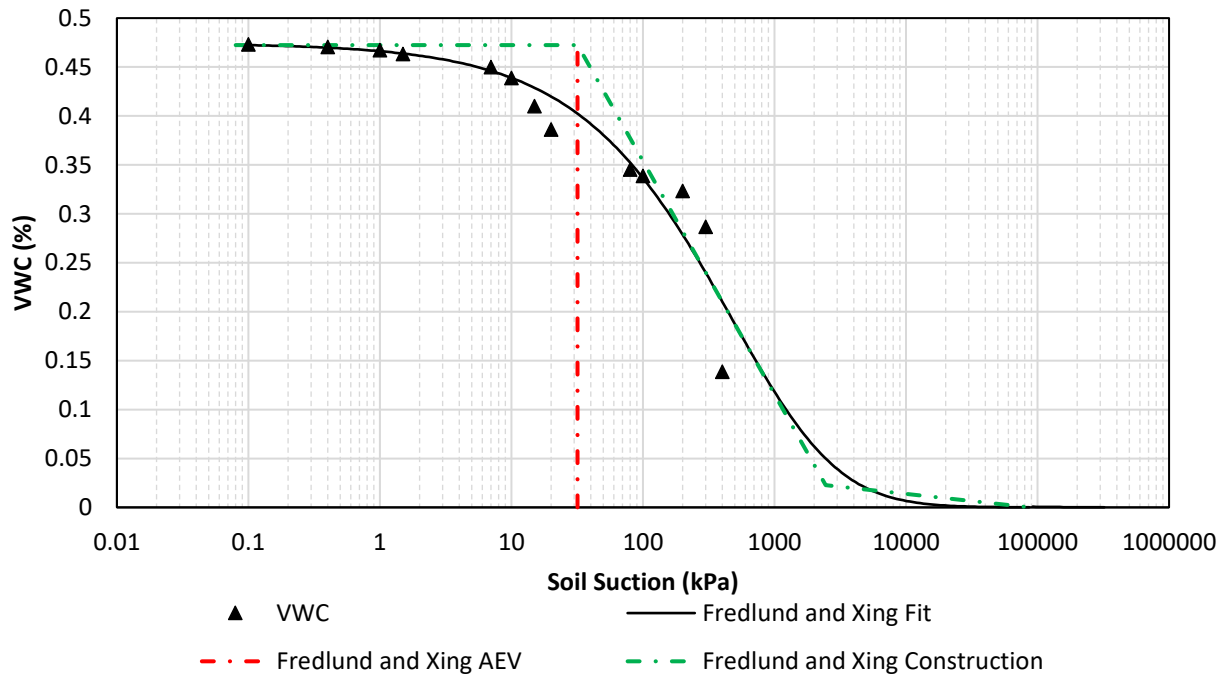
Figure I.21. Soil-water characteristic curve for first Subgrade test.

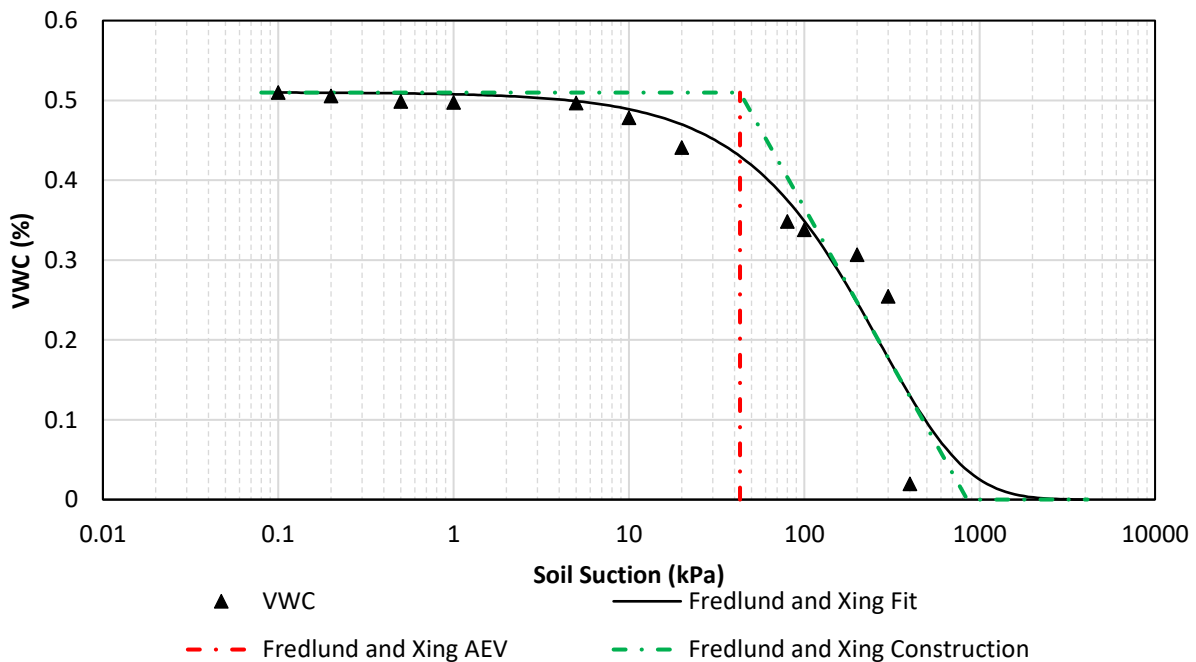
Figure I.22. Soil-water characteristic curve for second Subgrade test.

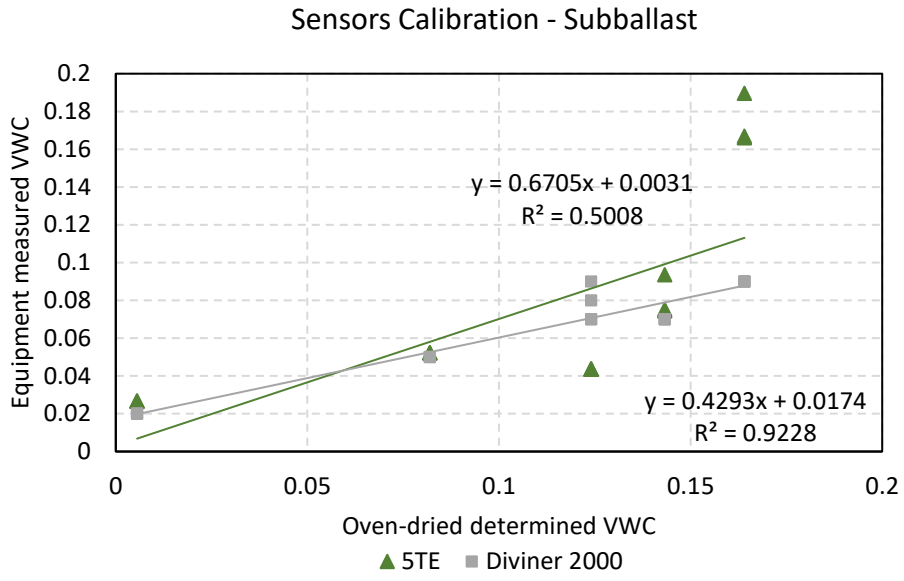
Figure II.0.1. Diviner and 5TE sensor calibration for Clean Sub-ballast.

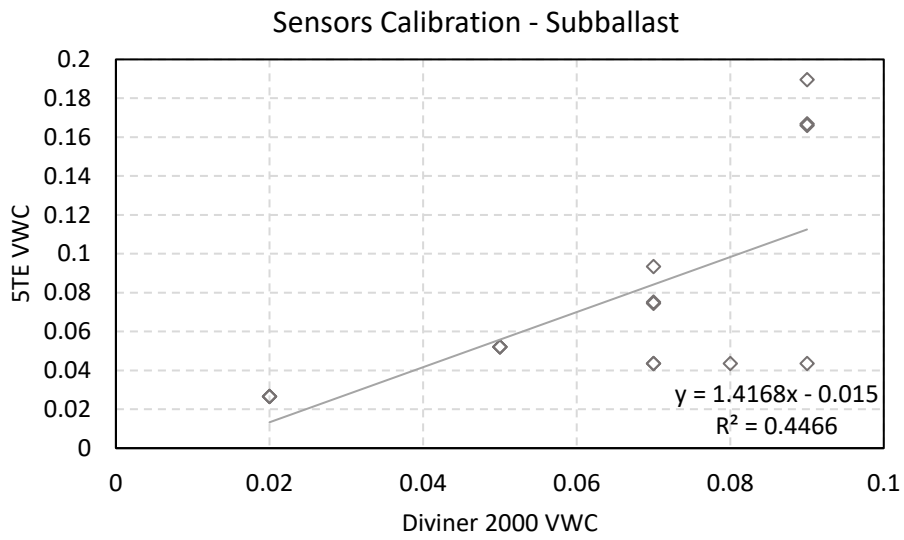
Figure II.0.2. Diviner vs. 5TE measurements for Clean Sub-ballast.

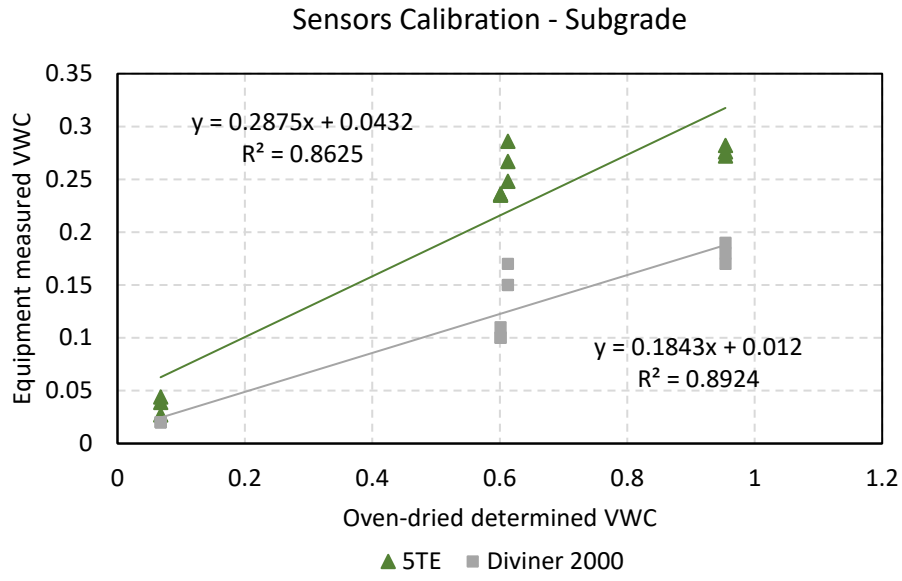
Figure II.0.3. Diviner and 5TE sensor calibration for Subgrade.

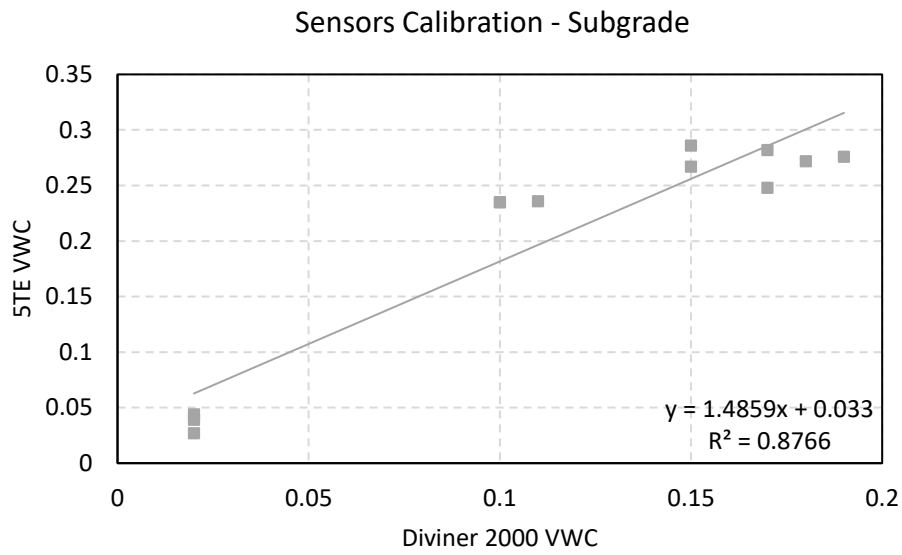
Figure II.0.4 Diviner vs. 5TE measurements for Subgrade.
