Serviceability of Graphitized Carbon Steel

Evan Vokes   ©

requirements for the degree of *Master of Science*

Materials Engineering

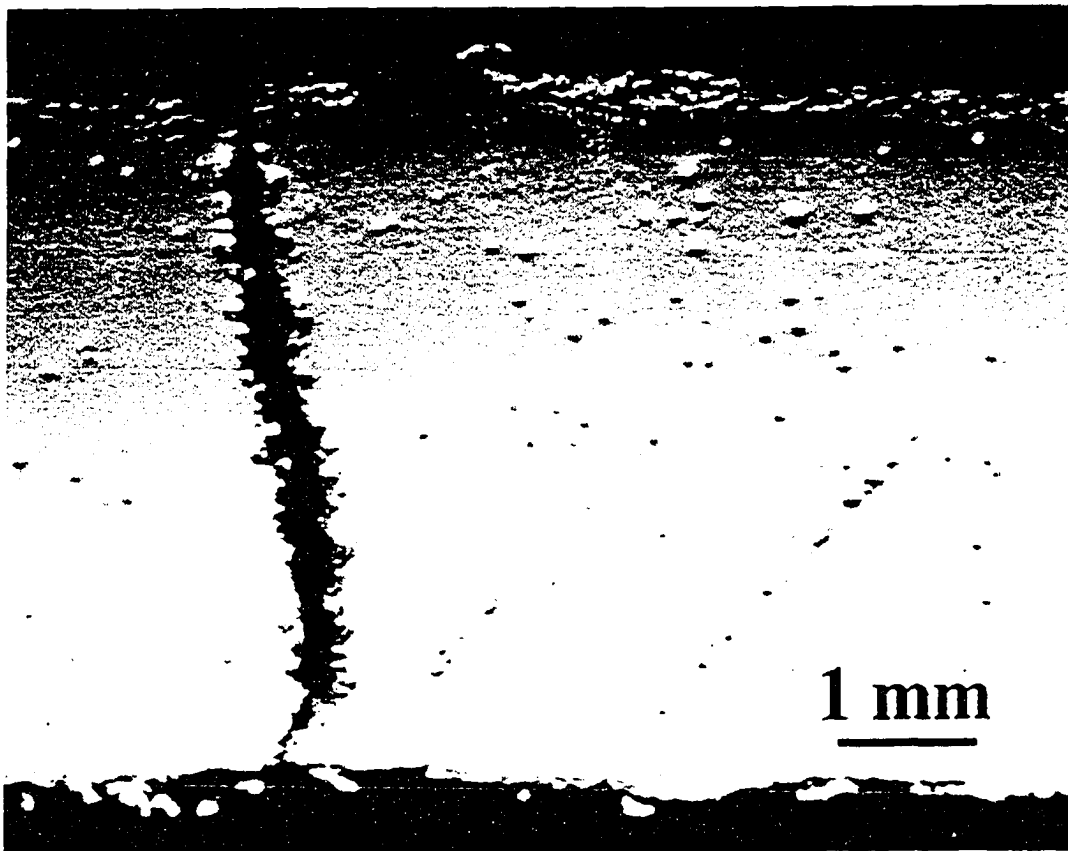
Furtado and Le May [35] found evidence that the occurrence of planar base metal graphitization showed little to no evidence of creep damage in a steam piping failure. The lack of general creep deformation near the localized fracture surface gave evidence that creep properties will not dominate mechanical properties; nor was there any evidence of purely mechanical overload. The only evidence was decohesion of graphite along a plane of defects. The unetched microstructure in Figure 3.4-1 shows the advanced planar graphitization concentration was far in excess of the presence of random graphite.

Figure 3.4-1 Failure due to planar graphitization of 100 000 hr service exposed C-Mo steel[55]

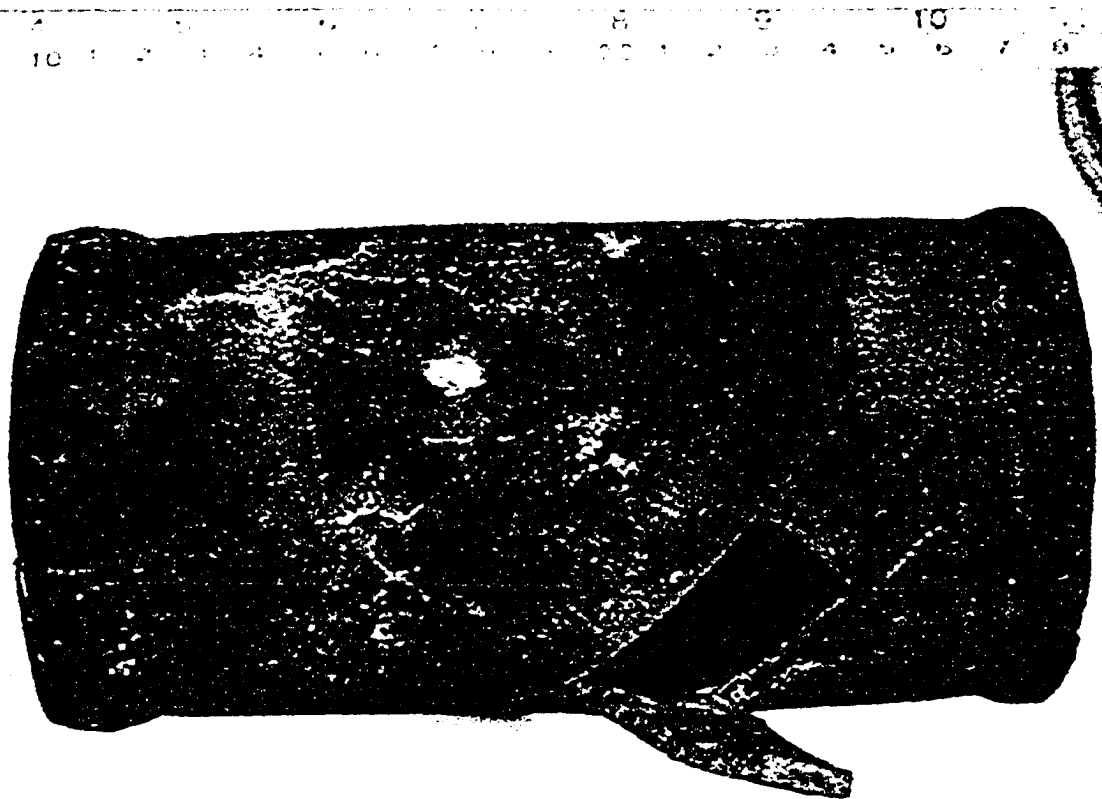
properties but cannot reflect actual service conditions. Creep testing shows how a materials microstructure and mechanical properties are affected by temperature and time. Accelerated creep testing is used to suggest a future time when a materials properties might be compromised. Furtado and Lemay's [34] experience with planar graphite (Figure 4.1-1), shows that choosing any one of the individual testing methods may not reflect the true criteria of a problem requiring that a comprehensive fitness for service assessment evaluate all related phenomena.

Figure 4.1-1 Steam piping ruptured due to planar graphitization [34]

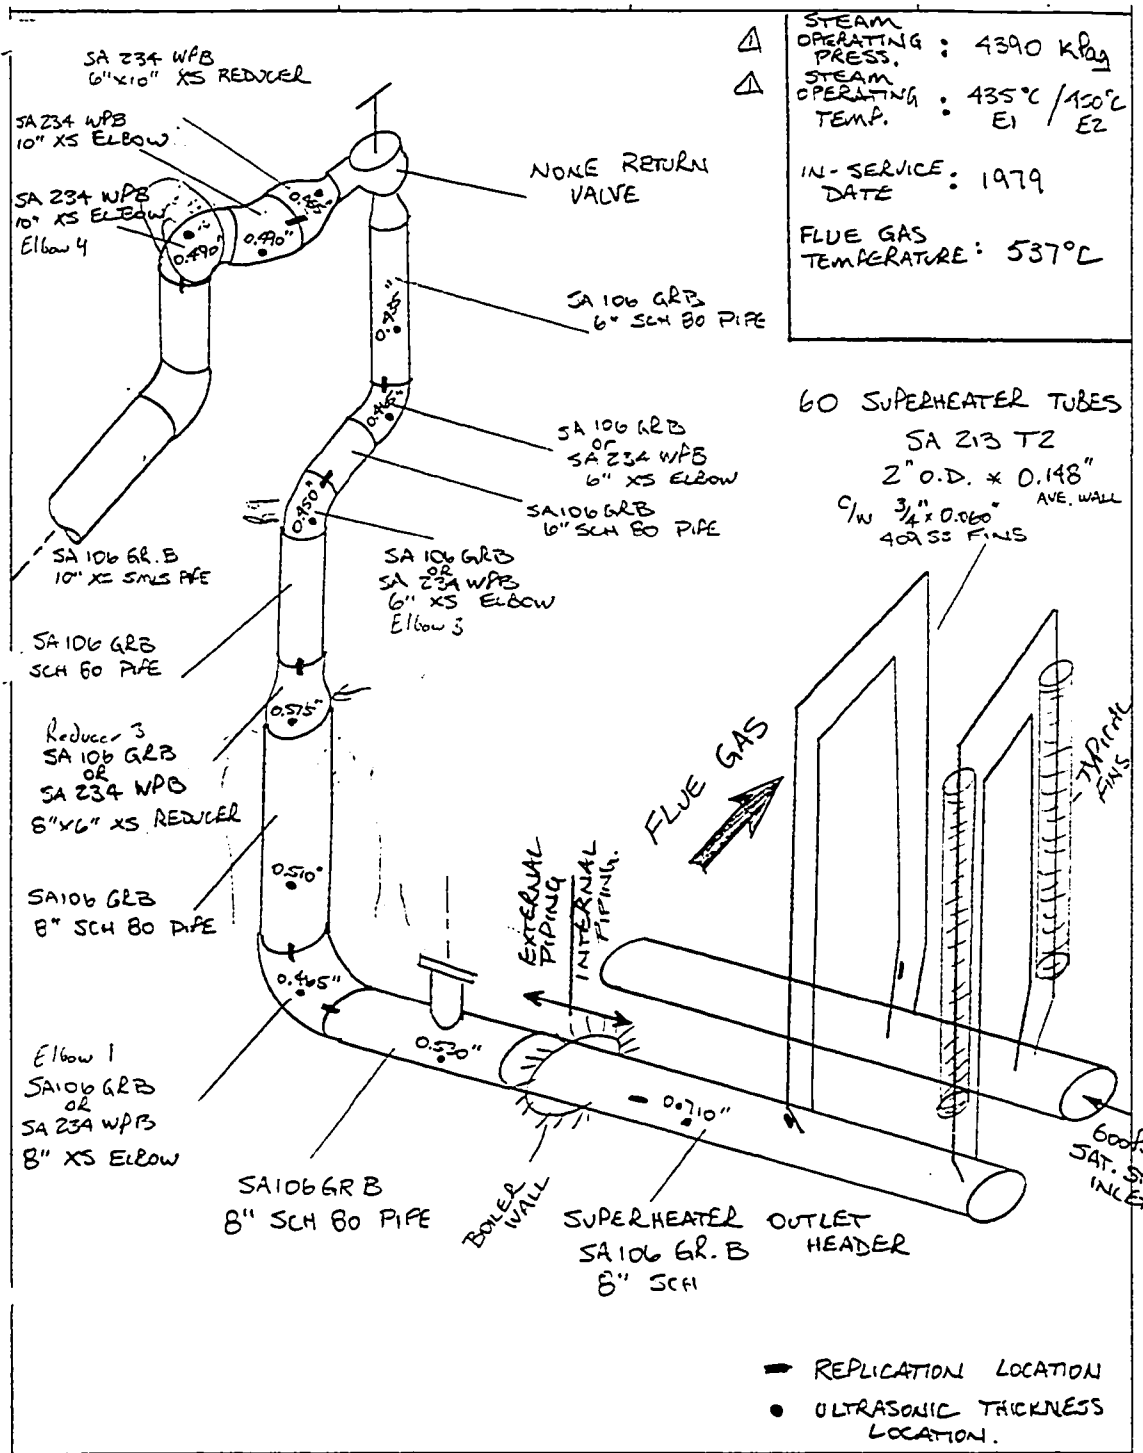
Figure 5.2-1 shows a section of the E1 WHB piping from the superheater to just beyond the first block valve. Elbows 1, 3, 4 and Reducer 3 have been labelled in this partial piping schematic. Numbering is based on the section cuts as detailed in the full piping schematic included in Appendix A. The focus of material selection was based on suspect weld joints identified by Canspec replication and Microdur hardnesses [2]. Additionally, eight neutrados sections of elbows near the graphitized replications, two reducers and several piping sections were retained, and the balance of material was disposed of. A further one half of Elbow 1, which is the mirror half of the elbow used by Canspec to perform microstructure analysis, was salvaged.

Figure 5.2-1 Piping schematic from E1 WHB showing Non-Destructive Examination sites adjacent to boiler. Most of the research material comes from this section of piping and appropriate materials are labelled with their respective research designations.

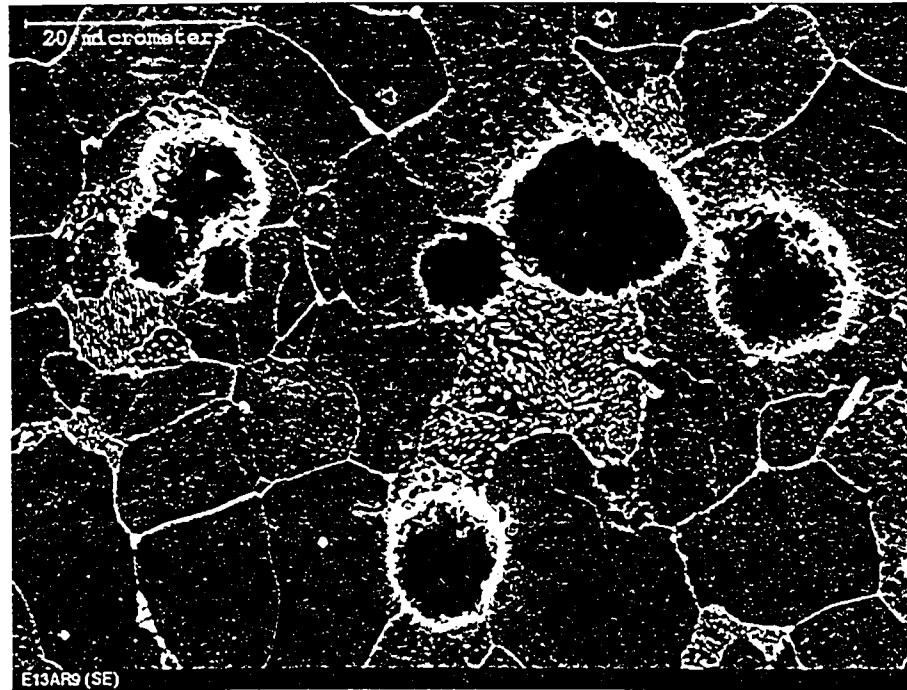
Figure 7.2-2 Planar graphitized Reducer 3 showing graphite nodules and spheroidized iron carbides in degraded pearlite colonies.

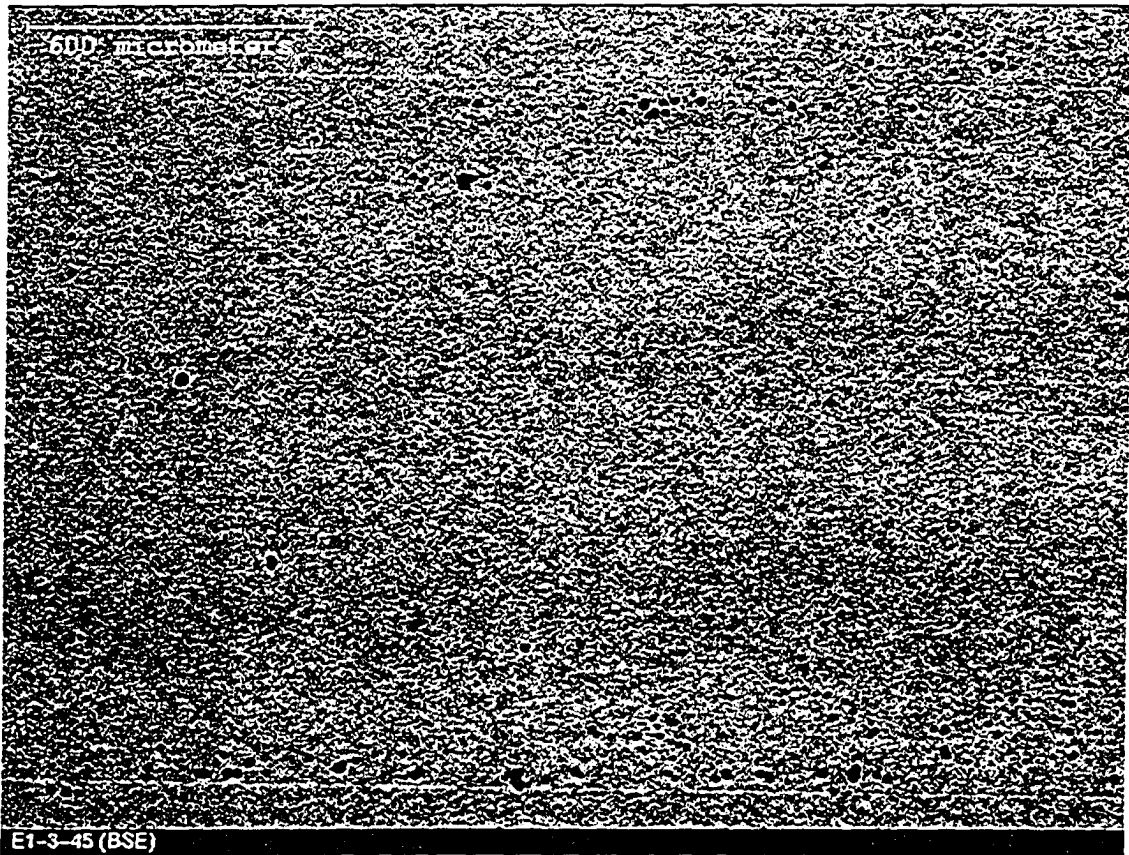
Figure 7.2-3 Representative low magnification microstructure from Elbow 3 showing planar graphitization.

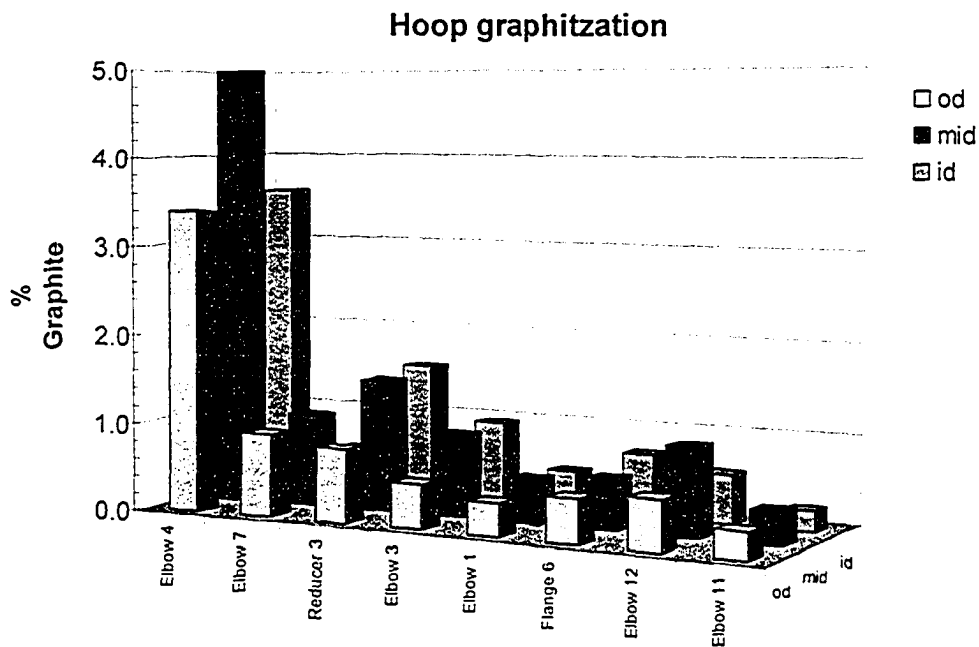
Although there is no distinct trend to follow between relative amounts of graphite for each wall location, the following graphs in Figures 7.2-9 and 7.2-10 show that often it is indeed the middle of the pipe that has the greatest amount of graphite. It may be surmised that there is a slight tendency for the graphite to follow a midwall trend when analysed in terms of wall location.

Figure 7.2-9 Relationship of graphite location to average graphite composite for selected material types. location as well as average composite density for hoop direction.

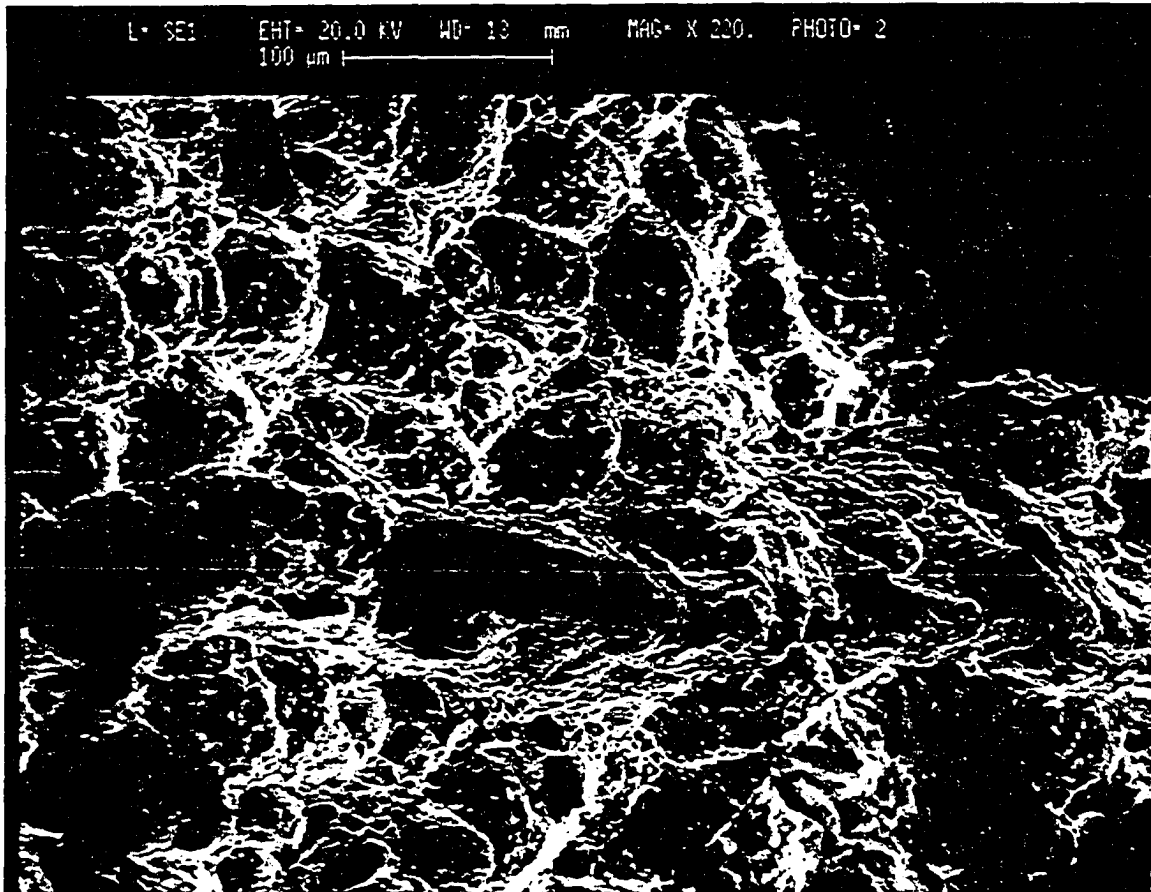
Figure 7.6-1 Surface resulting from compliance testing of Elbow 1 showing fracture surface due to ductile tearing

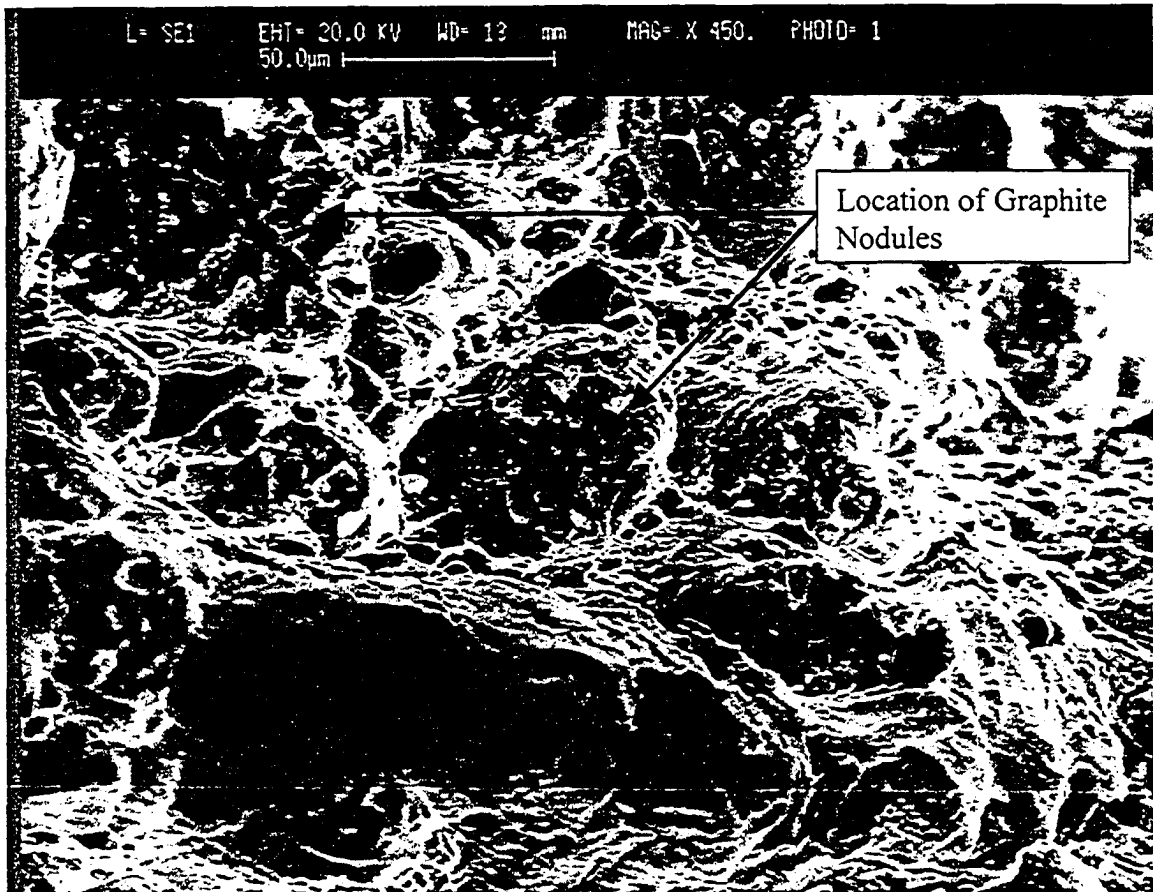
Figure 7.6-2 SEM image of ductile tearing surface of Elbow 1 after compliance testing and morphology of unusual shaped graphite nodules.

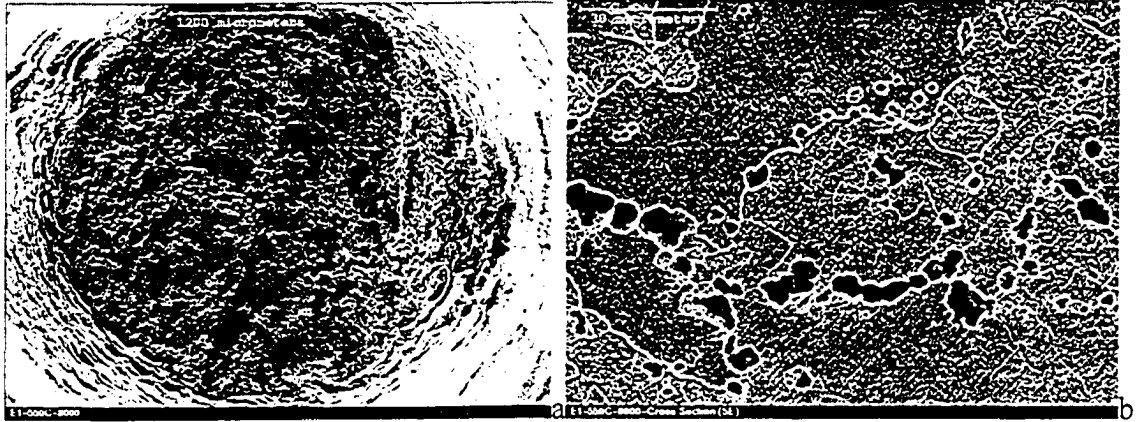
Figure 7.7-6 Elbow 1 tested at 550 °C and 8000psi (55.2 MPa) fracture cone (a) showing lines of graphitization that may be associated with final fracture. Cross section of the same sample (b) showing plane of graphite adjacent to fracture tip.

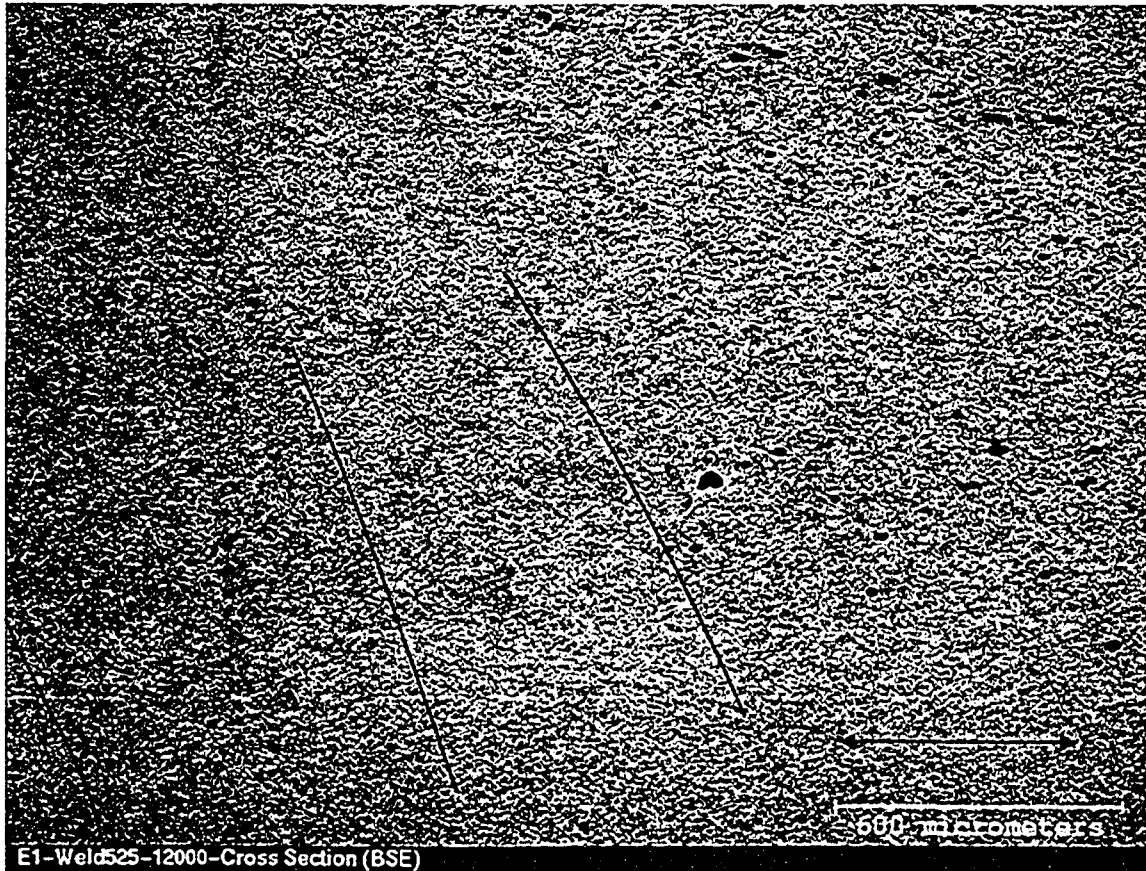
Figure 7.7-8 Post creep micrograph of Elbow 1 Weld tested at 525°C and 12000 psi(82.7 MPa) with direction of stress shown. Lines have been added to show the A3 temperature zone, A1 temperature zone and fusion line. The presence of graphitization starts after the A1 temperature line indicating the graphite is not a weld related effect.

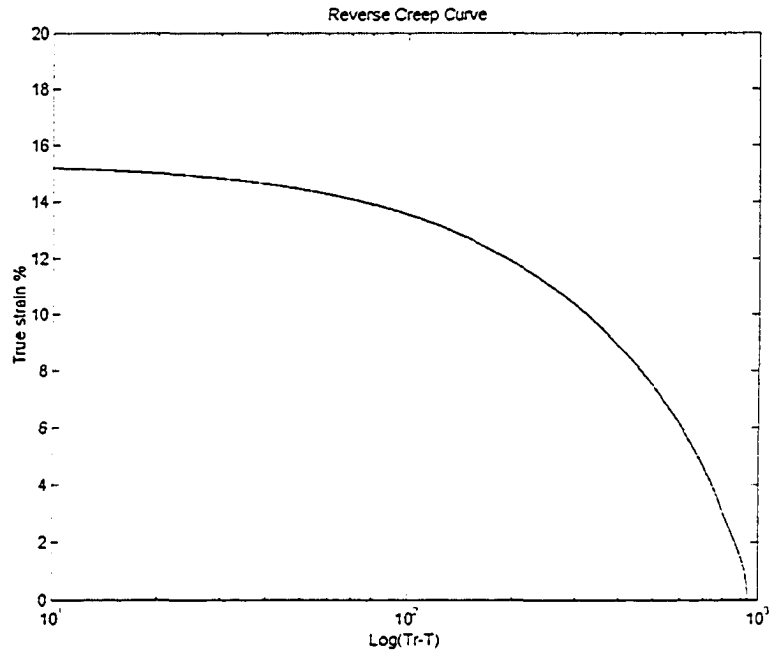
Figure 8.2-3 does not even approximate the conditions that we expected to observe.

Figure 8.2-3 Reverse creep plot for Elbow 1 showing deviation from linear trend, negating useful Omega analysis

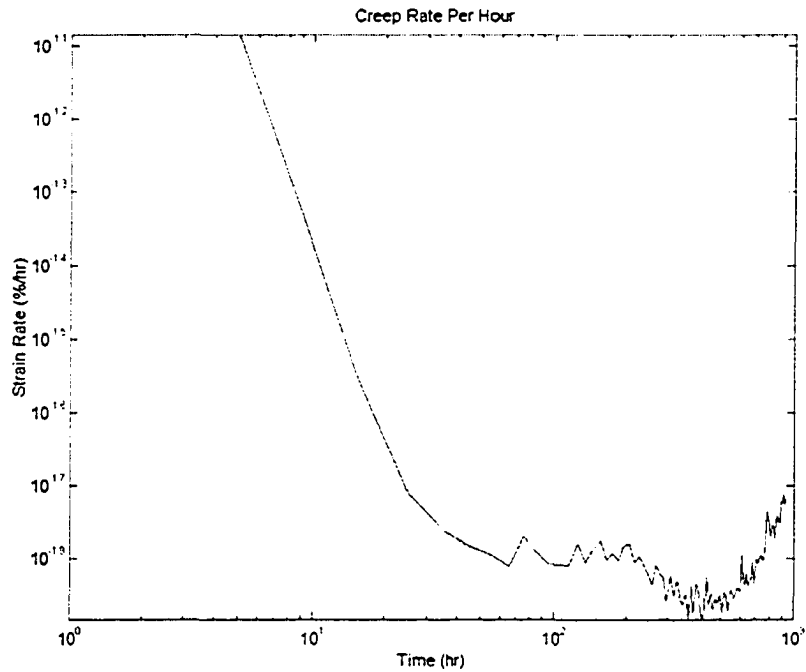
Examining in Figure 8.2-4 shows that the minimum strain rate is achieved between four

Figure 8.2-4 Strain acceleration for Elbow 1 525 °C 55.2MPa (8000psi) showing minimum creep rate achieved at half of rupture life

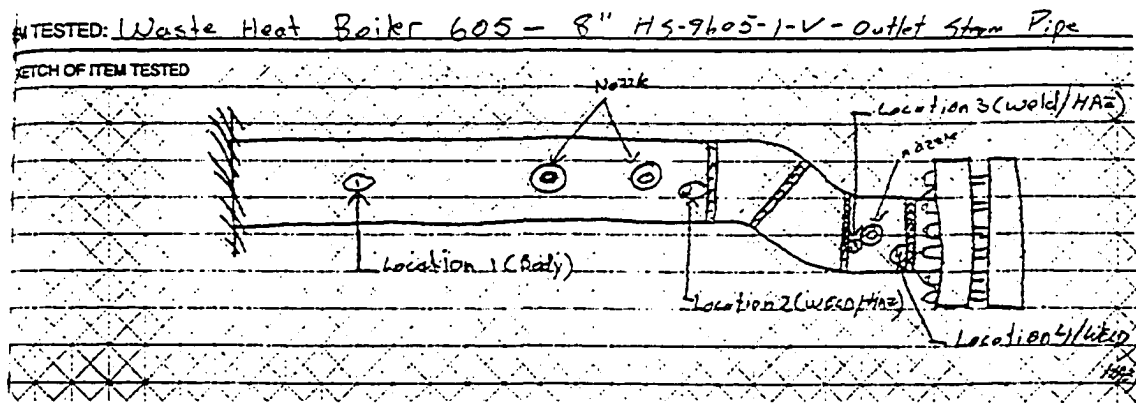
Figure 9.1-1 showed E2 replication performed by accepted industry practice completely

missed the presence of graphite, which would have existed at the time of inspection.

Figure 9.1-1 Sketch of Replication sites of E2 WHB showing locations only taken on piping and adjacent to weld on piping side [2]

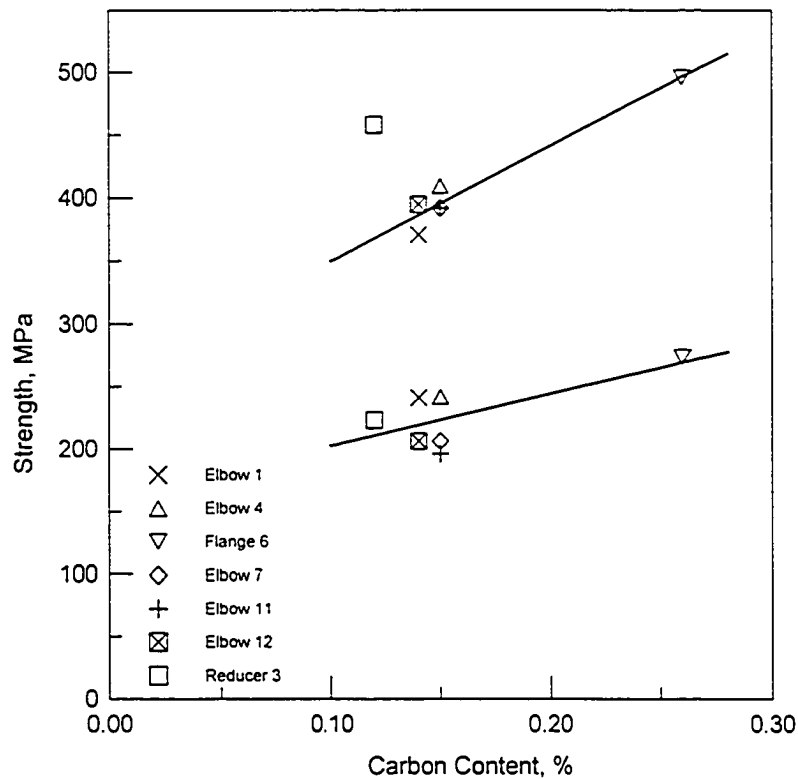
Classic literature can show that the strength of carbon steel can always be linked to the carbon content. Figure 9.3-1 shows agreement with theory with the exception of the ultimate tensile strength of planar graphitized Reducer 3. There will be some variation in this type of analysis due to the effects of grain size but the strength of graphitized carbon steel is certainly associated with carbon content.

Figure 9.3-1 Effect of carbon content on mechanical strengths showing good correlation for ultimate tensile and yield strength with the exception of ultimate strength of planar graphitized Reducer 3

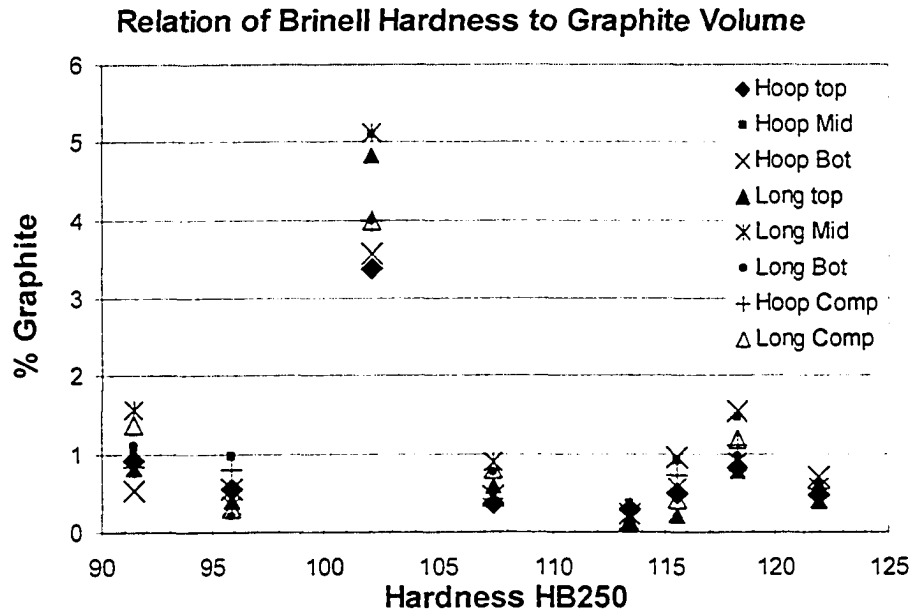
Figure 9.3-4 Relationship between hardness testing and degree of graphitization The series starts from the left with randomly graphitized Elbows 7, 12, 4, 1 and 11 and then finishes with planar graphitized Reducer 3 and finishes with random graphitized Flange 6

Based on results of Figure 9.3-4, all materials with a hardness exceeding BH 115 would be rejected. This would not separate the random graphite from planar graphite due to different hardnesses associated with different manufacturing methods, but the presence of graphite and the indication that the matrix is hard would indicate the possible existence of planar graphite rather than random graphite. Since the forming method has an influence on hardness, separating based on higher base metal hardness can not separate Flange 6 from Reducer 3. Furthermore the method could only be used if there is significant degradation of the microstructure which is associated with base metal graphitization. The method would not be able to help or assist in cases of suspected HAZ graphitization nor would it be useful at this stage for materials other than carbon steel. The rule would only be useful when replications indicate graphite and hardnesses indicate higher relative Brinell hardnesses, limiting the observation to service exposed materials. It must be
