ASSESSMENT AND REHABILITATION OF FC GIRDER BRIDGES

A thesis submitted to the Faculty of Graduate Studies and Research in partial fulfillment of the requirements for the degree of Doctor of Philosophy

Structural Engineering

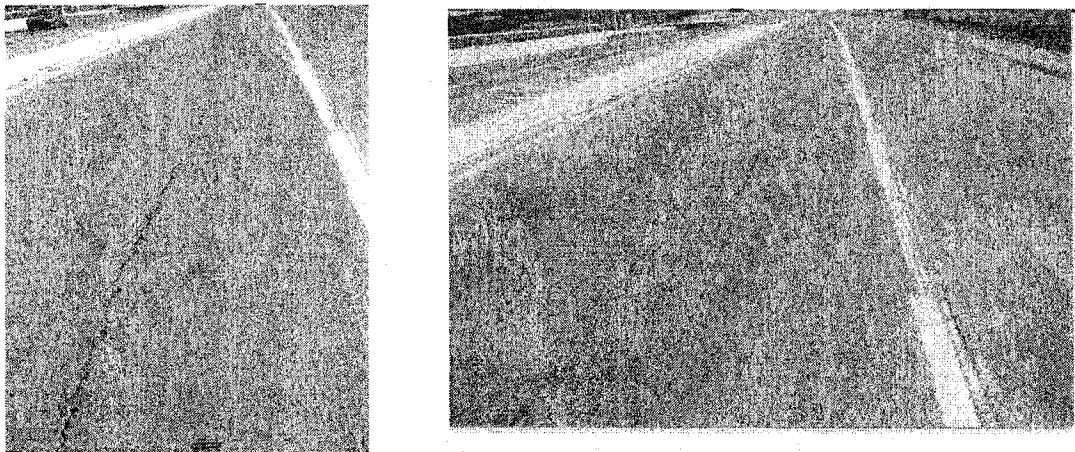
Fig. 1.4: Significant cracking over shear keys

Frequent problems with shear keys led researchers to investigate the causes and suggest remedies. It was observed that shear keys deteriorated regardless of the shape and size of the girder cross section. For example, even though the behaviour of a box girder bridge may be different from a channel-shaped girder bridge, damage always occurred in the form of longitudinal cracking at shear key locations.

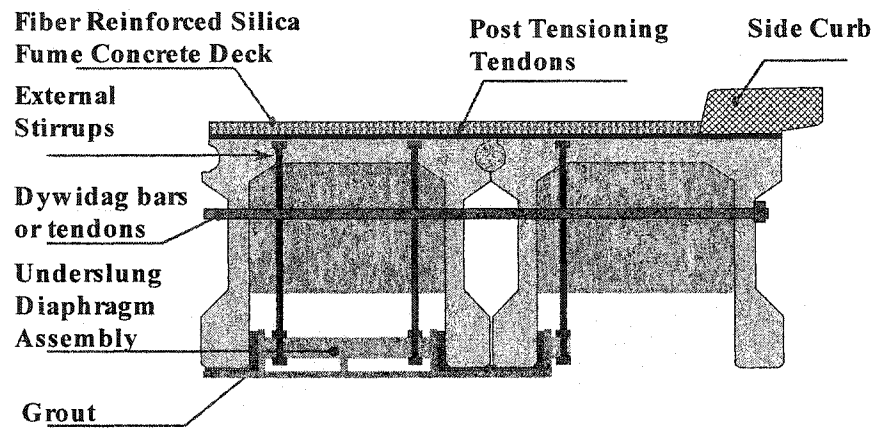
Figure 3.1: Schematic showing some rehabilitation schemes

Later it was felt that a transverse diaphragm was needed in addition to the lateral stressing system to make the girders torsionally rigid and to better distribute the load among the girders. This was made possible with the help of a lateral steel under-slung diaphragm. Figure 3.1 shows a schematic of some of the rehabilitation schemes discussed above.

Most of the rehabilitation schemes that followed were some variation or combination of lateral stressing and lateral bracing of the system. Table 3.16 shows the number of bridges that were rehabilitated by using each of the rehabilitation schemes. Taking a closer look at the distribution among the schemes it can be easily observed that there was no particular favourite in the rehabilitation process of these bridges, though the largest number of bridges were rehabilitated by using post tensioned Dywidag bars. However, if we lump together the bridges that were rehabilitated by using strands and Dywidag bars in the same category of lateral stressing, it can be observed that 34 bridges were rehabilitated by lateral stressing only. Moreover, in most bridges a non-reinforced, non-composite, high-density concrete deck was added on top of the girders (as shown in Figure 3.1) to act as the wearing surface, no matter what the rehabilitation scheme was.

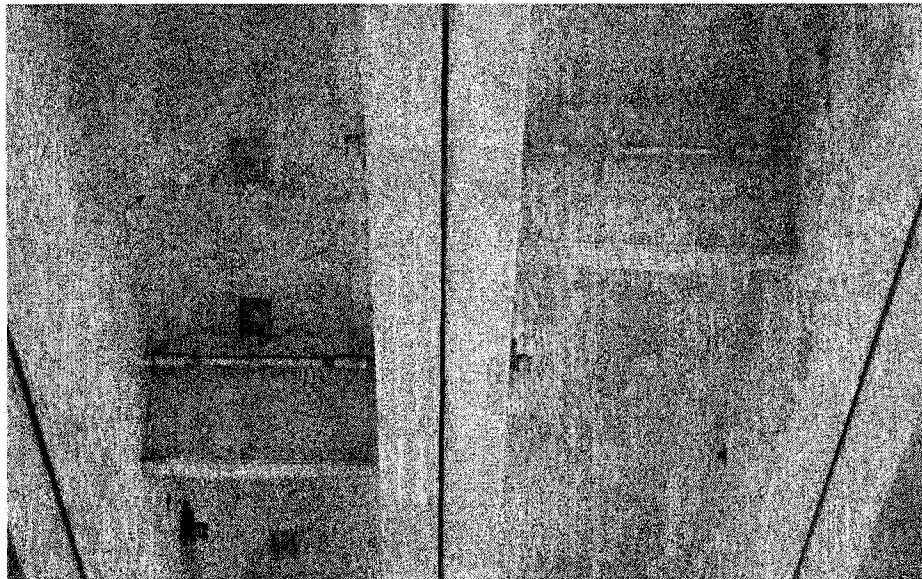
Figure 3.2: Lateral stressing with superbolts

The rehabilitation schemes employing lateral stressing of the system tend to impart compression to the shear key area, through the prestressing force, and utilize additional load sharing capabilities obtained from grouting the hollow spaces between adjacent girder legs to improve load sharing between the girders. The addition of the concrete deck on top of the girders is meant to provide a rigid layer, which will improve both the load sharing and load distribution between the different girders, even though it does not improve the torsional rigidity of the girders. If the concrete overlay is a part of the structural rehabilitation, it is usually post tensioned in the transverse direction. In other cases, the concrete overlay may only be used as a wearing surface and not post tensioned. Figures 3.2 to 3.5 show pictures of some rehabilitation schemes used on FC Girder Bridges.

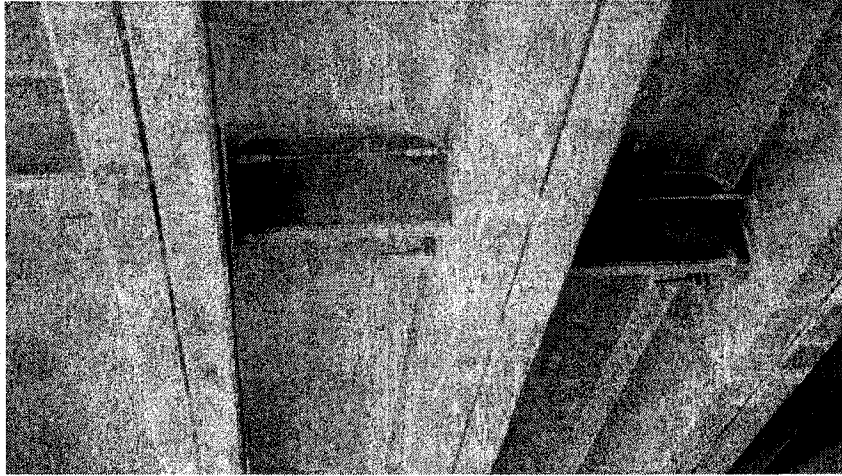
Figure 3.3: Lateral stressing with staggered dywidag bars

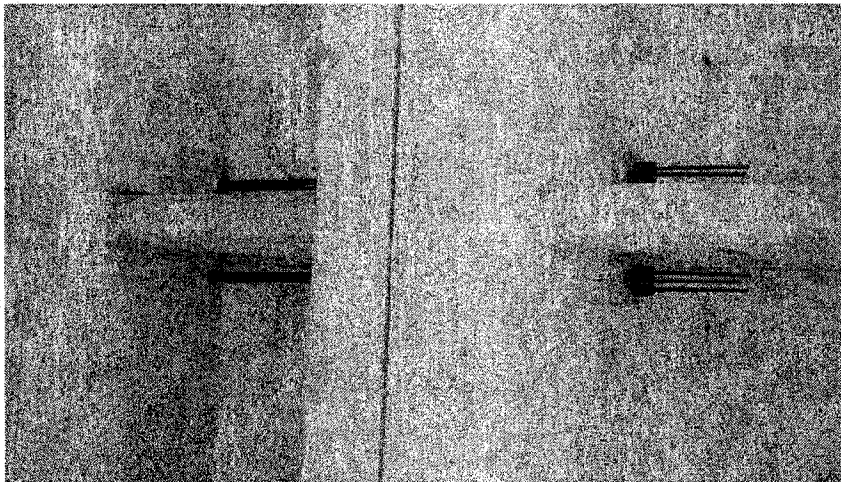
Figure 3.4: Lateral stressing with prestressing tendons

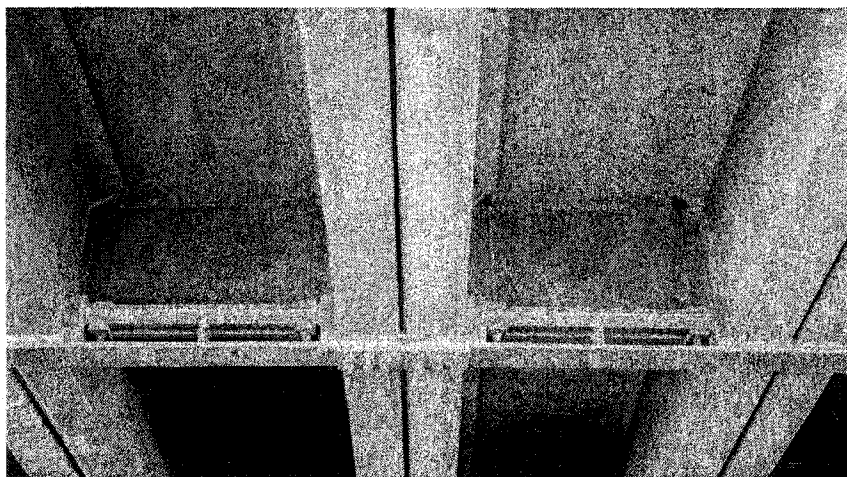
Figure 3.5: Lateral bracing with channel type underslung diaphragms

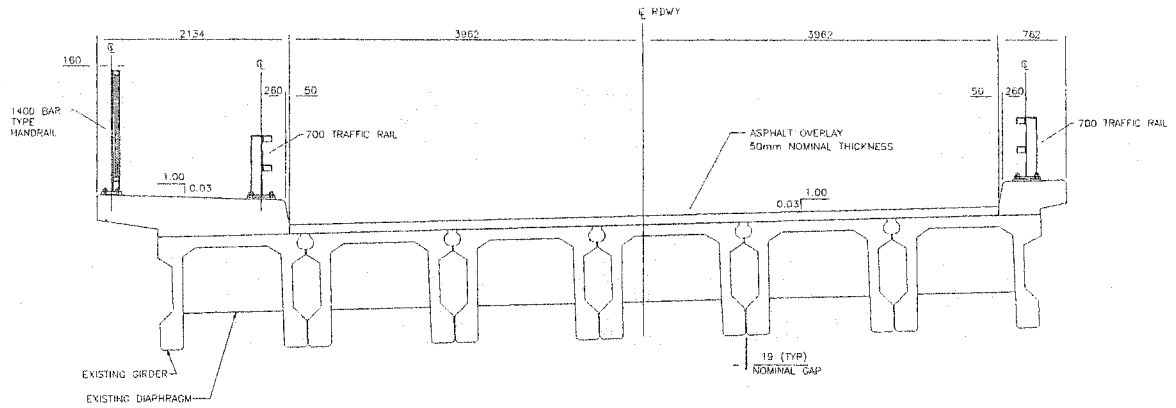
Figure 5.1 shows the plan of the original 99th Ave. FC Girder Bridge in Fort Saskatchewan. Figures 5.2 and 5.70 show the elevation of the bridge. As illustrated in figures 5.3 and 5.71, the superstructure of the bridge consists of six precast prestressed channel-shaped FC girders. Before rehabilitation, the bridge had no cast in place concrete deck and its asphalt pavement was extensively cracked in both transverse and longitudinal directions. While cracks in asphalt, especially the transverse cracks, are usually related to material properties and temperature effects, initiation of the longitudinal cracks is a result of the relative movement of the adjacent girders. Figures 5.4 and 5.5 show the cracking of asphalt before rehabilitation.

Figure 5.3: Section of the bridge, before rehabilitation

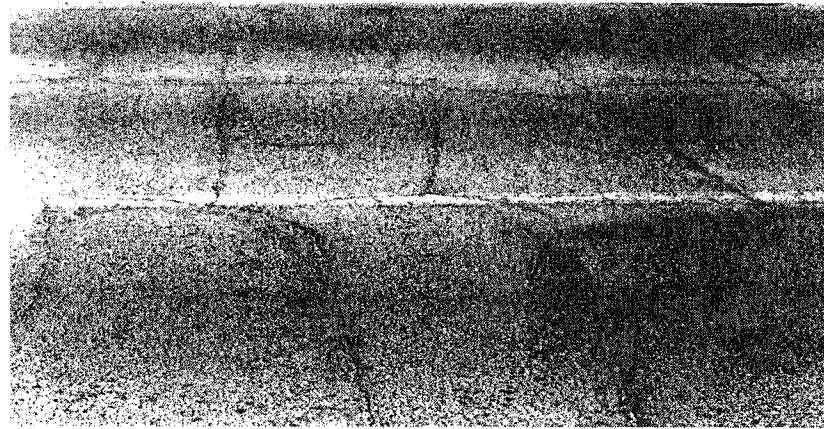
Figure 5.4: Longitudinal and transverse cracks in apshalt, before rehabilitation

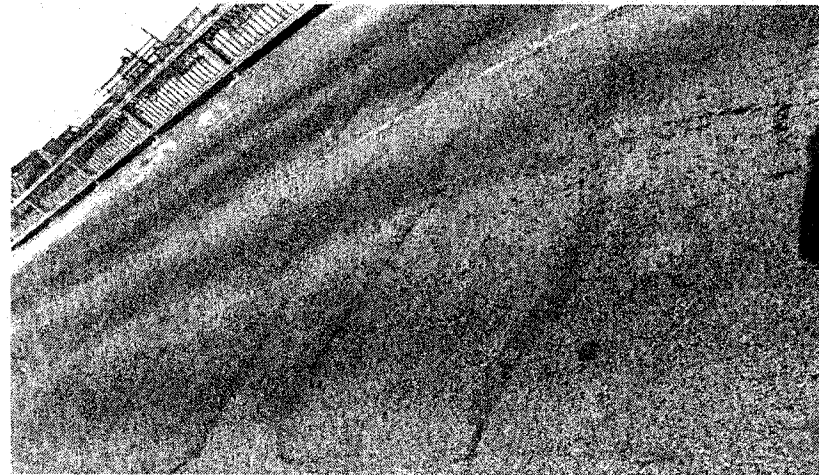
Figure 5.5: Cracks in the asphalt pavement, before rehabilitation

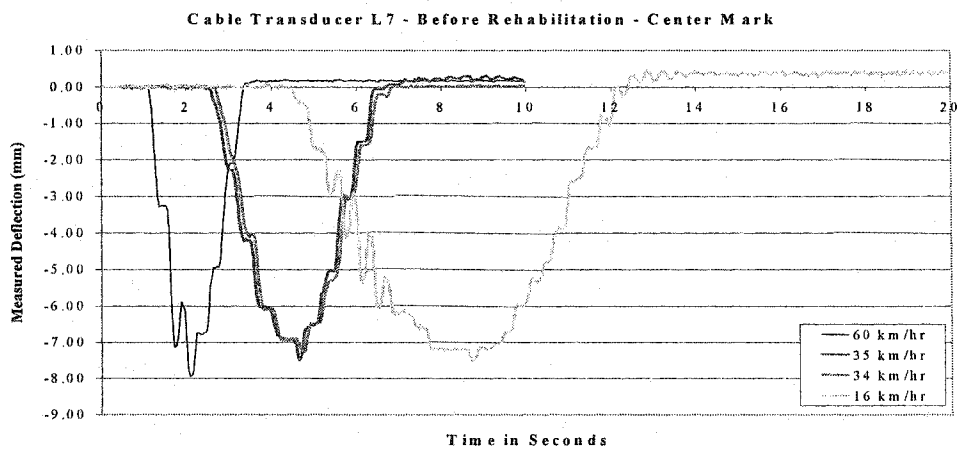
Figure 5.35: Dynamic response of cable transducer L7, truck in right lane

Figures 5.35 through 5.37 show the measured deflection in dynamic tests before rehabilitation. For the truck on the right lane and on the centre mark, the largest measured deflection was at the location of cable transducer L7 (Figures 5.35 and 5.36). For the truck on the left lane, the largest response was at the location of cable transducer L3 (Figure 5.37). Figures 5.38 and 5.39 show the deflection in dynamic tests after the rehabilitation. Cable transducers L9 and L1 show the largest response for the truck on the right and the left lanes, respectively.

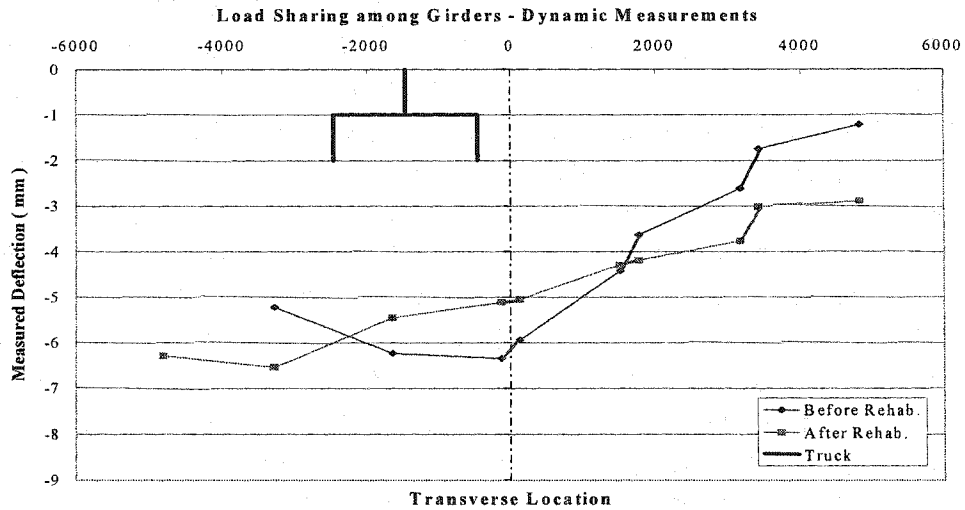
Figure 5.40: Load sharing based on deflections, Dynamic test, truck in right lane

Load sharing, based on the average of the deflections in the dynamic tests with different speed of the truck, is presented in figures 5.40 through 5.42. The load sharing information from the dynamic measurements is in excellent agreement with the information from the static test. It also confirms an improvement in the load sharing after rehabilitation, especially since a better contribution from the edge girders was achieved after rehabilitation.

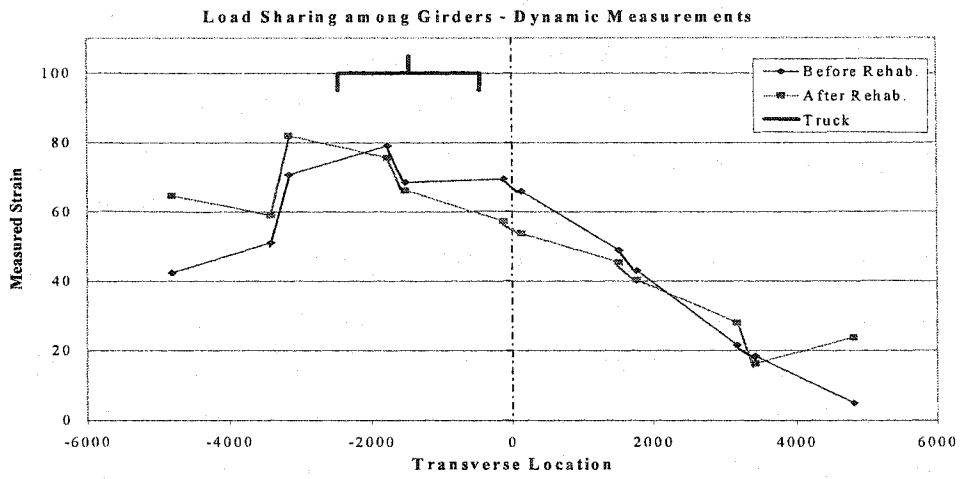
Figure 5.53: Load sharing in dynamic test based on strains, truck in right lane

The influence line for strains, at the location of the strain gage with the largest response is plotted in figures 5.48 through 5.52. Load sharing based on strain measurements in dynamic tests is presented in figures 5.53 through 5.55, indicating an improvement due to rehabilitation. To allow for the comparison of the static test results and dynamic test results with varying speed of the truck, measured strains are plotted versus the location of the front axle in figures 5.56 through 5.60.

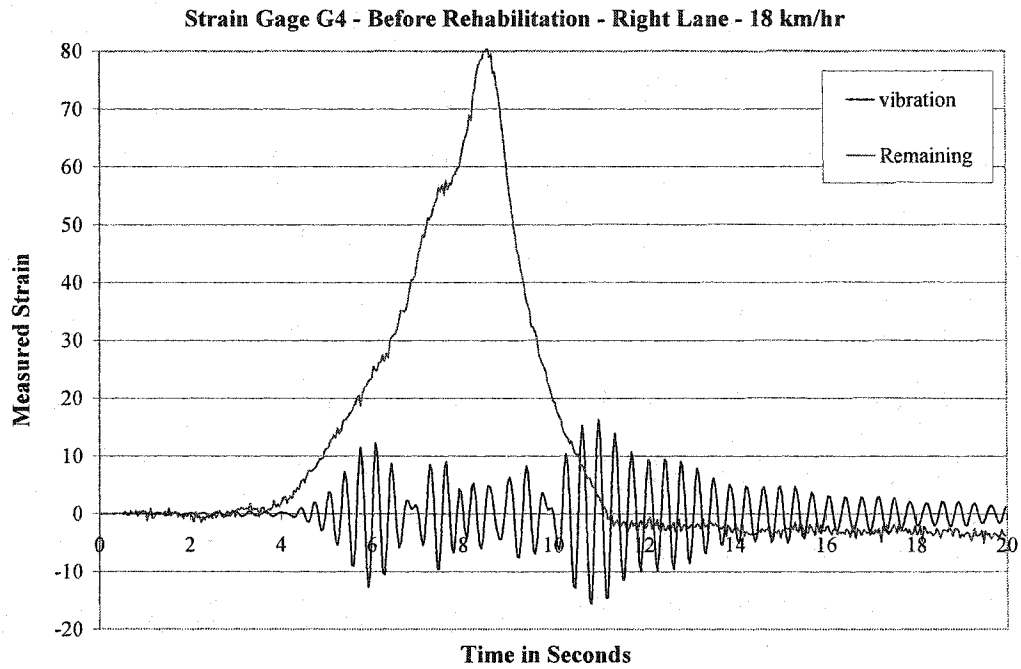
Figure 5.61: Vibration of the bridge in dynamic test, truck on right lane, before rehabilitation

Digital filtration techniques were used to isolate any response within frequencies 2 and 4 Hz. Figures 5.61 and 5.62 show how a response can be broken into the vibratory and non-vibratory components. The non-vibratory component is referred to as the pseudo-static part, since it represents the response that remains after the vibrations have been filtered out and hence represents the static part. This exercise was conducted to compare the pseudo static portion of the dynamic load test with the results of the static load test. Before rehabilitation, the bridge vibrated at a frequency of 2.78 Hz in all tests. After rehabilitation, the frequency of vibration has reduced to 2.64 Hz. At these frequencies, as presented in figure 5.63, all girders move up and down simultaneously. Hence, these frequencies correspond to the first vertical mode. As shown in this figure, in some cycles G12 shows larger response than G1, while in other cycles G1 has the largest response. This indicates that the second mode (torsional mode) is combined with the main mode of vibration (vertical mode).

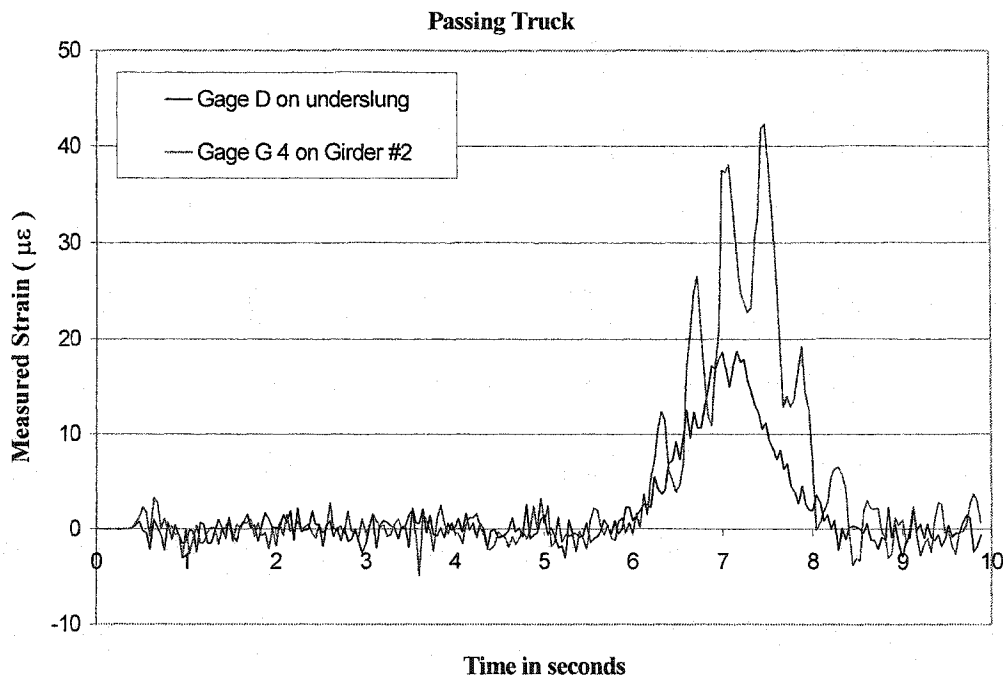
Figure 5.64: Measured strain in the underslung assembly caused by passing truck load

$31 / 50 \times 23 = 14.3$ tonnes. For this truck, maximum strains at locations A through D (see figure 5.12) were respectively 8, 13, 6, and 19 $\mu\varepsilon$. Figure 5.64 shows the response of gauge D on the underslung diaphragm and gauge G4 on the FC girder #2 to this truck.

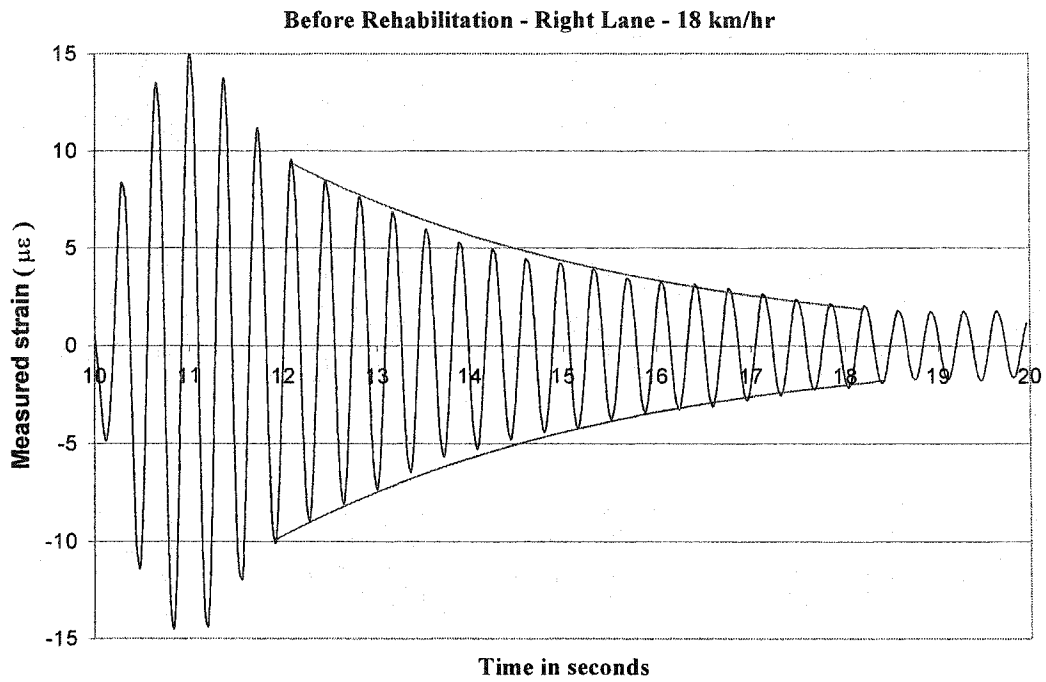
Figure 5.65: Free vibration of the bridge and its damping, before rehabilitation

Damping of the bridge for its first vertical mode shape can be determined based on strain measurements. After the truck completely passes the bridge, the bridge vibrates freely at a combination of its natural frequencies. In measuring damping, it is ideal to isolate each natural frequency. However, for frequencies close to each other, there is always concern about filtering effects. A solution that avoids filtering problem and minimizes the effect of the torsional mode is to average the response of all the strain gages. Figures 5.65 and 5.66 respectively show the vibration of the bridge before and after the rehabilitation using this technique. Non-linear best fit analyses have been performed on the results of the tests

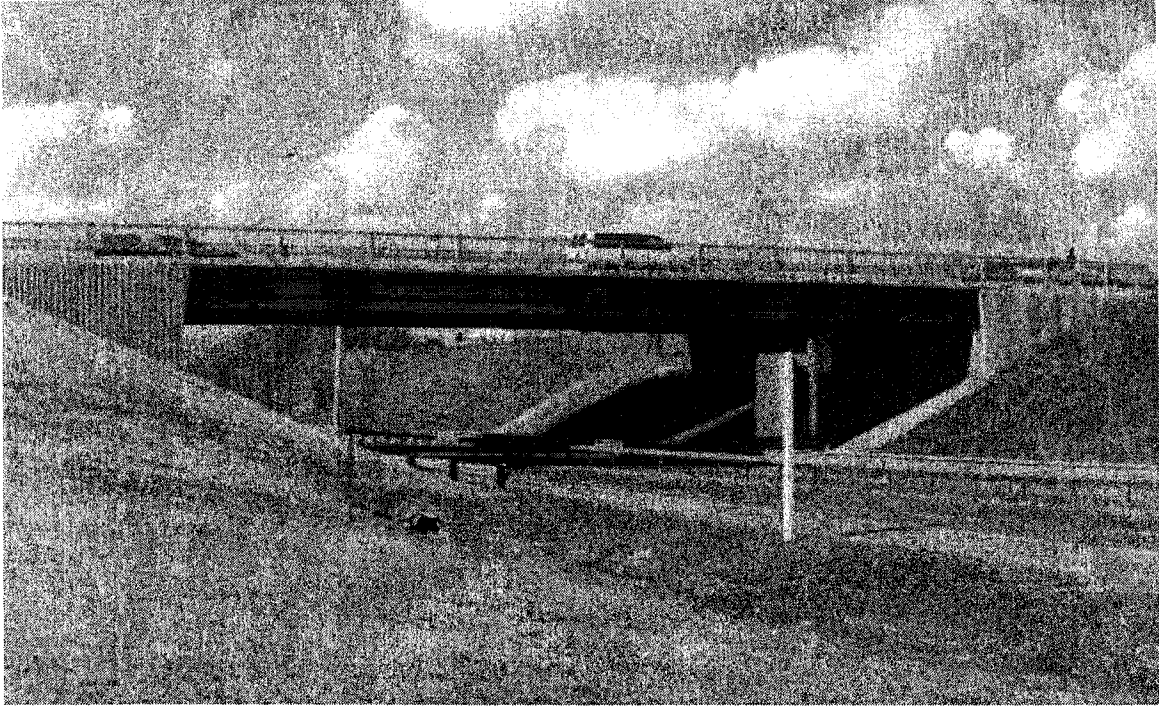
Figure 5.70: View of the 99[th] Ave. Fort Saskatchewan bridge

Figure 5.71: View of underside of the bridge

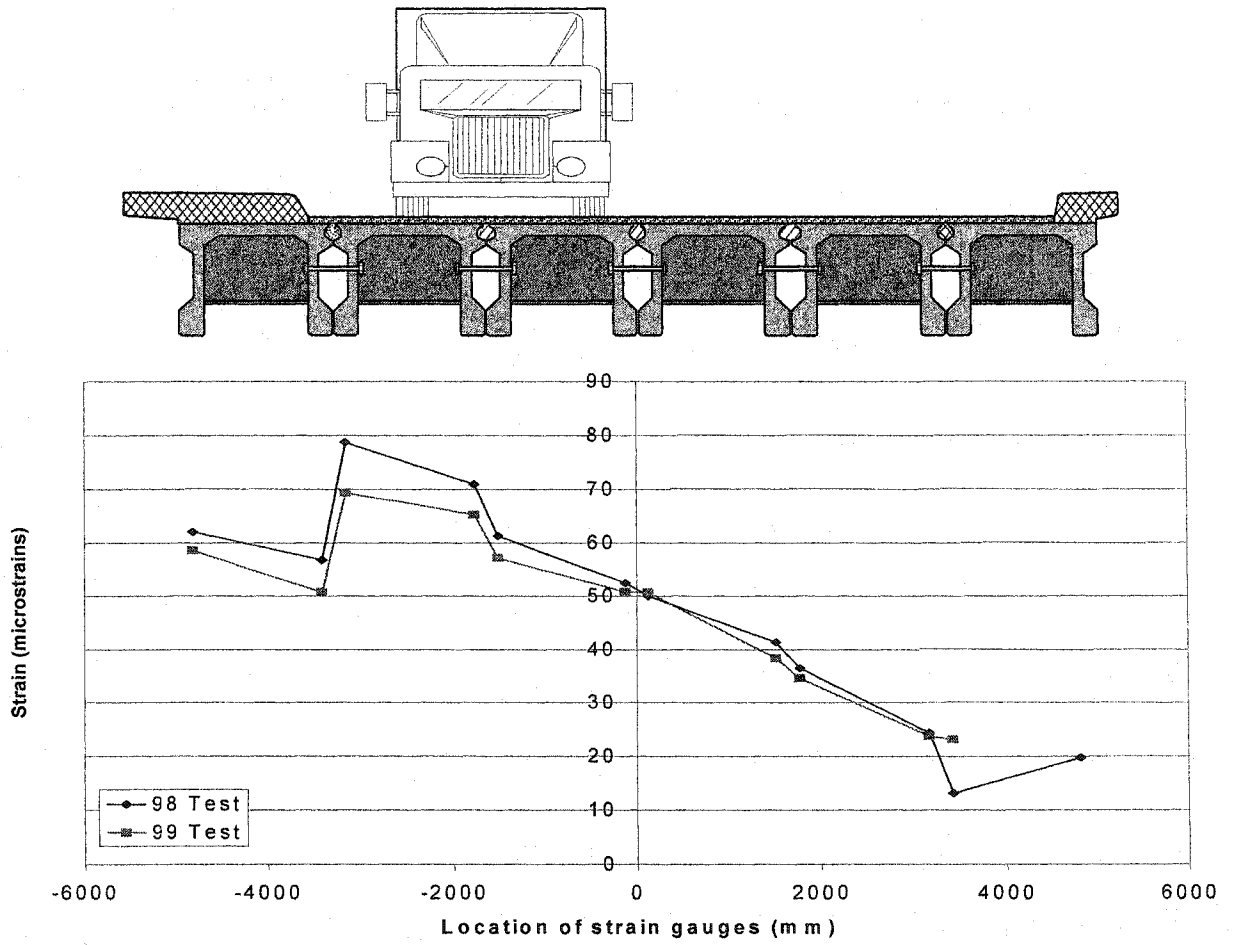
To conduct periodic monitoring and to test the reproducibility of the earlier data, a series of dynamic load tests were again carried out in 1999, using the same set of gauges, which have been permanently installed to the bridge. A comparison of the 1998 after rehabilitation results and the 1999 results showed that no significant change has occurred in the structural behaviour of the bridge. Moreover excellent agreement between the results of the two years confirmed the reliability of the testing methods and the apparatus used. Figure 6.1 shows the strain comparison, measured in the load tests from the two years. The slight difference between results from the two years can be attributed to the

Figure 6.1: Comparison of 1998 and 1999 test results in terms of Strain

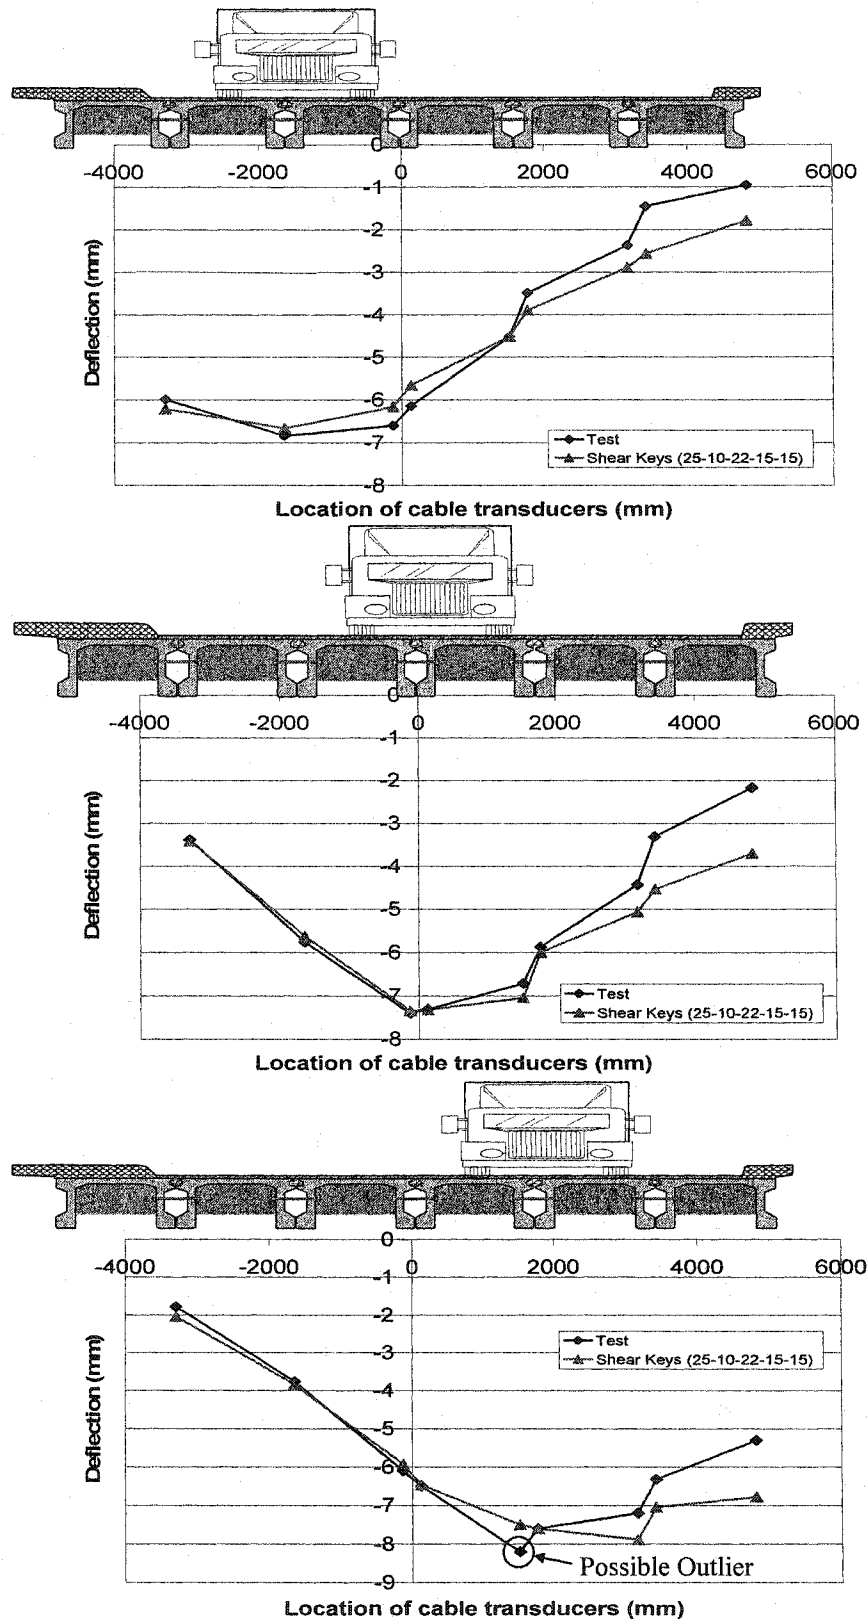
Figure 6.14: Model to test comparison using the deflection indicator and stiffness combination shear keys (25-10-22-15-15)

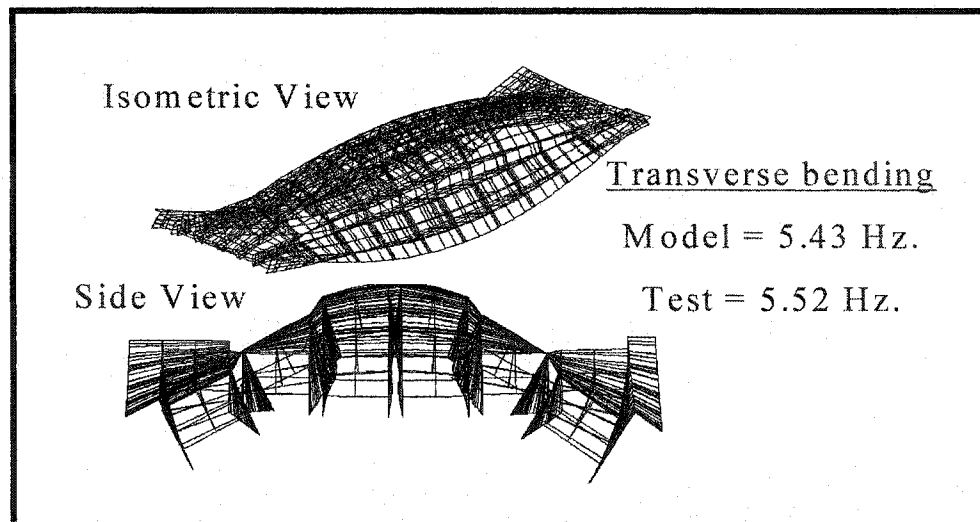
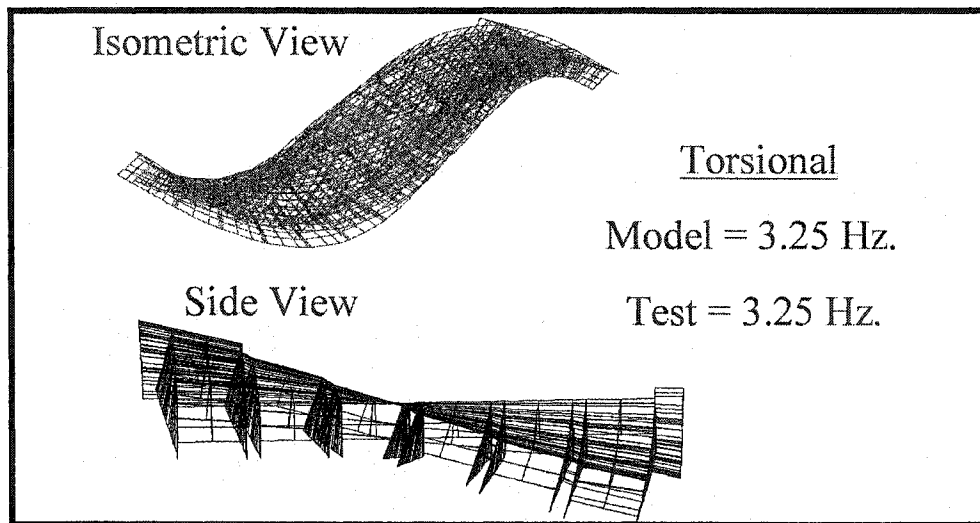
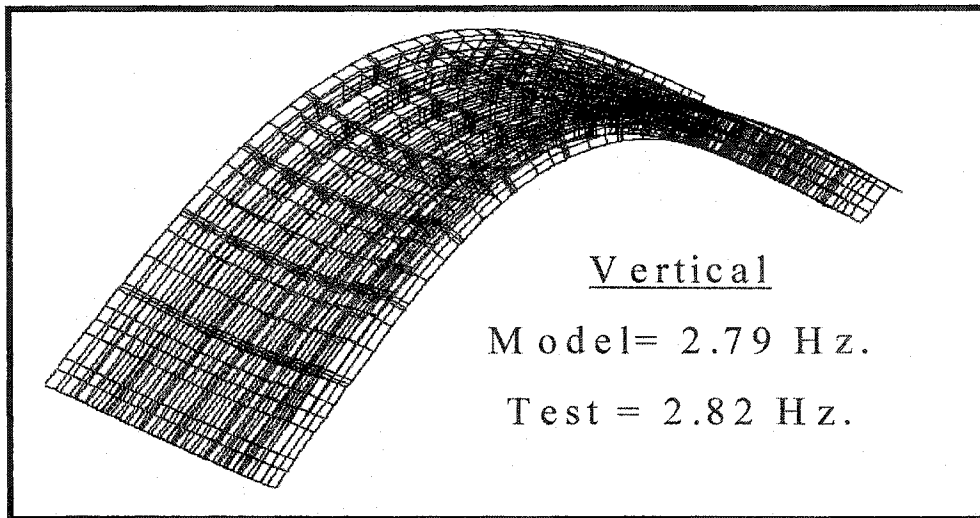
The natural frequencies for the first three modes of vibration, and their mode shapes, obtained from the ambient vibrations test are shown in Figure 6.15. Of particular interest is the transverse bending mode shape, which produces vertical movements in alternate sets of girders hence, inducing distress in the shear keys.

Figure 6.15: Model to test comparison using the natural frequency & mode shape indicator, before rehabilitation

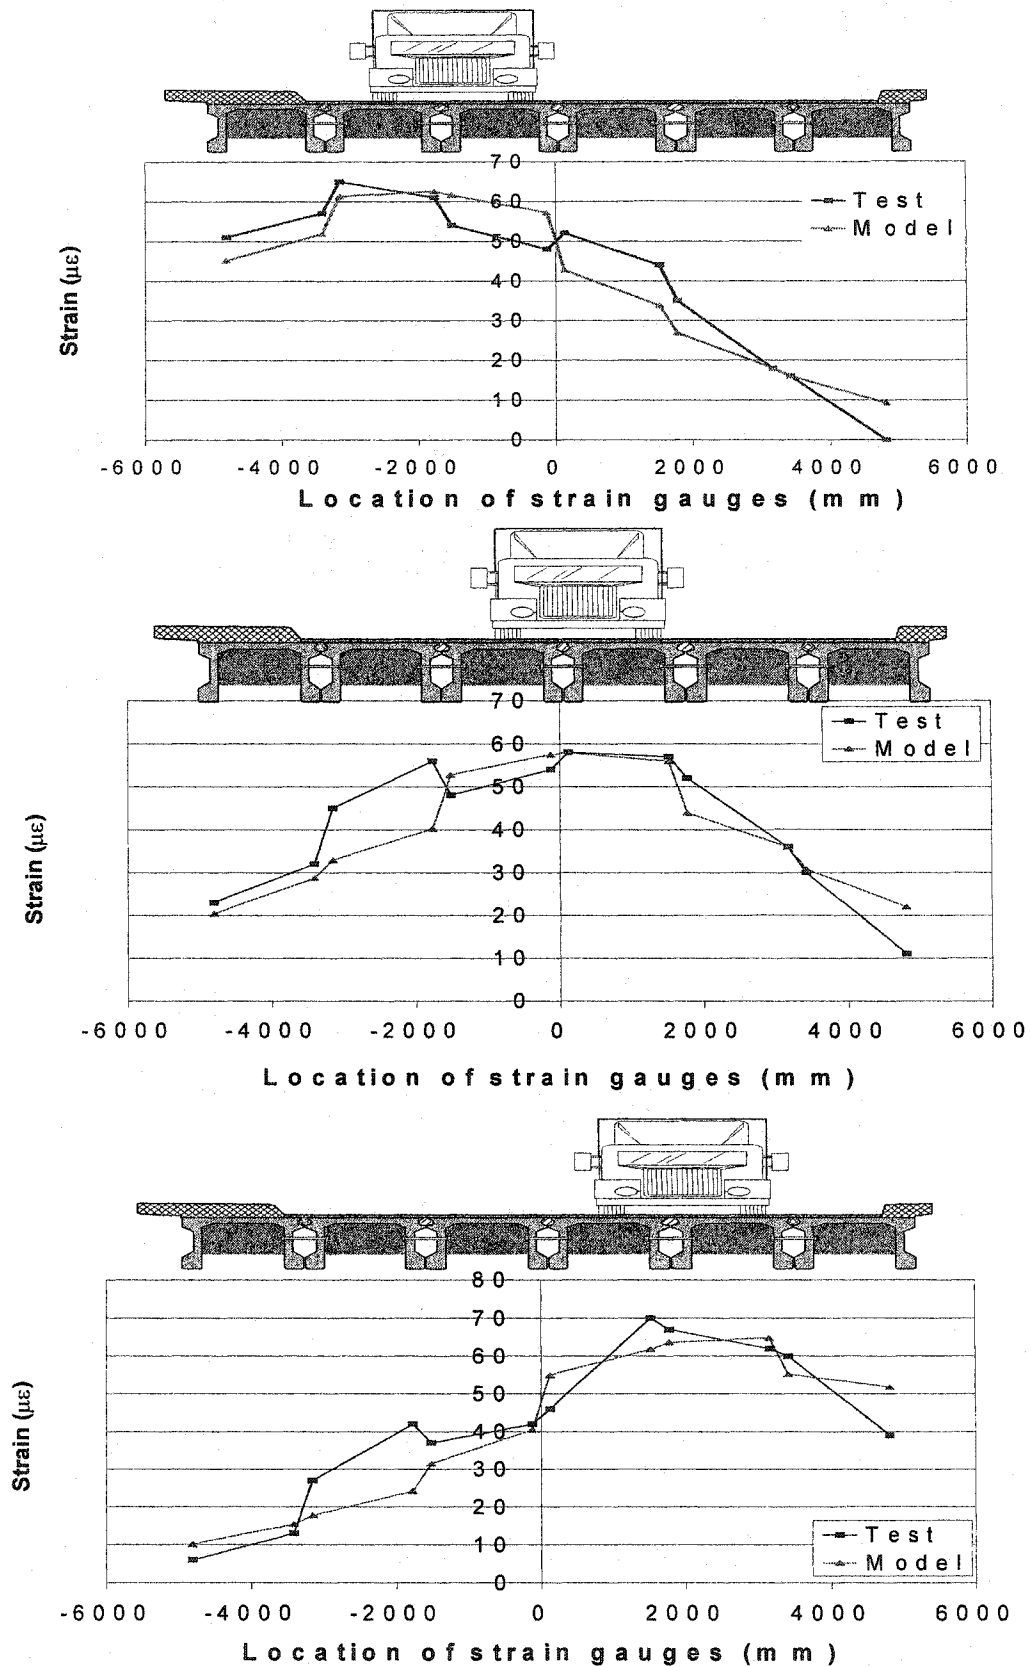
changing any further parameters, the model matched well with the test results. Figure 6.16 shows the strain comparison of the model and the test.

Figure 6.16: Model to test comparison using the strain indicator, before rehabilitation

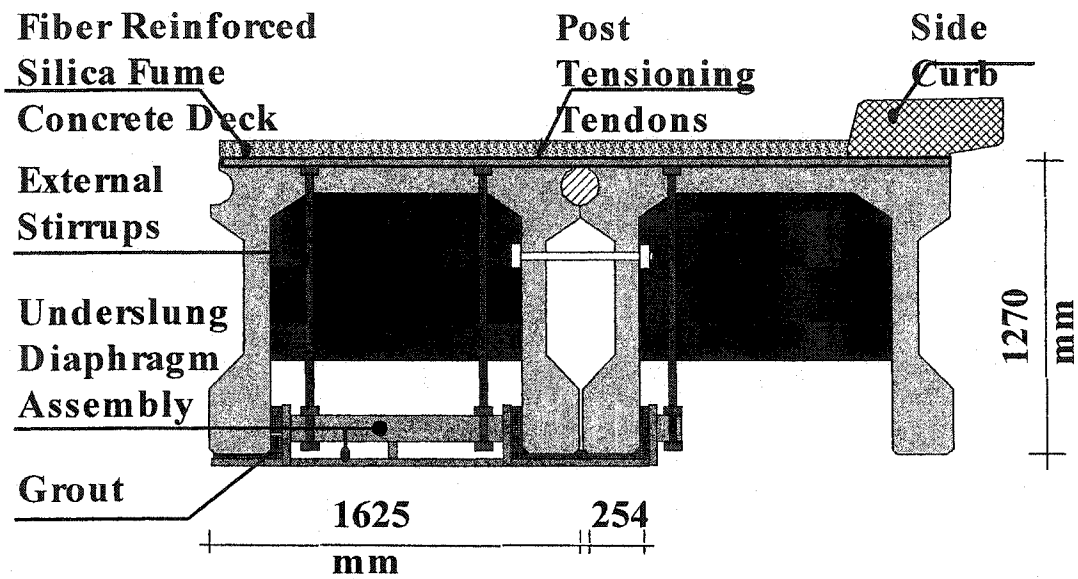
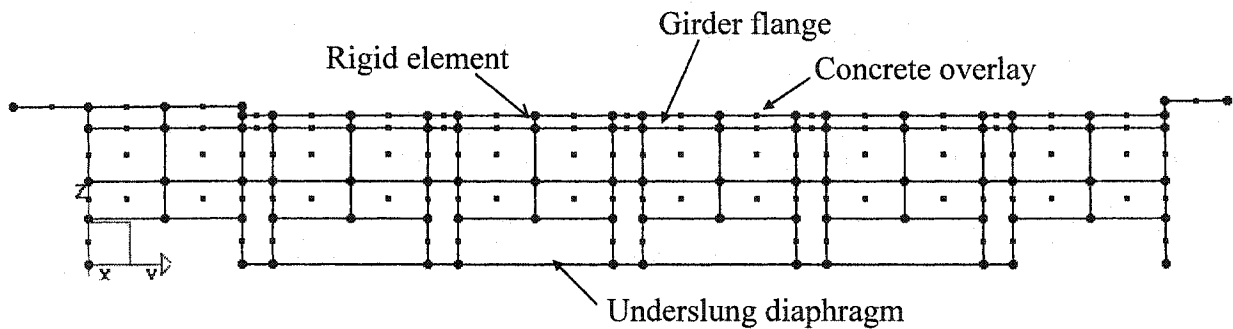
Figure 6.17: Cross section of the actual bridge showing combination of rehabilitation schemes

Figure 6.18: Model cross section of the bridge with rehabilitation schemes incorporated

The actual bridge was strengthened by a combination of two rehabilitation schemes. The asphalt on the original bridge was replaced by a 100 mm transversely prestressed, fibre reinforced, silica fume concrete overlay without any reinforcement, and transversely running steel underslung diaphragms, as can be seen in Figure 6.17. The steel underslung diaphragms were modeled by using the beam element whereas the concrete overlay was modeled with the help of shell elements of the program. To maintain the vertical distance between the horizontal centroidal planes of the girder top flange and the concrete overlay shell planes, vertical rigid elements were used in the model. Figure 6.18 shows the model cross-section illustrating the girder flange plane; the concrete overlay plane and the rigid element connecting the two planes. The beam elements used for underslung diaphragms are also visible in this figure. Table 6.7 below gives the material and section properties used for the concrete overlay and the underslung diaphragm in the model after rehabilitation.

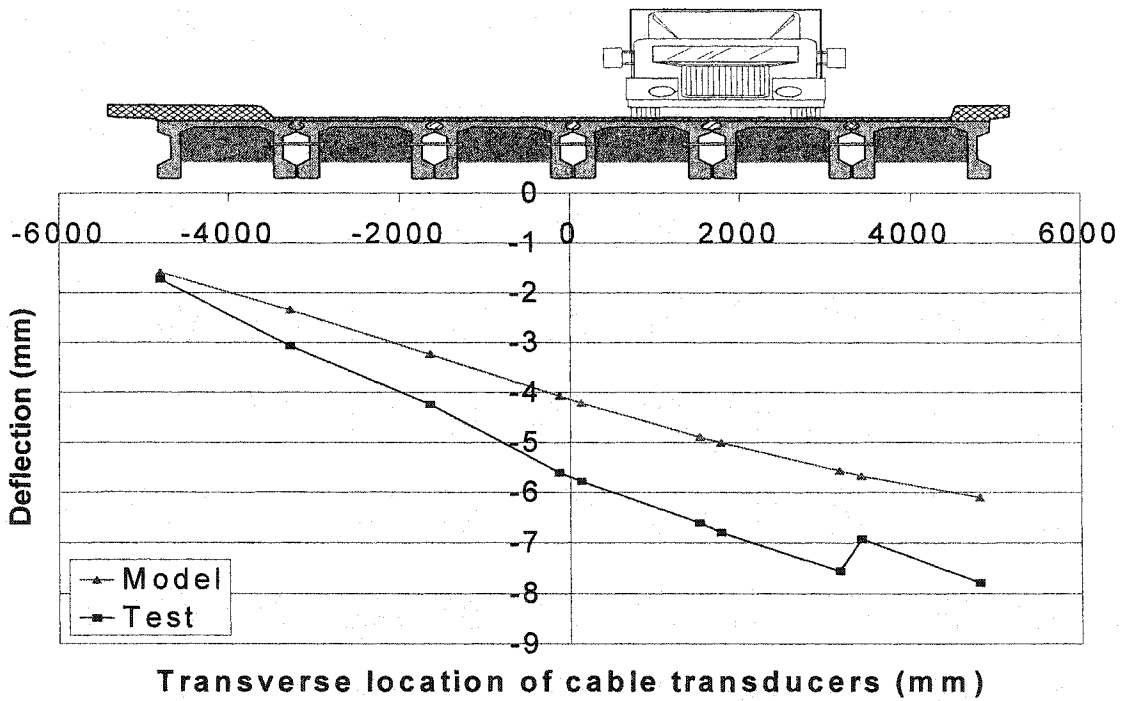
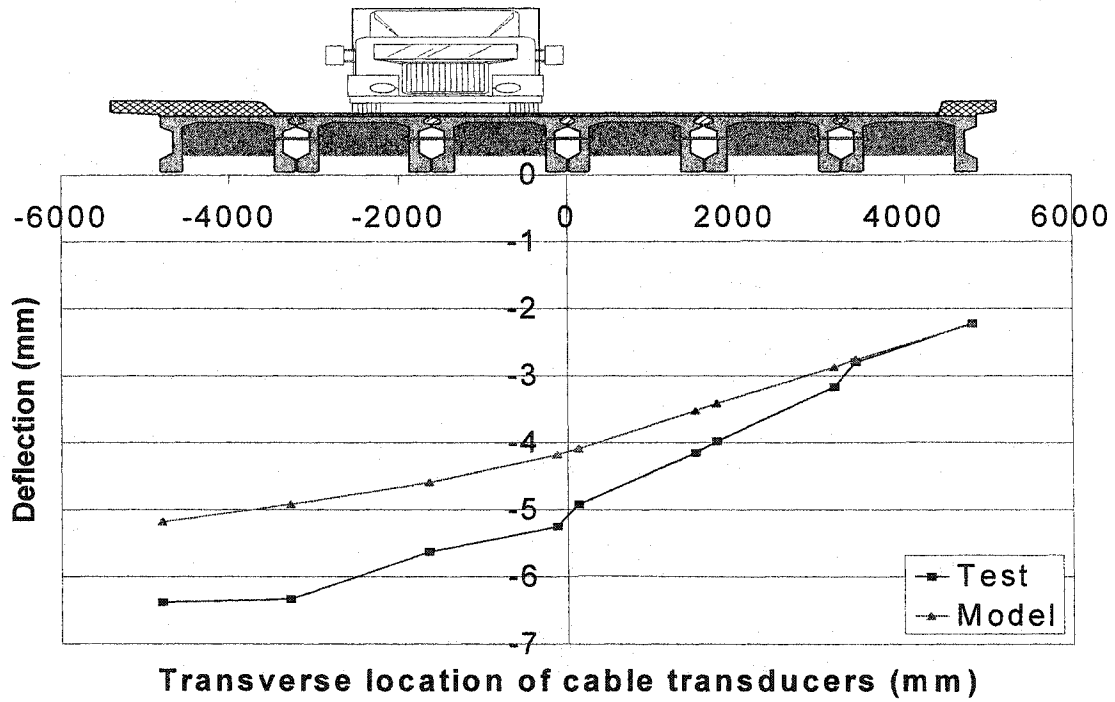
The comparison showed the model to be stiffer than the real test with respect to all the three parameters. Figure 6.19 shows the comparison of the test and model deflections while Table 6.9 gives the comparison of the test and model natural frequencies of vibration. The same trend is repeated in the strain information and is illustrated in Figure 6.20

Figure 6.19: Model to test comparison using the deflection indicator, after rehabilitation
