University of Alberta

Sustainable mine reclamation and landscape engineering

Gordon Thomas McKenna

A thesis submitted to the Faculty of Graduate Studies and Research in partial fulfilment of the requirements for the degree of Doctor of Philosophy

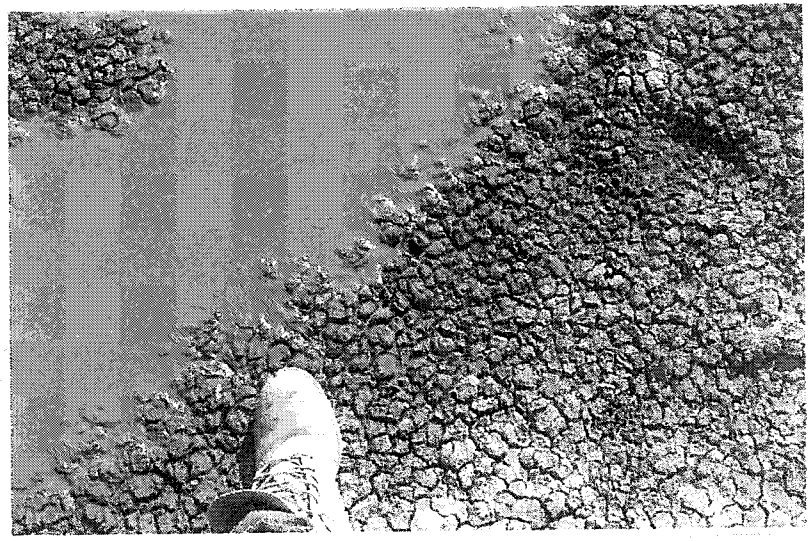
Figure 7-17 Gully erosion on constructed landforms. A: Shallow ponded water and the effect on Kc fill. B: 1m deep gully on Kc slope before regrading. C: Active gully erosion in a reclaimed area. D: Gully repairs in reclaimed area.

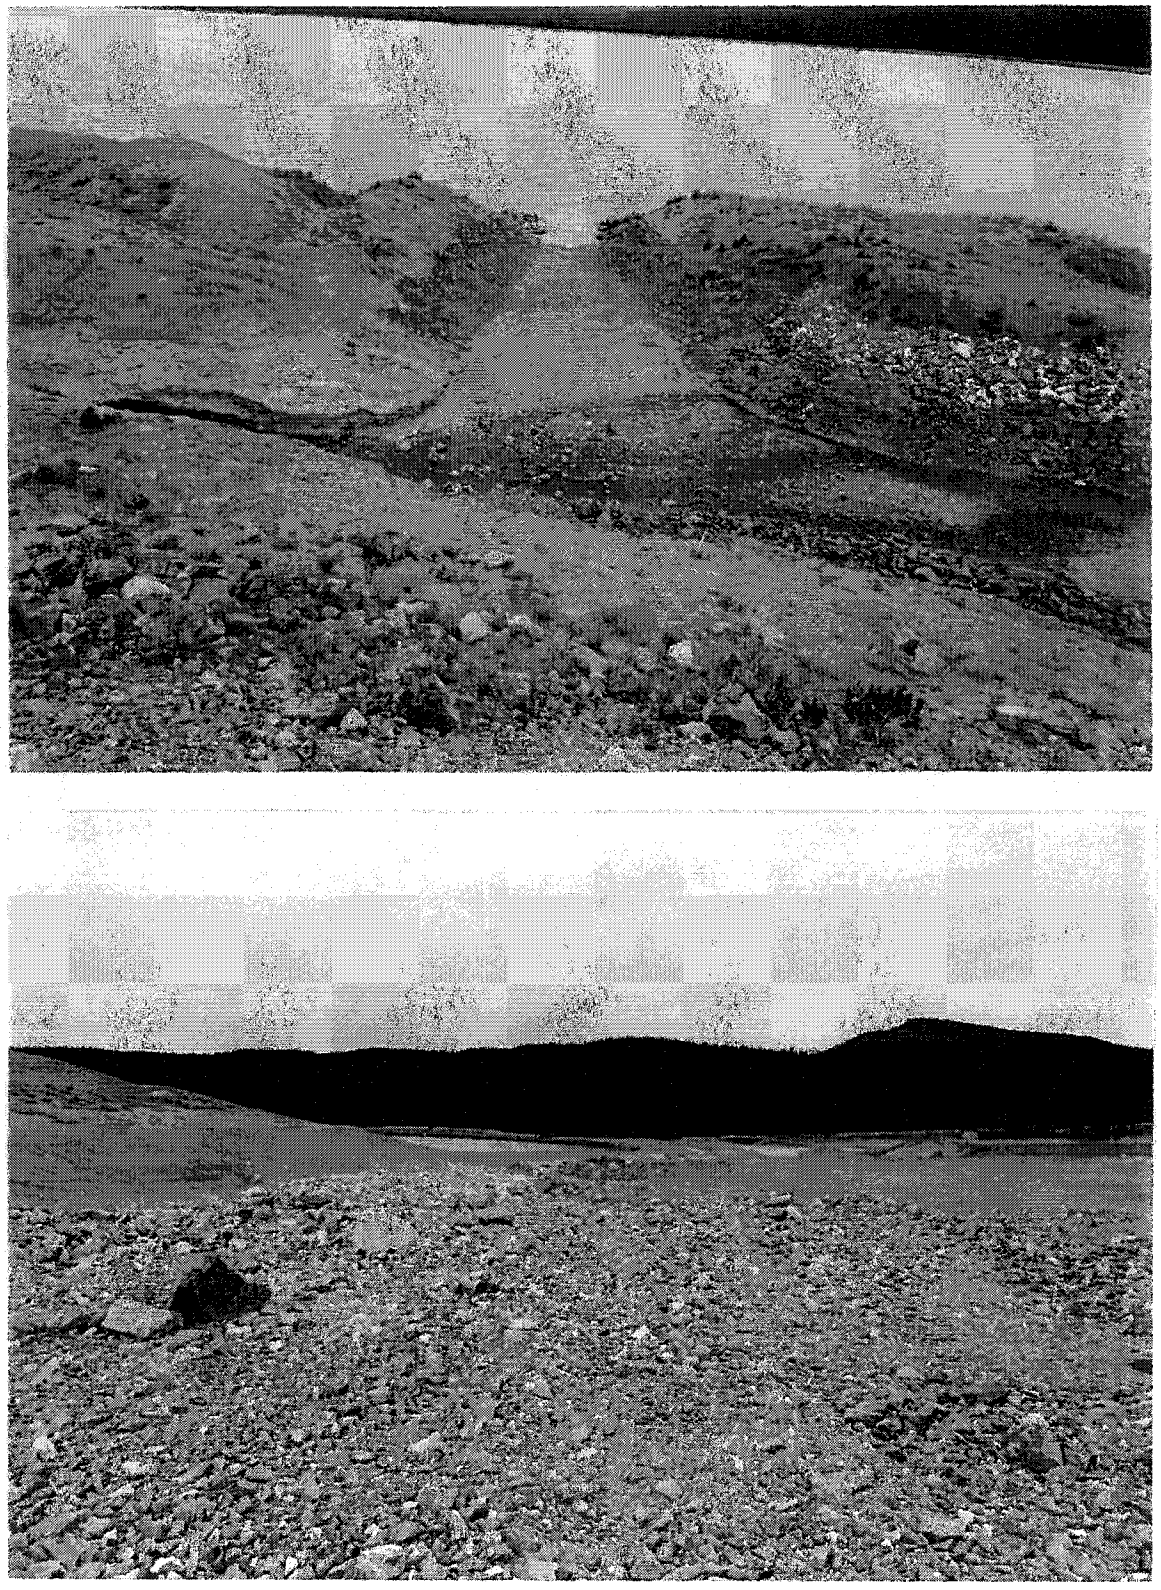
Plate 3.6 **This spillway on a tailings pond was designed by a hydrologist, and the correct channel shape used, but the rip rap was too expensive and was not placed. Lower swale is undesigned and field fit by a capable dozer operator.**

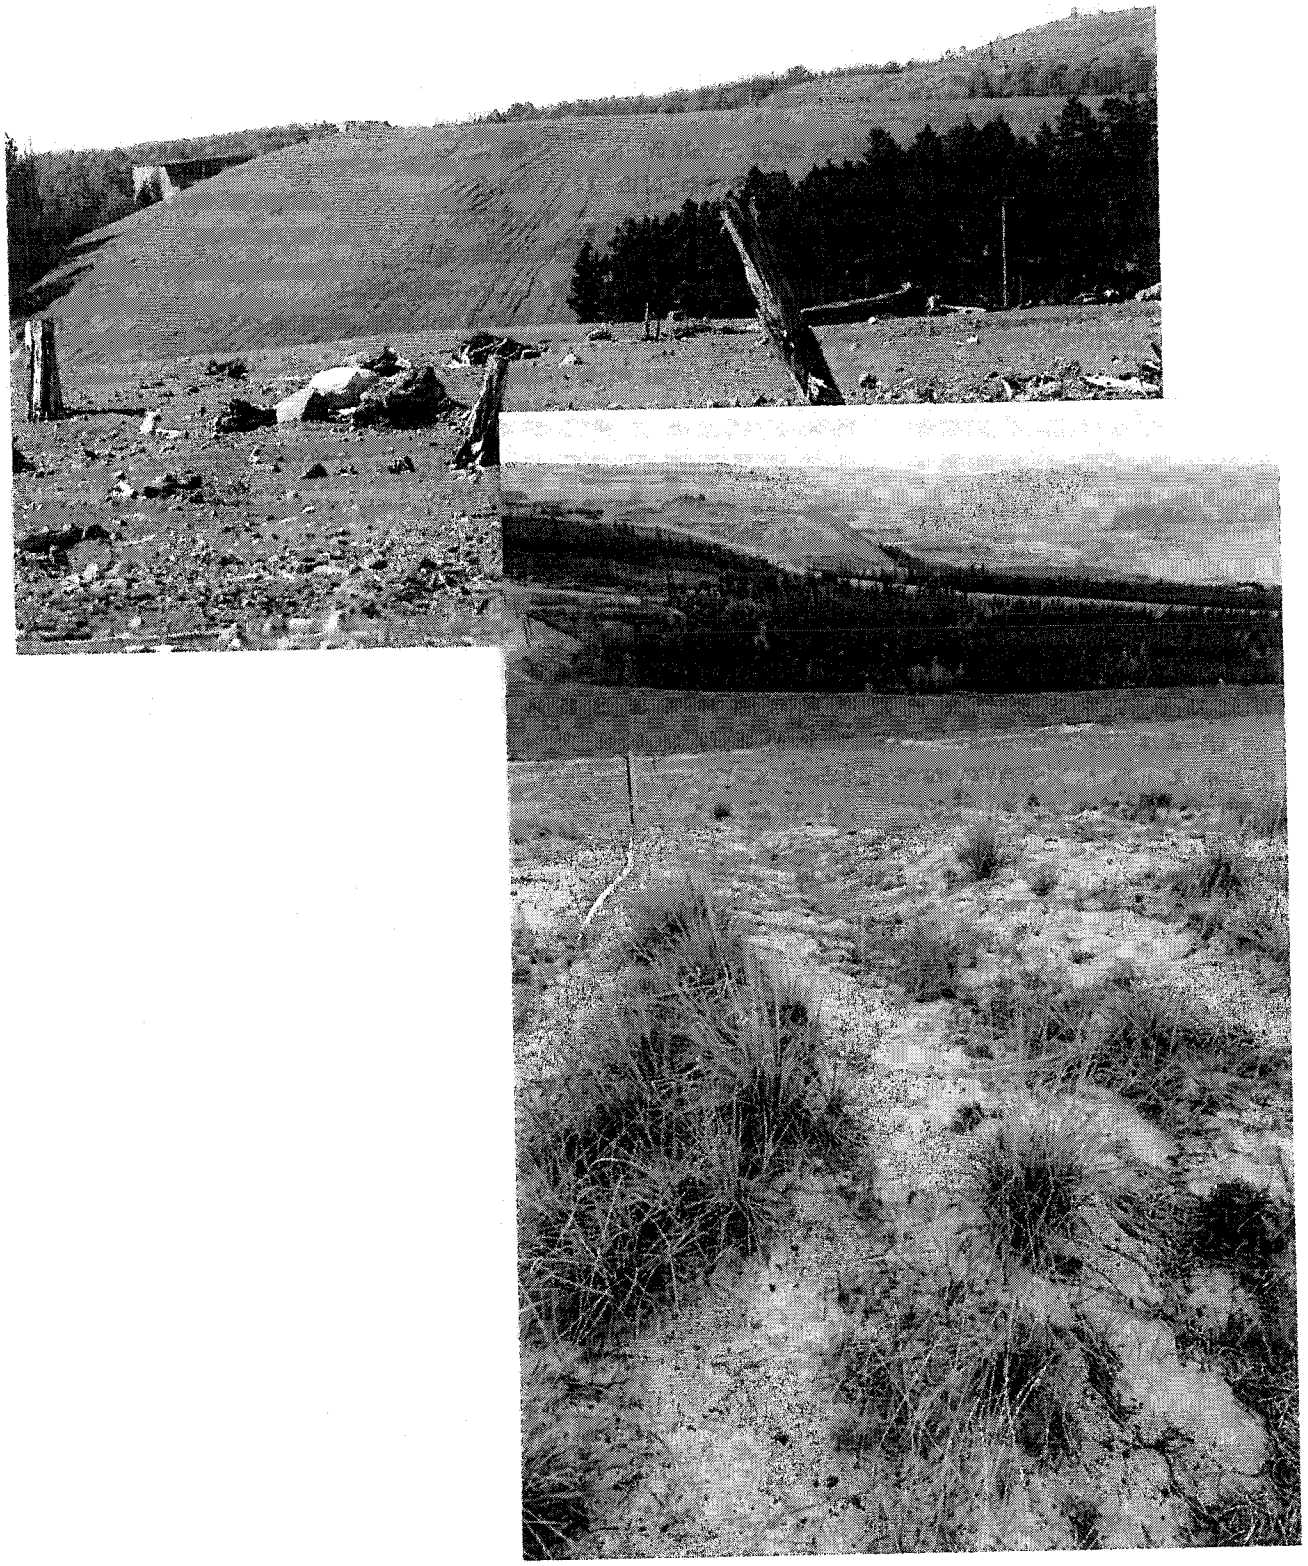
Plate 4.3 **A tailings sand slope showing initial signs of rilling and gullying. (Tree-stumps on waste rock dump in foreground are snags for raptors). The lower photo shows a sparsely vegetated and actively eroding tailings dam slope.**

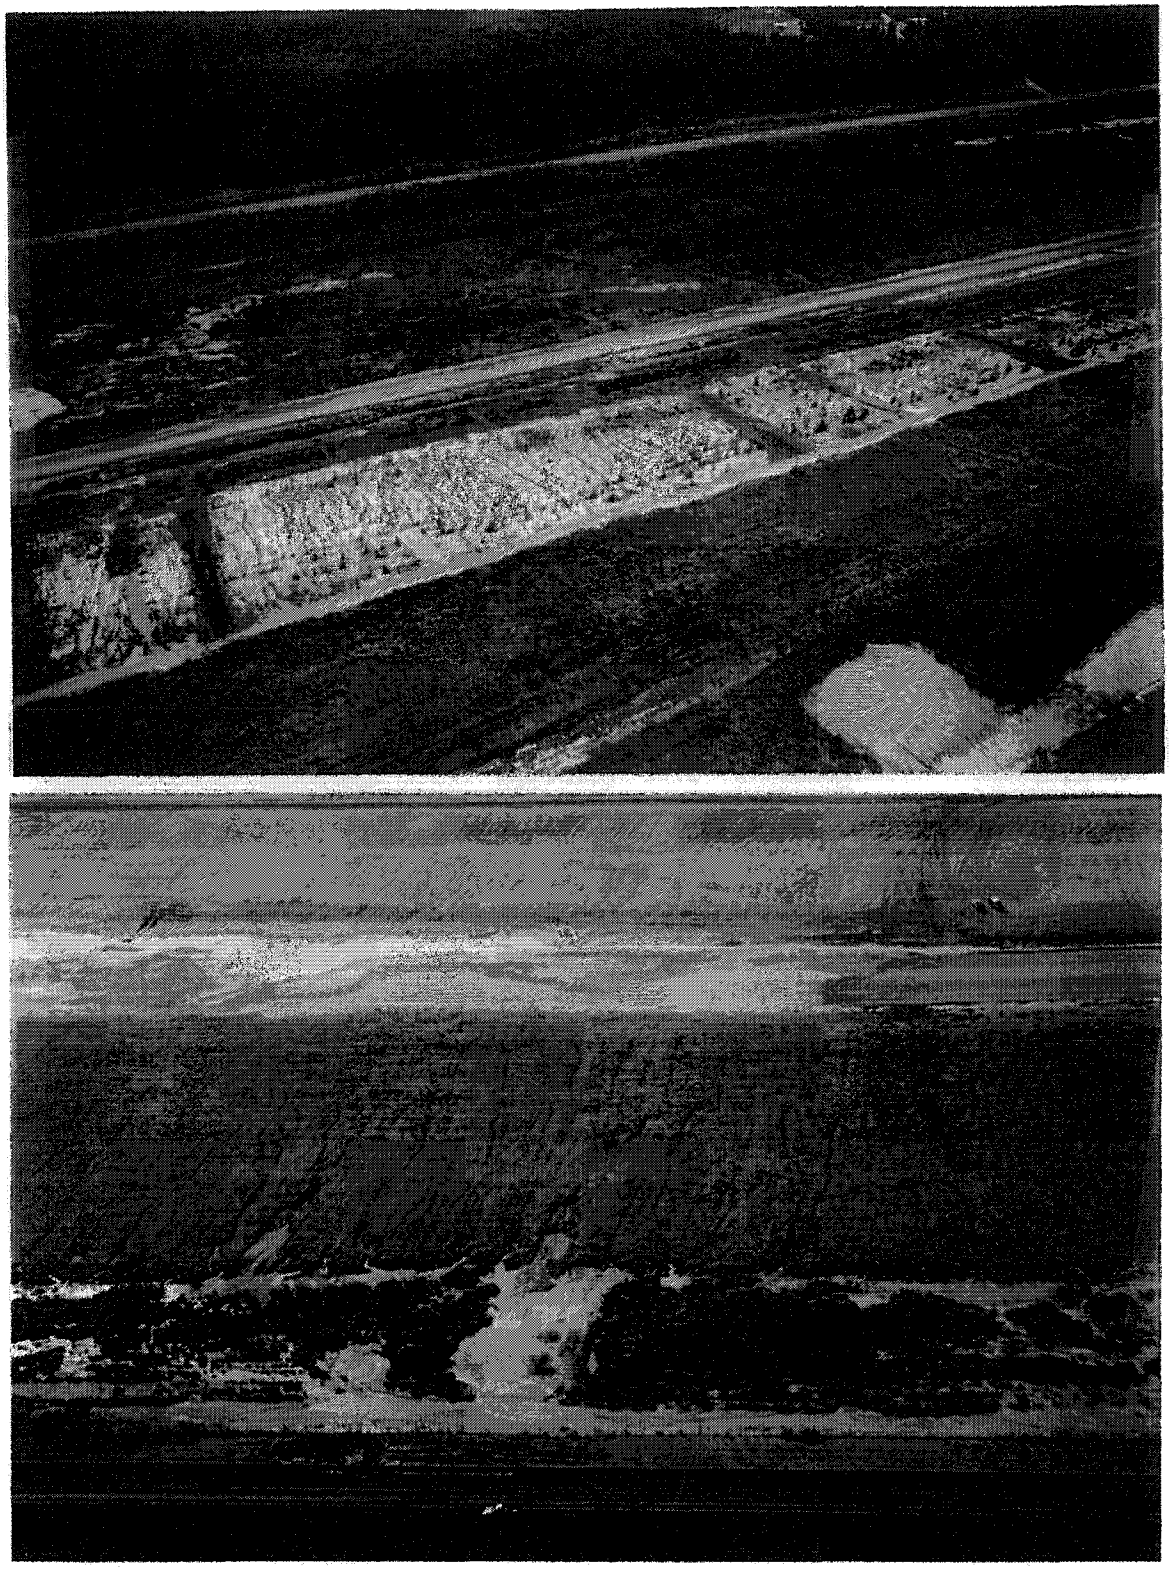
Plate 4.4 Two sparsely vegetated and eroding tailings sand slopes.

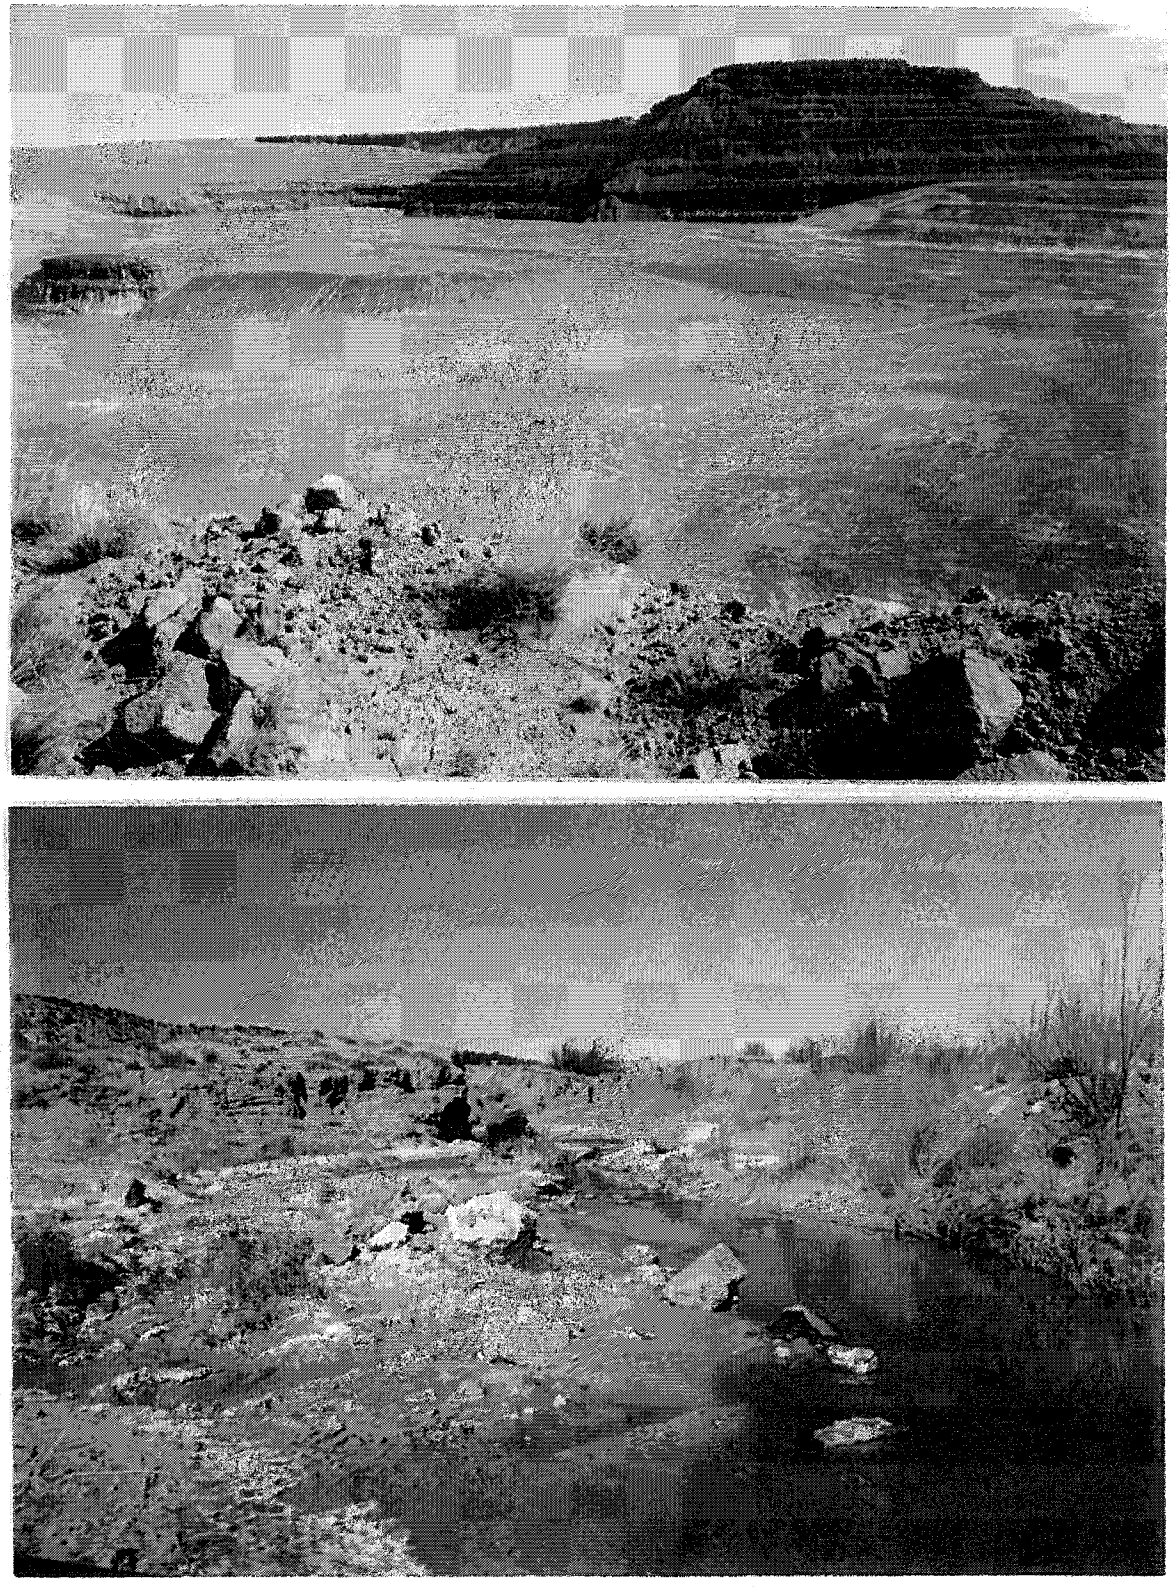
Plate 4.9 **Tens of millions of dollars were spent reclaiming this site, but to little benefit. The site will be permanently fenced off due to concerns about selenium and radioactivity, not to mention lack of vegetation.**
