FAILURE IN MINE HIGHWALL

IN SOFT SEDIMENTARY ROCK

A THESIS

FALL, 1989

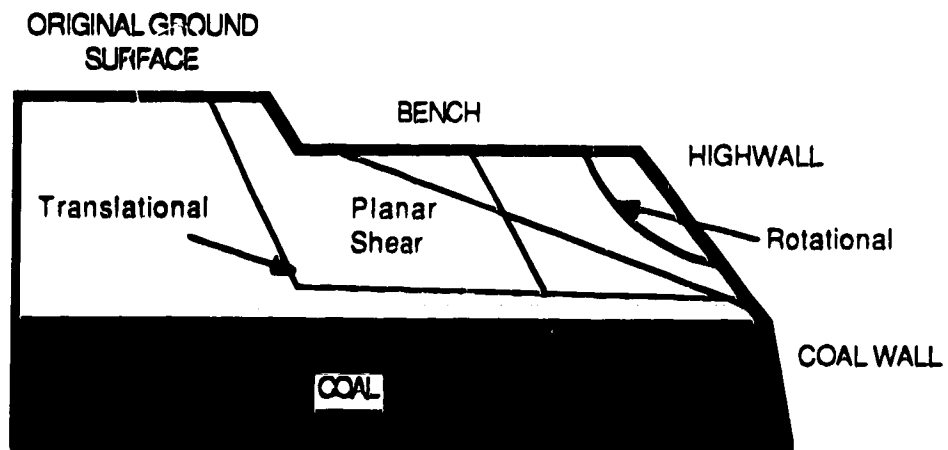
2. Potential modes of movements came from the past studies by Tsui (1988), Barron et al (1986), Fenton et al (1986), and Wade and Peterson (1986), and Moell et al (1984). They indicated that the primary mode would be a translational block or planar shear action, as shown in Figure 3.6, with secondary rotational failures near the highwall crest. In addition, exfoliation from the highwall face was expected to be commonplace.

Figure 3.6   Potential modes of highwall
deformation

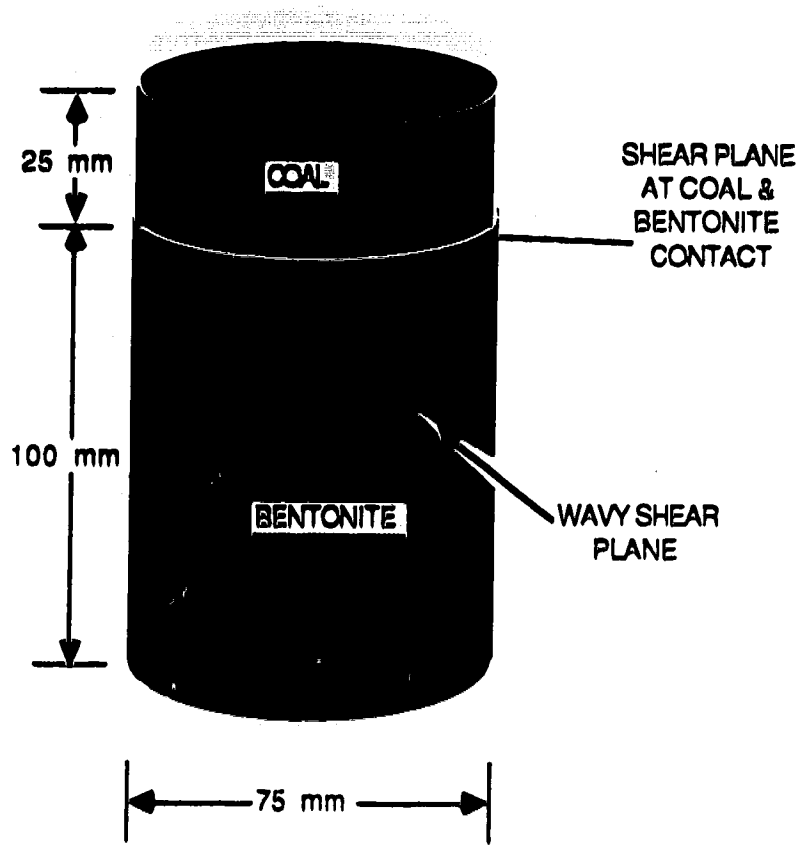
Figure 4.2   Location of slickensides observed in
       core taken from hole S6, June, 1987

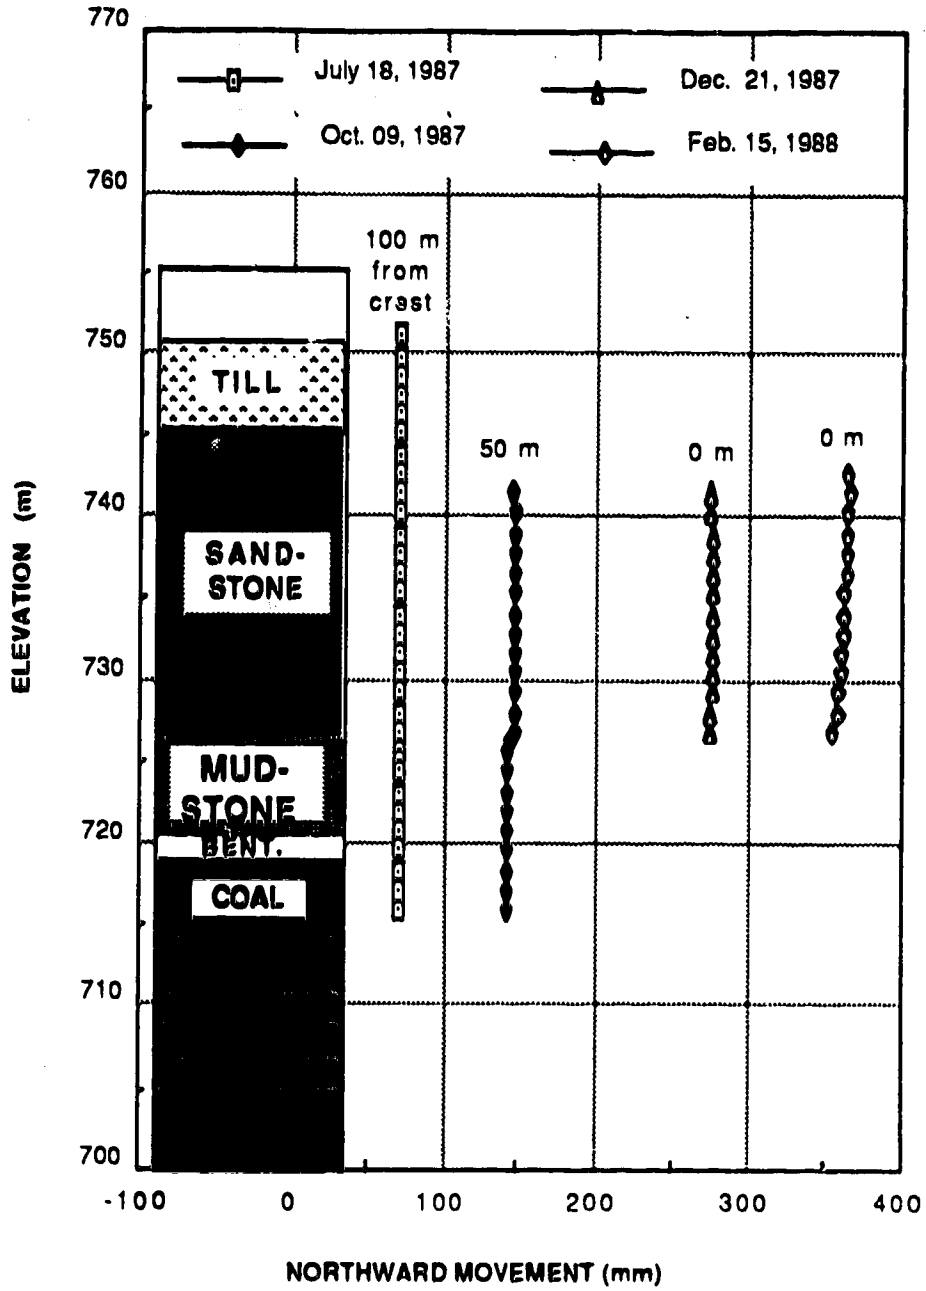
Inclinometer S1 was pinched off just above the sandstone/mudstone contact probably due to a shear plane, Figure 4.3. Its new base at elevation 726.2 metres could still be tracked by the survey support.

Figure 4.3   Movement of inclinometer S1

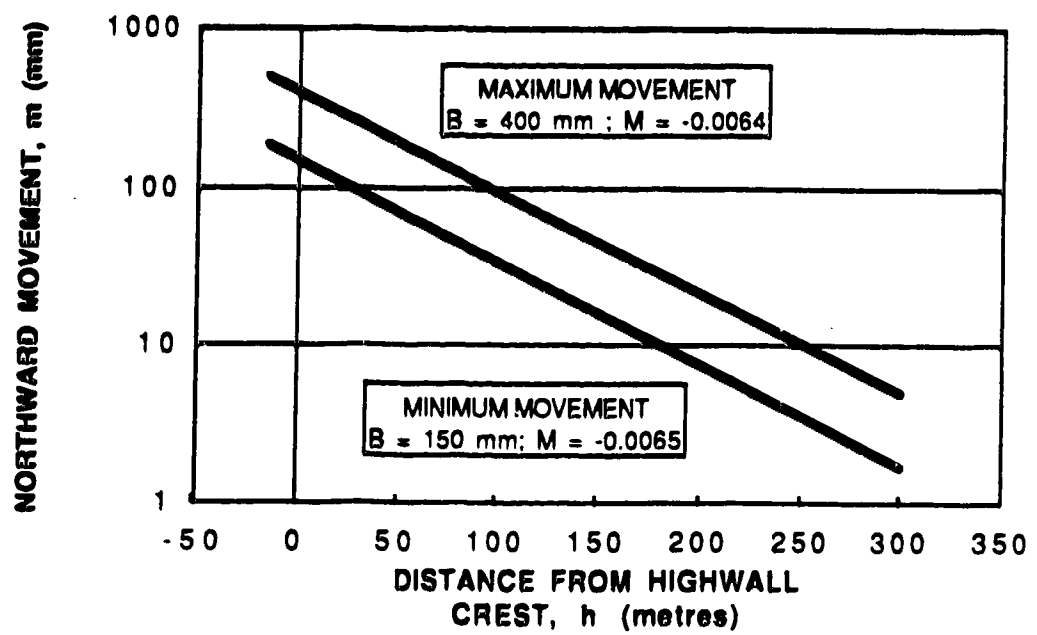
Figure 4.20   Range of movements in overburden at
elevation 730 metres

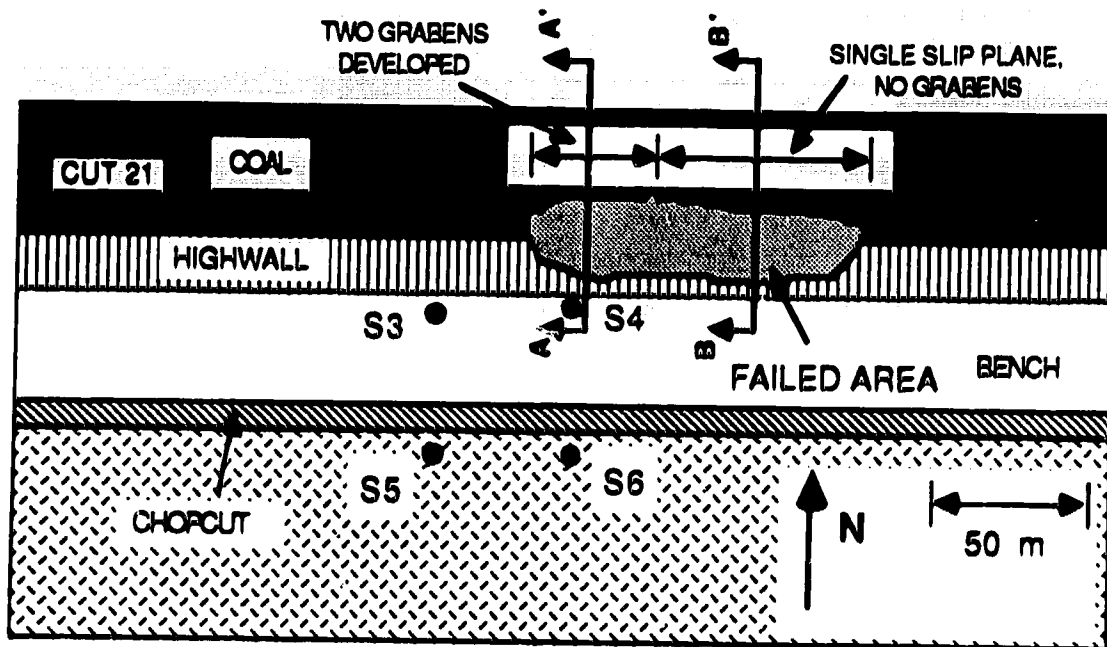
Figure 6.1   Plan view of highwall failure in Pit
03 April, 1988

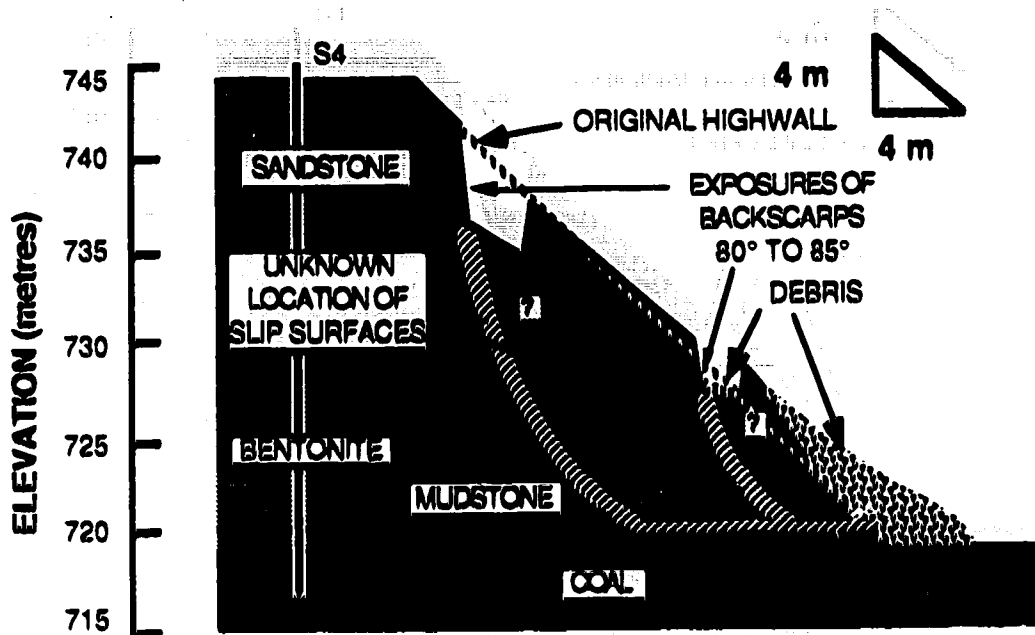
Figure 6.2   Post Failure Topography at Section A-A' through the west end of the failure, as observed on April 7, 1988.

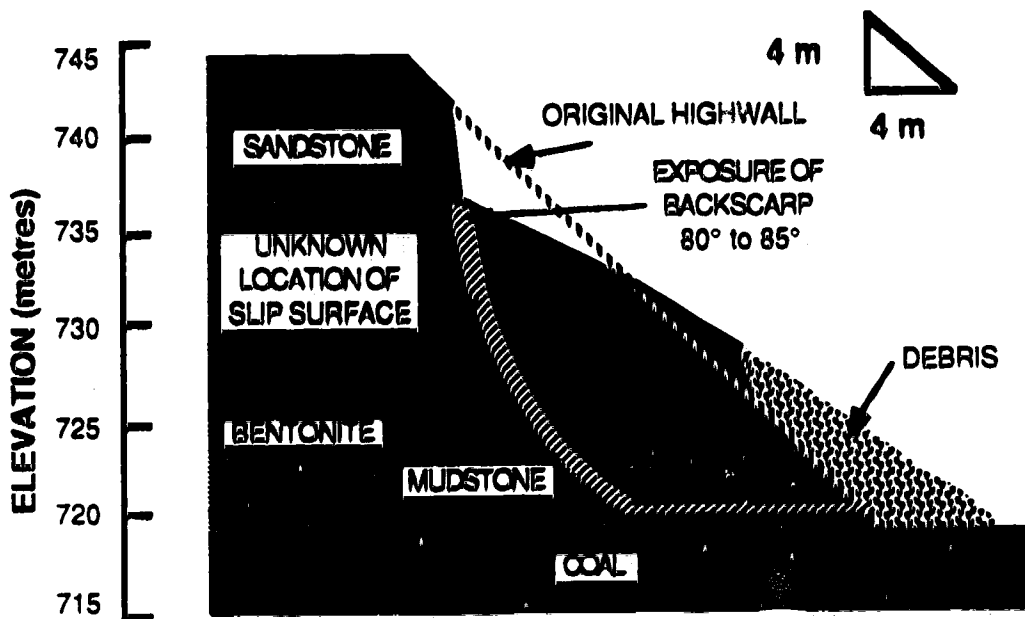
Figure 6.3   Post failure topography at Section B-B' through the east end of the failure as observed on April 7, 1988.

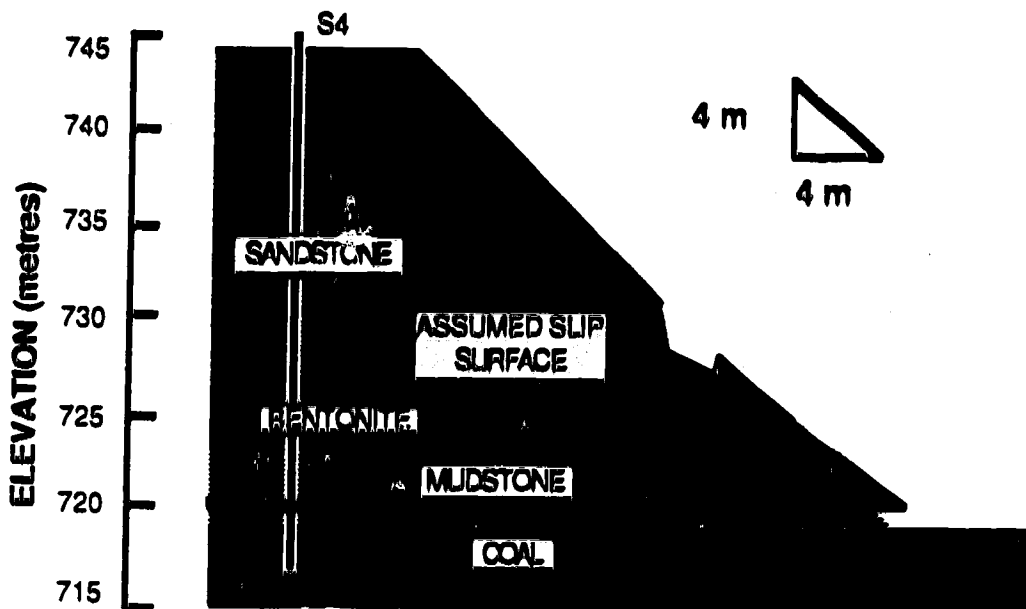
Figure 6.5   Failure model at Section A-A': After
failure of toe block, one to three weeks after
highwall was cut, between Mar. 18 and April 2,
1988.

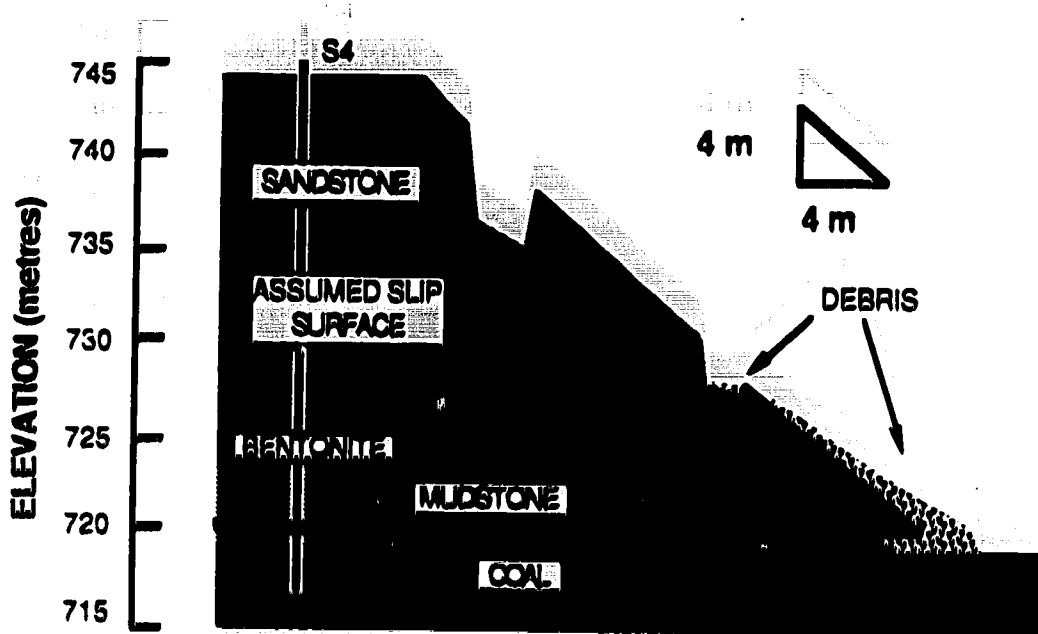
Figure 6.6   Failure model at Section A-A': After
failure of rear block, three to four weeks after
highwall was cut, approximately April 4, 1988.

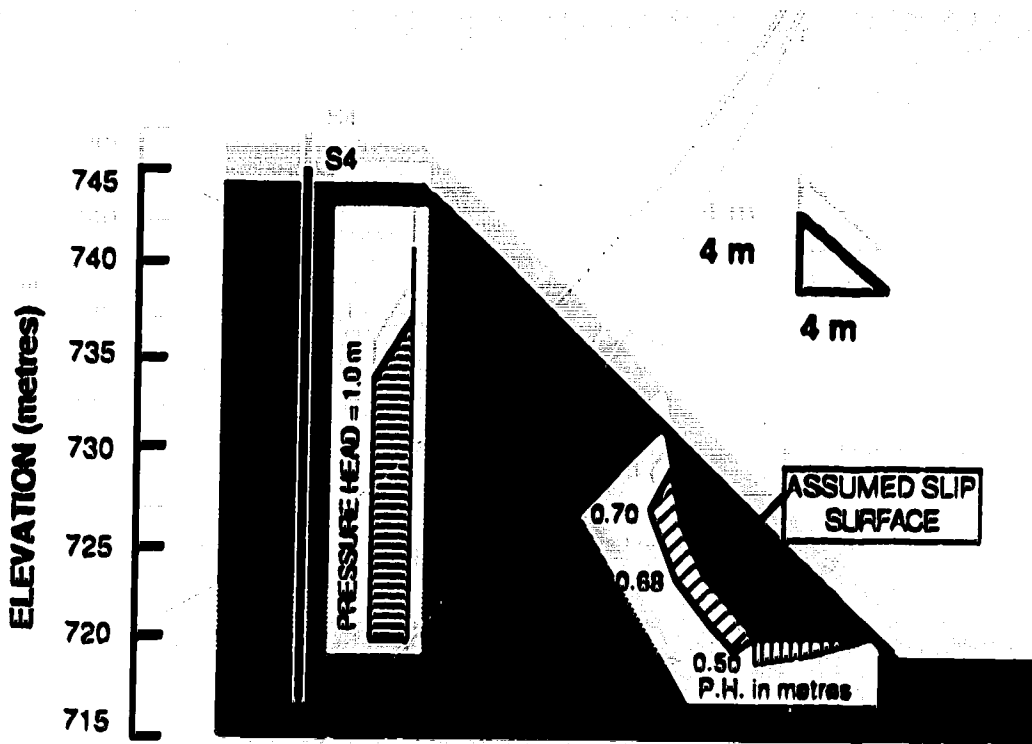
Figure 6.7   Pore Pressure Distribution assumed for

Figures 6.7 and 6.8 show the assumed water pressure distributions one to two weeks and two to three weeks after the highwall was cut. These were used in the analyses for the toe failure. Figure 6.9 presents the piezometric head three to four weeks after the cut was made, applicable to the rear failure.

failure analyses - one to two weeks after highwall
was cut.

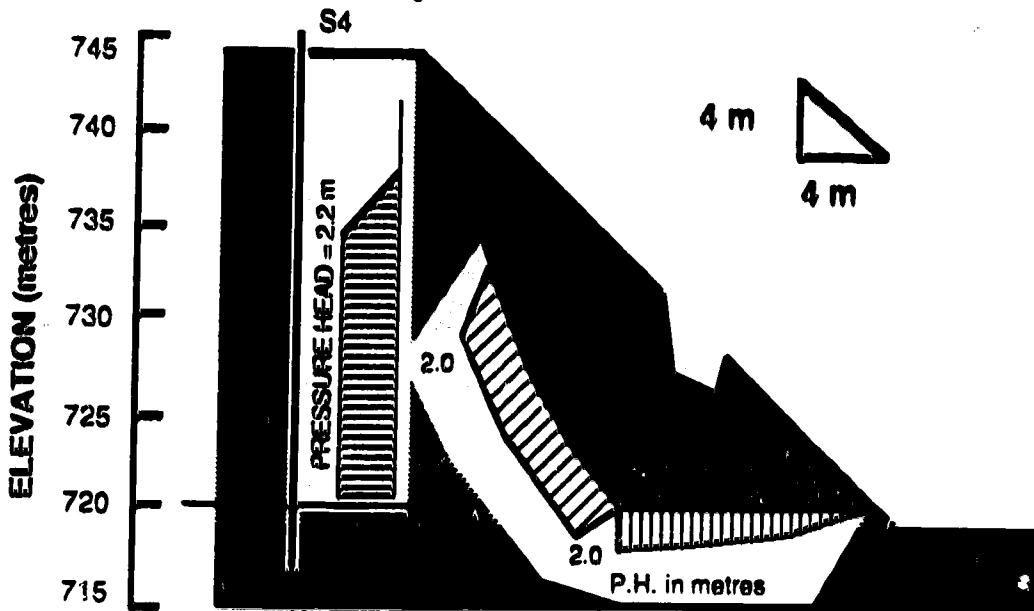
Figure 6.8   Pore Pressure Distribution assumed for
failure analyses - two to three weeks after
highwall was cut.

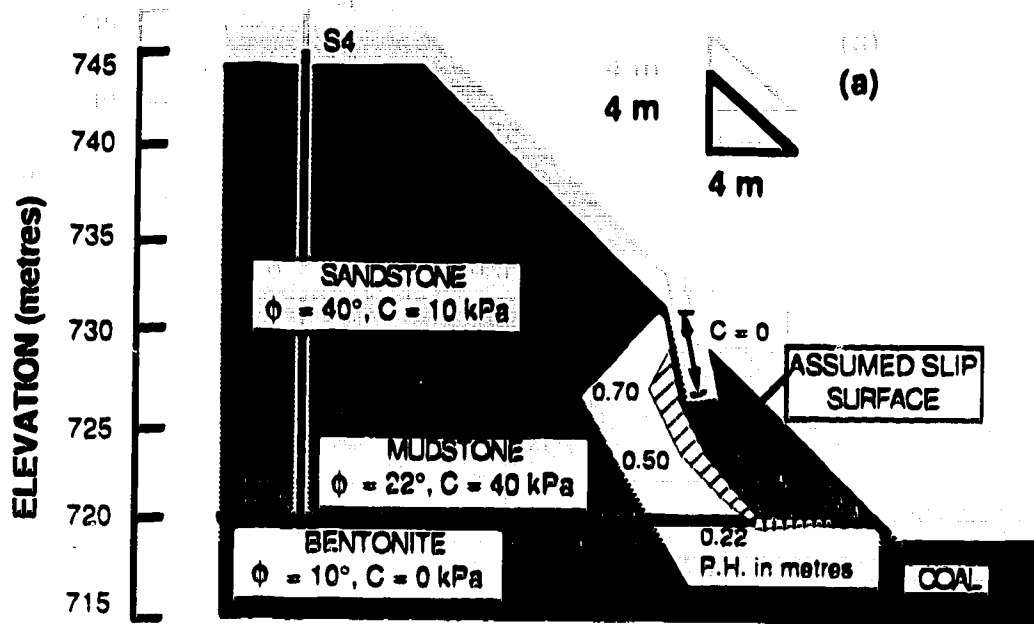
Figure 6.10 Stability analyses for toe failure (a)
Geometry, water pressures, and strength parameters,

(b) FOS plotted against λ. to find FOS that
satisfies moment and force equilibrium.

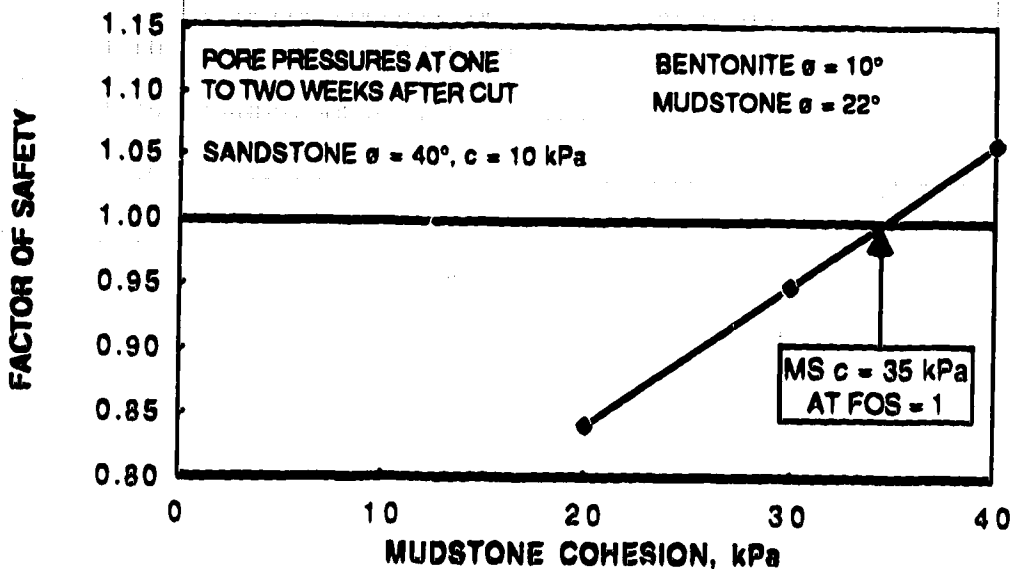
Figure 6.11 Magnitude of mudstone cohesion
mobilized at a FOS of unity.

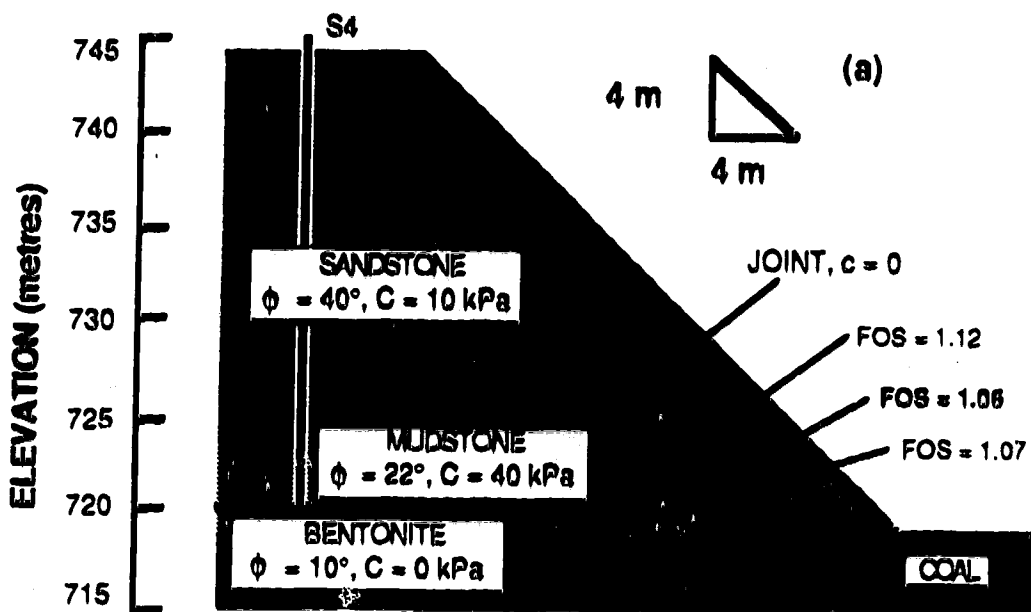
Figure 6.12 Assumed slip surfaces for search of
critical one at toe failure (i.e. slip surface with
lowest FOS).

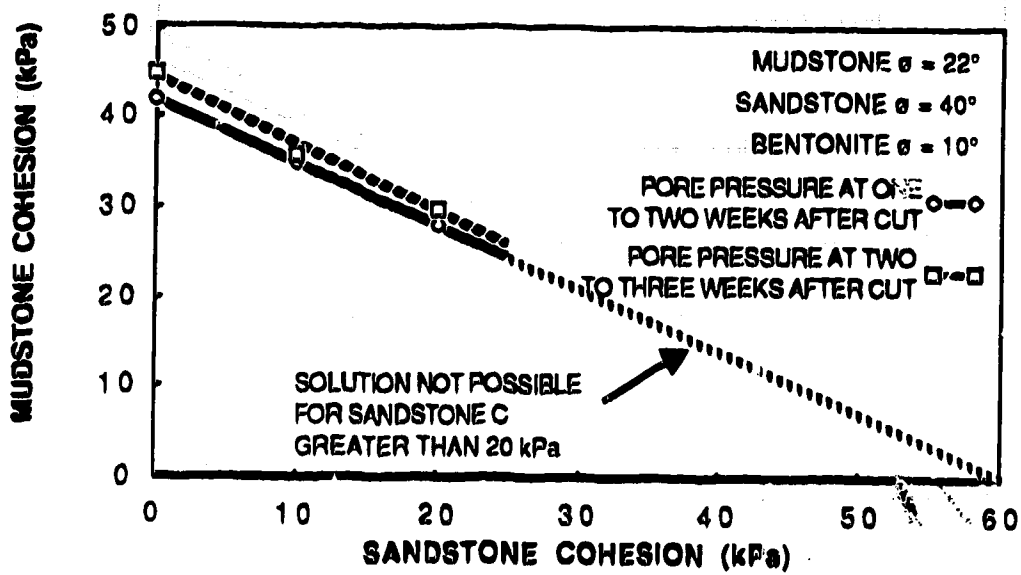
Figure 6.13 Combinations of mudstone and sandstone
cohesions mobilized at toe failure.

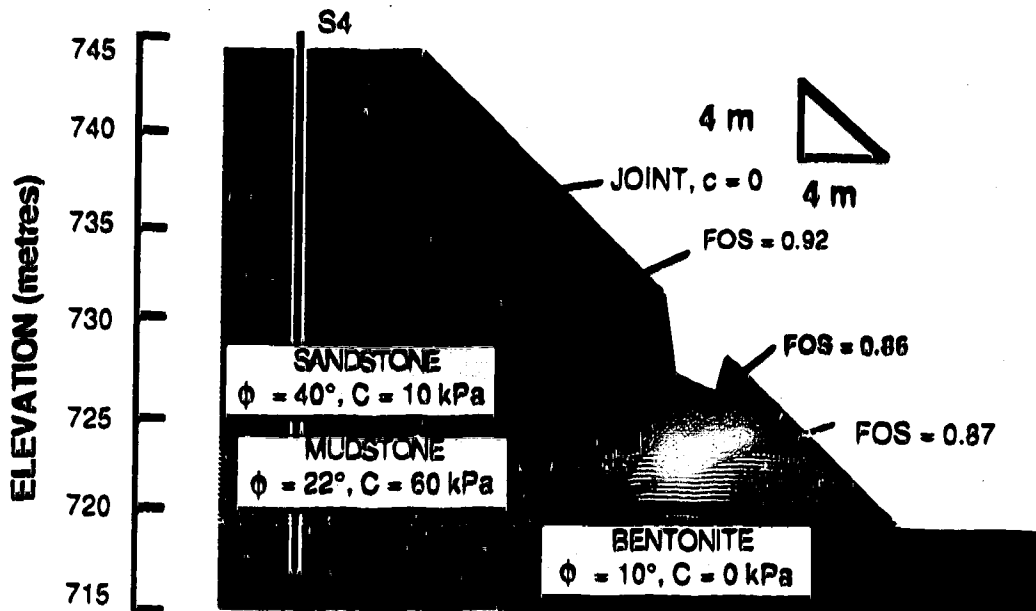
Figure 6.14 Assumed slip surfaces for search of
critical one at rear failure.

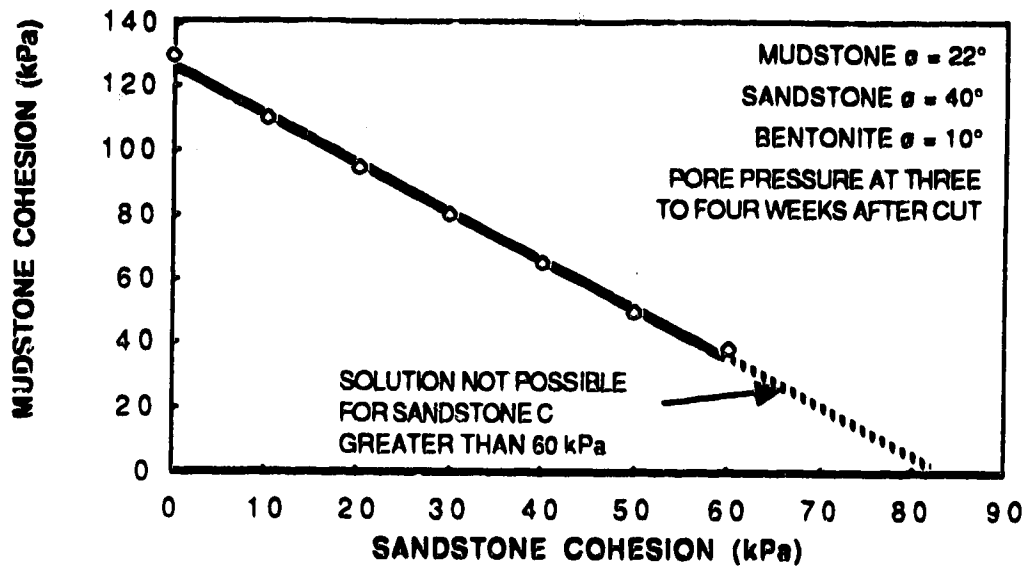
Figure 6.15 Combination of mudstone and sandstone
cohesions mobilized at rear failure.

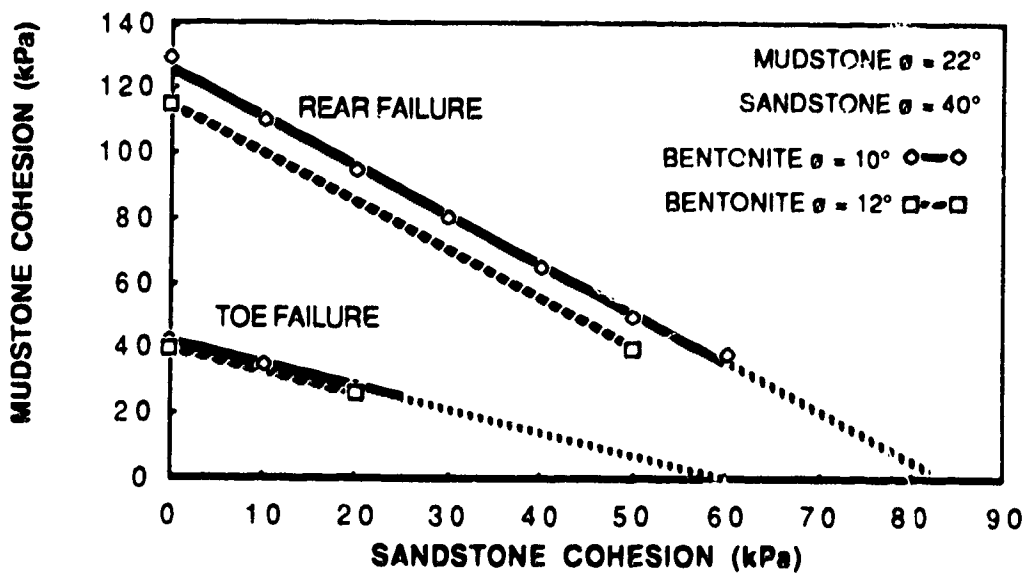
Figure 6.16 Combined results of toe and rear
failures.

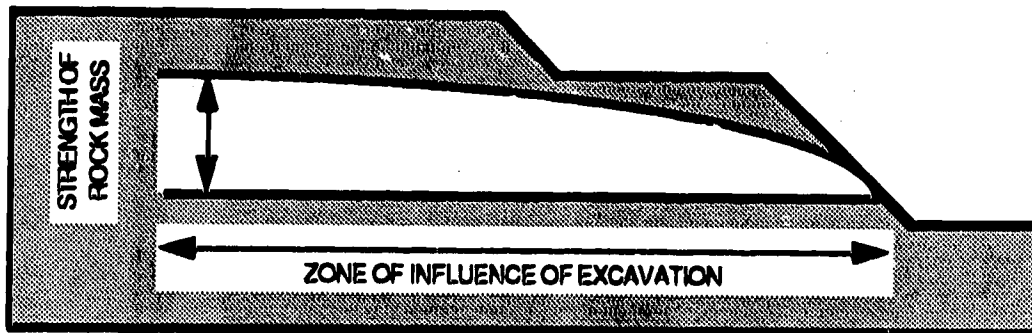
Figure 6.17 Conceptual model of reduction in rock
mass strength from and undisturbed state beyond the
zone of excavation to the highwall face.

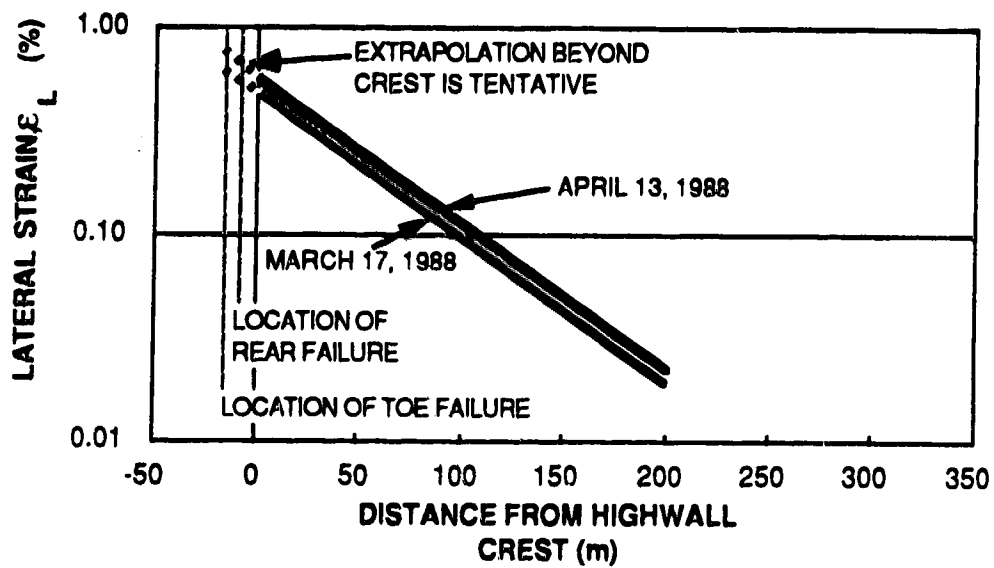
Figure 6.18 Lateral strain field for March. 17 and
April 13, 1988 on line S4-S6.

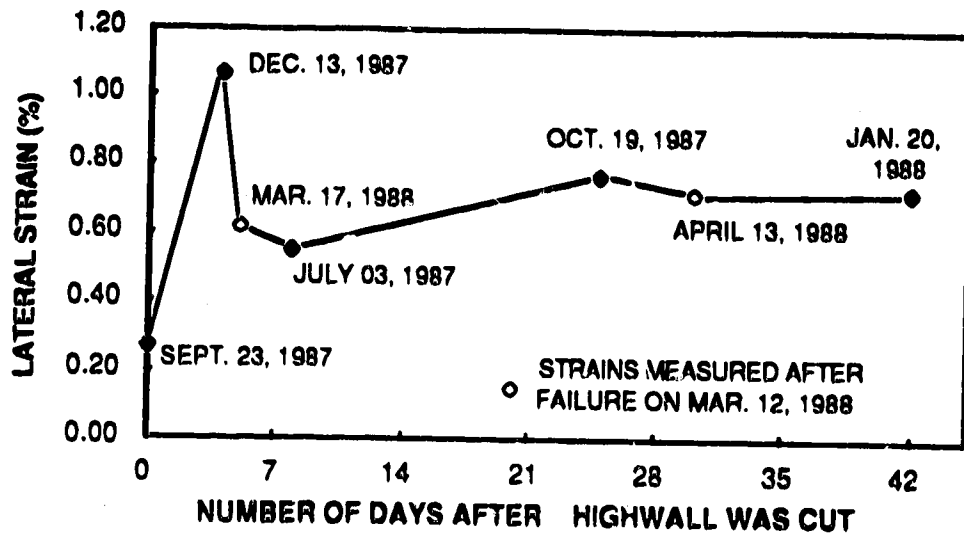
The variation in strain over time at the toe and rear failure locations is shown in Figures 6.19 and 6.20 with the results for March 17 and April 13, 1988 shown as clear symbols. Additional strain data was plotted as dark symbols for similar positions in the highwall after the three previous cuts on June 25, 1987, September 23, 1987, and December 9, 1987. Interestingly, the strains were similar after each cut was made.

Curves fit through the points on Figures 6.19 and 6.20 (ignoring the anomalous strain at December 13, 1987) were

transferred to Figures 6.21 and 6.22. These figures were then used to estimate the strains at the time of failure.

Figure 6.19 Variation in strain along backscarp of toe failure after a highwall was cut.

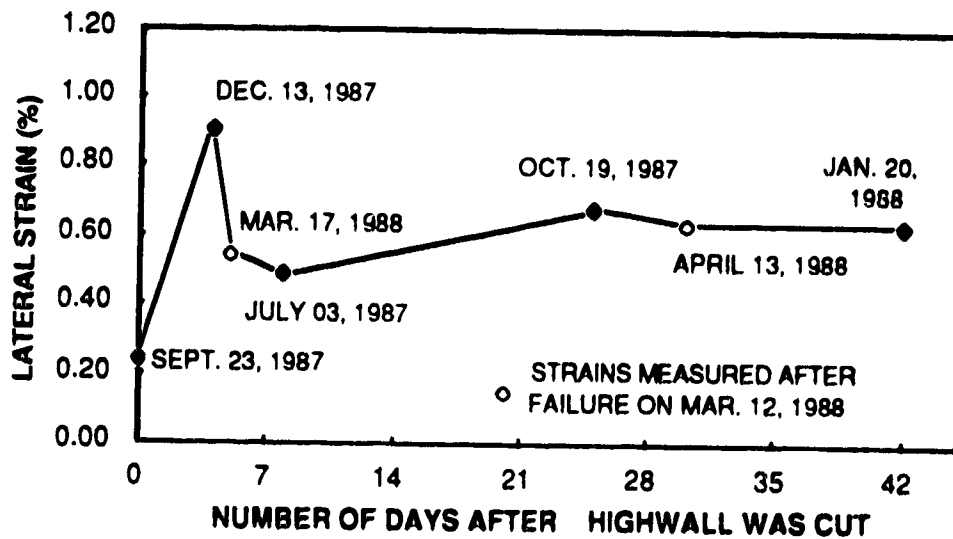
Figure 6.20 Variation in strain along backscarp of rear failure after a highwall was cut.

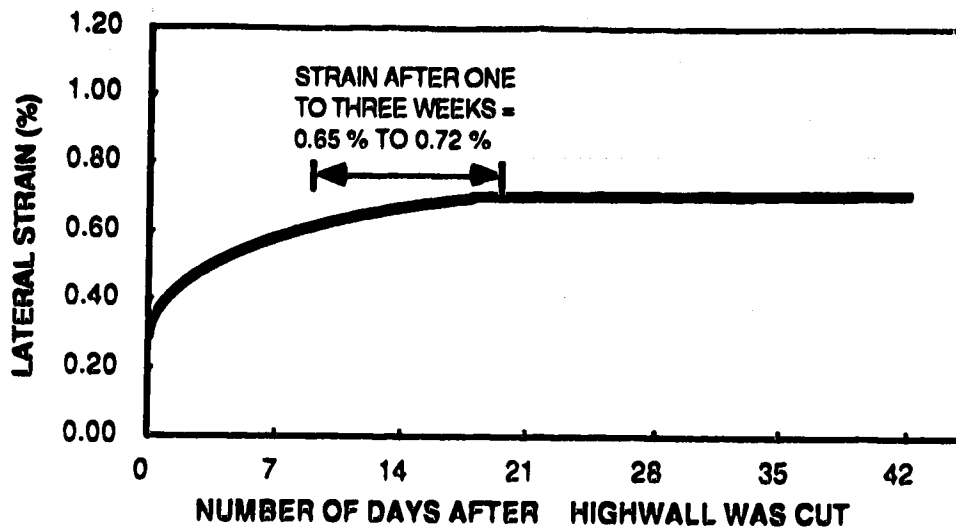
Over the duration of the monitoring program, several sections of the highwall experienced lateral strains greater than 0.65% and did not fail. Figures 6.19 to 6.22 showed how the strains developed after four different highwalls were cut. All four had lateral strains above 0.65% but only one of them failed.

Figure 6.21 Generalized development of strain along backscarp of toe block after a highwall was cut.

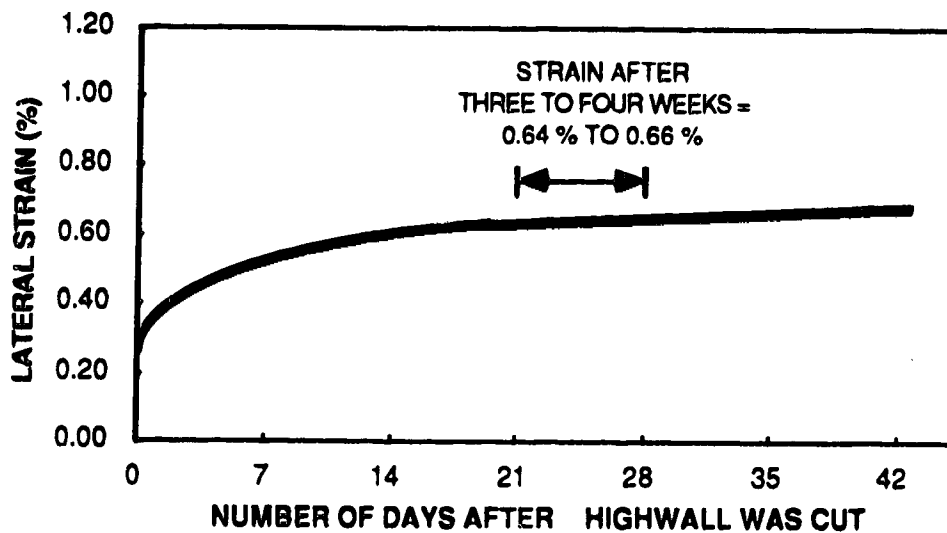
Figure 6.22 Generalized development of strain along backscarp of rear block after a highwall was cut.

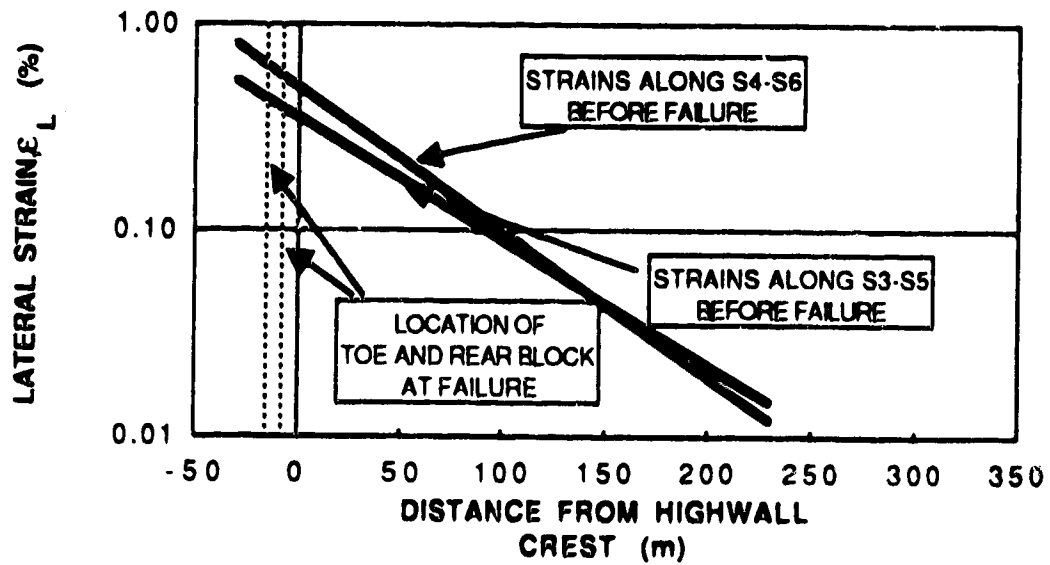
Figure 6.23 presents the strain field on March 17, 1988 along lines S4-S6 and S3-S5. It shows that five days after the highwall was cut, the lateral strains along line S4-S6 were greater than along line S3-S5. As listed in Table 6.4, the lateral strains at the toe and rear failure along line S4-S6 were 0.62% and 0.54%, respectively. Along line S3-S5, where the highwall was stable, the lateral strains were found to be 0.20% less.

Figure 6.23 Lateral strains mobilized at elevation 730 metres on March 17, 1988, five days after the highwall was cut.

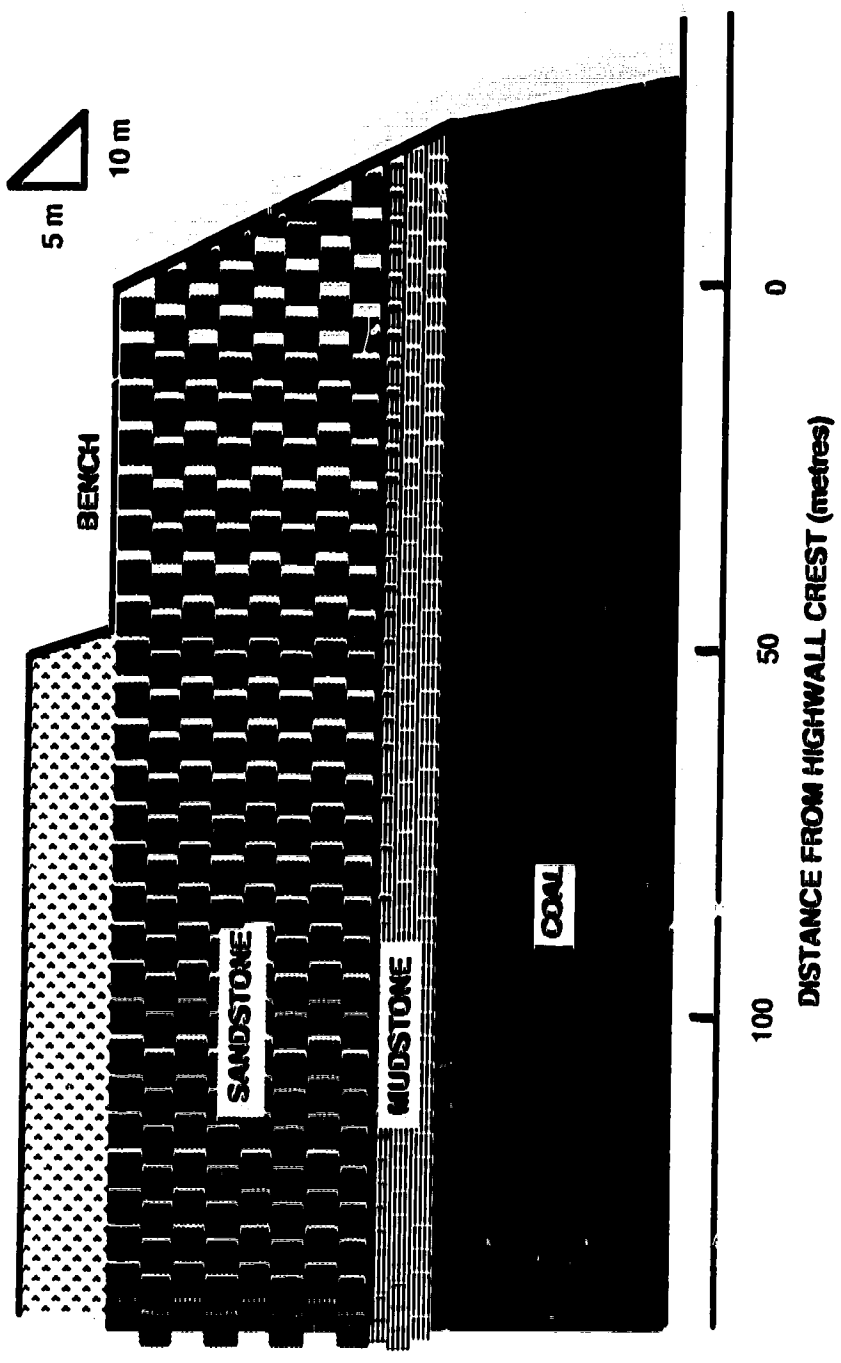
Figure 6.24 : Schematic of "Progressive Loosening" concept

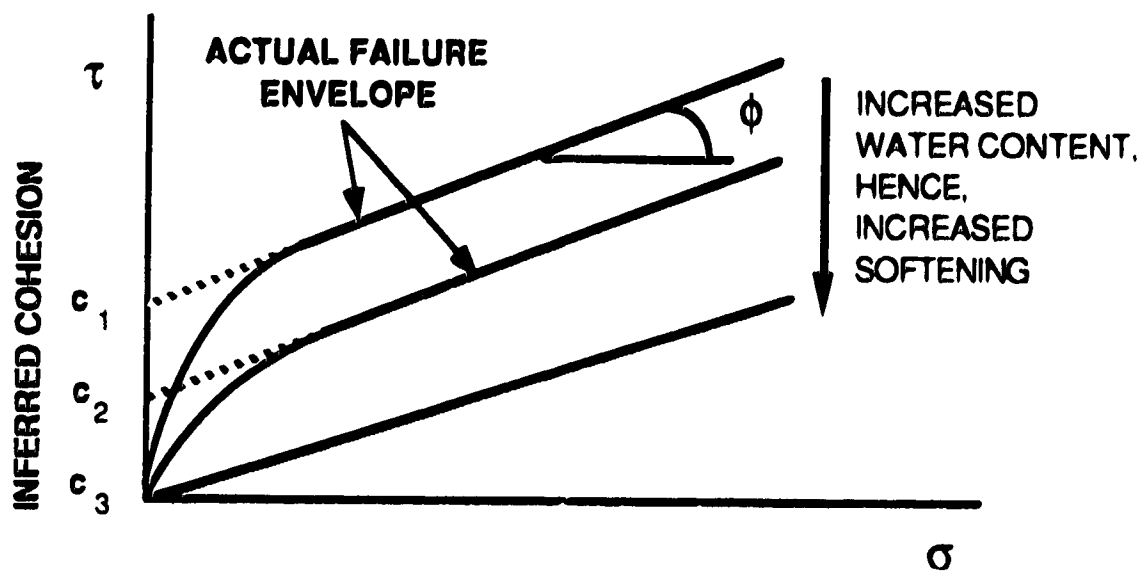
Figure 6.25 Schematic of "Progressive Softening"
concept.

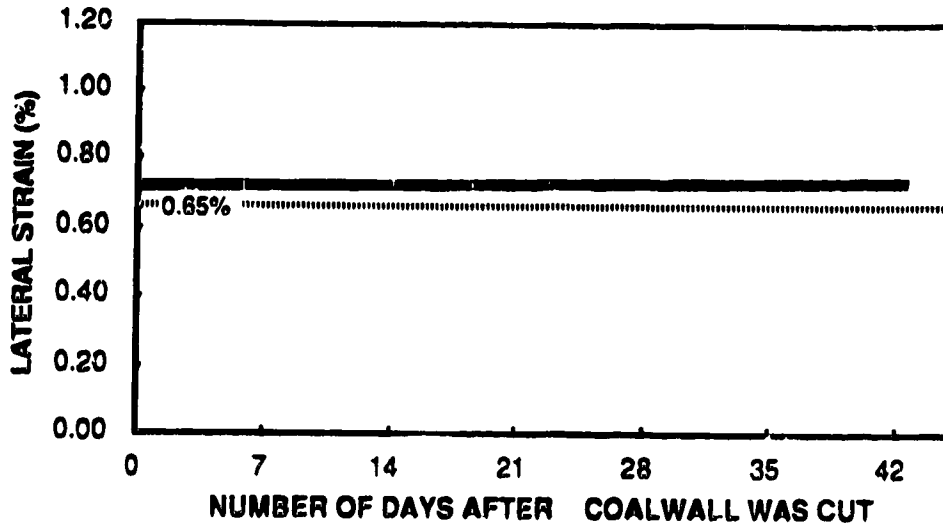
More evidence is available to caution use of the concept of a critical strain. Figure 6.26 presents the strains along line S2-S4-S6 after the coalwall was cut. These strains were found at a distance of 15 metres beyond the highwall crest, coincident with the location of the toe failure on Cut 21. Figure 6.26 shows lateral strains of 0.73% were mobilized after the coalwall was cut, yet three of the four highwalls monitored during this program continued to stand.

Figure 6.26 Generalized development of strain on
line S2-S4-S6 after the coal was excavated. At
elevation 730 metres, 15 metres in front of
highwall crest.

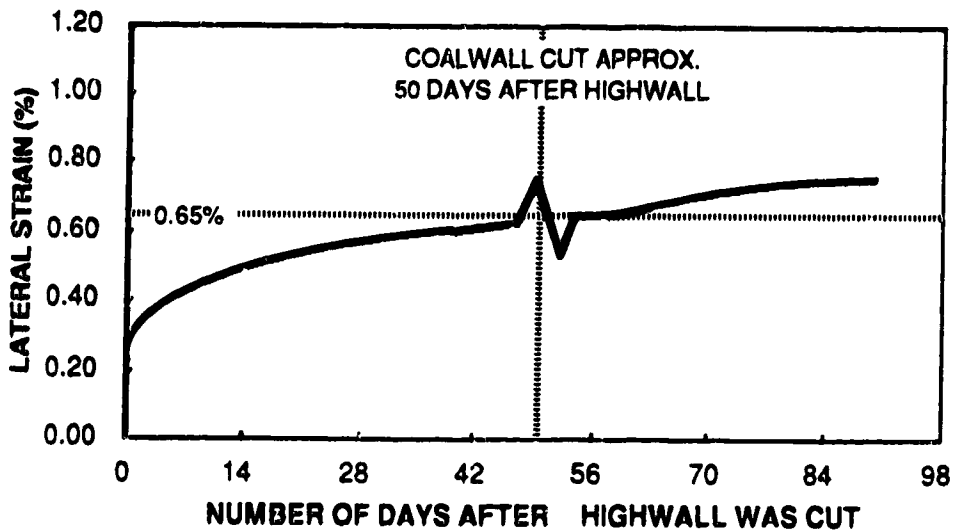
Furthermore, the lateral strains along line S1-S3-S5 tended to exceed 0.65% after the coalwall was cut and the highwall remained intact throughout. Figure 6.27 shows the general development of strains 15 metres beyond the crest from the time when the highwall was cut to after the coal had been excavated and indicates that lateral strains developed in excess of 0.65%.

Figure 6.27 Generalized development of strain on
line S1-S3-S5 after the highwall and coal were
excavated. At elevation 730 metres, 15 metres in
front of highwall crest.

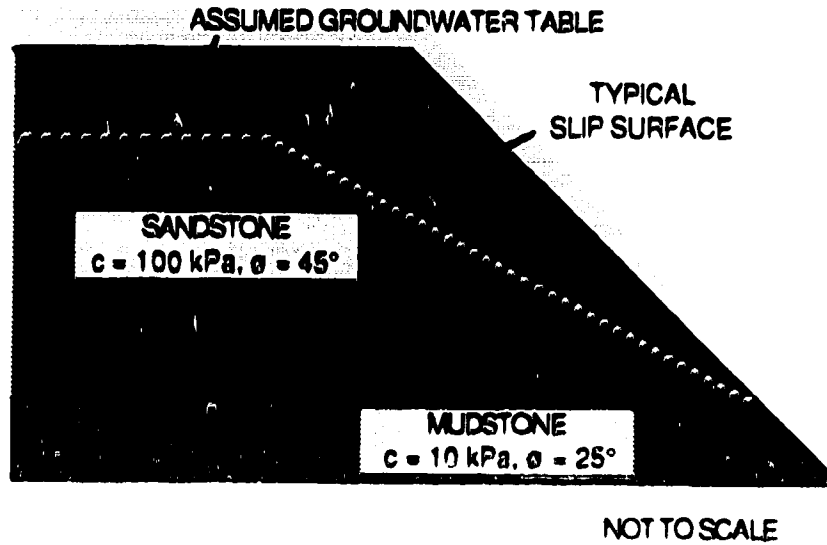
Wade and Peterson (1986) investigated the stability of the highwall in Pit 03 by assuming a composite slip surface similar to the ones presented in Figures 6.13 and 6.15. The slip surface geometry assumed by these authors is shown in Figure 6.28. A slip indicator installed in 1984 indicated that the base of the slip plane was located at the sandstone/mudstone contact instead of in the bentonite.

Figure 6.28   Section used by Wade and Peterson

(adapted 1986) to evaluate stability of highwall in
Pit 03.

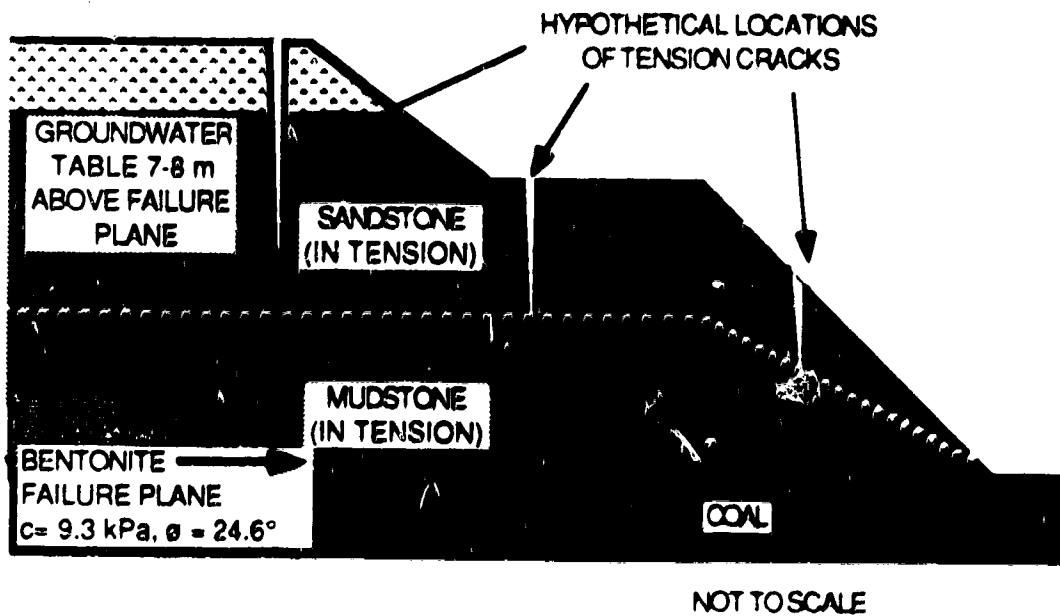
Barron et al (1986) assumed a plane shear mechanism, as shown in Figure 6.29, to model a failure in Pit 03 in the spring of 1984. Several tension cracks were located in the failure area and were assumed to penetrate to the basal slip plane, assumed to be the bentonite seam above the coal. The strength parameters for the bentonite used by these authors are shown in Table 6.5. The sandstone and mudstone strength above the bentonite were assumed to be zero because of a tension crack. Water pressures were obtained from 20 piezometers in the area and it was concluded that a phreatic surface was located 7 to 8 metres above the failure plane. The planar shear model developed by Barron et al (1986) accurately simulated the development of the tension cracks.

Figure 6.29   Planar Shear Model used by Barron and
Stimpson (adapted 1986) to analyse failure of
highwall in Pit 03 in spring, 1984.

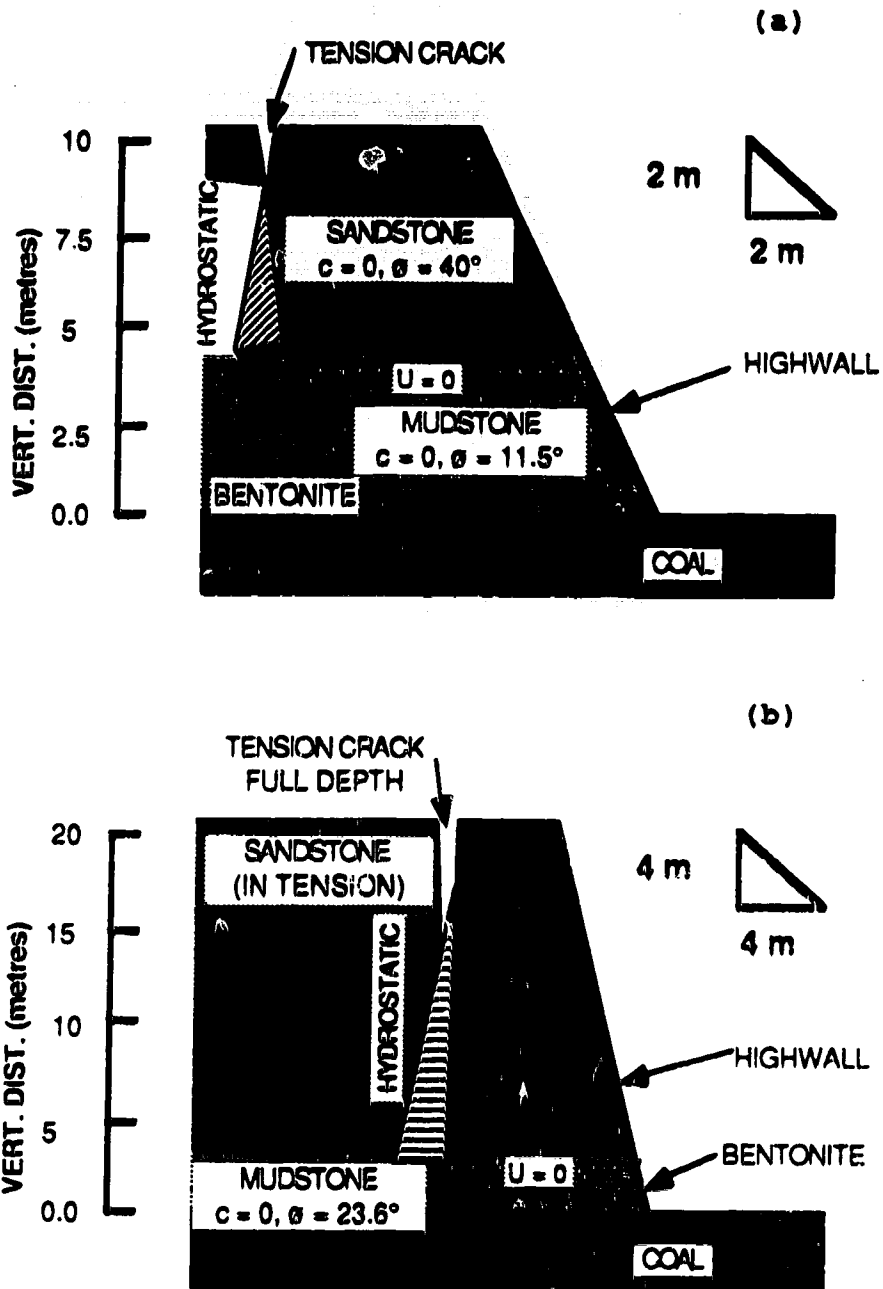
Two slides had occurred in Pit 03 in July, 1984 and were analysed by Tsui (1988). Tension cracks were observed just before the slides started and were assumed to mark the top of a steep back scarp that followed vertical joints, as shown in Figure 6.30(a) and (b). The base of slips was assumed to be located at the sandstone/mudstone contact, which was a shear zone created by ice thrusting (Section 2.4).

Figure 6.30   Sections used by Tsui (adapted 1988)
to analyse two highwall failures which occurred in
Pit 03 in July, 1984: (a) Slide 1 and (b) Slide 2.
