UNIVERSITY OF ALBERTA

GEOTECHNICAL ASPECTS OF LINED RESERVOIRS

A Thesis

Master of Engineering

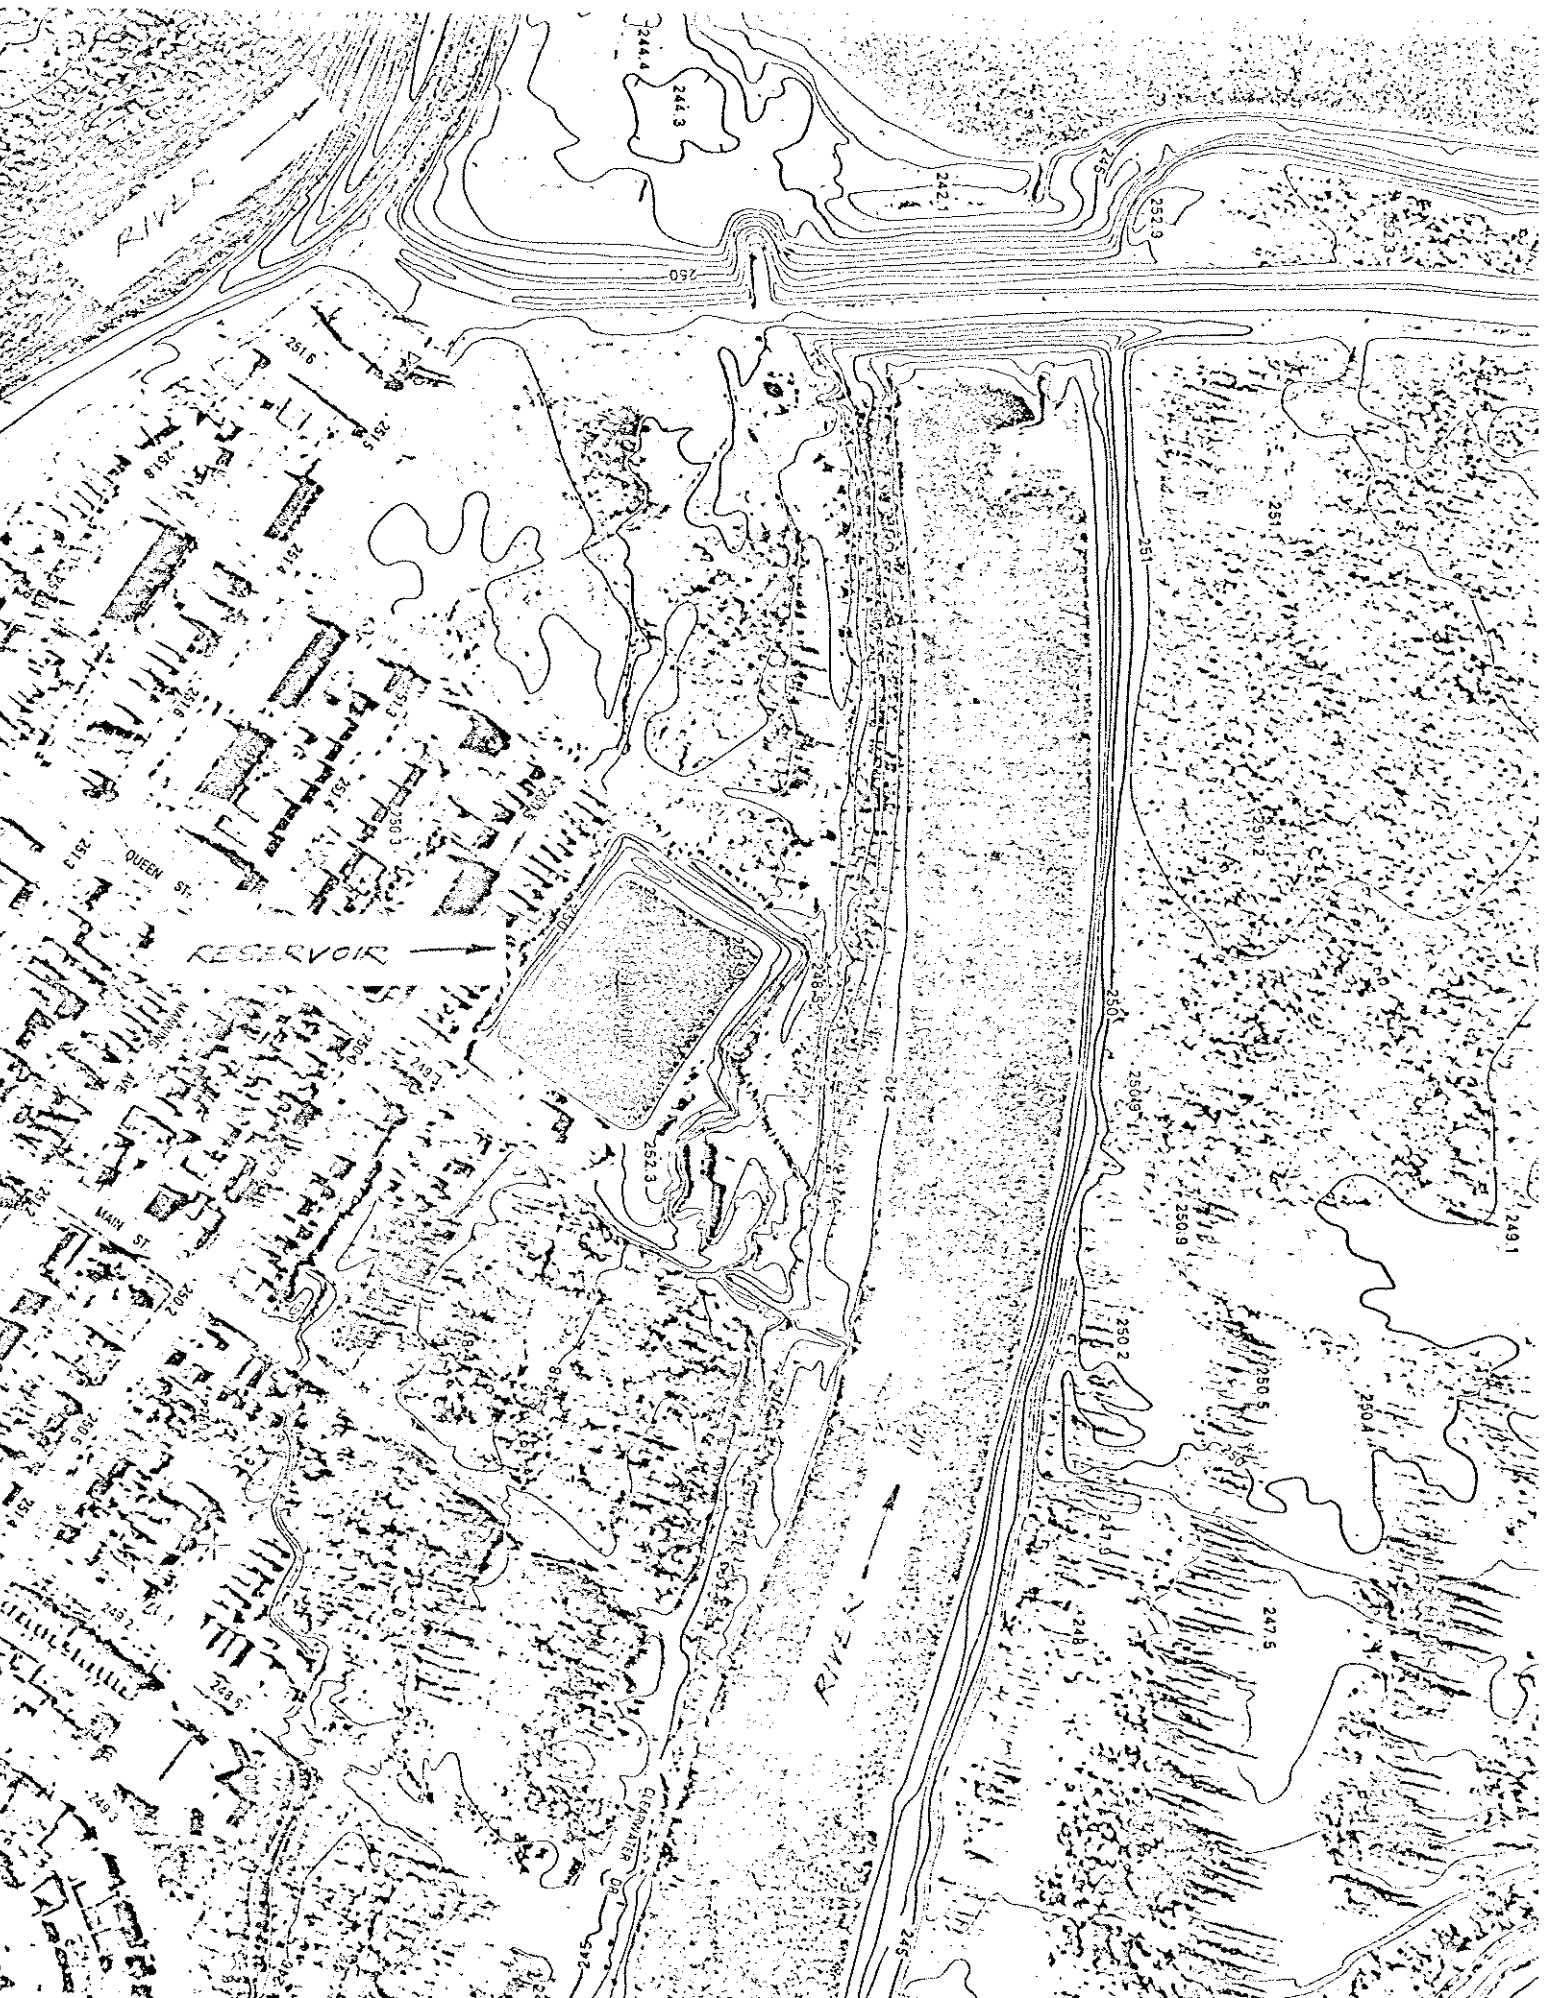
Figure 3.4 : LOCALITY PLAN,
(Case History A)

The embankment is founded directly on the clay stratum. The presence of organics in this material and its low strength suggest that the soil is probably quite compressible. Variations in embankment crest level of up to 1.5 m as shown on the contour plan Fig.3.4 indicate that substantial differential movements have occurred with almost certain cracking of the embankment accompanying these movements. The limits for susceptible soils

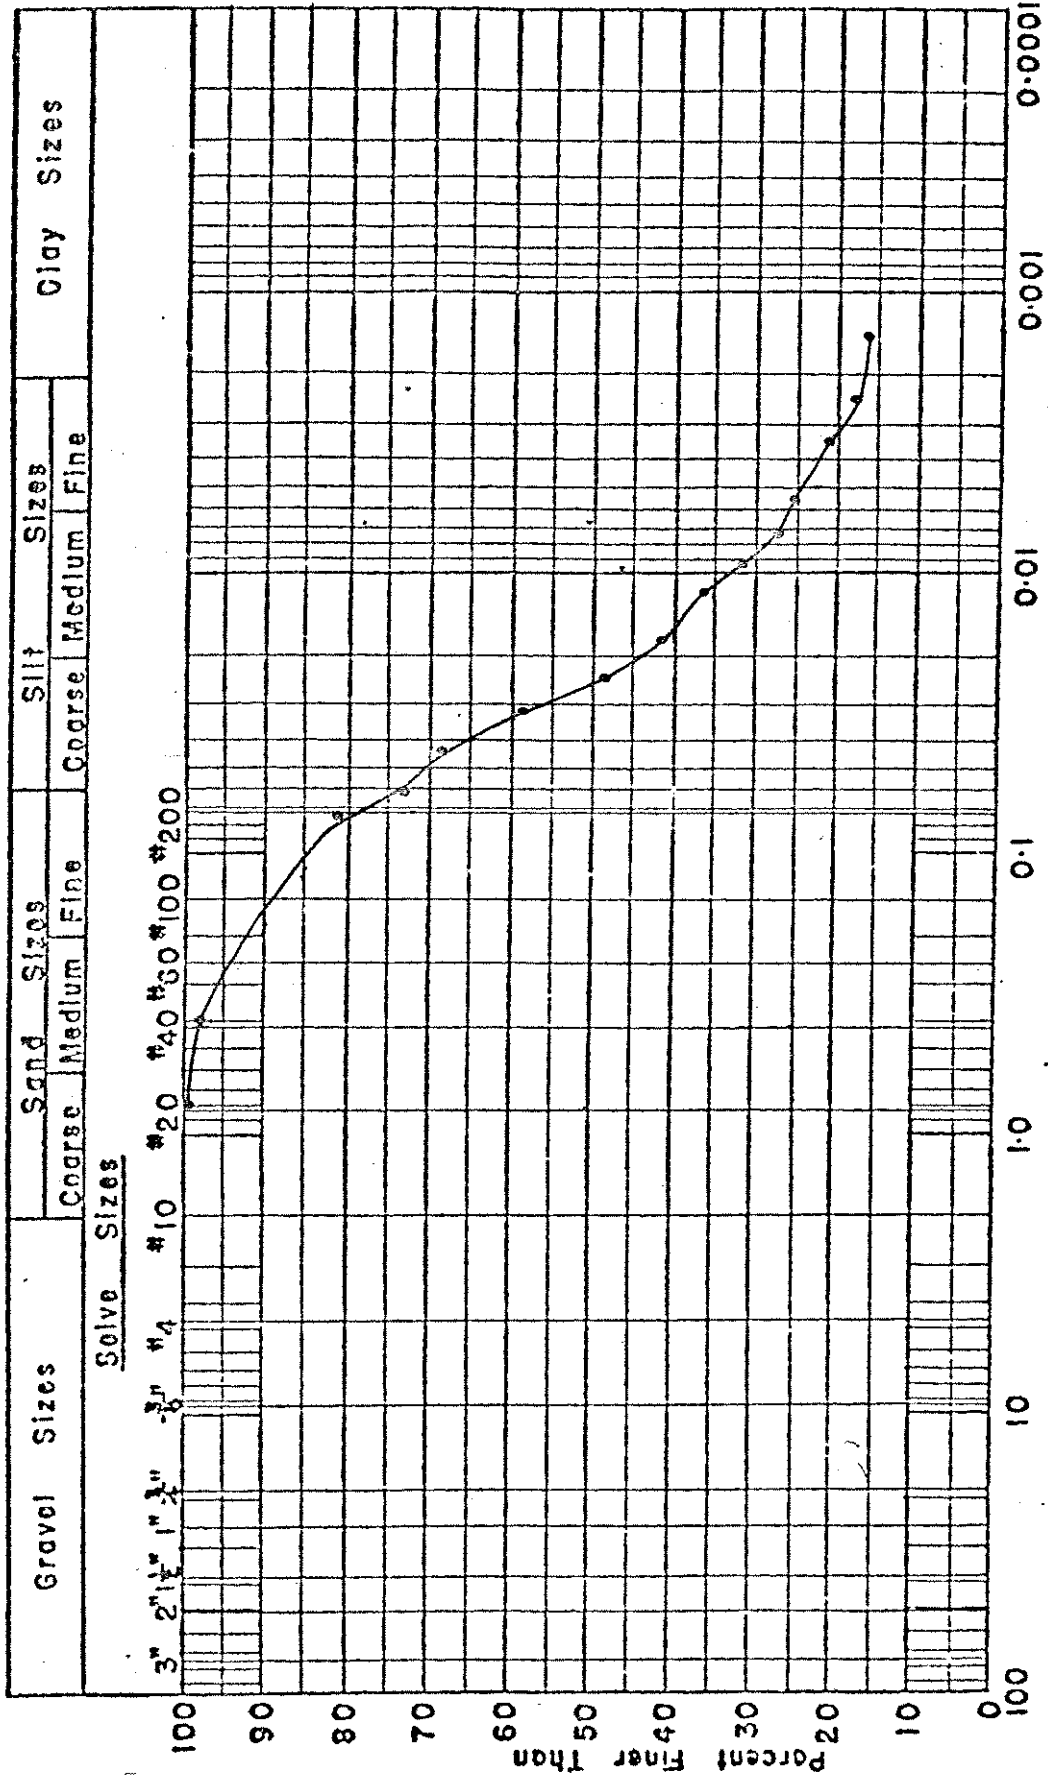
Figure 3.6 : GRAIN SIZE CURVE FOR EMBANKMENT
 (Case History A)

suggested by Sherard et al (1963) are superimposed on the grading curve (Figure 3.6).

No backing system, such as underdrains, filters, were used to control seepage in the embankment in the case of liner leakage. Where the embankment is susceptible to cracking and piping provision of such a control would be prudent.

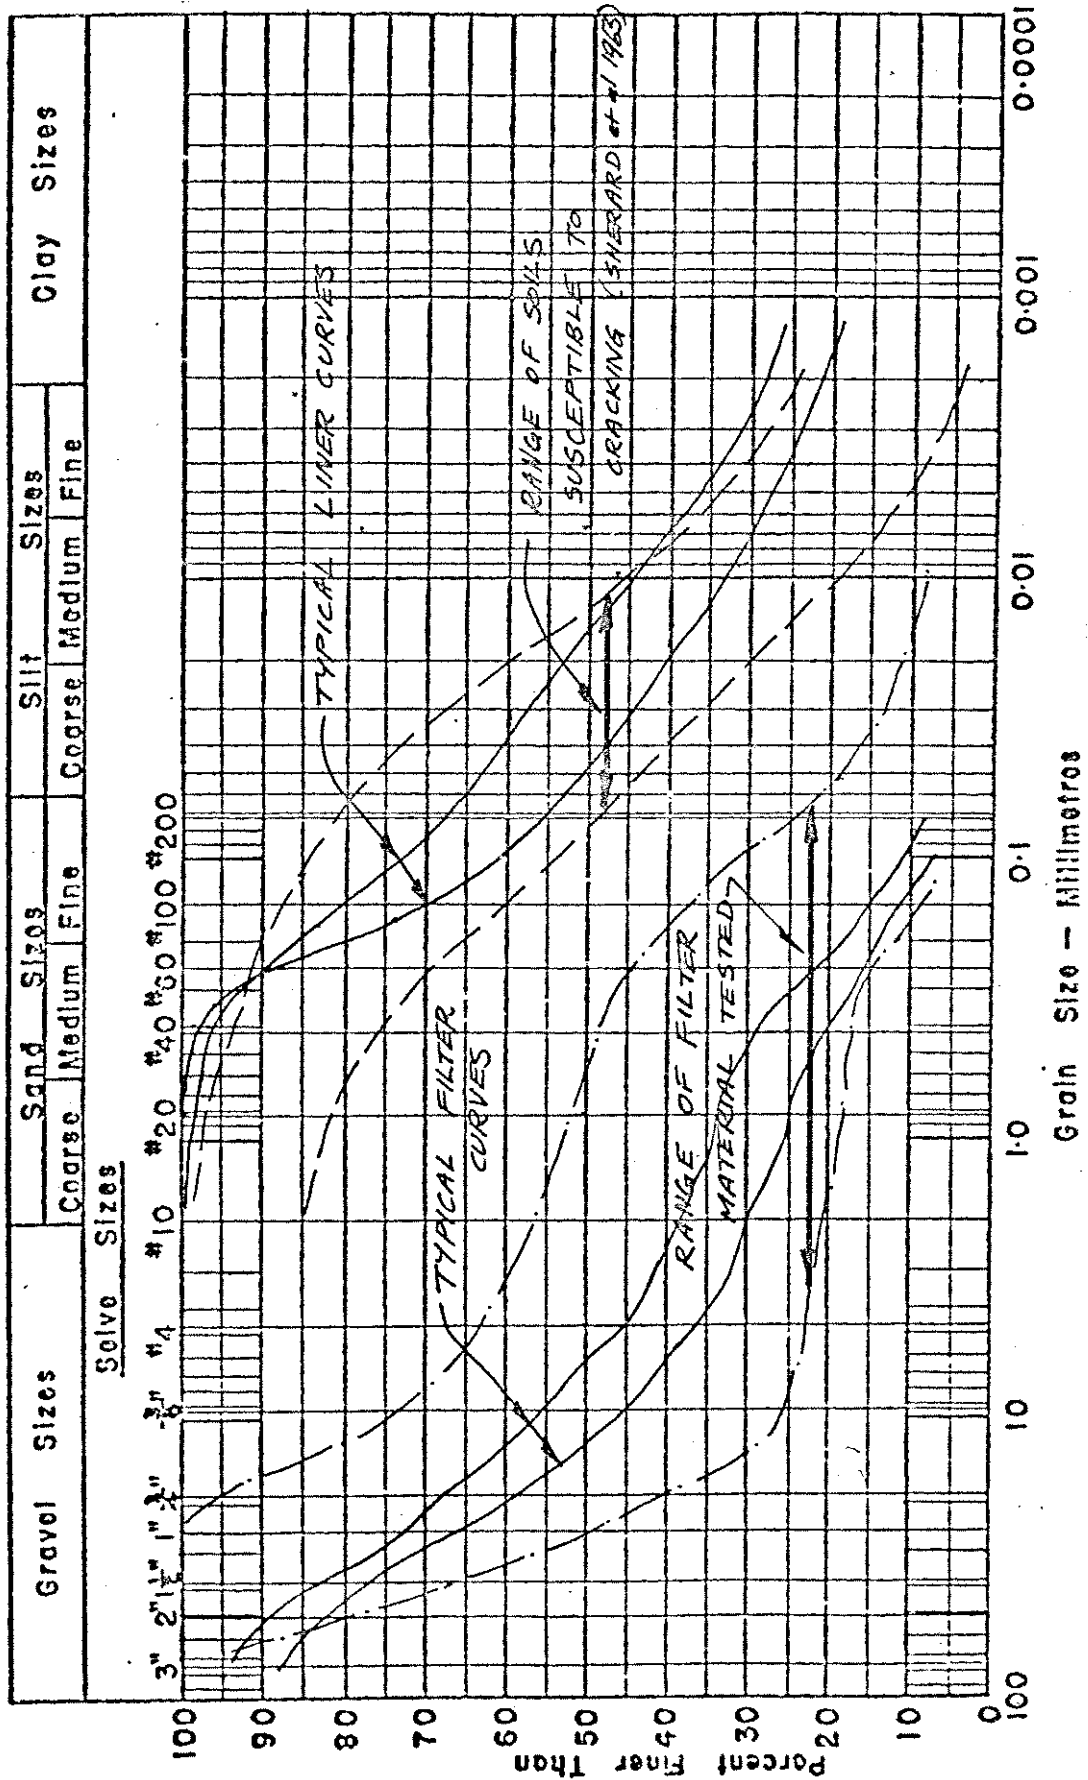
Figure 3.12 : GRAIN SIZE CURVES FOR LINER AND FILTER MATERIALS
(Case History B)

The liner is underlain by a gravel blanket. Some grading curves for this layer are shown on Figure 3.12. The material generally satisfies the filter requirement for the silty clay liner. However in some cases it is poorly graded with few sand sizes. This material may still act as a filter but testing would be required to confirm this. The lack of sand sizes is particularly important when considering the sealing of filters under dispersive clays.

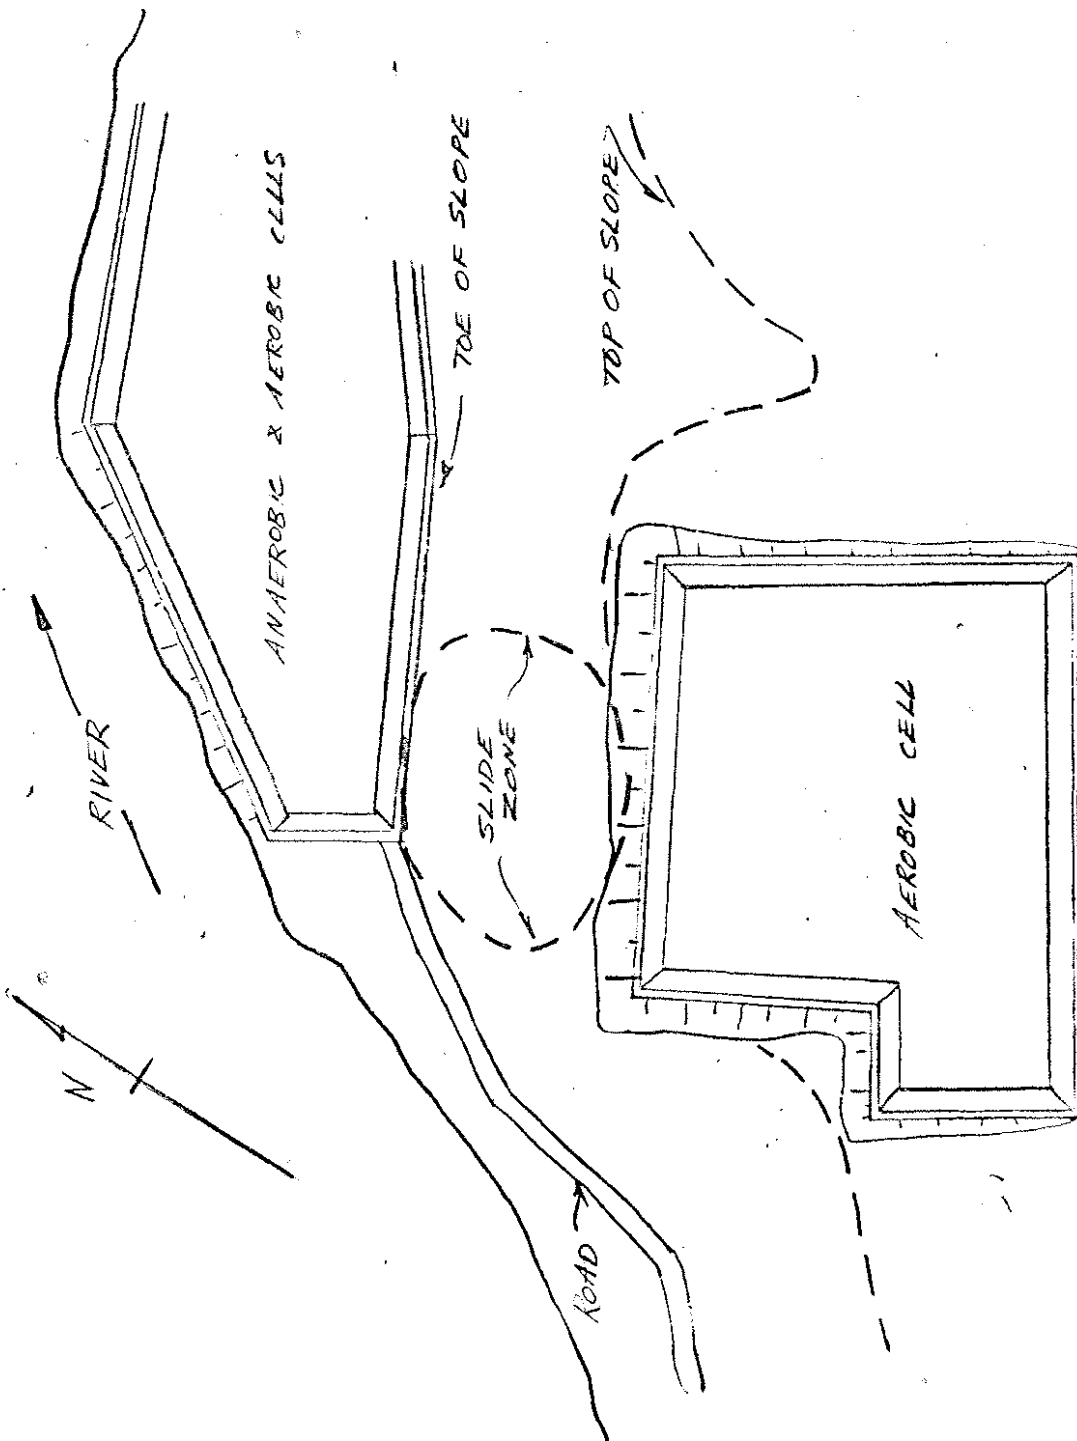
Figure 3.16: General layout
(Case History C)

About five years after construction a 120 m long crack developed in the crest of the north dyke, and the ground dropped up to 3.7 m. The extent of the slide is shown in Figure 3.16.

To have prevented the slope failure, seepage from the cell should not have been allowed to reach the slope. An impermeable liner, with an effective permeability of less than 10^{-8} cm/s, such as a plastic membrane could have been used, or seepage could have been prevented from reaching the slope by a deep continuous drain in front of the cell embankment, or the use of a cutoff between the top of the slope and the reservoir.

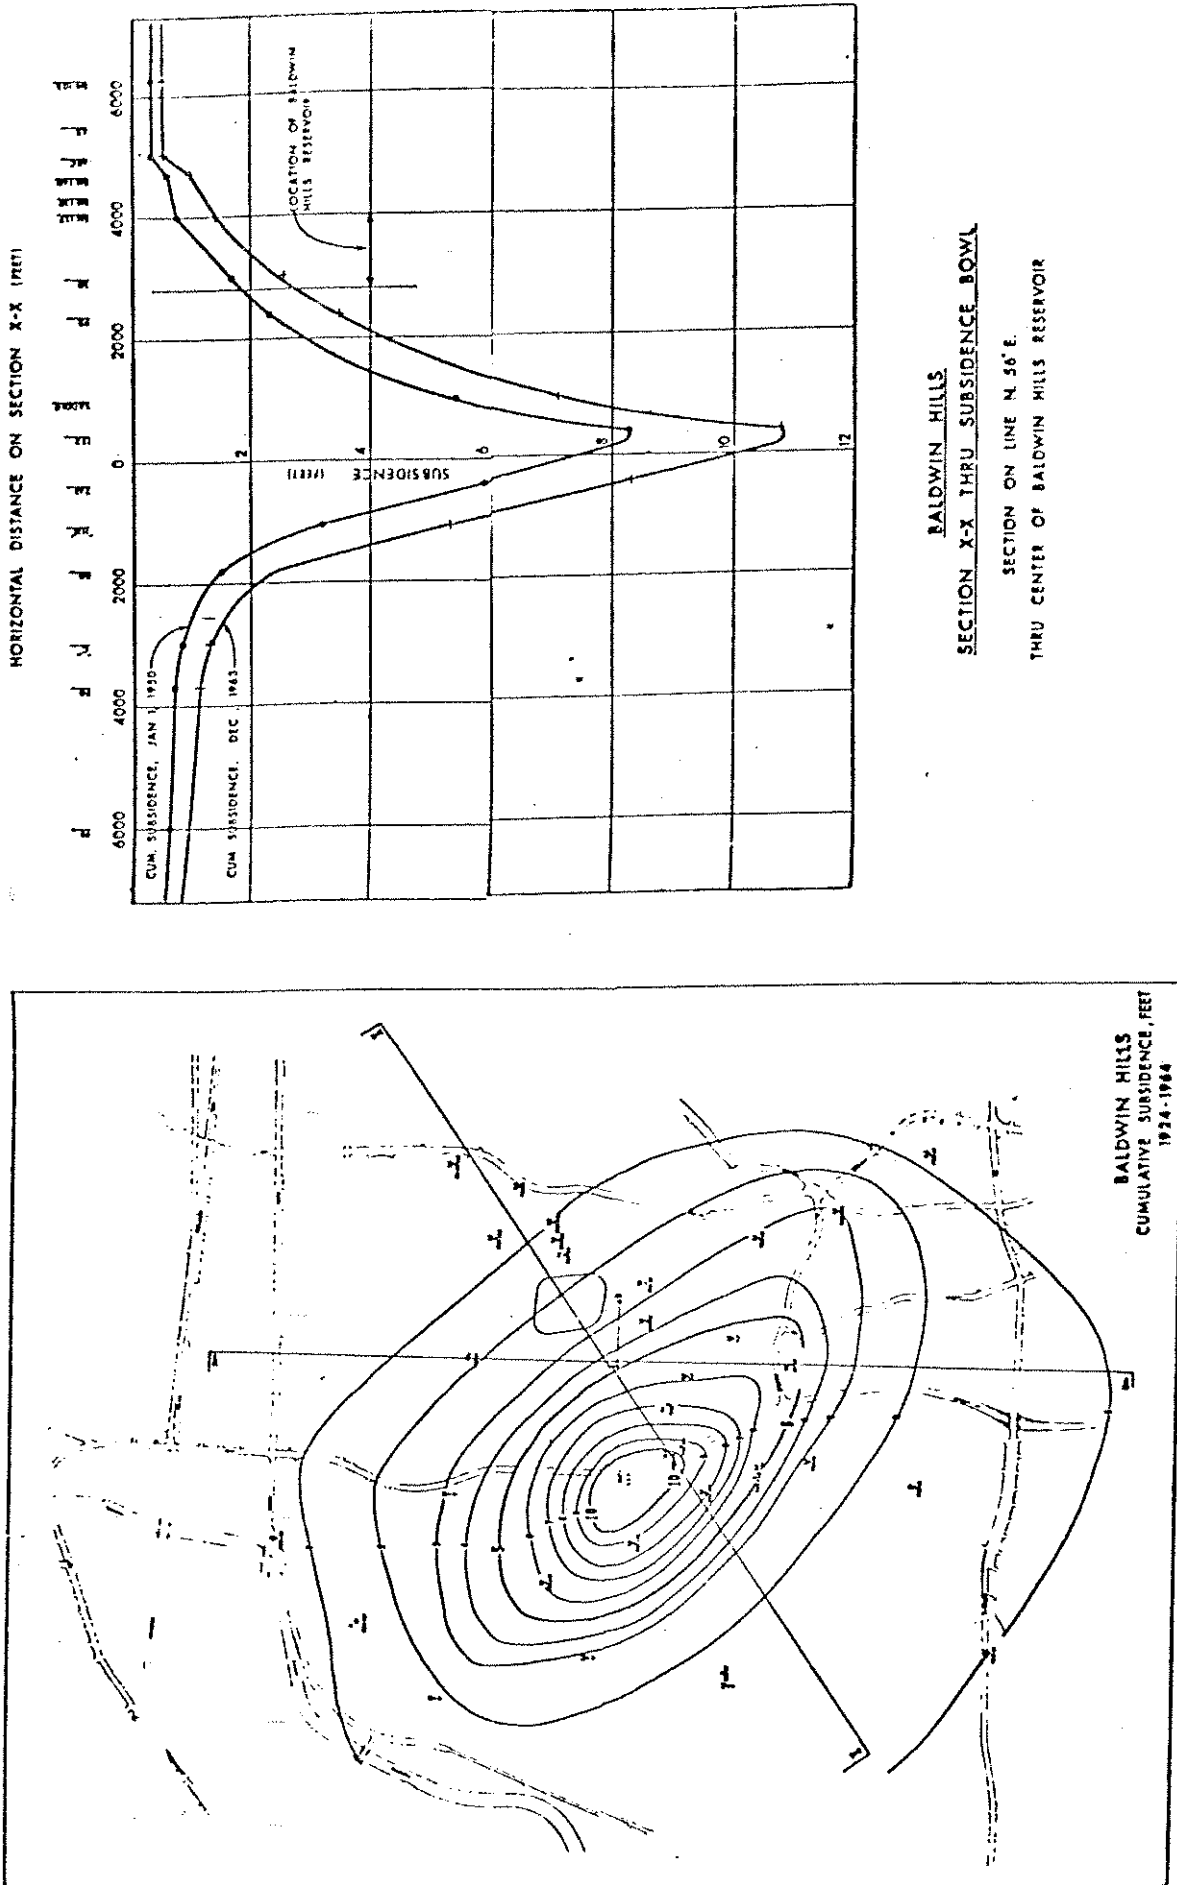
Figure 3.20 : SUBSIDENCE BOWL, BALDWIN HILLS
(Case History D)

The anticlinal feature shown in Figure 3.19 has been the site of oil accumulation and was developed as an oil field from 1924. Associated with the extraction of oil was the development of a bowl of subsidence in the region. This bowl is shown in Figure 3.20. The location of the reservoir is shown on this Figure. The vertical differential movement over the lifetime of the reservoir was as much as 6½".
