Cracking in Hot-dip Galvanized Welded Joints of Steel Platform
Structures

Abstract

In a recent construction project, a platform structure made up of 350W and 300W steel underwent a double dip galvanizing process. Prior to the galvanizing process, the platform was fabricated to completion, which included numerous welds throughout the design. After galvanizing, cracks were found originating in the welds and propagating into the base material. To the steel designer, this posed a new and curious problem. Previously, similar structures had undergone the same processing with no cracking.

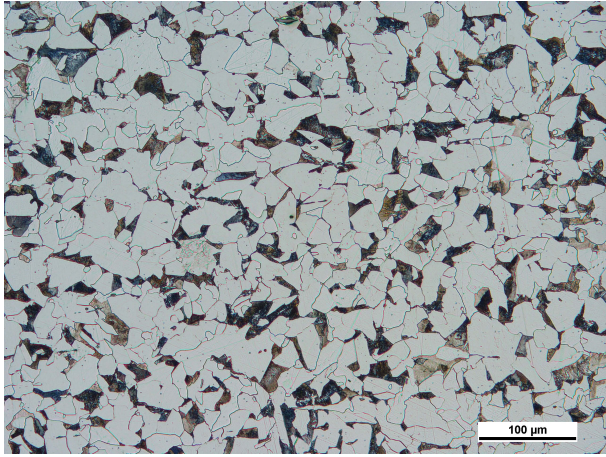
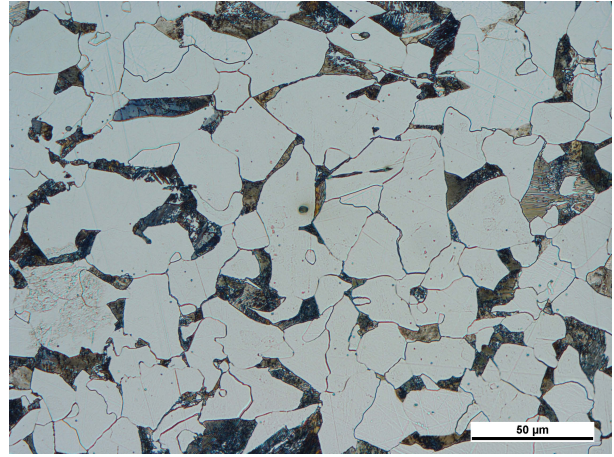
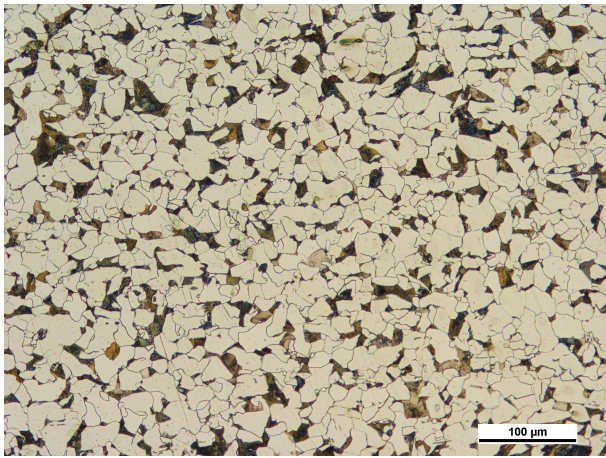
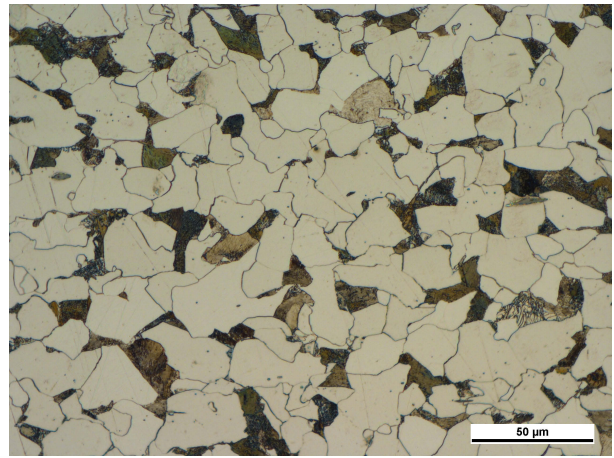
Fig. 2.2: Base material of the T-joint

Images showing the microstructure of the samples taken from a T-joint are given in Fig. 2.2. These images show the samples etched with a 5% nital mixture to give a well defined image of the grain structure, size, and any inclusions. The lighter grains are ferrite, since the nital etch would not corrode the ferrite quickly. The darker grains are a carbide formation, but there are also inclusions present. It is also interesting to note that in the 50X magnification images, some grain boundaries appear thicker than usual or than expected. This implies the presence of carbides and inclusions in the grain boundaries.

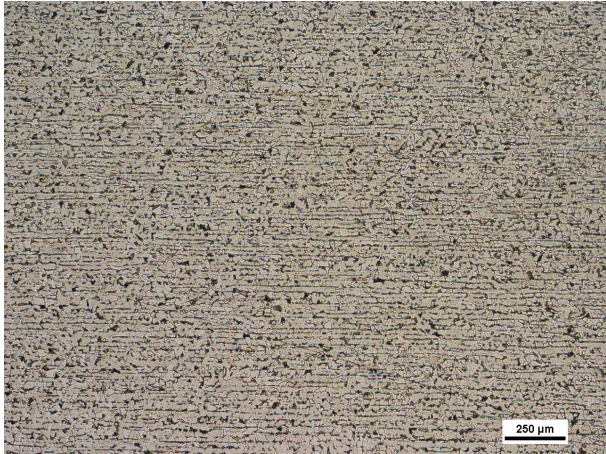
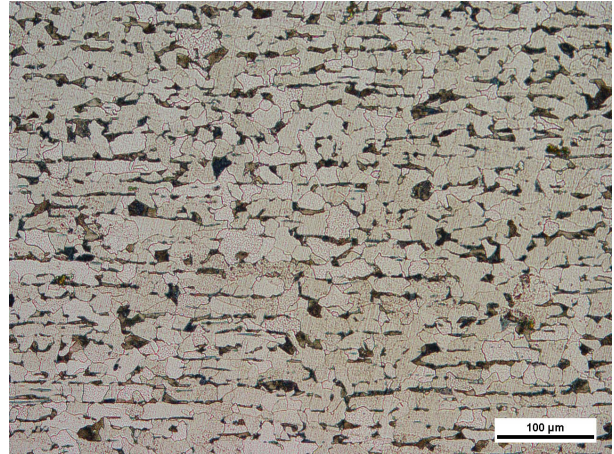
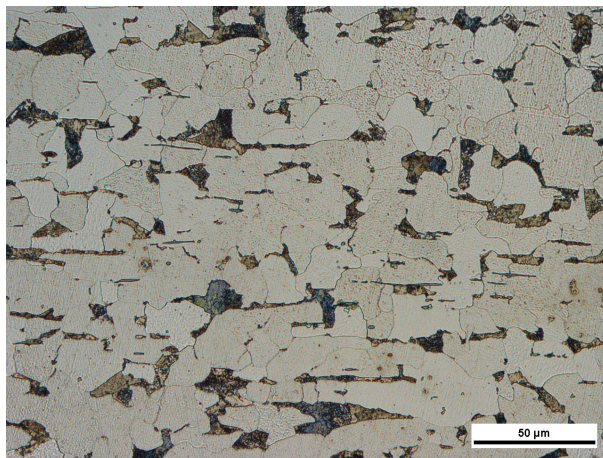
Fig. 2.3: Base material of the corner joint

The corner joint samples show similar features and the same carbide formation. Images showing the base material at different magnifications are displayed in Fig. 2.3. Similar thick grain boundaries or small carbide formations are seen in image Fig. 2.3(c). Further optical microscope images of the base material's microstructure and varying magnifications can be found in Appendix A.

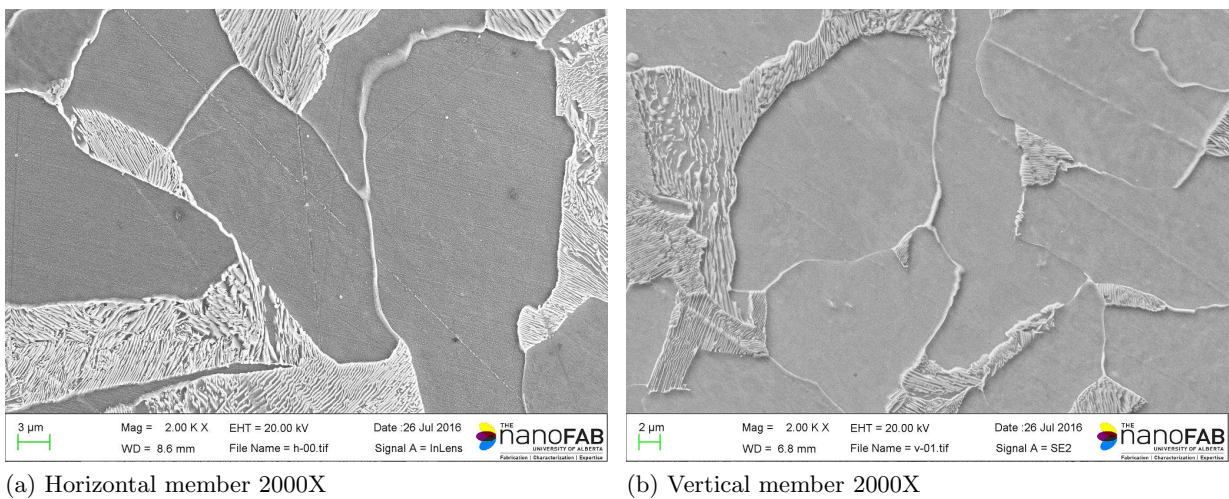
Fig. 2.5: SEM images of the T joint base material

The thicker grain boundaries are an interesting observation and could be a critical clue in the investigation of the cracked platforms. Once again in Fig. 2.5, thicker grain boundaries are seen. Grain boundary segregation is an important factor for temper embrittlement; however, key elements must be present. To analyze the make up of the thicker grain boundaries, EDS line scans were used. EDS line scans do not give an exact composition of the grain boundary (which may be considered inaccurate for smaller elements anyway), but it will give a relative reading, in case the concentration of certain elements is higher at the grain boundary. This will give an idea of what elements the grain boundaries are composed of. Two different sites and their EDS scans are shown in Fig. 2.7 and Fig. 2.8.

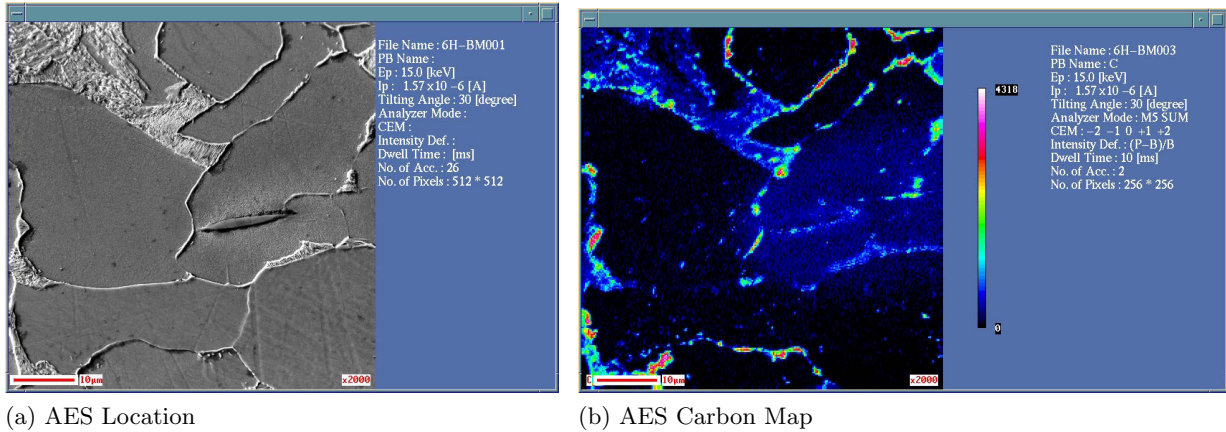
Fig. 2.6: AES carbon mapping

in ferrite can be compared, using values for the activation energy and maximal diffusion found in literature [51, 52]. Table 5.2 shows the diffusivity of each element at 450 °C. It is important to note that carbon has the highest diffusivity, which explains the large amount of carbon segregation found in Fig. 2.6. However, following carbon is phosphorus and sulfur. Given the heating, cooling and stress cycle that occurred in the steel structure, it is likely that phosphorus would have diffused in a similar way to carbon.

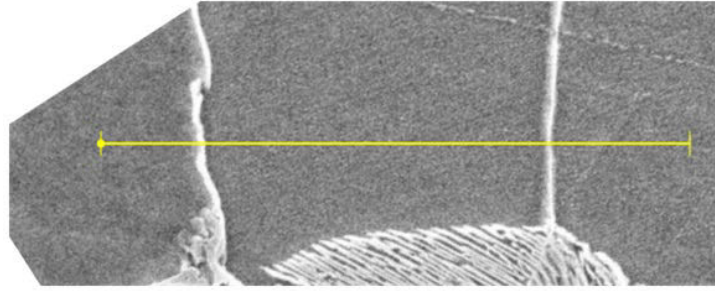
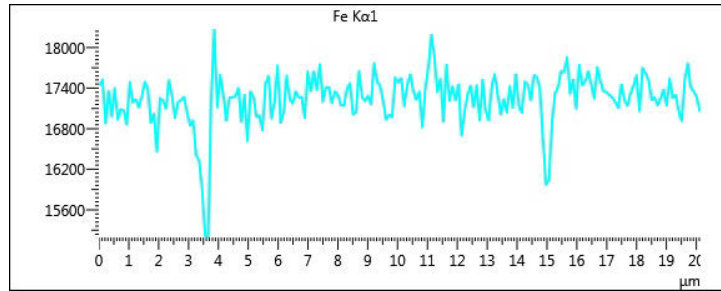
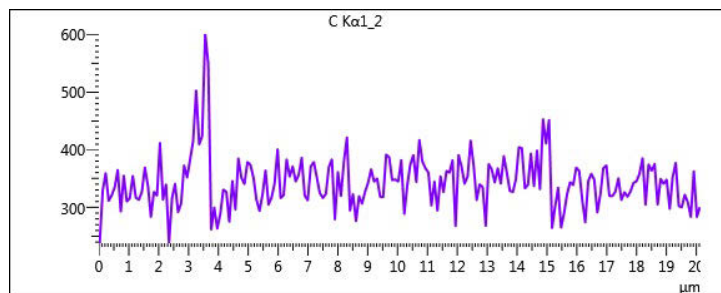
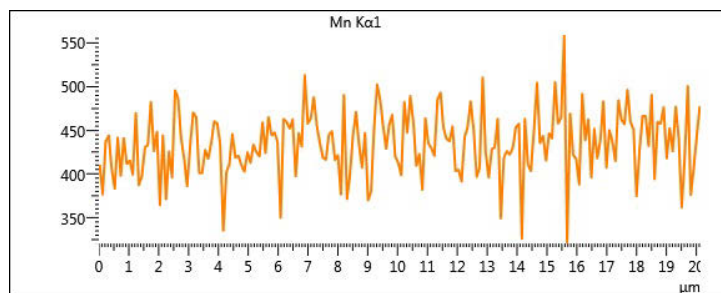
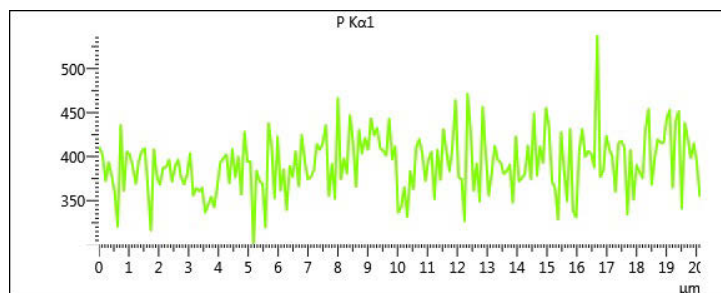
Fig. 2.7: EDS line scans of site A

When looking at the results of site A in Fig. 2.7, there is a clear dip in the iron content at both grain boundaries. This is expected as the ferrite grains would have much higher iron content than the grain boundaries, but also shows it is not cementite that has formed. Carbon however has a large spike on the first grain boundary and a relatively smaller spike on the second. In contrast, both manganese and phosphorus only spike on the second grain boundary. These results would indicate that some type of carbide has formed on the first grain boundary and the second grain boundary is made up of segregated impurities. The rise of phosphorus content in the second grain boundary is a significant finding, however, since it is directly related to temper embrittlement. Manganese is also reported to be a culprit element in temper embrittlement susceptibility; however, it is well documented that phosphorus is the main element of concern when dealing with temper embrittlement [10, 19–24]. To study this further, a separate site on a separate sample was used. Site B shows not only a line scan across a grain boundary, but also across an inclusion. It can be seen from the results that going across the inclusion spikes aluminum, manganese, and sulfur towards the edge. However, the grain boundary once again appears to spike the phosphorus content. The manganese content may also be higher in the grain boundary, but due to the large amount of manganese in the inclusion, the spike may not be detectable from the scan. Overall, the phosphorus content spiking at the grain boundary is a key finding and is cause for further investigation and testing into temper embrittlement.

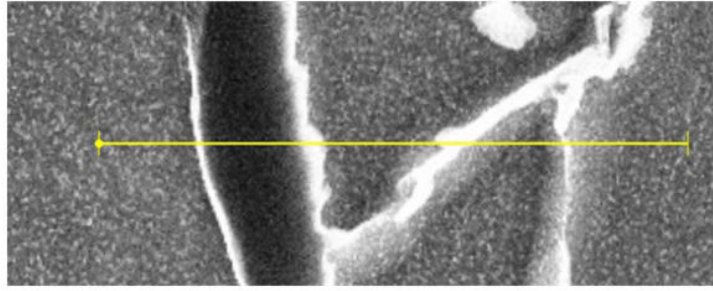
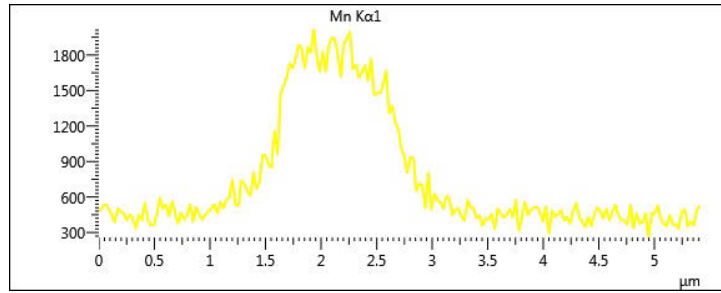
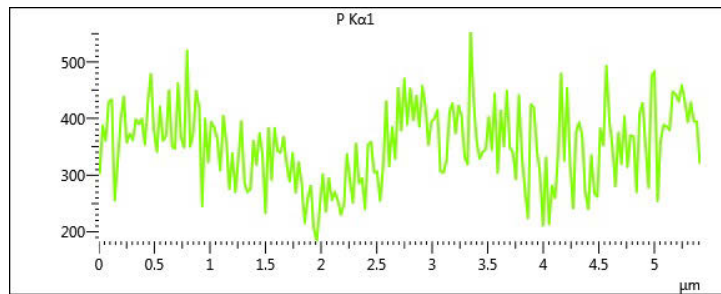
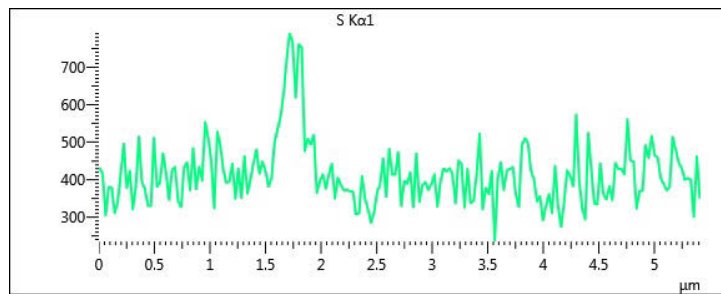
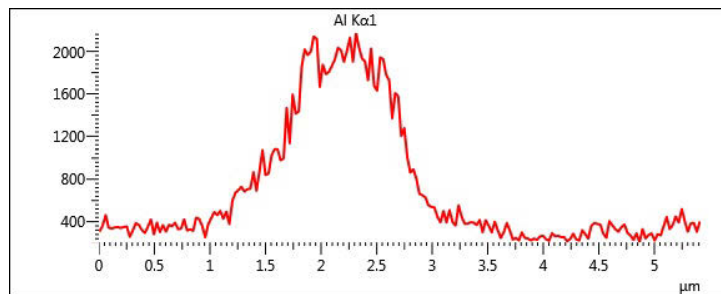
Fig. 2.8: EDS line scans of site B

The inclusions are mainly composed of manganese, silicon and oxygen. This is typical of 350W steel and is not a cause for concern. Other inclusions may be found within the steel composed of manganese and sulfur (as perhaps in Fig. 2.8) which is also typical of structural steel since the manganese will bond and consume the excess sulfur.

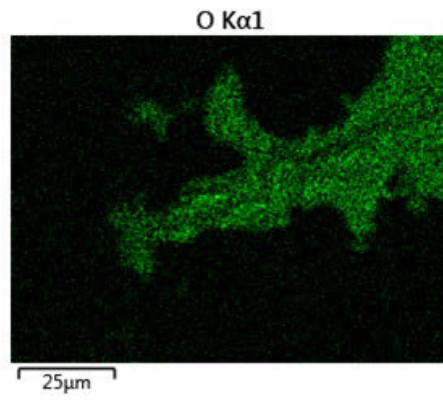
(c) O EDS map

The results shown in Fig. 2.12 do not show anything irregular or noteworthy. There is no increase of zinc content in the crack, which suggests LME may not be the embrittlement case [8, 25]. Also, there seems to be a build up of oxidation in the crack, which is the inclusion that was seen from the optical microscope images. This may be due to the water used while grinding the sample or from exposure to the air, but in either case it is not unexpected.

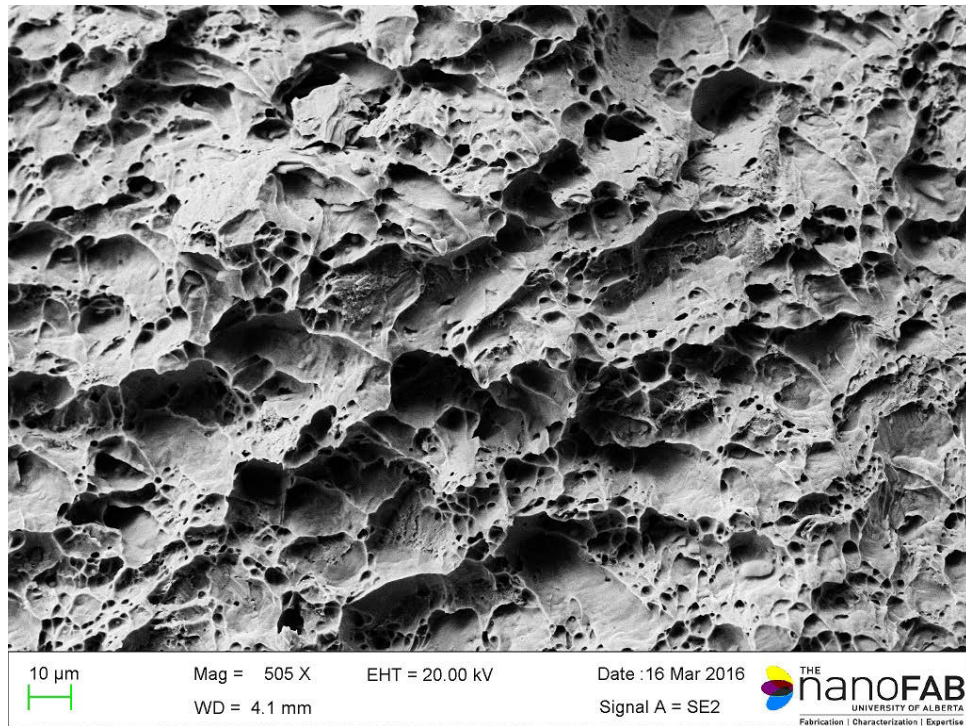
Fig. 2.15: Fresh fracture surface

In comparison, a fresh crack was made by fracturing the same base material at ambient temperature. An SEM image of 500X magnification is shown in Fig. 2.15. In comparison to the features seen in Fig. 2.14(b), the dimple features are much smaller. The largest dimples are about $10\mu\text{m}$ with many smaller dimples across the surface.

Looking at the images of the provided samples, it can be seen there is little to no deformation of the steel on the fracture surface. It does not show any characteristics of ductile fracture, such as cup and cone features or plastic deformation. Furthermore, when examining the fracture surface under the SEM there is no evidence of deformation of the grains, the dimples seen are the same size as the grains ($20\mu\text{m}$), and the surface shows smooth areas between the grain boundaries. Even more explicitly in Fig. 2.15, microvoids can be seen across the surface. Given the distinction in these features, the difference in fracture mode can be seen directly when comparing Fig. 2.13 and Fig. 2.15. Given that 350W is expected to have very ductile behavior, the brittle fracture mode in the provided samples is critical to determining why the steel platforms cracked and supports the notion of an embrittlement factor present.

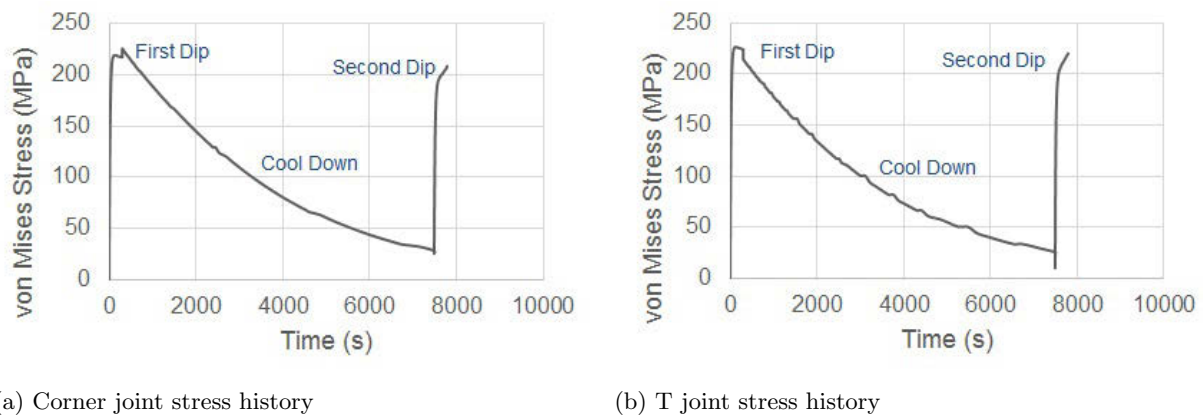
Fig. 3.9: Stress at the crack locations during galvanizing by the FEA model

The plots show the expected stress profile from a double dip galvanizing process. The corner joint node reaches a peak stress of 226 MPa while the T-joint node reached a peak stress of 225 MPa. These stresses are significantly large and could obviously be the driving force for crack propagation. However, the stresses are not within the possibility of exceeding the yield strength of the material. This supports the notion that an embrittlement mechanism must have been present to cause the cracking in the steel platform structures. Another point worthy to note

is the stresses of hoisting the platform proved minuscule in comparison to the thermal stresses. The stress of hoisting reached approximately 10 MPa in the corner joint, which accounts for 4.5% of the 226 MPa peak stress value shown in Fig. 3.9. To further investigate the role of the thermal stresses, a contour plot of the stress distribution was applied to the model with a deformation scale factor of one. At the instant of peak stress, the stress distribution across the model is captured. The entire model with the contour plot is seen in Fig. 3.10.

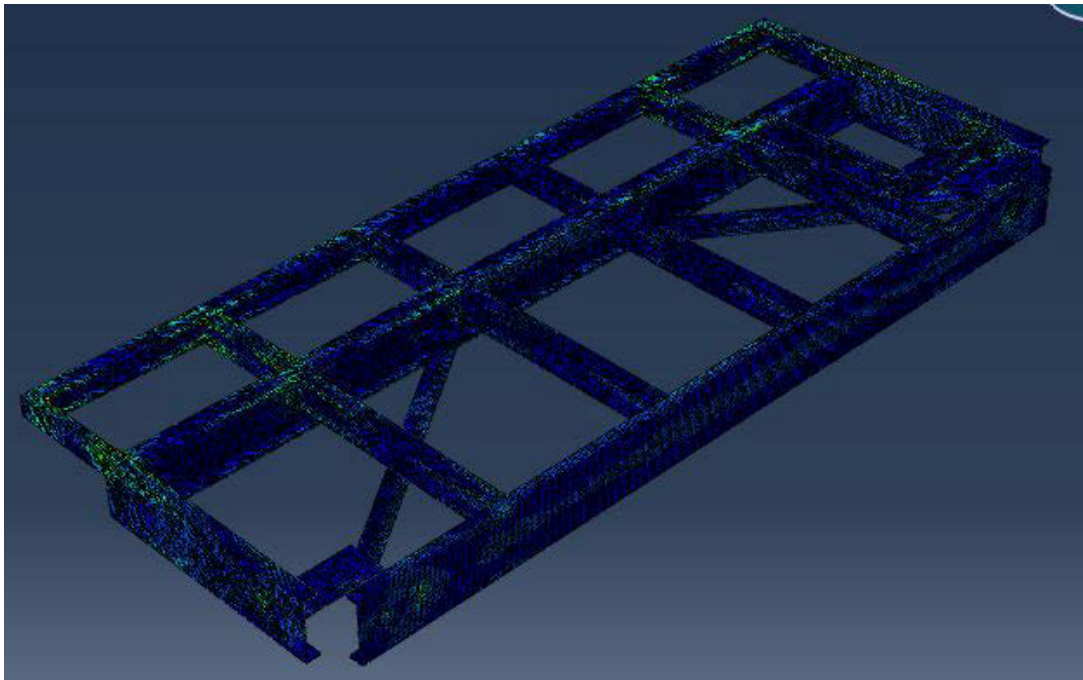
Fig. 3.10: Contour stress plot of the entire model

The image shows the stress is mainly concentrated in the beams that are submerged in the galvanizing bath and their connections. Fig. 3.10 gives an idea of the stress distribution across the entire model, but for the area of interest a more magnified view is needed to get the exact stress distribution at the joints, and to determine if it matches the cracking that was found. The detailed contour images during peak stress along with an image of the actual crack locations is given in Fig. 3.11 and Fig. 3.12.

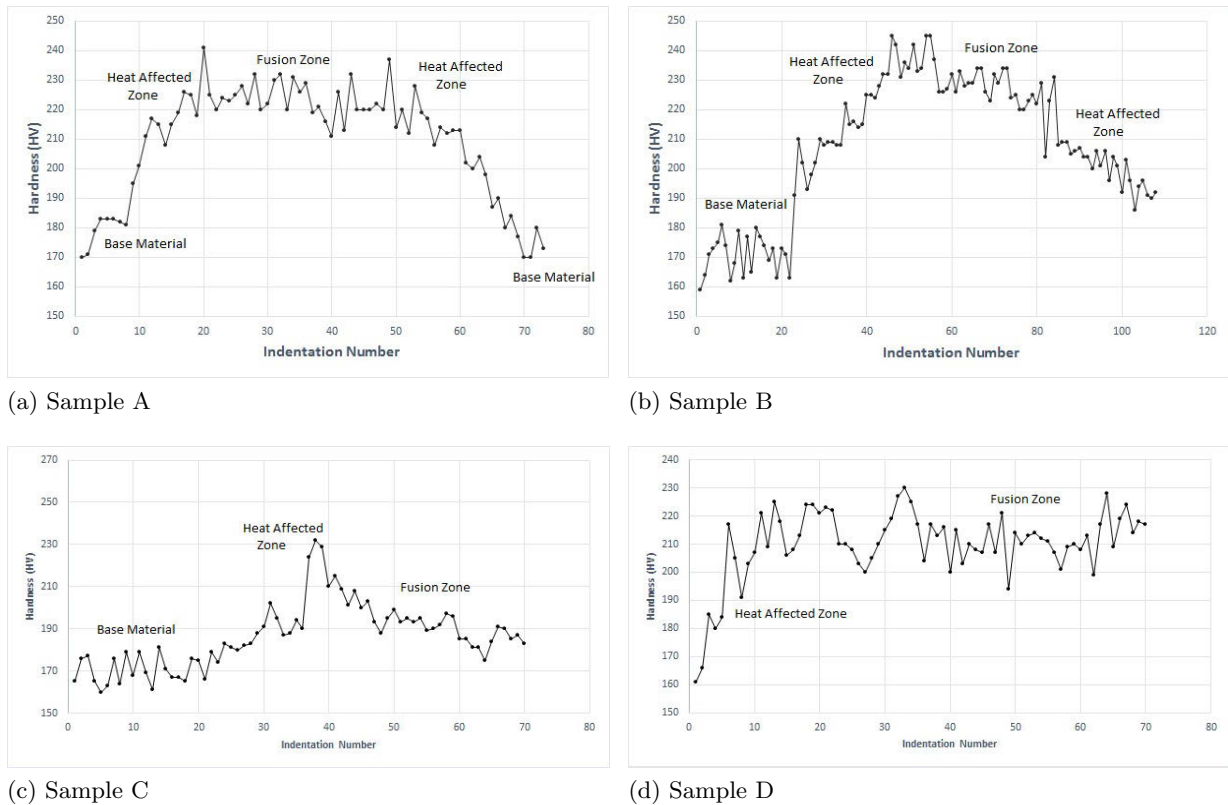
Fig. 4.2: Hardness measurements across weld cross sections

The hardness testing results all show an increase in hardness from the base material to the weld area. The most classic shape of hardness testing across a weld is seen in Fig. 4.2(a) with a rise and fall of the hardness values. Fig. 4.2(b) shows this shape somewhat as well, but the hardness does not drop off as steeply, possibly due to a larger heat affected zone. It is important to note that in neither case is the hardness of the heat affected zone larger than the hardness of the fusion zone. Fig. 4.2(c) and (d) however show a much more unusual shape. Fig. 4.2(c) shows a very gradual increase from the nominal base material value of 170 HV, so much so that it is almost not noticeable. However, there is a very noticeable spike in hardness at the center of the sample. But overall the weld hardness from this sample did not show the same increase in magnitude as the others. Finally, the sample in Fig. 4.2(d) shows similar values to the samples

in Fig. 4.2(a) and (b) and also the same large increase as the indentations move into the weld zone on the left side of the plot. The hardness does not drop on the right but this is likely due to hardness mapping not reaching outside the weld zone.

The most significant data from the hardness testing is the peak value. In Fig. 4.2(a), (b), (c), and (d) the maximum hardness readings are 241 HV, 245 HV, 232 HV, and 230 HV respectively. It is also important to note that the hardness of the base material consistently reads 170 - 180 HV. These values are expected for 350W and 300W steel along with their welds. Ultimately these results show that there is nothing irregular with the hardness levels of the material, which is supported by the typical pearlitic carbide structure seen in Chapter 2.

As previously noted, both LME and hydrogen embrittlement depend heavily on a susceptible microstructure which is measured by hardness testing. But even the peak hardness values in any region are very short of the minimum hardness values reported for susceptibility to LME and hydrogen cracking. Given these hardness results and the lack of zinc found in the mid-crack and near the crack arrest, LME is not a reasonable explanation for cracking. This also eliminates one of the three contributing factors for hydrogen embrittlement. This makes the notion of hydrogen cracking unlikely. It would be very unusual and perhaps even extraordinary to discover hydrogen cracking in a case with such low hardness. But the considerable stresses induced by the double dip galvanizing process must still be considered, along with the hydrogen that is charged into the material during pickling. Further investigation into hydrogen embrittlement is warranted.

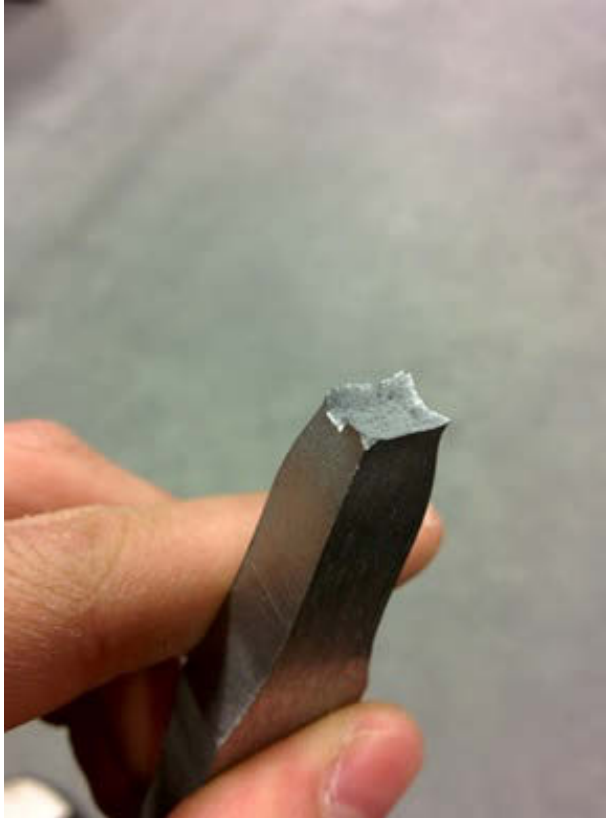
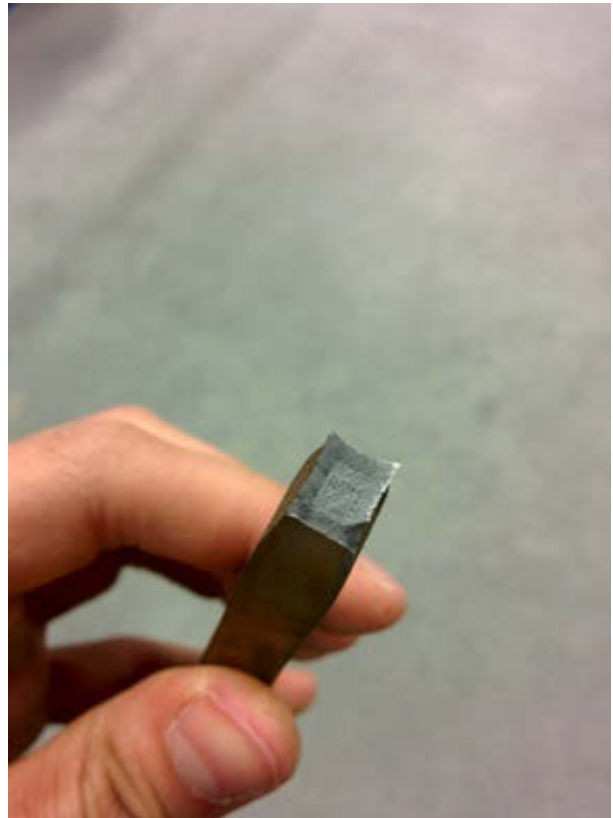
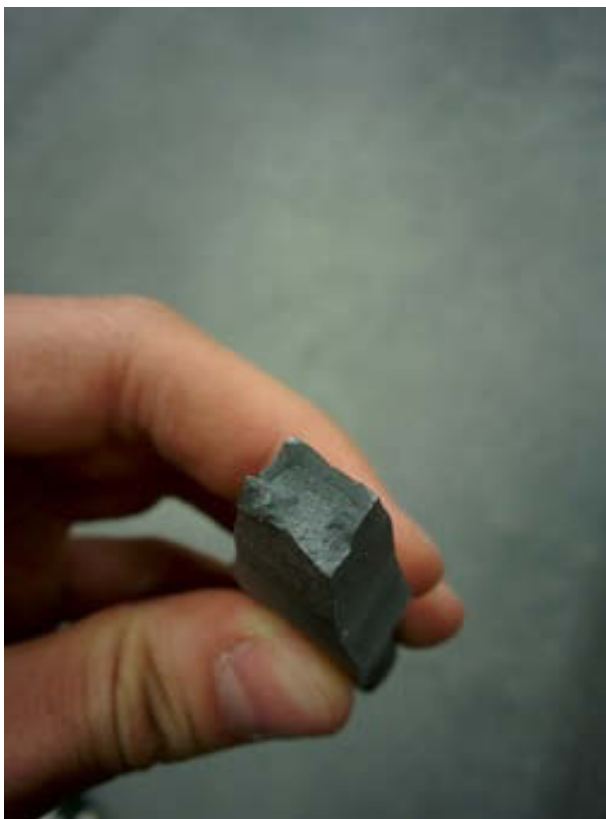
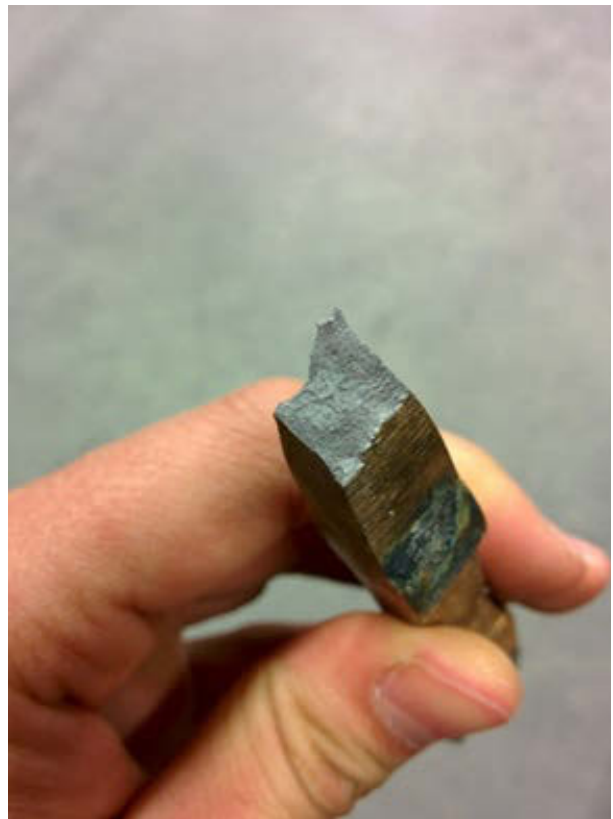
Fig. 4.3: Fracture surfaces of hydrogen-charged samples

Despite the results of the hardness testing, the experimental study on hydrogen embrittlement was still carried out through tension testing. The fracture surfaces of the tension tests with hydrogen-charged samples is shown in Fig. 4.3. Fig. 4.3(a) and (b) shows the fracture surface of the base material sample not pickled and pickled. Similarly, Fig. 4.3(b) and (c) show the sample across the weld pickled and not pickled. It should also be noted that in Fig. 4.3(c) and (d) the fracture did not occur in the weld, but in the base material.

The main purpose of this experiment is to compare the fracture surface of the samples that were pickled against the samples that were not. However, a visual inspection of all four samples fracture surfaces shows no significant difference. Similar features are found on each surface and more significantly they all share ductile features. Evidence of ductile fracture is shown by the cup and cone features and plastic deformation. The pickling process and introduction of hydrogen into the steel had no impact on the mechanical properties. Overall it can be said there is no difference in fracture mode among the different samples.

The fracture surfaces of the tension testing all showed signs of ductile fracture and no resemblance to the fracture surfaces of the cracked samples. Charging the samples with hydrogen and fracturing them failed to recreate the fracture surface from the galvanizing cracking, and moreover the fracture surfaces of the pickling samples matched the ductile surfaces of the unpickled

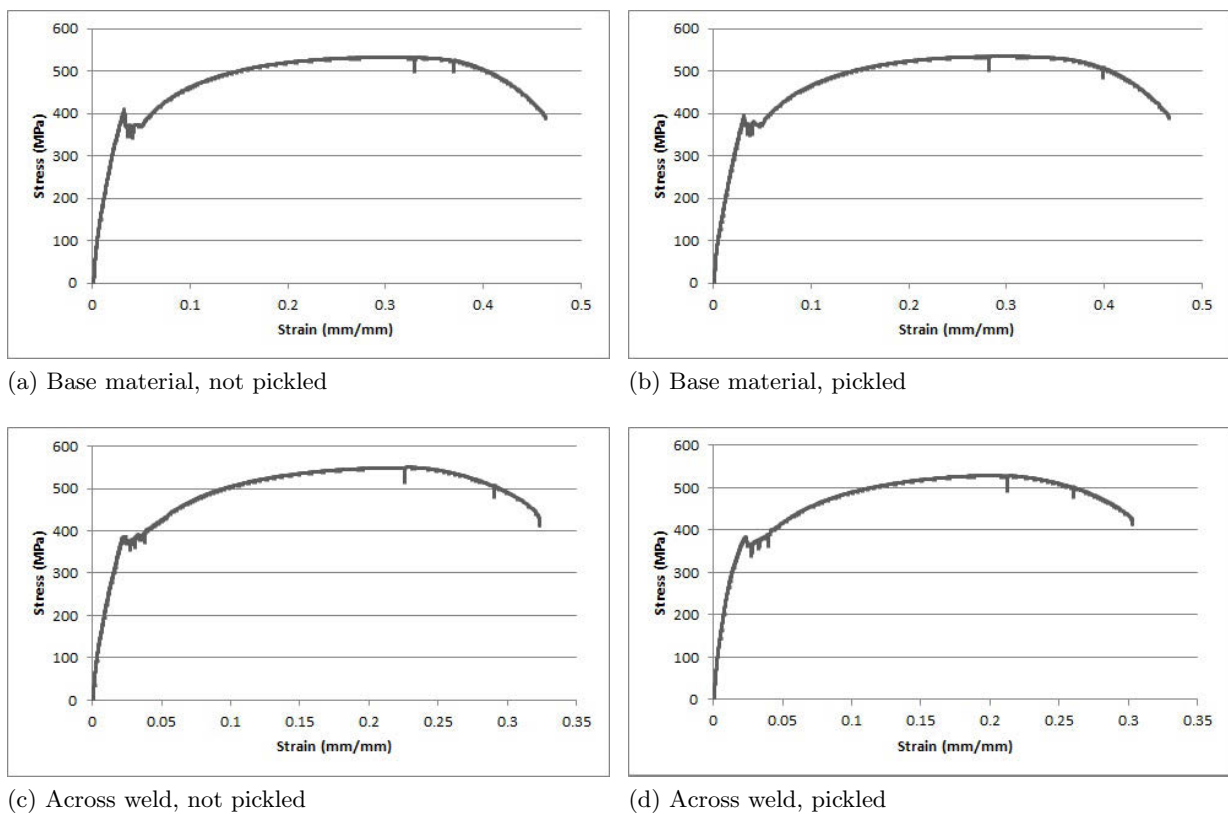
Fig. 4.4: Tension test results of hydrogen-charged samples

To support the discussion of the visual inspection of the fracture surface, the data from the tension tests were also analyzed. The numerical stress–strain data from the tension testing is graphically shown in Fig. 4.4 for each different type of sample, which includes the pickled base material and weld samples, and the unpickled base material and weld samples. The images show no change between the samples that were pickled and the samples that were not. The ductile behavior is the same with both types of samples showing a large plastic region and necking before the final fracture. The only difference between the samples is the welded samples did not have as large a plastic region as the base material samples, since they did not experience as

much strain before fracture. This is an interesting result since the welded samples both broke in the base material. In any case, all the graphs show the typical behavior of an elastic region and large plastic region, meaning deformation along with necking and ductile fracture. It appears the pickling process and introduction of hydrogen into the steel or welds has no effect on the material's fracture toughness or tensile behavior.

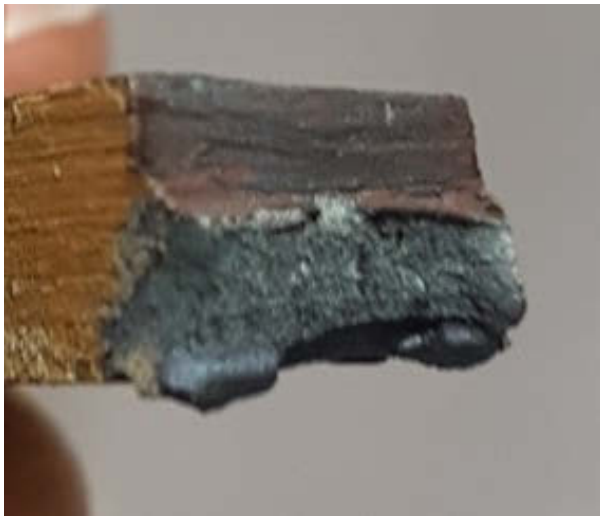
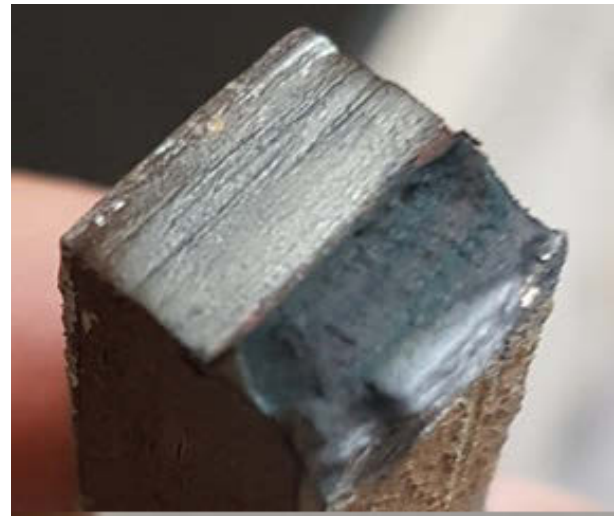
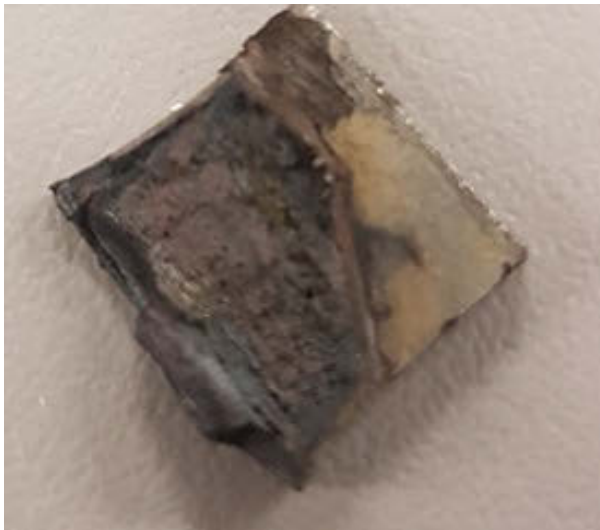
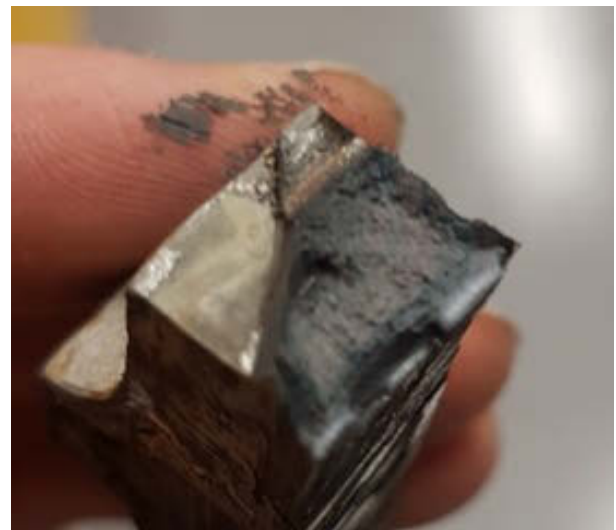
Fig. 5.2: Fracture surfaces of temper embrittlement test

The fracture surfaces of four different samples from the temper embrittlement test are shown in Fig. 5.2. Samples were taken from two different beams and are composed of purely base material. All of the samples broke in a similar fashion, with sudden fracture and typically with only one or two strikes with the hammer and chisel. There was minimal bending of the sample

during fracture and some of the surfaces turned blue upon fracture, which is thought to be the oxidation of the grain boundaries. Each fracture surface shows relatively flat features and does not show signs of multiple cracks. In contrast to the hydrogen embrittlement samples, there is no stretching of the material and no cup and cone like features. Overall it seems there are signs of ductile fracture, and rather the features of the surface point towards brittle fracture. The surfaces of these samples more closely resemble the original fracture surface samples. However, it is much more telling if the samples are observed microscopically and then compared to the original crack surfaces.

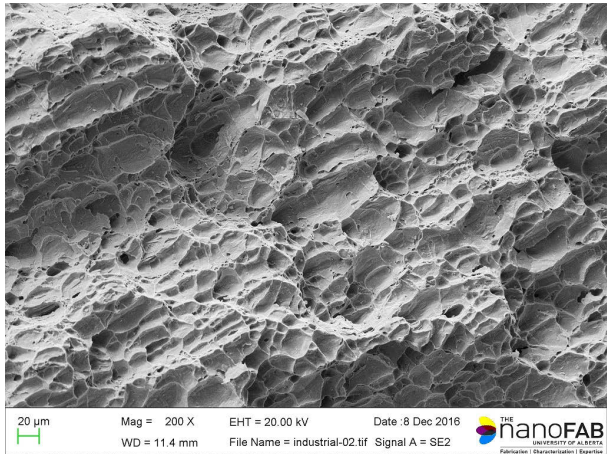
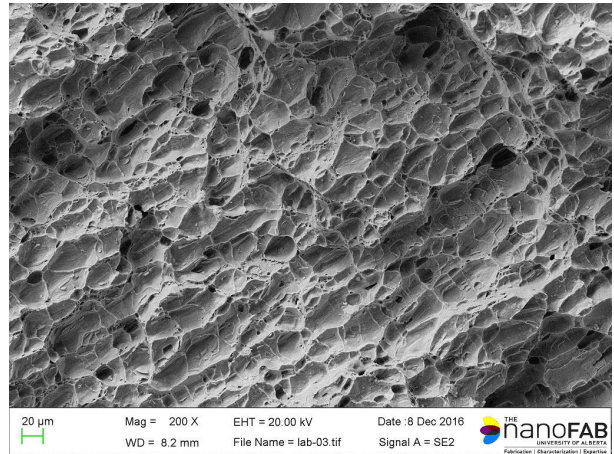
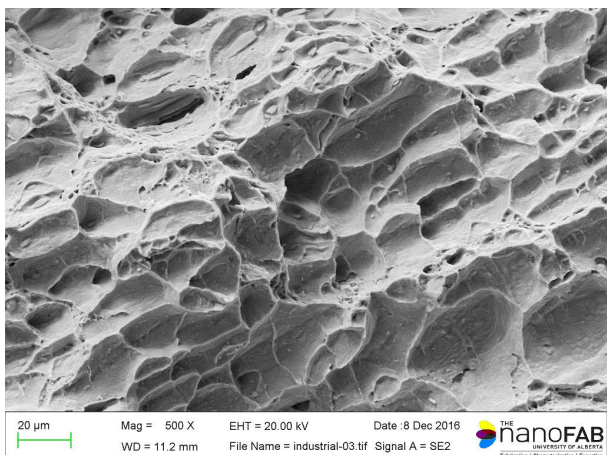
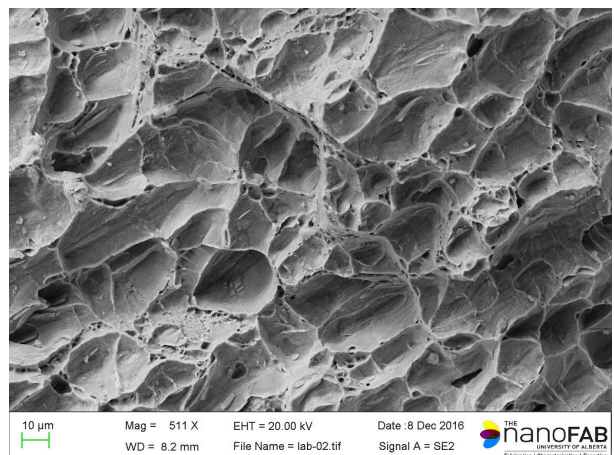
Fig. 5.3: Comparison of 200X & 500X SEM images of the received fracture surface and lab fracture surface

In Fig. 5.3(b) and (d) the images of the lab sample fracture surface are shown at 200X and 500X respectively. The lab surfaces show the same features, grain boundary separation and similar dimple sizes as the received fracture surfaces. Fig. 5.3(a) and (c) give a comparison to the provided sample's fracture surfaces from Fig. 2.14. The similarities between the two fractures is stunning. The only noticeable difference in the images is that in Fig. 5.3(d) there are a few microvoids present, which seem to all be along the grain edges.

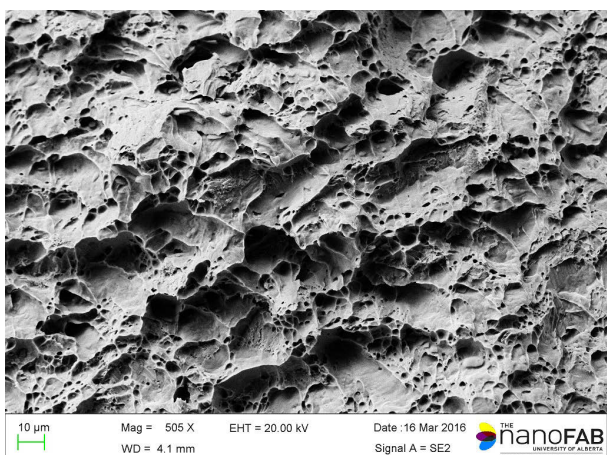
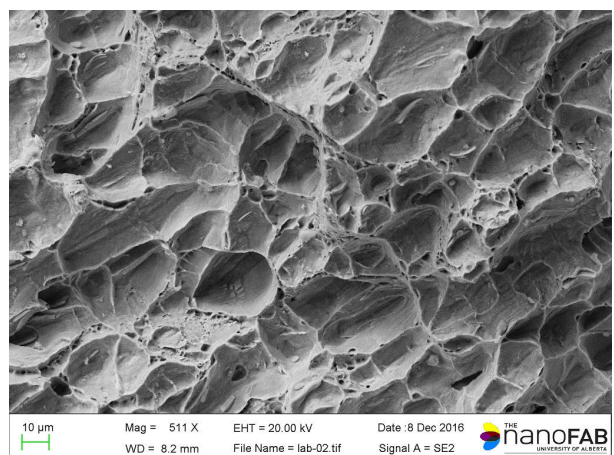
Fig. 5.4: Comparison of 500X SEM images of the ambient fracture surface and galvanizing temperature fracture surface

Similarly, in Fig. 5.4 a comparison is shown of the ambient lab fracture sample in Fig. 5.4(a) and the temper embrittlement testing fracture sample in Fig. 5.4(b). Both images are shown at 500X. The difference in the deformation of the surface is apparent as there are many microvoids and the grain boundaries are not recognizable in Fig. 5.4(a). The obvious differences in this comparison also reinforces the idea of how stark the similarities are between the surfaces in Fig. 5.3. For the same material to behave so differently under different temperature conditions is a key finding. The similarities and differences between the comparisons shows that the original fracture is recreated by elevated temperature fracture. The increase in the material's temperature clearly has an impact on its fracture toughness, thought to be caused by the diffusion of phosphorus and other impurities to the grain boundaries. Overall, the temper embrittlement testing proved a temperature activated embrittlement mechanism is present.
