**A Methodology for Evaluating Rainfall-induced Railway
Ground Hazards Encountered at Port Douglas, June 1998**

Submitted to the Faculty of Graduate Studies and Research
in partial fulfillment of the requirements for
the Degree of Master of Science
in Geotechnical Engineering

Fall 2006

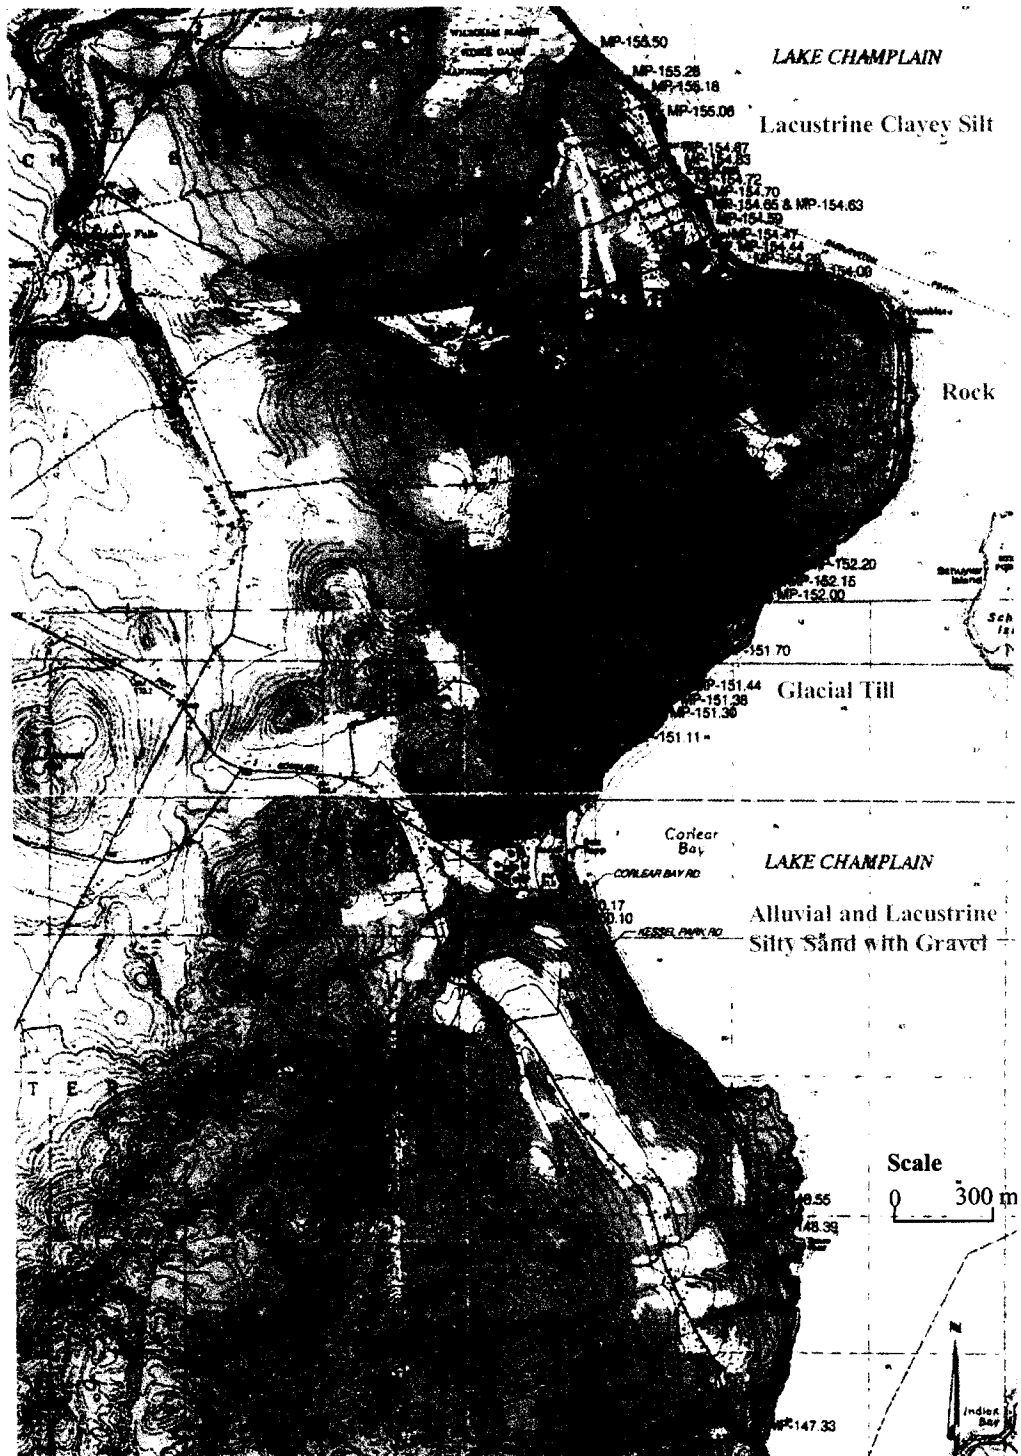
Figure 1-2 Damage sites along CPR between MP 147.33 and 155.50
(from Canadian Pacific Railway, 1998)

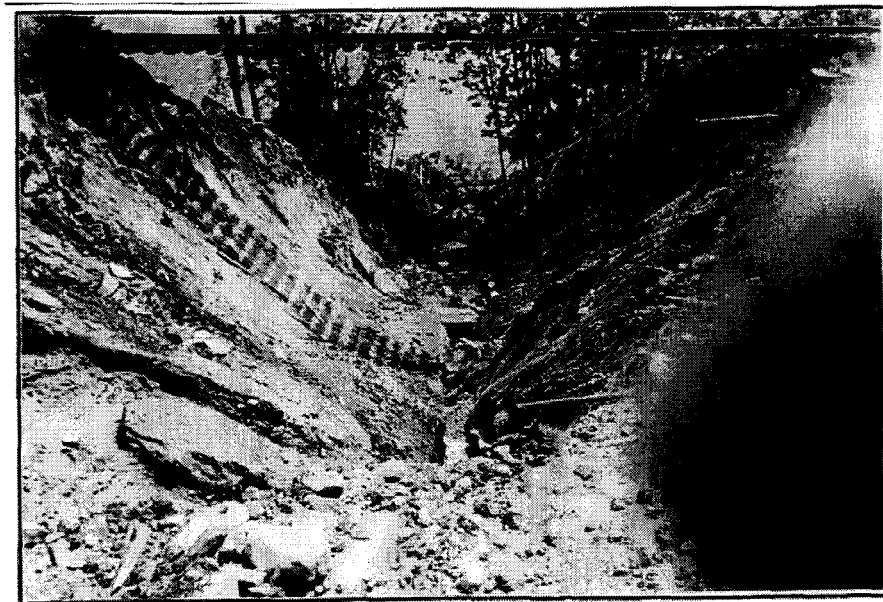
Figure 1-4 Complete overland flow erosion of railway embankment at MP 154.44
(from Canadian Pacific Railway, photograph taken in July 1998)

Close to the site 154.47, another embankment overland flow erosion was also investigated at MP 154.44 at the end of June 1998. At the site 154.44 a stream went through the earth embankment in a stone box culvert, which was 1 m wide and 0.9 m in height, to provide drainage. The embankment was built of local lacustrine silt and fine sand materials with a height of 12 m and side slopes of approximately 1.4H:1V. As shown in Figure 2-13, the erosion length at the track level was around 23 m and the failure depth was 12 m.

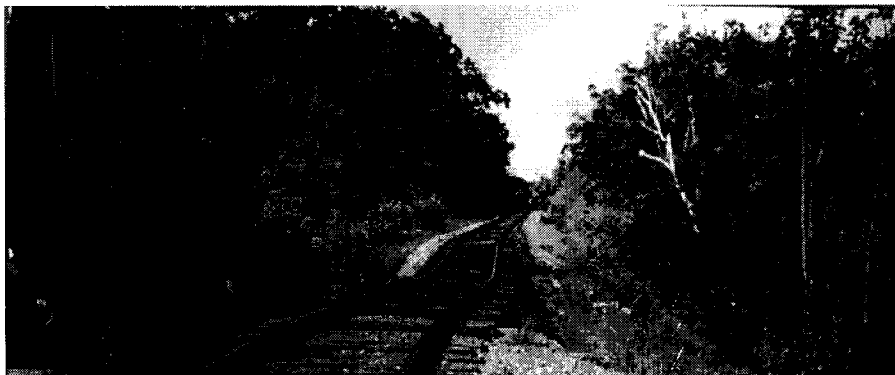
Other embankment slides occurred in the Port Douglas area, like the one indicated in Figure 2-17. No detailed descriptions are presented due to the lack of enough information.

Figure 2-17 Embankment slide along railway (from Canadian Pacific Railway)

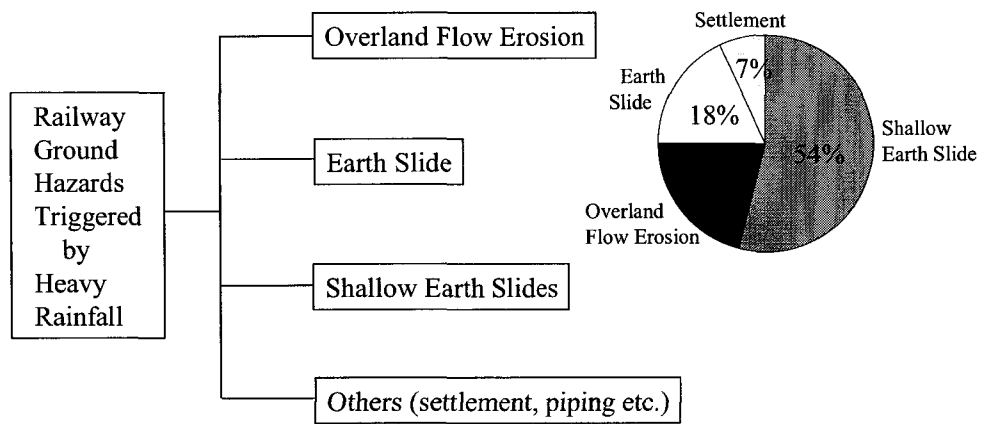
To classify the types of railway ground damages in the Port Douglas region during the prolonged rainfall in June 1998, a classification was carried out on the basis of the severity of the damage, according to Keegan's Railway Ground Hazards Classification System. Figure 2-20 shows the classification of the railway embankment damage types triggered by heavy rainfall. Embankment overland flow erosion is the most serious failure type, since the railway subgrade is washed out and leaves the track unsupported. This kind of damage usually occurs at a site where the embankment crosses a stream valley. It may result from both embankment soil strength decrease and water erosion. Earth slide refers to shear failure of the railway subgrade, which means that the overall factor of safety of the embankment is less than 1. Shallow earth slide is a common failure type for railway embankments during a period of heavy rainfall. This type of damage is

less severe than embankment overland flow erosion and landslide. A shallow earth slide causes the embankment to fail locally in the surface region due to rainfall infiltration and erosion while the overall stability of the embankment is secure. Occasionally, other types of ground hazards occur such as settlement and piping during a rainfall period. At Port Douglas, embankment shallow earth slides accounted for around 54 percent of the railway ground damage. Overland flow erosion and earth slides accounted for 21 percent and 18 percent, respectively. Settlement of the embankment accounted for only 7%.

Figure 2-20 Classification of rainfall-induced railway ground hazards found at Port Douglas CPR site

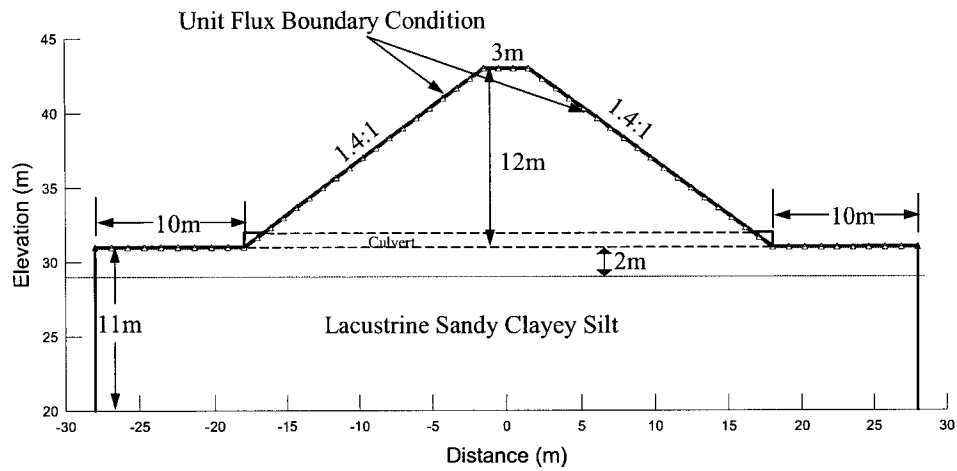
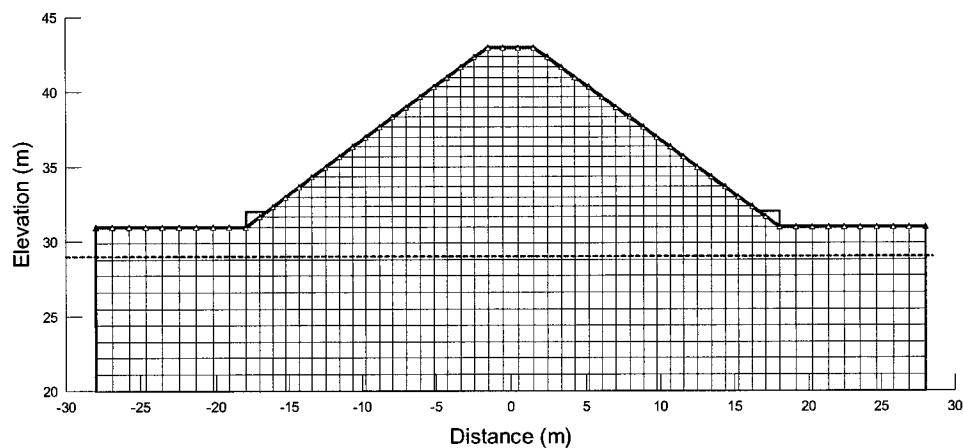
Figure 3-4 Geometry and finite element mesh for embankment at MP 154.47

The embankments at MP 154.47 & 154.44 had similar geometries and soil profiles. The following analysis and results represent are for both embankments. The embankment at MP 154.47 was 12 m high and had side slopes of 1.4H:1V (35.5°), with an embankment crest width of 3 m (see Figure 3-4 (a)). The location and size of the culvert are also shown in figure 3-4(a). The culvert, however, was not modeled in the seepage and stability modeling. The analysis lateral and bottom edges of the embankment were located at a distance of 10 m and 11 m from the toe and base of the embankment, respectively, in order to avoid any influence of the boundary conditions on the seepage process within the embankment area. A fine finite element mesh was designed, as shown in Figure 3-4 (b), with a total of 966 elements. Tsaparas (Tsaparas et. al., 2002) found that a fine mesh design was required for transient seepage analysis in order to overcome unstable solutions related to the non-linearity of the water flow equation and to use of steep permeability functions.

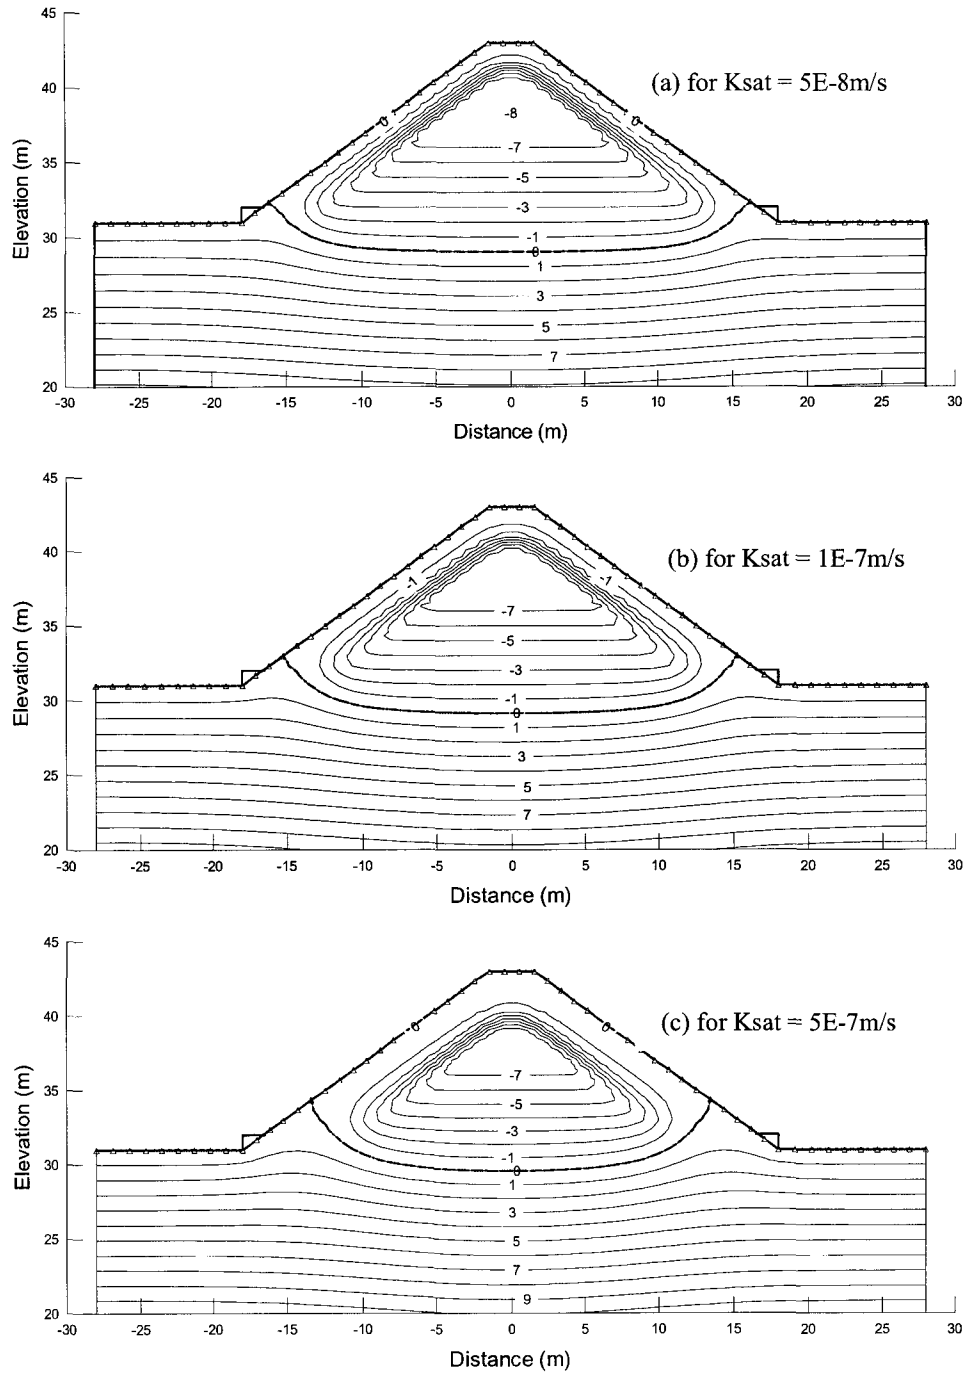
The seepage modeling results are presented in Figures 3-8, 3-9 and in Appendix C. Figures 3-8 and 3-9 illustrate the final pore-water pressure profile after June 27 for the initially dry and wet embankments, respectively. These figures show that the pore-water pressure distributions had similar patterns for all analysis scenarios. As expected, near the

embankment surface, the matric suction decreased due to the applied rainfall, and the core of the embankment presented higher suctions than the region near the ground surface. The figures also show that for the same initial condition and the same distribution of rainfall, the higher the value of K_{sat} , the greater the decrease of the matric suctions from the initial condition and the deeper the wetting front.

Figure 3-8 Pore-water pressure head profiles after June 27 for initially dry embankment at MP 154.47 (contour unit: meters)

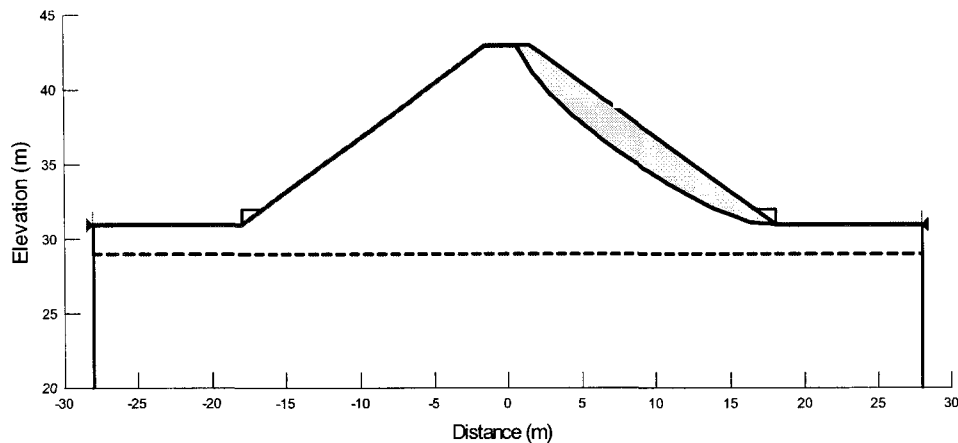
Figure 3-10 Critical slip surface for embankment at MP 154.47 if matric suction not considered

For the slope stability analysis, if the soil matric suction is not considered, the factor of safety of the embankment would be 0.95 if the shear strength parameters $c' = 3$ kPa and $\Phi' = 27^\circ$ were used and the critical slip surface was relatively shallow, as is shown in Figure 3-10. This indicates that the embankment would be unstable if no soil matric suction existed.

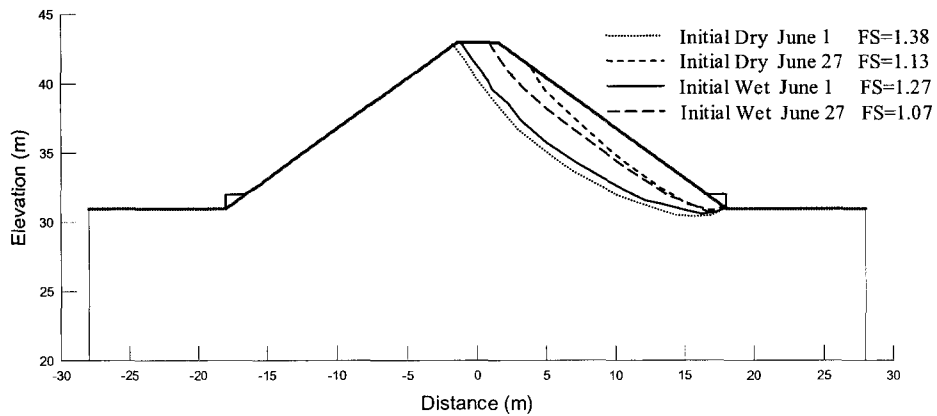
Figure 3-11 Critical slip surfaces for initially dry and wet embankments at MP 154.47
by using $c'=3\text{kPa}$, $\Phi'=27^\circ$, and $\Phi^b=12^\circ$

The stability results obtained when considering the soil matric suction are presented in Table 3-1 for both the initially dry and wet embankment conditions on June 1 (i.e., before the rainfall in June) and on June 27 (i.e., after heavy rainfall) by using soil strength parameters of $c' = 3$ kPa, $\Phi' = 27^\circ$ and $\Phi^b = 12^\circ$. The initial factors of safety equaled 1.38 and 1.27 for the initially dry and wet embankments, respectively, indicating that in both of the conditions, the embankment was relatively stable. For the initially dry embankment, after June 27 the factor of safety decreased by 11%, 18% and 26%, respectively, for the $K_{sat} = 5E-8$ m/s, $K_{sat} = 1E-7$ m/s and $K_{sat} = 5E-7$ m/s cases. This decrease resulted from the decrease in the soil matric suction due to the rainfall infiltration and, hence, the decrease of the soil shear strengths. The embankment was in a marginally stable condition after June 27 with a factor of safety of 1.13 and 1.02 for the $K_{sat} = 1E-7$ m/s and $K_{sat} = 5E-7$ m/s scenarios. For the initially wet embankment, the factor of safety decreased by 10%, 16% and 22% for the cases of $K_{sat} = 5E-8$ m/s, $K_{sat} = 1E-7$ m/s and $K_{sat} = 5E-7$ m/s, respectively. Again, the rainfall infiltration drove the embankment into a marginally stable or unstable condition. Figure 3-11 shows the critical slip surfaces for both the initially dry and wet embankments. For the initially dry embankment, the critical slip surface on June 1 was slightly deeper than that of the initially wet embankment. In both circumstances, the critical slip surface moved toward the ground surface with time due to the rainfall infiltration.

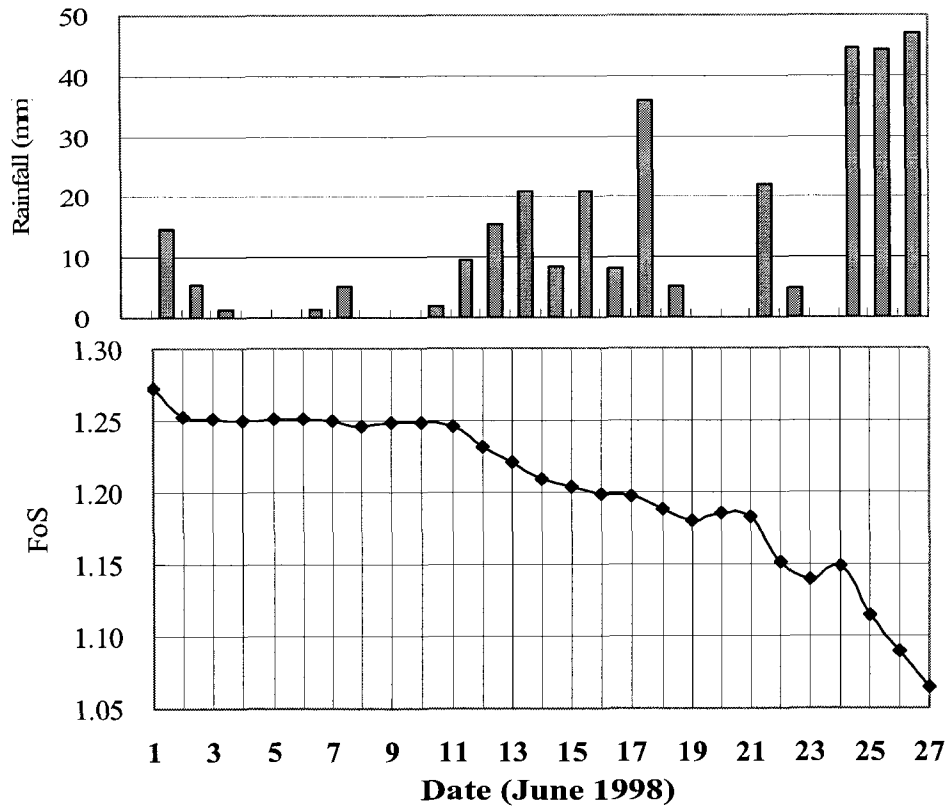
Figure 3-12 Change in the factor of safety with time for initially wet embankment at MP 154.47 by using $K_{sat} = 1E-7m/s$, $c'=3kPa$, $\Phi'=27^\circ$ and $\Phi^b=12^\circ$

The change in the embankment stability with time was modeled by taking the day-to-day pore-water pressure distribution as an input for the stability analysis. The results for the initially wet embankment with $K_{sat} = 1E-7$ m/s and using $c'=3$ kPa, $\Phi'=27^\circ$ and $\Phi^b=12^\circ$ are presented in Figure 3-12, together with the rainfall data. From Figure 3-12, the 14 mm rainfall on June 2 decreased the factor of safety of the embankment by 1.6% from 1.272 to 1.252. From June 3 to June 11, the factor of safety almost remained unchanged since either no rainfall or only a very small amount of rainfall occurred in this period. Then a continuous decrease in the factor of safety occurred until June 19, from a value of 1.25 on June 11 to 1.18 on June 19, a decrease of 5.2% resulting from the continuous rainfall infiltration from June 12 to June 19. After June 19, the factor of safety increased slightly during the dry period of June 20 and 21 and then decreased due to the rainfall on June 22 and 23. A high-intensity rainfall of more than 44 mm per day occurred between June 25 and June 27. After the three days heavy rainfall on June 25, 26 and June 27, the factor of safety of the embankment decreased by 6.6% from 1.15 to 1.07. The effect of these three days of heavy rainfall accounted for 41% of the total decrease of the factor of safety of the embankment for the 27-day period from June 1 to June 27. The prolonged antecedent rainfall from June 2 to June 24 also had an influence on the embankment instability by accounting for 59% of the total decrease of the factor of safety of the embankment.

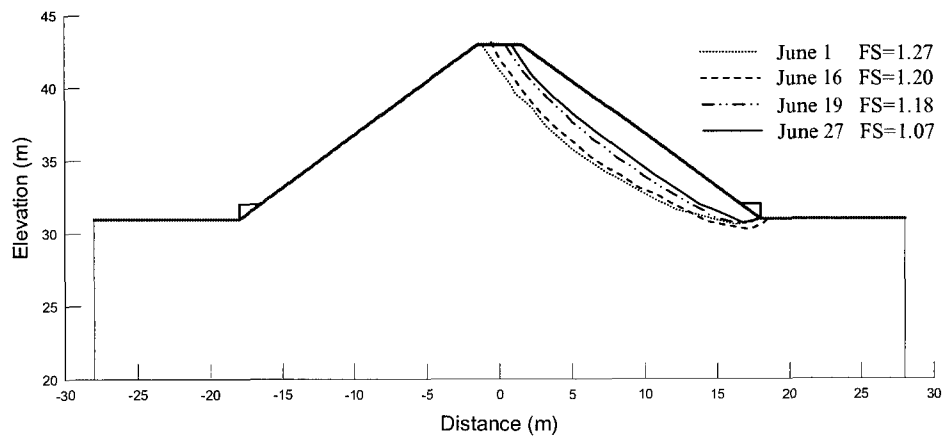
Figure 3-13 Evolution of critical slip surfaces for initially wet embankment at MP 154.47 by using $K_{sat} = 1E-7m/s$, $c'=3kPa$, $\Phi'=27^\circ$, $\Phi^b=12^\circ$

Figure 3-13 presents the evolution of the critical slip surface with time for the $K_{sat} = 1E-7$ m/s initially wet embankment, using parameters of $c'=3$ kPa, $\Phi'=27^\circ$ and $\Phi^b=12^\circ$. It shows a relatively deep critical slip surface on June 1. As the rainfall infiltrated and the matric suction in the near ground surface region decreased rapidly, the critical slip surfaces moved towards the ground surface.

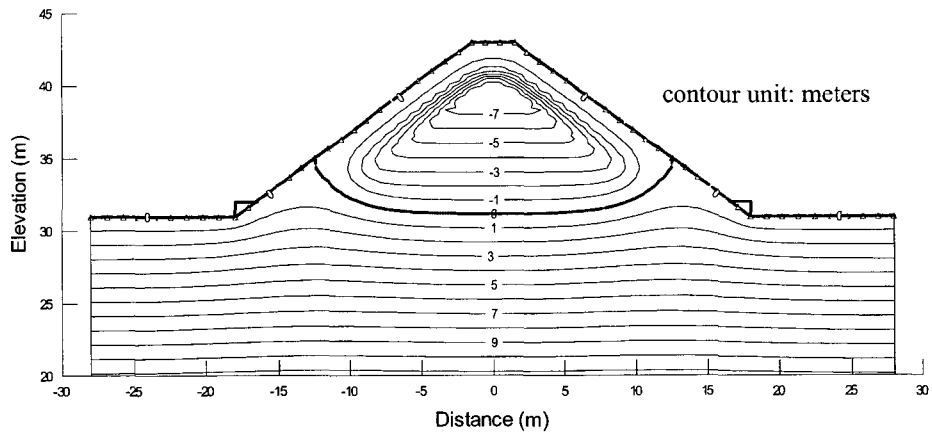
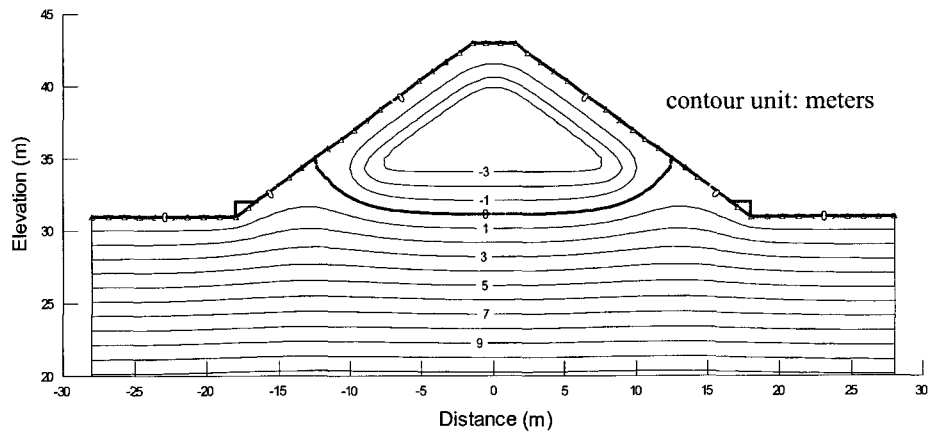
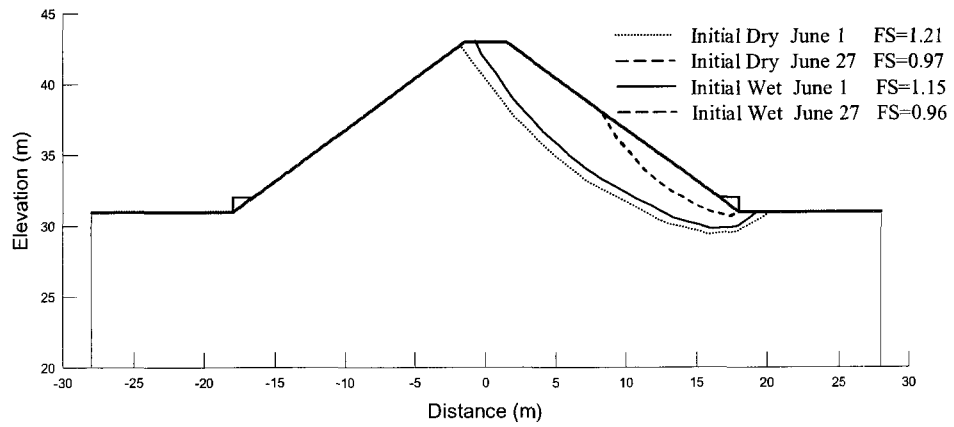
Figure 3-14 Seepage and stability results for embankment at MP 154.47 with an initial groundwater table at the base of the embankment

Finally, to consider the different initial ground water conditions, an analysis of an initial ground water table right at the base of the embankment was conducted, using the hydraulic conductivity function with $K_{sat} = 1E-7$ m/s and the shear strength parameters of $c'=3$ kPa, $\Phi'=27^\circ$ and $\Phi^b=12^\circ$. The pore-water pressure distribution and slope stability results are presented in Figure 3-14, which reveals that at the toes of the embankment, the ground water table rose due to the rainfall infiltration. The slope stability results indicate that the local area of the toes of the embankment failed first.

The modeling results for the embankments at MP 154.47 and MP 150.17 also show that a region around the toes of the embankment had been saturated by rainfall infiltration. Therefore a collapse may have first occurred at an embankment toe, weakening the overall stability of the embankments. In this circumstance, if the embankments were subjected to a sudden loading, for example, the loading of a train, the overall slope may have failed suddenly. This possibility may explain why the embankment at MP 150.17 failed when a train came even though the overall stability of the embankment, as indicated by the numerical modeling, appeared to be a stable condition. The evidence that

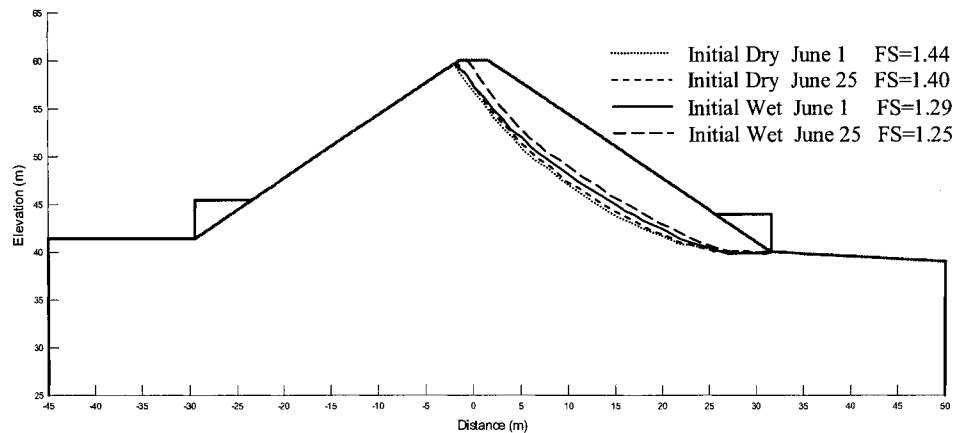
Figure 3-20 Critical slip surfaces for initially dry and wet embankments at MP 150.17 by using $K_{sat} = 1E-6$ m/s, $c'=0$, $\Phi'=30^\circ$, and $\Phi^b=15^\circ$

Table 3-3 provides the factors of safety for the initially dry and wet embankments. The results in this table were prepared by considering the increase of soil strength due to matric suction and by using the shear strength parameters $c'=0$, $\Phi'=30^\circ$ and $\Phi^b=15^\circ$. The initial factors of safety of 1.44 for the initially dry embankment and 1.29 for the initially wet embankment show that under both conditions the embankment was stable. After June 25, the factor of safety of the initially dry embankment decreased by 2.1%, 2.2% and 3.2%, respectively, for $K_{sat} = 5E-7$ m/s, $K_{sat} = 1E-6$ m/s and $K_{sat} = 5E-6$ m/s cases. The factor of safety of the initially wet embankment decreased by 2.8%, 3.0%, 3.8%, respectively, for $K_{sat} = 5E-7$ m/s, $K_{sat} = 1E-6$ m/s and $K_{sat} = 5E-6$ m/s scenarios. These results show that the intermittent rainfall from June 1 to June 25 reduced the stability of the embankment slightly and that the embankment would have remained stable if only the rainfall infiltration had acted on it. Figure 3-20 illustrates the critical slip surfaces for the initially dry and wet embankments with a saturated hydraulic conductivity of $1E-6$ m/s and using the mean shear strength values. It can be observed that the initially dry embankment presented a deeper critical slip surface than the initially wet embankment. After the precipitation event from June 1 to June 25, the critical slip surfaces of both the

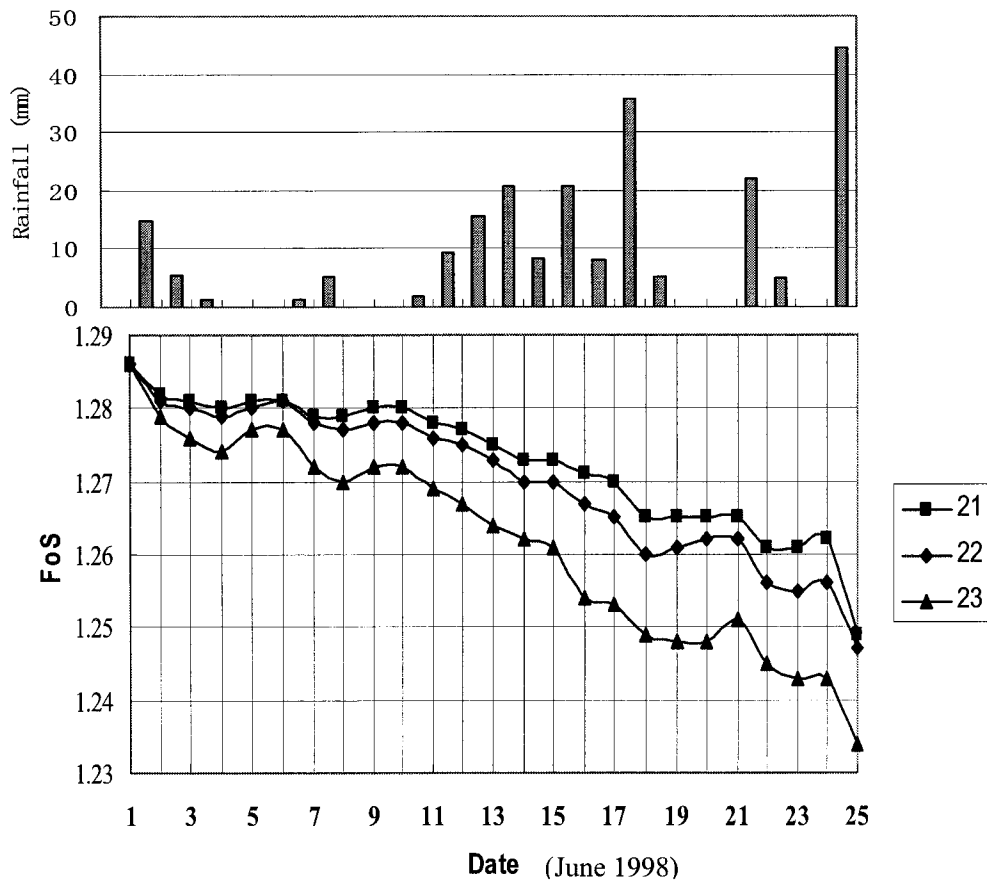
Figure 3-21 Change in factor of safety with time of initially wet embankment at MP 150.17

presented in Figure 3-21, together with the rainfall data. The figure shows that the factor of safety of the embankment decreased gradually with time due to the precipitation. The factor of safety increased slightly during the dry periods of June 5, June 6, June 9, June 10, June 20 and June 21. It can also be noted that the 44 mm rainfall on June 25 reduced the stability of the embankment significantly. The prolonged antecedent rainfall from June 2 to June 24 also had an influence on the embankment stability. In Figure 3-21, the three lines for the different hydraulic conductivity cases show that the higher the hydraulic conductivity of the embankment material, the faster the decreased of the embankment stability.

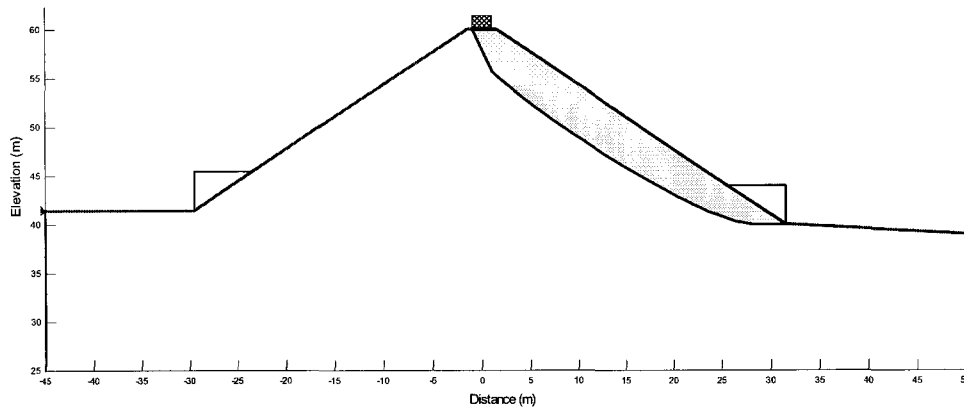
Figure 3-22 Critical slip surface for initially wet embankment at MP 150.17 with a train loading 60kPa (FS=1.15)

To simulate the effect of train loading on the embankment stability, an external load of 40 kPa and 60 kPa distributed along 2 meters was applied on the embankment crest. The results are summarized in Table 3-5 and Figure 3-22, which show that a train loading of 60kPa could bring the initially wet embankment into a marginally stable condition with a factor of safety of 1.15. The train loading was likely to have been a contributory factor in the slope failure at MP 150.17.

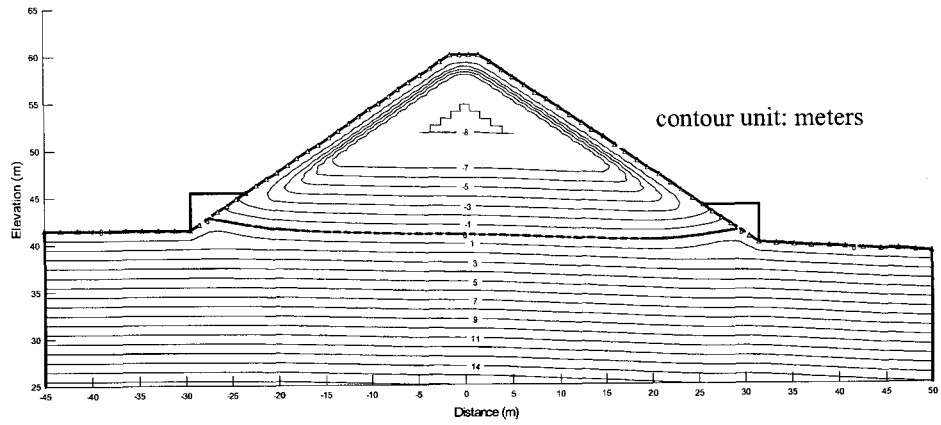
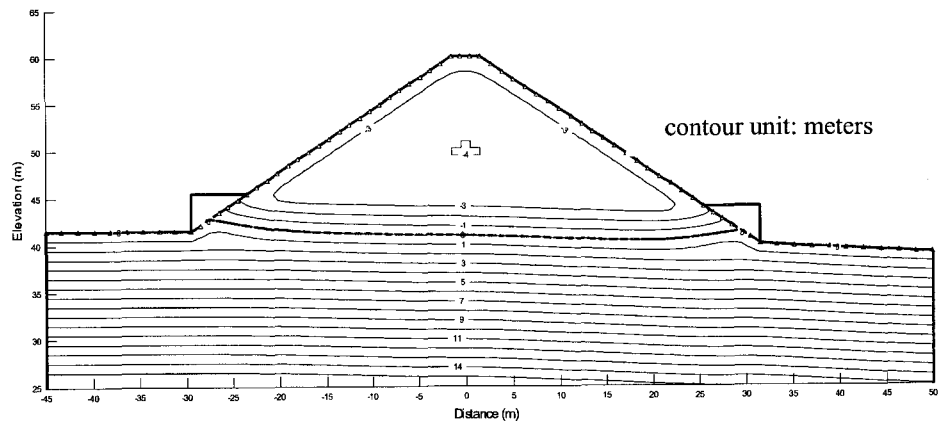
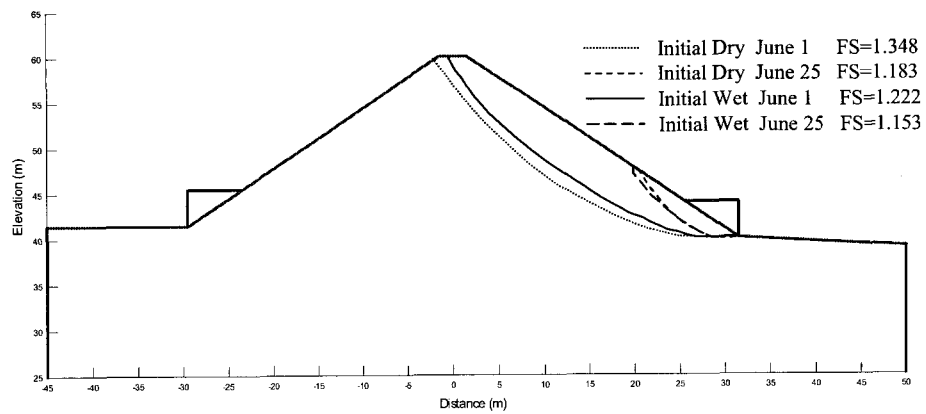
Figure 3-23 Pore-water pressure distributions and slope stability results for embankment at MP 150.17 with an initial groundwater table at the base of the embankment

Finally, to consider different initial ground water conditions, an analysis of an initial ground water table right at the base of the embankment was conducted. In this analysis, the hydraulic conductivity function with $K_{sat} = 1E-6$ m/s and the shear strength parameters of $c'=0$, $\Phi'=30^\circ$ and $\Phi^b=15^\circ$ were used. The pore-water pressure distributions and slope stability results are presented in Figure 3-23, which shows that the toes of the embankment most likely failed first after the prolonged rainfall from June 1 to June 25. An assumed upstream water level rise is provided in Figure 3-24 (a) and its effect on the embankment stability was analyzed. From Figure 3-24 (b), it can be seen that upstream water level change had little effect on the downstream slope stability because of the low hydraulic conductivity of the embankment material. Figure 3-25 shows the critical slip surfaces after June 25 for the initially wet embankment when a train loading of 40 kPa or 60 kPa distributed along 2 meters at the embankment crest was included. The factors of safety of the embankment reached 1.13 and 1.10 with a 40 kPa and 60 kPa train loadings, respectively, indicating a barely stable condition. This finding suggests again that the train loading might have contributed to the slope failure at MP 150.17.

the fuel lines were broken prior to the derailment may confirm that the toe of the embankment failed first, damaging a section of the culvert near the outlet and breaking the fuel line. The train loading may have triggered the overall failure of the slope.

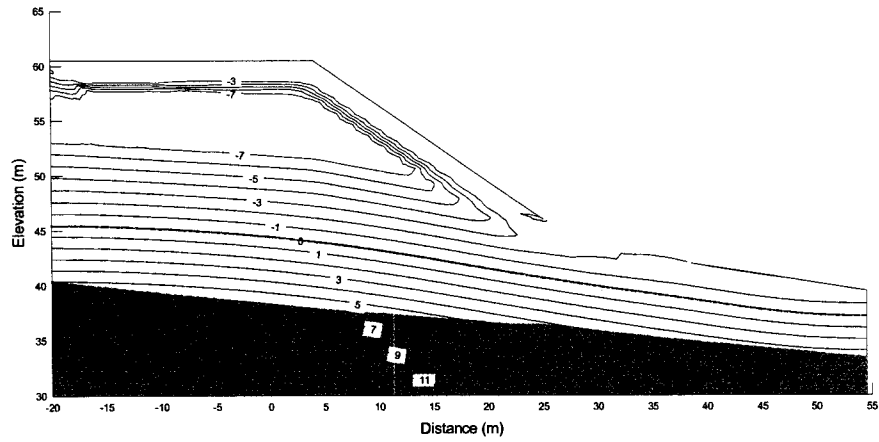
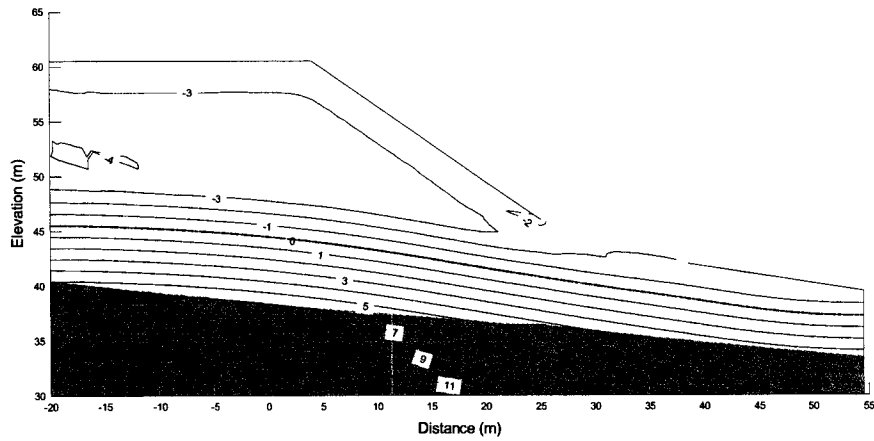
Figure 3-28 Final pore-water pressure head profiles after July 5
for initially dry and wet embankments at MP 150.10 (contour unit: meters)

The numerical modeling results are presented in Figures 3-28, 3-29 and Table 3-7. Figure 3-28 shows the final pore-water pressure profile for the initially dry and wet embankments. Near the ground surfaces rainfall infiltration reduced the soil matric suction and a high matric suction region was in the middle of the embankment.

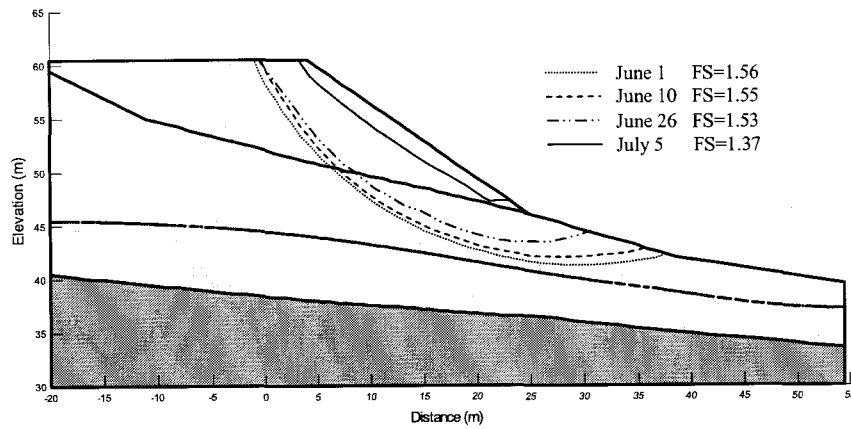
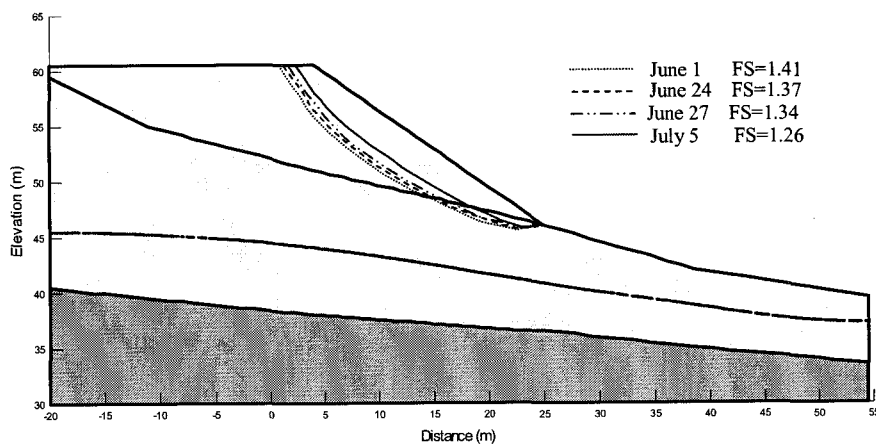
Figure 3-29 Move of critical slip surface with time for embankment at MP 150.10

As can be seen in Table 3-7, the factor of safety of the embankment gradually decreased with time. The initial factors of safety were 1.56 and 1.41 for the initially dry and wet embankments, respectively, indicating a fairly stable condition. After the rainfall on July 5, the factor of safety decreased to 1.37 for the initially dry embankment and 1.26 for the initially wet embankment. A great decrease in the factor of safety occurred due to the prolonged rainfall. The numerical results, however, show that the embankment appeared to have been still safe in terms of its overall stability. Figure 3-29 shows the change in the

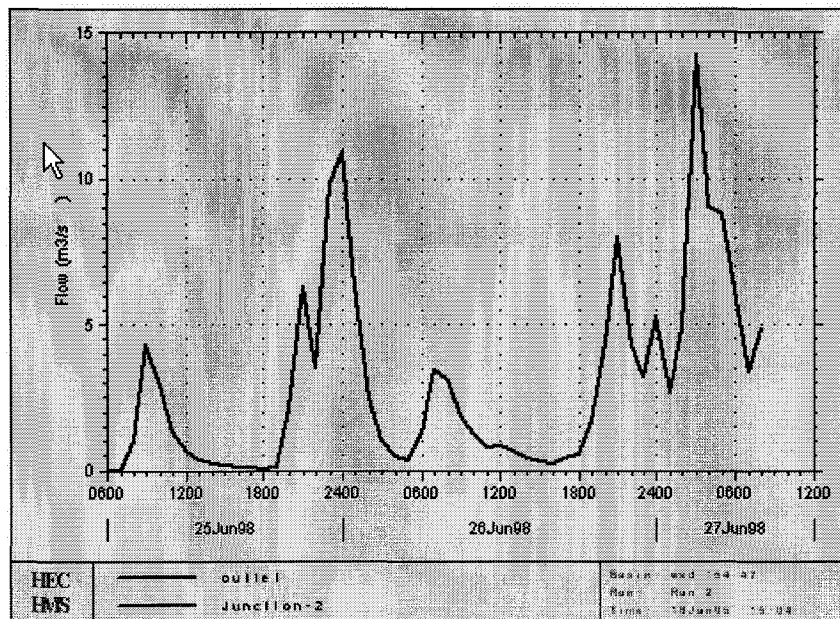
Figure 4-6 Modelled hydrograph at outlet of watershed 154.47

Figure 4-5 shows the hydrologic model for watershed 154.47. In this model, six subbasin elements are used. The hourly hydrograph at the outlet of watershed 154.47 and the water surface profile near the culvert are represented in Figures 4-6 and 4-7, respectively. From Figure 4-6, it can be seen that the peak flow at the outlet of watershed 154.47 was $14\text{m}^3/\text{s}$ at around 3:00am on June 27, 1998. The flow capacity of the culvert was $9\text{m}^3/\text{s}$ (see Figure 4-7). This figure indicates that the culvert was not large enough to convey the water flow.

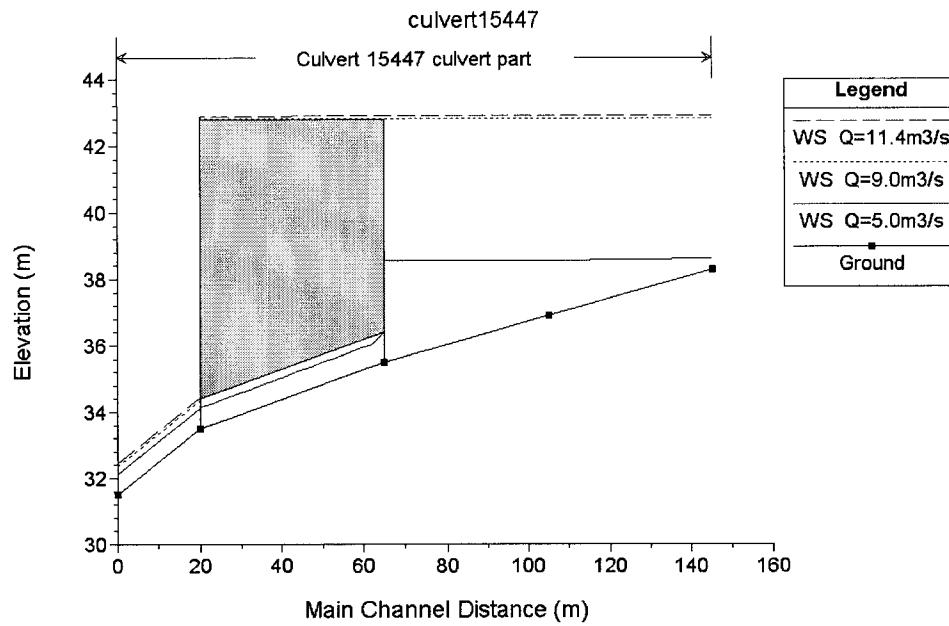
Figure 4-7 Modelled water surface profile at culvert 154.47

The hydrology and hydraulic results for all the watersheds are provided in Appendix D, and a summary of the results are given in Table 4-4 which shows that for watersheds 154.47 and 147.33, the flow capacities of the culverts were less than the peak flows, so overtopping and erosion of embankment could occur. However, for watershed 154.44 and watershed 152.15, the culverts were large enough to handle the water flows. This finding suggests that overland flow erosion occurred at both culverts that were adequate and inadequate to handle the water flow.
