THE UNIVERSITY OF ALBERTA

A REPORT ON SLOPE INSTABILITY ALONG THE OLDMAN RIVER AND TRIBUTARIES IN THE VICINITY OF LETHBRIDGE, ALBERTA

> Ъу A.F. RUBAN

SUBMITTED TO THE FACULTY OF GRADUATE STUDIES AND RESEARCH IN PARTIAL FULFILLMENT OF THE REQUIREMENTS FOR THE DEGREE OF MASTER OF ENGINEERING IN

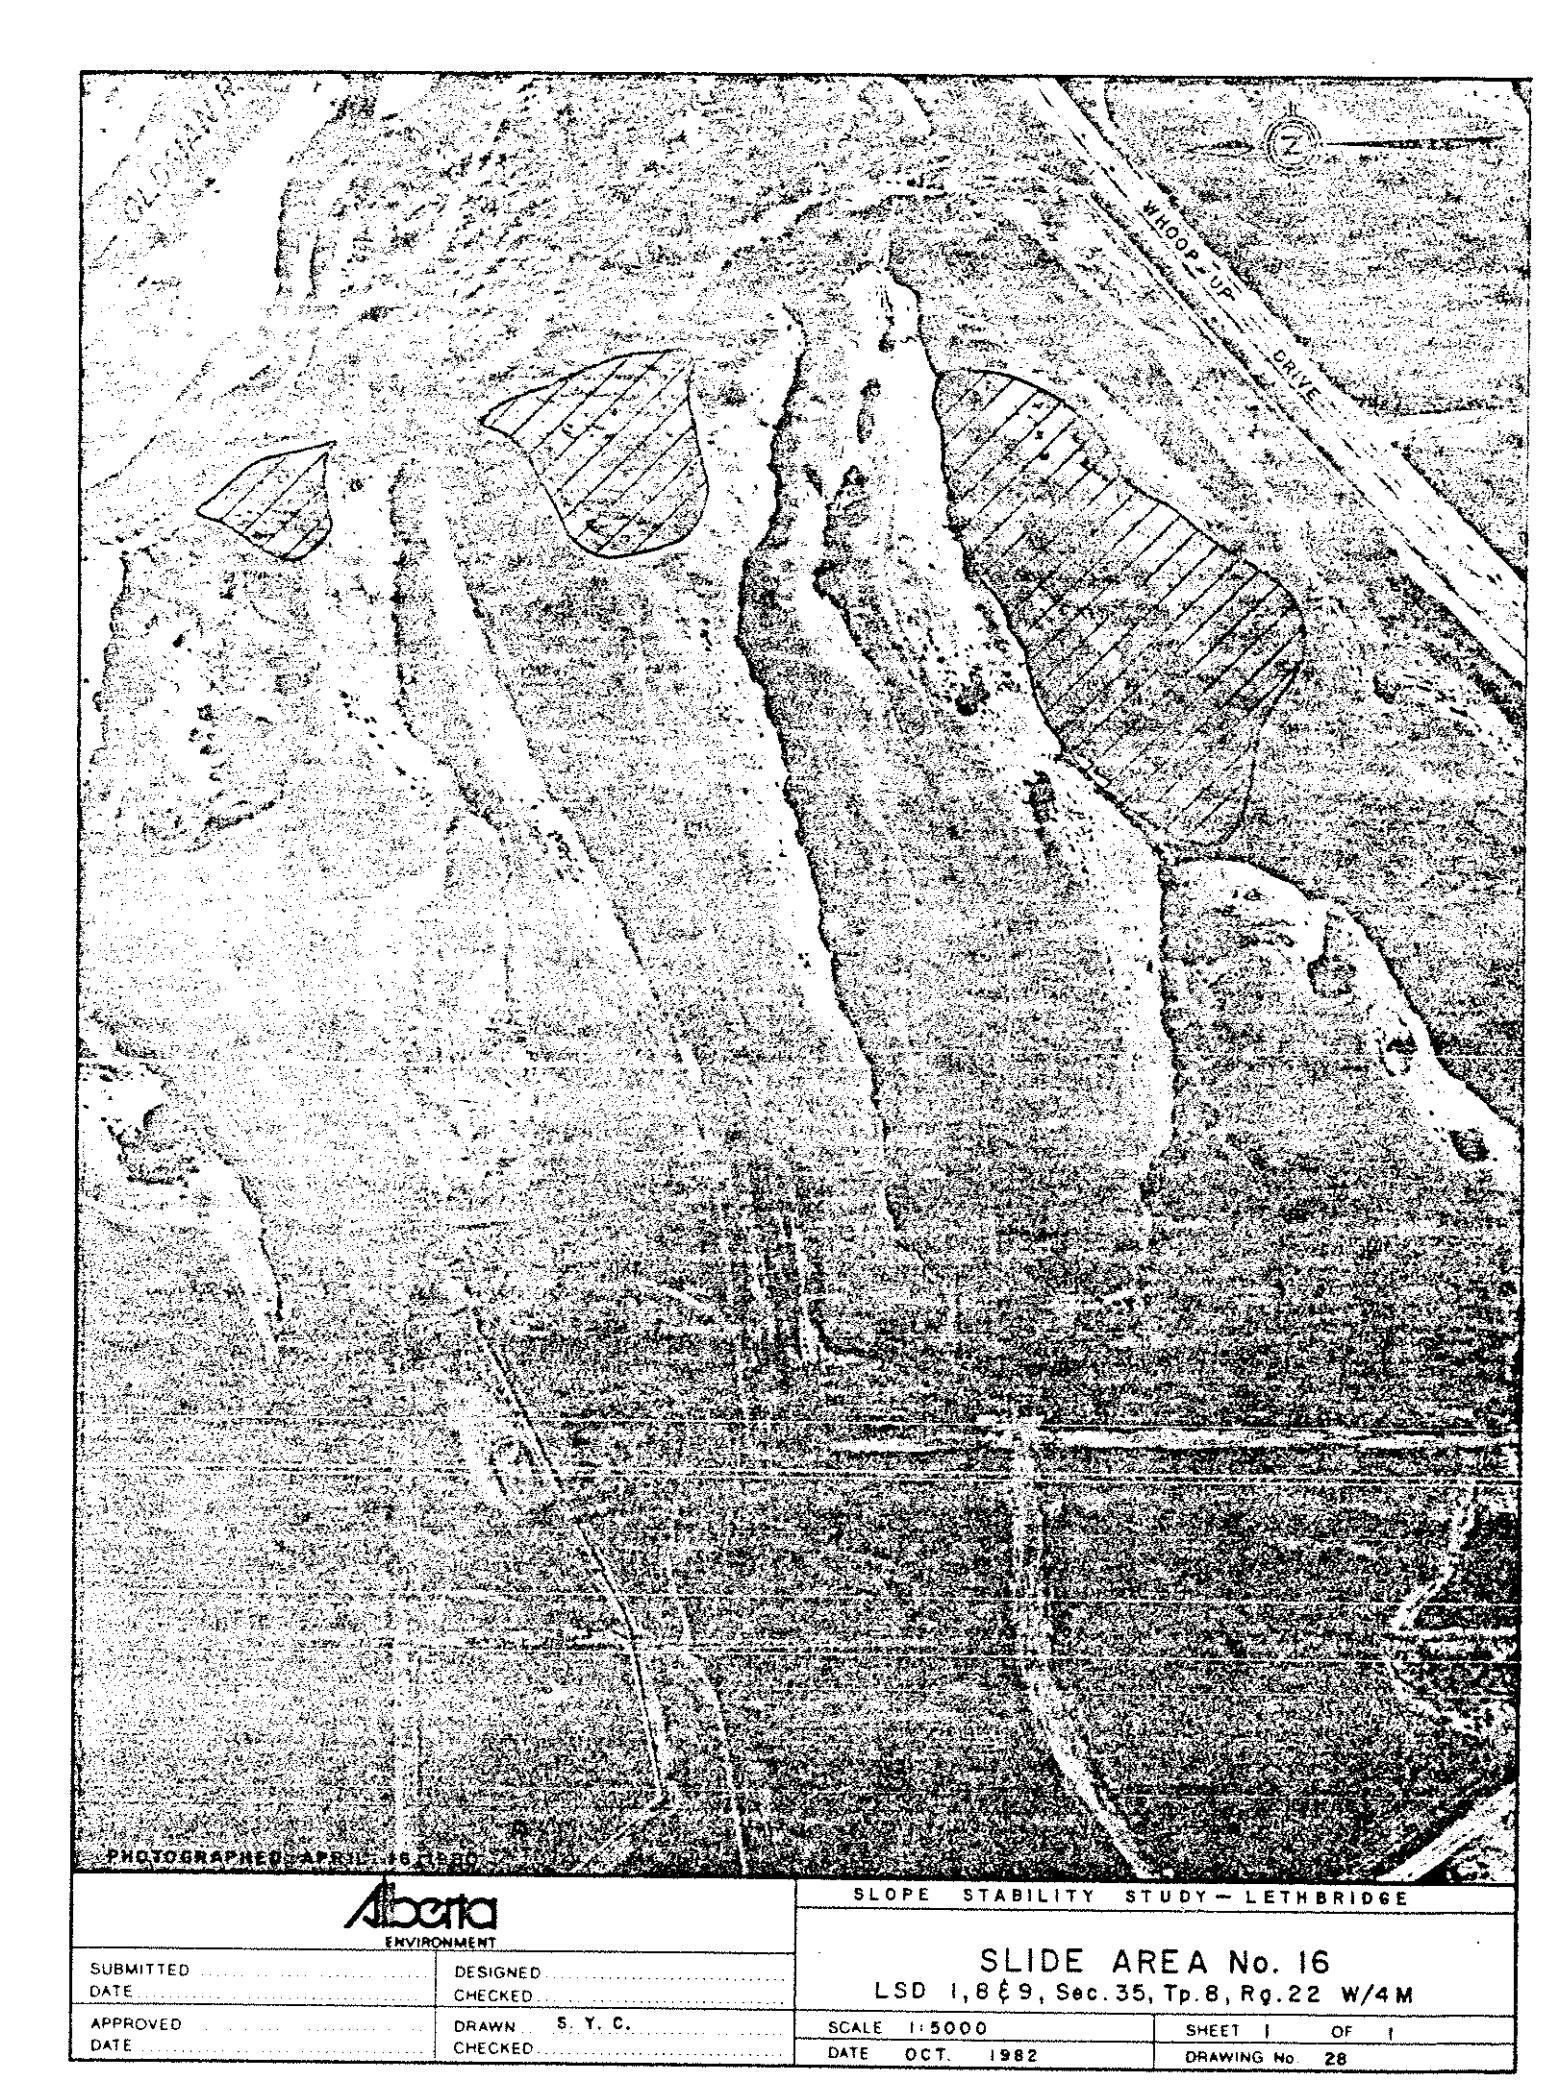
Situated on the west bank of the Oldman River, this slide area involves a section of land which has been subjected to coal mining operations at a depth of approximately 100 metres below the crest of the west valley slope. The area comprises a slide in LSD 8, a slide in LSD 9 and an extensive series of tension cracks along the south bank of a major coulee in LSD 1.

The two slides occur at the ends of ridges or spurs where the floodplain and west valley wall intersect. It is postulated that the slides may have been triggered by subsidence over old mine workings and adits which underlie the ends of the spurs. Both slides are characterized by steep headscarps (up to 10 metres) and a hummocky lower slide morphology. No signs of recent movement are evident, although some activity periodically occurs from the steep headscarp by a toppling block type failure.

The largest slide in this area (17-A) consists of down thrown blocks at the base of the slide and a series of blocks part way down the slope face, indicating a retrogressive series of failures. The suspected mode of failure is combined rotational-translational, with the translational movement occurring along the old mine tunnels and adits which were typically near river level.

The fourth slide in the area is located on the south bank near the upper end of the coulee. This smaller slide (approximately 60 metres in length) is also a shallow rotational failure confined to the overburden soils. A deeply eroded trench with near vertical walls forms the base of this V-shaped coulee. It is suspected that oversteepening at the base of the coulee is the probable triggering mechanism for this slide.

None of the coulee or riverbank slides are presently active.

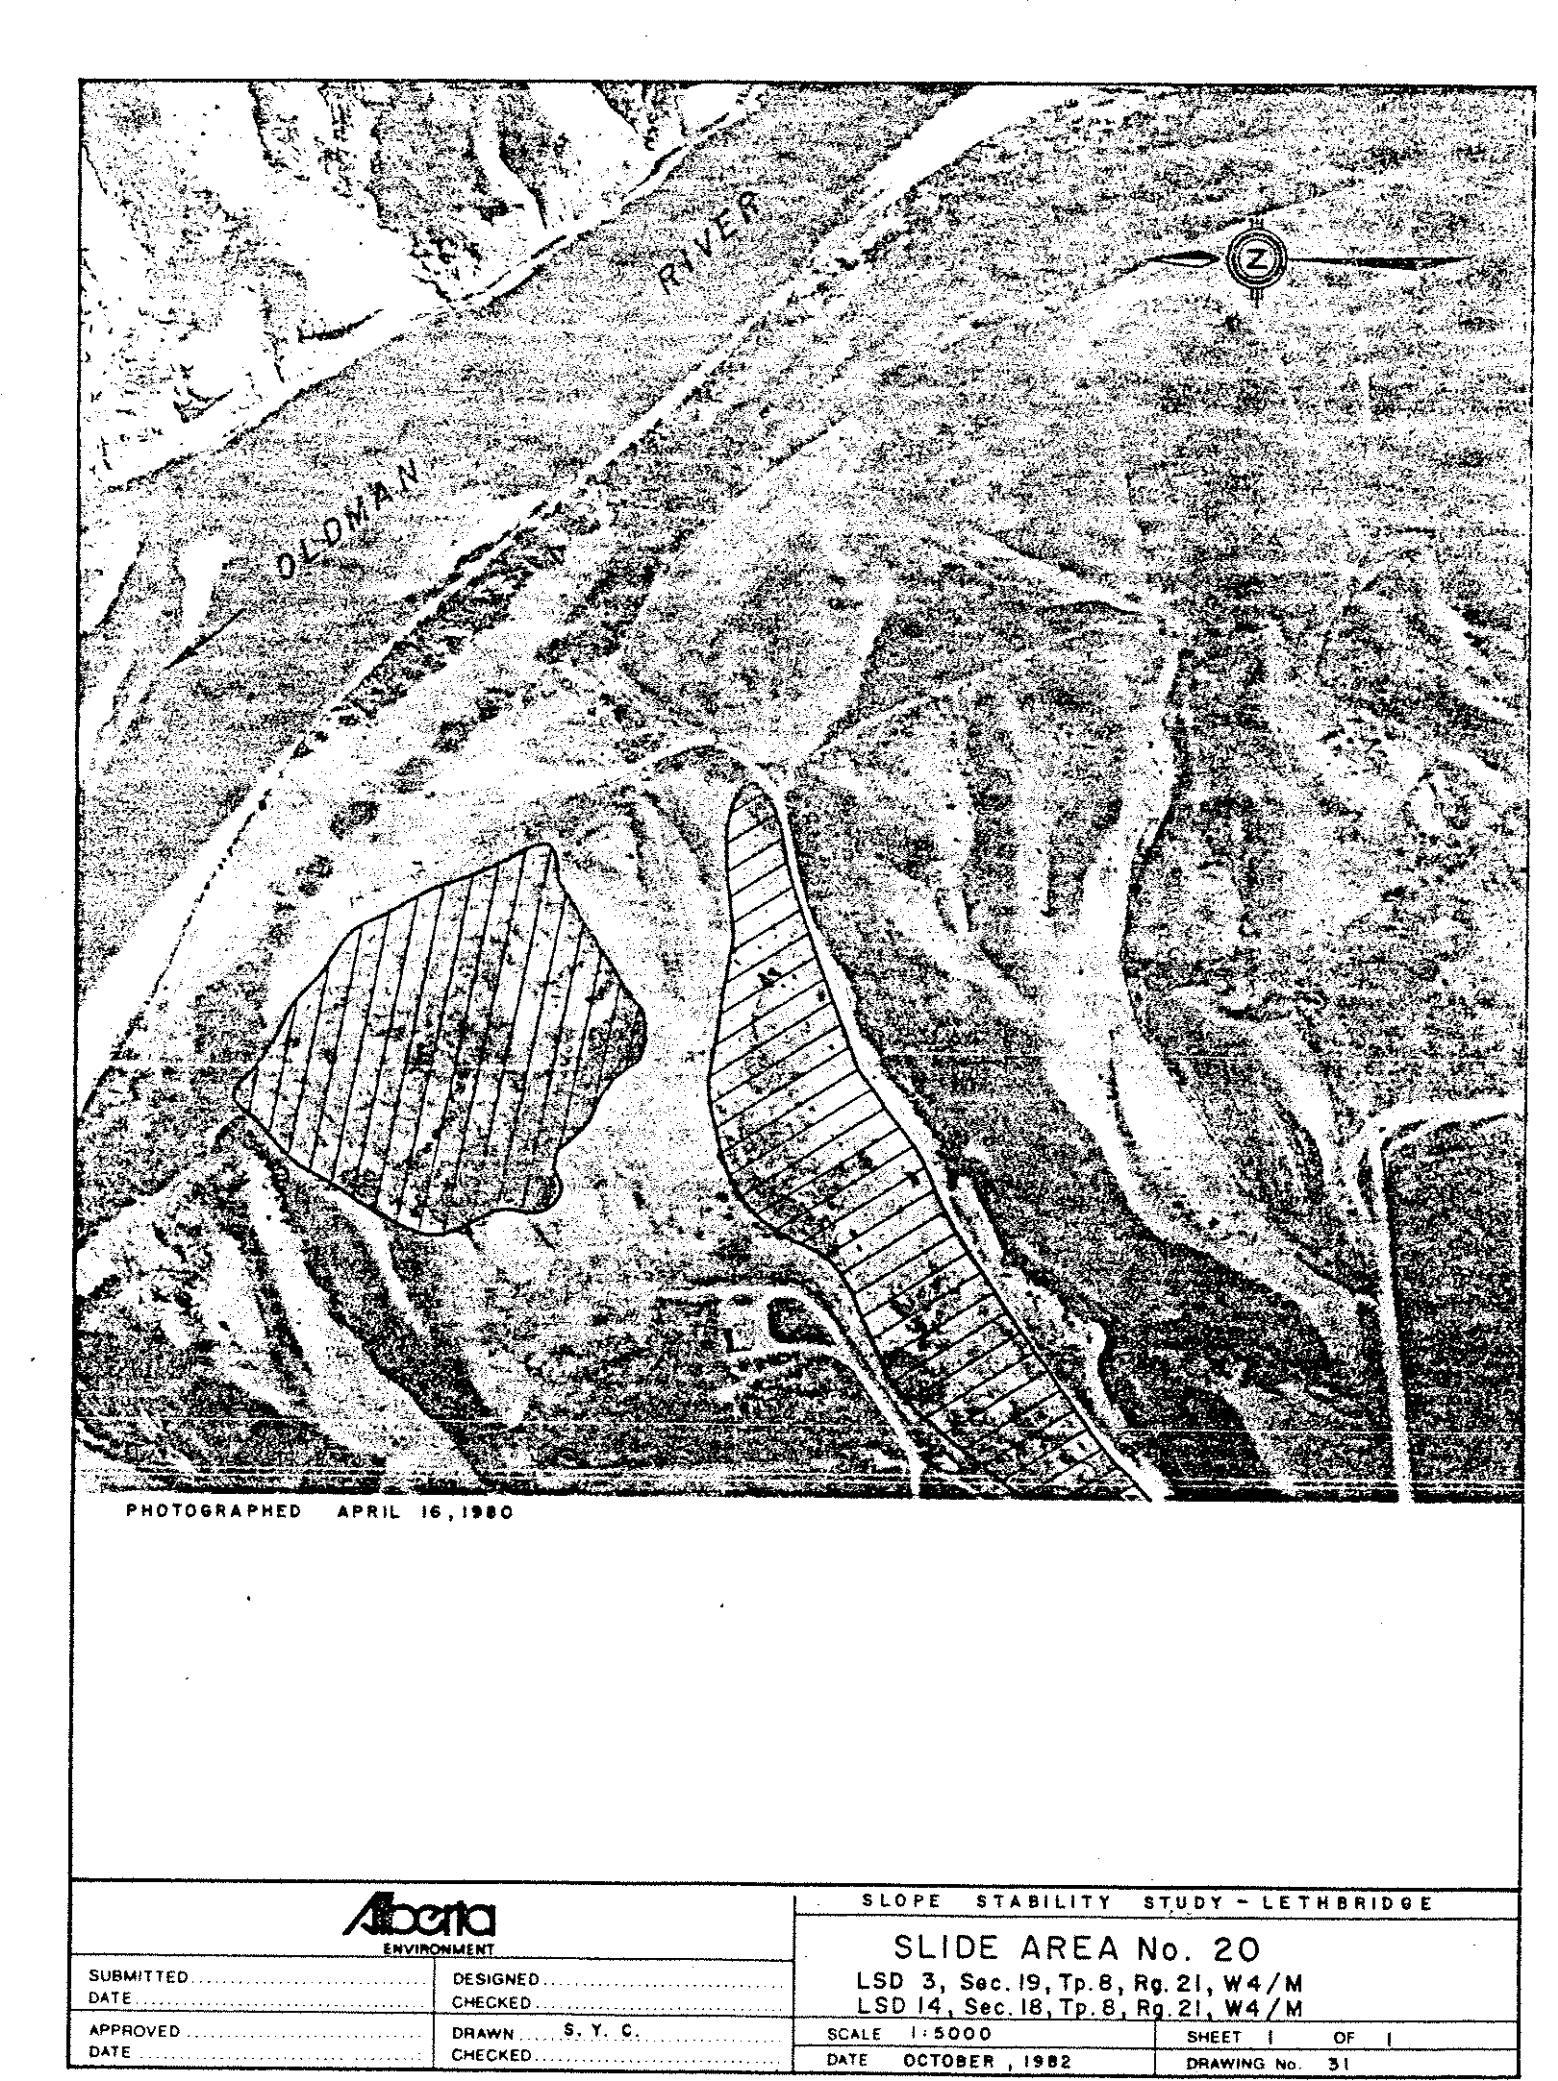
The slope movements are very old with no obvious triggering mechanism. A possible explanation for the overburden movement may involve a bedrock surface which had eroded locally, leaving a dip towards the river and coulee. This local dipping surface would serve as a plane for a postulated combined rotational-translational failure.

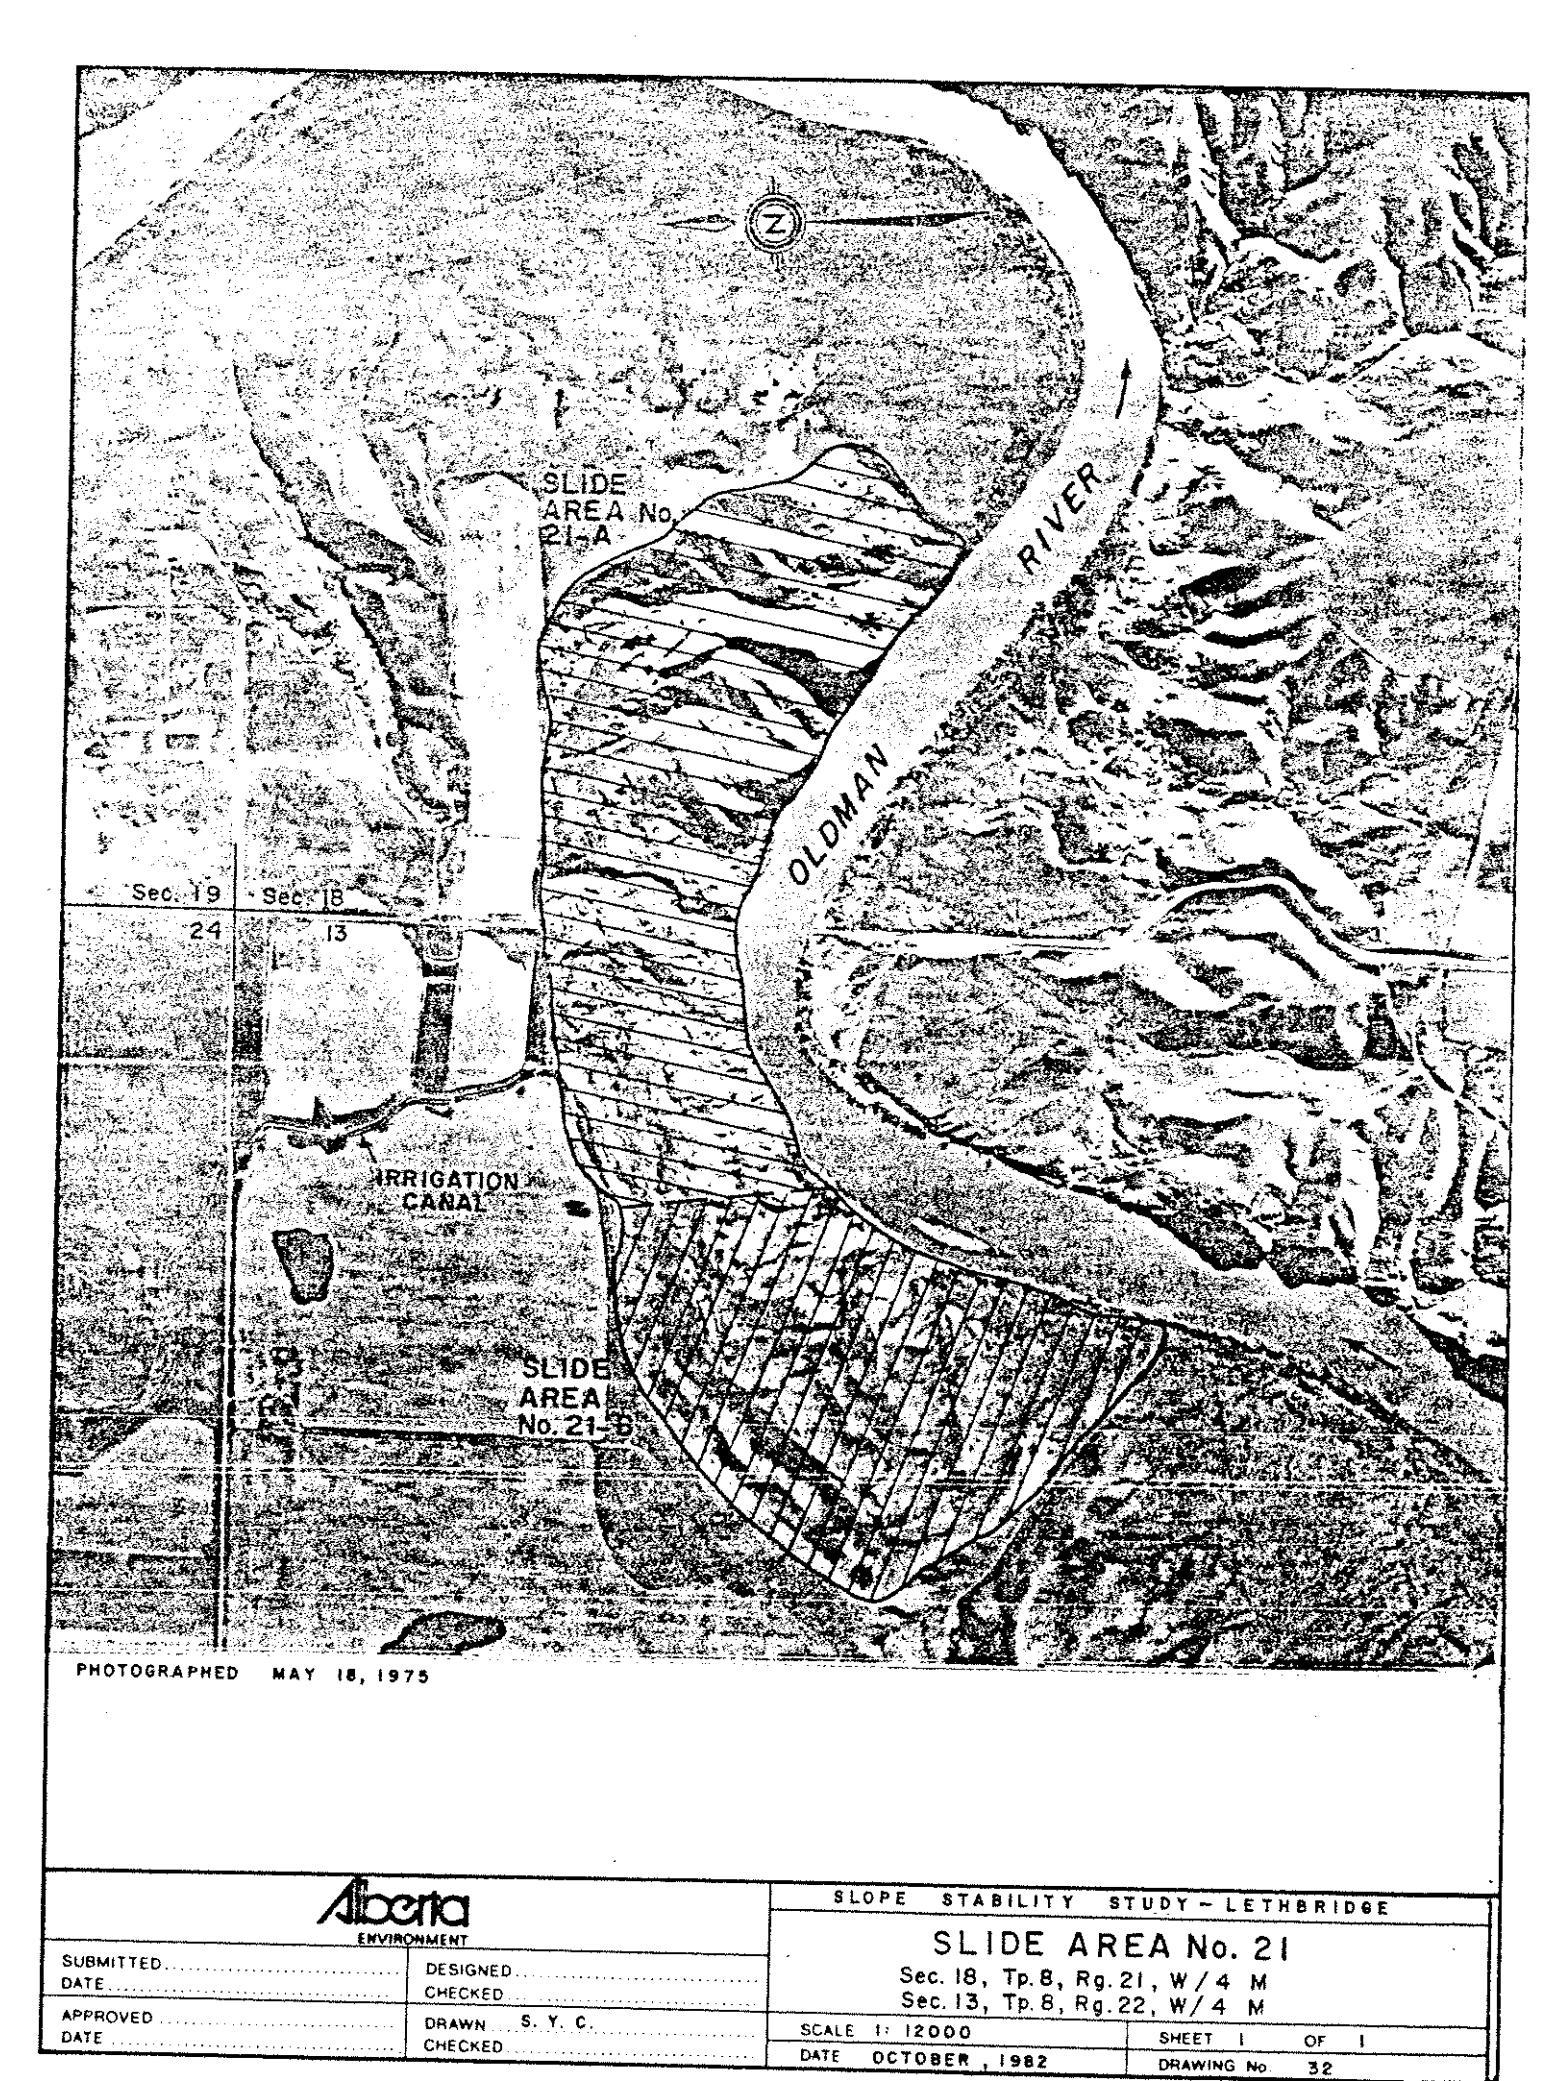
The active area (21-A) is presently experiencing several types of instability. The major source of the instability is excess irrigation water which has been dumped onto the slope and permitted to run uncontrolled down to the river level. The main irrigation canal which supplies water for the farmers on the west side of the Oldman River, terminates at the crest of the slope. Surplus irrigation water dumped onto the slope face has saturated the local Pleistocene sediments. The steep-walled gulleys formed by erosion have experienced a number of shallow rotational failures. This particular feature is most readily apparent along the east edge of the slide mass.

The continuous supply of water has formed a local perched groundwater table resulting in a series of retrogressive rotational slides, particularly in the central portion of the slide mass. In some places the soils have formed a flow type failure with the surface morphology expressing a viscous fluid type of movement. Several areas of ponded water are visible on the face of the slope.

The slope failures appear to be generally confined to the soils overlying the Upper Cretaceous bedrock. Near vertical exposures of the Oldman Formation along the eastern portion of the slide indicate the bedrock is relatively stable. In the central portion of the slide, debris has either fallen or flowed overtop of the bedrock forming a talus which varies up to 50 metres in width or more. Erosion at the base of the slope removes material which acts as a stabilizing toe berm. As the talus is slowly eroded, it no longer provides toe support for the material further upslope and results in further movement.

The western portion of the slide (21-B) exhibits a well rounded mature topography with no indication of recent activity. This section of the slide is estimated to have occurred while the river was downcutting. The slide morphology consists of a steep backscarp, backward rotated downdrop blocks on the upper and lower slide zone. The slide appears to be a combined multiple retrogressive rotational-translational type failure with the lower failure surface at the bedrock - overburden contact. The bedrock contact is estimated to be approximately 50 metres above river level. A substantial quantity of material is believed to be deposited at the toe of the slope forming a large talus at the base.
