TITLE OF THESIS/TITRE DE LA THÈSE An Investigation of the Edgerton Landslide, Wainwright, Alberta.

UNIVERSITY/UNIVERSITÉ University of Alberta.

DEGREE FOR WHICH THESIS WAS PRESENTED/ GRADE POUR LEQUEL CETTE THÈSE FUT PRÉSENTÉE M Sc

YEAR THIS DEGREE CONFERRED/ANNÉE D'OBTENTION DE CE GRADE Fall 1976

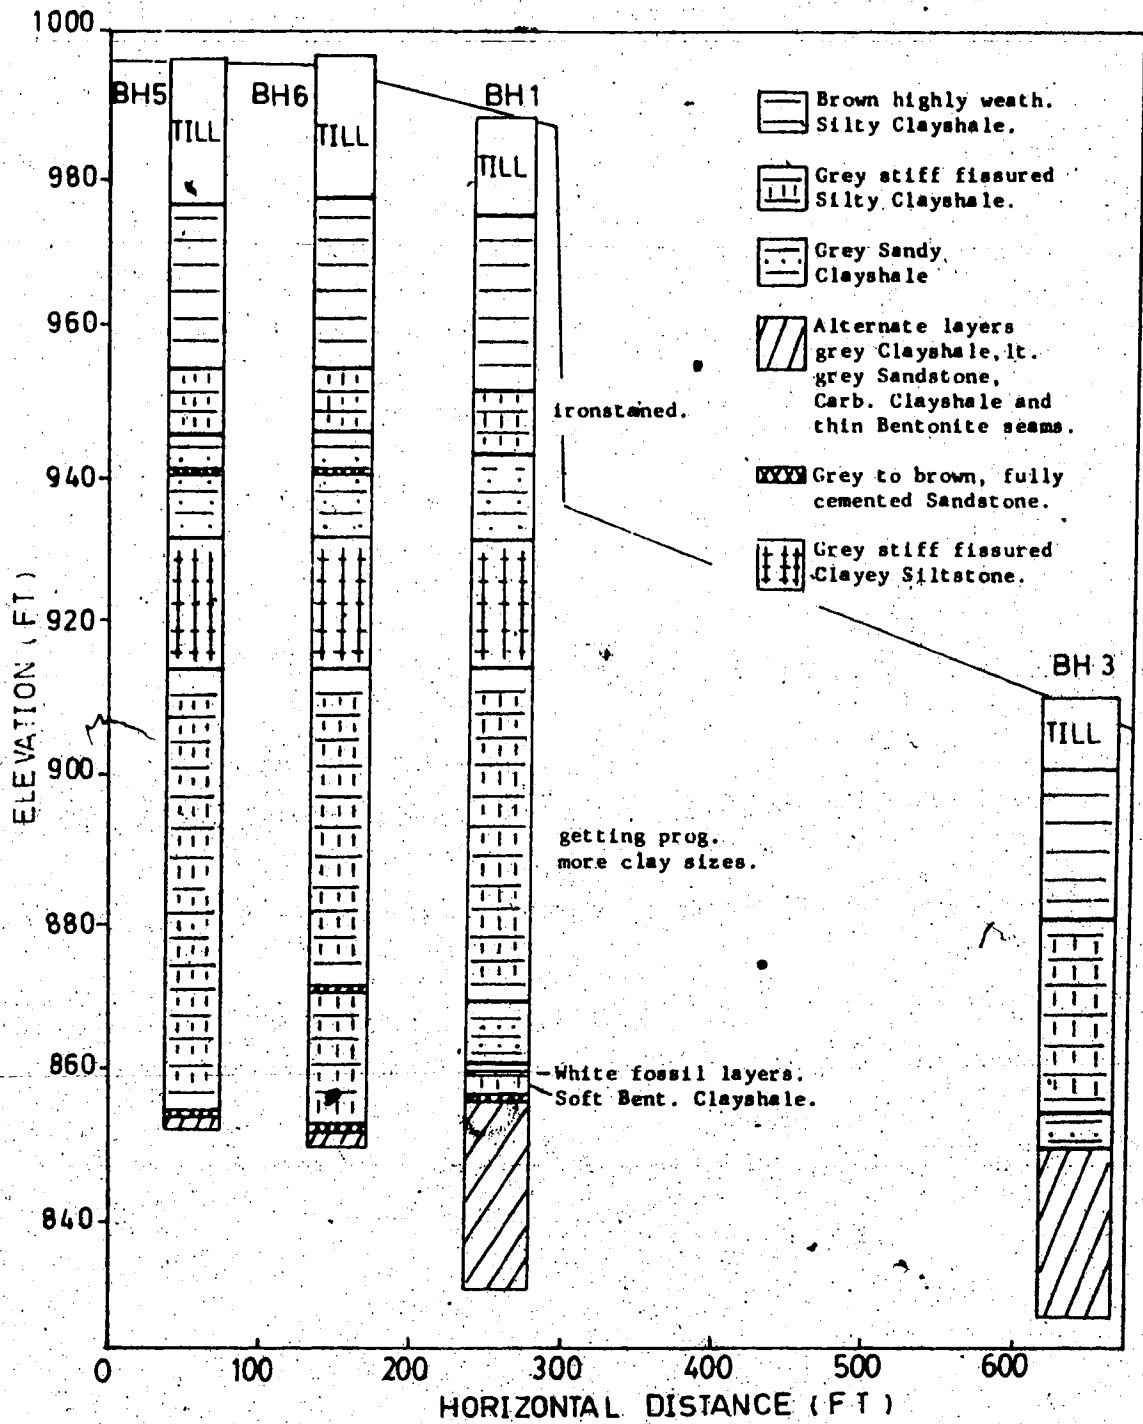
FIGURE 3.2 STRATIGRAPHIC PROFILE OF THE NORTH SLIDE

Figure 3.2 shows the stratigraphic profile for BH5, BH6, BH1 and BH3, as located in Figure 2.2. Good correlation exists between BH5, BH6 and BH1 however the correlation with BH3 is not as apparent. It seems that BH3 has been displaced downwards due to previous landsliding. It should be noted that each soil type contains large amounts of clay sizes, and that clayshale seams are prominent in the sequence.

Weathering was observed in each borehole and seems to parallel the ground surface at a depth of about 35 feet. It should be noted that there appears to be an upward flexing of the sandstone stratum at approximate elevation 855 feet (Figure 3.2), as it approaches the valley axis, observed from BH5, BH6 and BH1, which may indicate evidence of valley rebound. It should also be noted however, that the sandstone stratum was not detected in BH3. Figure 3.3 shows the stratigraphic profile for BH2, BH4 and BH7 on the South Slide. Weathering again parallels the ground surface down to a depth of some 35 feet. Fossil layers were found in BH2 at a depth of 66 feet, which corresponds in elevation with those layers found in BH1. Small fossil specks were also found in BH4, at a depth of about 46 feet, (Figure 3.3) that is a downward displacement of some 10 feet from BH2. This feature may reflect displacements in the soil mass due to previous landsliding.

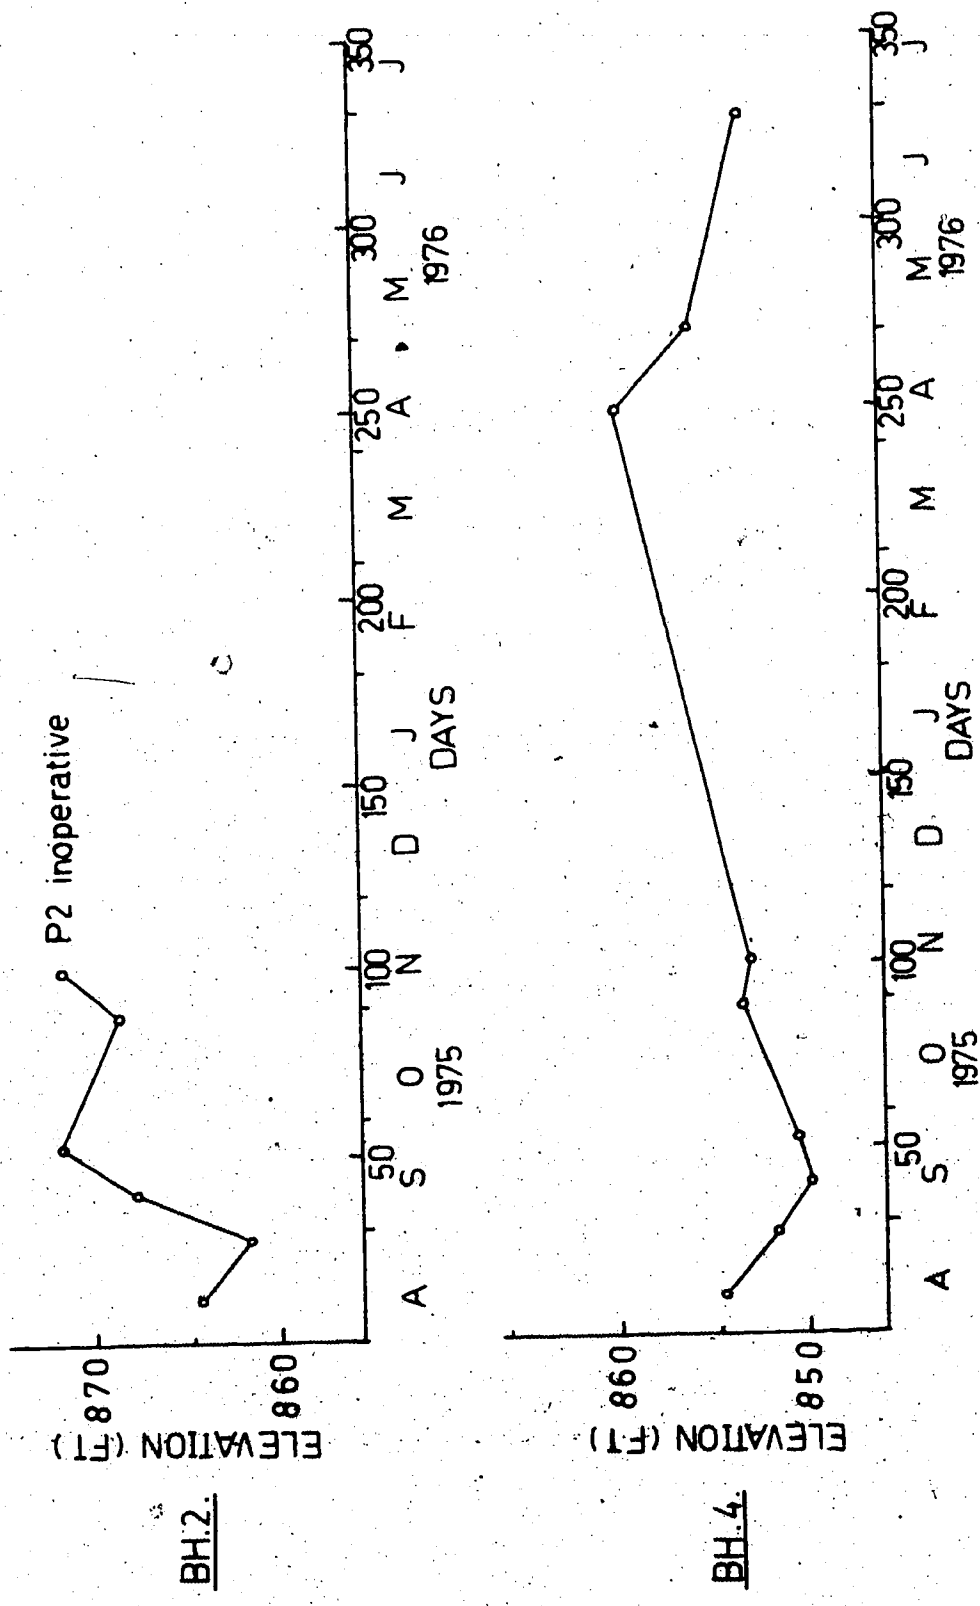
FIGURE 3.4 PIEZOMETRIC READINGS

Piezometers P1, P2 and P4 were installed in boreholes BH1, BH2 and BH4 respectively. Pore pressures were monitored throughout the fall of 1975 until early December, and read again in April 1976. The piezometric levels are shown in Figure 3.4. Average readings of 1.2 and 1.1 kg/cm² were recorded by P2 and P4 respectively during fall, 1975. No readings were taken during winter, however, when the slide was revisited in late March, 1976, thaw had started at the top of the slide, and streams of water were observed flowing into the cracks along the scarp of the South Slide, and similarly along the North Slide. The lower part of the slides were still frozen, and protected by a snow cover about 2 feet deep, such that seepage of water from the slopes was prohibited, and thus pore pressures would be expected to have been at their highest at this time. Unfortunately readings could not be obtained, due to the problem of the console freezing.

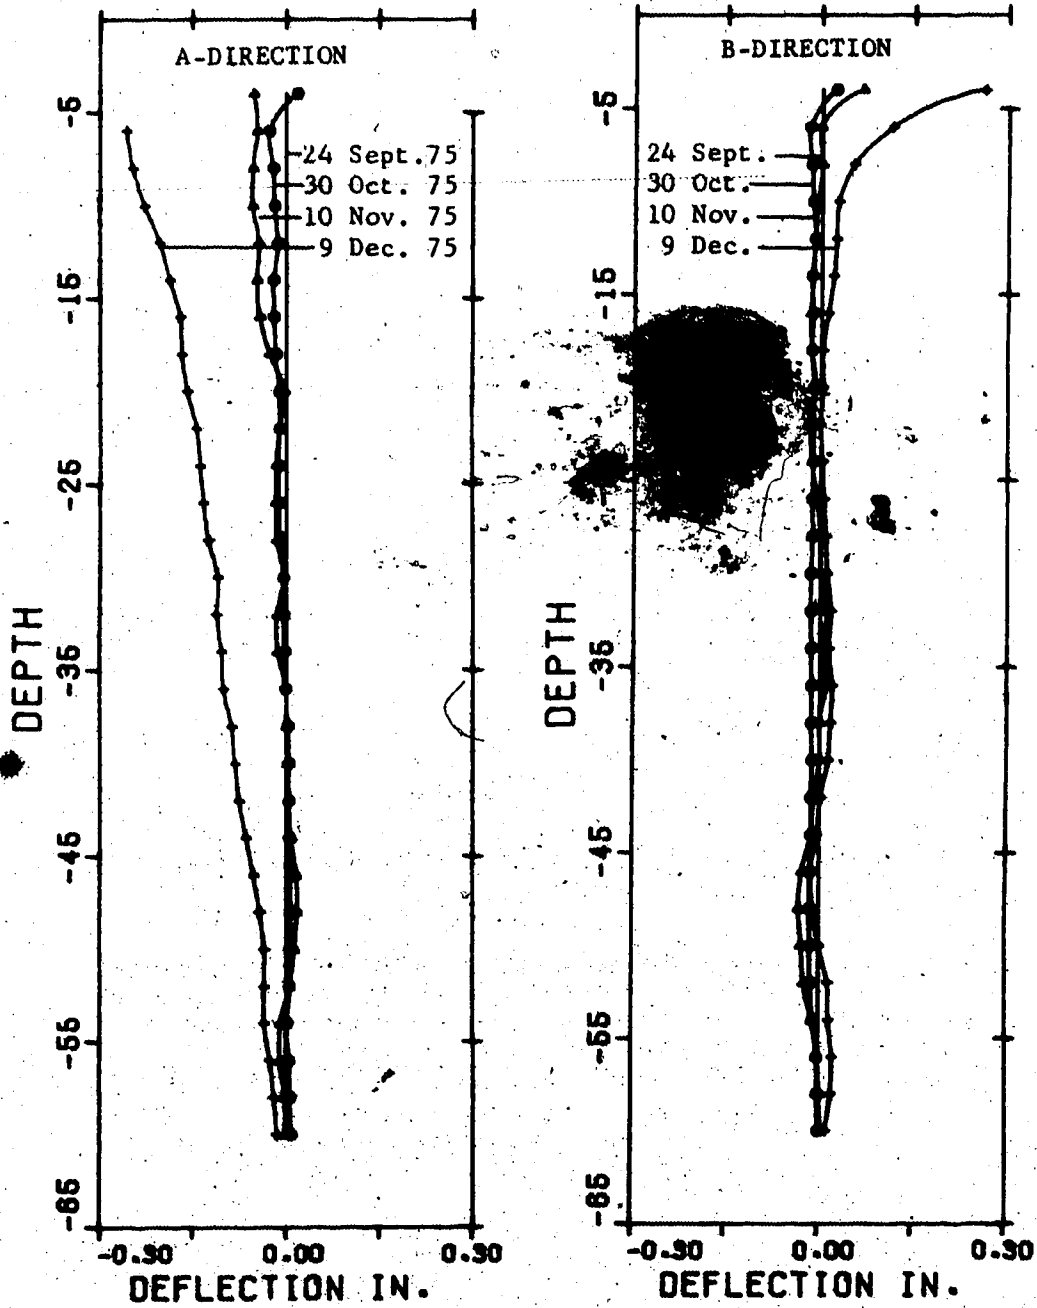
FIGURE 3.5 SLOPE INDICATOR READINGS FROM BH2

the vicinity of the failure plane, hence it was not possible to lower the inclinometer to the bottom of the hole. The instrument stuck at a depth of 60 feet below the top of the pipe, hence this depth has been regarded as the upper limit of the failure plane. It can be seen from Figure 3.5 that no other shearing planes existed above the point. S4 was successfully monitored during September and October 1975, however it also had blocked off at a depth of 44 feet by early November 1975, after which time, no further readings were obtained. The results of S3 (Figure 3.6) indicate no substantial creep movements up to date, and thus it was not possible to define the depth of the failure plane. It is expected that this slope indicator will be monitored in future to follow creep movements.

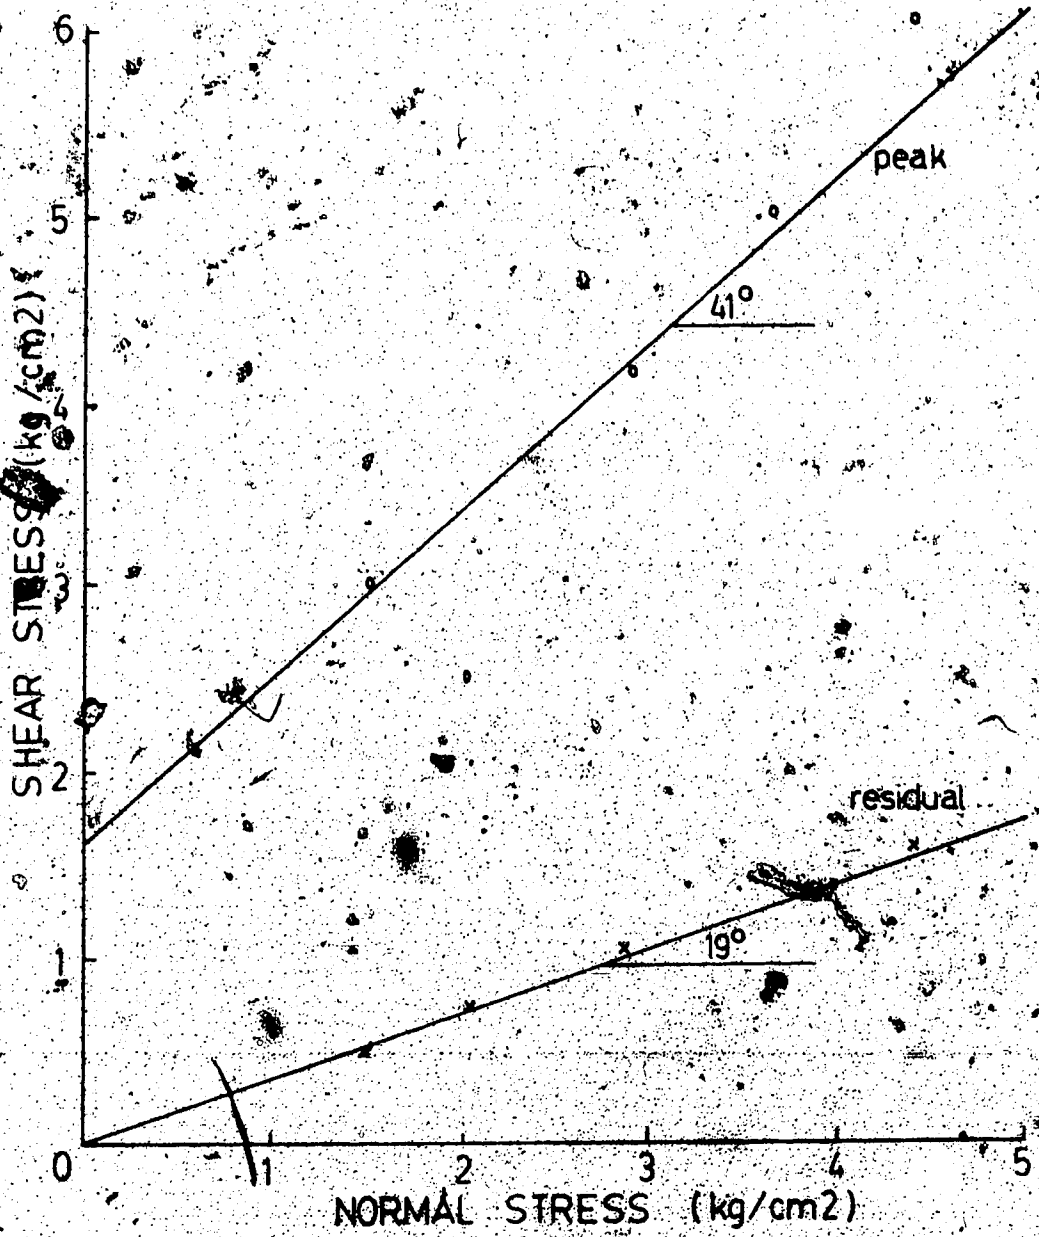
FIGURE 4.1. MOHR ENVELOPE FOR UNWEATHERED SILTY CLAY SHALE

normal effective stress on the samples. This was the procedure adopted by Kenney (1967), who stated that area correction affects both the shear stress and the normal effective stress and hence σ_1 / σ_3 remains constant. This practice was also adopted by Cullen and Donald (1971). The Mohr envelope for this series of test is shown in Figure 4.1.

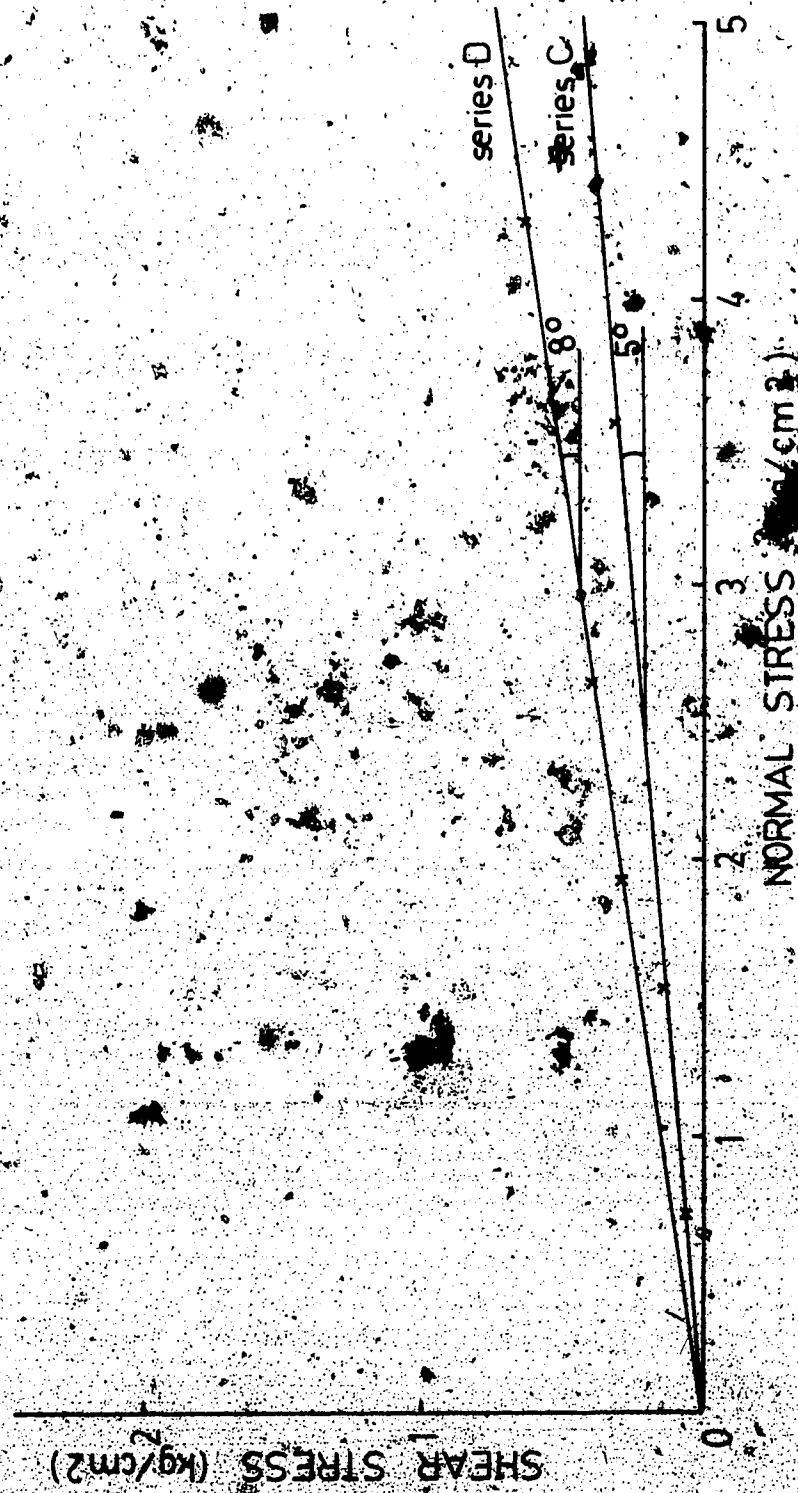
FIGURE 4.3 MOHR ENVELOPE FOR REMOULDED BENTONITE CLAY SHALE

Two series (C and D) of multi-stage reversal tests were carried out on the remoulded clayshale. Results of these tests are presented in Appendix C. Series C tests are shown in Figures C12 to C14 and series D tests in Figures C15 to C17. The Mohr envelopes for both series of tests are shown in Figure 4.3, and two different residual angles of shearing resistance of 5 and 8 degrees respectively were obtained.
