Corrosion of Aluminum Alloys in Wastewater Treatment Aeration Tanks

A thesis submitted in partial fulfillment of the requirements for the degree of

Materials Engineering

Severe localized corrosion was found throughout an aeration tank of a modular wastewater treatment plant. Specifically, pitting, crevice corrosion, galvanic corrosion, and intergranular corrosion (IGC) were observed on the 5000 and 6000 series aluminum alloys used in the tank's construction. One of the suspected environmental causes of corrosion was an aeration tank process additive, namely a coagulant – either aluminum sulphate (Alum) or polyaluminum chloride (PACl; Isopac). Laboratory scale corrosion cells were designed to isolate, simulate, and evaluate the corrosivity of the coagulants (in relevant quantities) on the metallic alloys of construction. Additionally, due to presence of deposit found throughout the tank (resulting in under-deposit corrosion), fabricated crevices were installed on the tested alloys to help simulate crevice corrosion environments. The solution conditions in the cells were monitored throughout the duration of the immersion testing in order to assess whether the cells were within nor

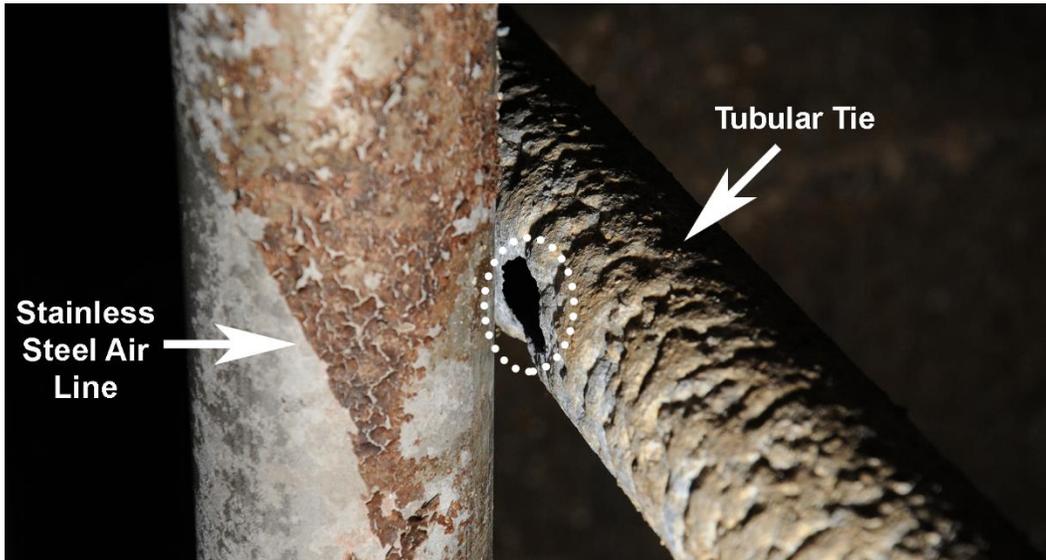
Multiple inspections [1,2] and failure investigations (Appendix A) performed by the author revealed severe corrosion damage throughout the aeration tank and on collected specimens. The collected specimens examined include: (1) a large portion of tubular tie, (2) one aeration piping bracket, portions of both the tank (3) floor and (4) wall, and varying amounts of (5) deposits removed throughout the tank. The following list summarizes the findings from both the inspections and failure investigations. Moreover, some of the results of both activities are illustrated in Figures 1-1 through 1-3.

Figure 1-1: Through wall corrosion (indicated by the dotted oval) of a tubular tie immediately adjacent to aeration piping [1].

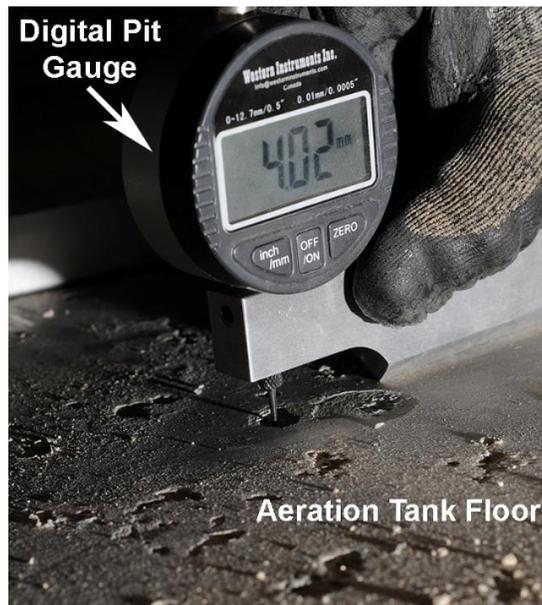
Figure 1-2: “Pit measurements taken from the deepest identified pit on the floor of the aeration tank. After brushing deposits clear.” [1] The gauge indicates that the pit is ~4 mm deep (~42% of the thickness assuming 9.53 mm / 0.375 inch thickness) [1].

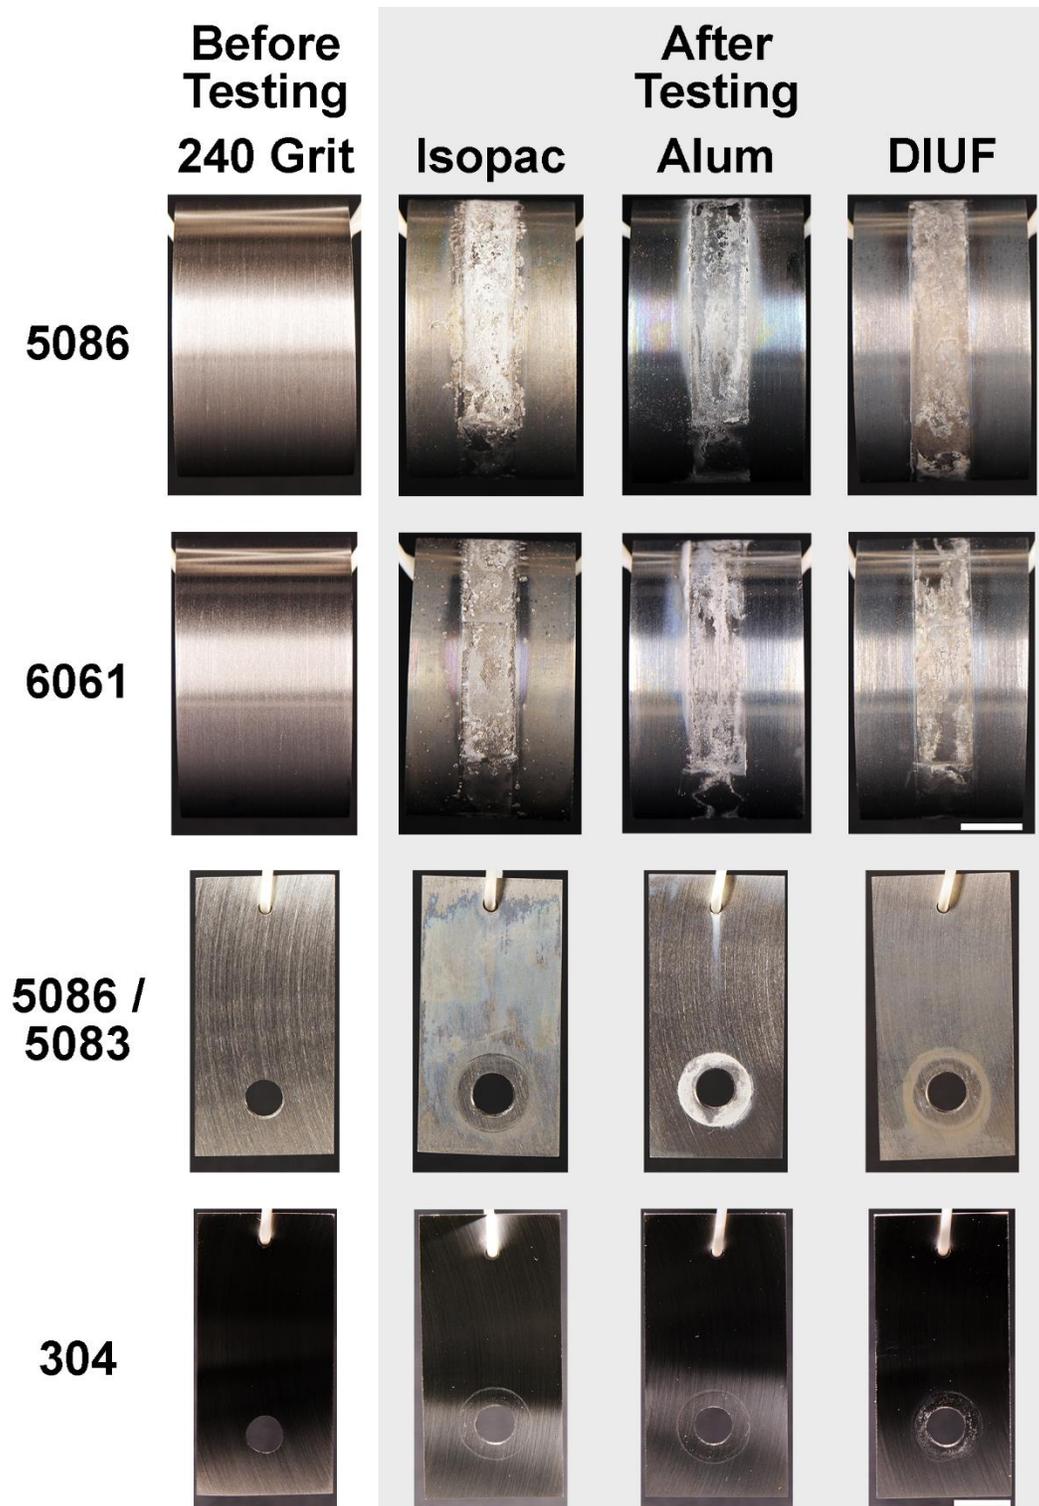
Figure 4-1: Representative images of corrosion coupons, before and after the 28-day immersion testing, from the twelve electrolyte-alloy combinations. Both scale bars are 1 cm.

Comparing the different electrolyte-alloy combinations after immersion testing to before testing, all aluminum alloy coupons appeared to have varying amounts of deposit present on both the exposed and crevice surfaces. The deposit on the exposed surfaces appeared to be a tarnish, whose colour and amount of surface area coverage varied between the coupons. Conversely, the 304 stainless steel coupons appeared to only have deposit present on or immediately adjacent to the crevice surface. The buildup of tarnish on the aluminum alloy coupons and lack of tarnish formation on the 304 coupons is shown in Figures 4-2 and 4-3, respectively.

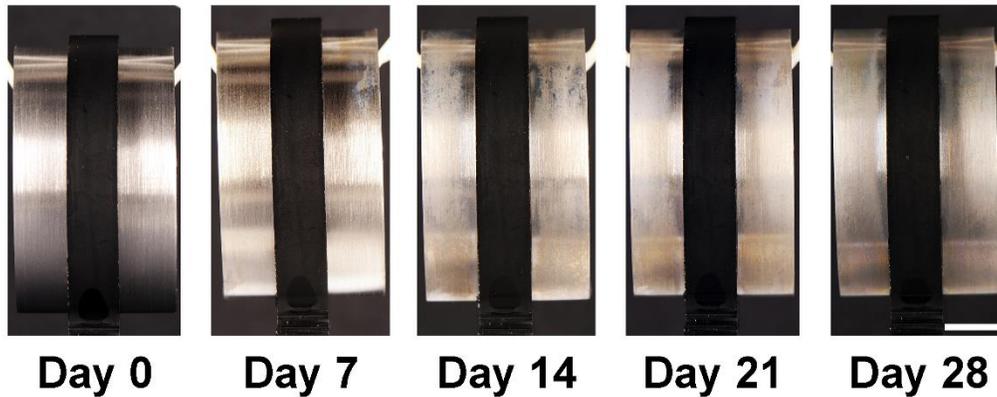
Figure 4-2: Representative image of tarnish build-up on the aluminum alloy coupons throughout the 28-day immersion testing. Electrolyte-alloy combination presented is Isopac-5086. The coupon was still wet and the scale bar is 1 cm.

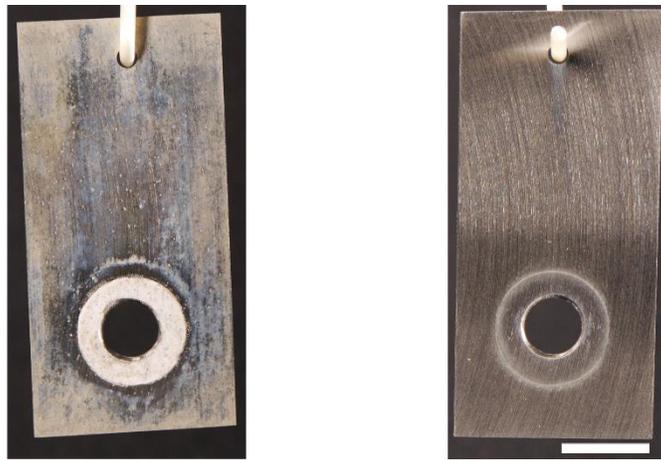
The deposit on and adjacent to the crevice surfaces of all the alloys appeared creamy white in colour. The amount of deposit varied among each combination; yet, for the 5086 and 6061 alloys, the presence of deposit was most prominent on the coupons in the Isopac solution, followed by Alum, then DIUF. Regarding the 5086/5083 alloy, deposit was consistently present on and adjacent to the crevice surfaces of the coupons in the Alum solution. Moreover, deposit also appeared to be originating from the hook hole. There was little deposit present on the 5086/5083 coupons in DIUF and Isopac solutions; however, one side from one of the three coupons per combination appeared to have deposit (Figure 4-4). Regarding the other surfaces of the remaining two coupons per combination, all surfaces appeared relatively similar. There were some differences in the amount of deposit present on the crevice surface; however, this difference is believed to have occurred due to the inherent variability of deposit precipitating out of solution, or the unwanted dislodgement of deposit when the crevice formers were removed. Finally, all 304 coupons exhibited small amounts of deposit on and adjacent to the crevice surface.

Figure 4-4: 5086/5083 coupons which exhibited deposit on and adjacent to the crevice surface. The coupon on the left was in Isopac solution, while the coupon on the right was in DIUF. Scale bar is 1 cm.

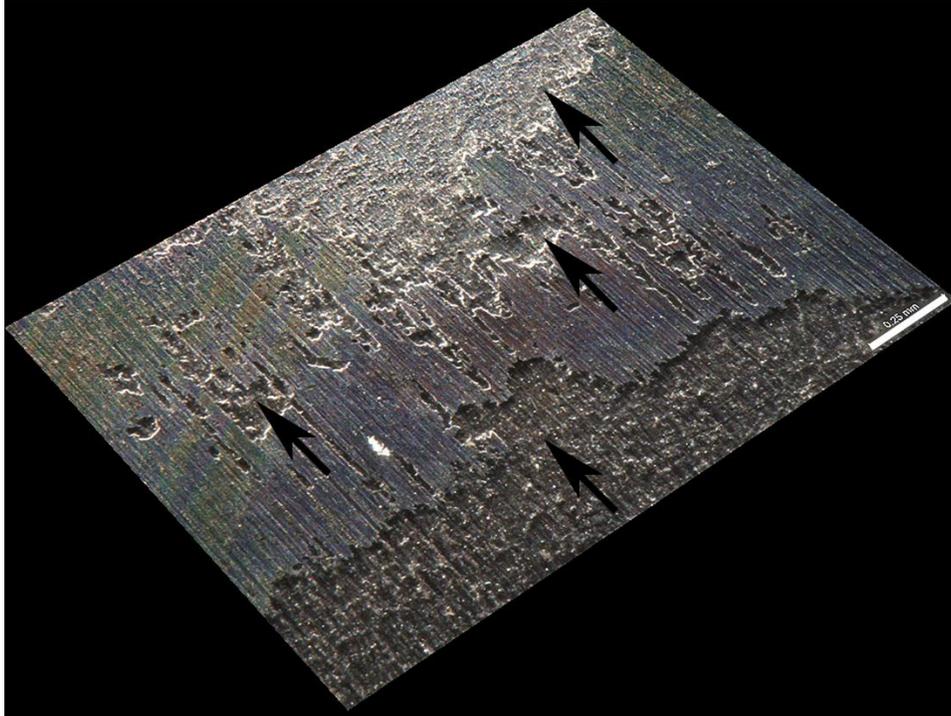
Higher magnification images of the coupon surfaces illustrates the morphology of the corrosion damage. Unless otherwise indicated, the following images were taken of the coupon surface before cleaning. Figures 4-8 and 4-9 show metal loss on the crevice surface of the 5086 alloy. The damage in Figure 4-8 looked somewhat round or elongated in shape – with no directionality. Meanwhile, the damage in Figure 4-9 was irregular in shape and appeared to have initiated in the grooves formed from the 240 grit surface finish. These oriented grooves appear to eventually consolidate into wide and shallow metal loss. Whichever way the metal loss initiates and subsequently propagates, this damage signifies that crevice corrosion had occurred.

Figure 4-9: Additional image of corrosion (black arrows) on the crevice surface of 5086 alloy in Isopac solution. Again, crevice corrosion has occurred. Arrows are also oriented parallel to the grinding marks. Scale bar is 0.25 mm.

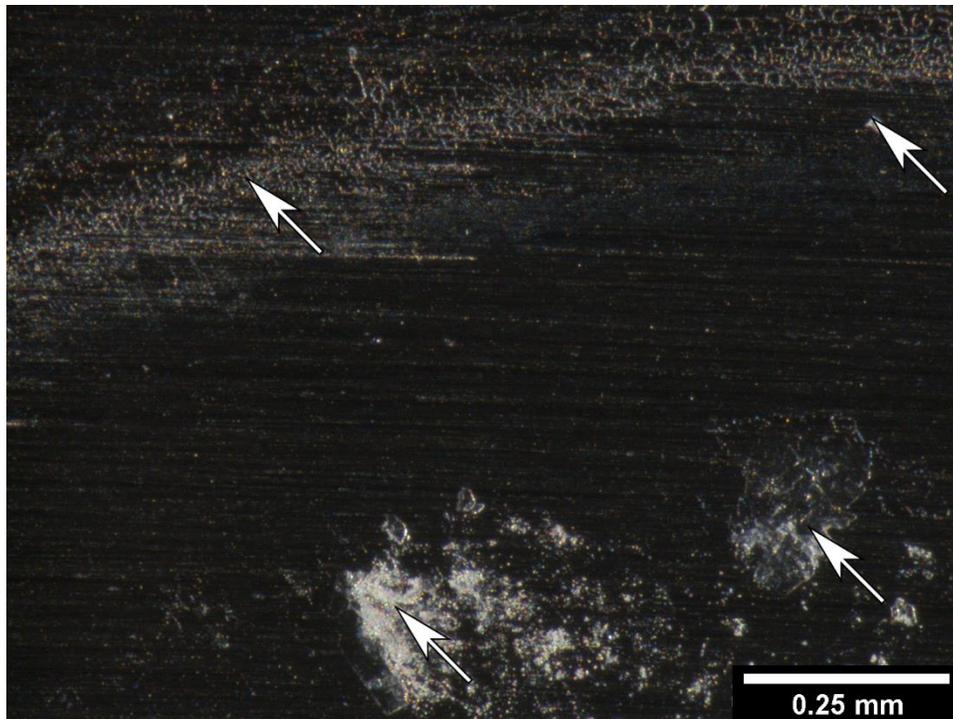
Figure 4-12: 304 alloy in Isopac solution; both of the exposed (top of picture) and crevice (bottom of picture) surfaces. Deposit is also observed on the surfaces (white arrows).

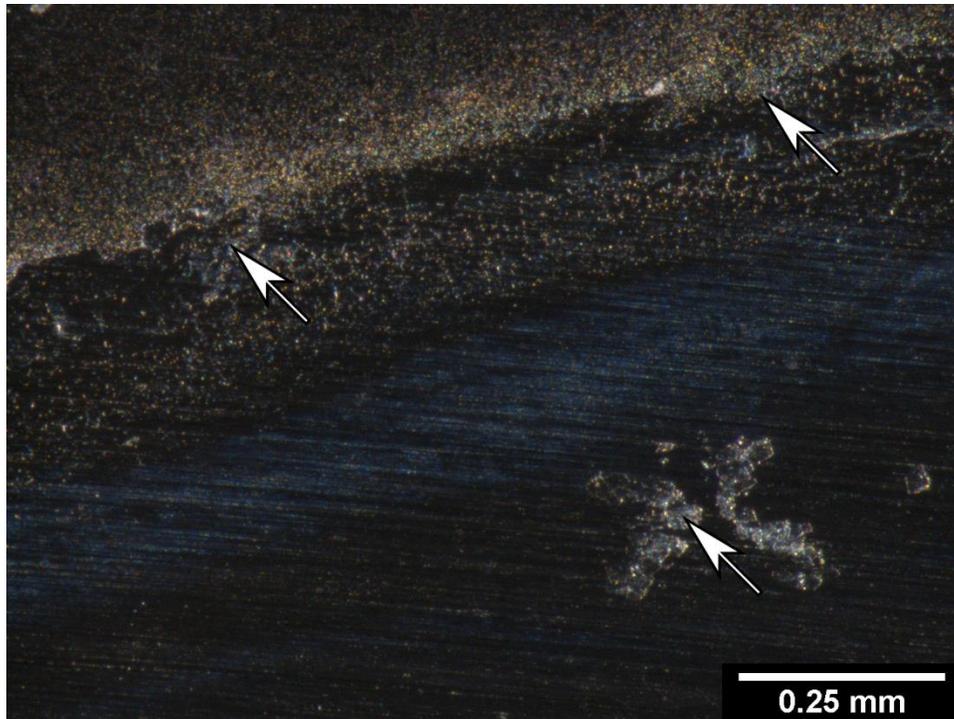
Figure 4-18: 304 alloy in Alum solution; both of the exposed (top of picture) and crevice (bottom of picture) surfaces. Deposit is also observed on both surfaces (white arrows).

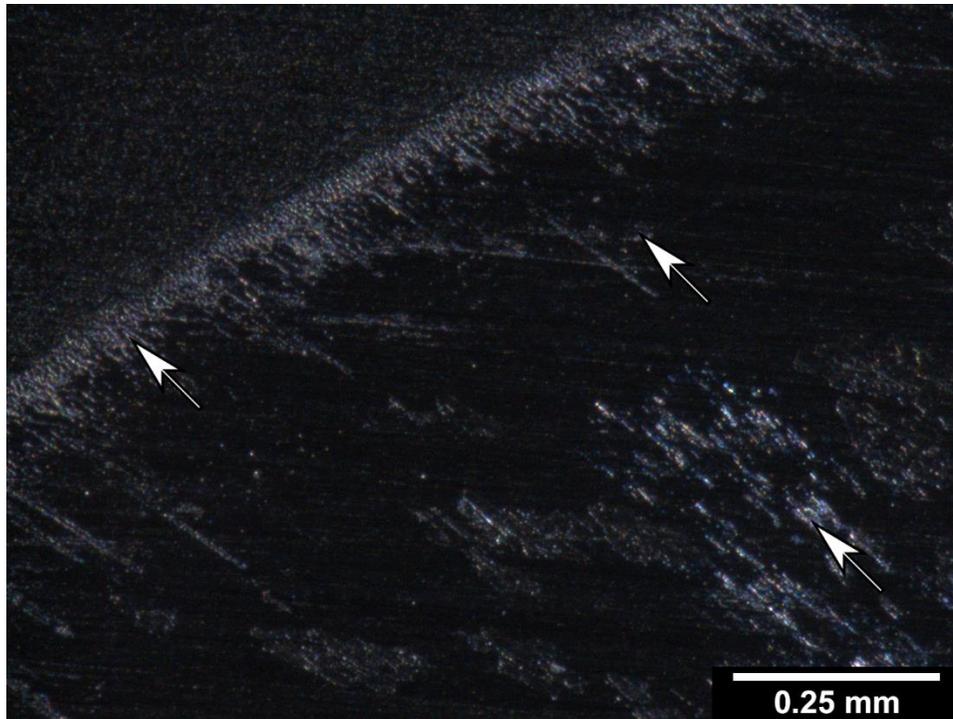
Figure 4-23: 304 alloy in Alum solution; both of the exposed (top of picture) and crevice (bottom of picture) surfaces. Deposit is also observed on the surface (white arrows). Scale bar is 0.25 mm.

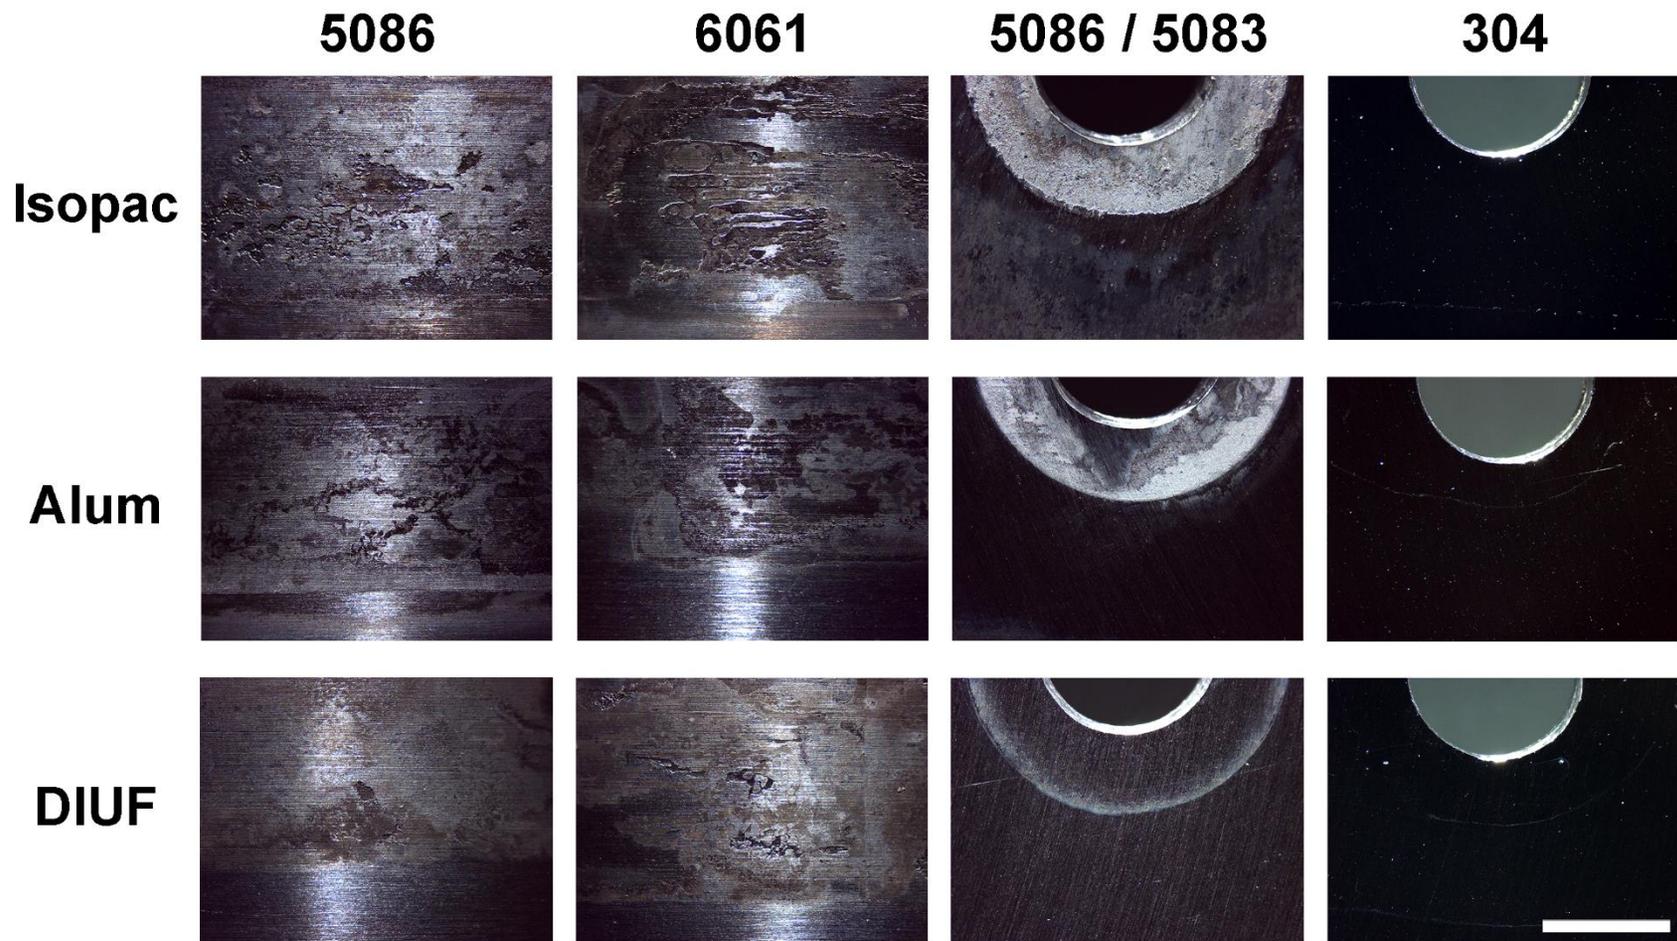
The “After Testing, After Cleaning” stereo micrographs from Figures 4-7, 4-14, and 4-19 were organized based off their respective electrolyte-alloy combination. These images are presented below in Figure 4-24. At this magnification ( $\sim 8\times$ ), the shape of the pit openings, on the crevice surfaces, appear irregular and elongated for both the 5086 and 6061 coupons in all three electrolytes. The corrosion damage on the 5086/5083 coupons in both Isopac and Alum look more wide and shallow, and irregular in shape. Conversely, at this magnification, it is difficult to identify the morphology of the corrosion damage on the 5086/5083 coupons in DIUF. At higher magnification, the small pit openings are round in shape (as shown in Figure 4-22). Ultimately, crevice corrosion was identified on all of the aluminum alloys tested in the Isopac, Alum, and DIUF electrolytes. Moreover, the crevice corrosion appeared more pronounced on the aluminum alloys exposed to Isopac, followed by Alum then DIUF. Regarding the depth of metal loss, the crevice corrosion on all of the aluminum alloys in the

aforementioned electrolytes appeared to be superficial. This assessment in depth is only qualitative; no depth measurements were performed in this study.

As opposed to the three aluminum alloys, no crevice corrosion was observed on the 304 stainless steel in any of the above-mentioned electrolytes. Deposit was identified on the stainless steel in each of the three electrolytes; however, no metal loss could be found – even during inspection at higher magnifications.

Figure 4-24: Composite images of all twelve electrolyte-alloy combinations after immersion and cleaning. Scale bar is 5 mm.

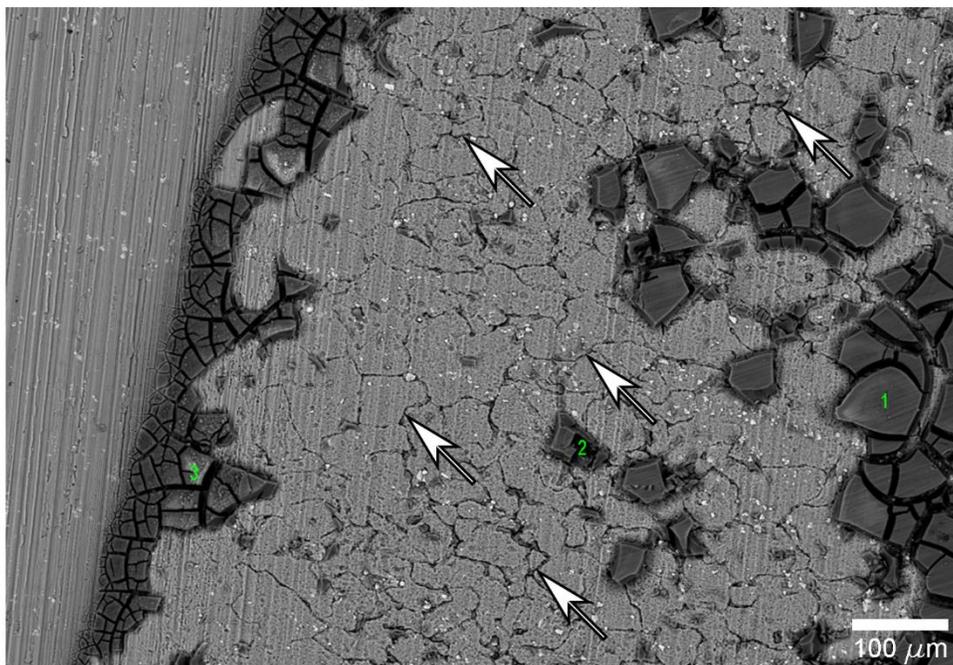
Figure 4-26: Representative BSE image of deposit collected from sheet coupons. The three green numbers cover the locations where EDX data was acquired. IGC (white arrows) can be identified on the crevice surface (right side of image; exposed surface is on the left side of the image, beyond the deposit). Image taken at a 20 kV accelerating voltage and a 11 mm working distance.

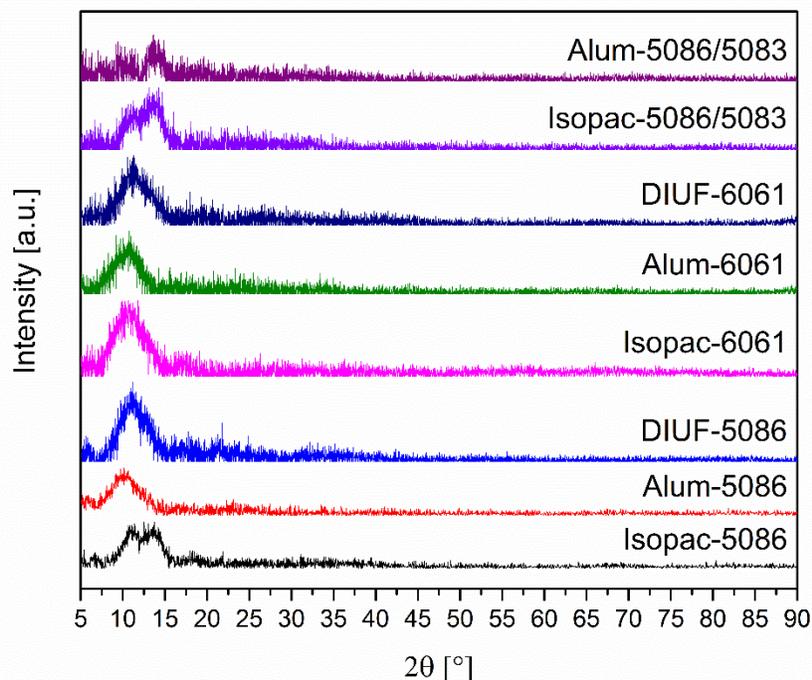
All XRD patterns did not exhibit any combination of peaks of known crystalline compounds. There appears to be some noise in the patterns (in the form of many small peaks), as well as a broad peak between 10 and 15°. This broad peak corresponds to the quartz of the zero background slide used for holding the deposit specimen during testing. The lack of any crystalline compounds suggests that there are only amorphous compounds present in the deposit, or there is not enough crystalline material to meet the minimum volume percent required for detection. Further analysis of the deposits using FTIR was performed to substantiate the former.

Figure 4-27: Representative XRD patterns of deposit collected from eight of the twelve electrolyte-alloy combinations.

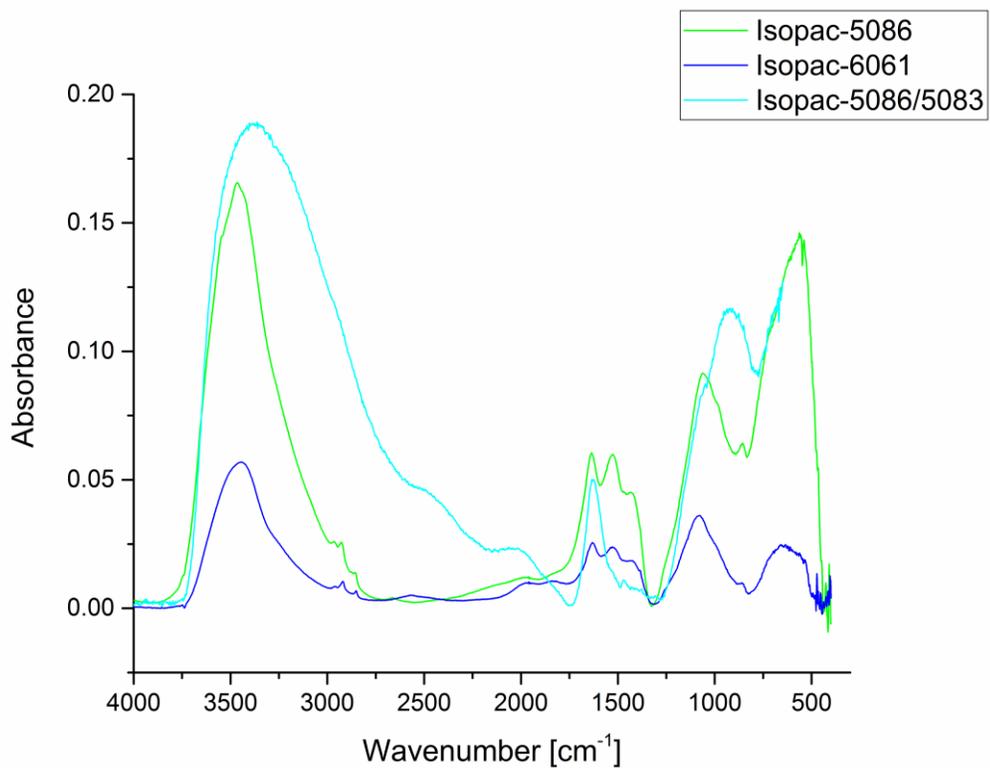
Figure 4-28: Representative FTIR spectra of 5086, 6061, and 5086/5083 alloys in Isopac solution.

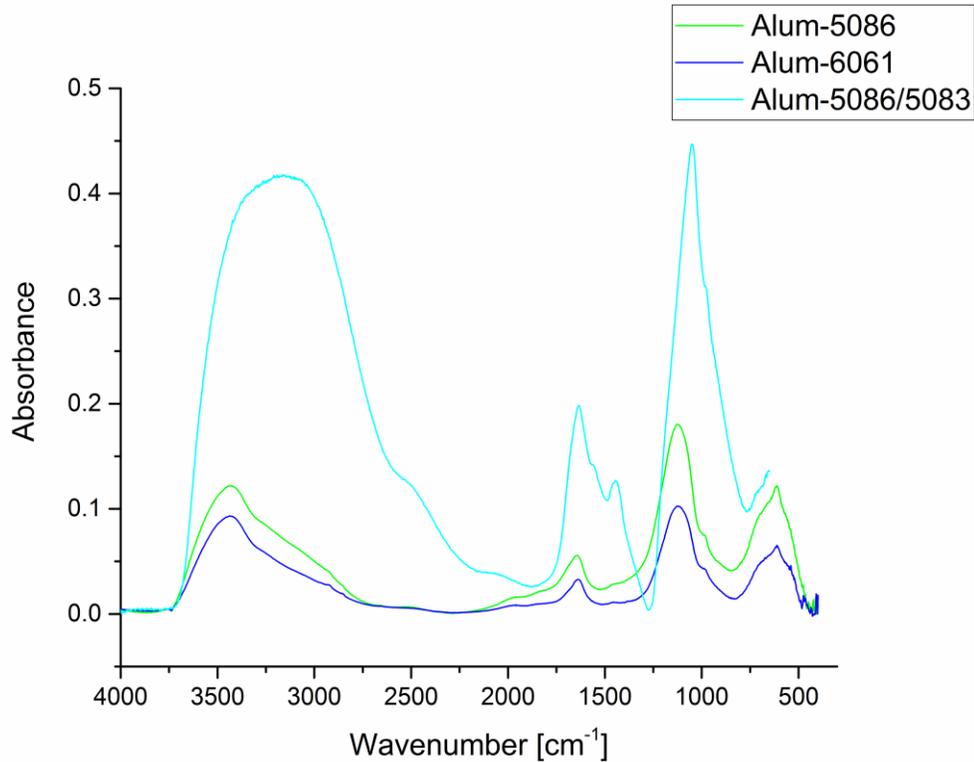
Figure 4-29: Representative FTIR spectra of 5086, 6061, and 5086/5083 alloys in Alum solution.

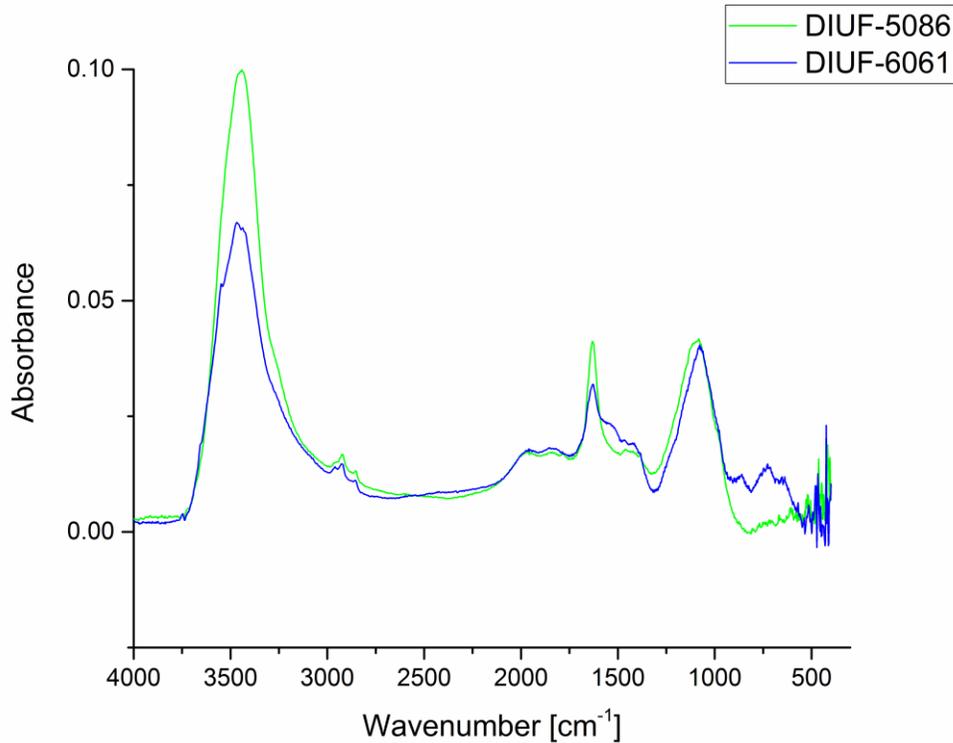
The collected spectra of the deposits from 5086 and 6061 alloys in DIUF are displayed in Figure 4-30. As with the aluminum alloys in coagulant solutions, strong peaks identified around  $3500\text{ cm}^{-1}$  and  $1000\text{ cm}^{-1}$  suggest the presence of either bayerite or gibbsite [4–6]. The peaks between  $1500$  and  $1700\text{ cm}^{-1}$  also indicate either the presence of aluminum oxide ( $\text{Al}_2\text{O}_3$ ) [6] or water (through a peak produced by HOH bending) [5]. However, there are discrepancies between the collected spectra and the peak wavenumber data provided in Appendix E. Again, it is entirely possible that amorphous aluminum oxides and hydroxides are present in the deposits formed on either the 5086 or 6061 alloys; however, it cannot be definitively confirmed.

Figure 4-30: Representative FTIR spectra of 5086 and 6061 alloys in DIUF.

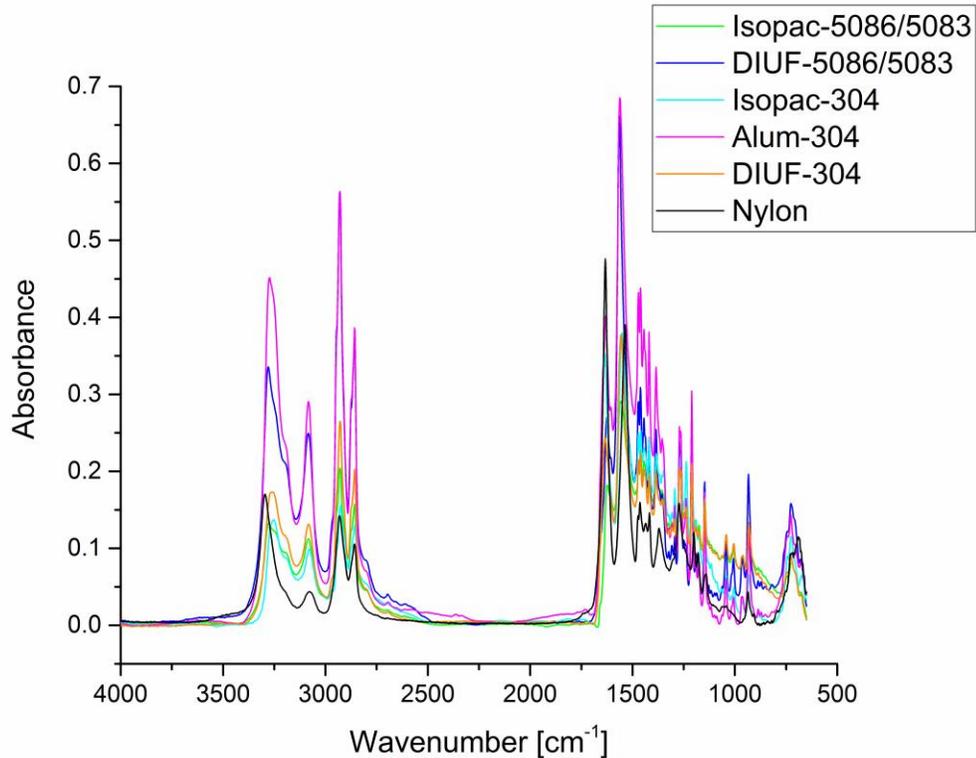
found to match the spectra of the nylon 6,6 washers used as crevice formers. Both the FTIR spectra and EDX compositional data confirm that the deposit produced on the 304 stainless steel alloys in all three electrolytes is indeed nylon. This information further indicates that nylon was transferred onto the surfaces of the coupons during installation and possibly removal of the crevice formers.

Figure 4-31: Representative FTIR spectra of nylon present in the deposits of the 304 alloy in all three electrolytes, and on the 5086/5083 alloy in both Isopac solution and DIUF.

Also included in Figure 4-31 is nylon deposit which was found on the crevice surface of the 5086/5083 alloy in Isopac solution and DIUF. The presence of two different spectra collected from the 5086/5083 alloy in Isopac solution indicates that both corrosion products had formed and nylon transfer had occurred. Meanwhile, the presence of nylon on the 5086/5083 alloy in DIUF indicates that only nylon transfer had occurred. This point is supported by the previously collected EDX data, which contains both large amounts of carbon and nitrogen.

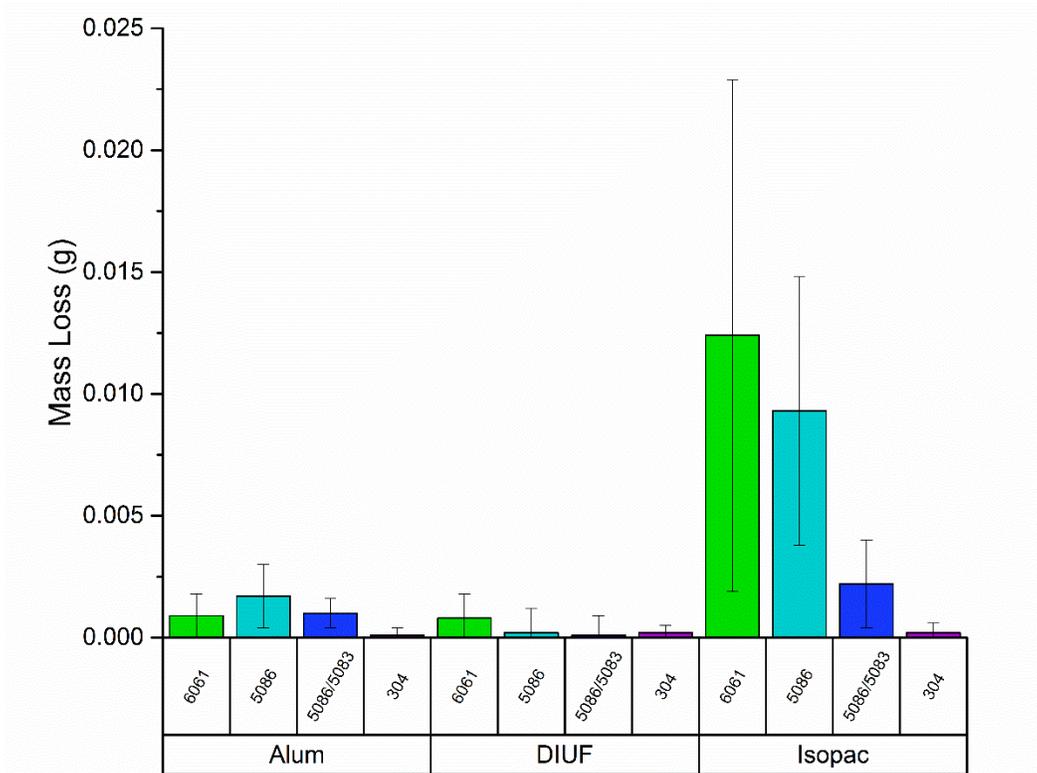
Figure 4-32: Average mass loss measurements for the twelve electrolyte-alloy combinations used in immersion testing.

All of the aluminum alloys in Isopac solution had relevant mass loss, whereas only 5086 and 5086/5083 alloys in Alum solution had mass loss measurements which were relevant. Relevance is judged based on the lower bound of the mass loss confidence interval being greater than zero. If this lower bound is greater than zero, then the mass loss is said to be relevant, and vice versa. Conversely, the calculated mass loss for the 304 stainless steel in all three electrolytes, the aluminum alloys in DIUF, and 6061 in Alum were negligible. Even though the average measurements were greater than zero, the corresponding confidence intervals rendered said measurements irrelevant.

Regarding the 6061 alloy coupon in DIUF that had its crevice former moved during the immersion testing, the calculated average mass loss and confidence interval for the DIUF-6061 combination presented in Figure 4-32 could be changed. The value presented in the figure ( $0.0008 \pm 0.0010$  g) includes the mass loss measurements for all three coupons in the DIUF-6061 set. If it is assumed that the mass measurement of the disturbed coupon is invalid, the average mass loss and confidence interval for the DIUF-6061 combination, using the remaining two coupons, would be  $0.0010 \pm 0.0025$  g. Therefore, even with the coupon removed, the mass loss measurement for this combination would be irrelevant.

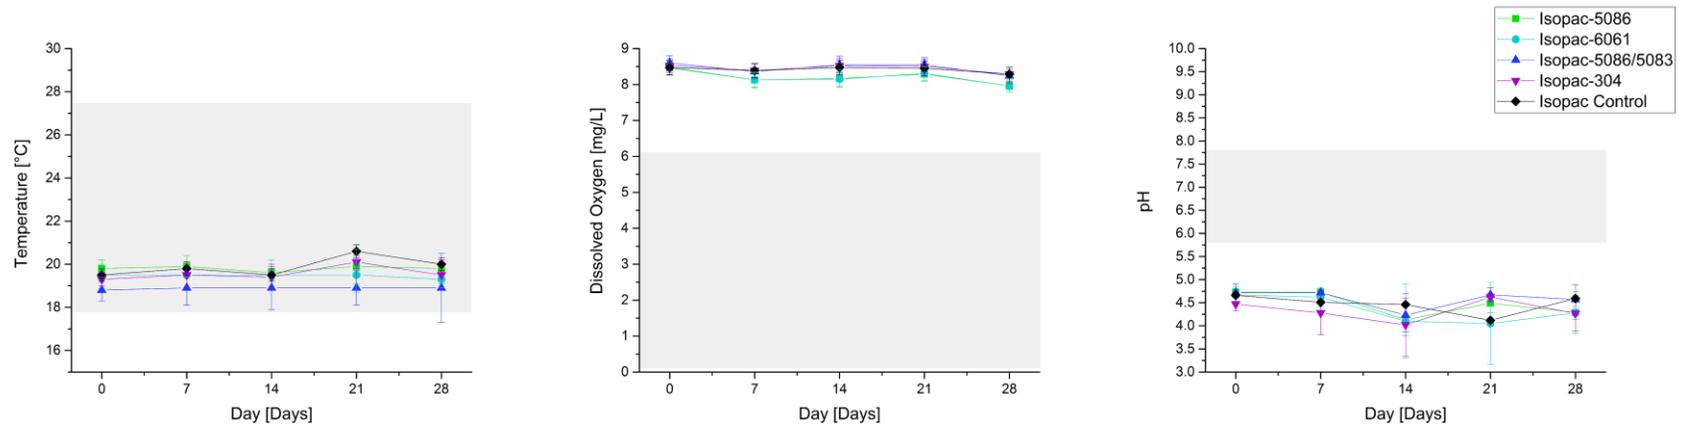
Figure 4-33: Average T, DO, and pH measurements for the four alloys in Isopac solution compared to the Isopac solution control. The shaded region in each graph is the operating range of the aeration tank.

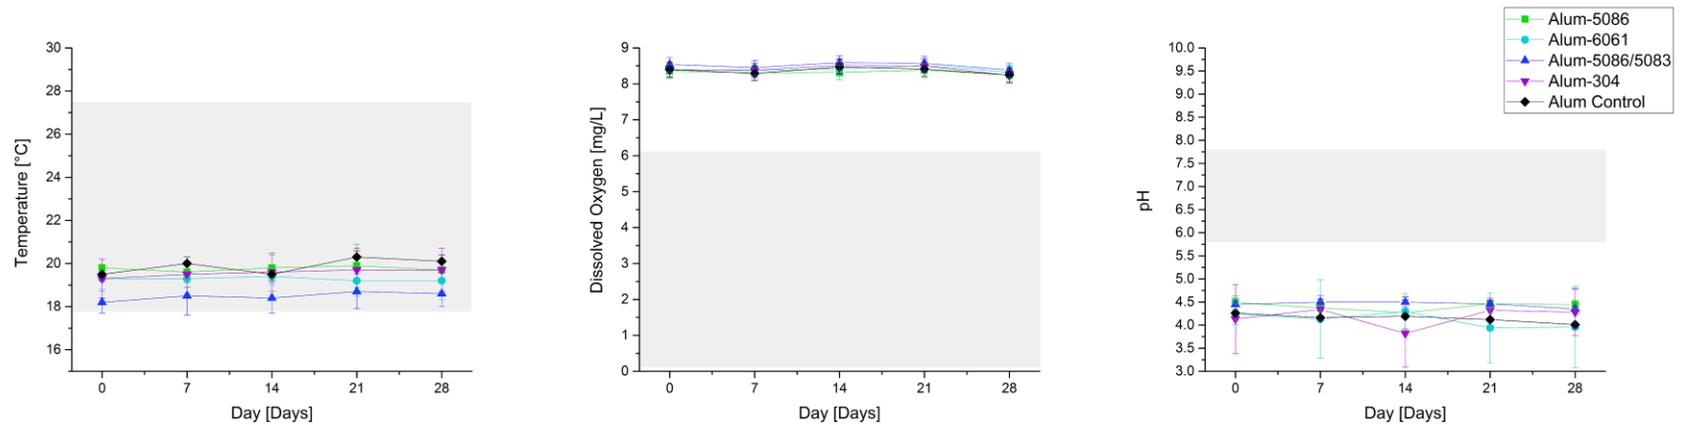
Figure 4-34: Average T, DO, and pH measurements for the four alloys in Alum solution compared to the Alum solution control. The shaded region in each graph is the operating range of the aeration tank.

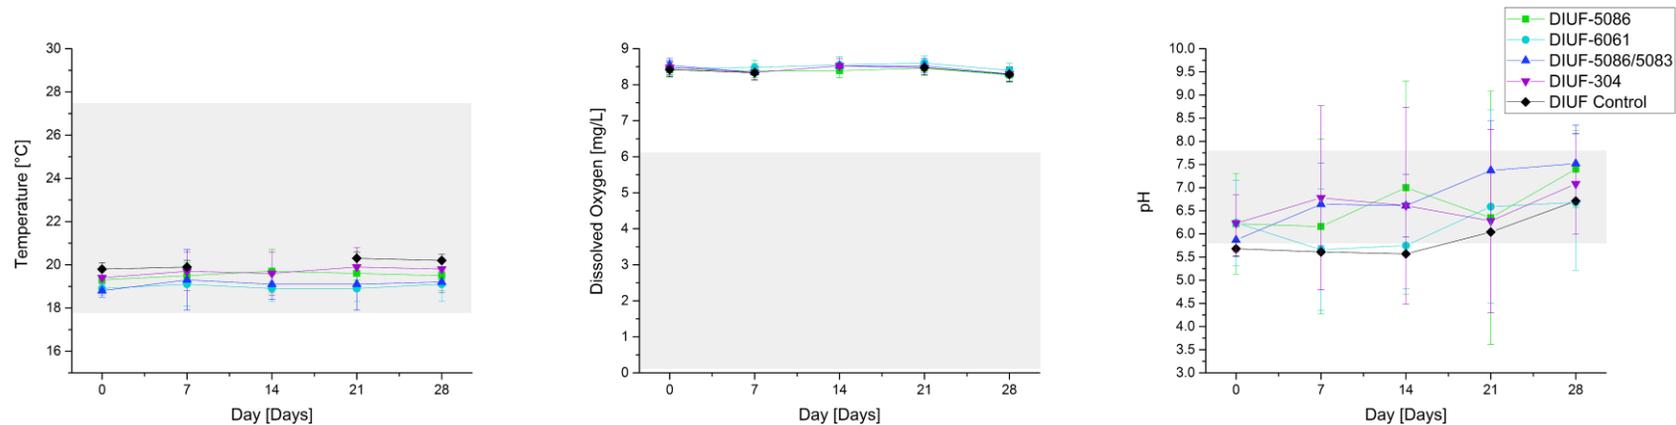
Figure 4-35: Average T, DO, and pH measurements for the four alloys in DIUF compared to the DIUF control. The shaded region in each graph is the operating range of the aeration tank.

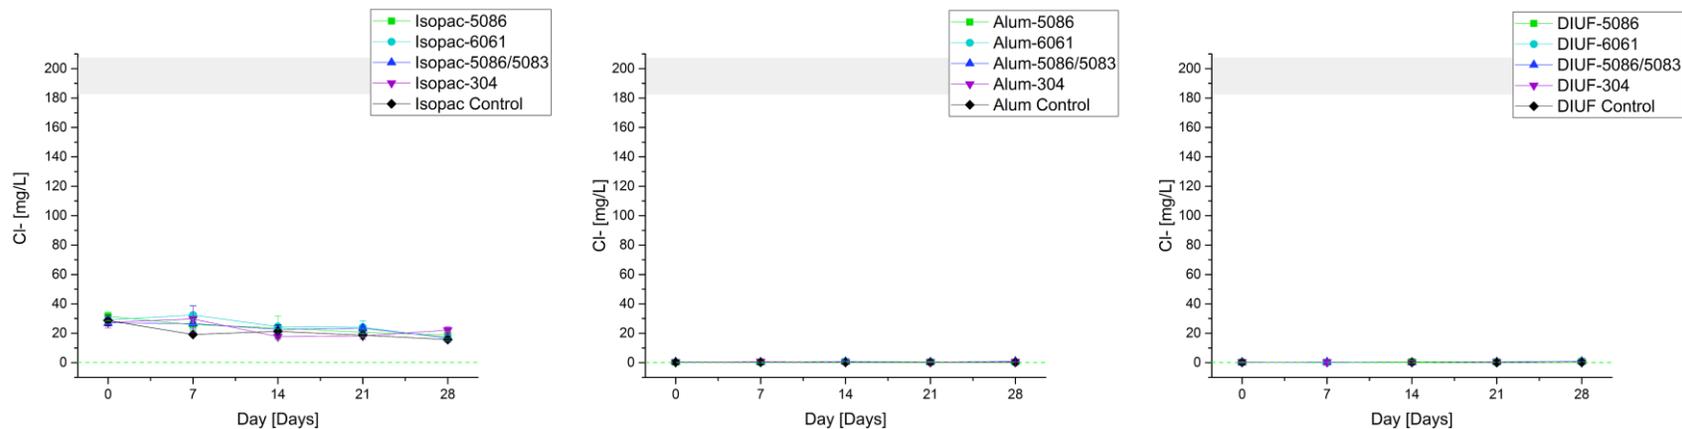
Figure 4-36: Average  $\text{Cl}^-$  measurements for select immersion cells compared to relevant control solution. The shaded region in each graph is the operating range of the aeration tank, while the green dashed line is the detectability limit of the  $\text{Cl}^-$  probe (at 0.1 mg/L).

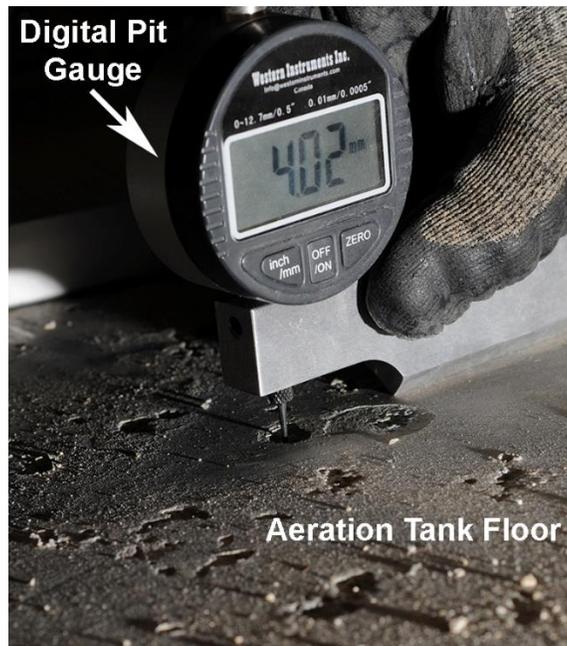
Figure A-2: “Pit measurements taken from the deepest identified pit on the floor of the aeration tank. After brushing deposits clear.” [1] The gauge indicates that the pit is ~4 mm deep (~42% of the thickness assuming 9.53 mm / 0.375 inch thickness) [1].

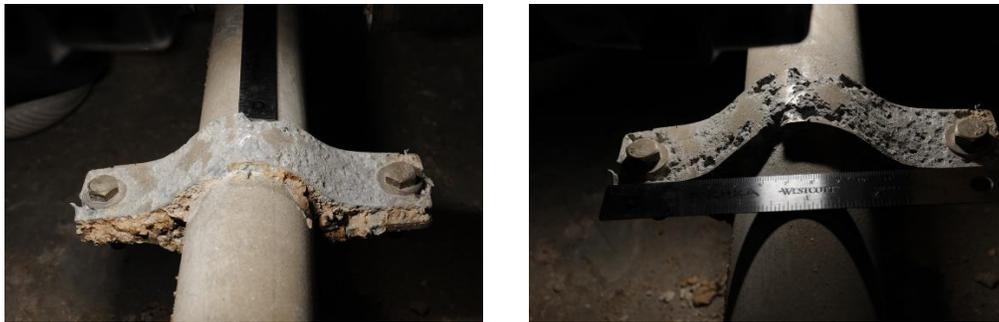
Figure A-3: Localized corrosion on brackets, shown with direct (left) and oblique (right) lighting [1].

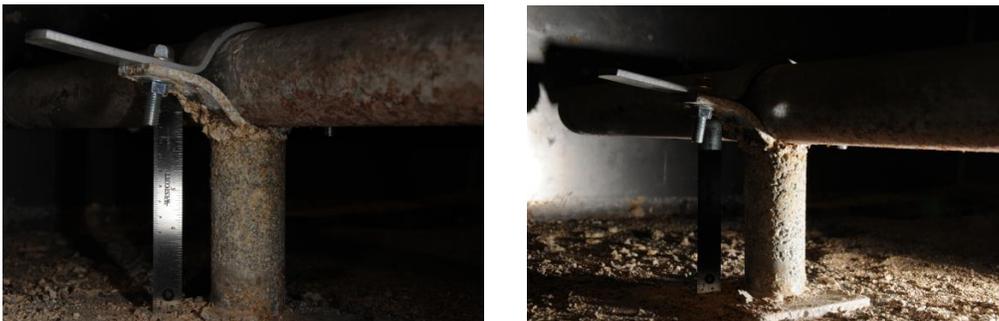
Figure A-4: Pipe support under brackets of an aeration line [1]. Pipe support exposed to both direct (left) and oblique (right) lighting conditions [1].

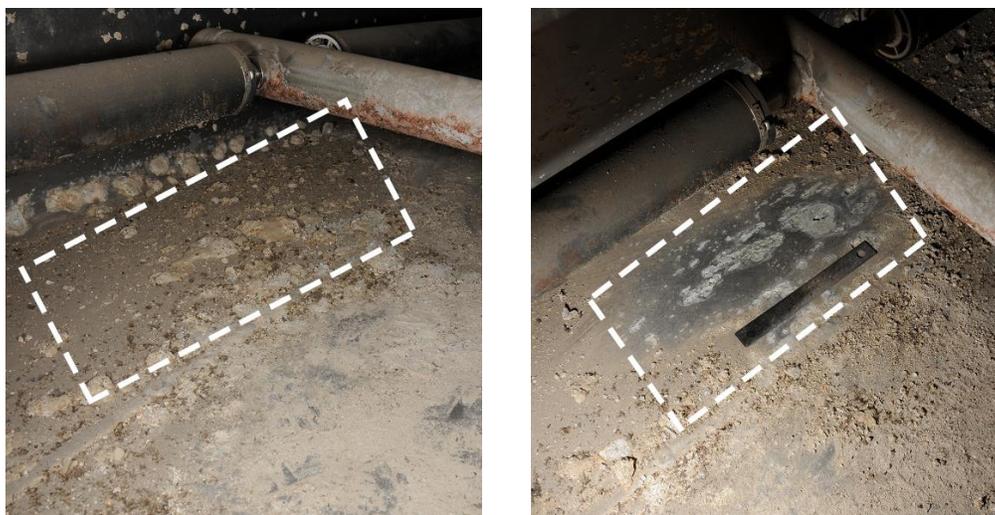
Figure A-6: Before (left) and after (right) removal of “sludge” deposits (dashed rectangle) from the aeration tank floor [1].

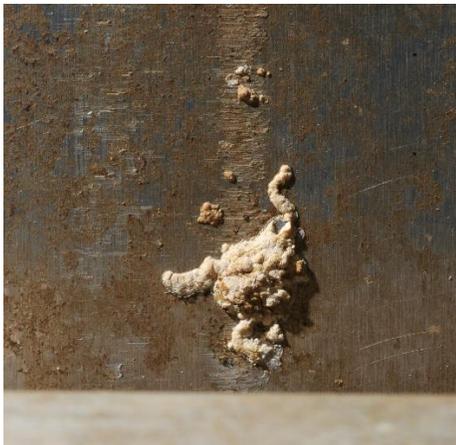
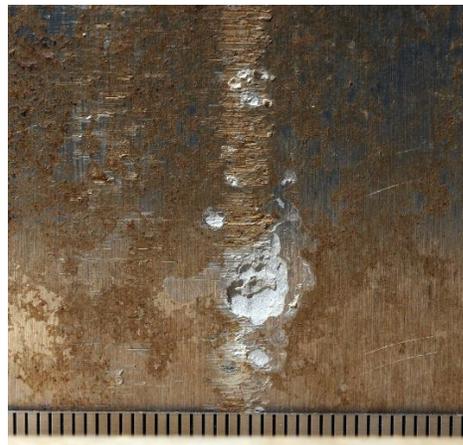
Figure A-9: “Crusty top hat” deposit on tooling marks located on vertical wall of gusset plates [1]. Images taken before (left) and after (right) removal of the deposit [1]. 1 mm divisions on the ruler in the right image [1].

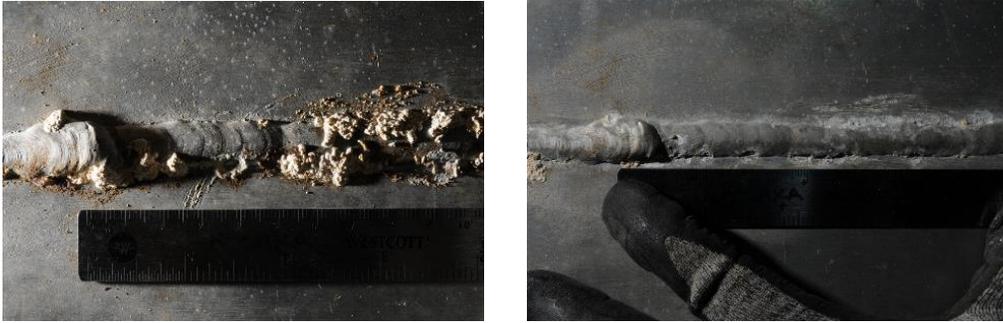
Figure A-10: Before (left) and after (right) removal of “crusty top hat” deposits from horizontal wall welds [1].

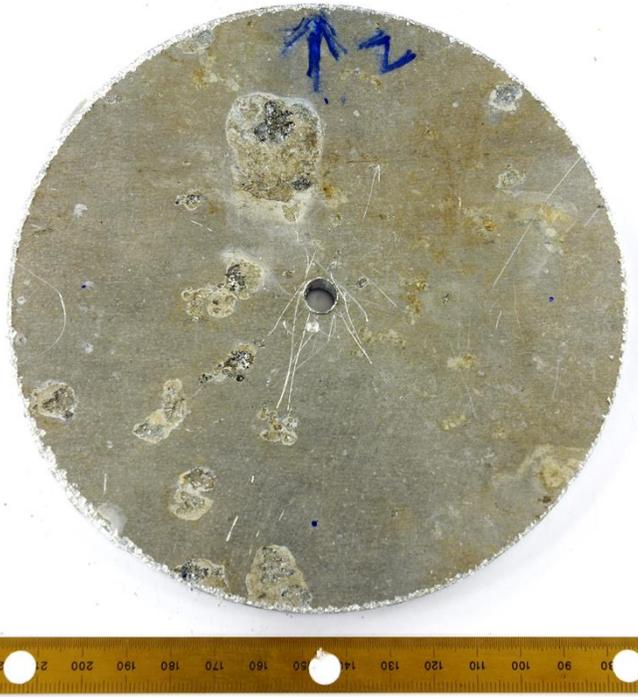
Figure A-15: As collected cut-out of floor section. Note the pits still contain metal shavings/other debris produced during removal the section from the aeration tank. (Blue arrow points north). Hole in the center is due to the hole saw used to extract the disc. Scale is in mm.

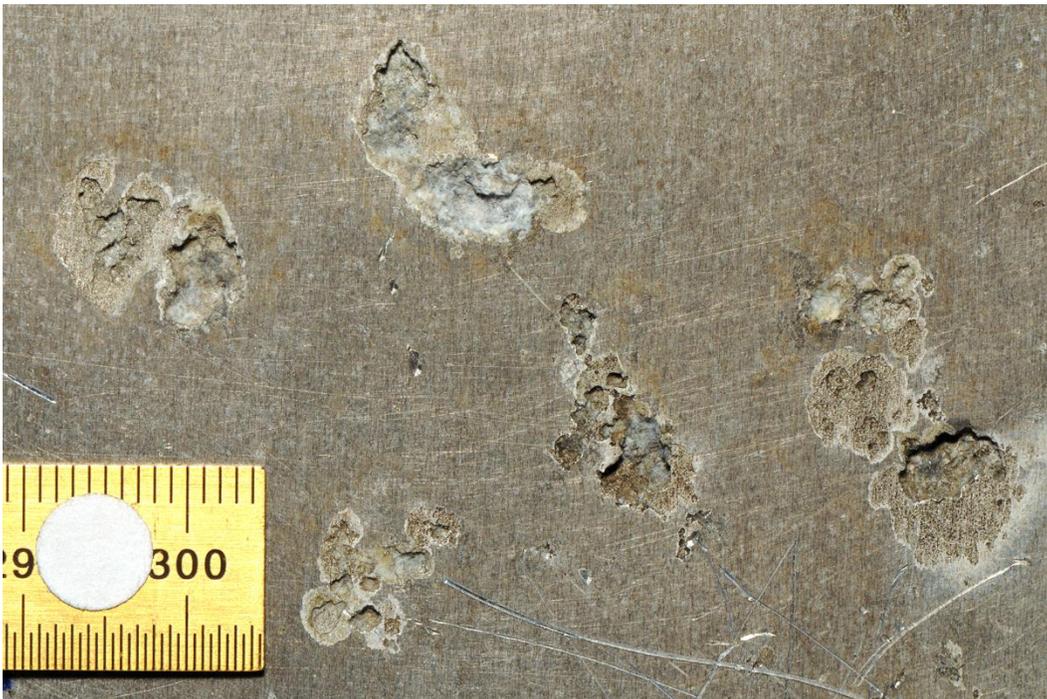
Figure A-17: Close-up of small pits. Scale is in mm.
