Corrosion of Aluminum Alloys in Wastewater Treatment Aeration Tanks

A thesis submitted in partial fulfillment of the requirements for the degree of

Materials Engineering

Severe localized corrosion was found throughout an aeration tank of a modular wastewater treatment plant. Specifically, pitting, crevice corrosion, galvanic corrosion, and intergranular corrosion (IGC) were observed on the 5000 and 6000 series aluminum alloys used in the tank's construction. One of the suspected environmental causes of corrosion was an aeration tank process additive, namely a coagulant – either aluminum sulphate (Alum) or polyaluminum chloride (PACl; Isopac). Laboratory scale corrosion cells were designed to isolate, simulate, and evaluate the corrosivity of the coagulants (in relevant quantities) on the metallic alloys of construction. Additionally, due to presence of deposit found throughout the tank (resulting in under-deposit corrosion), fabricated crevices were installed on the tested alloys to help simulate crevice corrosion environments. The solution conditions in the cells were monitored throughout the duration of the immersion testing in order to assess whether the cells were within nor

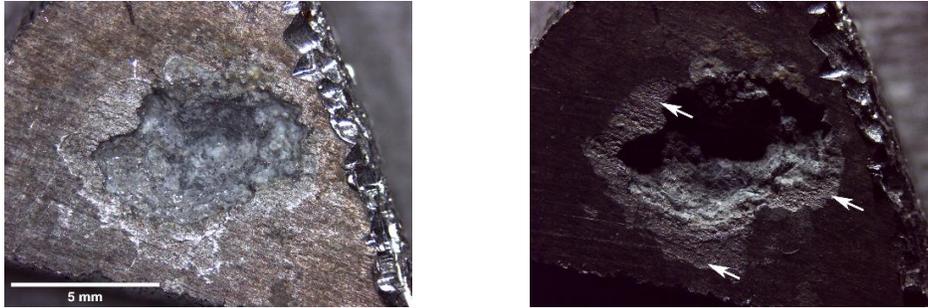
Figure A-18: Stereomicroscope images of small floor pit, with varying amounts of indirect lighting. Alignment of the rolling direction with some features in the pits (white arrows; parallel to rolling direction) can also be observed.

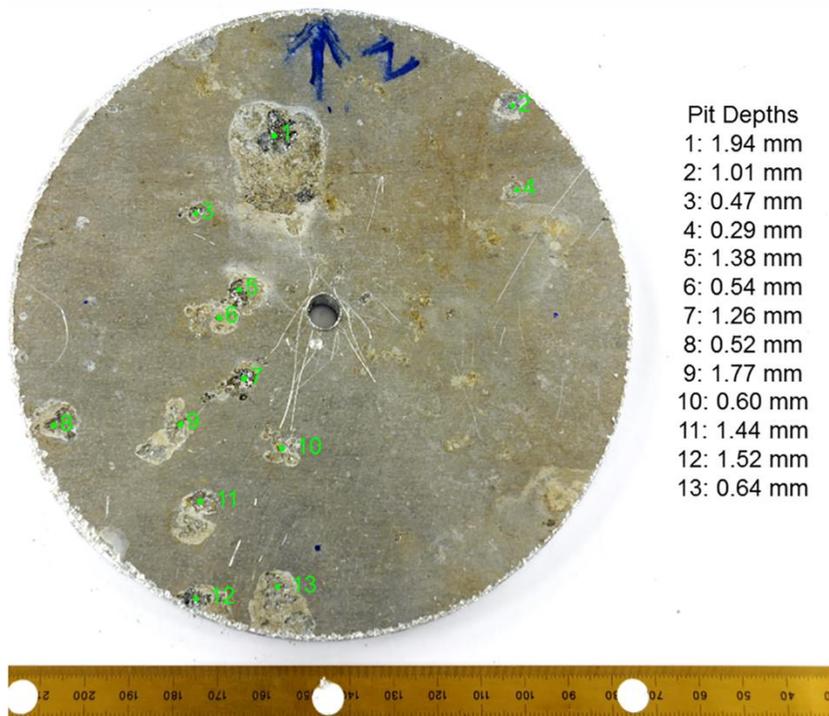
Figure A-19: Location of pit depth measurements. Scale is in mm.

Pit Number	Depth Measurements	
	[inch]	[mm]
1	0.076	1.94
2	0.040	1.01
3	0.019	0.47
4	0.011	0.29
5	0.054	1.38
6	0.021	0.54
7	0.050	1.26
8	0.020	0.52
9	0.070	1.77
10	0.024	0.60
11	0.057	1.44
12	0.060	1.52
13	0.025	0.64
<b>Average ± CI</b>	0.041 ± 0.013	1.03 ± 0.33

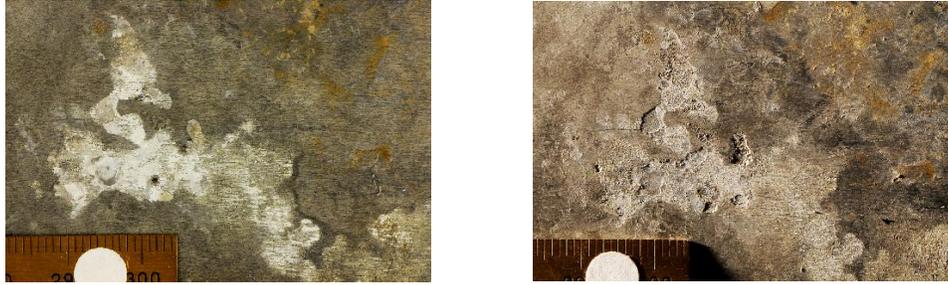
Figure A-21: Corrosion (as small, irregular shaped pits) on the bottom of the aeration tank floor. Images collected with varying amounts of indirect lighting. Scale is in mm.

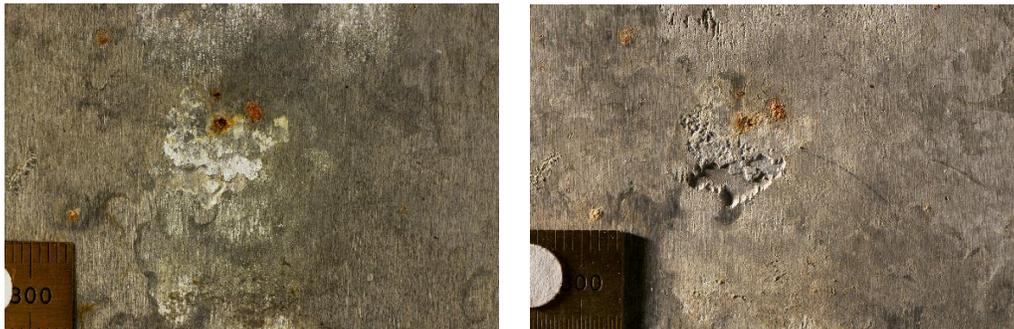
Figure A-22: Corrosion (as small, irregular shaped pits) on the bottom of the aeration tank floor. Images collected with varying amounts of indirect lighting. Scale is in mm.

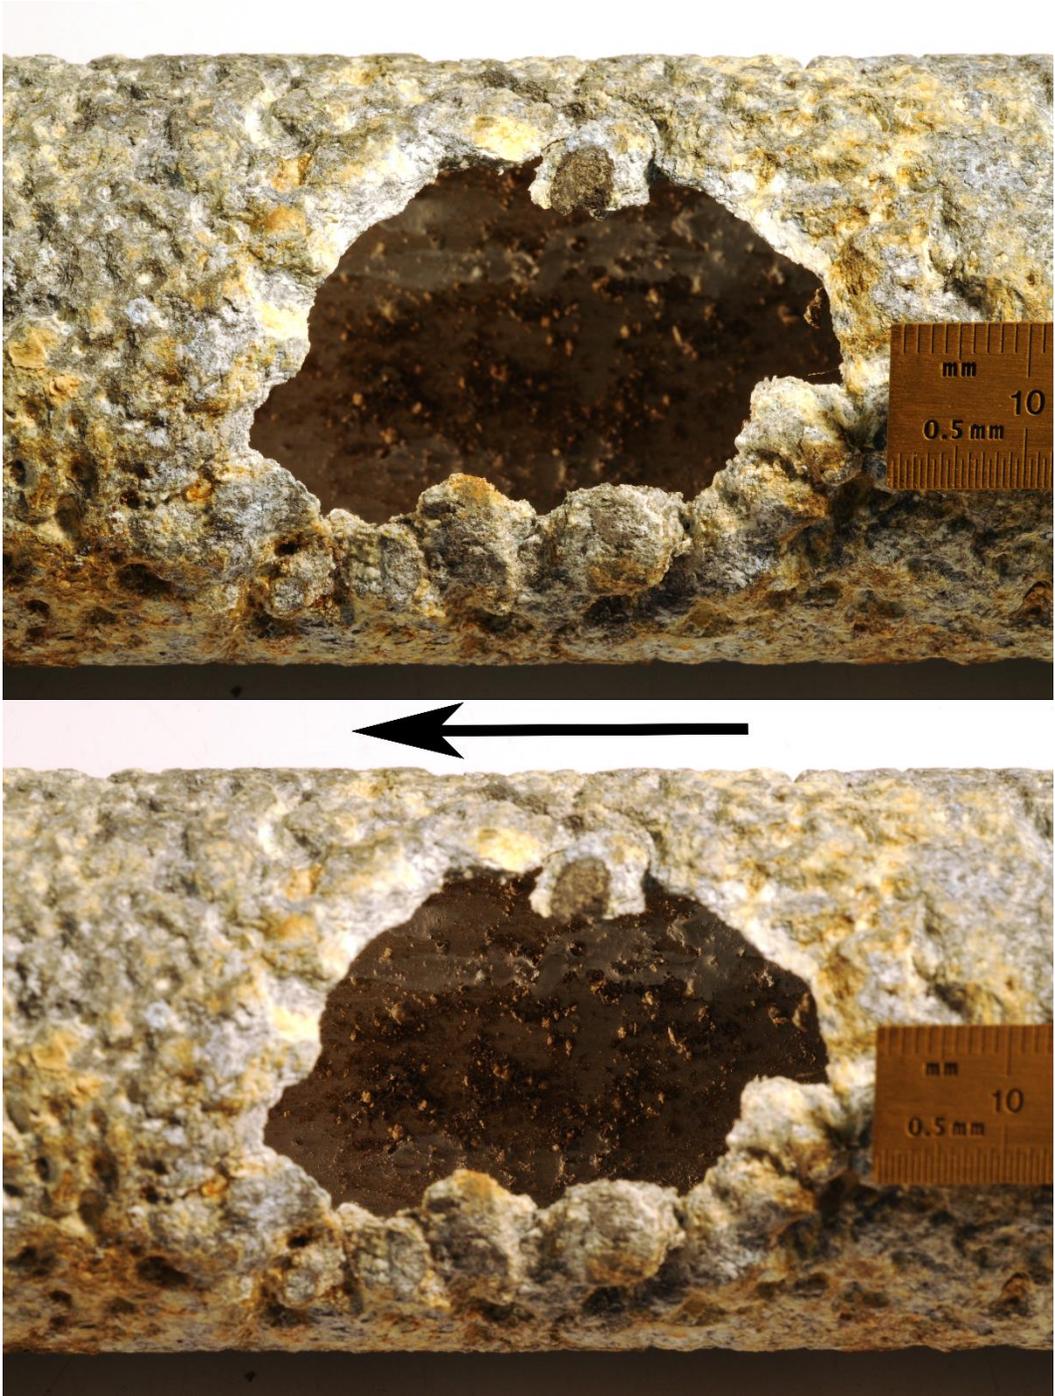
Figure A-25: Hole in north section of tubular tie. Composite image with focus on the outside (top image) and inside (bottom image) of the tie. Arrow points north. Scale is in mm.

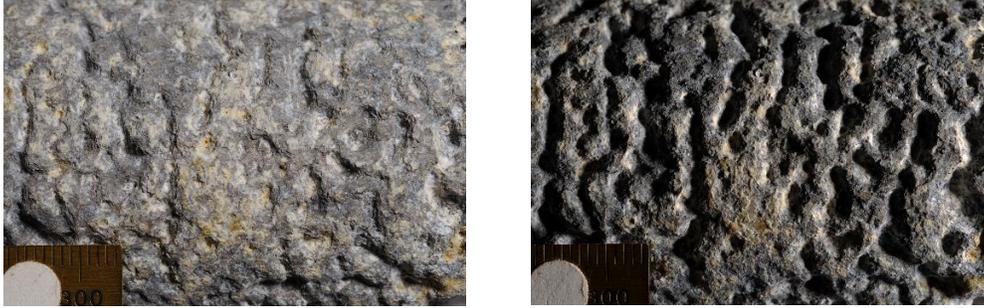
Figure A-26: Pits on opposite side of through-wall hole. Images collected with varying amounts of indirect lighting. Scale is in mm.

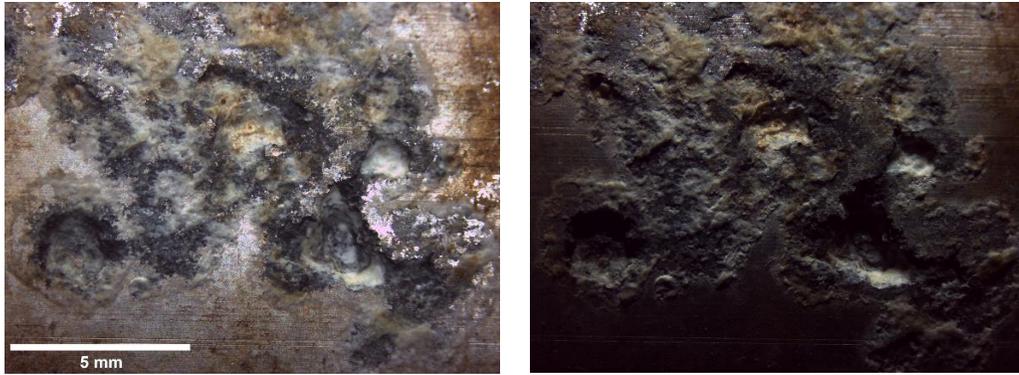
Figure A-30: Pits in south section of tubular tie. Images collected with varying amounts of indirect lighting.

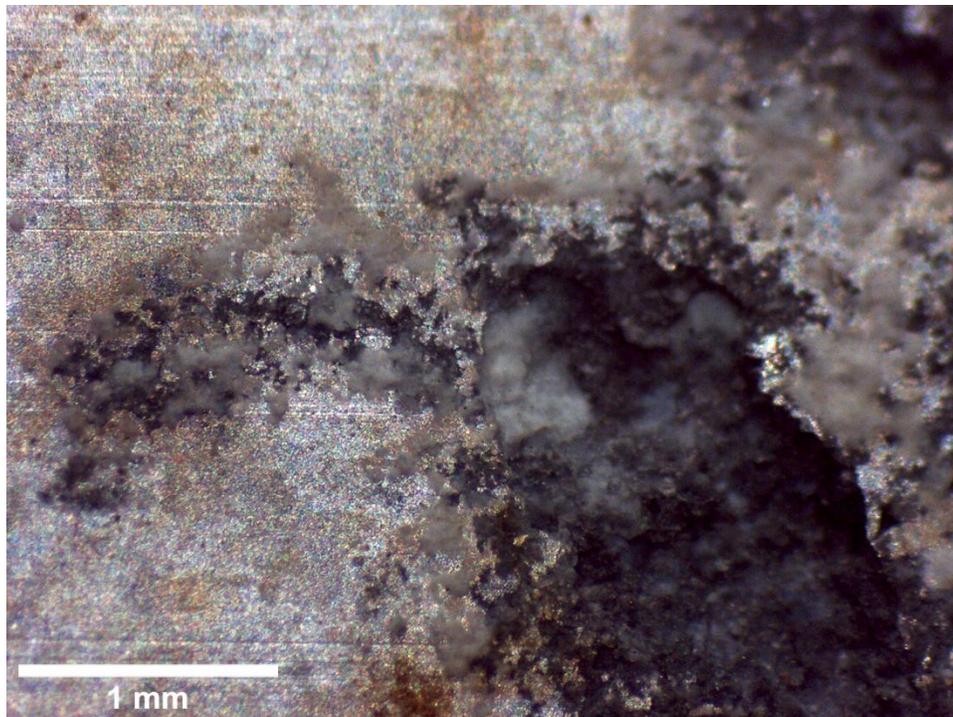
Figure A-32: Close-up of small pits (from above composite images).

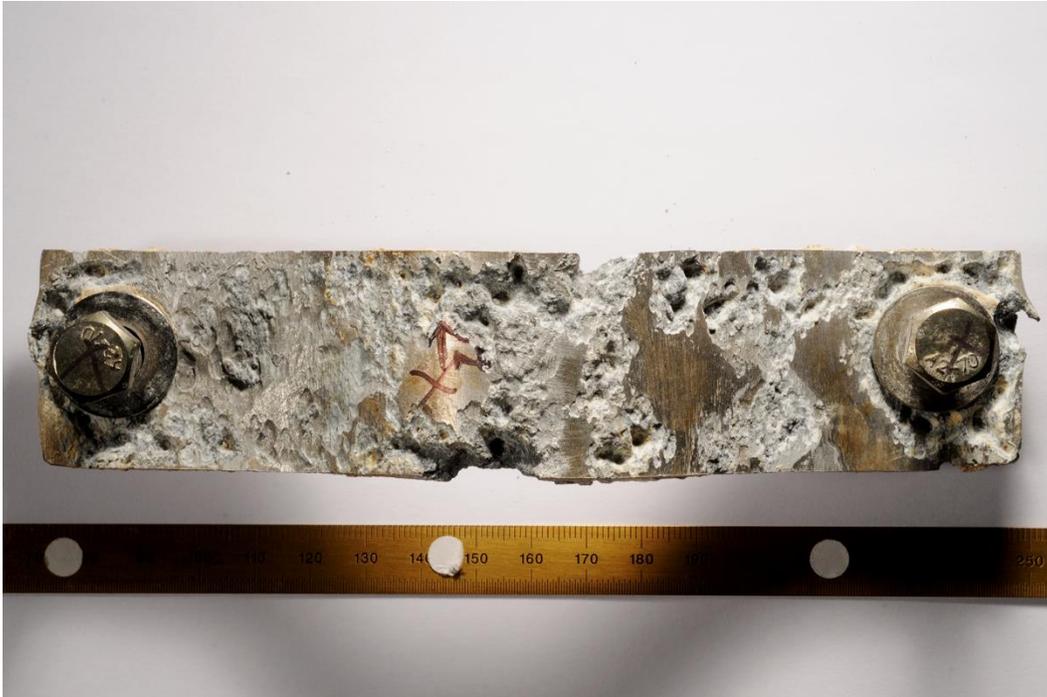
to be undamaged (Figures A-33 and A-36). However, deep pits were identified immediately adjacent to or slightly below where the washers were installed (Figure A-38). It is believed that galvanic effects from the stainless steel bolts and washers were exacerbating the corrosion damage observed on the bracket; particularly in locations immediately adjacent to where the bolts and washers were installed.

Figure A-33: As collected photo of bracket, with nuts, washers, and bolts (hardware). Arrow on the bracket points towards the north wall of the aeration tank. Scale is in mm.

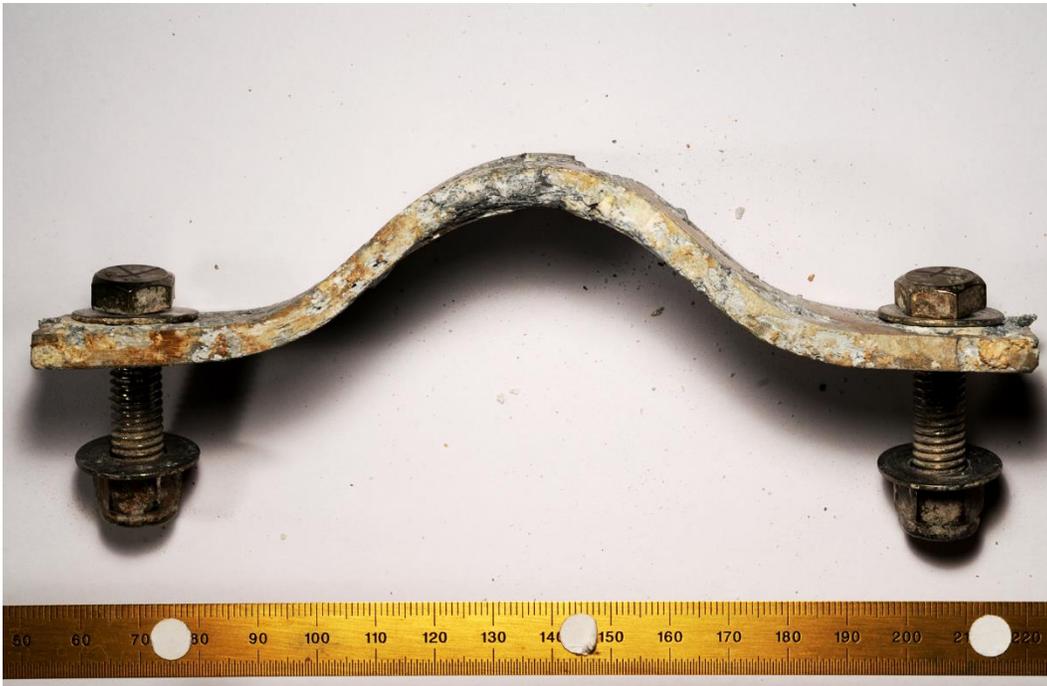
Pitting was also observed on the sides and bottom of the bracket (Figures A-34, A-35, and A-39). The pitting size and morphology on the bottom of the bracket was similar to what was observed on the top of the bracket; however, the pits appeared to be shallower. Meanwhile, pits on the side of the bracket appeared to be smaller in area and had either a round or irregular opening.

Figure A-34: As collected photo of bracket side, with hardware. Scale is in mm.

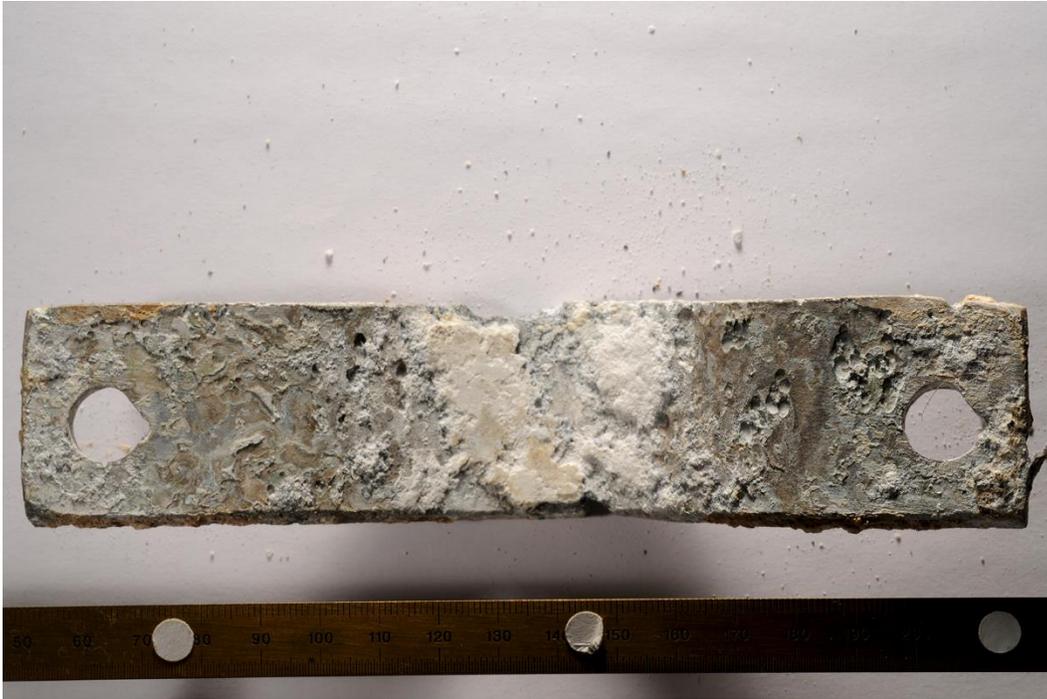
A large amount of creamy white deposit was found on the bottom of the bracket (Figure A-35), where the bracket was in direct contact with a 304 stainless steel aeration line. In other locations, on the bottom of the bracket, there appeared to be either exposed metal or grey, yellow, or dark brown deposit. This deposit is believed to be from exposure to the wastewater process fluid. On the side of the bracket, within most pits, there appeared to be small amounts of creamy white deposit (Figure A-39). Meanwhile, in other locations or areas of pits absent of white deposit, there appeared to be either exposed metal or grey, yellow, or dark brown deposit (Figure A-34). This deposit is also believed to be from exposure to the wastewater process fluid.

Figure A-35: Bottom of bracket with hardware removed. Scale is in mm.

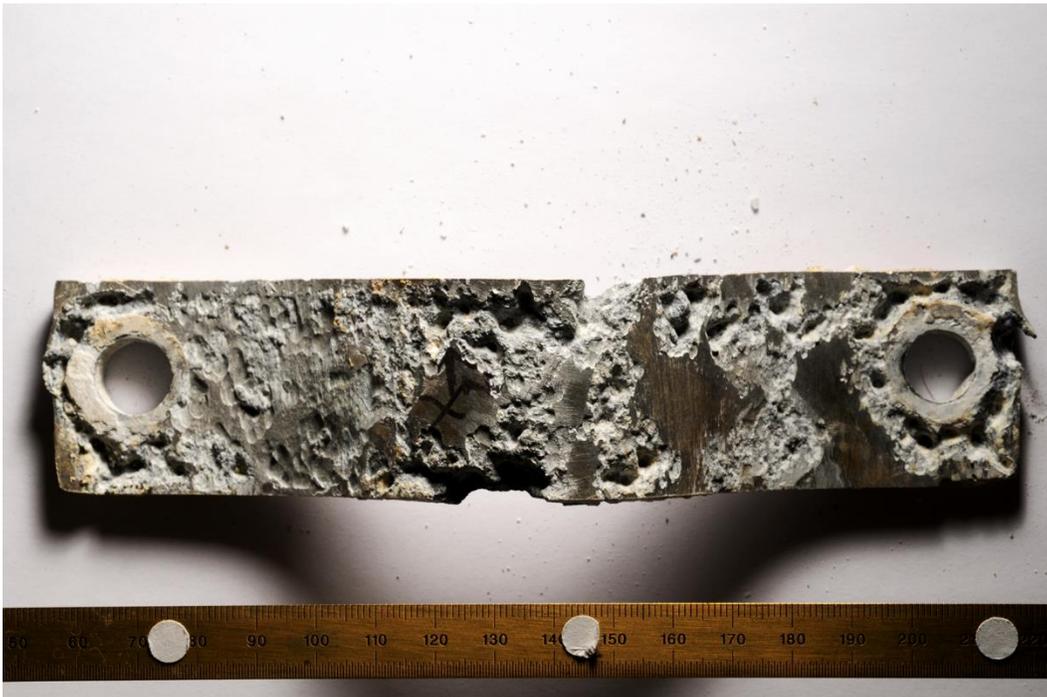
Pits of varying diameter (Figure A-36) were found on the top bracket surface. The pits appeared to have a wide, shallow opening with multiple smaller pits encapsulated within them. The smaller pits were elliptical in shape, deeper, and also exhibited signs of undercutting (Figures A-36 through A-38). In most locations, within the pits, there appeared to be small amounts of creamy white deposit. Meanwhile, in areas of pits absent of white deposit, there appeared to be either exposed metal or grey, yellow, or dark brown deposit. This deposit is believed to be from exposure to the wastewater process fluid. Additionally, most areas where 304 stainless steel bolts and washers covered the bracket were found

Figure A-36: As collected photo of the top of the bracket, with hardware removed. Arrow on the bracket points towards the north wall of the aeration tank. Scale is in mm.

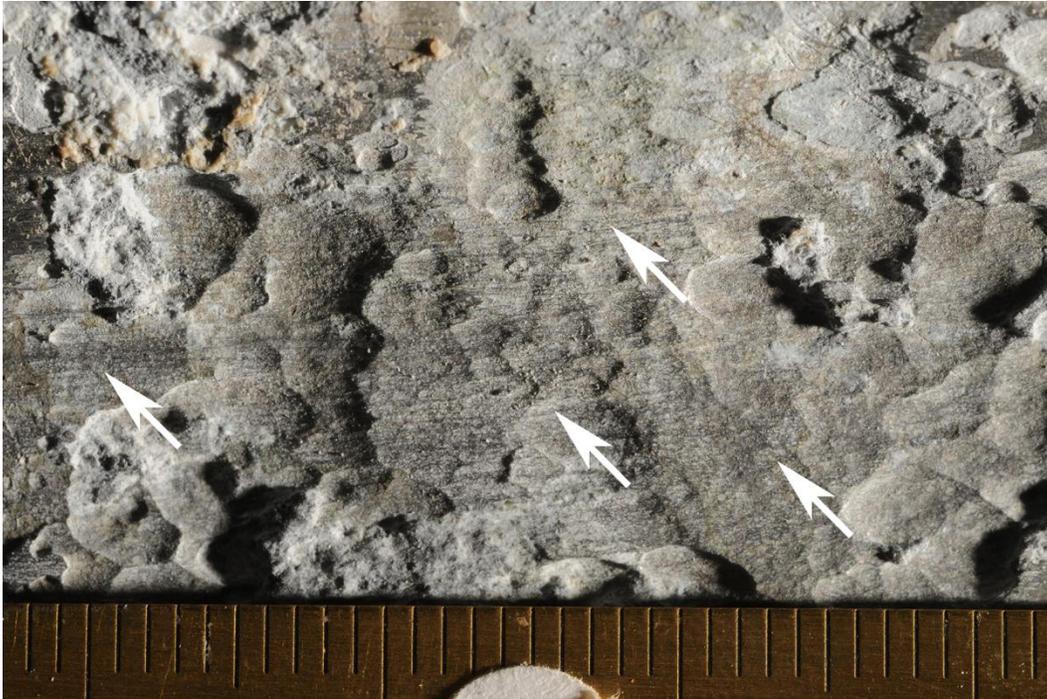
Also observed on the top surface of the bracket were surface fabrication markings (longitudinal lines); however, they appeared to have very little directionality (Figure A-37).

Figure A-37: Close-up on bracket pits and surface fabrication markings (white arrows). Scale is in mm.

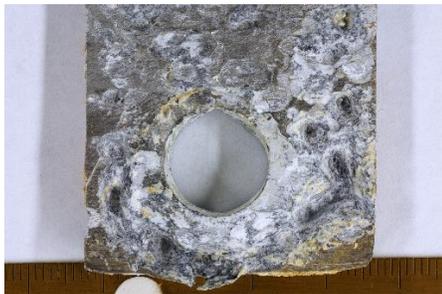
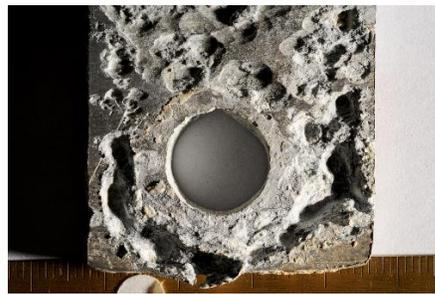
Figure A-38: Deep pits found immediately adjacent to where washers were installed. Images collected with varying amounts of indirect lighting. Scale is in mm.

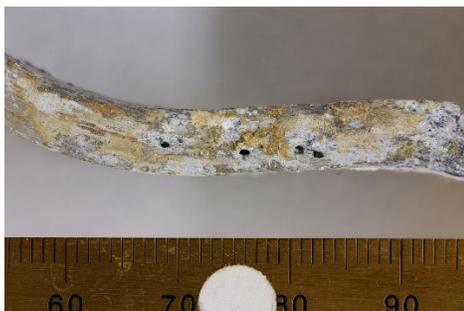
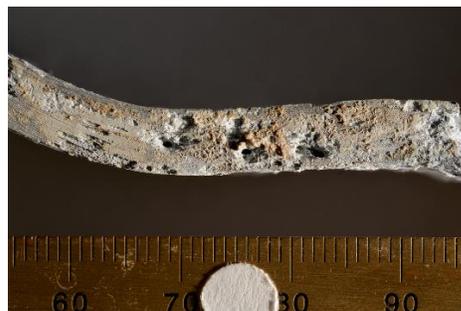
Figure A-39: Pitting identified on the side of the bracket. Images collected with varying amounts of indirect lighting. Scale is in mm.

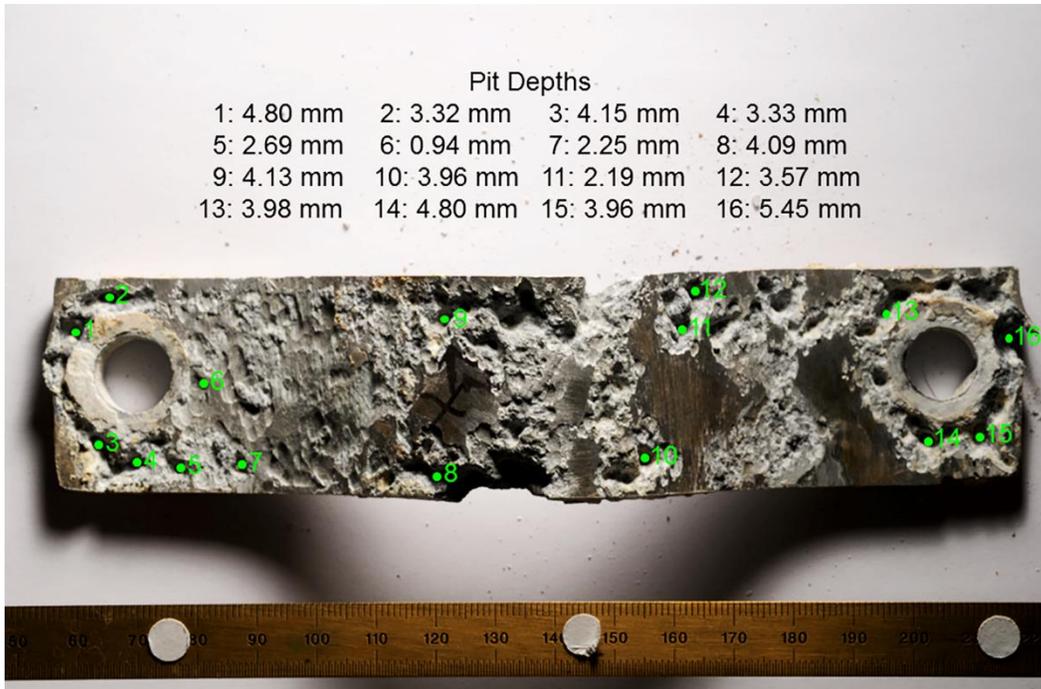
Figure A-40: Pit depths on the top of the bracket. Arrow on the bracket points towards the north wall of the aeration tank. Scale is in mm.

Pit Number	Depth Measurements	
	[inch]	[mm]
1	0.189	4.80
2	0.131	3.32
3	0.163	4.15
4	0.131	3.33
5	0.106	2.69
6	0.037	0.94
7	0.089	2.25
8	0.161	4.09
9	0.163	4.13
10	0.156	3.96
11	0.086	2.19
12	0.141	3.57
13	0.157	3.98
14	0.189	4.80
15	0.156	3.96
16	0.215	5.45
<b>Average ± CI</b>	0.142 ± 0.024	3.60 ± 0.61

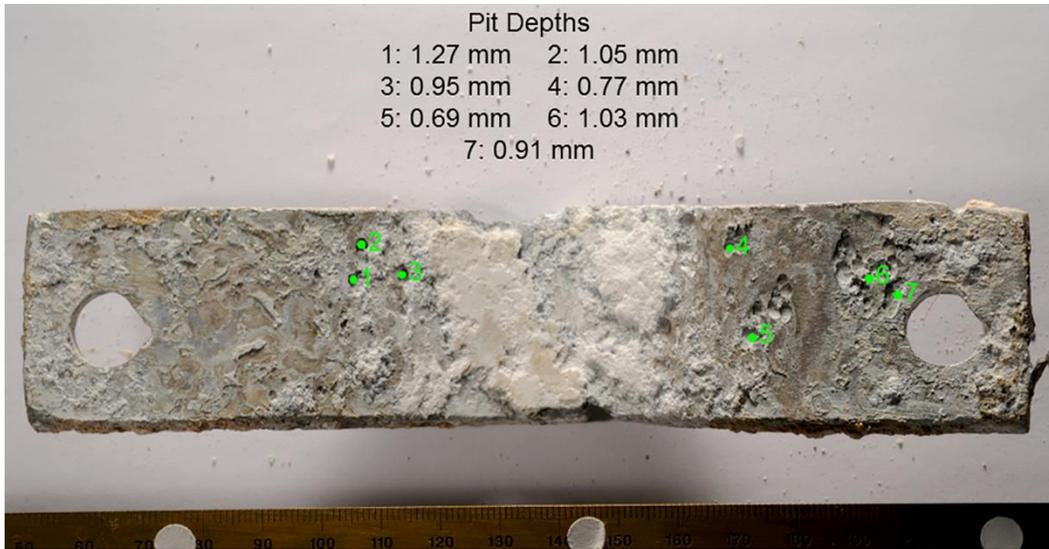
Figure A-41: Pit depths on the bottom of the bracket. Scale is in mm.

Pit Number	Depth Measurements	
	[inch]	[mm]
1	0.050	1.27
2	0.041	1.05
3	0.037	0.95
4	0.030	0.77
5	0.027	0.69
6	0.041	1.03
7	0.036	0.91
<b>Average ± CI</b>	<b>0.038 ± 0.007</b>	<b>0.95 ± 0.18</b>

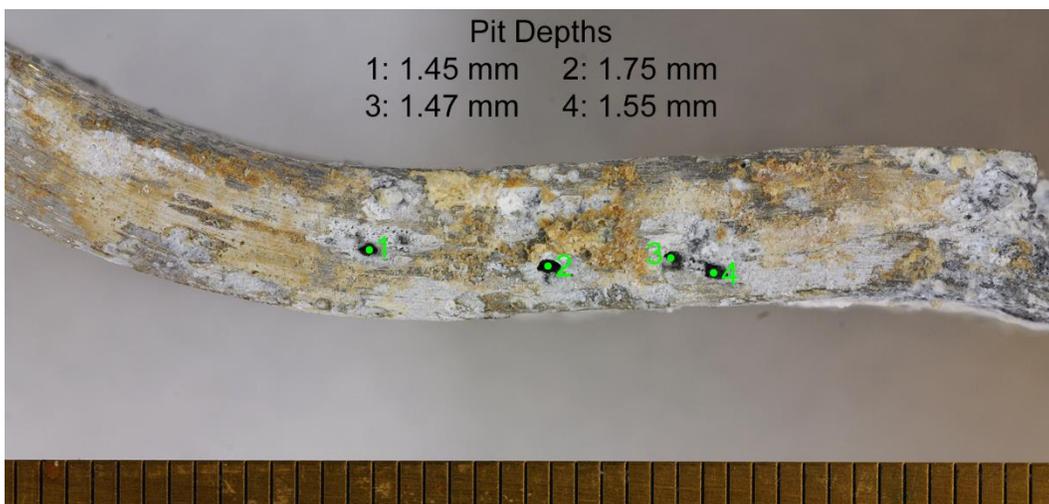
Figure A-42: Pit depths on the side of the bracket. Scale is in mm.

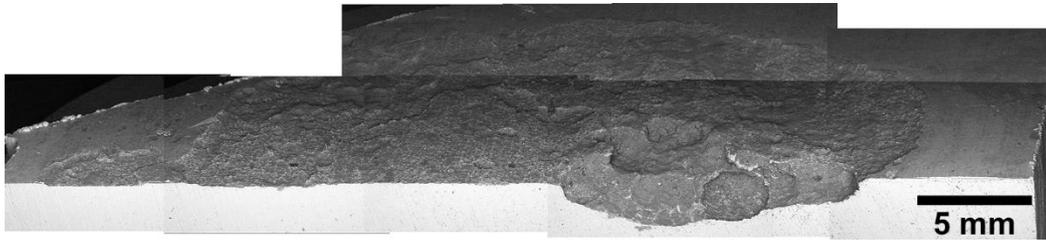
The morphology of the large pit is shown below in Figures A-44 through A-46. Pits within pits could be observed. Moreover, deposit was found to be

Figure A-44: Composite BSE image of the large 5.1 cm diameter pit. Able to discern pits within pits.

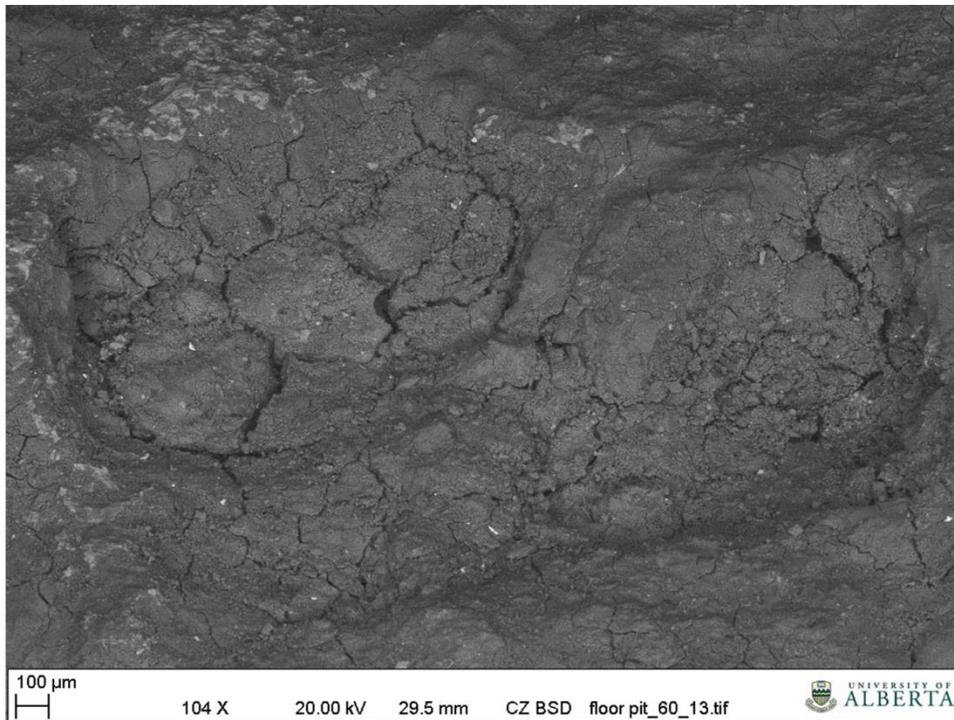
Figure A-45: Close-up of pits within pits (BSE image).

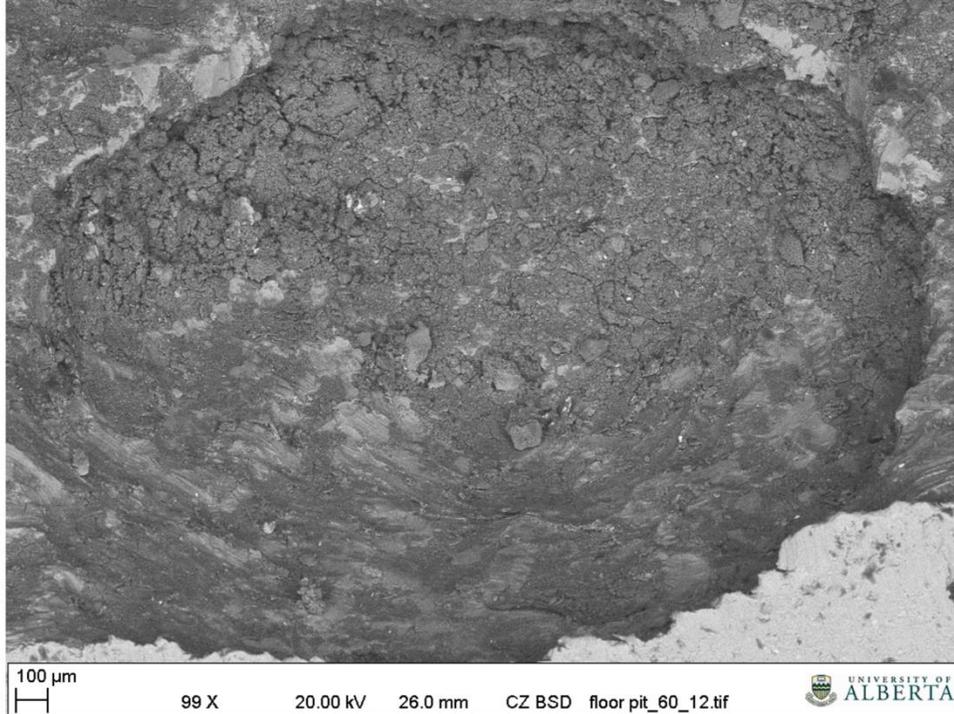
Figure A-46: Deposit within pits; image of the deepest pit (BSE image). Abrasion marks from handling can be seen in the foreground (bottom half of the image within the pit) as curved scatches.

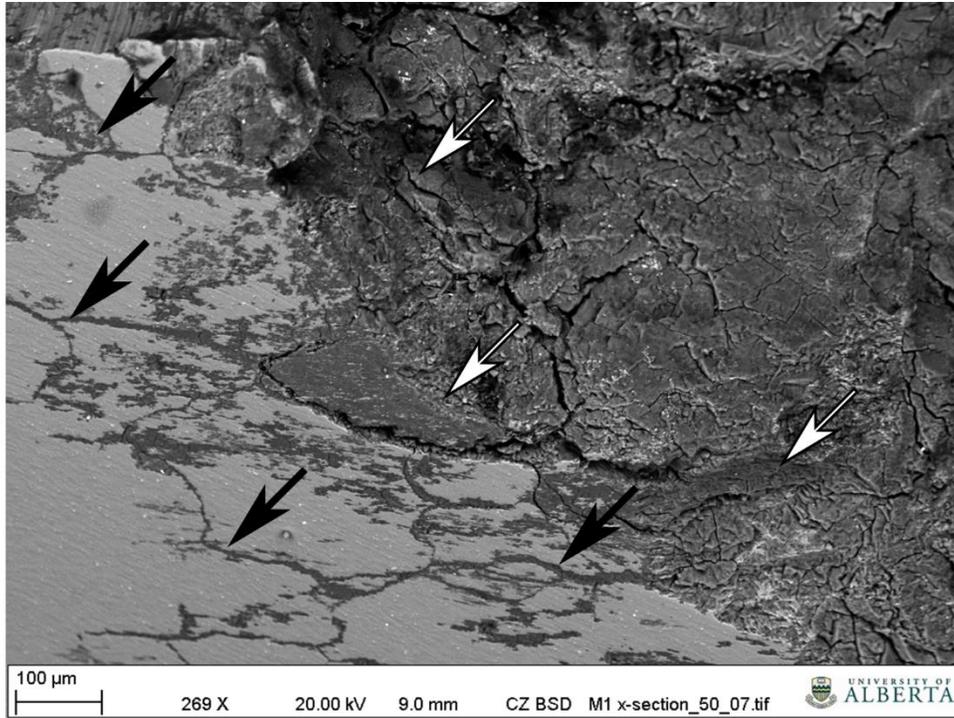
The morphology of the tie pits and buildup of deposit are shown below in Figures A-48 through A-53. In addition to pitting, intergranular corrosion (IGC) was observed both at and below the surface of the pits (Figures A-49 through A-

Figure A-49: Close-up on IGC (black arrows) and deposit (white arrows) at the large pit opening (BSE image).

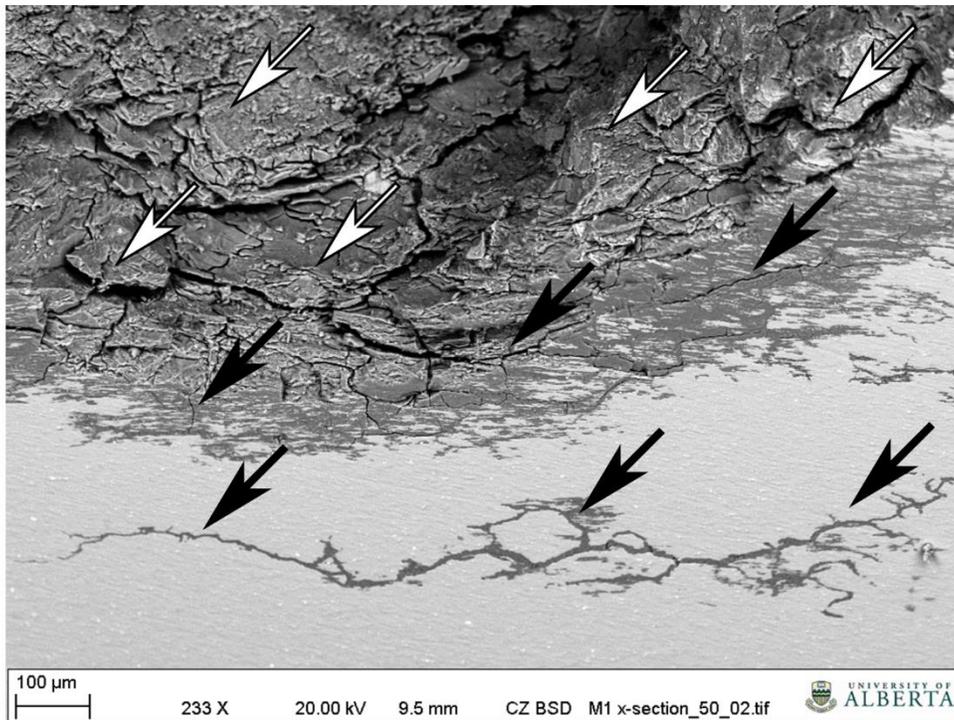
Figure A-50: Close-up BSE image of IGC (black arrows) and deposit (white arrows) at the bottom of the large pit opening.

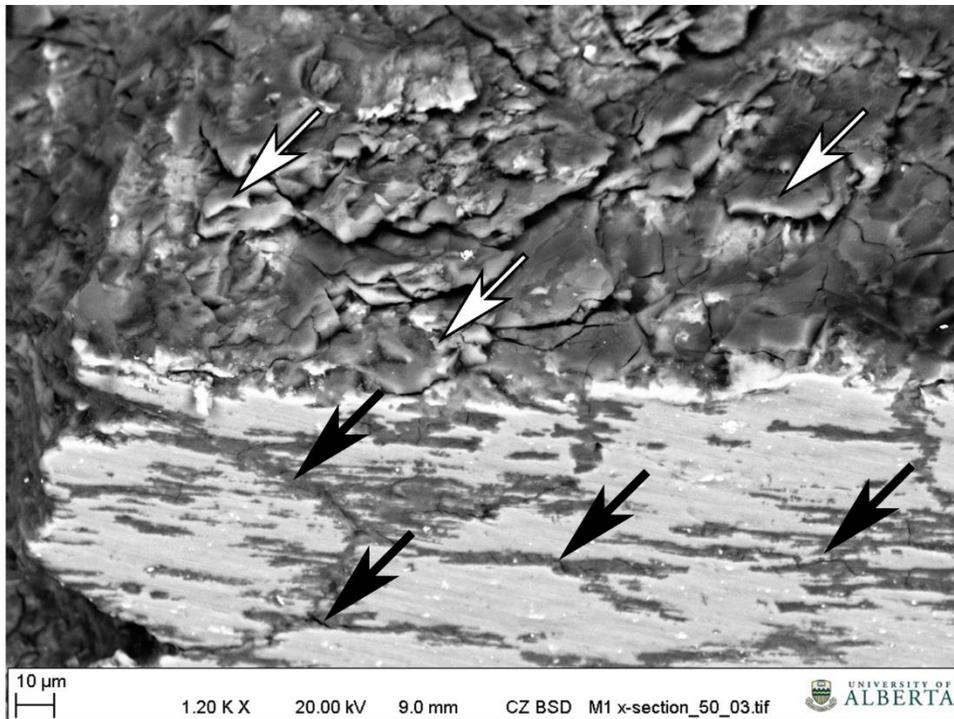
Figure A-51: Additional close-up BSE image of deposit (white arrows) on the pit surface, as well as IGC (black arrows).

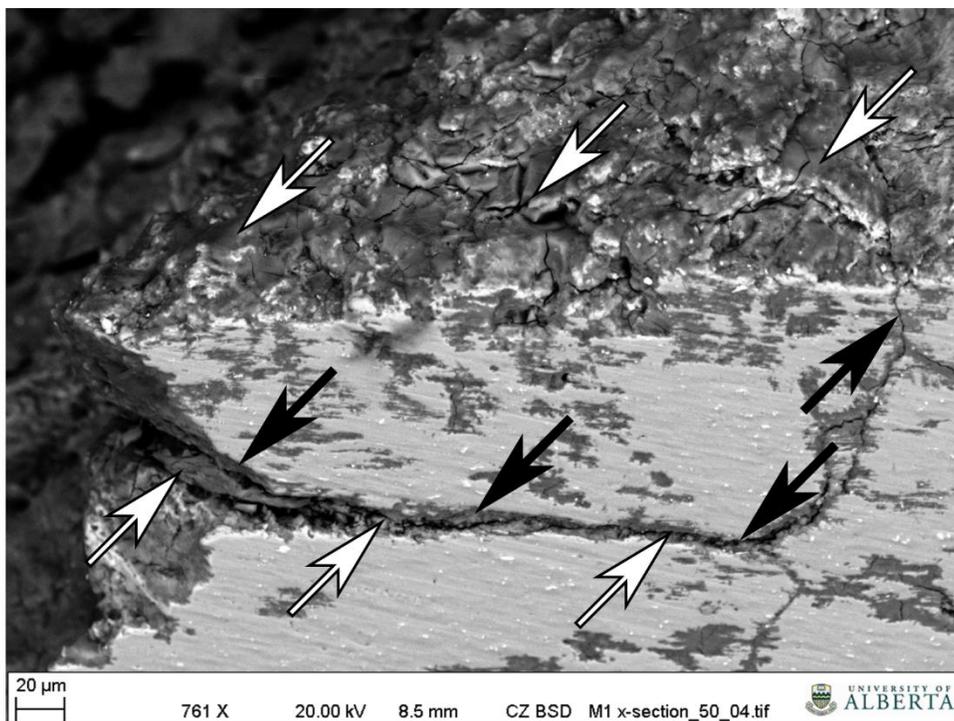
Figure A-52: Close-up BSE image of deposit (white arrows) on the pit surface, as well as IGC (black arrows) around an entire grain. There also appears to be deposit build-up between the grains (white arrows).

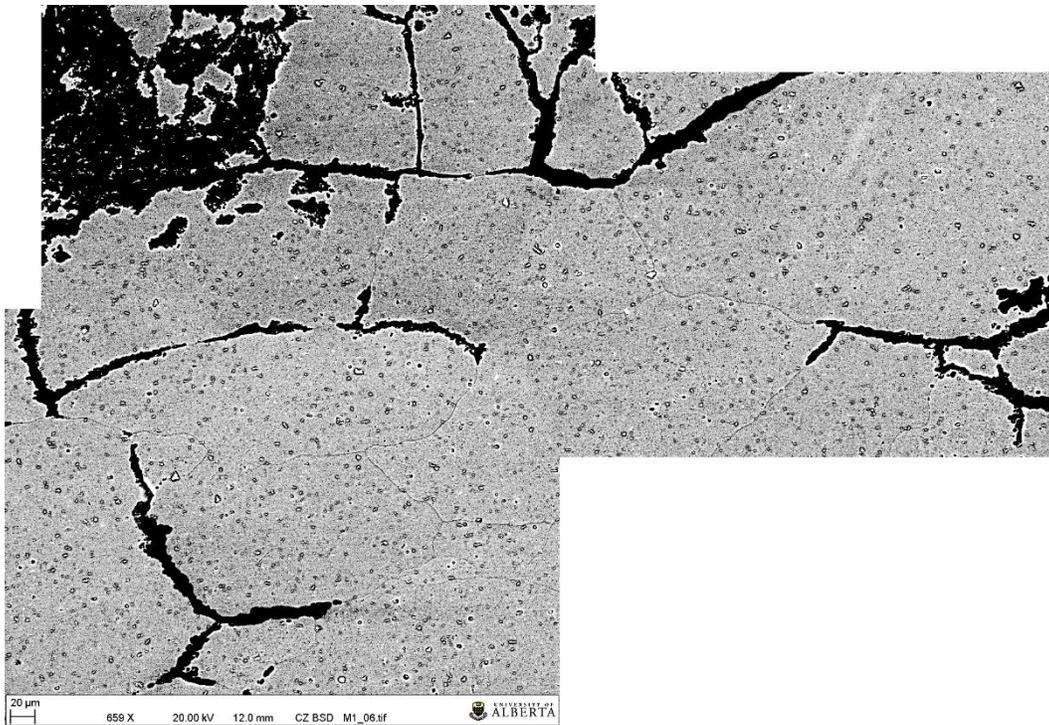
Figure A-57: Close-up BSE image of IGC (from Figure A-56).

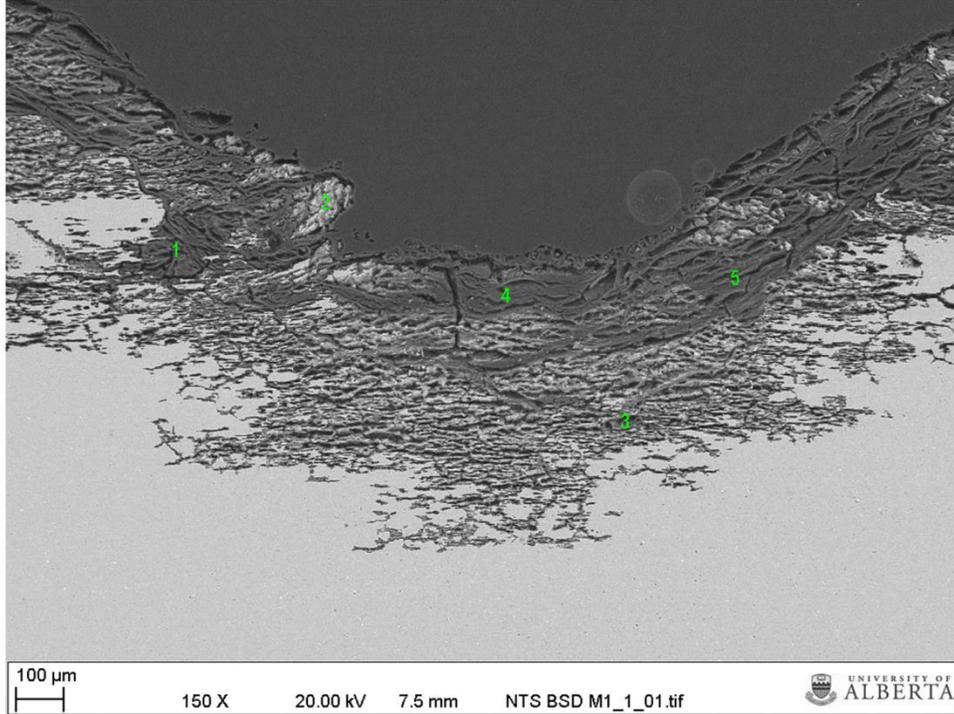
As identified on the floor cross-section, high concentrations of aluminum and oxygen were present in the deposits; both of which are indicative of aluminum corrosion products [3,4,7]. Chlorine and sulphur were also found in several locations, and – as chloride and sulphate – cause corrosion in aluminum and aluminum alloys [3,4]. Additionally, copper was identified in several locations. Again, copper is known to cause corrosion in aluminum and aluminum alloys [3,4,7–10].

Figure A-59: BSE image of pit in mounted tie cross-section. Numbers indicate where EDX data was collected.

Point	Element [Normalized Weight %]									
	Al	O	Si	P	S	Cl	Na	Fe	Ca	Mg
1	30.2	53.8	2.9		4.0	2.3	0.4	2.7	3.7	
2	58.4	31.8	5.8						1.8	2.2
3	57.5	32.7	2.3		1.9	0.7		1.3	1.7	1.9
5	27.8	54.9	2.0	2.2	3.3	2.3	0.3		6.4	0.8

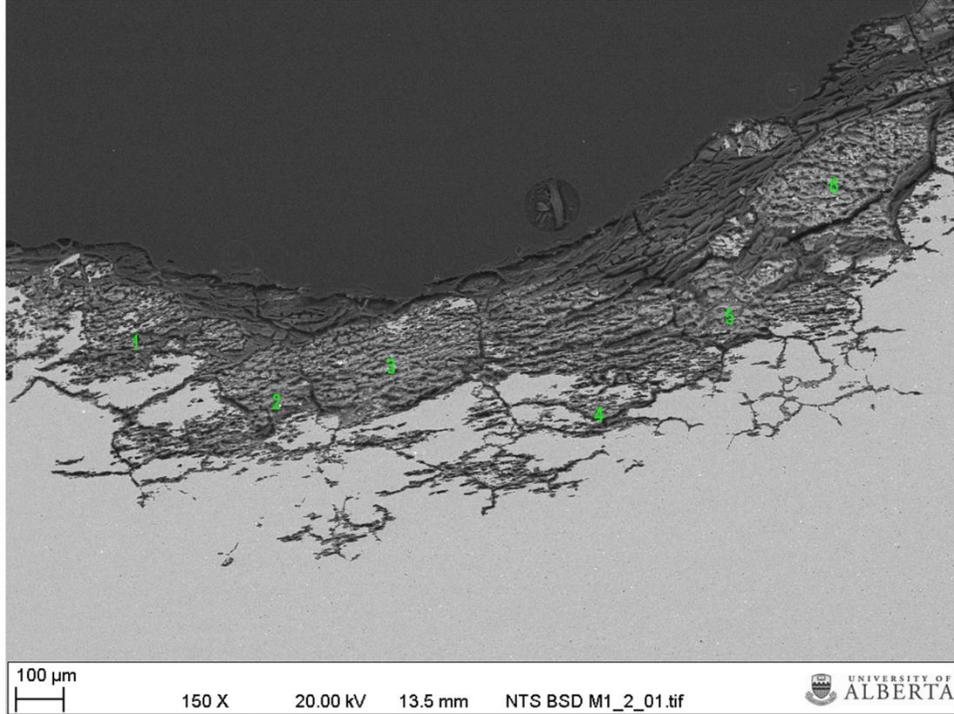
Figure A-60: BSE image of pit in mounted tie cross-section. Numbers indicate where EDX data was collected.

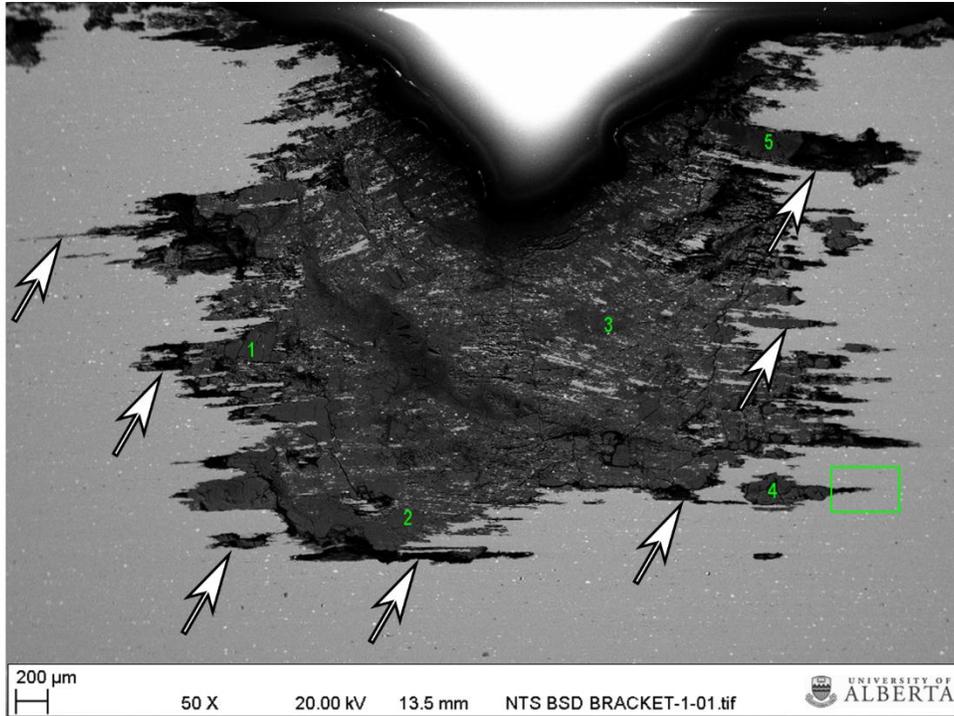
The morphology of the bracket pits is shown below in Figures A-65 through A-71. Moreover, severe tunnelling<sup>4</sup> was also observed both at and below the surface of the pits (Figures A-65 through A-71). At high magnification, crystallographic

Figure A-65: BSE image of large pit on the top of the bracket. Numbers indicate where EDX data was collected. Tunnelling (white arrows) can also be observed. Green box is the location of Figure A-66.

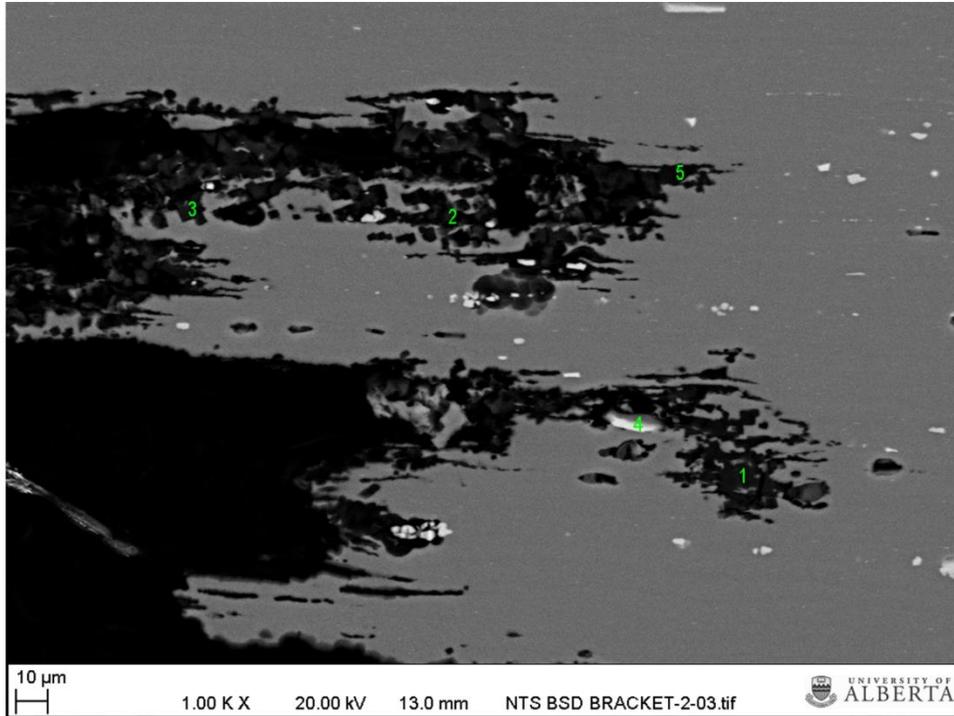
Figure A-67: Close-up on tunneling (from Figure A-65; BSE image). Numbers indicate where EDX data was collected.

Point	Element [Normalized Weight %]									
	Al	O	Si	Mn	S	Na	Fe	Cr	F	Mg
1	36.3	54.5	0.3		2.6	1.1			4.0	1.2
2	39.6	53.2	0.1		2.5	1.0			1.5	2.1
3	41.9	50.2	1.1		2.9	0.1			1.7	2.1
4	48.1	18.1	3.2	7.7			16.7	2.2	3.6	0.4
5	36.0	56.8			2.1	3.2				1.9

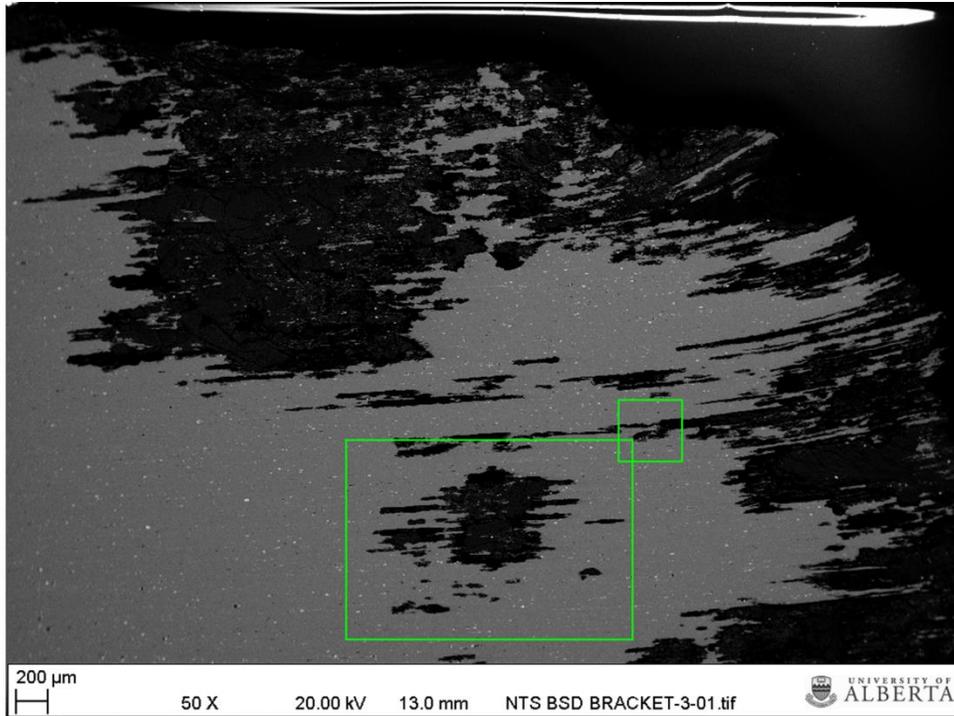
Figure A-68: BSE image of pitting and tunneling on the side of the bracket. The large green box is the location of Figure A-69, while the small green box is the location of Figure A-70.

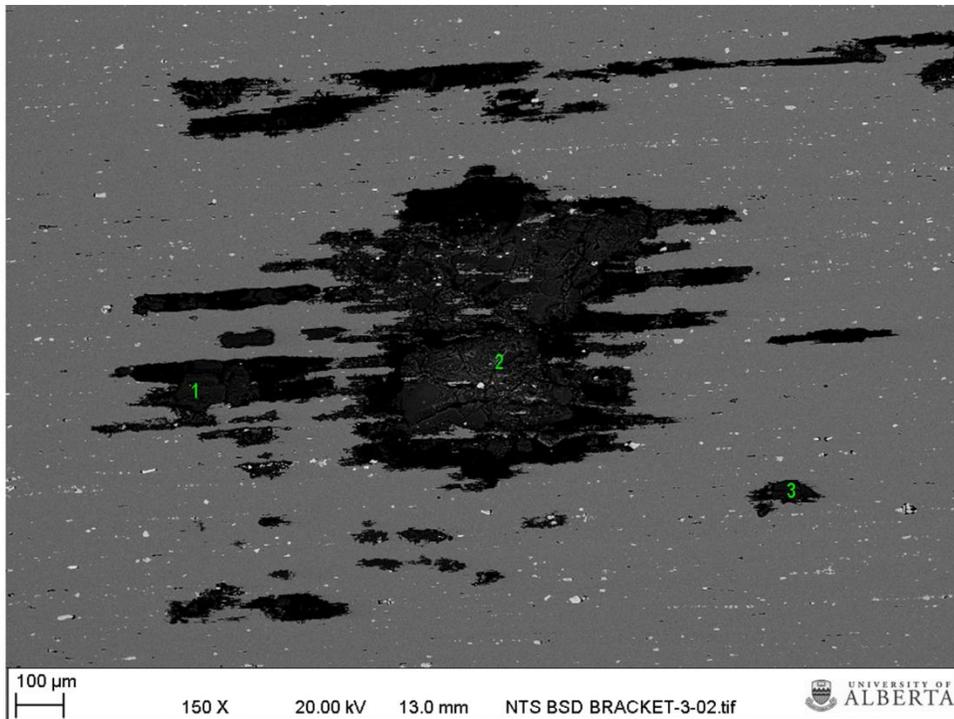
Figure A-69: Close-up on tunneling (from Figure A-68; BSE image). Numbers indicate where EDX data was collected.

Point	Element [Normalized Weight %]							
	Al	O	Si	S	Na	Ca	F	Mg
1	32.3	60.3	0.4	0.7	0.1	0.6	4.7	0.9
2	31.0	61.4	0.6	0.6		0.7	4.4	1.3
3	35.8	58.0	0.2	0.9	0.5	0.3	3.0	1.3

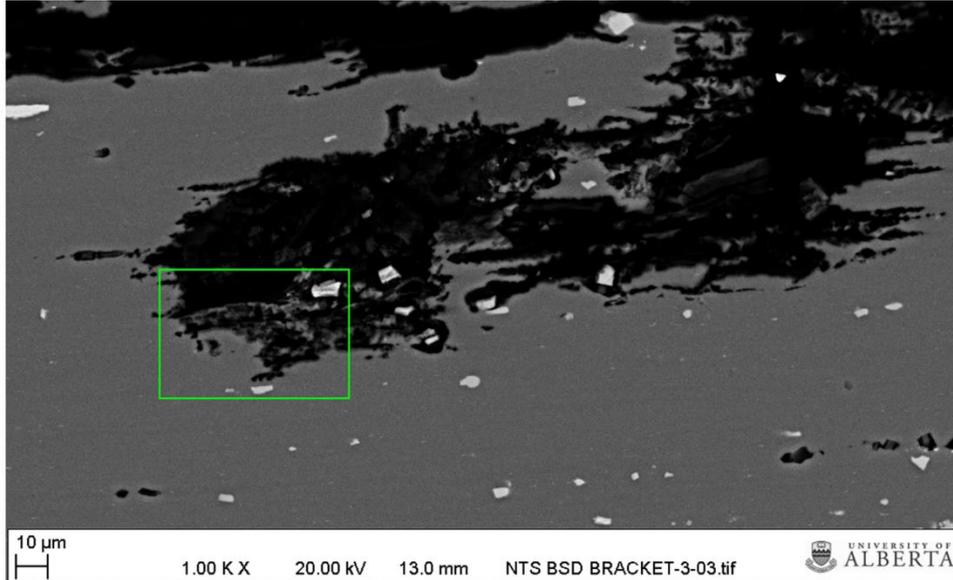
Figure A-70: Close-up on tunneling (from Figure A-68; BSE image). Green box is the location of Figure A-71.
