Corrosion of Aluminum Alloys in Wastewater Treatment Aeration Tanks

A thesis submitted in partial fulfillment of the requirements for the degree of

Materials Engineering

Severe localized corrosion was found throughout an aeration tank of a modular wastewater treatment plant. Specifically, pitting, crevice corrosion, galvanic corrosion, and intergranular corrosion (IGC) were observed on the 5000 and 6000 series aluminum alloys used in the tank's construction. One of the suspected environmental causes of corrosion was an aeration tank process additive, namely a coagulant – either aluminum sulphate (Alum) or polyaluminum chloride (PACl; Isopac). Laboratory scale corrosion cells were designed to isolate, simulate, and evaluate the corrosivity of the coagulants (in relevant quantities) on the metallic alloys of construction. Additionally, due to presence of deposit found throughout the tank (resulting in under-deposit corrosion), fabricated crevices were installed on the tested alloys to help simulate crevice corrosion environments. The solution conditions in the cells were monitored throughout the duration of the immersion testing in order to assess whether the cells were within nor

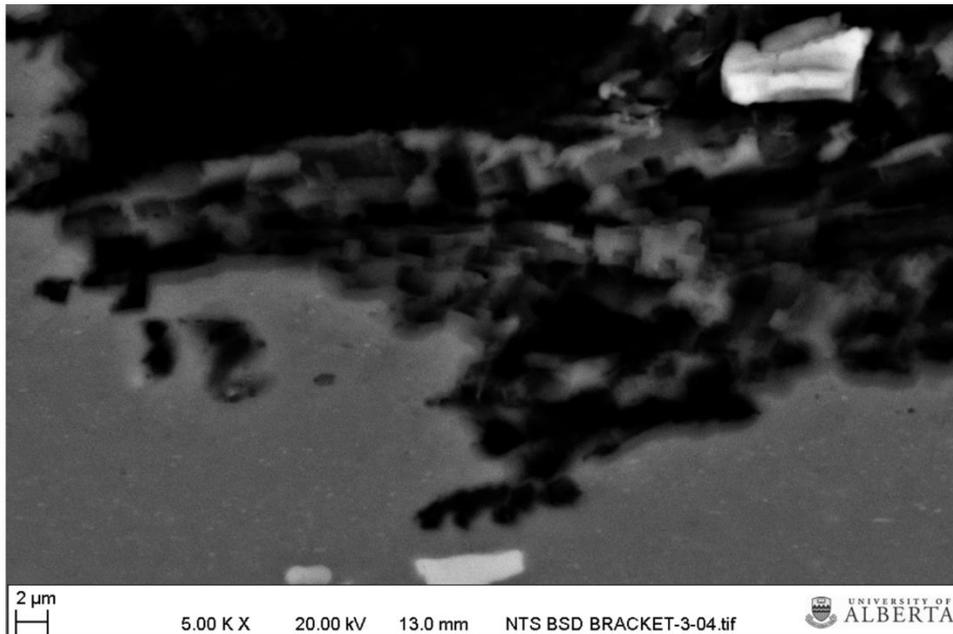
pits (in the shape of cubes) were found on the walls of the pit tunnels (Figure A-71). Additionally, deposit appeared to be covering the surface of the pits (exposed to the process fluid), as well as in the tunnels. It should be noted that the cut surface of the mounted specimen was polished to a 1 micron finish. The specific surface preparation achieved for the mounted cross-section was performed as follows: 240, 320, 400, 600, 800, and 1200 grit sequential wet-grinding with silicon carbide grit paper, followed by 3 micron and 1 micron polishing with diamond suspension. The cross-section was then cleaned. Finally, the specimen was unetched and not carbon coated.

Figure A-71: Close-up of crystallographic pitting on the tunnel surfaces (from Figure A-70; BSE image).

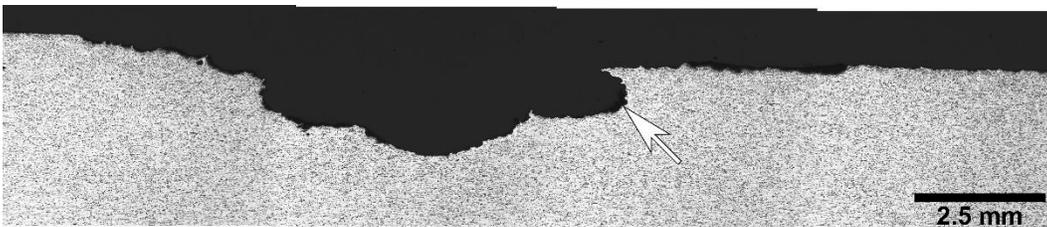
Figure A-75: Composite image of the deepest portion of the 5.1 cm pit. Undercutting (white arrow) can also be observed.

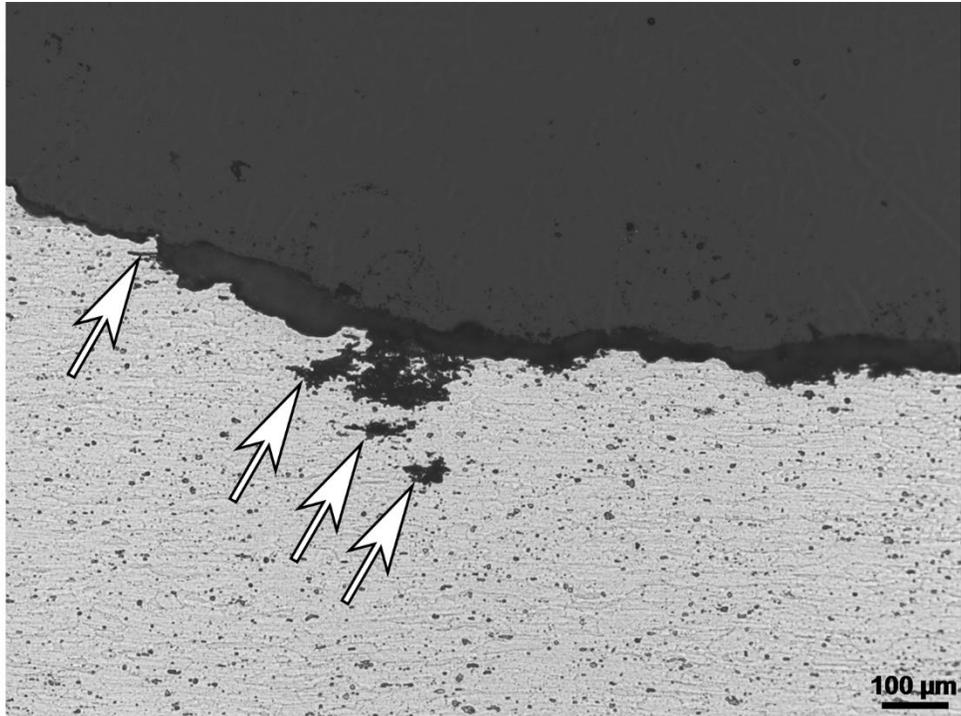
Figure A-76: Tunneling (white arrows) near the bottom of the deepest part of the pit (left of the deepest pit; from Figure A-75).

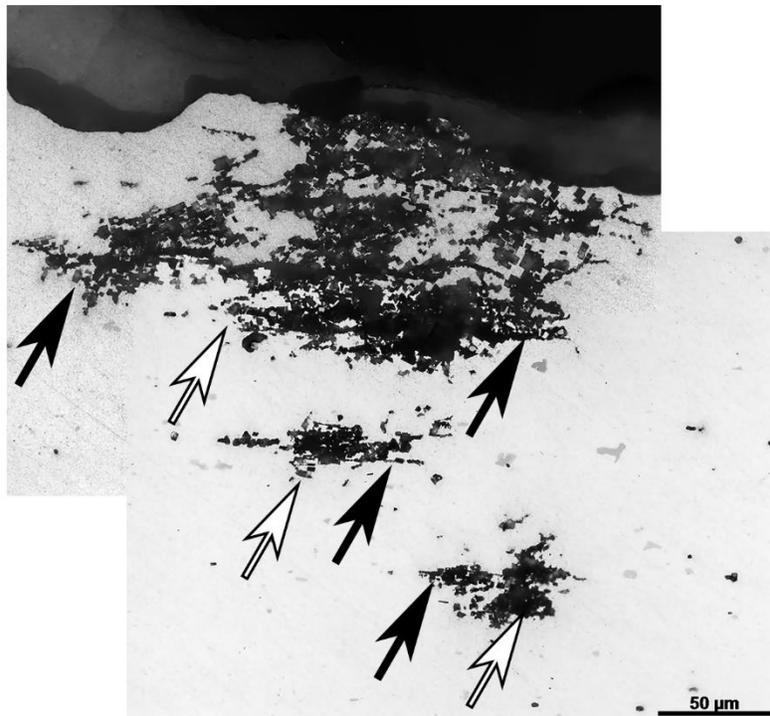
Figure A-77a: Close-up on tunneling (white arrows) and crystallographic pitting (black arrows). Figure A-77a is un-etched; from Figure A-76.

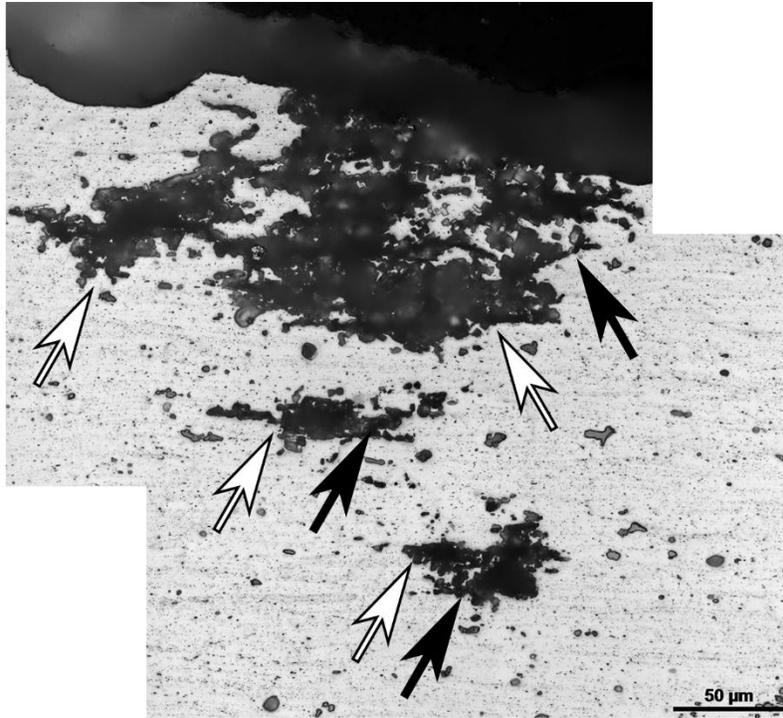
Figure A-77b: Close-up on tunneling (white arrows) and crystallographic pitting (black arrows) – after etching same region from Figure A-77a. Figure A-77b is etched; from Figure A-76.

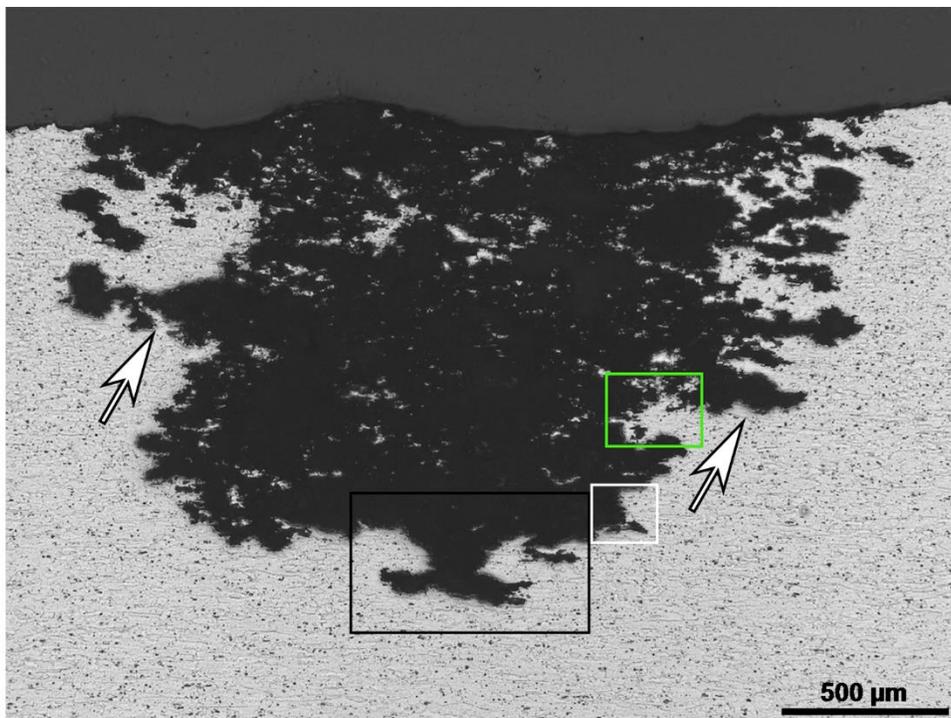
Figure A-78: Image of smaller pit (from Figure A-74). Tunnelling (white arrows) can also be observed. Black, white, and green boxes contain Figures A-79, A-80, and A-81, respectively. Tunneling is also observed in the black box.

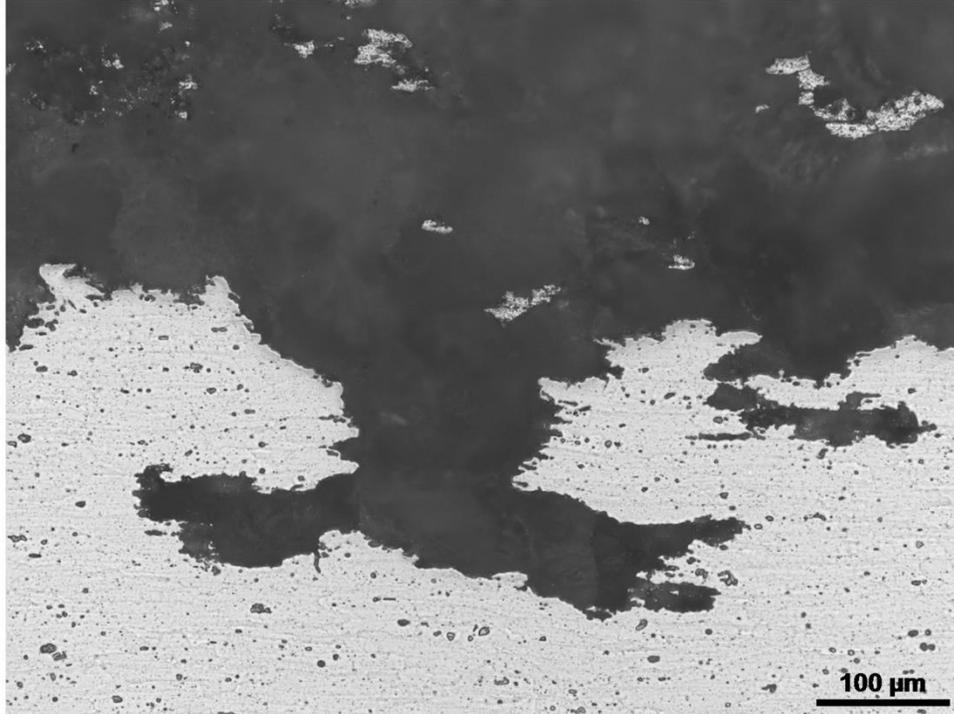
Figure A-79: Tunneling at the bottom of the deepest part of the smaller pit (from Figure A-78).

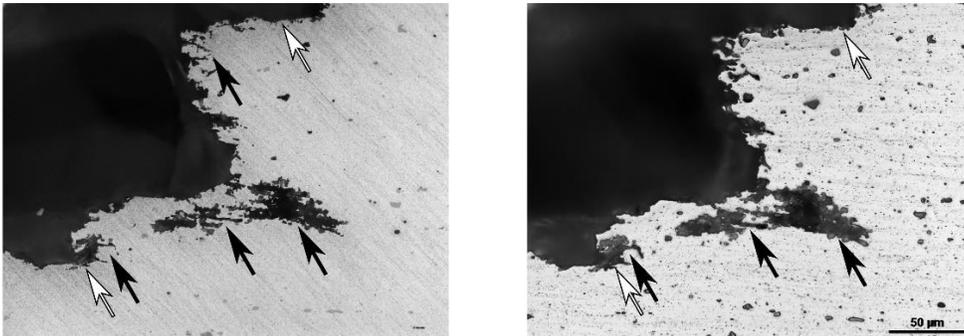
Figure A-80: Close-up on tunneling (white arrows) and crystallographic pitting (black arrows) (from Figure A-78). The left image is un-etched while the right image is etched.

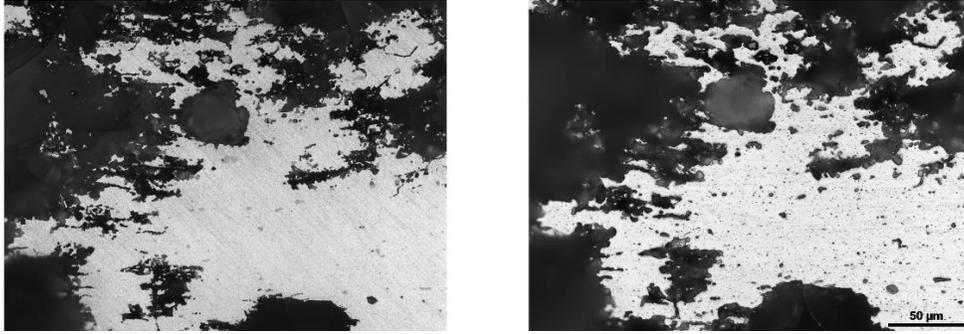
Figure A-81: Close-up on tunneling and crystallographic pitting (from Figure A-78). The left image is un-etched while the right image is etched.

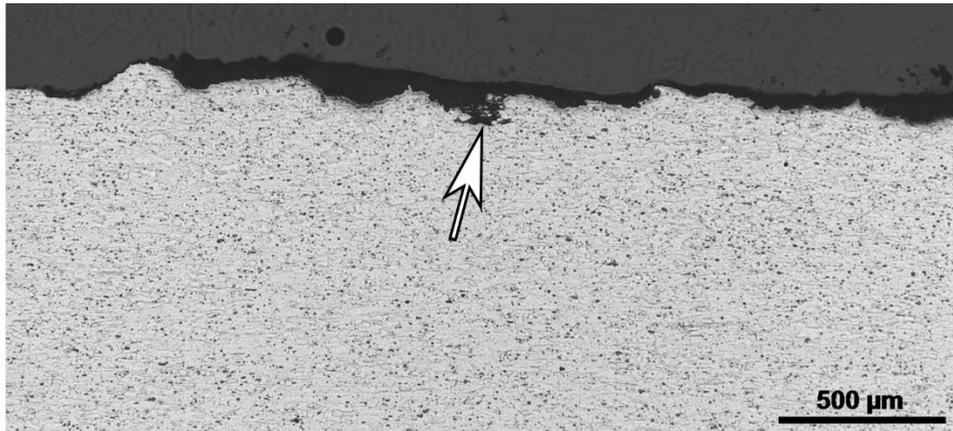
Figure A-82: Very small pit at the surface of the floor cross-section exhibiting tunneling (white arrow).

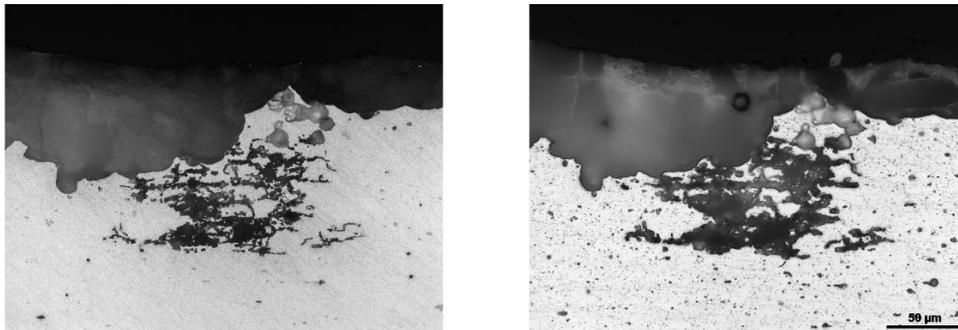
Figure A-83: Close-up on tunneling and crystallographic pitting (from Figure A-82). The left image is un-etched while the right image is etched.

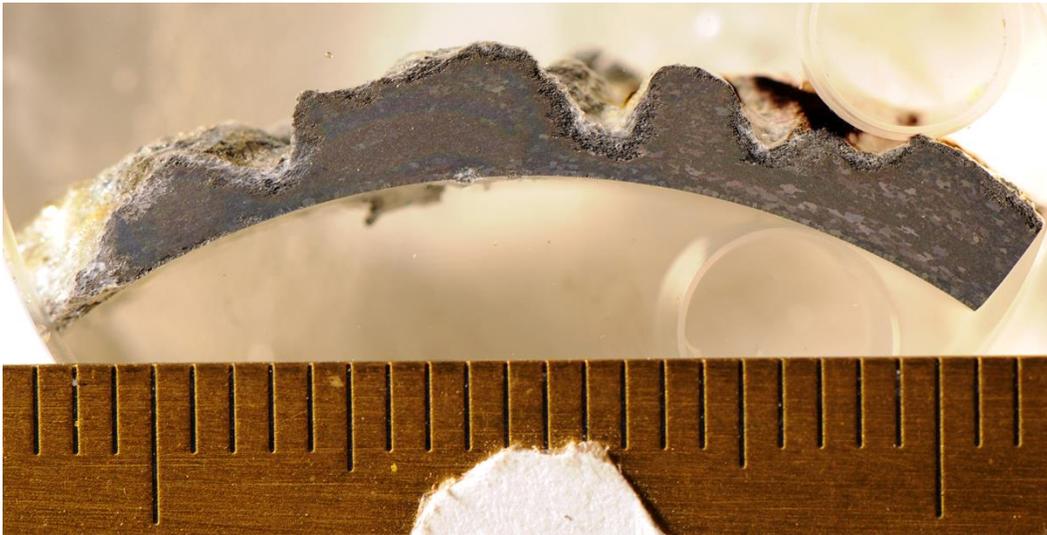
A-93. Corrosion damage was found on all of the cross-section surfaces (Figures A-84, A-85, A-88, A-90, and A-93). Again, in addition to pitting, IGC was observed both at and below the surface of the pits (Figures A-86, A-87, A-89, A-91, and A-92) as well as on un-pitted surfaces (Figure A-93). As with the unmounted cross-section (Section 2.3.2.1), corrosion was found to have occurred both in the grains and at the grain boundaries (Figures A-87, A-89, A-91, and A-92). Moreover, the most severe damage was found on the portion of the cross-section which was immediately adjacent to the through-wall hole (Figures A-85 through A-87) and, consequently, the 304 stainless steel aeration piping.

Figure A-84: Overall image of etched tubular tie cross-section (in the radial direction; labelled “Hole Circumference”). Scale is in mm.

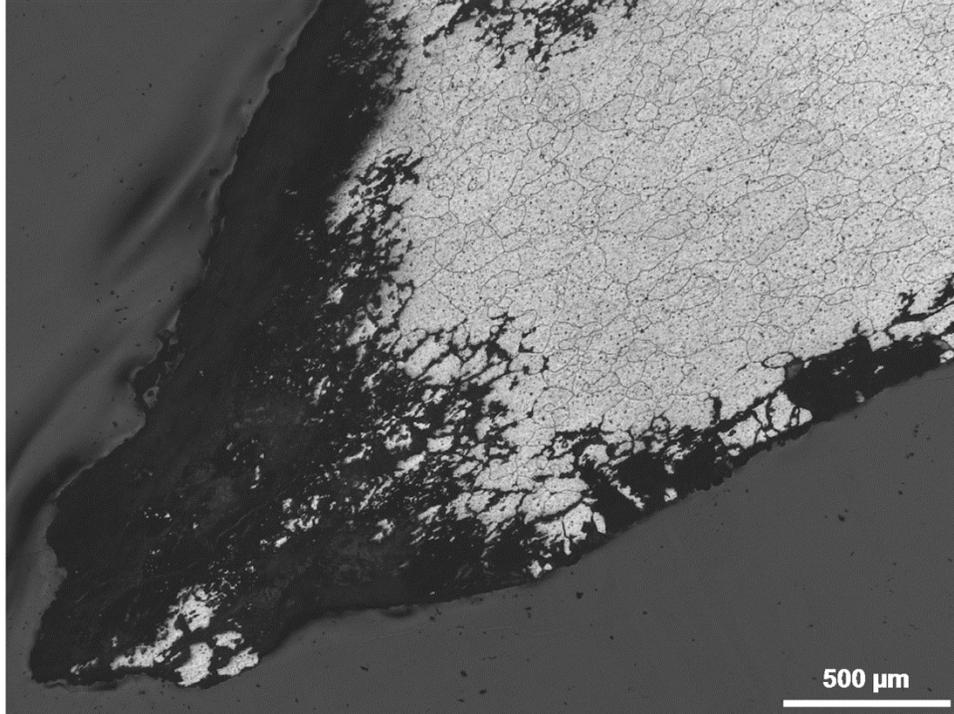
Figure A-85: Severe corrosion damage on portion of the tie immediately adjacent to the through-wall hole (from Figure A-84).

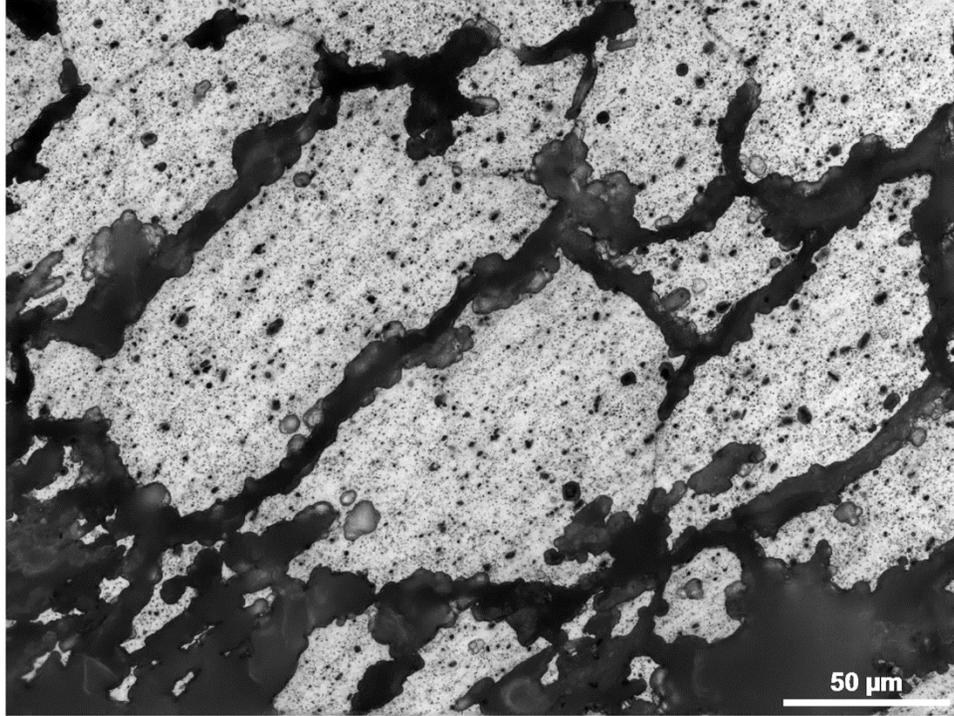
Figure A-87: Close-up on IGC and pitting (from Figure A-86).

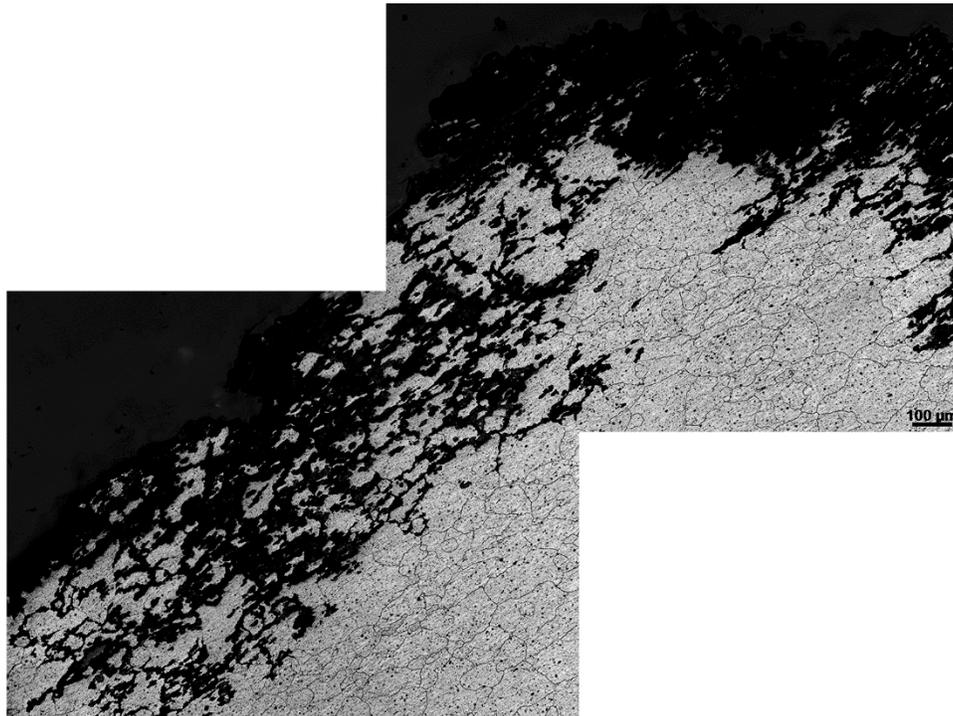
Figure A-88: IGC and pitting on the outer diameter of the tie cross-section (from Figure A-84).

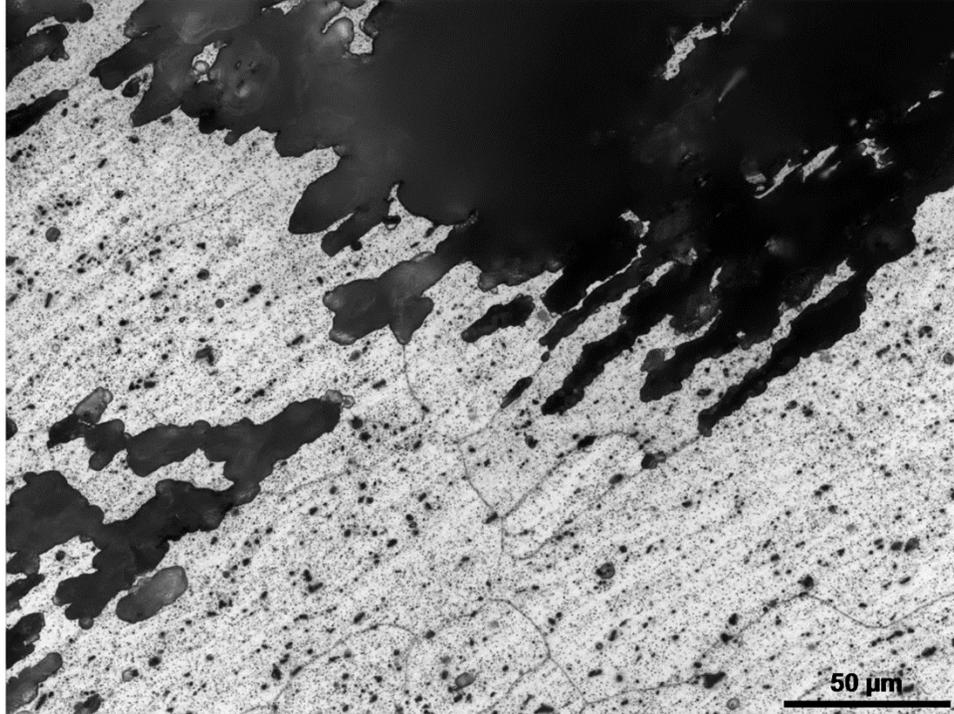
Figure A-89: Close-up on IGC and pitting (from Figure A-88).

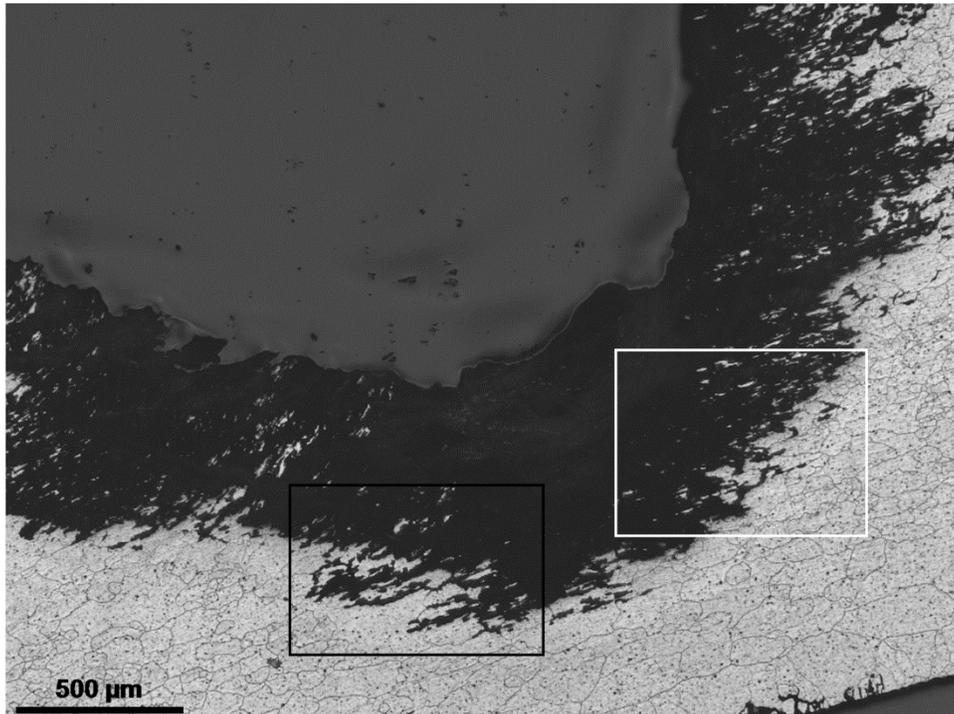
Figure A-90: Large pit on the outer diameter of the tie cross-section (from Figure A-84). The black and white boxes contain Figures A-91 and A-92, respectively.

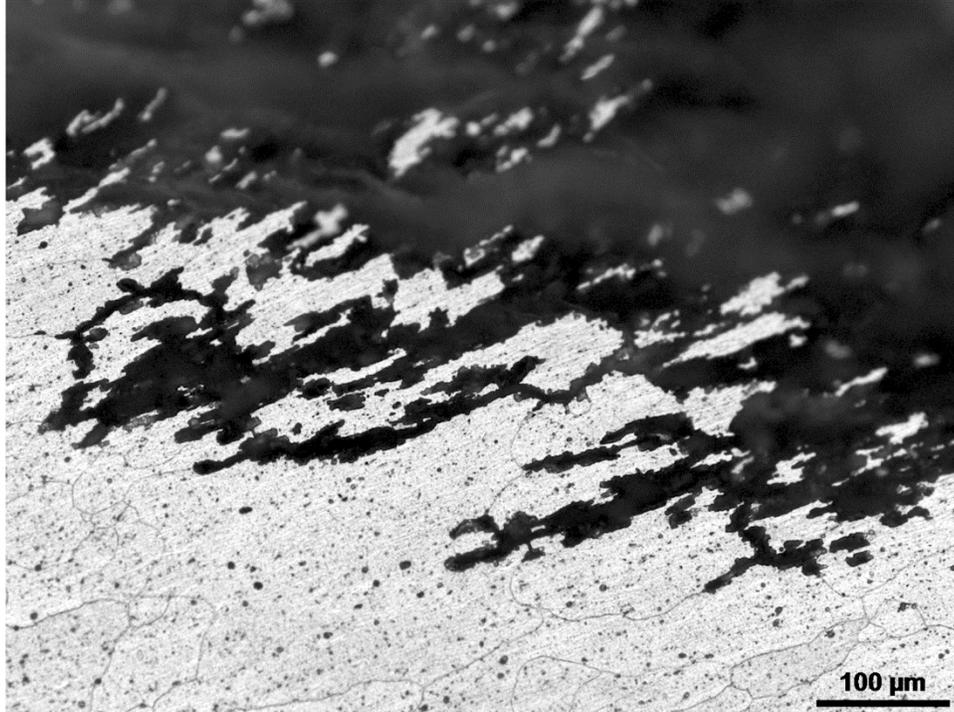
Figure A-91: IGC and pitting near the bottom of the large pit (from Figure A-90).

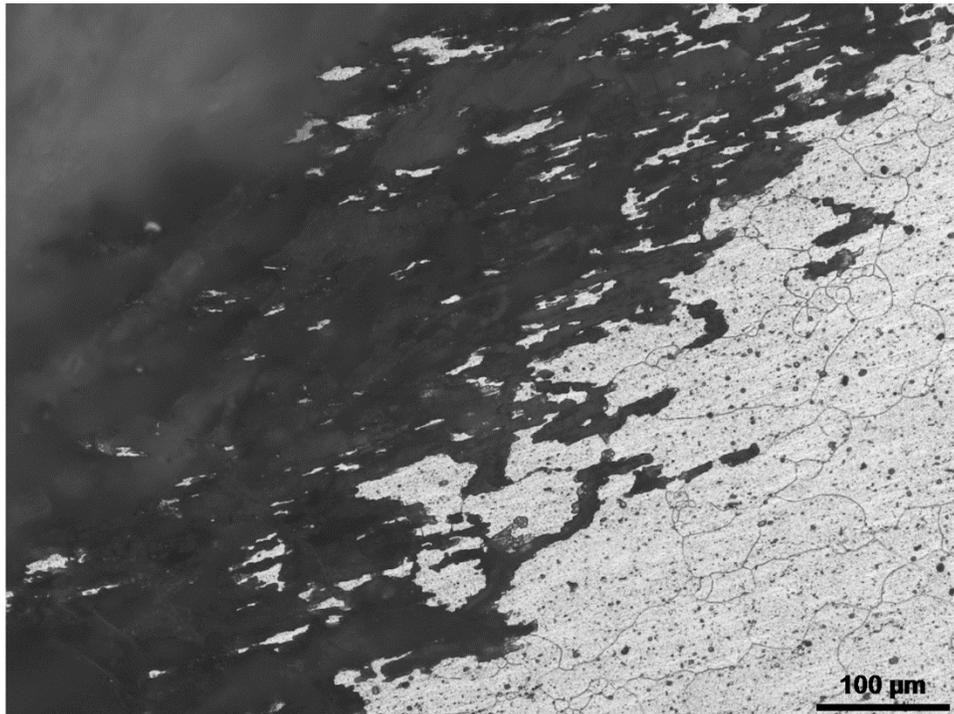
Figure A-92: IGC and pitting near the bottom of the large pit (from Figure A-90).

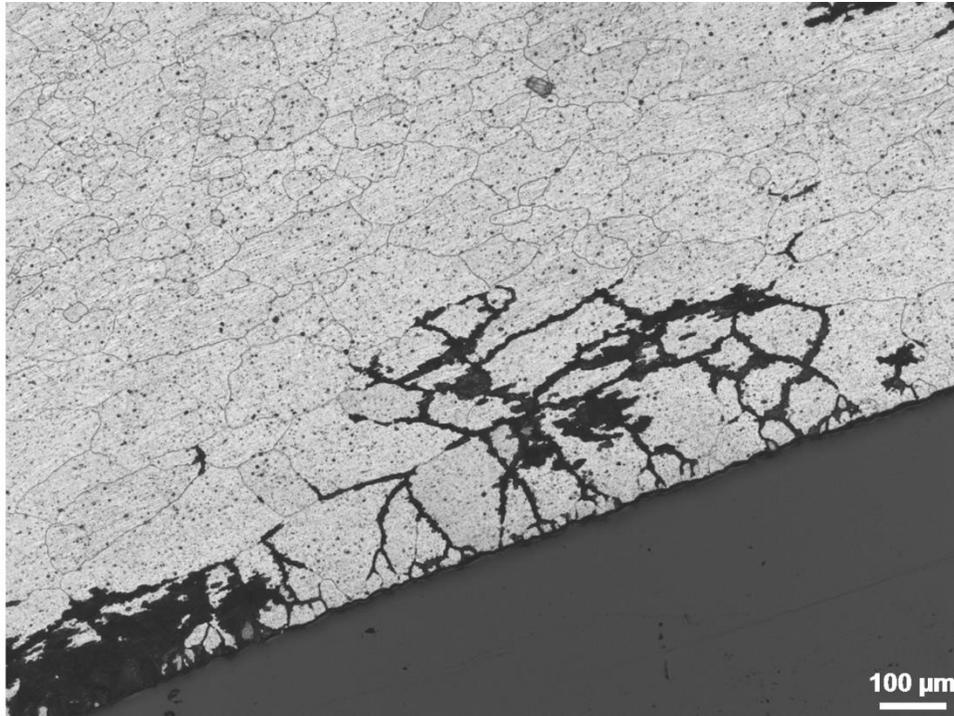
Figure A-93: IGC and pitting on the inner diameter of the tie cross-section (from Figure A-84).

Regarding the IGC found in the tubular tie, the cracks were identified both at and below the surface. From the collected evidence, the IGC appears to have initiated from any surface of the tie which was exposed to process fluid. Moreover, it is believed that the IGC was due to the composition of the wastewater process fluid – 6061 is susceptible to IGC in chloride solutions [25,26].

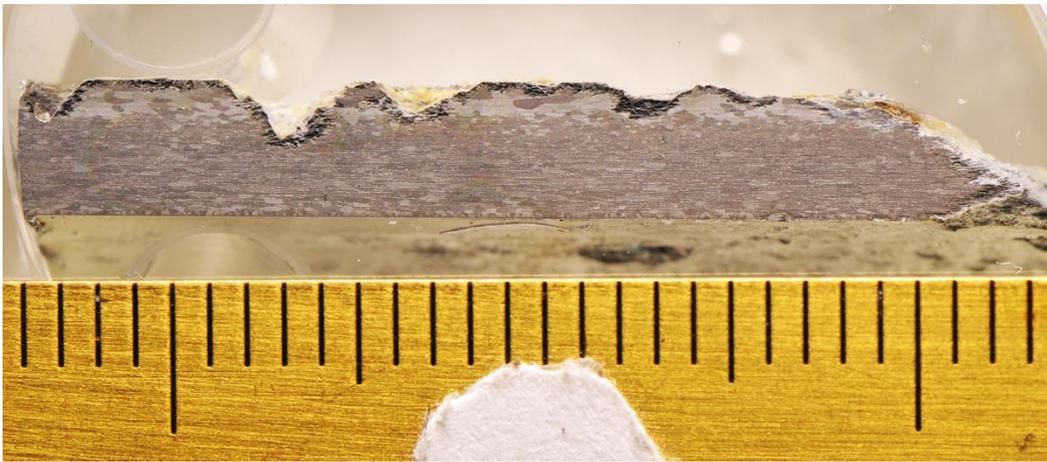
The second tie cross-section (in the axial direction; labelled “Hole Axial”) and its microstructure are shown below in Figures A-94 through A-102. Corrosion damage was found on all of the cross-section surfaces (Figures A-94, A-95, A-97, and A-99). Pitting and IGC were observed both at and below the surface of the pits (Figures A-96, A-98, A-100, A-101, and A-102) as well as on un-pitted surfaces (Figures A-95 and A-96). As with the “Hole Circumference” cross-section (Section 2.4.1.3), the most severe damage was found on the portion of the cross-section which was immediately adjacent to the through-wall hole (Figures A-97 and A-98). Finally, there also appeared to be some preferential corrosion in the extrusion or drawing direction of the tie (Figures A-97, A-98, A-100, A-101, and A-102). It is believed that the corrosion is preferentially attacking both grain boundaries and any build-up in dislocation density in the extrusion or drawing direction.

Figure A-94: Overall image of etched tubular tie cross-section (in the axial direction; labelled “Hole Axial”). Scale is in mm.

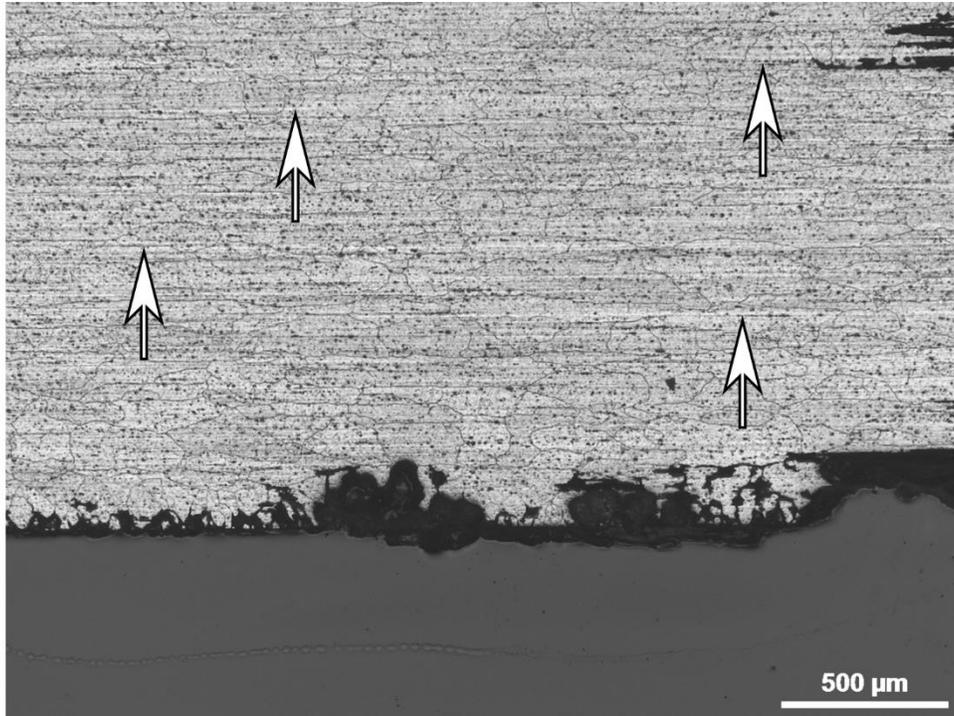
Figure A-95: Corrosion damage on the inner diameter of the tie cross-section (from Figure A-94). White arrows are perpendicular to the above-mentioned directionality of the microstructure.

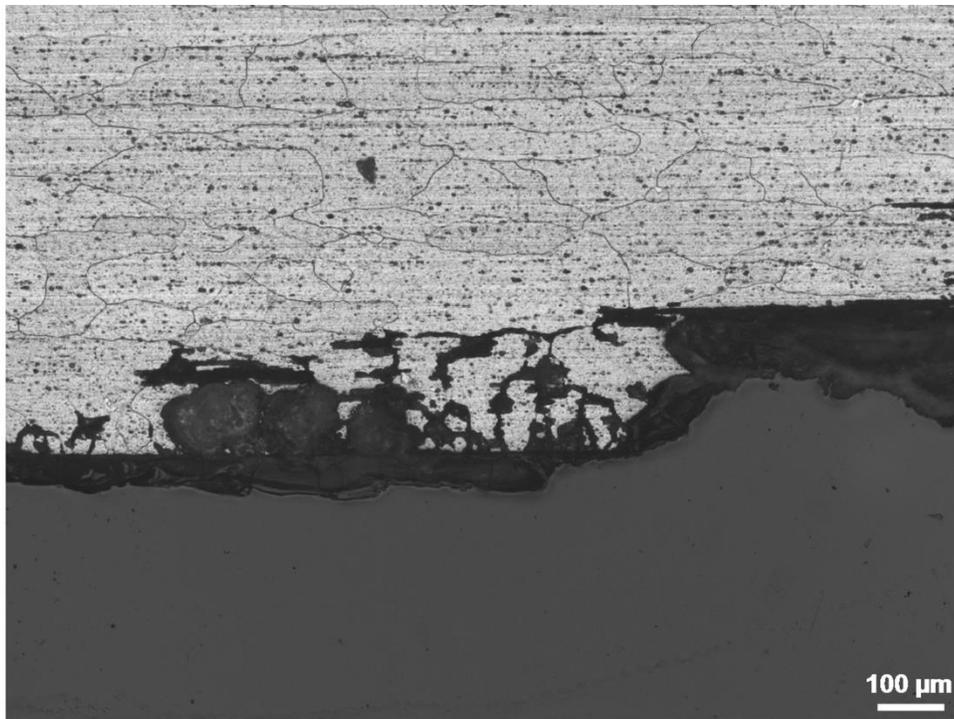
Figure A-96: Close-up on IGC and pitting (from Figure A-95).

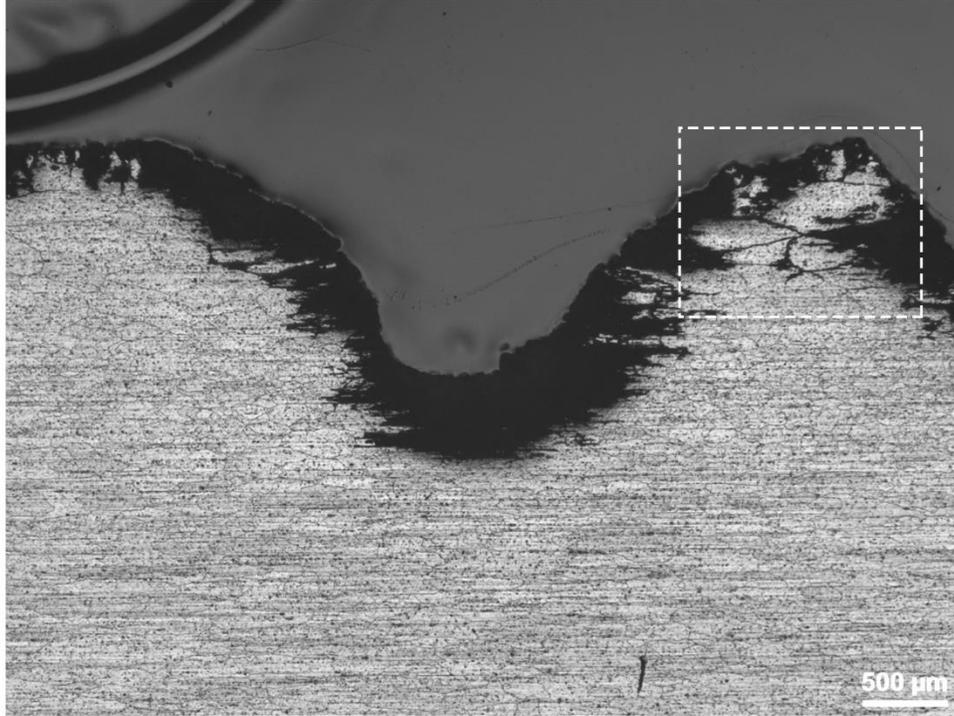
Figure A-99: Large pit on the outer diameter of the tie cross-section (from Figure A-94). The white dashed box contains Figure A-102.

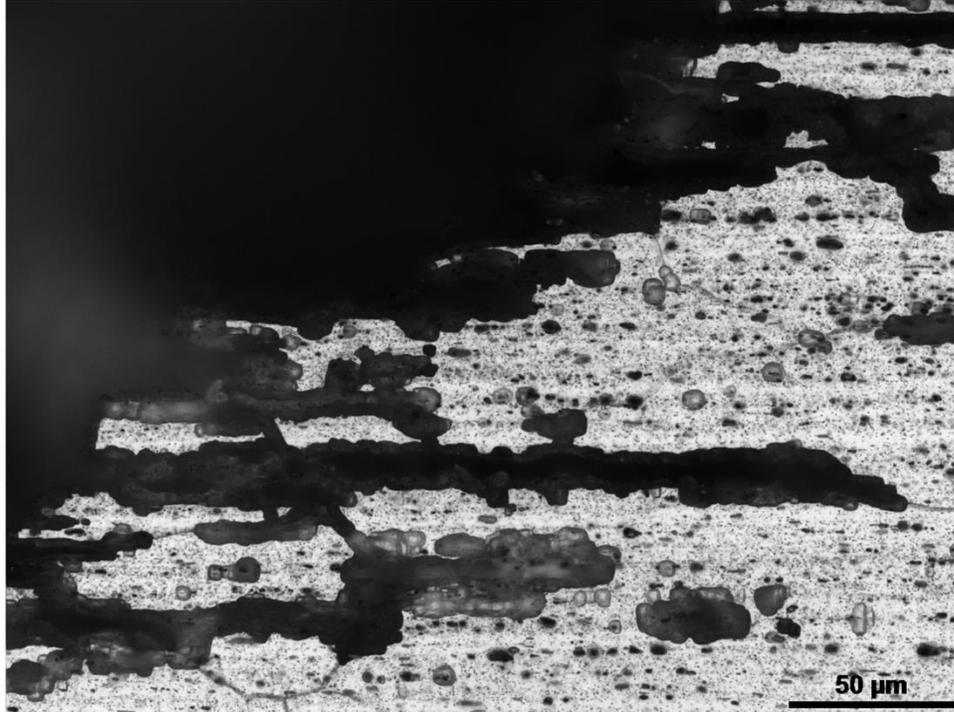
Figure A-101: Close-up on IGC, pitting, and preferential corrosion in the extrusion or drawing direction at the bottom of the large pit (from Figure A-100).

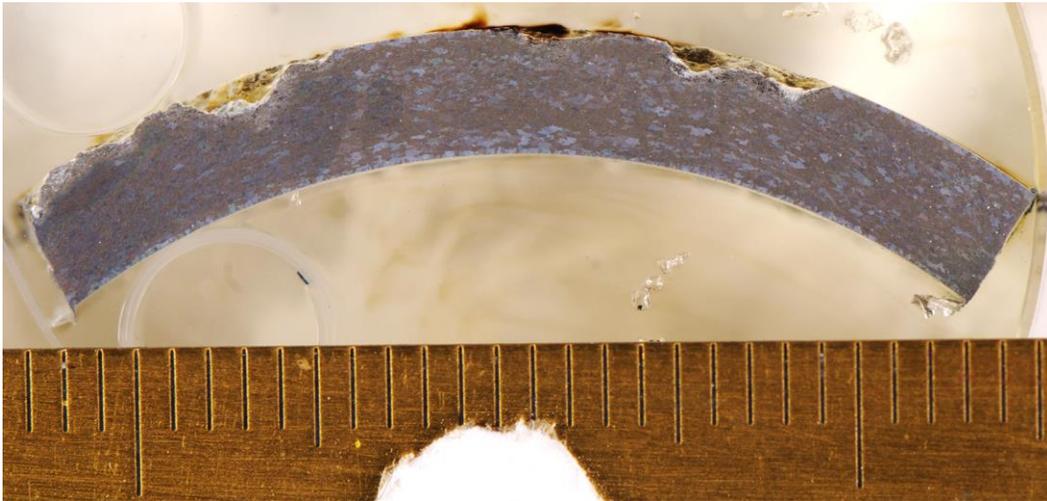
The third tie cross-section (in the radial direction; labelled “End Circumference”) and its microstructure are shown below in Figures A-103 through A-106. Corrosion damage was found primarily on the outer diameter of the tie cross-section (Figures A-103 and A-104). IGC was also observed both at and below the surface of the pits (Figures A-105 and A-106). Overall, the corrosion damage was found to be less severe on this cross-section as compared to both cross-sections removed adjacent to the through-wall hole. It is believed that galvanic effects from the proximity of the stainless steel aeration piping are exacerbating the corrosion damage observed on both the “Hole Circumference” and “Hole Axial” cross-sections.

Figure A-103: Overall image of etched tubular tie cross-section (in the radial direction; labelled “End Circumference”). Scale is in mm.

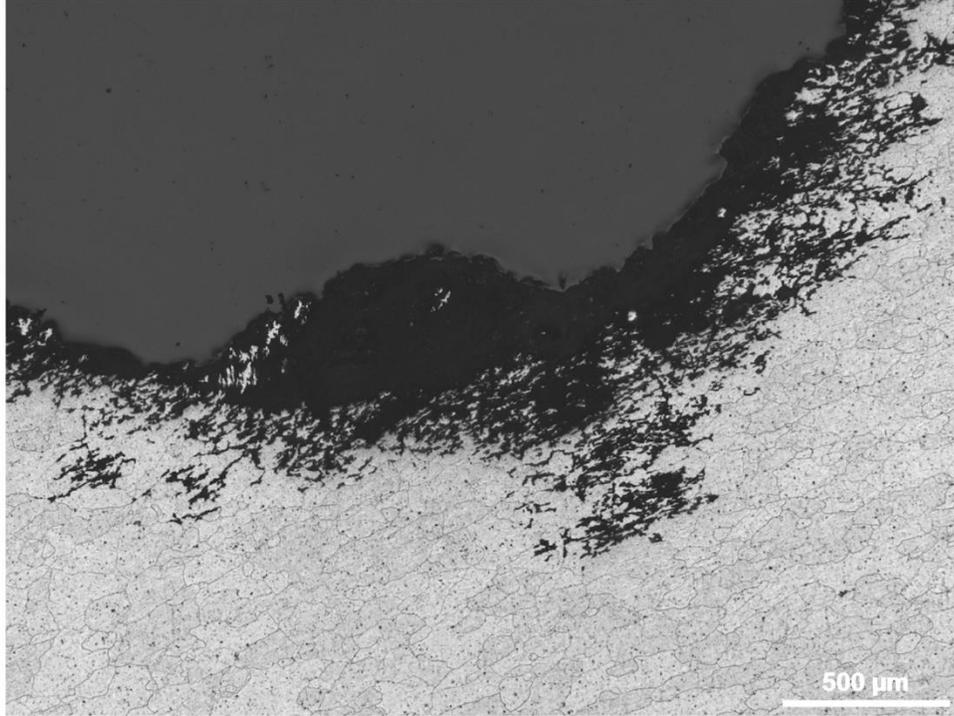
Figure A-104: Large pit on the outer diameter of the tie cross-section (from Figure A-103).

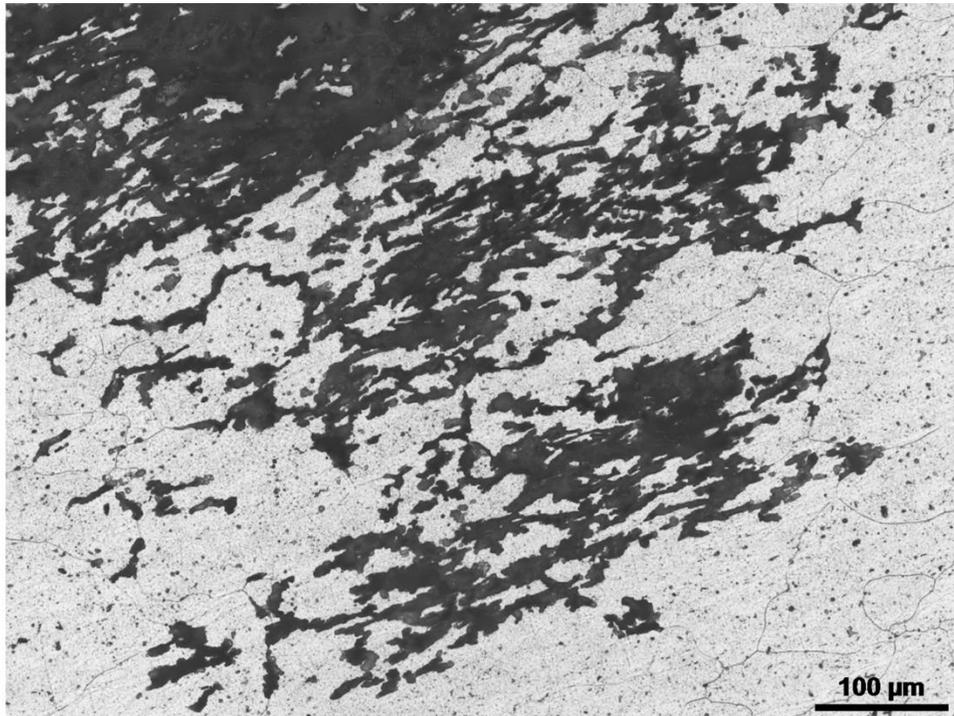
Figure A-105: IGC and pitting at the bottom of the large pit (from Figure A-104).

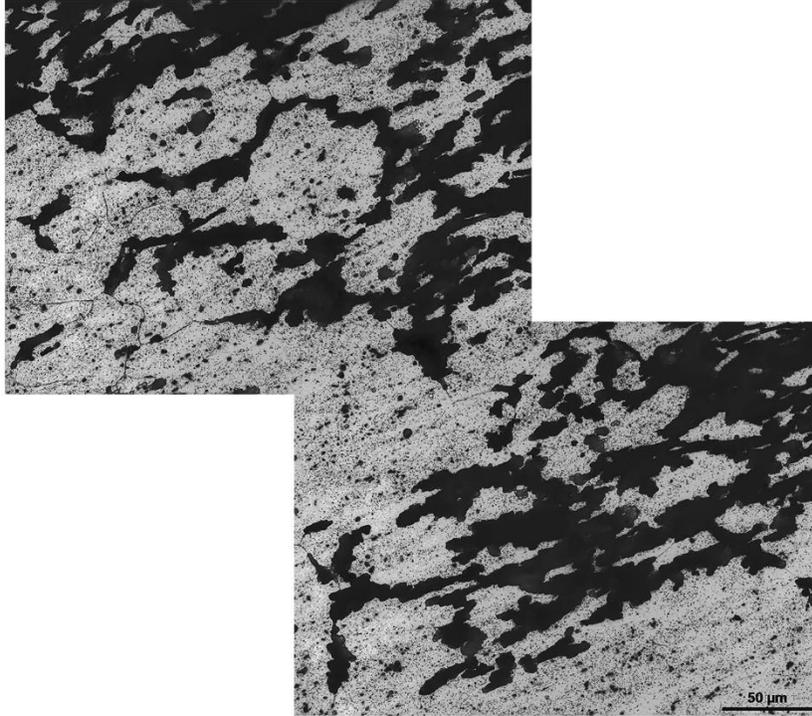
Figure A-106: Close-up on IGC and pitting (from Figure A-105).

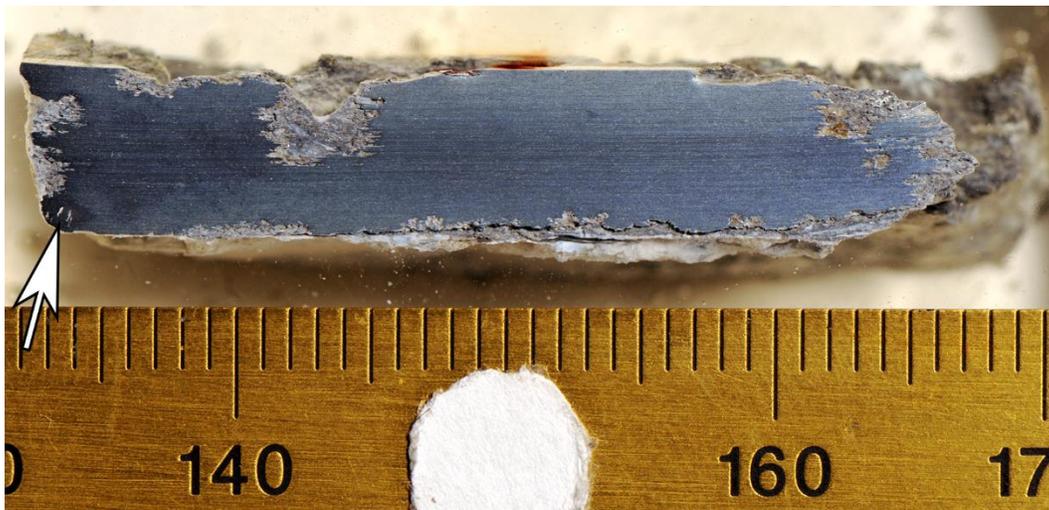
The aeration line bracket cross-section and its microstructure are shown below in Figures A-107 through A-119. This cross-section (Figure A-107) is the same cross-section which was prepared for SEM examination. Pitting was found on all surfaces of the cross-section (Figures A-107, A-108, A-113, and A-115).

Figure A-107: Overall image of etched aeration line bracket cross-section. The mark on the bottom left corner (white arrow) is an artifact from the etching process. Scale is in mm.

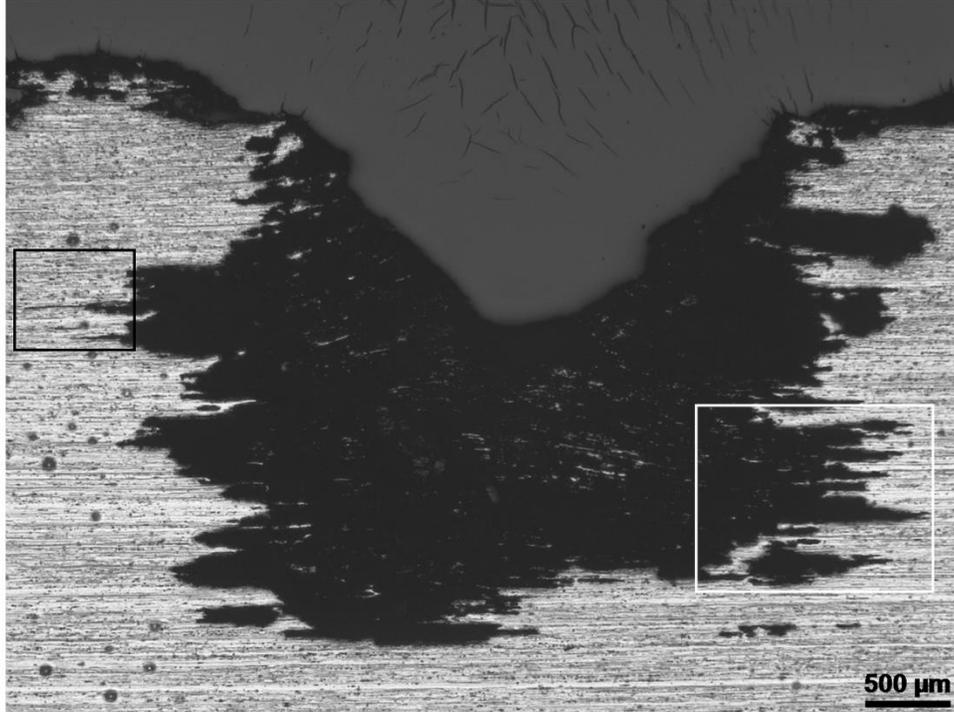
On the top and bottom of the cross-section, the pits appeared to be elliptical in shape, and exhibited signs of undercutting (Figures A-108 and A-113). Although pitting on the top and bottom of the cross-section appeared similar in shape, pitting on the top was deeper than on the bottom. At higher magnification, tunneling could be seen originating from and below pit surfaces (Figures A-109 through A-112, and A-114). Finally, crystallographic pits (in the shape of cubes) were found on the walls of the pit tunnels (Figures A-110, A-117, and A-119). Due to the etching process – as found with the floor cross-section – it becomes difficult to view the

Figure A-108: Large pit on the top of the cross-section (from Figure A-107). The white box contains Figure A-109 while the black box contains Figure A-110.

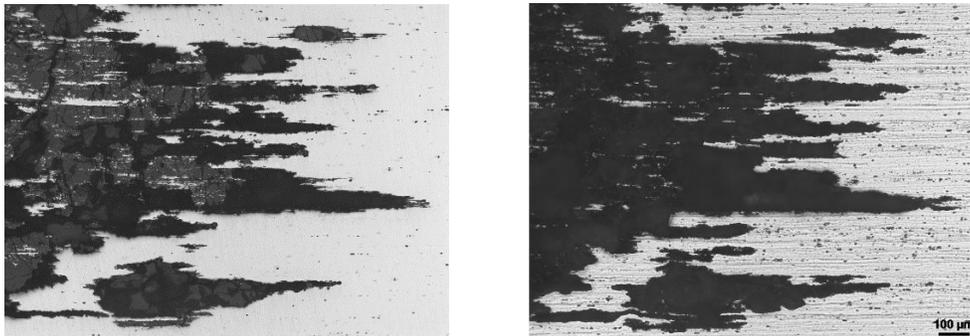
Figure A-109: Tunneling near the bottom right of the large pit (from Figure A-108). The left image is un-etched while the right image is etched.

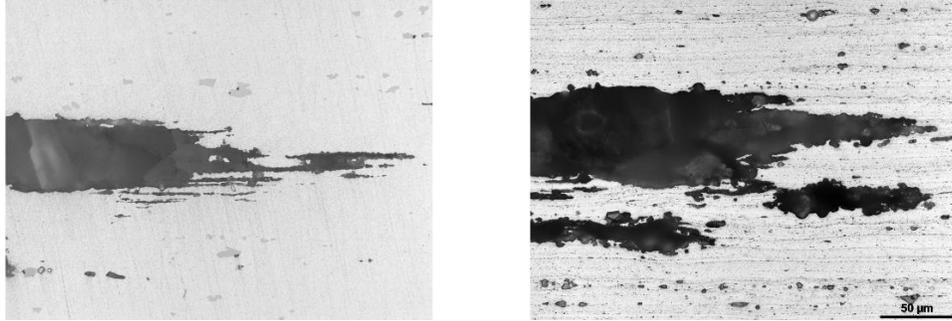
Figure A-110: Close-up on tunneling and crystallographic pitting (from Figure A-108 – near the top right corner). The left image is un-etched while the right image is etched.

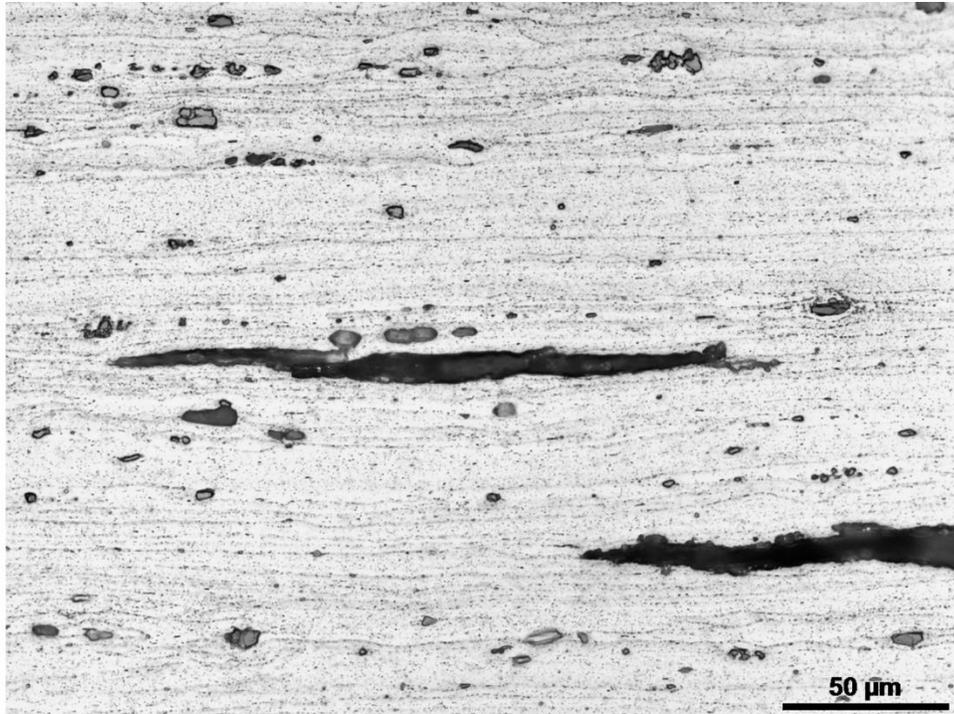
Figure A-112: Close-up on tunneling (from Figure A-111).

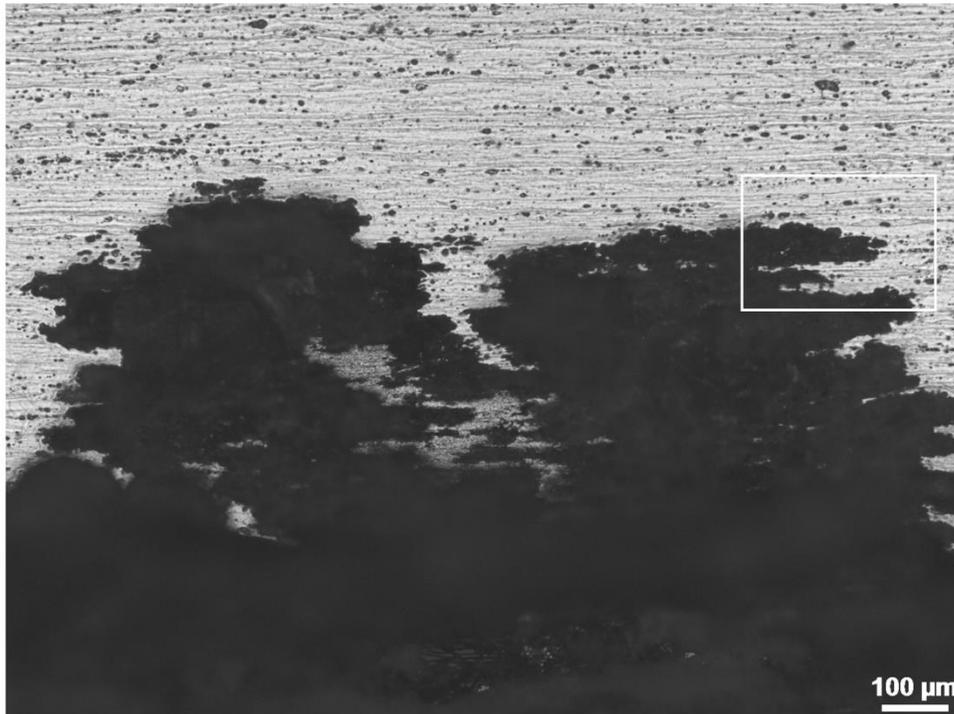
Figure A-113: Pits on the bottom right of the cross-section (from Figure A-107). White box contains Figure A-114.
