Corrosion of Aluminum Alloys in Wastewater Treatment Aeration Tanks

A thesis submitted in partial fulfillment of the requirements for the degree of

Materials Engineering

Severe localized corrosion was found throughout an aeration tank of a modular wastewater treatment plant. Specifically, pitting, crevice corrosion, galvanic corrosion, and intergranular corrosion (IGC) were observed on the 5000 and 6000 series aluminum alloys used in the tank's construction. One of the suspected environmental causes of corrosion was an aeration tank process additive, namely a coagulant – either aluminum sulphate (Alum) or polyaluminum chloride (PACl; Isopac). Laboratory scale corrosion cells were designed to isolate, simulate, and evaluate the corrosivity of the coagulants (in relevant quantities) on the metallic alloys of construction. Additionally, due to presence of deposit found throughout the tank (resulting in under-deposit corrosion), fabricated crevices were installed on the tested alloys to help simulate crevice corrosion environments. The solution conditions in the cells were monitored throughout the duration of the immersion testing in order to assess whether the cells were within nor

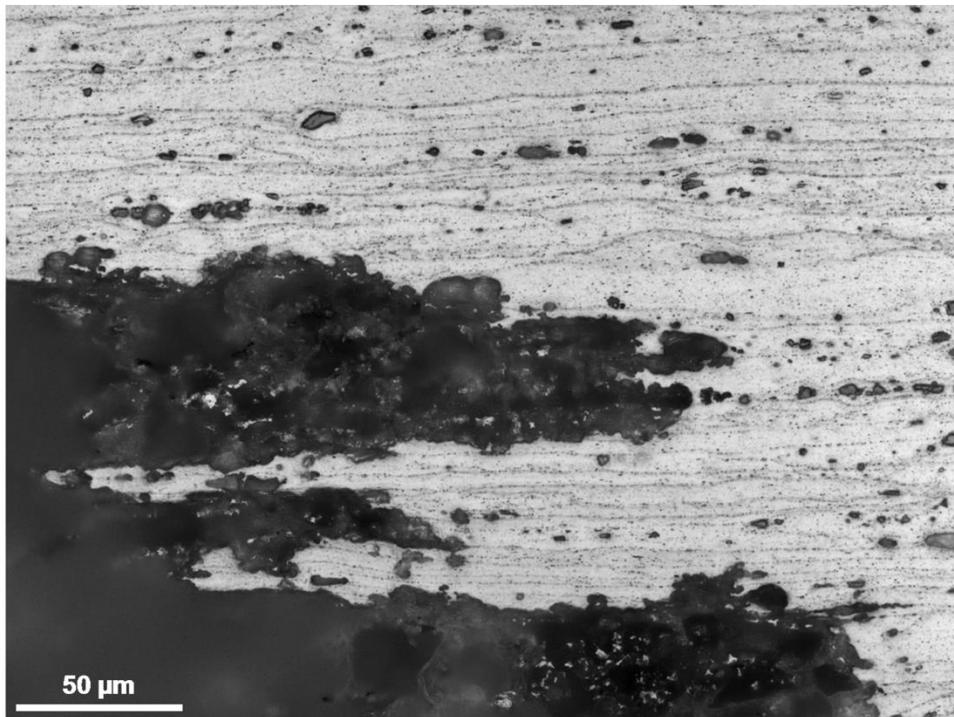
Figure A-114: Close-up on tunneling (from Figure A-113).

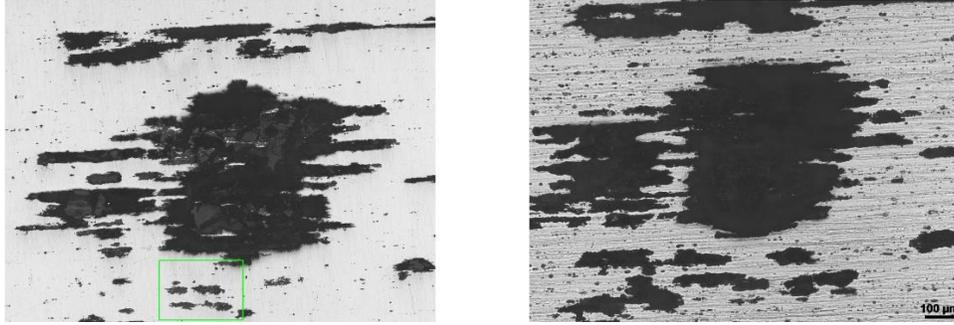
Pitting was also observed on the sides of the bracket; however, these pits appeared to be smaller in area, with either a round or irregular opening, and deeper (Figure A-115, A-116, and A-118). Both tunneling and crystallographic pits were also identified. Finally, there also appeared to be some preferential corrosion in the rolling direction of the bracket (Figures A-111, A-115, and A-118). It is believed that the corrosion is preferentially attacking both grain boundaries and any build-up in dislocation density in the rolling direction.

Figure A-116: Tunneling in the cross-section (from Figure A-115). The left image is un-etched while the right image is etched. The green box in the left image is Figure A-117.

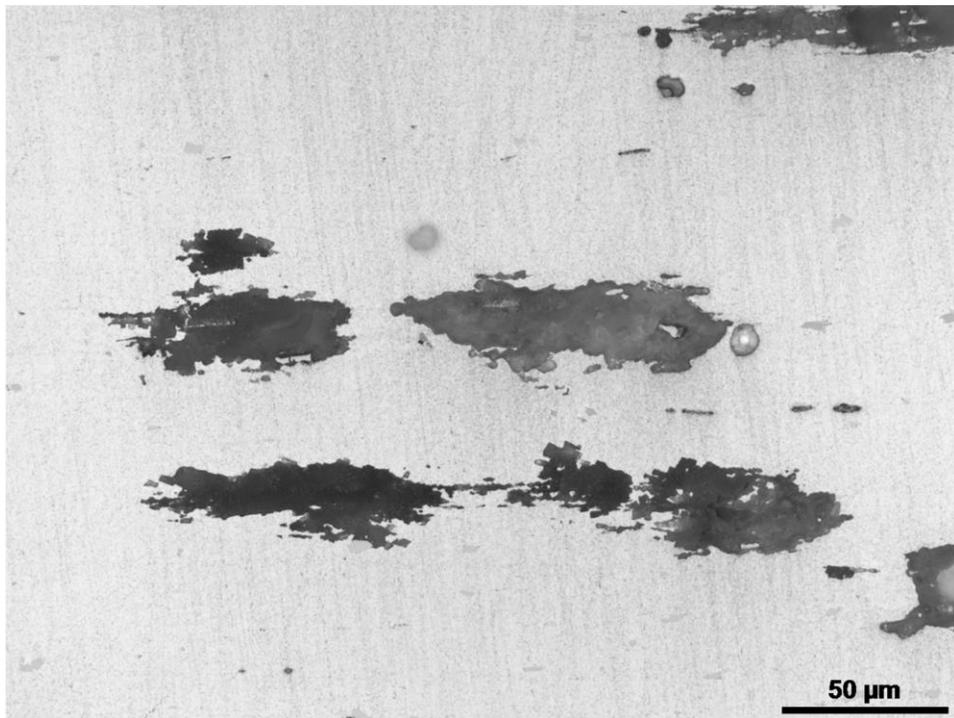
Figure A-117: Close-up on tunneling and crystallographic pitting (un-etched; from left image in Figure A-116).

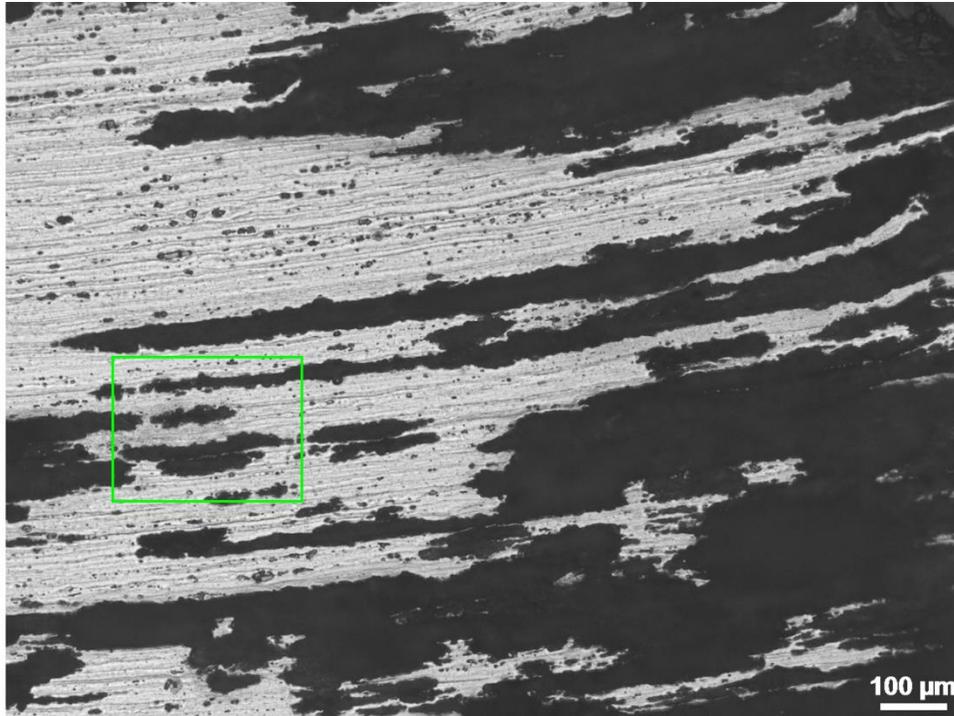
Figure A-118: Pitting, tunneling, and preferential corrosion in the rolling direction (from Figure A-115). The green box contains Figure A-119.

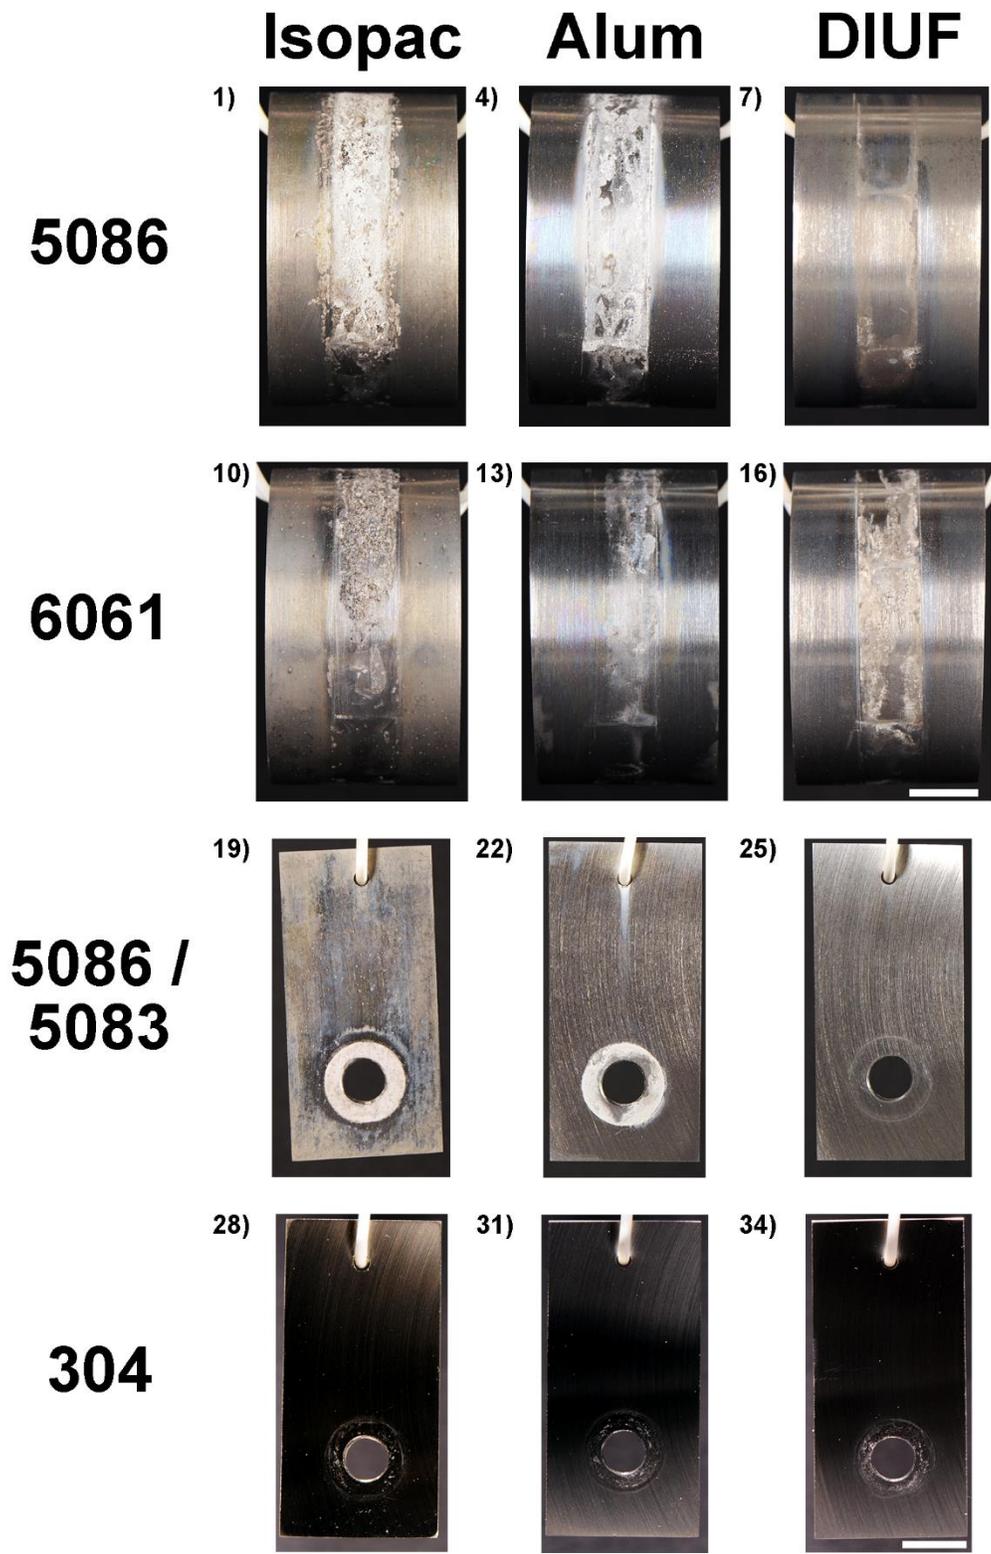
Figure D-1: Composite image of corrosion coupons of different alloys in various test solutions.

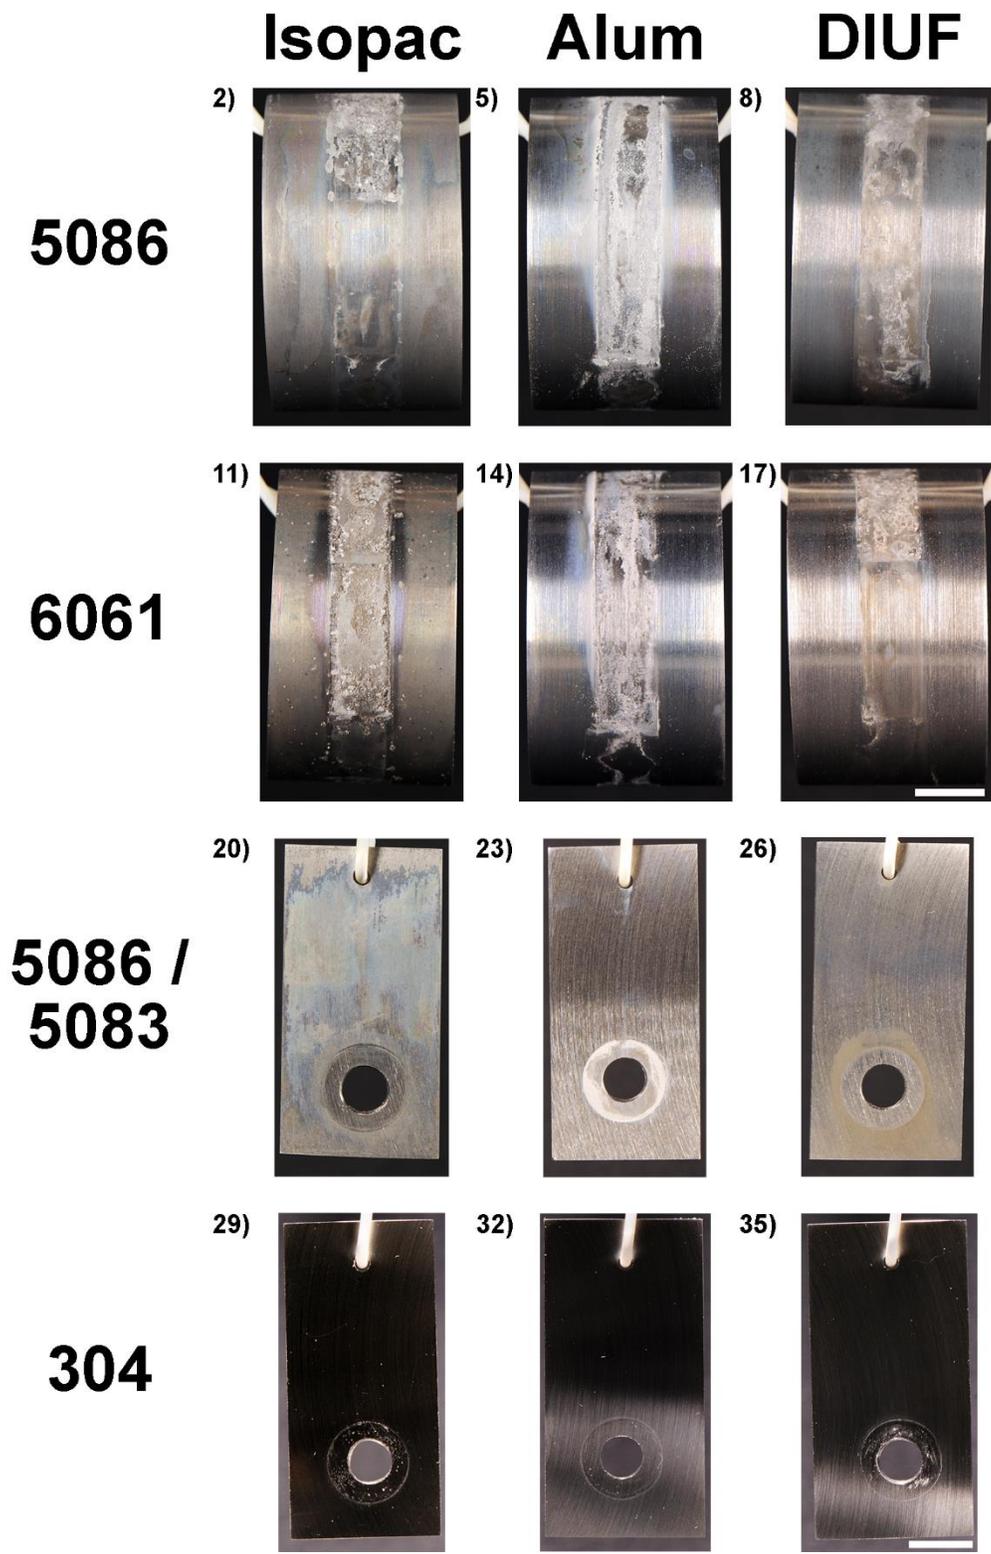
Figure D-2: Composite image of corrosion coupons of different alloys in various test solutions.

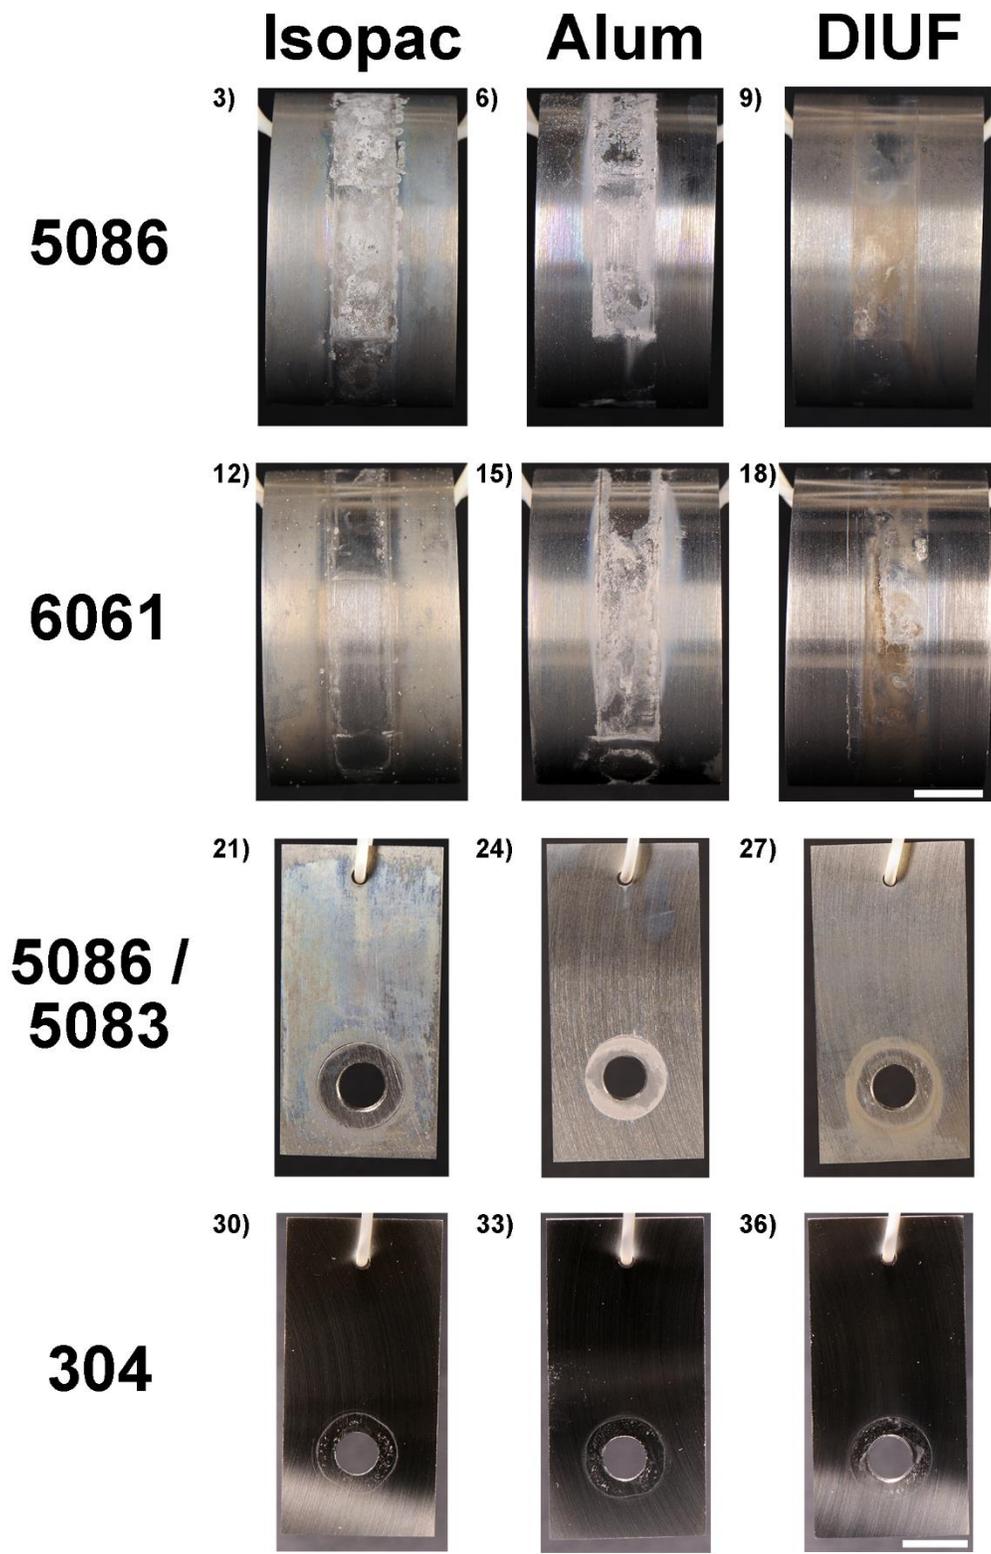
Figure D-3: Composite image of corrosion coupons of different alloys in various test solutions.

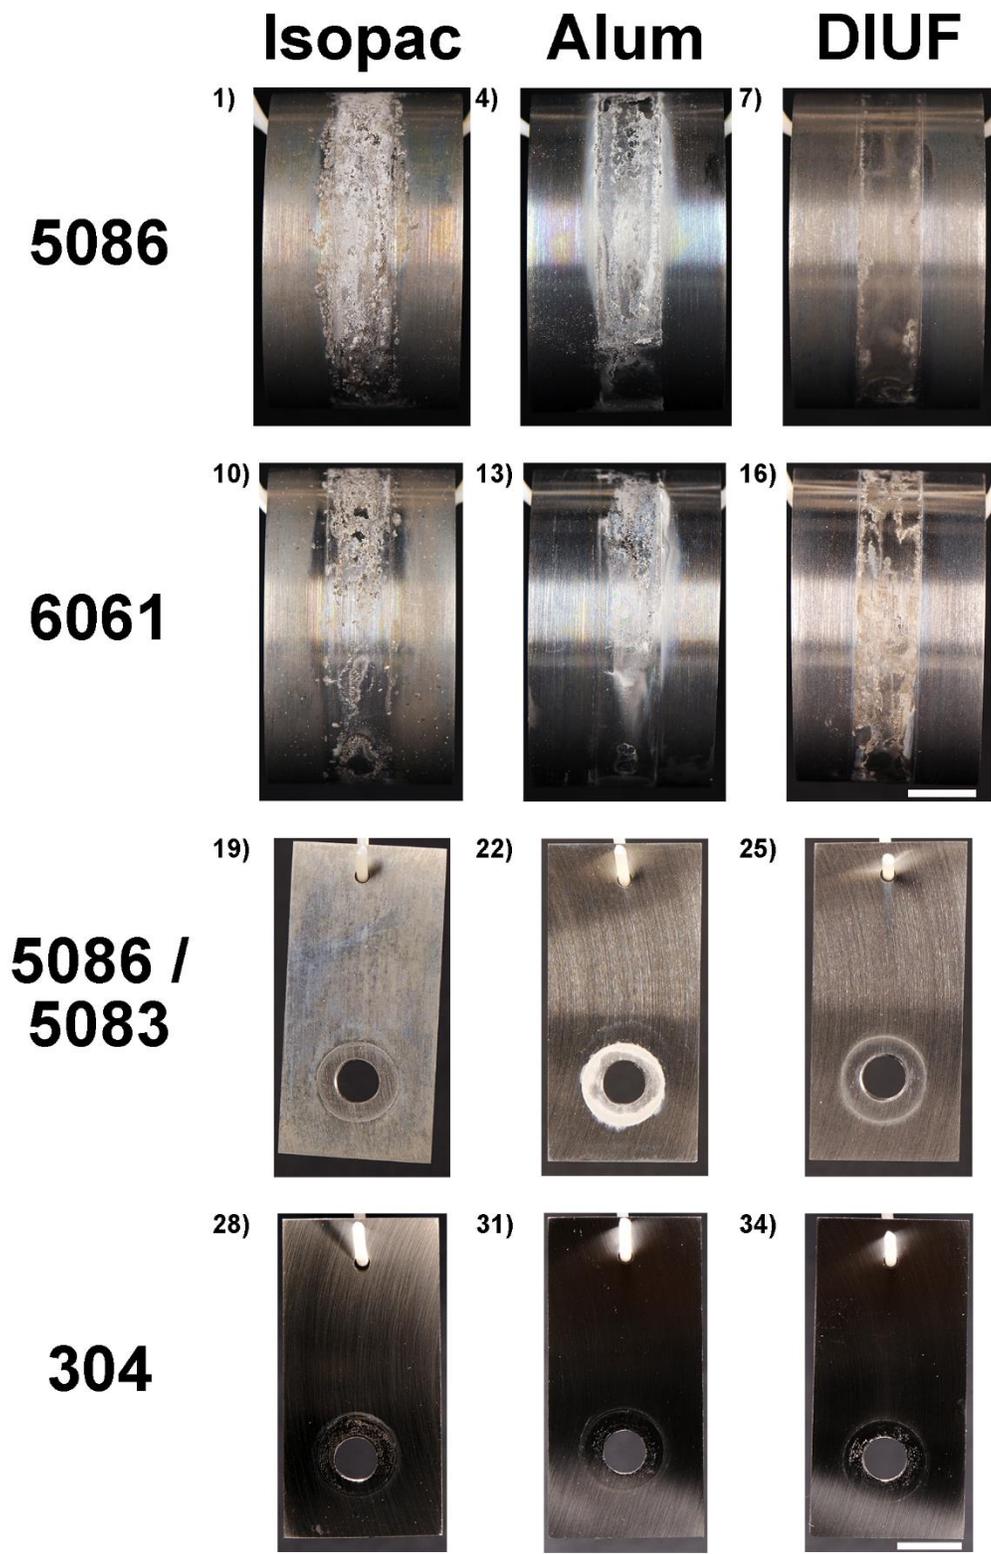
Figure D-4: Composite image of corrosion coupons of different alloys in various test solutions.

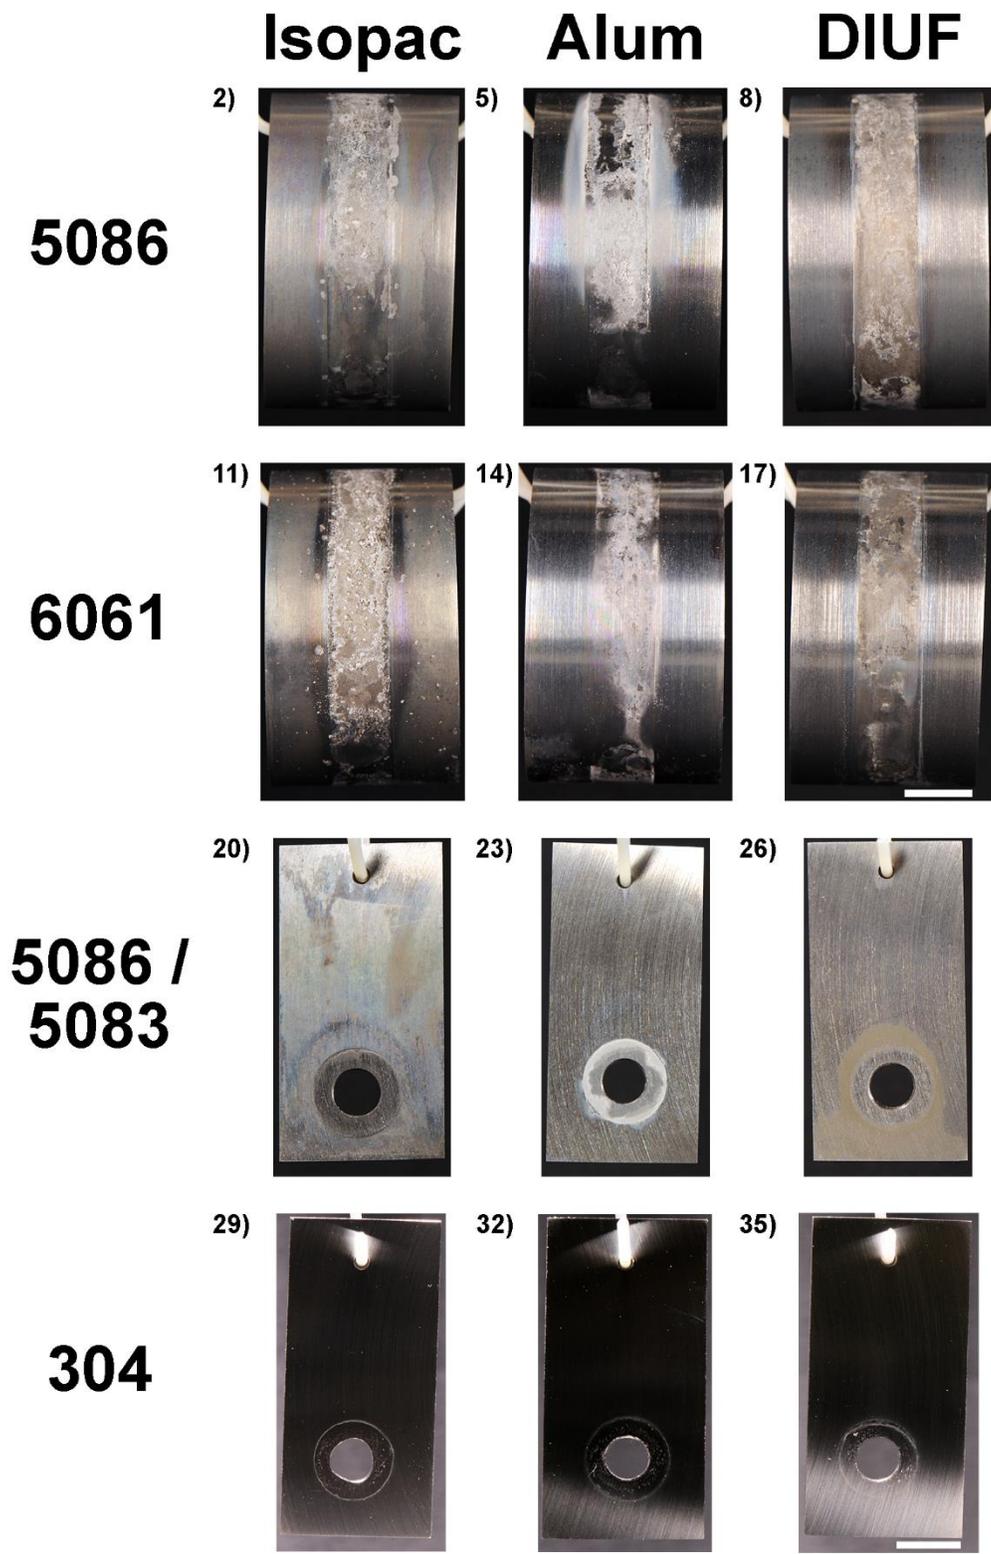
Figure D-5: Composite image of corrosion coupons of different alloys in various test solutions.

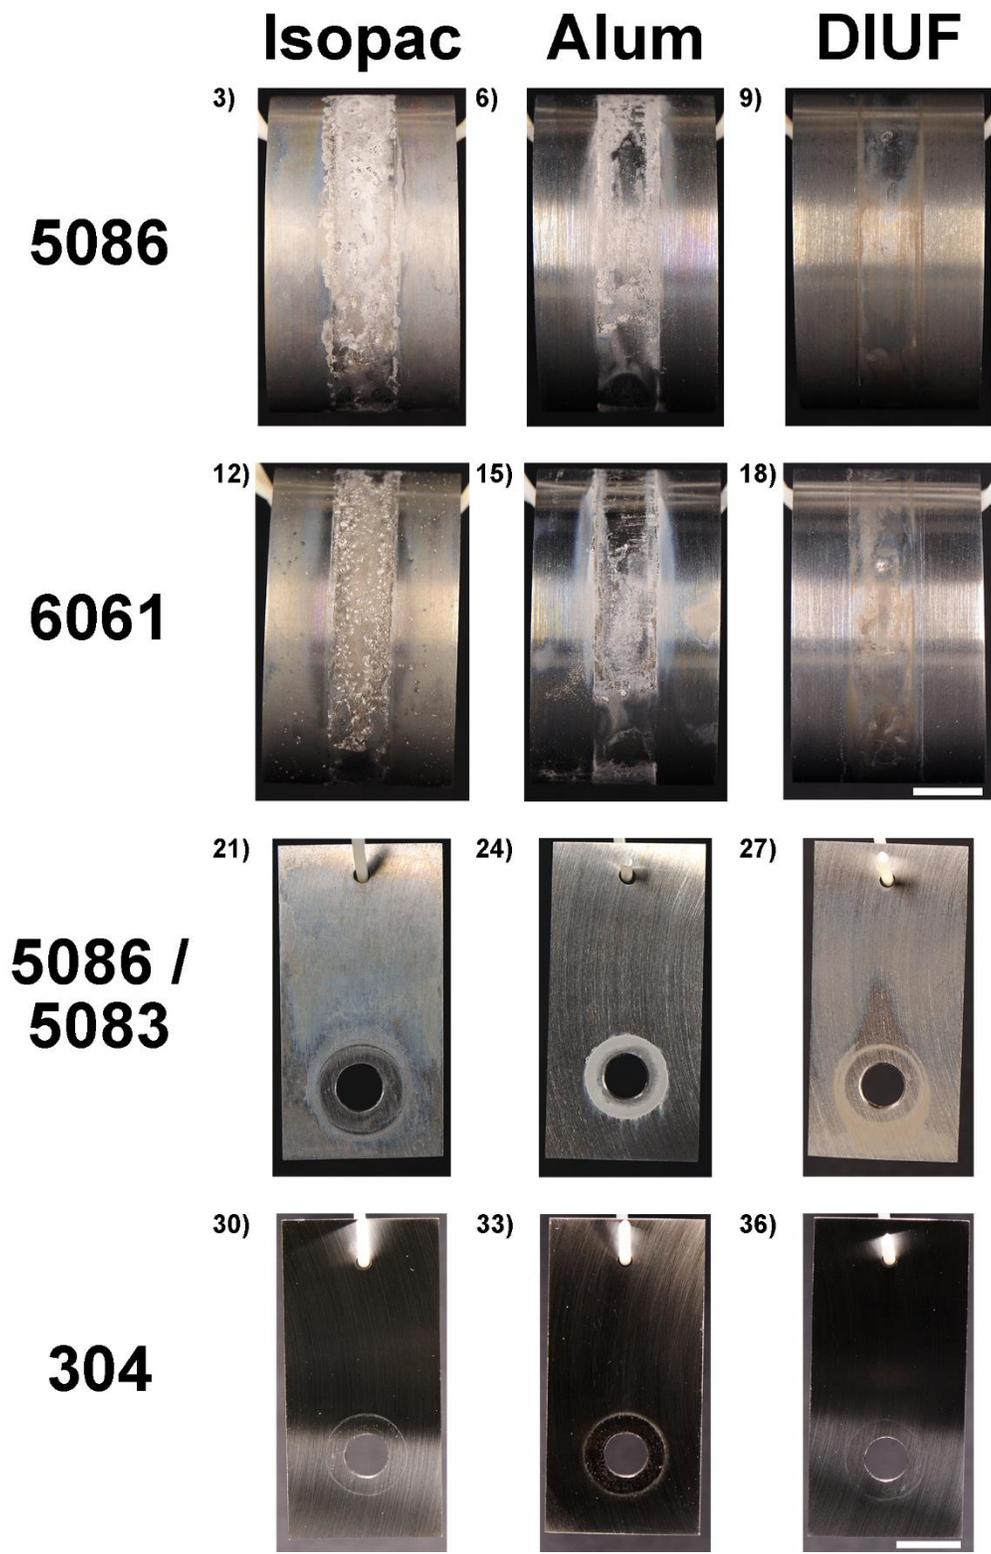
Figure D-6: Composite image of corrosion coupons of different alloys in various test solutions.
