OBSERVATION OF THE DESIGN
AND PERFORMANCE OF THE
DEMPSTER HIGHWAY

SUBMITTED TO
THE UNIVERSITY OF ALBERTA
DEPARTMENT OF CIVIL ENGINEERING

APRIL 1985

B. E. LINGNAU

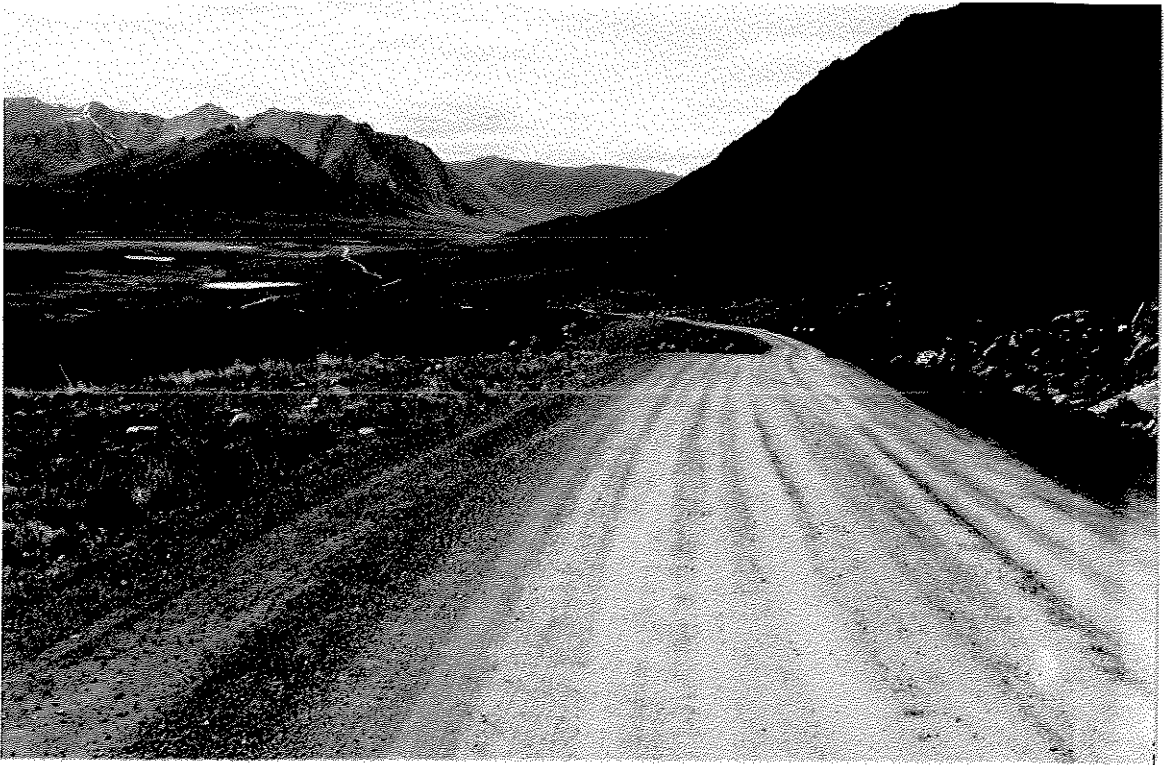
PLATE 5: Highway reconstruction underway near Km. 81 in alpine "tundra" of the Ogilvie Mountains (looking north). Remnant aufeis is visible at the left.

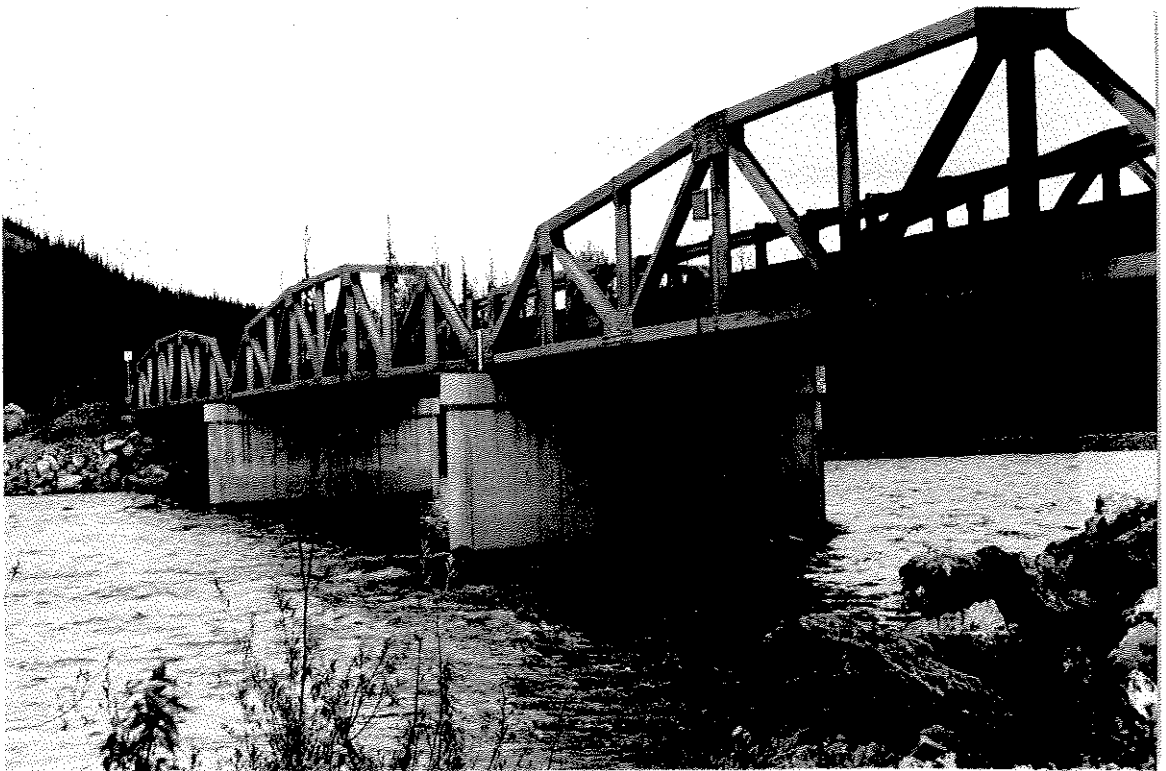
PLATE 8: The Jeckell bridge over the Ogilvie River Bridge comprises 110 m. triple span. (Km. 196)

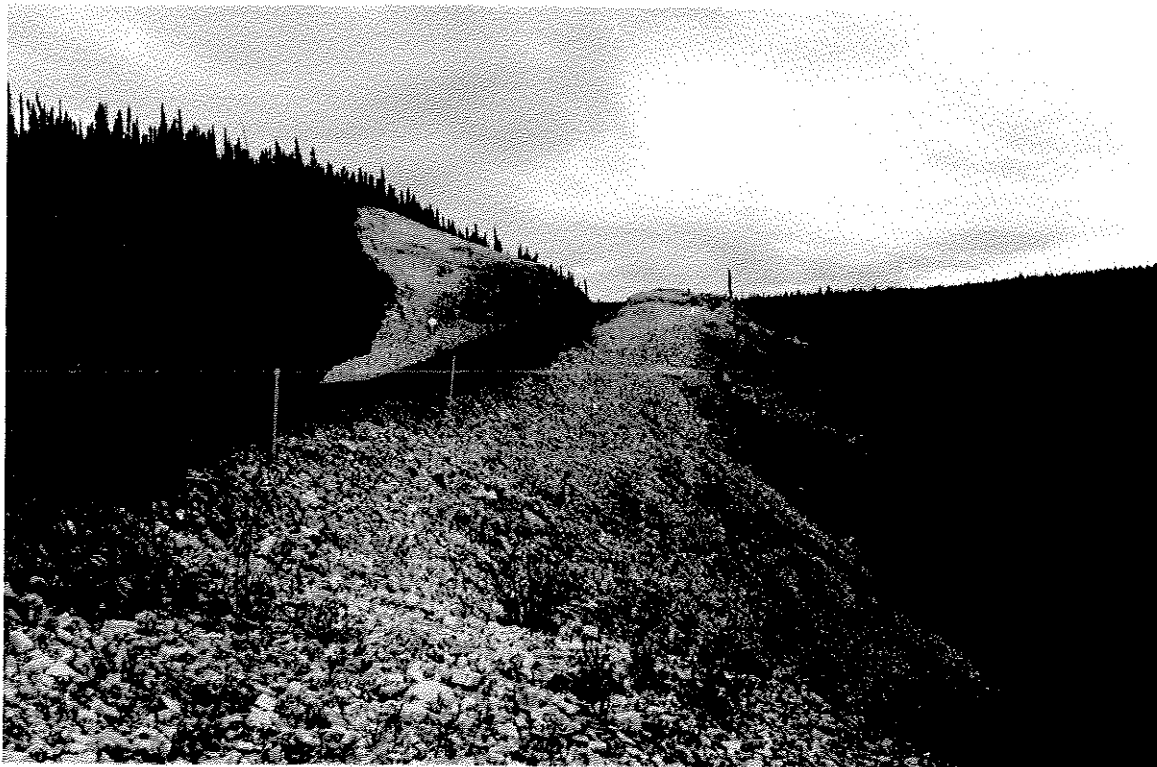
PLATE 11: Cut/fill transition at Km. 354. Limestone breccia in rock cut.

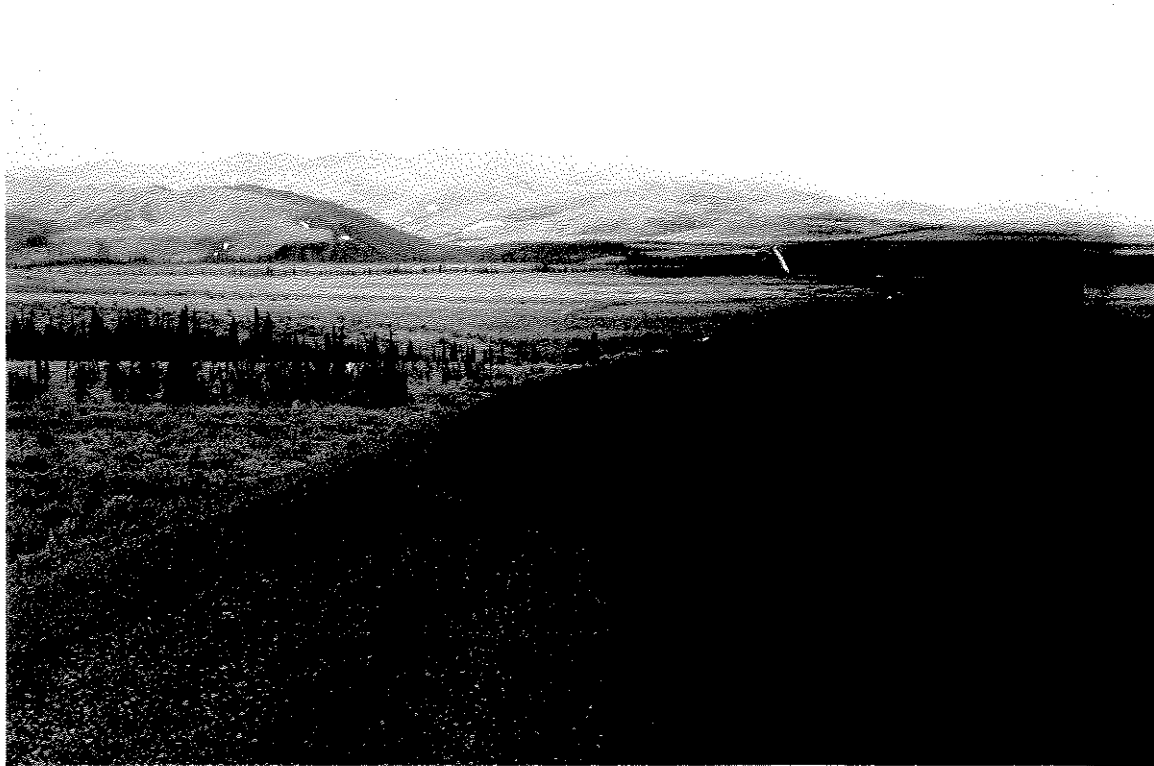
PLATE 16: Shale embankment about 6 years old at Km. 412. Snow fence (centre) and large cut and fill (background) are visible.
(9 miles north of Arctic Circle).

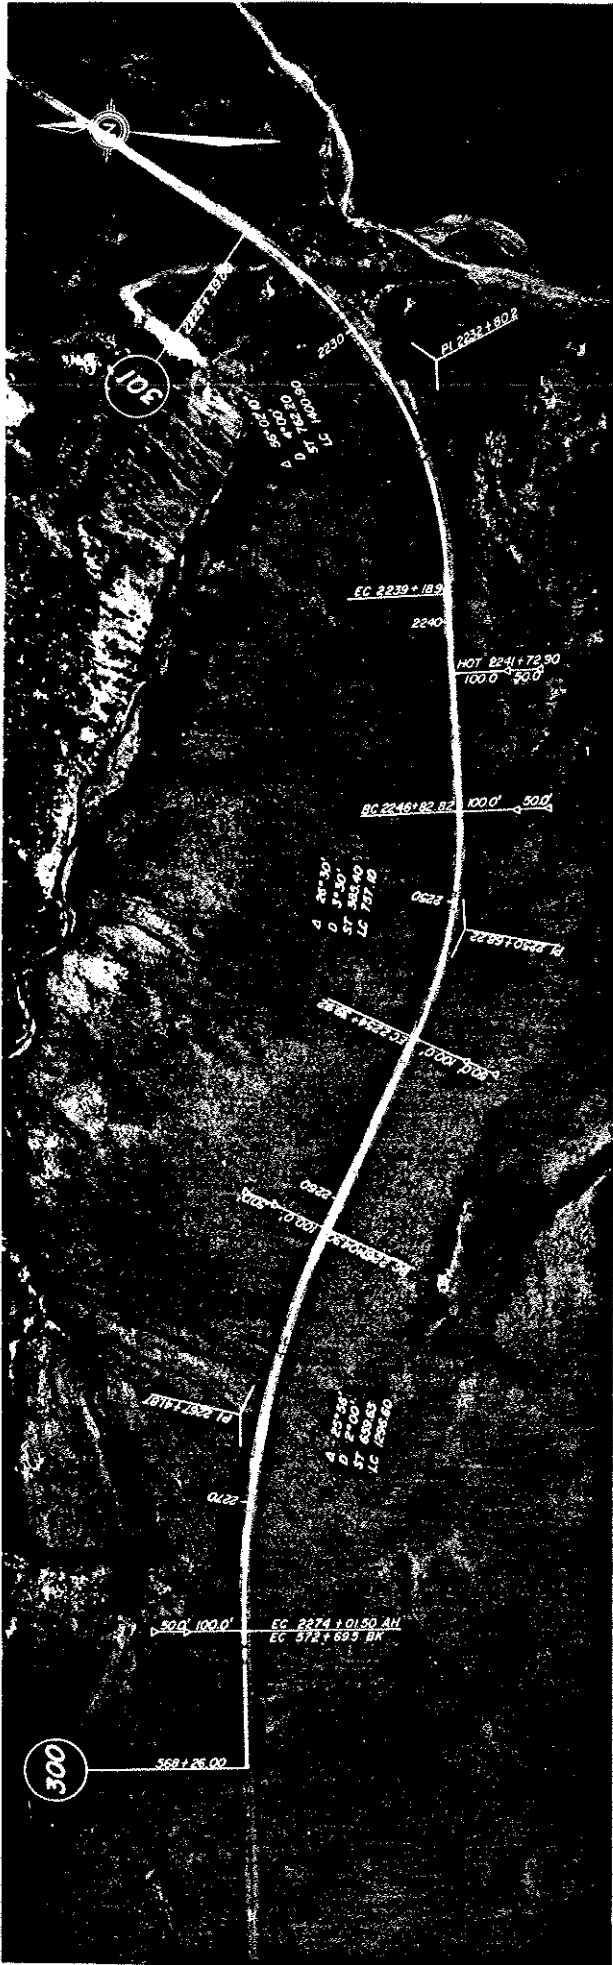
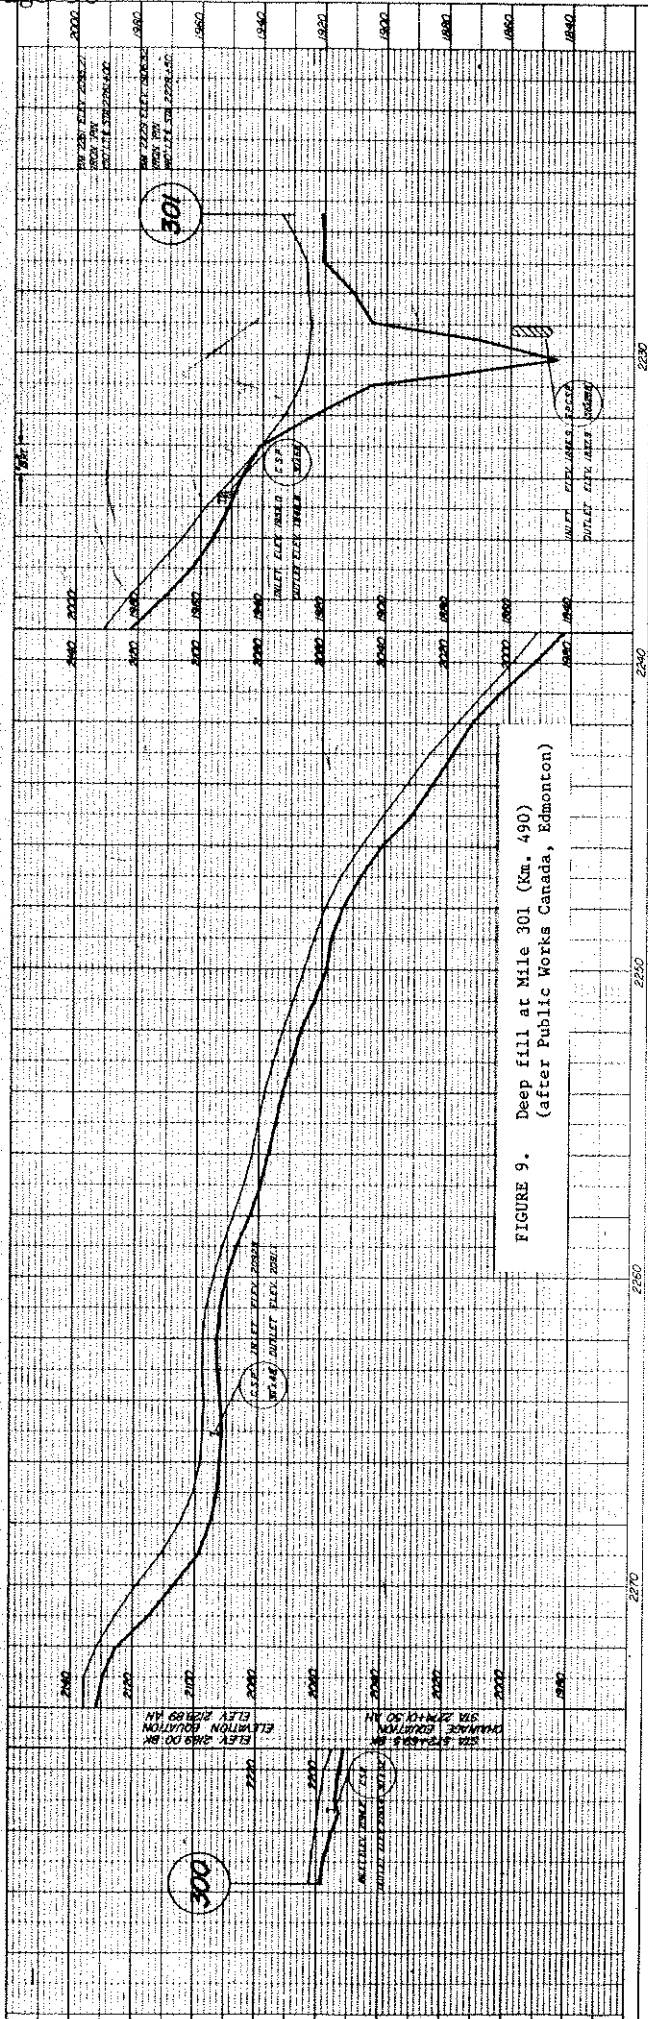
FIGURE 9. Deep fill at Mile 301 (Km. 490) (after Public Works Canada, Edmonton)

The deepest fill was encountered at about Kilometer 490. Figure 9 shows a deeply incised valley and braided stream traversed by the fill. Large culverts (4.0 m diameter) are required to accommodate

the severe spring runoff. General specifications called for fill sideslopes of 2:1 (26.5 degrees), but the actual slopes were 25.5 and 22.5 degrees. Minor sloughing, erosion and bulging of the slopes had occurred and may account for the discrepancy in slope angle.

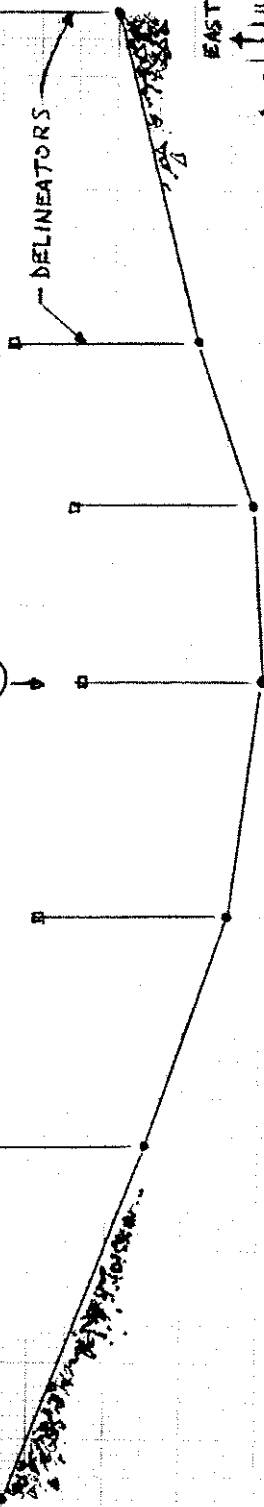
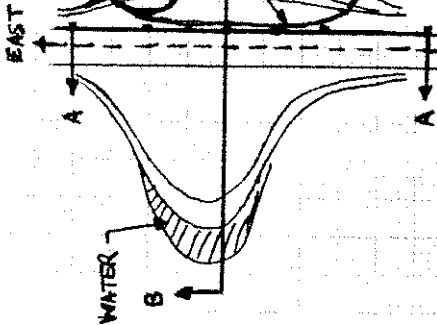
Figure 10. CROSS SECTION: SIDESLOPE FAILURE
(KILOMETER 526)

Only one large failure of an embankment shoulder was encountered along the entire length of highway; at Kilometer 526 (PLATE 20). This is indeed remarkable, when one considers that sideslope angles of 35 degrees were used on some high fills. Standard fill sections in temperate zone highways are typically sloped at about 26 degrees (Thomson, 1984).

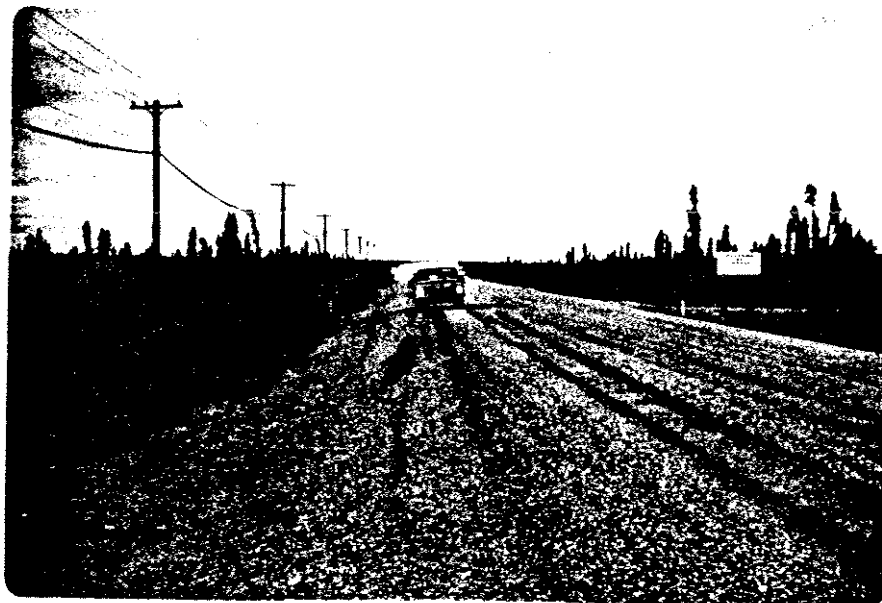
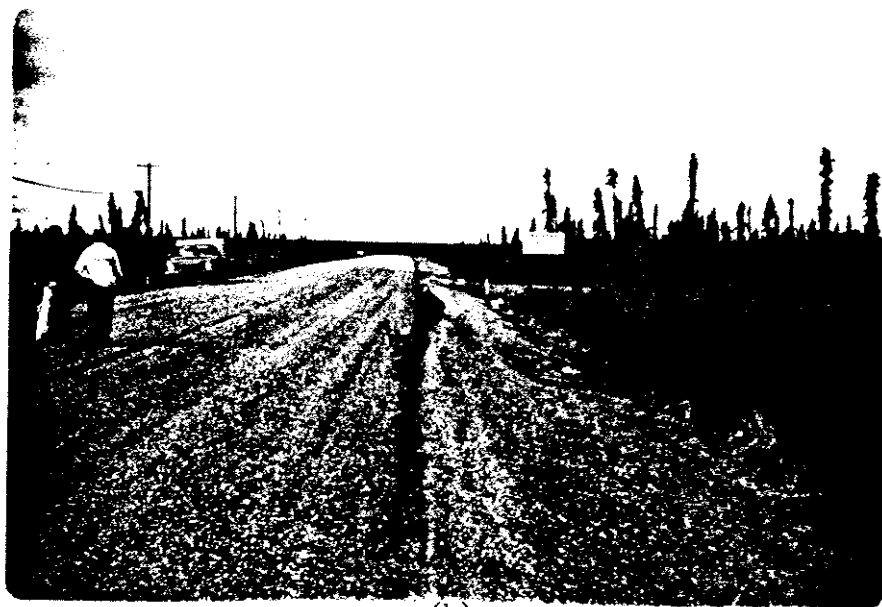
PLATE 28 Airport Road about 10 Km. east of Inuvik.
Looking west - note water ponding in ditch on right - some
minor loss of section (slumping) on left (south) shoulder.
(after Cook/Huculak)

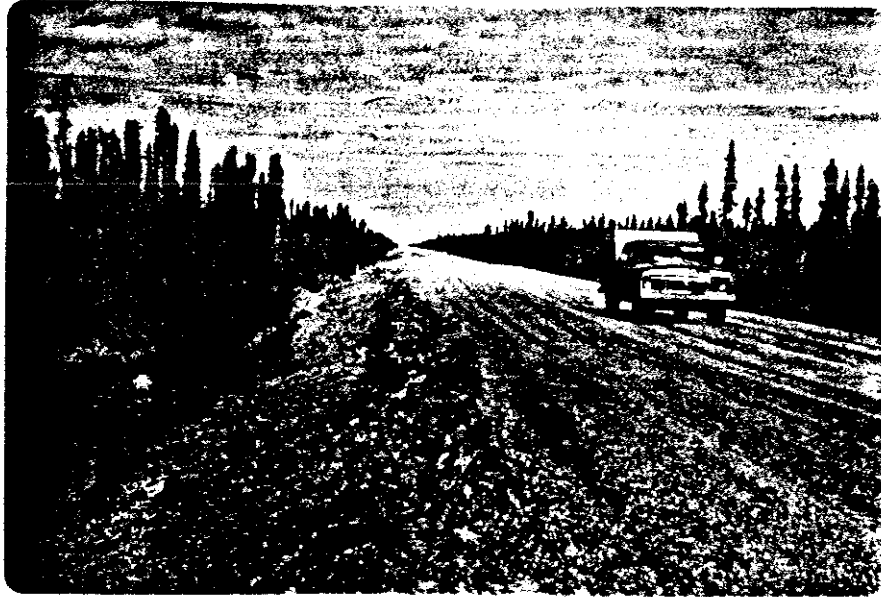
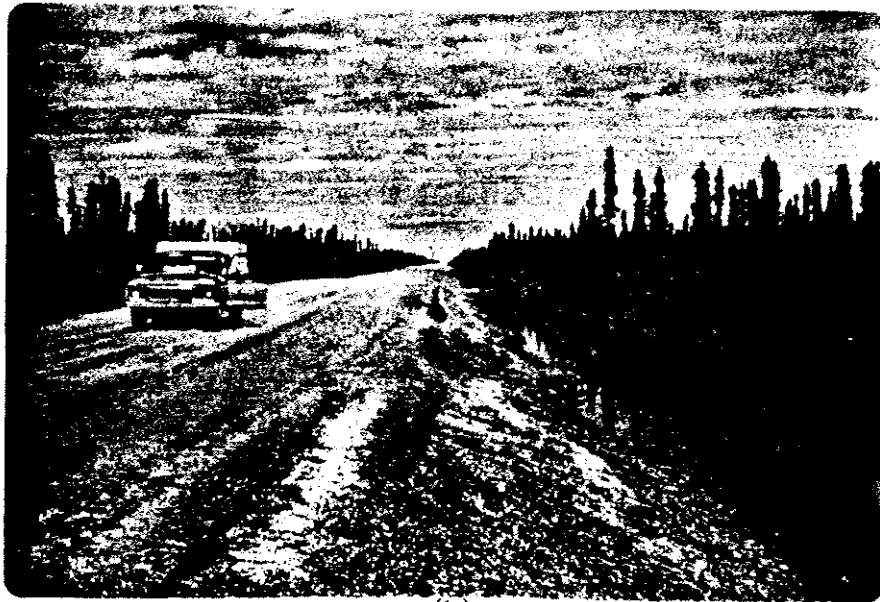
PLATE 29 Flat, poorly drained terrain. (Km. 630)
Looking north - water on both sides and running through grade at
base - flat, poorly drained terrain. Extensive surface undulations:
settlement and loss of section (slumping of shoulders).
(after Cook/Huculak)

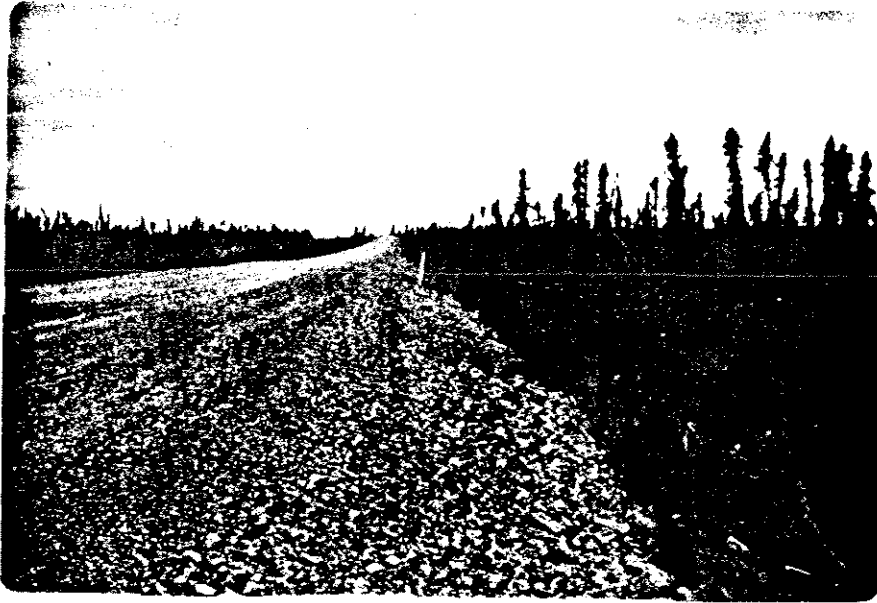
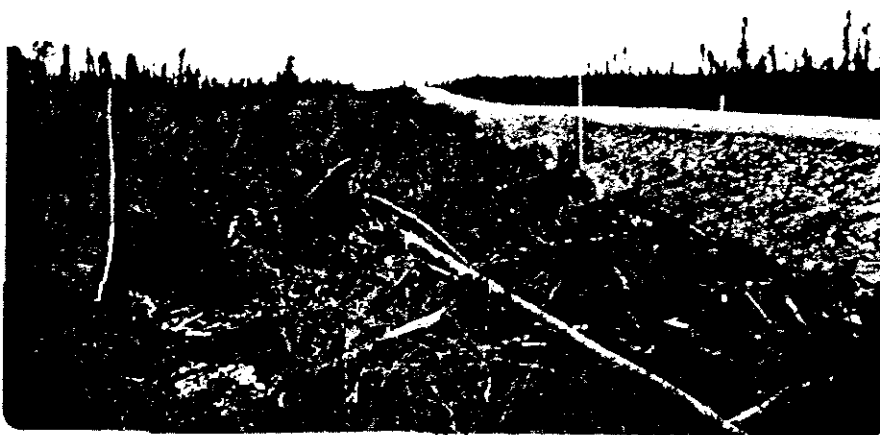
FIGURE 20 Minor surface undulations. (Km. 729)

Extensive thawing and settlement (0.6 metres) occurred beneath and adjacent to the embankment shown in Figure 21. This was due primarily to the presence of a relatively thin insulating peat cover and previously disturbed terrain. The embankment appears to have subsided in a relatively uniform manner, probably a result of summer thaw consolidation following winter placement. The embankment was brought to grade in the summer of 1971 and the sandstone/limestone core appears to have retained the general design shape in spite of the settlement. Minor surface undulations can be seen in Figure 20.

Looking west - embankment has generally retained original x-section but has settled approximately 0.5 to 0.6 m.

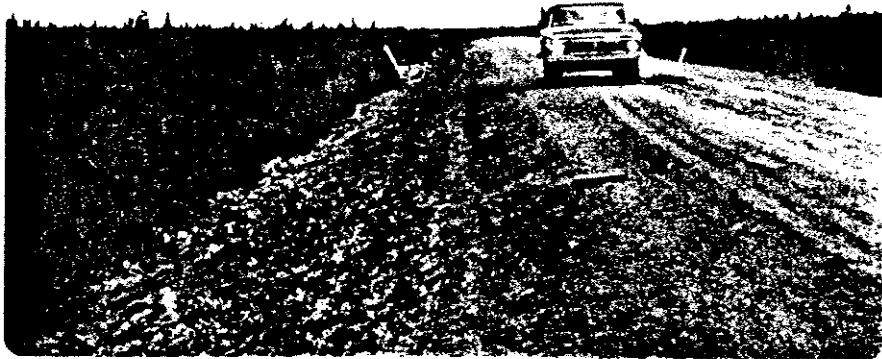
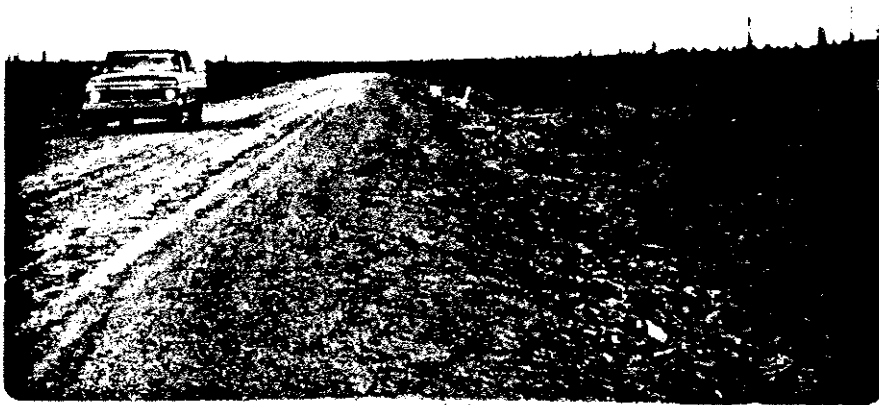
A fine-grained core with a substantial shale cap (0.5 - 1.0 m thick) was placed in the winter of 1972 south of Campbell Lake near Kilometer 716. (PLATE 30, Figure 22). Minor slumping and loss of section has occurred (0.2 m settlement) over a period of 6 years. The permafrost has degraded relatively uniformly, except in the left ditch where subsurface seepage was apparent from a borehole log.

PLATE 30 Embankment with a fine grained core capped with shale (Km. 715).

Looking north - site is similar to Site 4 except no water in upslope ditch - settlement is greater than at Site 4

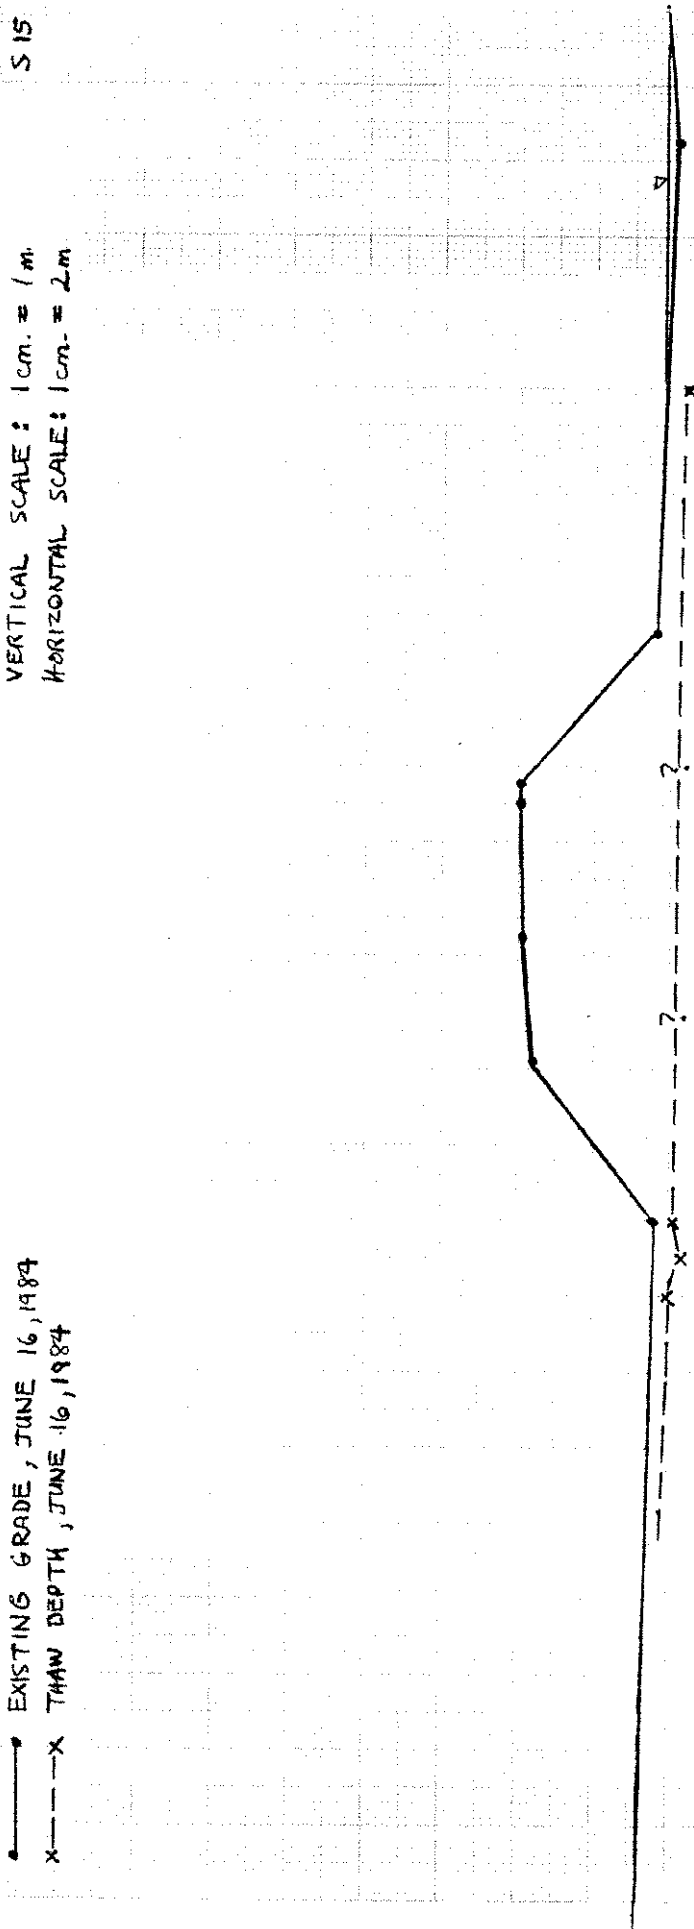
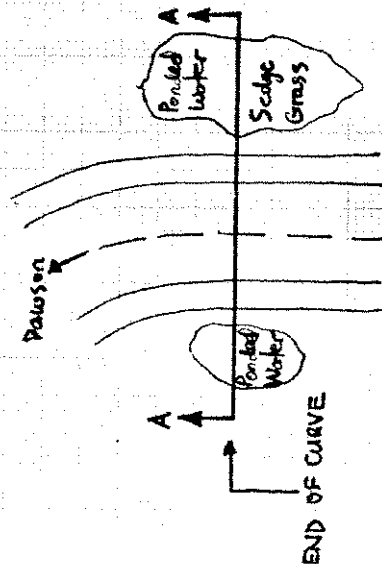
Figure 28. CROSS SECTION : DEMPSTER HIGHWAY
(KILDMETER 122)

The embankment section shown in Figure 28 has apparently not subsided significantly. Thaw penetration adjacent to the embankment (0.3 m) was slightly greater than in undisturbed areas (0.1 m); PLATE 7 illustrates the terrain in the vicinity. A section was obtained 20 kilometers to the north (Figure 29) in floodplain terrain. Thaw depth beneath the embankment was about half that of the ditches (1 m). Trees tipping in towards the embankment were good indicators of

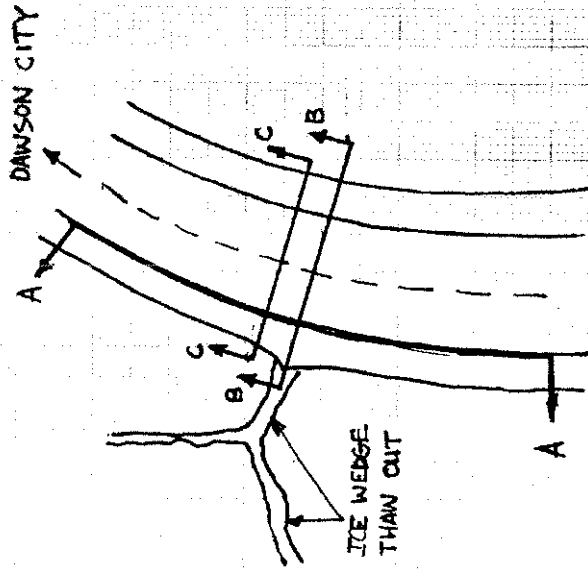
Thawing of polygonal ground ice produced the embankment deformations shown in Figure 30. Since the deformations are highly localized, they can be easily repaired. Thaw of the ground ice resulted in the water filled depressions shown in PLATE 12. Trees were tipping in random directions in response to thermally induced subsidence (natural causes). The vegetative mat in this region was up to 0.5 m thick and overlays at least 6 metres of silty clay of low plasticity, which was sandier with depths.

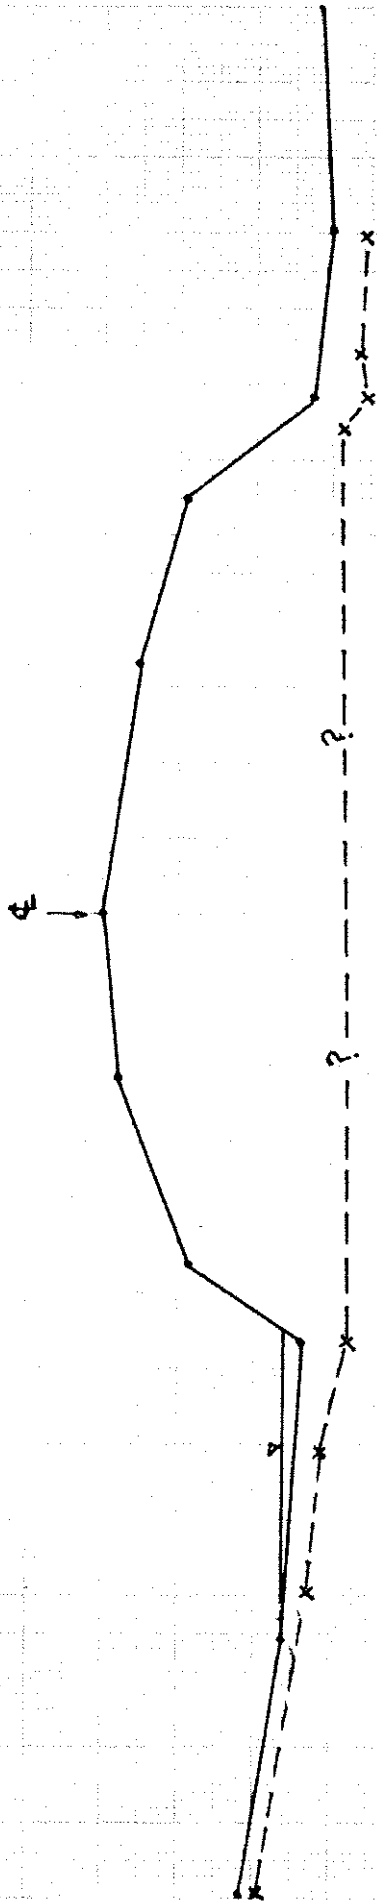
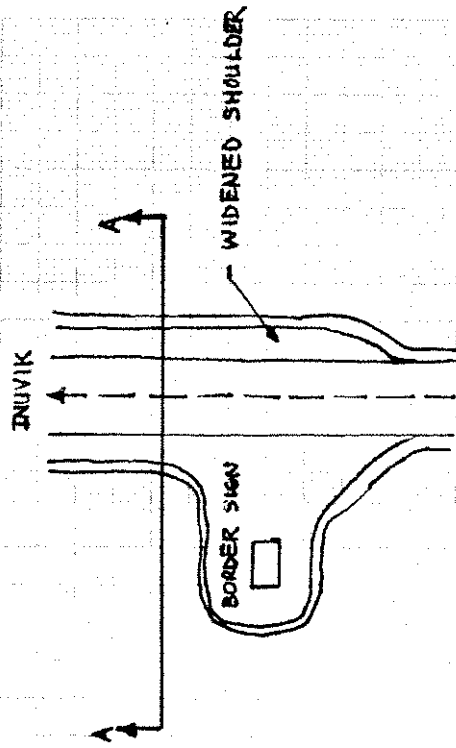
Figure 31. CROSS SECTION : DEMPSTER HIGHWAY
(KILOMETER 0, N.W.T./YUKON BORDER)

In the higher alpine areas such as the Richardson Mountains surficial soils were thin and supported little or no vegetative cover depending on altitude and slope angles. The thaw depth shown in Figure 31 is deceptive because it actually represents the depth to rock; true thaw depth is presumeable somewhat deeper. Felsenmeer is a common terrain feature of the Richardson Mountains which provides a thermally stable base for embankments.

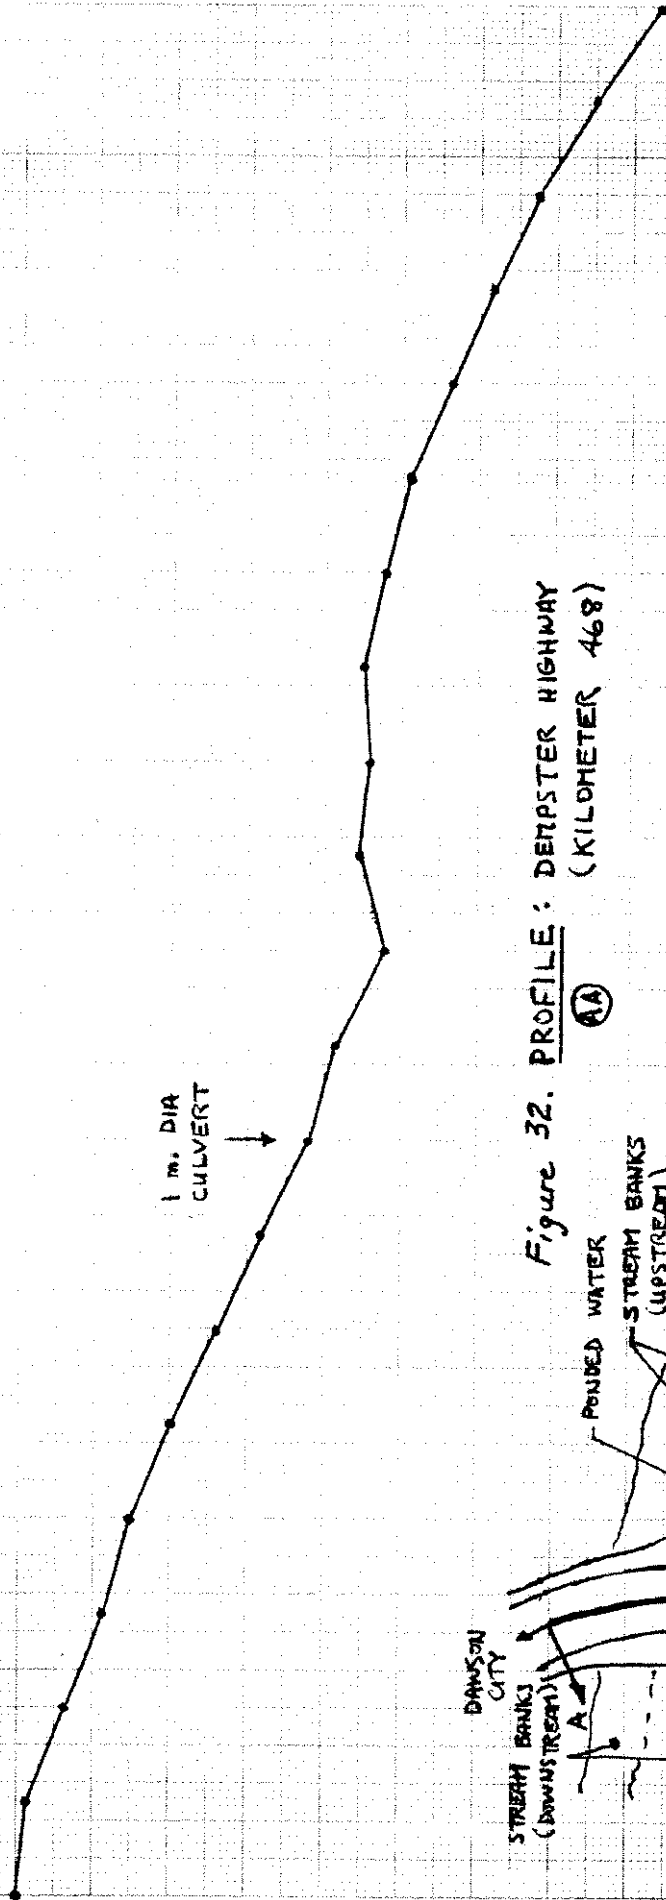
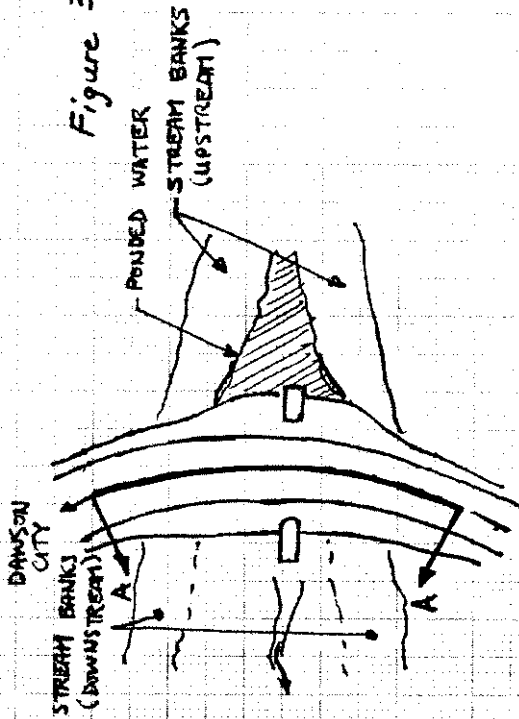
Figure 32. PROFILE: DEMPSTER HIGHWAY
(KILOMETER 468)

Differential settlement between the embankment and the culverts occasionally occurred during construction due to consolidation of ice-rich backfill, or culvert subsidence from thermal degradation of

underlying ice-rich soils. The latter case was recently observed (PLATE 25). Figure 32 was an attempt to illustrate the relationship between culvert location and embankment settlement. Clearly, the correlation is not exact -- nor should it be since several factors are involved: soil type, depth, ice content, location of taliks, and massive ground ice.
