Structural Engineering Report No. 240

# **BEHAVIOUR AND REHABILITATION OF DISTORTION-INDUCED FATIGUE CRACKS IN BRIDGE GIRDERS**

by  
Mark D'Andrea  
Gilbert Y. Grondin  
and  
Geoffrey L. Kulak

September 2001

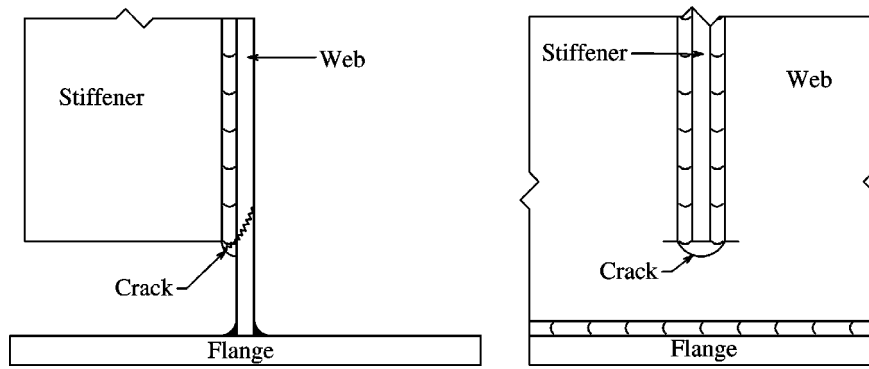
**Figure 2-3** Schematic of Web Crack at End of Transverse Stiffener (Fisher, 1978)

The large stresses that develop in the web gap region cause fatigue cracks to initiate in a relatively short time. These fatigue cracks usually extend across the weld toe at the end

of the transverse stiffener and into the web as shown in Figure 2–3. Fisher (1978) investigated distortion-induced fatigue cracking at the ends of transverse stiffeners and found that some cracks propagated further into the web and then turned upwards, perpendicular to the primary stress field. Similar crack patterns were observed by Fraser *et al.* (2000).

The typical crack pattern, shown in Figure 2–3, and the out-of-plane deformation of the web gap, idealized in Figure 2–2, illustrate that fatigue cracks in web gaps are the result of the compound effect of Mode I (crack opening mode) and Mode III (tearing mode) (Fraser *et al.*, 2000). As the web gap deforms, the top surface of the crack will move further out-of-plane than the bottom surface of the crack. Figure 2–4 illustrates Mode I and Mode III crack movement. Under in-plane loading conditions alone, fatigue crack propagation occurs as Mode I.

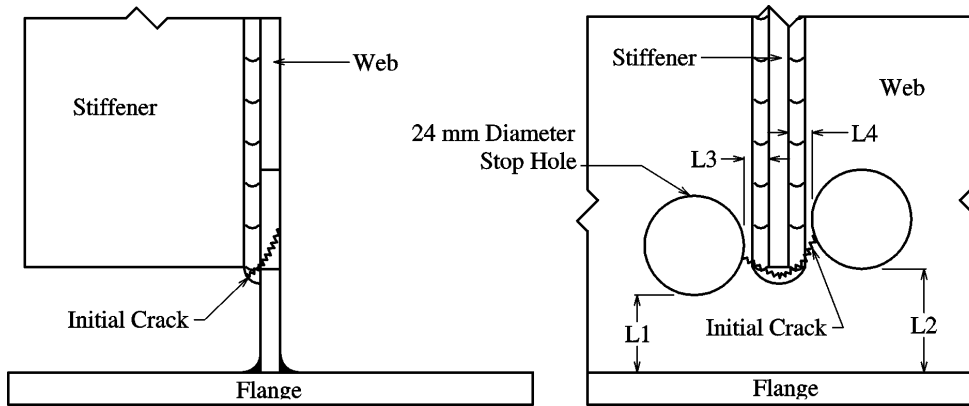
**Figure 4-1** Typical Location of Stop Holes and Initial Cracks in Test Specimens

Joint**	Distances to Stop Holes (mm) (see Figure 4-1)				Comments
	L1	L2	L3	L4	
9	N/A*	N/A	N/A	N/A	No apparent cracking.
11	N/A	N/A	N/A	N/A	No apparent cracking.
13	63	58	17	10	<i>East Face</i> <sup>†</sup> : crack extends across bottom of stiffener similar to cracks in Figure 4-2. <i>West Face</i> : no apparent cracking
15	N/A	N/A	N/A	N/A	No apparent cracking.
8	N/A	N/A	N/A	N/A	Small crack in weld at bottom of transverse stiffener.
10	46	46	5	5	<i>West Face</i> : crack extends across bottom of stiffener similar to cracks in Figure 4-2. <i>East Face</i> : crack extends laterally across holes similar to crack shown in Figure 4-3.
12	42	45	7	-6	<i>West Face</i> : crack extends across bottom of stiffener similar to cracks in Figure 4-2. <i>East Face</i> : no apparent cracking.
14	43	43	10	-6	<i>West Face</i> : crack extends across bottom of stiffener similar to cracks in Figure 4-2 <i>East Face</i> : no apparent cracking.

Joint**	Distances to Stop Holes (mm) (see Figure 4-1)				Comments
	L1	L2	L3	L4	
9	N/A*	N/A	N/A	N/A	No apparent cracking.
11	32	29	7	11	<i>East Face</i> <sup>†</sup> : crack extends across bottom of stiffener similar to cracks in Figure 4-2. <i>West Face</i> : no apparent cracking
13	47	50	8	-2	<i>East Face</i> : crack extends across bottom of stiffener similar to cracks in Figure 4-2. <i>West Face</i> : crack extends laterally across holes similar to crack shown in Figure 4-3.
15	N/A	N/A	N/A	N/A	No apparent cracking.
8	N/A	N/A	N/A	N/A	No apparent cracking.
10	51	54	2	6	<i>West Face</i> : crack extends across bottom of stiffener similar to cracks in Figure 4-2. <i>East Face</i> : crack extends laterally across holes similar to crack shown in Figure 4-3.
12	45	48 (69)***	17	15 (8)	<i>West Face</i> : crack extends across bottom of stiffener similar to cracks in Figure 4-2. <i>East Face</i> : crack extends laterally across holes similar to crack shown in Figure 4-3.

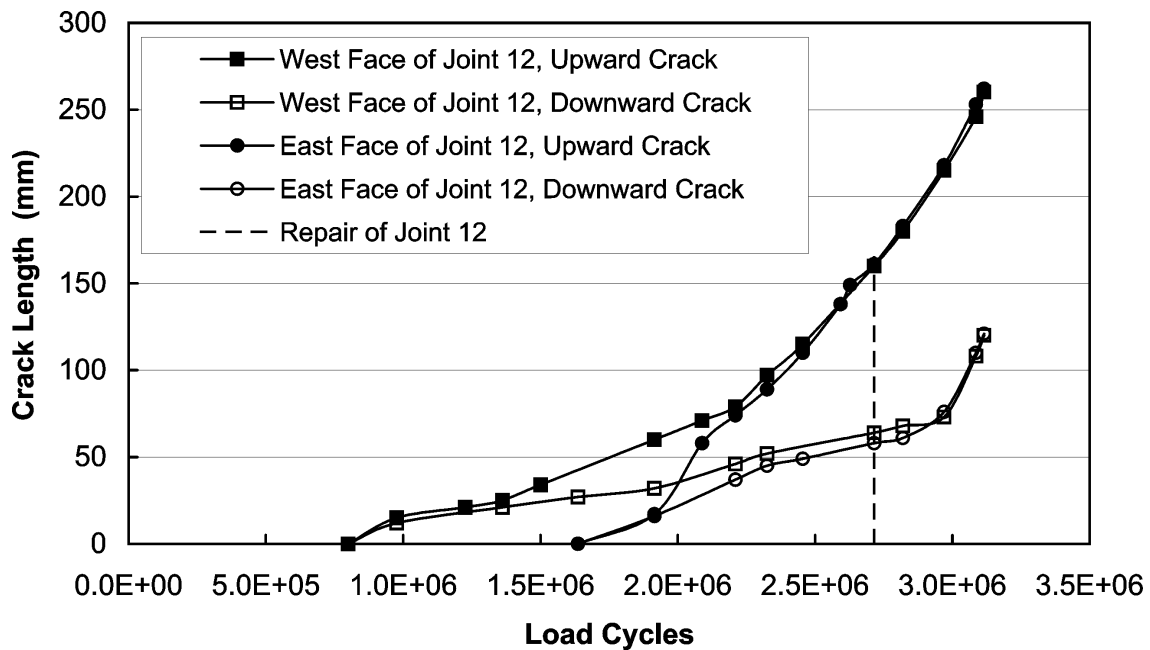
Figure 4-18 Joint 12 Crack Length vs. Load Cycle, Specimen 3

As shown in Table 4-3, a crack was detected along the weld at the bottom of the stiffener at Joint 12 where no stop holes had been drilled. The approximate crack initiation site is identified in Figure 4-17 as the “0” position. A fatigue crack was detected at one million load cycles. Cracks were observed to be moving both up and down the web from the bottom of the stiffener. Figure 4-18 shows the crack length versus load cycle plots for the crack at Joint 12. The crack propagation curves indicate that the crack became a through-thickness crack between 1.6 million and 1.9 million cycles. At 1.6 million cycles the crack had not surfaced on the east face of the web, but at 1.9 million cycles the east side of the crack had already reached a length of 32 mm. Therefore, the zero position for the east side of the crack, as shown in Figure 4-19, was taken as halfway between the bottom and top crack tips at 1.9 million cycles. The crack growth rate of the west side of the upward moving crack at Joint 12 increased from a crack growth rate of approximately  $45 \times 10^{-6}$  mm/cycle to approximately  $200 \times 10^{-6}$  mm/cycle, the same rate as on the east face. Figure 4-18 shows that the crack growth on the west and east sides of the downward crack was similar. The crack growth rate of the downward crack was approximately  $35 \times 10^{-6}$  mm/cycle.

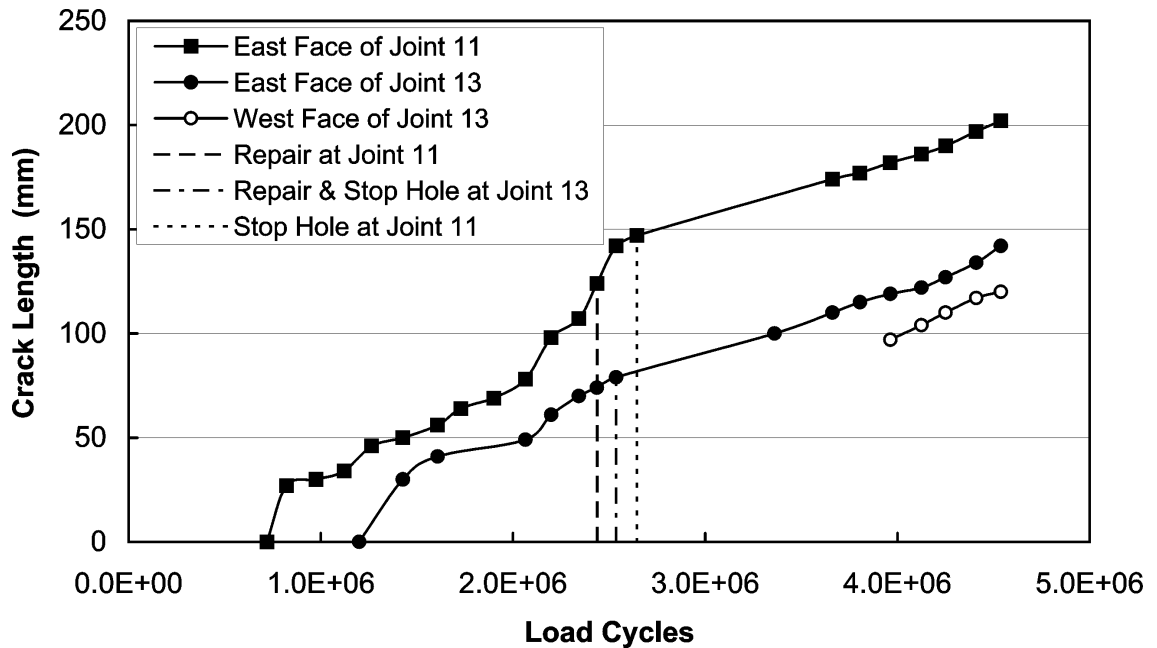
Figure 4-20 Crack Length vs. Load Cycle, Specimen 4

Test specimen 4 was tested at a bottom fibre stress range of 50 MPa, corresponding to a maximum stress of 62 MPa and a minimum stress of 12 MPa. Figure 4-20 shows crack length versus load cycle plots for the cracks at joints 11 and 13. A fatigue crack was detected at the stop hole on the east face of the web at Joint 11 after approximately 800 000 load cycles. The crack remained a part-through-thickness crack throughout the test. The crack growth rate increased from an initial rate of about  $45 \times 10^{-6}$  mm/cycle to  $125 \times 10^{-6}$  mm/cycle before the joint was repaired. At 1.4 million cycles another crack was detected at Joint 13. The crack growth rate remained more-or-less constant at  $42 \times 10^{-6}$  mm/cycle until the joint was repaired. (The crack growth after repairs will be discussed in Section 4.1.5.) The crack at Joint 13 also remained a part-through-thickness crack. Figures 4-21 and 4-22 show the location of all the cracks at Joints 11 and 13, respectively.

A repair of the fatigue crack at Joint 11 was performed at 2.4 million cycles. At that time the crack had reached a length of 125 mm and was progressing at a relatively fast rate, as can be seen from Figure 4-20. The fatigue crack at Joint 13 was repaired 100 000 cycles later.
