Experimental and Numerical Investigation of Fatigue Behavior of Pearlitic Rail Steels

A thesis submitted in partial fulfillment of the requirements for the degree of

Department of Mechanical Engineering University of Alberta

2. Experimental Failure Analysis of Pearlitic Rail Steels in Service

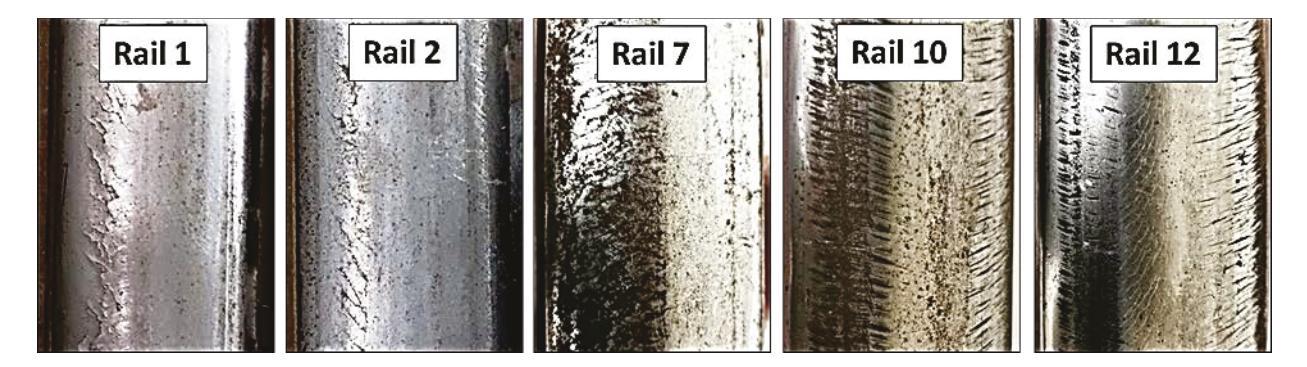
Figure 2.1 Top view of running surface of the rail samples.

Visual inspection of Rail 1 and Rail 2 surfaces reveals moderate cracking at the midgauge regions in each of these rails. Rail 7 shows heavy cracking at the gauge and mid-gauge regions. Light cracking can be seen on top of Rail 10 and mid-gauge of Rail 12. There are also regularly spaced grooves on the surfaces of Rail 10 and Rail 12. These are grinding marks left over from the last grinding that took place prior to their removal.

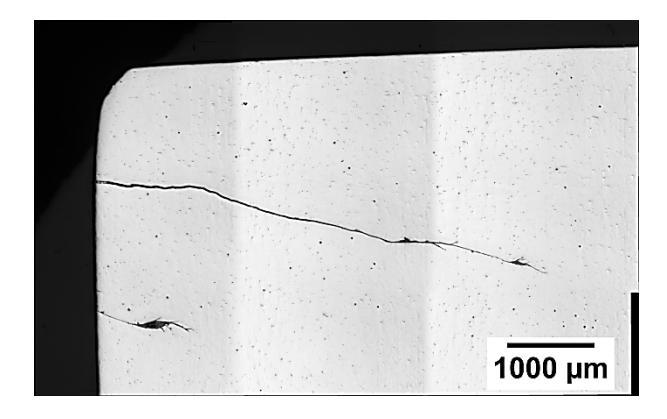
Rail 1-TT specimen exhibited two (2) cracks with depths of 3053 and 2545 μ m in the top of rail region (Figure 2.10). These were most likely a continuation of cracks that had initiated in the mid-gauge region.

Figure 2.10 Cracks in the top of rail region of Rail 1 (Rail 1-TT).

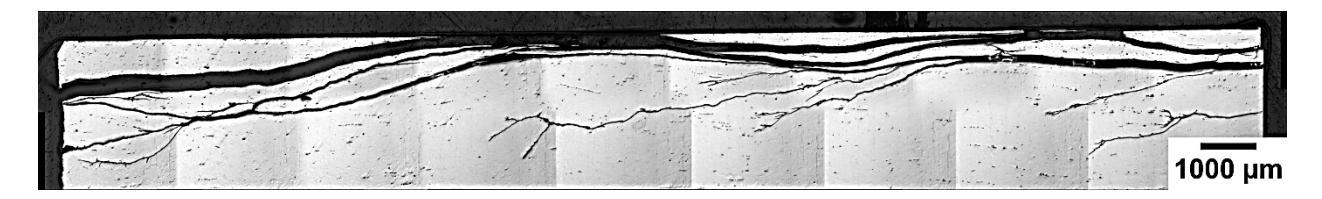
Evaluation of **Rail 1-LT** specimen revealed severe damage in the mid-gauge region and a network of cracks (Figure 2.12). Since the cracks were connected, it was impossible to distinguish them individually. Therefore, it was only feasible to measure the maximum depth of these cracks, which was 2219 μ m.

Figure 2.12 Cracks in longitudinal section of the mid-gauge region of Rail 1 (Rail 1-LT).

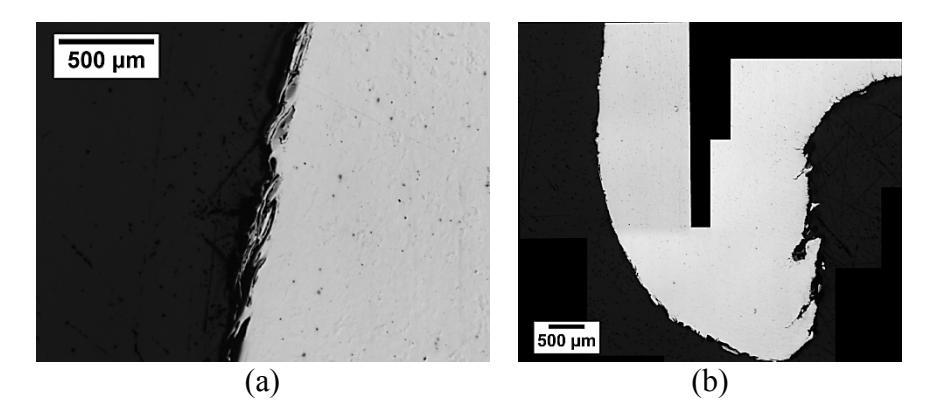
Rail 2: Similar to Rail 1-TG specimen, delamination was the main damage mechanism at the gauge region of **Rail 2-TG** specimen, but it was more severe in Rail 2-TG than in Rail1 (Figure 2.13a). Multiple delaminations were found in clusters and the lengths of these clusters were between 1100 and 1400 μ m. It was observed that the bottom of gauge region had been plastically deformed which had resulted in a *plastic flow lip* (Figure 2.13b). A number of cracks had initiated at the plastic flow lip which had angles between 70° to 90°, lengths between 100 and 150 μ m and depths between 50 to 150 μ m.

Figure 2.13 (a) Delamination at the gauge region of Rail 2 (b) Plastic flow lip (Rail 2-TG).

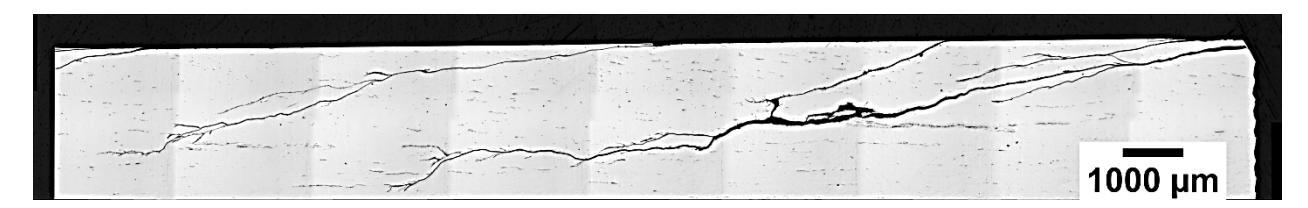
For **Rail 2-LT** specimen, the cracks had angles between 10° and 15° (Figure 2.16). The two (2) major cracks had lengths of 9438 and 14473 µm and depths of 1743 and 2409 µm, respectively. Also, two (2) smaller cracks were found which had lengths of 3466 and 3853 µm and depths of 985 and 665 µm.

Figure 2.16 Cracks in longitudinal section of the mid-gauge region of Rail 2 (Rail 2-LT)

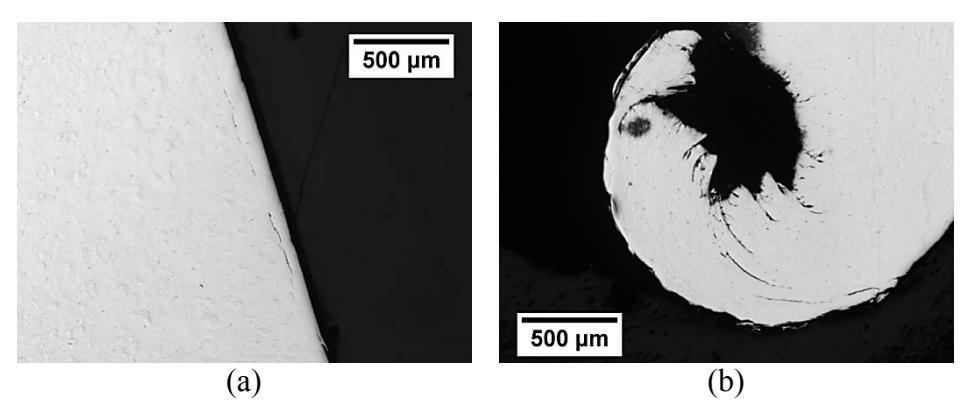
Rail 10: As shown in Figure 2.19a, it was observed that delamination was again the main damage mechanism at the gauge region of **Rail 10-TG** specimen. But, it was much less severe than Rails 1 and 2. The crack initiation angles were under 8° and their final lengths were mainly between 150 and 300 μ m. The plastic deformation at the bottom of the gauge region was excessive resulting in a severely deformed plastic flow lip (Figure 2.19b). Similar to Rail 2, a number of cracks had initiated at the plastic flow lip. The geometrical characteristics of these cracks were similar to the ones in Rail 2 (angles between 70° to 90°, lengths between 100 and 150 μ m and depths of between 50 to 150 μ m).

Figure 2.19 (a) Delamination at the gauge region of Rail 10 (b) Plastic flow lip (Rail 10-TG).

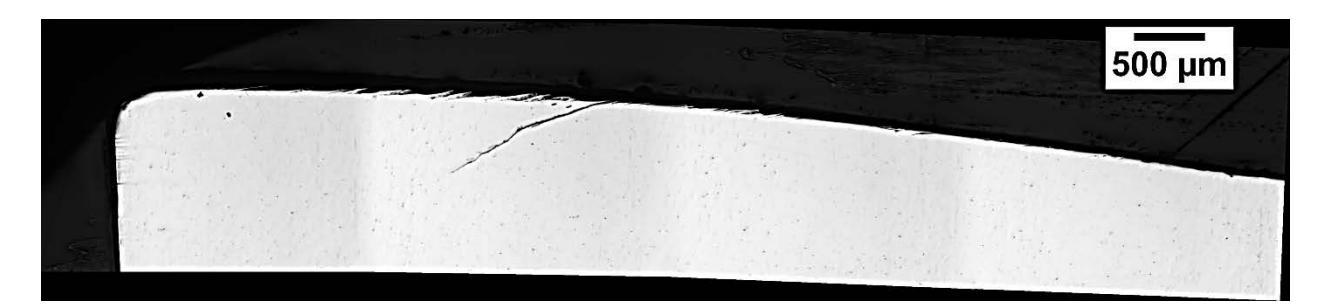
The damage pattern at the gauge corner and mid-gauge regions of the **Rail 10-TG** specimen (Figure 2.20) was very different from the previous rail samples. There was only one (1) short major crack in the mid-gauge region of Rail 10-TG specimen. The crack had an angle of 22°, a length of 1268 μ m and a depth of 563 μ m. Besides this major crack, a number of shallow surface cracks were observed at the mid-gauge region of the specimen. Theses cracks had angles mostly between 10° and 15°, lengths of about 130 to 200 μ m and depths of 20 to 30 μ m.

Figure 2.20 Cracks in the mid-gauge region of Rail 10 (Rail 10-TG).

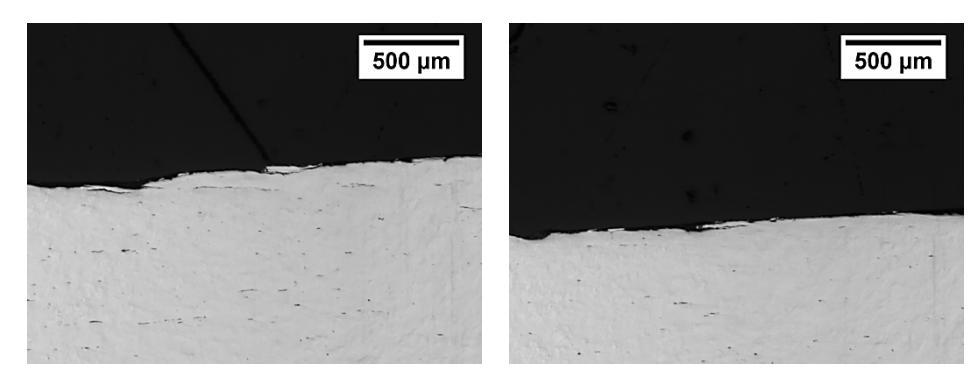
Rail 10-LG specimen showed delamination as the main cause of failure, and there were no major cracks on the rail running surface (Figure 2.23). As shown in Figure 2.24, a number of cracks were observed on the running surface of **Rail 10-LT** specimen. The cracks had angles between 20° and 25°. Based on their lengths, the cracks could be categorized into three types: short, medium and long cracks. The two (2) long (major) cracks had lengths of 1462 and 1815 μ m and depths of 510 and 661 μ m, respectively. The lengths of two (2) medium cracks were 804 and 515 μ m and their depths were 366 and 319 μ m. The short cracks had lengths between 200 and 350 μ m and their depths were between 75 and 125 μ m.

Figure 2.23 Delamination in longitudinal section of the gauge region of Rail 10 (Rail 10-LG).

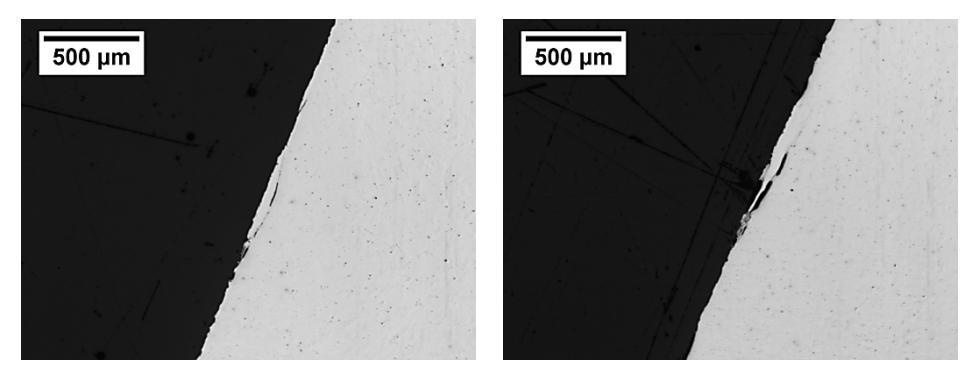
Rail 12: As shown in Figure 2.25, several delaminations were observed at the gauge region of **Rail 12-TG** specimen. Rail 12-TG specimen also showed four (4) major cracks along with a number of shallow surface cracks in the mid-gauge region (Figure 2.26). The major cracks had angles between 25° and 40° . The longest one had a length of 954 µm and a depth of 610 µm. The three other cracks had lengths between 441 and 584 µm and depths between 185 to 371 µm. Evaluation of **Rail 12-TT** specimen revealed that shallow surface cracks with angles between 13° and 18° were the main cause of damage at the top of rail region (Figure 2.27). Most of these cracks had lengths between 30 and 70 µm and depths between 20 and 30 µm. A short vertical crack with a length of 280 µm was also observed.

Figure 2.25 Delaminations at the gauge region of Rail 12 (Rail 12-TG)

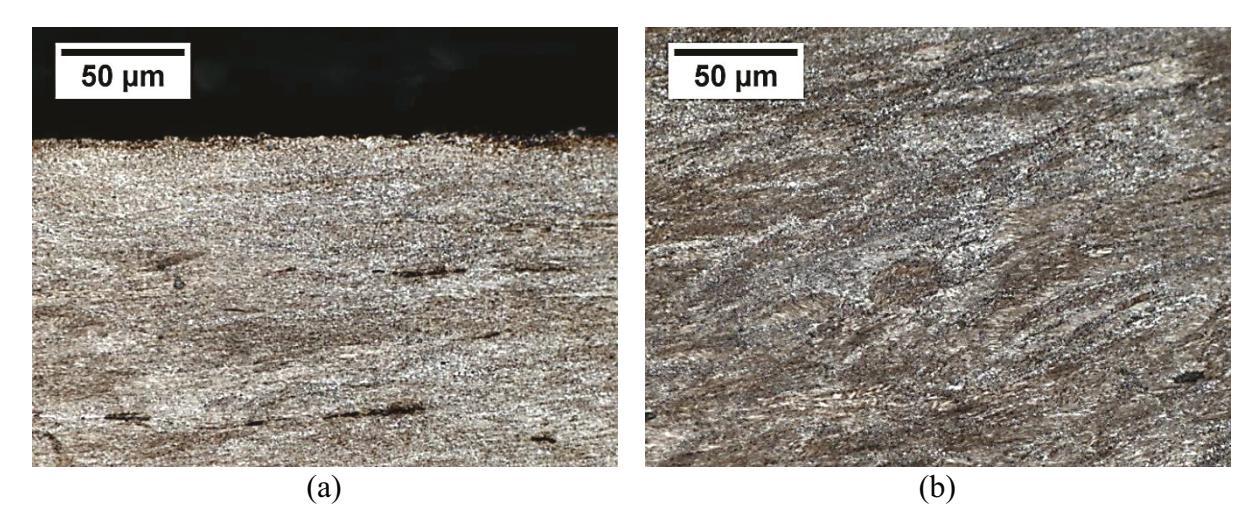
results in a distinct layer. Below this layer-like structure, deformation of pearlite colonies was observed (Figure 2.30b). It was also observed that the angle between the plastic deformation lines and the normal to rail surface (which indicates shear strain) (Tyfour *et al.* 1996) gradually decreased as the depth from the surface increased. The mildly deformed region (region II) which had experienced small shear strains was observed between the depths of 2505 and 4788 μ m (Figure 2.31a). No plastic deformation (region III) was observed in the microstructure below depth of 4788 μ m (Figure 2.31b).

Figure 2.30 Largely deformed region (region I) at higher magnification: (a) Layer-like structure (b) Deformed pearlite colonies (Etched Rail 1-LT).

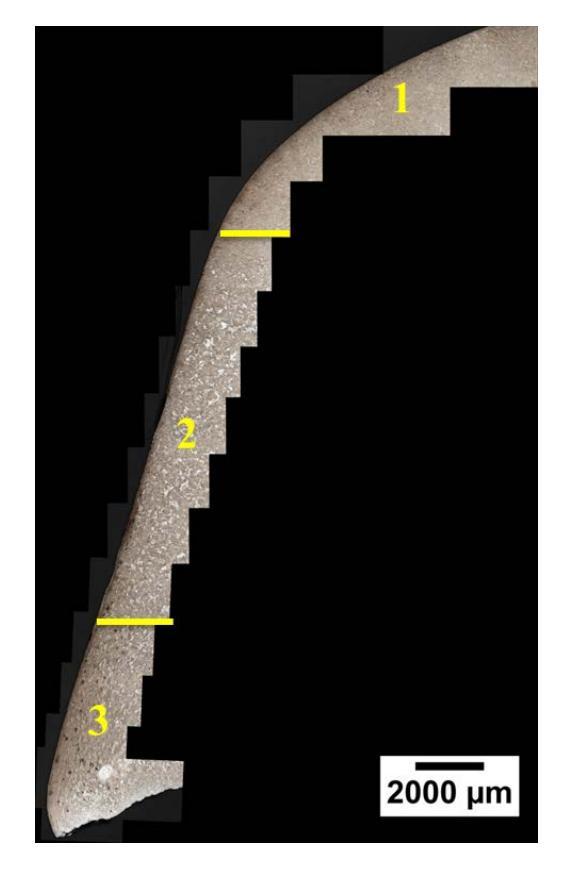
Etched **Rail 1-TG** specimen showed that the mid-gauge region had structure similar to the largely deformed region (in Rail 1-LT specimen) and a layer-like structure could be observed in the middle of the zone close to the rail running surface (Figure 2.32a). The rail gauge region of 1-TG specimen could be divided into three (3) zones (Figure 2.33). In the upper gauge zone (zone 1), pearlitic structure experienced mild plastic deformation (Figure 2.34a). A thin plastically deformed layer (Figure 2.34b) was seen at surface of the middle zone (zone 2). At the lower gauge zone (zone 3), the pearlite colonies aligned to the surface as a result of plastic deformation (Figure 2.34c).

Figure 2.33 Location of (1) Upper gauge zone (2) Middle Gauge zone (3) Lower gauge zone at the gauge region of Rail 1 (Etched Rail 1-TG).

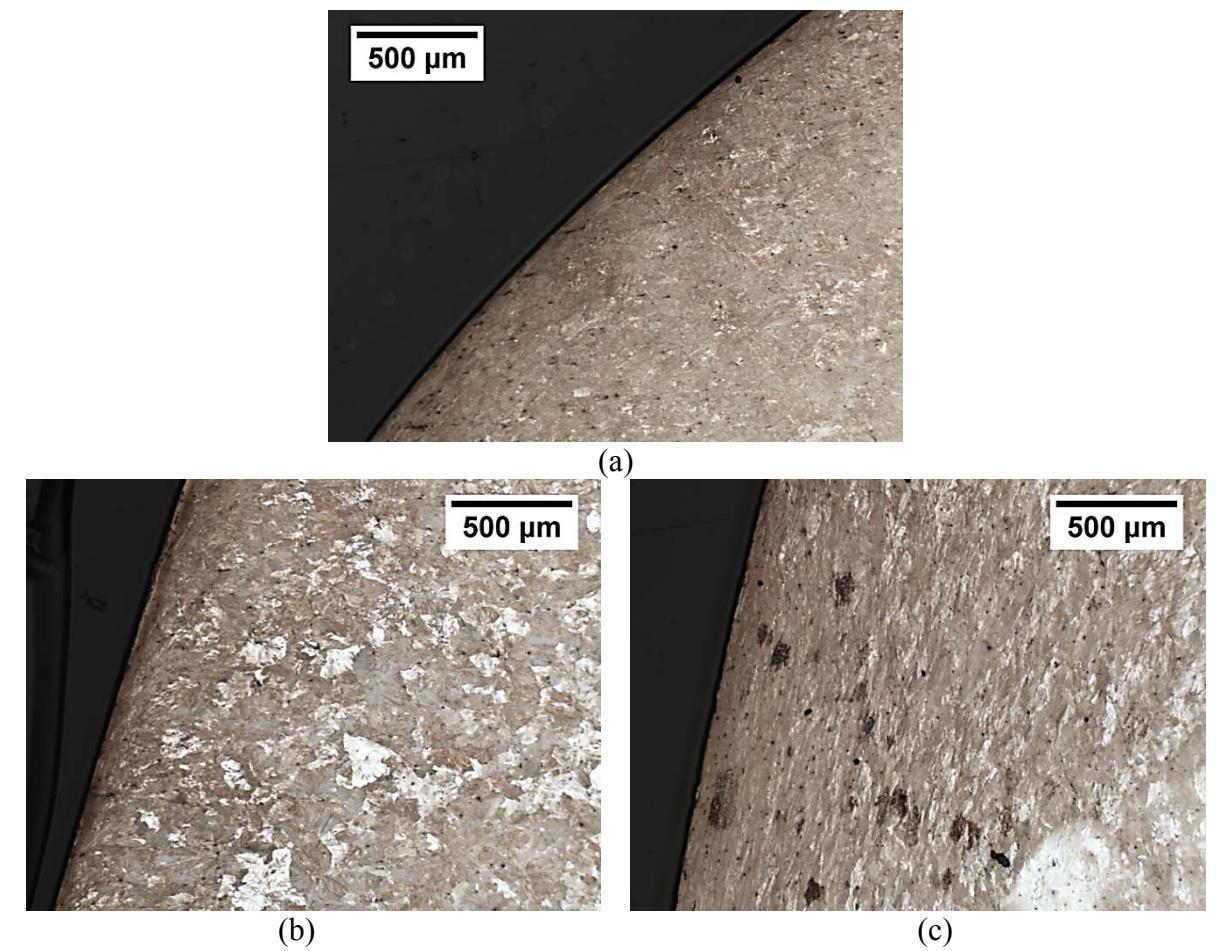
Figure 2.34 Plastic deformation at (a) Upper gauge zone (zone 1) (b) Middle gauge zone (zone 2) (c) Lower gauge zone (zone 3) (Etched Rail 1-TG).

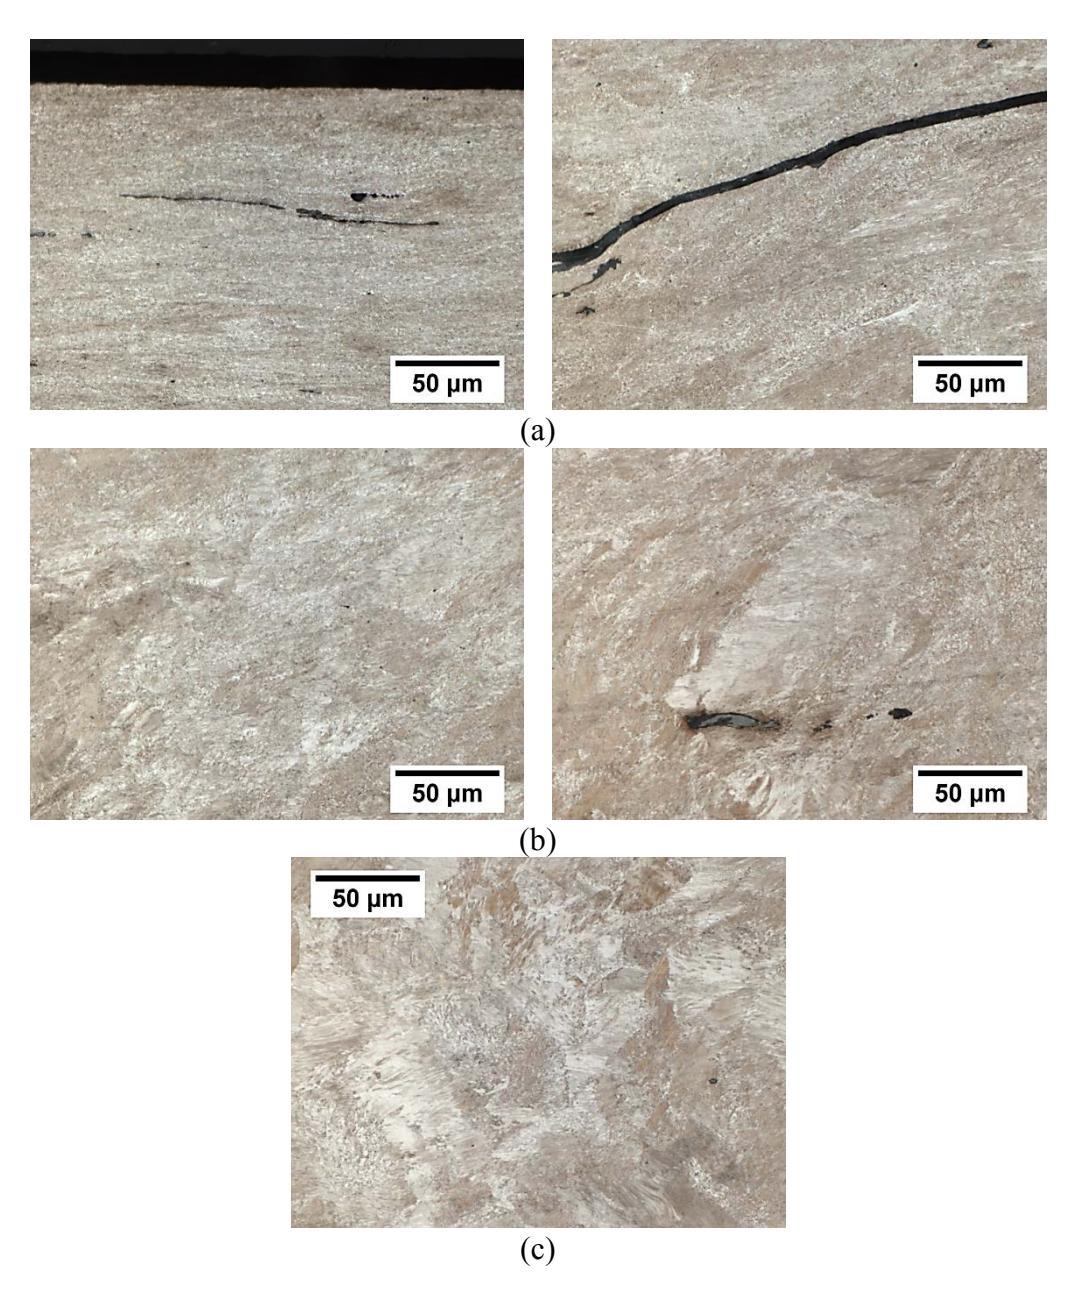
Rail 2: Similar to Rail 1-LT specimen, etched **Rail 2-LT** specimen consisted of three (3) regions. From the rail running surface to a depth of 2598 μ m there was a largely deformed region (Figure 2.35a) followed by a mildly deformed region up to depth of 4857 μ m (Figure 2.35b). The layer-like structure was observed again and pearlite colonies were deformed similarly as in Rail 1-LT specimen. Etched **Rail 2-TG** specimen revealed that the microstructure in the mid-gauge region was largely deformed and exhibited a layer-like structure in the middle (close to the surface) (Figure 2.36a). However, the size of the layer-like structure was smaller in comparison to Rail 1. Four (4) zones could be identified at the gauge region of Rail 2-TG specimen. There was a mildly deformed zone (Figure 2.37a) at the top of gauge region followed by a small zone

Figure 2.35 (a) Largely deformed region (b) Mildly deform region (c) undeformed region (Etched Rail 2-LT).

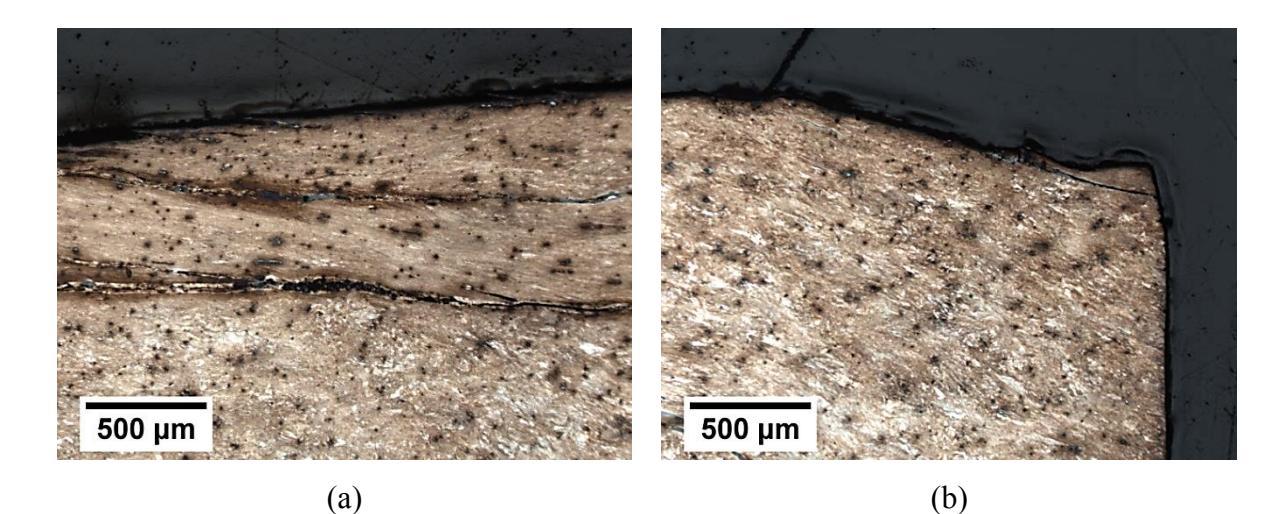
Figure 2.36 (a) Layer-like structure (b) deformed pearlite colonies in the mid-gauge of Rail 2 (Etched Rail 2-TG).

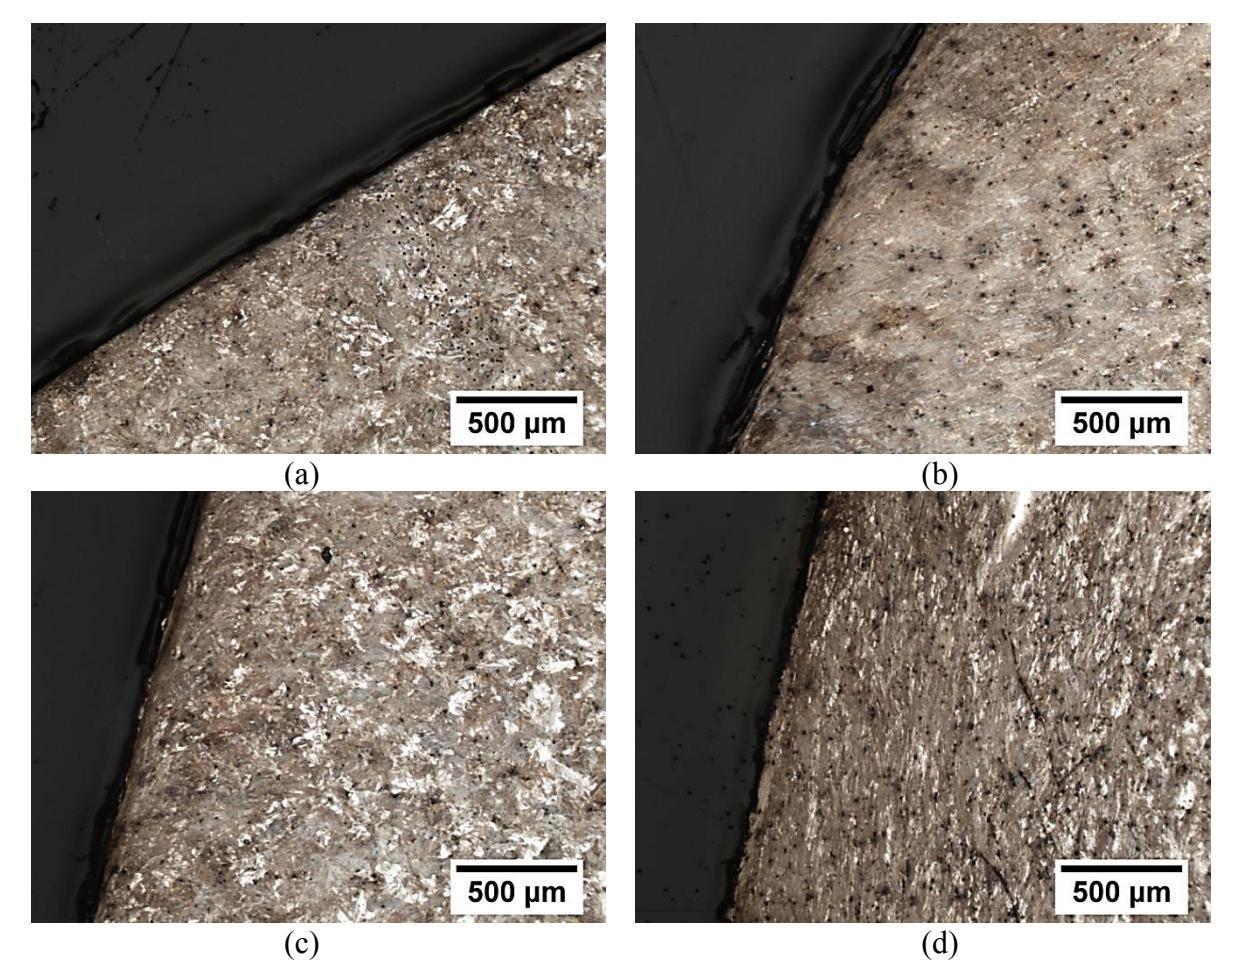
which had a thick plastically deformed layer (Figure 2.37b). Similar to Rail 1, a thin surface layer had experienced plastic deformation in the middle of gauge region (Figure 2.37c). The lower gauge zone experienced large plastic deformation which had resulted in alignment of pearlite colonies to the surface (Figure 2.37d) and formation of a plastic flow lip. The layer-like structure could be seen at the plastic flow lip and adjacent area.

Figure 2.37 Plastic deformation at (a) Upper gauge zone (b) Intermediate zone (c) Middle gauge zone (d) Lower gauge zone (Etched Rail 2-TG).

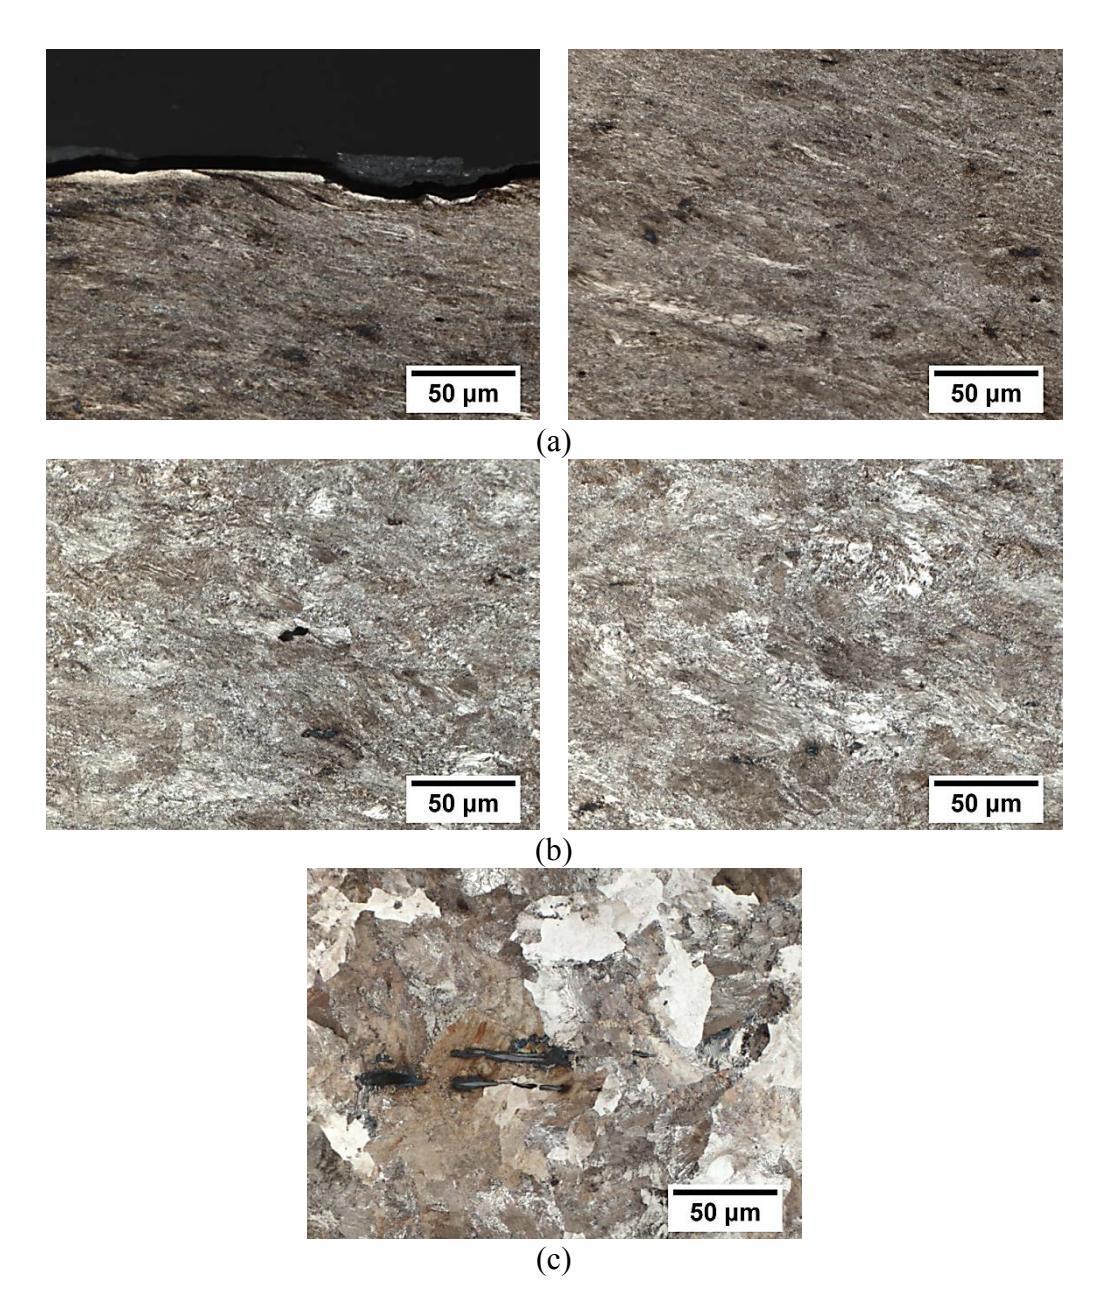
Rail 7: For etched **Rail 7-LT** specimen, the depth of largely deformed region was 3030 μ m from the surface (Figure 2.38a). Then, to a depth of 4831 μ m there was a mildly deformed region (Figure 2.38b). The deformation features of this specimen were similar to Rail 1-LT and 2-LT specimens.

Figure 2.38 (a) Largely deformed region (b) Mildly deform region (c) undeformed region (Etched Rail 7-LT).

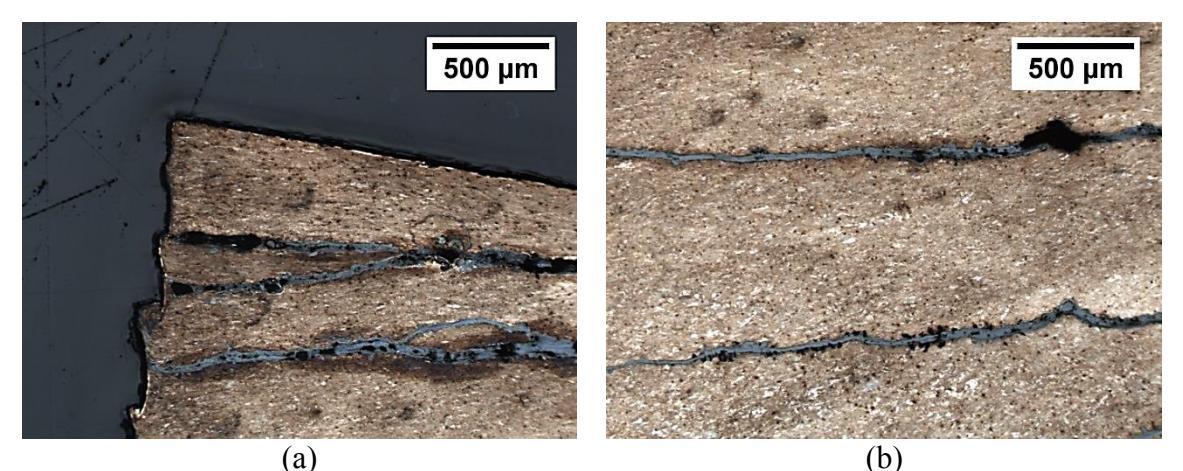
Etched **Rail 7-TG** specimen showed that the mid-gauge and gauge corner regions had been largely deformed and a thin layer-like structure could be observed in the area close to the rail running surface throughout the region (Figure 2.39a). The gauge region could be divided into two (2) zones. The upper zone (from top to the middle of the gauge region) had experienced significant plastic deformation up to few millimeters (Figure 240a). In the lower zone, as a result of plastic deformation, the pearlite colonies had been aligned to the rail running surface (Figure 2.40b) and a small plastic flow lip had formed. Unlike the two previous rails, there was no zone with a thin plastically deformed layer in the middle of the gauge region.

Figure 2.39 (a) Layer-like structure (b) Deformed pearlite colonies in the mid-gauge of Rail 7 (Etched Rail 7-TG).

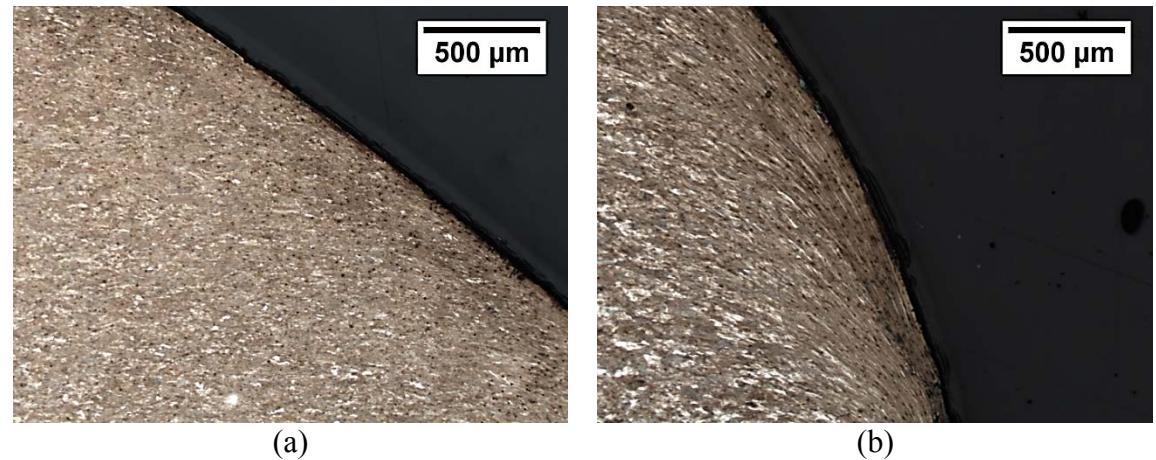
Figure 2.40 Plastic deformation at (a) Upper gauge zone (b) Lower gauge zone (Etched Rail 7-TG).

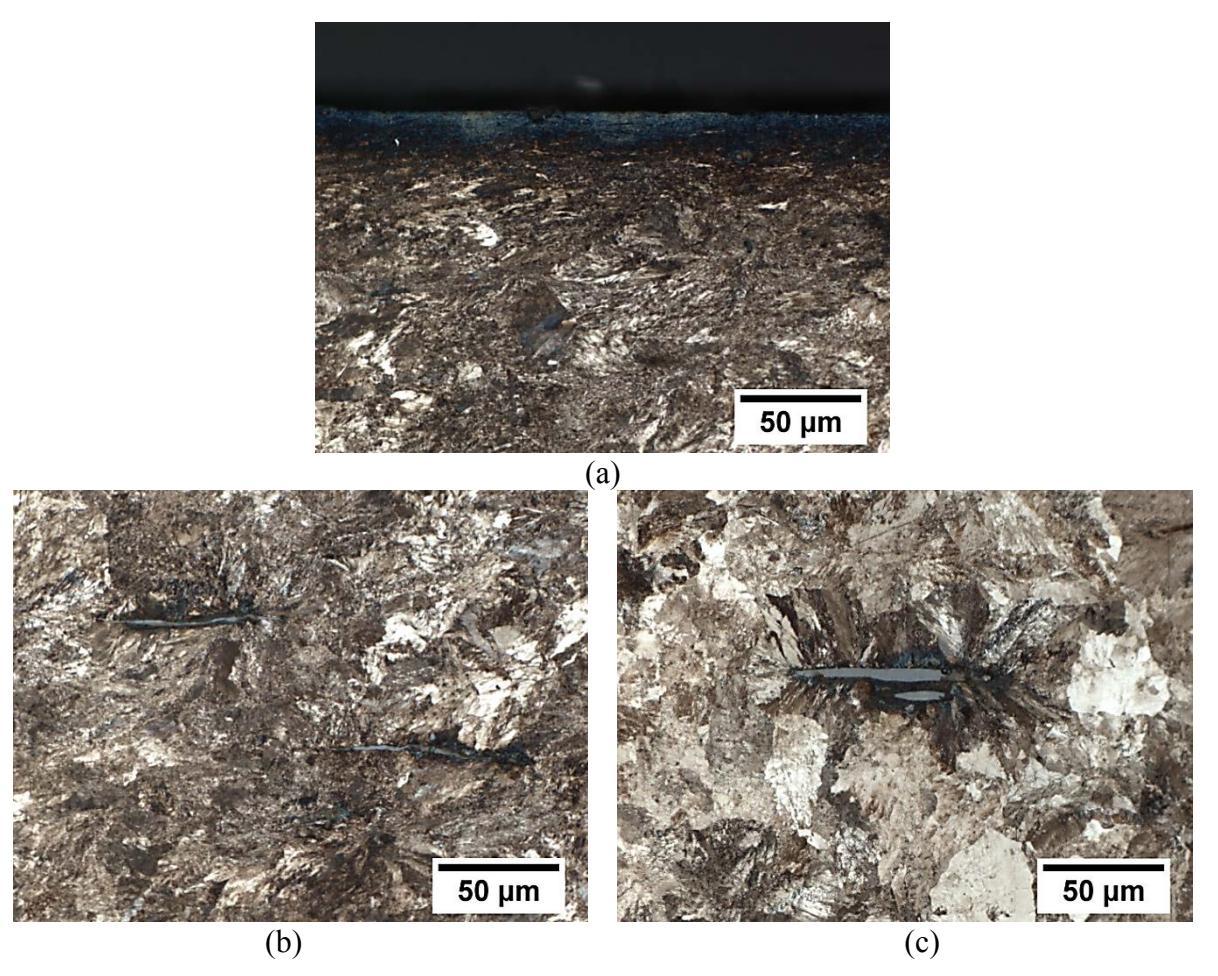
Rail 10: Etched **Rail 10-LT** specimen had also three (3) regions, but the thicknesses of the regions were reduced in comparison to the previous rails. From the rail running surface to a depth of about 695 µm there was a largely deformed (Figure 2.41a) region and between 695 and 1420 µm there was a mildly deformed region (Figure 2.41b). Examining the area close to the rail running surface at higher magnification (500x) revealed that the layer-like structure was thin and titled pearlite colonies were dominant. Etched **Rail 10-TG** specimen exhibited mildly deformed mid-gauge and gauge corner regions (Figure 2.42). Similar to Rail 2, there were four (4) zones at the gauge region. At the top of gauge region, there were no traces of plastic deformation (Figure

Figure 2.41 (a) Largely deformed region (b) Mildly deformed region (c) Undeformed region (Etched Rail 10-LT).

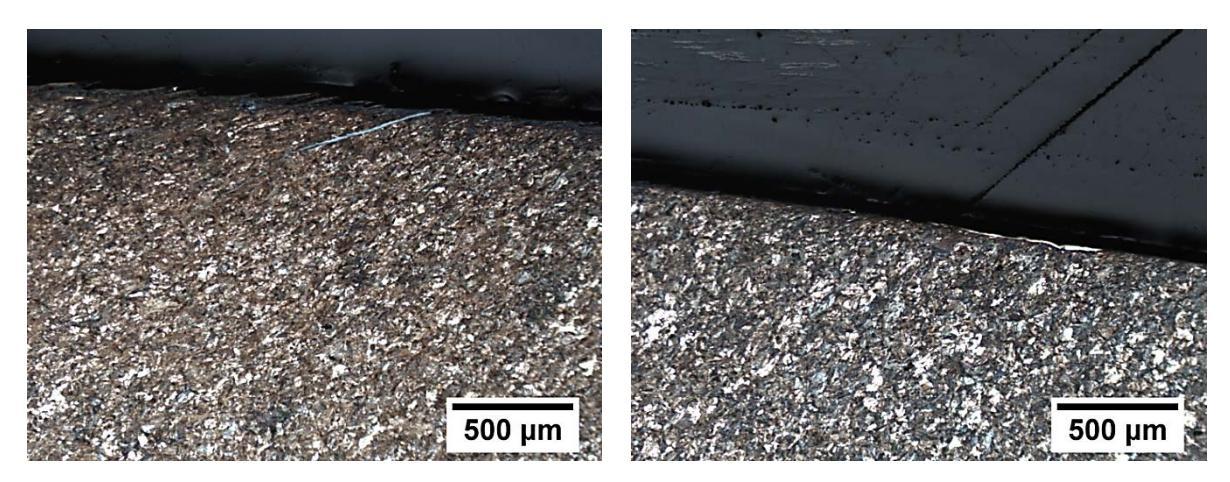
Figure 2.42 Plastic deformation in the mid-gauge and gauge corner regions of Rail 10 (Etched Rail 10-TG).

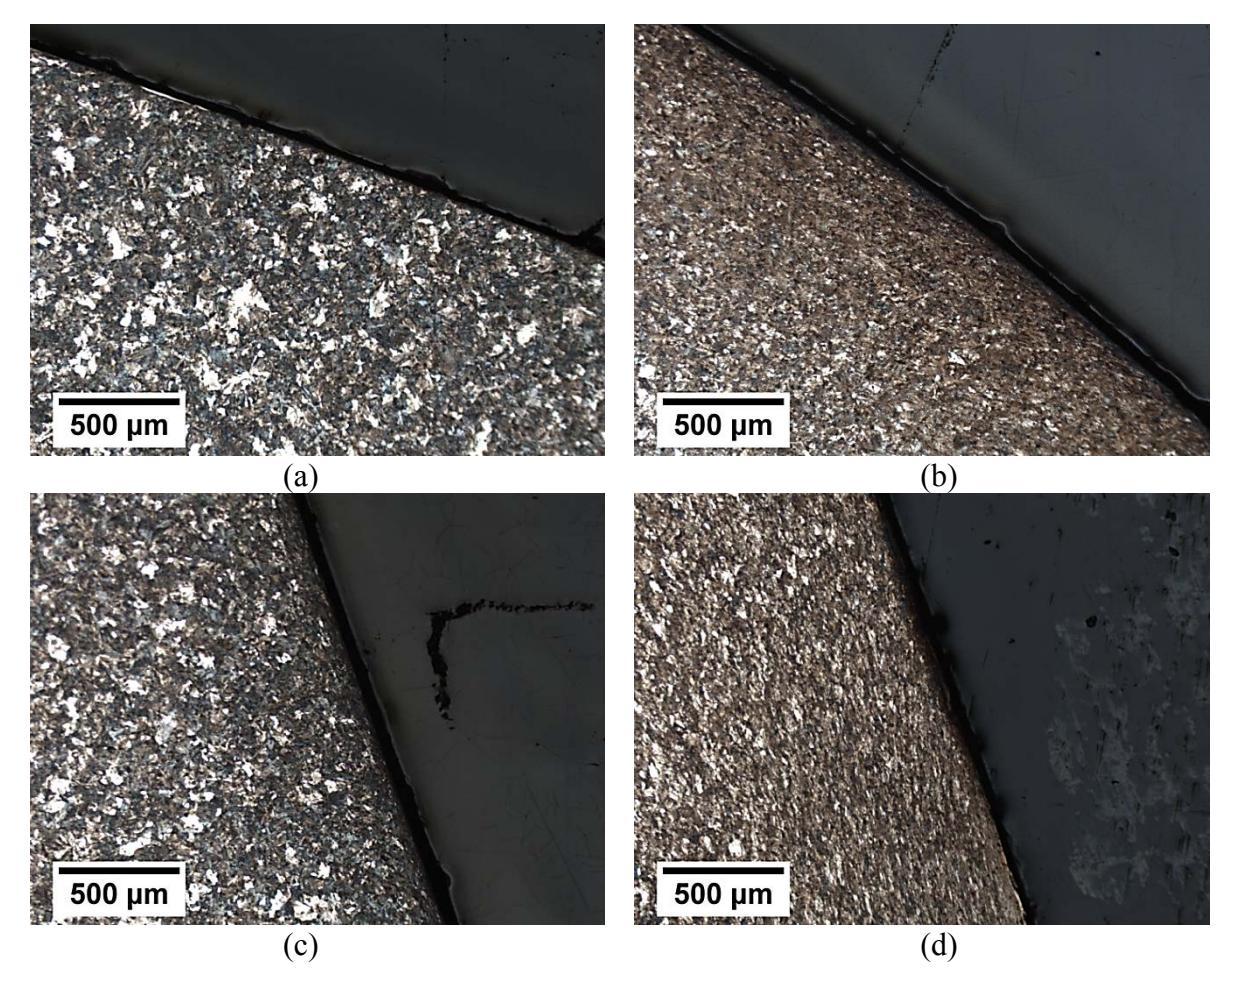
2.43a). Then, there was a small zone which had been significantly deformed up to a few millimeters (Figure 2.43b). Similar to Rails 1 and 2, a thin plastically deformed layer could be observed at the surface of the middle of gauge region (Figure 2.43c). Severe plastic deformation of the lower gauge zone had created a plastic flow lip with a dominant layer-like structure (Figure 2.43d).

Figure 2.43 Plastic deformation at (a) Upper gauge zone (b) Intermediate zone (c) Middle gauge zone (d) Lower gauge zone (Etched Rail 10-TG).

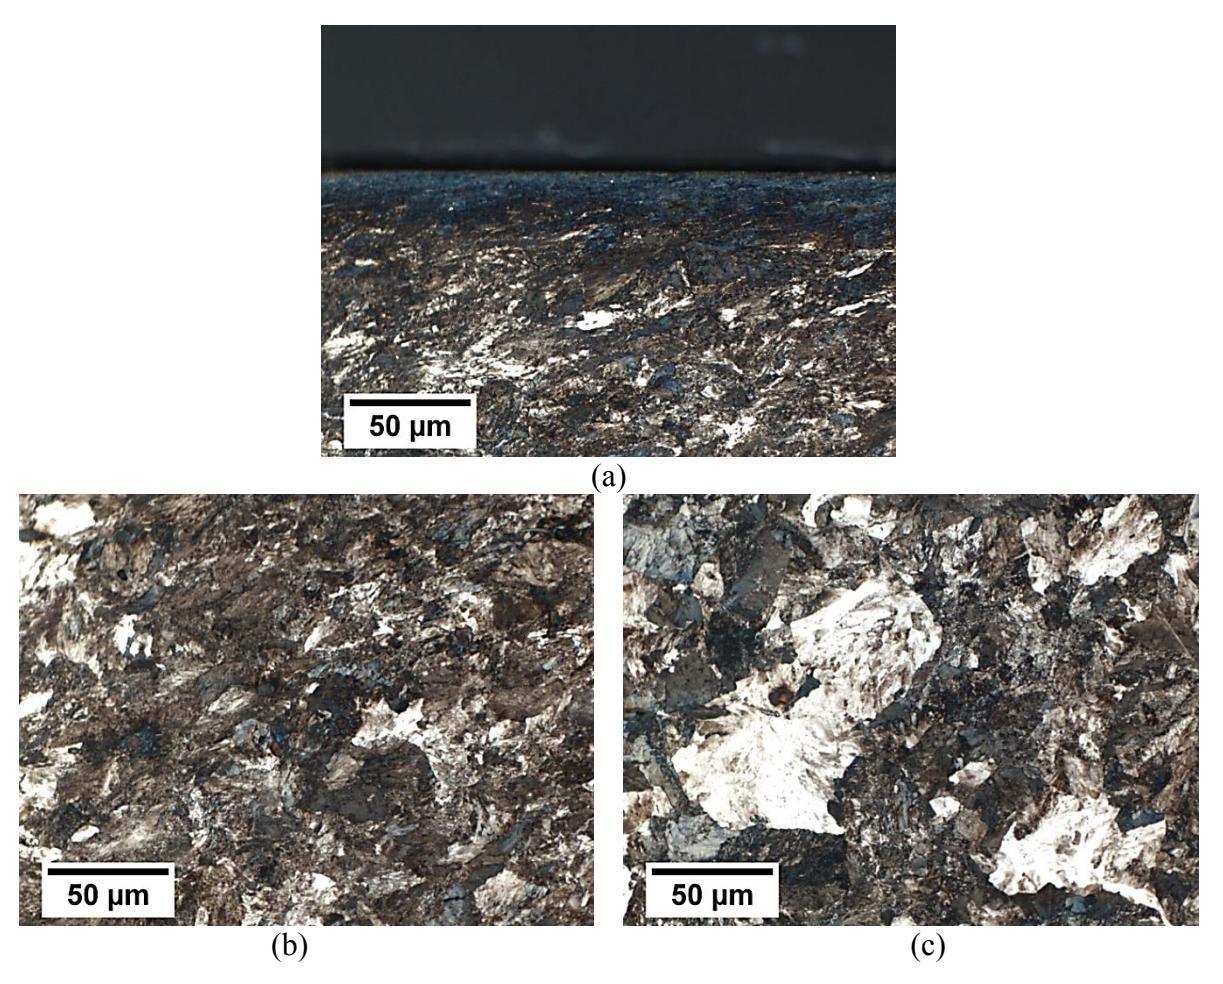
Rail 12: the plastic deformation characteristics of etched **Rail 12-LT** and Rail 10-LT specimens were very similar to each other. The largely deformed region of Rail 12-LT (Figure 2.44a) had a depth of 803 μ m, followed by mildly deformed region (Figure 2.44b) to a depth of 1576 μ m. Also, the mid-gauge and gauge corner regions of etched **Rail 12-TG** specimen (Figure 2.45) had microstructures similar to the corresponding regions from Rail 10-TG. The gauge region of Rail 12-TG specimen consisted of three (3) zones. The upper gauge zone (Figure 2.46a) experienced significant plastic deformation up to a few millimeters while the middle zone (Figure 2.46b) consisted of a thin plastically deformed layer. Aligned pearlite colonies and a small plastic flow lip were observed at the lower gauge zone (Figure 2.46c).

Figure 2.44 (a) Largely deformed region (b) Mildly deformed region (c) Undeformed region (Etched Rail 12-LT).

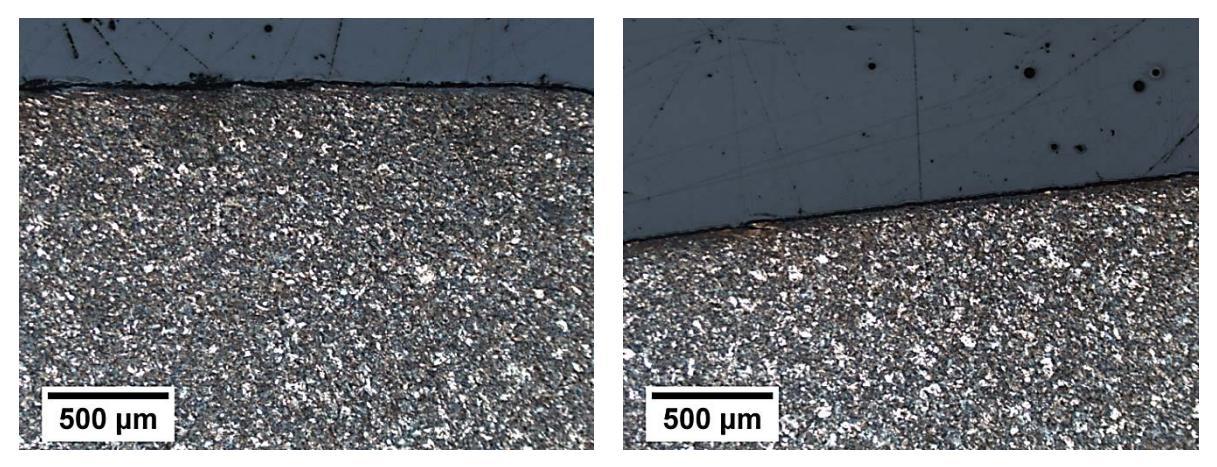
Figure 2.45 Plastic deformation in the mid-gauge and gauge corner regions of Rail 12 (Etched Rail 12-TG).

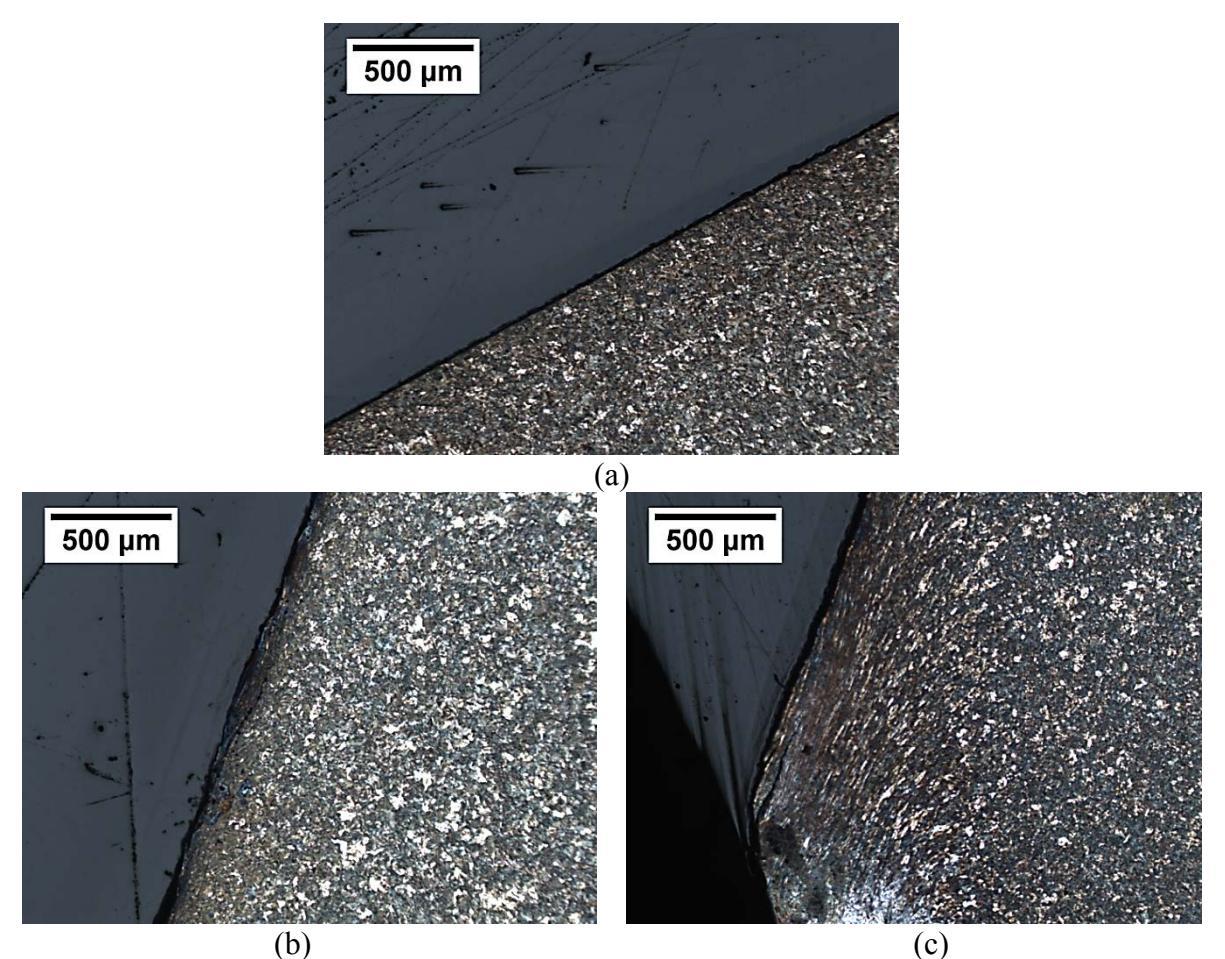
Figure 2.46 Plastic deformation at (a) Upper gauge zone (b) Middle gauge zone (c) Lower gauge zone (Etched Rail 12-TG).

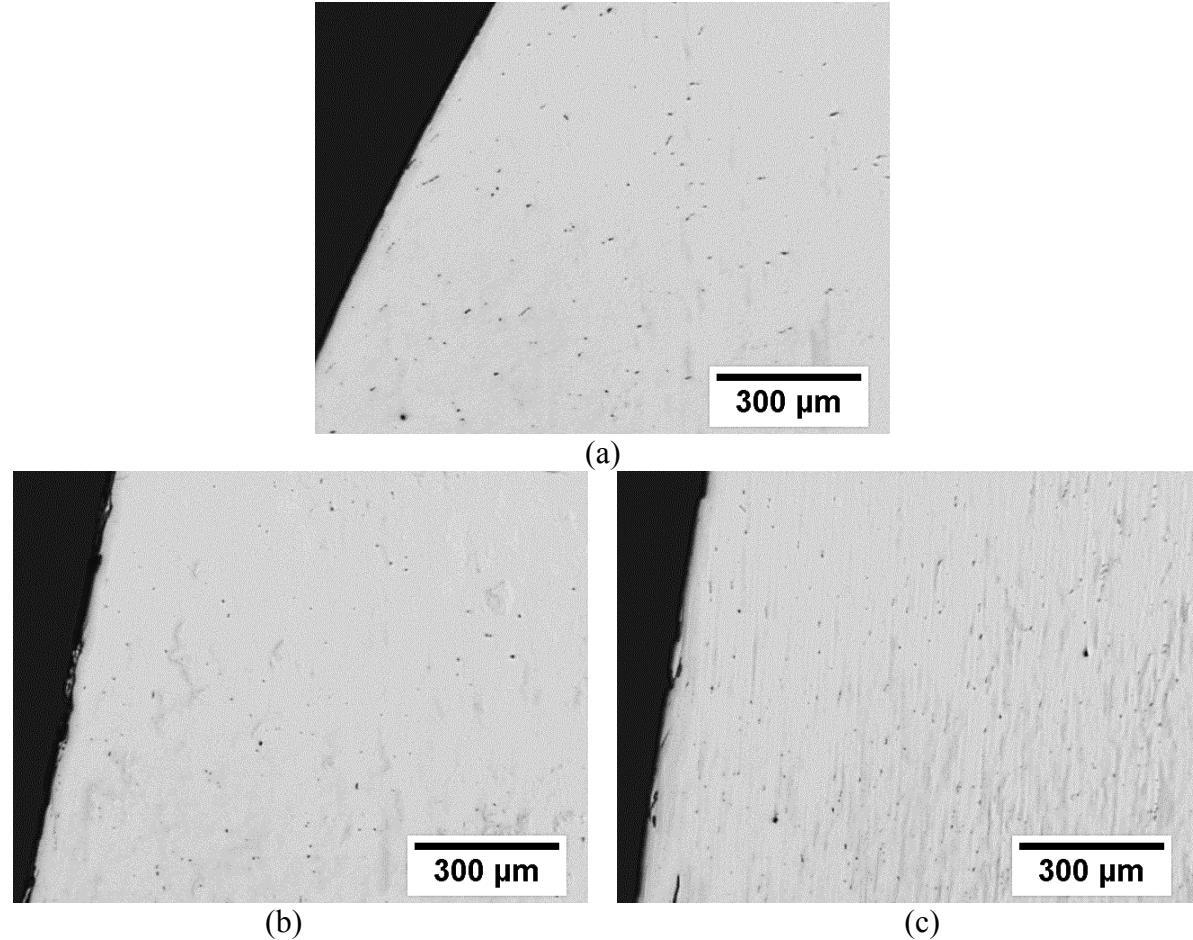
Rail 1: Examination of **Rail 1-TG** specimen revealed that in the upper zone of the rail gauge region, most of the inclusions had circular or elliptical shape. Besides, a few needle-like inclusions could be observed in this zone (Figure 2.47a). There were no traces of needle-like inclusions in the middle gauge zone and all of the inclusions were circular or elliptical (Figure 2.47b). In the lower gauge zone, the inclusions were mostly circular or elliptical along with several needle-like inclusions in the area close to the plastic flow lip (Figure 2.47c). At the mid-gauge region of the Rail 1-TG specimen, numerous needle-like inclusions were observed in the zone near the rail running surface (Figure 2.48a). Below this zone, circular or elliptical inclusions were dominant and only a few needle-like inclusions could be seen (Figure 2.48b). The **Rail 1-TT** specimen showed that the top of rail region was similar to the mid-gauge region in terms of shape and distribution of inclusions (Figure 2.49). Evaluation of **Rail 1-LG** and **Rail 1-LT** specimens exhibited axially aligned inclusion stringers (Figure 2.50).

Figure 2.47 Inclusions in the (a) Upper gauge zone (b) Middle gauge zone (c) Lower gauge zone (Rail 1-TG).

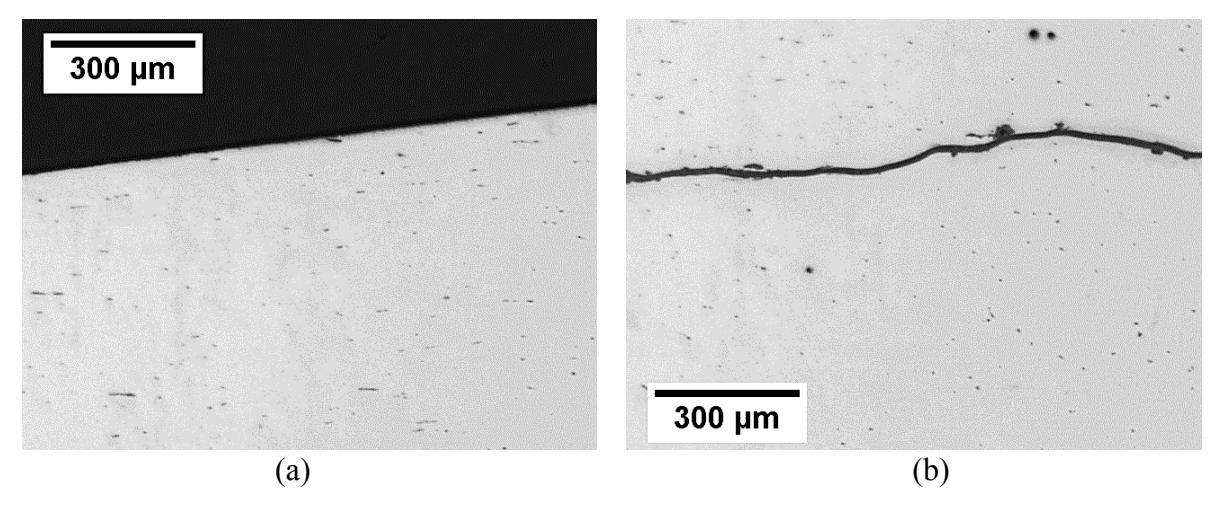
Figure 2.48 Inclusions in the mid-gauge region of Rail 1: (a) near-surface area (b) below the near surface area (Rail 1-TG).
