Experimental and Numerical Investigation of Fatigue Behavior of Pearlitic Rail Steels

A thesis submitted in partial fulfillment of the requirements for the degree of

Department of Mechanical Engineering University of Alberta

2. Experimental Failure Analysis of Pearlitic Rail Steels in Service

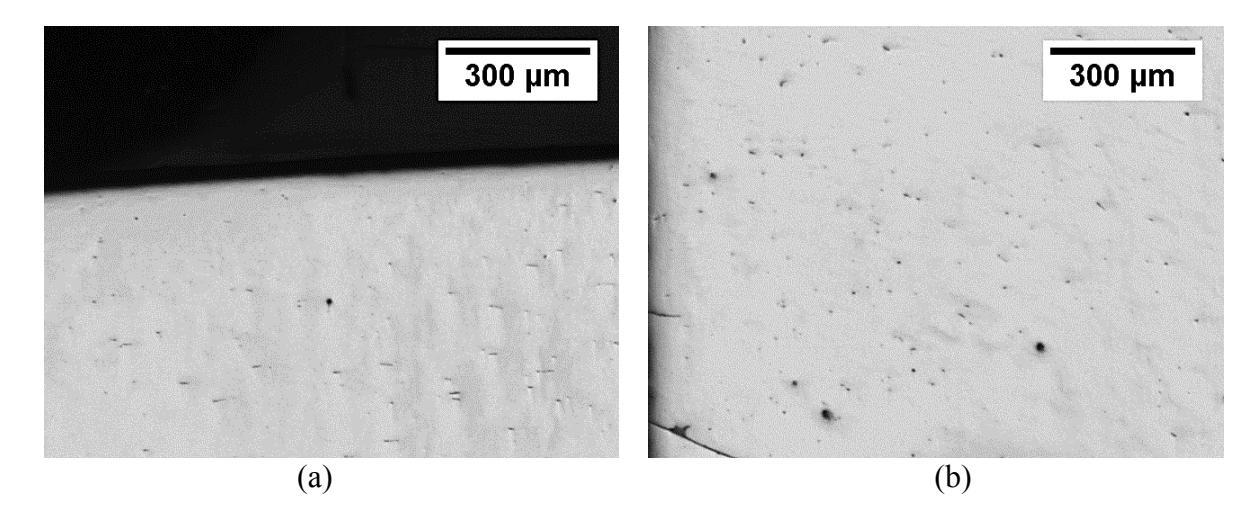
Figure 2.49 Inclusions in the top of rail region of Rail 1 (a) near-surface area (b) below the near-surface area (Rail 1-TT).

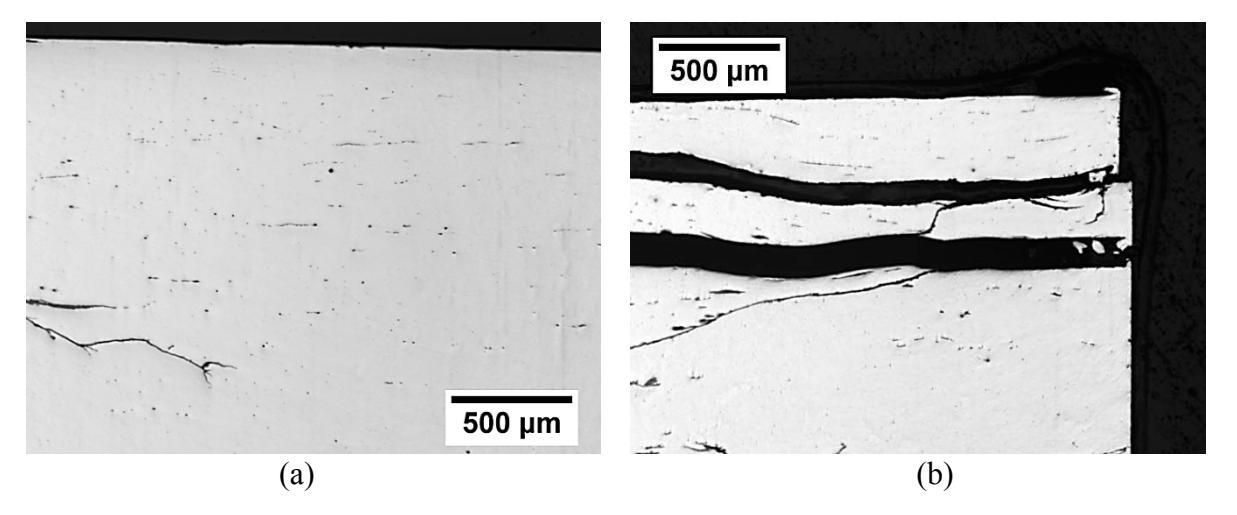
Figure 2.50 Inclusion stringers in longitudinal section of the (a) gauge and (b) mid-gauge region of Rail 1 (Rail 1-LG and LT, respectively).

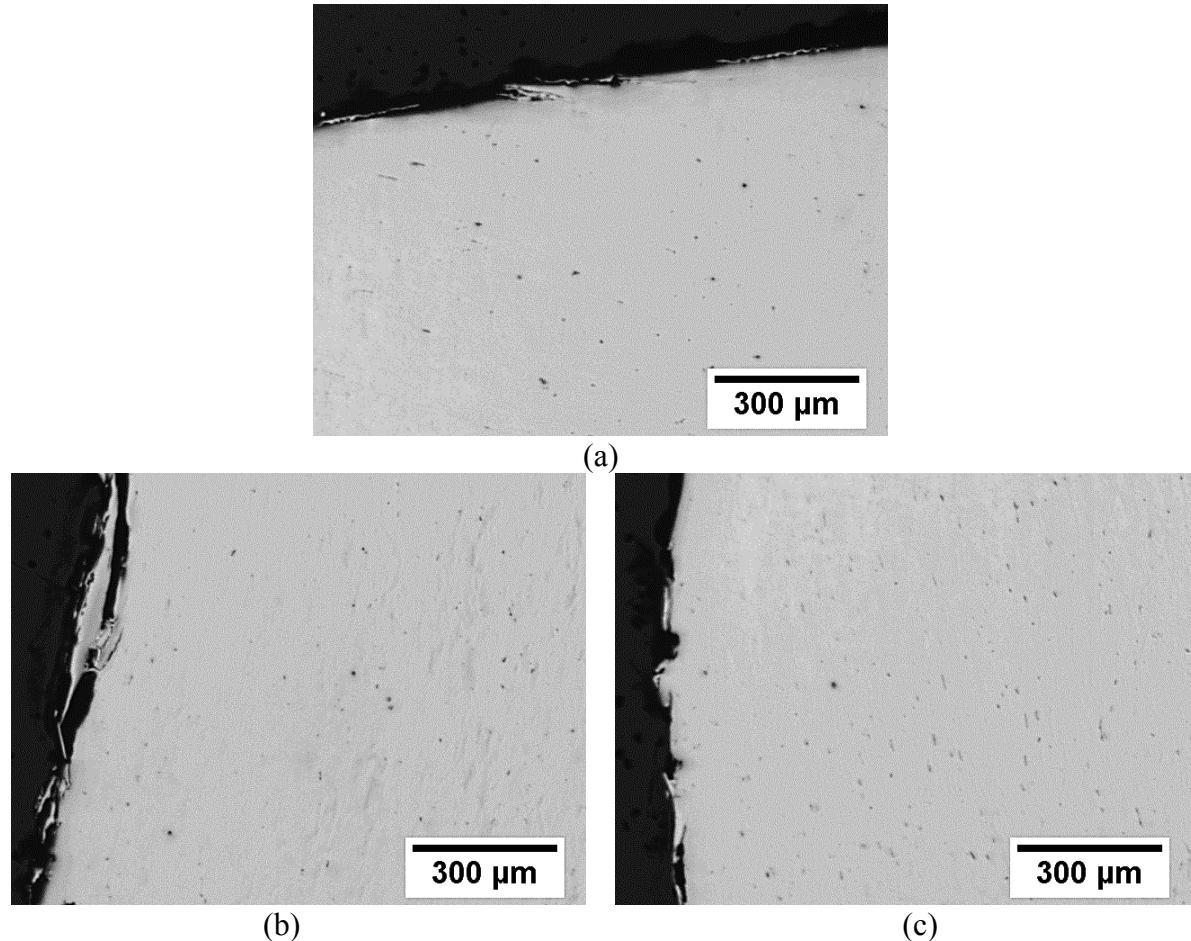
Rail 2: The inclusions in the upper and middle gauge zones of **Rail 2-TG** specimen were circular or elliptical with the exception of a few needle-like inclusions in the upper gauge zone (Figs 2.51a-b). In the lower gauge zone of Rail 2-TG specimen, many needle-like inclusions were observed near the plastic flow lip (Figure 2.51c). In the mid-gauge region, circular and elliptical inclusions were the dominant type (Figure 2.52). A number of needle-like inclusions could be seen mostly in the zone near the rail running surface (Figure 2.52a). **Rail 2-TT** showed

Figure 2.51 Inclusions in the (a) Upper gauge zone (b) Middle gauge zone (c) Lower gauge zone (Rail 2-TG).

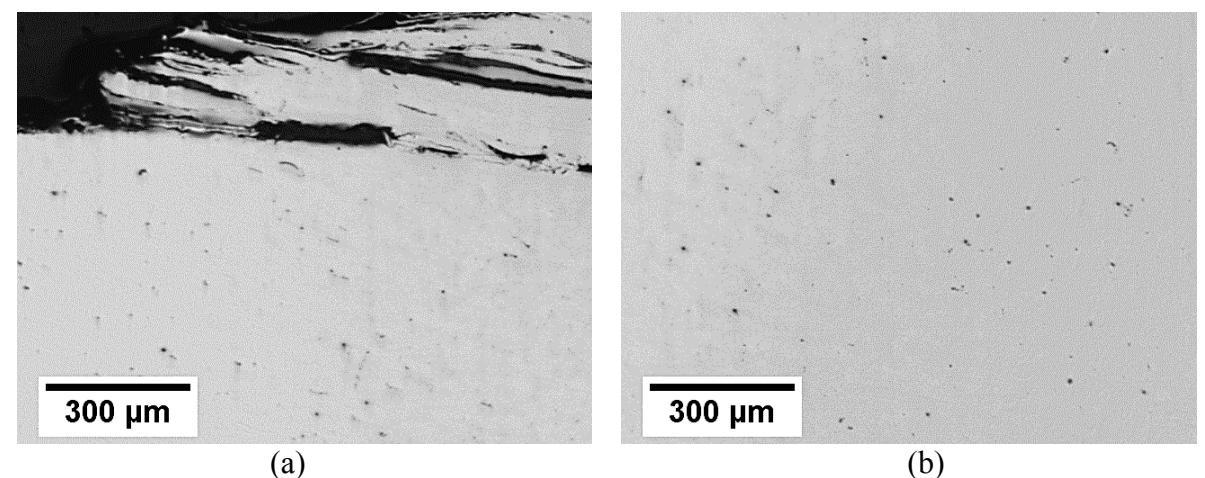
Figure 2.52 Inclusions in the mid-gauge region of Rail 2: (a) near-surface area (b) below the near surface area (Rail 2-TG).

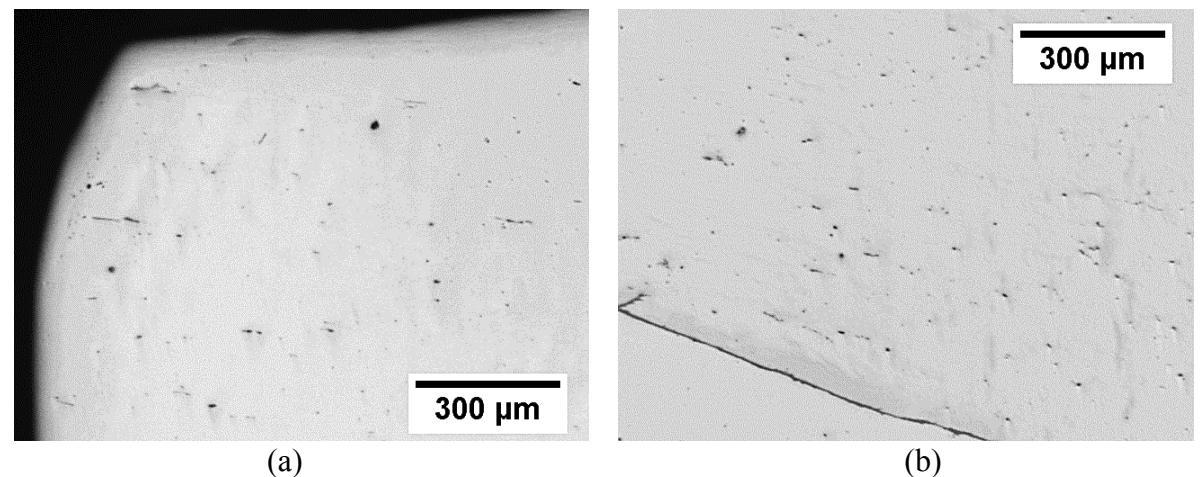
that shape and distribution of inclusions in the top of rail region were similar to the mid-gauge region (Figure 2.53). Rail 2-LG and Rail 2-LT specimens consisted of inclusion stringers which were axially aligned (Figure 2.54).

Figure 2.53 Inclusions in the top of rail region of Rail 2 (a) near-surface area (b) below the near-surface area (Rail 2-TT).

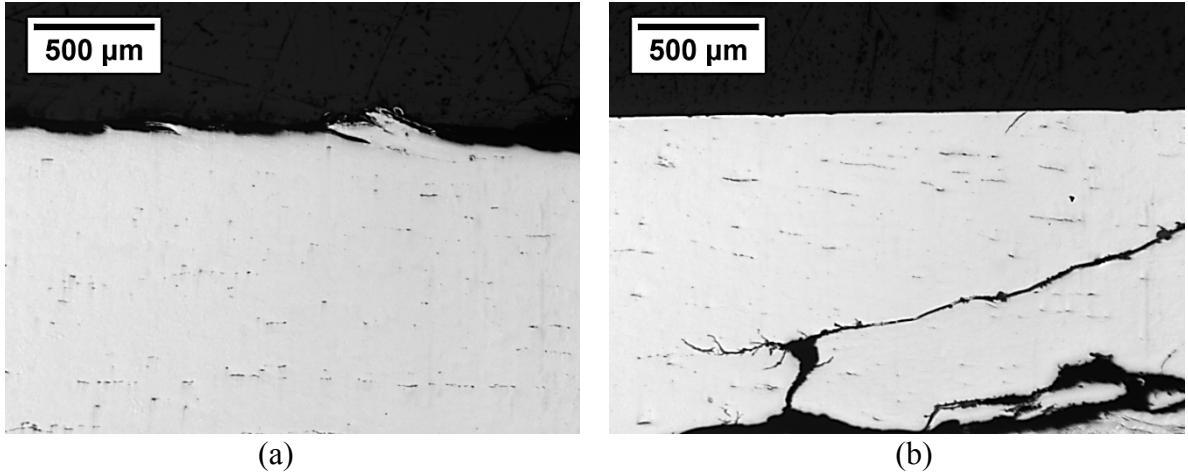
Figure 2.54 Inclusion stringers in longitudinal section of the (a) gauge and (b) mid-gauge region of Rail 2 (Rail 2-LG and LT, respectively).

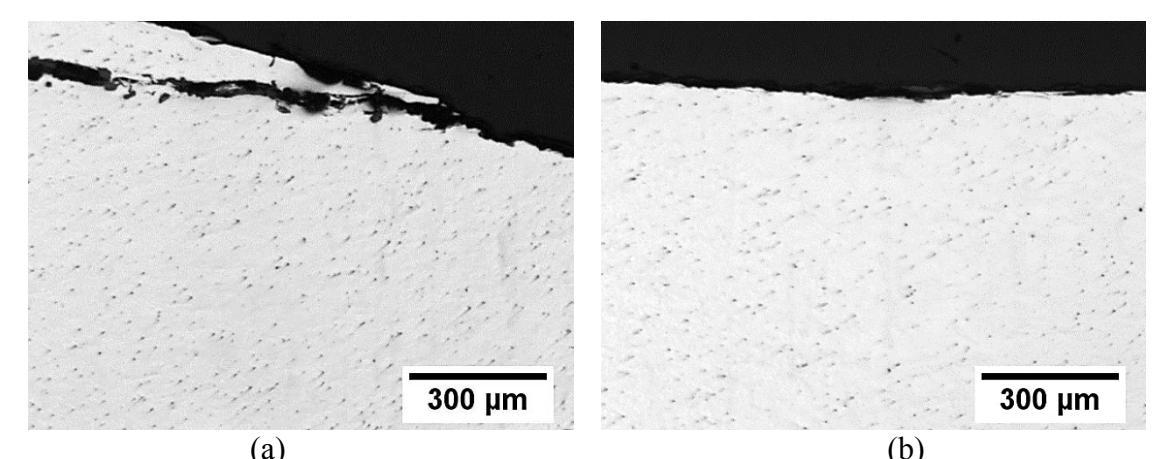
Figure 2.55 Inclusion in the (a) mid-gauge (b) top of rail region of Rail 7 (Rail 7-TG and TT, respectively).

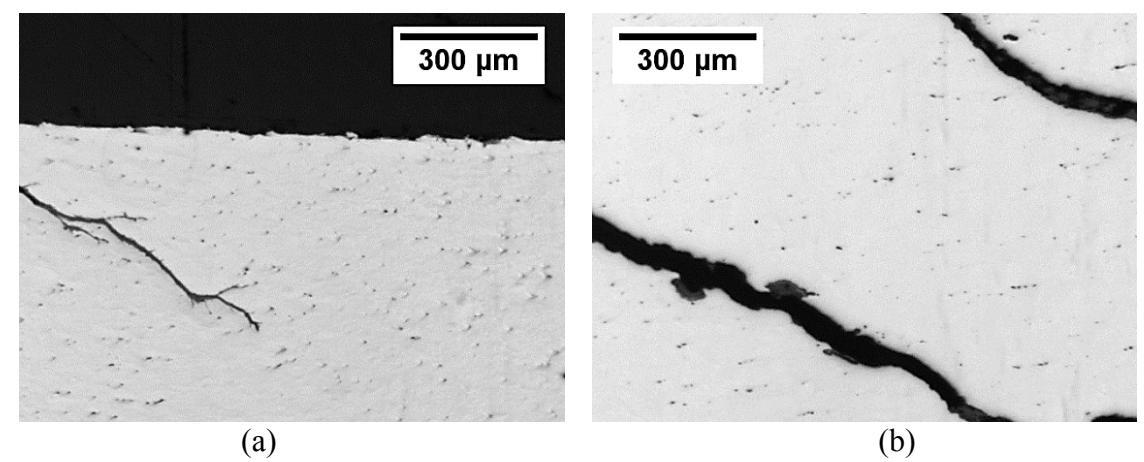
Rail 7: Evaluation of **Rail 7-TG** specimens showed that the inclusions in the upper gauge zone were predominantly circular or elliptical. In the lower gauge zone, several needle-like inclusions could be observed in a small area in the vicinity of the plastic flow lip and the rest of the zone contained circular or elliptical inclusions. The mid-gauge region of Rail 7-TG specimen and the top of rail region of **Rail 7-TT** specimen were covered by finely dispersed circular or elliptical inclusions could be traced in these regions (Figure 2.55). No axially aligned inclusion stringers were spotted in **Rail 7-LG** and **Rail 7-LT** specimens. Instead, circular or elliptical and many needle-like inclusions could be seen throughout the specimens (Figure 2.56).

Figure 2.56 Inclusion stringers in longitudinal section of the (a) gauge and (b) mid-gauge region of Rail 7 (Rail 7-LG and LT, respectively).

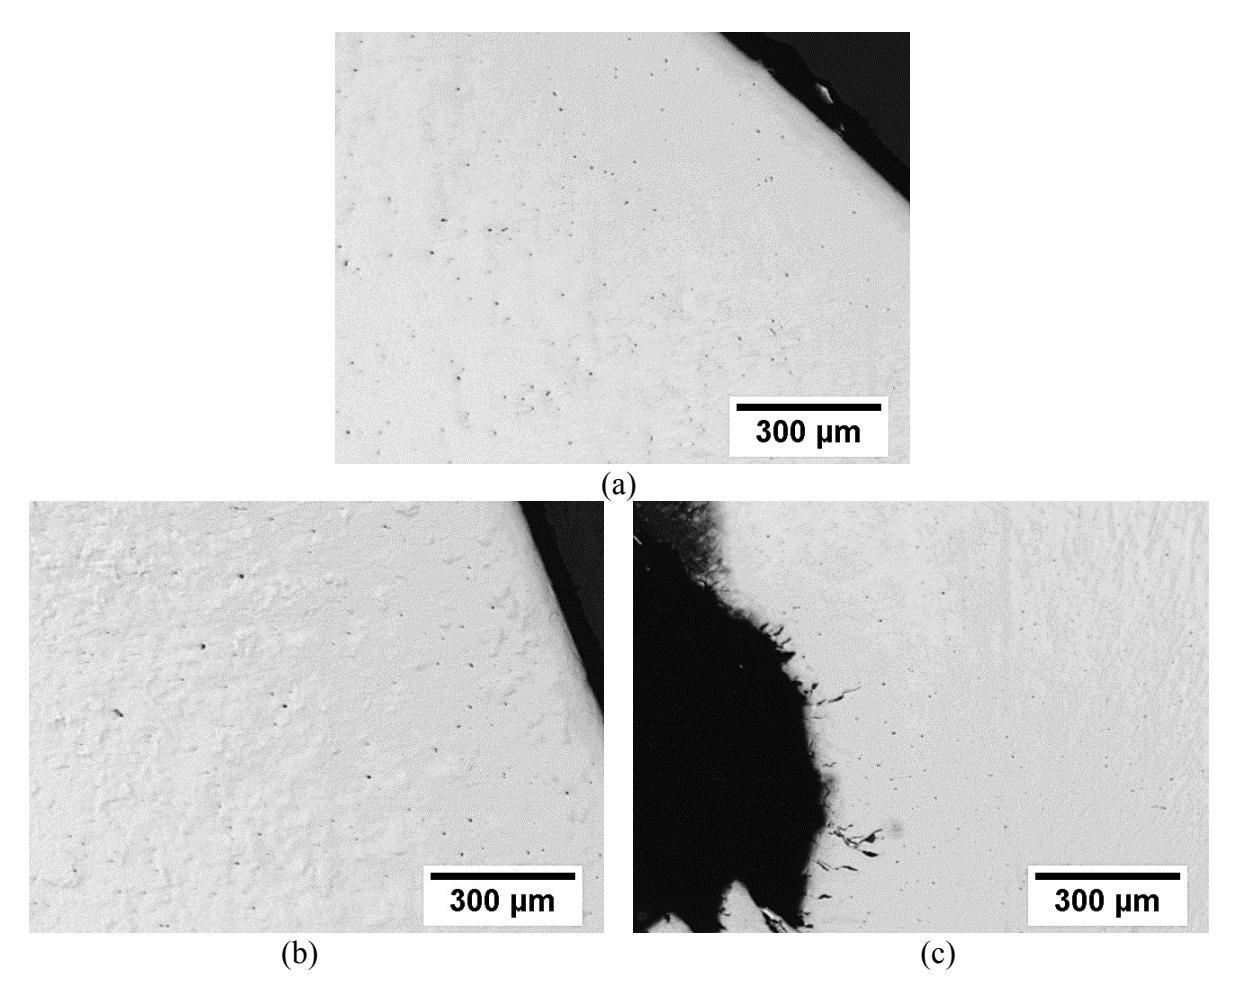
Rail 10: No traces of needle-like inclusion could be seen in the gauge region of **Rail 10-TG** specimen and all of the inclusions were circular or elliptical (Figure 2.57). Only a few needle-like inclusions were observed in the mid-gauge region of Rail 10-TG specimen and the top of rail region of **Rail 10-TT** specimen and circular or elliptical inclusions were the dominant type (Figure 2.58). **Rail 10-LG** and **Rail 10-LT** specimens contained axially aligned inclusion stringers (Figure 2.59).

Figure 2.57 Inclusions in the (a) Upper gauge zone (b) Middle gauge zone (c) Lower gauge zone (Rail 10-TG).

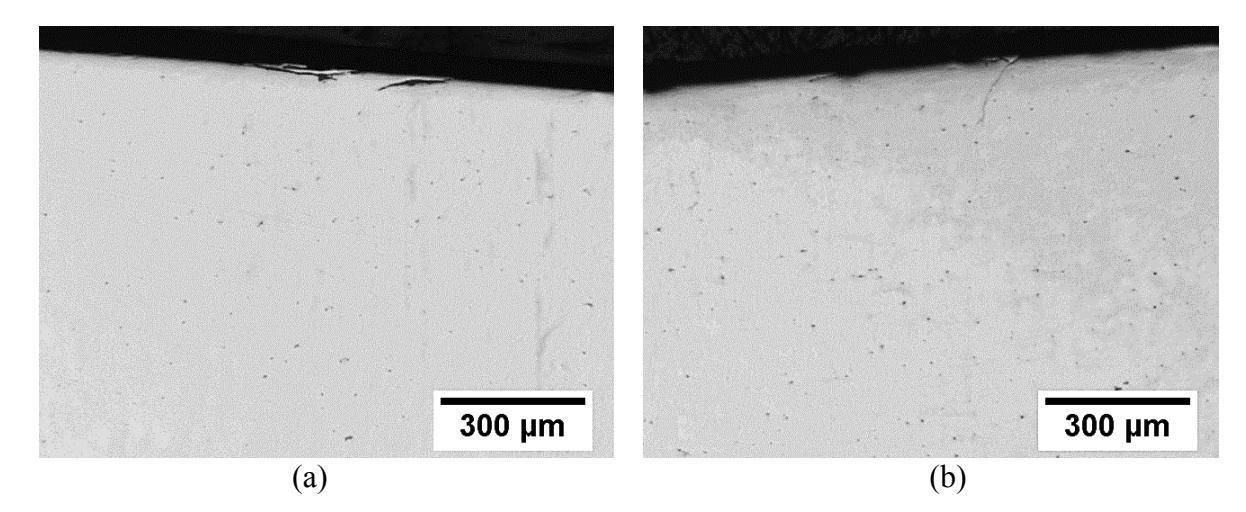
Figure 2.58 Inclusion in the (a) mid-gauge (b) top of rail region of Rail 10 (Rail 10-TG and TT, respectively).

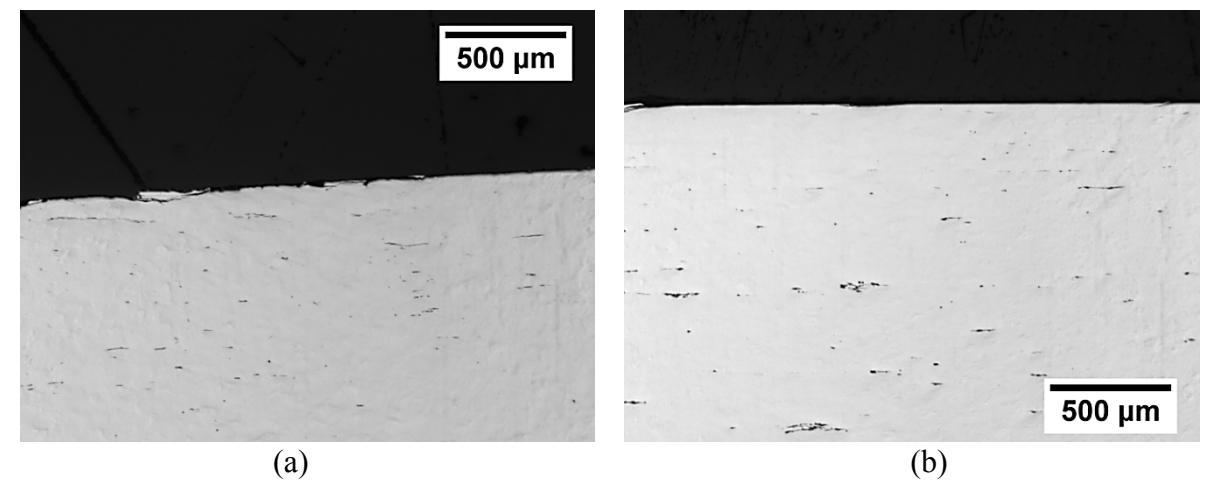
Figure 2.59 Inclusion stringers in longitudinal section of the (a) gauge and (b) mid-gauge region of Rail 10 (Rail 10-LG and LT, respectively).

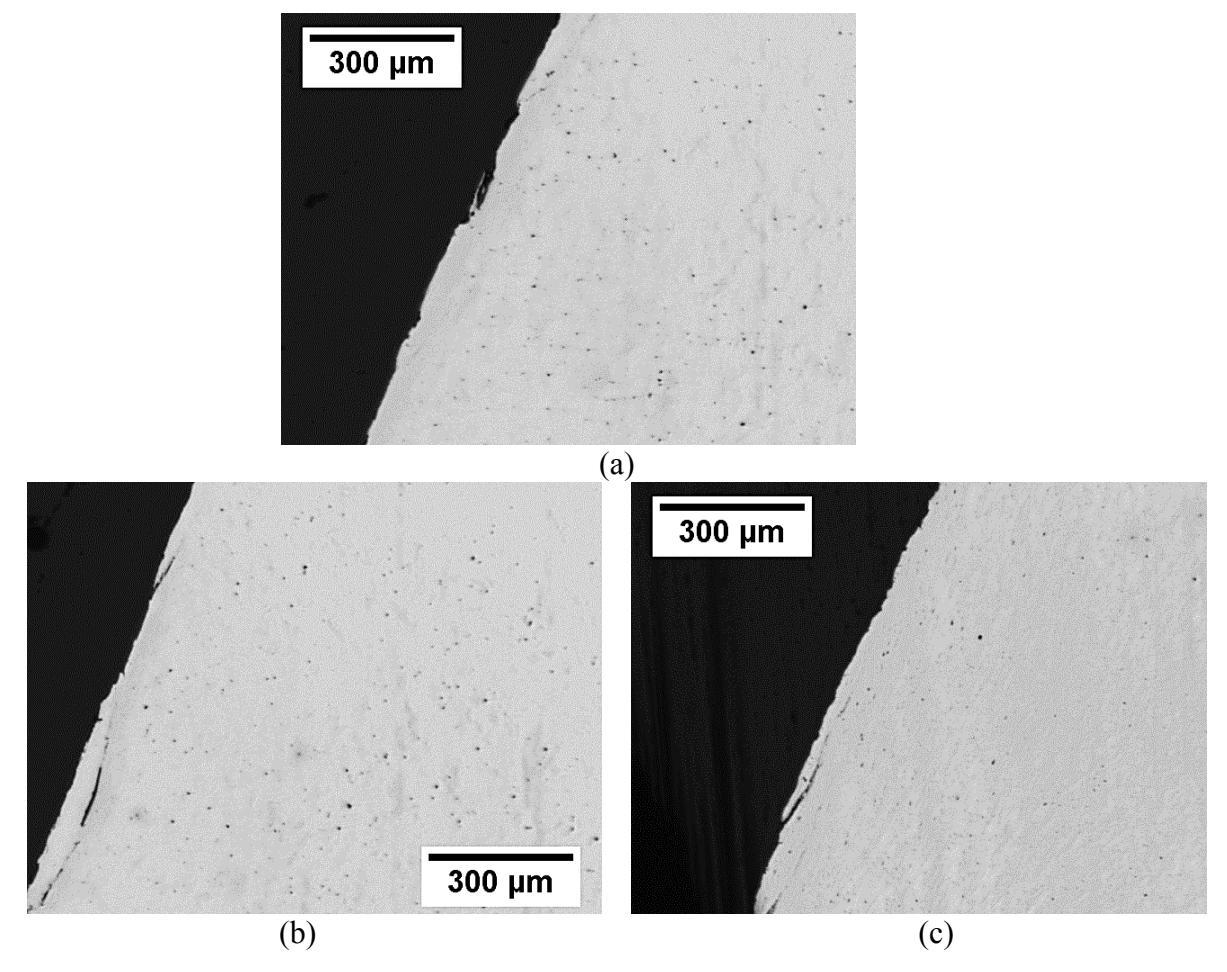
Rail 12: Circular or elliptical inclusions were the dominant types of inclusions in the gauge region of **Rail 12-TG** specimen and only a few needle-like inclusions could be seen in the lower gauge zone near the plastic flow lip (Figure 2.60). In the mid-gauge region of Rail 12-TG specimen and the top of rail region of **Rail 12-TT** specimen, inclusions were mostly circular and elliptical along with a few needle-like ones (Figure 2.61). Inclusion stringers, axially aligned, were observed in **Rail 12-LG** and **Rail 12-LT** specimens (Figure 2.62).

Figure 2.60 Inclusions in the (a) Upper gauge zone (b) Middle gauge zone (c) Lower gauge zone (Rail 12-TG).

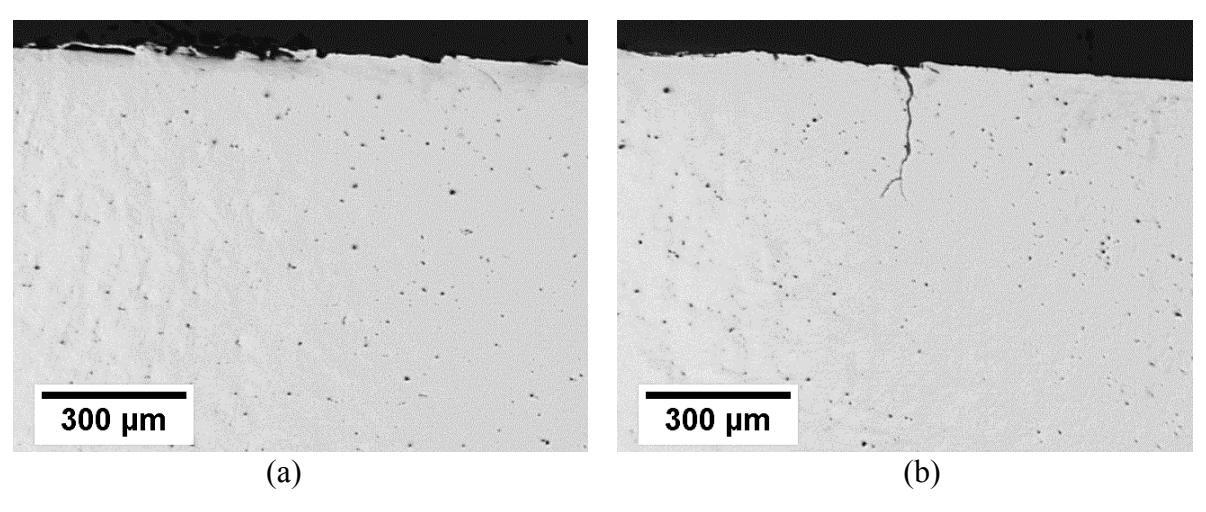
Figure 2.61 Inclusion in the (a) mid-gauge (b) top of rail region of Rail 12 (Rail 12-TG and TT, respectively).

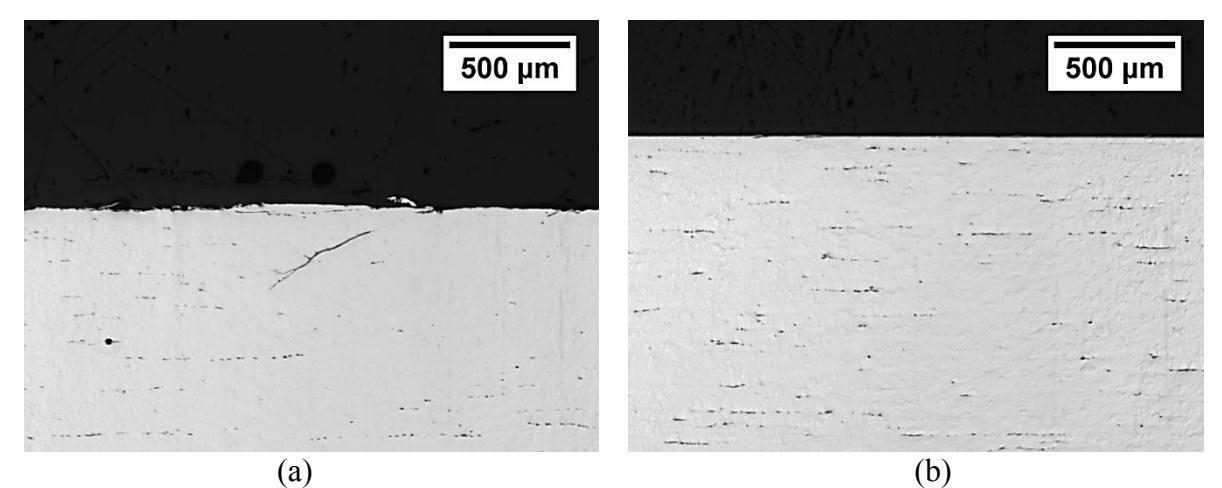
Figure 2.62 Inclusion stringers in longitudinal section of the (a) gauge and (b) mid-gauge region of Rail 12 (Rail 12-LG and LT, respectively).

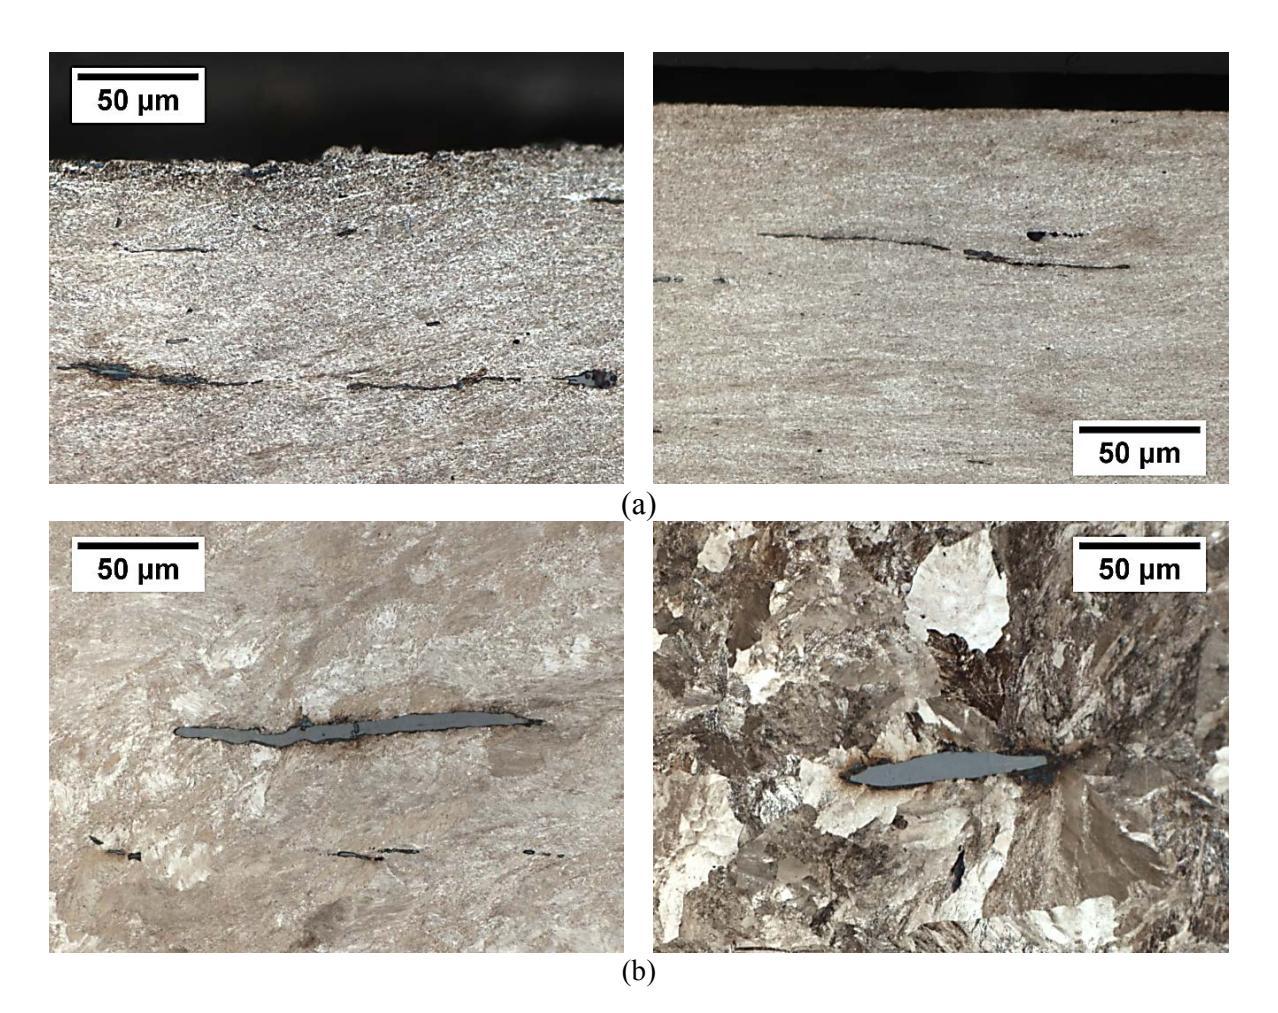
In the mid-gauge regions, several needle-like inclusions were seen in the near-surface area with layer-like structure which was severely deformed as a result of high shear loads. Outside this area, inclusions were mostly circular and elliptical and only a few needle-like inclusions could be observed. Evaluation of mid-gauge regions in the longitudinal direction (**LT specimens**) showed that the MnS based inclusion stringers in the area near the running surface were heavily deformed and flattened (Figure 2.63a). Away from the running surface, the inclusions were less elongated and more elliptical (Figure 2.63b).

Figure 2.63 (a) Flattened MnS based inclusions in near-surface area (b) Undeformed inclusions.

These observations were in agreement with the study done by Garnham *et al.* (2010) on the deformation of ductile inclusions in rail steel under rolling contact loads. They observed that MnS based inclusions at the depths of used rail heads were in the form of axially aligned elongated ellipsoids and had circular or elliptical shapes in the transverse cross sections. As a result of cyclic strain accumulation near the surfaces of the rail heads, these inclusions had become gradually flattened in axial and transverse directions, leading them to have a disc shape. These flattened MnS based inclusions act as planes of weakness and expedite RCF by facilitating initiation and propagation of cracks.

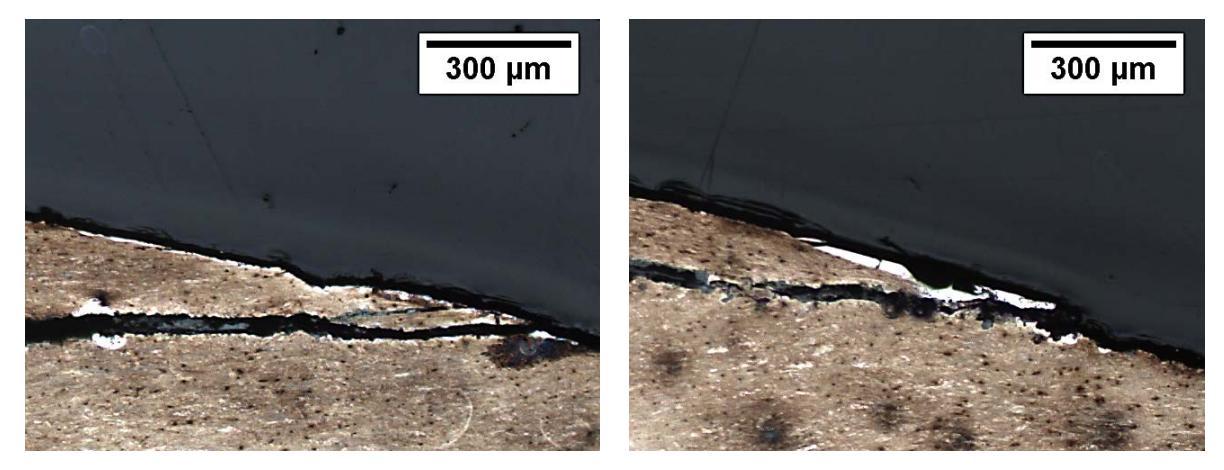
Rail 7: unlike the two previous rails, WELs could be seen at the surface of the etched Rail **7-LT** specimen (Figure 2.66). Significant portions of the WELs were located at the opening of the cracks on the surface. Examination of the etched **Rail 7-TG** specimen also showed the presence of white etching islands at the surface of the mid-gauge and gauge corner regions, mainly at the openings of the cracks (Figure 2.67). Thin WELs could be seen all over the upper and lower gauge zones (Figure 2.68).

Figure 2.67 WEL at the mid gauge and gauge corner regions of Rail 7 (Etched Rail 7-TG).

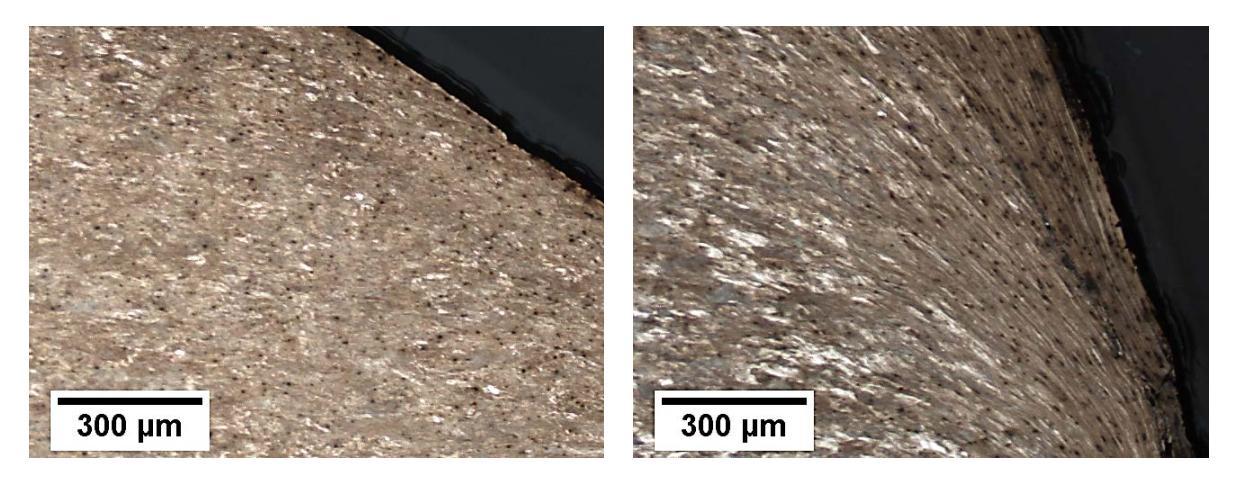
Figure 2.68 WEL at the upper and lower gauge zones (Etched Rail 7-TG).

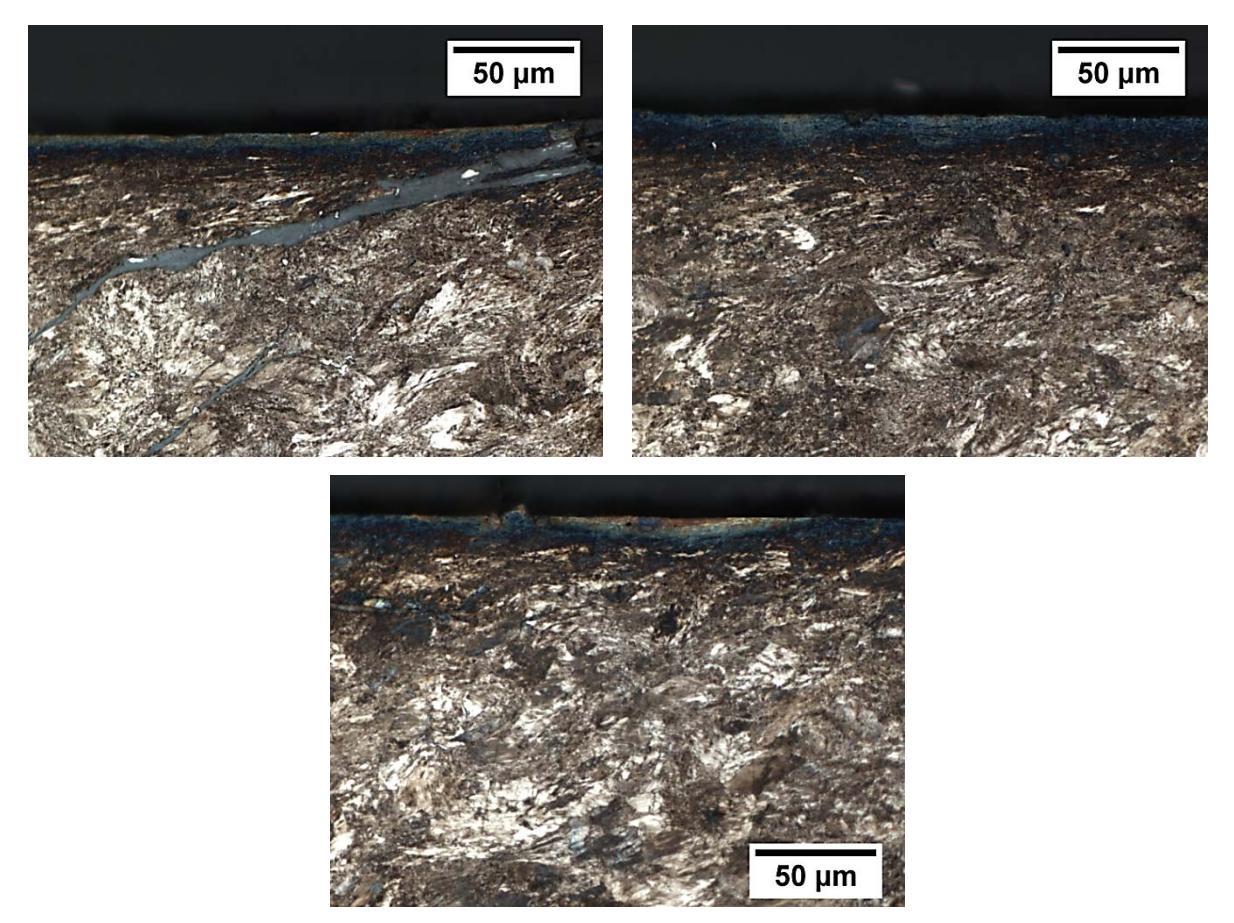
Rail 10: A continuous layer with navy blue color was observed at the surface of the etched Rail 10-LT specimen. Evaluation of this layer at a higher magnification revealed that it was a WEL stained by the residual etchant (Figure 2.69). The attempts to remove the stain by repeating the metallographic preparation were unsuccessful. In addition to the WEL at the surface, pieces of white etching material could be seen inside the cracks. One interesting observation was existence of a large piece of white etching material inside one of the cracks (Figure 2.70). While presence of white etching material at subsurface is common for bearings (Sadeghi et al. 2009), it has not been reported for rails. One possible explanation could be that the white etching material formed due to severe plastic deformation caused by crack face rubbing (Gould et al. 2017). Examination of the etched Rail 10-TG specimen showed a continuous WEL at the surface of the mid-gauge region and several white etching islands in the gauge corner region (Figure 2.71). Several thin WELs were observed at the surface of the upper gauge zone (Figure 2.72a). An area near the end of the middle gauge zone (close to the lower gauge zone) was covered with a thick continuous WEL (Figure 2.72b). In addition, a continuous thin WEL could be observed all over the lower gauge zone (Figure 2.72c).

Figure 2.69 WELs at surface of longitudinal section of the mid-gauge region of Rail 10 (Etched Rail 10-LT).

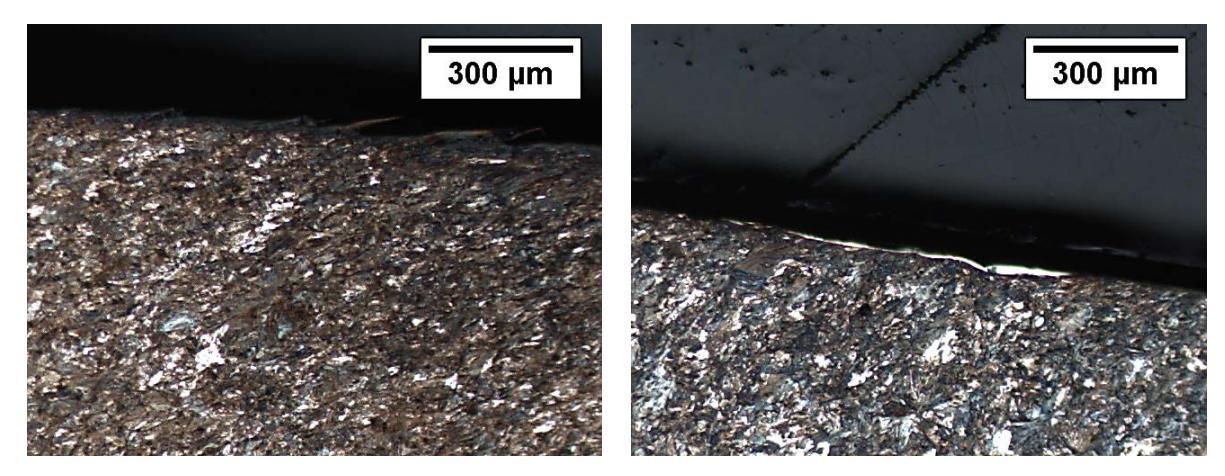
Figure 2.71 WEL at the mid gauge and gauge corner regions of Rail 10 (Etched Rail 10-TG).

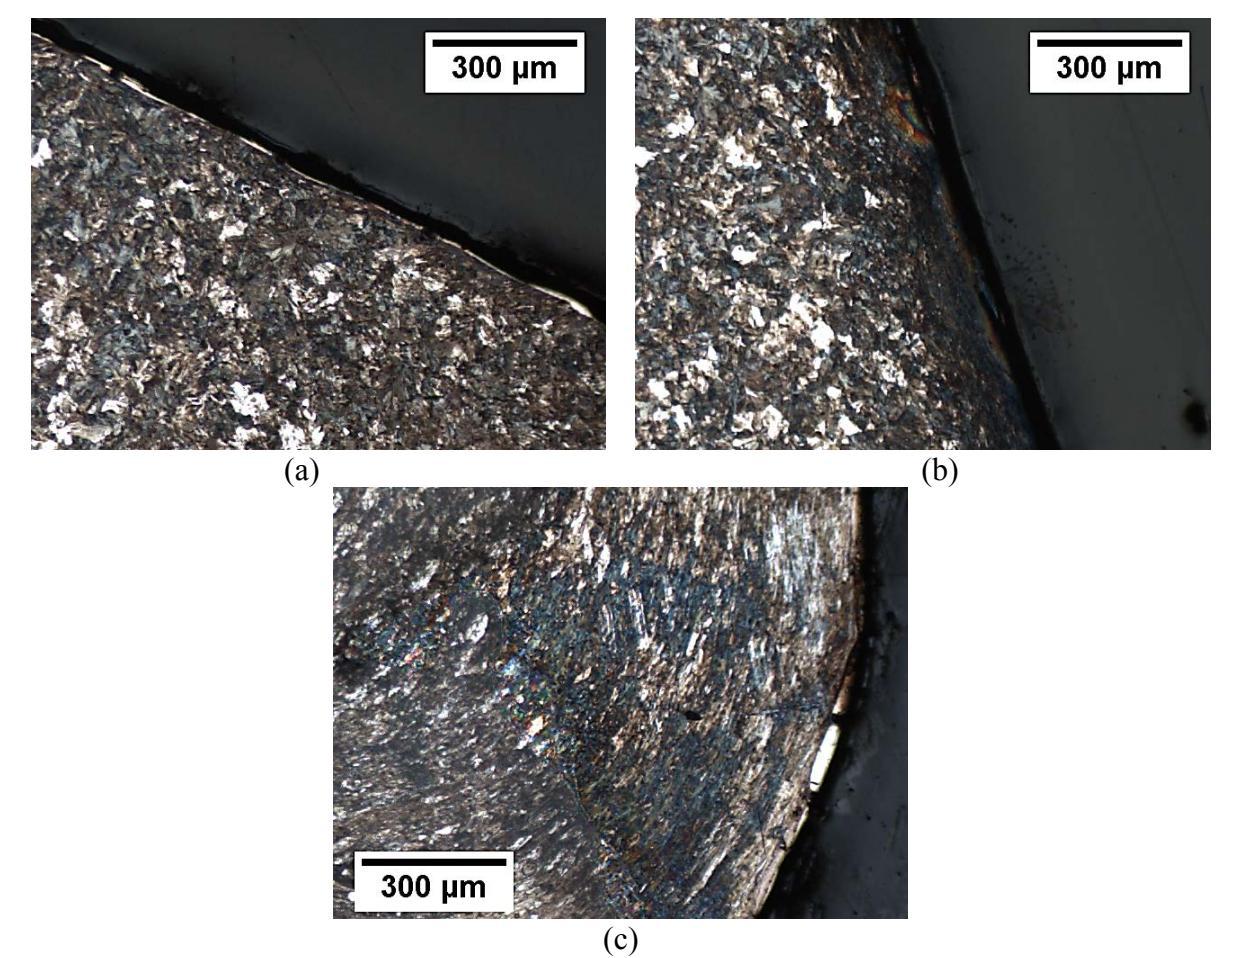
Figure 2.72 WEL at the (a) Upper gauge zone (b) Middle gauge zone (c) Lower gauge zone (Etched Rail 10-TG).

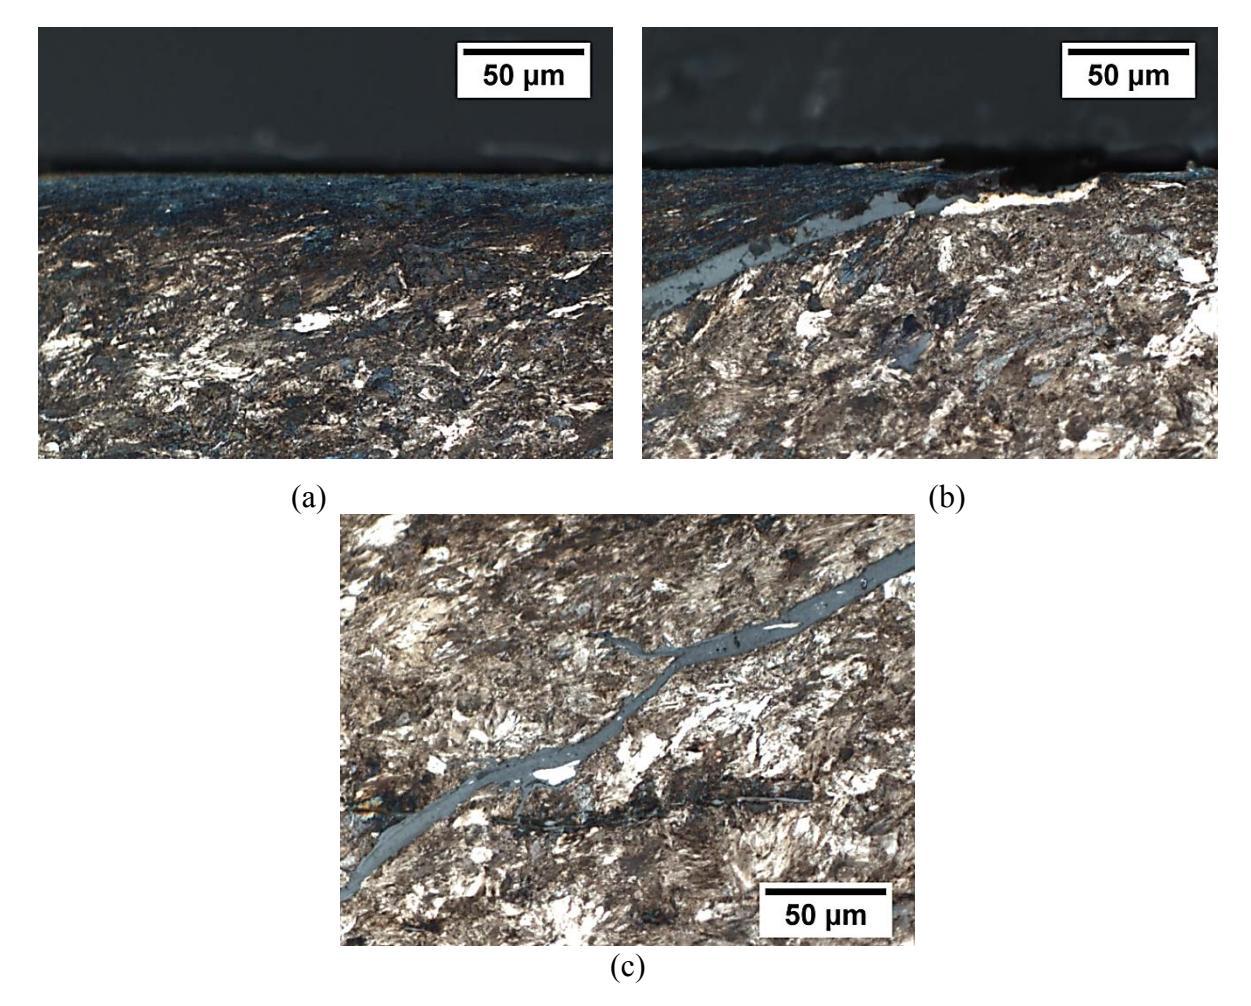
Rail 12: Similar to Rail 10, a large area at the surface of the etched **Rail 12-LT** specimen was covered with a continuous WEL that was stained by the residual etchant (Figure 2.73a). Also, pieces of white etching material were observed inside the cracks (Figure 2.73c). Evaluation of the etched **Rail 12-TG** specimen revealed that the surfaces of mid-gauge and gauge corner regions were cover by a continuous WEL (Figure 2.74). While there was no WEL at the surface of the upper gauge zone, a continuous WEL was observed throughout the surfaces of the middle and lower gauge zones (Figure 2.75).

Figure 2.73 WELs at surface of longitudinal section of the mid-gauge region of Rail 12 (Etched Rail 12-LT).
