**Management of Geohazards at Lihir Gold Mine
Papua New Guinea**

by
Mohan Singh

**Master of Science
in
Mining Engineering**

2 Investigation of Phase 12 Slope Failure

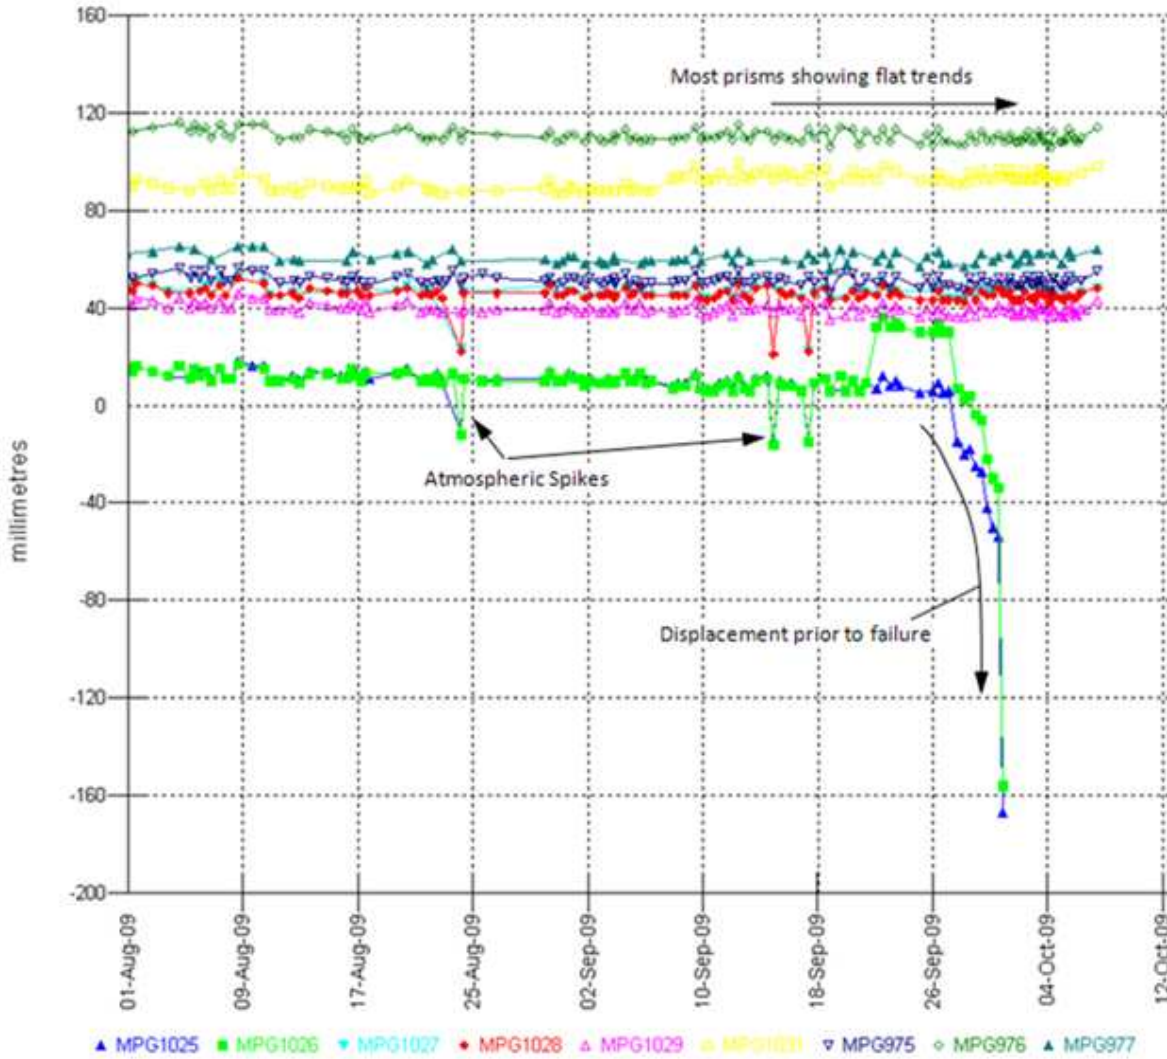
Figure 8: Prism monitoring results from southern end of Phase 12

No other prism in the PH12 area recorded any significant displacement and continued to record flat trends before and after the failure as illustrated in Figure 8. This included prism 1027 located closest to the failure boundary. It should be noted that there was no indication of displacement recorded prior to 27/09/09.

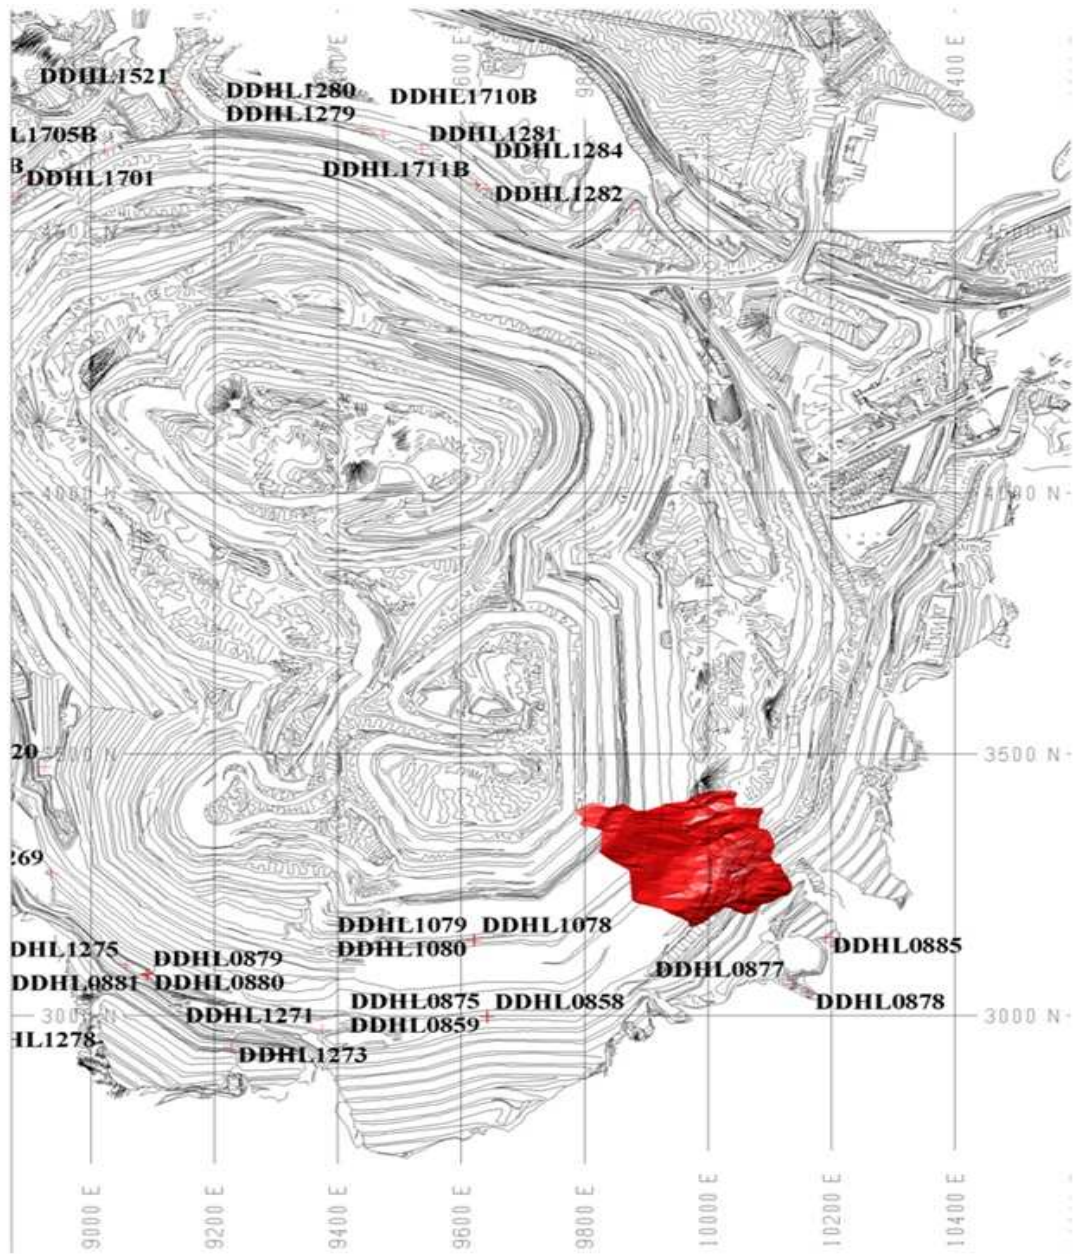
Figure 9: Locations of vibrating wire piezometers

Vibrating wire piezometers (VWPs) were located south of the PH 12 failure, they were DDHL 885, 878 and 877. These instruments were installed at 1078, 1074 and 1029 mRL respectively as shown in Figure 9. Their monitoring was covered by a monthly schedule which was reviewed quarterly to ensure that the frequency of monitoring was adequate for the observed changes in groundwater heads. A review of this monitoring schedule was last conducted in August 2009.

Groundwater levels at VWP DDHL 885 indicated an increase of 1.52 m in the months leading up to the PH12 failure as shown in Figure 10. This equated to a very small increase in pressure, some 14 kPa and was the only VWP adjacent to the PH12 failure to indicate increase in groundwater levels. The other VWPs DDHL 878 and 877 either showed no change or a decreasing trend.

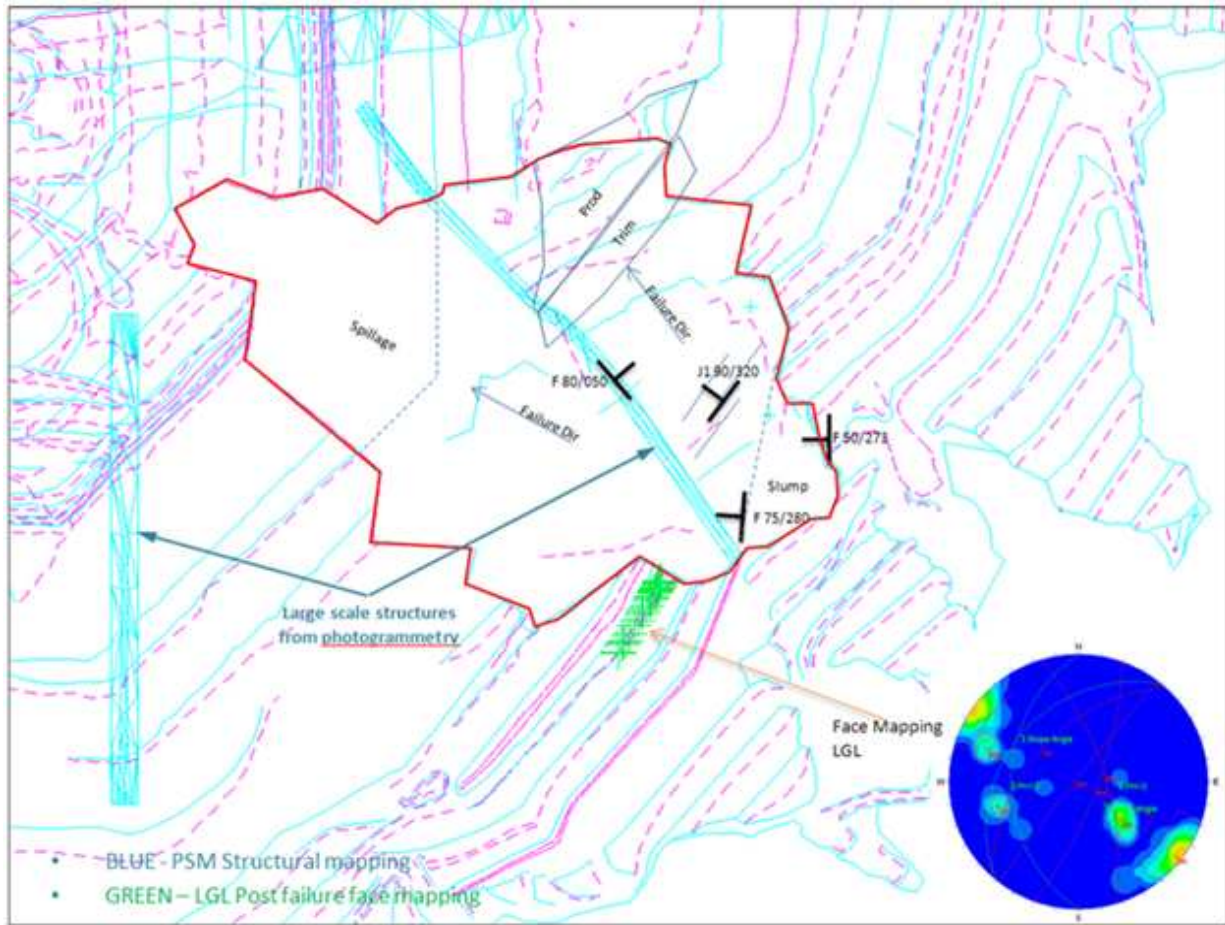
Figure 13: Structural geology

Location of mapped structures relative to the failure outline are shown in Figure 13, which also shows the recorded major structures and interpreted wireframes (blue) of structures derived from

photogrammetry by PSM Consultants. The failure boundary was surveyed using reflectorless instruments and shows the extent of failure plus the associated spillage into the old Minifie pit below.

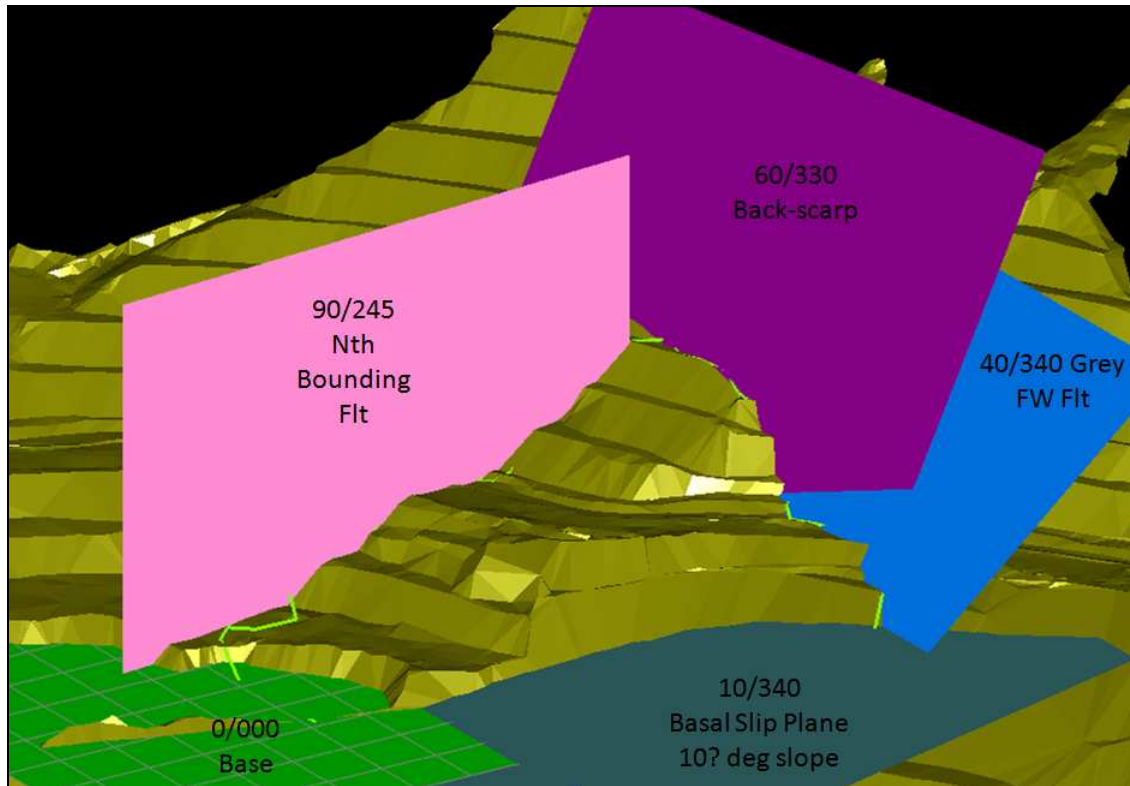
Figure 15: Structural geology interpretation

structures undercut the slope, a shallow planar sliding plane must be present below the failure mass. This was interpreted to dip at between 10° to 13° toward an azimuth of 340° .

Observed joints varied in orientation both in dip and strike, especially in the failure back-scarp area. Generally, most structures dip in a North-West direction. The interpreted three dimensional failure model illustrated in Figure 15 was produced based on structural mapping and observation.

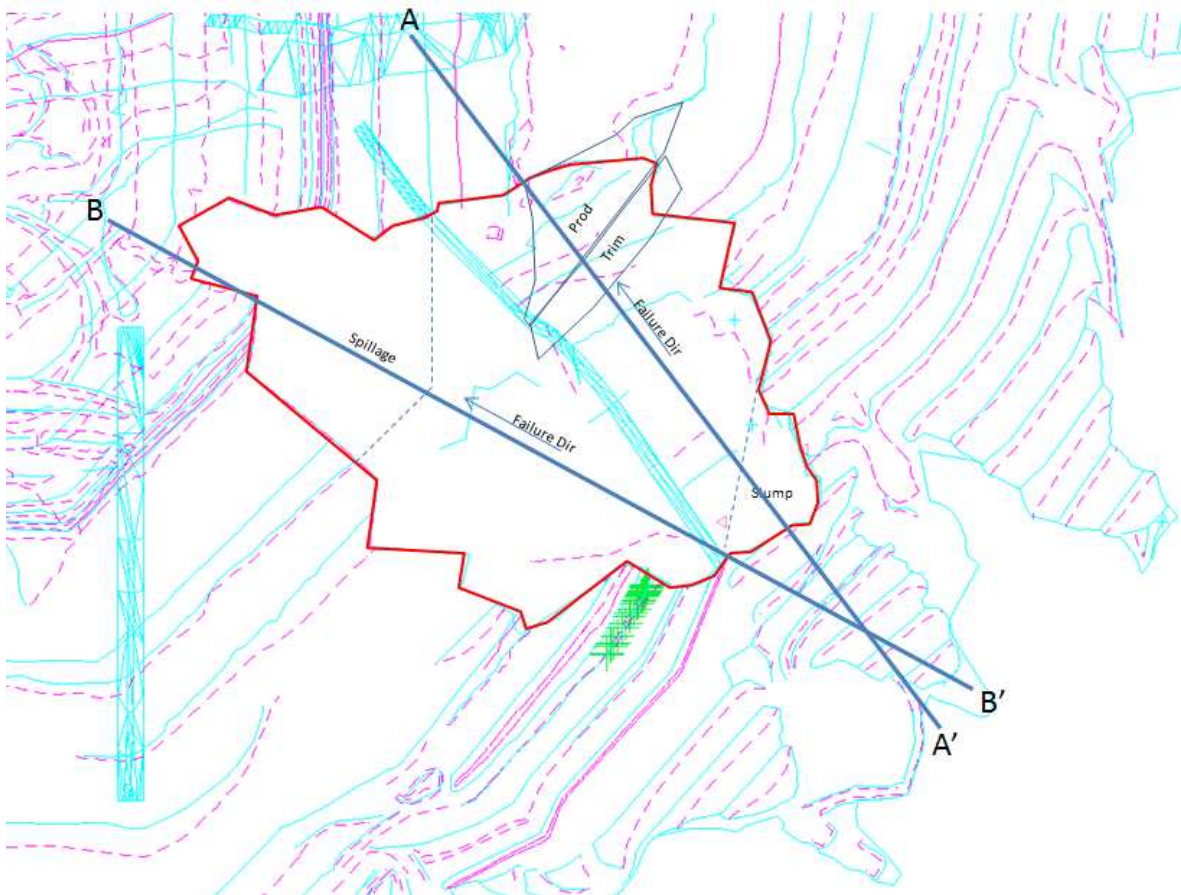
Figure 19: Cross section locations

Two cross-sections of the failure are presented in Figures 20 and 21. Cross section locations are shown in Figure 19.

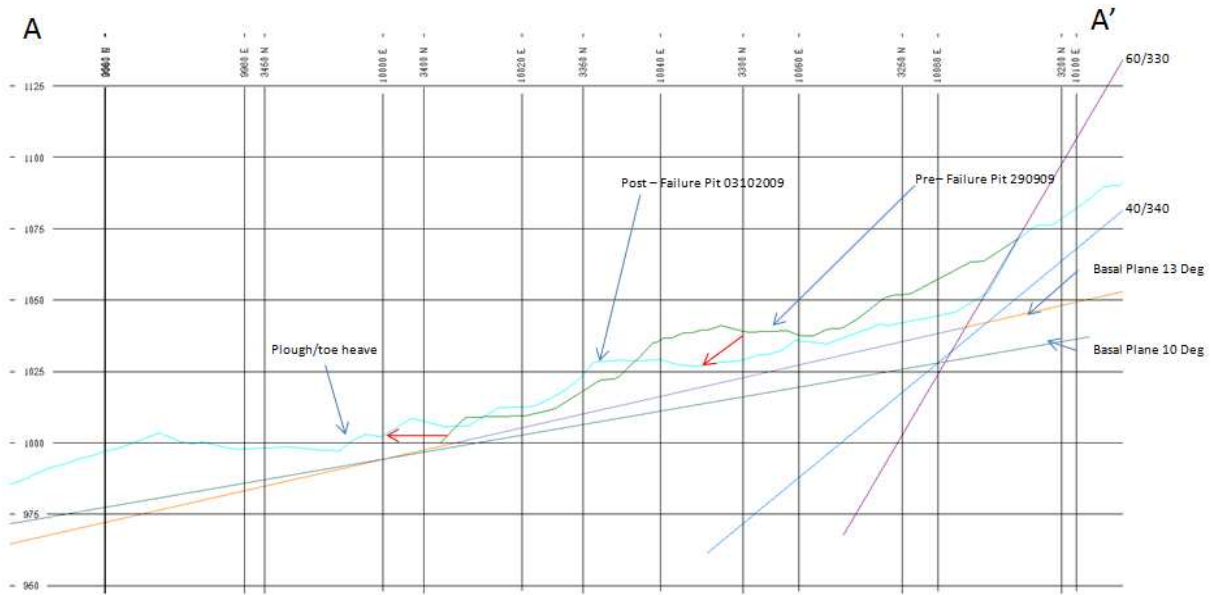
Figure 20: Cross section A-A'

No stability analysis was conducted. Both models were constrained by the back scarp plane (60°/330°). The variation in angle of the basal low angle structure affected the volume of the failure mass but not the potential cutback requirements. Due to relatively fast rate of failure, the steeper basal slip plane model was more likely and preferred for geotechnical stability analysis.

As discussed above, the likely primary trigger to failure was blasting of the 980 shots during excavation of Phase 12. This allowed a low angle structure to daylight in the newly formed Phase 12 wall.
