NAME OF AUTHOR *Richard Robert Smith*
TITLE OF THESIS *The Effect of Environment
on the Early Stages of
Metal Fatigue*
UNIVERSITY *of Alberta*
DEGREE FOR WHICH THESIS WAS PRESENTED *MSC in Engineering*
YEAR THIS DEGREE GRANTED *1976*

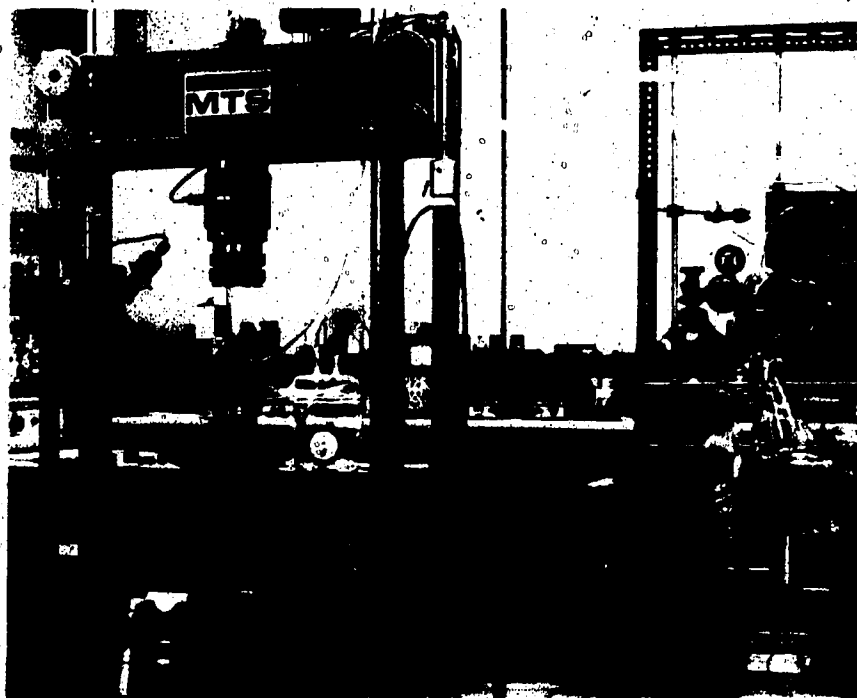
Figure 2. The fatigue test system, showing the MTS, microscope, humidity gage and other components of the gas train.

For dry hydrogen testing, bottled (99.99%) hydrogen gas was passed through a cold finger liquid nitrogen trap (for condensing water) into a large pressure flask where a small relative humidity gage was installed. The gas was then routed through the sample chamber. The waste gas was bubbled through two oil traps to prevent any atmospheric gas from back-diffusing into the system.

Optical microscopy was used to compare the results of the scanning electron microscope and microstructural examination of the original material. A special optical microscope stage was built on the MTS in order to monitor the fatigue damage as the tests progressed.
