Recent developments of upstream membranes for rockfill dams

A THESIS

OF Master of Engineering

Geotechnique

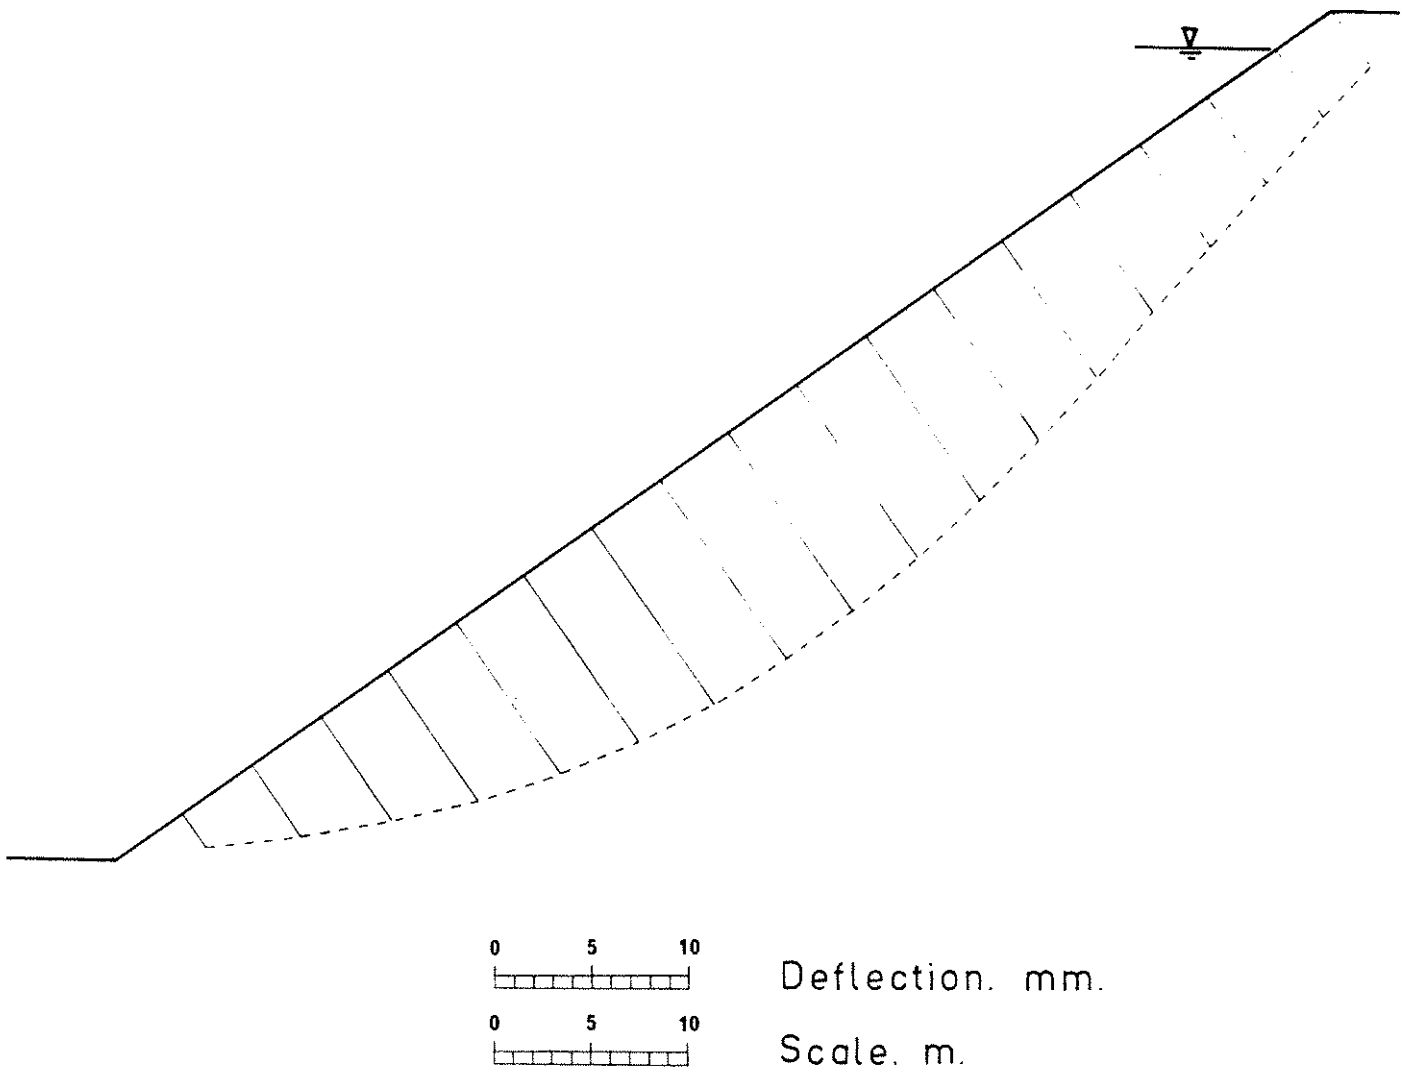
Figure 3. Deflection of an upstream membrane under the action of water forces.

Deflection of membrane normal to face.
Water loading only.
No restraint at the toe.

Concrete membranes are able to accommodate some deflection of the fill without cracking. For example a 500 mm deep slab 10 m wide can deform 5 mm in the centre without cracks developing. Consideration of the mode of deformation of the membrane on a rockfill dam under the action of the water forces will show that the cracks would form on the downstream side of the membrane. See Figure 3 for the deflected membrane shape of a 44 m high dam with a 525 mm membrane tapering to 300 mm on a rockfill dam with a modulus of deformation of 120 MPa. The upstream side of the membrane will everywhere be in compression. If cracks on the downstream side of the membrane are permitted and if the impermeability of the concrete is sufficient then larger deformations are allowable. For the same slab, 10 mm of deflection could occur before the cracks would have penetrated 200 mm into the slab. Taking the concrete to the limit of its compressive strength, say 25 MPa, a deflection of 60 mm in the centre of the slab would occur before failure. Provided no shear deformations occurred the concrete could still remain watertight as the water face would be in compression. Cracking of the
