**Fatigue Rehabilitation of Coped Steel Beams Using Carbon Fibre
Reinforced Polymers**

Master of Science
in
Structural Engineering

Department of Civil and Environmental Engineering

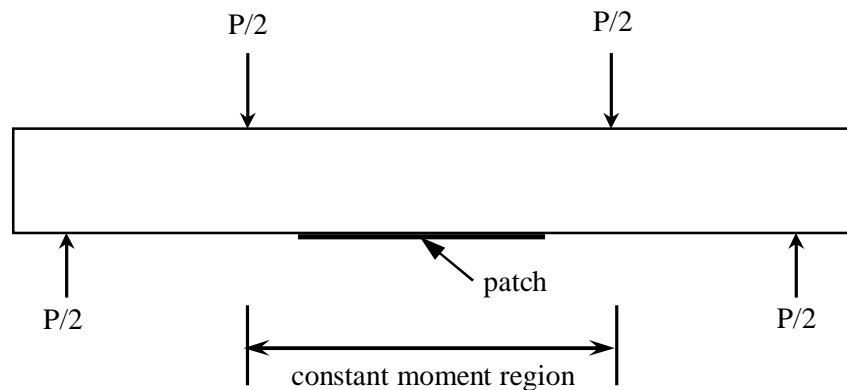
Large scale tests for fatigue repair of steel using FRPs have also been done. The most common configuration is for the application of the repair on the tension flange in the constant moment region of a beam in four-point bending (Figure 2-3).

Figure 2-3 Four-point bending

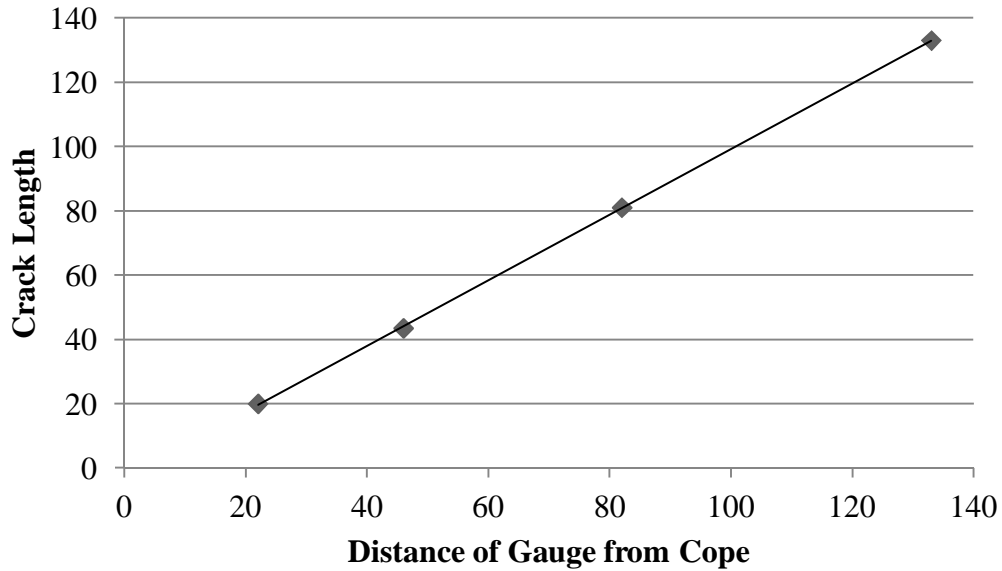
Figure 3-6 shows a schematic of this calibration method. The distance of gauge from the cope is plotted against the actual crack length at the point where a significant change in strain amplitude slope is observed. The data is then fit with a least squares trend line. The formula for the trendline will act as a calibration factor for the determining the crack length using the same method for the double sided repairs.

Figure 3-6 Schematic of correlation between change in slope of strain amplitude and observed crack length

The crack length was then detected by finding the number of cycles at which the strain gauges showed a marked change in strain amplitude slope under cyclic loading. If the crack were to pass directly beneath the gauge location, then the strain amplitude slope ($d\varepsilon/dN$) would increase drastically as the crack would now also reflect crack opening strain. Conversely, if the crack were to pass alongside the strain gauge location, the gauge would show decrease in strain amplitude slope.

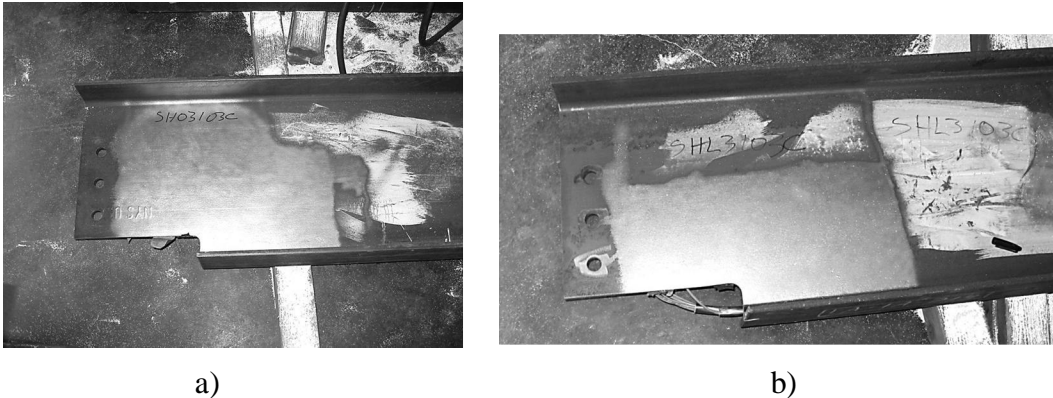
Figure 3-9 Beams prepared to white metal surface condition a) SHO3103C b) SHL3103C

Figure 3-9 shows beams SHO3103C and SHL3103C prepared to white metal finish. A white metal finish is such that there are no residues on the steel, and due to the roughness of the metal, the surface appears is no longer shiny, but appears to be white and dull. This was done with a portable sandblaster connected to a compressed air source. Once the metal surface was sufficiently roughened, any excess sand and particulate was removed from the surface using a wet/dry vac. It is very important that the patch be applied to the steel as soon after the metal surface preparation as possible, because the steel oxidizes when left exposed. A

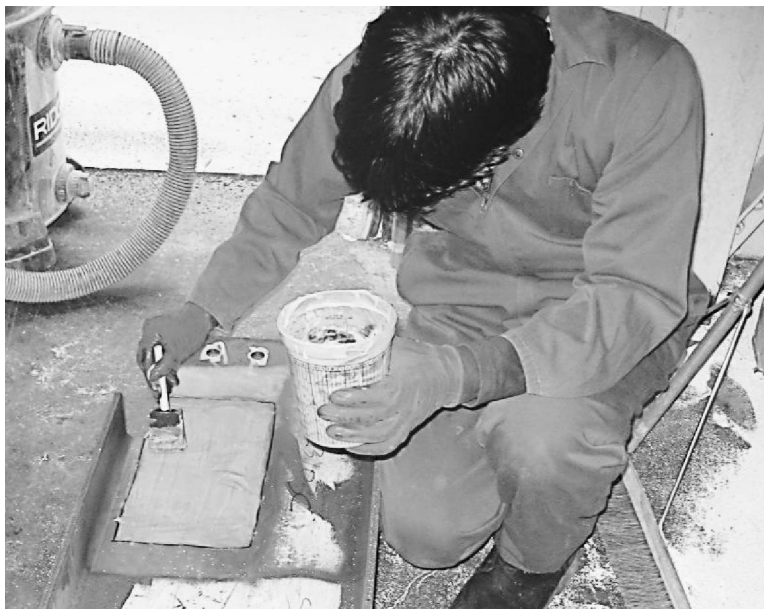
As soon as surface preparation on the steel surface was completed, the Primer, Sikadur® 330 was mixed with an A:B ratio of 4:1 by weight. The primer mixed then was immediately applied to the steel in a thin layer (Figure 3-10). This epoxy is a thick creamy texture coming once mixed. A disposable sponge tipped paintbrush was used to apply it directly to the prepared steel. The primer was applied evenly to the steel surface until the surface was completely covered, and the opalescent hue was nearly gone.

Figure 3-10 Application of Sikadur® 330 primer to SHL3103C

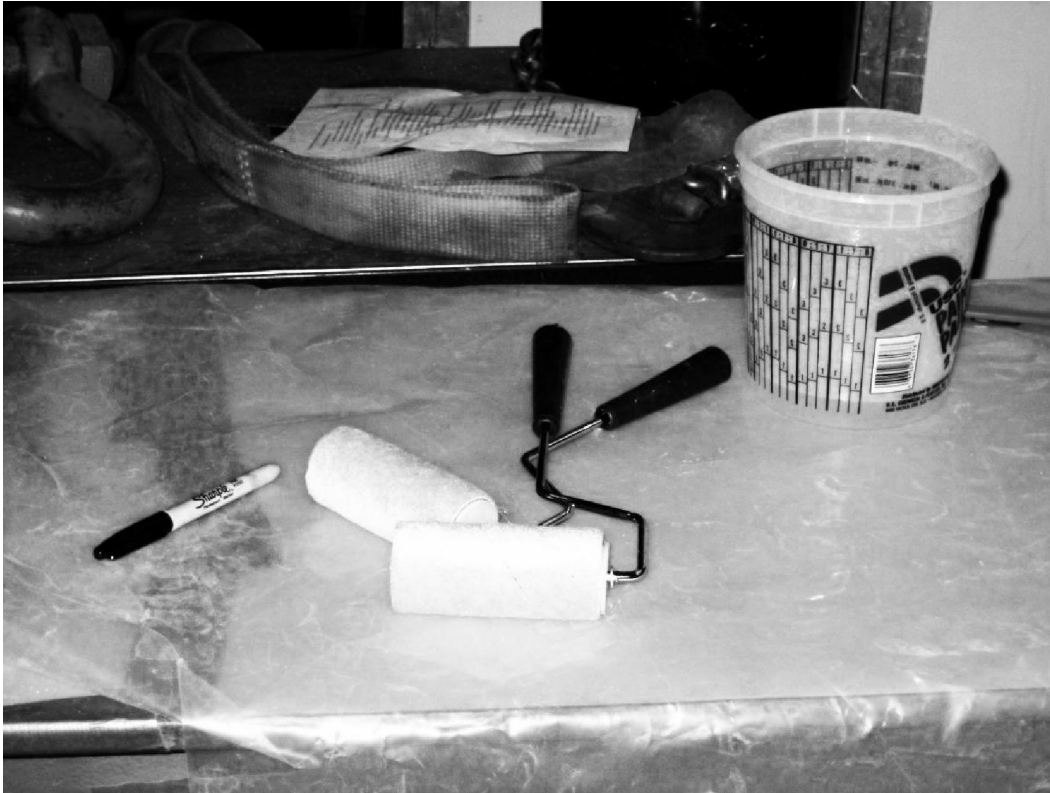
The fabric saturant, Sikadur® 300, was mixed with a component ratio A:B of 2.9:1 by weight. The saturant was applied to the fabric on a worktable coated with polyurethane. Figure 3-11 shows the polyurethane protected work surface. Also shown in the figure are the paint rollers and prepared saturant epoxy. The purpose of the polyurethane layer was to prevent any epoxy from becoming permanently affixed itself to the work surface. A bead of saturant the length of the patch was poured directly onto the protected work surface and spread into a thin layer using a paint roller. The dry fabric was placed directly onto the treated

Figure 3-11 Polyurethane protected work surface.

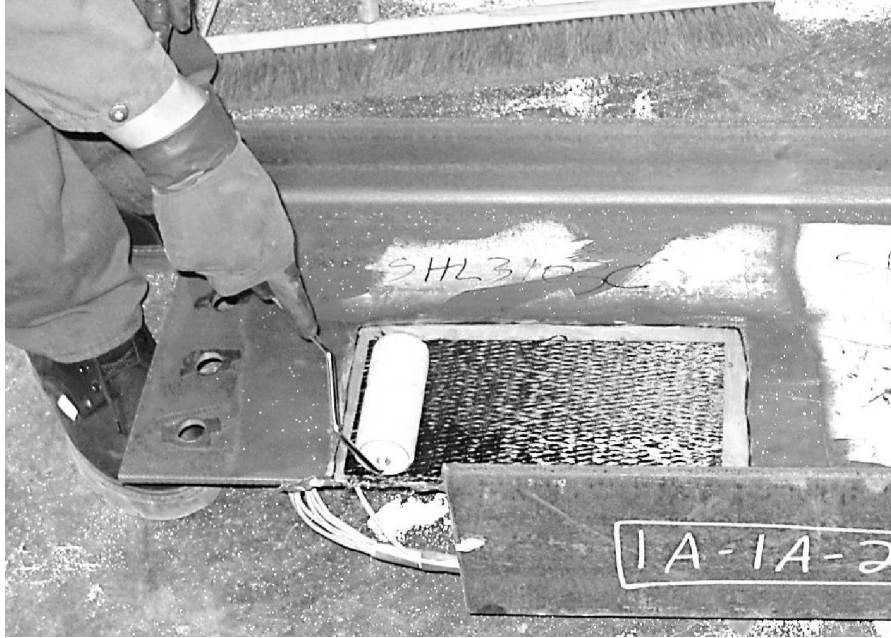
Figure 3-12 shows the patch application process. The saturated fabric was then placed on the primed steel. The process is wet-on-wet; therefore, the saturated (wet) fabric was placed directly on the uncured (wet) primer. Once placed, a paint roller was used to smooth out any air bubbles, remove excess saturant and ensure full contact between the steel and the fabric. Each subsequent layer of fabric was saturated and applied immediately wet-on-wet to the previous layer. No inter layer epoxies or primers were used. Once the patch was applied, it was allowed to cure for a minimum of twenty-four hours prior to moving the beam.

Figure 3-12 Application of FRP patch to steel beam

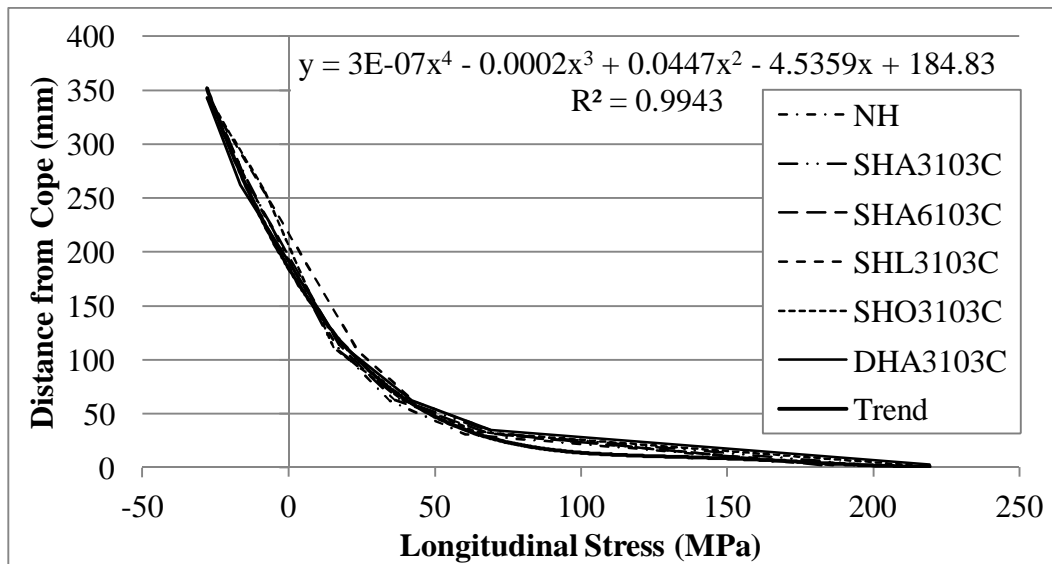
All specimens were statically loaded prior to cyclic testing to verify the stress gradient via the longitudinal strain gauges mounted on the cope line. Figure 4-1 shows the longitudinal stress in the steel beam versus the distance from the cope at the gauge location. All locations have very good agreement on the stress gradient.

Figure 4-1 Comparison of longitudinal strain distribution for all specimens prior to pre-cracking

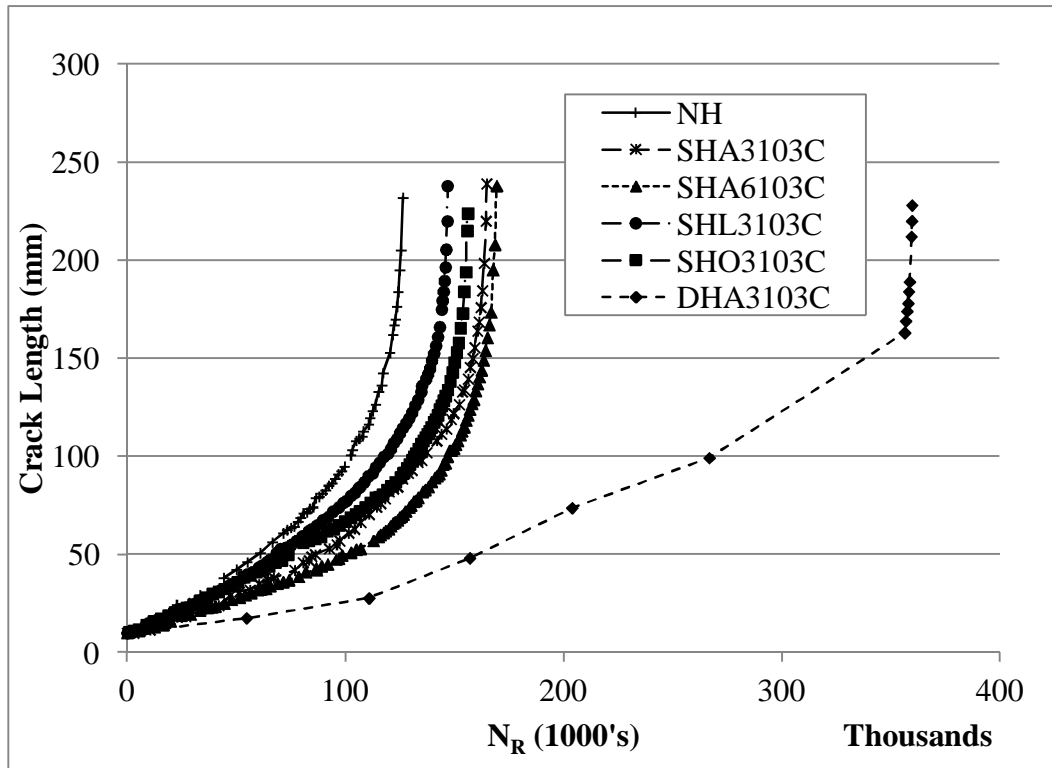
Figure 4-2 shows the crack growth for the beams, normalized at the pre-crack length. The data has been normalized at 10 mm crack length. This represents the remaining fatigue life (N_R) of the specimens after the pre-cracked specimen has been repaired.

Figure 4-2 Crack propagation for all specimens versus remaining fatigue life after repairs have been applied

The crack growth for this beam reported in Figure 4-2 is a combination of the strain gauge data and bare steel data from Figure 4-8. The CFRP data for a crack length of 140 mm has been omitted due to the fact that major delamination has already started occurring at that point. For this reason the CFRP data is no longer an indicator of actual crack length.

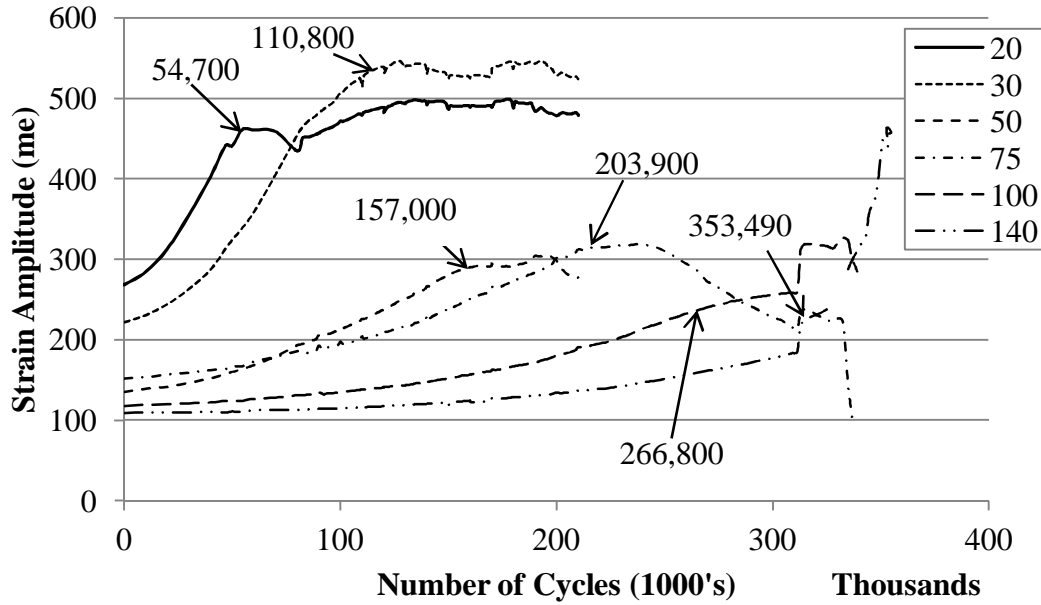
Figure 4-7 shows the strain amplitudes recorded for the CFRP mounted strain gauges on specimen DHA3103C. As discussed in section 3.3.2, the crack is considered to have crossed the gauge when there is a significant change in slope in the strain amplitude. The arrows indicate the points on the graph where the significant change in slope occurred. The arrow labels indicate the number of cycles corresponding to that point.

Figure 4-7 Strain amplitudes for carbon fibre mounted gauges on specimen DHA3103C

Table 4-4 shows the summary of the number of cycles at which the strain amplitude chart (Figure 4-7). The actual distance from the cope for the gauges is also reported. The crack length at these numbers of cycles was calculated using calibration equation [4-1].

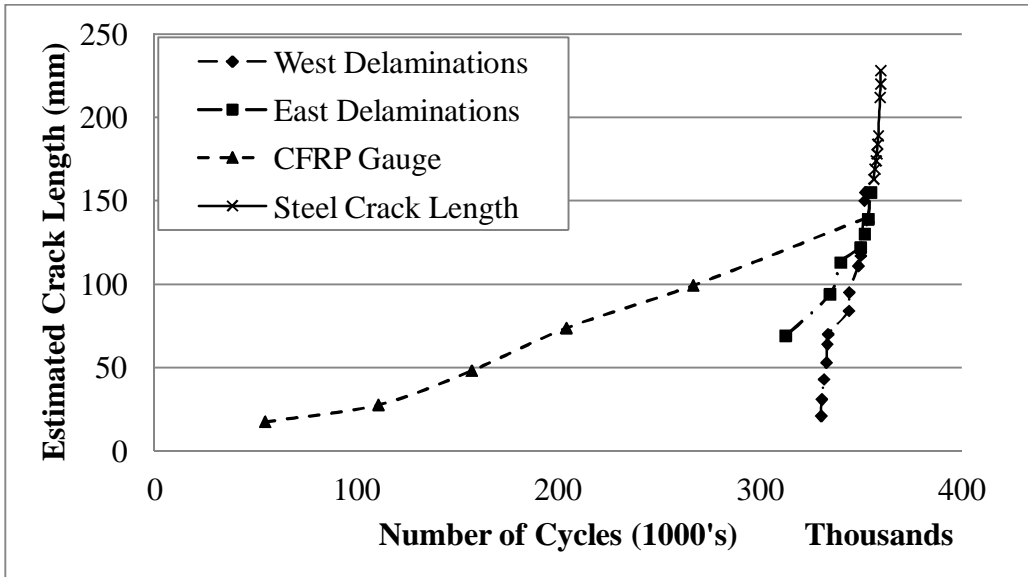
Figure 4-8 shows the crack growth progression of beam DHA3103C. Detecting the crack length was a challenge as it could not be measured directly in the patched area. Four lines are visible on this chart. The first two lines, with filled

diamonds and squares, indicate the delamination to the end of the patch for the CFRP patch on the West and East sides of the beam respectively. The number of cycles and perpendicular distance from the cope were recorded for each side of the patch as each delamination occurred. The third line, with the filled triangles, indicates interpolated crack length based on the CFRP mounted strain gauges as discussed in section 3.3.2. The fourth line, marked with x's indicates the crack growth measured visually once the crack extended beyond the CFRP patch. The crack length indicated on this line is a chord length from the origin of the crack to the crack tip.

**Figure 4-8 Crack length for double sided three layer per side repair
DHA3103C**

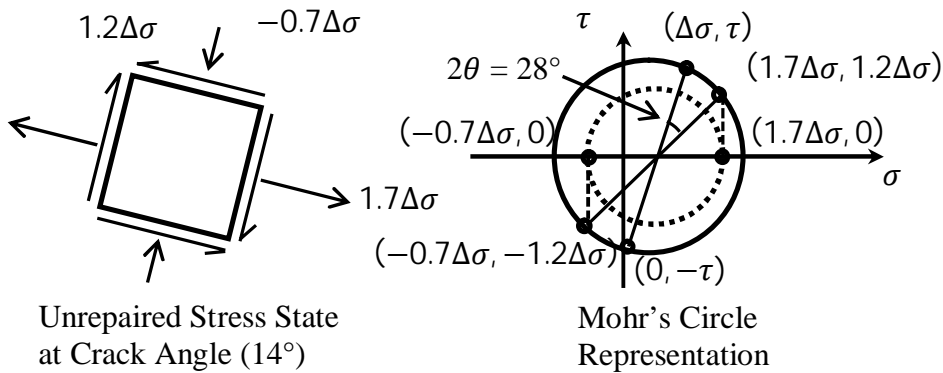
Alternatively, an analysis can be performed to determine what interaction must occur in order to shift the crack angle to 14° from the vertical. Figure 4-25 shows the unrepaired stress state at the crack propagation angle of 14° from the vertical. The minimum interaction with the CFRP patch that is required to render this the principal stress direction would be to have the entire shear portion of the stress taken by the CFRP. This would leave the principal stresses of $1.7\Delta\sigma$ and $-0.7\Delta\sigma$ for the repaired stress. This repaired stress state is shown as the dashed inner circle in the Mohr's Circle representation.

Figure 4-25 Mohr's circle representation of unrepaired stresses at crack propagation angle

Figure 4-26 shows the repaired element from Figure 4-25, rotated to the fibre direction. On the corresponding Mohr's Circle Representation, this repaired

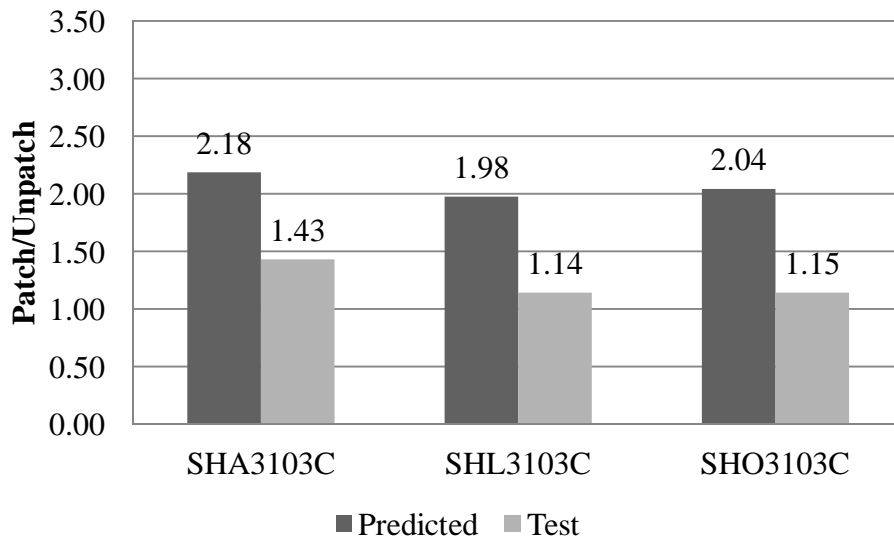
Figure 5-8 shows the effect of the repair orientation. All specimens for the repair orientation parameter are three layer single sided repairs. The effectiveness in this case is measured as the number of cycles to grow the crack from the 10 mm pre-crack to a final length of 30 mm for the unrepaired specimen divided by the number of cycles for the same crack growth for the unrepaired control specimen. The dark bar shows the theoretical effectiveness based on the analytical model proposed in chapter 5. The light bar represents the effectiveness as observed in the experiment. The most effective repair was the angled patch at an effectiveness of 1.43, followed by the orthogonal patch and finally the longitudinal patch with effectiveness of 1.15 and 1.14 respectively.

Figure 5-8 Effect of patch orientation at 30 mm crack length, comparing analytical model to experimental data

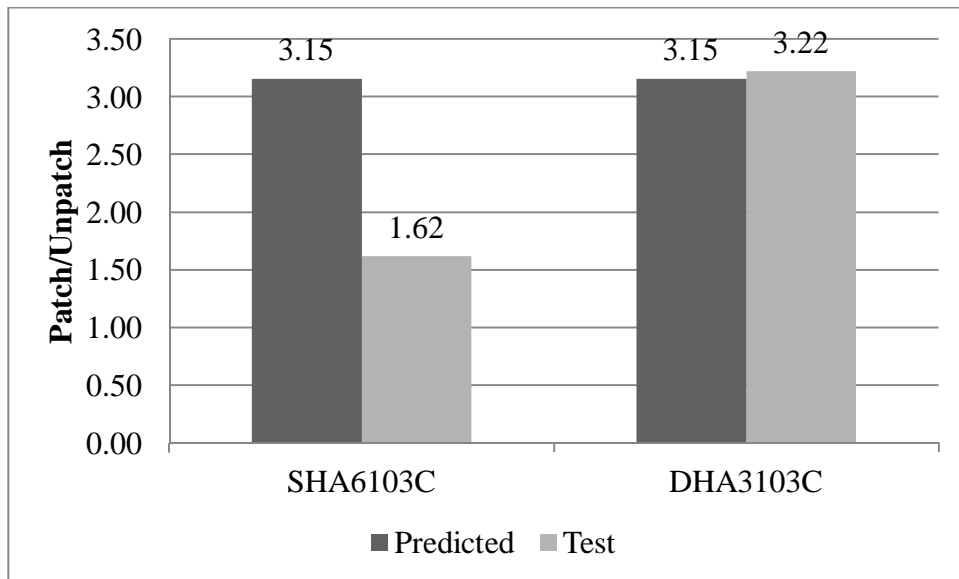
Finally, Figure 5-10 shows the comparison of the effectiveness between the analytical model and the experimental test for specimens SHA6103C with six layers applied to a single side, and specimen DHA3103C with three layers applied to each side of the web. For these two specimens the ETR is equivalent, and thus the predicted effectiveness is also equivalent at 3.15 repaired/unrepaired. The measured effectiveness in the test was only 1.62 for the single sided repair and is nearly doubled at 3.22 for the double side repair.

The single sided repair was significantly less effective in the experiment. This is due to the primary failure mode, which is adhesive failure and debonding. The double sided repair has two adhesive layers, and thus also has two shear planes for transfer of shear to the FRP patch. Two shear planes means that the stresses in each shear plane is only half that of an equivalent repair system with only one shear plane. The double sided repair, then had a much greater ability to develop full tensile strength in the patch.

Figure 5-10 Effect of patch eccentricity

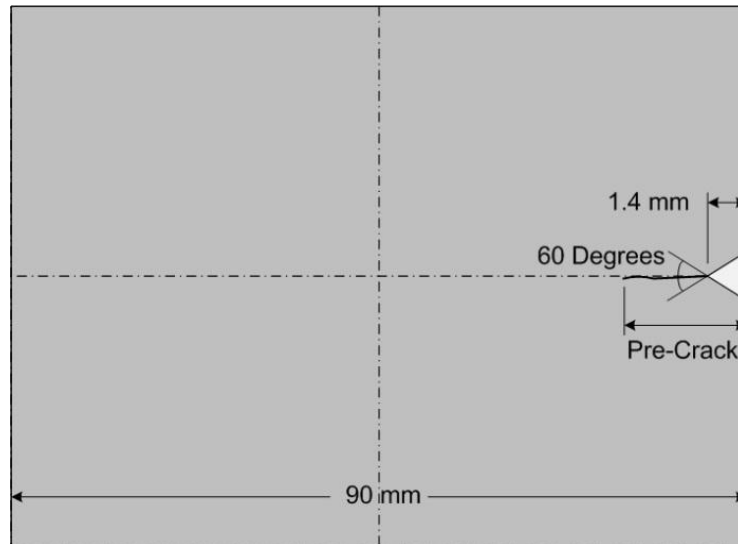
Figure 6-2 Steel notch design

For pre-cracking purposes and for Specimen 8, Figure 6-2 illustrates the notch design. The notches were modified from ASTM E-338-97. The standard called

for an 11 mm notch. However, this large notch size did not accommodate the small size of the specimens or the small pre-crack lengths considered in the study. For this reason the notch depth was modified to 1.4 mm. Notches were applied using a sharp 60° Swiss file. The notch was placed along one edge at mid span of the specimen, 250 mm from one end. Actual measured notch depths are recorded in Table 6-2.
