**Combining Rock Slope Ranking Methods and Performance Monitoring Techniques for
Rockfall Geohazards to Advance Geotechnical Asset Management in Alberta**

A thesis submitted in partial fulfillment of the requirements for the degree of

Geotechnical Engineering

Department of Civil and Environmental Engineering
University of Alberta

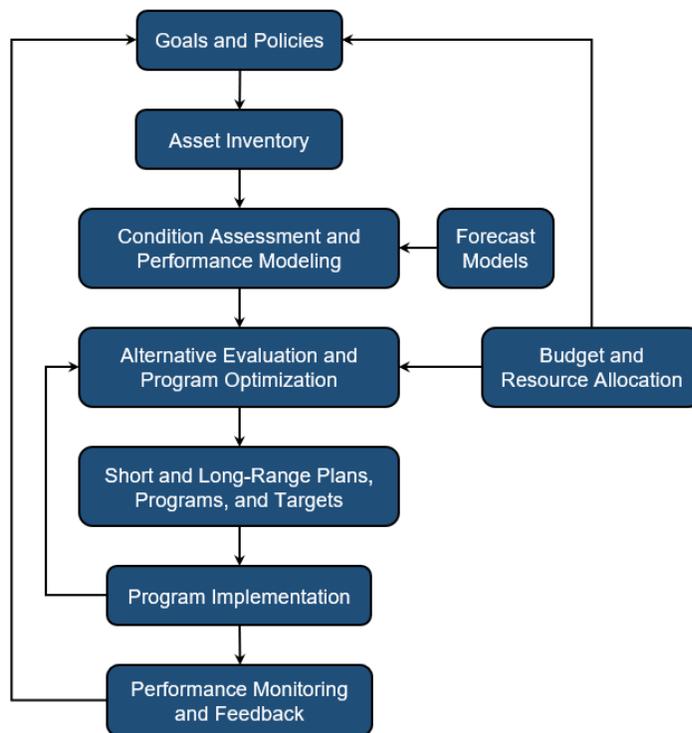
Figure 2-1: Geotechnical Asset Management process (modified from Thompson 2017)

Often program alternatives must be considered to account for uncertainties in funding, costs, and emerging hazards. Standardized performance measurements must be established so that cost/benefit relationships can be used to optimize the program's efficiency (Thompson 2017). This in turn gives rise to the need for robust analytical tools capable of measuring and monitoring the performance of a geotechnical asset. The development of an asset inventory is a continuous process; following the initial assessment and identification of an unstable asset, continued monitoring is required to maintain adequate allocation of resources. Figure 2-1 provides an outline for a typical GAM process.

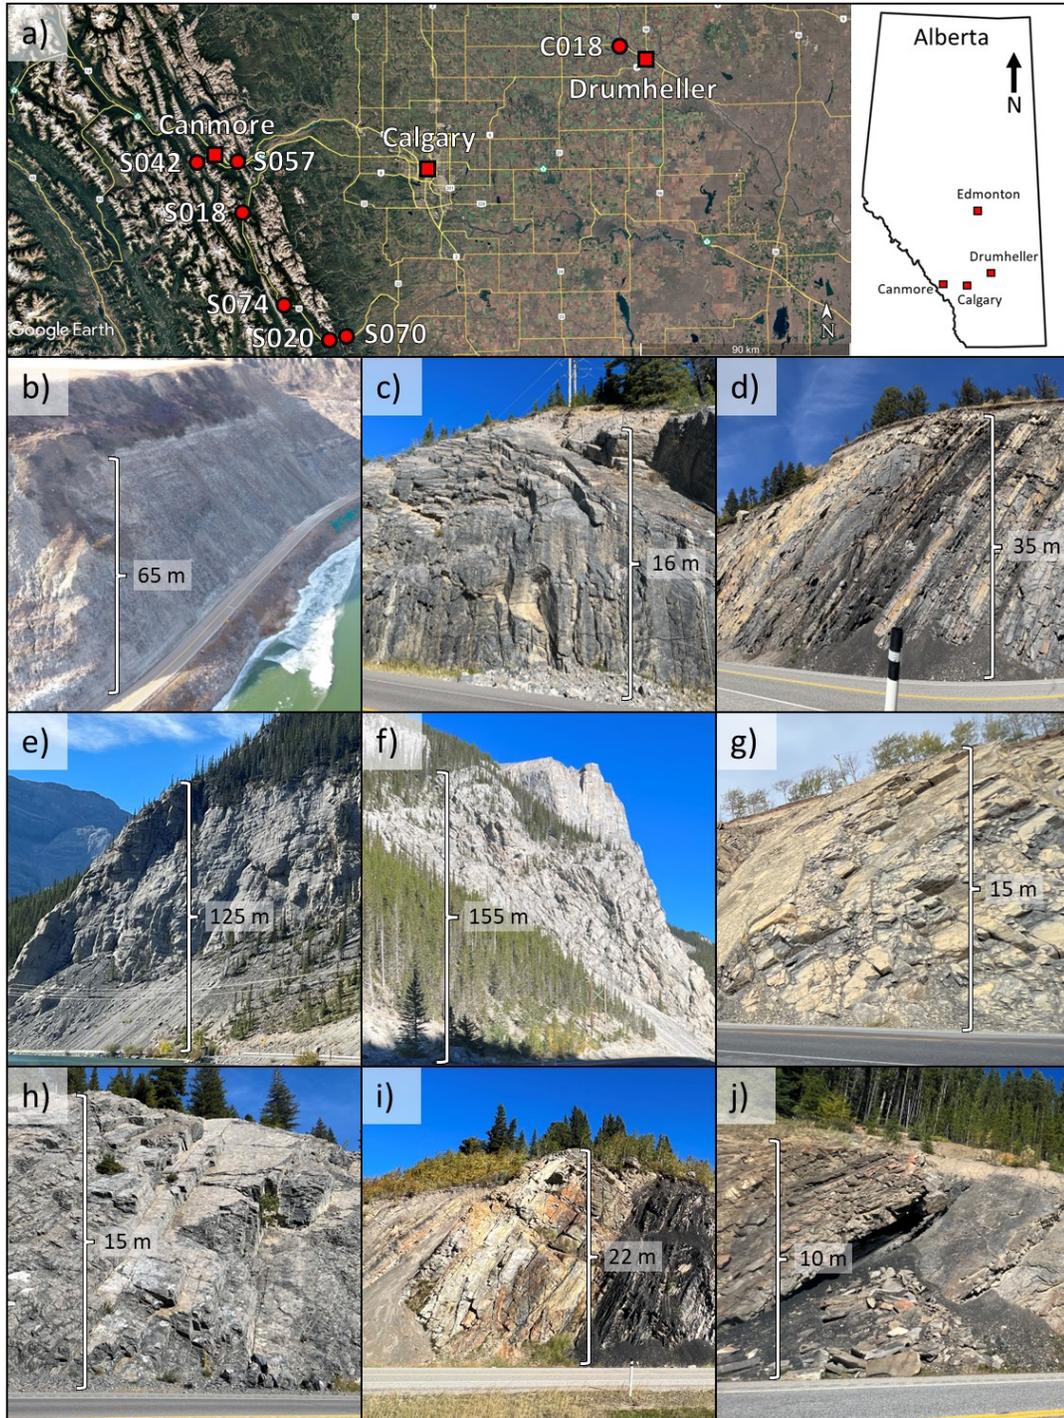
Figure 3-1: a) Location of rock slope study areas with Alberta map reference (Google Earth 2022). Site photos and approximate slope heights of b) C018, c) S018, d) S020, e) S042-North, f) S042-South, g) S057-A, h) S057-B, i) S070, and j) S074.

The slope inspections and application of rating systems were completed on November 12, 2021 for site C018 in Central Alberta, and between September 24 to 25, 2022 for sites S018, S020, S042, S057, S070, and S074, in Southern Alberta. Limited tools were required for the application of the selected rating systems, which included: a range finder with built-in clinometer, a 2-m-long measuring stick, and two measuring tapes with lengths of 6 m and 30 m. Preliminary ratings developed for C018 were published by Wollenberg-Barron et al. (2022) and have been updated for inclusion in this study. The locations of the study sites and representative photographs are shown in Figure 3-1.

Note that small and large rockfall block volumes were applied to both the north and south slope portions of S042. The varying RLs associated with different failure mechanisms were incorporated into this study as additional data points to analyze the effectiveness of each rating system at capturing the change. The inclusion of the additional RL data increased the total number of slopes to 12 for each of the following comparative analyses. The GRMP ratings, estimated slope angles, and results of each other rock slope and rock mass rating system for each study area are presented in Table 3-1 and may be inspected together with the slope photos presented in Figure 3-1.

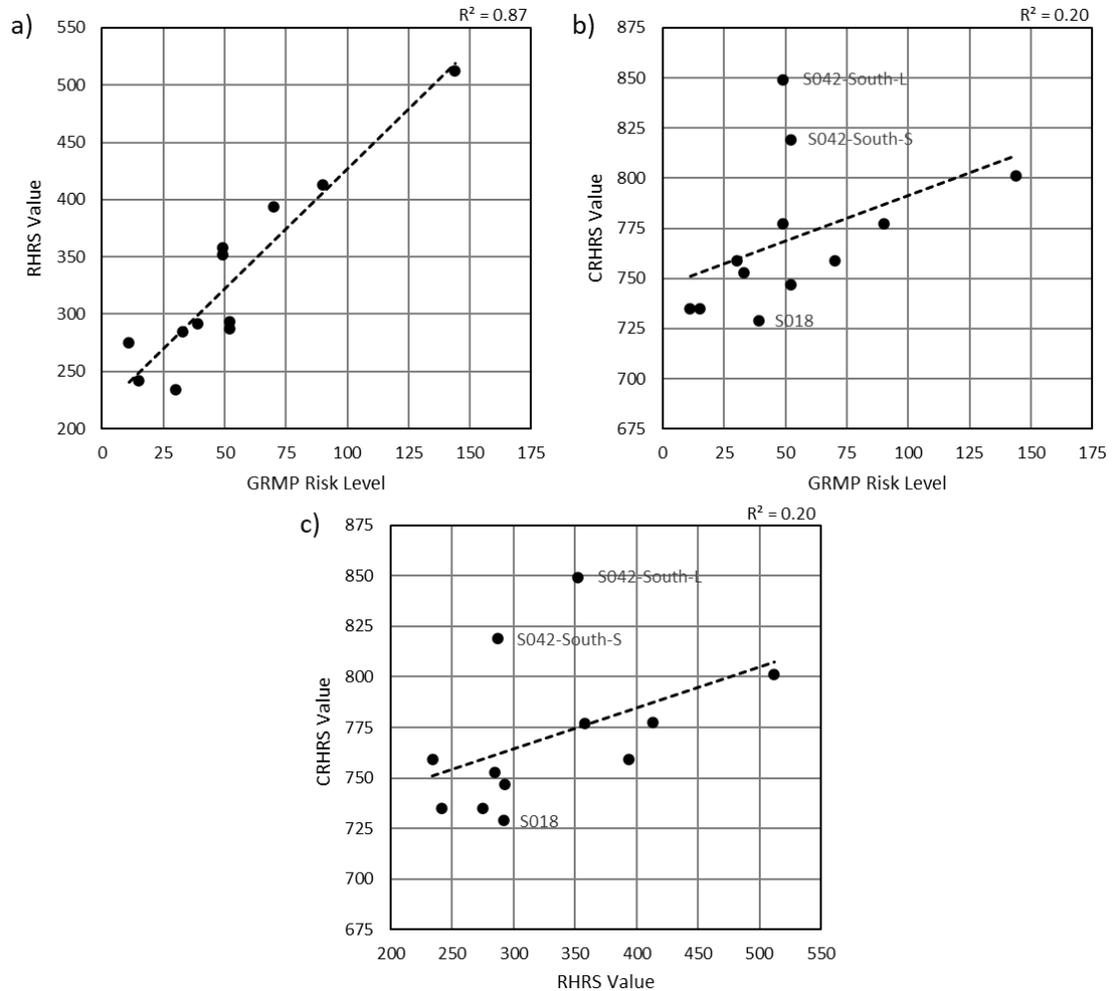
Figure 3-2: Correlation between a) RHRS and GRMP risk level, b) CRHRS and GRMP risk level, c) CRHRS and RHRS. Slope scores with greatest deviation from correlation trendline identified.

The RHRS and CRHRS scores were compared directly (Figure 3-2c) to review the impact of the additional parameters at each of the rock slopes. The significant deviation from the trend of S042-South-L, S042-South-S, and S018 resulted in an overall poor correlation between the two rating systems, with an R^2 value of 0.20. Excluding S042-South-S and S042-South-L from Figure 3-2b and Figure 3-2c increase the R^2 to 0.72 and 0.69, respectively. While having less than half of the total summed parameters, the relative risk of a slope is well predicted through the RHRS categories alone, when taking the GRMP RL as a good proxy for the documented risks at these sites. A similar conclusion was reached via the statistical analysis conducted for the CRHRS (Russel et al 2008 and Santi et al. 2008), indicating that the total scores could be reasonably estimated measuring only 4 to 6 key parameters.

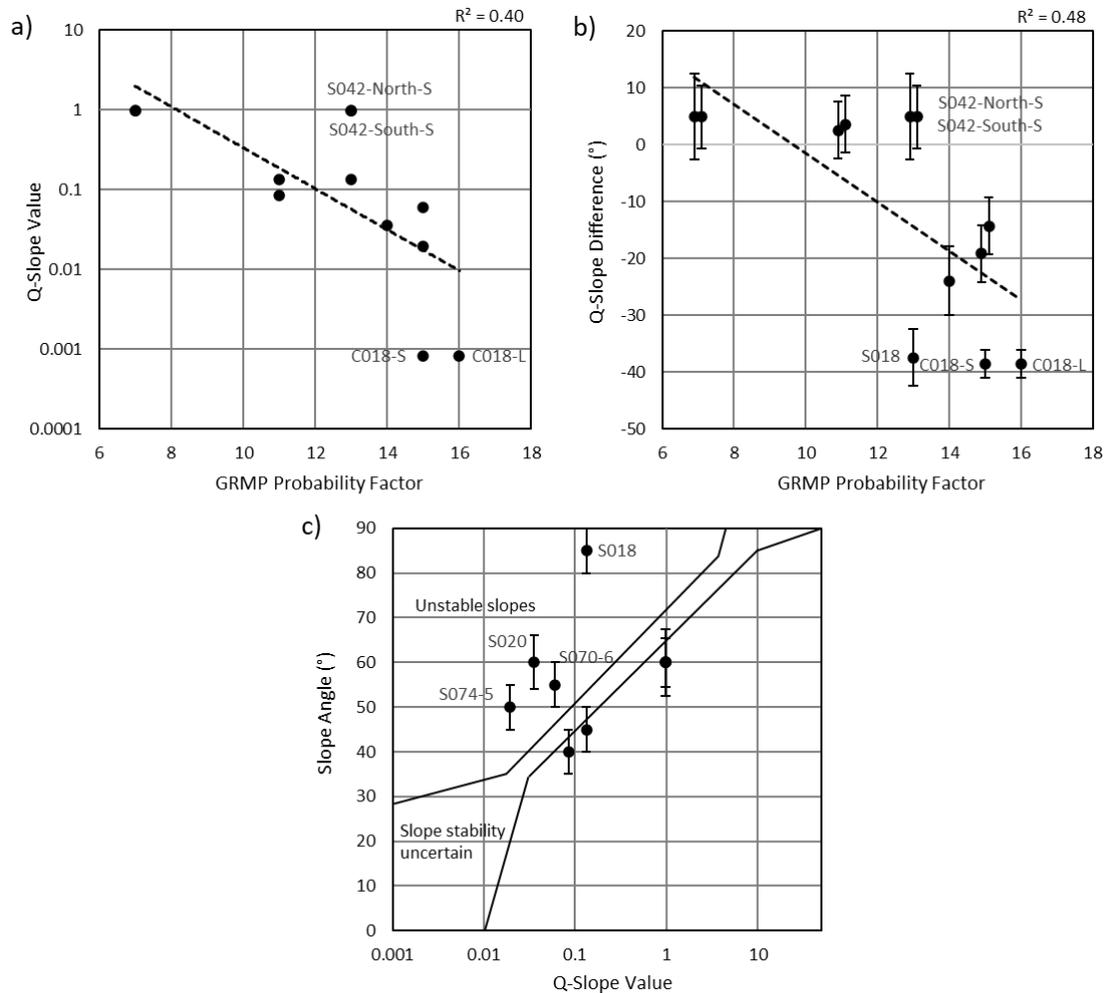
Figure 3-3: Developed correlation between GRMP probability factor and a) Q-Slope on Log scale and b) difference between Q-Slope β and actual slope angle; c) Slopes plotted on Q-Slope stability chart from Barton and Bar (2015). Unstable slopes and scores with greatest deviation from correlation trendline identified.

The calculated Q-Slope values were directly plotted against the GRMP PF in Figure 3-3a with a corresponding R^2 value of 0.40. Equation (3-4) was applied to each Q-slope value, and the difference from the actual slope angle and calculated β angle was plotted against the GRMP PF (Figure 3-3b) where the resulting R^2 value was 0.48. Finally, each Q-Slope value was plotted on the Q-Slope stability chart (Figure 3-3c) to see where they lay

S042-North-S and S042-South-S were identified as outliers in the Q-Slope analysis while S042-North-L and S042-South-L fit reasonably well. This is likely attributed to Q-Slope not accounting for rockfall event sizes, only through the mechanism in which it occurs by application of appropriate O-factors. The increased GRMP PF between the two failure mechanisms results in a large deviation from the trend in Figure 3-3a and Figure 3-3b. Additionally, it's worth noting that the Q-Slope Equation (3-5) was developed only for slope heights less than 30 m (Bar and Barton 2017). Considering S042 extends over 125 m high, a deviation from the trend of Figure 3-3b is not unexpected. The Q-Slope results of C018-S and C018-L plot well below the trend in Figure 3-3a and Figure 3-3b. This is a product of highly disaggregated sedimentary rock

present at the site. Furthermore, C018 is approximately 65 m high and, like S042, is beyond the intended slope height to apply Equation (3-5). The resulting Q-Slope value yields uncertain slope stability plotting outside the range of Figure 3-3c. S018 is an interesting case for Q-Slope since multiple rockfall mitigation measures exist at the site (mesh drape and rock bolts). The Q-Slope adjustment factor for slope reinforcement measures utilized for this case does not appear to fully capture the reinforcement impact. No factor exists for mesh drapes, which theoretically diminishes the consequence of a rockfall event, but which is not captured by Q-Slope. While the S018 Q-Slope value shows good correlation with the trend in Figure 2a, it deviates significantly from the trend of Figure 2b. This is attributed to the definition of the β angle as the steepest slope angle not requiring reinforcement (Bar and Barton 2017). The fact that the β angle calculated more closely resembles the approximate dip angle of the bedding plane at S018 rather than the vertical slope cut gives credit to this reasoning. The same reasoning can be applied to explain why S018 plots well into the unstable slope range in Figure 3-3c. It is interesting to note that while S070 and S074 consistently correlate well with a relatively low RL and PF they plot within the unstable slope portion of Figure 3-3c. The inclusion of these slopes in this study and their existence within TEC's rockfall geohazard database serves as an indicator that they are, or have previously been, unstable. This logic applies to each of the nine slopes in this study since none plot well inside the stable slope portion of Figure 3-3c.

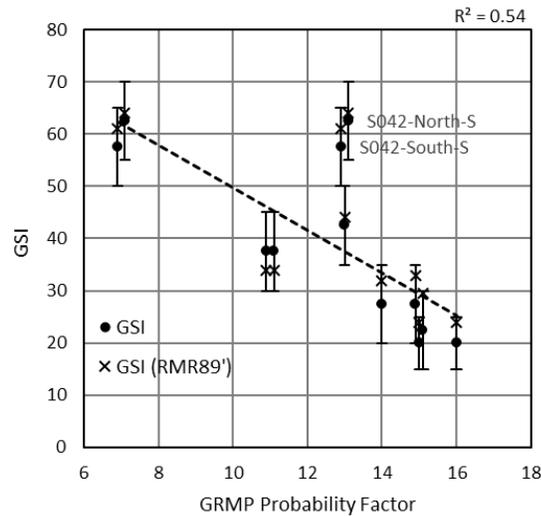
Figure 3-4: Correlation between and observed GSI, GSI from RMR89', and the prescribed GRMP probability factor for each slope.

An appropriate RMR score was determined for each slope and adjusted to fit the RMR₈₉' requirements for direct comparison to GSI using Equation (3-6). Figure 3-4 presents the correlation between GSI, RMR₈₉', and GRMP PF for each of the slopes included in this study. Vertical error bars correspond to the representative bounds of the GSI range selected for each of the slopes. The computed GSI value using RMR₈₉' and Equation (3-6) proved very effective and fell within the representative GSI range for each of the slopes included in this study. The average percent difference of RMR₈₉' to the median GSI value was 9% which is not significant from a practical geotechnical engineering perspective.

The only significant deviation from the trend presented in Figure 3 was S042-North-S and S042-South-S. This is attributed to the same reasoning as in Figure 3-3a and

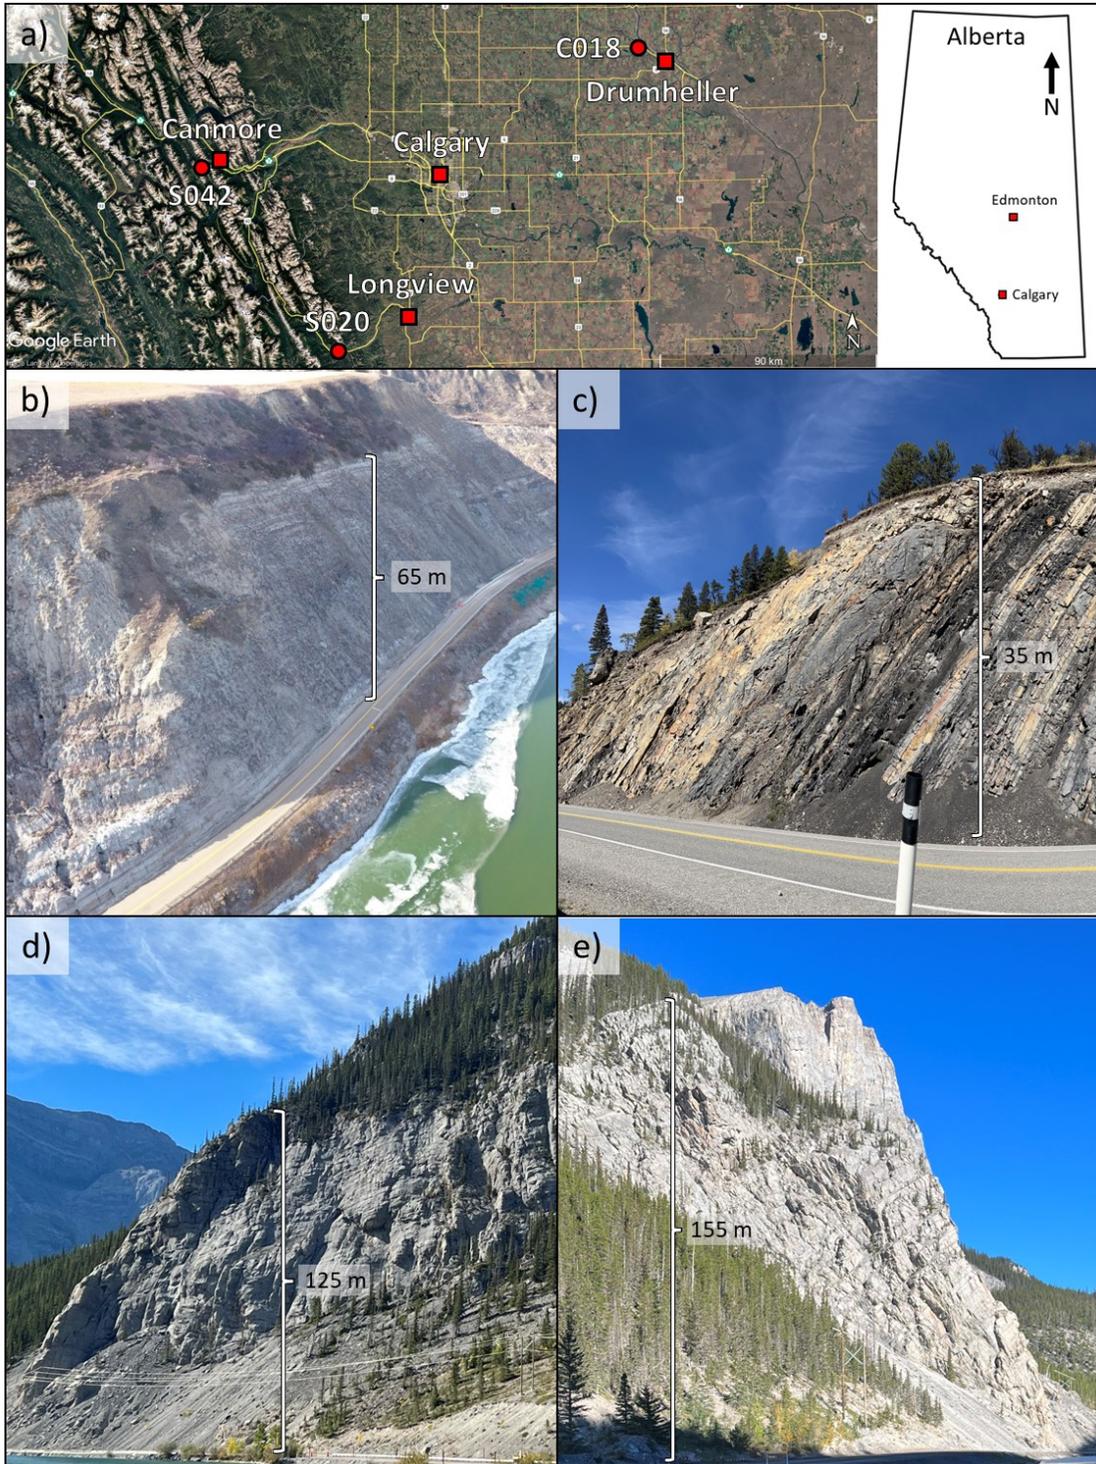
Figure 4-1: a) Location of rock slope case studies (red circles) with map of Alberta and populated centres (red squares) as reference (Google Earth 2022). Slope photos and approximate slope heights of b) C018, c) S020, d) S042-North, and e) S042-South.

The rock slopes included in this study had been identified as rockfall hazards by TEC and their consultants through the GRMP. Remote sensing data was collected at each site utilizing either ground-based LiDAR or UAV photogrammetry on a 0.5- to 2-year frequency, over a period of at least three years. Slope inspections and the application of rock slope and rock mass rating systems as initial condition assessment tools were conducted on November 12, 2021 for site C018, and between September 24 and 25, 2022 for sites S020 and S042. Due to the opposing slope aspects at the S042 site (S042-North and S042-South), separate LiDAR scanning datums were required to capture the entire slope. The locations and representative photographs for each of the study sites are shown in Figure 4-1.

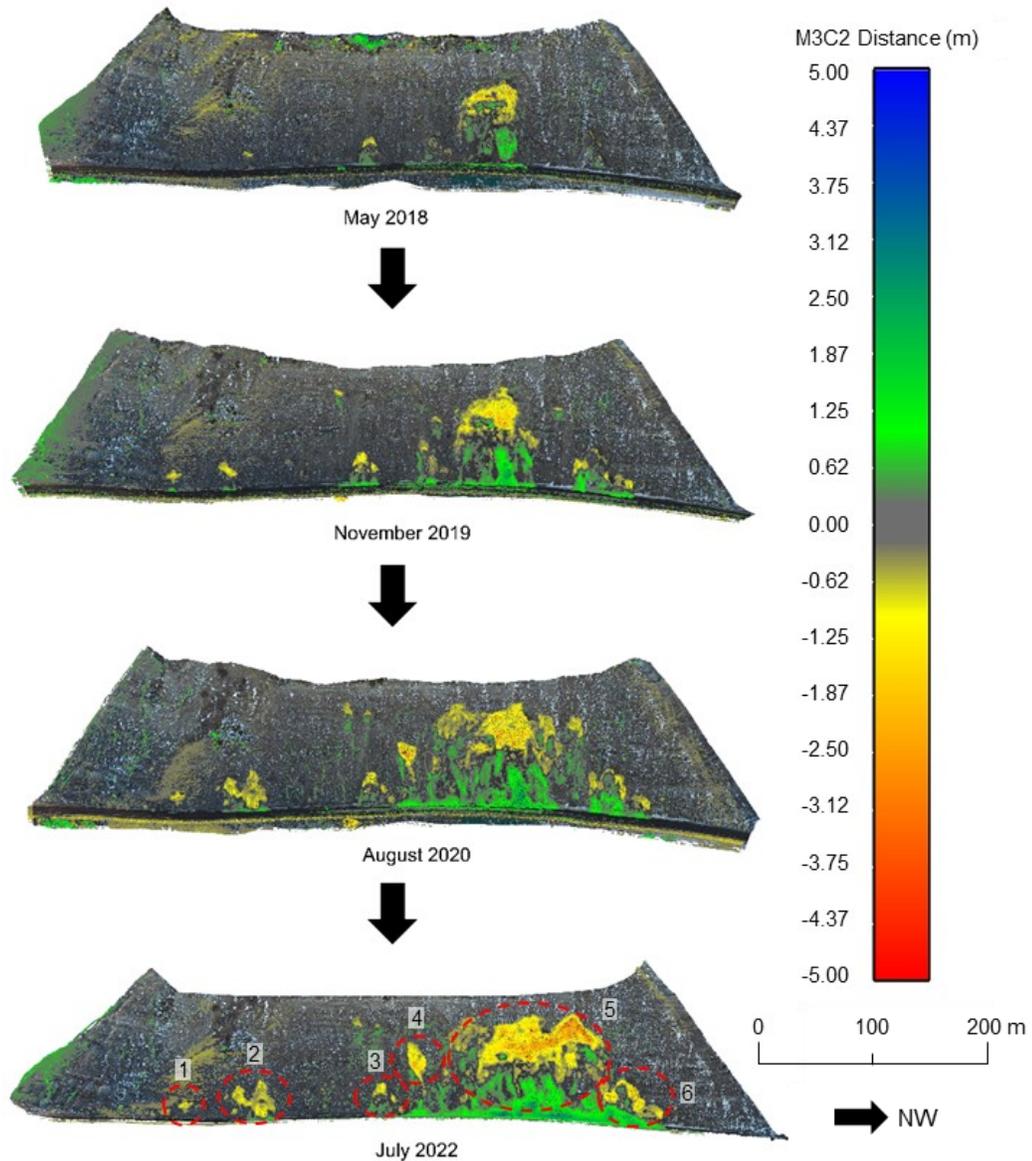
Figure 4-2: Results of the change detection analyses for the C018 site with the six active zones highlighted. Each change detection is relative to December 2017.

corresponds to an approximate point spacing between 4 and 100 mm, respectively. The wide range of cloud densities is attributed to the densification of the earlier point clouds (Rodriguez et al. 2020). However, the range of point cloud densities was not found to have a significant impact on the change detection results, while the lower density clouds were less computationally expensive. The LoD for the C018 site change detection analysis was determined for each set of reference and aligned clouds following the methodology presented in Section 4.3. A homogenized LoD of 0.2 m was applied to each change detection analysis in order to assess the cumulative slope change across multiple years of change detection. The results of the change detection analysis and progressive material loss between 2018 and 2022 at the C018 site is presented in Figure 4-2.

To estimate the volumes of change from each of the change detection analyses conducted for the C018 site, CloudCompare’s 2.5D Volume tool was applied to six active zones (noted on the July 2022 change detection in Figure 4-2) corresponding to areas of the greatest measured change. Due to the highly disaggregated nature of the rock mass comprising the C018 site, it was not feasible to isolate individual detachments from the

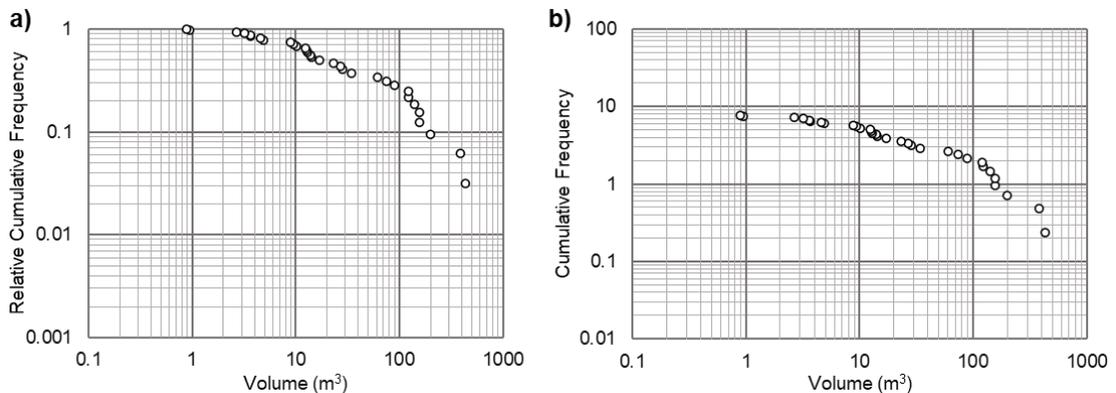
Figure 4-3: a) Relative and b) absolute cumulative frequency of detected volumes changes from the active zones of the C018 site.

Failure volume-frequency relationships for changes detected at the C018 site were estimated utilizing the change measured at each of the six active zones between each of the available point clouds. While these measured changes do not directly correspond to isolated detachments from the slope, they act as an approximation of the progressive material loss over the current monitoring period. It is likely that some of these measured volumes are a combination of several smaller events occurring throughout the period between capture of remote sensing data. The largest of the measured incremental changes was approximately 432 m³, occurring between August 2020 and November 2021. While quite large, this volume is reasonable considering the two debris flows in 2017, which triggered the initiation of a remote sensing program at the C018 site, had an estimated combined volume of 1,300 m³ (Rodriguez et al. 2020). The volume-frequency plots developed for the C018 site are presented in Figure 4-3. The frequency for an event greater than or equal to 1 m³ was estimated by applying a best-fit trendline to Figure 4-3b which resulted in a frequency of approximately 8.0 events per year.

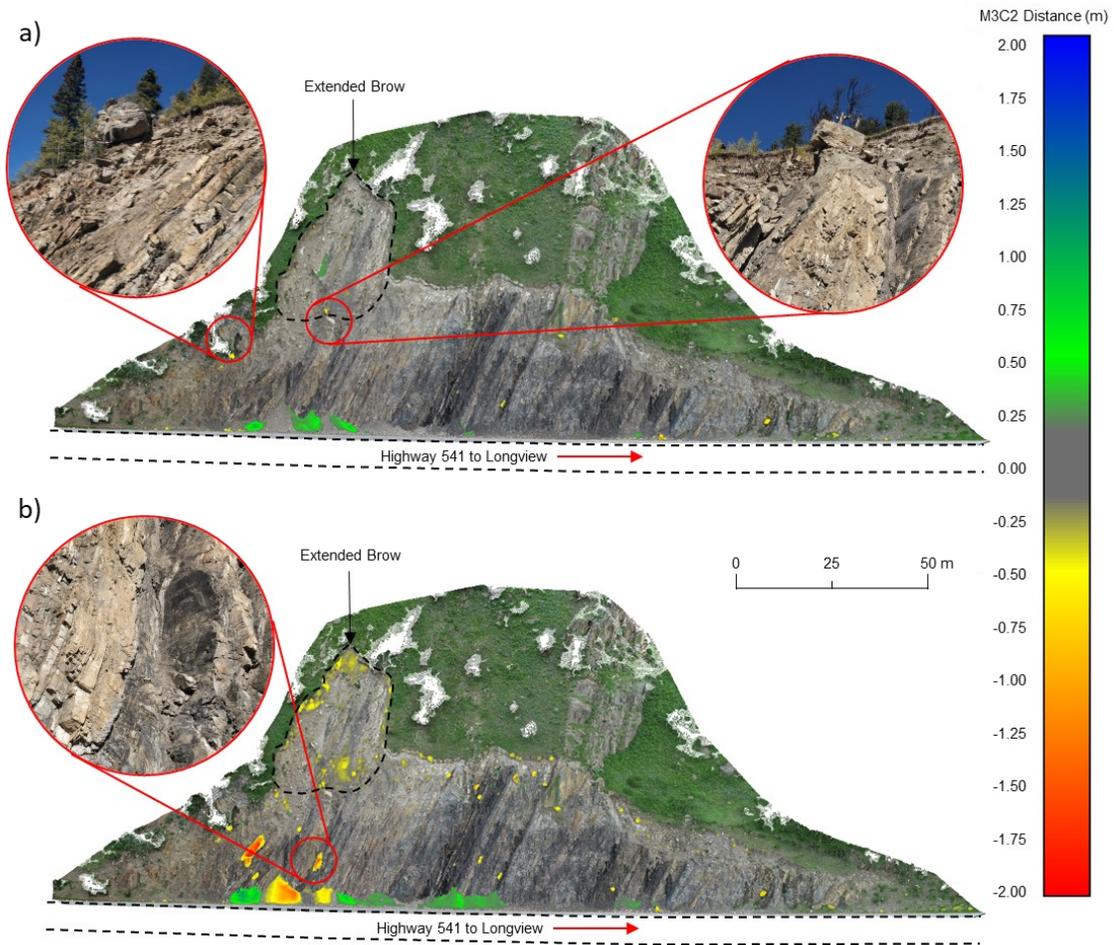
Figure 4-4: Results of the change detection analyses conducted for the S020 site from a) 2020 to 2021, highlighting two boulders perched at the brow of the slope and b) 2020 to 2022, highlighting slickenside rock surface exposed after recent rockfall.

The change detection analyses from 2020 to 2021 and 2020 to 2022 are presented in Figure 4-4a and Figure 4-4b, respectively. Two boulders which are perched within the surficial colluvial soil along the brow that are highlighted in Figure 4-4a are expected to eventually fall. However, no movement from them was detected during the current monitoring period. Erosion of the block-in-matrix colluvial soil across the brow of the slope appears to be a prominent rockfall failure mechanism at the S020 site. Additionally, highlighted in Figure 4-4b is the presence of a slickensided discontinuity surface, which likely contributed to a rockfall event detected between 2021 and 2022 with an estimated volume of approximately 6.3 m³. Other potential failure mechanisms identified include weathering of the interbedded coal seams, leading to reduced confinement of the surrounding, more competent rock, producing further rockfalls and block toppling along joints nearly parallel to the slope face.

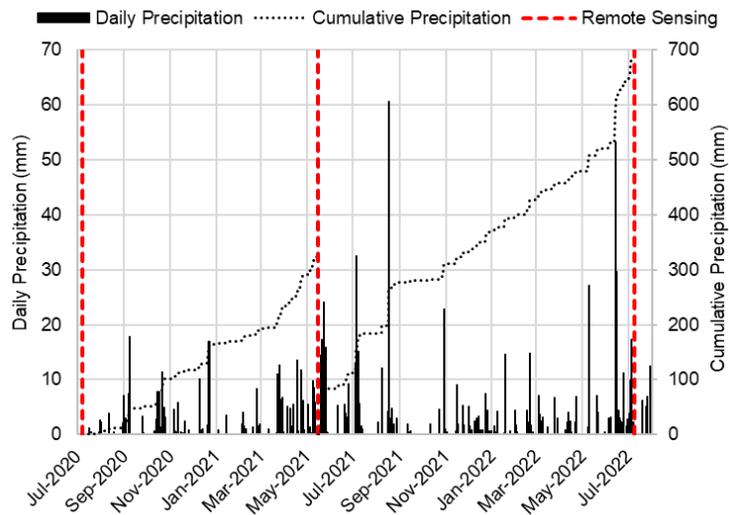
Figure 4-5: Recorded precipitation near the S020 site compared to the collection dates of remote sensing data.

A review of precipitation data from weather stations near the S020 site was conducted to understand the drastic difference in rockfall volumes between the 2021 and 2022 change detection results. In Figure 4-5 the daily and cumulative precipitation spanning the current remote sensing period is presented. The 2021 UAV survey was completed in May

of 2021, while the 2020 and 2022 scans were conducted in July. The difference in cumulative precipitation between the consecutive remote sensing dates was found to be approximately 390 mm. This is possibly a result of the early capture of remote sensing data in 2021, with approximately 180 mm of cumulative precipitation between May and July of 2021, but more likely a result of several large precipitation events which occurred during the summer months of 2021 and 2022. Two of these events produced more than 50 mm of precipitation in 24 hours. This suggests that the occurrence of intense precipitation events is another major factor contributing to failure frequency and volumes at the S020 site, and would explain the large volume of displaced material between spring of 2021 and 2022.

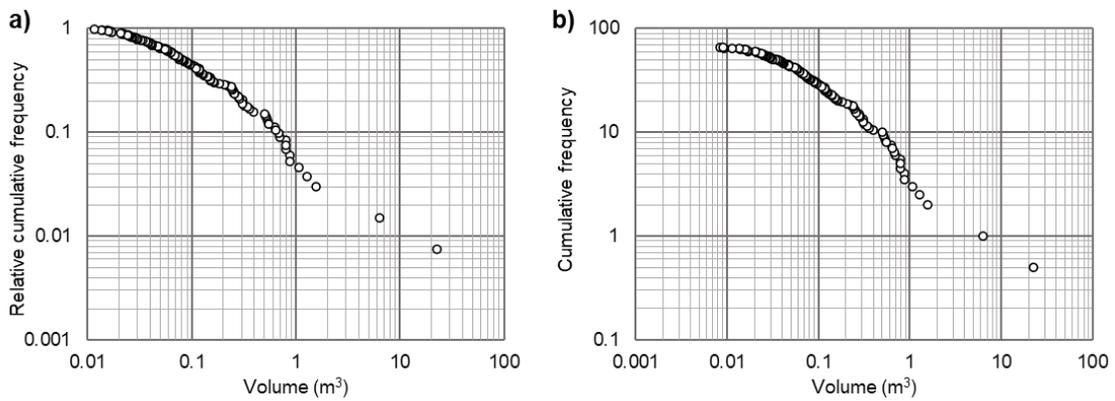
Figure 4-6: a) Relative and b) absolute cumulative frequency of detected volumes changes from the active zones of the S020 site.

The individual event volumes extracted from the change detection analysis conducted for the S020 site were used to develop the failure volume-frequency plots presented in Figure 4-6. It should be noted that the material losses due to surficial erosion

detected within the Extended Brow were excluded from this figure, as they could not be attributed to individual event volumes. A best-fit trendline was applied to the section of the curve crossing 1 m^3 in Figure 4-6b to determine an appropriate event frequency. The frequency for events greater than or equal to 1 m^3 at the S020 site was estimated at 4.7 per year.

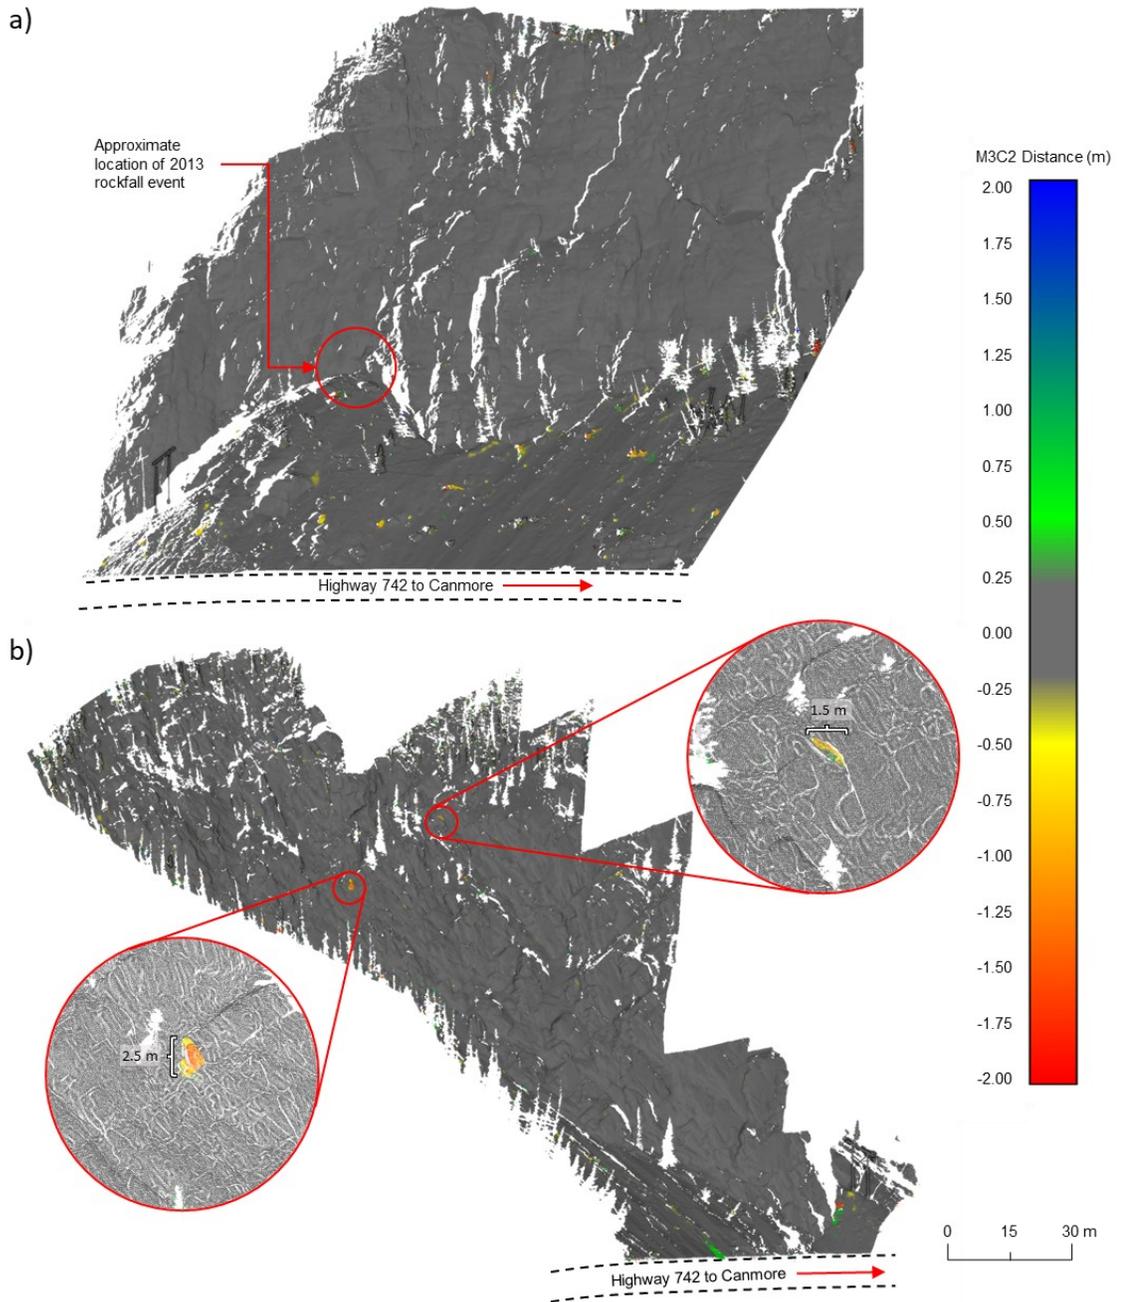
Figure 4-7: Results of the change detection analyses for the S042 site from 2018 to 2022 for a) S042-North, highlighting the approximate location of the 2013 rockfall event and b) S042-South highlighting location of two largest detected rockfalls (Modified from Wollenberg-Barron et al. 2023).

The change detection results between 2018 and 2022 for both S042-North and S042-South are presented in Figure 4-7a and Figure 4-7b, respectively. Compared to the two previously discussed slopes, a relatively small number of rockfalls were detected from the S042 site. This is attributed to the higher quality of rock comprising the S042 site compared to both the C018 and S020 sites. From the current period of change detection results, it is difficult to discern the prominent failure mechanisms present; wedge failures are the most likely, occurring between the prominent bedding plane and intersecting discontinuities. Erosion of the talus slope, undercutting larger blocks which eventually fall is another mechanism present which results in material reaching the highway. While the rock mass comprising S042-South appears to be of slightly lower quality than S042-North, the large rockfall event in 2013, with an estimated volume of 15 m³, originated from the north slope. Its approximate location is highlighted in Figure 4-7a. The two largest rockfalls detected during this analysis period originated from S042-South, as highlighted in Figure 4-7b; the events occurred between 2020 and 2022, and have volumes estimated at 2.10 m³ and 0.42 m³. The final resting place of these rockfalls could not be confirmed, nor the degree of disaggregation they experienced during the fall. While other slope movements greater than 1 m³ were detected, they originated from the talus slope (previous rockfall events that were contained on the talus) rather than as detachments from the S042 rock face.

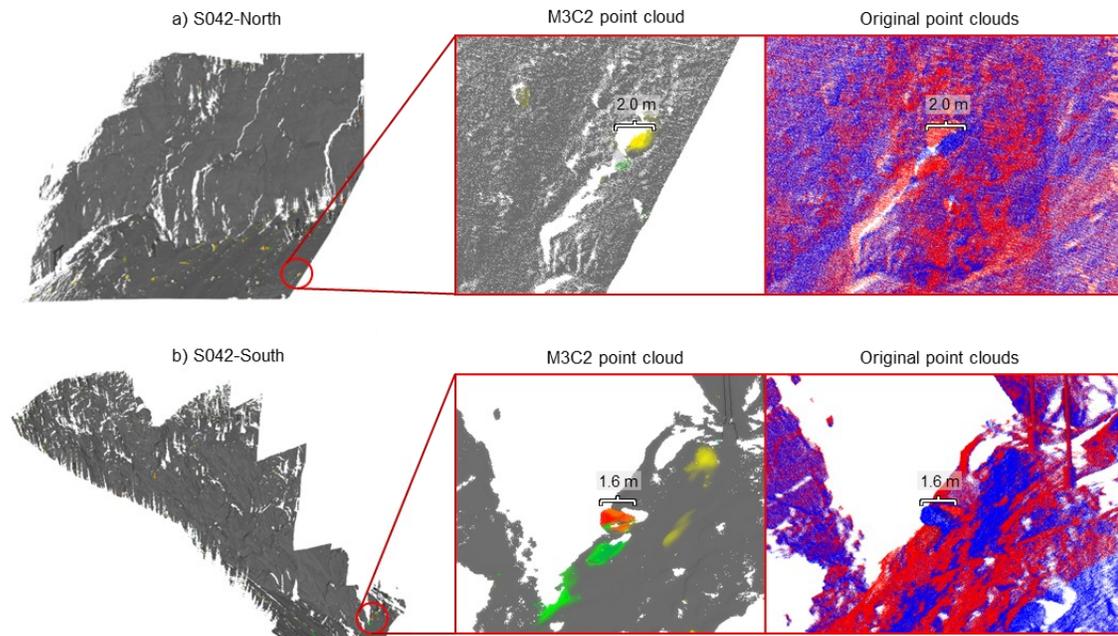
Figure 4-8: Technique used to determine if talus slope movements reached the highway. Examples from a) S042-North and b) S042-South utilizing both the M3C2 point clouds and original point clouds. The 2018 and 2022 point clouds are displayed in blue and red, respectively.

To account for all potential slope movements which could impact Highway 742, the change detection results for both the rock slope and talus slope were reviewed for movements. Only movements detected within the talus slope which appear to have reached the highway below were included in the volume calculations.

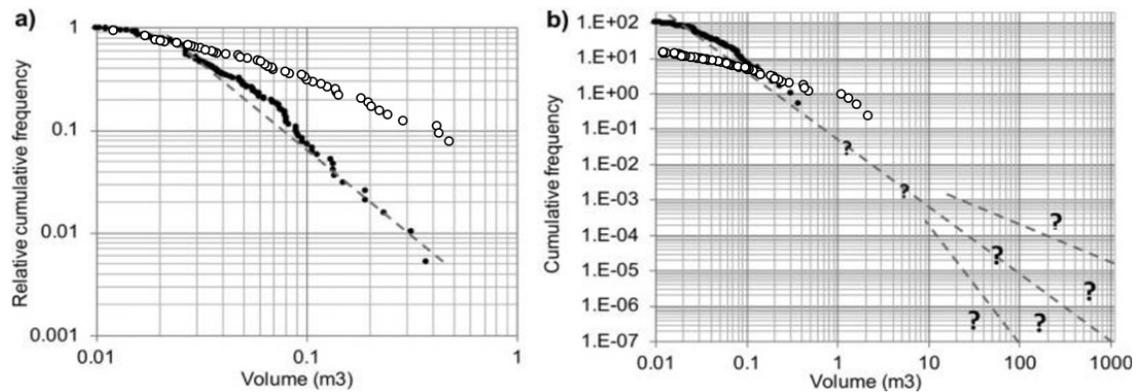
Figure 4-9: a) Relative and b) absolute cumulative frequency of detected slope movements from the S042 site change detection (white circles) overlain on previously developed failure volume-frequency plots (black dots) (modified from Macciotta et al. 2019).

A failure volume-frequency relationship was previously developed for the S042 site (Macciotta et al. 2019), and the results of the current change detection analysis are overlain in Figure 4-9 for comparison. The previously developed failure volume-frequency relationship utilized rockfall blocks which were present along the toe of the talus slope and therefore, had reached the highway. The relationship developed from the change detection results presented herein is of detachments from the slope and movements within the talus slope which had no distinct endpoint, unlike the examples shown in Figure 4-8 which were likely to have reached the highway. The difference between the two could be interpreted as a quantifiable effectiveness of the talus slope for

reducing a rock block's energy, or an indication of larger rockfall blocks breaking up before reaching the highway. Importantly, the difference between the two plots also results from the limitations imposed by the LoD of the change detection analysis performed, as rockfall blocks less than 20 cm were not detected (it is noted that blocks of this and lower volumes would be the most commonly found on the road). A best-fit trendline was applied to the section of the curve crossing 1 m³ in Figure 4-9b to determine an appropriate event frequency. The frequency for events greater than or equal to 1 m³ at the S042 site was estimated at 0.7 events per year.

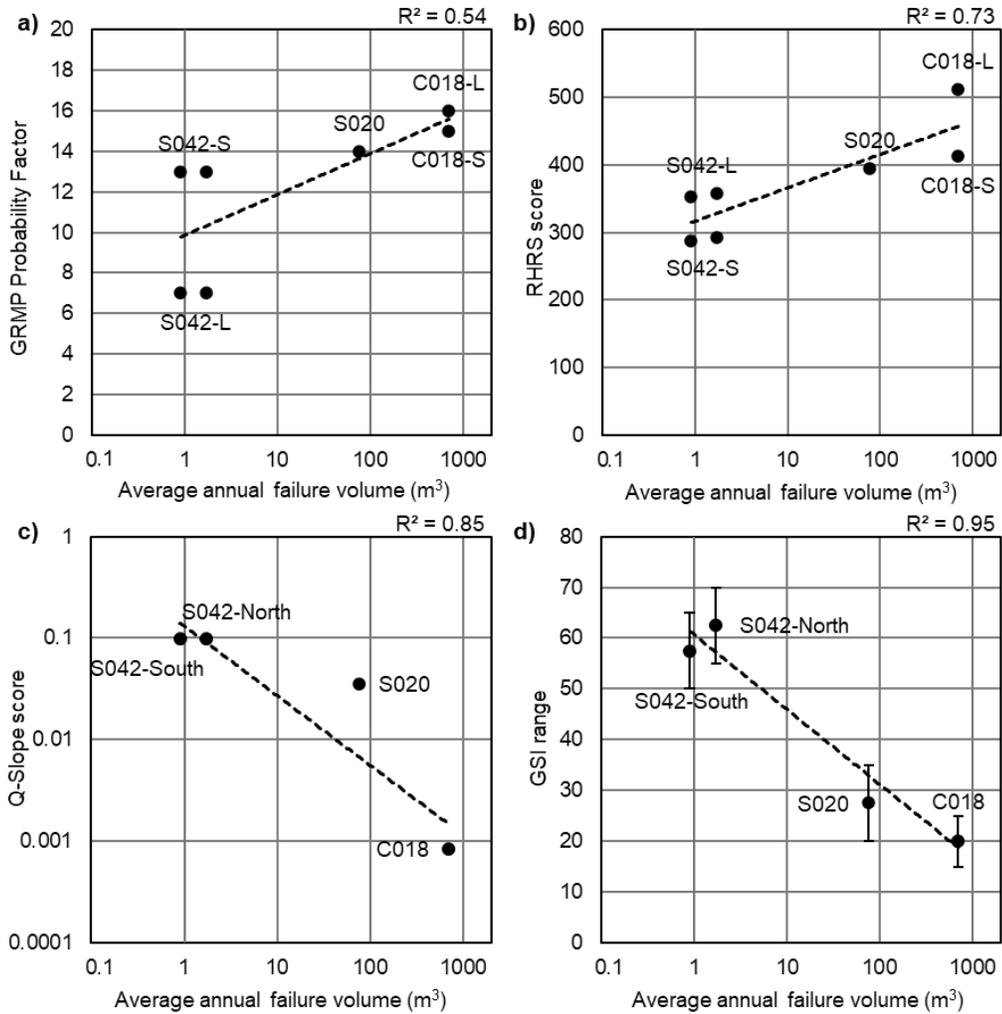
Figure 4-10: Correlations derived from the measured annual average failure volume and shortlisted condition assessment tools, including a) the GRMP PF, b) the RHRS, c) Q-Slope, and d) GSI.

In Figure 4-10 the calculated average annual failure volume was plotted against the GRMP PF, RHRS, Q-Slope, and GSI values for each of the study sites. The average annual failure volume, across the x-axis, was plotted on a logarithmic scale to accentuate the relatively large range of failure volumes from the three study sites. Trendlines were applied to determine a coefficient of determination (R^2) for each. The resulting R^2 values indicate a strong correlation between the annual average failure volumes and each of the condition assessment tools. The lowest R^2 was 0.54 for the correlation with the GRMP PF, shown in Figure 4-10a, which is attributed to the variation in GRMP PF between the rockfall volume thresholds assigned to the S042 site. This deviation is not unexpected as the GRMP PFs and RLs for the S042 site were previously identified as a prominent outlier in the analysis of condition assessment tools presented in Wollenberg-Barron et al. (2023). The other R^2 values presented in Figure 4-10b, Figure 4-10c, and Figure 4-10d for RHRS, Q-Slope, and GSI, respectively, ranged from 0.73 to 0.95. This gives credit to the robustness of the RHRS, Q-Slope, and GSI as rock slope and rock mass rating systems.

Comparing the R^2 values from Figure 4-10 and Figure 4-11, the use of annual event frequencies (Figure 4-11) derived from failure volume-frequency relationships appears to be a slightly more robust failure metric, although more laborious to derive.

Annual failure volumes (Figure 4-10) are more easily extracted from change detection results and may be updated annually to reflect the changing condition of a site.

The change detection results for the C018 site indicate that the erosional processes of the highly disaggregated rock mass which has led to debris flows, rockfalls, and rockslides have an estimated average annual failure volume of 696 m³, and will continue to progress. The progressive deterioration observed from the change detection of the C018 site indicates that additional large failure events, such as debris flows, are likely to occur if remedial measures are not put in place. This assessment is corroborated by the results presented in Figure 4-10 and Figure 4-11, indicating a much higher likelihood of

be smaller than the limits of detection for the site. The S042 site is a challenging case for the application of condition assessment tools due to its significant height and limited access. The results from Figure 4-10 and Figure 4-11 may be utilized to assist TEC and its consultants in the selection of rockfall volume thresholds and GRMP PFs for the S042 site which are more representative of the likelihood of failure indicated by the change detection results. The failure volumes detected from the S042 site were much lower than the large rockfall event in 2013 which originated from S042-North, with an estimated volume of 15 m³. This implies that the return period for this failure volume is much greater than the current remote sensing monitoring period. The remote sensing program for the S042 site should be continued to provide further insight into the frequency of relatively large volume events. Although, from the results presented in this paper, the scanning frequency could be reduced to once every two years without significantly impacting its value.

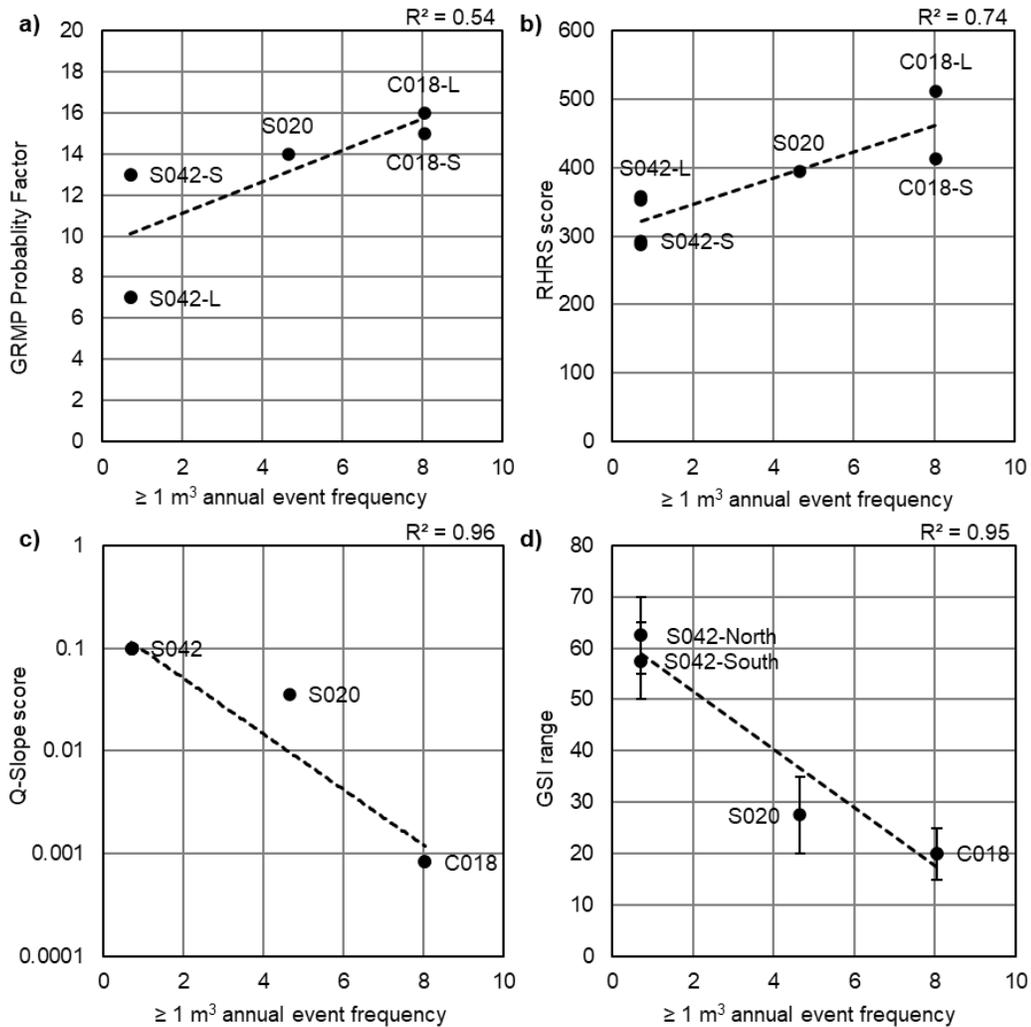
Figure 4-11: Correlations derived from the estimated annual frequency for events greater than or equal to 1 m^3 and each shortlisted condition assessment tool, including a) the GRMP PF, b) the RHRS, c) Q-Slope, and d) GSI.

The annual frequency for events greater than or equal to 1 m³ was plotted against the GRMP PF, RHRS, Q-Slope, and GSI values for each study site in Figure 4-11. Like Figure 4-10, trendlines were added to determine the R² of each which resulted in relatively high values ranging from 0.61 to 0.94. The R² for the correlation between the GRMP PF and annual event frequency, presented in Figure 4-11a, was slightly greater than that of Figure 4-10a, with a value of 0.61. This may be a result of fewer data points

used to develop Figure 4-11a since events from both S042-North and S042-South were combined to develop a more representative failure volume-frequency plot for the S042 site.

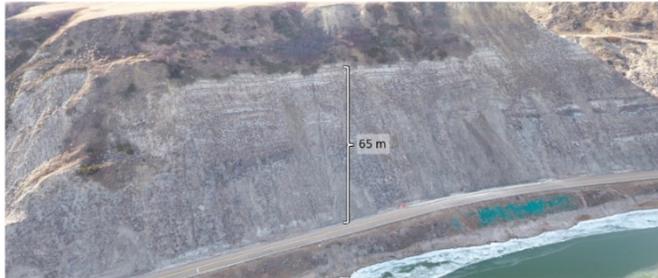
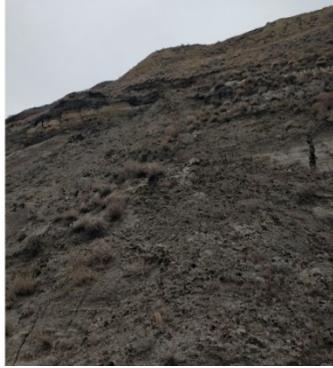
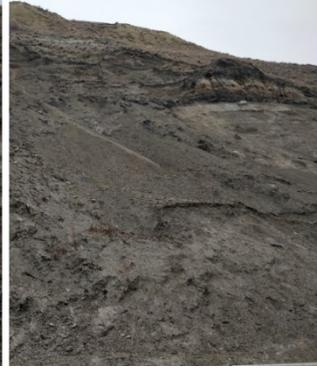
S018 – Galatea Creek Rock Cut – GSI and Joint Set Number

J_n: 9 (Three joint set)

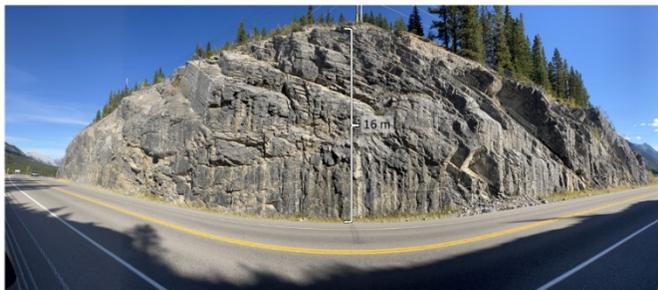
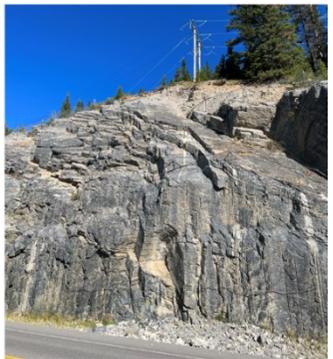
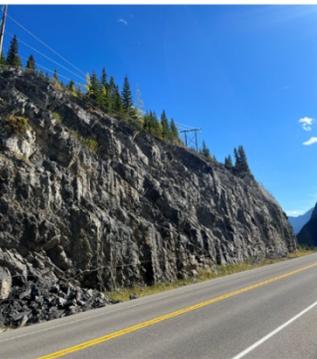
S020 – Highwood House Rockfall Hazard – GSI and Joint Set Number

Jn: 12 (Three joint sets plus random joints)

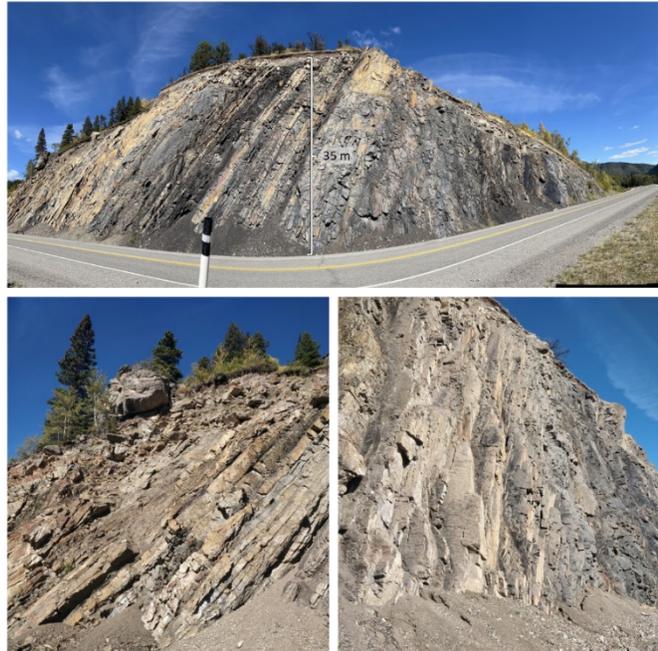
S042 – Spray Lakes Rockfall (North) – GSI and Joint Set Number

Jn: 9 (Three joint sets)
