**Combining Rock Slope Ranking Methods and Performance Monitoring Techniques for
Rockfall Geohazards to Advance Geotechnical Asset Management in Alberta**

A thesis submitted in partial fulfillment of the requirements for the degree of

Geotechnical Engineering

Department of Civil and Environmental Engineering
University of Alberta

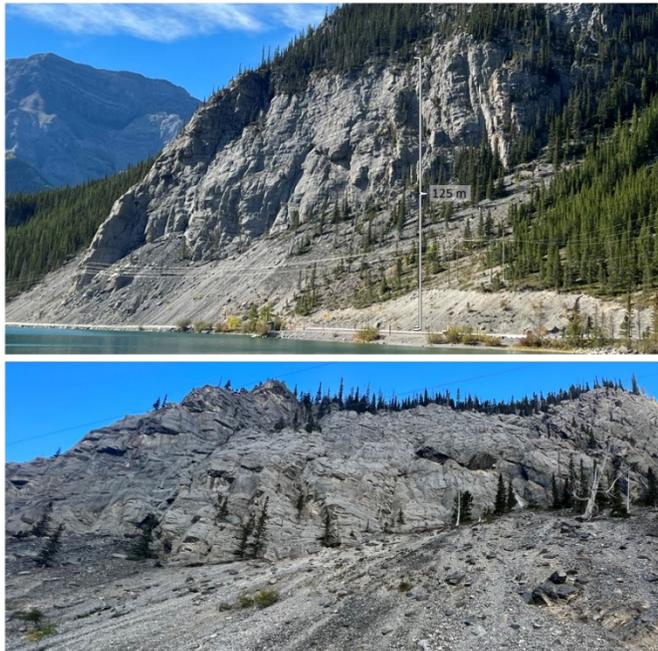
5042 – Spray Lakes Rockfall (South) – GSI and Joint Set Number

Jn: 9 (Three joint sets)

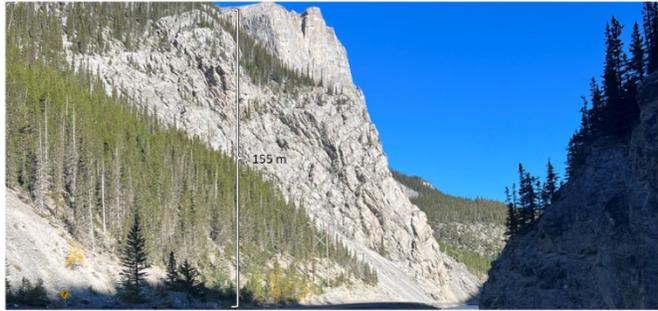
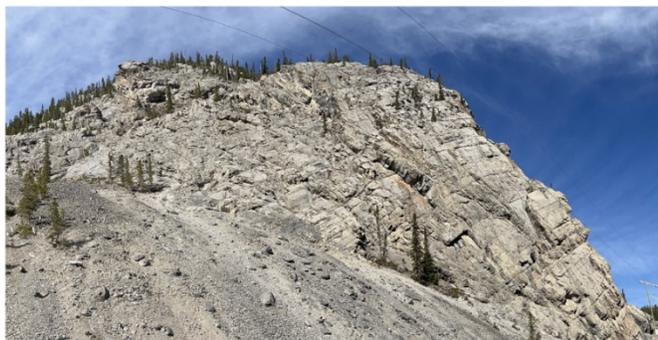
5057 – Hwy 1A, Exshaw, Site A – GSI and Joint Set Number

Jn: 15 (Four or more joint sets, random, heavily jointed)

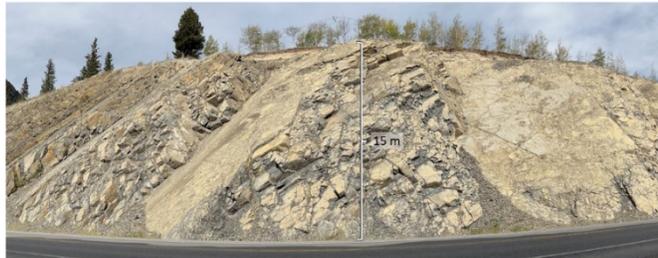
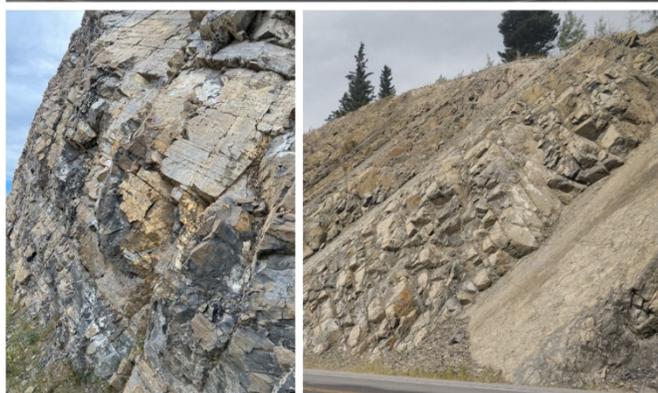
S057 – Hwy 1A, Exshaw, Site B – GSI and Joint Set Number

Jn: 12 (Three joint sets plus random joints)

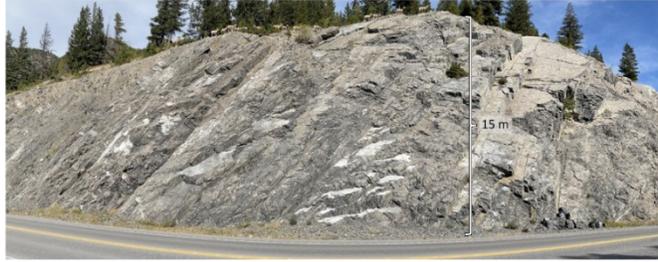
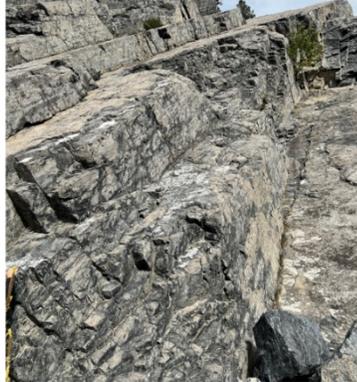
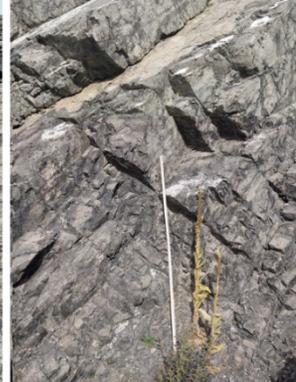
S070 – East of Fir Creek Rock Cut – GSI and Joint Set Number

Jn: 12 (One joint set plus random joints)

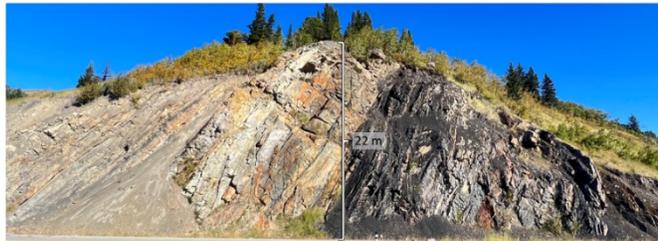
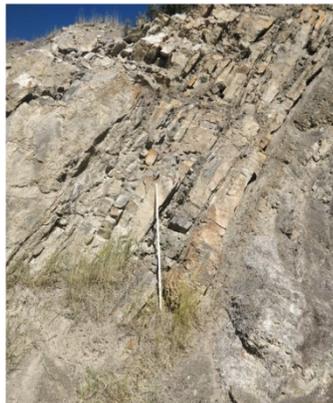
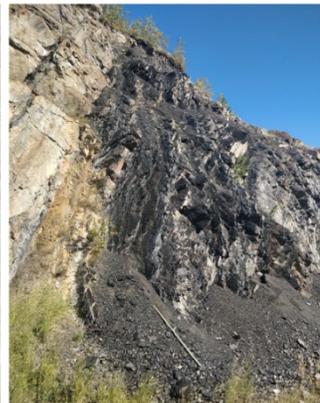
S074 – Lipsett Ridge Rock Cut – GSI and Joint Set Number

Jn: 12 (One joint set plus random joints)
