**University of Alberta**

**Klapperhorn Mountain Debris Flows**

**A thesis submitted to the Faculty of Graduate Studies and Research  
in partial fulfillment of the requirements for the degree of**

**Master of Science**

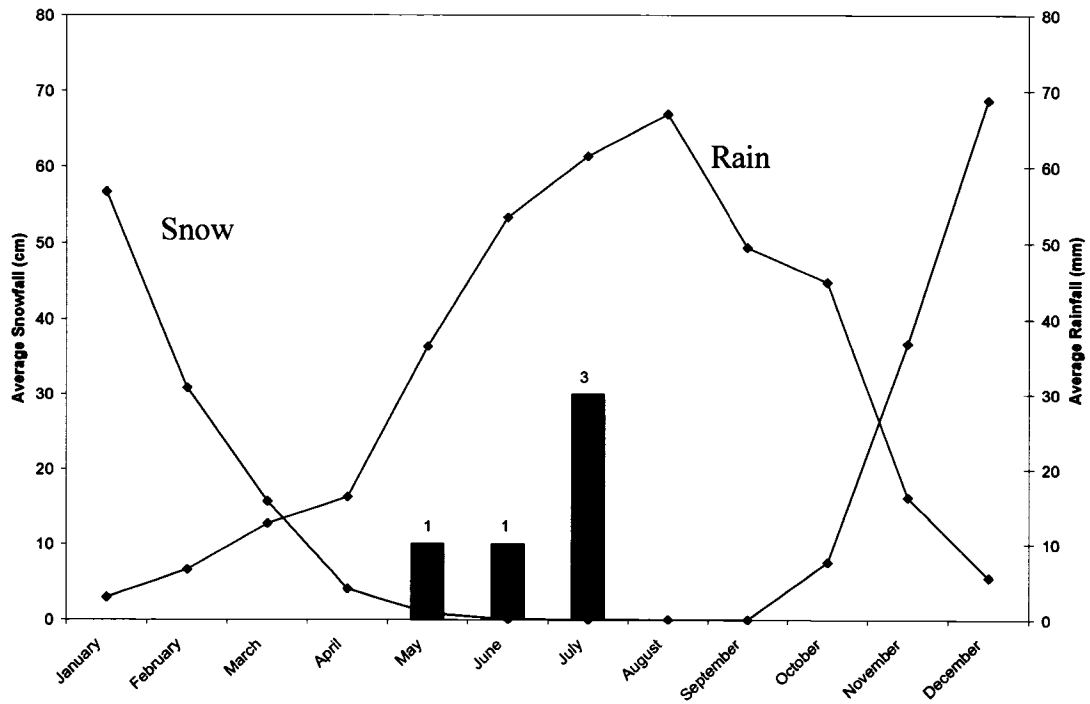
Figure 2.4. Monthly snowfall and rainfall averages at the Robson Ranch weather station at the base of Klapperhorn Mountain. Monthly averages are calculated based on data from 1975 to 1992. Columns indicate the number of historical debris flows recorded in each month. Note that only the July 1988 debris flow occurred during 1975 to 1992 weather data interval. See text for details.

The weather data and historical record suggest that rainfall is the primary trigger for debris flow events (Figure 2.4). The number of recorded debris flows in each month show that rainfall is a likely trigger for debris flow events. Accurate snow depth data are not available for the upper regions of Klapperhorn Mountain, so snowmelt cannot be ruled out as a contributing factor in the May 1993 event. Photographs of Klapperhorn Mountain from May 2002 show snow on Klapperhorn Mountain, suggesting that snow melt may also be a debris flow trigger (Figure 2.5).

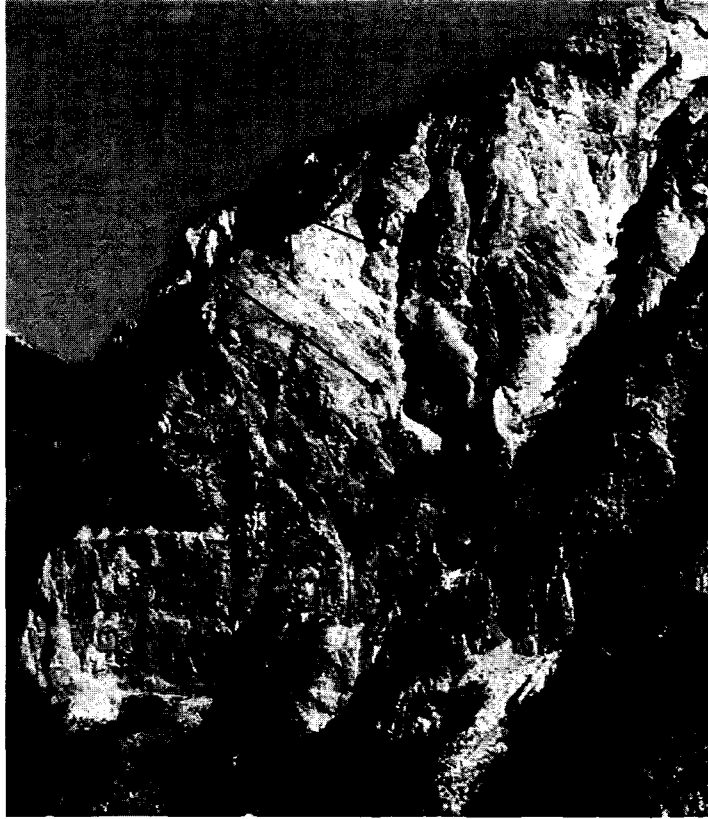
Figure 3.4. Rock fall chute in bedrock terrain units in basin 54.3b. Multiple rock fall chutes are visible. The upper arrow indicates an individual chute and the lower arrow indicates accumulation of rock fall debris at the base of the chute.

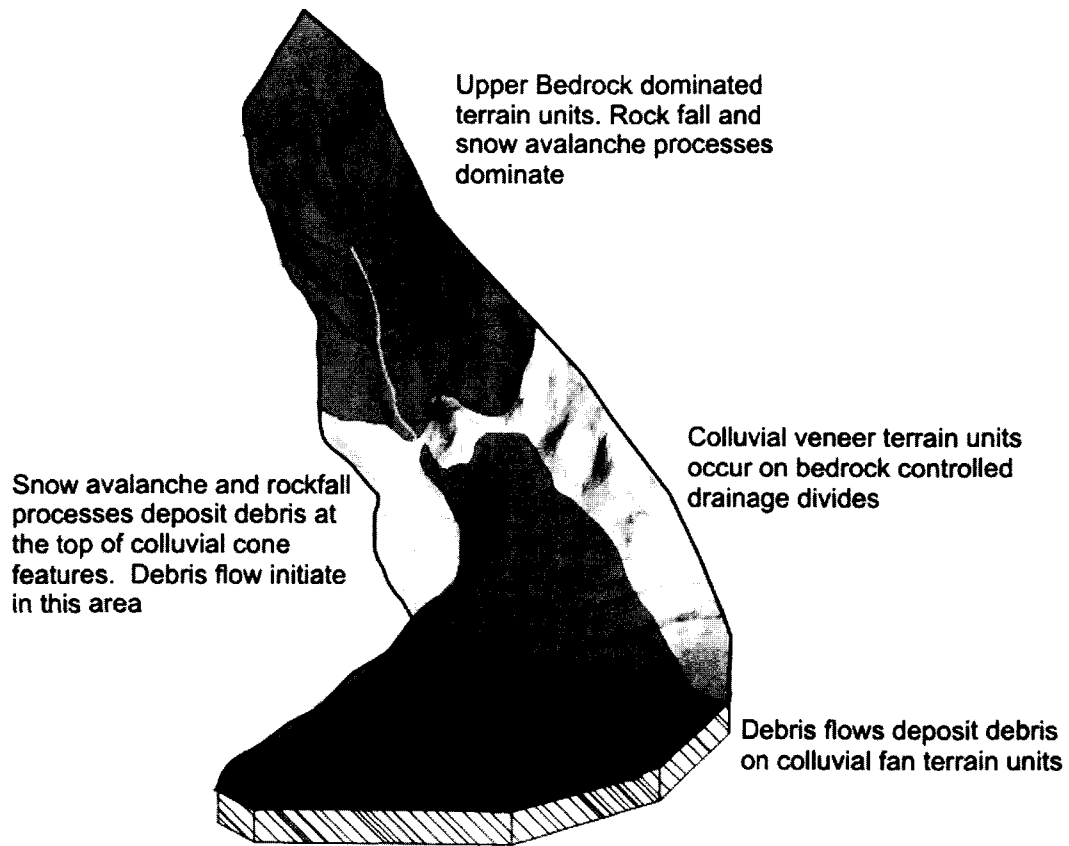
Figure 3.9. Sketch of the distribution of debris flow process within the drainage basins at Klapperhorn Mountain. The morphology and initiation processes within basins may vary (Chapter 4), but the overall transport process is similar in each basin. Yellow lines are avalanche tracks, green lines are rock fall chutes, and blue line is a debris flow channel.

The distribution and characteristics of the terrain unit and features in Figure 3.1 provide a debris transport model at Klapperhorn Mountain (Figure 3.9). In this overall debris transport model, debris is derived from bedrock weathering and rock fall processes, and is transported down slope by avalanche and rock falls. Debris accumulates on the colluvial cone units that drape the lower slopes of the mountain below 1200 - 1300 m. Debris is then mobilized primarily through debris flows and is transported to the base of the mountain, where it is deposited on fans. The morphology of basin 53.6 differs from the other basins, as it is much larger (Table 2.3) and does not have a well defined colluvial cone unit above the colluvial fan. However, the overall debris transport scenario is similar in each basin. The effect of basin morphology on the debris flow hazard is discussed in Chapter 4.

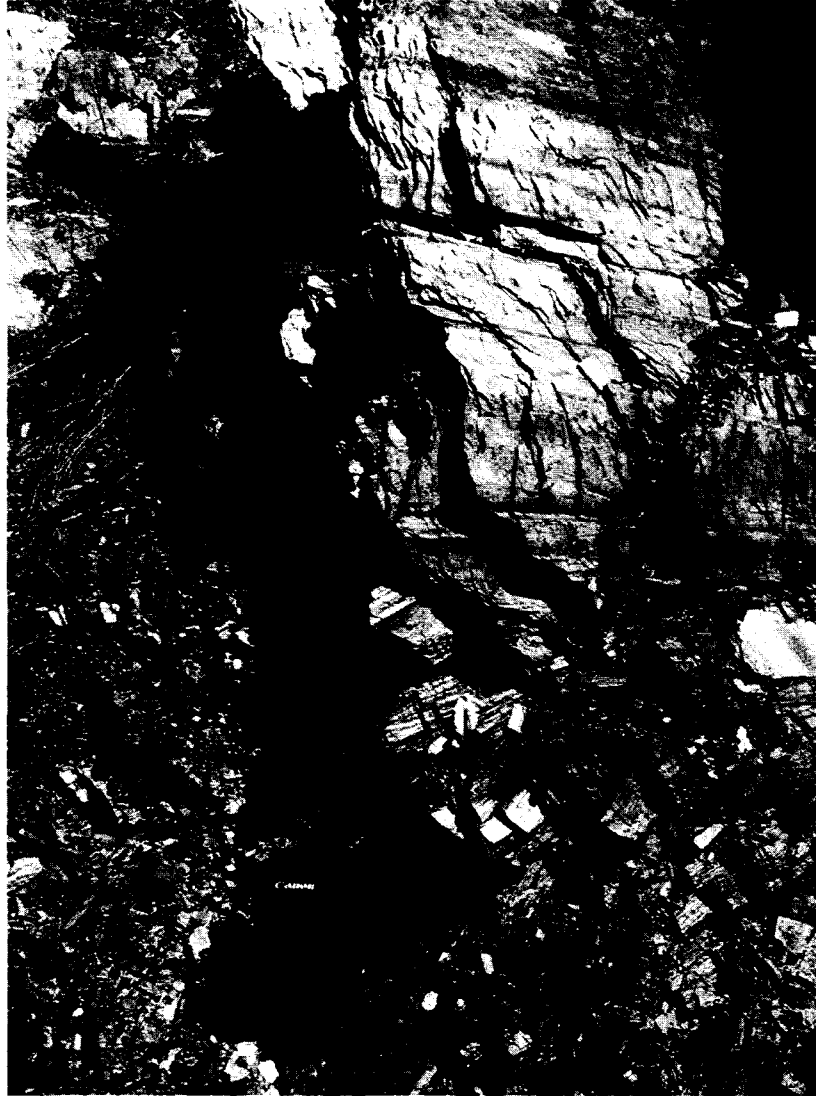
Figure 3.14. Exposed phyllite unit in basin 55.0. Note the rapid weathering to produce fine grained material. The phyllite breaks easily along cleavage planes and contributes fine fraction material to debris flow processes. Cobble size and small phyllite grains are observed in the debris flow deposits at Klapperhorn Mountain.

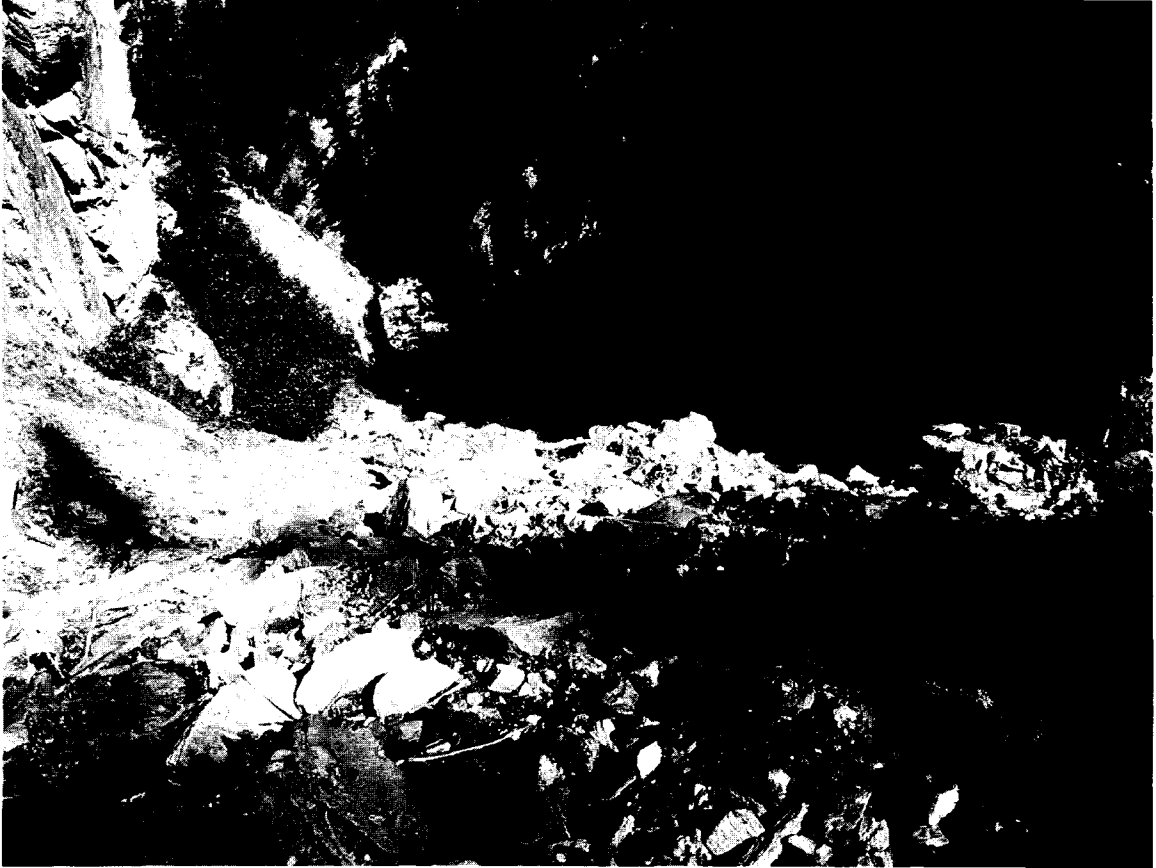
Figure 4.1. Looking down the Cc-dar terrain unit in Basin 53.6. This unit slopes at up to 35°. Stream flow is concentrated on the east side of the unit (right side of photograph), but flowing water is visible throughout the unit. Landslide failures within this unit may trigger debris flows within basin 53.6. Boulders are up to 2 m.

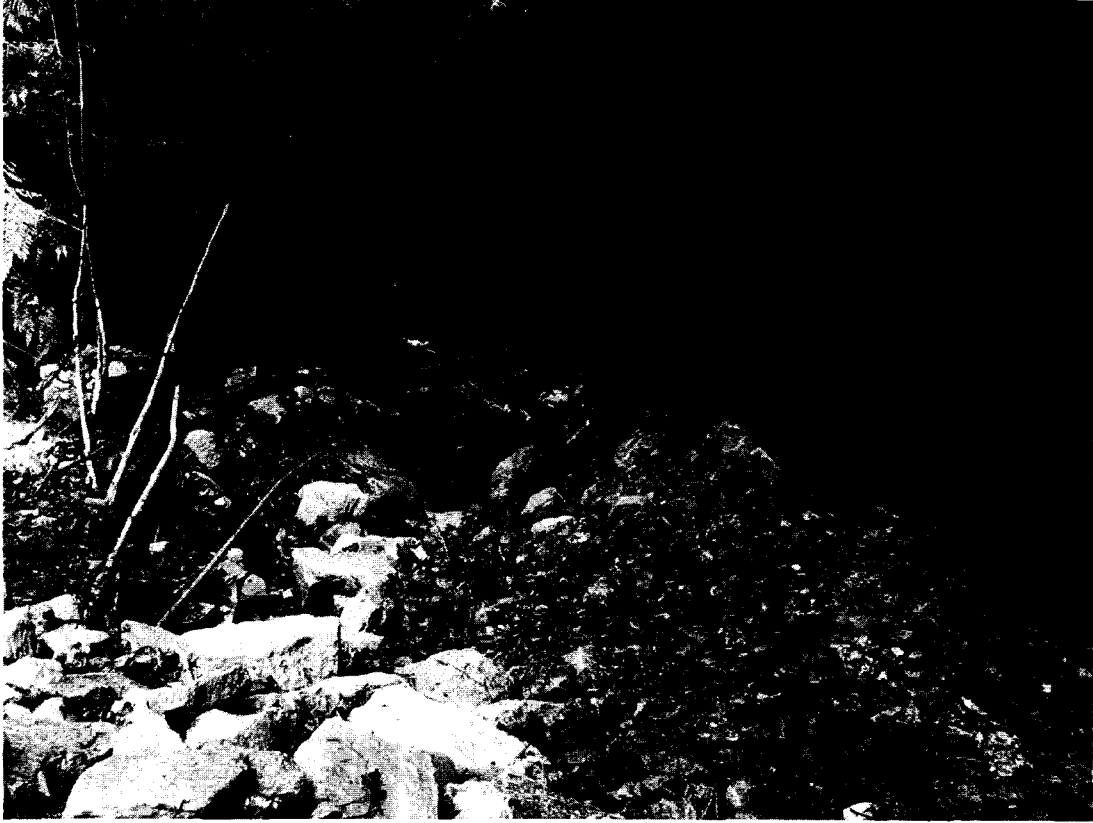
Figure 4.7. View down channel 'c' immediately below the avulsion point in channel 'd'. Note the large levee features and poorly incised channel, indicating debris flow deposition. Avulsion likely occurs along an 8 m length of channel 'd' that has a reduced slope of  $17^\circ$ . Localized deposition causes increased flow depth that exceeds the height of the channel banks.

average of 17°. This section of lower gradient likely reduces flow velocity, causes local deposition and increases flow height resulting in avulsion and flow in the secondary channels (Figure 4.7). A third possibility is that coarse woody debris may temporarily block channels during debris flow events. Logs and branches are visible in some debris flow channels and on debris flow fans, but there is no direct evidence that they have caused channel avulsion.

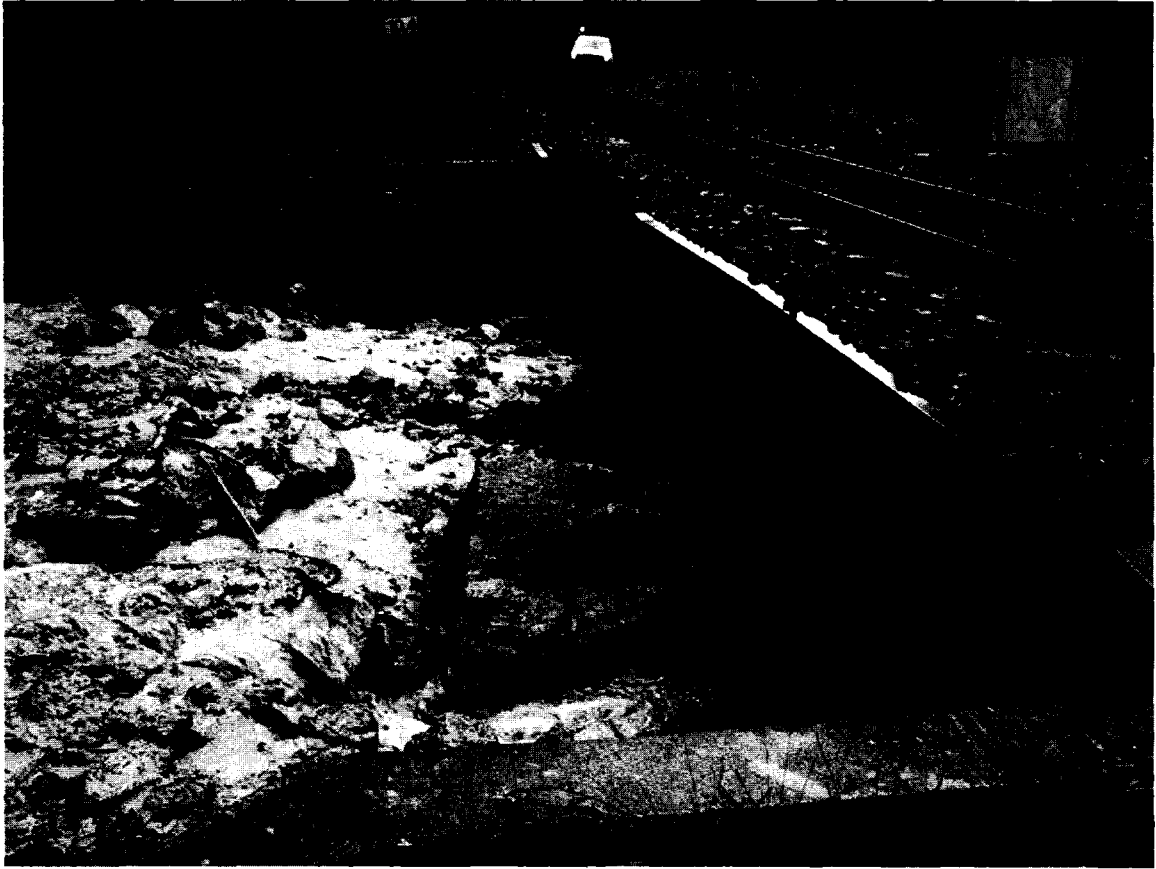
Figure 4.9. Debris flow deposition within channel 'd' in basin 54.0 on July 18, 2001. Similar deposition channel 'a' in basin 53.6 caused track failure (Chapter 2). Photo courtesy Tim Keegan.
