Investigation of Corrosion and Crack Morphology Behavior under Disbonded Coatings on
Pipelines

Abstract

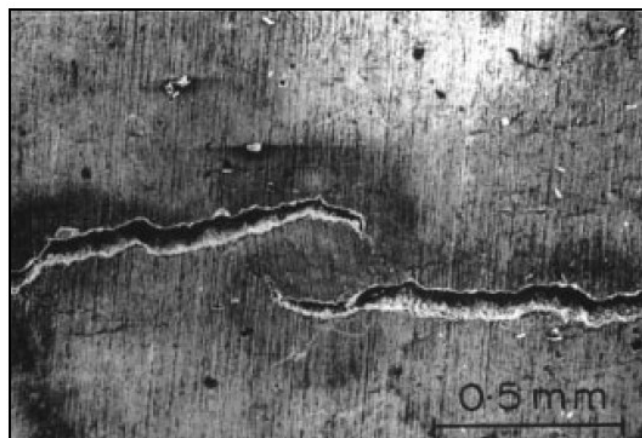
Crack growth through crack coalescence is considered to be a crack growth mechanism for later stages of crack growth and crack extension prior to failure; Figure 2-7 is an example of crack coalescence. Crack coalescence can occur not only in coplanar cracks that adjoin tips, but also in non-coplanar cracks that are displaced from each other in the hoop direction, in cases when they are sufficiently close. Coplanar cracks that are closely positioned to each other have high odds of interaction between their stress fields. Due to the mixed loading mode (Mode I and Mode II), the crack tips change direction and grow towards each other until they approach coalescence [27].

Figure 2-7: Cracks Coalescing [4]

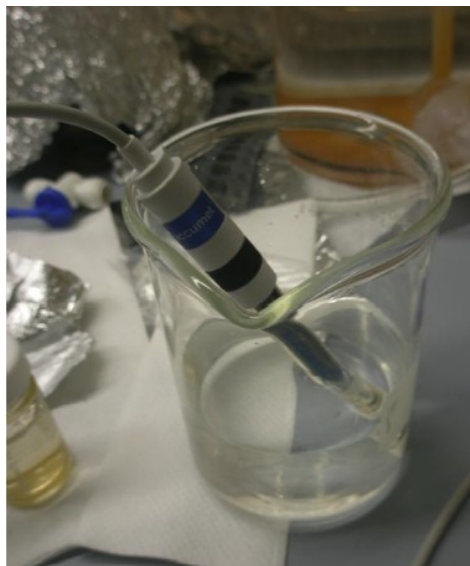
The resistivity measurements were performed with an Accumat conductivity probe calibrated in a commercial Fisher Scientific solution with a known resistivity, and immersed into the solution of interest. Figure 3-4 shows the Accumat electrode for resistivity measurements.

Figure 3-4: Accument Electrode for Resistivity Measurements [4]

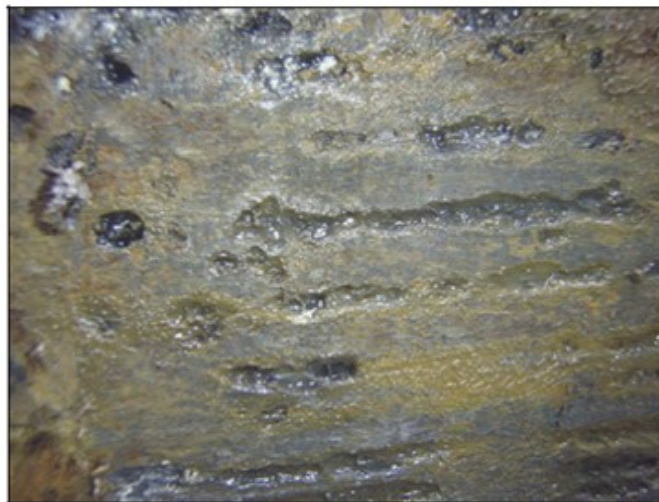
Figure 4-1: Corrosion under a Disbonded Coating

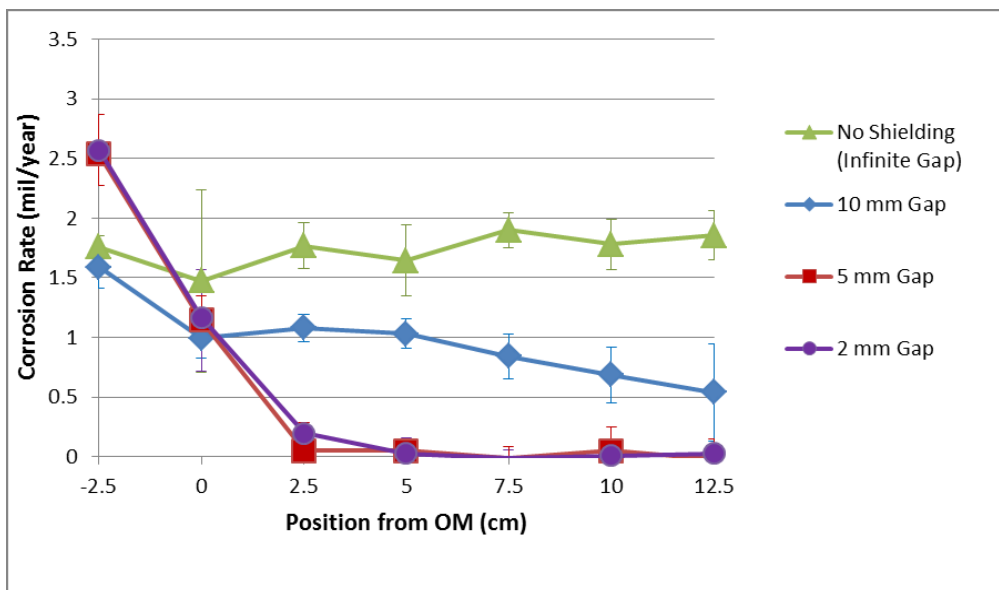
The corrosion rate of the pipeline steel at different positions from the OM (consistent with the positions shown in Figure 2) was obtained for various CO₂ concentrations: 2% CO₂, 5% CO₂, and 20% CO₂ shown in Figure 4-5, Figure 4-6, Figure 4-7, respectively. The results represent the average corrosion value and the associated error, obtained from at least two test repetitions; tests that exhibited a higher scatter in the results had a higher number of repetitions. The error bars represent the standard deviation between the results of the repeated experiments.

Figure 4-6: Corrosion Rate in Deaerated C2 Ground Water Solution at Various Positions from the OM for a Solution Purged with 5% CO₂, Determined Based on 30-Day Tests Through Weight Loss Analysis

From analyzing Figure 4-5 to Figure 4-7, it can be seen that the corrosion rate was lower at all the positions for the test purged with 2% CO₂ compared to 5% CO₂, and almost three times higher for the test purged with 20% CO₂.

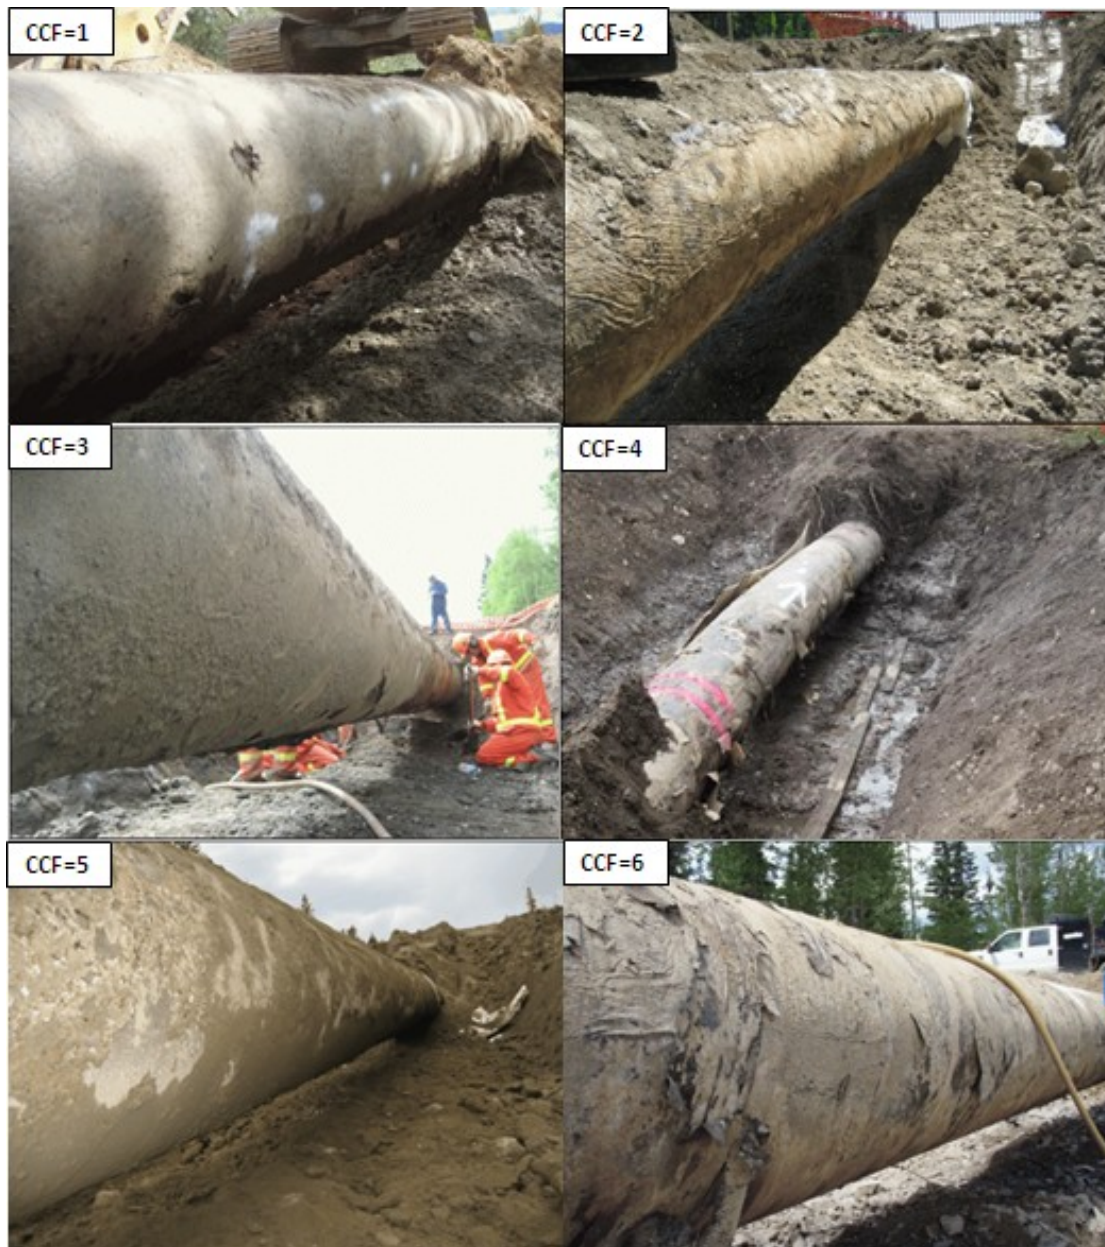
Figure 5-3: Images from the Field Showing the Asphalt Coating Condition for Various CCF Factors

Images from the field illustrating the coating condition for various CCF factors are shown for tape coatings and asphalt coatings in Figure 5-2 and Figure 5-3, respectfully. For CCF=1 in Figure 5-2, the purpose of the overlaid rectangle is to conceal the writing on the coating during field excavations.

By analyzing Figure 5-8 it can be seen that the average corrosion rate under asphalt coatings is fairly consistent for all the CCF values, which can be explained by the fact that asphalt coatings fail cohesively in a brittle manner, often creating disbonded patches, as seen in Figure 5-3. Since asphalt coatings are known to be compatible with CP, in an event of a coating disbondment, CP can reach the pipeline and protect it from corrosion. Therefore, the corrosion rate in the case of asphalt coatings, is more dependent on the level of CP and soil characteristics (e.g. drainage, conductivity) than the coating condition. This explanation is also consistent with the average corroded area analysis, where the average corroded area remains fairly consistent for all the CCF values.

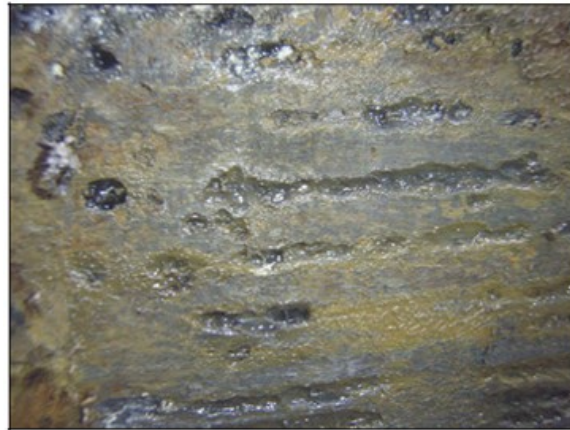
Figure 5-7: Corrosion under a Wrinkled Coating with Minor Alkaline Precipitates

The importance of the refinement process discussed above is to isolate the cases that more likely occurred under near neutral pH conditions, where insufficient CP was reaching the pipeline and a protective iron-carbide coating did not form on the surface to inhibit the corrosion of steel. Figure 5-7 shows a corrosion site under wrinkled coating where only minor quantities of CaCO_3 and FeCO_3 can be observed; this site was characterized as a near neutral pH site. The corrosion rate as a function of CCF for the near-neutral pH environment, and potentially-high pH analysis is plotted in Figure 5-8 for tape coatings and asphalt coatings. As the main interest of this work remains with the near-neutral pH cases, the remaining potentially alkaline pH cases are not presented.
