**Landslide Mitigation Using Granular Shear Keys:  
Observations from a Review of 38 Case Studies**

A thesis submitted in partial fulfillment of the requirements for the degree of

Geotechnical Engineering

Department of Civil and Environmental Engineering  
University of Alberta

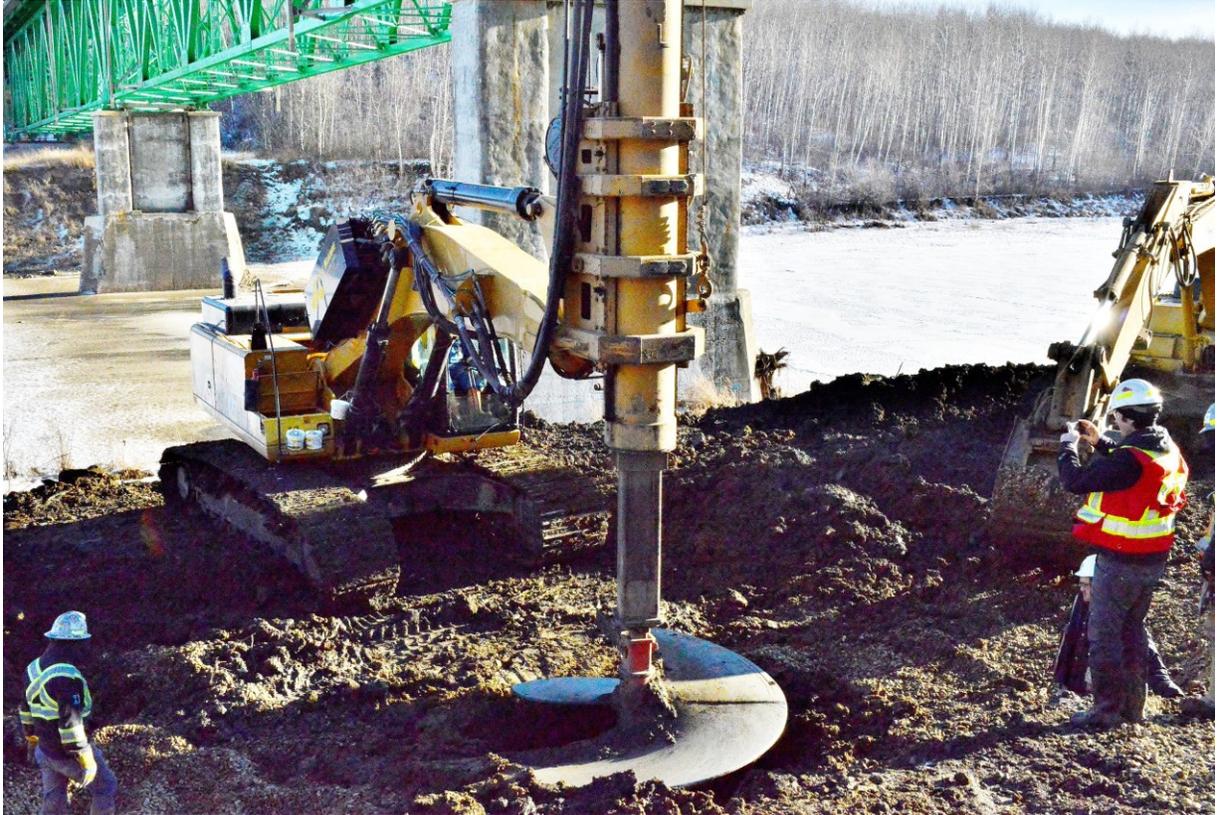
*Figure 2.13: A large-diameter auger being used in the installation of a rockfill column along a riverbank underneath a bridge. Photo by Hugh Gillen.*

and shear loads is expected (Proudfoot D. , 2016). As with trenched shear keys, rockfill columns are a suitable option when the right-of-way is limited, such as along a riverbank (see Figure 2.13).

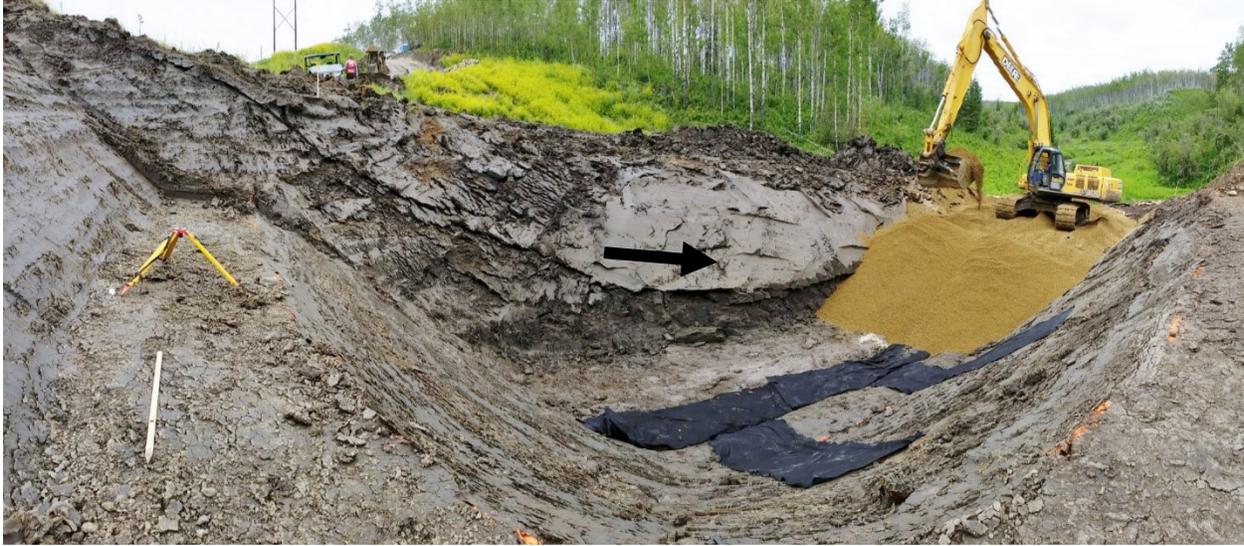
*Figure 3.15: A slip surface can be seen during panelled construction of a granular shear key (McLachlan, 2016). The direction of sliding is indicated by a black arrow. Photo by Duncan McLachlan. Used with permission.*

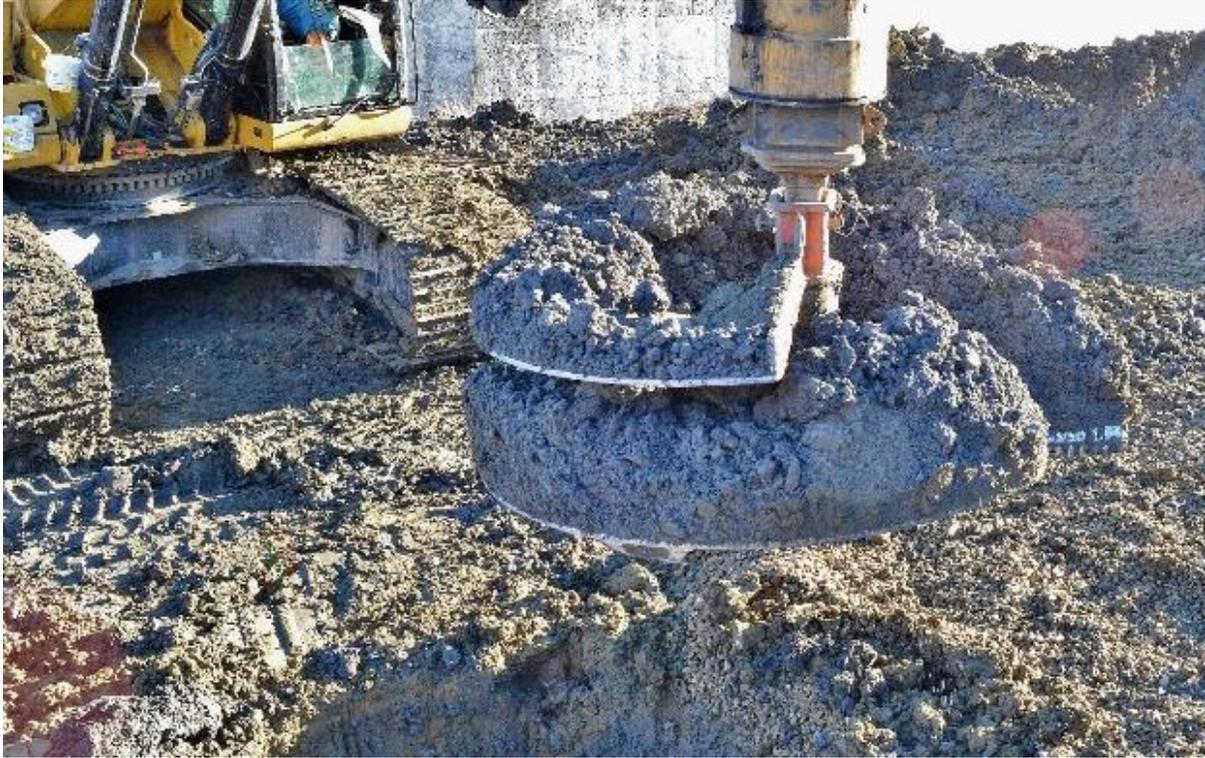
*Figure 3.17: Pictured is a 2.13 m diameter auger in the process of lifting soil from a hole that is being excavated for a rockfill column. Photo by Hugh Gillen.*

In foundation reinforcement projects, vibro-replacement using jetting water (i.e. the wet process) or vibro-displacement without the use of jetting water (i.e. the dry process) are used to install rockfill columns. The construction of rockfill columns for landslide mitigation is typically achieved by means of a large-diameter auger to pre-bore the columns (see Figure 3.17). Barksdale and Bachus (1983) remark that this approach is common in the presence of stiff soils or stiff lenses. If the soil is prone to sloughing, a steel sleeve can be used to assist with construction or individual holes can be relocated (Yarechewski & Tallin, 2003). Once bored, the hole can be backfilled with granular material.

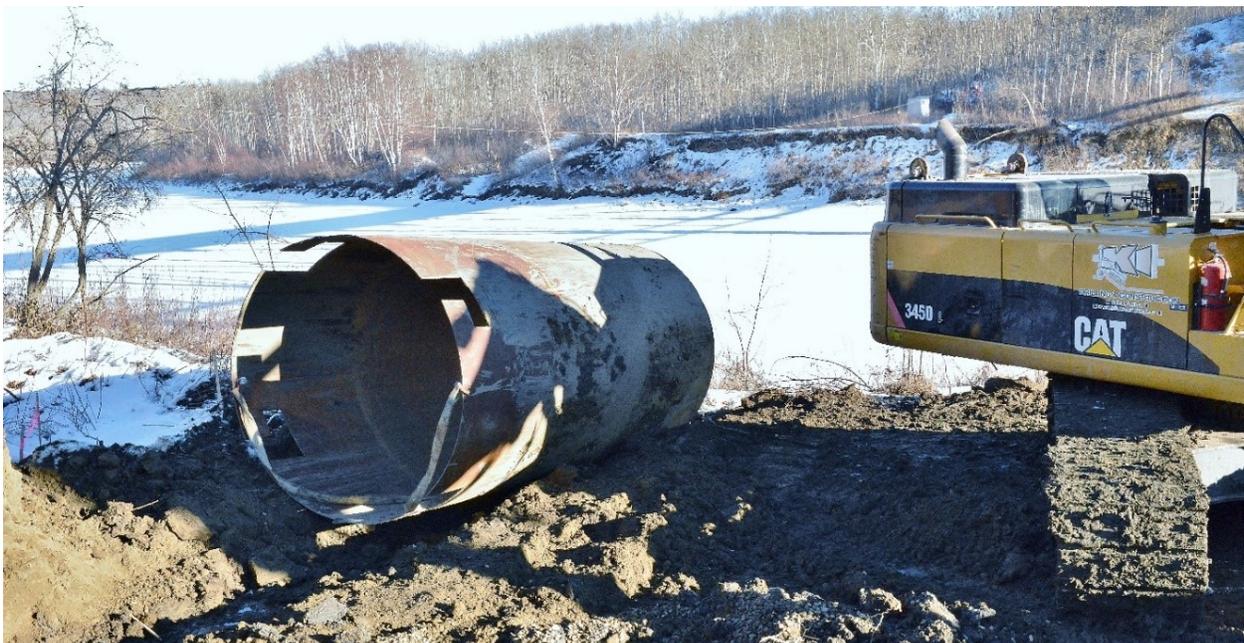
Figure 5.1: A steel sleeve used to help maintain hole stability during the construction of rockfill columns. Photo by Hugh Gillen.

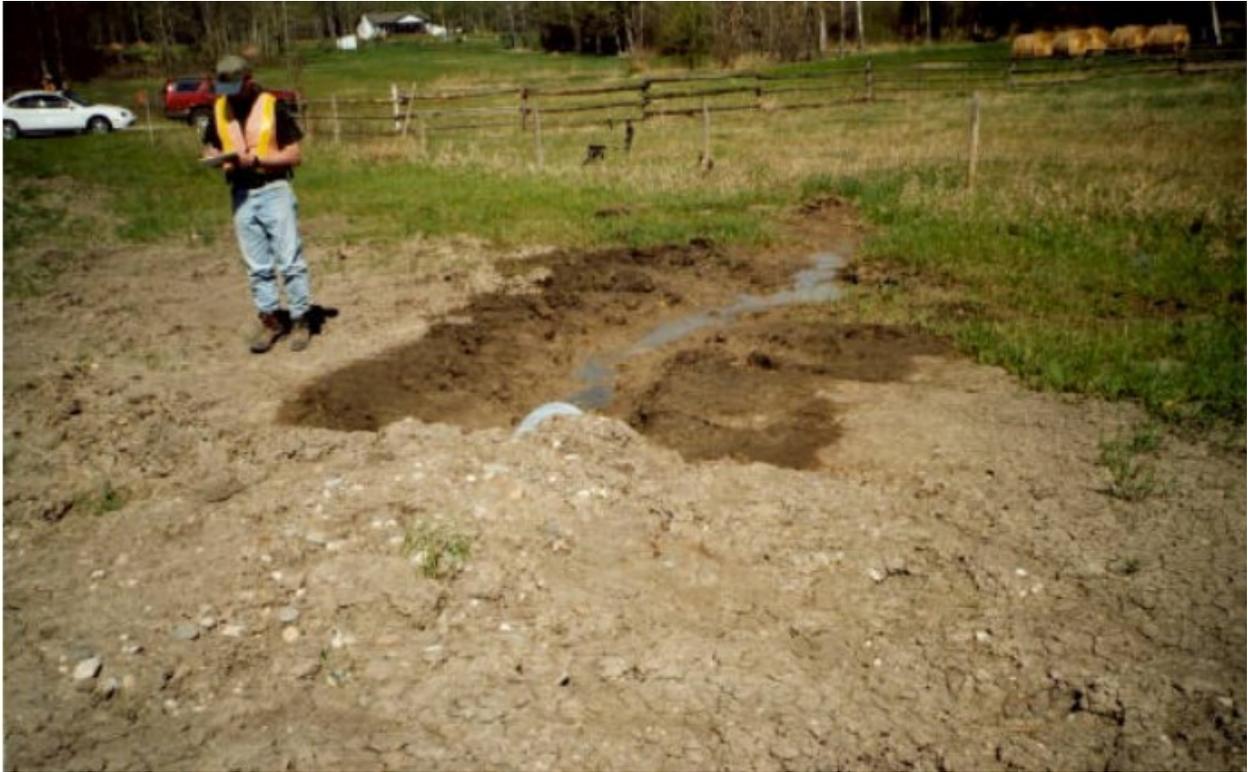
*Figure A-26: Continuous flow coming from the outfall pipe draining the granular toe key (Tetra Tech EBA, 2002). Reproduced with permission from Alberta Transportation.*

This slide was originally repaired without appropriate drainage measures. Once seepage was observed, a weeping tile was installed but movement and settlement persisted for the next 3-4 years. It was concluded that a possible reason for this was the bathtub effect. The bathtub effect is the result of a free-draining backfill becoming saturated and subsequently creating a zone of deeper wetting (Karl Engineering Consultants Ltd., 2007). This zone of deeper wetting would have been located within the soft clay deposits that had been identified. The bathtub effect is known to typically result in some amount of deformation. In this case, the soft clay deposits may have softened because of the exposure to the deeper wetting zone.

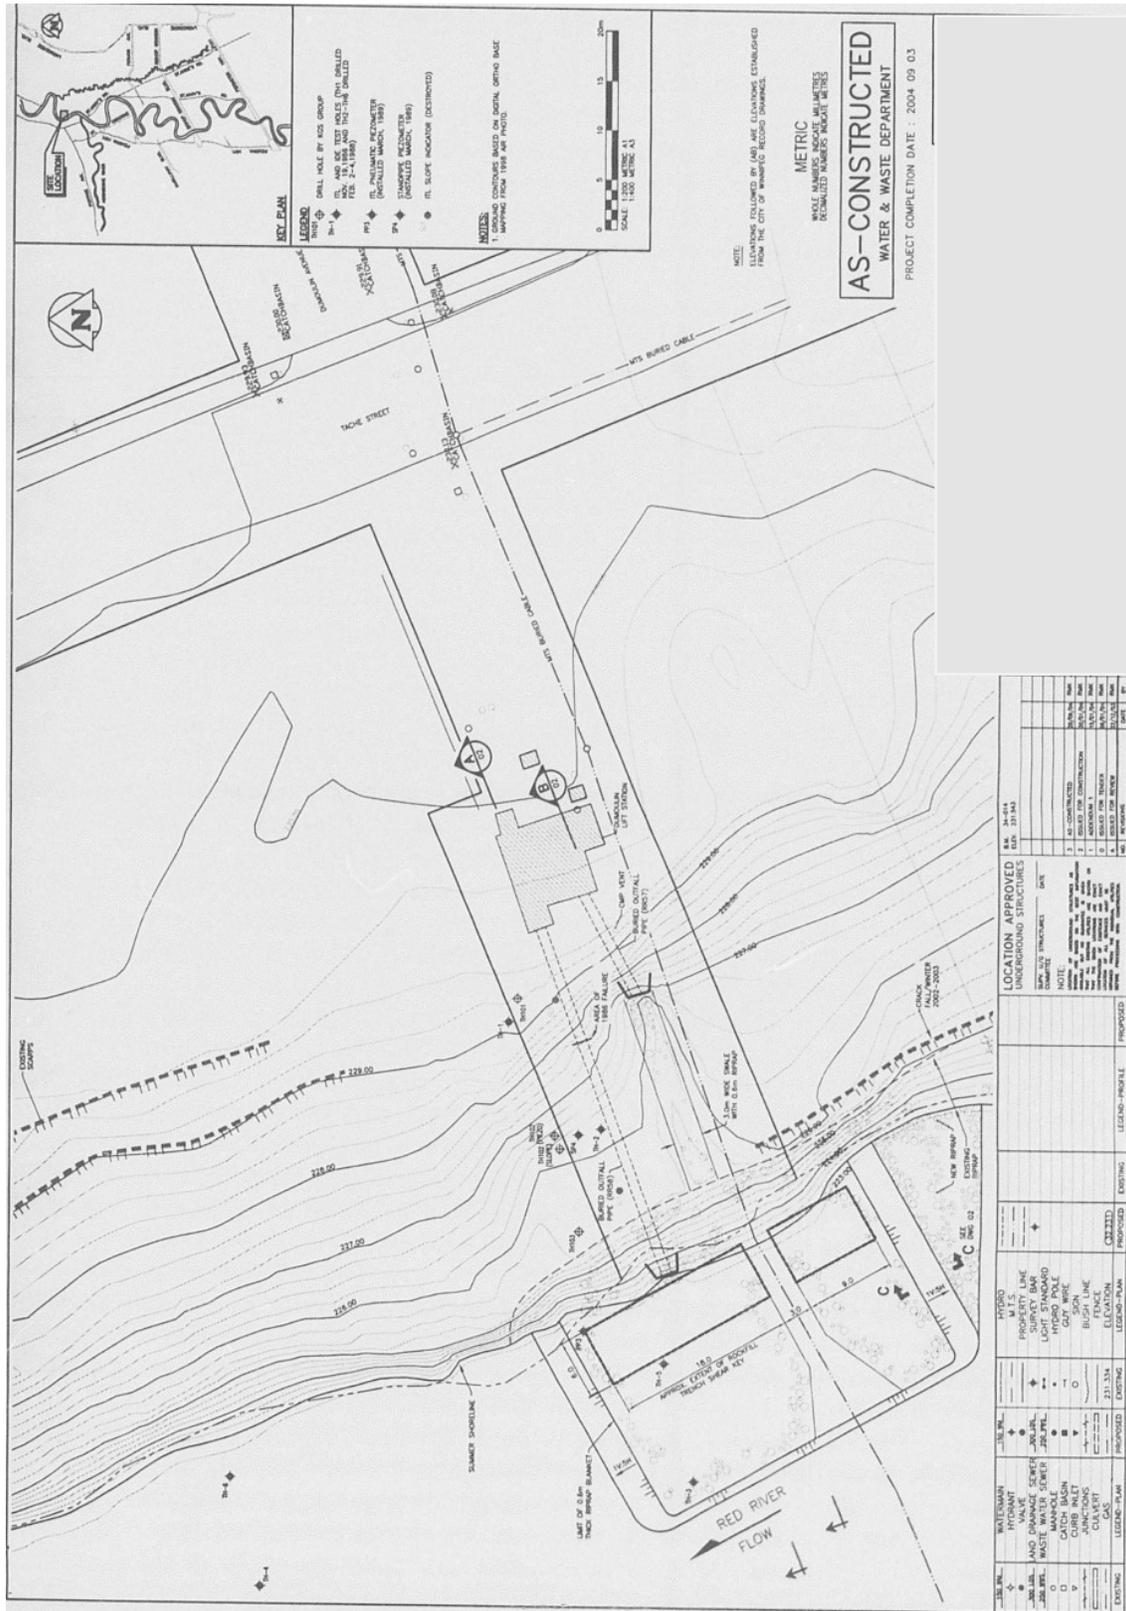
Figure A-74: Plan map of the repairs at the Rue Dumoulin site. Reproduced from KGS Group (2004), with permission.
