# ALBERTA CENTRE FOR RECLAMATION AND RESTORATION ECOLOGY NOTES

## Prioritization can improve cost effectiveness of seismic line restoration

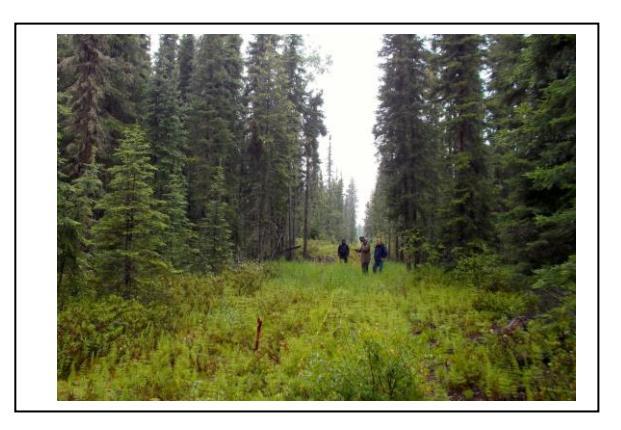
**Fig. 1** Ground photo illustrating typical vegetation conditions along legacy seismic lines in the boreal forest of Alberta. Many lines fail to recruit trees many decades post-disturbance resulting in arrested succession.

Our results show that approximately one third of the existing seismic lines within our study landscape will fail to regenerate to a height of three metres within 50 years. Upland mesic sites showed a relatively strong ability to regenerate on their own (passive restoration), while lowland (bogs and fens) and upland dry sites were slow to recover. This suggests that active forms of restoration are required to speed vegetation recovery.
