28 Downie Slide, British Columbia, Canada

KATHERINE S. KALENCHUK, D. JEAN HUTCHINSON, MARK DIEDERICHS, AND DENNIS MOORE

ABSTRACT

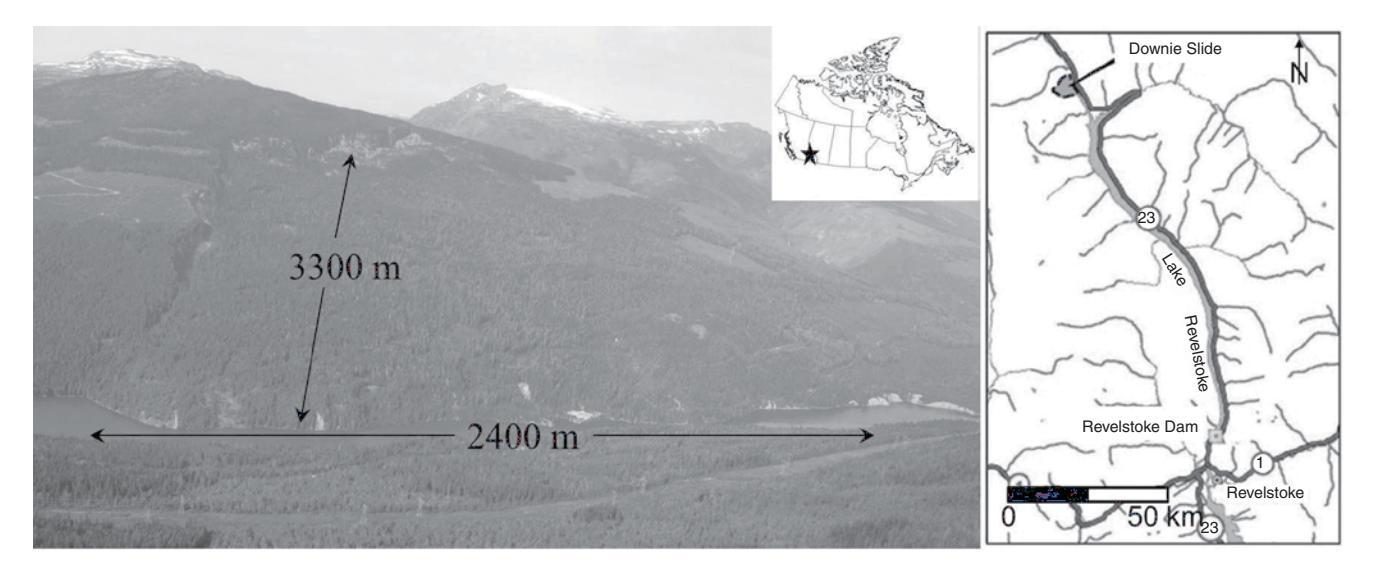
Fig. 28.1. Left: Overview photo of Downie Slide viewed from the east side of the valley, August, 2008. Right: Location of Downie Slide, north of the town of Revelstoke, British Columbia, Canada.

Downie Slide, the largest known active slope instability in the world, is located 64 km north of the Revelstoke Dam on the west bank of the Revelstoke Reservoir, in the Columbia River valley, British Columbia, Canada (Fig. 28.1). This massive, active, composite, extremely slow-moving rockslide has a volume of 1.5 billion m³. It measures 3300 m from toe to head scarp and 2400 m along the toe, with a maximum thickness of approximately 250 m. Downie Slide is thought to have been initiated by glacial retreat, approximately 10,000–12,000 years ago (Piteau *et al.*, 1978; Brown and Psutka, 1980). Total slope displacements are estimated between 250 and 300 m (Patton and Hodge, 1975), but there is no evidence that the slide failed rapidly or blocked the valley (BC Hydro, 2010).

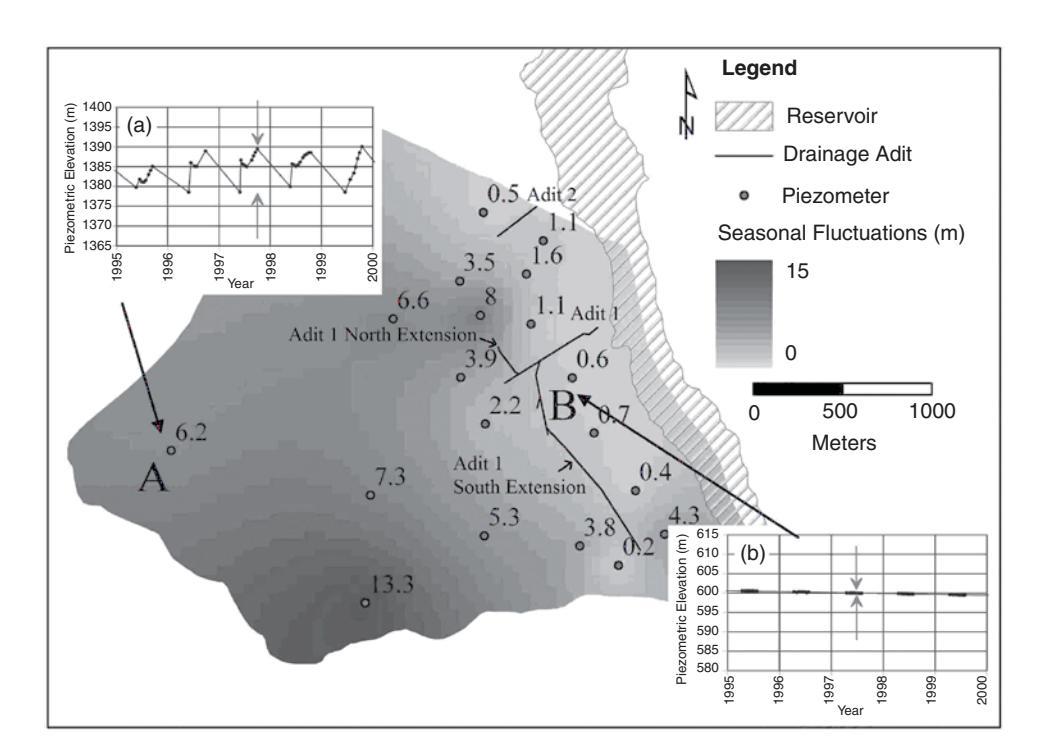
Fig. 28.3. Spatial variation in the magnitude of seasonal groundwater fluctuations in the upper water table at Downie Slide. Data from point A show high seasonal fluctuations near the head scarp recharge zone; and data from point B show very little annual variation (from Kalenchuk *et al.*, 2009a). The lower water table shows similar trends.

Groundwater levels peak seasonally between May and August, first at lower elevations and later in the year within the higher regions of the slope. Water levels decline through the fall, and minimum levels are reached during the winter months. The magnitude of seasonal fluctuations differs spatially (Fig. 28.3). Typical water table fluctuations on the upper part of the landslide are of the order of 10 m, but they locally exceed 25 m and, in rare instances, can be up to 85 m. These high-amplitude seasonal variations are controlled by infiltration in the highly fractured and dilated upper region of the landslide, which is a recharge zone. No streams cross this area. Through the central portion of the slope, 5-m fluctuations are normal, and near the toe, seasonal variations are nearer 1 m. Streams are observed through these regions, where infiltration is limited by thick ground cover. The small magnitude of seasonal fluctuations near the reservoir reflects relatively steady-state reservoir levels and the influence of drainage measures.

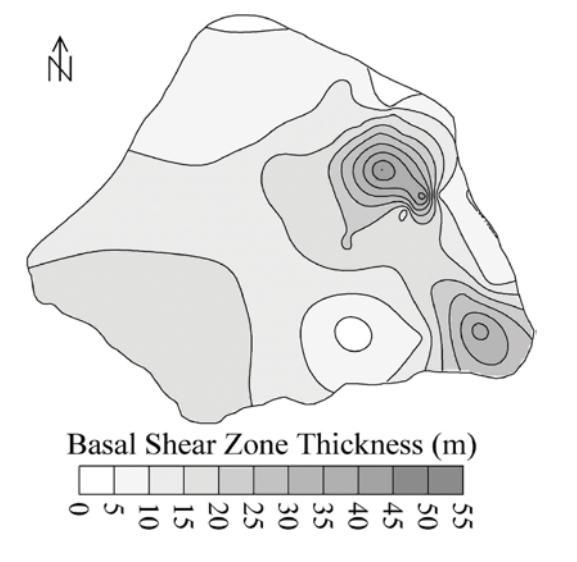
Fig. 28.4. Variability in the thickness of the Downie Slide basal shear zone.

The basal shear zone at Downie Slide ranges in thickness from less than 2 m to nearly 50 m (Fig. 28.4). The shear zone is typically thinner where slip surfaces follow foliation planes, and thicker where the shear cross-cuts foliation; these differences contribute to spatial variation in the magnitude of deformation observed across Downie Slide. Numerical modeling by Kalenchuk *et al.* (2012b) assumes that thin regions are effectively stiffer than thicker regions. Differences in shear zone stiffness induce localized stress concentrations, which contribute to complex three-dimensional slope deformation.

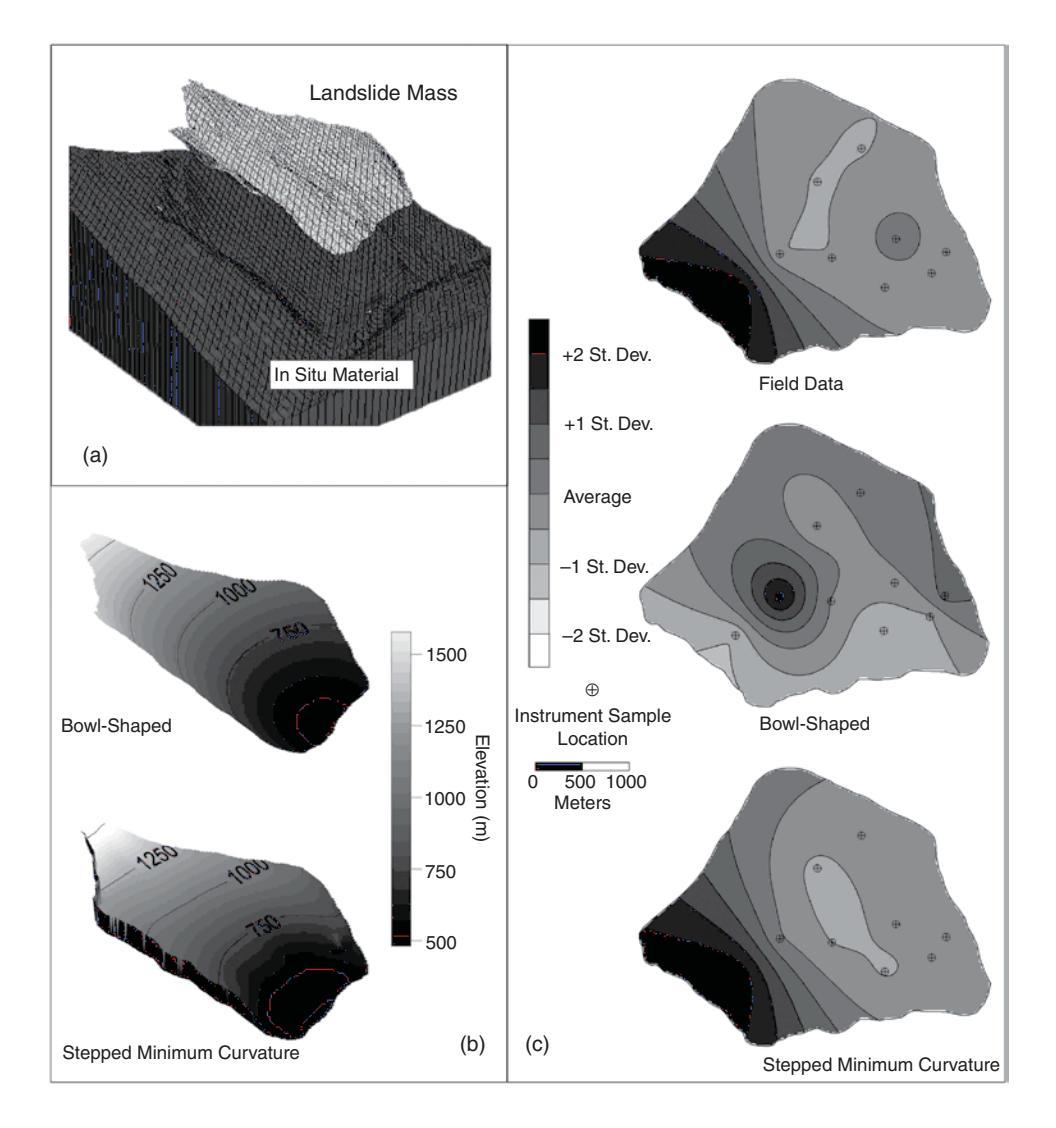
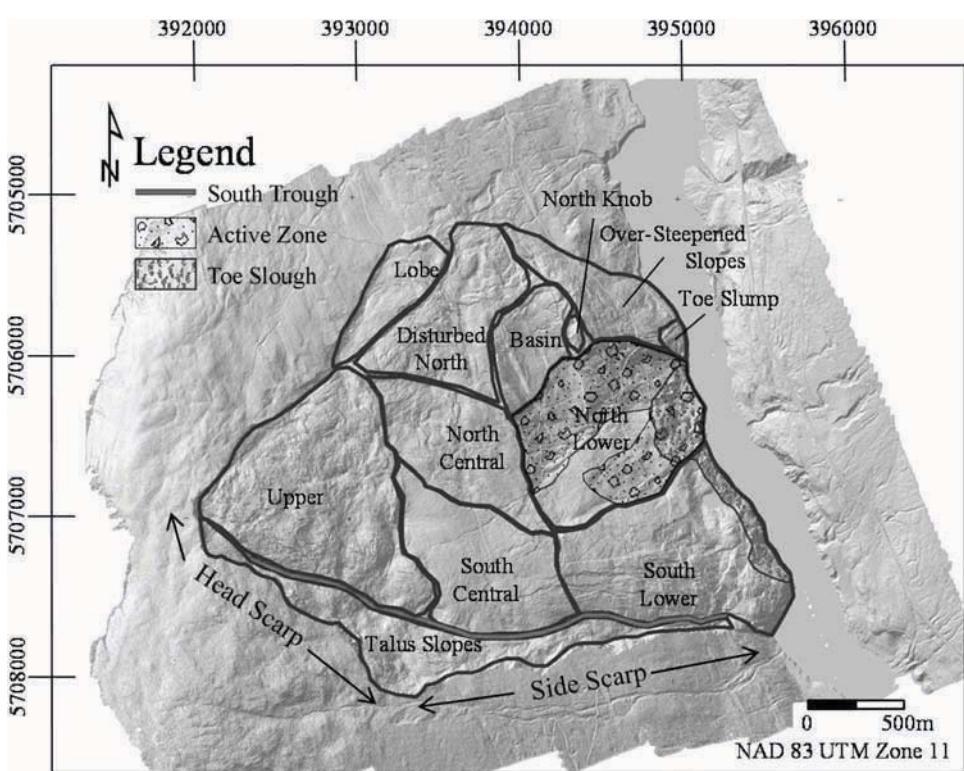
Fig. 28.5. (a) Illustration of the three-dimensional numerical model used to simulate slope behavior. (b) Three-dimensional interpretations of shear surface geometry. (c) Comparison of deformations measured in numerical models to field observations of landslide behavior. Contour plots show deformations standardized by plotting displacement rate contour intervals corresponding to the average and standard deviation of each dataset.

Figure 28.5 illustrates two different interpretations of the Downie Slide basal slip surface geometry. The first interpretation is an oversimplified bowl-shaped geometry. The second interpretation is a moderately undulating geometry, interpreted using a stepped minimum curvature algorithm. This undulating geometry is geologically reasonable for Downie Slide because the shears are associated with foliation, which has been gently warped by folding. The stepped feature along the south and west margins of the landslide matches the prominent side and head scarps, although it should be noted that the true depth of

Figures 28.5 and 28.8 illustrate spatial variation in the behavior of Downie Slide. With the exception of surficial instabilities near the reservoir, the highest deformation rates are on the upper part of the slope; the central region of landslide has the lowest rates; and moderate rates are observed near the toe.

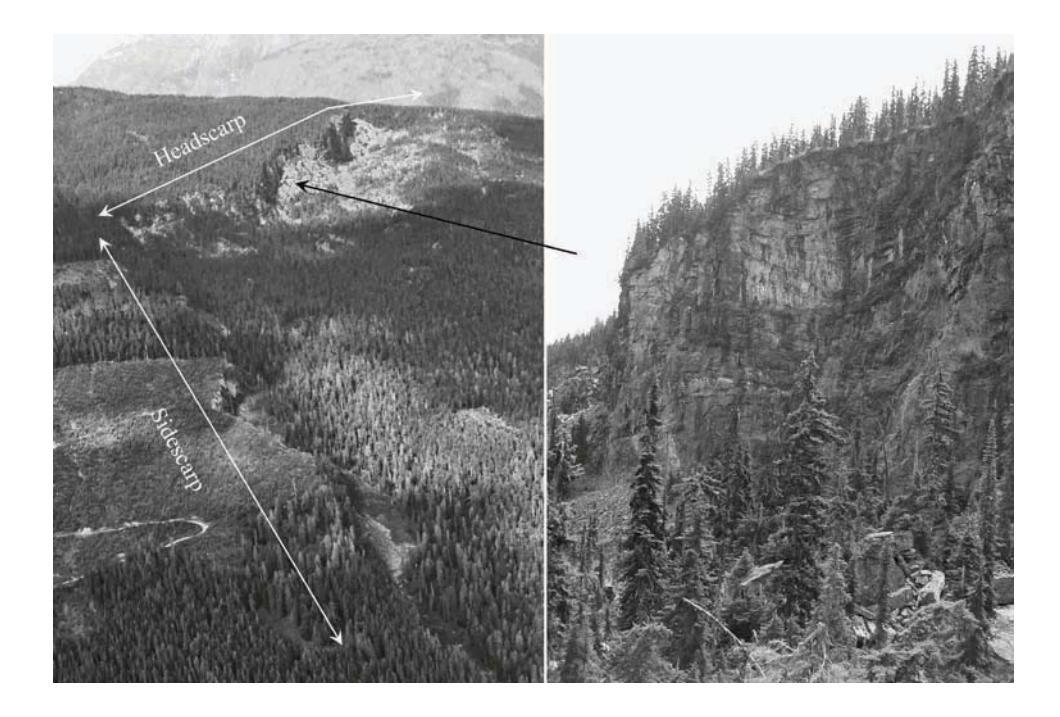
Fig. 28.7. Left: View of the Downie Slide scarps, looking west. Right: The prominent head scarp reaches heights of up to 120 m.

Downie Slide is bounded to the south and southwest, respectively, by prominent side and head scarps (Fig. 28.7). These scarps are near-vertical and reach heights up to approximately 120 m. The west limit of the head scarp coincides with the hinge zone of a major monoclinal flexural fold associated with Phase 3 deformation (Brown and Psutka, 1980). The north landslide boundary, which can be clearly recognized in LIDAR imagery (Fig. 28.6), has a distinct northeast-trending linear alignment. Where this boundary curves to the southeast near the toe of the landslide, streams continue to flow northeast toward the river valley. This linearity suggests a structural control on the location of the north landslide boundary.

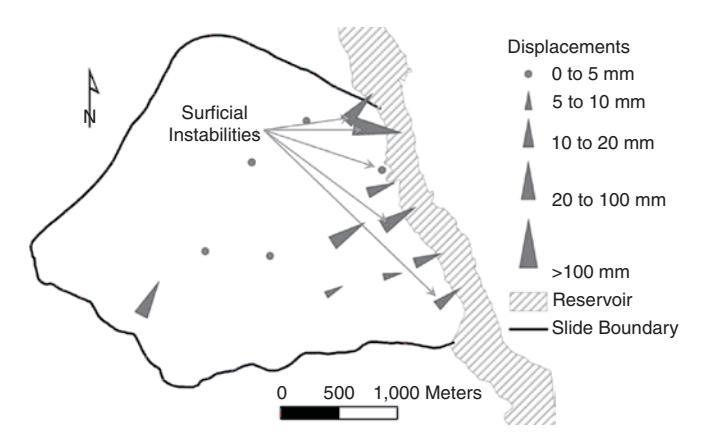
Fig. 28.8. Annual displacements defined by deformation measured since impoundment of the Revelstoke Reservoir (data from 1985–2003).

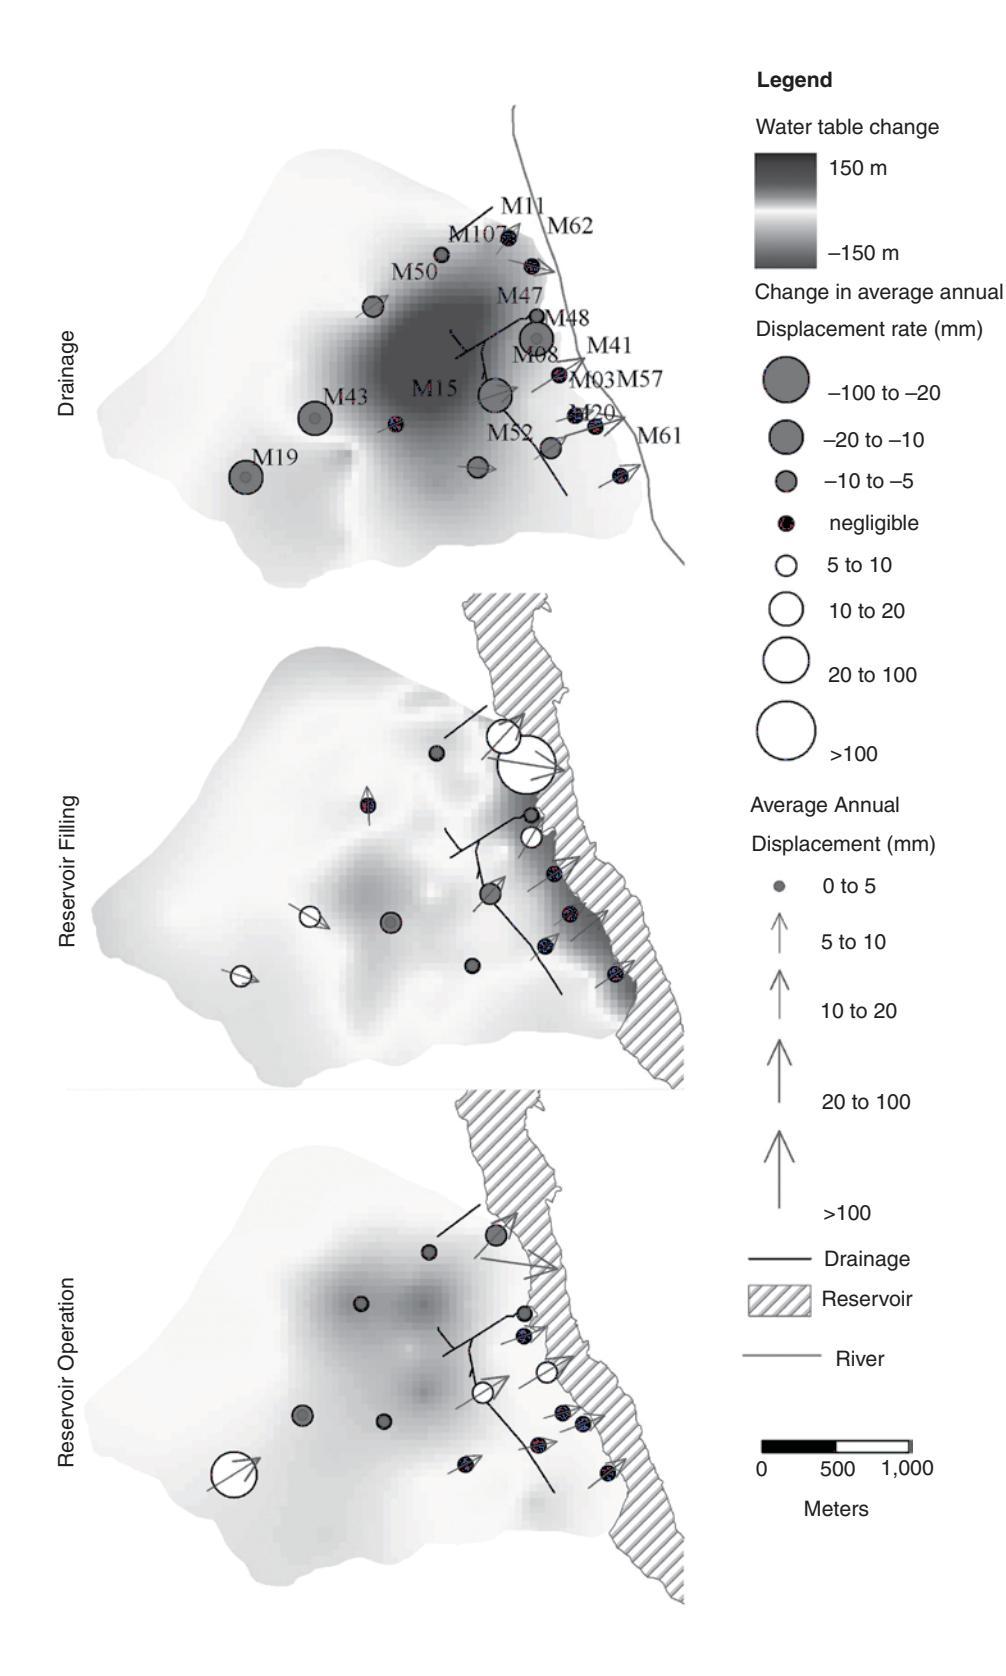
Groundwater levels have a strong influence on the behavior of Downie Slide (Fig. 28.9), and have changed in response to

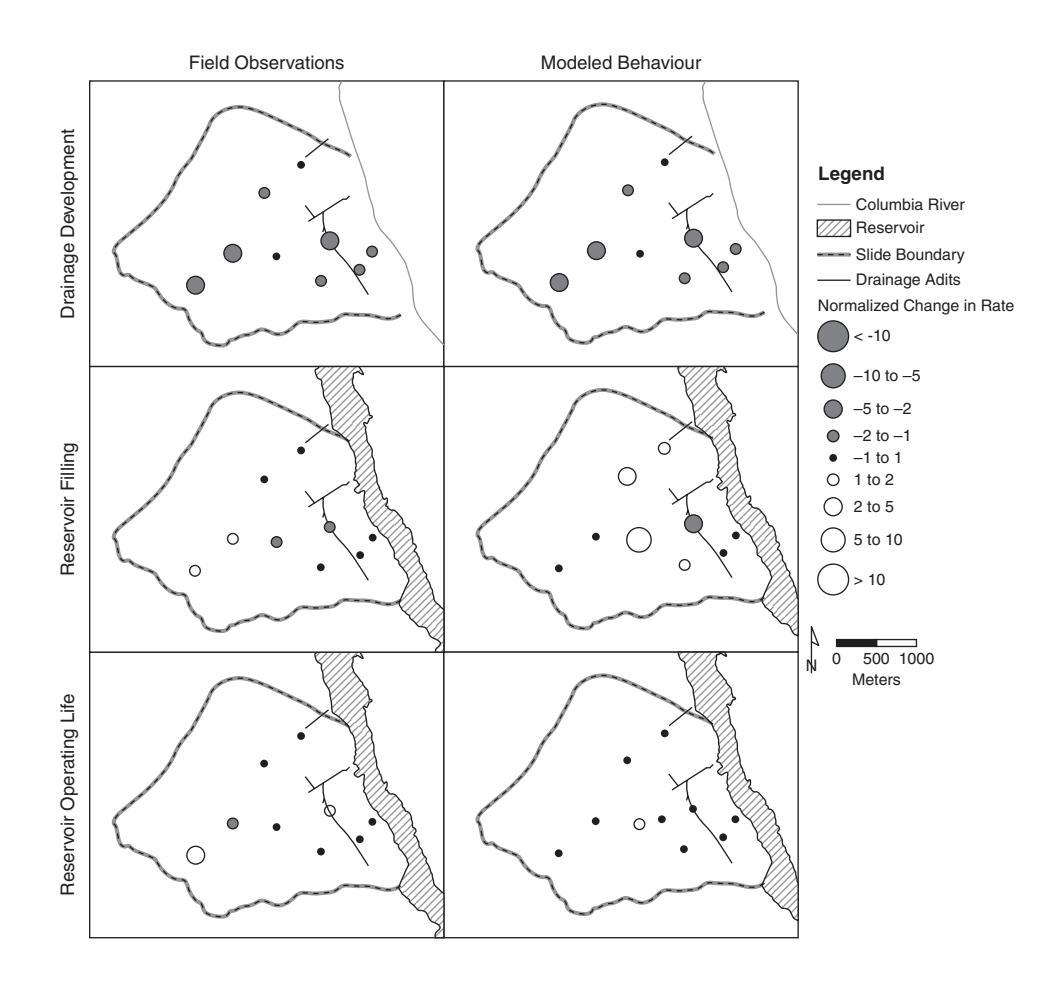
Numerical simulation of changing groundwater conditions yielded reasonable correlations with field observations (Fig. 28.10). Specifically it simulated:

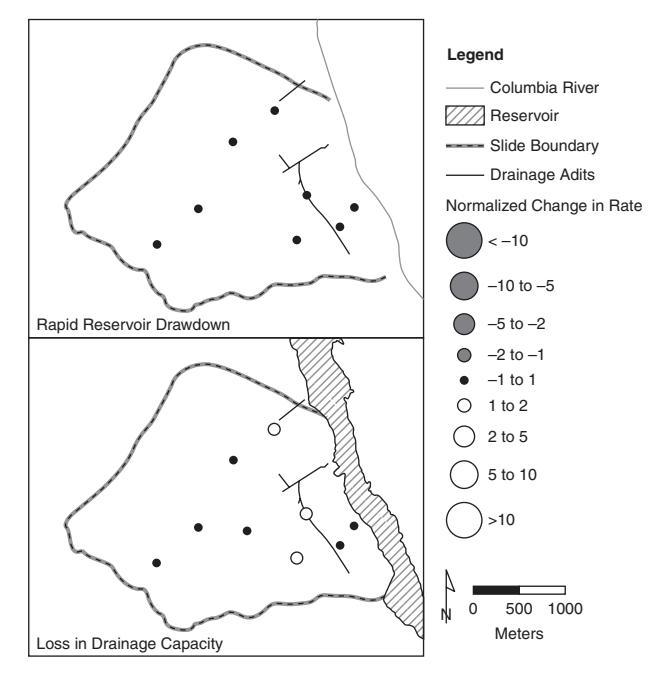
Fig. 28.11. Sophisticated numerical models have been used to forward test potential trigger scenarios at Downie Slide; hypothesized deformation rate change in response to (top) rapid reservoir drawdown, and (bottom) total loss of drainage capacity (after Kalenchuk, 2010).

opposite direction, as those observed during the original installation of the drainage system. Although total failure of the drainage system is extremely unlikely, particularly with continued site maintenance, simulations indicate that this worst-case scenario would only cause minor slope accelerations, at a maximum at the low end of the range of very slow slides.
