BIAXIAL MONOTONIC AND FATIGUE BEHAVIOUR OF A
MULTIDIRECTIONAL GLASS FIBRE REINFORCED EPOXY PIPE

A thesis submitted to the Faculty of Graduate Studies in partial fulfillment of the
requirements for the degree Masters of Science

Department of Mechanical Engineering

Spring, 1999

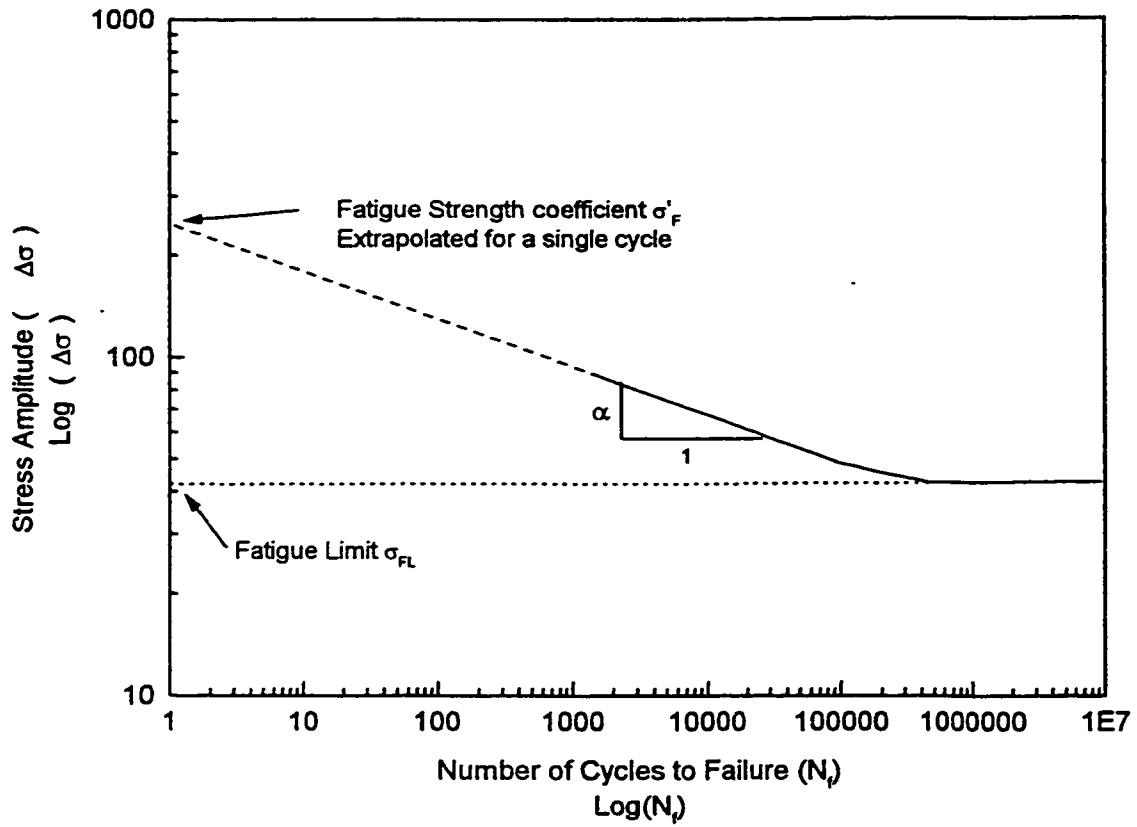
Figure 1-2: Graphical illustration of the S-N curve based on steel. Shows the characteristic fatigue life performance of a material.

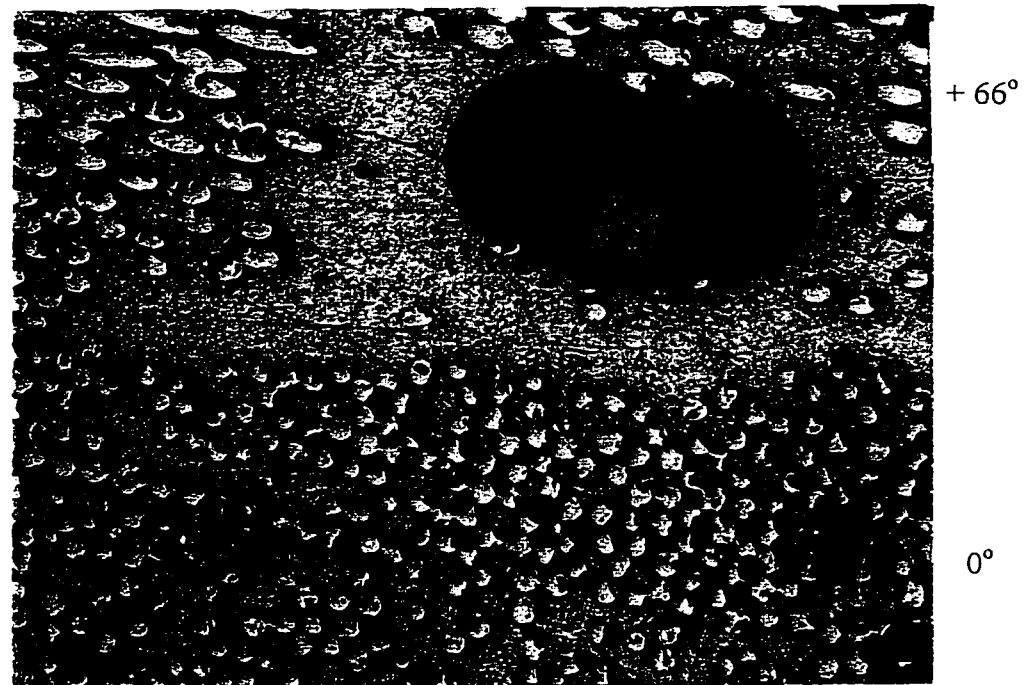
Figure 2-8b: A segment of the cross-section of the pipe, seen in Figure 2-4, magnified 440x, note the excess resin (white areas) between the layers.

Micrographs were taken of a representative cross-section, shown in Figure 2-4, of the multidirectional pipe at 40 times magnification, as illustrated in Figures 2-8a and 2-9a, with the corresponding micrographs taken at 440 times magnification, as illustrated in Figures 2-8b and 2-9b. The specimens were prepared for micrographs according to Hull (1979) [40]. These micrographs illustrate the persistence of voids (porosity) within the layers with an increased void density in the 0° plies and at the ply interface. Also note the resin-rich areas and fiber packing in the 0° plies, illustrated in Figure 2-9b. Note these micrographs do not give a representative sample of the void content found in the pipe, as these micrographs are solicited cases to show the resin rich areas and fiber packing. Only an idea of the void content can be obtained from these cross-sections.

The most common micro-scale imperfections that were observed in the composite pipe were voids (porosity), which are the entrapment of air in the resin. Micrographs were taken of a representative cross-section of the multidirectional pipe at 40 times magnification, as illustrated in Figures 2-8a and 2-9a, with the corresponding micrographs taken at 440 times magnification, as illustrated in Figures 2-8b and 2-9b. These micrographs illustrate the persistence of voids (porosity) within the layers with an increased void density in the 0° plies and at the ply interface. Also note the resin-rich areas and fiber packing in the 0° plies, illustrated in Figure 2-9b.

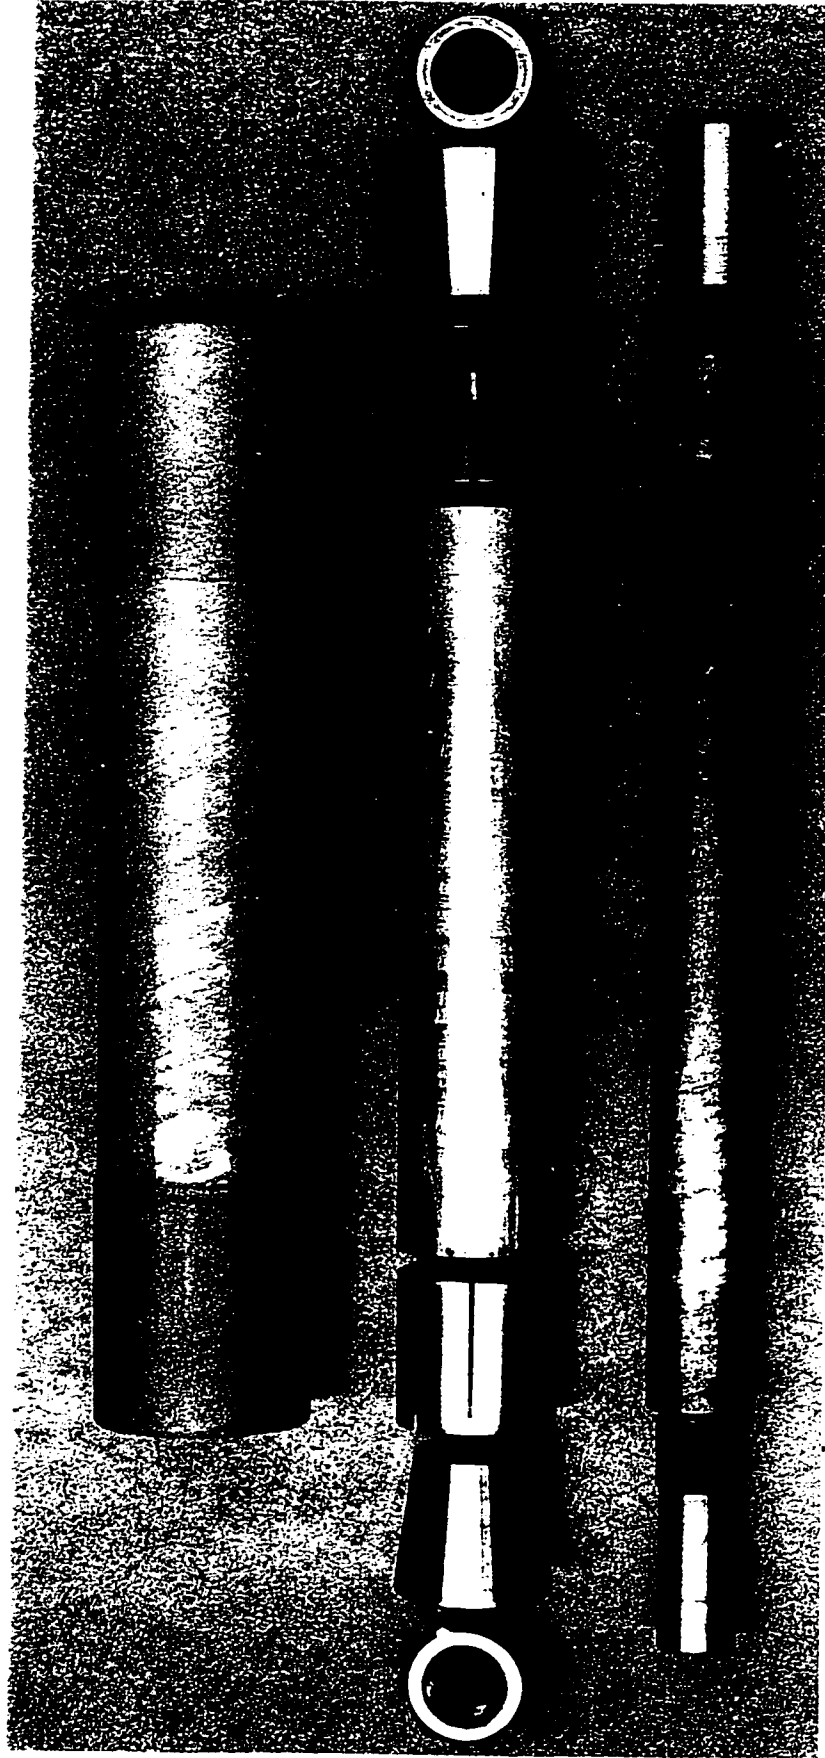
Figure 3-7: A photograph of the disassembled mandrel used to centering the specimen for indexing and machining.
