THE UNIVERSITY OF ALBERTA

LAY-UP AND RATE EFFECTS ON FIBREGLASS/EPOXY  
LAMINATES AND TUBULARS

A THESIS  
SUBMITTED TO THE FACULTY OF GRADUATE STUDIES AND RESEARCH  
IN PARTIAL FULFILMENT OF THE REQUIREMENTS FOR THE DEGREE  
OF MASTER OF SCIENCE

DEPARTMENT OF MECHANICAL ENGINEERING

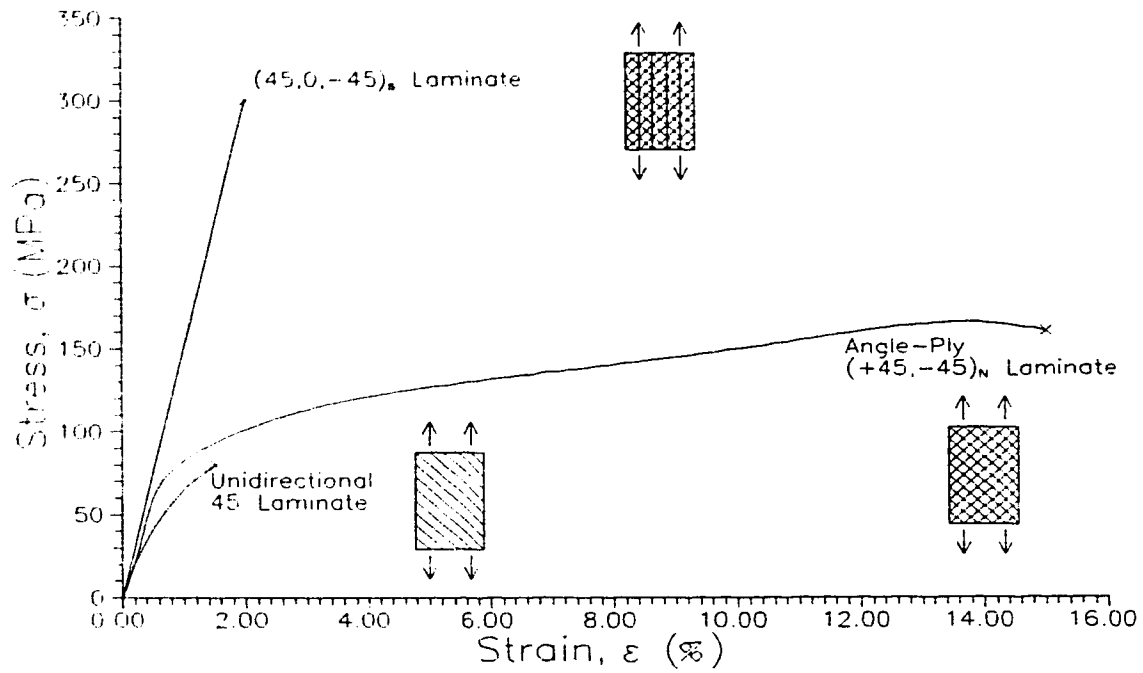
Figure 1.1 Stress-Strain Behaviour of Unidirectional 45°, Angle-Ply  $\pm 45^\circ$  and  $[45^\circ, 0^\circ, -45^\circ]_s$  Fibreglass/Epoxy Laminates

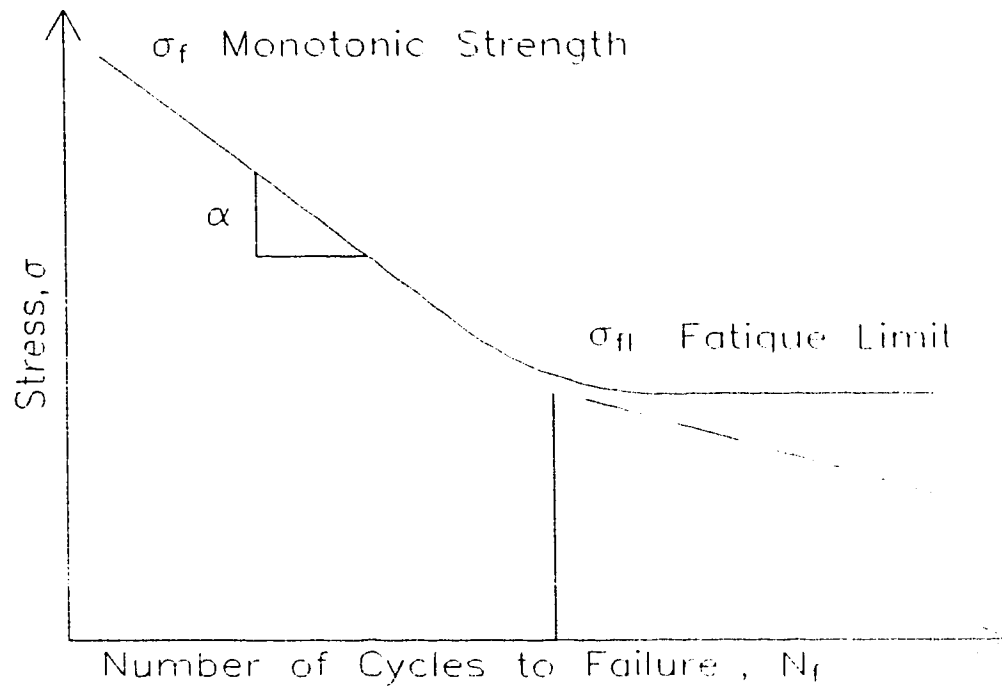
Figure 2.1 Typical S-N Curve for Metal

The classical approach to describe the fatigue life of most metals is to determine a relationship between stress and number of loading cycles to failure. This is ascertained through the performance of cyclic loading tests with a predetermined ratio of maximum stress to minimum stress and varying stress levels. Figure 2.1 shows a log-log plot of the failure stress,  $\sigma$ , with respect to number cycles to failure,  $N_f$ , which is used to characterize the fatigue life of metals. Three parameters to extract from this graph are:  $\sigma_f$ , is the intercept of the S-N curve with the y axis;  $\alpha$ , the slope of the S-N curve, and  $\sigma_n$ , the point where the S-N curve changes slope. The  $\sigma_f$  parameter may be approximated to the monotonic strength,  $\alpha$  is the change in the number failure cycles with respect to stress level and the fatigue limit or endurance limit,  $\sigma_n$ , marks the point where any additional decrease in stress level does not produce a failure or indicates a change in fatigue behaviour. These parameters are constant and rate independent for metals at room temperature.

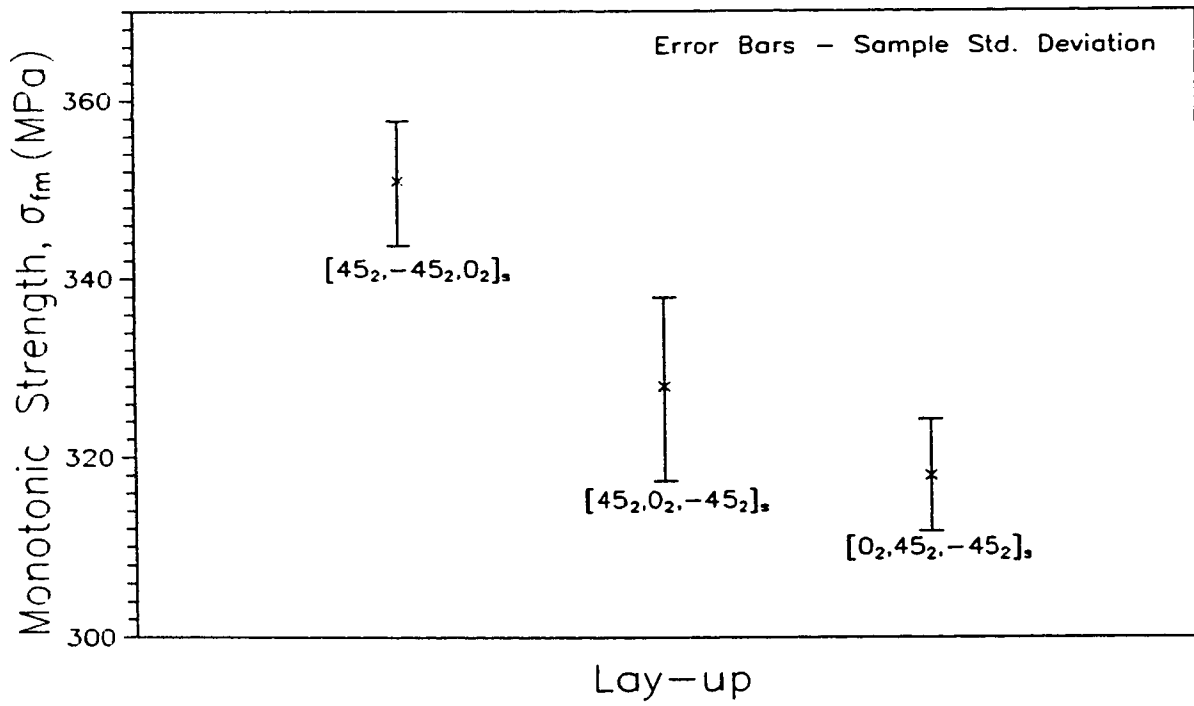
Figure 3.2 Monotonic Failure Strengths

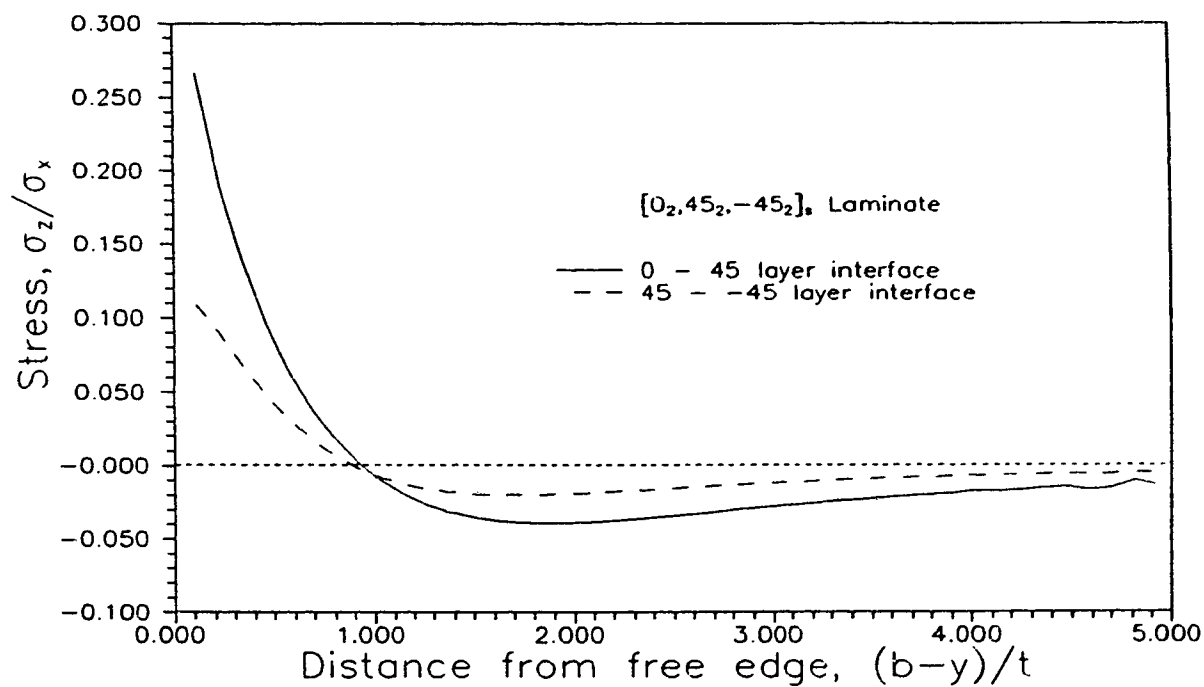
Figure 3.8 Normalized Interlaminar Normal Stress,  $\sigma_z/\sigma_x$ , Verses Distance From Free Edge,  $(b-y)/t$ , of a [0<sub>2</sub>, 45<sub>2</sub>, -45<sub>2</sub>], Laminate

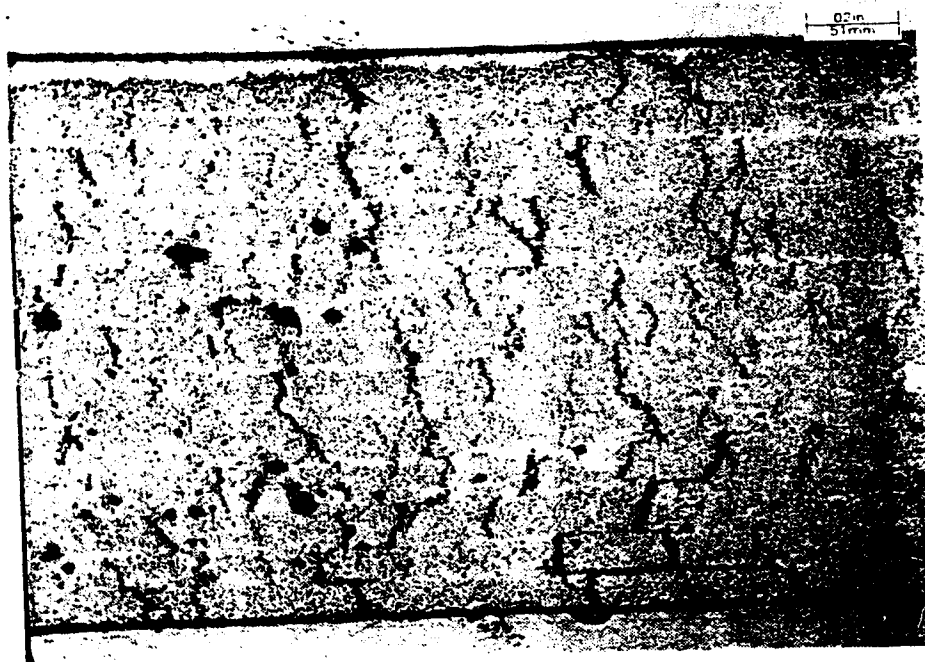
a. 0H:1A - Fast Rate

b. 0H:1A - Slow Rate

Figure 5.17 Axial Tension  $\pm 55^\circ$  Tubes - Matrix Cracking

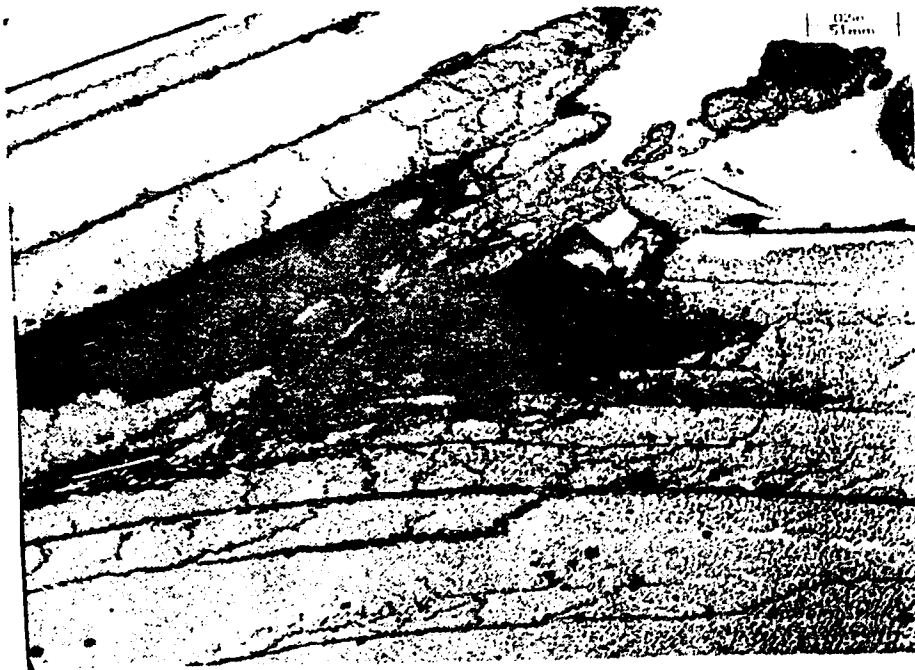
a. 0H:-1A

b. 2H:1A

Figure 5.18  $\pm 55^\circ$  Tube Failures

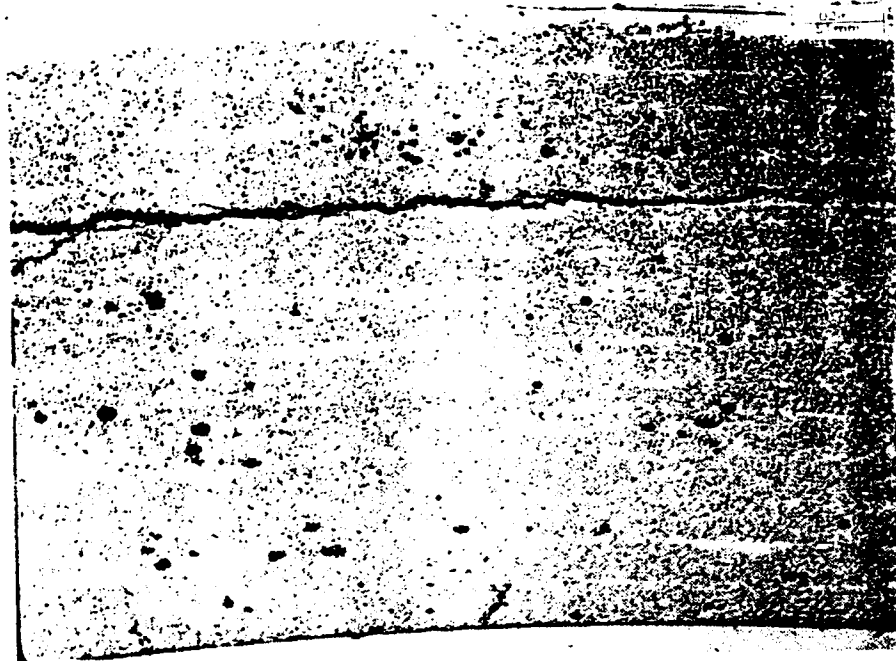
a. 2H:1A

b. 1H:0A

Figure 5.19  $\pm 55^\circ$  Tubes - Delamination

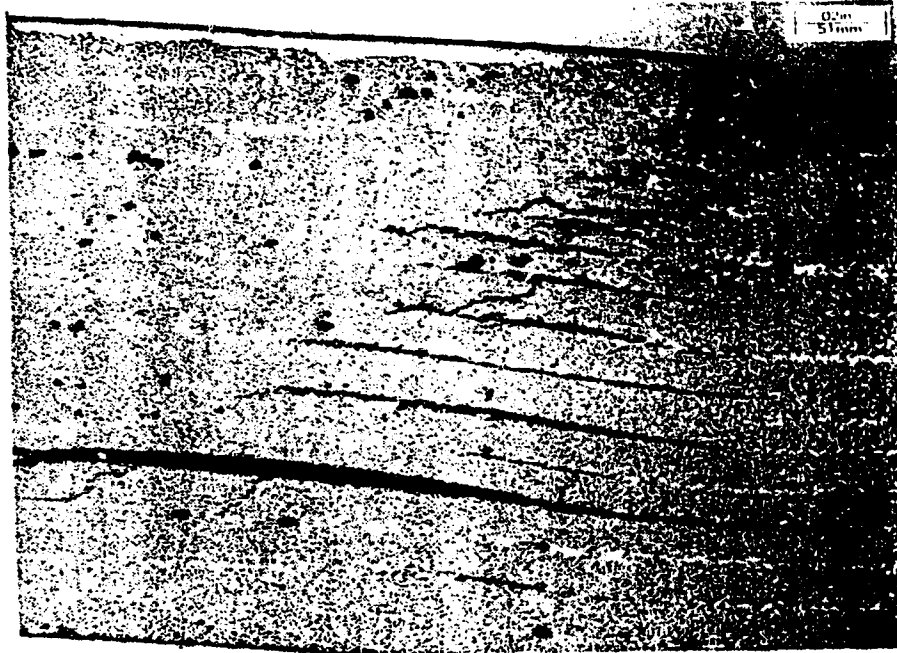
Figure 5.20 Micrograph of Grip Damage - Stress Ratio 1H:0A
