Title of Thesis: Performance of EPB-TBM in Mixed Face Conditions:
City of Edmonton South LRT Extension – University Station
to Health Sciences Station

Performance of EPB-TBM in Mixed Face Conditions:

City of Edmonton South LRT Extension – University Station to Health Sciences Station

Geotechnical Engineering

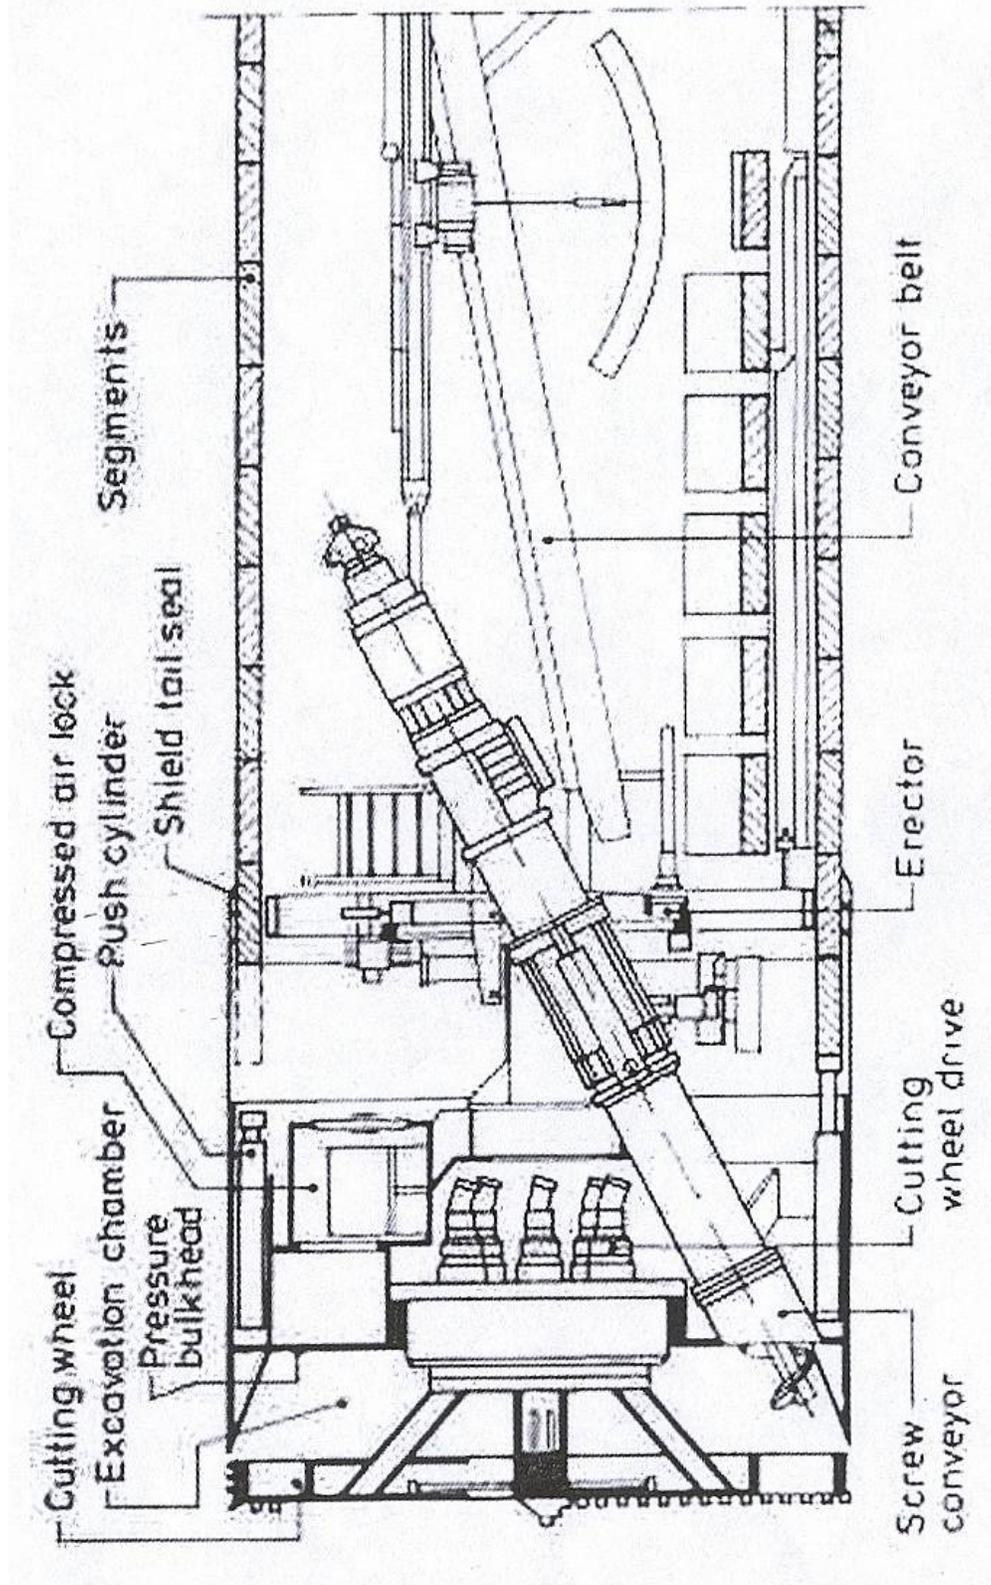
Figure 2-1 Generalised cross-section of an Equalised Pressure Balance Tunnel Boring Machine (Maidl et al., 1996)

The advance of the TBM through the ground is accomplished through the use of hydraulic rams which press against the completed tunnel lining. Once a sufficient amount of soil has been excavated, the hydraulic rams of the TBM can be retracted and the tunnel extended the length of the advance, using pre-cast concrete segments. Typical advances for EPB-TBMs are similar to open-faced TBMs, between 1 and 1.5m, depending on the design and size of the TBM. Once the construction of the tunnel lining, typically using pre-cast concrete, is complete the tunnel cycle starts over.

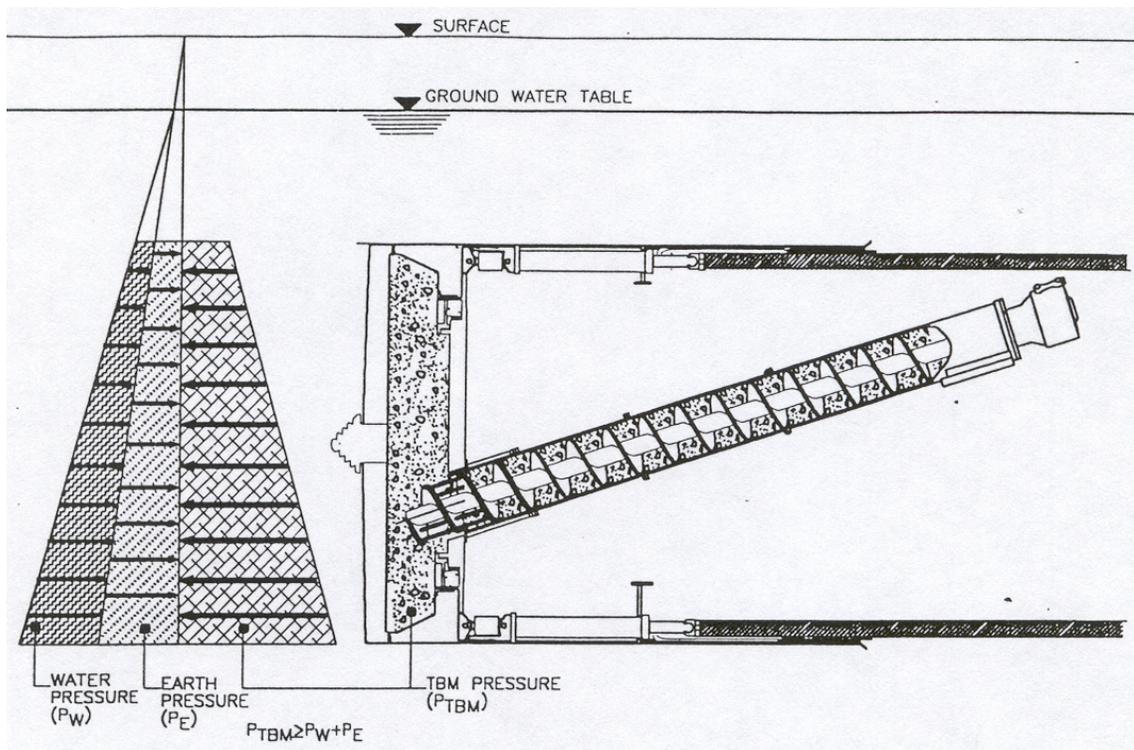
Figure 2-5 Principle of Equalised Pressure Balance (Lovat)

Ground movements ahead of the face are a function of the balance between the earth pressures in-situ and the pressures maintained in the excavation chamber of the TBM by the conditioned soil (Figure 2-5, p 14). In order to achieve complete control over the system, the pressure maintained in the excavation chamber of the TBM should be as large as the combined earth and water pressure acting on the face. However, in the operation of an EPB-TBM, the pressure maintained in the excavation chamber should be large enough to prevent the active failure of the face, and the large soil movements expected as the excavation chamber pressure nears the active failure criteria. Passive failure of the soil face will result in the heaving of the ground ahead of the EPB-TBM. This mode of failure is likely only at shallow depths, when the over-thrusting of the TBM during advance can cause the soil face to fail passively. By increasing the overburden the likelihood of this failure mode is reduced.

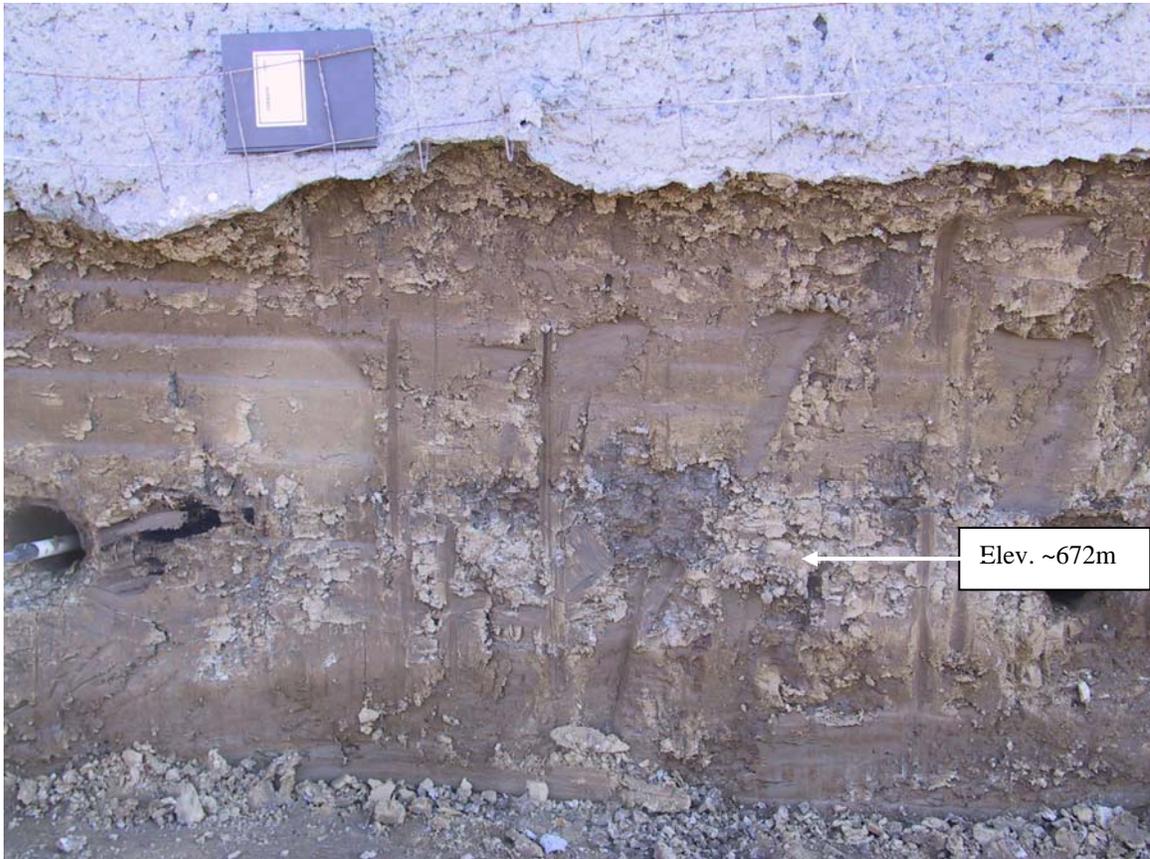
Figure 3-3 Exposed face of Lake Edmonton Clay during portal excavation, soil anchors present in left of photo at Elev. 672m.

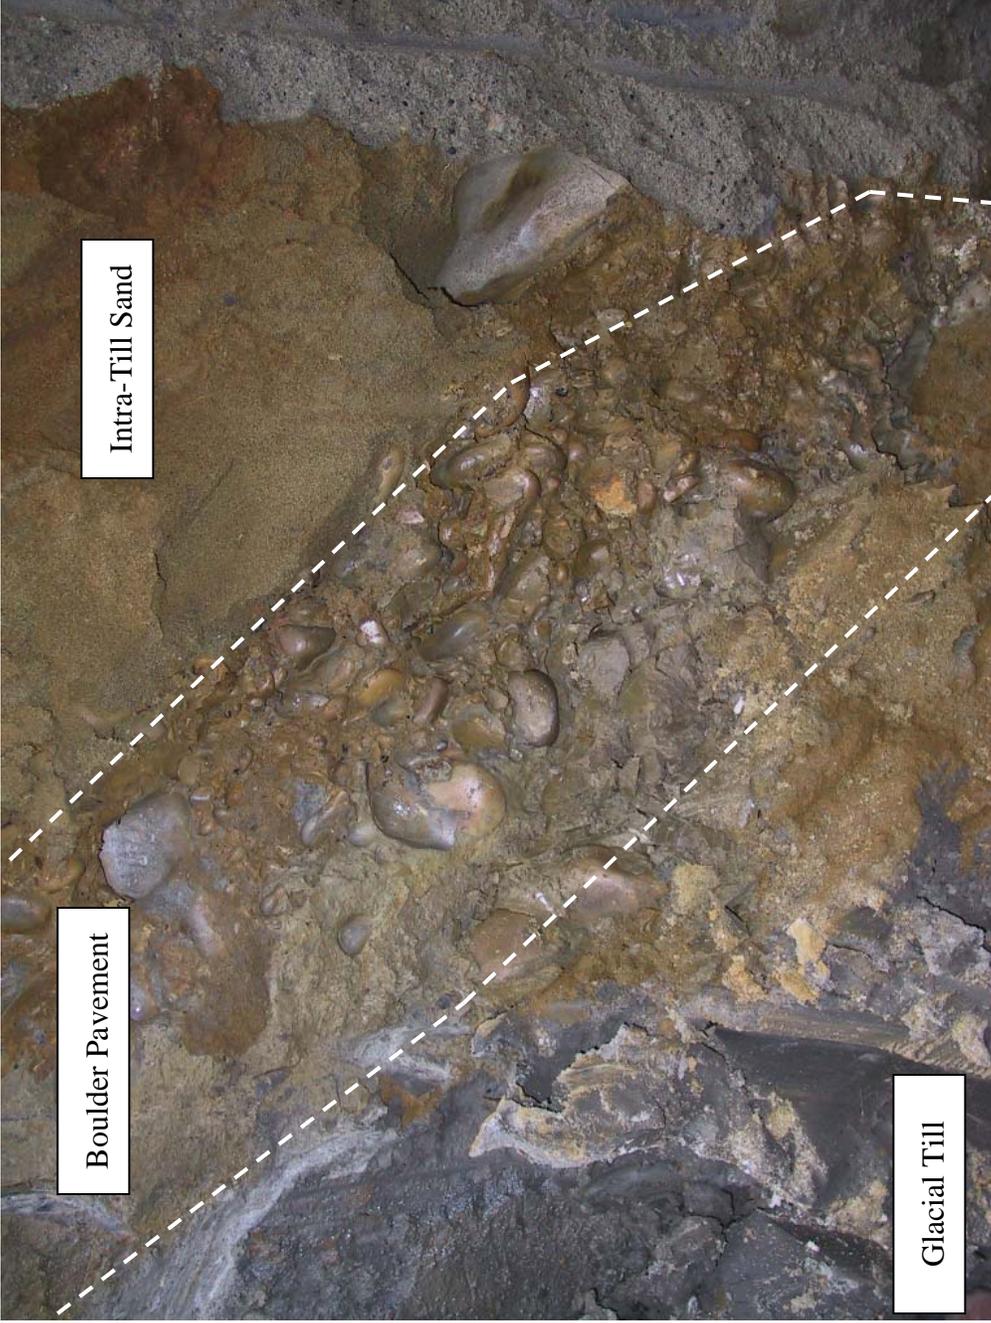
Figure 3-21 Boulder pavement at boundary of Glacial Till and Intra-Till Sands (elev. ~655m).

Figure 3-21 (p 58) illustrates a pocket of intra-till sand. Of note is the large quantity of cobbles present within the pocket. Figure 3-22 (p 59) shows two bands of intra-till sand cut in two by a layer of Glacial Till. Limited boulder pavement can be noted at transitions between the Glacial Till and the intra-bedded sands present. The thickness of the most upper intra-bedded sand layer in this Figure is in the order 0.5m. Figure 3-23 (p 60) shows a layer of intra-till sand striking through the tangent pile wall with additional, but less oxidised intra-till sands above it.

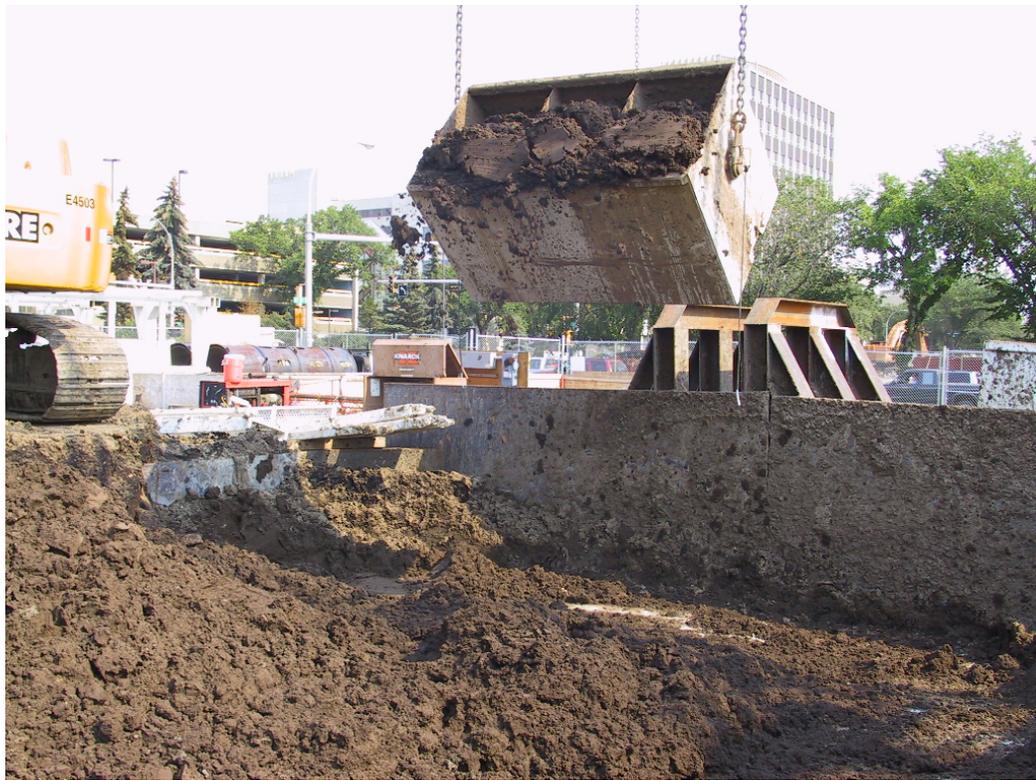
Figure 4-1 TBM spoil being dumped into muck bin.

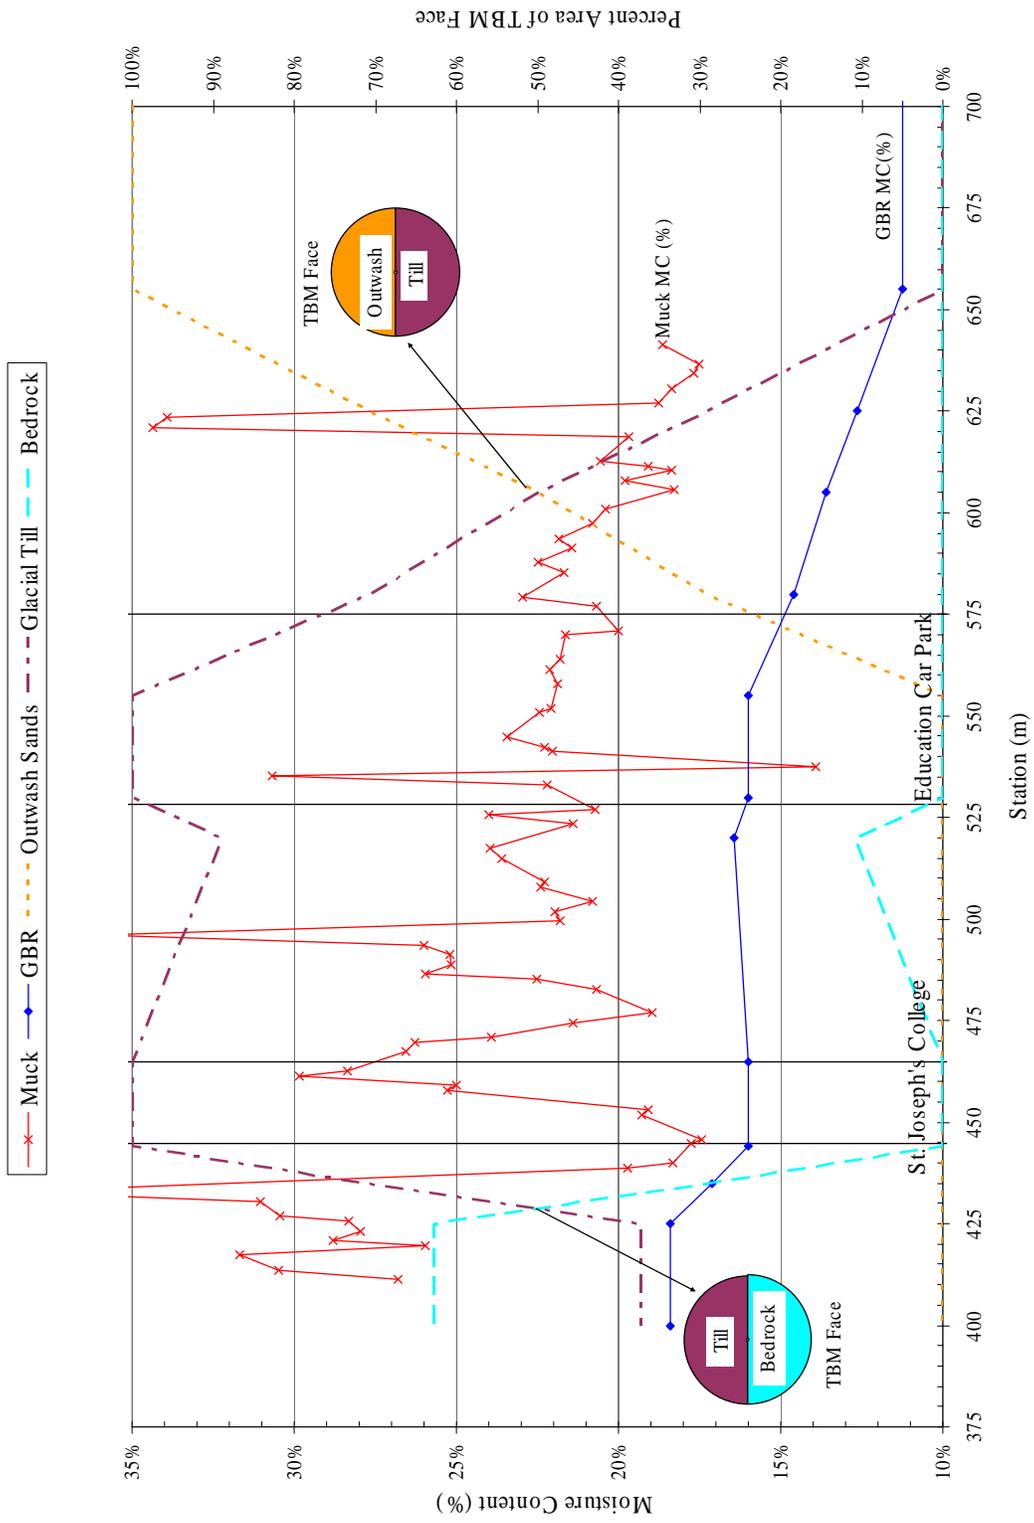
Figure 4-3 Moisture content of material excavated during construction of the Southbound LRT Tunnel and the inferred in-situ moisture content of the soil.

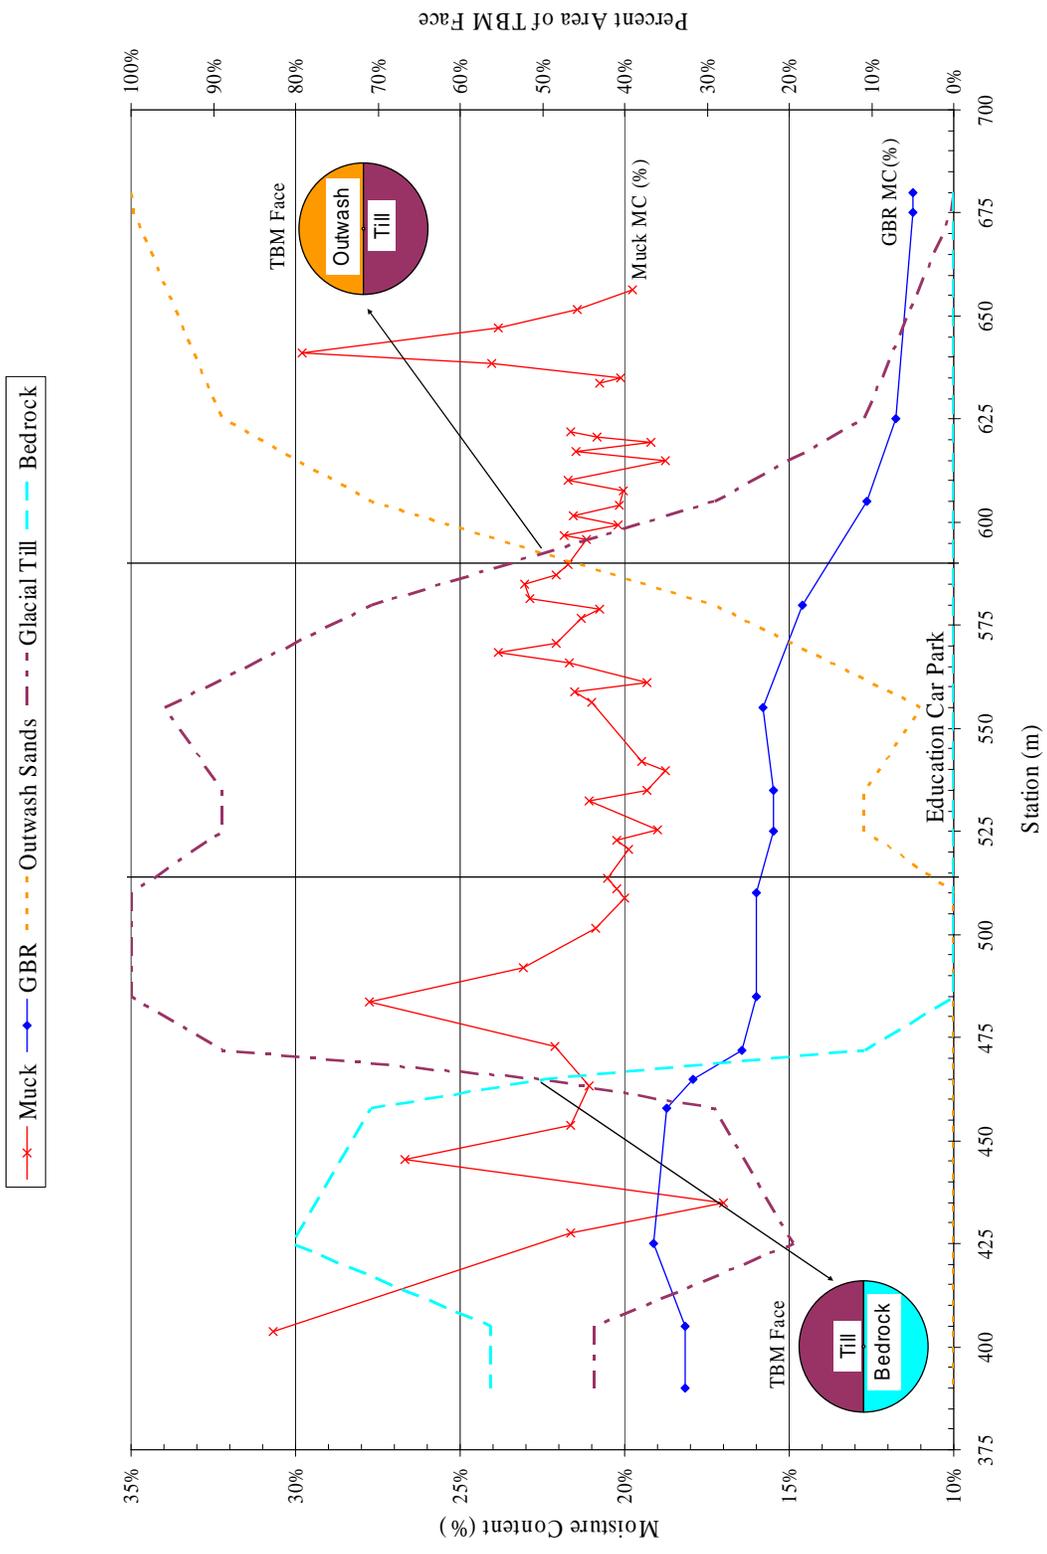
Figure 4-4 Moisture content of material excavated during construction of the Northbound LRT Tunnel and the inferred in-situ moisture content of the soil.

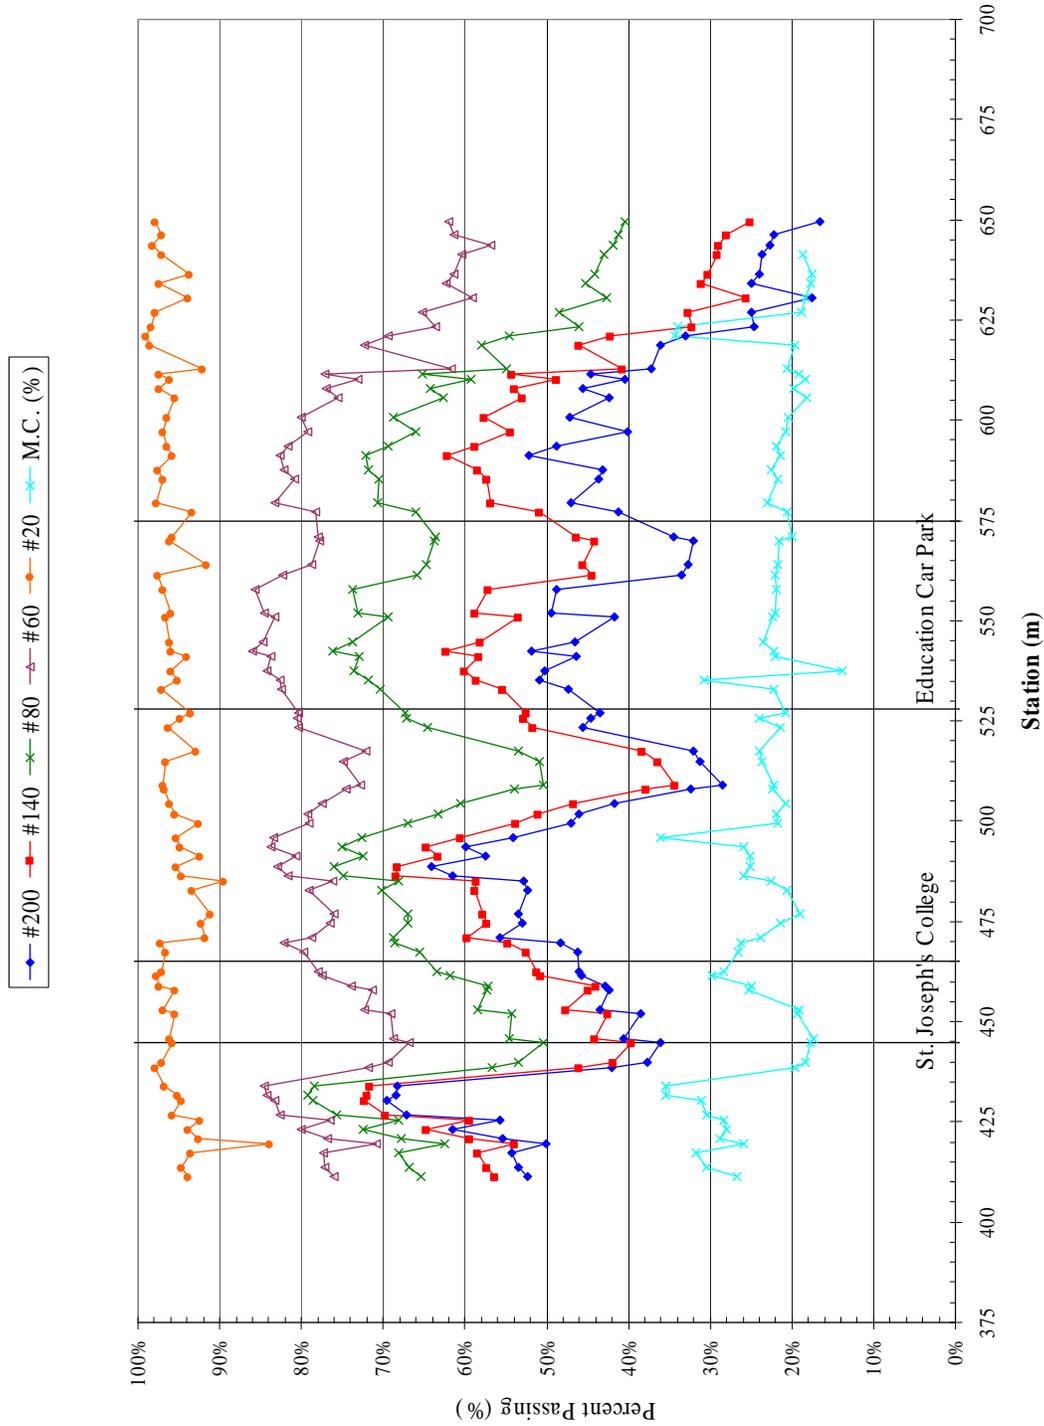
Figure 4-5 Grain size distribution and moisture content of material excavated during construction of Southbound LRT Tunnel.

In both Figures 4-5 (p 79) and 4-6 (p 80) the moisture contents of the TBM spoil were included. The general character of the spoil moisture content appeared as a subdued reflection of the fines content of the material being excavated. Aside from upsets in process control, where excessive quantities of foam were injected, examples being significant spikes in spoil moisture content at Stn. +625m, +530m, and +460m during the construction of the Southbound Tunnel, changes in the fines content of the in-situ material larger than 10% were reflected in the spoil moisture content. The more dramatic the change in fines content, the more dramatic the change in spoil moisture content.

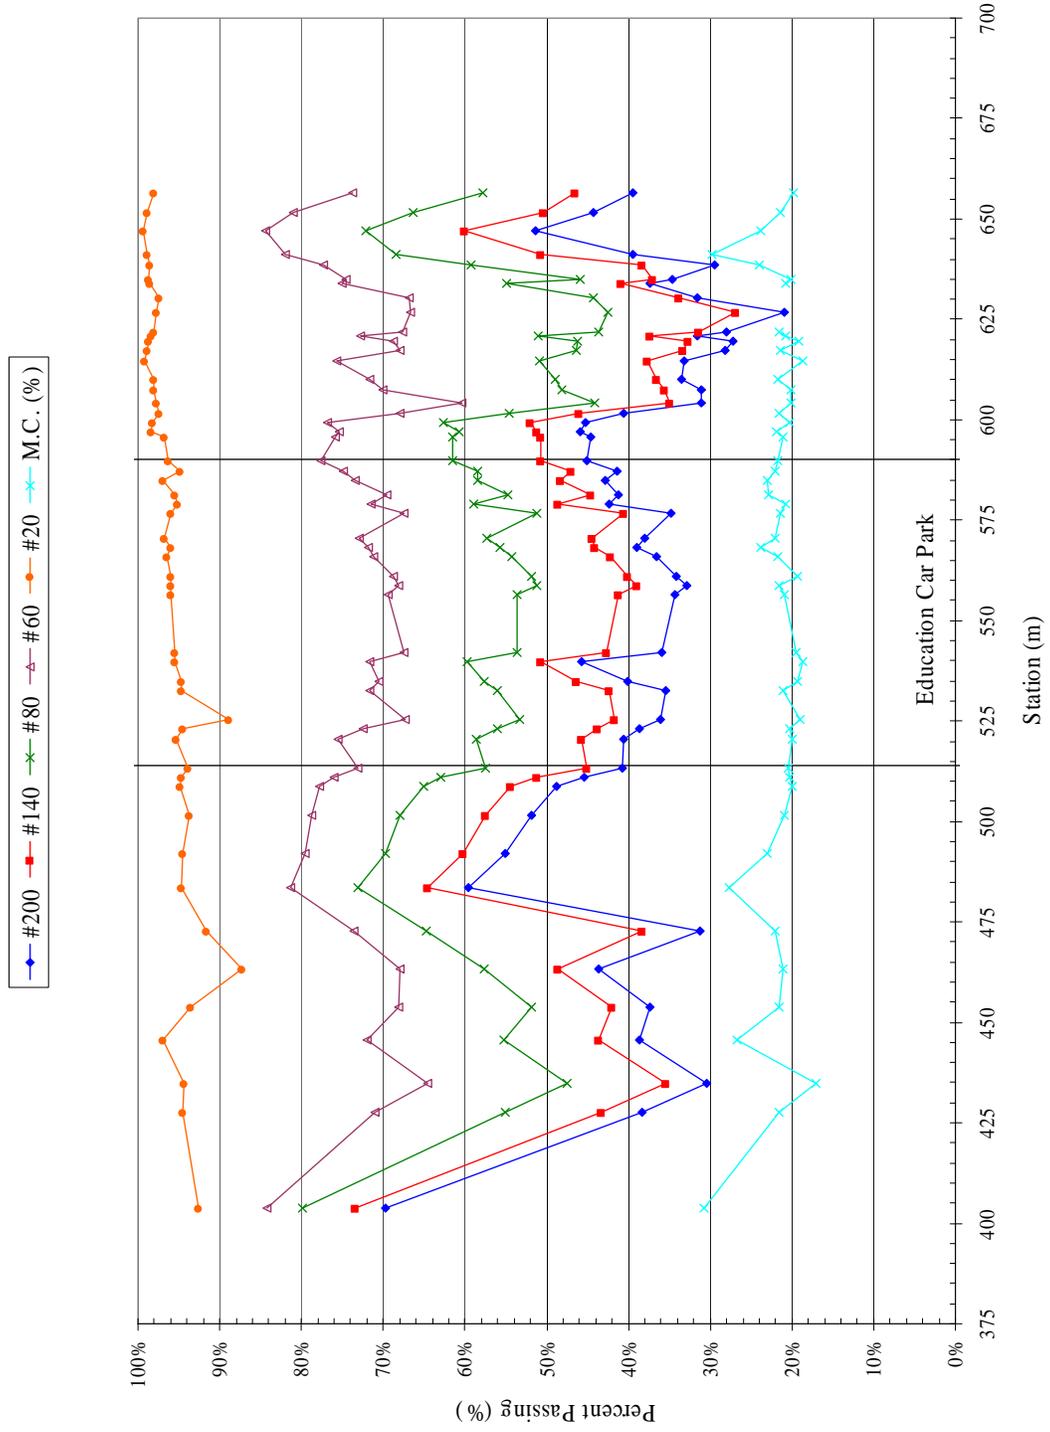
Figure 4-6 Grain size distribution and moisture content of material excavated during construction of Northbound LRT Tunnel.

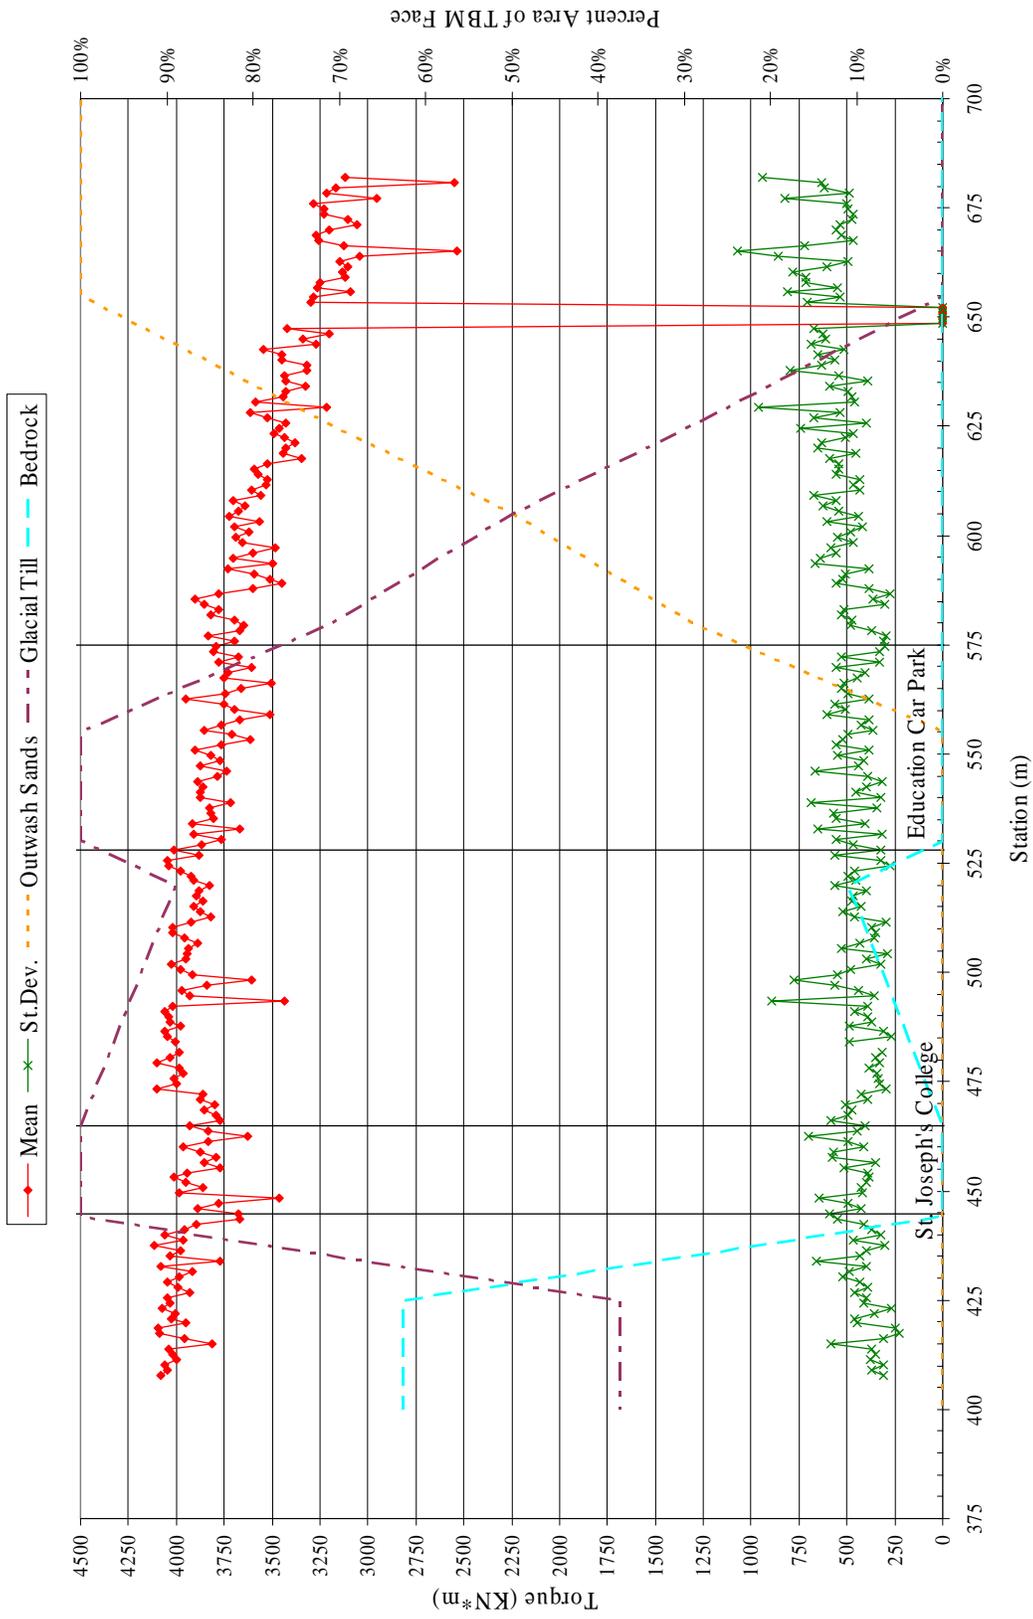
anomaly of zero torque at Stn. +650 was the result of mechanical break down and technical difficulties with the TBM.⁷ By the time contact was made with the Glacial Till at Stn. +625m, the standard deviation had decreased to ~550 KN*m. The standard deviation remains at or near this value until Stn. +600m. After Stn. +600m, the standard deviation decreased to ~500 KN*m. It remained at this order for the remainder of construction.

Figure 4-7 Cutting-head torque recorded during advance of TBM, Southbound Tunnel.

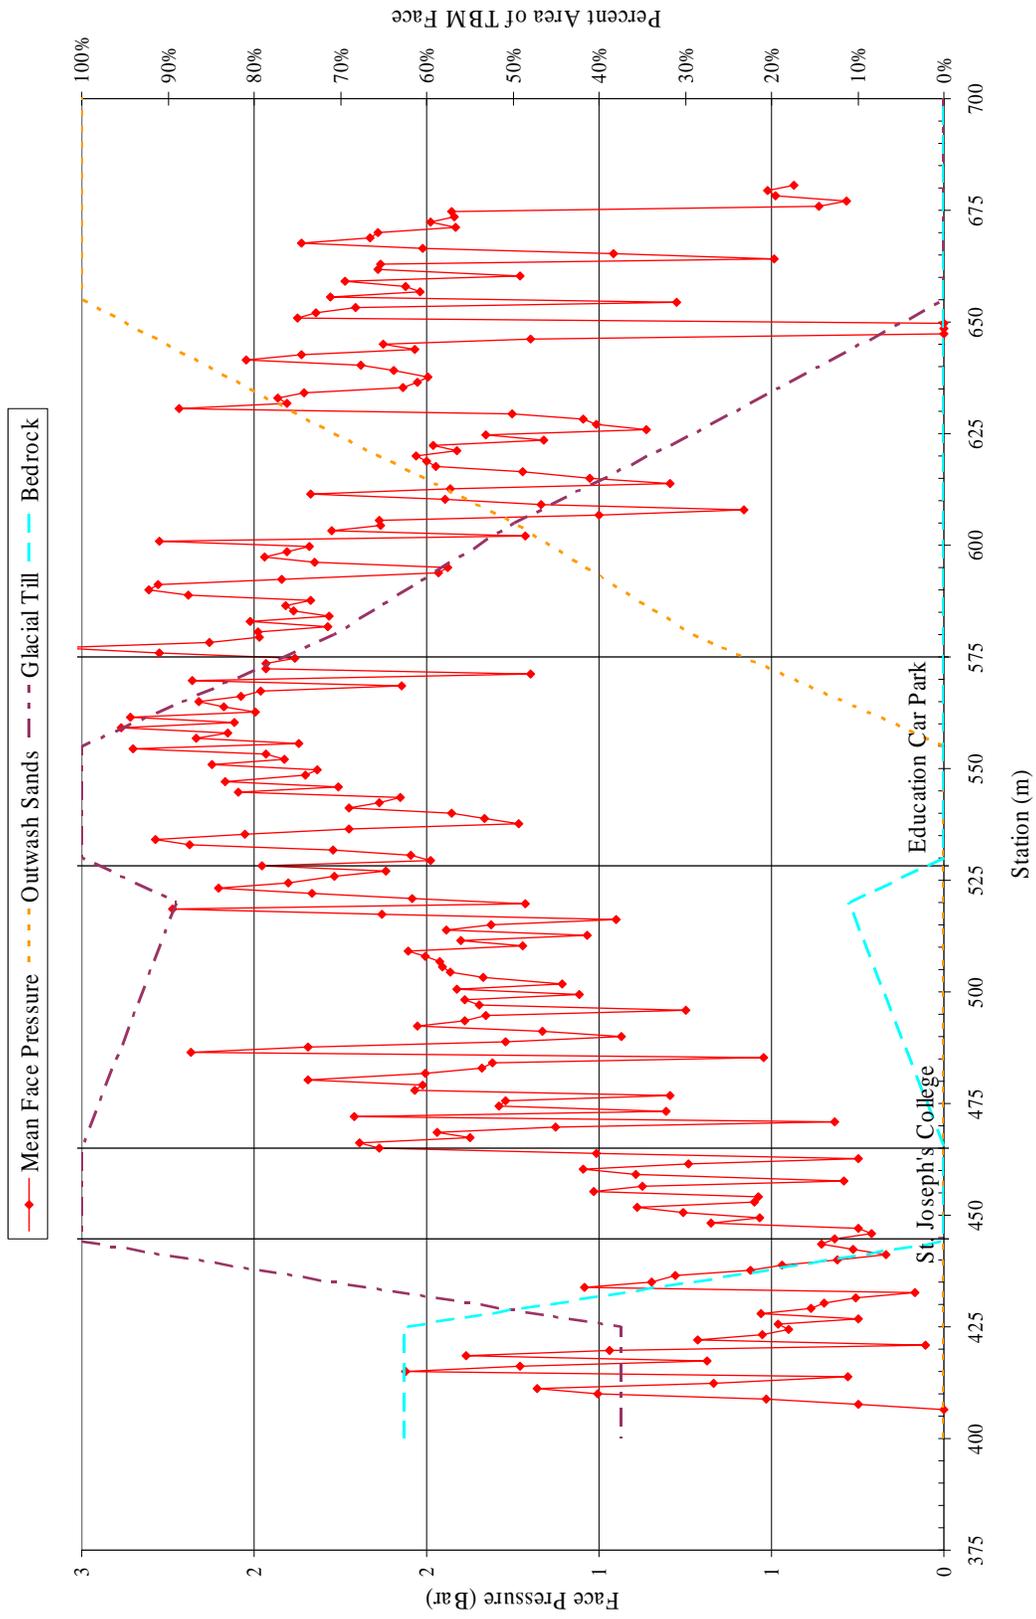
Tunnelling within the Outwash Sands and Silts between Stn. +675m and +625m, the observed mean face pressure was in the order of 1.6 bar. After making contact with the Glacial Till in the region of Stn. +625m, the mean face pressure from this point to Stn. +600m decreased to 1.3 bar. After Stn. +600m, the mean face pressure increased to a range of 1.9 to 2.1 bar from Stn. +600m to Stn. +525m. Stn. +525m marked the end of the passage underneath the Education Car Park and by this stage of tunnelling, the TBM face was full-face in the Glacial Till. From Stn. +525m to +450m, where operation was within a mixed face of Glacial Till and Bedrock, the mean face pressure decreased from 1.5 bar to 0.75 bar. The face pressures maintained after Stn, +450m to the end of construction varied greatly with most values falling between 0.25 bar and 0.75 bar.

Figure 4-8 Face Pressure recorded during advance, Southbound Tunnel.

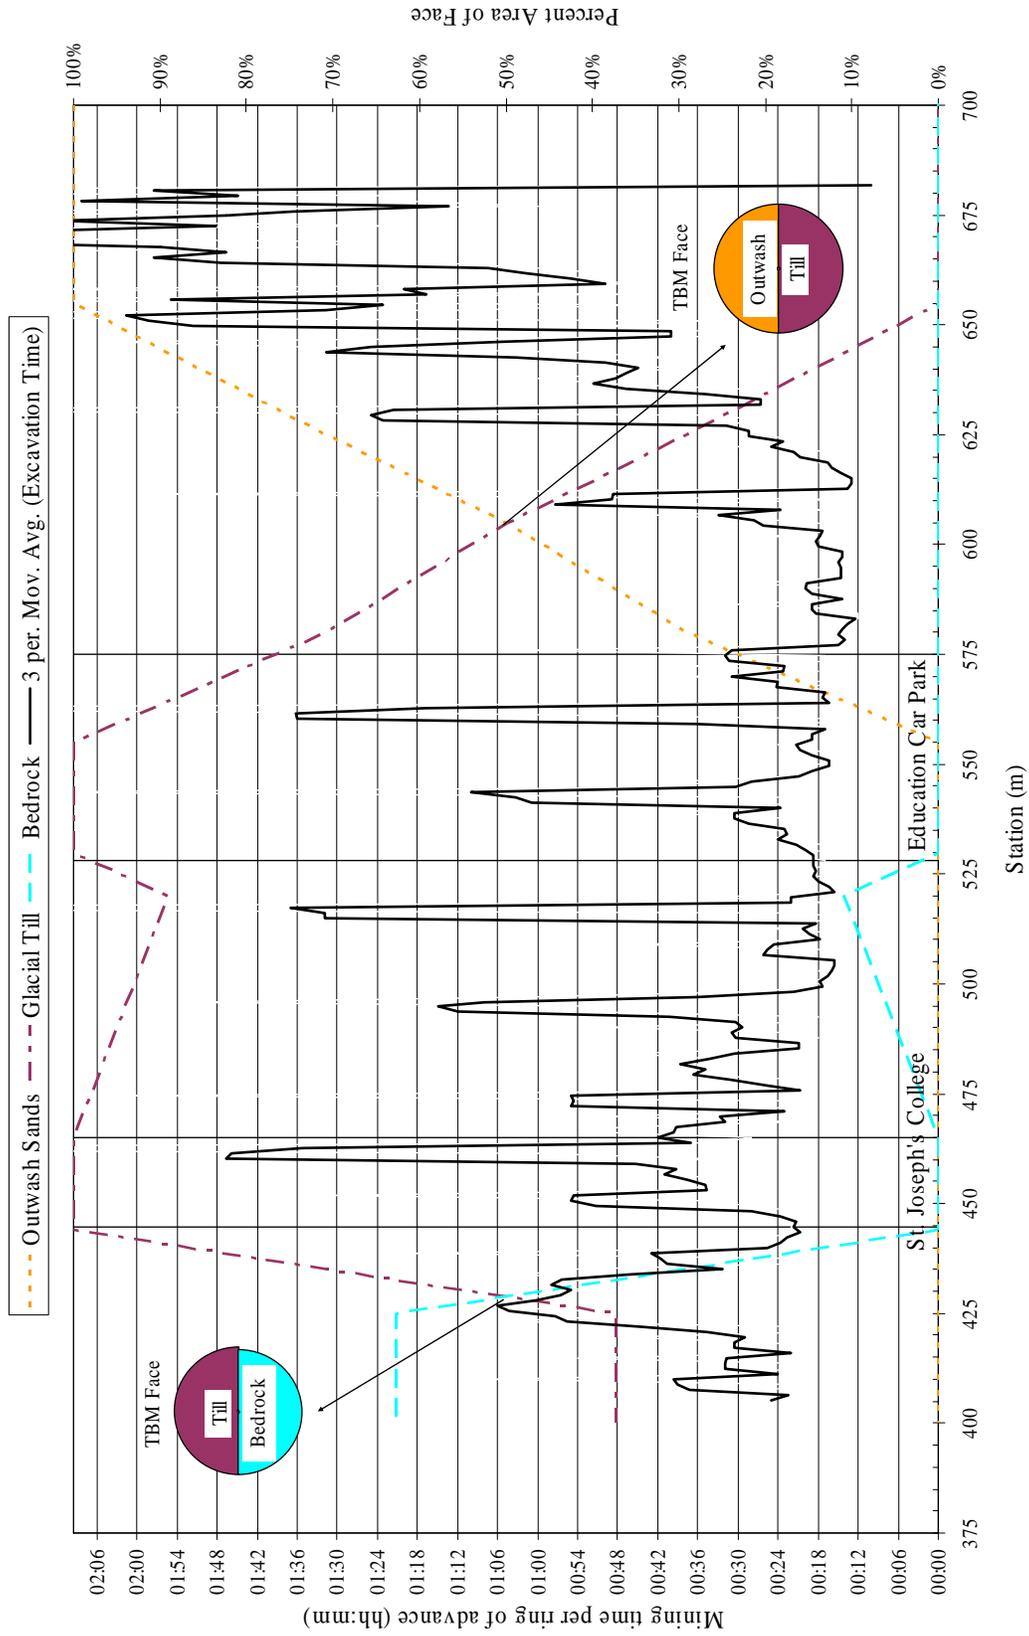
The Southbound and Northbound Tunnels were completed in 46 and 41 days respectively, with the Southbound Tunnel being some 28m, or 24 rings, longer than the Northbound Tunnel. Productivity early in construction was hindered by the need to run the muck train at a reduced size due to the limited worksite space which prevent a full muck train from being used. As a result, the full productivity of the TBM was not reached until the TBM had advanced sufficiently to allow the full assembly of the gantry, and the operation of a full train. Maximum productivity in the Southbound Tunnel was between 6 and 8 rings per day and was maintained between Stn. +600m and +500m. After Stn. +500m, until the end of construction, daily productivity varied between 5 and 7 rings per day. During construction of the Northbound Tunnel, maximum daily production was reached after Stn. +590m, and varied between 7 and 9 rings per day. This rate of construction was maintained for the rest of the construction of the tunnel save for the final 40m, where productivity was reduced to between 6 and 7 rings per day.

Figure 4-9 Time needed to excavate one ring during construction of Southbound LRT Tunnel.

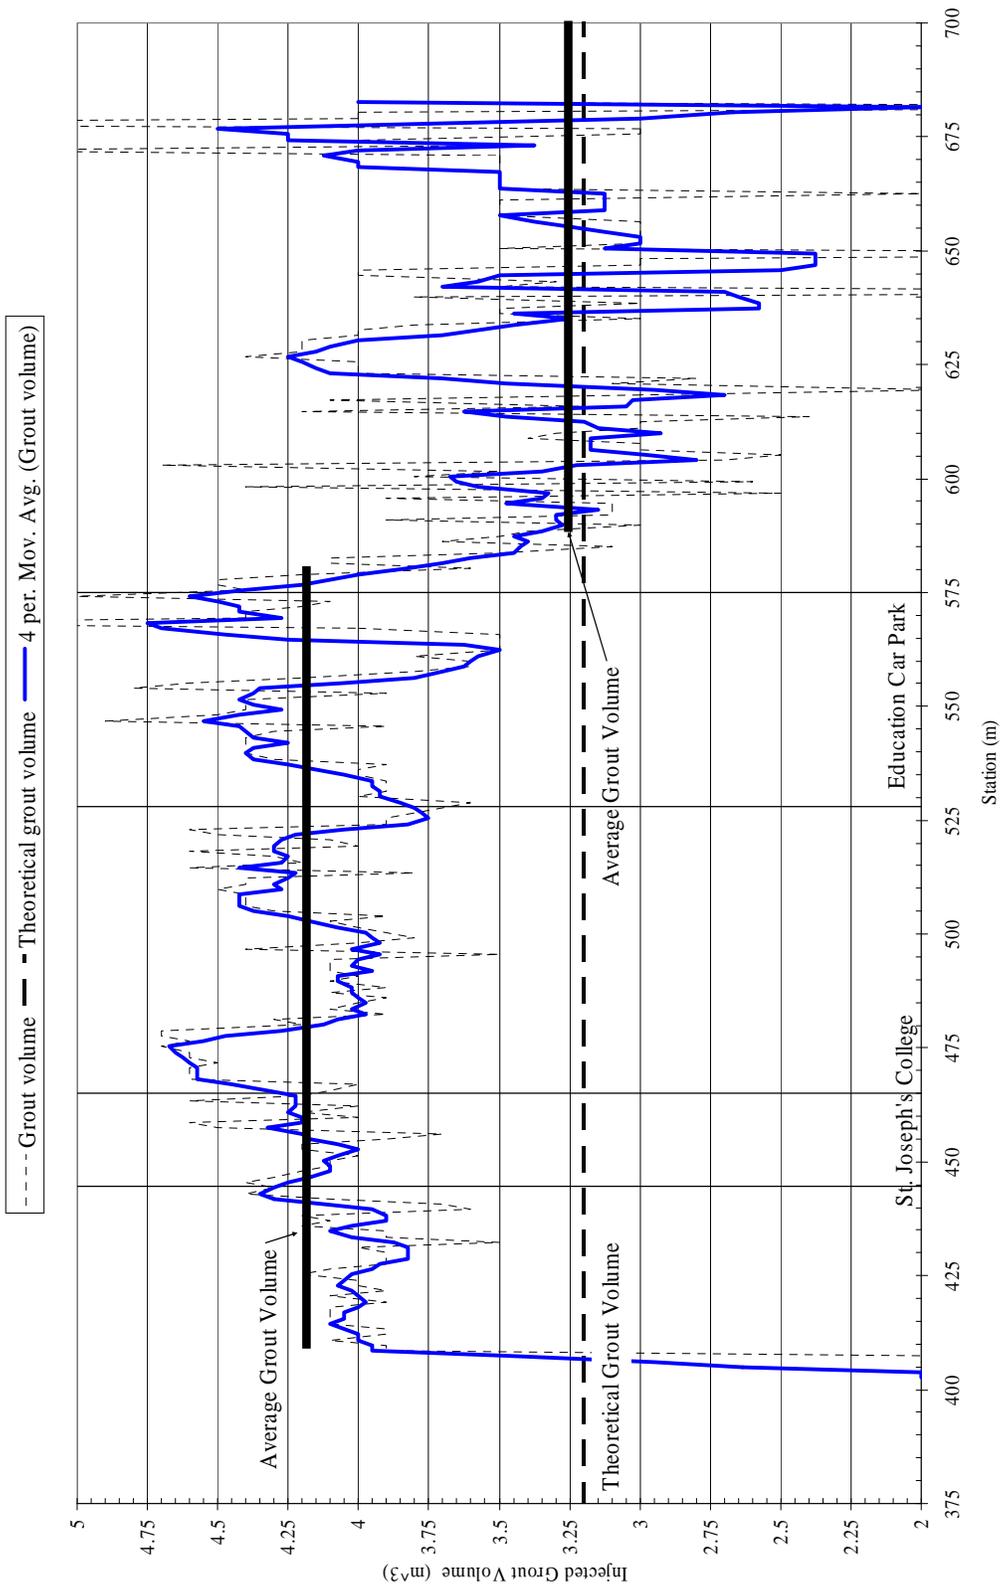
Figure 4-15 Injected grout volume per ring of excavation during construction of Southbound LRT Tunnel.

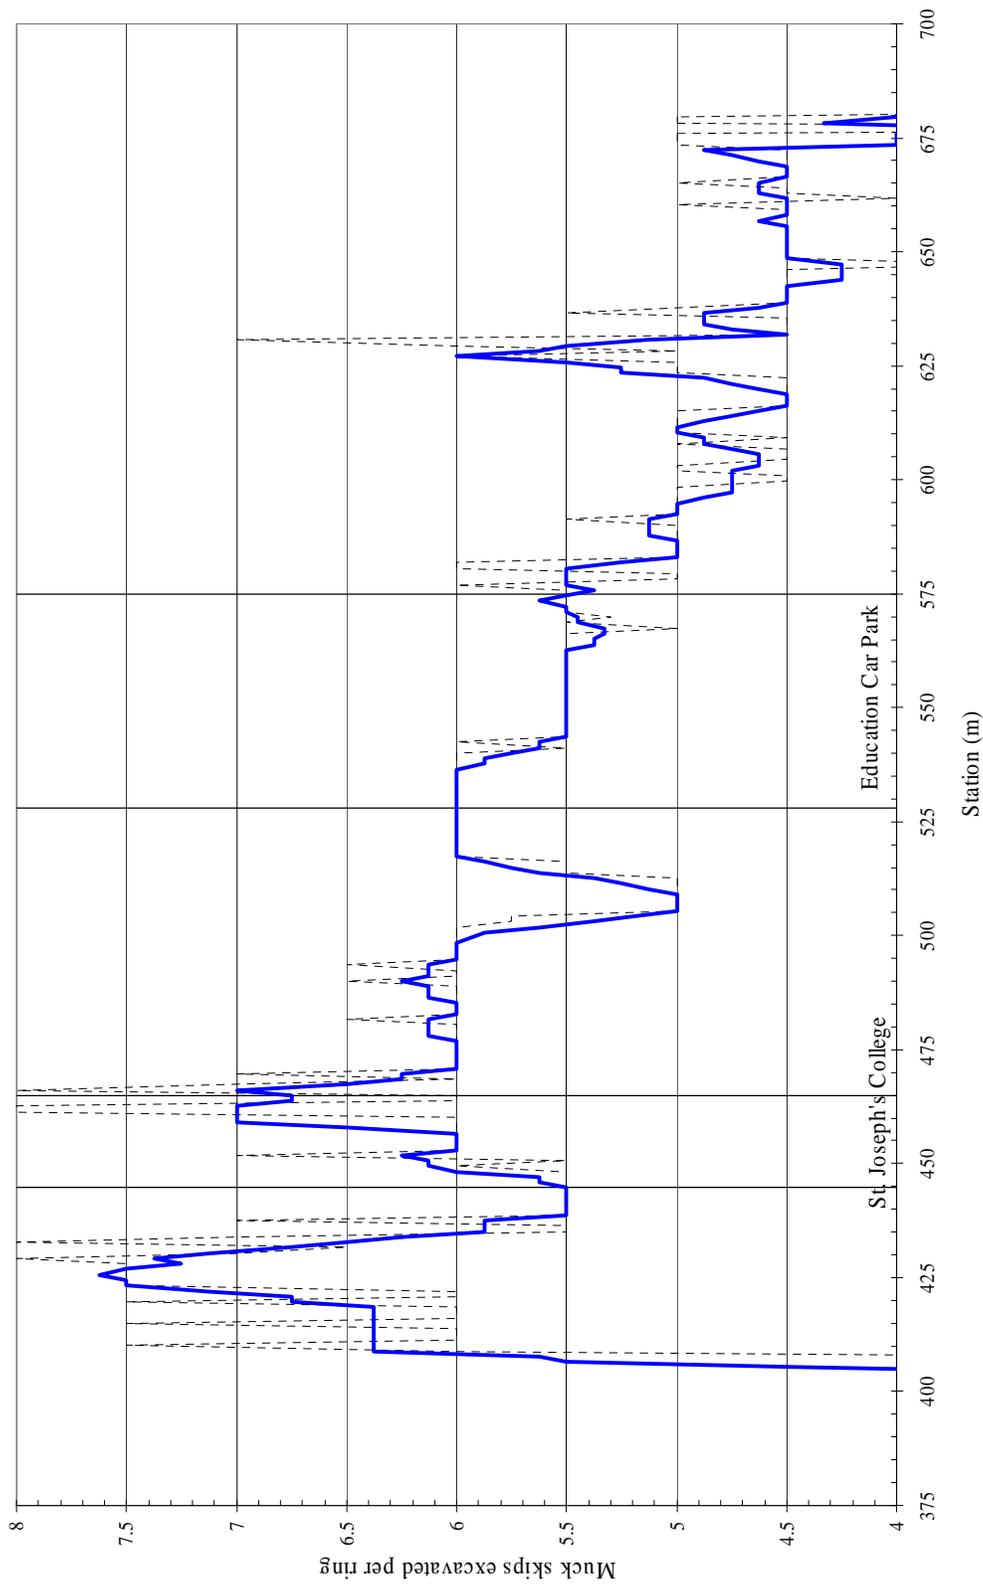
At no point did construction take place full face within the Bedrock. As a result, the bulking factors observed for the latter part of construction (after Stn. +475m Southbound, Stn. +500m Northbound) are valid for mixed face condition of Glacial Till and Bedrock. Operating in these mixed face conditions, construction of both tunnels produced between 6 and 7 muck cars per ring of advance. After Stn +425m, during Northbound construction, the number of muck cars increased to between 7 and 8. This region of Northbound construction also produced the highest fines content in the spoil suggesting a much greater fraction of bedrock at the tunnel face. These muck volumes correspond to a bulking factor of between 1.2 and 1.4 for tunnelling with mixed face conditions of Glacial Till and Bedrock with Glacial Till being the predominant material at the face. With Bedrock the predominant material at the face, the observed bulking factor increased to between 1.4 and 1.6. The bulking factor obtained approximates the anticipated dry bulking factor of between 1.3 and 1.4 for clay and 1.5 for shale. In this case of mixed face within the Bedrock and Glacial Till, the increase in bulking factor is largely a function of Bedrock content. Glacial Till would be effectively broken down during the mining process. In contrast, Bedrock would not be fully broken down by the mining process and the spoil would be a mixture of water, Glacial Till and Bedrock paste with intact cobbles of Bedrock.

Figure 4-19 Muck cars needed per ring of excavation during construction of Southbound LRT Tunnel.
