Title of Thesis: Performance of EPB-TBM in Mixed Face Conditions:
City of Edmonton South LRT Extension – University Station
to Health Sciences Station

Performance of EPB-TBM in Mixed Face Conditions:

City of Edmonton South LRT Extension – University Station to Health Sciences Station

Geotechnical Engineering

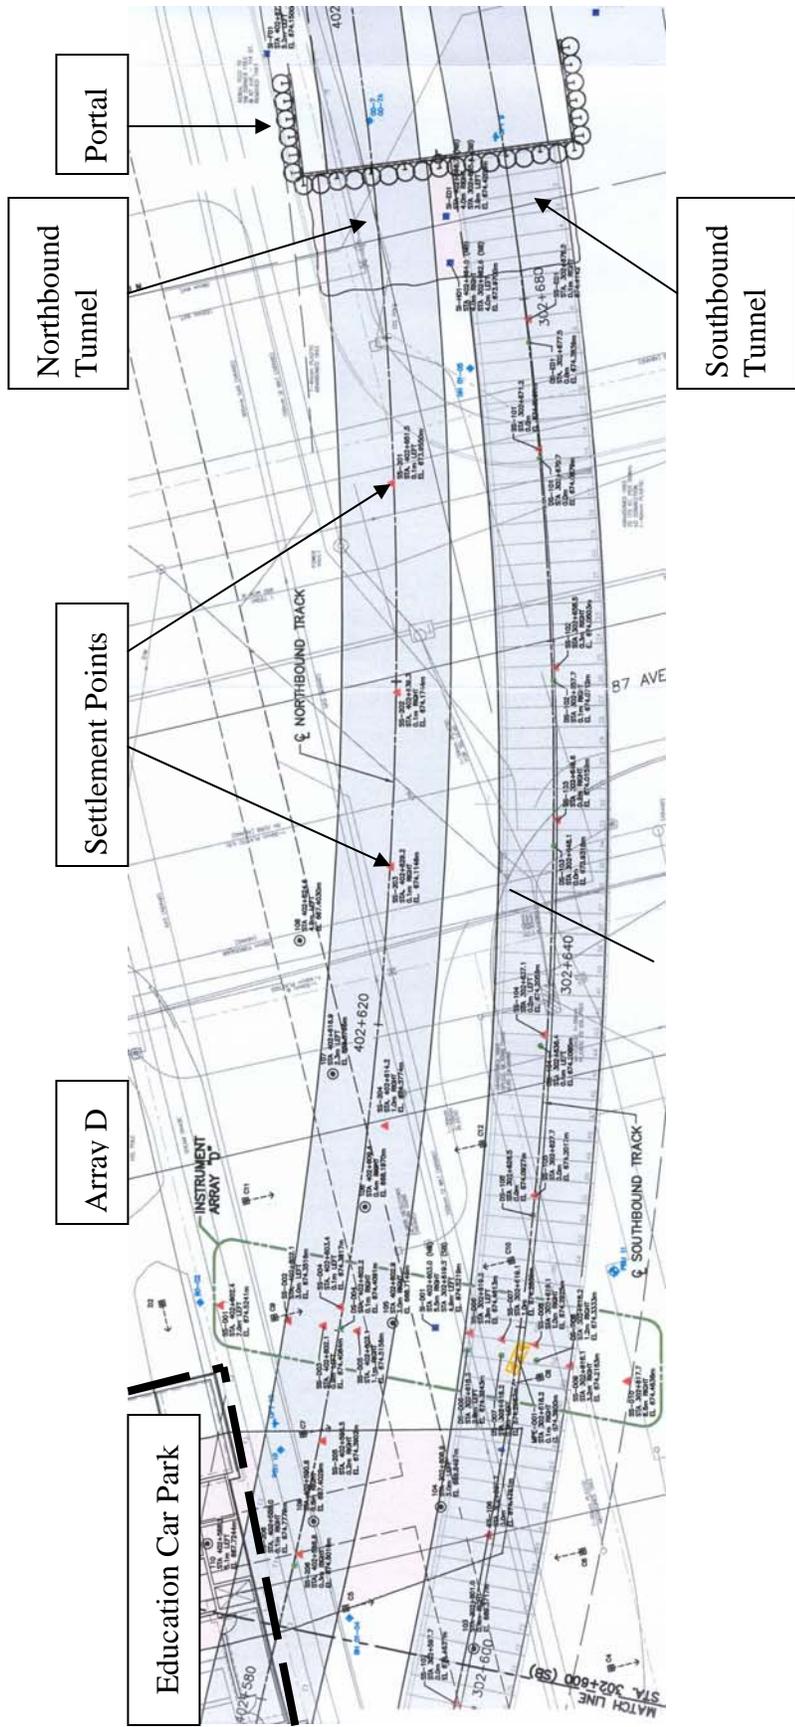
Figure 4-22 Instrumentation layout from portal to Education Car Park.

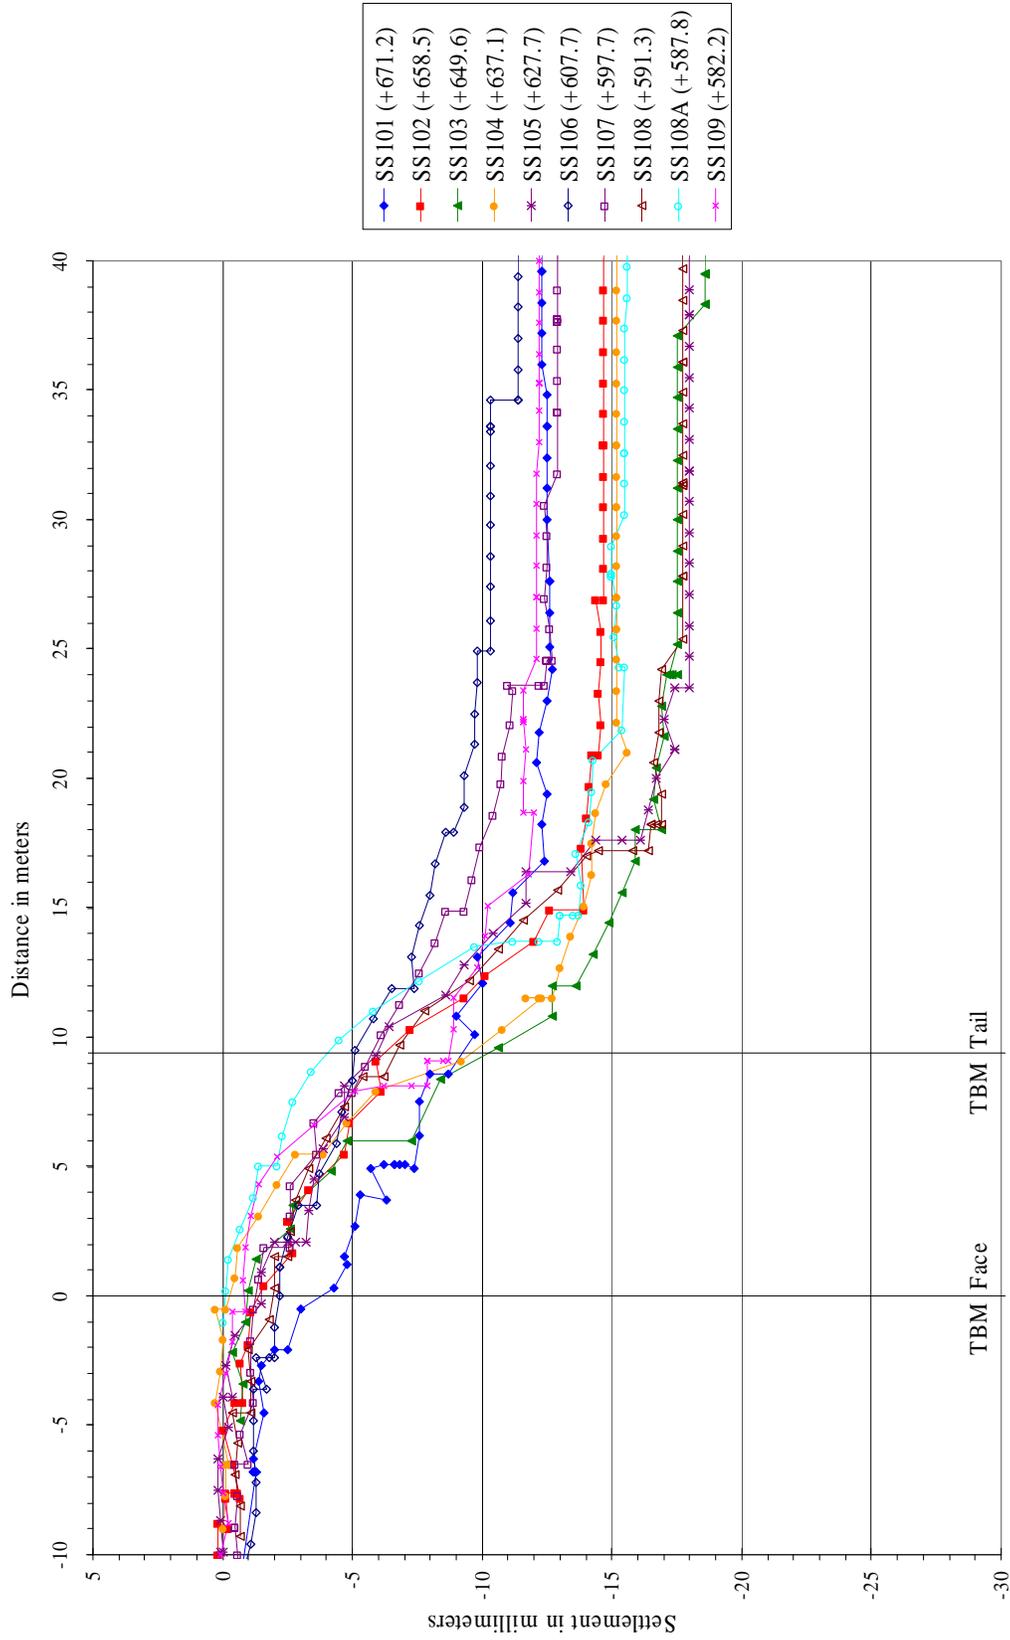
Figure 4-27 Observed shallow settlements during construction of Southbound Tunnel with proximity to TBM face, from Portal to Education Car Park.

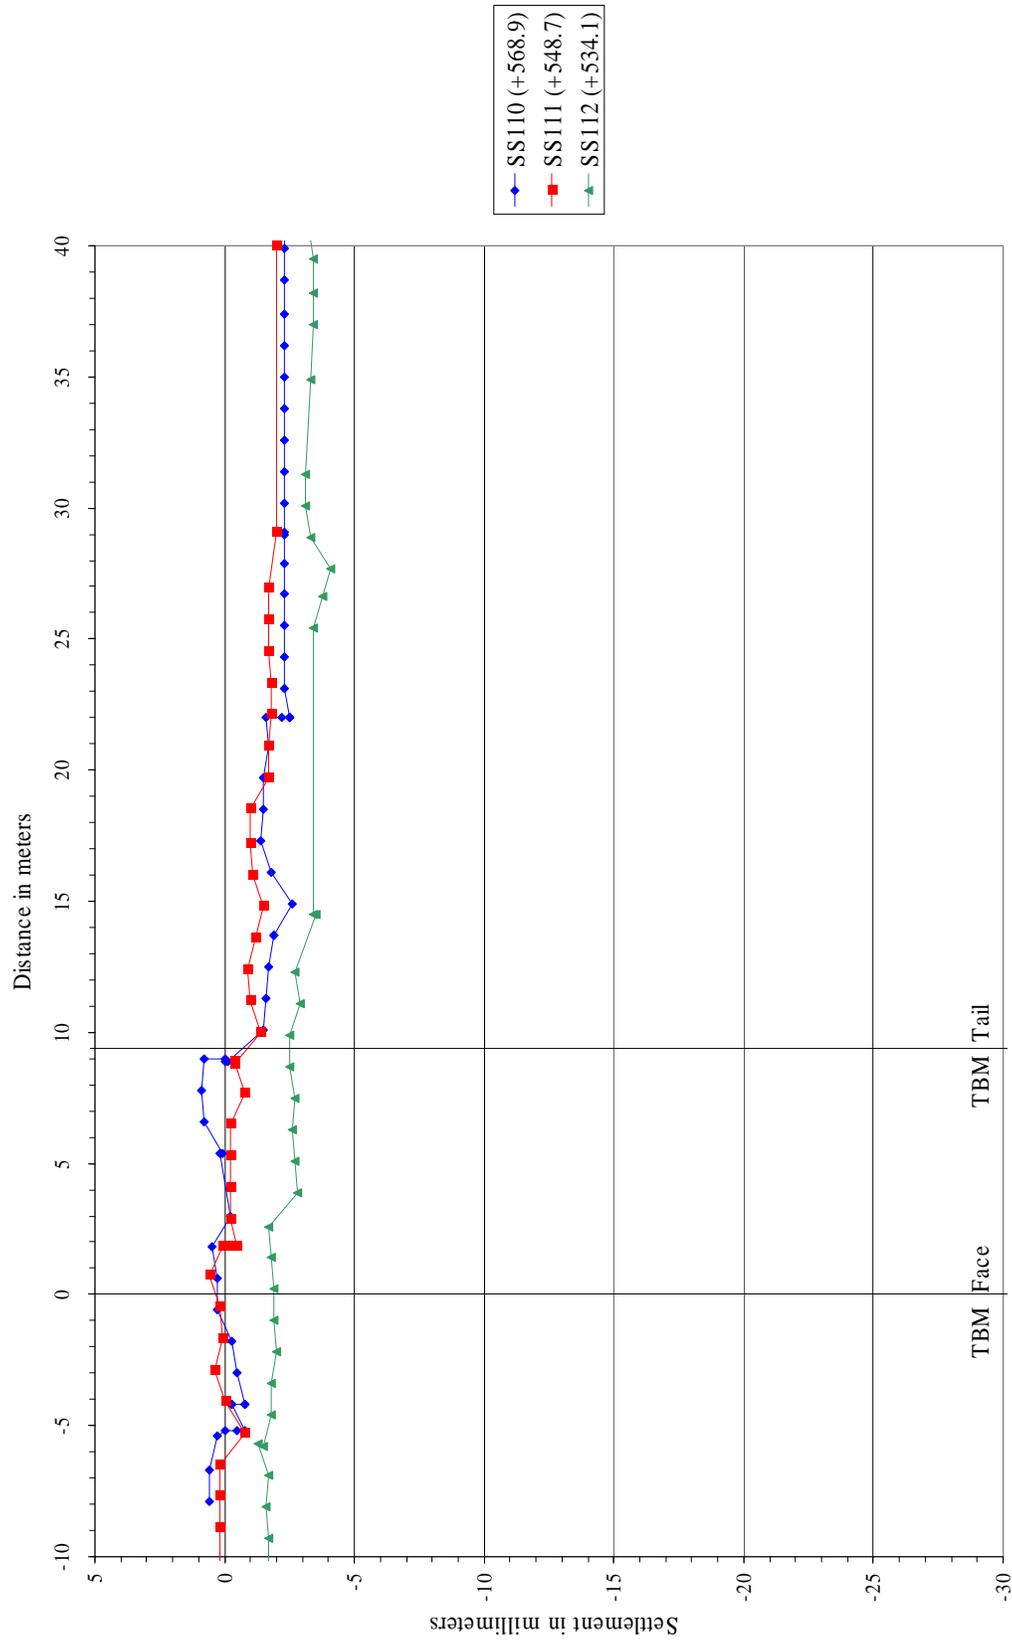
Figure 4-28 Observed shallow settlements during construction of Southbound Tunnel with proximity to TBM face, Education Car Park.

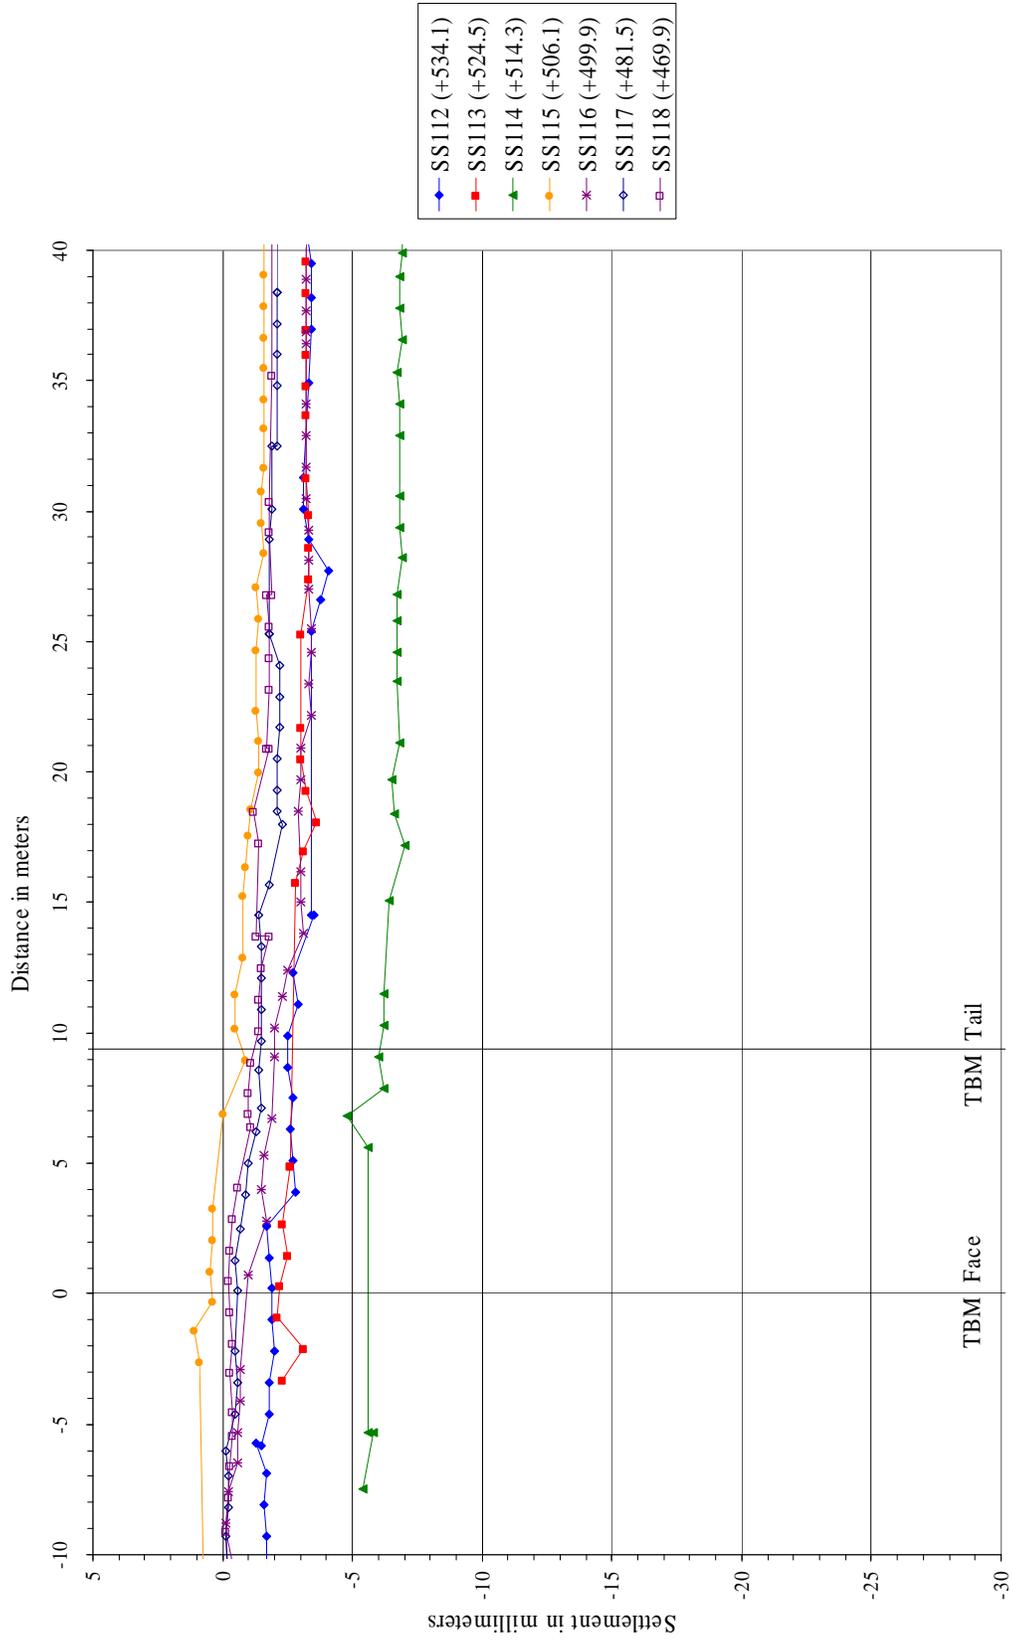
Figure 4-29 Observed shallow settlements during construction of Southbound Tunnel with proximity to TBM face, Education Car Park to St. Joseph's College.

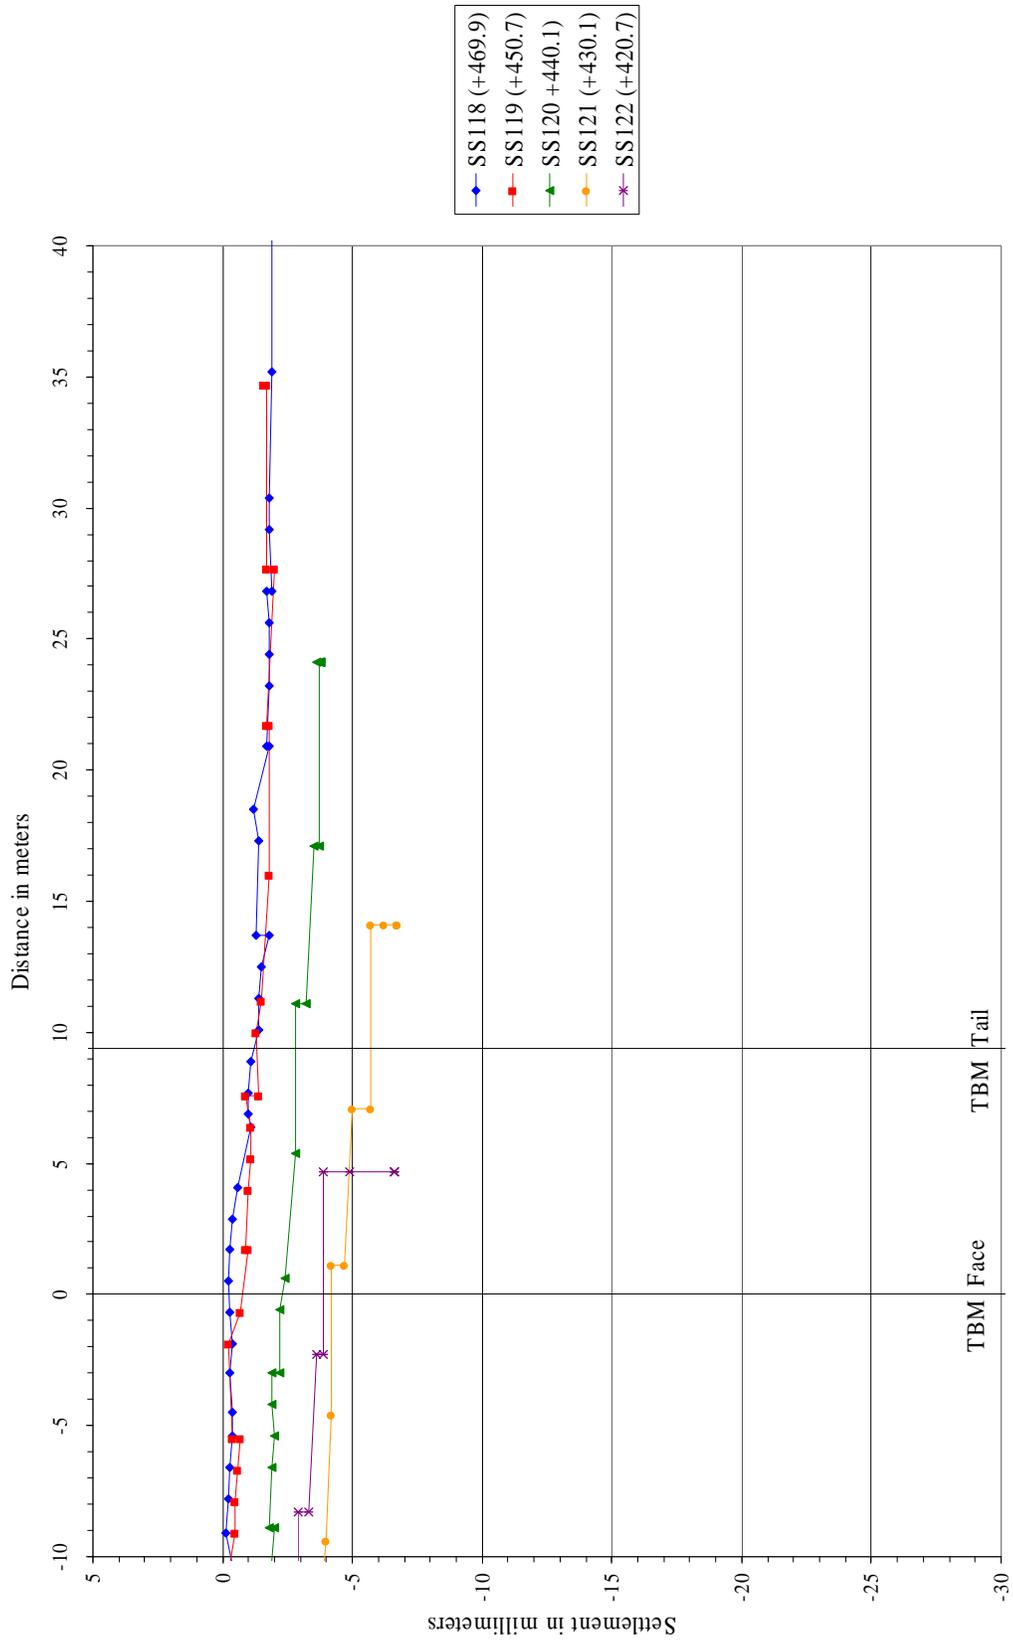
Figure 4-30 Observed shallow settlements during construction of Southbound Tunnel with proximity to TBM face, St. Joseph's College to breakthrough.

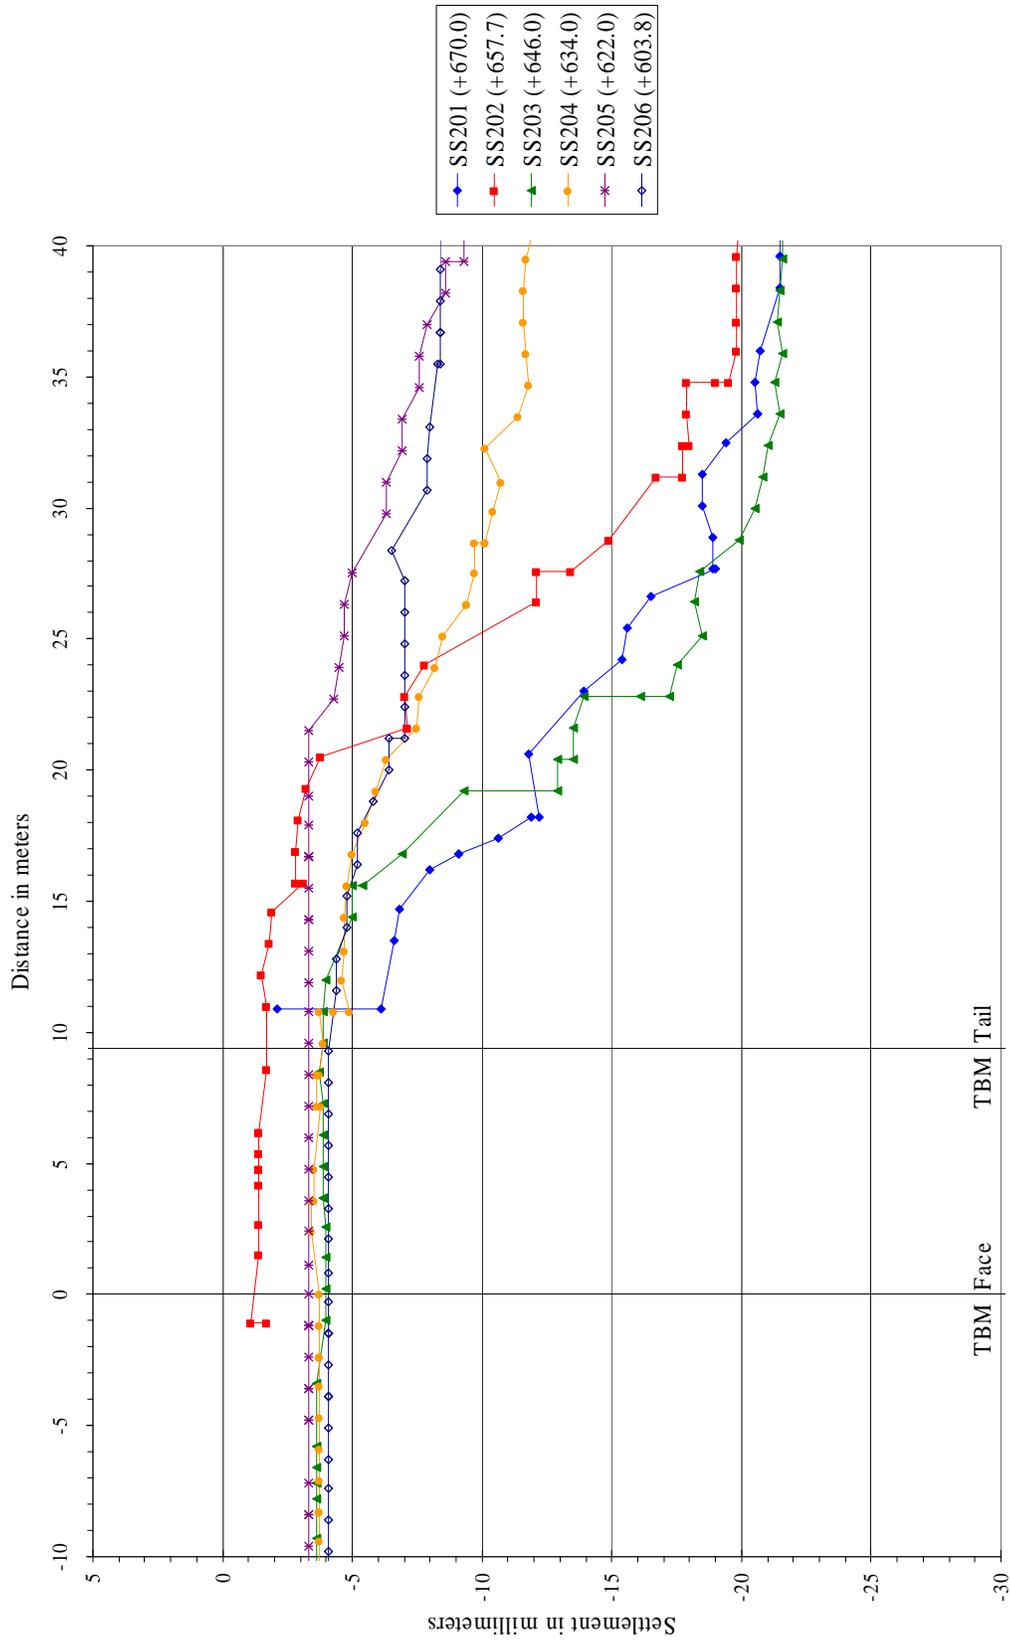
Figure 4-31 Observed shallow settlements during construction of Northbound Tunnel with proximity to TBM face, from Portal to Education Car Park.

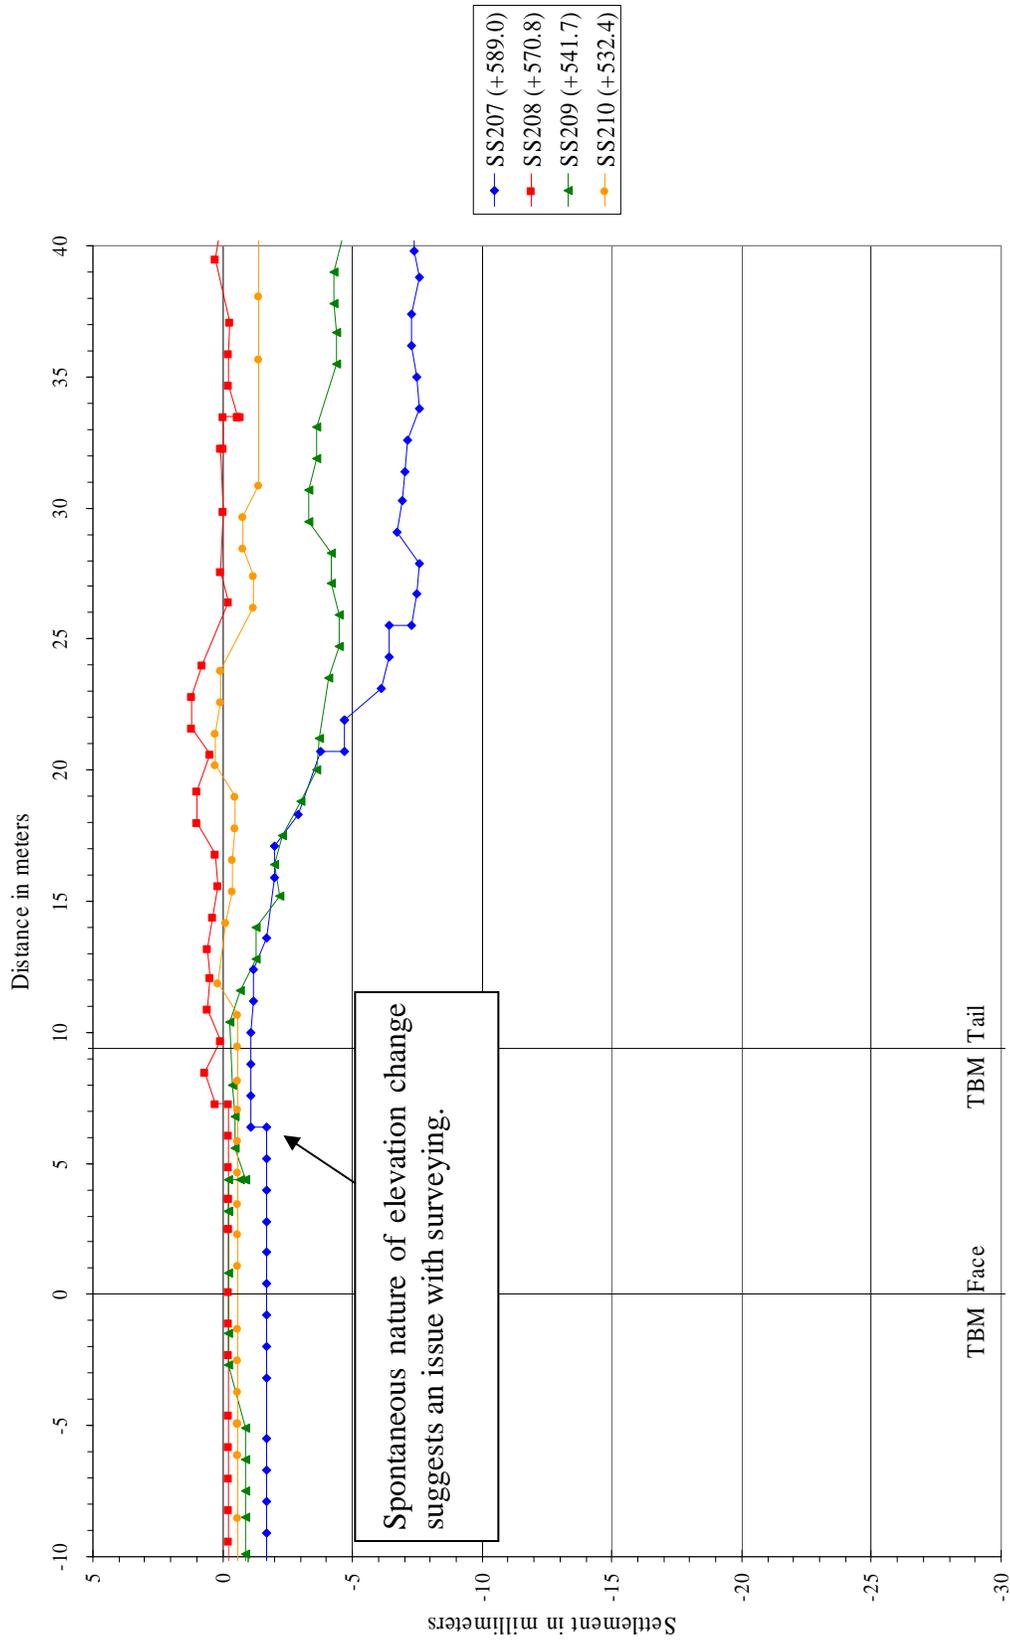
Figure 4-32 Observed shallow settlements during construction of Northbound Tunnel with proximity to TBM face, Education Car Park.

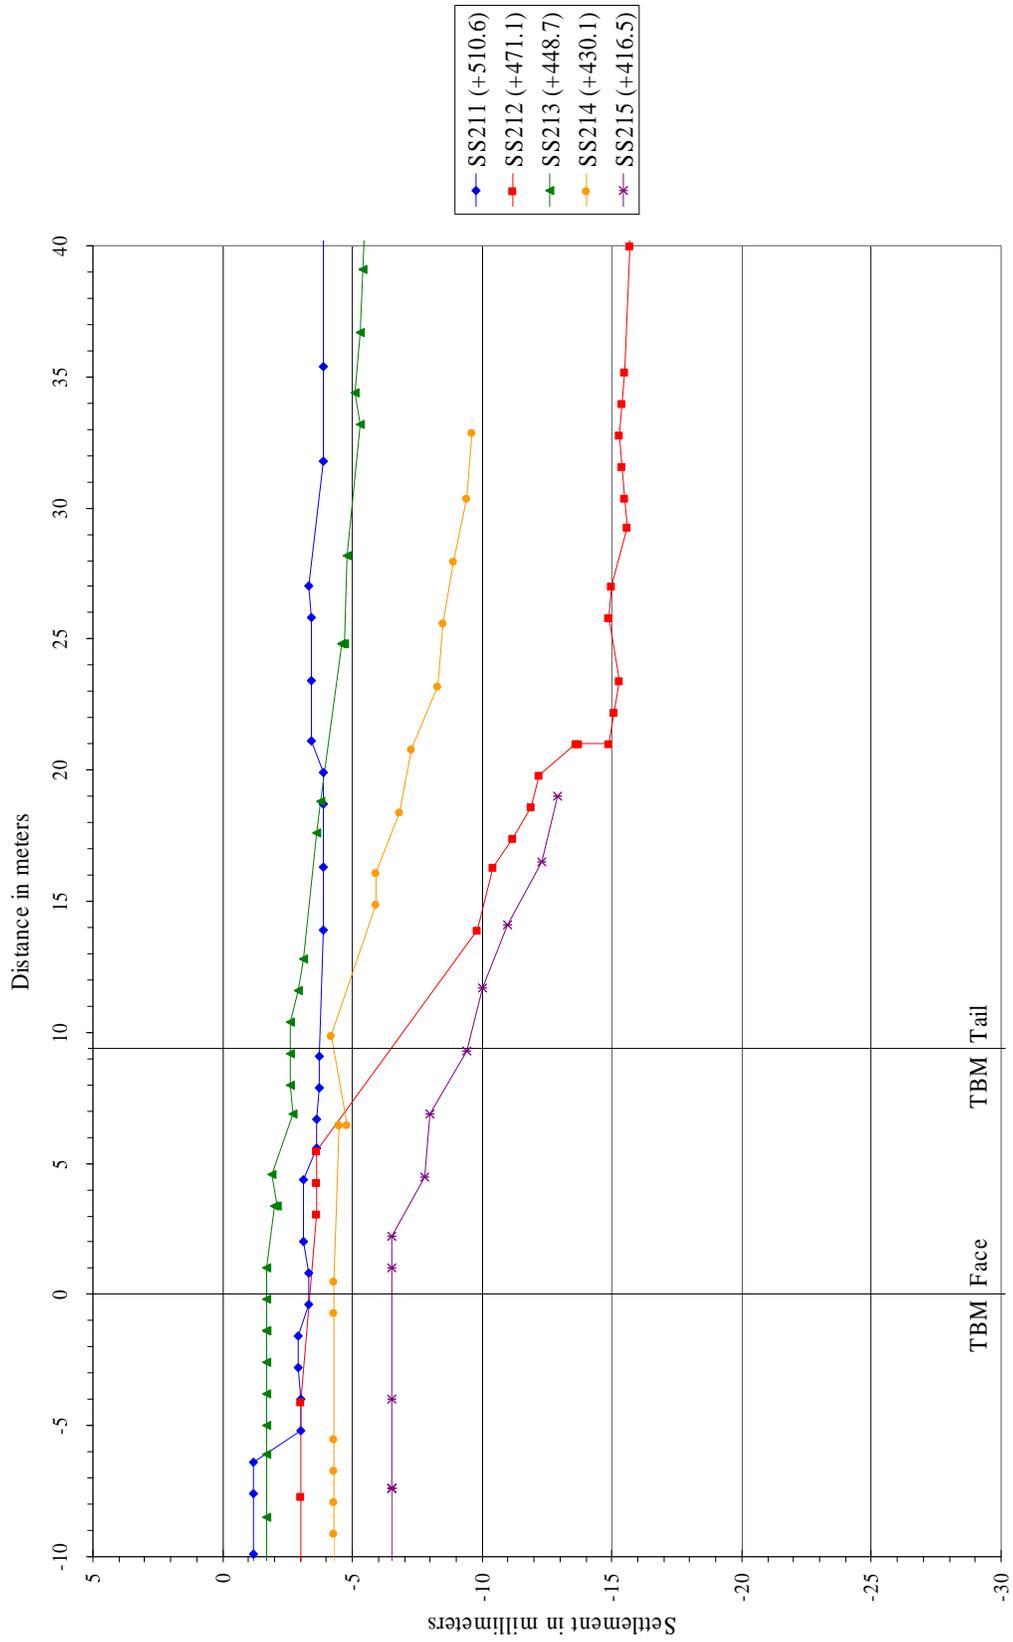
Figure 4-33 Observed shallow settlements during construction of Northbound Tunnel with proximity to TBM face, from Education Car Park to breakthrough.

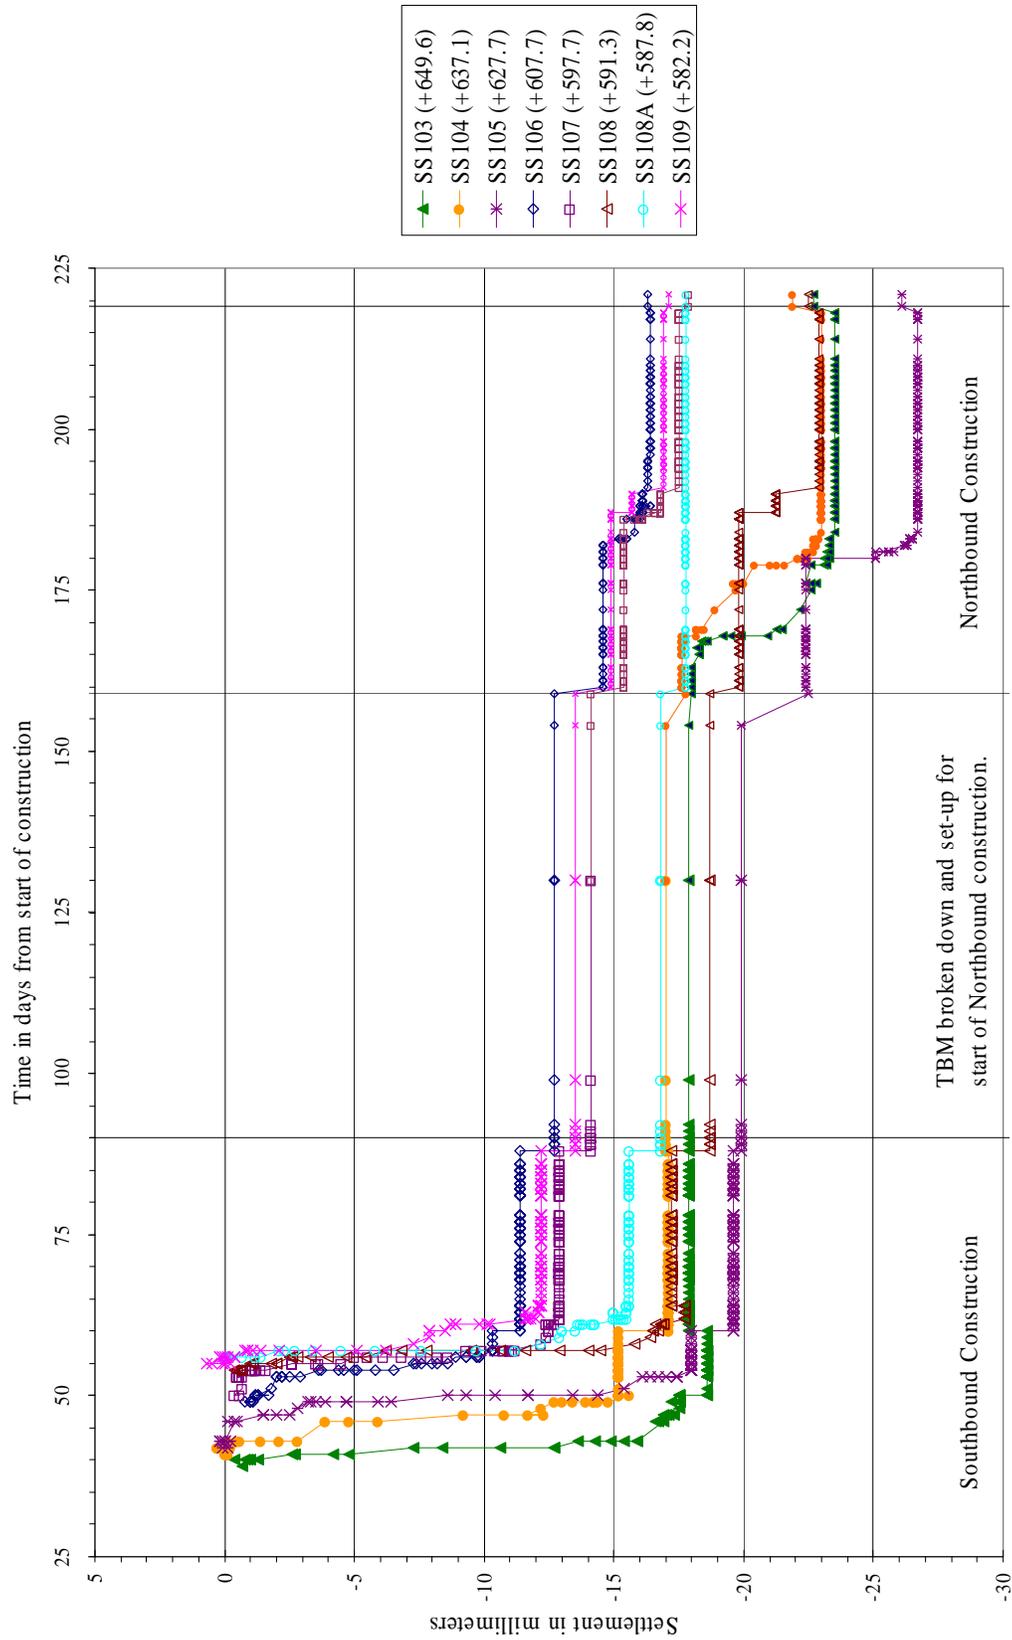
Figure 4-34 Observed shallow settlements in Southbound alignment instruments over the course of construction with respect to time, from Portal to Education Car Park.

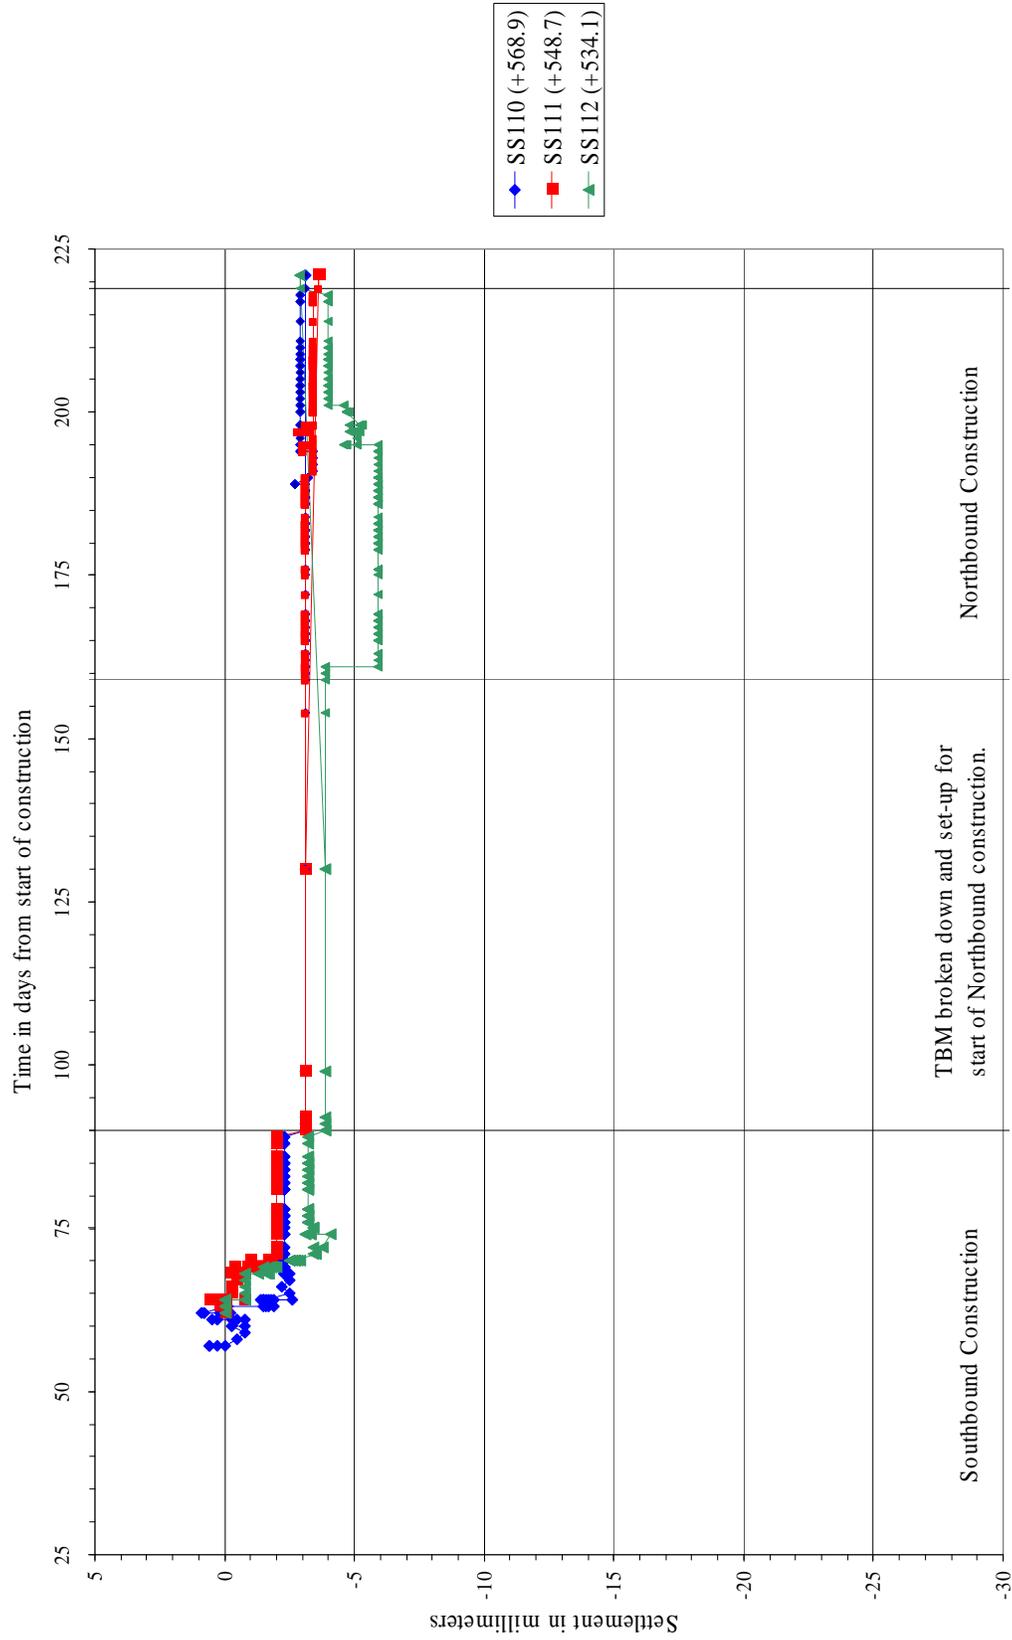
Figure 4-35 Observed shallow settlements in Southbound alignment instruments over the course of construction with respect to time, Education Car Park.

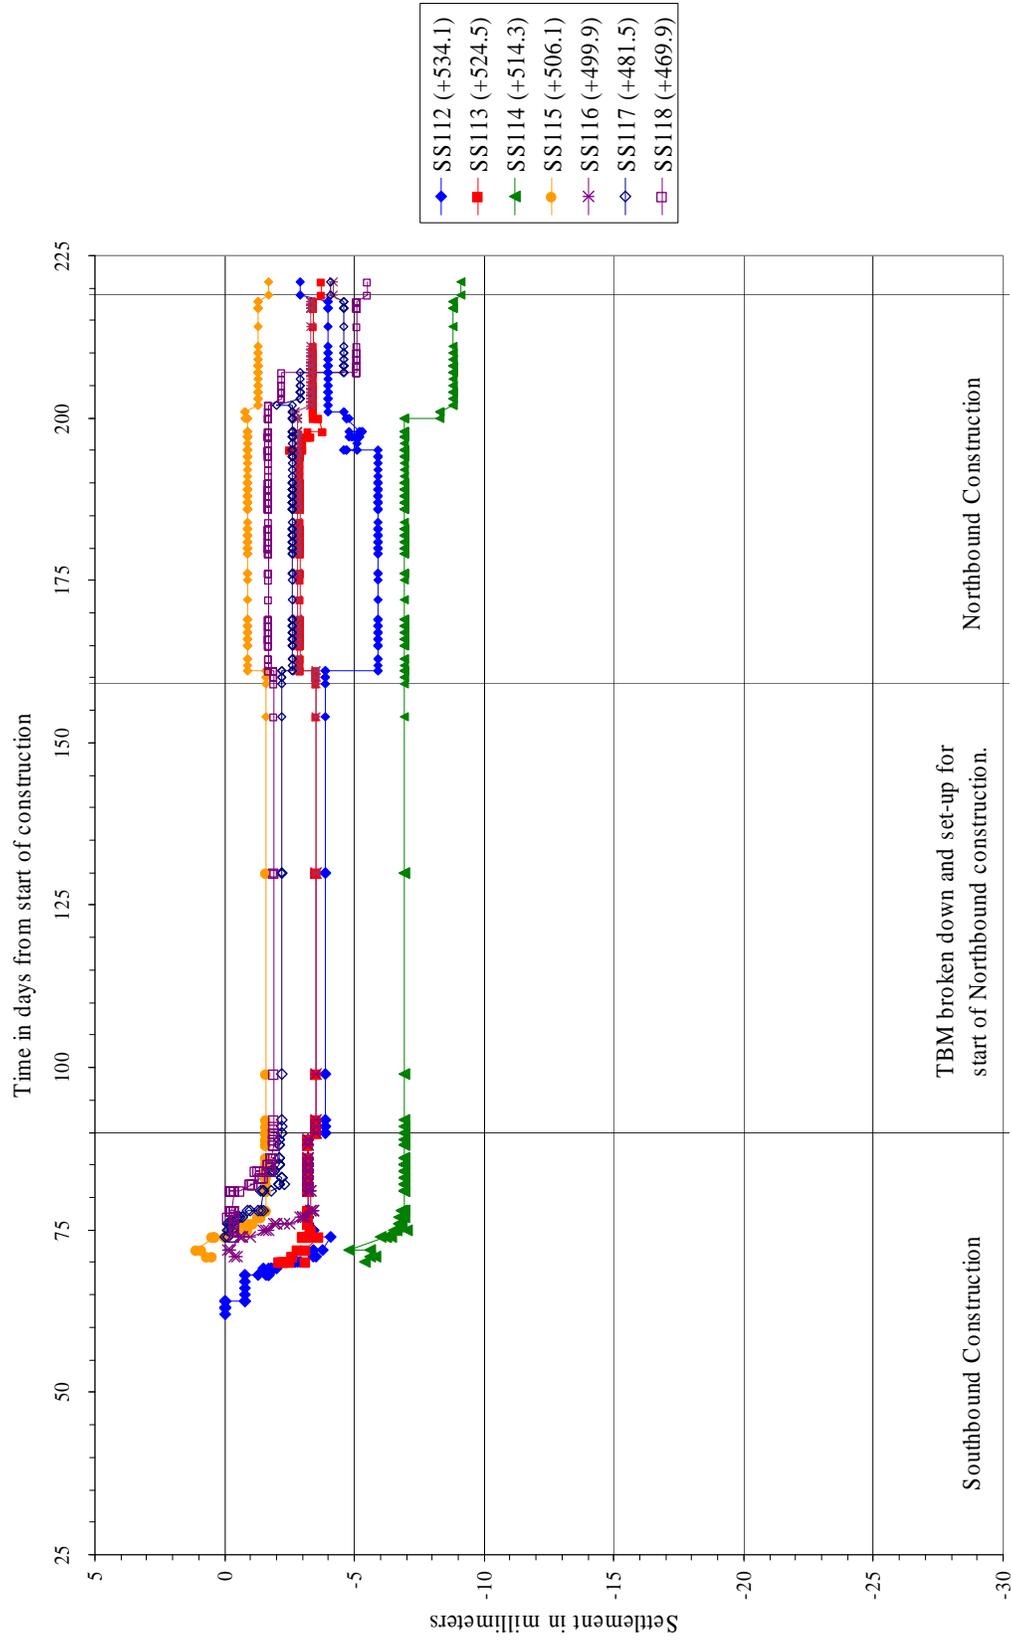
Figure 4-36 Observed shallow settlements in Southbound alignment instruments over the course of construction with respect to time, from Education Car Park to St. Joseph's College.

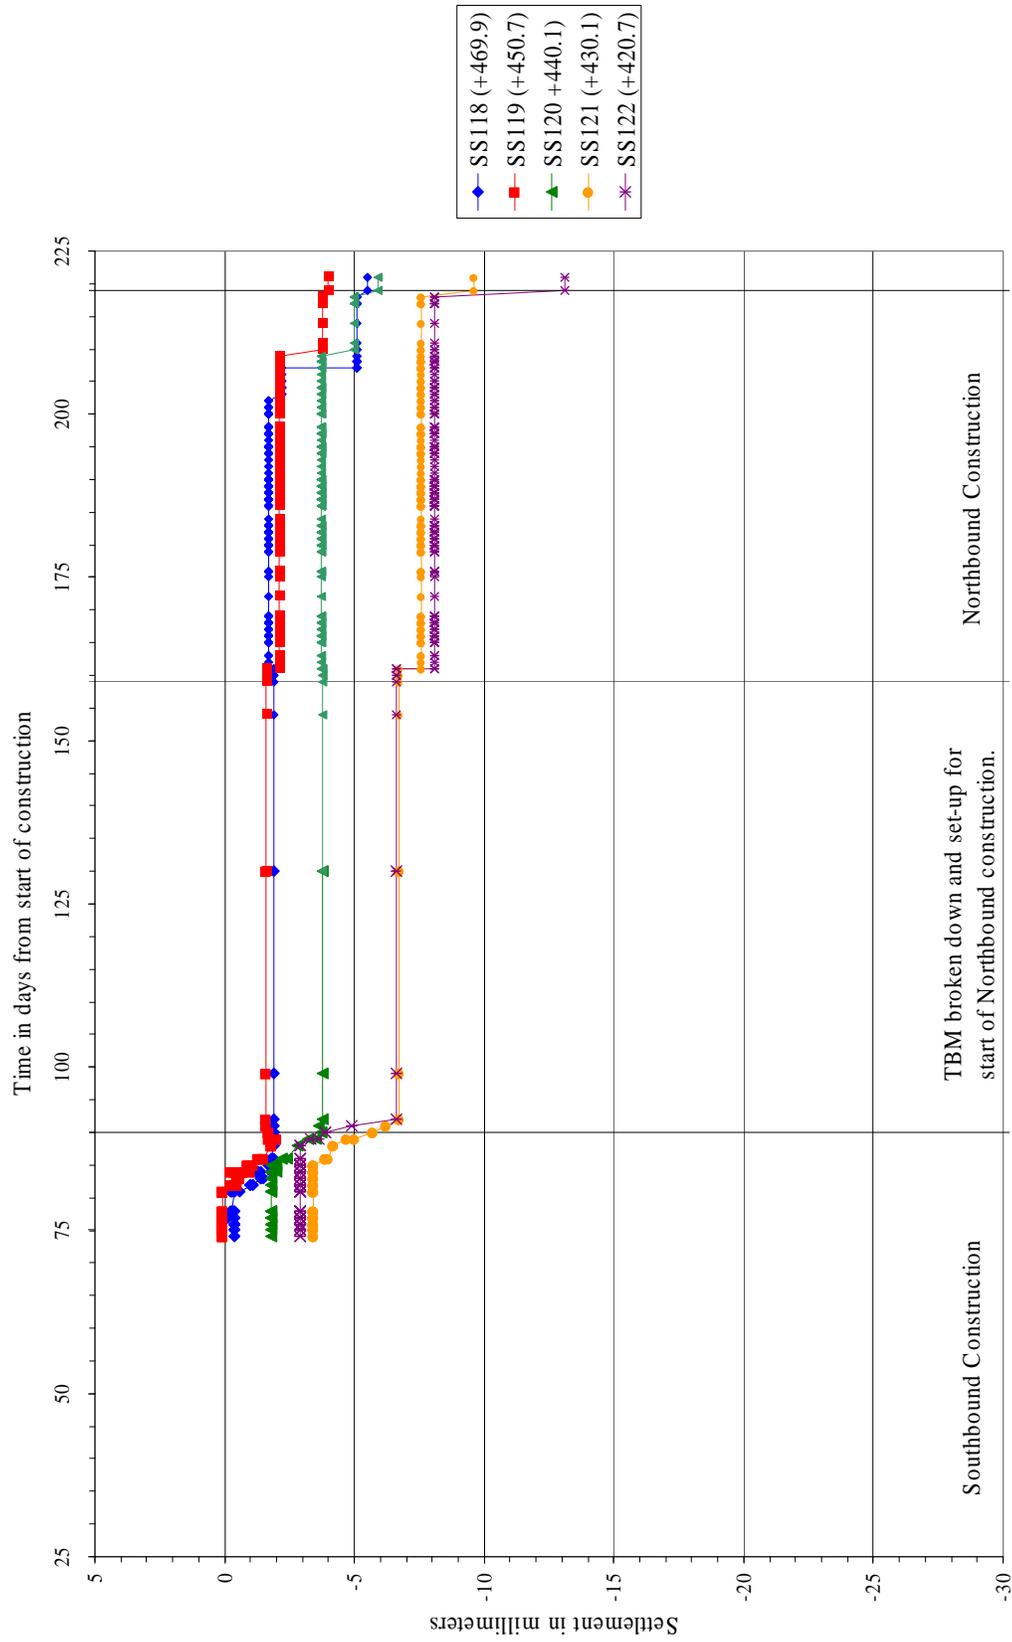
Figure 4-37 Observed shallow settlements in Southbound alignment instruments over the course of construction with respect to time, from St. Joseph’s College to breakthrough.

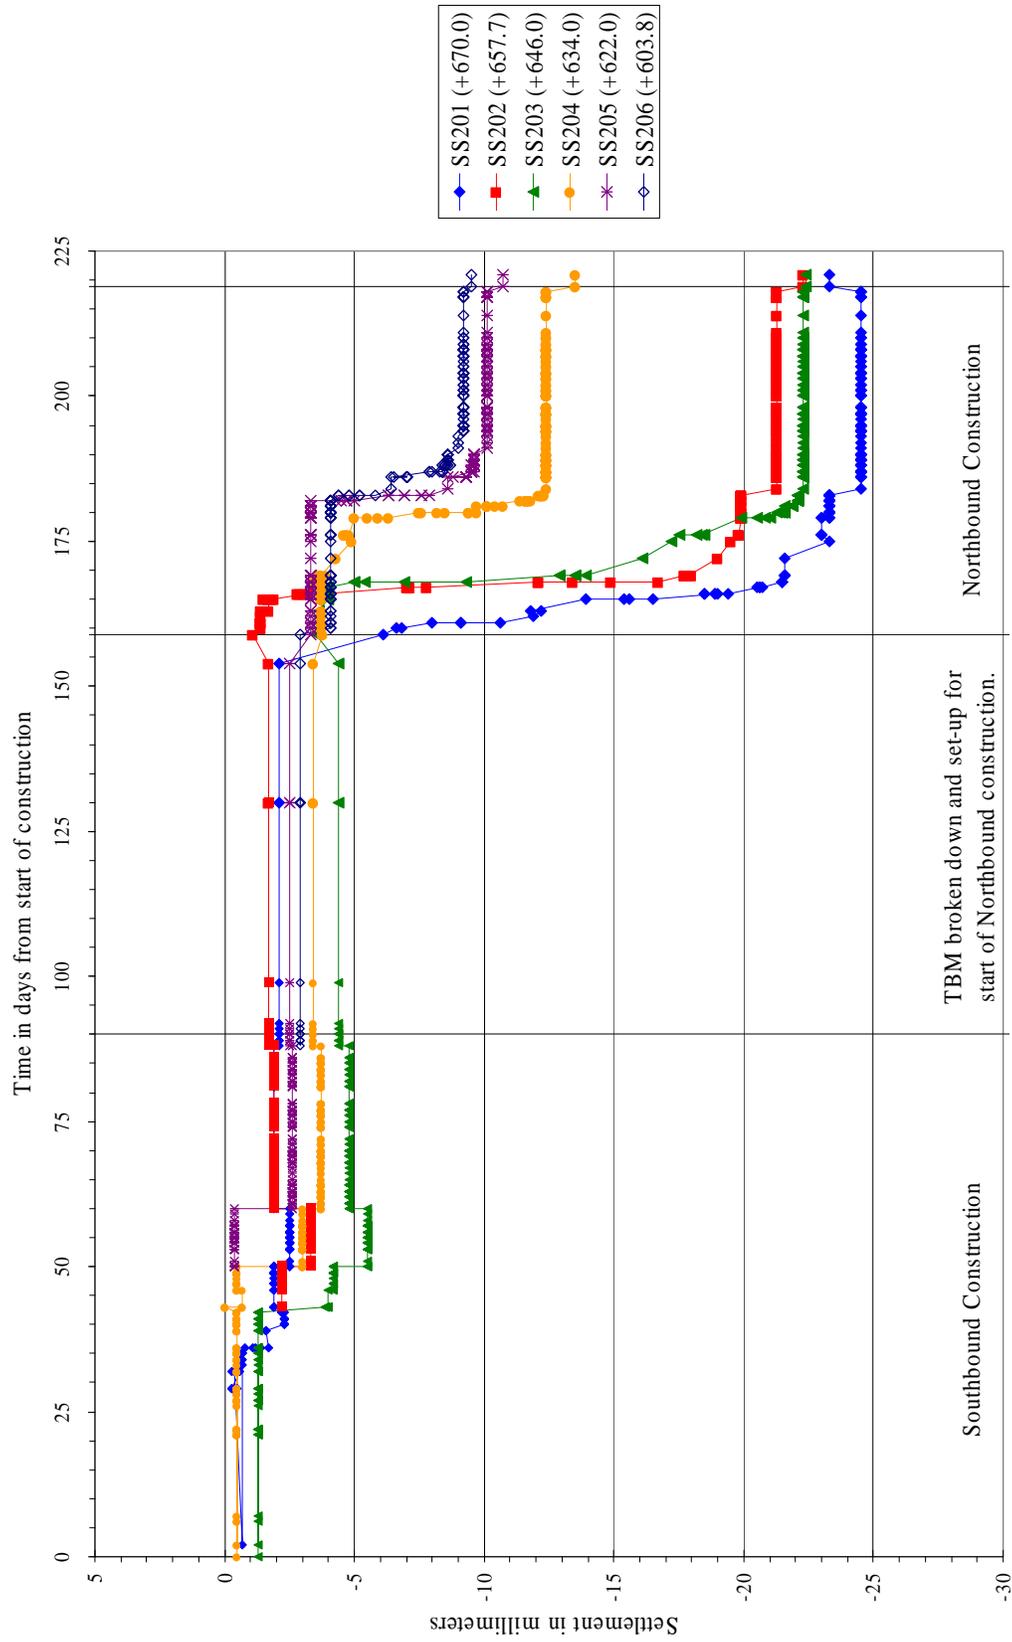
Figure 4-38 Observed shallow settlements in Northbound alignment instruments over the course of construction with respect to time, from Portal to the Education Car Park.
