Title of Thesis: Performance of EPB-TBM in Mixed Face Conditions:
City of Edmonton South LRT Extension – University Station
to Health Sciences Station

Performance of EPB-TBM in Mixed Face Conditions:

City of Edmonton South LRT Extension – University Station to Health Sciences Station

Geotechnical Engineering

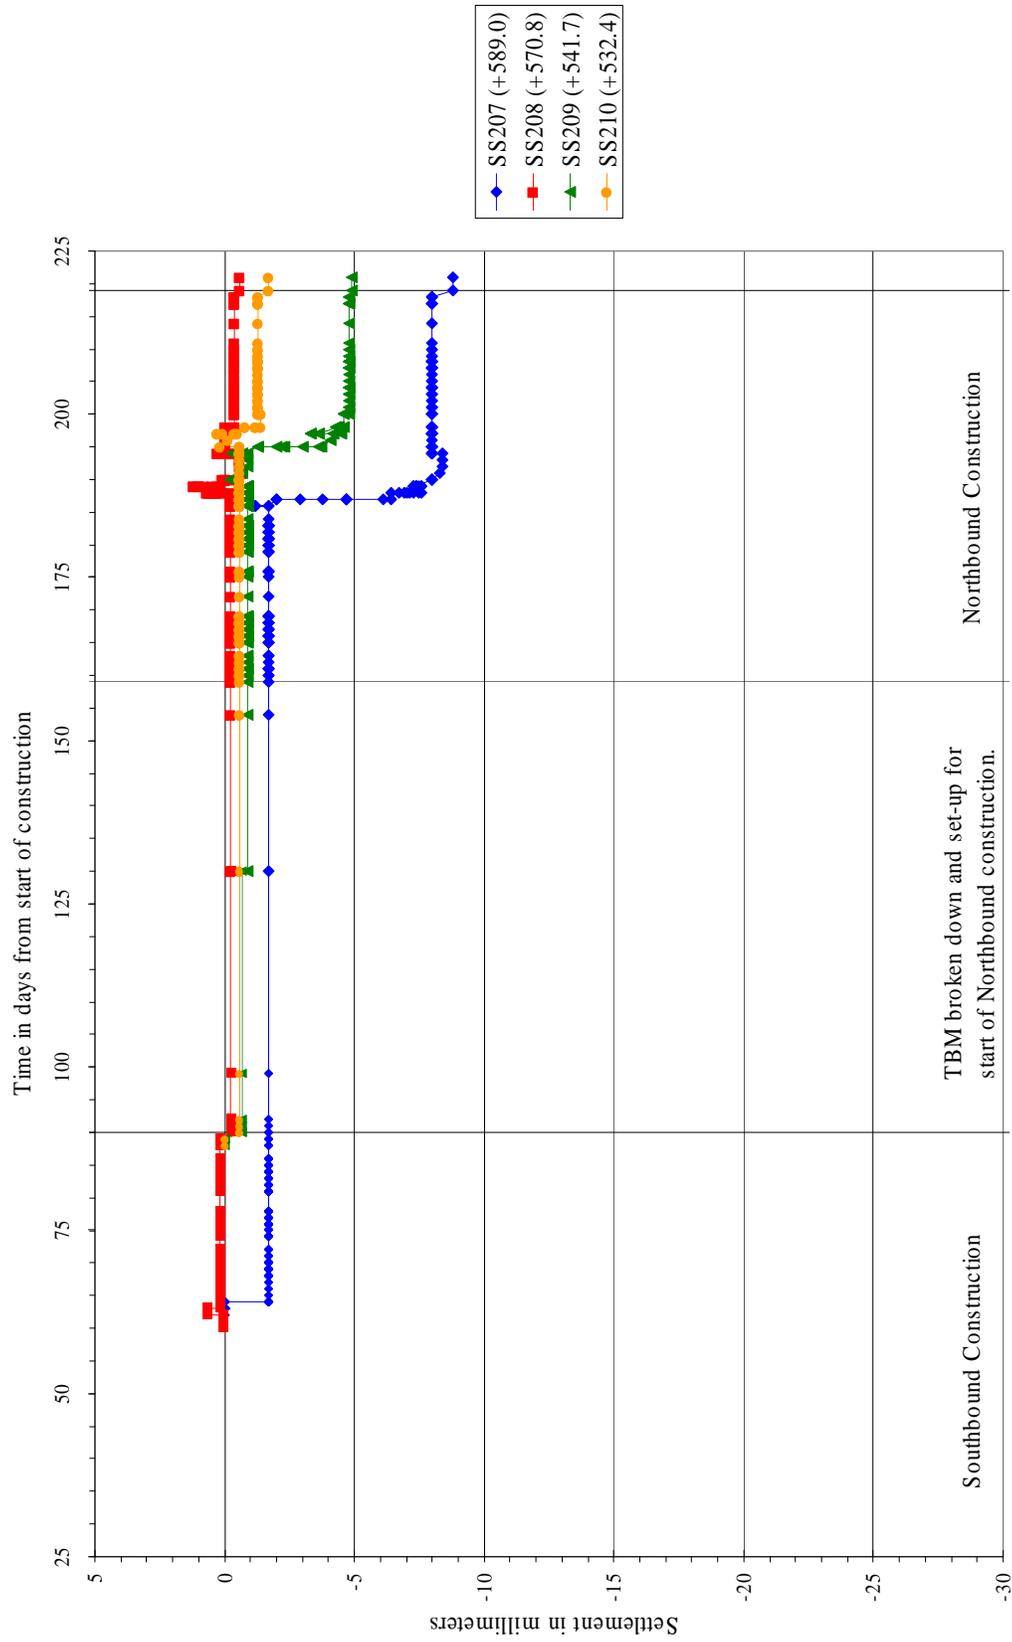
Figure 4-39 Observed shallow settlements in Northbound alignment instruments over the course of construction with respect to time, Education Car Park.

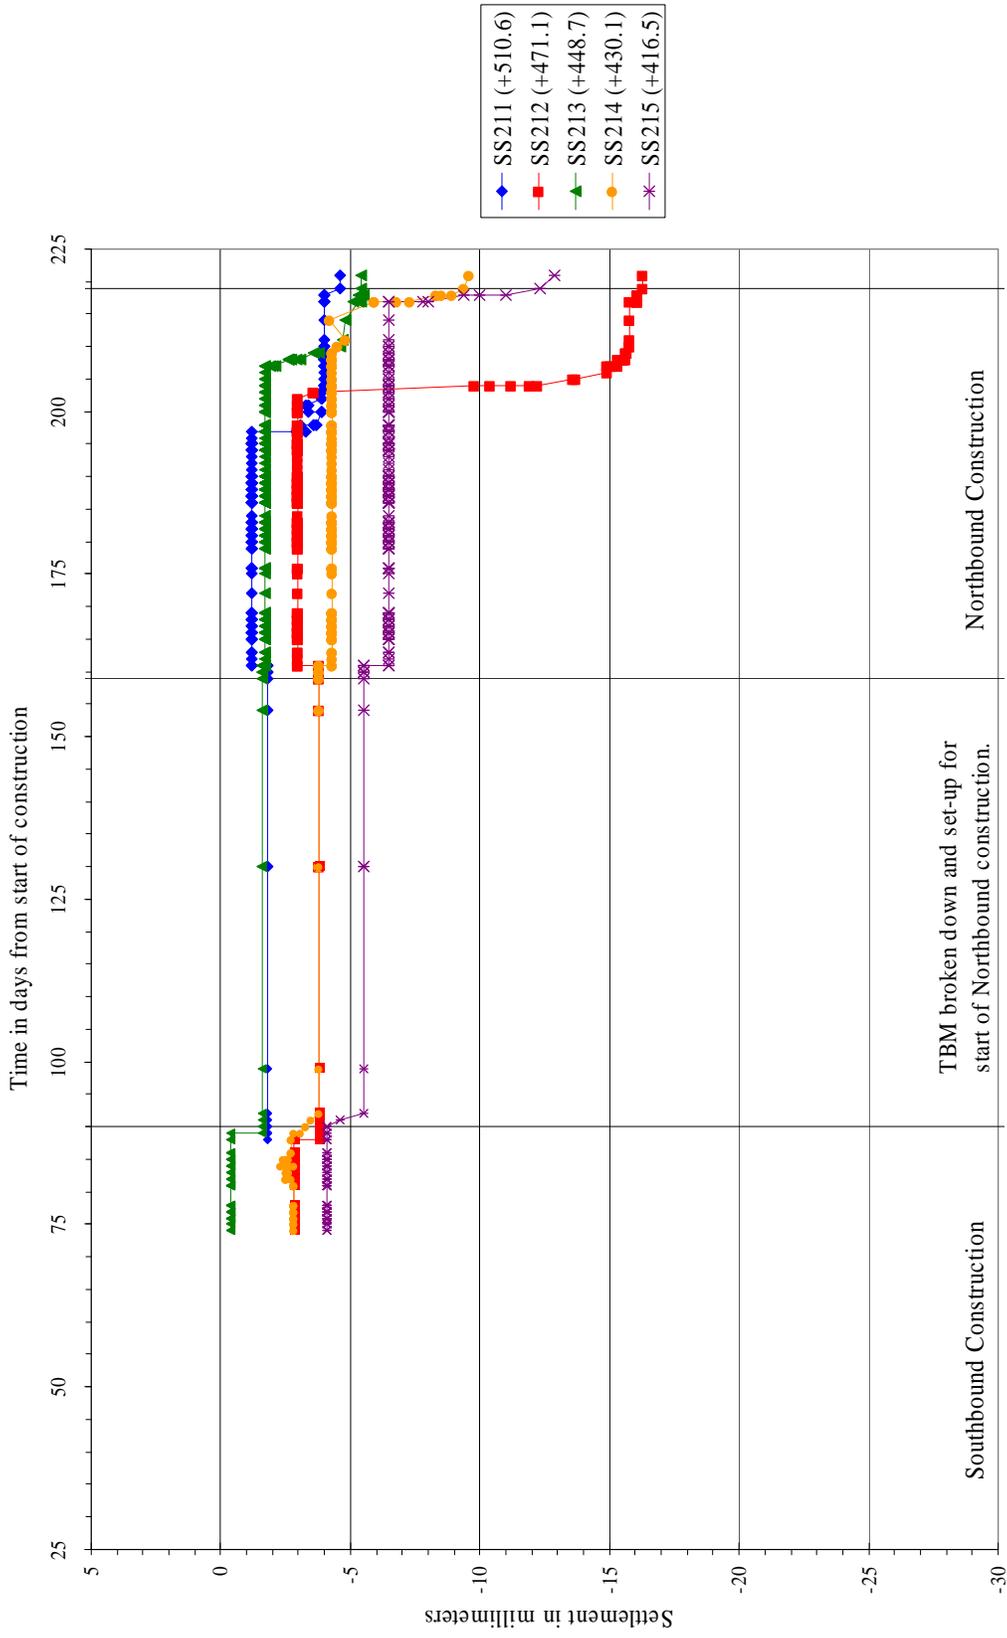
Figure 4-40 Observed shallow settlements in Northbound alignment instruments over the course of construction with respect to time, from the Education Car Park to removal shaft.

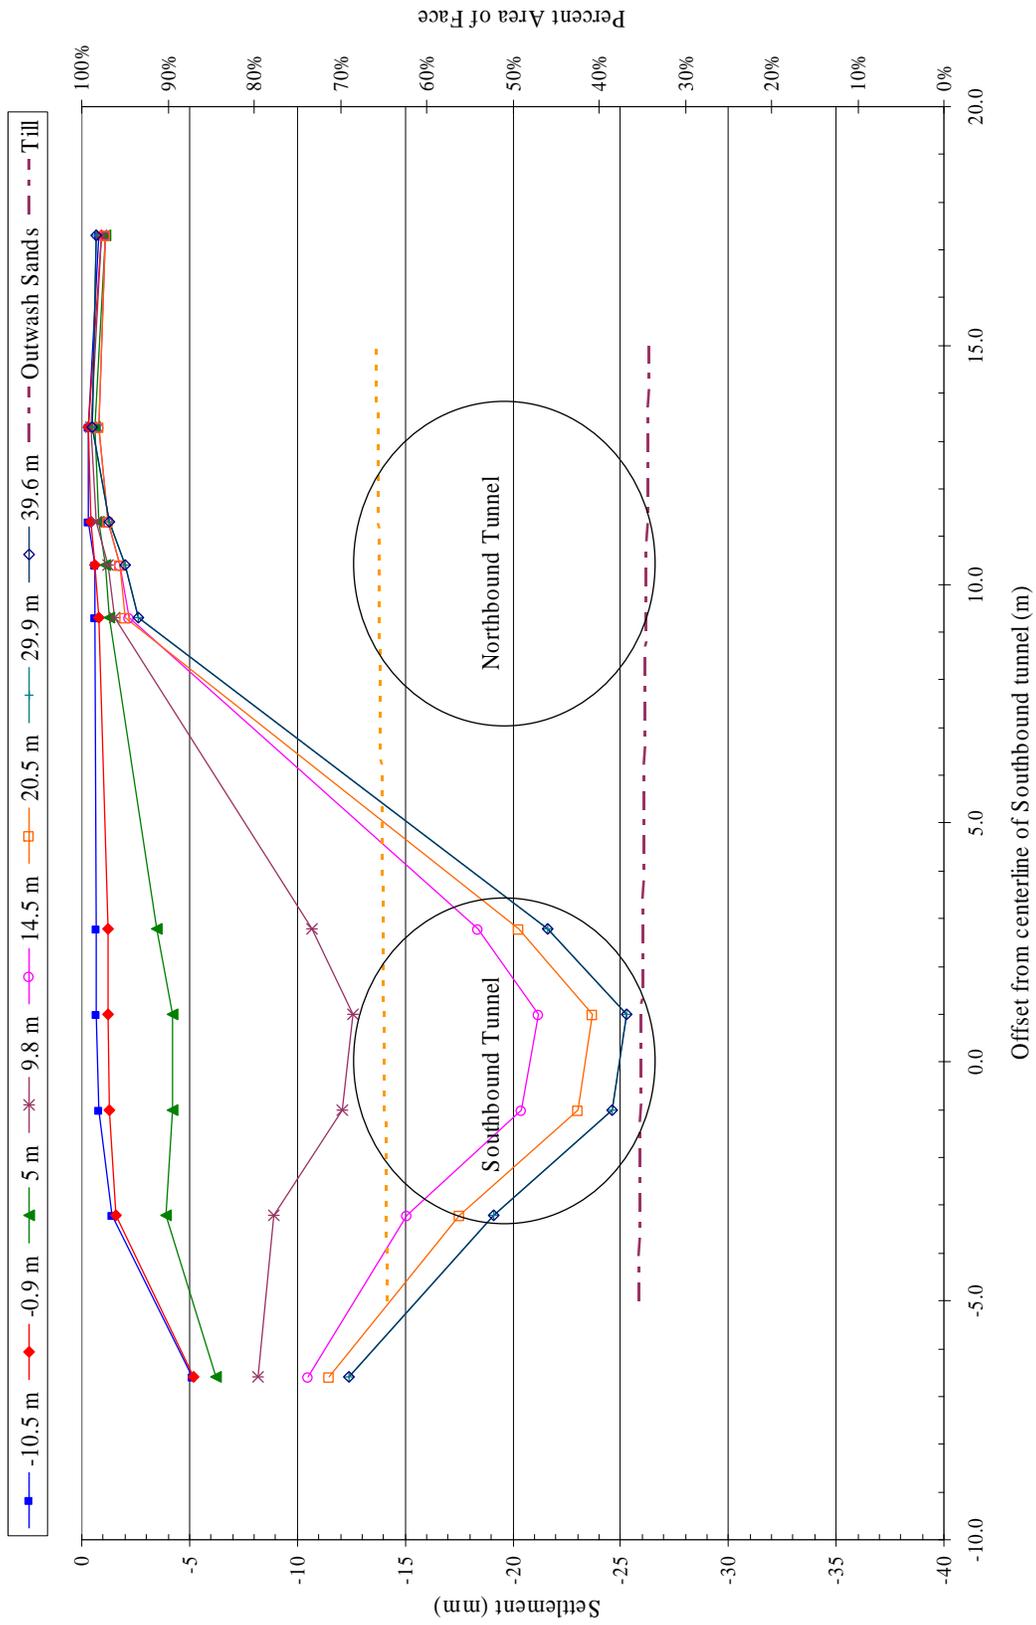
Figure 4-41 Observed shallow settlement at Array D during construction of Southbound Tunnel.

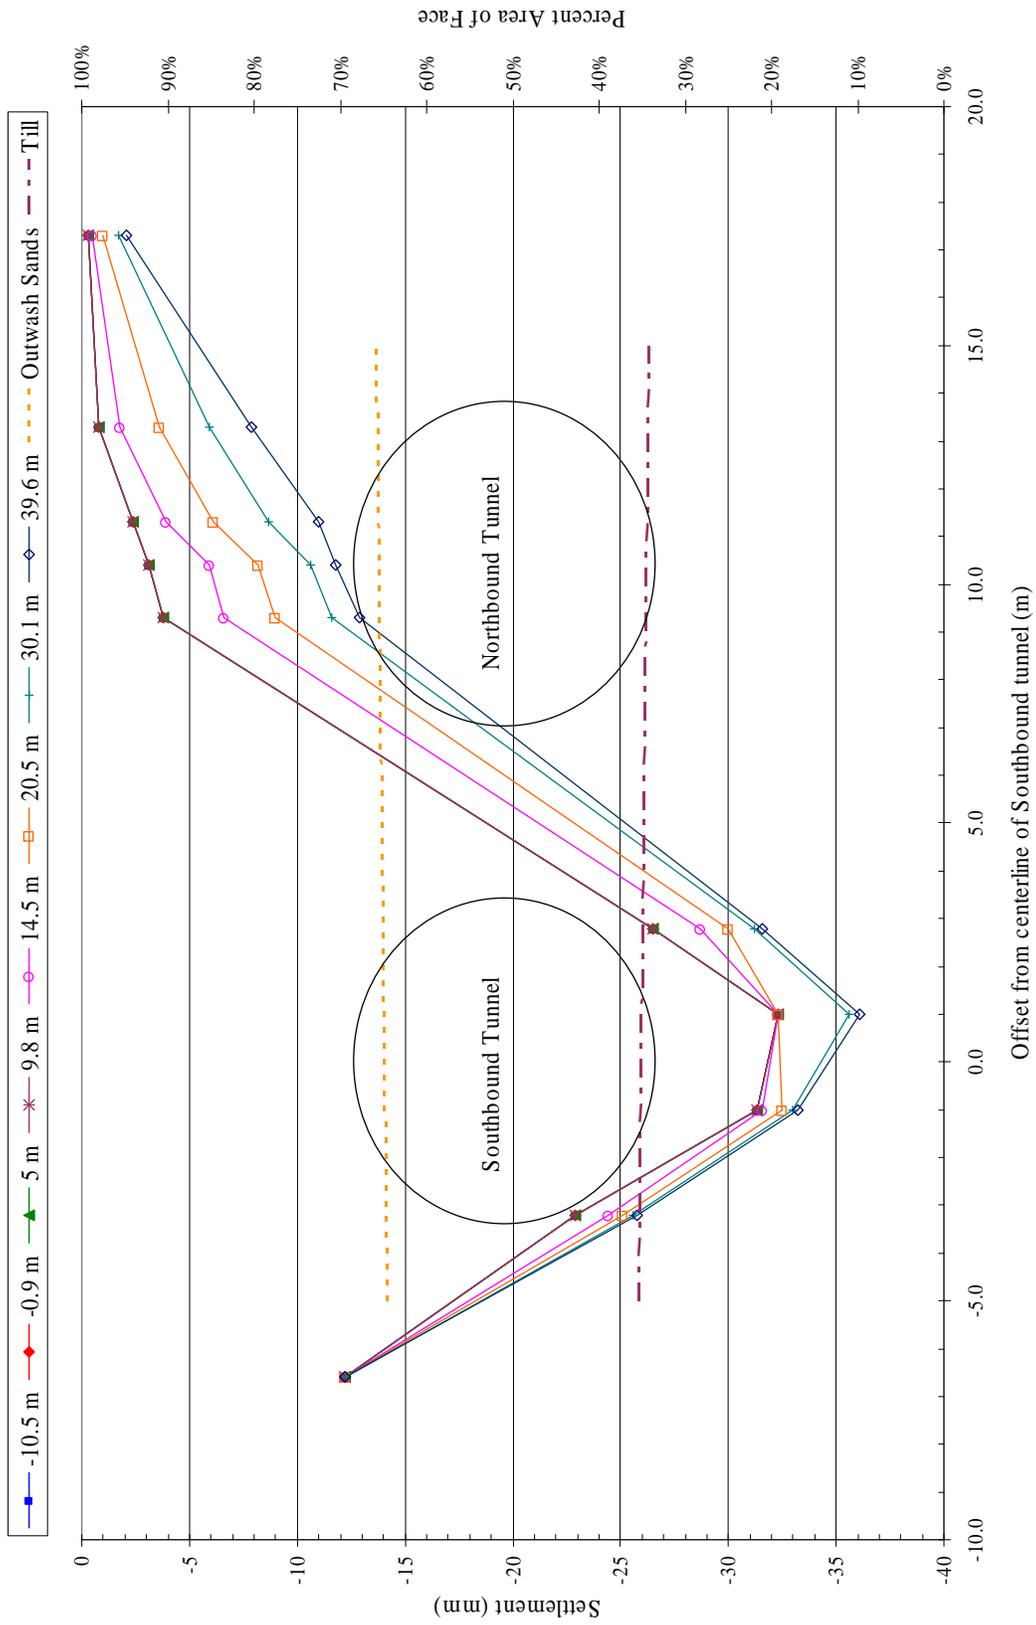
Figure 4-42 Observed shallow settlement at Array D during construction of Northbound Tunnel.

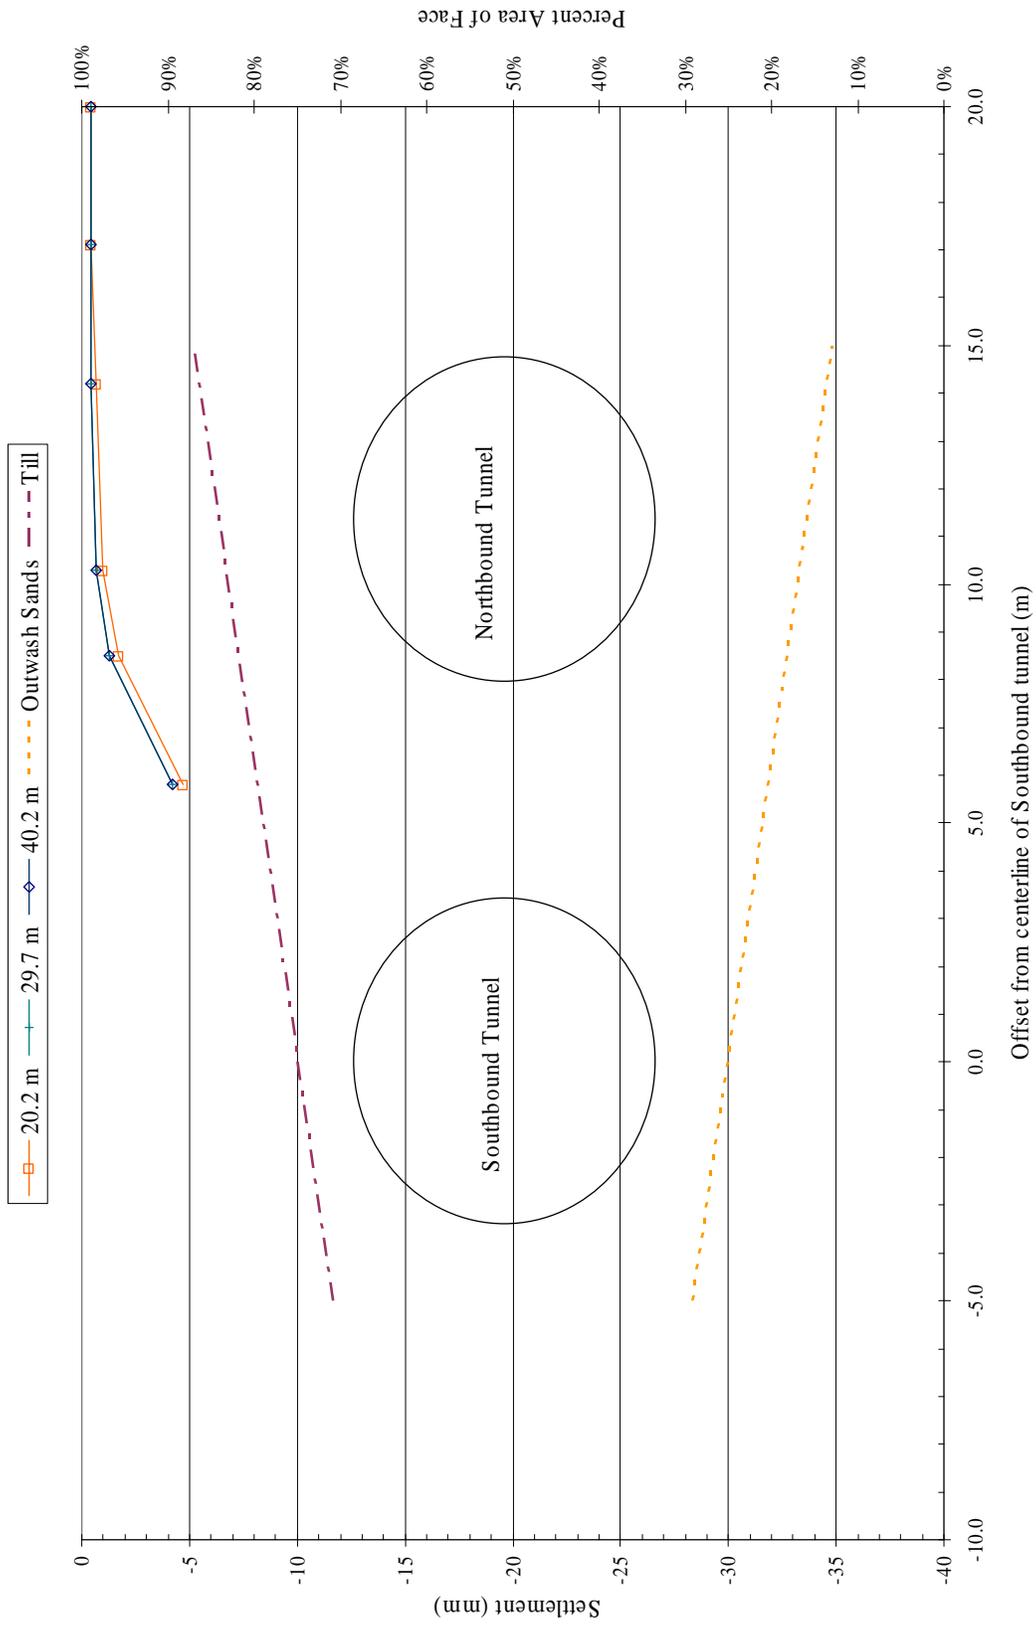
Figure 4-43 Observed shallow settlement at Array C during construction of Southbound Tunnel.

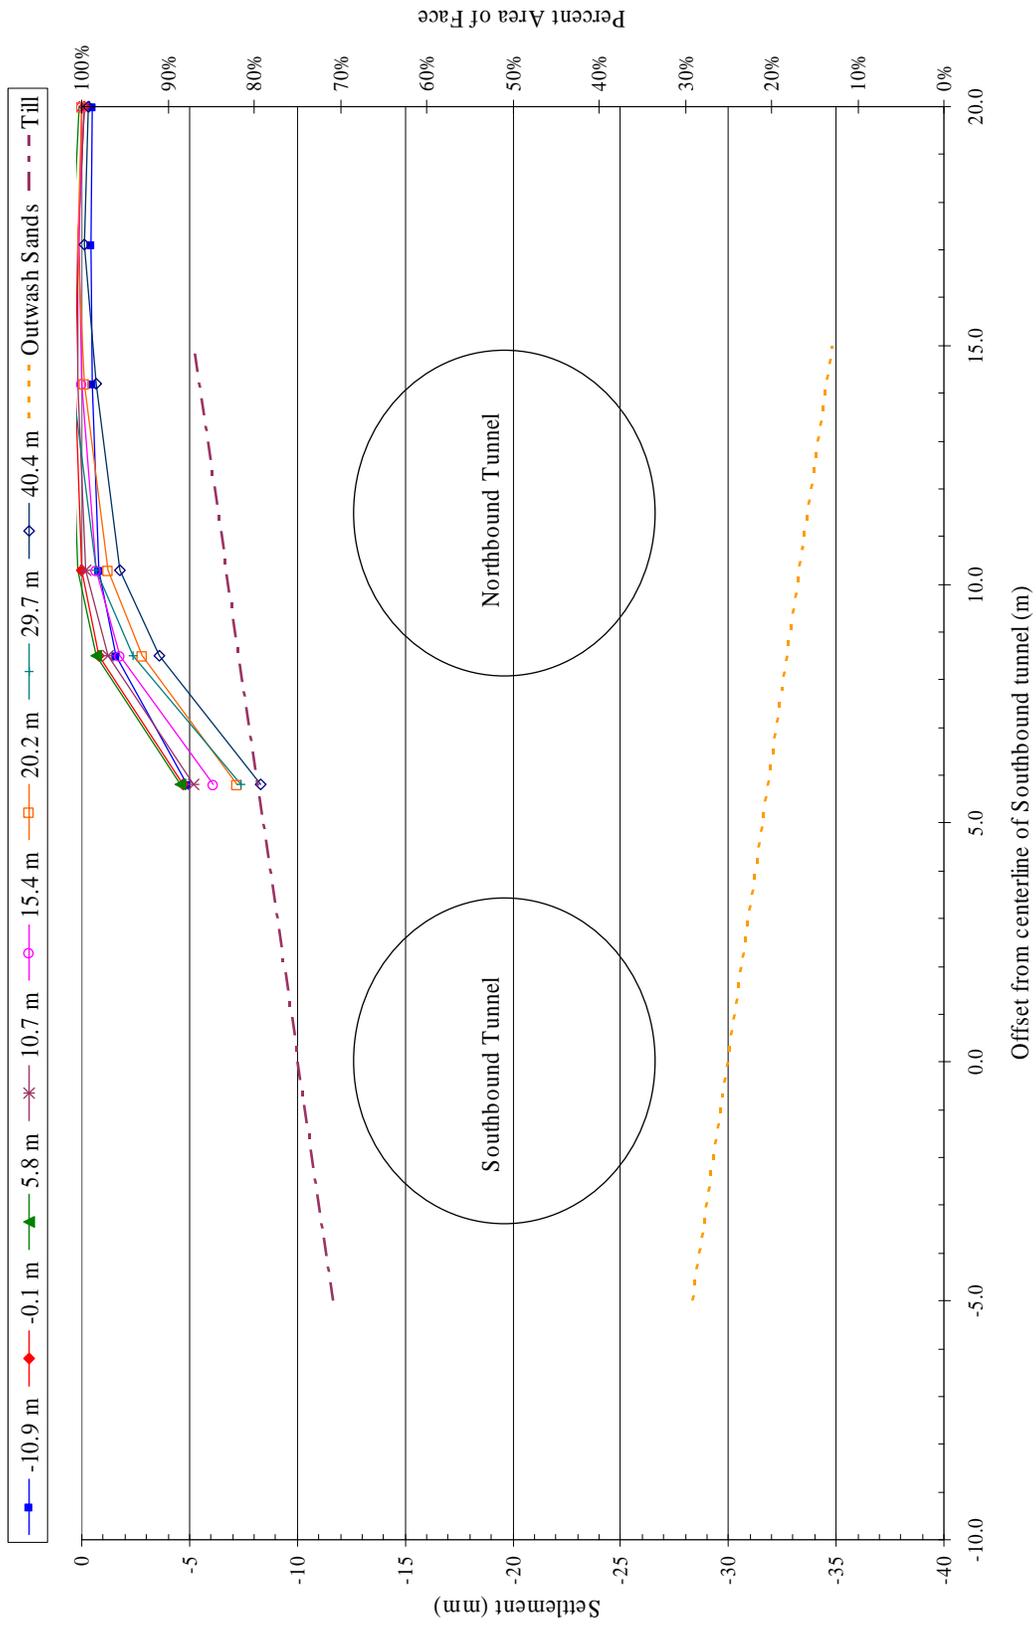
Figure 4-44 Observed shallow settlement at Array C during construction of Northbound Tunnel.

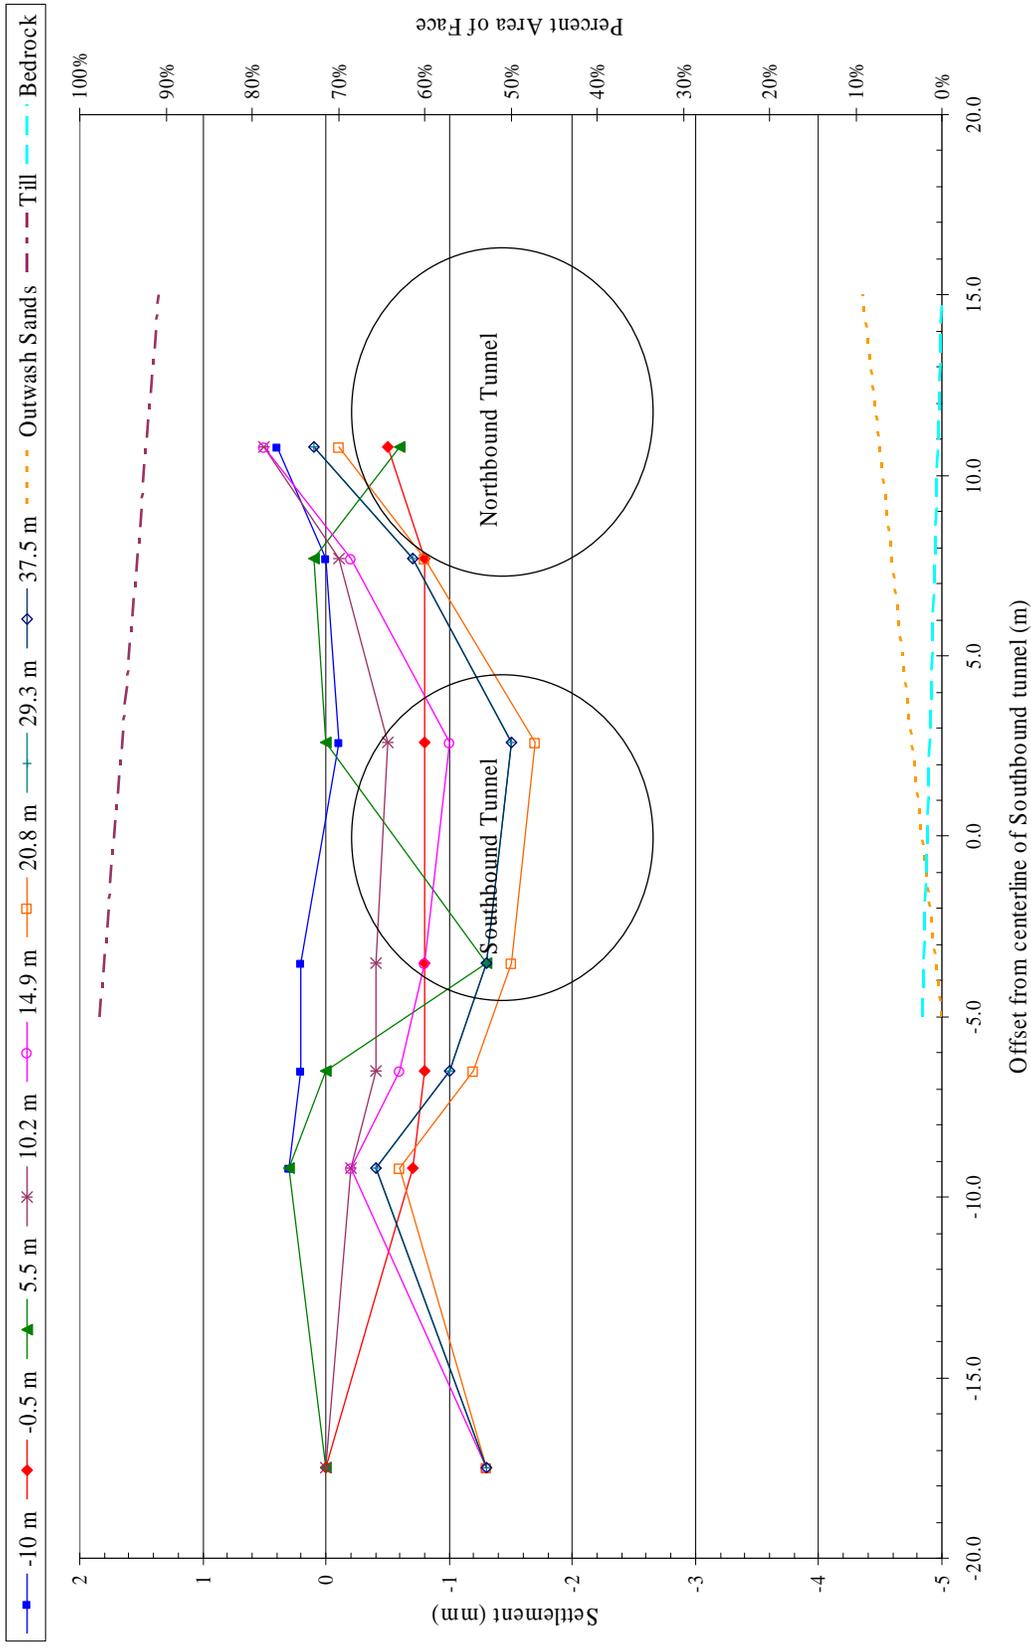
Figure 4-45 Observed shallow settlement at Array B during construction of Southbound Tunnel.

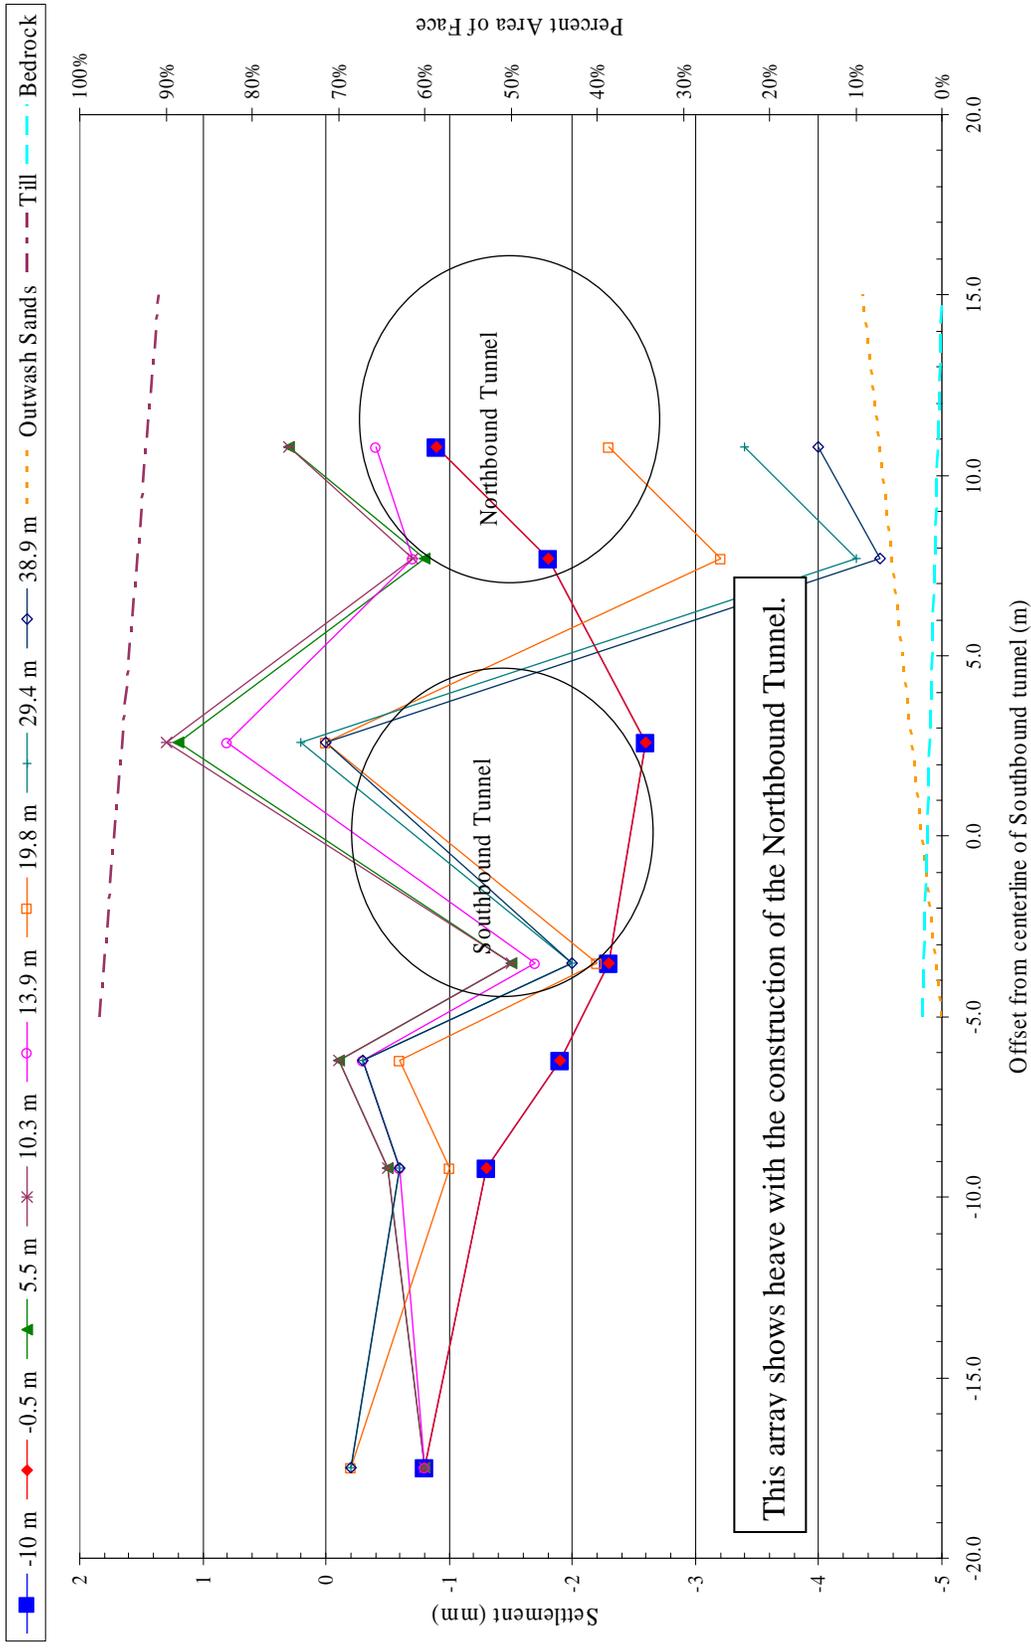
Figure 4-46 Observed shallow settlement at Array B during construction of Northbound Tunnel.

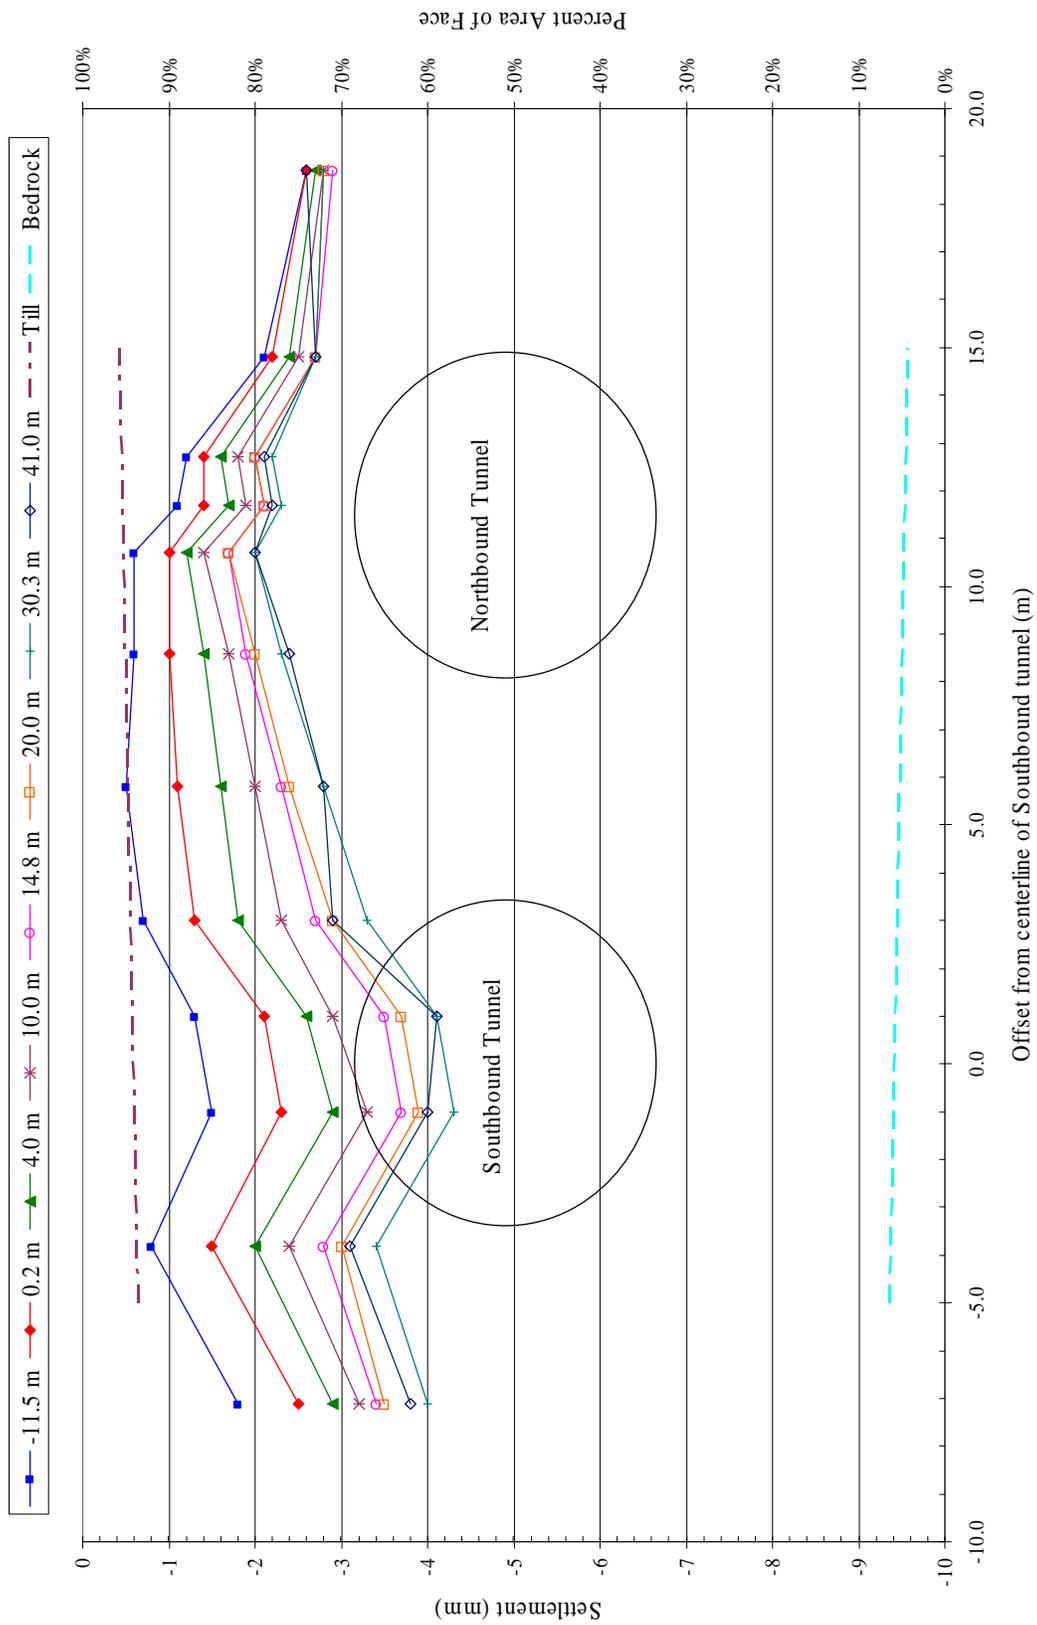
Figure 4-47 Observed shallow settlement at Array A during construction of Southbound Tunnel.

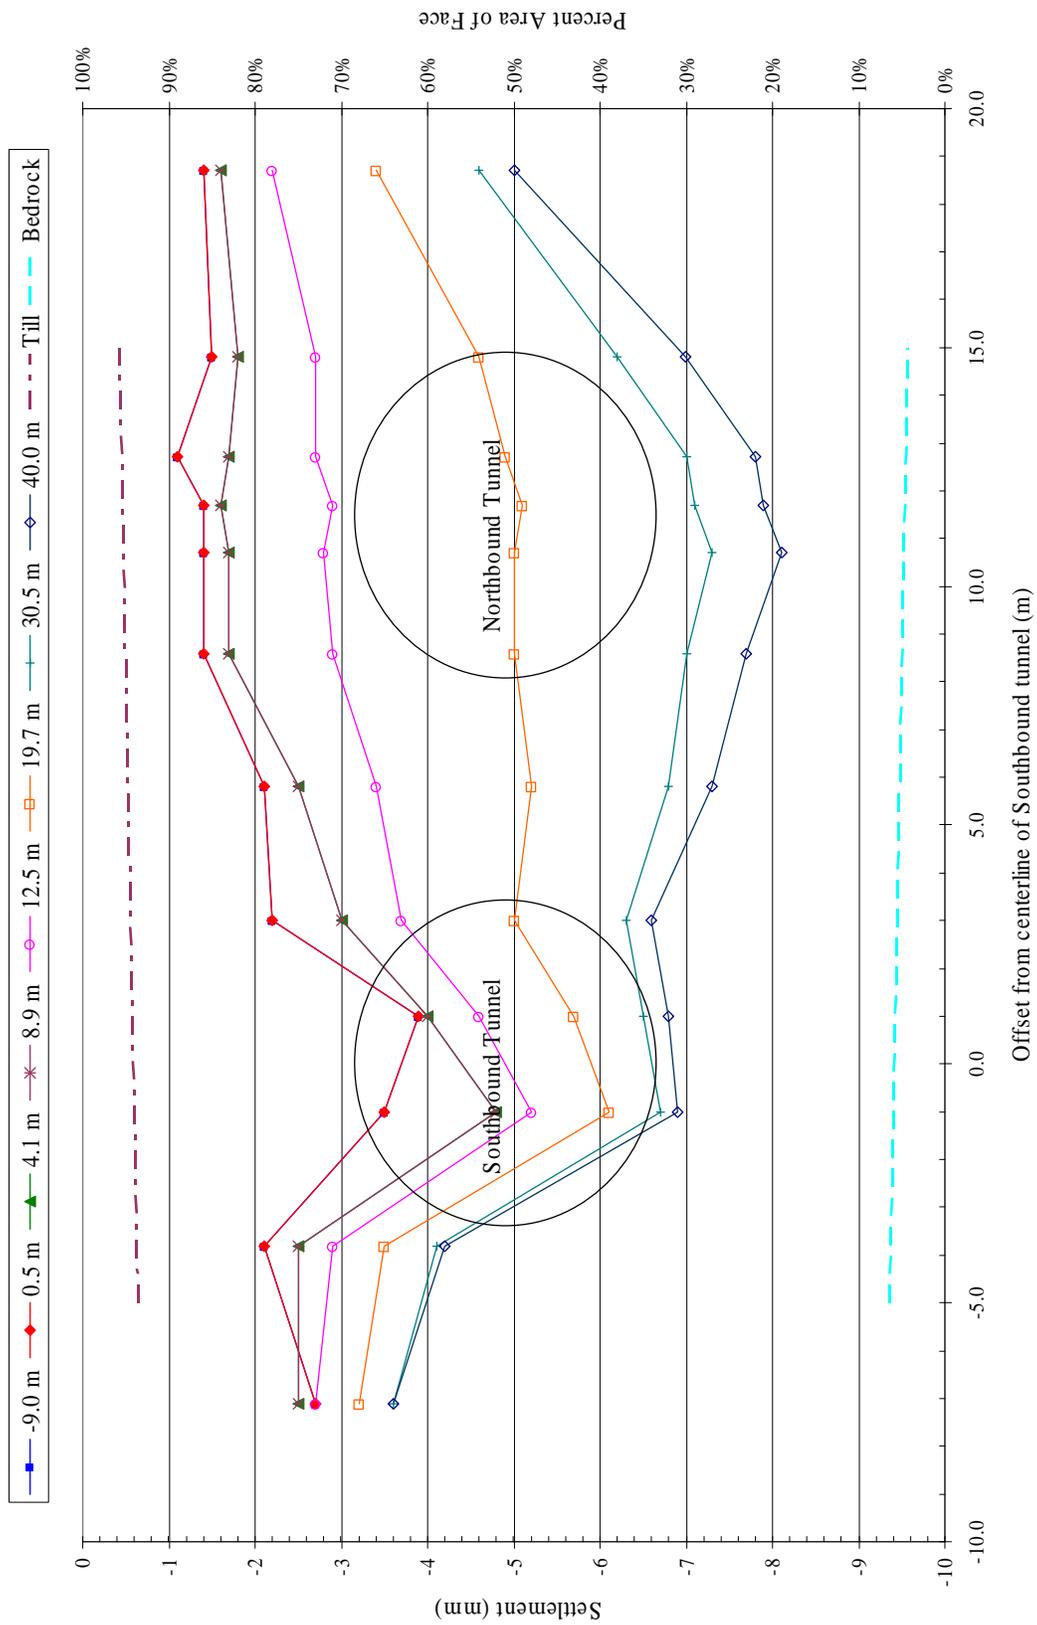
Figure 4-48 Observed shallow settlement at Array A during construction of Northbound Tunnel.

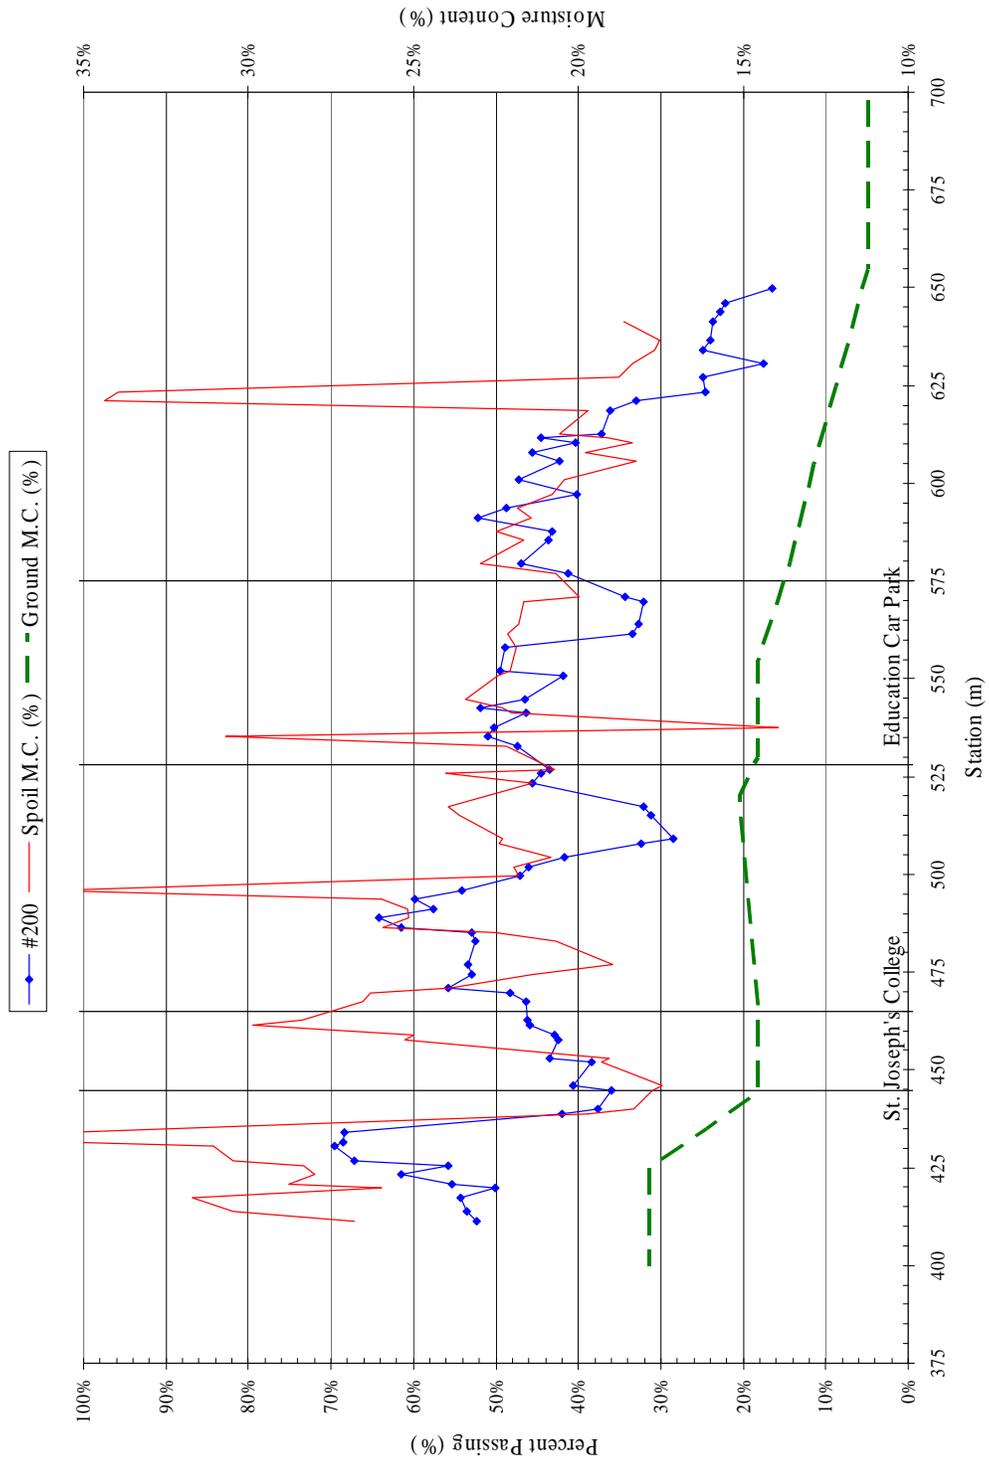
Figure 5-1 TBM spoil moisture content with inferred in-situ moisture content with the percentage of TBM spoil passing the #200 Sieve during Southbound construction.

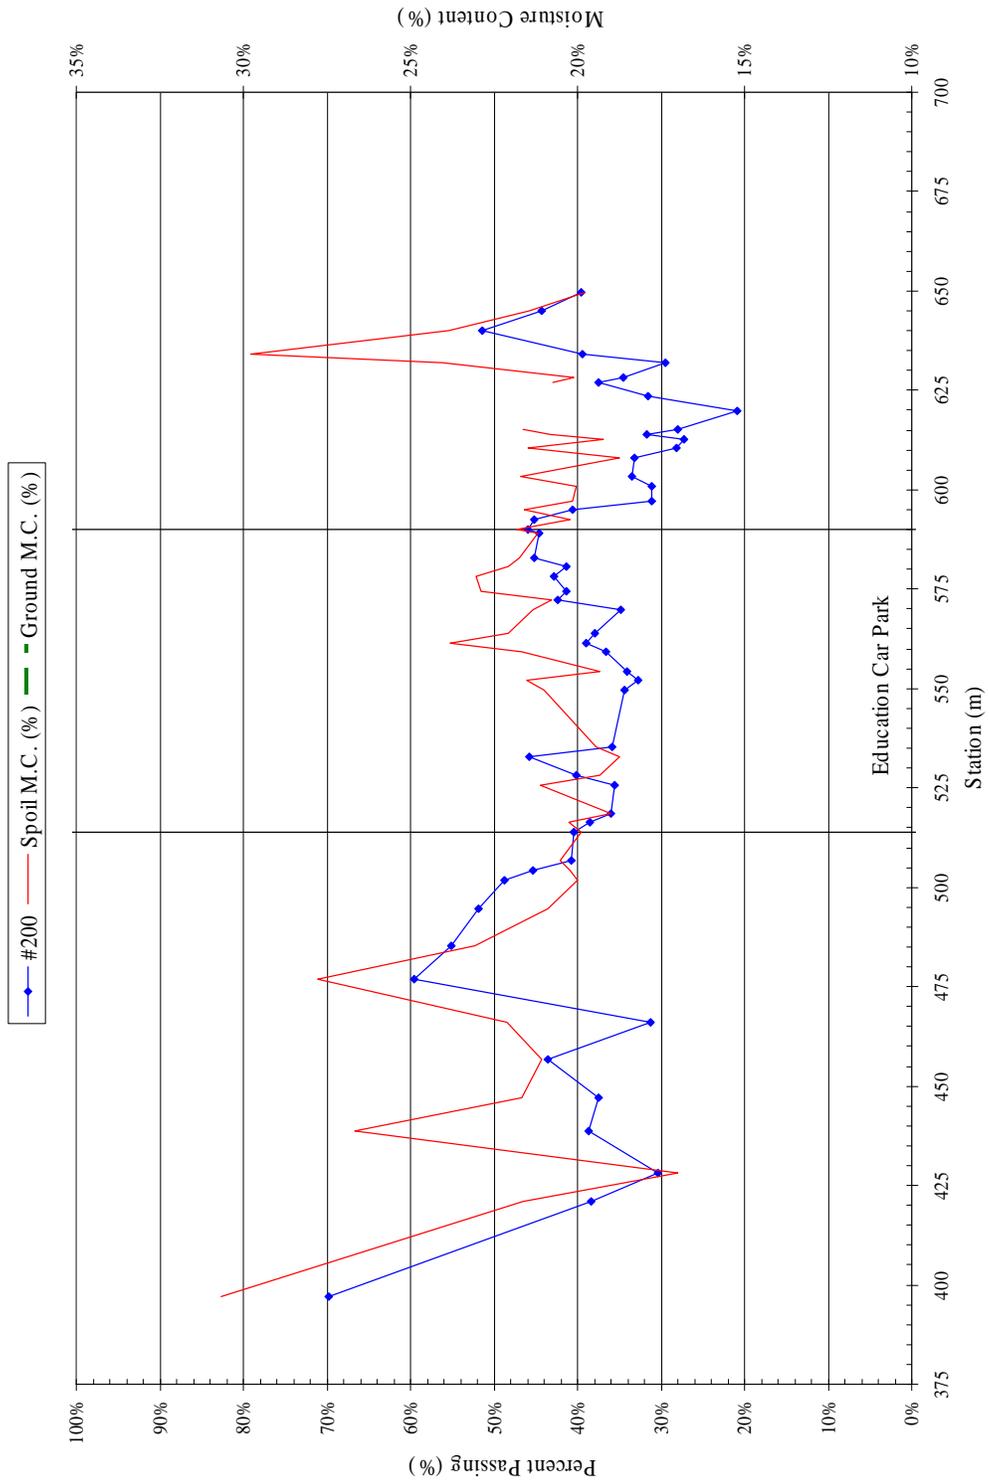
Figure 5-2 TBM spoil moisture content with inferred in-situ moisture content with the percentage of TBM spoil passing the #200 Sieve during Northbound construction.

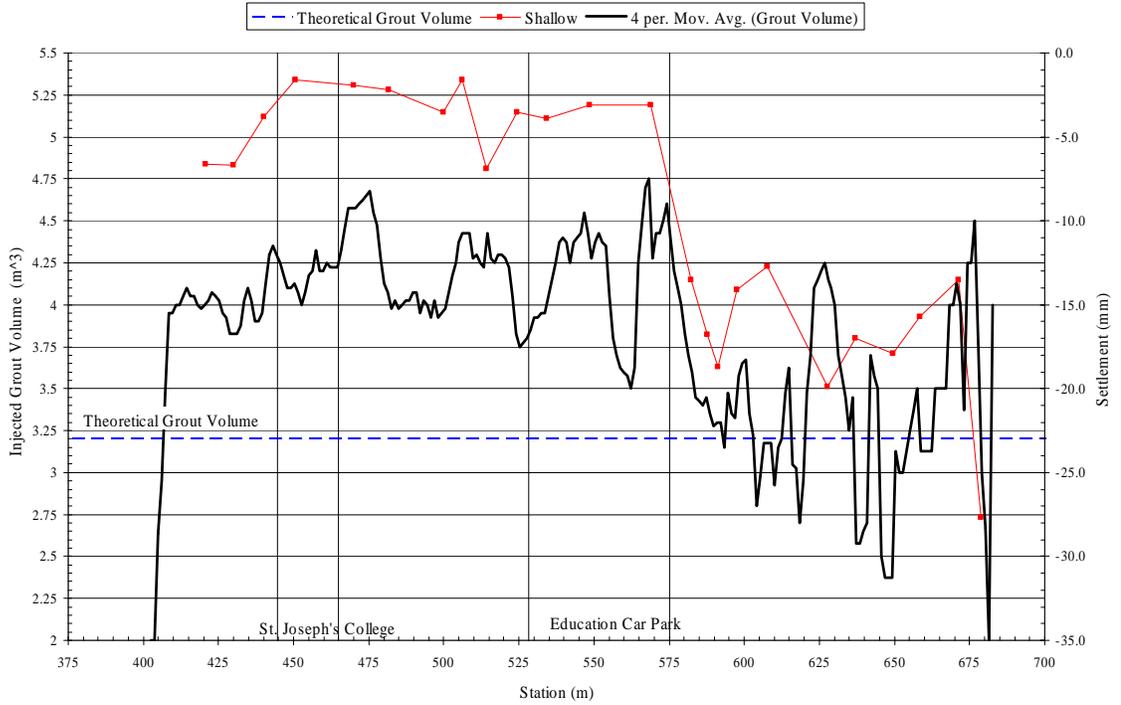
Figure 5-13 Injected grout volume per ring of advance during Southbound construction contrasted with observed shallow settlements.

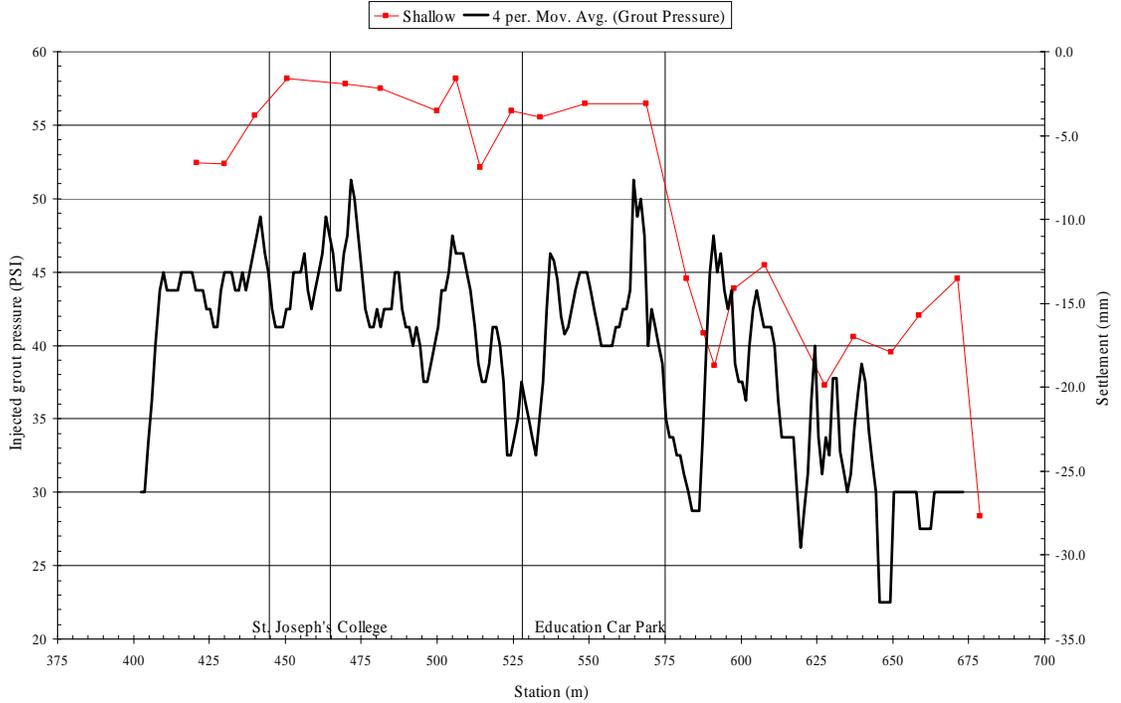
Figure 5-14 Injected grout pressure per ring of advance during Southbound construction contrasted with observed shallow settlements.

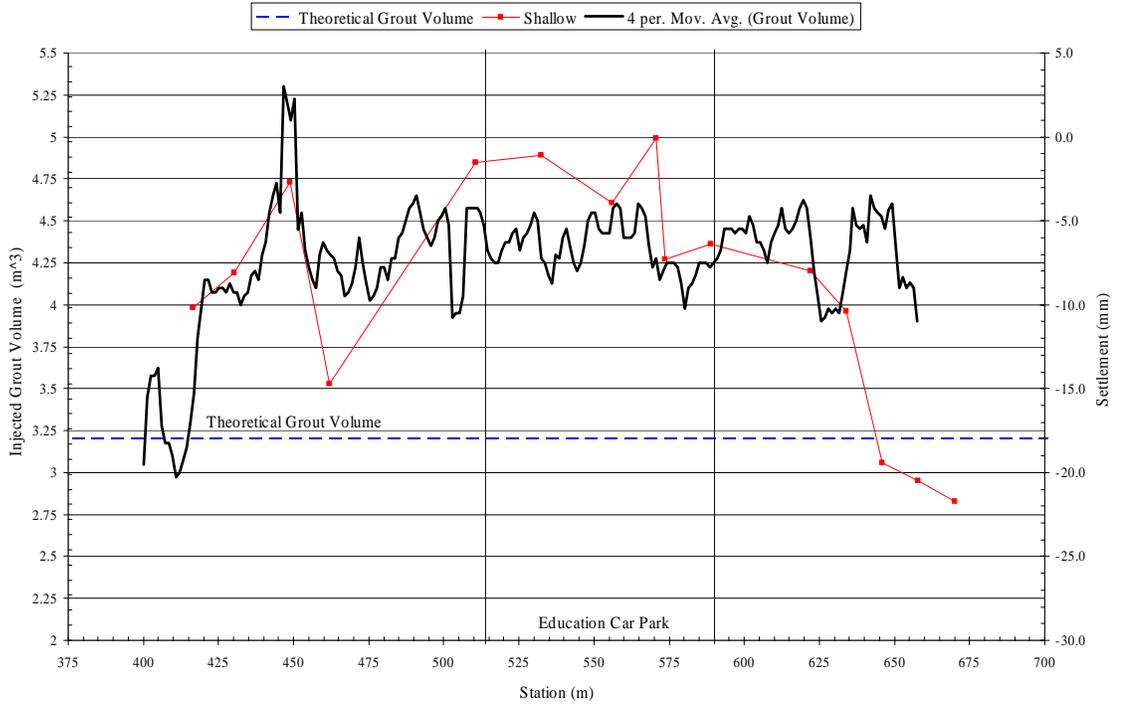
Figure 5-15 Injected grout volume per ring of advance during Northbound construction contrasted with observed shallow settlements.
