Title of Thesis: Performance of EPB-TBM in Mixed Face Conditions:
City of Edmonton South LRT Extension – University Station
to Health Sciences Station

Performance of EPB-TBM in Mixed Face Conditions:

City of Edmonton South LRT Extension – University Station to Health Sciences Station

Geotechnical Engineering

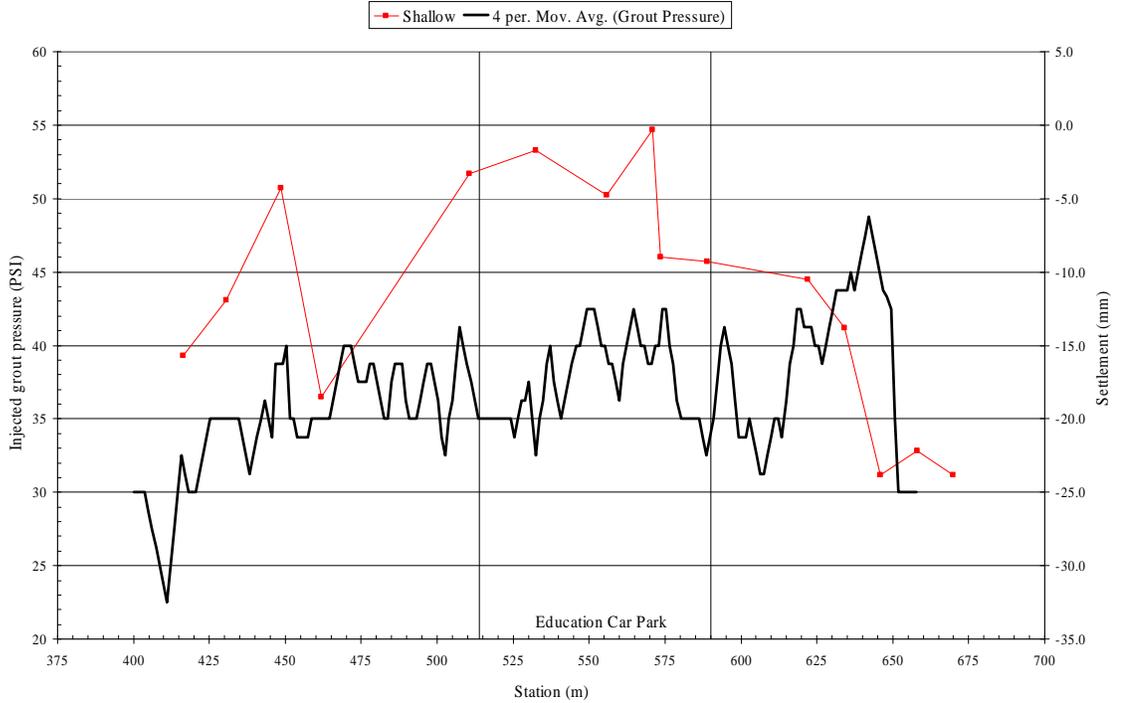
Figure 5-16 Injected grout pressure per ring of advance during Northbound construction contrasted with observed shallow settlements.

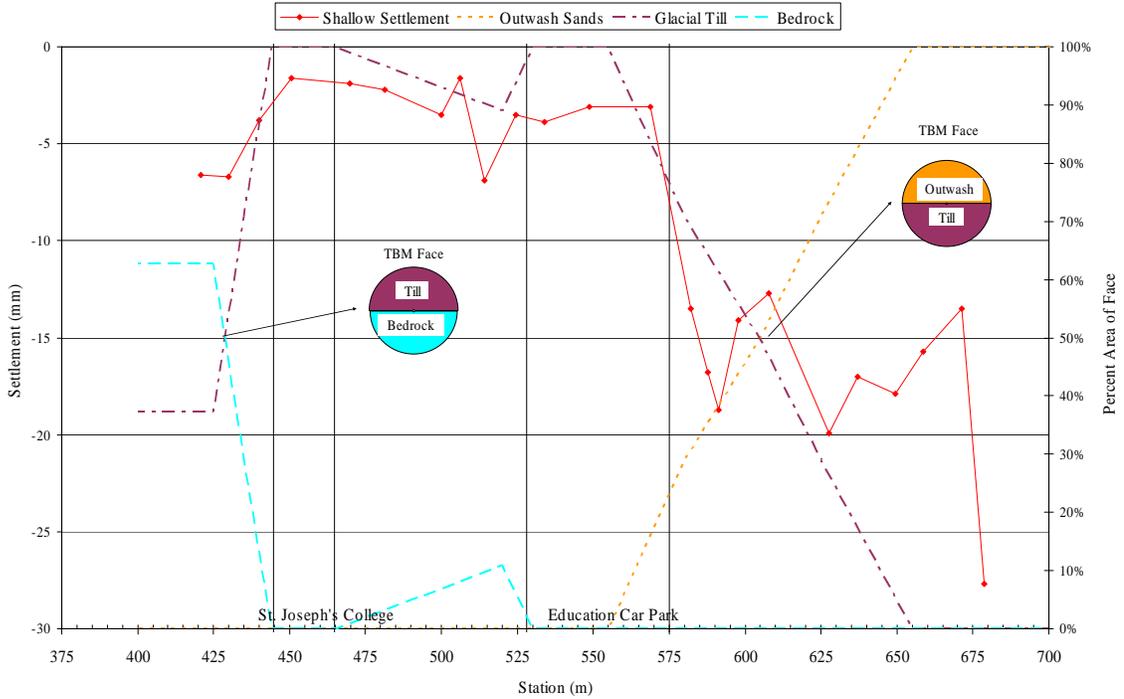
Figure 5-17 Observed shallow settlements during Southbound construction contrasted with inferred stratigraphy.

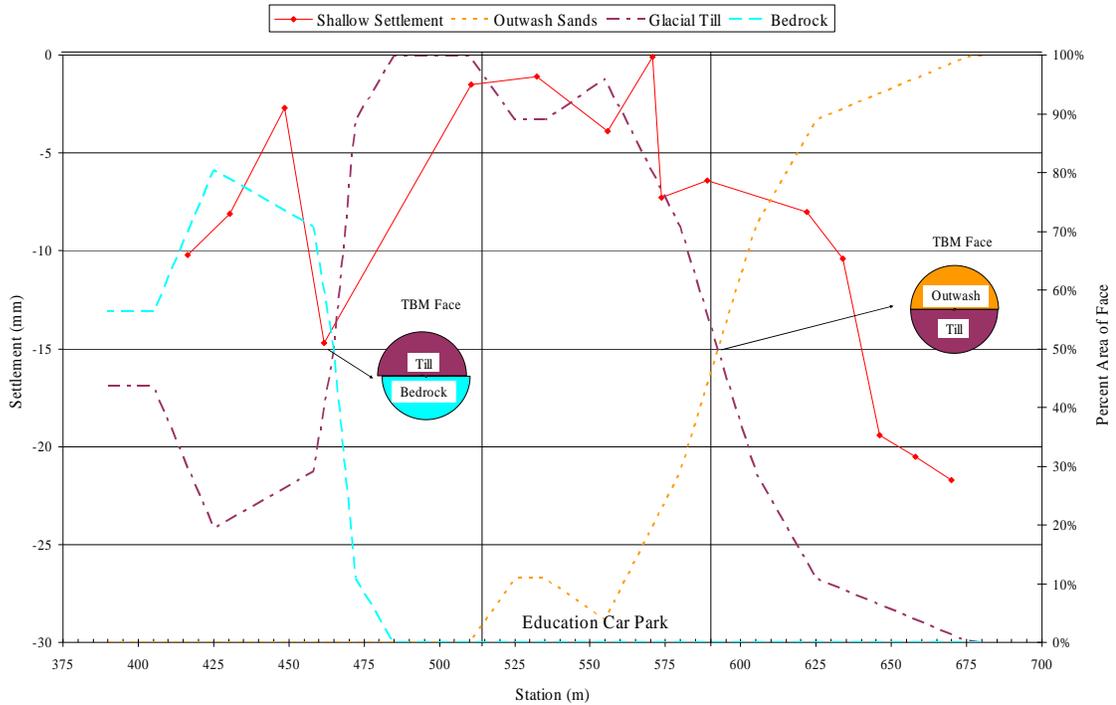
Figure 5-19 Observed shallow settlements during Northbound construction contrasted with the inferred stratigraphy.

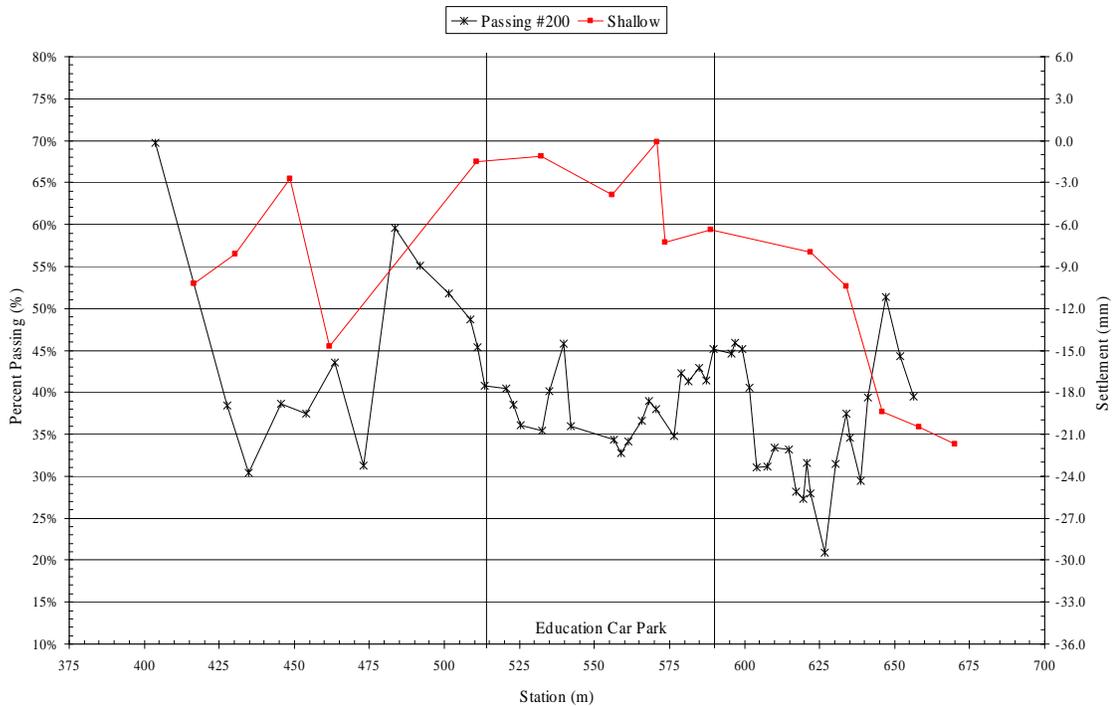
Figure 5-20 Observed shallow settlements during Northbound construction contrasted with grain size distribution of TBM spoil.

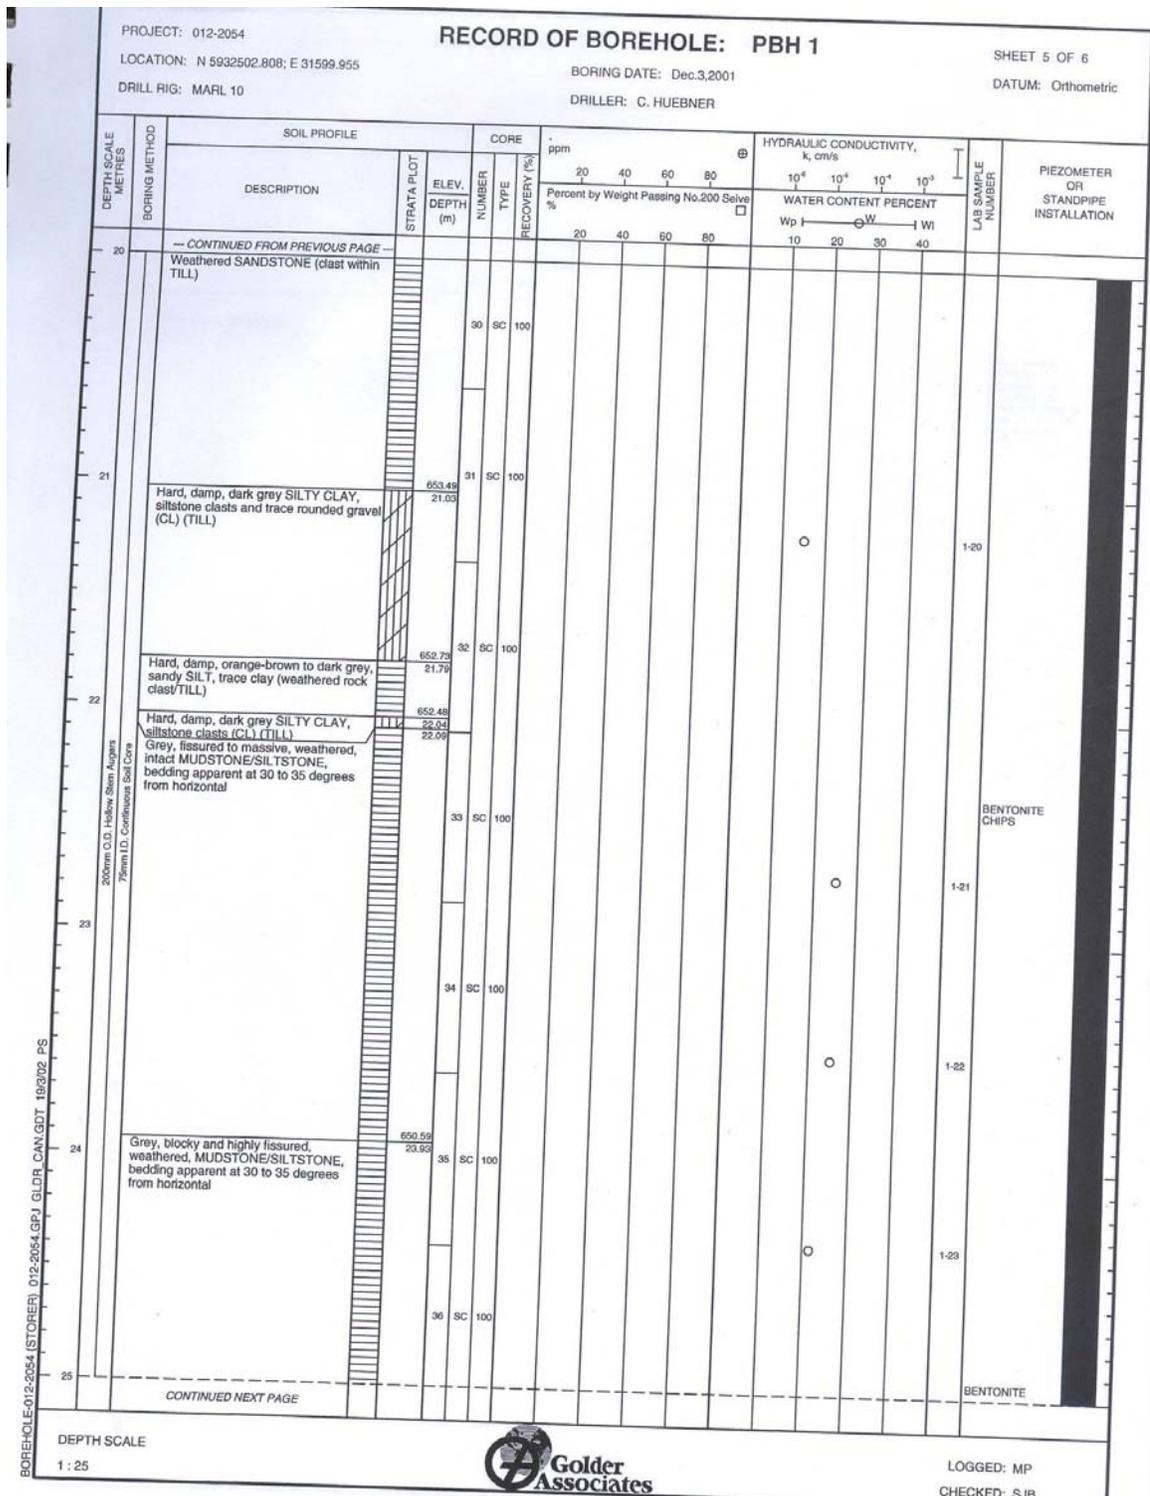
Figure E-1 A selection of the borehole log for Borehole PBH-1 focusing on the Bedrock (Golders).

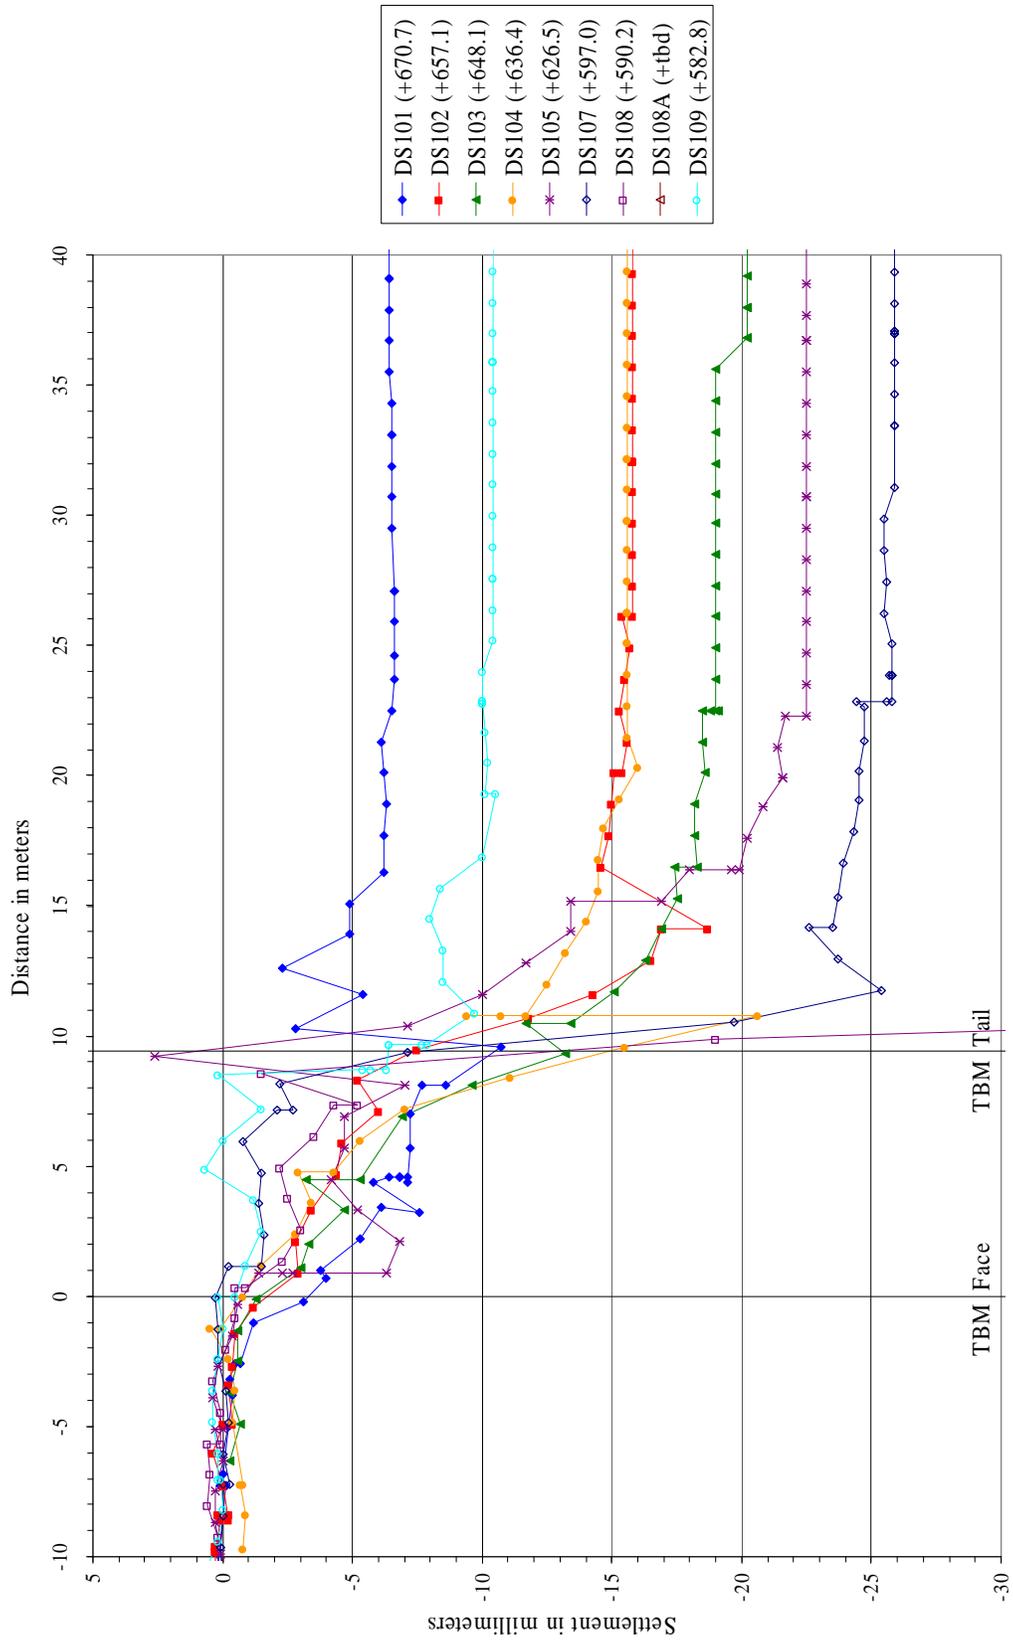
Figure G-1 Observed deep settlements during construction of Southbound Tunnel with proximity to TBM face, from Portal to Education Car Park.

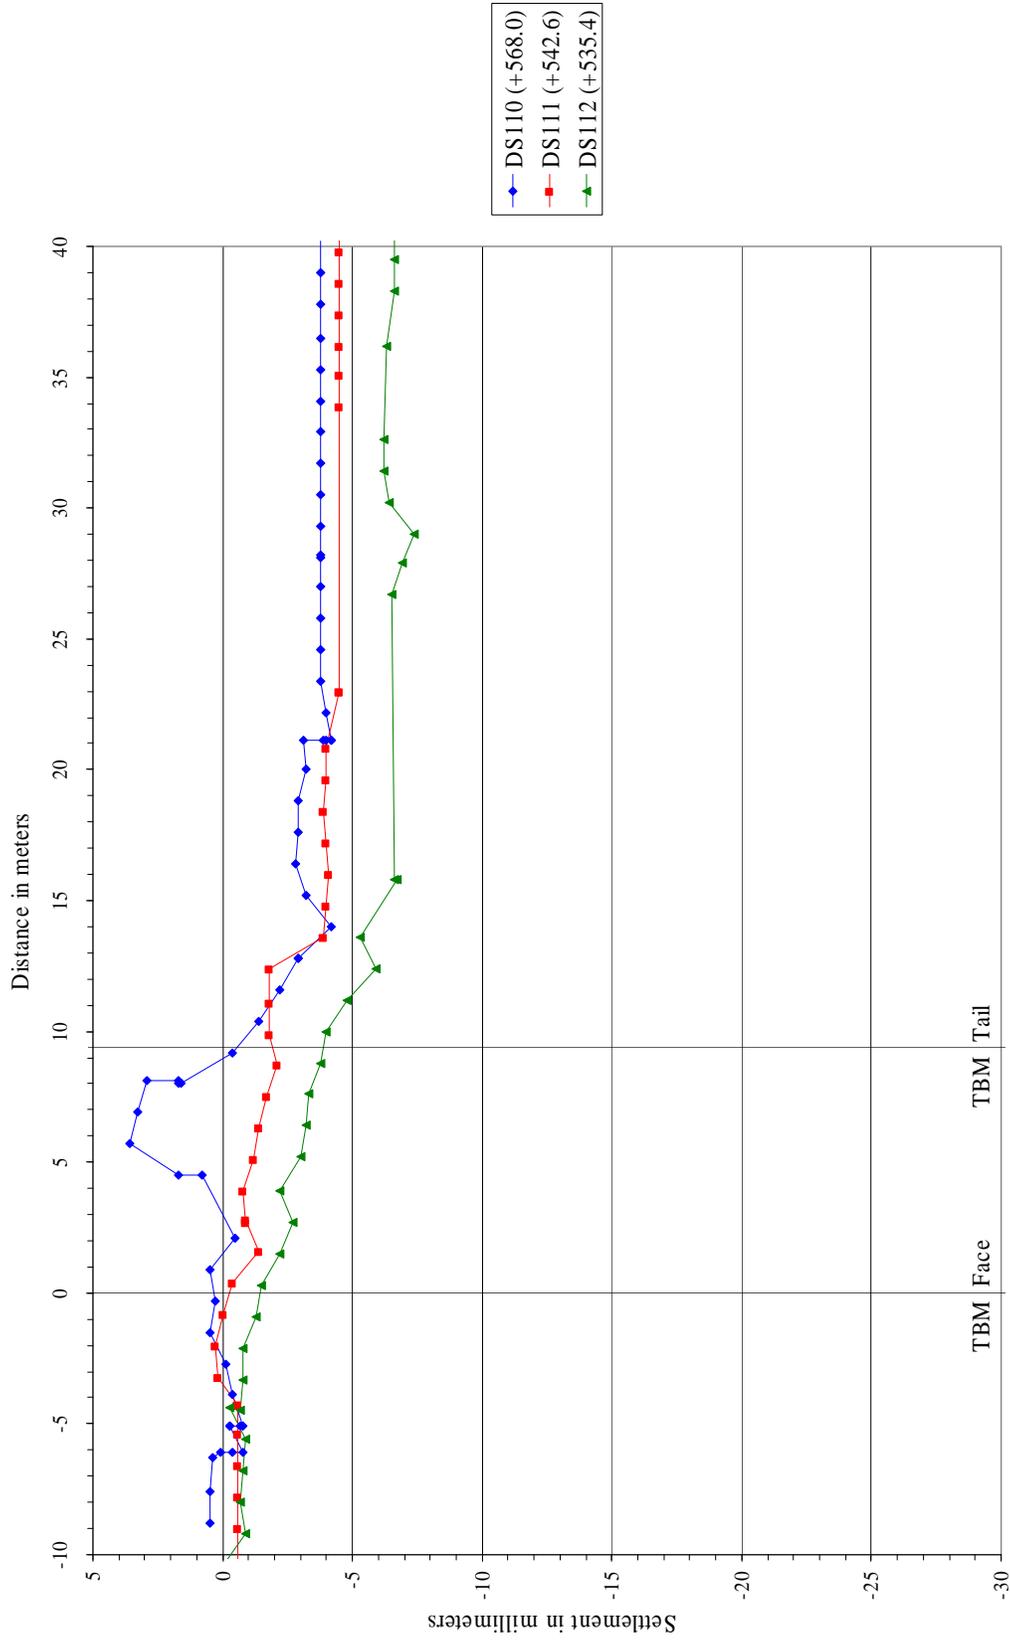
Figure G-2 Observed Deep settlements during construction of Southbound Tunnel with proximity to TBM face, Education Car Park.

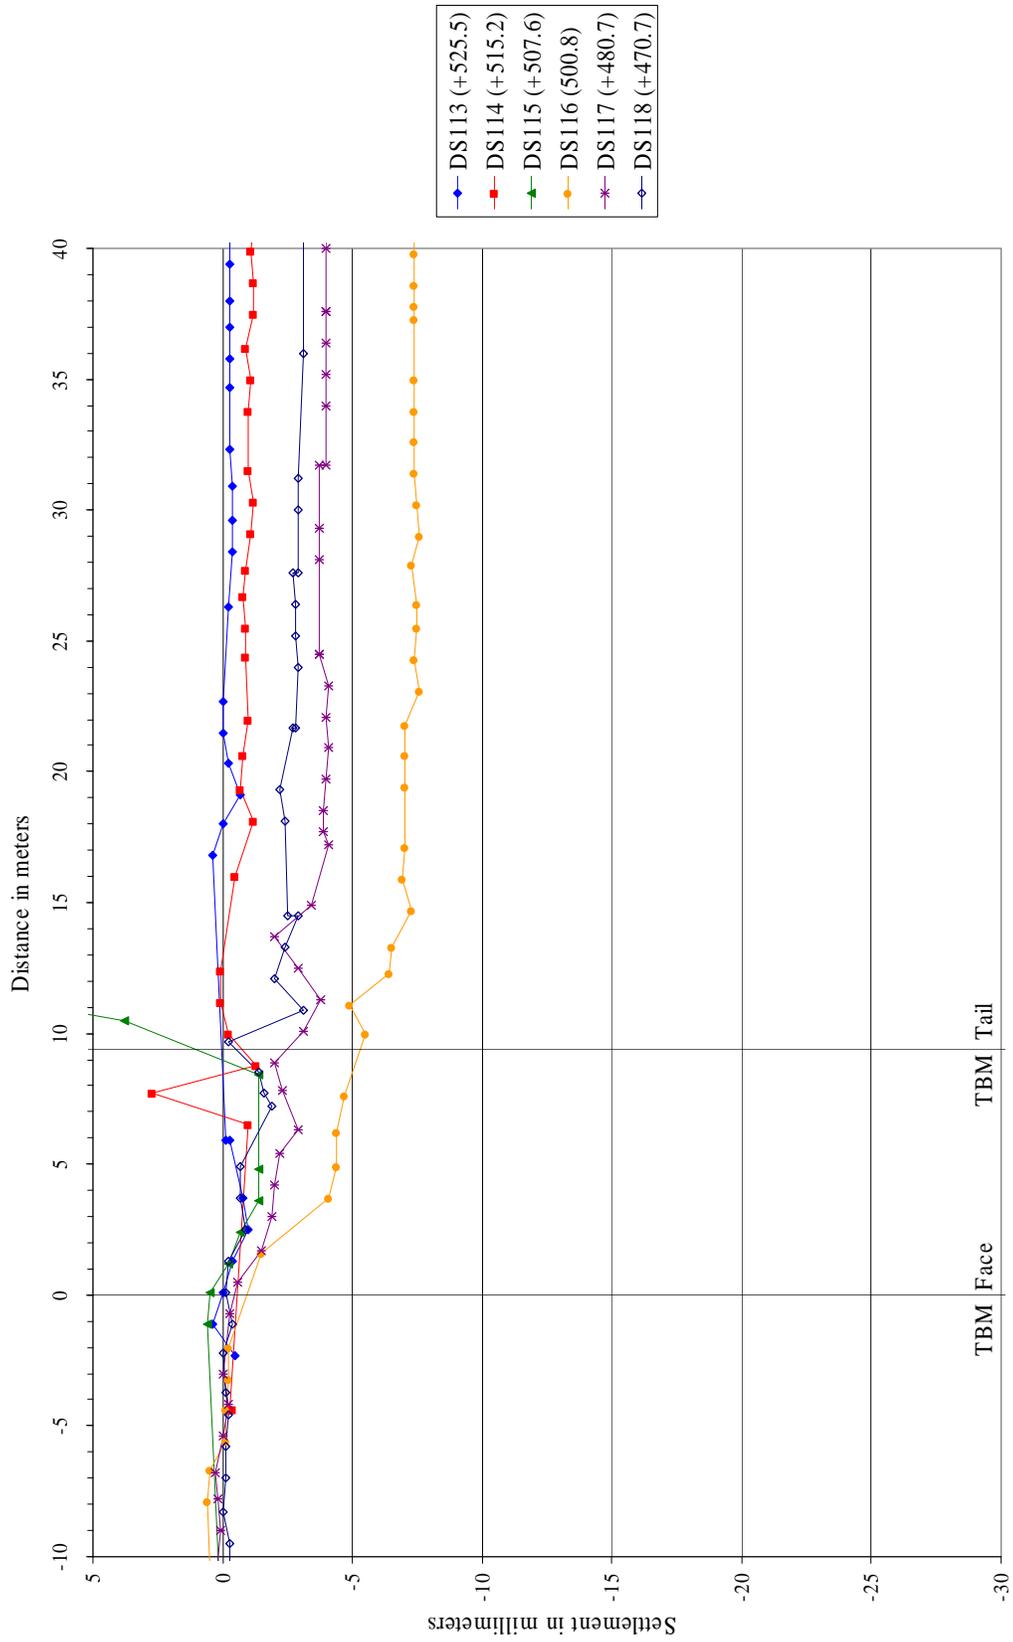
Figure G-3 Observed deep settlements during construction of Southbound Tunnel with proximity to TBM face, Education Car Park to St. Joseph's College.

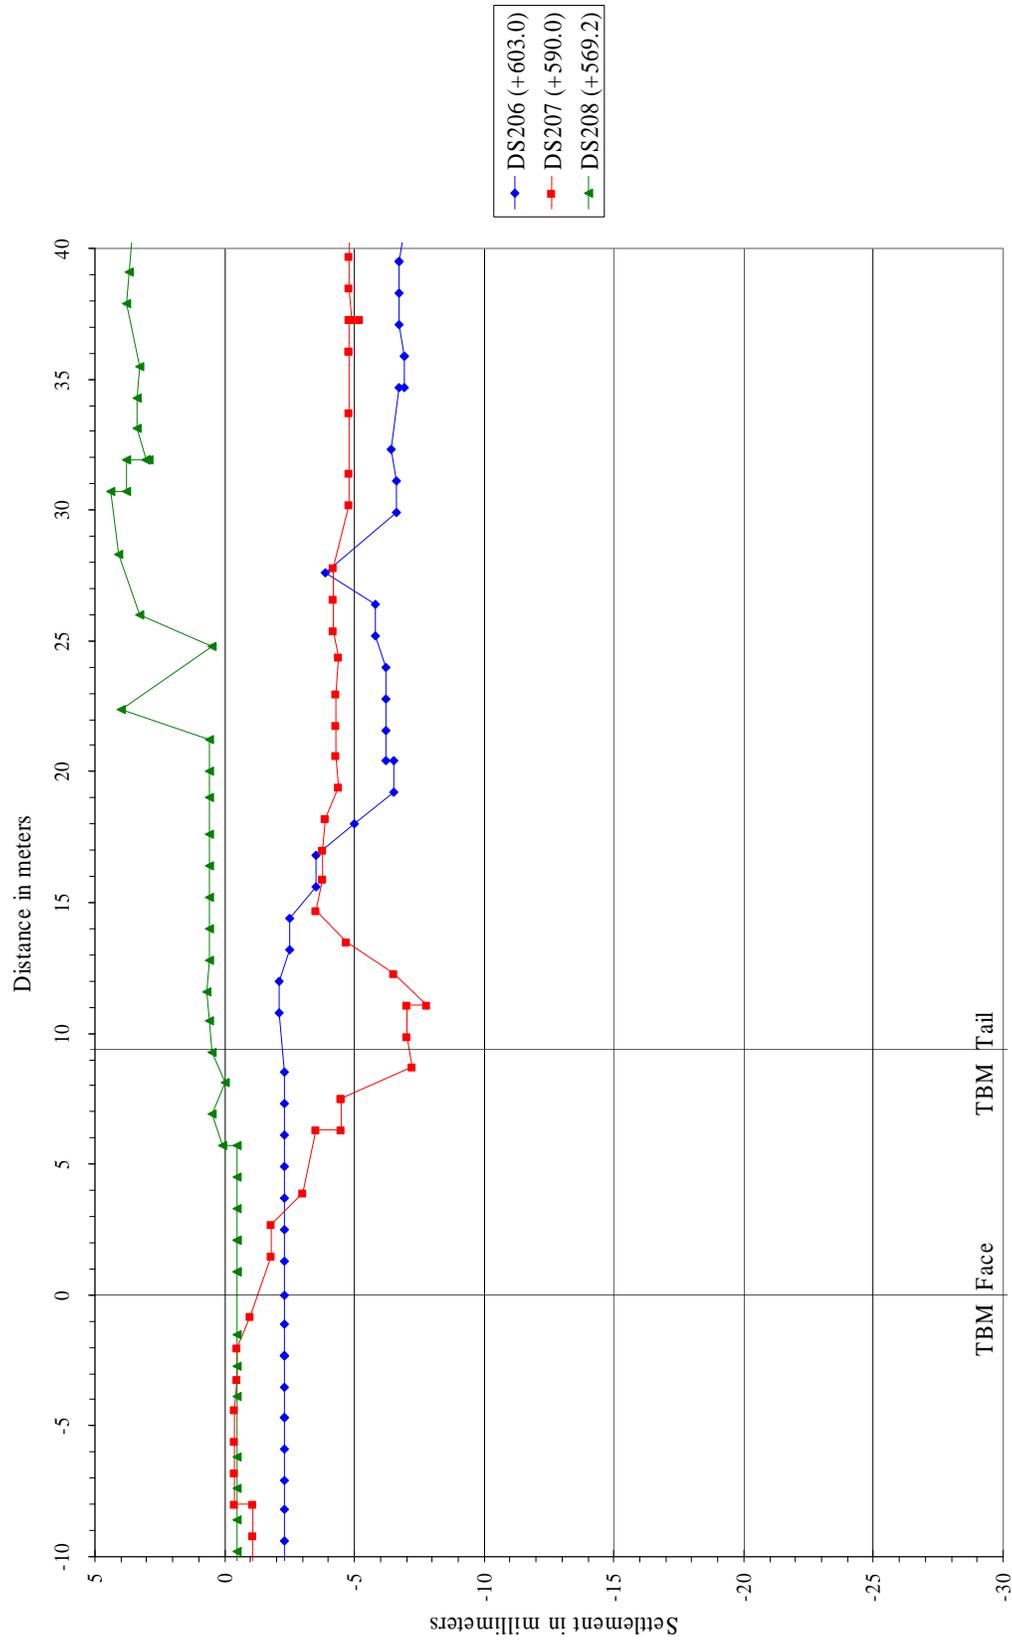
Figure G-4 Observed deep settlements during construction of Northbound Tunnel with proximity to TBM face, from Portal to Education Car Park.

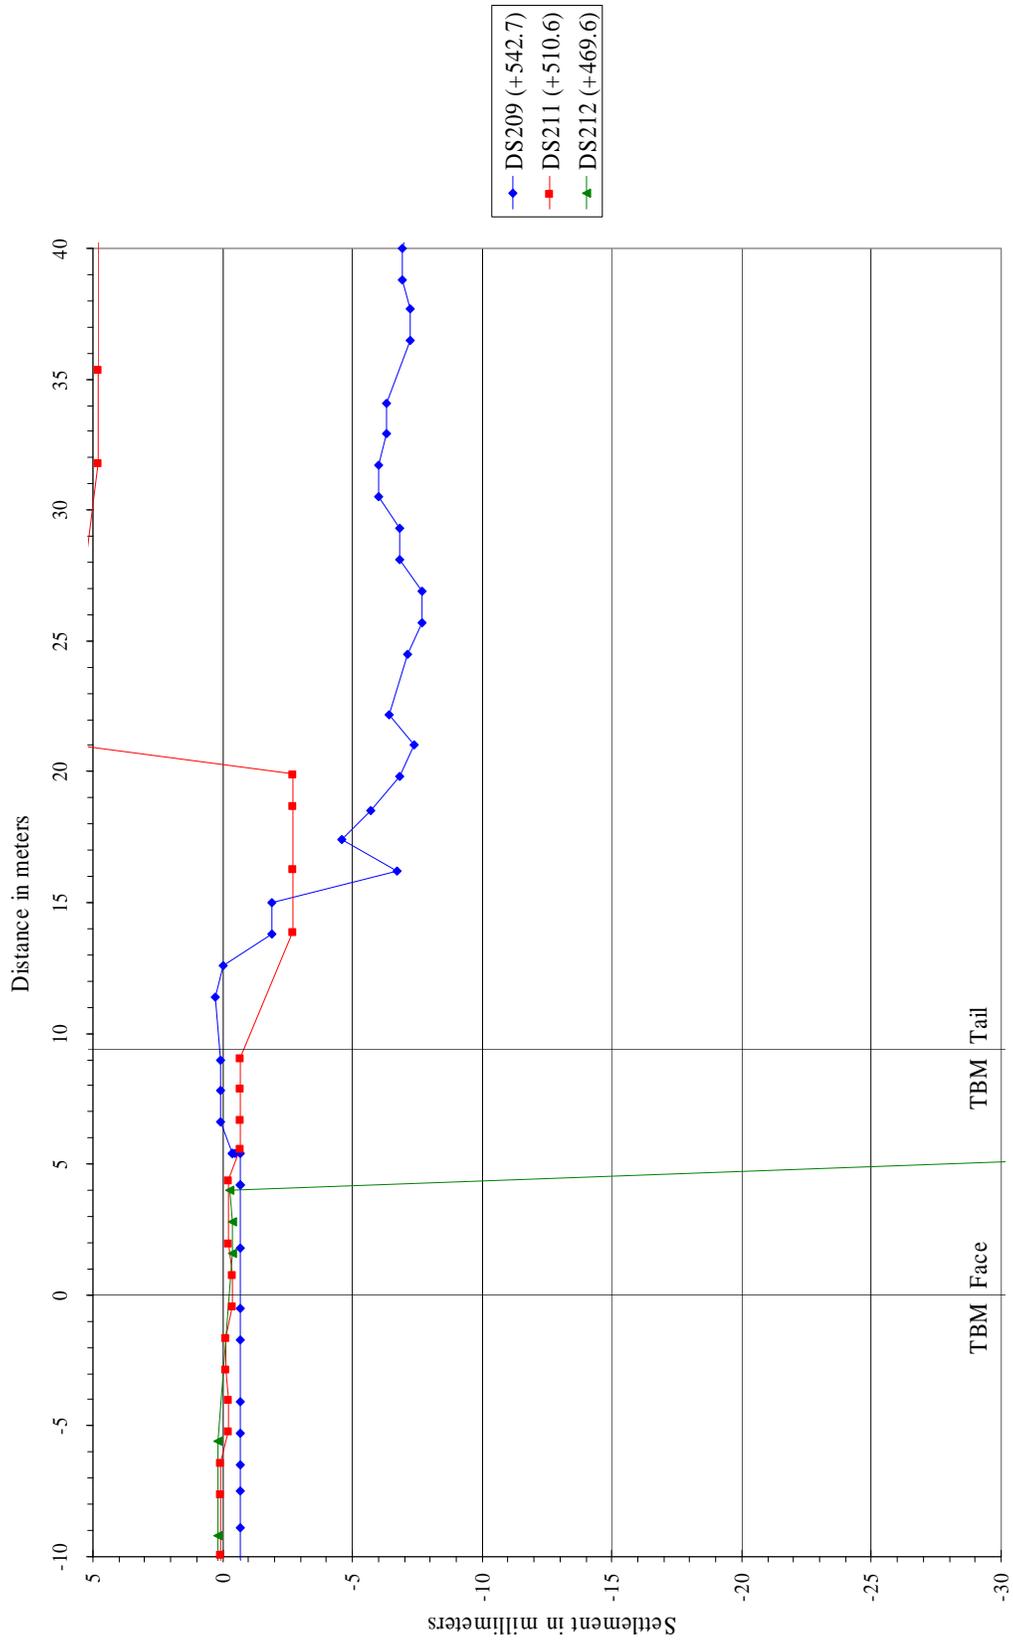
Figure G-5 Observed deep settlements during construction of Northbound Tunnel with proximity to TBM face, from Education Car Park to breakthrough.

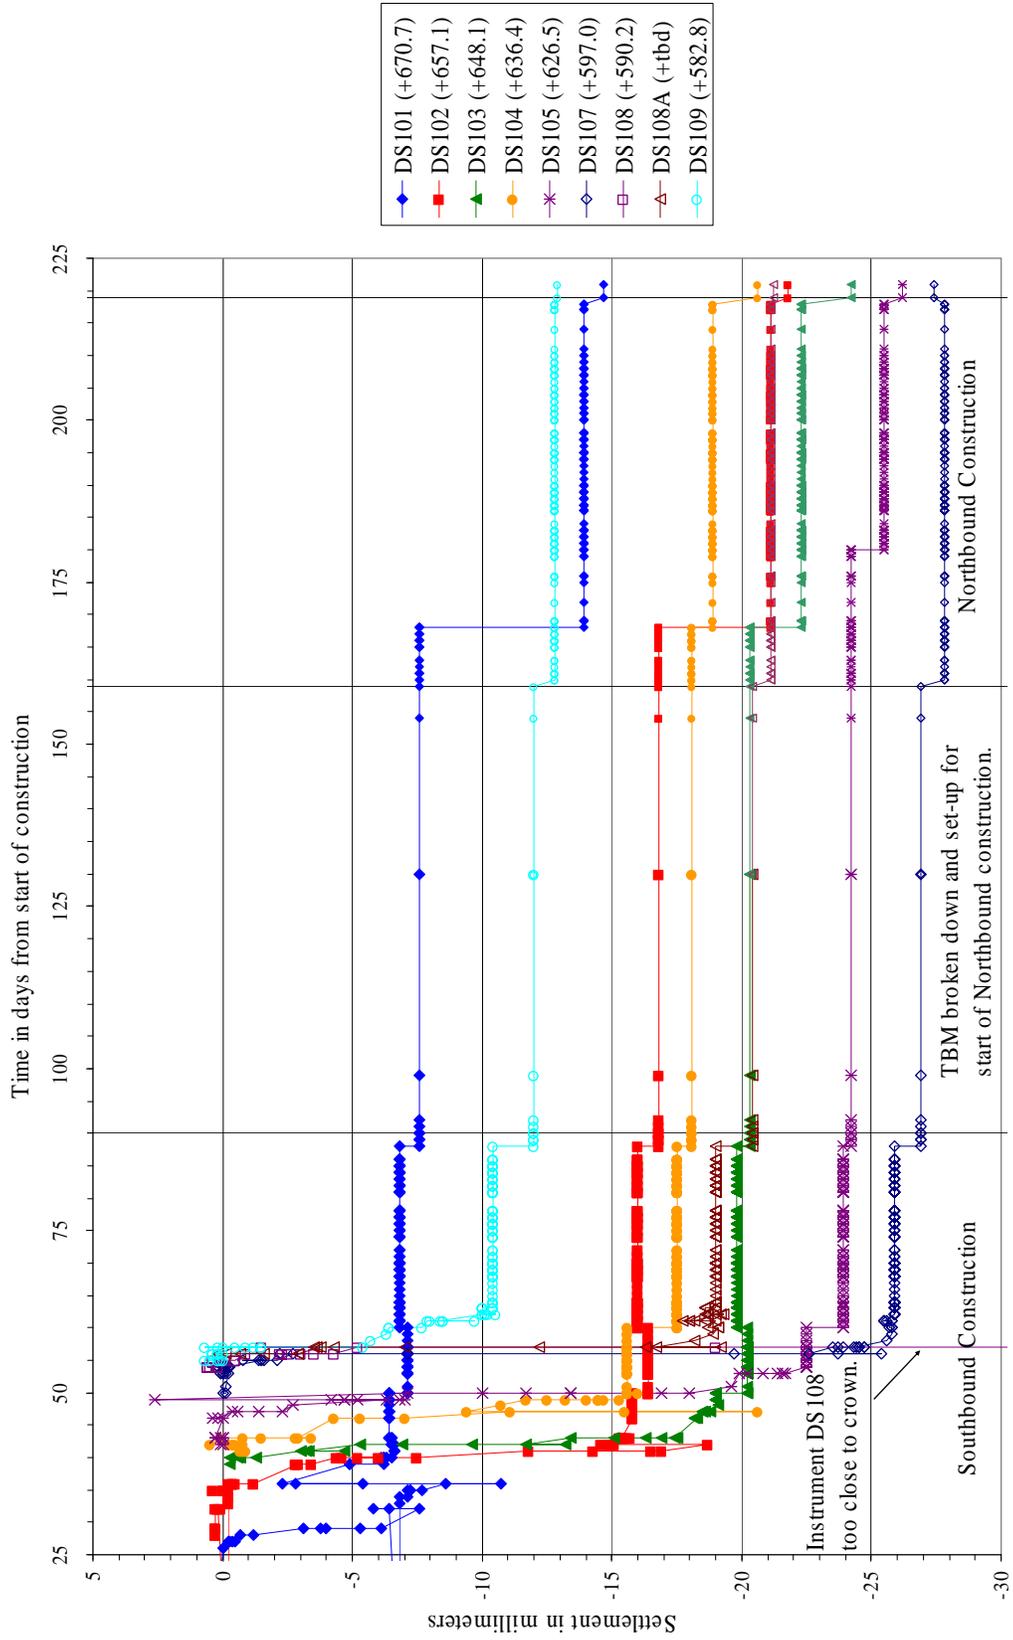
Figure G-6 Observed deep settlements in Southbound alignment instruments over the course of construction with respect to time, from Portal to Education Car Park.

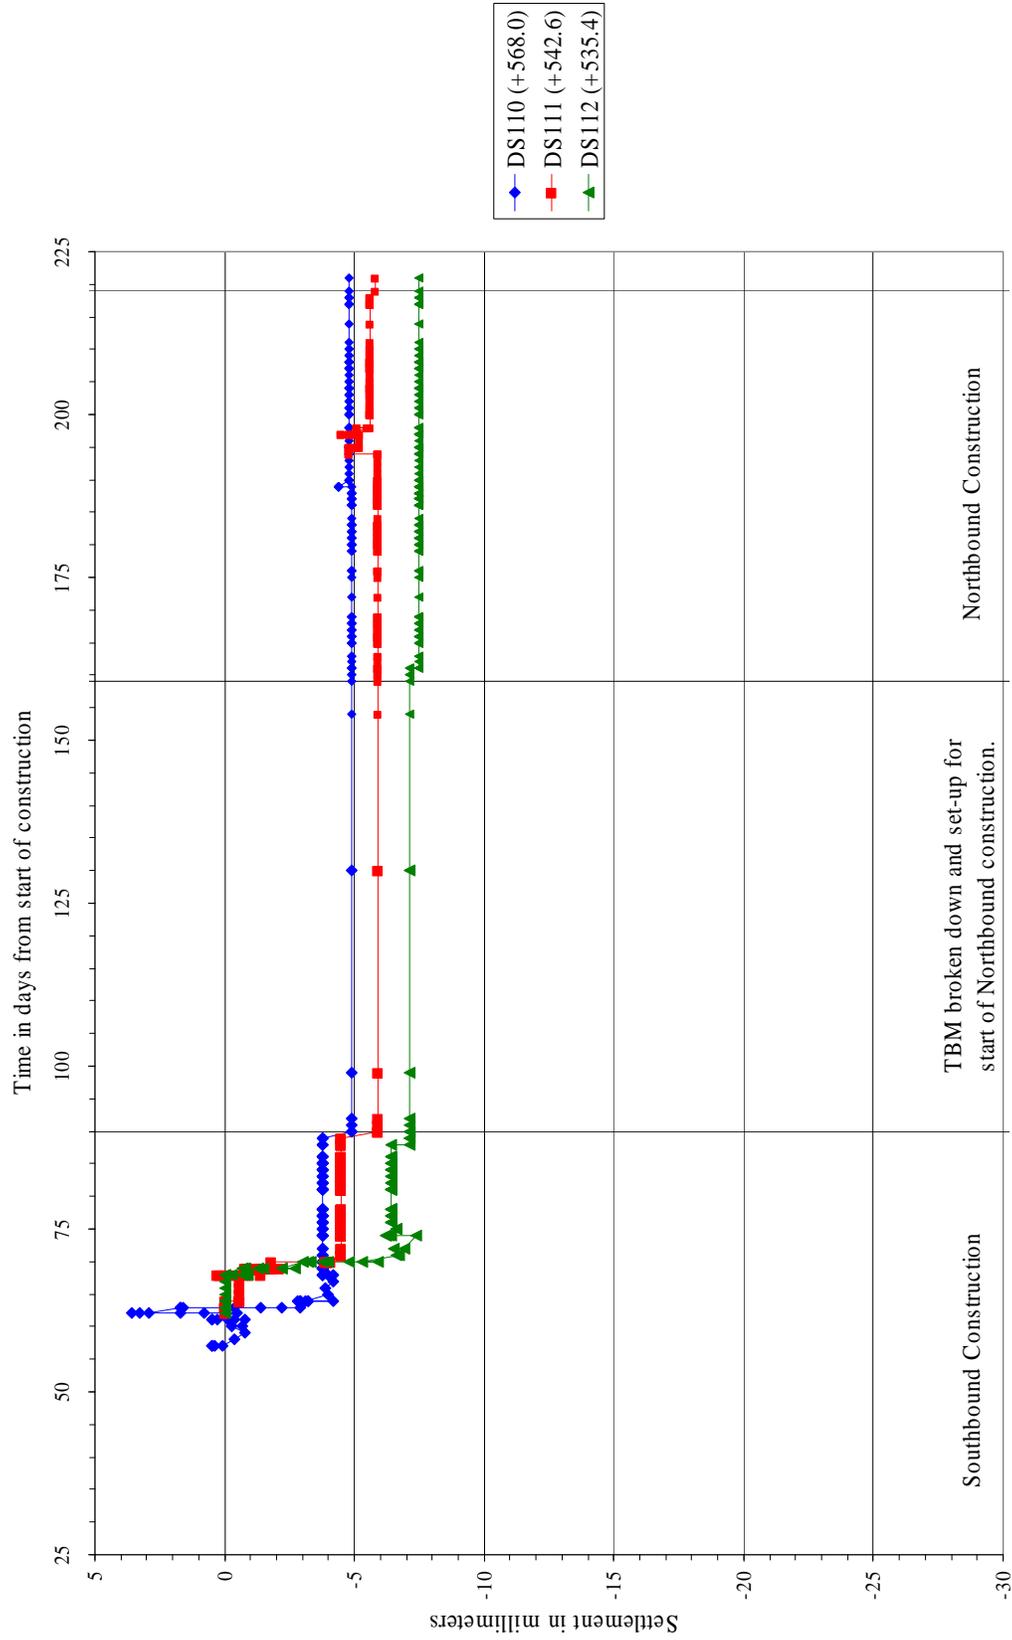
Figure G-7 Observed deep settlements in Southbound alignment instruments over the course of construction with respect to time, Education Car Park.

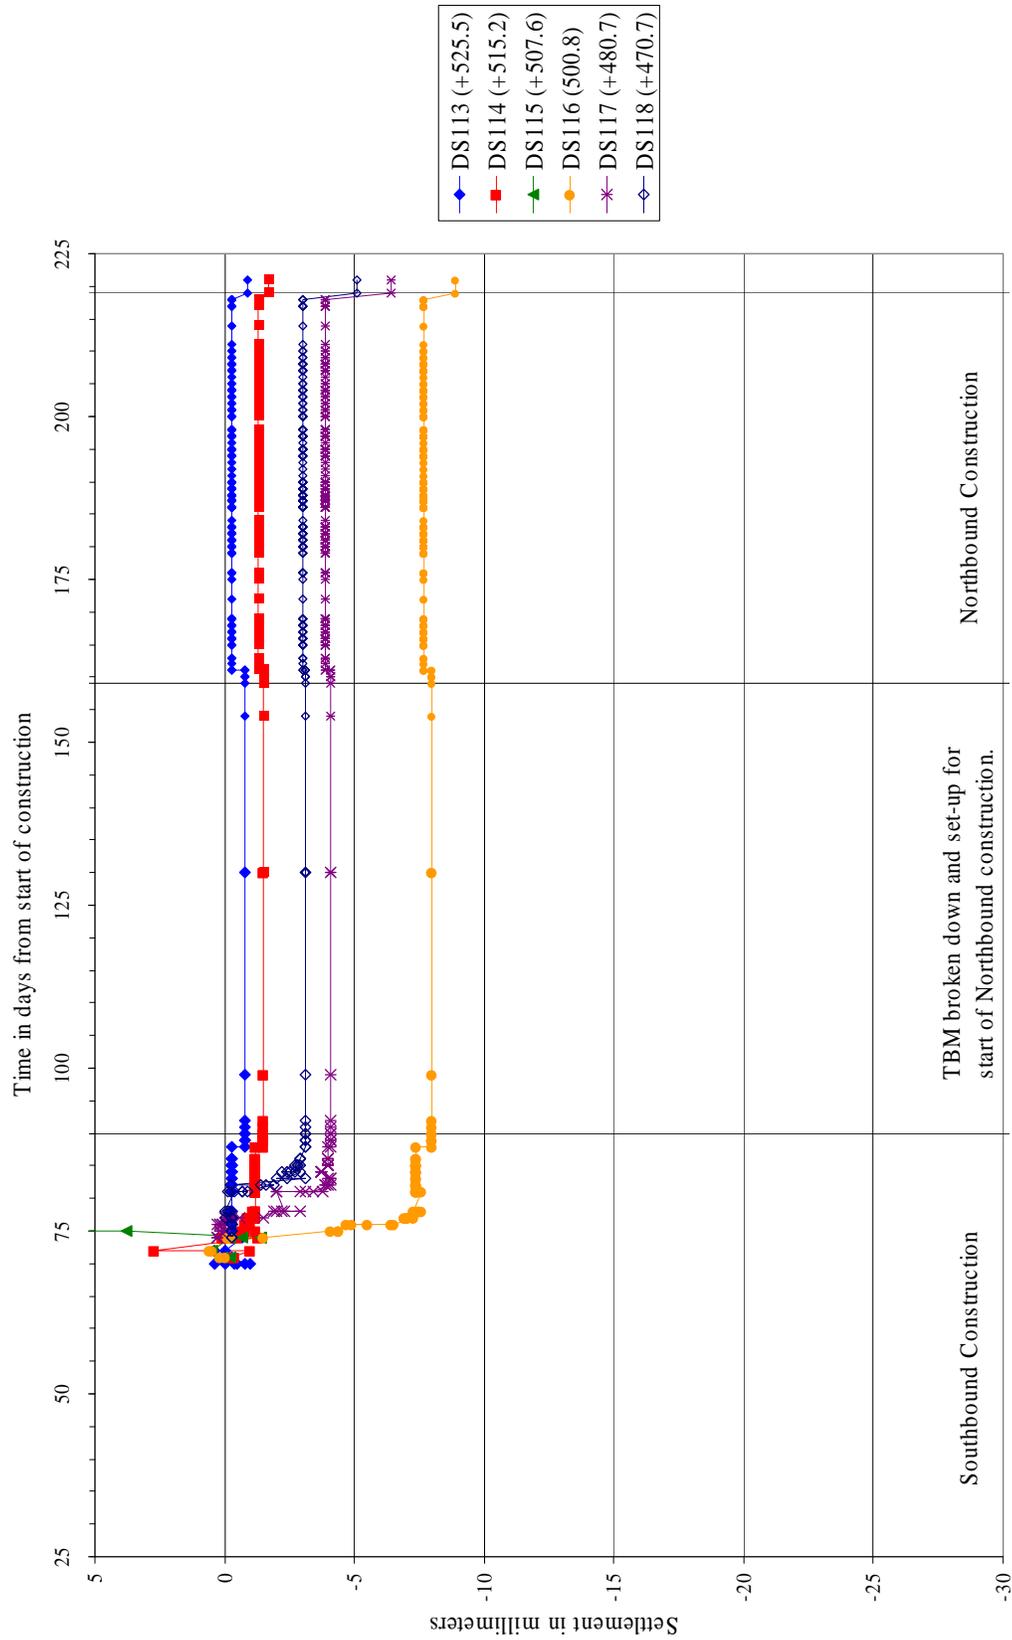
Figure G-8 Observed deep settlements in Southbound alignment instruments over the course of construction with respect to time, from Education Car Park to St. Joseph's College.

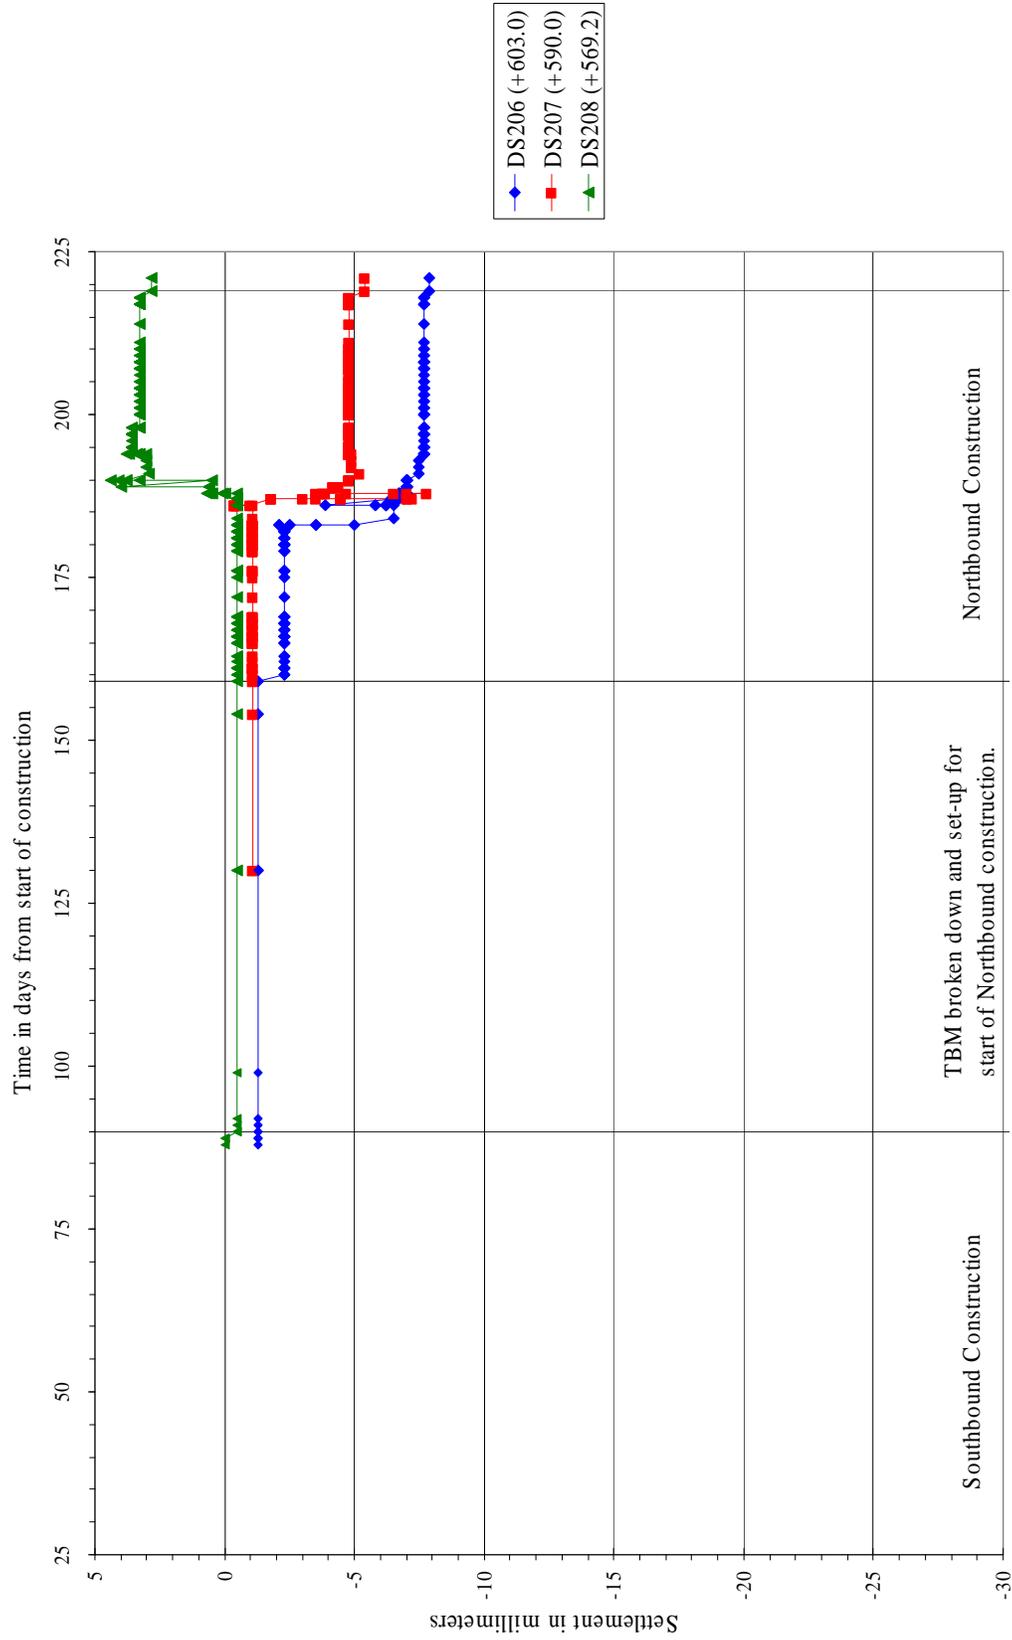
Figure G-9 Observed deep settlements in Northbound alignment instruments over the course of construction with respect to time, from Portal through Education Car Park.

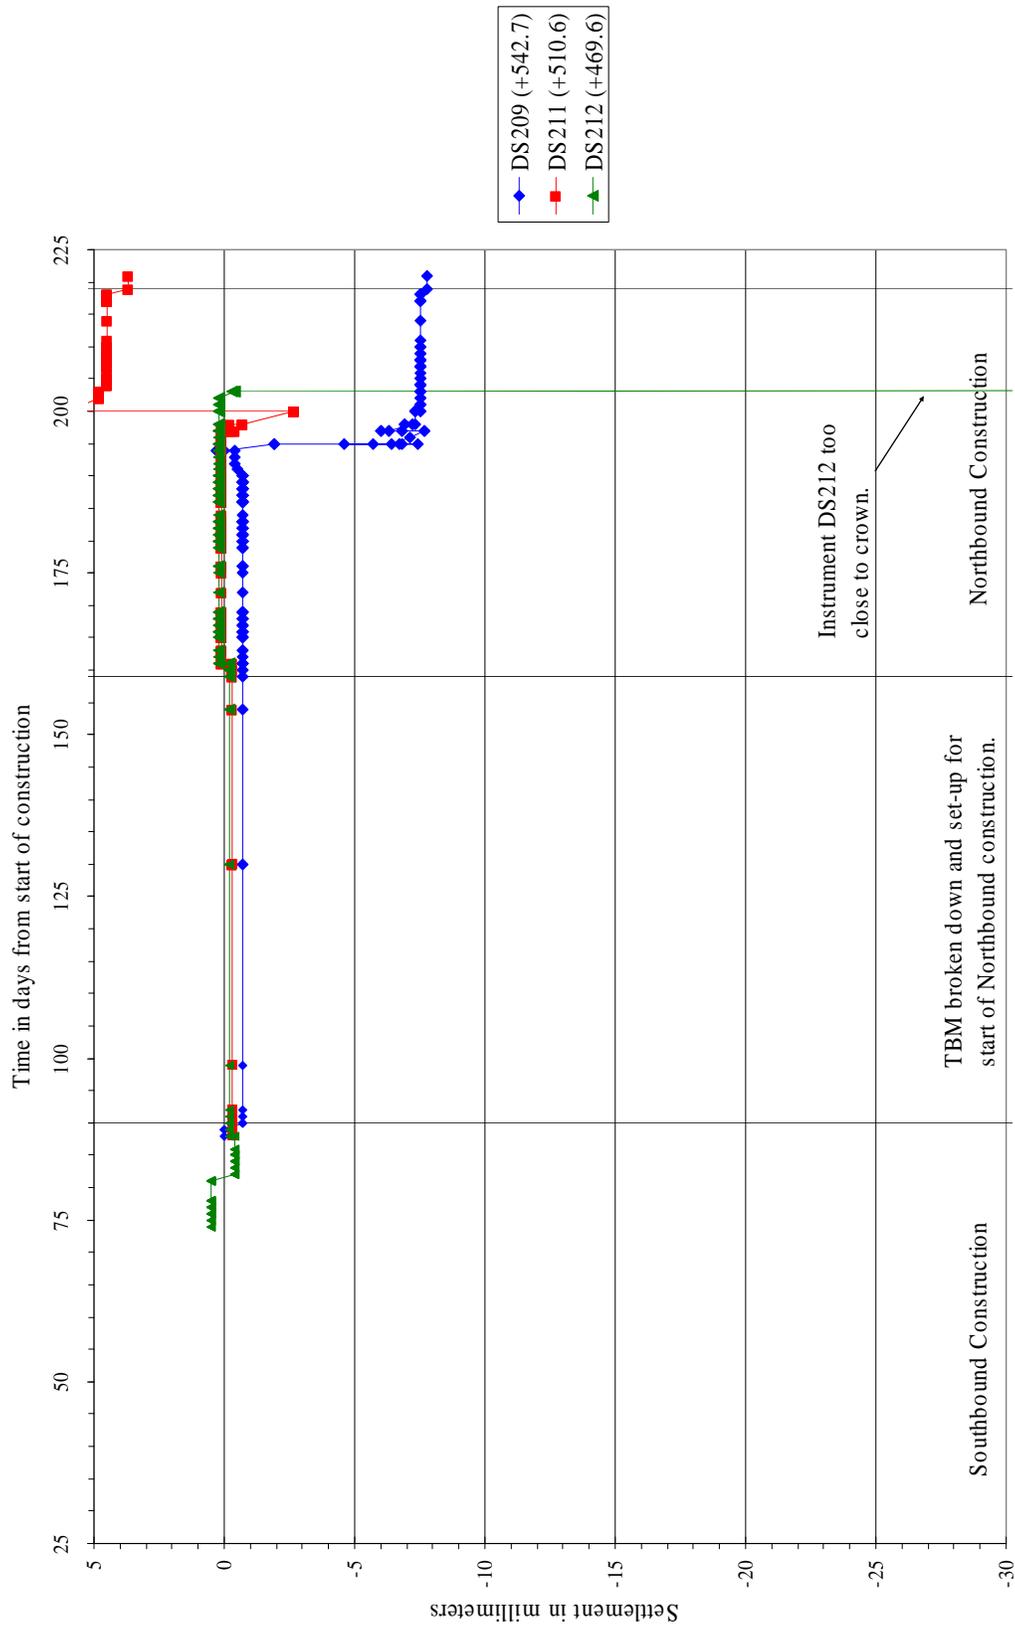
Figure G-10 Observed deep settlements in Northbound alignment instruments over the course of construction with respect to time, from Education Car Park to breakthrough.
